archeological investigations
volume 1: the white pass and yukon route
broadway depot and general offices buildings
september 1983

KLONDIKE GOLD RUSH

NATIONAL HISTORICAL PARK / ALASKA

Reference: Klondike Gold Rush National Historical Park, Package 104,
Historic Structures Report, Archeological Data Section, Depot
and General Offices Building

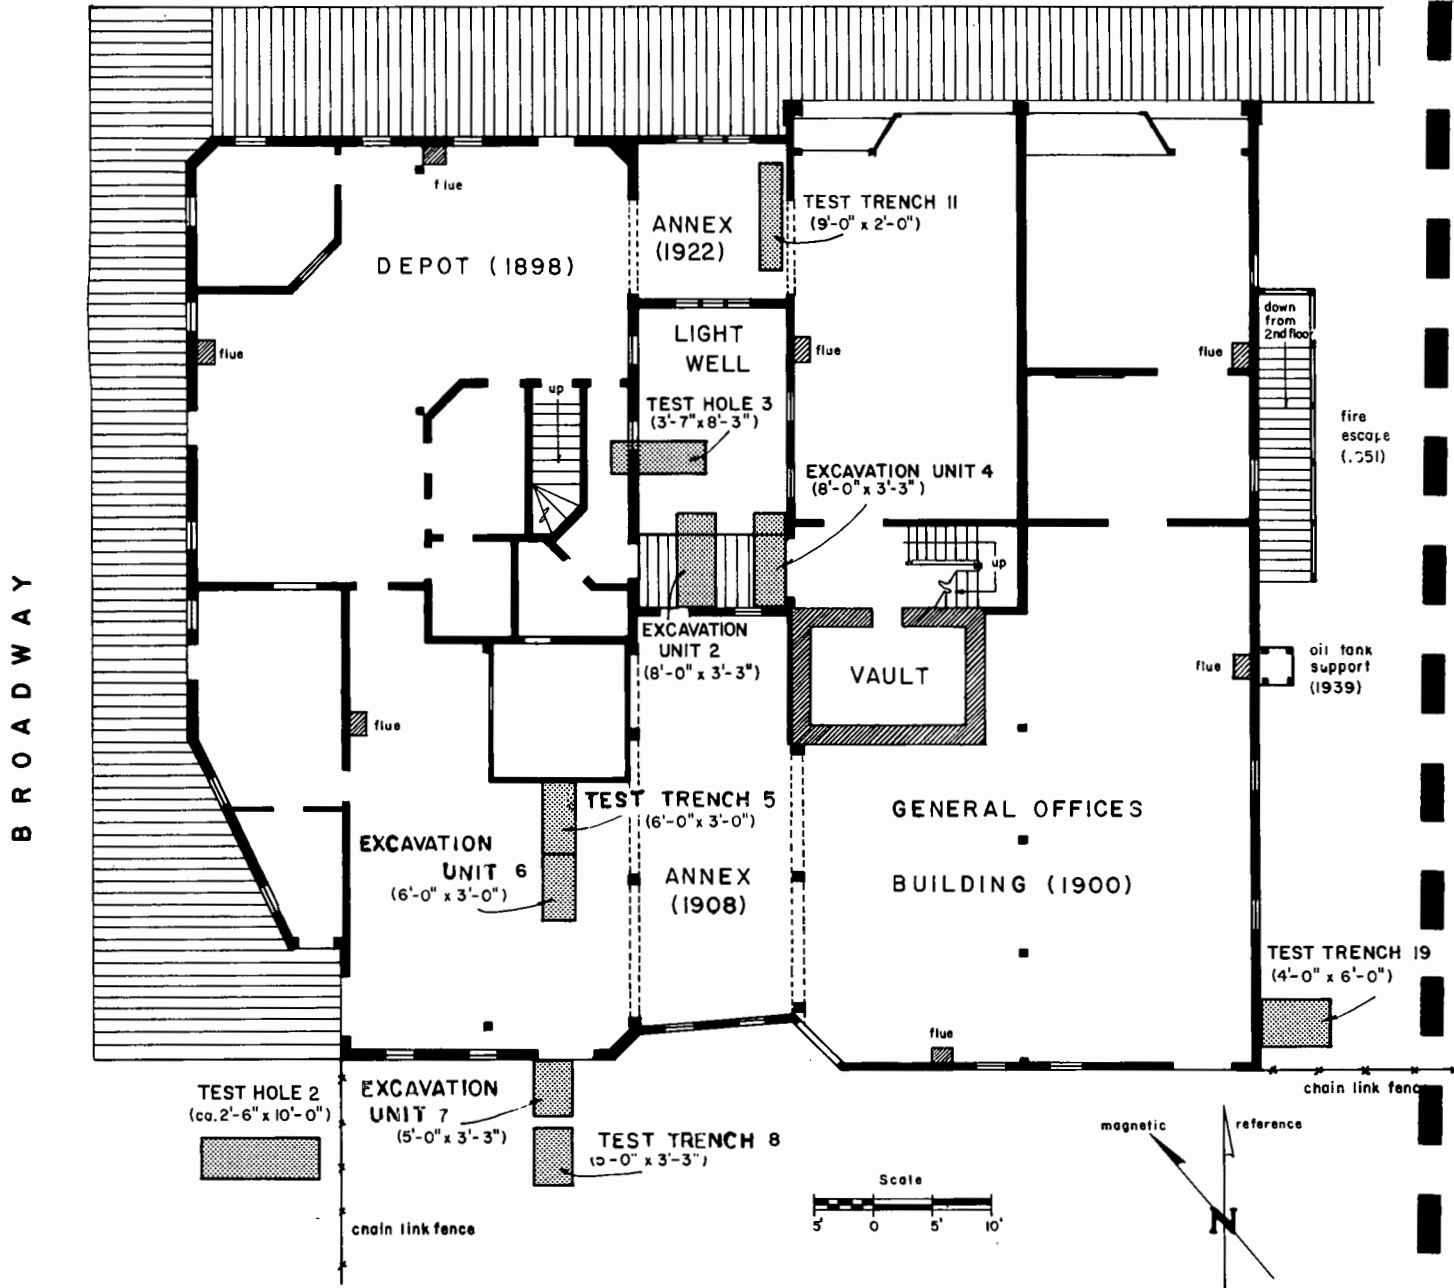
Fig.2: Location of archeological investigations

In October 1978, R & M Consultants, Inc. took two soils tests near the depot to assist the National Park Service in the design of the new foundations for the Depot and General Offices Buildings. One test was hand excavated by day laborers in the light well between the two buildings (TH #3). A local contractor dug the other (TH #2) with a small backhoe; the test was located 6.7 feet south of the southwest corner of the Depot (Figure 2). Since both tests indicated a deep stratification of historic deposits, controlled archeological excavations were proposed for the following spring, prior to exposure of the wood pier foundations. In April, 1979, the archeologist returned with a three person crew and excavated six test trenches (Figure 2): two in the light well (EU 2 and EU 4), two beneath the baggage room (EU 5 and TT 6), and two south of the Depot and immediately adjacent to the building (TT 7 and EU 8).

Because of frozen ground encountered in April, a return trip with one assistant was made in June, 1980. An additional test was placed under the 1922 addition between the two buildings in an attempt to clarify some relationships between strata uncovered in the earlier excavations (TT 11).

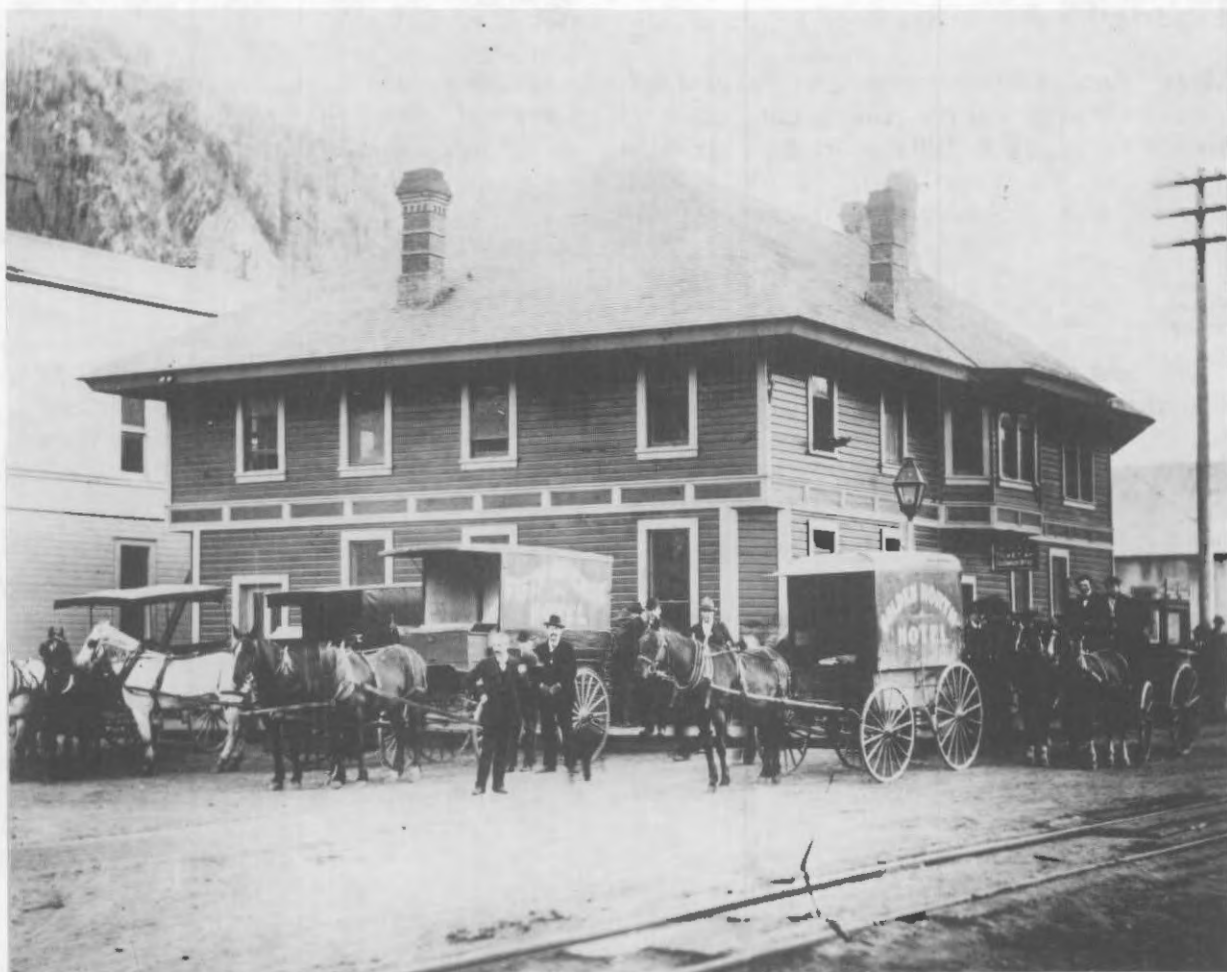
Figure 3: 1900 photograph of the Depot. (Yukon Archives).

More detailed historic and architectural information is contained in the Architectural and Historical Data sections of the Historic Structures Report (Cloyd 1981; Chappel n.d.). A photograph of the buildings in 1900 can be seen in Figures 3 and 4. Figure 5 shows them in 1979, during the archeological investigations.

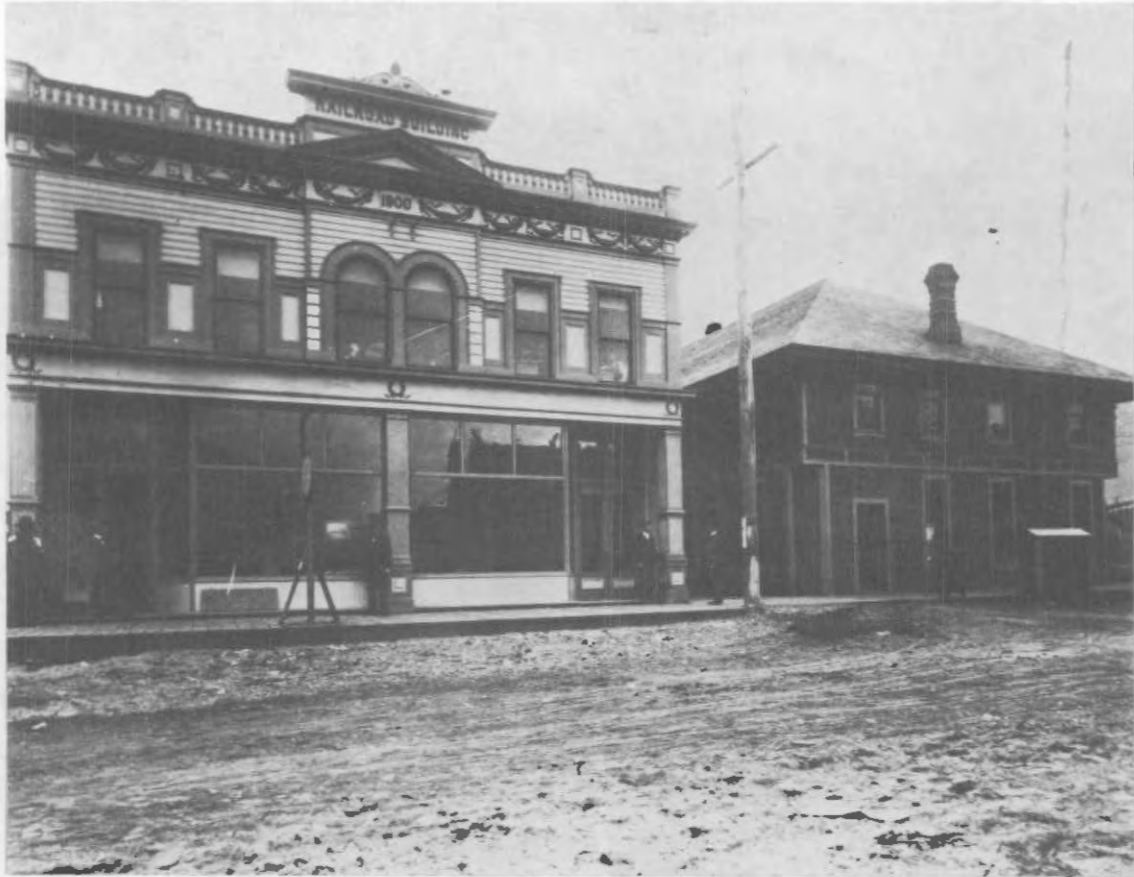
Figure 4: Summer 1900 photograph, north elevation of General Offices Building (left) and the Depot (right), looking to the southwest. (Yukon Archives).

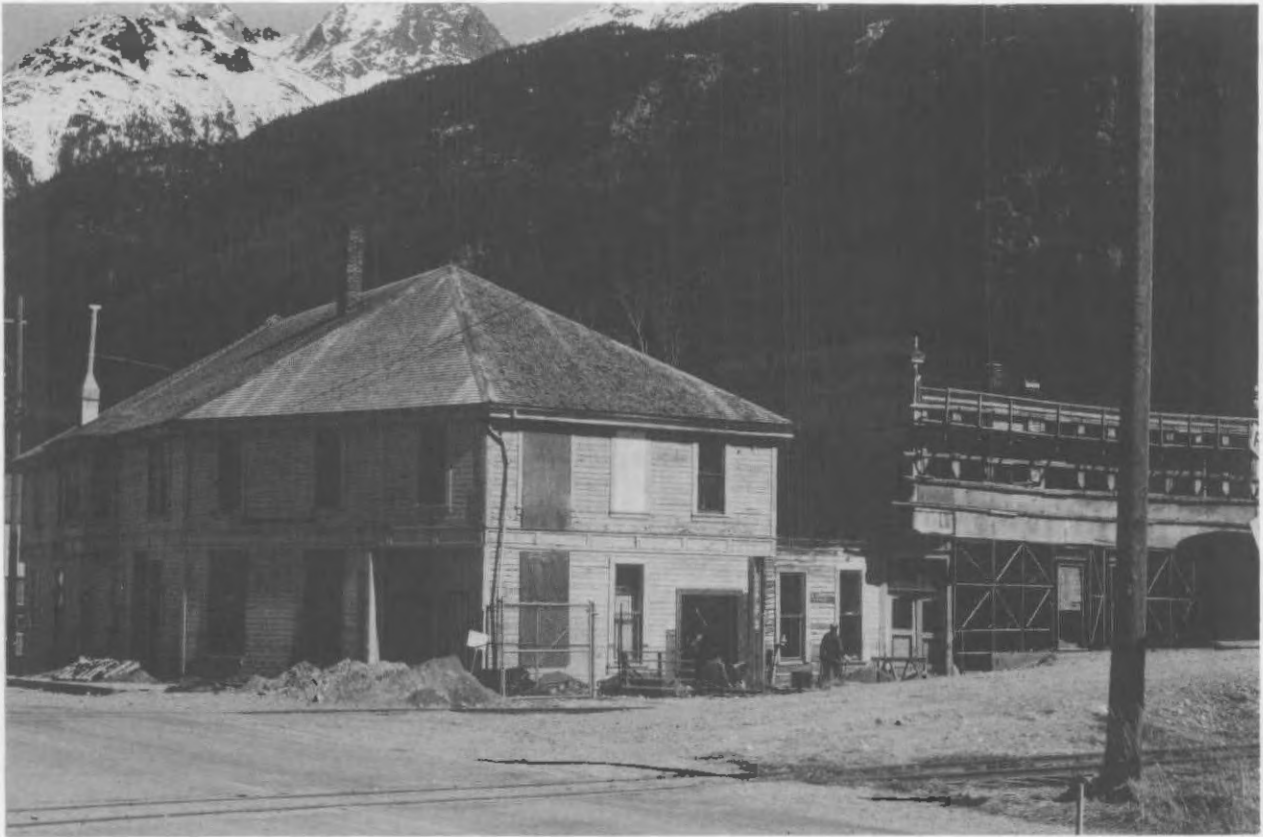
Figure 5: 1979 photograph of the Depot on the left and the General Offices Building on the right. Looking northeast.

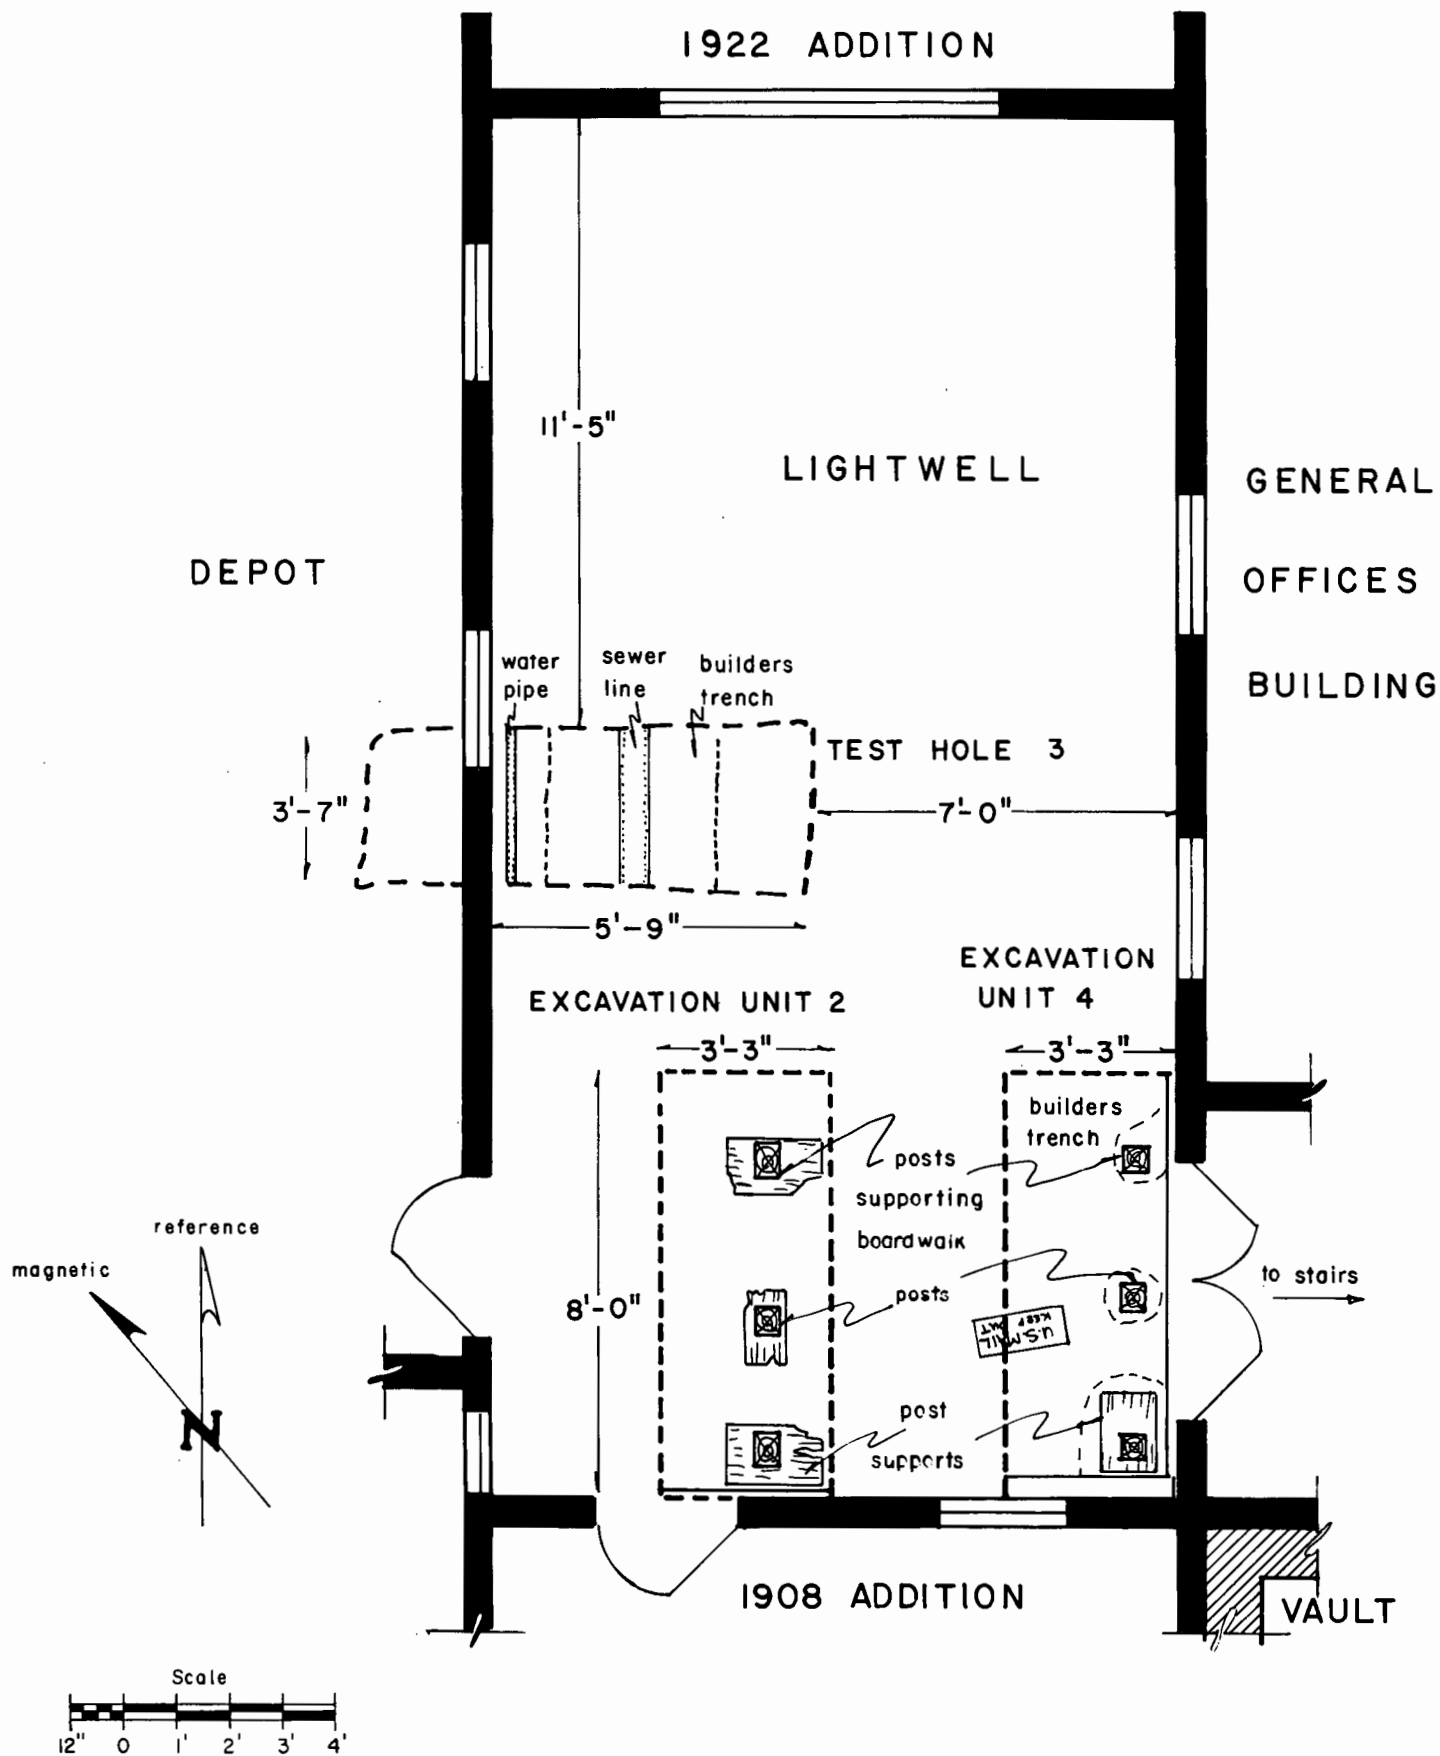
Fig.6: Plan of lightwell

A 2-1/2 inch diameter water pipe was found four inches below the surface, also running north to south and only three inches from the building wall.

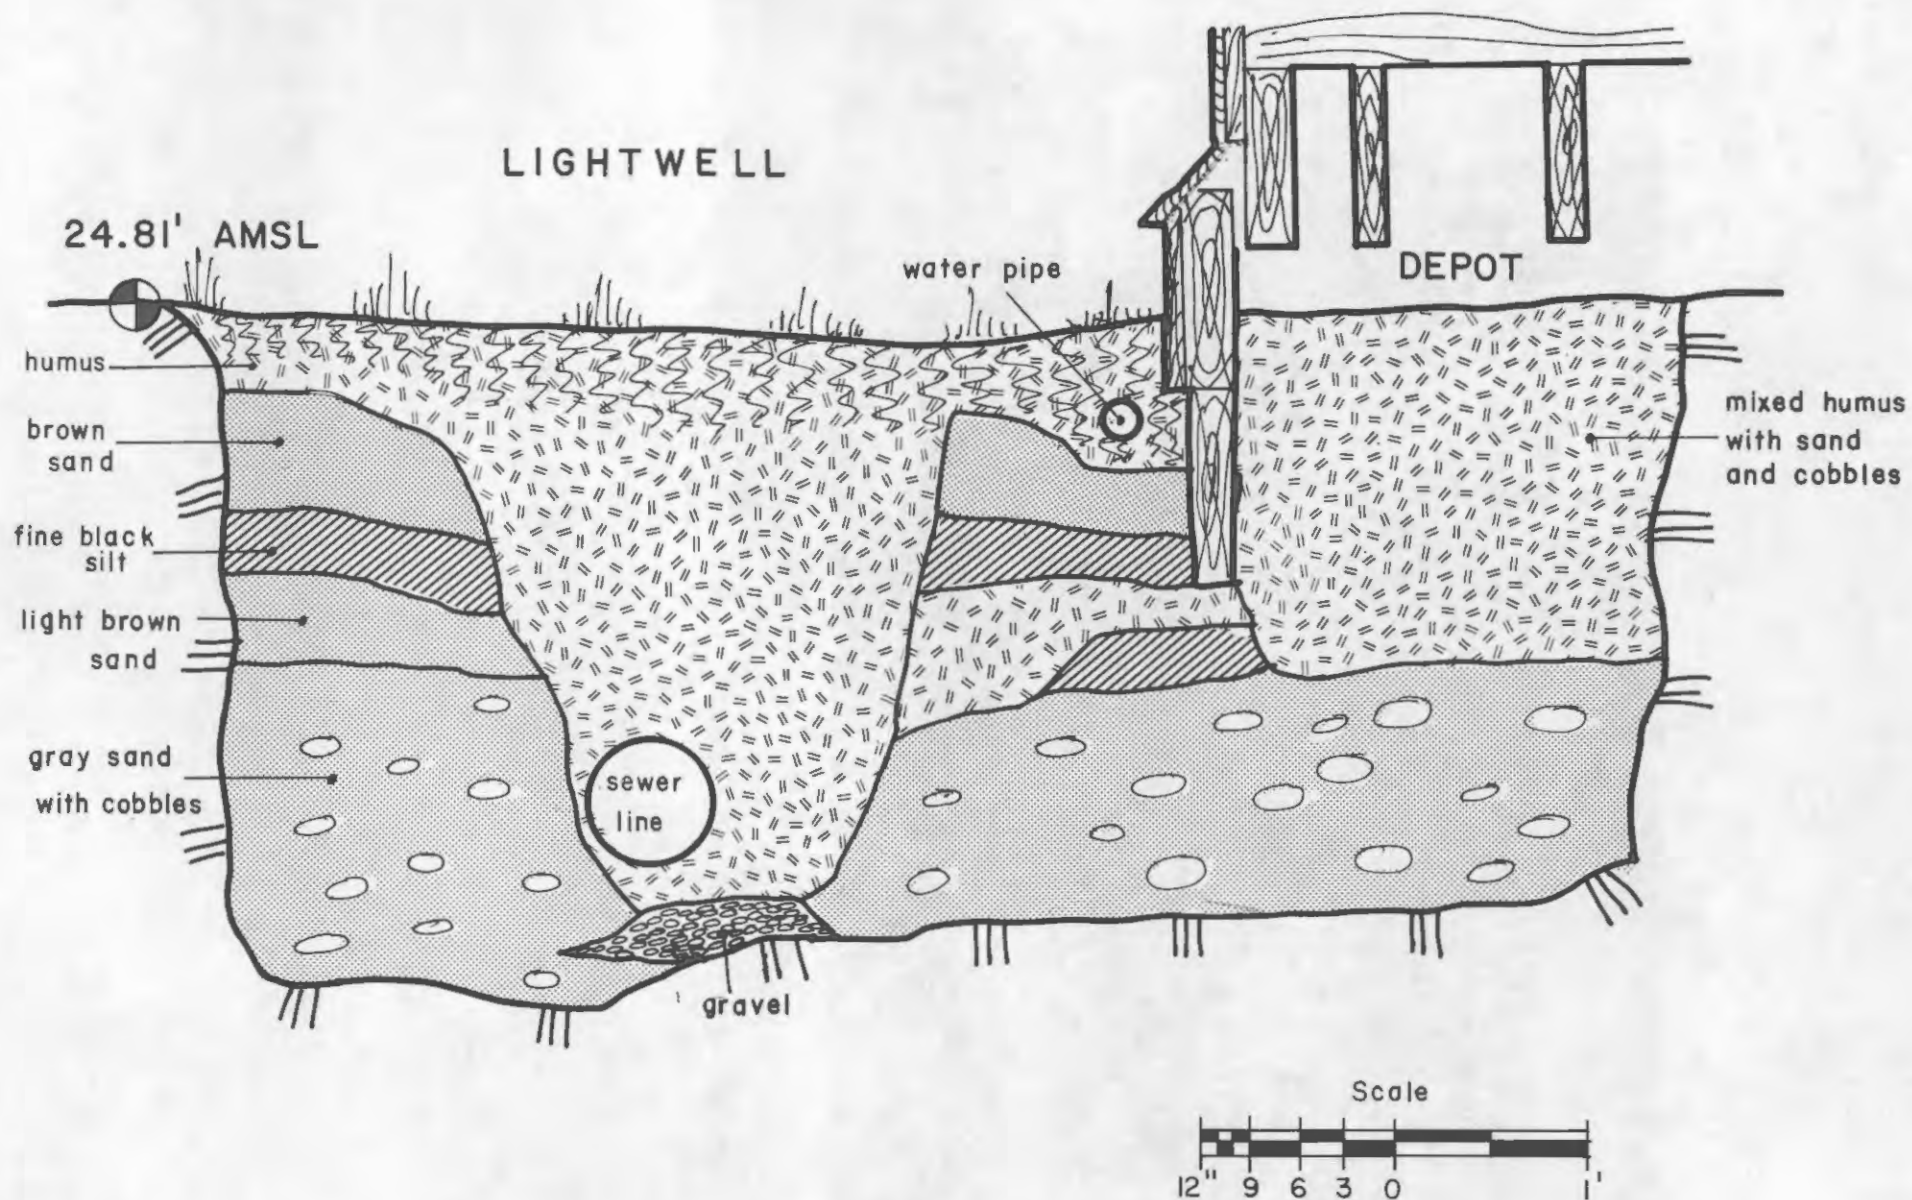
Fig.7: South profile of Test Hole 3

Both units contained only the one culture bearing deposit. Artifact content indicates that this layer accumulated slowly from 1898 to the present time. It appears that the area under the boardwalk was a natural collector of artifacts. It gives some clue as to the variety of

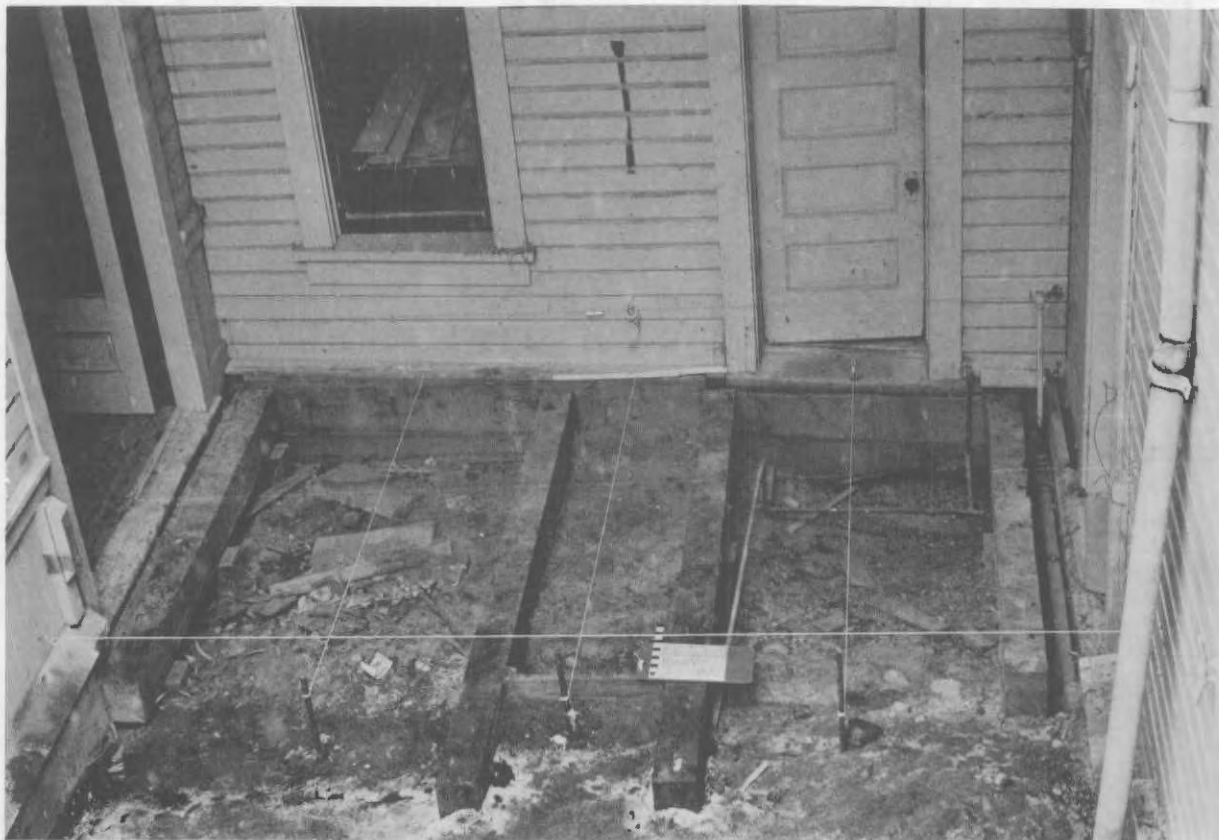
Figure 8: Photograph of Excavation Units 2 and 4, under the boardwalk between the Depot on the right and the General Offices Building on the left.

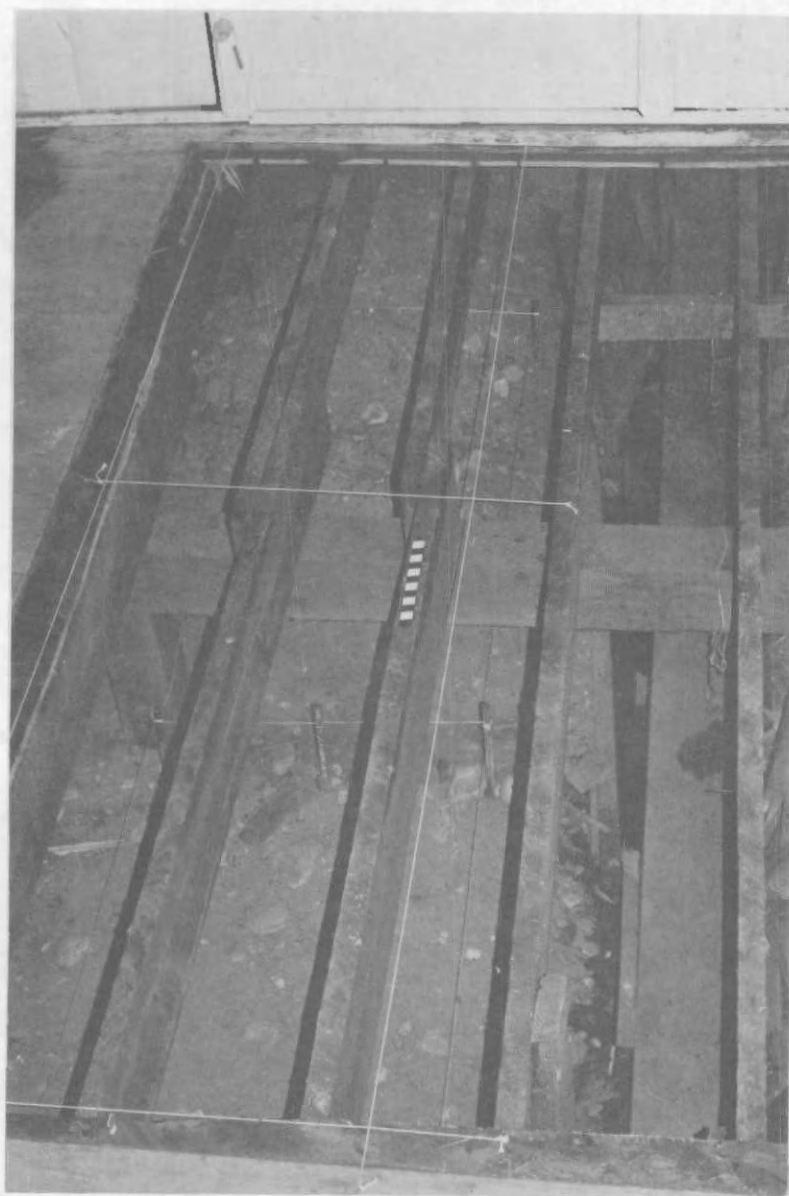
Figure 10: Photograph of Test Trench 5 and Excavation Unit 6 under the Baggage Room floor. Looking north.

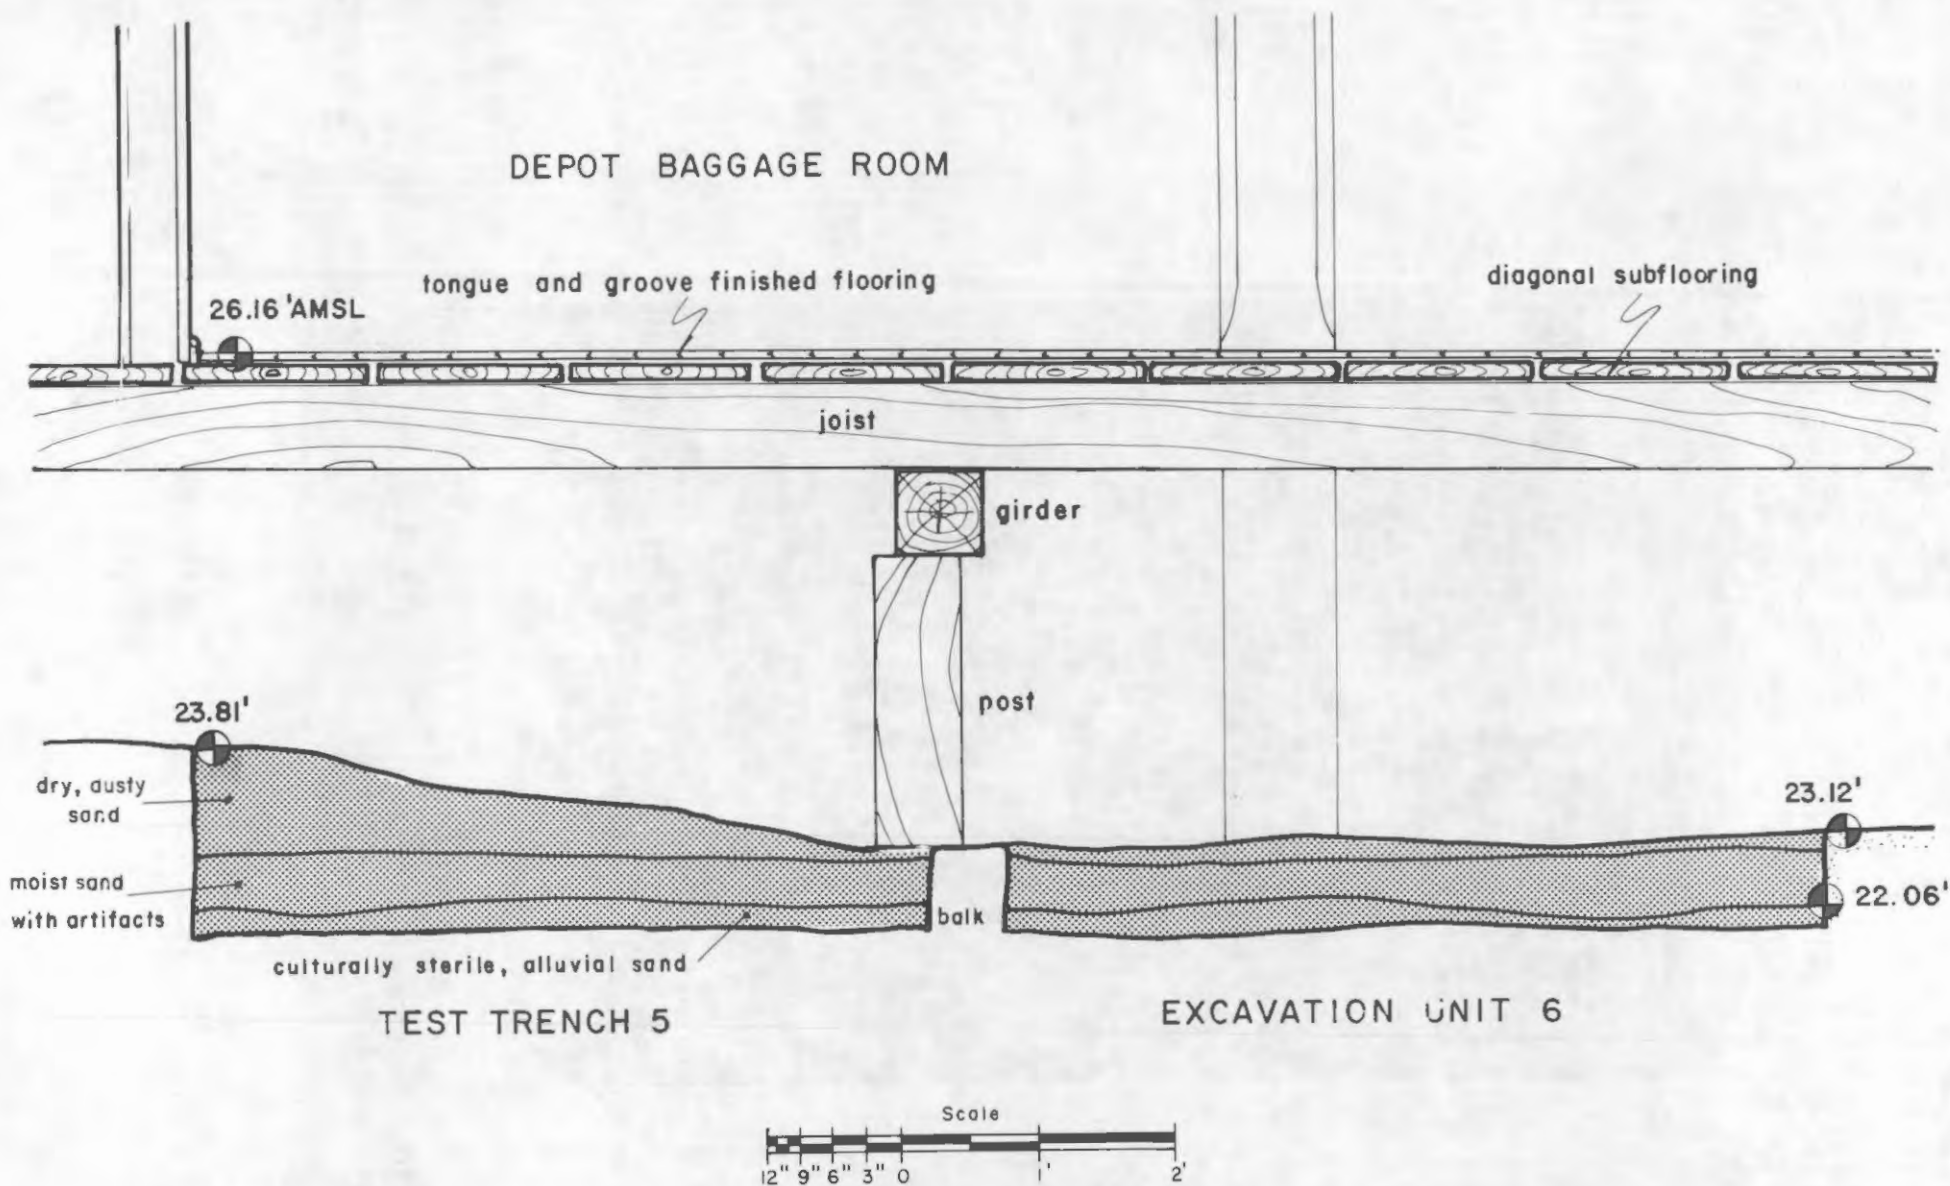
Fig. II: East profile of Test Trench 5 and Excavation Unit 6

of the items found under the baggage room floor. They had become so badly deteriorated that their original form is unknown. They were largely ferrous, suggesting that they were nails or tin cans.

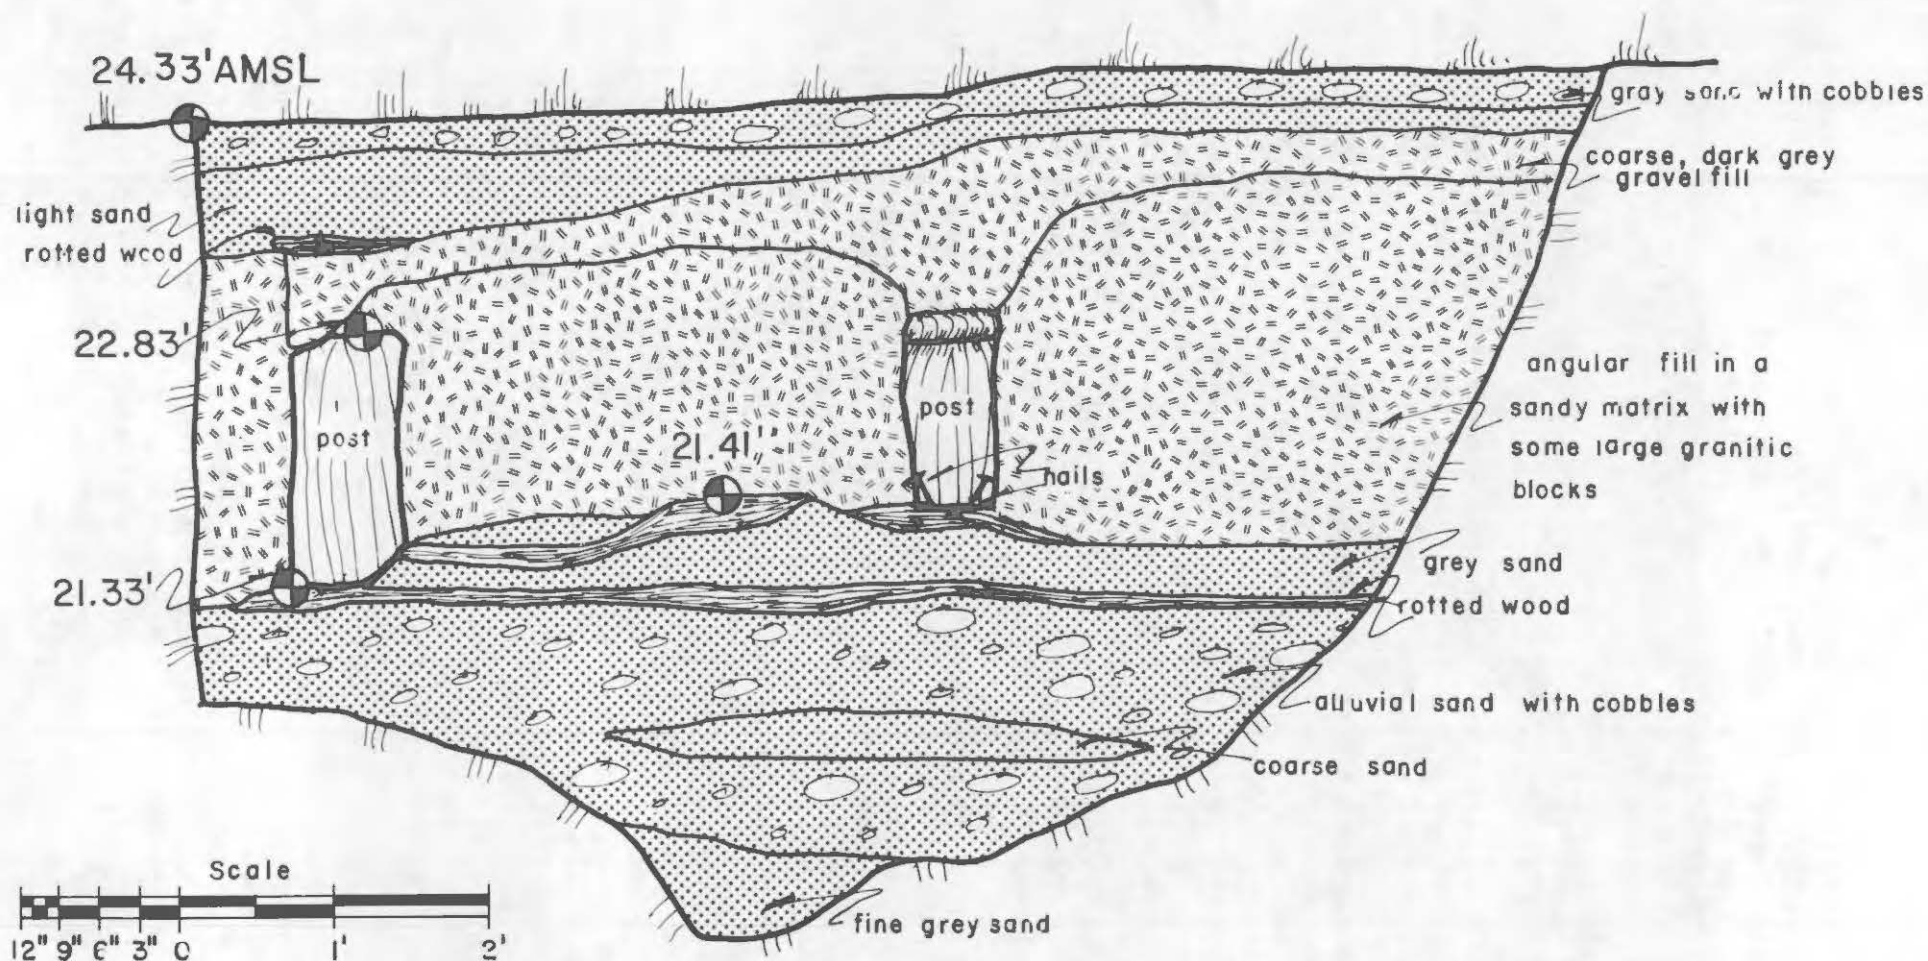
Fig.12:South profile of Test Hole 2

A coarse gravel underlaid the beach fill. It varied from 3 to 9 inches thick, and slumped down considerably in the area over what turned out to be a septic tank. This is probably material that sat under the boardwalk. Artifacts were relatively scarce in this layer, and represented a wide variety of activities common to all the Depot and General Offices deposits. Of the 69 artifacts found in this layer, 5.8 percent were Domestic, 1.4 percent were Personal, 21.7 percent were

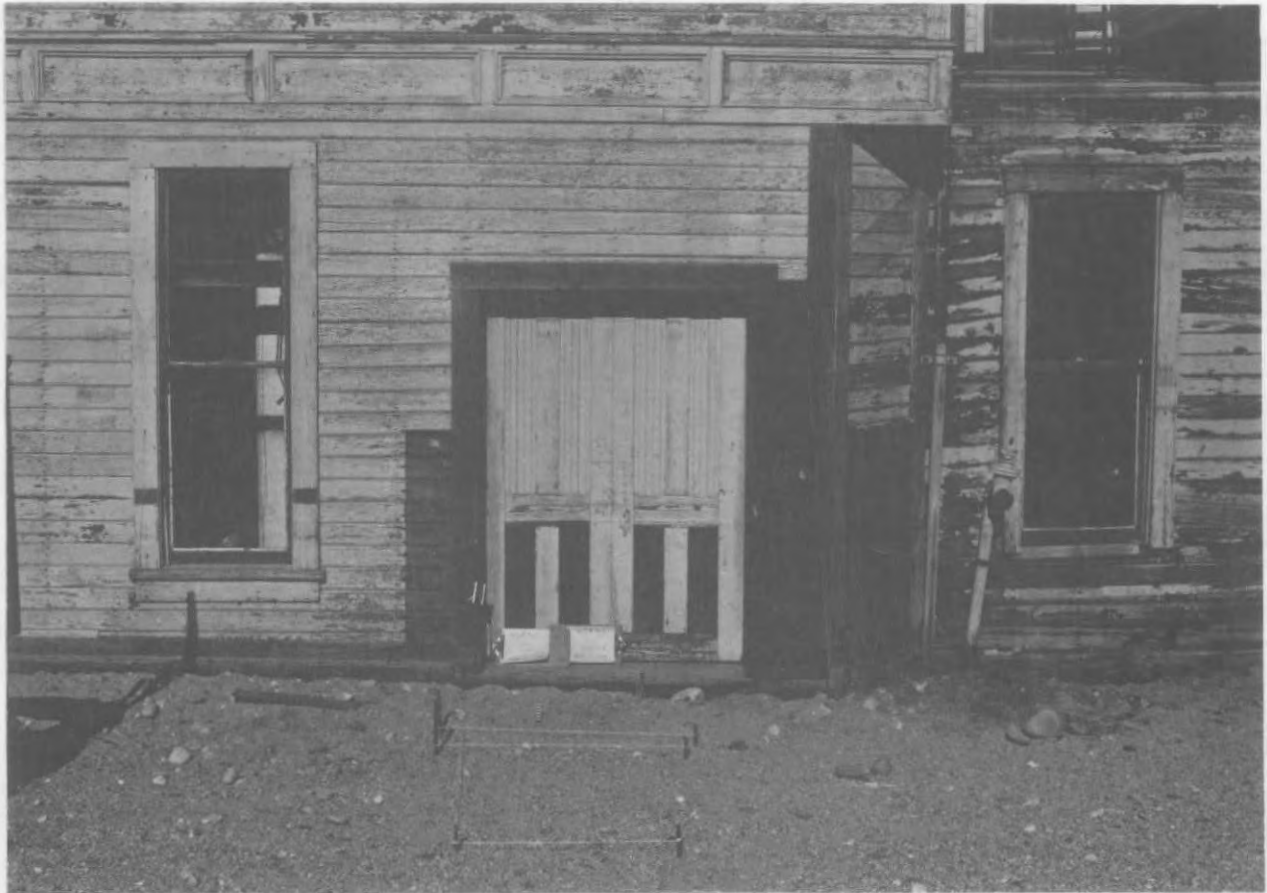
Figure 14: Excavation Unit 7 and Test Trench 8, outside the Baggage Room Door. Looking north.

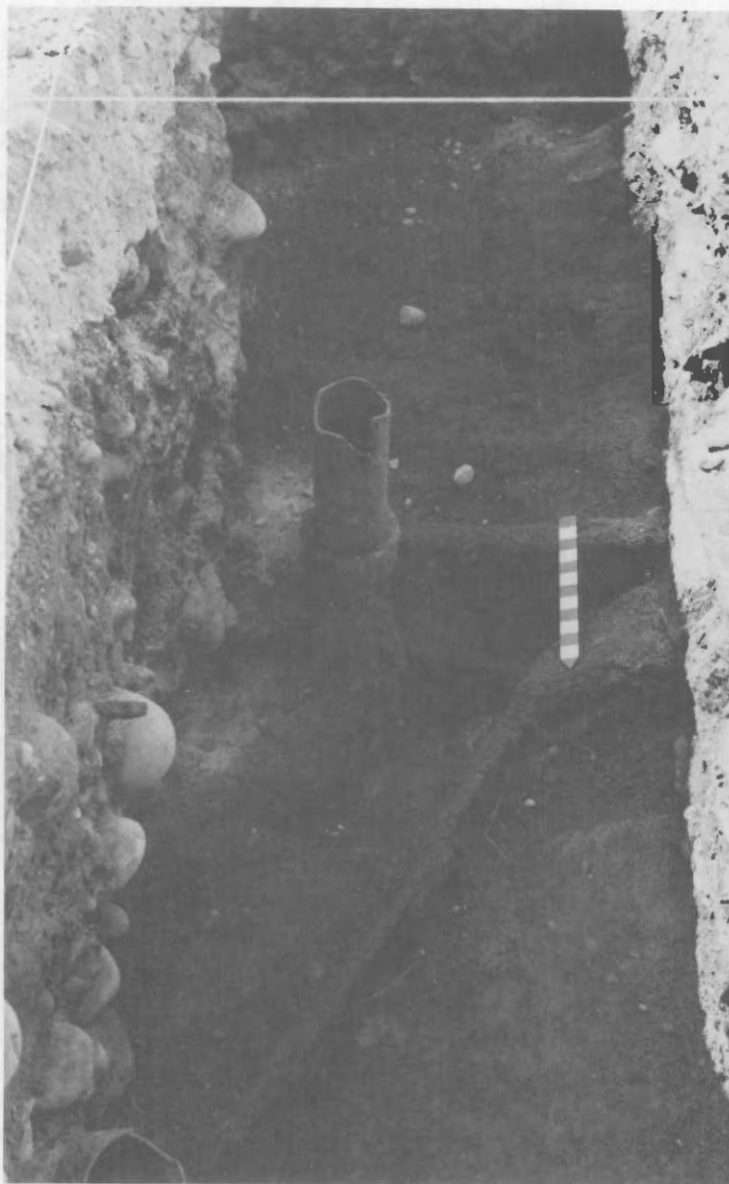
Figure 15: Intake and venting pipes on the septic tank, Excavation Unit 7 and Test Trench 8, looking south.

It was assumed by the stratigraphic sequence that the septic tank postdated the construction of the shop yards at the north end of town. This was indeed found to be the case. The shop yards were built in 1898. In the General Conditions Report of 1938 to 1942, it was reported

that "Early in May, 1941, the Bridge Gang began installing a septic tank at the Broadway Depot" (Chappell n.d.). This septic tank may have been in service only one year, as the depot was connected to the town sewer system in 1942 (Cloyd, personal communication).

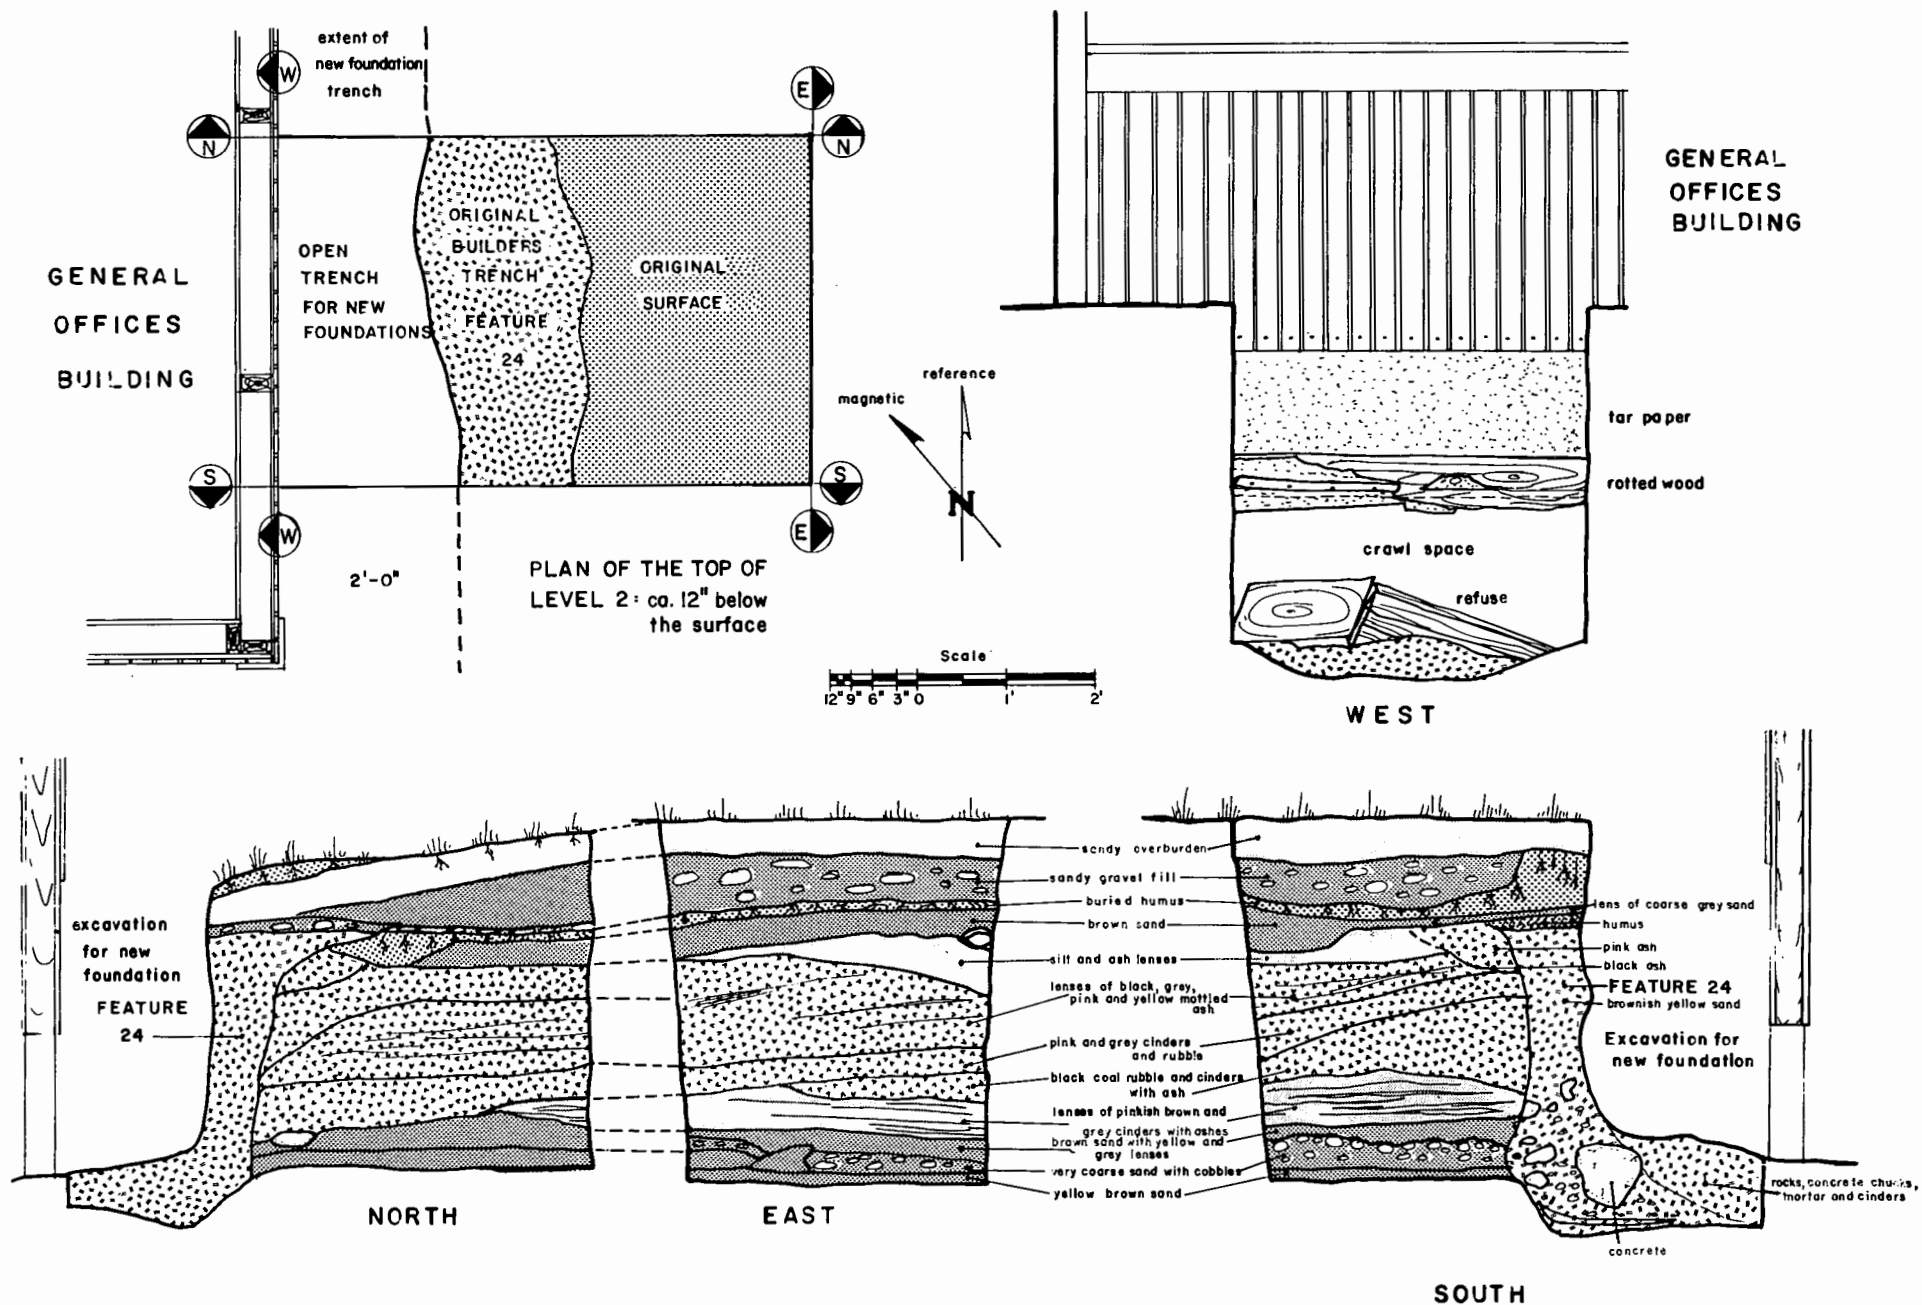
Fig.16: Plan and profiles of Test Trench 19

Below the sandy fill is a buried humus, the pre-1969 surface. It covers a brown sand which, in turn, covers an additional humus level. These layers overlie the top of a builders trench, which was not entirely

obliterated by the recent foundation work. This trench is probably not original to the building, but certainly predates the 1969 sale to the Park Service. It probably represents some maintenance activity on the foundations.

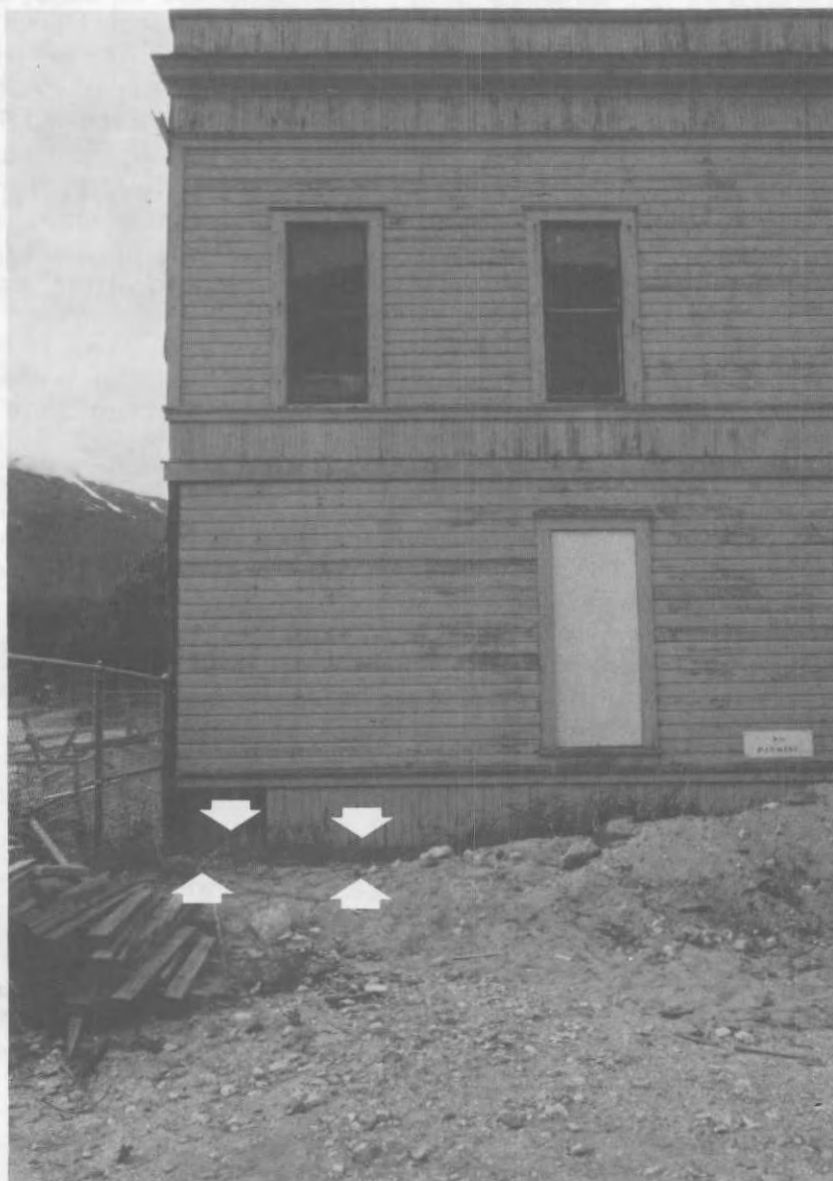
Figure 17: Photograph of location of Test Trench 19, at the southeast corner of the General Offices Building, looking west.
