SAMUEL MUMMA HOUSE

ANTIETAM NATIONAL BATTLEFIELD

HISTORIC STRUCTURE REPORT

June 1999

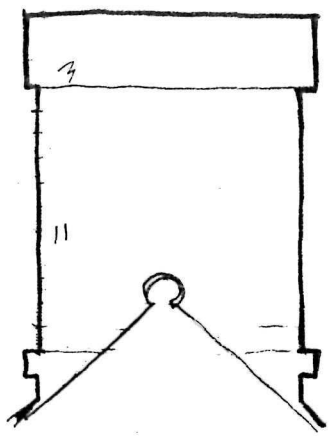
EXISTING CONDITION
ca 1992

DOCUMENTATION of DIFFERENCES BTWN. 1862 PHOTO and EXISTING BUILDING.

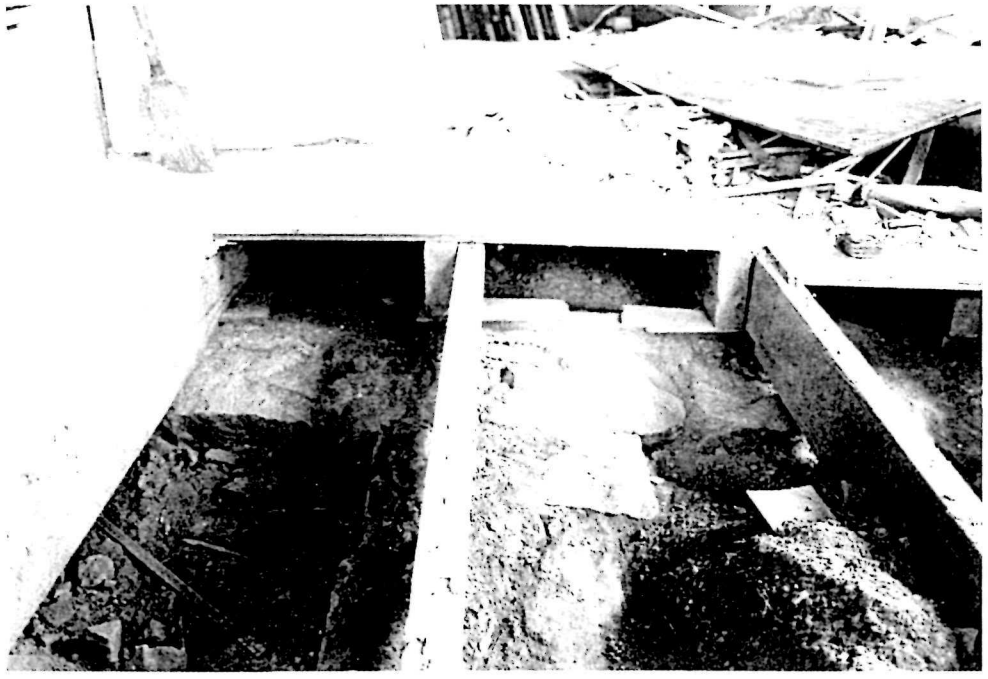
Mumma Farm House: Room 106, view of stone foundation and wing wall under existing floor. Stone foundation corresponds with location of former Northeast wall.

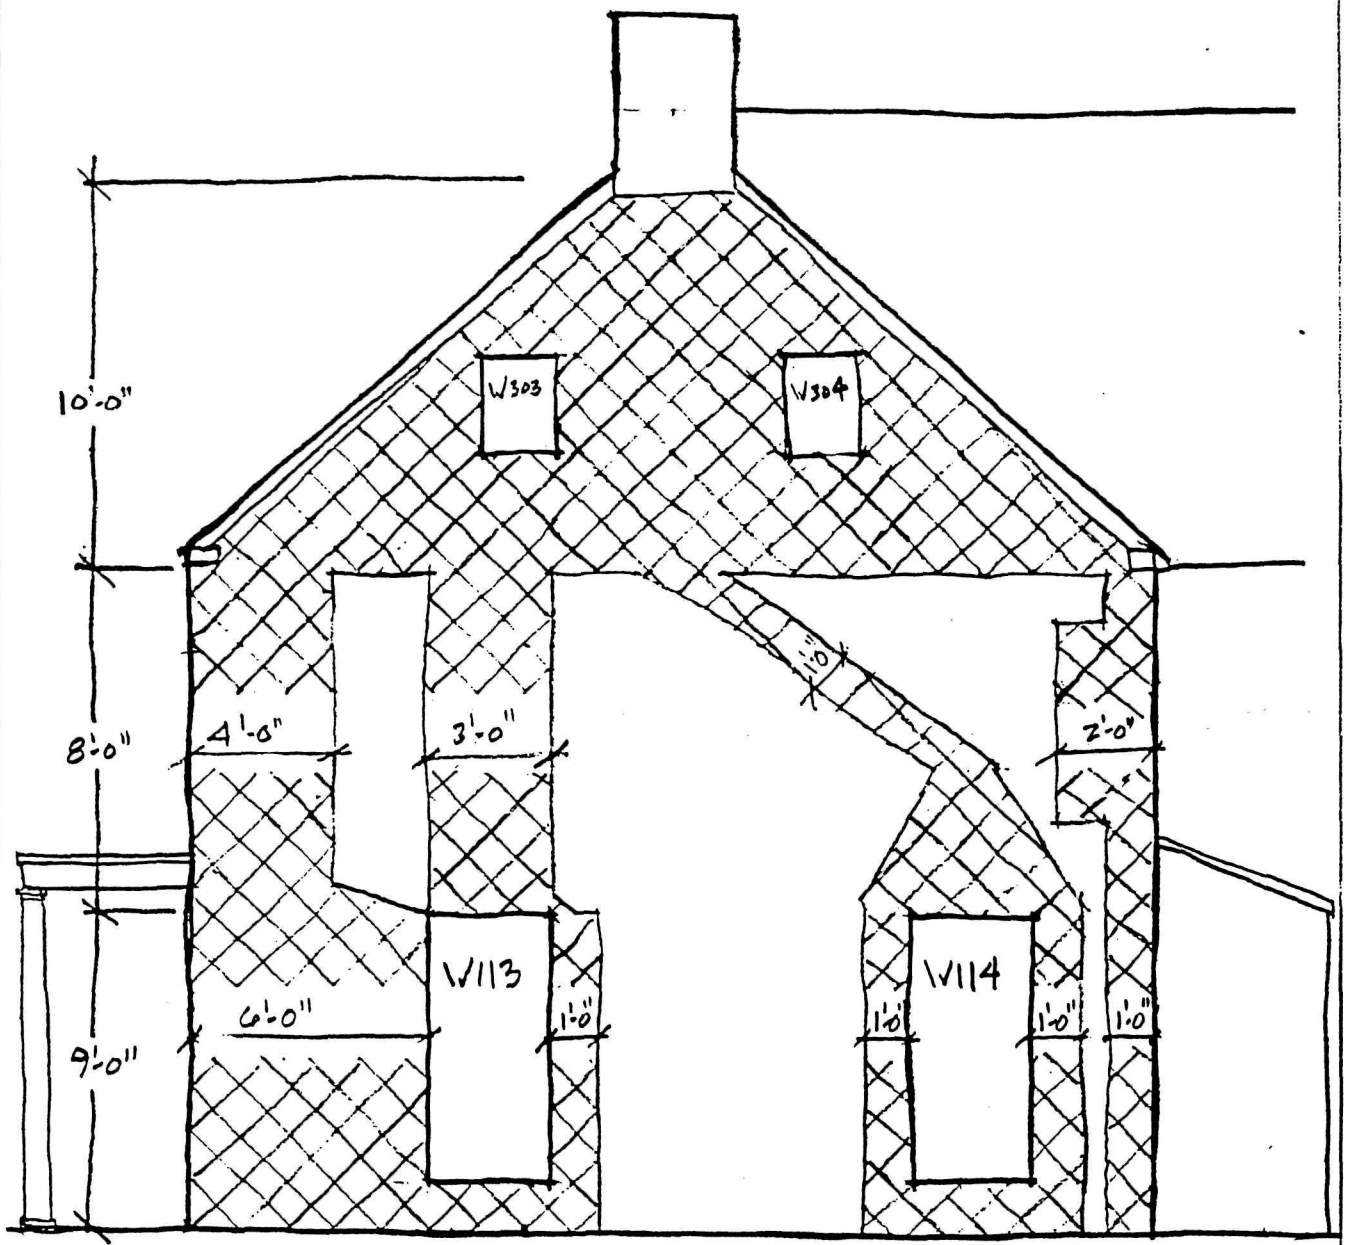
NORTHWEST ELEVATION NTS

AREAS TUCK-POINTED BETWEEN 75-100%

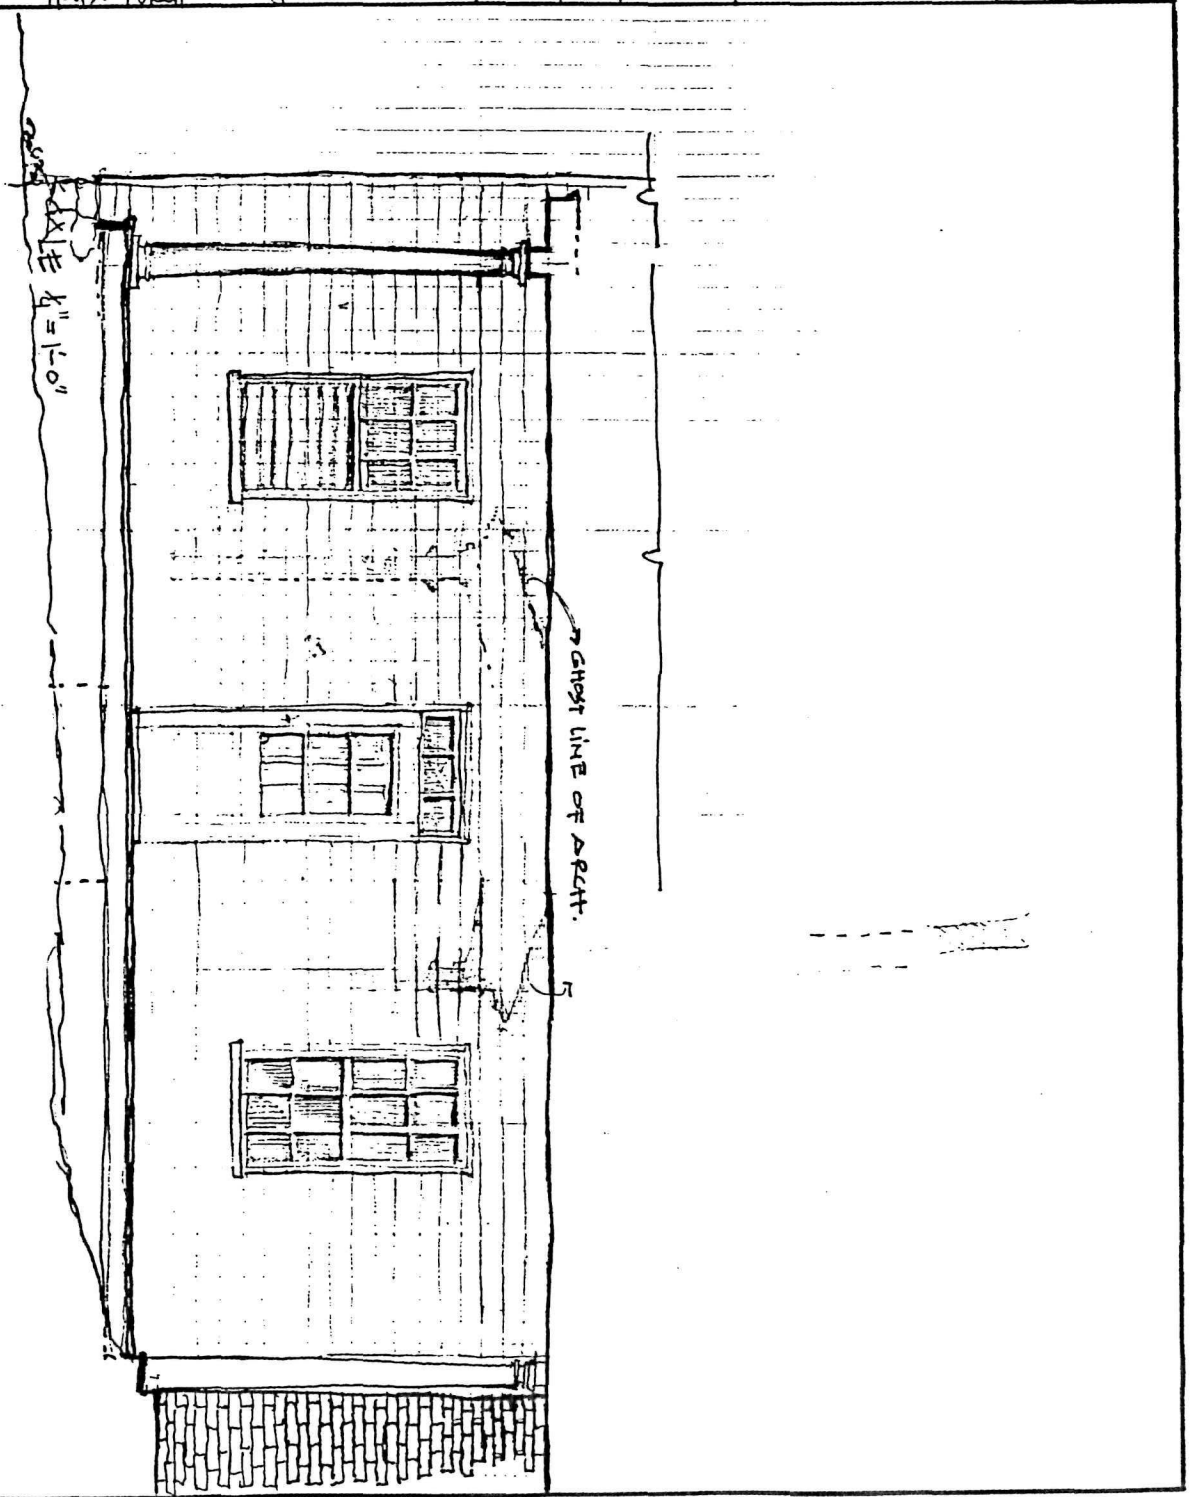
P1. Ghost marks are visible on either side of D103 visible here as dark staining compared to the field of siding. Paint has been removed from wood siding as part of Phase 3 project. The overall size and shape of the porch is apparent.

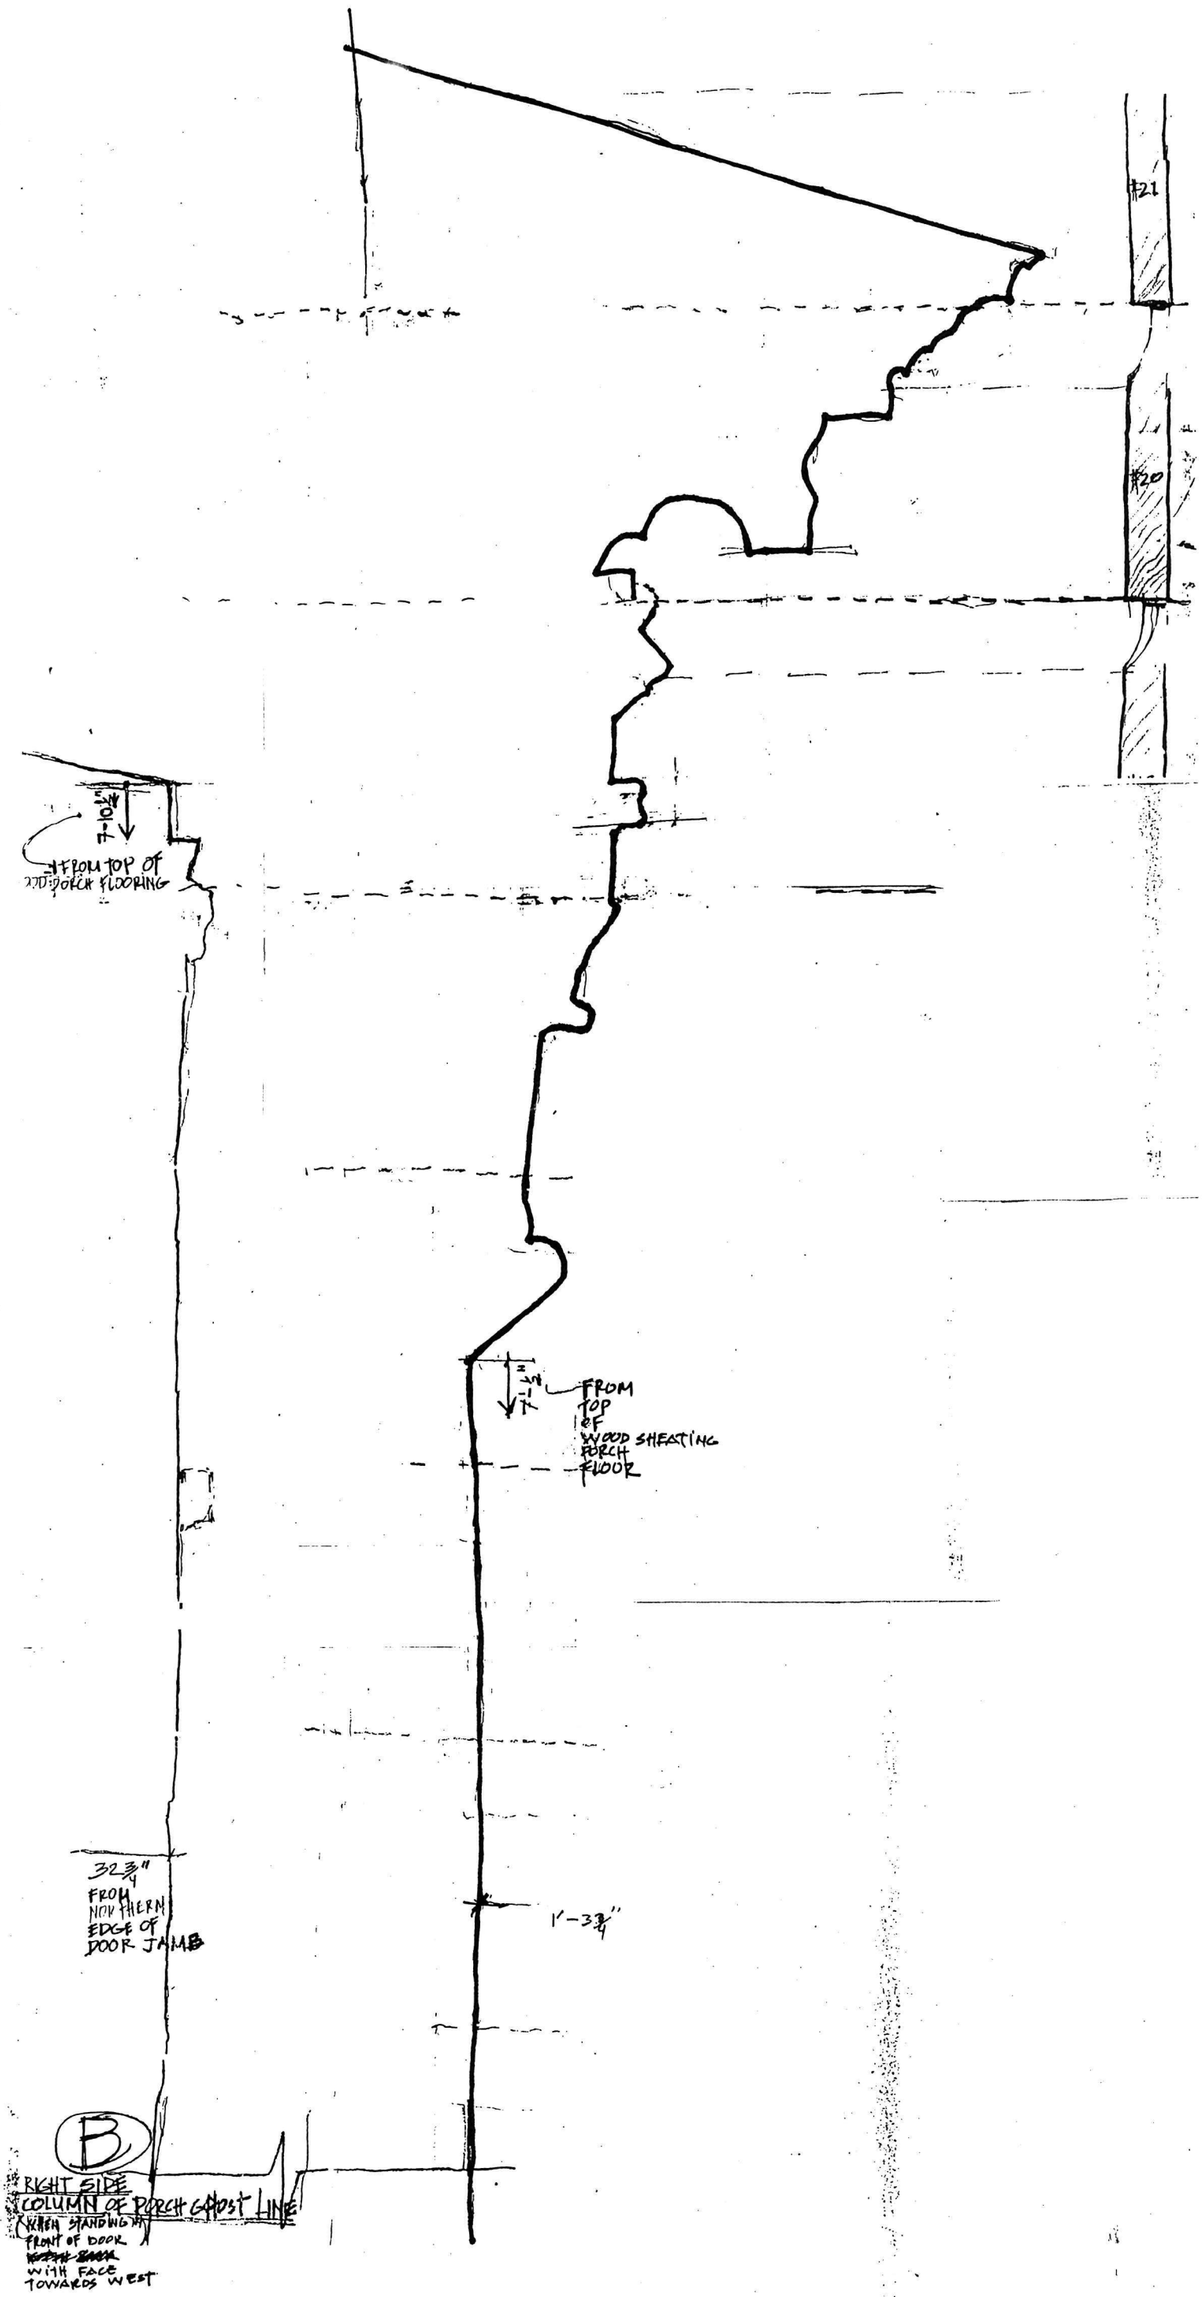
P2. The outline of the column and shape of the roof are visible here as the dark staining against the siding. The shape of the coved ceiling is visible to the right of the existing door opening.
