Bluffs Coffee Shop
Historic Structure Report

2018

2018
Historic Structure Report
Bluffs Coffee Shop
Doughton Park
Blue Ridge Parkway
(BLRI)

LCS#: 1167017
BLRI Building No. 106

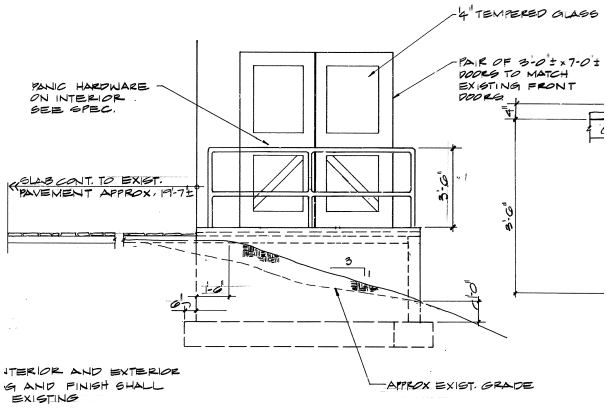
Figure B24. Drawing showing design added east doorway. Note single light-over-single panel design matching that of original doors. No photographic record of these doors has been found; however, the doors currently in place are replacements, as determined by visual inspection of the frame. (BLRI Coll., Drawing No. 106-80002, ETIC)

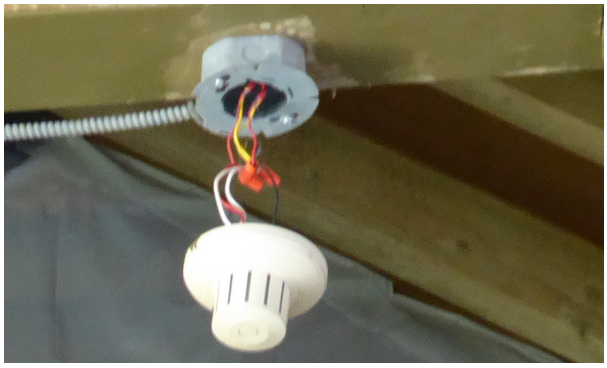
Figure C47. Typical wired smoke detector, detached from fixture box.

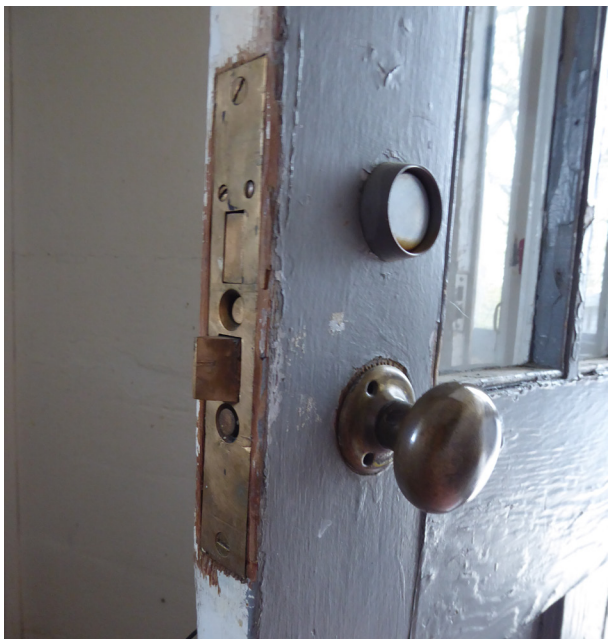
Figure C86. Typical original mortised lockset and brass knob.

Top, lock, and bottom rails measure 4", 7", and 9", respectively. Each door is hung with three, 4 ½" tall ball-pin hinges. A mortised lockset with 2 ¼" brass knob has both an un-keyed knob lock and deadbolt, which has been blanked out on the exterior (*Fig. C86*). A 4" barrel bolt is mounted on the secondary leaf, as is a 4" long head bolt with pull chain (*Fig. C87*). The doorway has a concrete subsill measuring 5" thick and an aluminum threshold measuring 4" wide by ⅝" thick. Lintel-

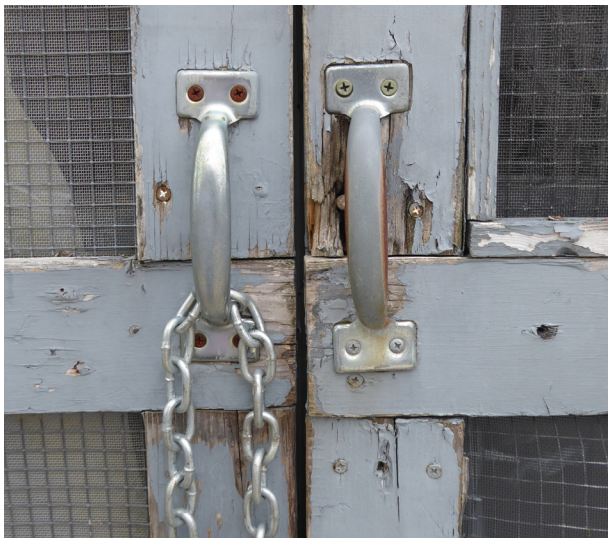
Figure C88. Exterior pull handles on screen doors. Note overall deterioration of doors and inferior construction.

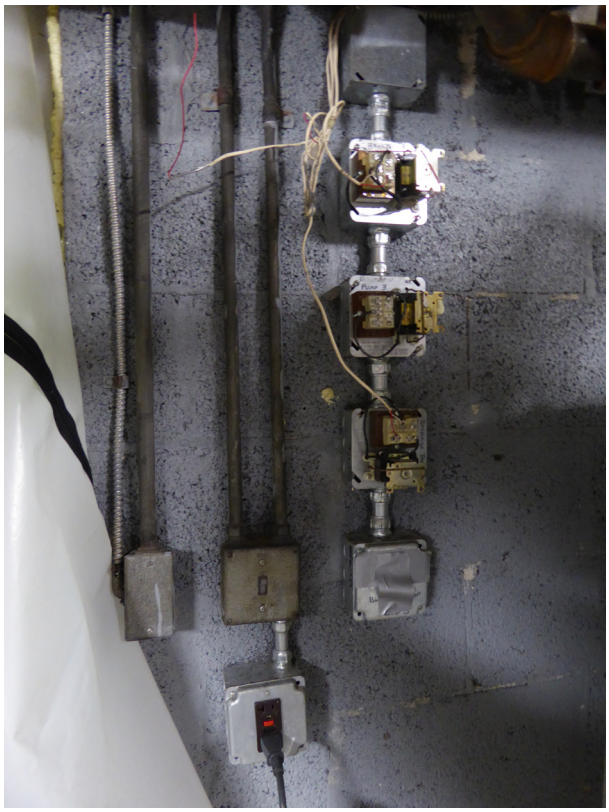
Figure C158. Switches and transformers east of doorway on north wall.

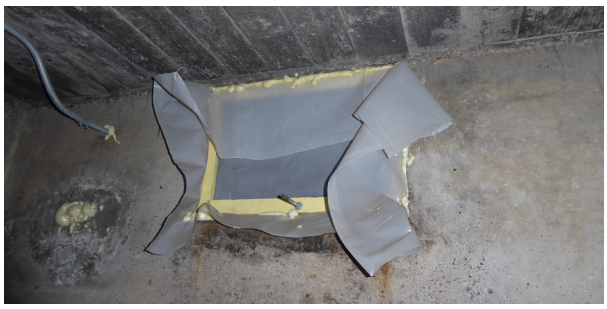
Figure C169. Secured coal door on west wall.

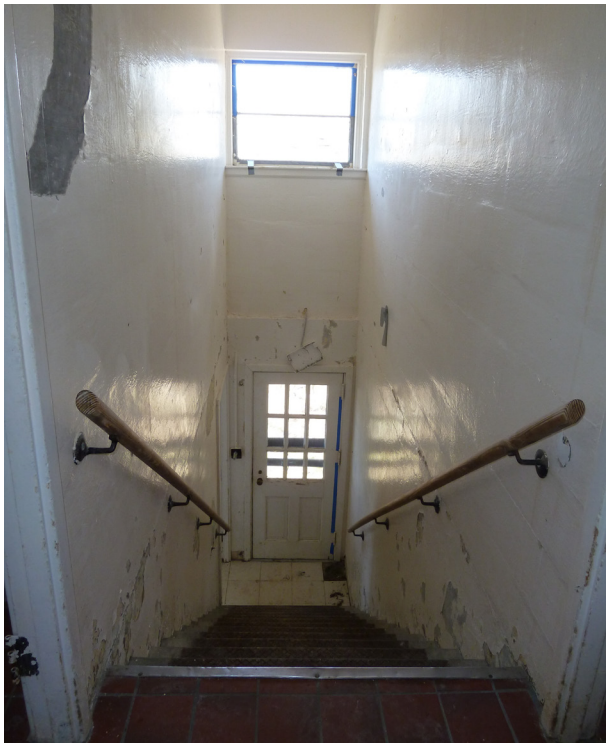
Room 103 consists of a passageway connecting Rooms 102, 104, and 105, and contains the staircase leading to the basement vestibule (Room 009). The area at the top of the stairs measures about 3’-8” by 5’-0”; the full length of the space over the stairs is about 19’-8” (*Figs. C220-C221*).

Figure C220. Room 003 - View looking north.

Figure C221. Room 103 - Oblique view looking southeast into Room 104.
