Fort Vancouver National Historical Site
McLoughlin House
Furniture Collection Condition Assessment

Alan Levitan
Conservator of Wooden Artifacts
Harpers Ferry Center
National Park Service

September 2008

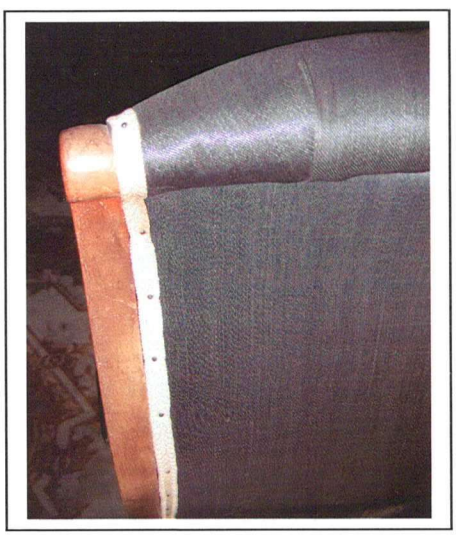
Both show upholstery and gimp are discolored from light damage
As seen in areas normally covered by gimp, show upholstery was originally light blue

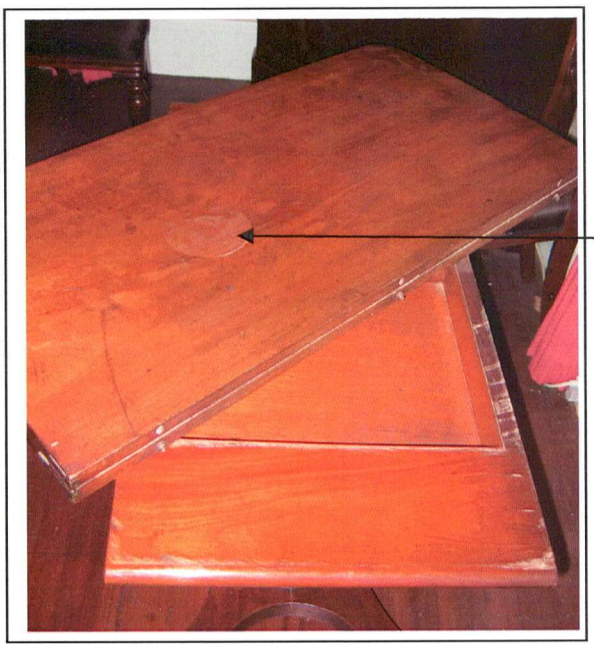
Water damage from placement of moist container on top of game table in dining room

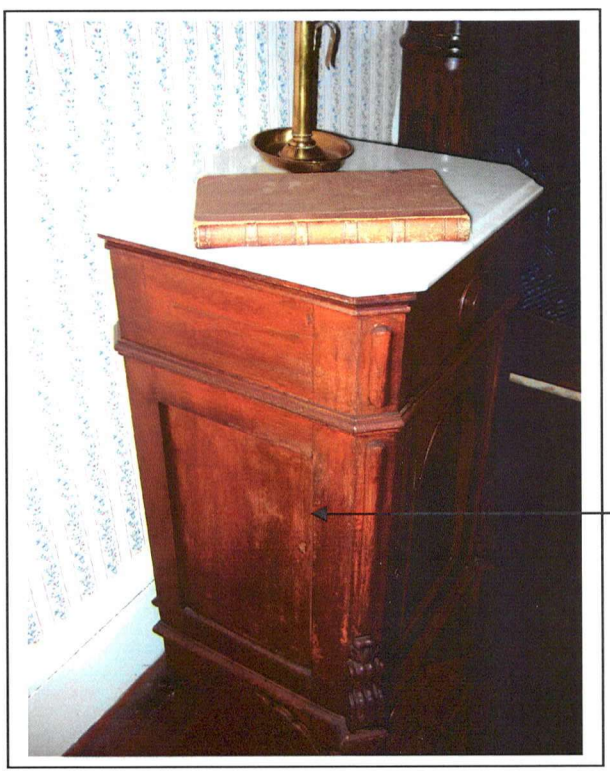
Water damage on bedstand, guest bedroom

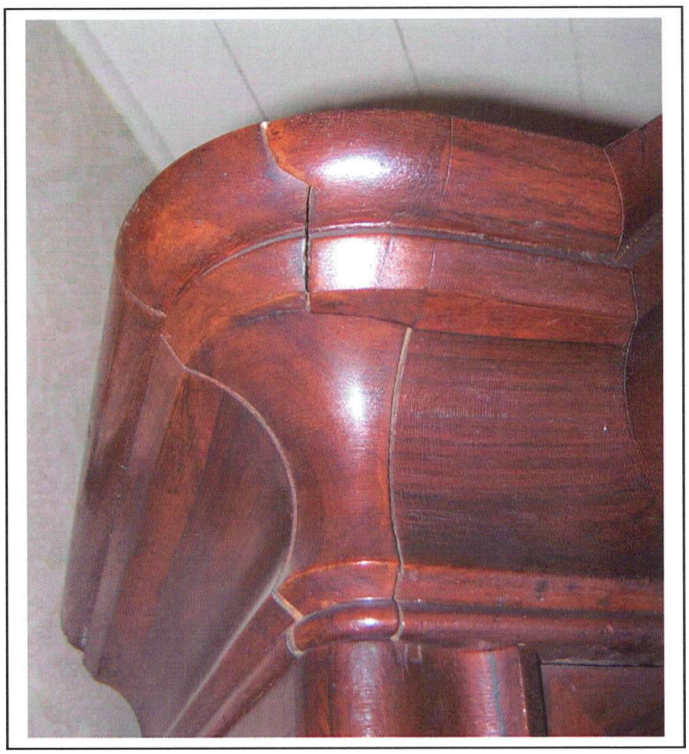
Separated glue joints at corner of armoire cornice

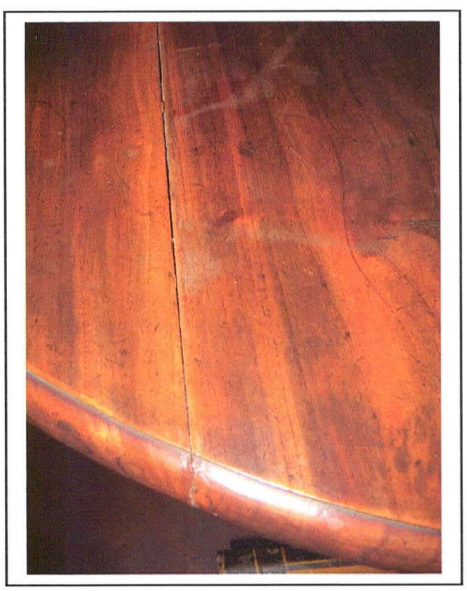
Failed glue joint on top surface of center table

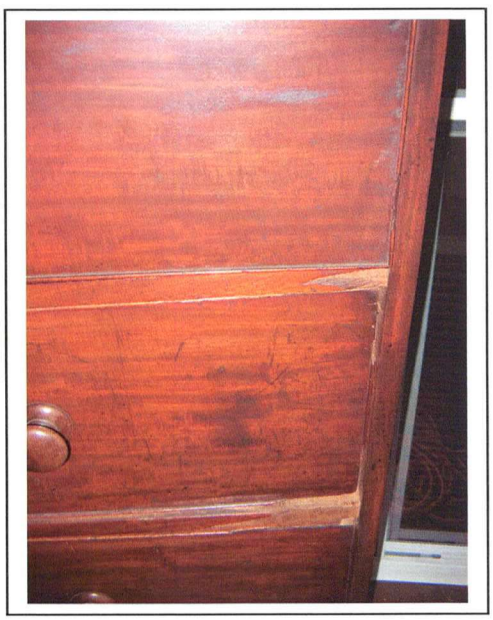
Missing and lifting veneer on drawer blades of chest of drawers

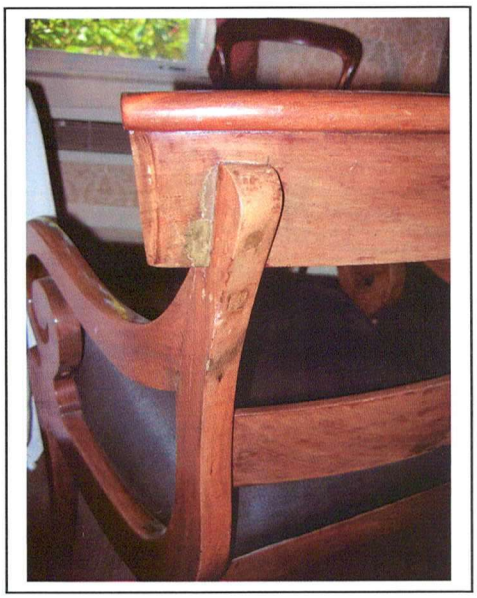
Inappropriate fill, poor attachment between crest rail and seat post

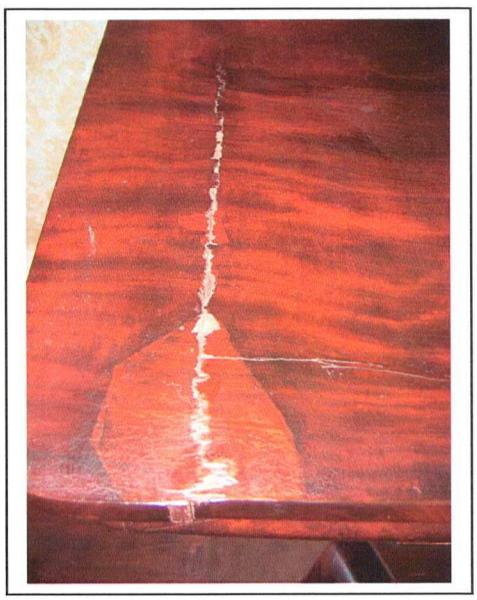
Recent split in veneered table top telegraphs through discolored veneer patch

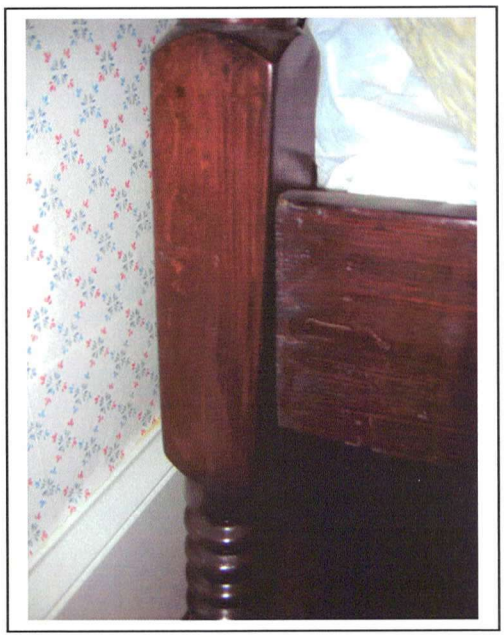
Partial separation between bed rail and headboard post

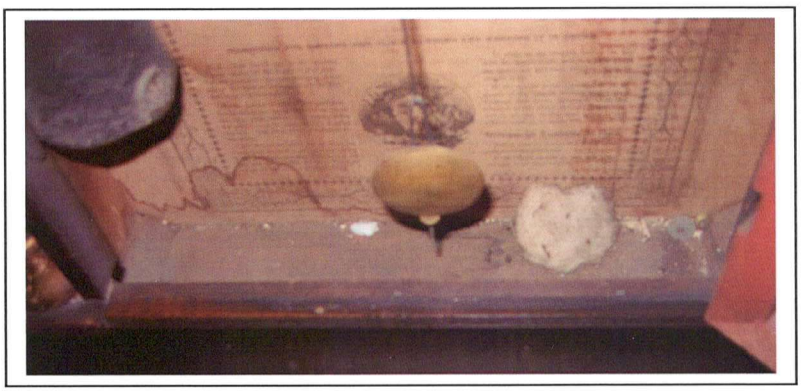
Rodent droppings and nest within mantle clock
