Grand Canyon Village
National Historic Landmark District
Cultural Landscape Report

Grand Canyon National Park
Arizona

January 2004

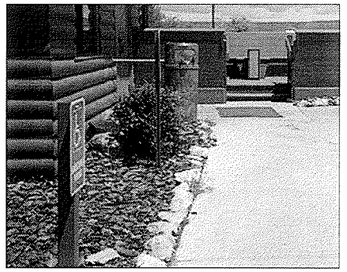
Exposed utility boxes

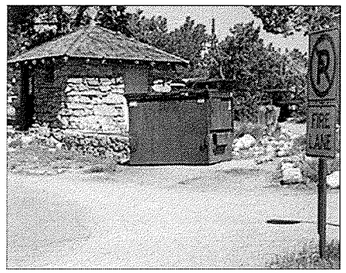
Visible dumpster

Damaged and inadequate bollards

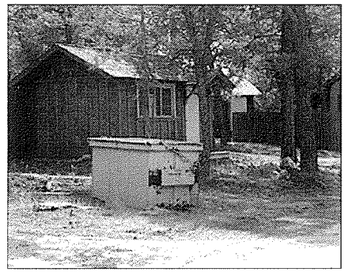
Visible material piles

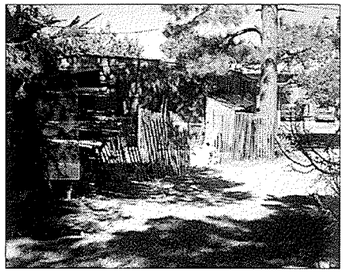
Material piles and damaged fencing

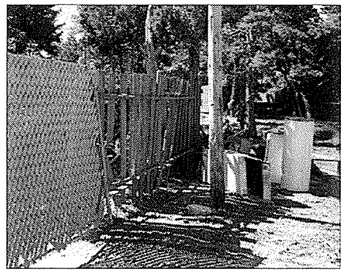
Abandoned appliances

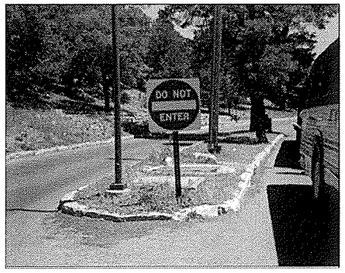
Excessive signage in historic median

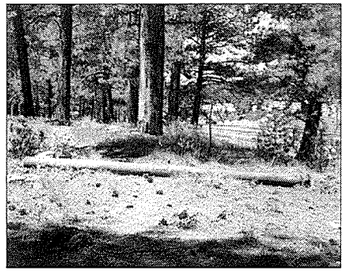
Visible construction remnants

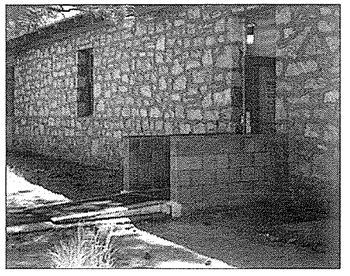
Concrete masonry unit wall

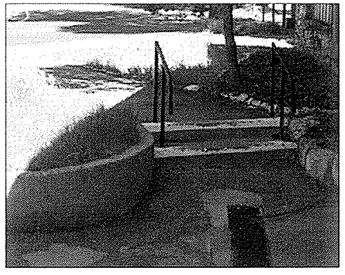
Concrete retaining wall

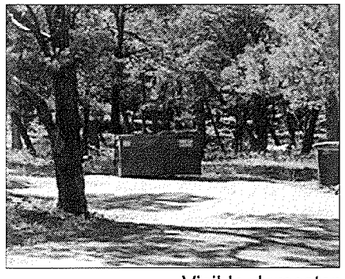
Visible dumpster

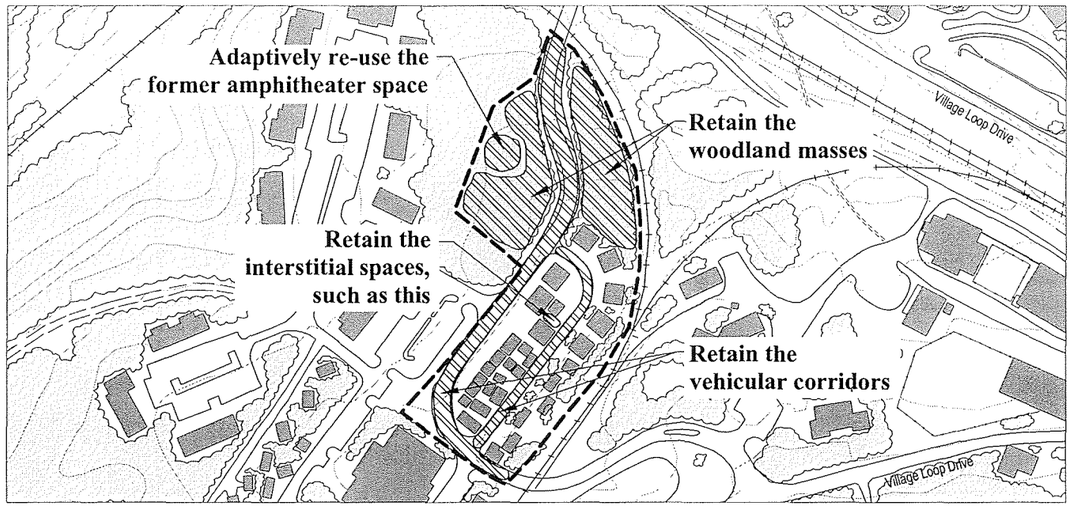
- Install stone or log edging to better define parking spaces and prevent damage to adjacent vegetation and buildings. During fieldwork, vehicles were observed parked too close to tree trunks, outside of the gravel parking spaces, and very close to cabin walls. These actions may result in damage to cultural and natural resources. Well-defined parking spaces may alleviate these problems.

- Protect vegetation from vehicular damage by adjusting the edges of parking spaces away from tree trunks and/or constructing barriers between parking spaces and trees.

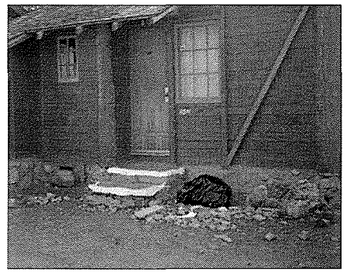
Incompatible Features

Refuse in front of cabin

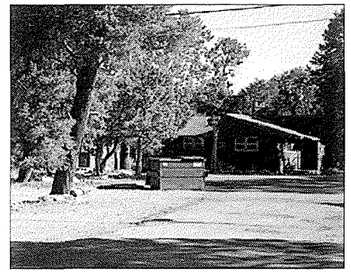
Visible dumpster

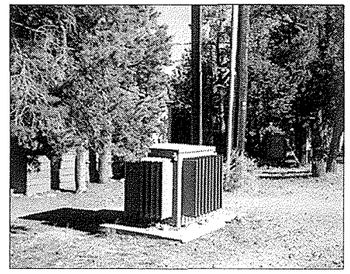
Exposed utility boxes
