Mary McLeod Bethune Council House

1318 Vermont Ave., NW, Washington DC

Beyer Blinder Belle
Architects & Planners LLP

Historic Structure Report

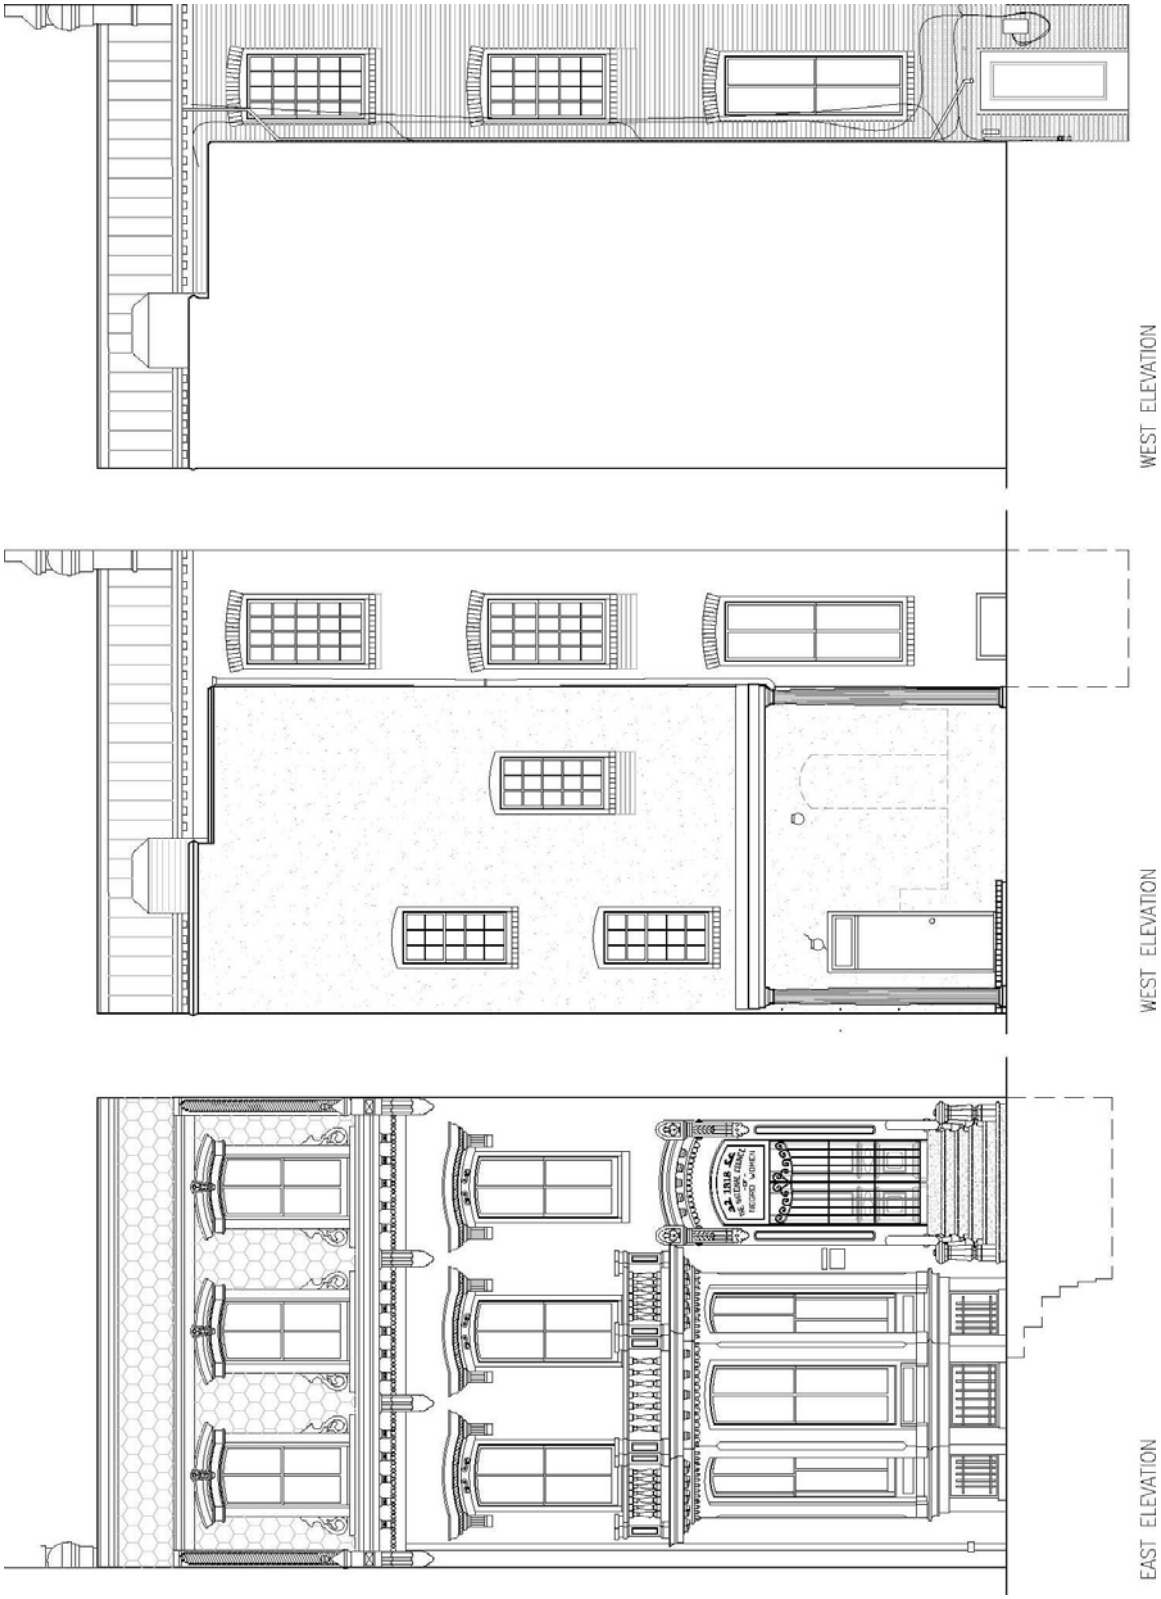
Figure 3-052a: East and West Elevations

Basement doors,	main entry, east		NC	Period 4		Lock difficult to operate. Needs replacement.	
Rear doors, DB05A, DB05B			NC	Period 4

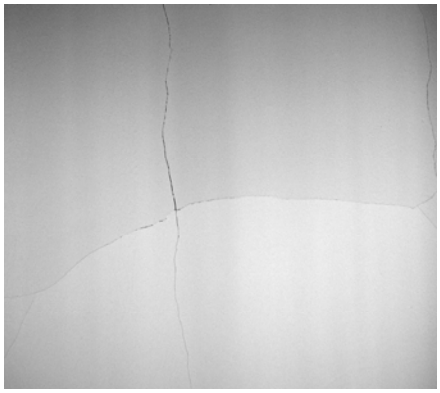
Figure 3-126: Room 101 – Paint cracking and pealing from wall. (Photo: BBB, 2007).

Figure 3-127: Room 101 –Worn & scratched frame and door. (Photo: BBB, 2007).

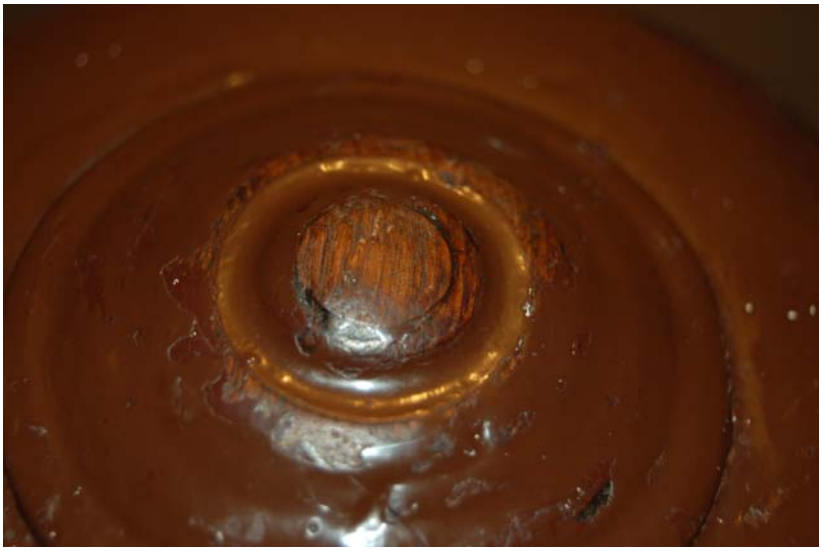
Other Features: Stair 2. The U-shaped stair with winders has turned wood balusters and newel post. The paint is worn off at the top of the basement newel, where the wood and a brass ring have been exposed. The wood appears to be oak or other heavy grained wood. See figure 3-174.
Open stringer with half-round overlap nosing with cove trim. Nosing returns at stringer. All is painted with rubber tread protectors.

Figure 3-174: Worn paint finish on newel post reveals wood beneath the paint. (Photo: BBB, 2007).

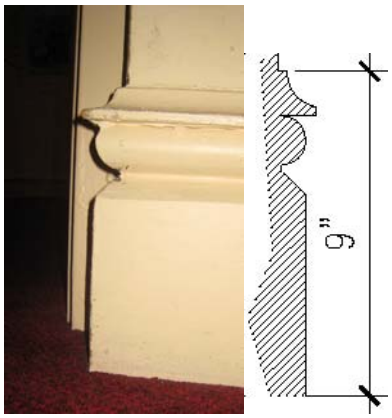
Figure 3-179: Base Profile. (Photo: BBB, 2007).

Door casings		Painted metal frames	NC	1975			
Arched openings	Second floor	Arch springing from brackets at masonry pilaster. Scroll bracket with imbrication design and floral rosettes.	C	Original		Arch in good condition. Brackets in very good condition- perhaps restored or replaced.

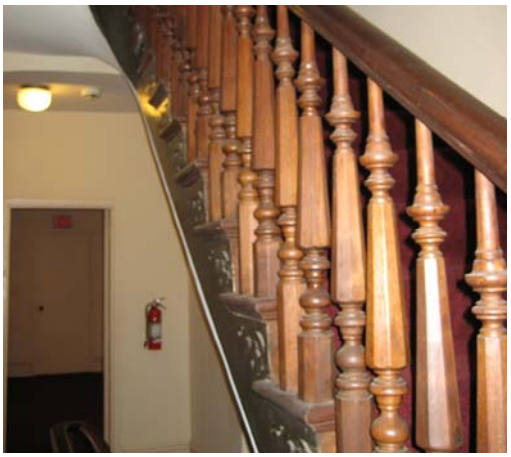
Figure 3-183: Stair detail. (Photo: BBB, 2007).

Other Features: The main feature in the room is the straight-run stair in walnut wood with winders near 2nd floor landing. Balusters are a combination turned and octagonally, tapered design. See figure 3-183. There is an open stringer stair with ornamental, bracketed treads and half-round overlap nosing with cove trim. The nosing returns at stringer. All balusters have a natural walnut paint finish except for two which have a grained walnut paint finish. Balusters and newel have natural stained wood finish. Railing and newels are similar to those of the front stoop.

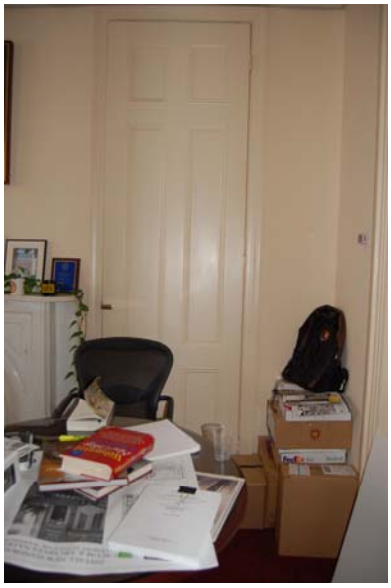
Figure 3-240: D302A. (Photo: BBB, 2007).

Doors: The closet door D302A is an historic door from Period 1. It is six-panel with period lever latching hardware. See Figure 3-240.

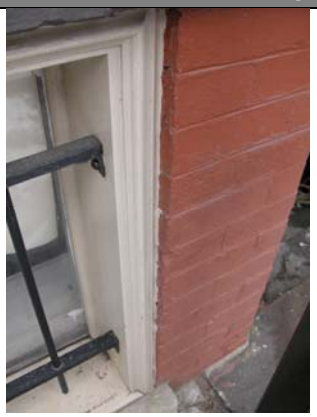
MASONRY 7

SYMBOL	CONDITION	LOCATION	EXAMPLE IMAGE
M-PNT	Paint Build-up	On east façade of building.	
DESCRIPTION		POTENTIAL CAUSES	
Multiple coats of paint (twelve) prevent the building from breathing and obscure building details. (Photo: Bay windows at basement level).		Multiple painting projects without stripping excessive paint layers.

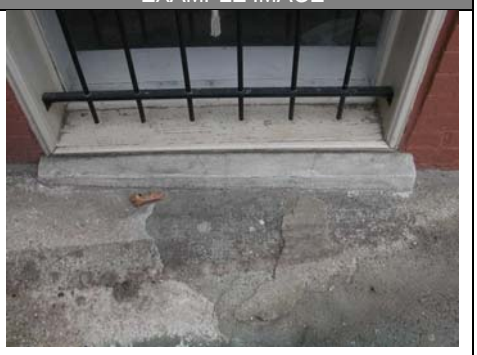
MASONRY 8

SYMBOL	CONDITION	LOCATION	EXAMPLE IMAGE
M-CRK	Pre-cast sills cracking	Basement Front (3 sills)	
DESCRIPTION		POTENTIAL CAUSES	
Hairline cracks at sill.		Exposure to weather, inadequate positive drainage and grade level too high relative to windows.

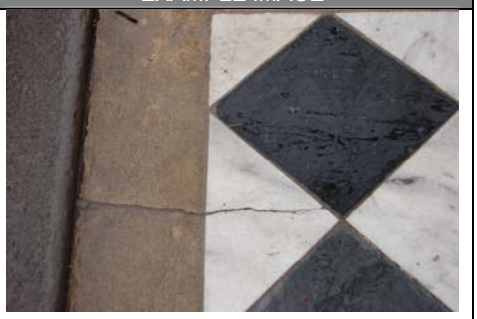
CONCRETE 1

SYMBOL	CONDITION	LOCATION	EXAMPLE IMAGE
C-CRK	SLAB CRACKING	Front Walk	
DESCRIPTION		POTENTIAL CAUSES	
Minor cracks in concrete slab and transmission into finished marble pavers.		Differential settling, unreinforced slab, inadequate or expansion and control joints.

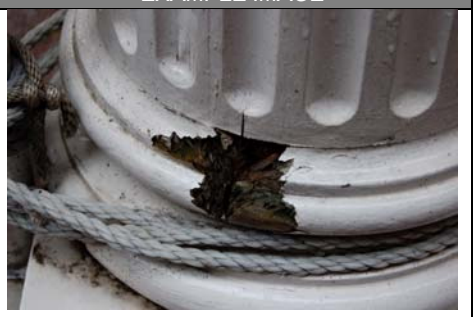
WOOD 4

SYMBOL	CONDITION	LOCATION	EXAMPLE IMAGE
W-DET	Deterioration	Rear Porch Column Base	
DESCRIPTION		POTENTIAL CAUSES	
Wood deterioration.		Inadequate surface drainage, paint failure. Wood species not water resistant or treated.

Some wood deterioration was noted at the base of the southern-most column at the rear porch (Figure 4-026). Similar deterioration was observed

Figure 4-026: Wood deterioration at column base. (Photo: RSA, 2007).

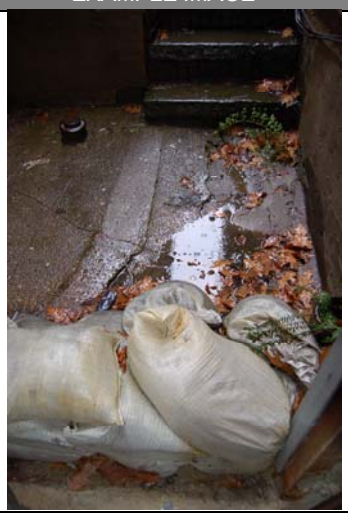
DRAINAGE 3

SYMBOL	CONDITION	LOCATION	EXAMPLE IMAGE
D-DET	Areaway Drains	Rear courtyard.	
DESCRIPTION		POTENTIAL CAUSES	
Inadequate drainage. Water backup.		Ground drains inadequately sized. Combined storm and sanitary sewer may backup during heavy rains.

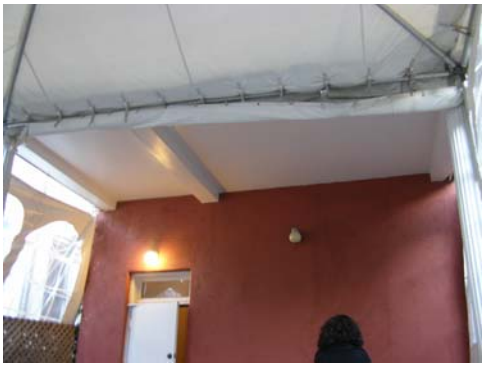
Figure 4-027: Rear Porch Roof Framing. (Photo: RSA, 2007).

at the connection of the southern edge beam of the porch roof to the building (Figure 4-027).

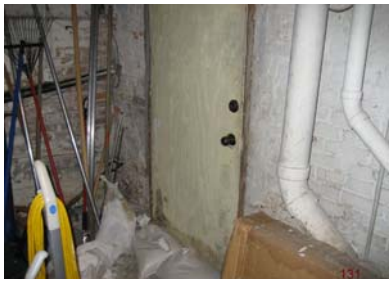
Figure 4-067: Room B05 - Existing mechanical room. (Photo: GHT, 2007).

The waste pipe in the house has been converted to plastic and appears to be in good to fair condition. The sewer line from the building to the street should be scoped to verify its integrity and provided with a functioning back flow device so sandbagging of the basement doors is not required, as shown in picture (Figures 4-067).

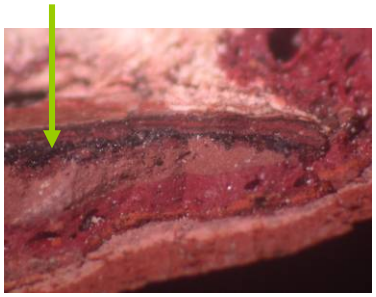
Figure 6-002: Sample MMB 001-012 (Exterior Painted Brick) Cross-section under reflected light

The painted brick (Sample 001-012) has evidence of twelve paint layers (Figure 6-002). Following the sixth paint layer is a heavy layer of black soiling. It is likely that this dates from the fire in 1966. Paint removed from the surface of the mortar sample at the 2nd floor window of the East elevation matched the chronology of the painted brick following this layer of soiling. Based on this information, it appears that the front façade was repointed following the fire and the entire façade was then painted. The finish layer before and after the fire are nearly identical in color. Both layers are a moderate reddish brown (Munsell 10R 3/4). This finish had a flat sheen and was matched by Benjamin Moore 1302.

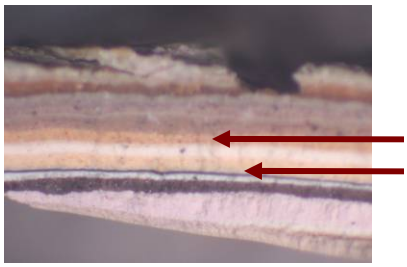
Figure 6-004: Sample MMB 001-004 (Exterior Coved Molding below Bay Window) Cross-section under reflected light

Samples 001-002, 001-003, 001-004, 001-005, 001-006, 001-010) appears to have been painted a light yellow color (Munsell 10YR 8/4-8/6) during the primary period of significance. This finish was used for the bay window woodwork (Figure 6-004), including the window frames, and the door surround. It had a semi-gloss sheen and was matched by Benjamin Moore 151. This finish was followed by a slightly paler yellow (Munsell 2.5Y 8.5/2-8.5/4). This color had a semi-gloss sheen and was matched by Benjamin Moore 295. A grayish yellowish brown color (Munsell 10YR 5/2) may also date to this period, just preceding the yellow campaigns.

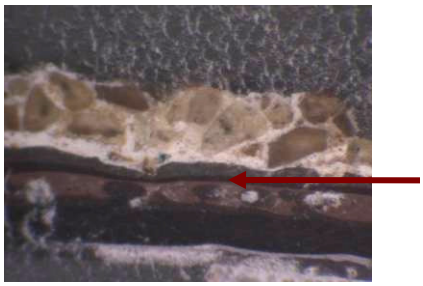
The cast-iron stair railing (Sample 001-001: Figure 6-005) initially had a yellowish white sanded finish. This finish was designed to create the appearance of stone on metal or wood substrates by either mixing sand into the paint prior to application or by blowing sand onto the wet painted surface. Paint colors used in this effect tended to be colors similar to brownstone or sandstone, such as the yellowish white used here. By the period of Mary McLeod Bethune's residency and the occupation of the house by the NCNW, the palette for this element had shifted to darker colors, including grays and browns. A dark grayish reddish brown (Munsell 10R 2/2) appears to be the finish from the primary period of significance. This finish has a semi-gloss sheen and was matched by Sherwin-Williams 2838.

Figure 6-005: Sample MMB 001-001 (Exterior Cast Iron Stair Baluster) Cross-section under reflected light with sanded paint as first finish

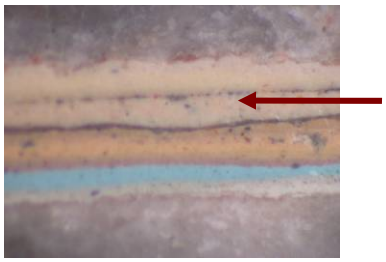
Figure 6-006: Sample MMB 100-002 (Vestibule Wall above Chair Rail) Cross-section under reflected light

The entrance vestibule was painted with two different finish colors. The current chair rail is a recent replacement, but above this element the walls (Sample 100-002: Figure 6-006) were painted a dark grayish yellow (Munsell 2.5Y 6/4) while below the walls (Sample 100-003: Figure 6-008) were a dark purplish gray (Munsell 10YR 5/1). The dark grayish yellow finish had a semi-gloss sheen and was matched by Sherwin-Williams 6130. The dark grayish purple also had a semi-gloss sheen and was matched by Benjamin Moore 1469. Later campaigns during the period of significance continued this trend of painting the upper portion and the lower portion two distinctly different colors.

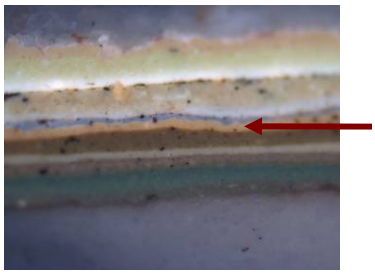
Figure 6-007: Sample MMB 100-002 (Vestibule Wall above Chair Rail) Cross-section under ultraviolet light

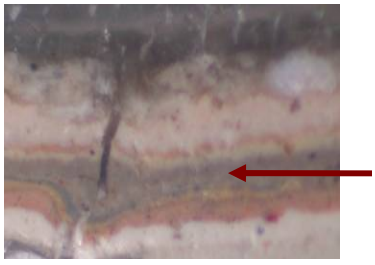
Figure 6-008: Sample MMB 100-003 (Vestibule Wall below Chair Rail) Cross-section under reflected light

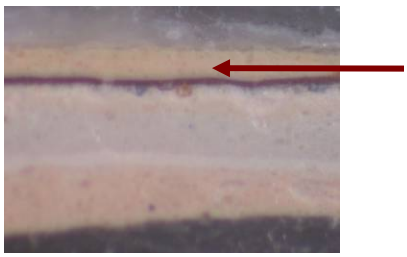
The walls in the back stair (Sample 105-005: Figure 6-010) were painted a pale orange yellow (Munsell 10YR 9/2-9/4). This finish had a semi-gloss sheen and was matched by Benjamin Moore 115.

Figure 6-010: Sample MMB 105-005 (Back Stair First Floor: North Wall above Baseboard) Cross-section under reflected light

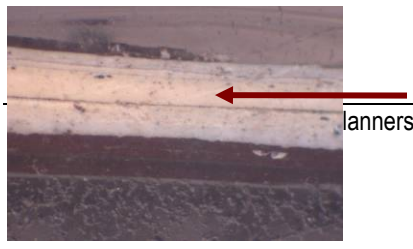
The woodwork in the second floor hallway (Sample 200-001: Figure 6-011 and Sample 200-005) was painted pale yellow (Munsell 2.5Y 8.5/2-8.5/4). This finish had a semi-gloss sheen and was matched by Benjamin Moore 295. This finish was used for the stairs and the baseboards. It is possible based on this evidence that the first floor stair woodwork was also painted this color during the period of significance.

Figure 6-011: Sample MMB 200-001 (Second Floor Hall

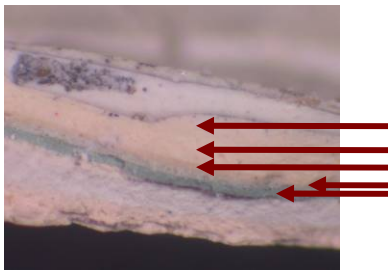
Figure 6-012: Sample MMB 201-005 (Room 201 Closet Door D201B Casing) Cross-section under reflected light

The next finish layer was a grayish yellow (Munsell 2.5Y 8/4). This finish had a semi-gloss sheen and was matched by Benjamin Moore 186. In Room 201, this finish was found on the walls and the closet door casing, but not the window casing. In Room 202, this finish was found on the walls, but not the woodwork. This finish was also used for the woodwork in Room 204 and Room 206.

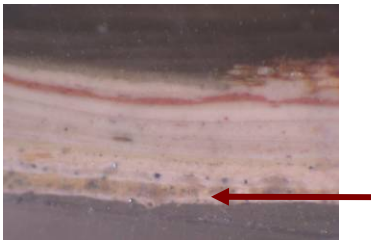
Figure 6-013: Sample MMB 303-001 (Room 303 Door D303B Casing to Room 302) Cross-section under reflected light

In Room 303, the woodwork (Sample 303-001: Figure 6-013) was initially painted with the pale yellows used in the hall (BM 295 and BM 186). This finish was followed by a pale greenish yellow (Munsell 2.5GY 8/4). This finish was matched by Benjamin Moore 395. This finish was also found on a window casing in Room 206 (Sample 206-001), but based on the chromochronology, it appears that this element was moved to the second floor during the first renovation following the fire.

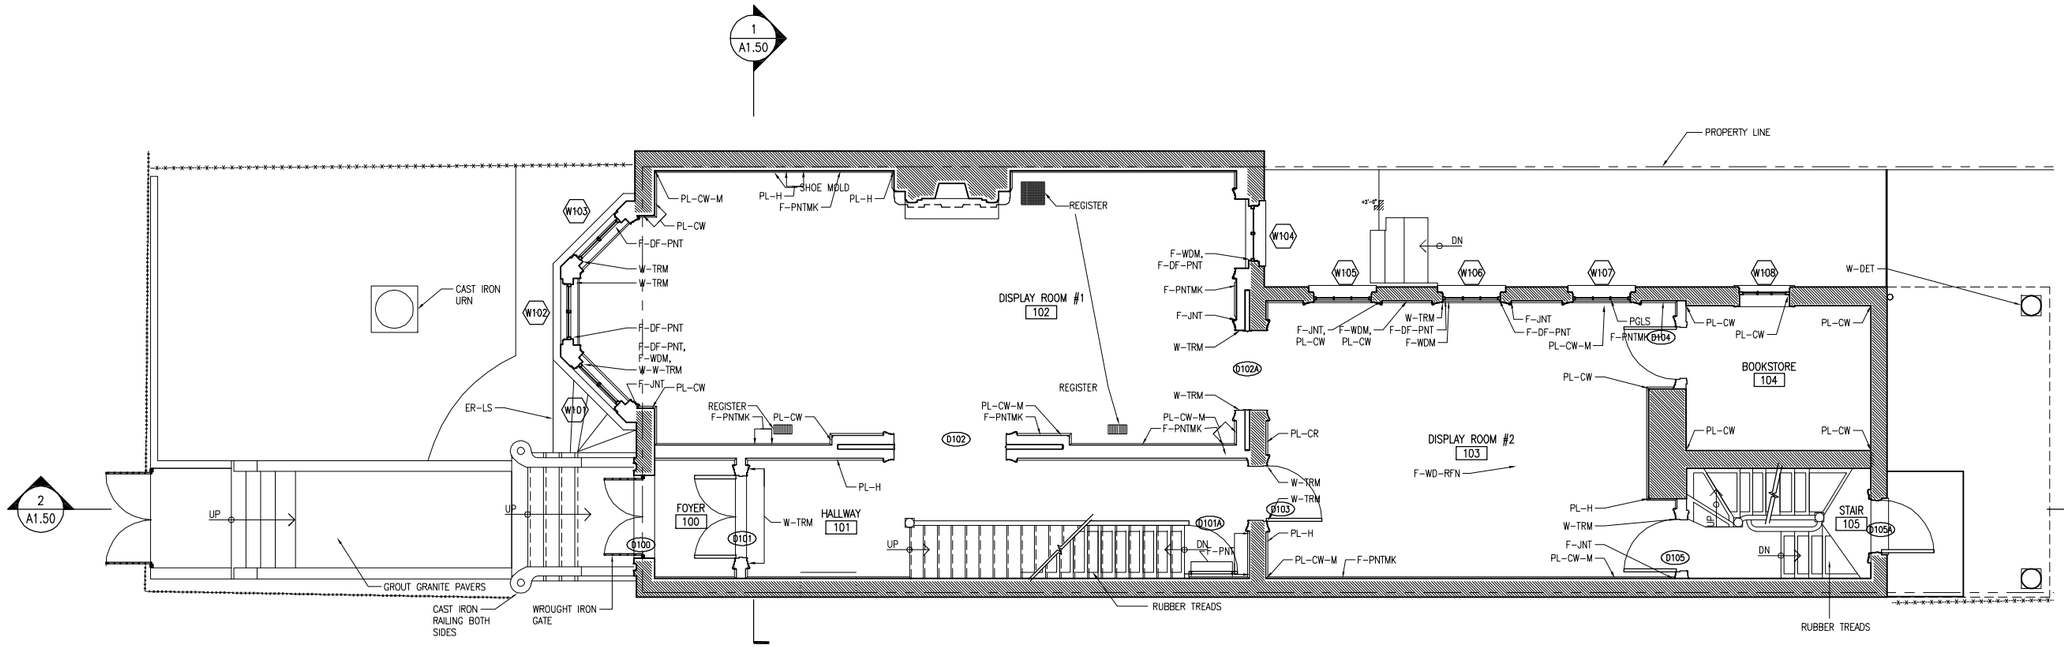
A1.20
SUB SHEET NUMBER

LEGEND	SEE HSR FIG. 4-003 & FIG. 4-009 FOR DETAILS.
C-CRK	CONCRETE SLAB CRACKING
D-DET	DRAINAGE DETERIORATION
F-CT	CEILING TILE DAMAGE
F-DPNT	DECORATIVE PAINT FAILURE
F-JNT	JOINT SEPARATION
F-PGL	PAINT ON GLASS
F-PNT	PAINT FAILURE
F-PPCH	PREVIOUS PATCHING
F-PNTMK	MARKS ON WALL
W-TRM	WOOD TRIM DETERIORATION
F-WTL	TILE DAMAGE
F-VCT	VINYL COMPOSITE TILE FAILURE
F-WDM	WATER DAMAGE
HW-DMG	HARDWARE DAMAGE
M-CRK	MASONRY CRACKING
M-DET	MASONRY DETERIORATION
M-HOLE	HOLE IN MASONRY
M-IIP	MASONRY INCOMPATIBLE INFILL PANELS
M-IM	MASONRY INCOMPATIBLE MORTAR
M-PNT	MASONRY PAINT BUILD-UP
M-ST-DET	MASONRY STONE DETERIORATION
MTL-DET	METAL DETERIORATION
PL-CW	PLASTER CRACKING
PL-CW-M	CROWN MOLDING CRACKING
PL-H	HOLE IN PLASTER
R-FL	ROOF FLASHING FAILURE
R-PAR	ROOF PARGING FAILURE
R-PNT	ROOF PAINT FAILURE
W-DET	WOOD DETERIORATION

BASEMENT CONDITION PLAN
TITLE OF DRAWING

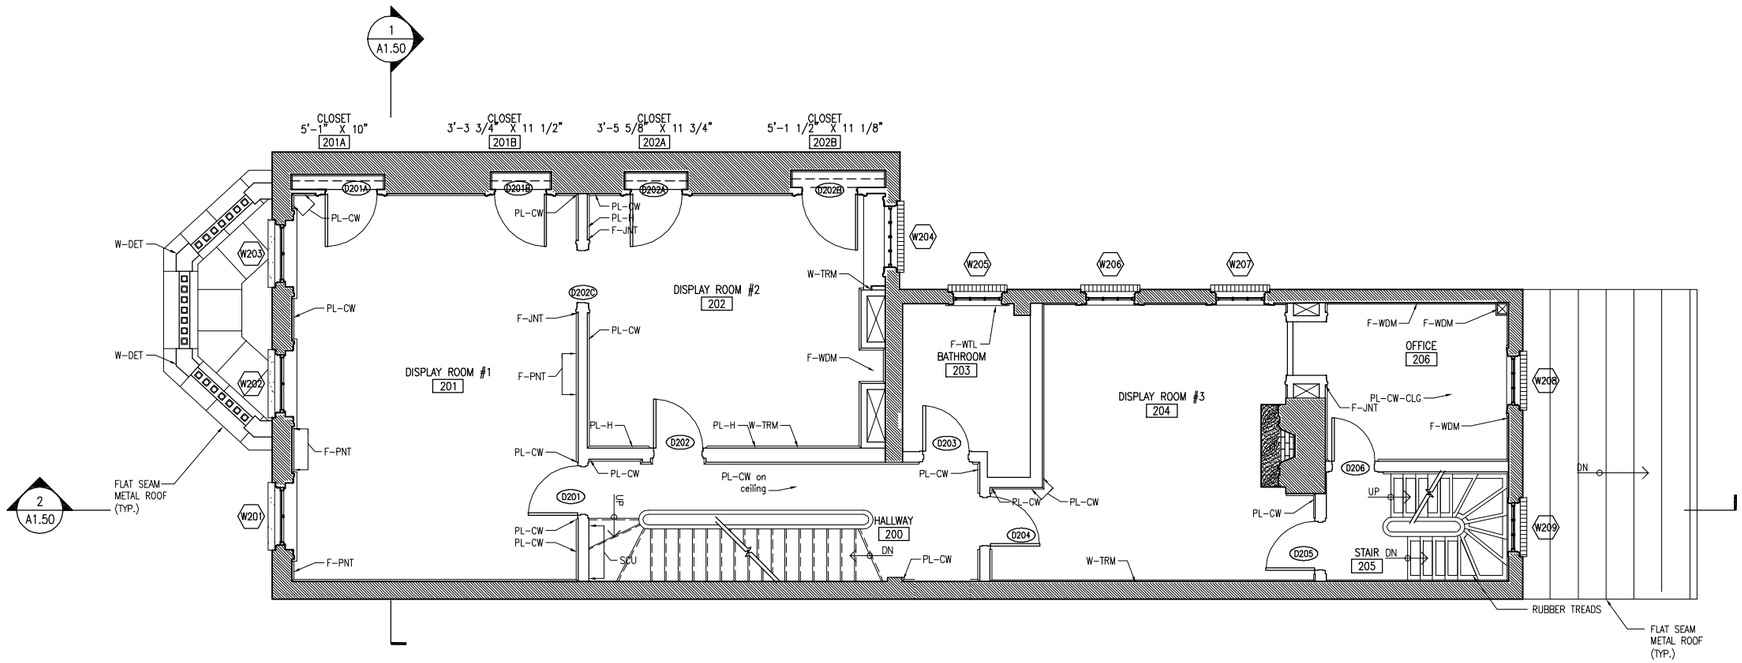
A1.21
SUB SHEET NUMBER

LEGEND	SEE HSR FIG. 4-003 & FIG. 4-009 FOR DETAILS.
C-CRK	CONCRETE SLAB CRACKING
D-DET	DRAINAGE DETERIORATION
F-CT	CEILING TILE DAMAGE
F-DPNT	DECORATIVE PAINT FAILURE
F-JNT	JOINT SEPARATION
F-PGL	PAINT ON GLASS
F-PNT	PAINT FAILURE
F-PPCH	PREVIOUS PATCHING
F-PNTMK	MARKS ON WALL
W-TRM	WOOD TRIM DETERIORATION
F-WTL	TILE DAMAGE
F-VCT	VINYL COMPOSITE TILE FAILURE
F-WDM	WATER DAMAGE
HW-DMG	HARDWARE DAMAGE
M-CRK	MASONRY CRACKING
M-DET	MASONRY DETERIORATION
M-HOLE	HOLE IN MASONRY
M-IIP	MASONRY INCOMPATIBLE INFILL PANELS
M-IM	MASONRY INCOMPATIBLE MORTAR
M-PNT	MASONRY PAINT BUILD-UP
M-ST-DET	MASONRY STONE DETERIORATION
MTL-DET	METAL DETERIORATION
PL-CW	PLASTER CRACKING
PL-CW-M	CROWN MOLDING CRACKING
PL-H	HOLE IN PLASTER
R-FL	ROOF FLASHING FAILURE
R-PAR	ROOF PARGING FAILURE
R-PNT	ROOF PAINT FAILURE
W-DET	WOOD DETERIORATION

1st FLOOR CONDITION PLAN
TITLE OF DRAWING

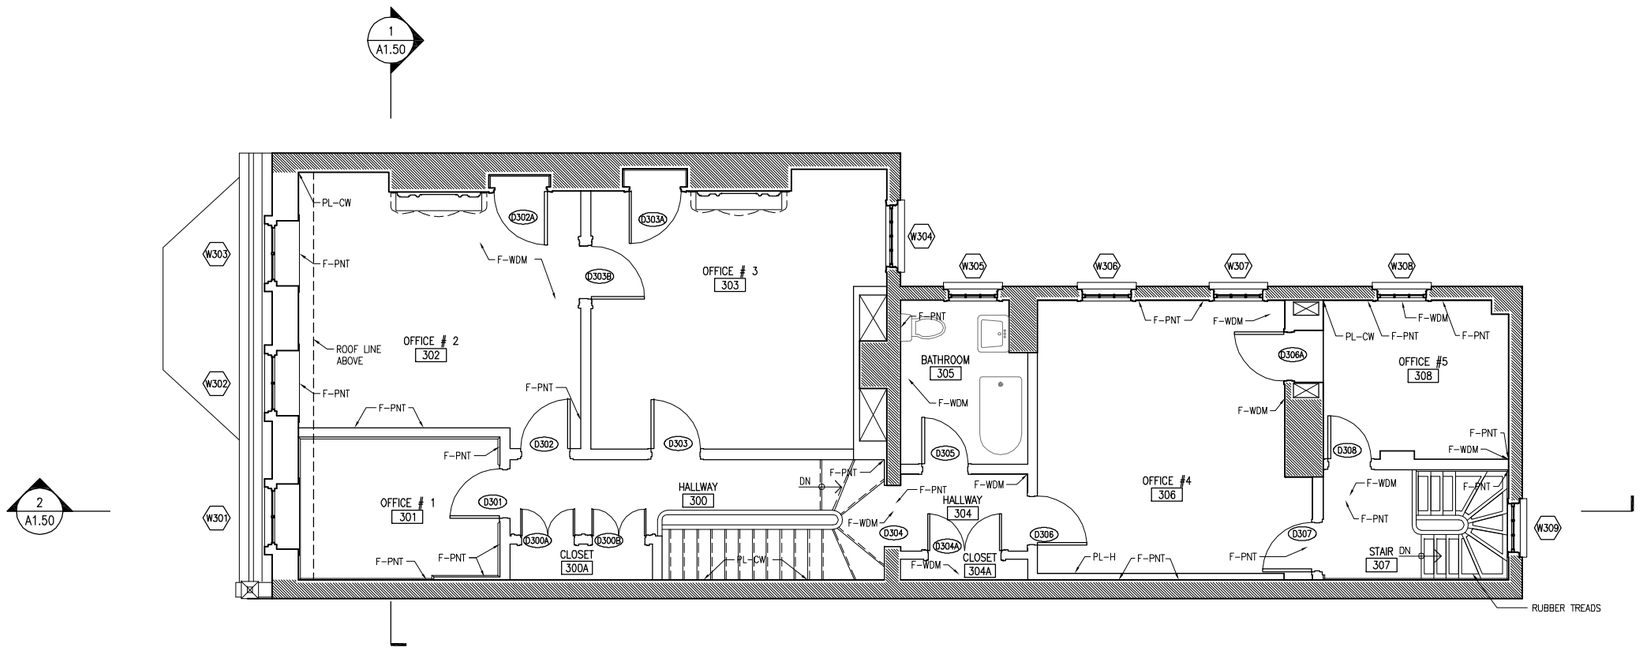
A1.22
SUB SHEET NUMBER

LEGEND	SEE HSR FIG. 4-003 & FIG. 4-009 FOR DETAILS.
C-CRK	CONCRETE SLAB CRACKING
D-DET	DRAINAGE DETERIORATION
F-CT	CEILING TILE DAMAGE
F-DPNT	DECORATIVE PAINT FAILURE
F-JNT	JOINT SEPARATION
F-PGL	PAINT ON GLASS
F-PNT	PAINT FAILURE
F-PPCH	PREVIOUS PATCHING
F-PNTMK	MARKS ON WALL
W-TRM	WOOD TRIM DETERIORATION
F-WTL	TILE DAMAGE
F-VCT	VINYL COMPOSITE TILE FAILURE
F-WDM	WATER DAMAGE
HW-DMG	HARDWARE DAMAGE
M-CRK	MASONRY CRACKING
M-DET	MASONRY DETERIORATION
M-HOLE	HOLE IN MASONRY
M-IIP	MASONRY INCOMPATIBLE INFILL PANELS
M-IM	MASONRY INCOMPATIBLE MORTAR
M-PNT	MASONRY PAINT BUILD-UP
M-ST-DET	MASONRY STONE DETERIORATION
MTL-DET	METAL DETERIORATION
PL-CW	PLASTER CRACKING
PL-CW-M	CROWN MOLDING CRACKING
PL-H	HOLE IN PLASTER
R-FL	ROOF FLASHING FAILURE
R-PAR	ROOF PARGING FAILURE
R-PNT	ROOF PAINT FAILURE
W-DET	WOOD DETERIORATION

2nd FLOOR CONDITION PLAN
TITLE OF DRAWING

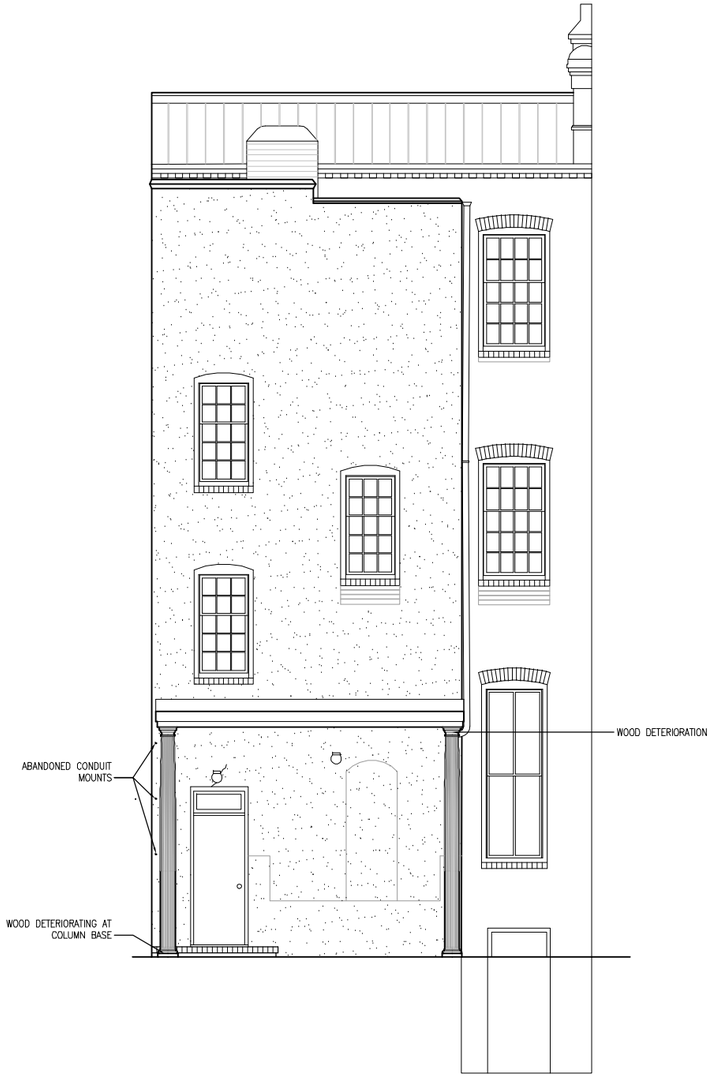
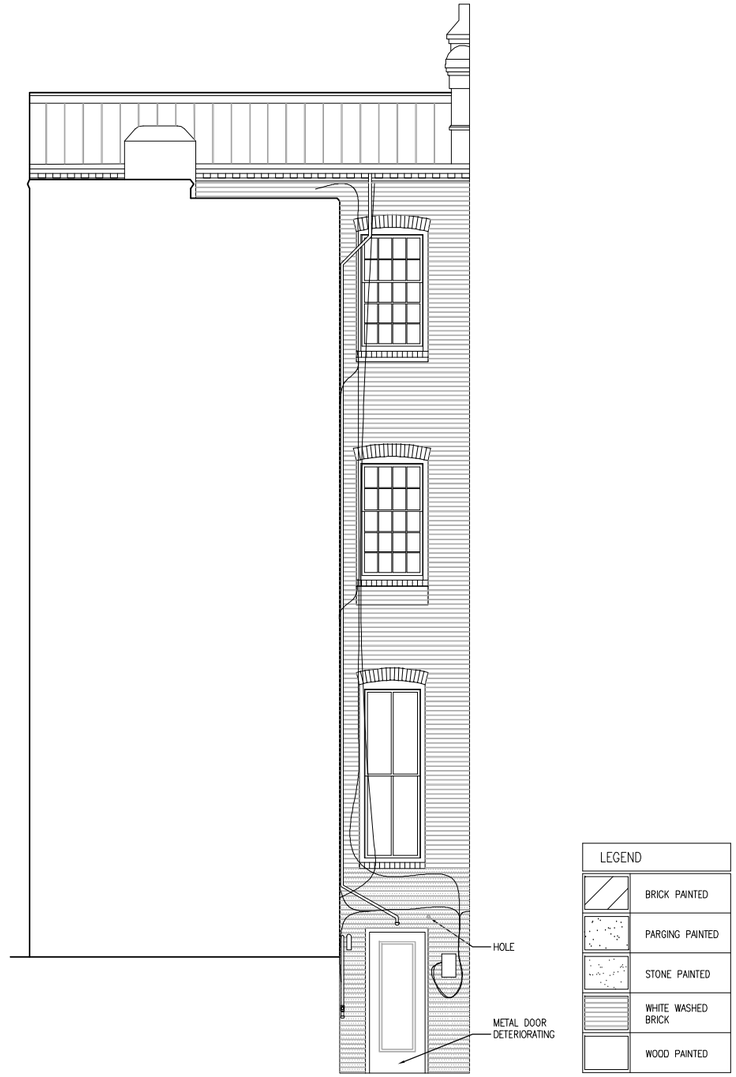
EAST & WEST CONDITION ELEVATIONS
TITLE OF DRAWING

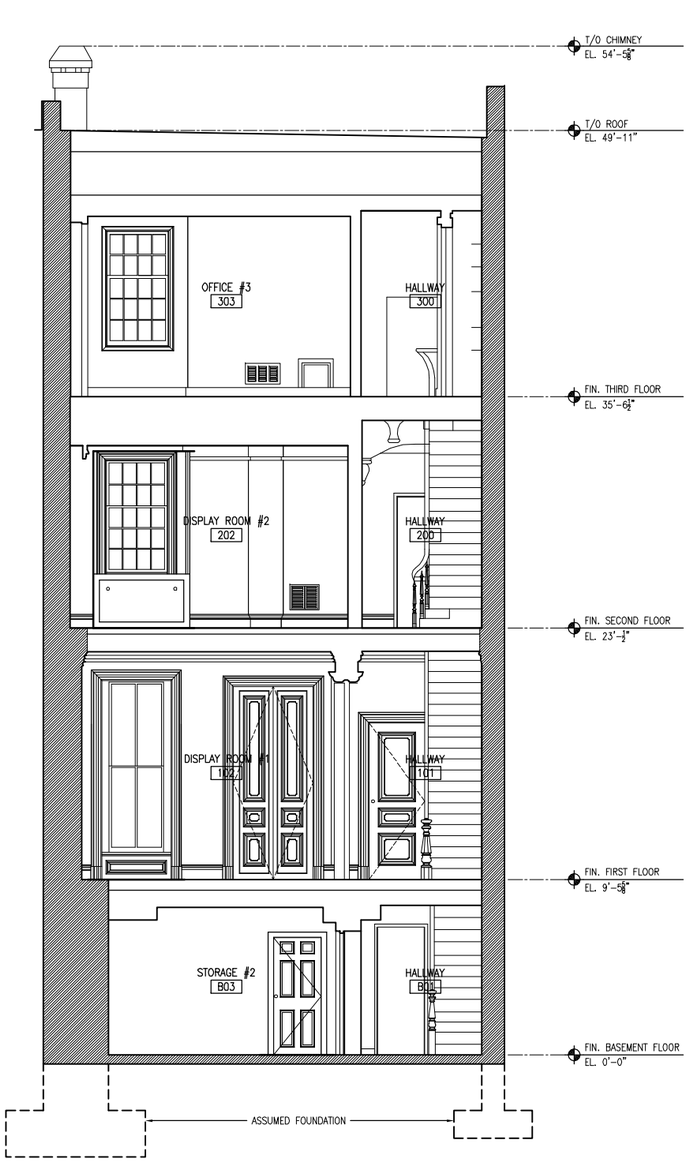
A1.41
SUB SHEET NUMBER

SOUTH CONDITION ELEVATION
TITLE OF DRAWING

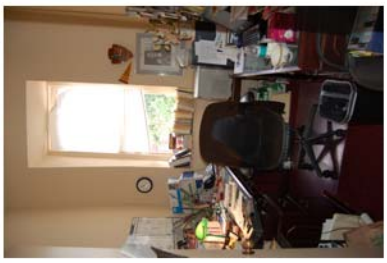
300_SW Damage_012407.JPG

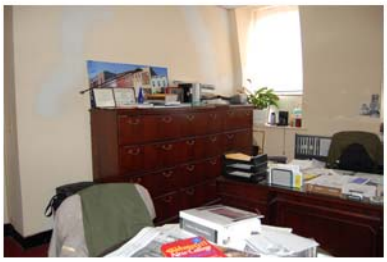
302_Ceiling Damage_030807.JPG

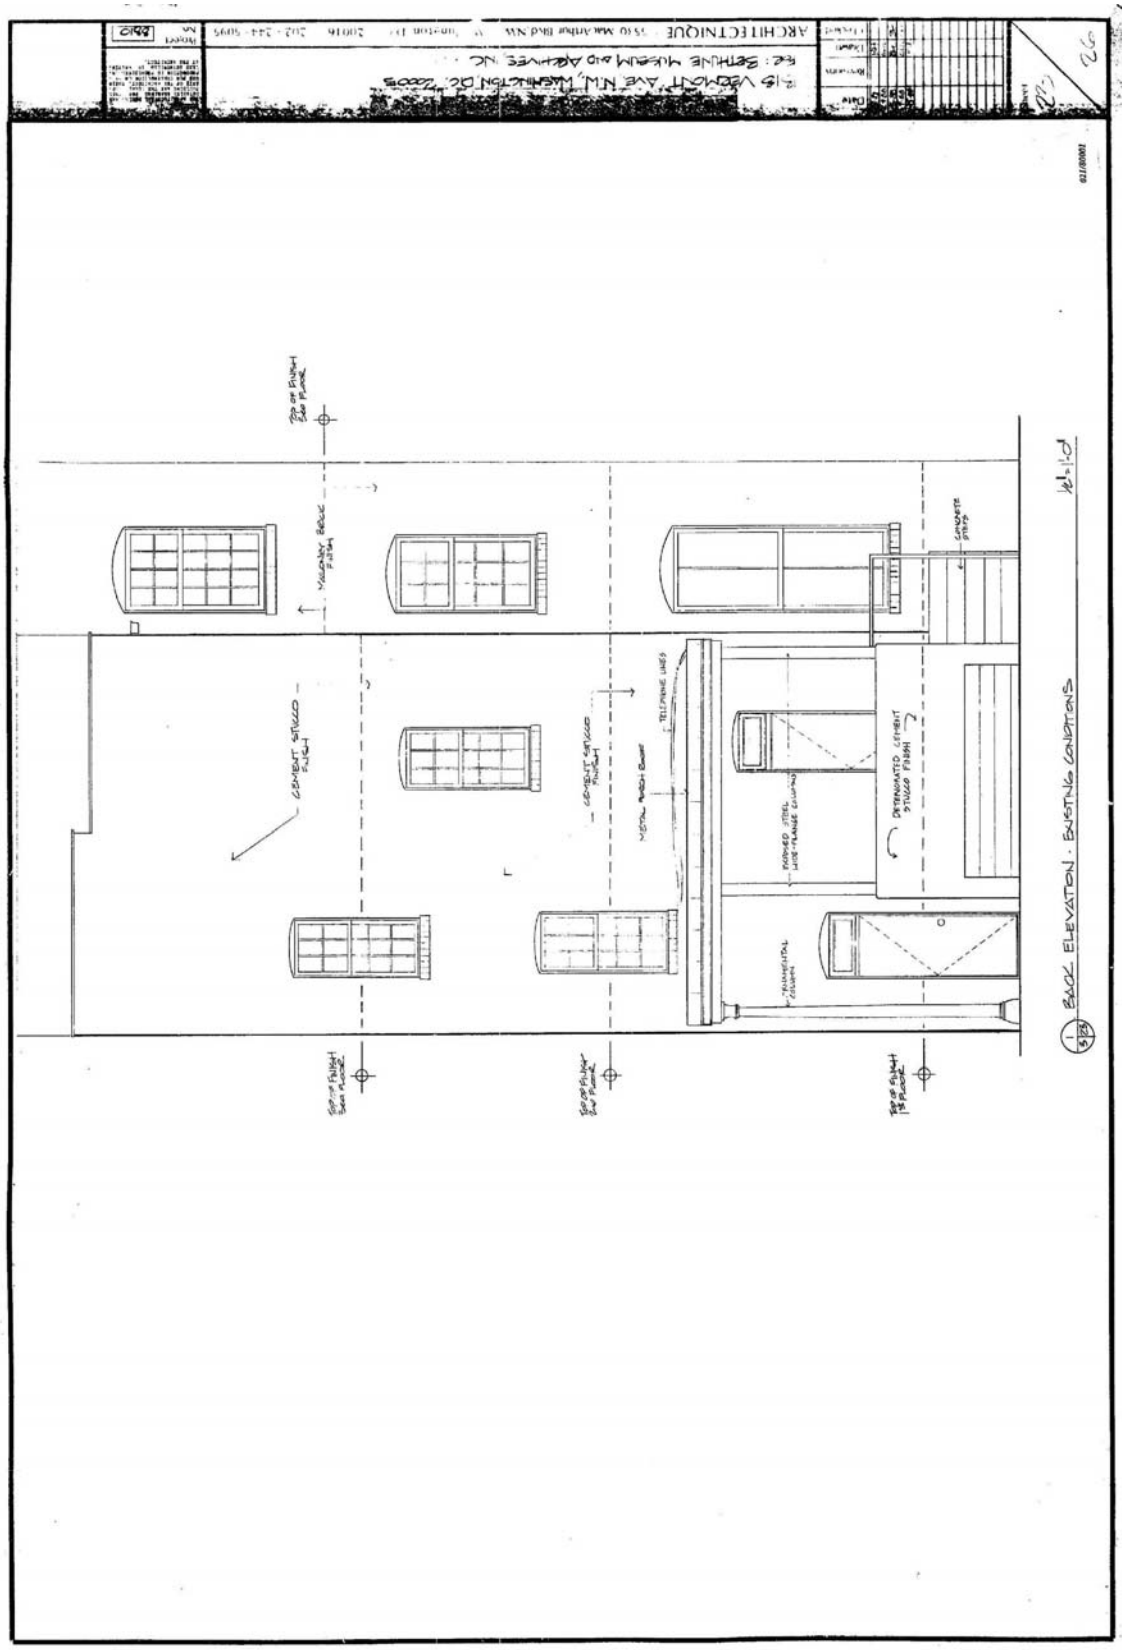
BACK ELEVATION - EXISTING CONDITIONS
CEMENT STUCCO FINISH
DETERIORATED CEMENT STUCCO FINISH
METAL MESH GUARD
TELEPHONE LINES
PAINTED STEEL WIRE-MESH GUARD
GUTTER
DOWNSPOUT
