ENGLISH CAMP

San Juan Island NHP

HISTORIC STRUCTURES REPORT - PART I

June 1969

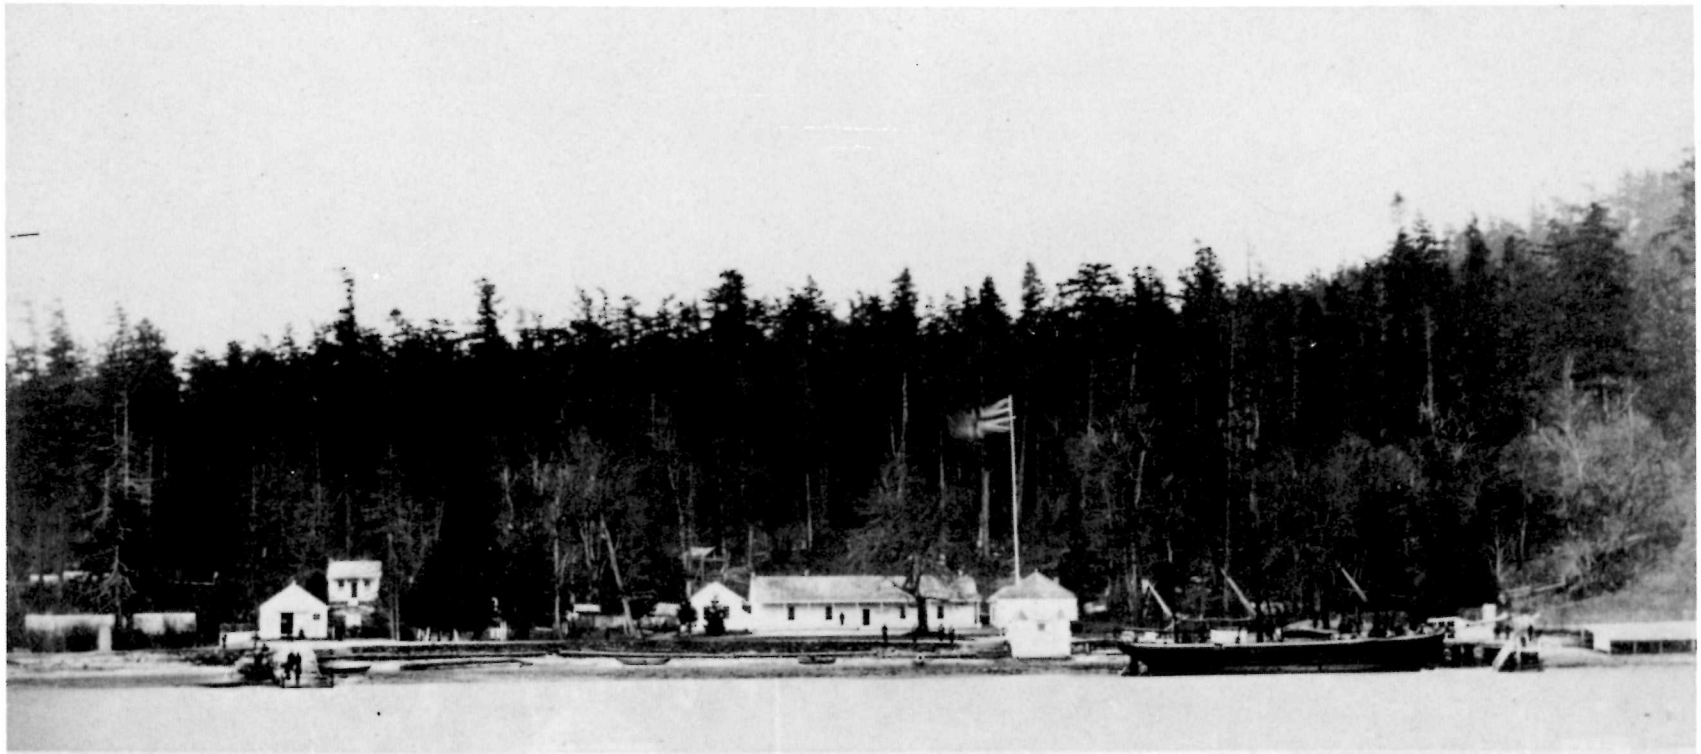
2. The storehouse, to the left of the photograph and immediately above the landing ramp, and the blockhouse, in front of the flag staff, are both white. Behind the left side of the blockhouse, a small portion of the barracks building still standing appears. Date of photograph is unknown; it was taken relatively early in the camp's history, for a later row of small buildings behind the main barracks does not appear. (The Public Archives of Canada, Ottawa.)

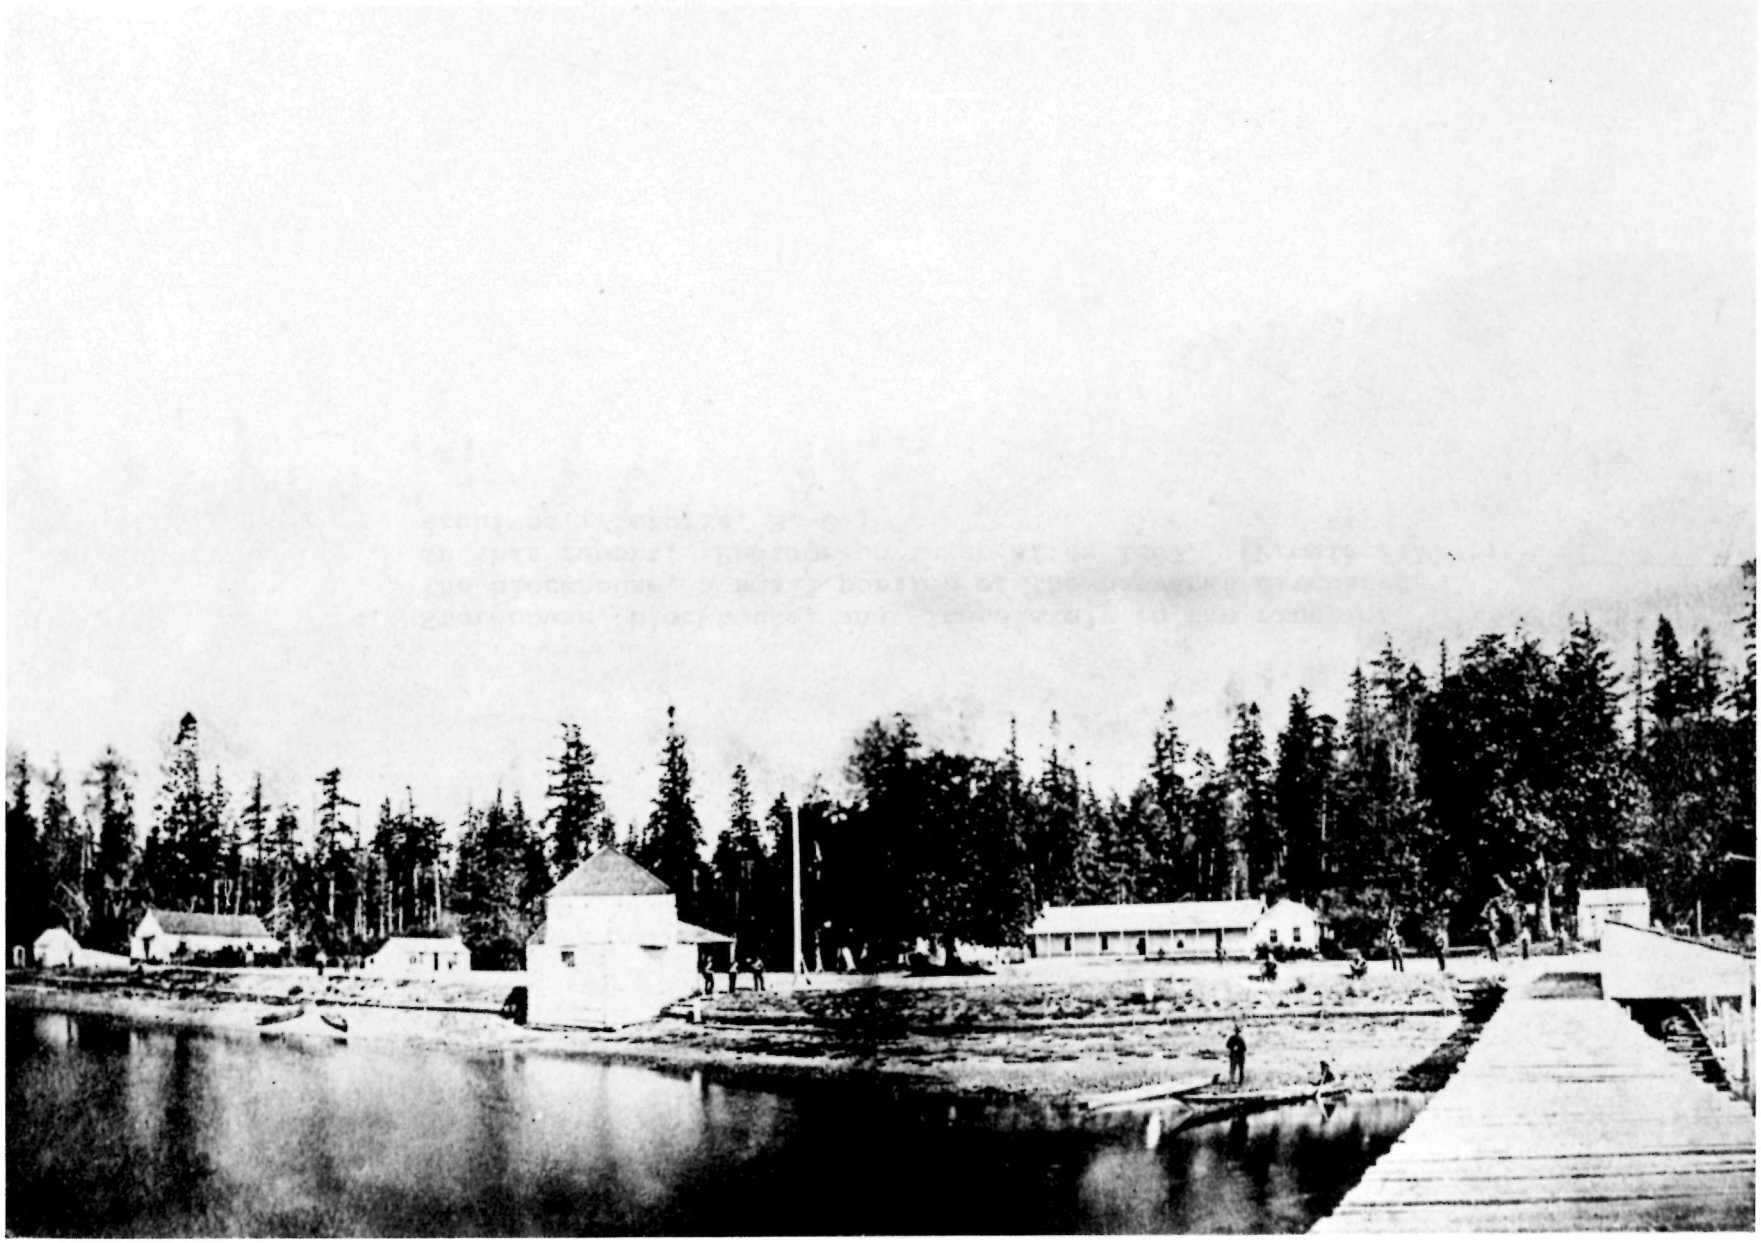
3. Storehouse, second structure from left. Blockhouse. Original portion of the barracks building immediately to the right of the long main barracks. This original portion had two windows in the end facing the camera. The extension added to this end had but one window in the end of it. (Provincial Archives, Victoria, B. C.)

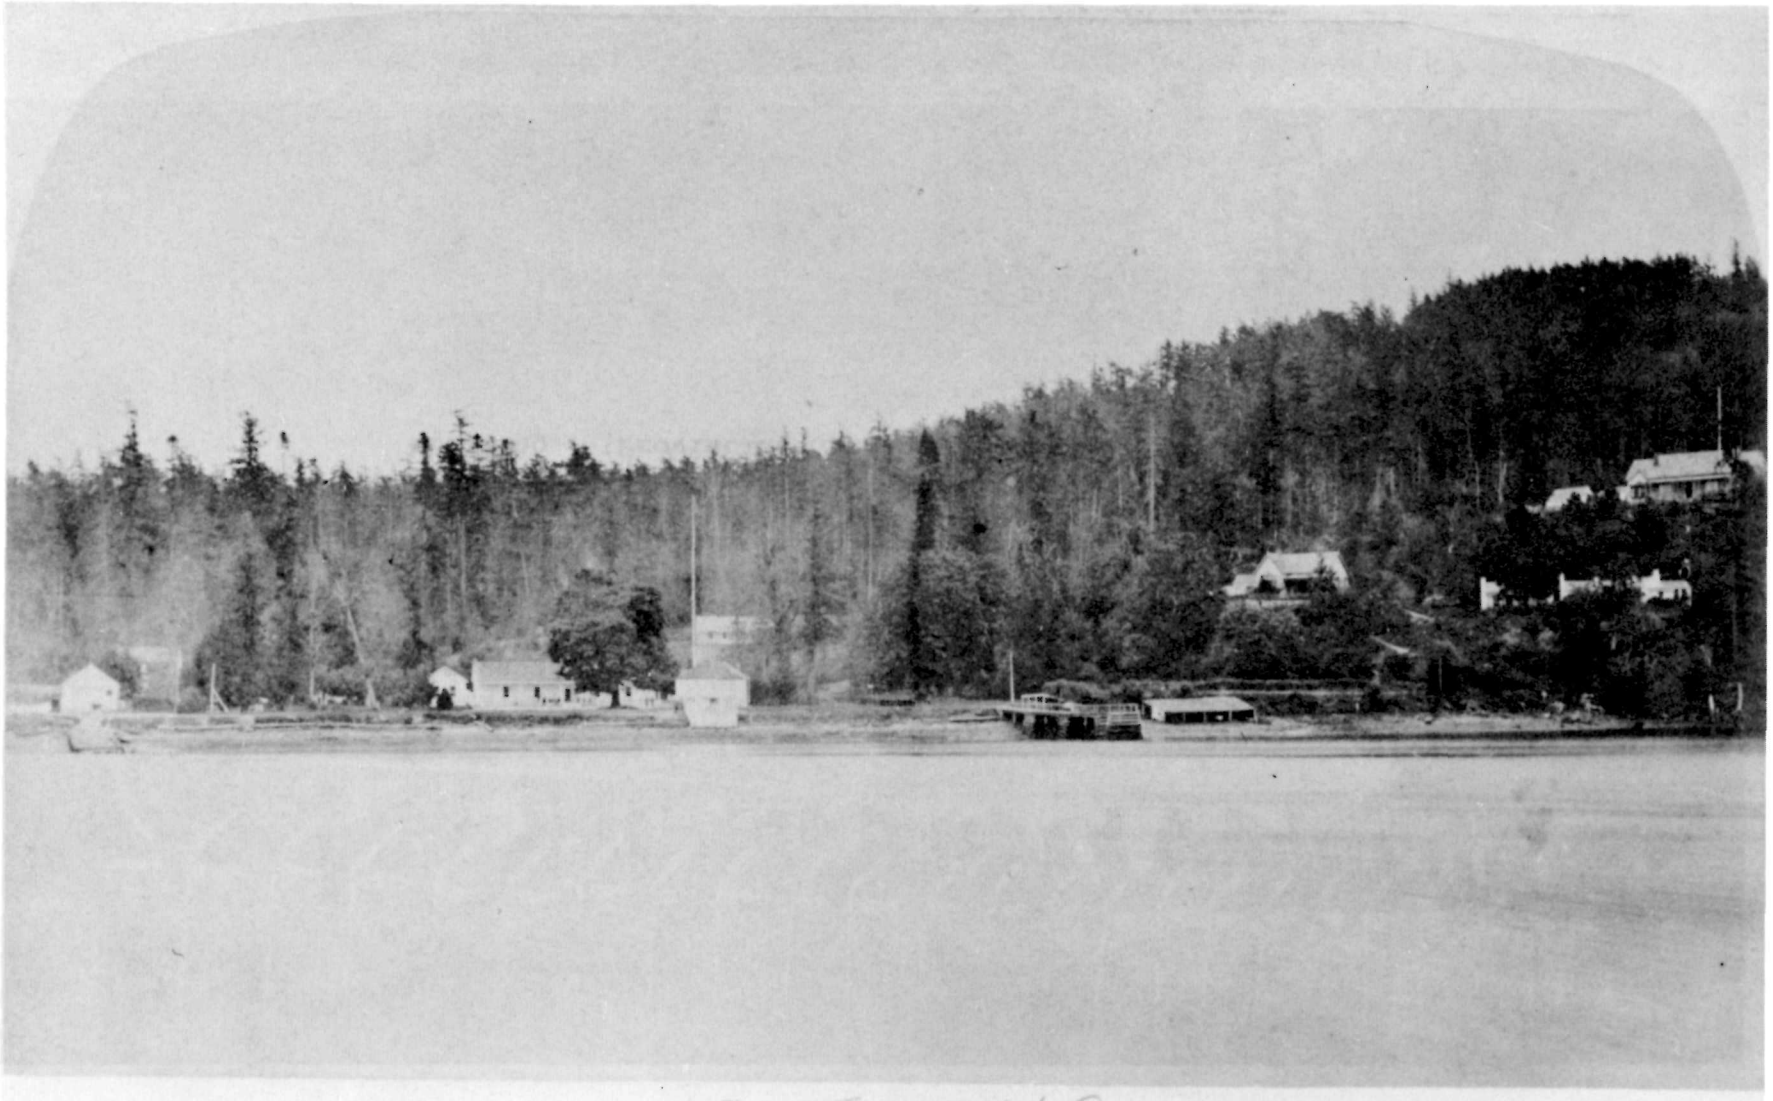
4. Storehouse, blockhouse, and, immediately to the right of the blockhouse, a small portion of the barracks discussed in this report. Photograph taken after 1867. (Provincial Archives, Victoria, B. C.)

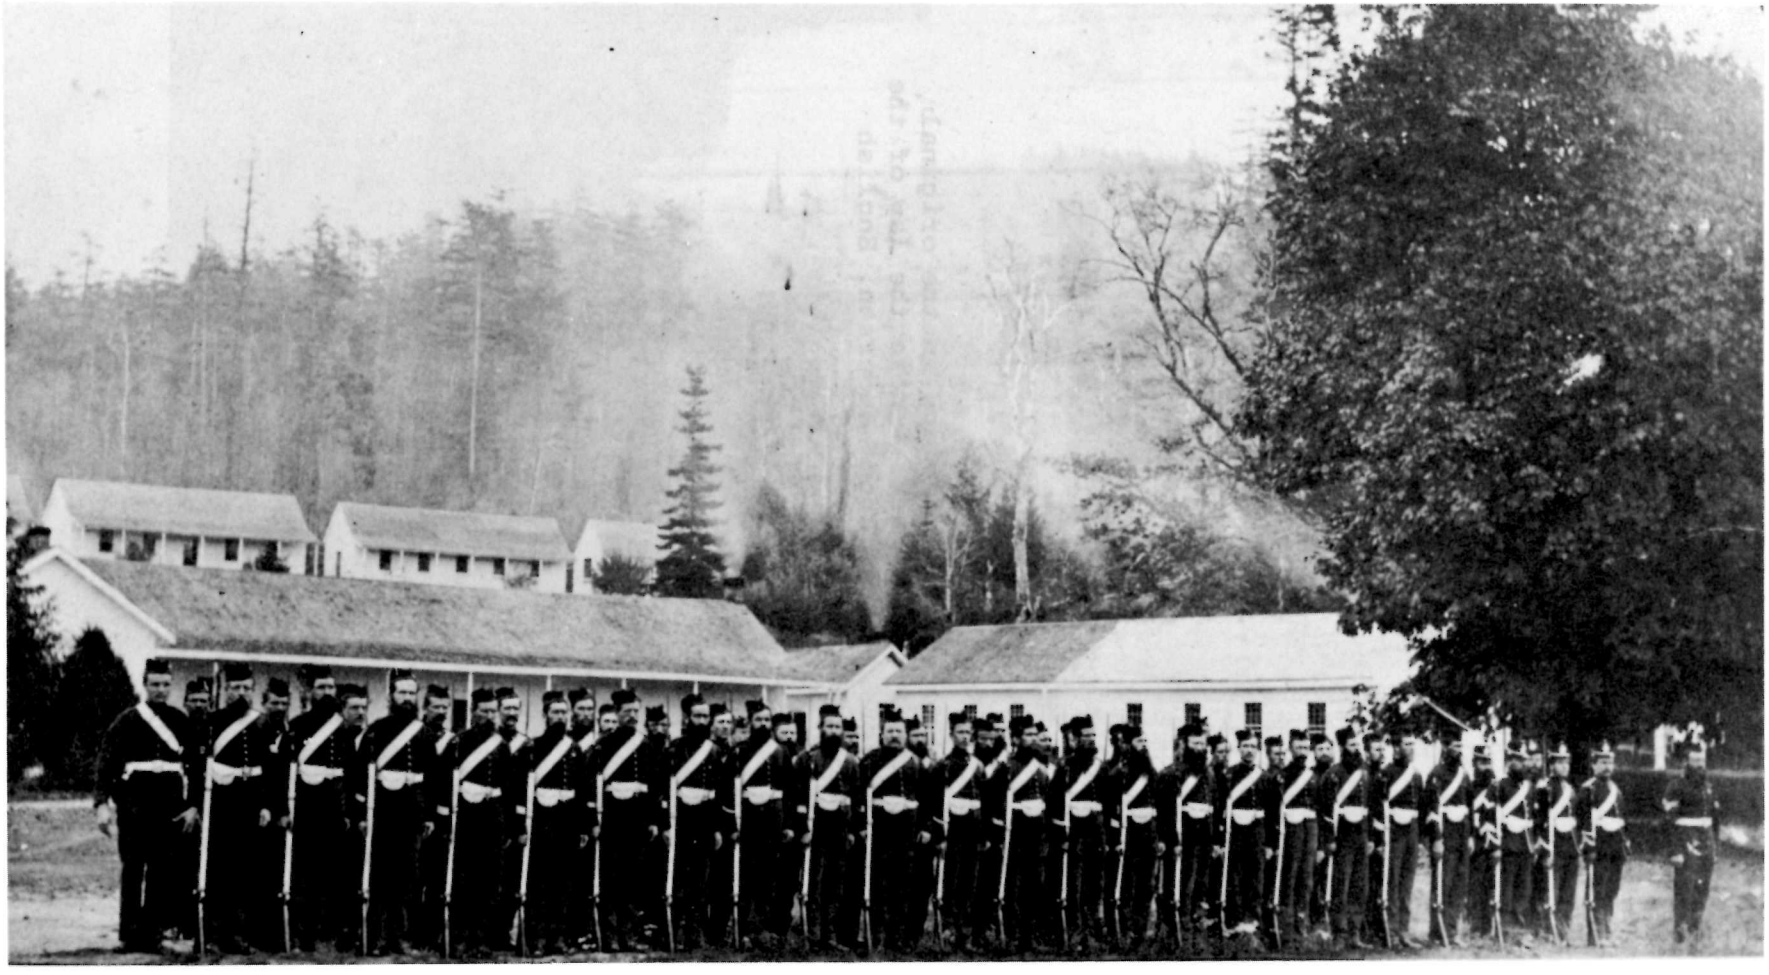
Possible uses for this lengthened building include: a second barracks, an orderly room (in part), a recreation room (in part), or unmarried NCO quarters. The windows along the northwest side (Photo No. 5) are of a number and size that suggest a concern for sufficient ventilation for sleeping quarters. On the southeast side today are the ruins of an exterior fireplace and chimney in the original portion of the building. Based on the remains of a foundation and photographic evidence, architects have concluded that a similar fireplace once stood toward the end of the addition to the building. (See architectural drawing.) A doorway exists there today.

5. Royal Marines in front of barracks. The barracks building discussed in this report is the long structure to the right. The change of color on the roof indicates the extension built sometime after 1866. The tree hides that portion of the roof that would give additional details about chimneys. Smoke appears to be rising, at a sharply different angle than at other chimneys, from behind the tree, indicating a chimney someplace at that end of the building. (Provincial Archives, Victoria, B. C.)

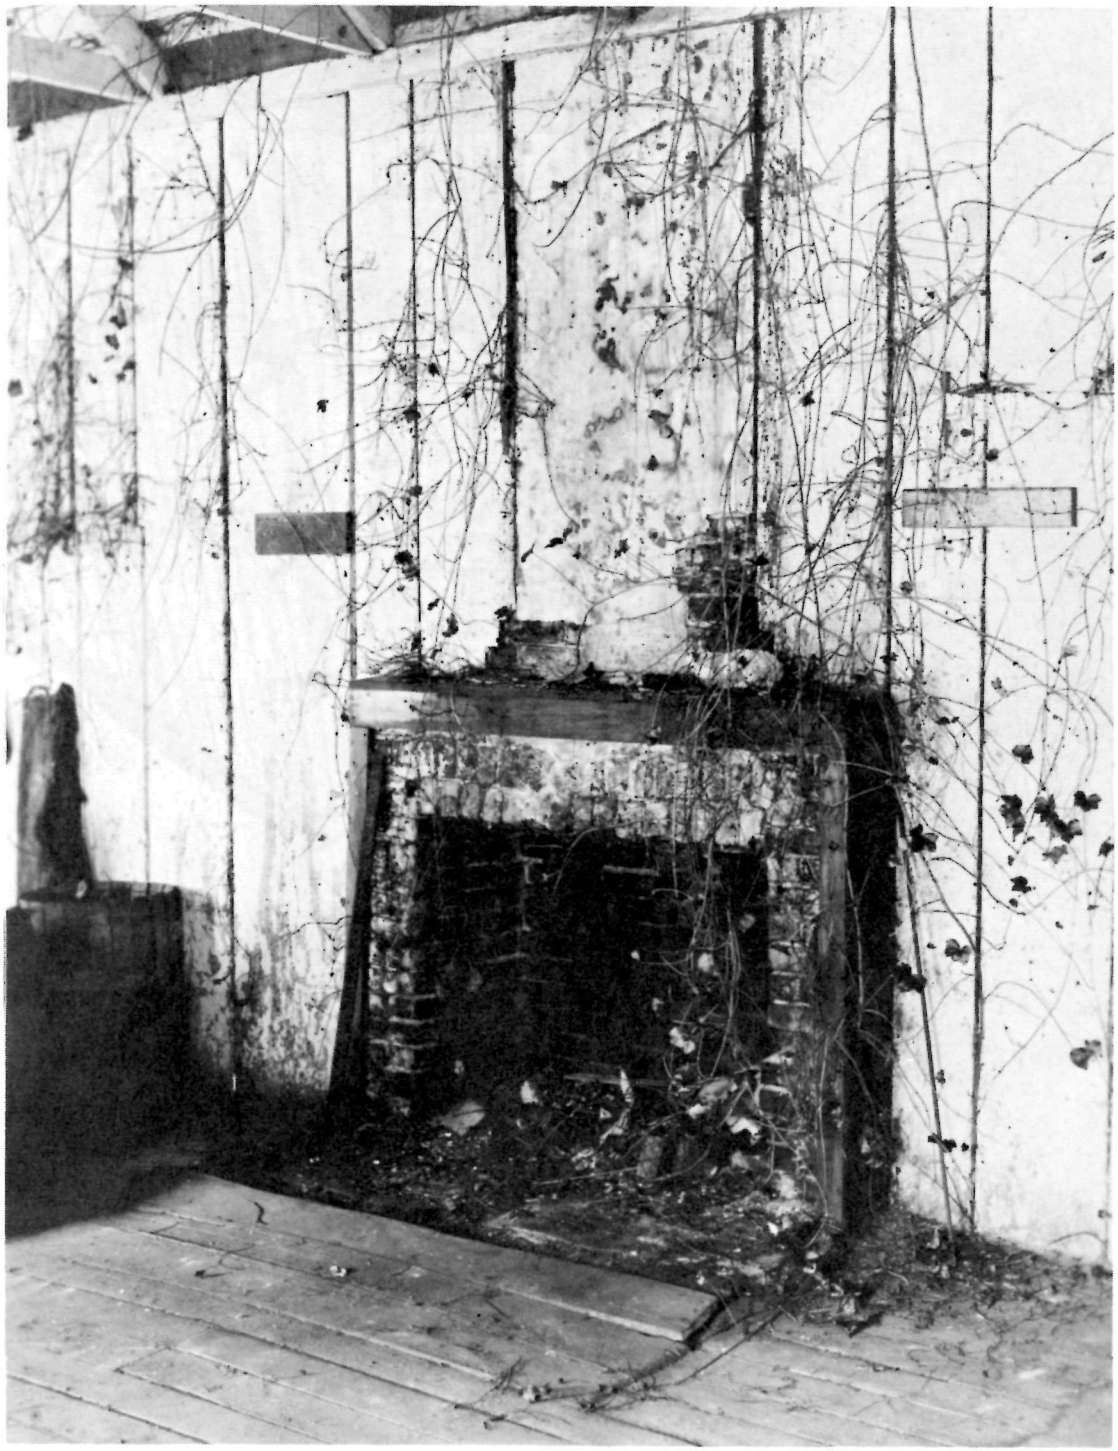
6. Said to be the fireplace in the original part of the barracks - note the lay of the rafters. (Mrs. Rhoda Anderson, English Camp, San Juan Island.)

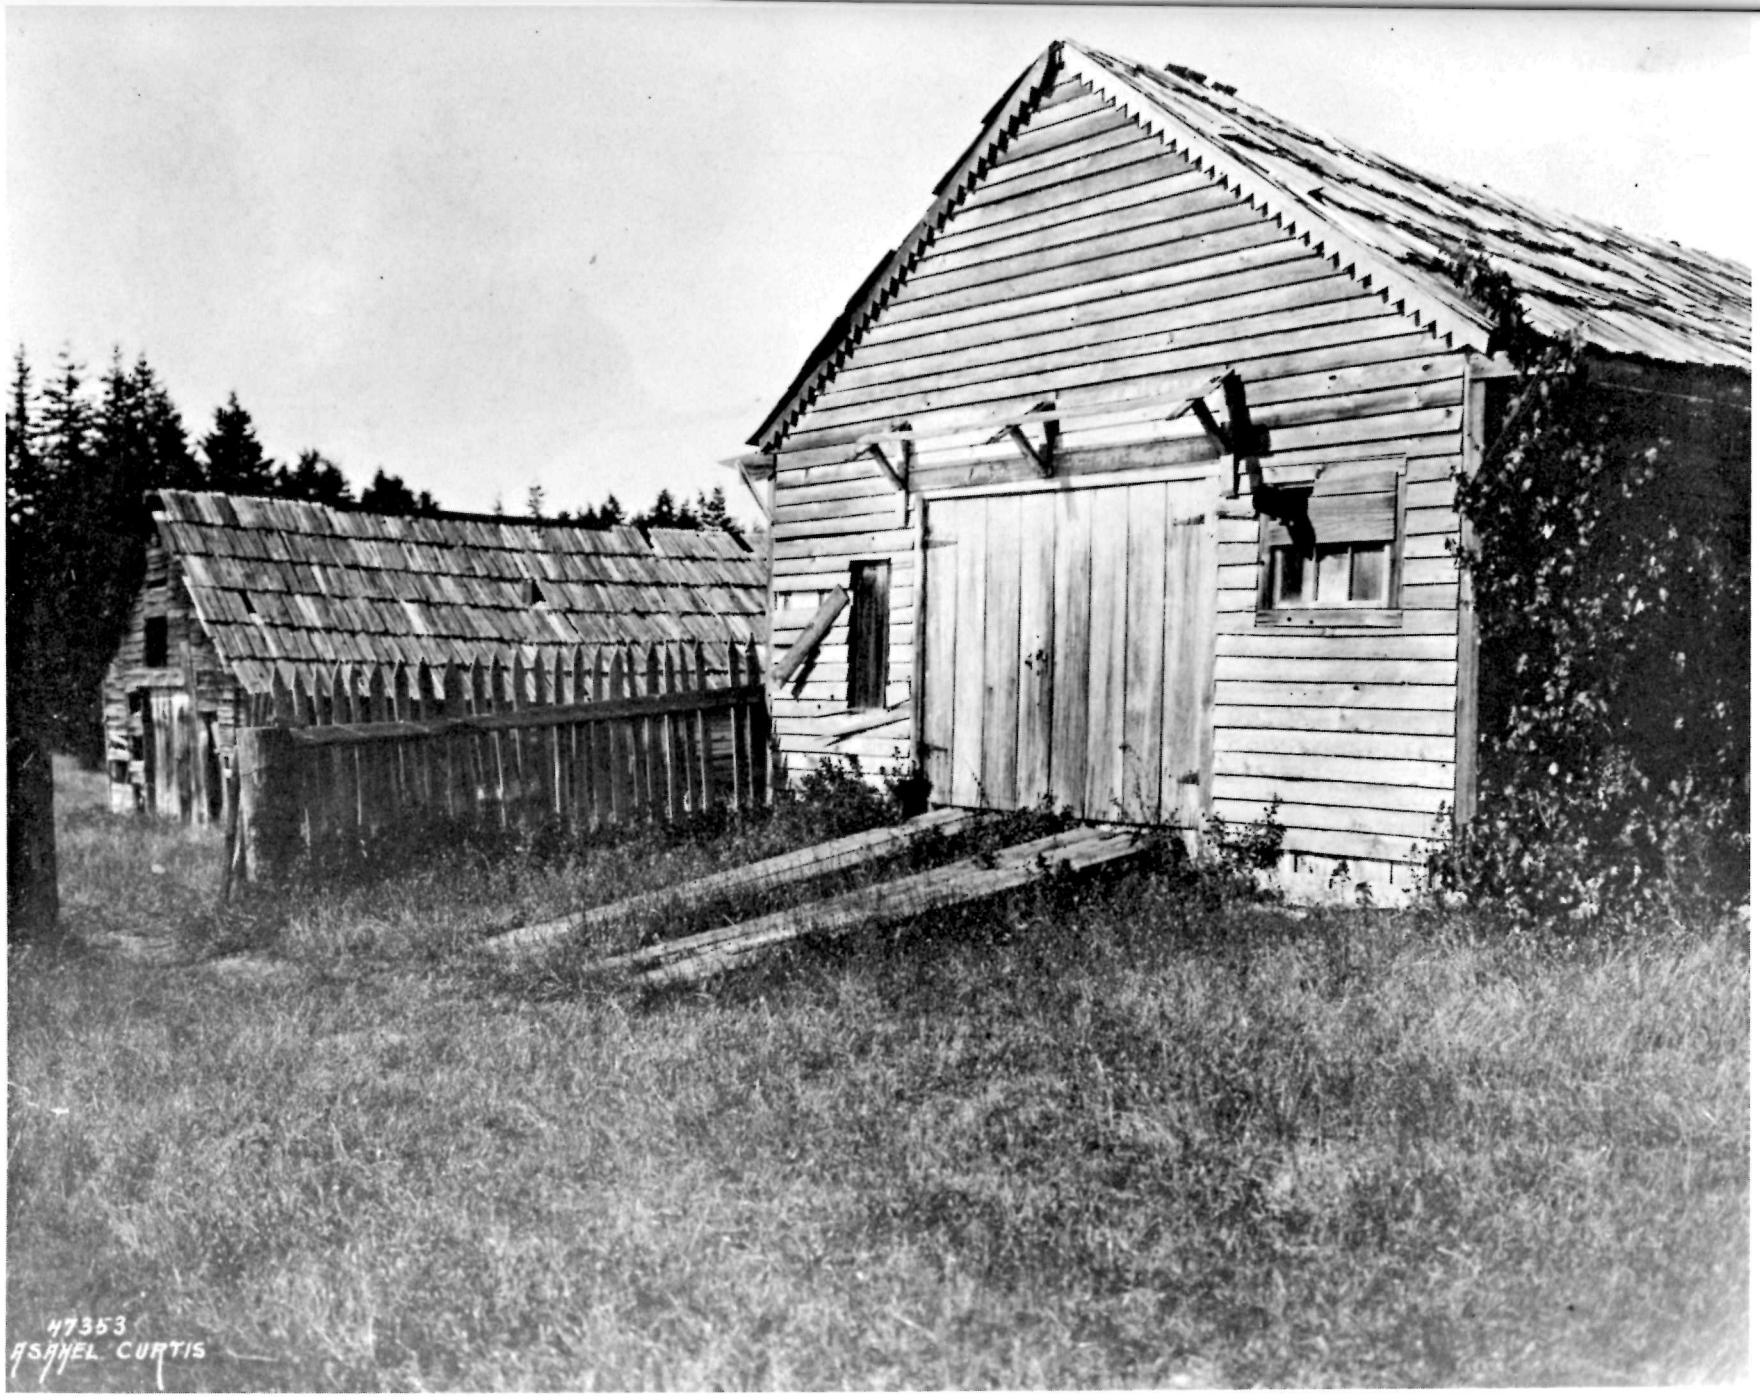
7. Storehouse. Photograph is dated July 24, 1924, and is in the Curtis Collection, Washington State Historical Society Tacoma, Wash. It is the only illustration to show the decorative bargeboards on the gable.

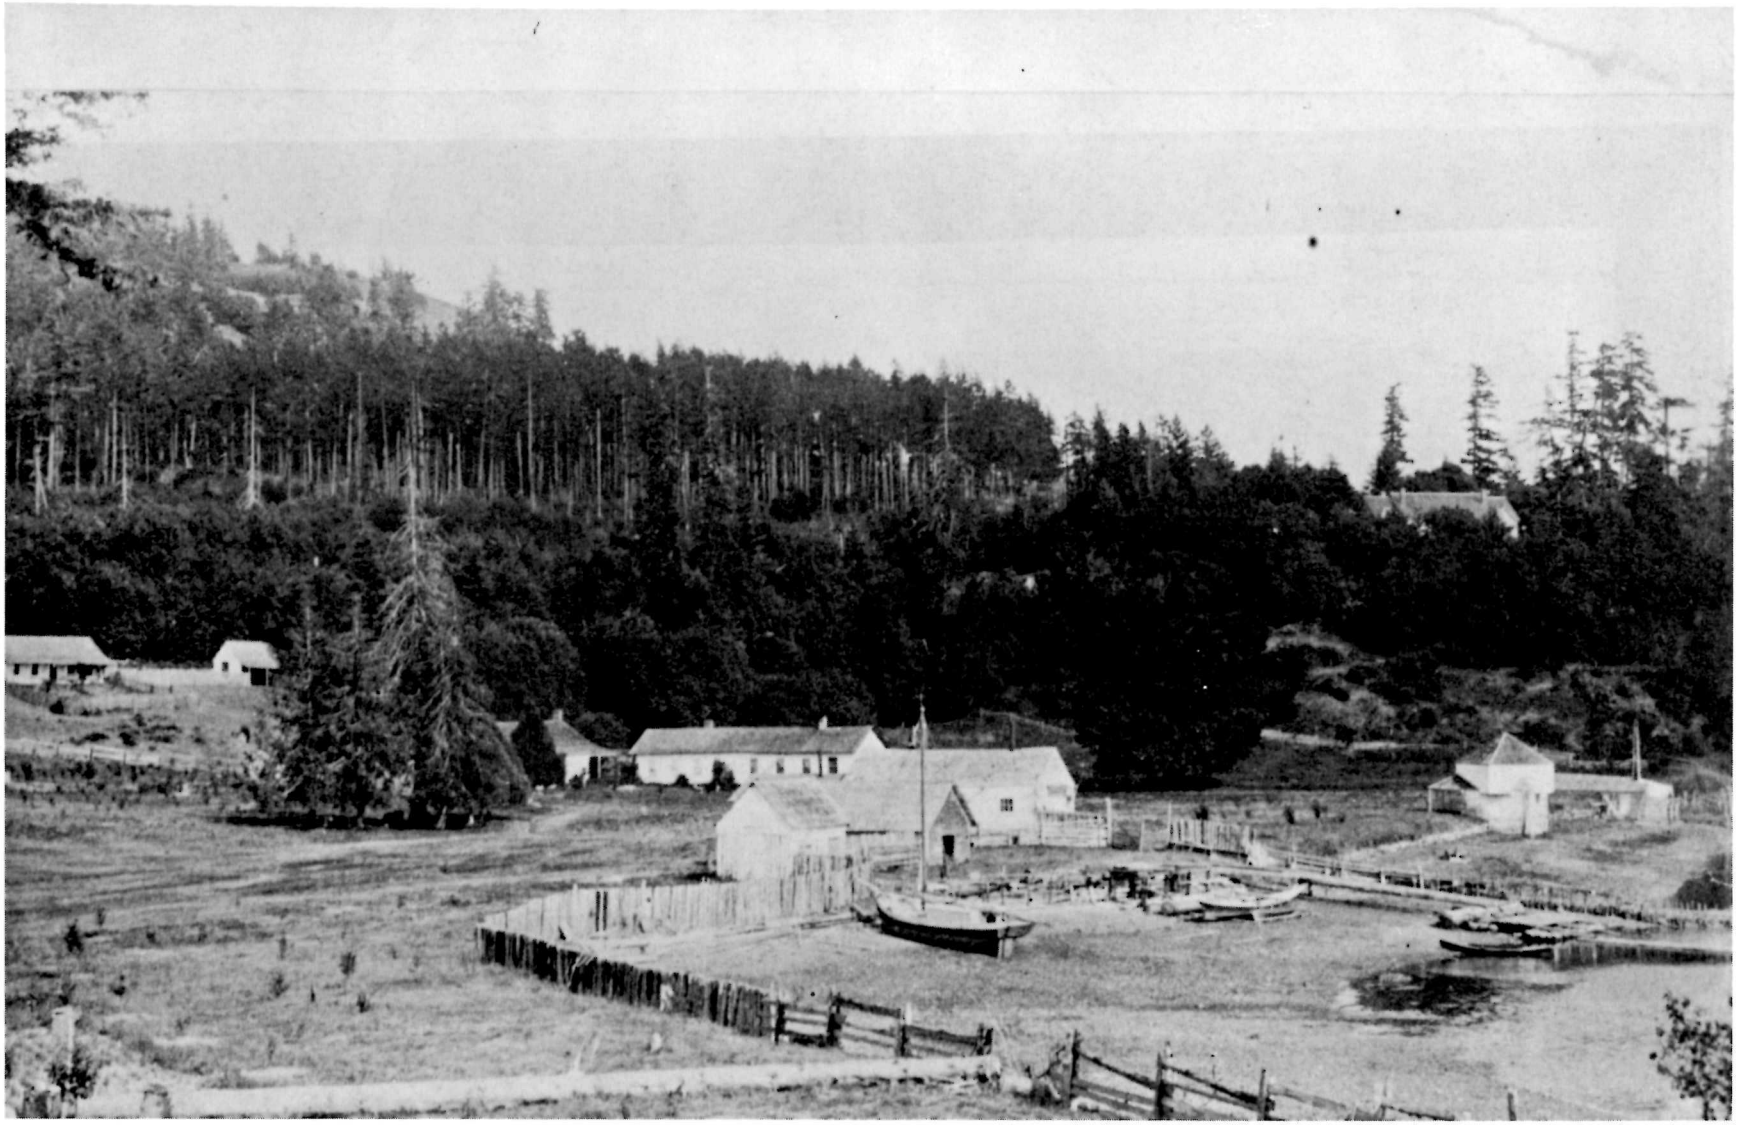
12. Another undated photograph showing numerous changes made by settlers. Photograph taken before 1895 when the commanding officer's house, in the trees, is said to have burned. This is the best known picture of the barracks; unfortunately, it is dated well after the marines' departure. (Friday Harbor Drug Co., San Juan Island.)

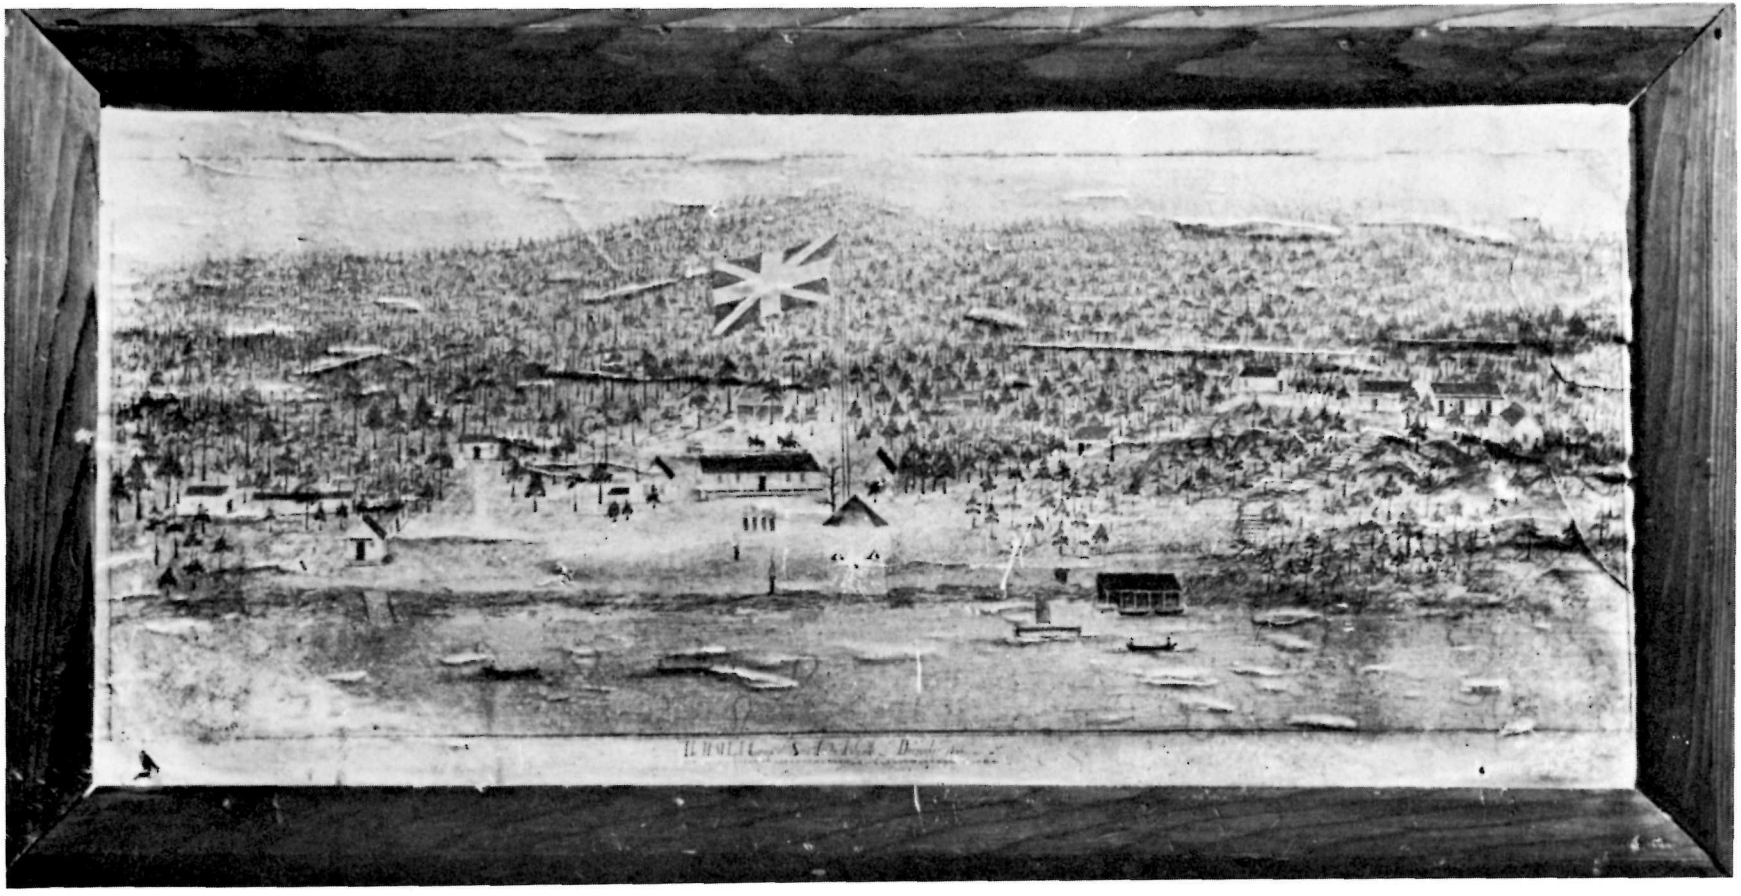
As early as 1866, a small addition appeared at the back end of the storehouse (Illustration No. 13). Ruins of an addition at this location are still to be found (Photos. No. 8 and 9). Architectural analysis will indicate if the present ruins are from the historic period or from later occupation.

13. Sketch of English Camp, 1866. Storehouse, toward left, shows an addition to the far end. This addition has different proportions than the ruins still to be found on the site. (National Park Service.)

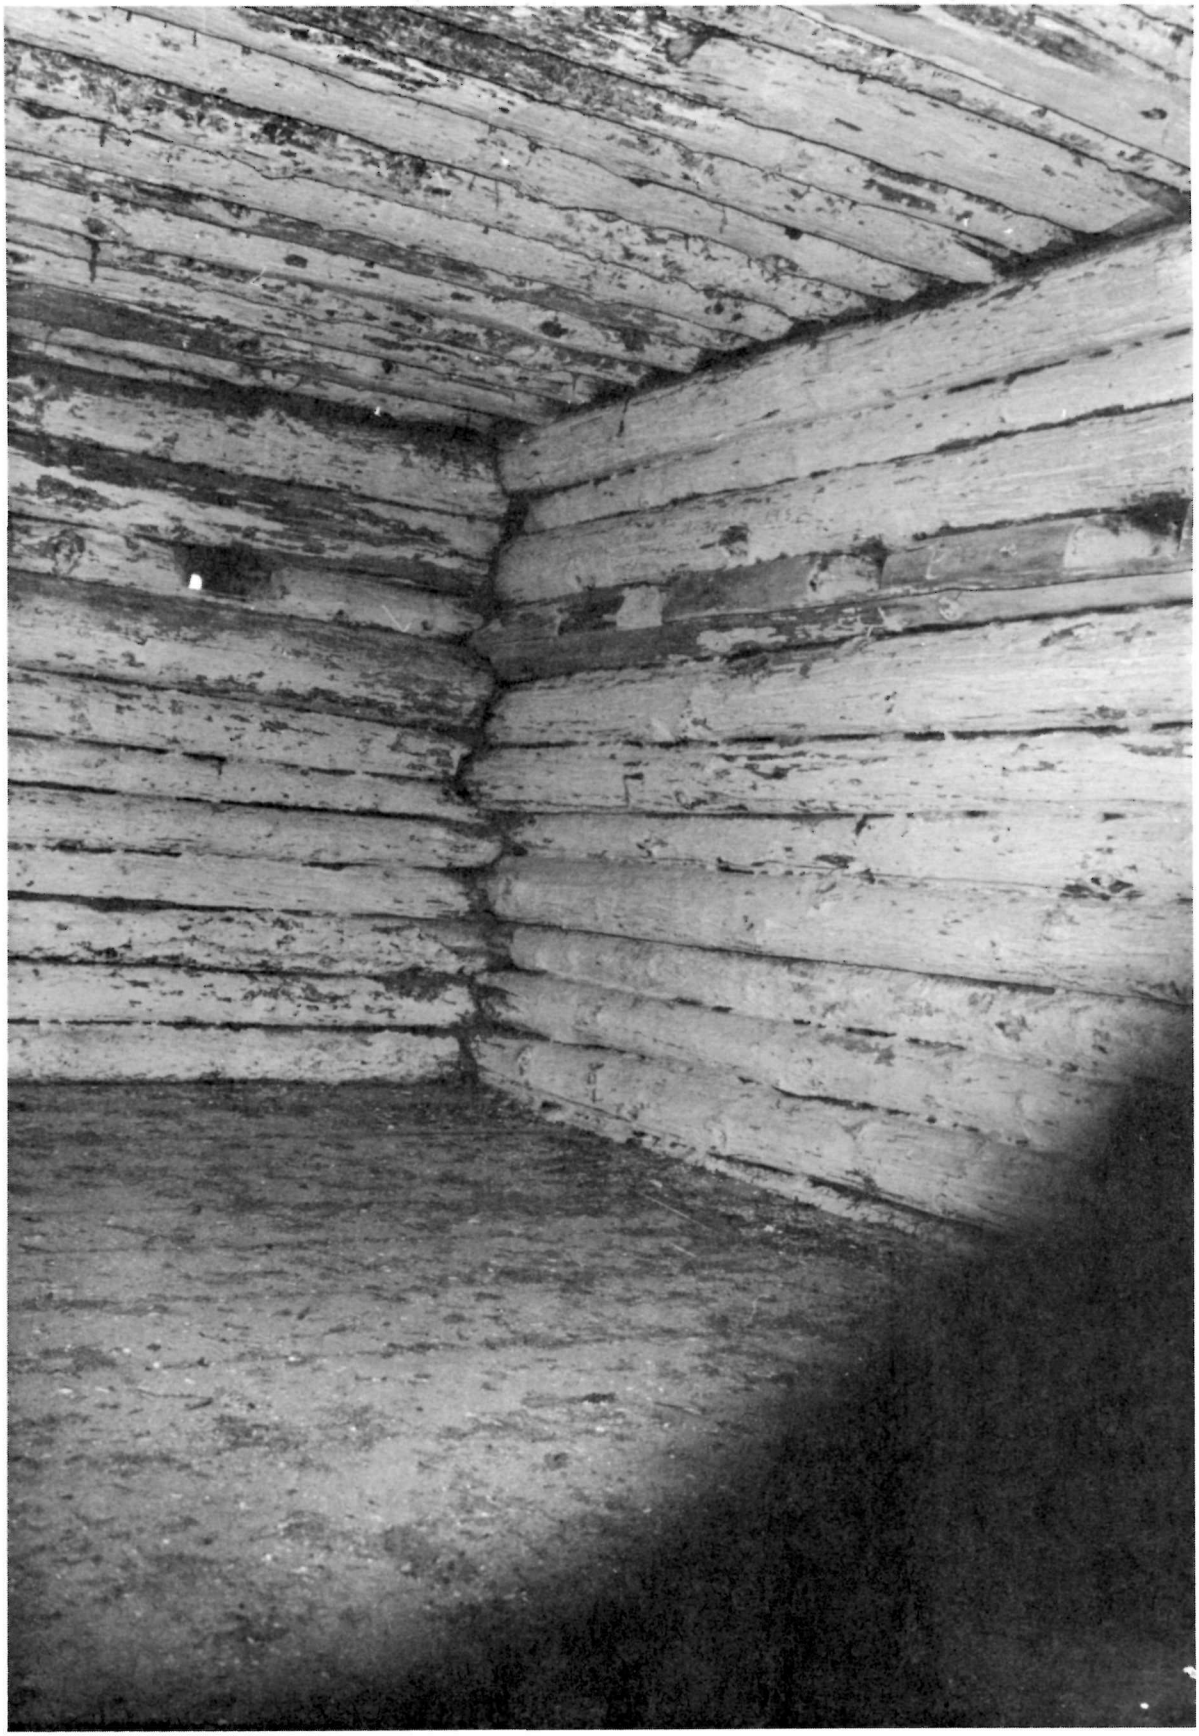
14. Interior of blockhouse today. Note log ceiling and rifle slots.

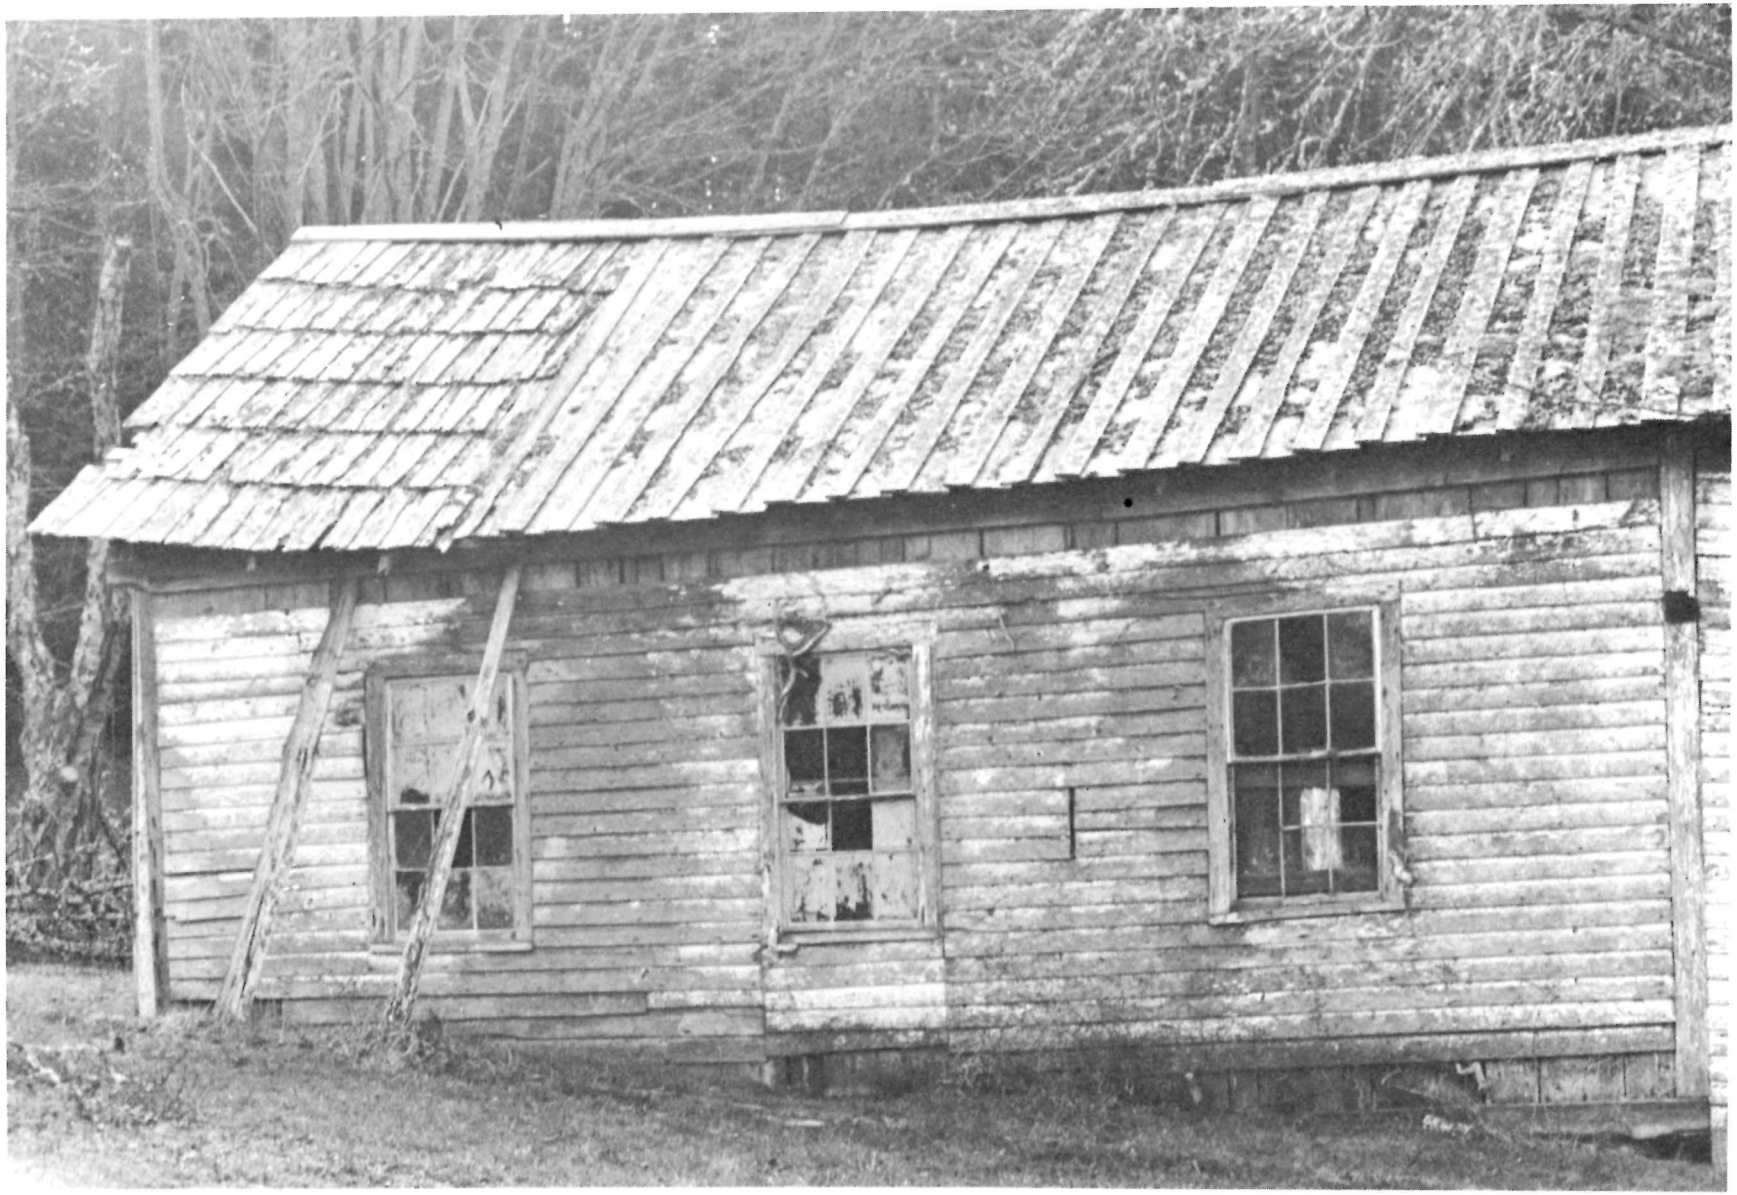
15. Southeast side of addition to the barracks. Doorway apparently cut in same area that a fireplace and chimney once stood.

16. Southeast side of original section of barracks. Fireplace rubble lies against building; boards cover fireplace opening.

17. Northeast side of original section of barracks.

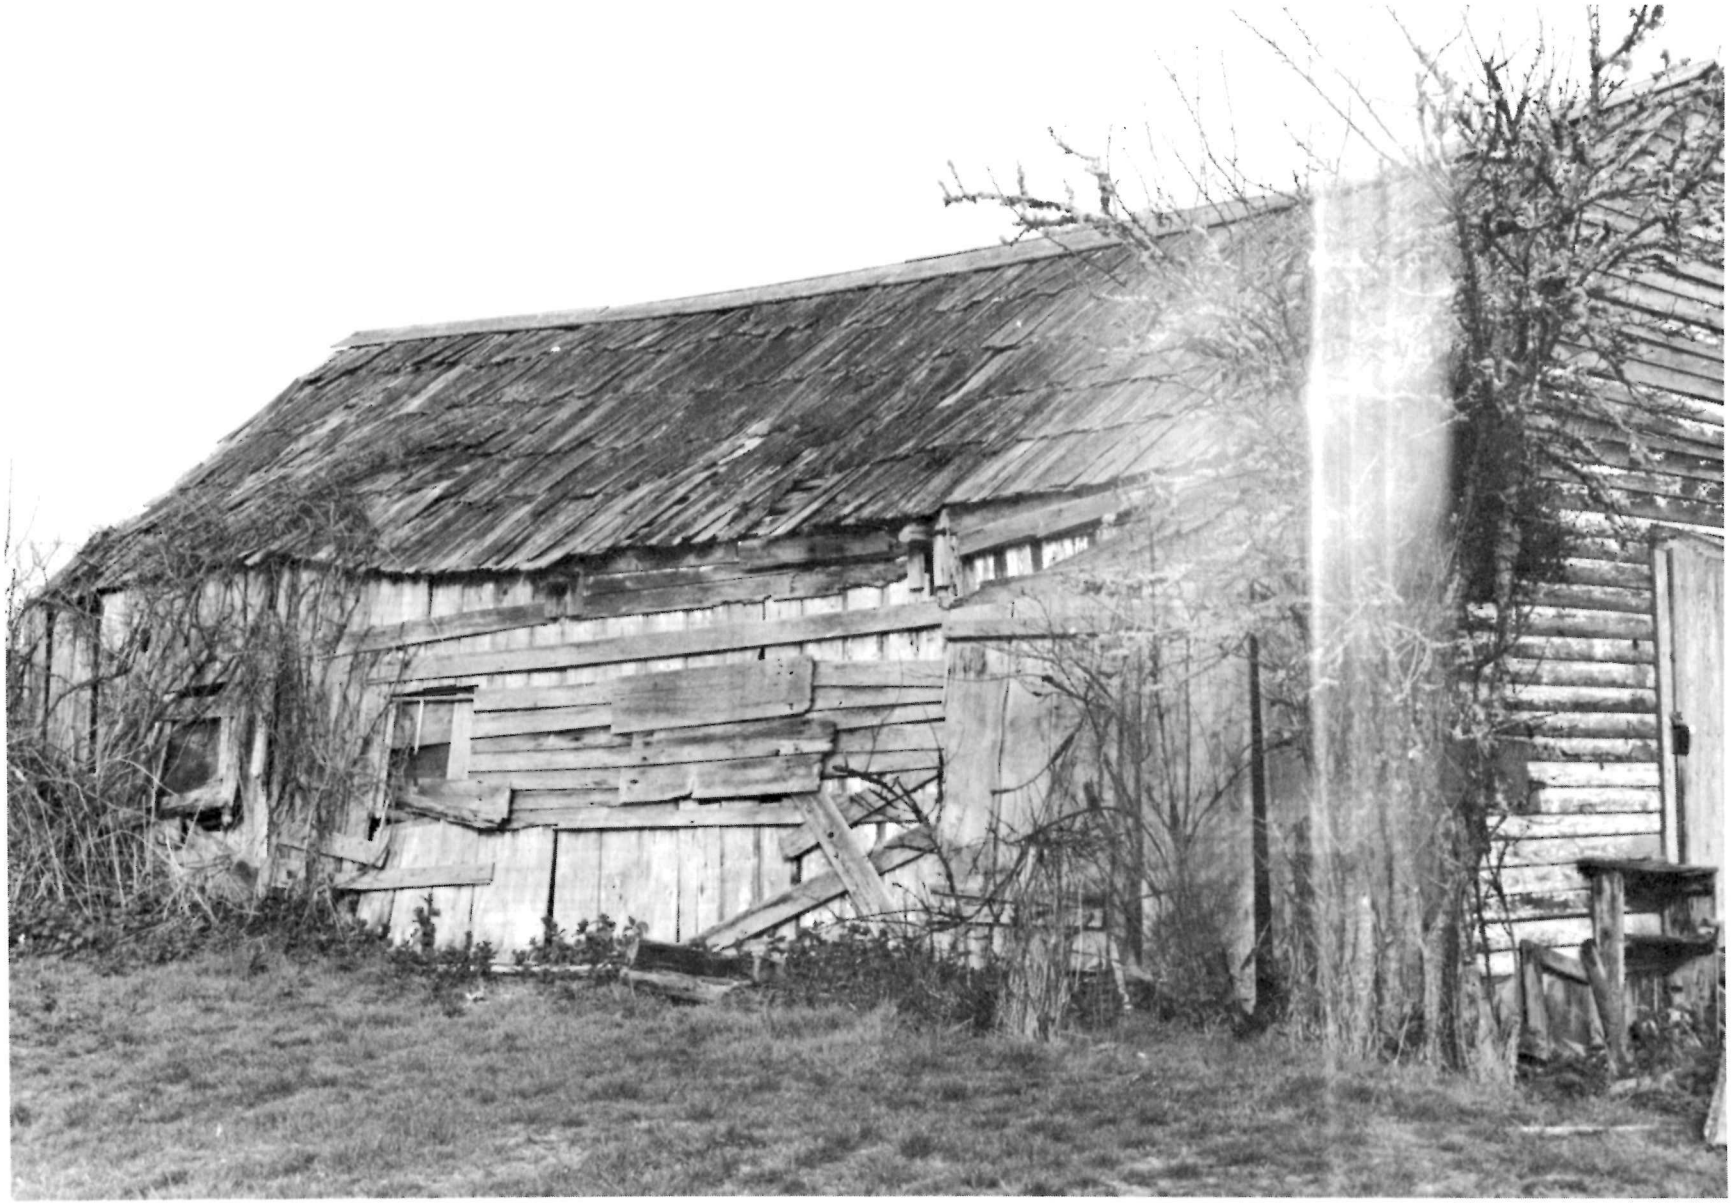
18. Southeast side of storehouse. The original board and batten walls were later sheathed with clapboard.
