FARMING AT THE WATER'S EDGE

An Assessment of Agricultural and Cultural Landscape Resources in the Proposed Port Oneida Rural Historic District at Sleeping Bear Dunes National Lakeshore, Michigan

Midwest Regional Office
National Park Service
Omaha, Nebraska

1995

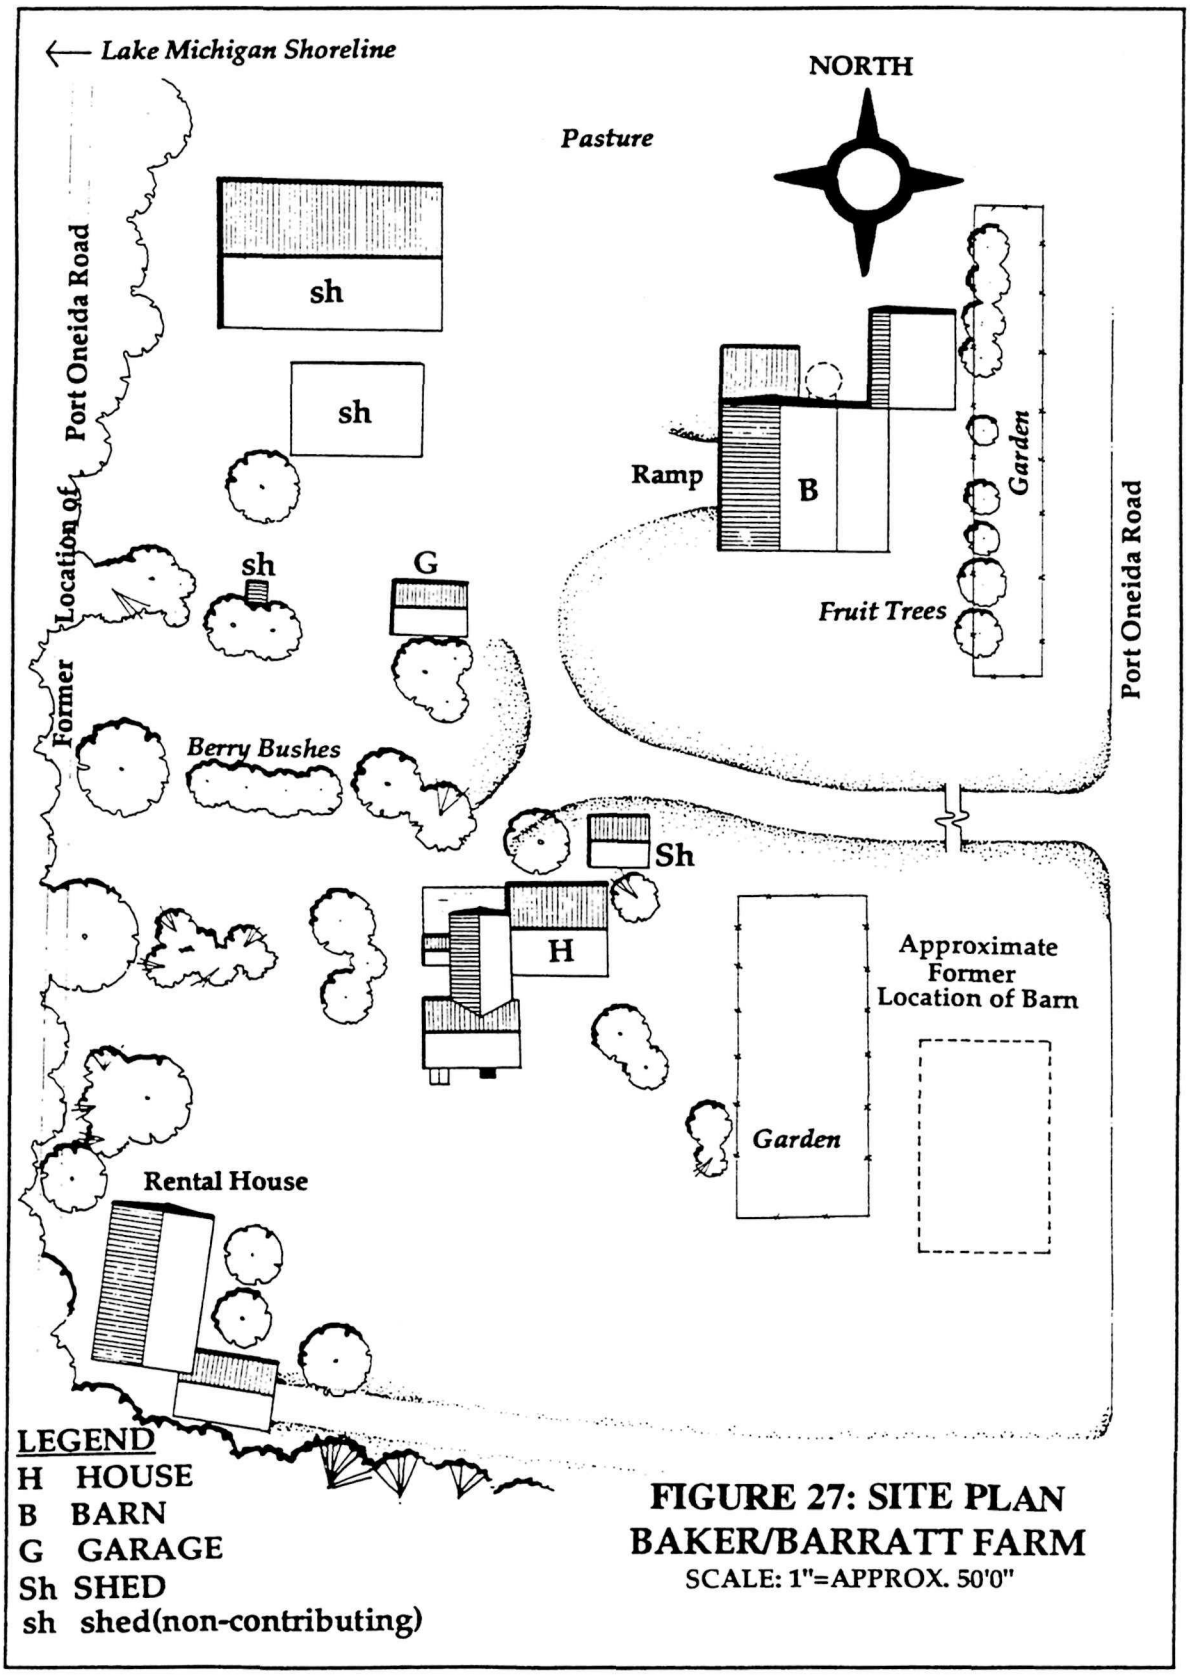
FIGURE 27: SITE PLAN
BAKER/BARRATT FARM
SCALE: 1"=APPROX. 50'0"

The house, barn, and chicken coop are altered, yet are in good to fair condition. The shed remains unaltered and is in excellent condition. The adjacent yard and pastures surrounding the farm are still in active use by Mr. and Mrs. Barratt, who continue agricultural activities on the farm.

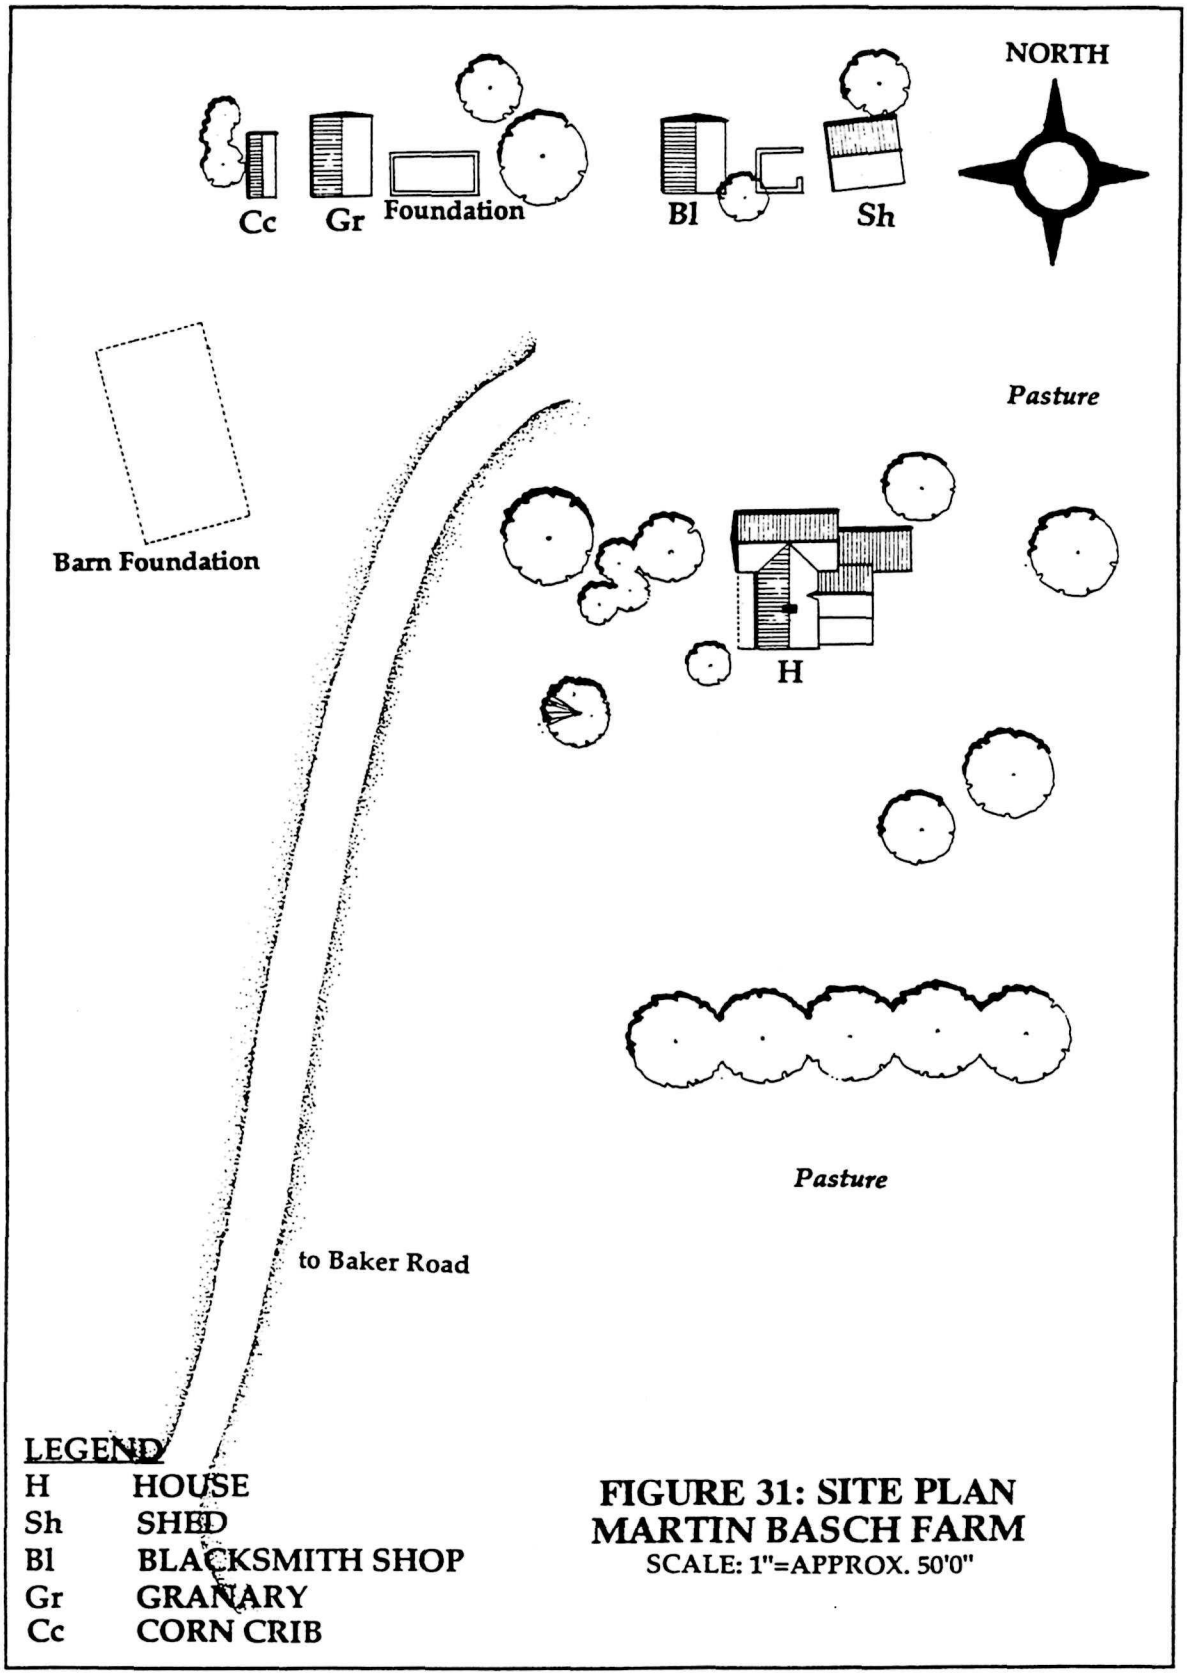
FIGURE 31: SITE PLAN
MARTIN BASCH FARM
SCALE: 1"=APPROX. 50'0"

All of the buildings that comprise this farmstead are in an advanced state of deterioration: they have been heavily vandalized during the approximately ten years since abandonment occurred. However, the skilled carpentry of Martin Basch is still evident in such exterior details as the pediments and circular gable windows that appear on the house.

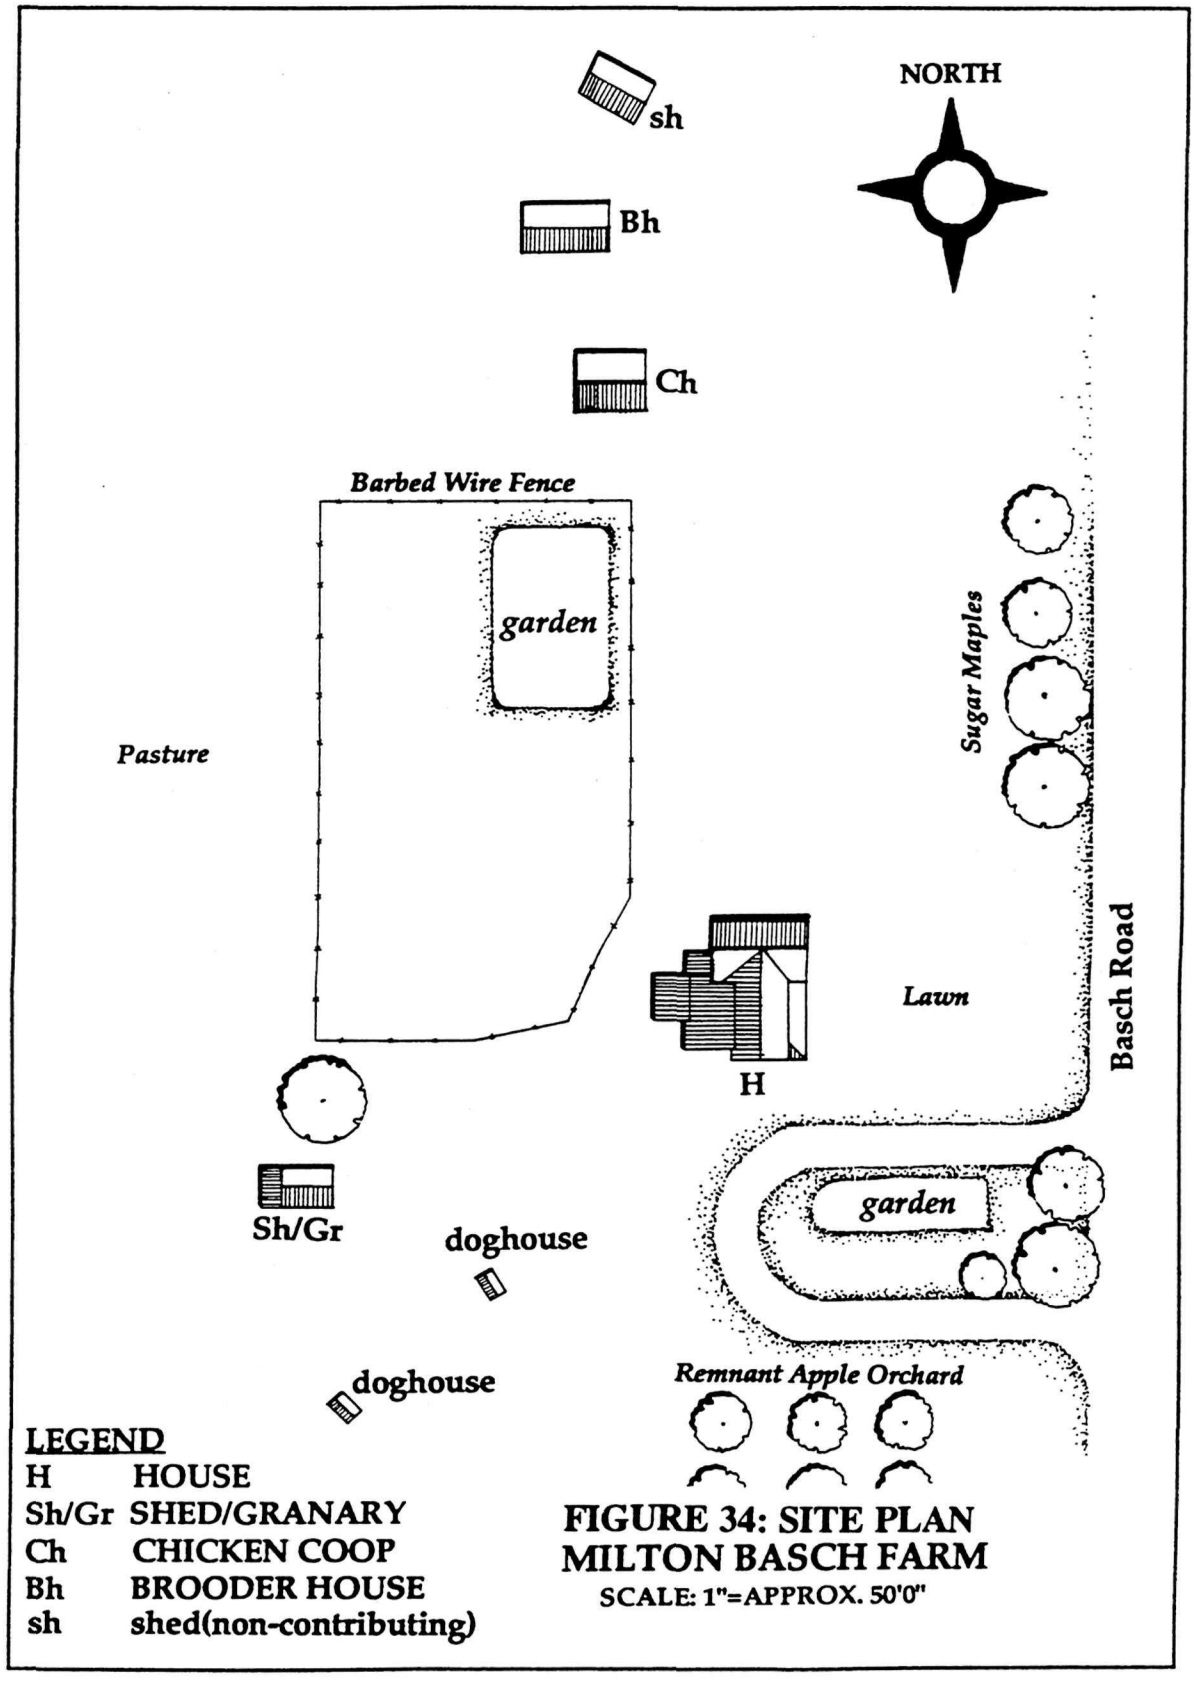
FIGURE 34: SITE PLAN
MILTON BASCH FARM
SCALE: 1"=APPROX. 50'0"

This is one of the few Port Oneida farms remaining in private ownership. The house is in excellent, unaltered condition. The shed/granary, chicken coop, and brooder house, although unaltered, are in fair condition and have deteriorated from neglect since farming ceased.

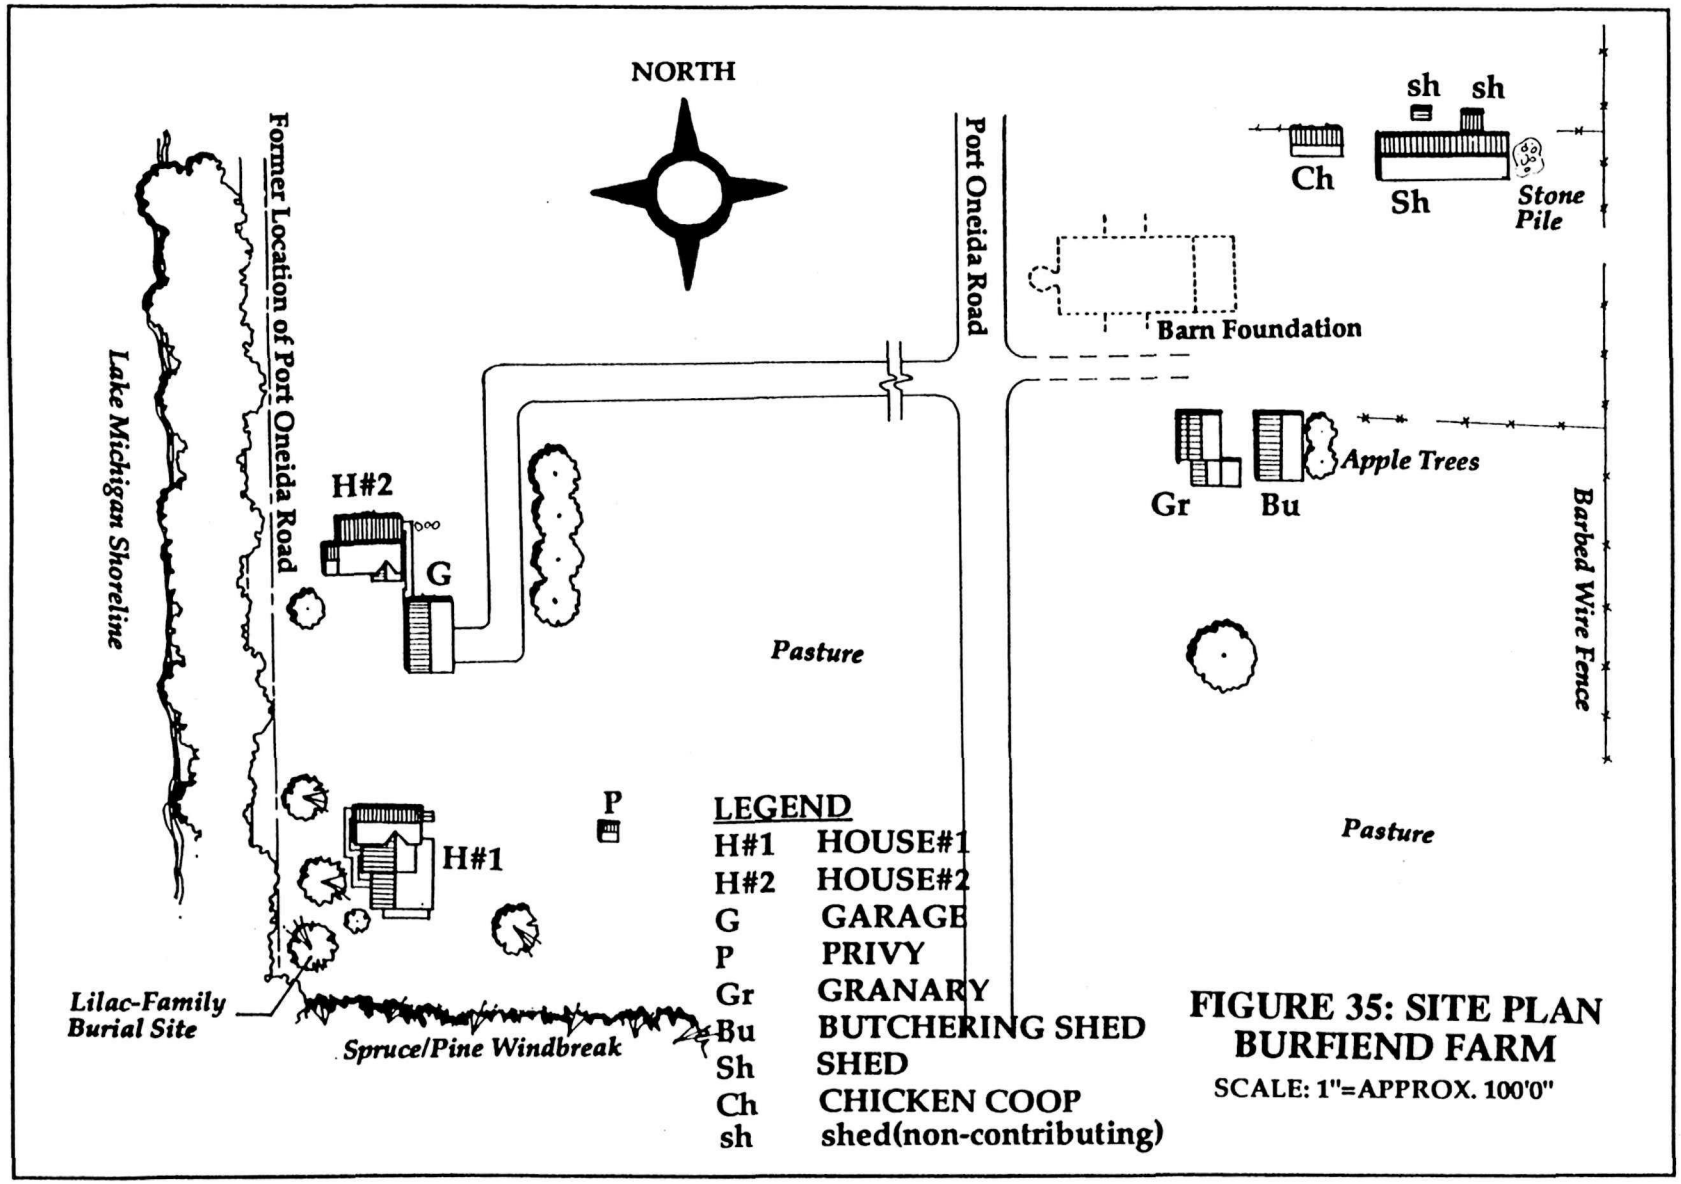
FIGURE 35: SITE PLAN BURFIEND FARM

The Burfiend houses and garage are altered, but in good condition. The unaltered privy remains in fair condition. The outbuildings have deteriorated to a greater degree, especially the granary, with its crumbling, concrete pier foundation. Other structures, including the butchering shed, chicken coop, and shed are in fair, but altered condition. The absence of the barn compromises the integrity of this farmstead; however, the presence of the barn foundation and the relatively high quality of the other buildings make it one of the most intact in the proposed district.

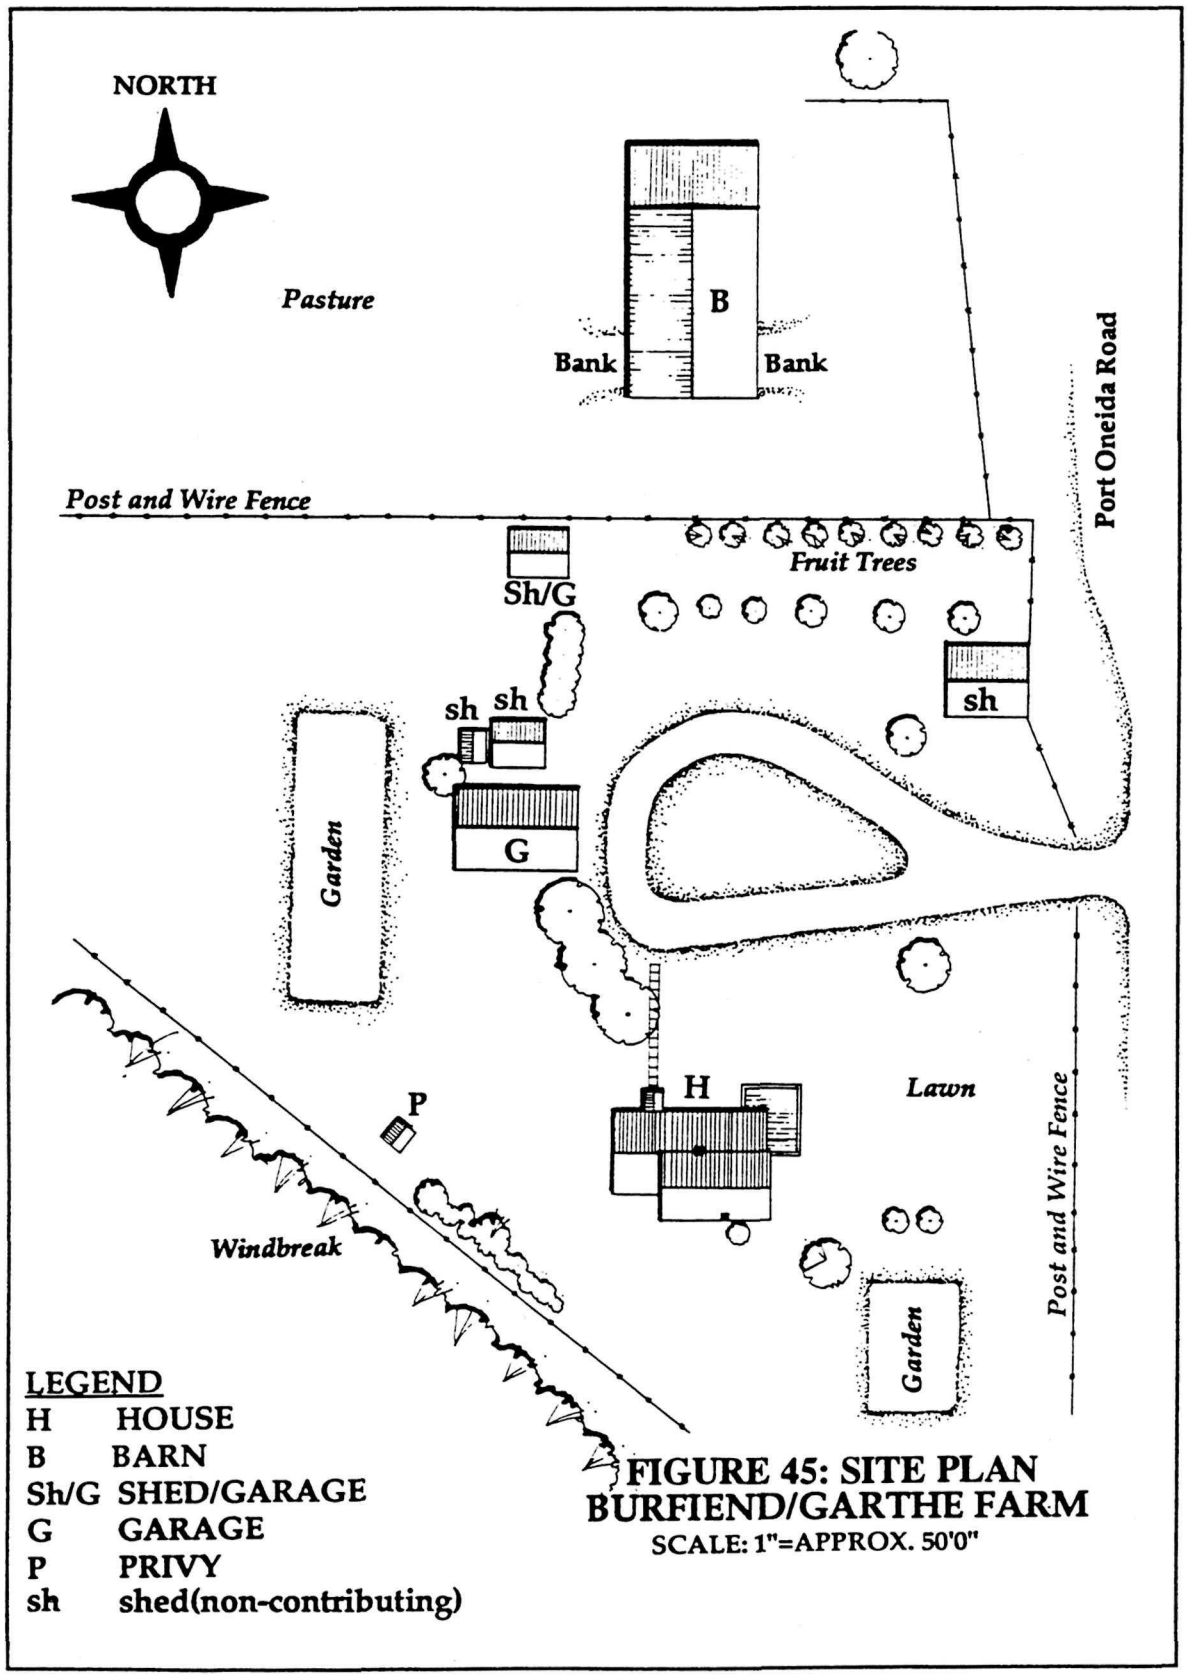
FIGURE 45: SITE PLAN
BURFIEND/GARTHE FARM
SCALE: 1"=APPROX. 50'0"

The Garthe house, barn, shed, and garage range from good to fair, altered condition. The privy is in excellent condition. This farm is one of only a few in Port Oneida that is occupied year round.

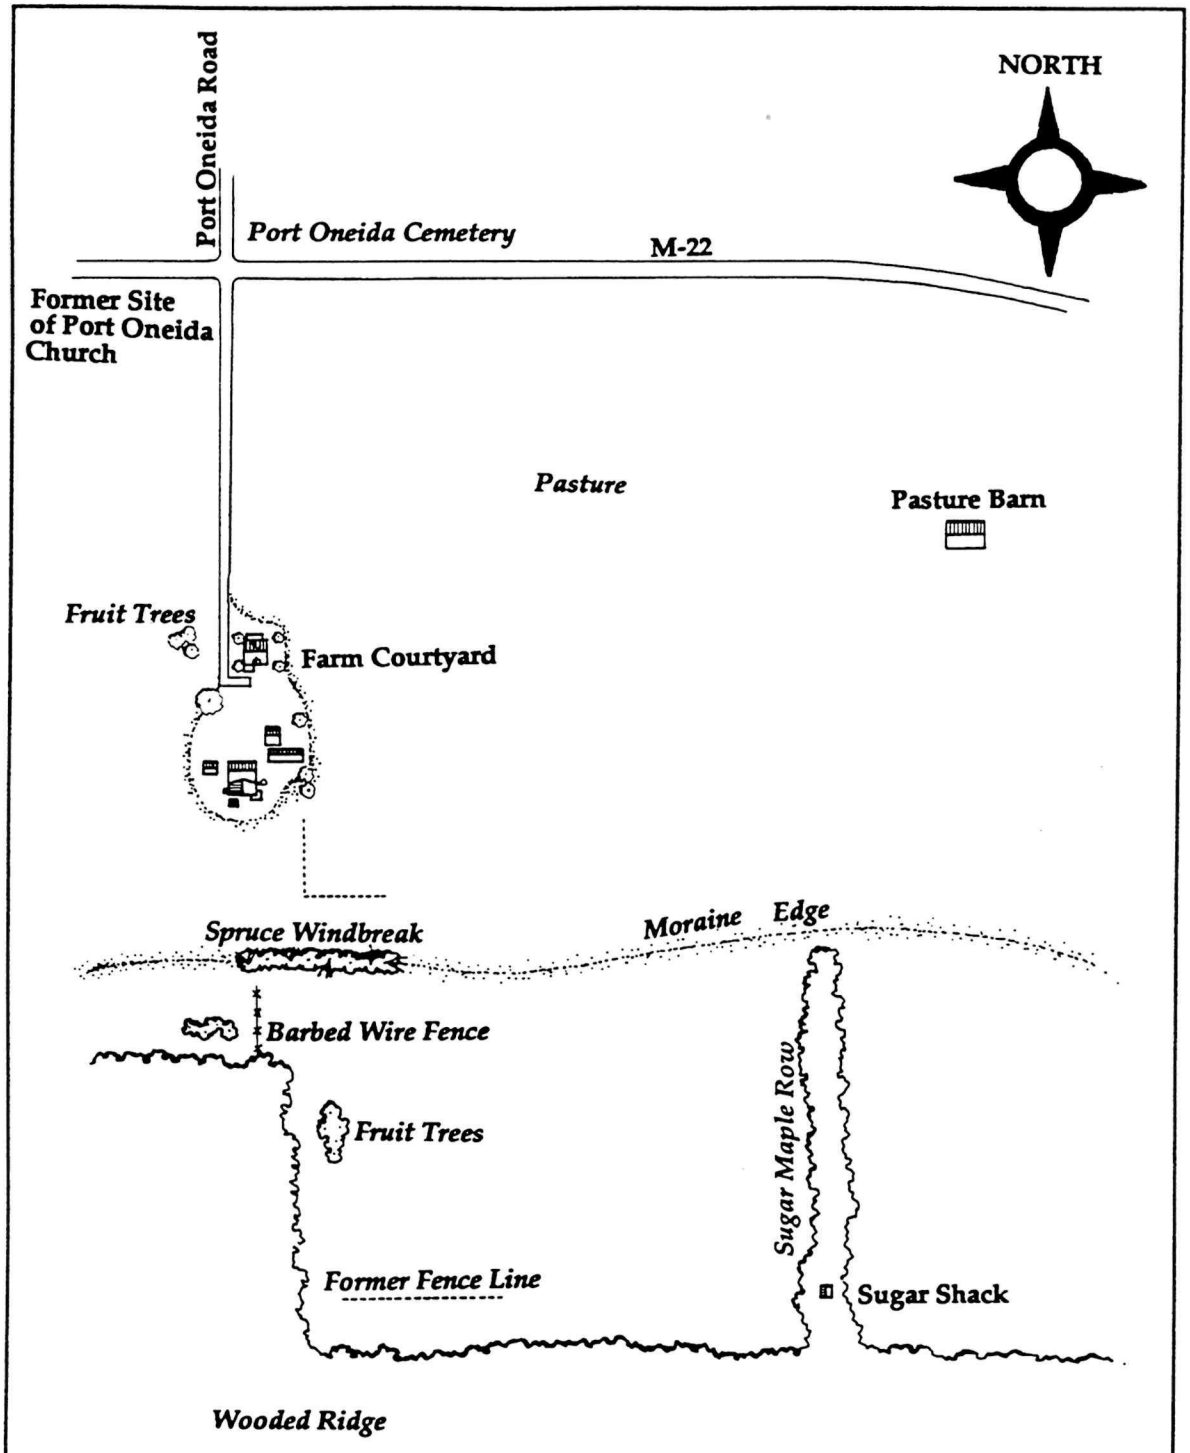
FIGURE 47: SITE PLAN
DECHOW/KLETT FARM--Landscape Setting
SCALE: 1"=APPROX. 100'0"

The Dechow/Klett farm is one of the most intact of all the Port Oneida farms. The house is relatively unaltered, and in good condition. The two barns, chicken coop, and sugar shack are in fair, unaltered condition, and the granary and brooder house are in fair, altered condition. The dairy addition was most advanced operation in Port Oneida. Many of the other buildings, especially the granary/corn crib, reveal the technological acumen of Elmer Klett. The sugar shack, located in a sugar maple wind break southeast of the farmstead on the side of the ridge, is the only example of an increasingly rare building type remaining in the proposed district. The well-constructed barns, granary, and sugar shack all lend themselves to interpretation by the NPS.

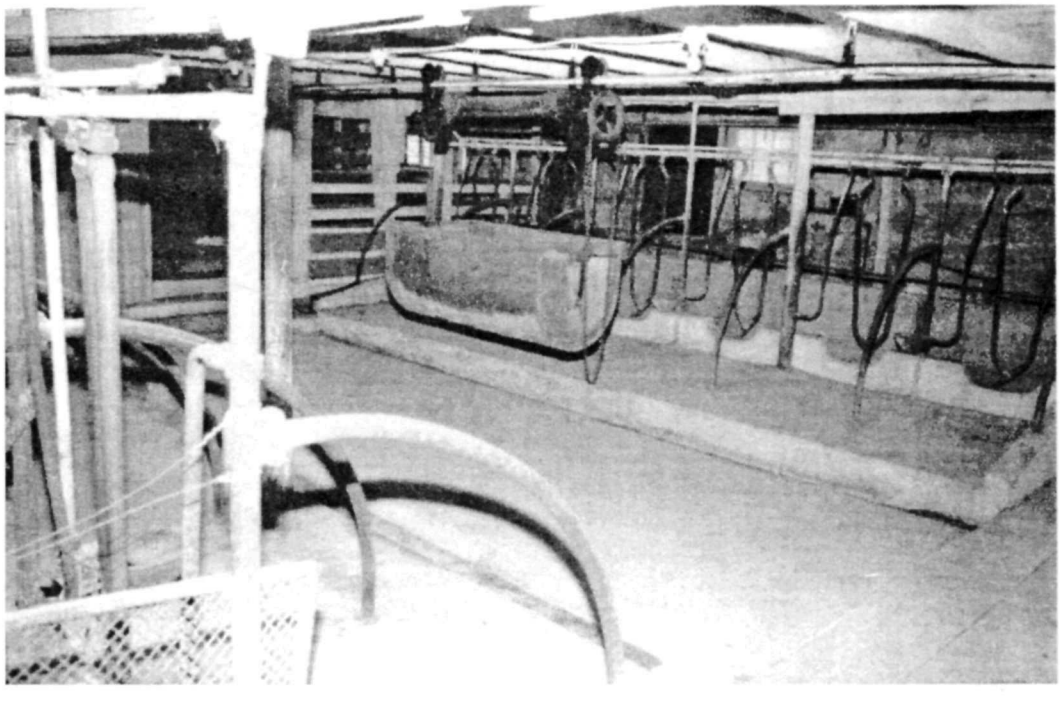
Figure 52. Interior view to cow stanchions and manure carrier in dairy addition of Dechow/Klett dairy barn, 1993.

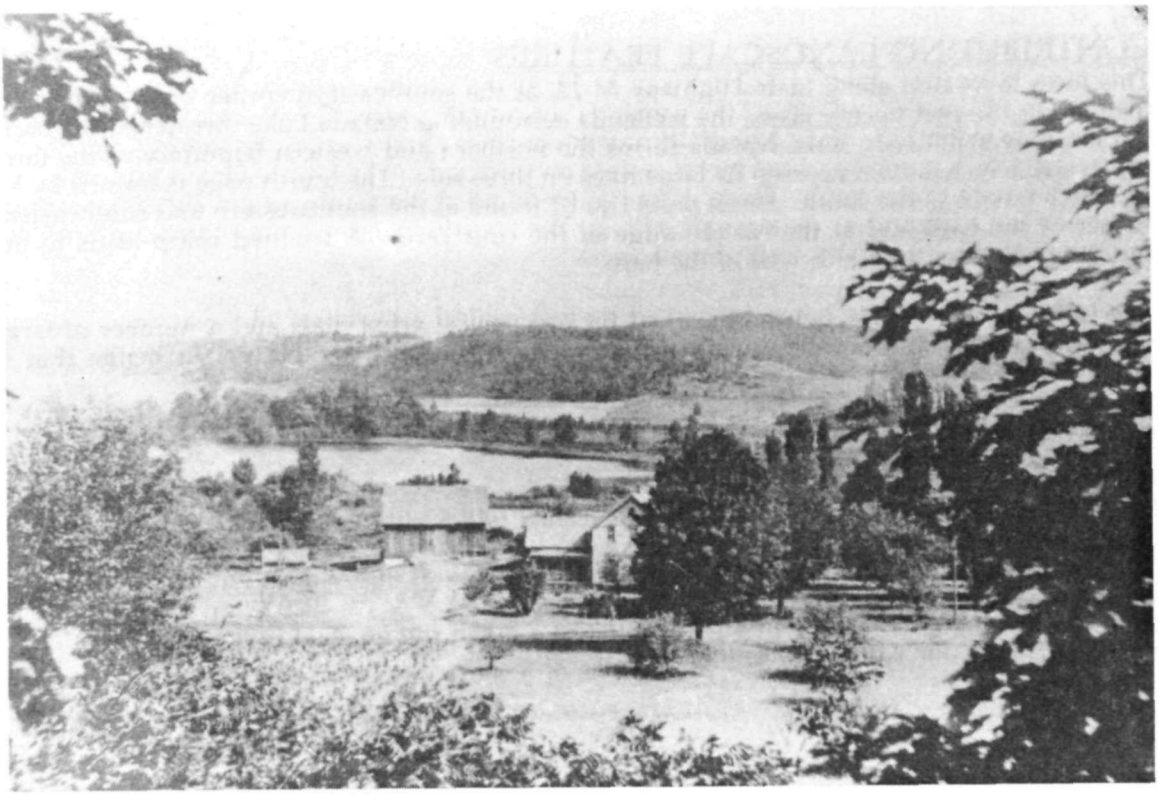
The Goffar/Roman house and barn are in good addition, although the barn is threatened by the approaching shoreline of Narada Lake. Both the house and barn retain high levels of integrity; however, the loss of related outbuilding compromises the overall quality of the farmstead.

Figure 61. Historic photograph of Goffar/Roman farm, date unknown (view to north).

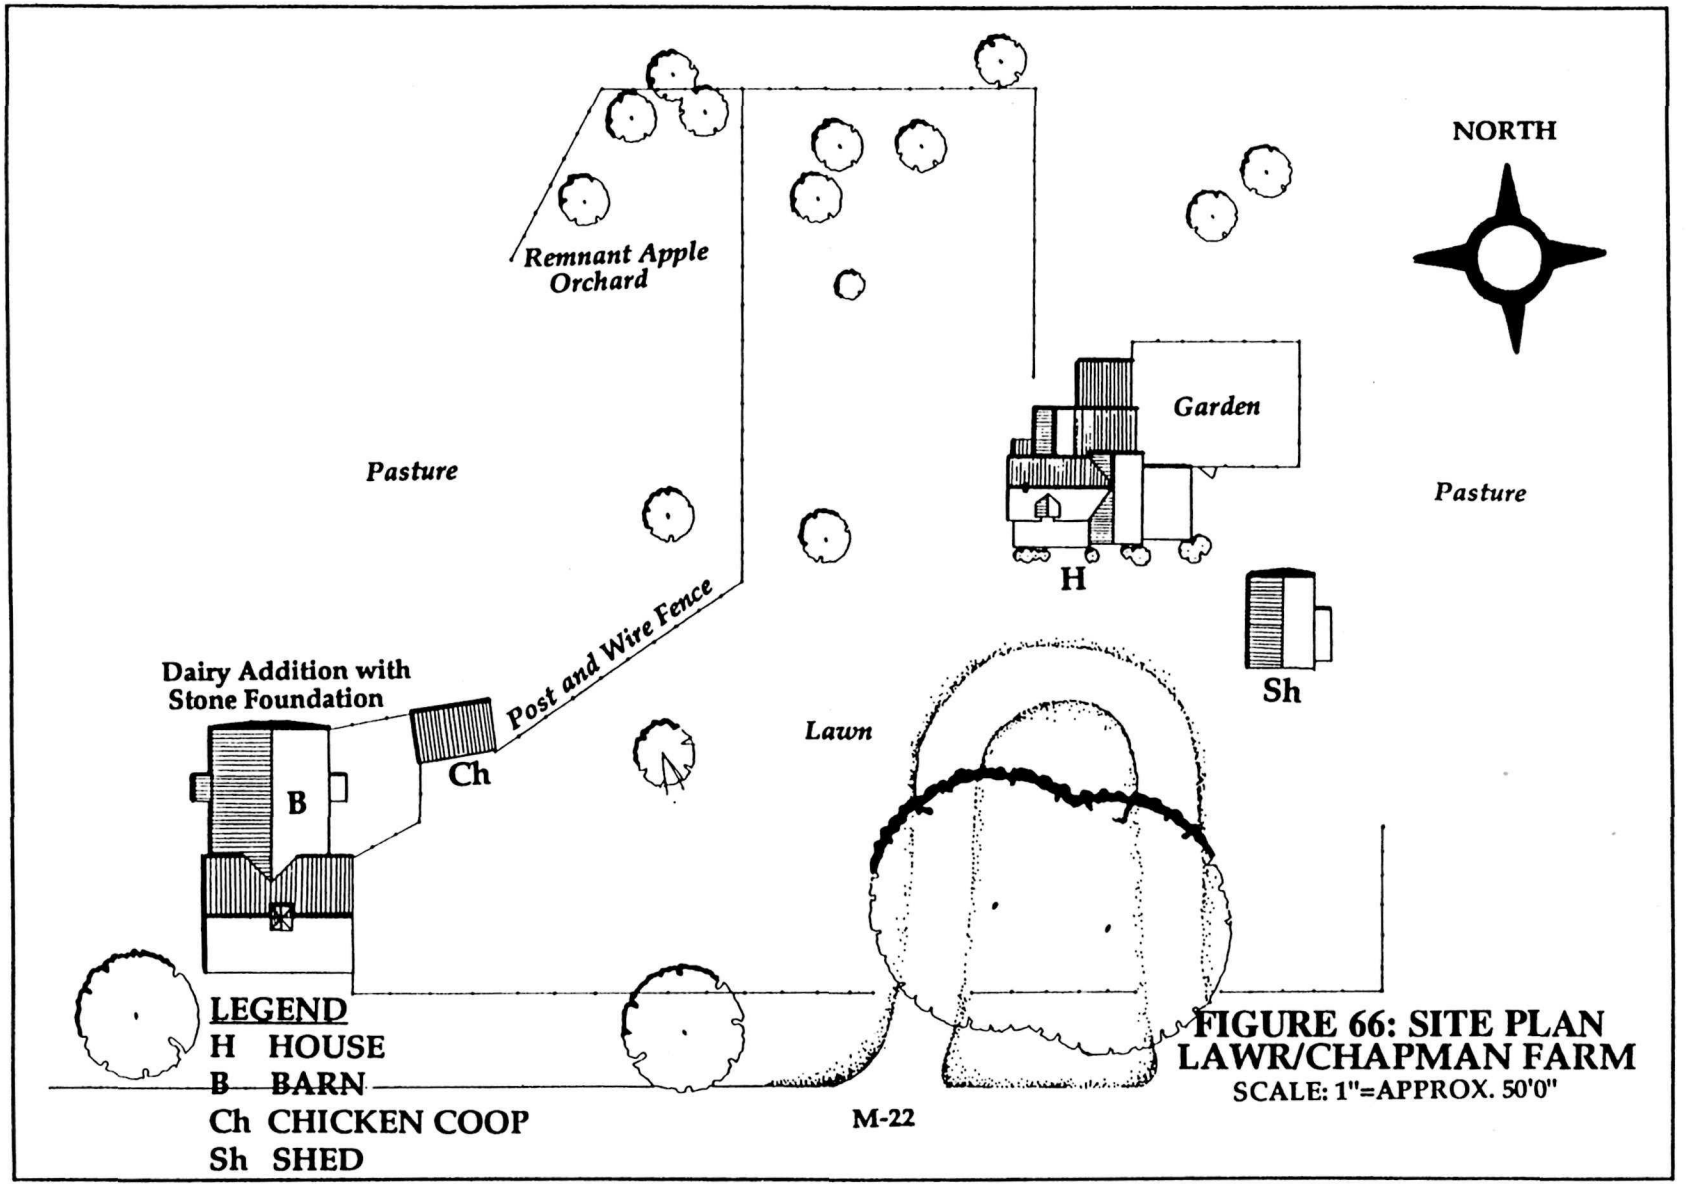
FIGURE 66: SITE PLAN
LAWR/CHAPMAN FARM
SCALE: 1"=APPROX. 50'0"

This house and the outbuildings have been altered by a succession of owners. However, all are in fair to good condition. The current owners maintain all of the buildings comprising the farm courtyard under a lease agreement.

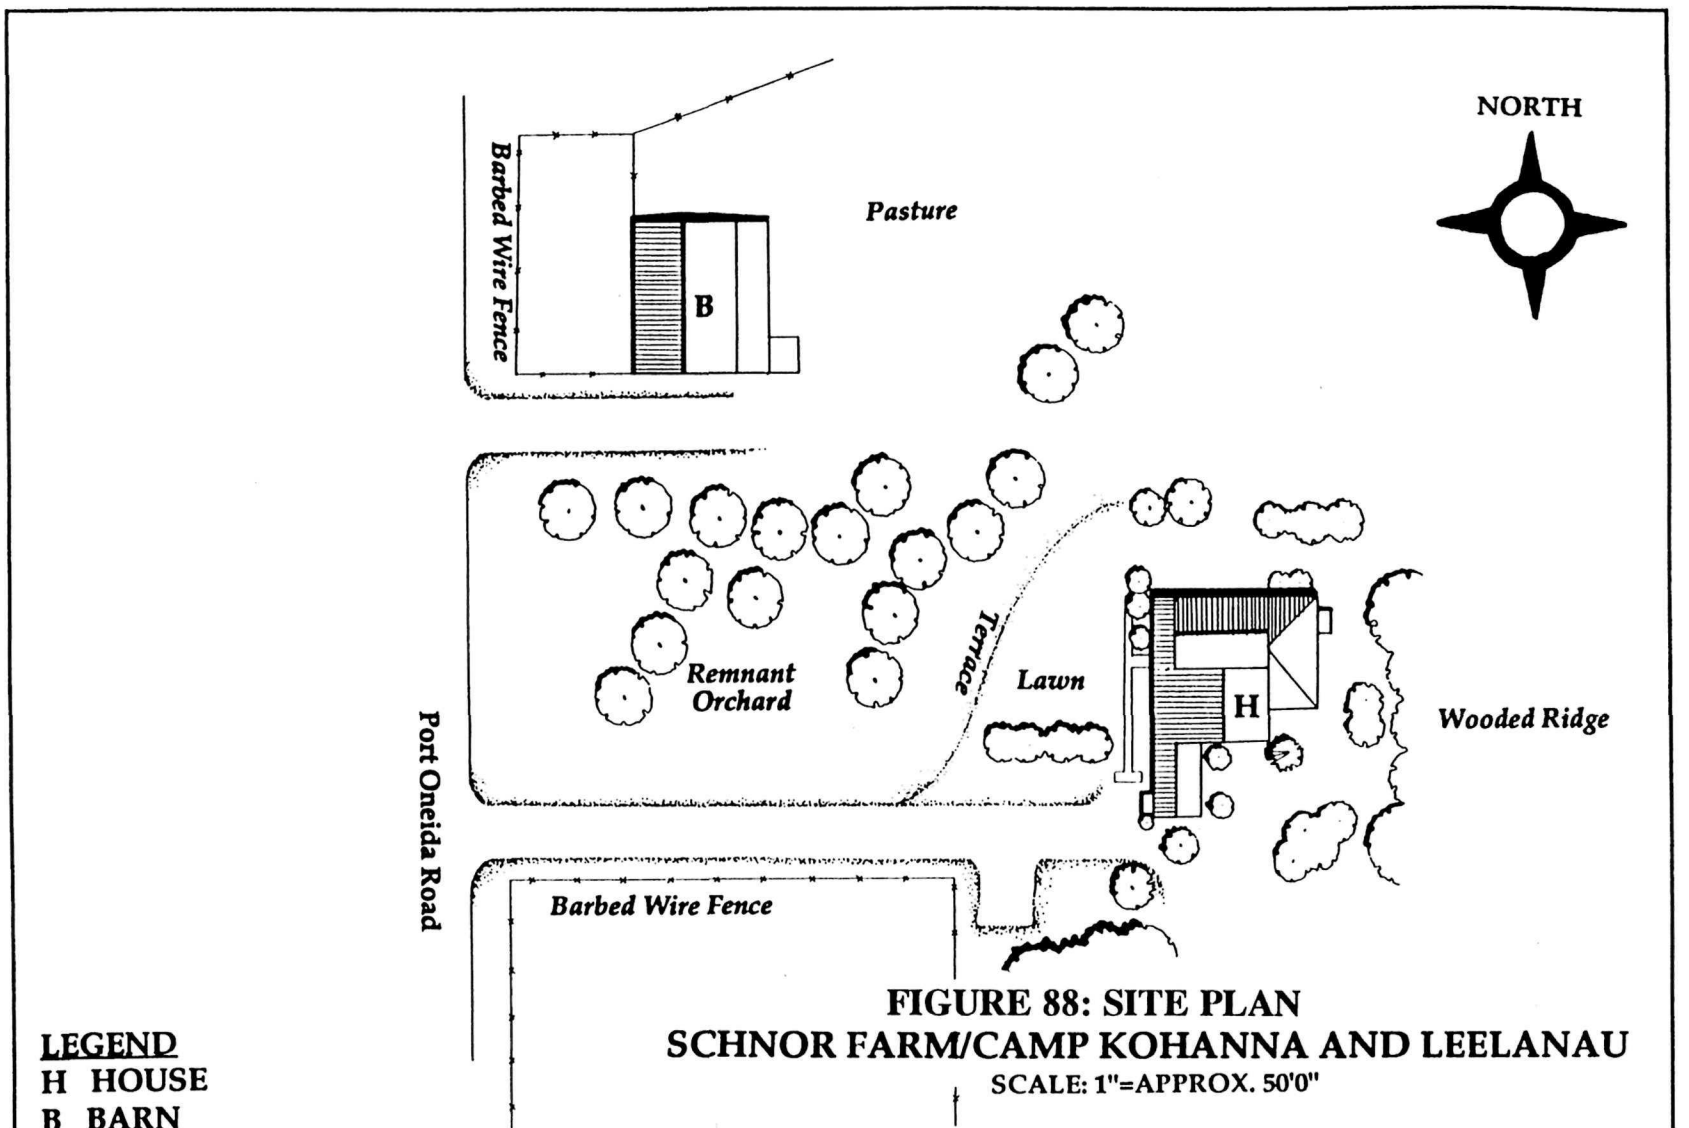
FIGURE 88: SITE PLAN
SCHNOR FARM/CAMP KOHANNA AND LEELANAU
SCALE: 1"=APPROX. 50'0"

Both the house and barn are in good but altered condition. The two camps maintain the former farmstead in accordance with scenic easement provisions administered by the National Park Service.

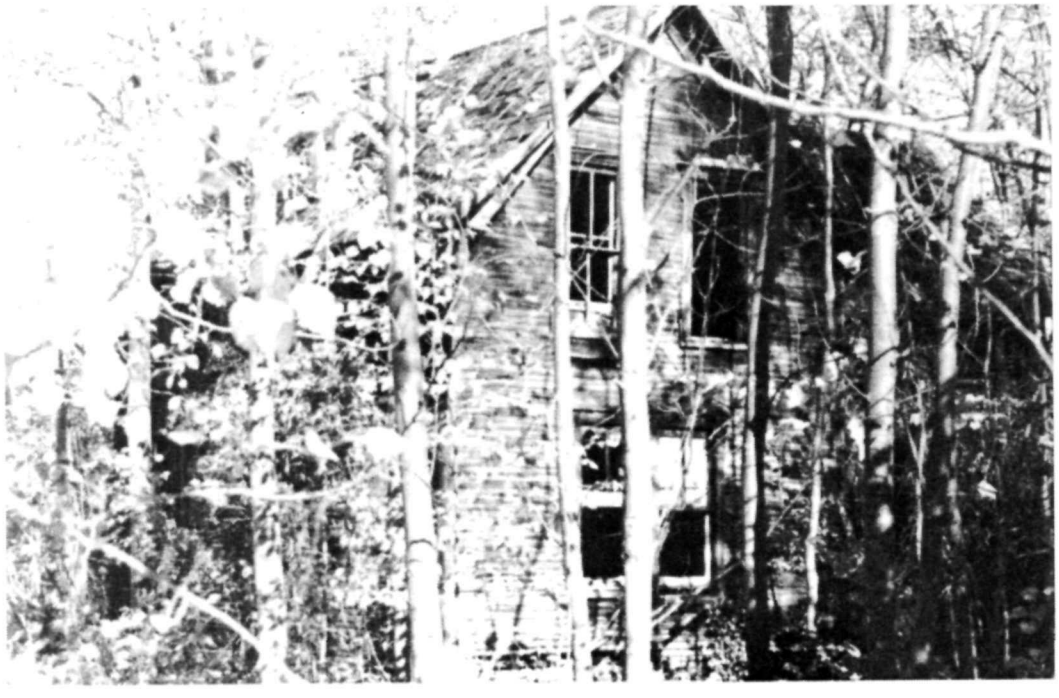
The house is the only structure remaining at this site. It is in an advanced state of decay and is surrounded by shrub vegetation. Despite its poor condition, the house exemplifies the upright and wing house style that predominates in Port Oneida.

Figure 99. Weaver house, 1994 (view to north).

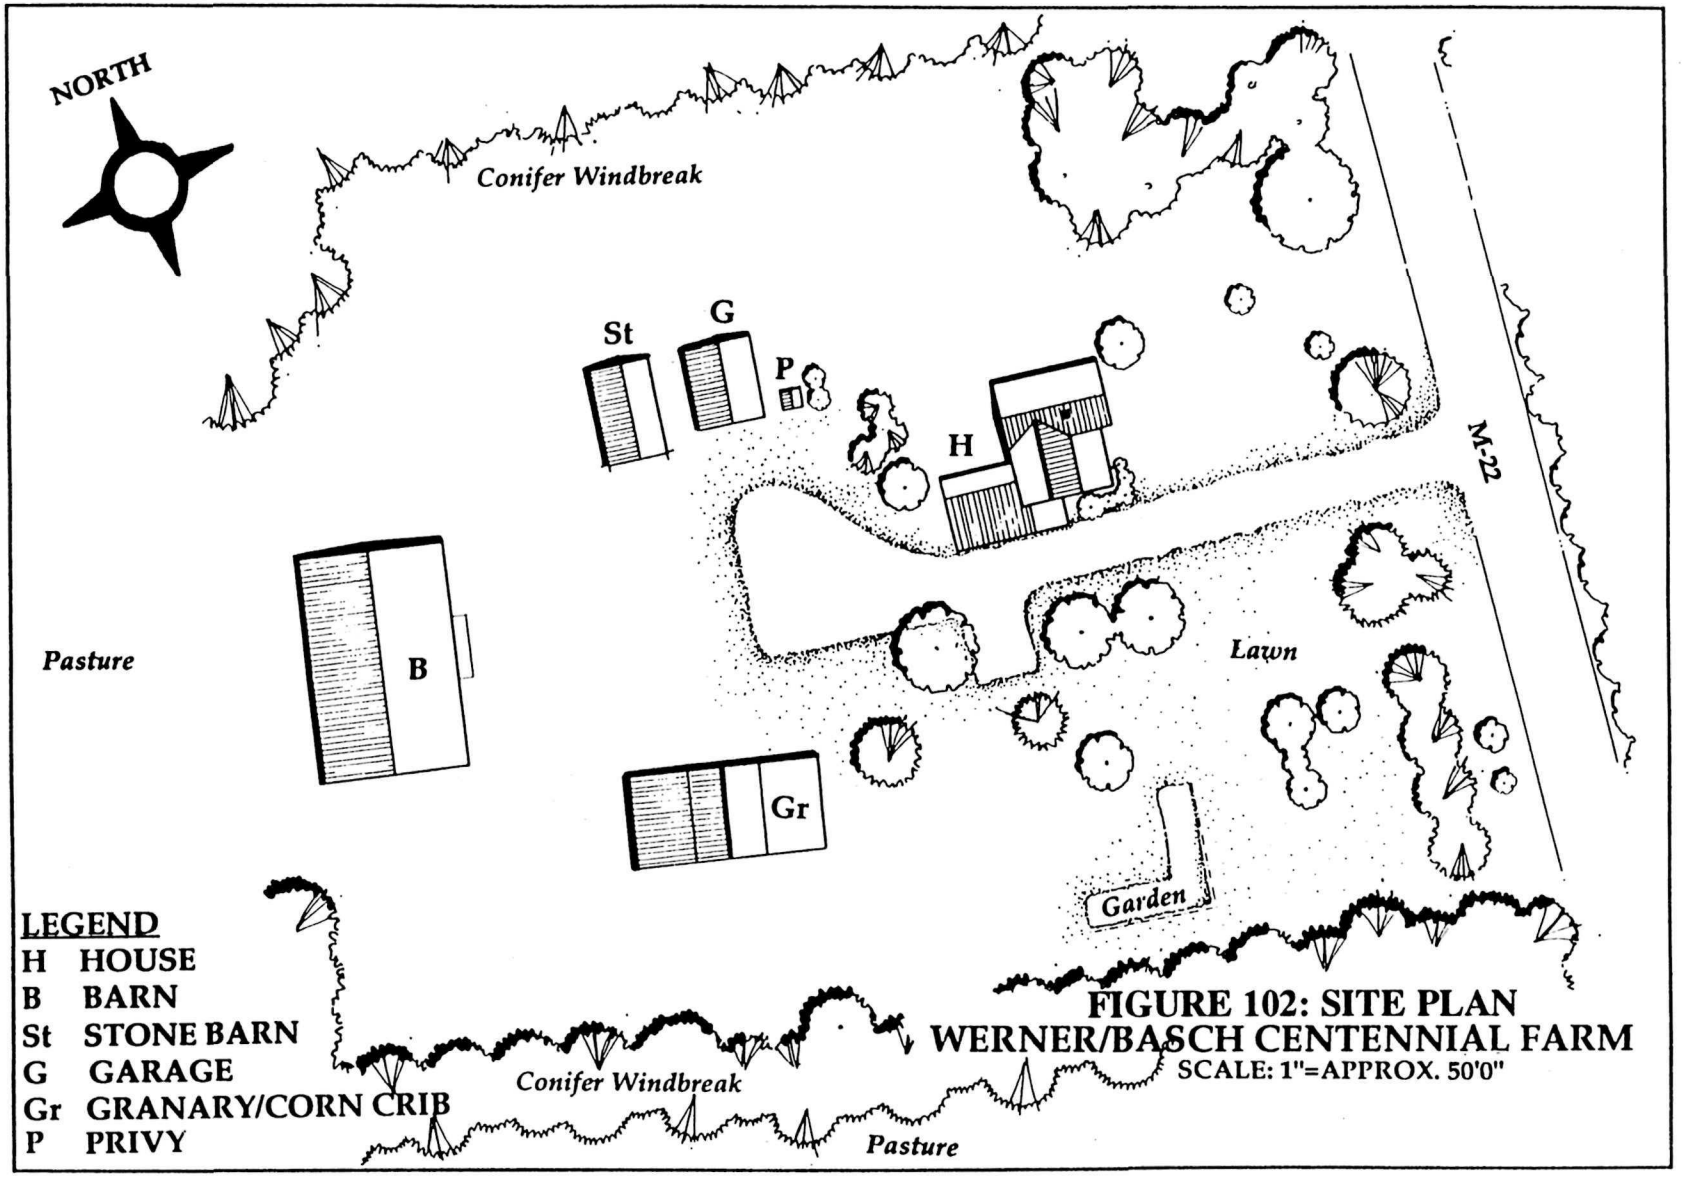
FIGURE 102: SITE PLAN
WERNER/BASCH CENTENNIAL FARM
SCALE: 1"=APPROX. 50'0"

The Werner/Basch farm is one of the oldest units remaining in Port Oneida; thus it is remarkable that each building remains in good to excellent condition. The entire farm retains a high level of integrity. The barn is one of the largest in the area, and the stone building is one of only two masonry structures in Port Oneida.
