existing condition survey

units 2, 3, and 4
volume 4
appendix A
part one

# ELLIS ISLAND
# STATUE OF LIBERTY NATIONAL MONUMENT

## EXISTING CONDITION SURVEY
## UNITS 2, 3 AND 4

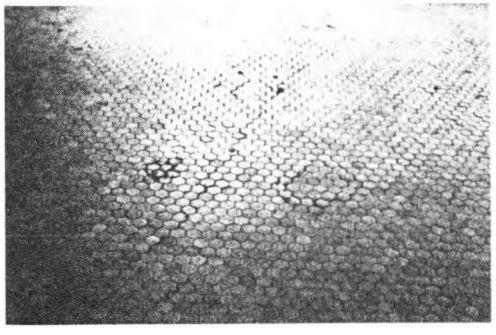
FAIR

60-85% intact. Some cracks in localized areas. Some tiles missing.

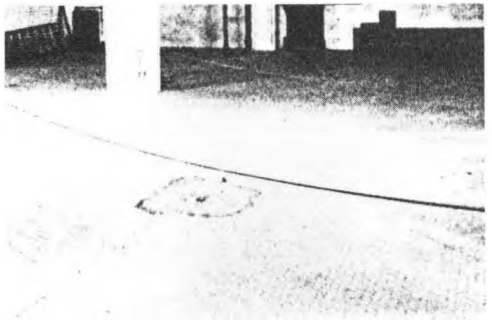
POOR

30-60% intact. Large cracks. Large areas missing.

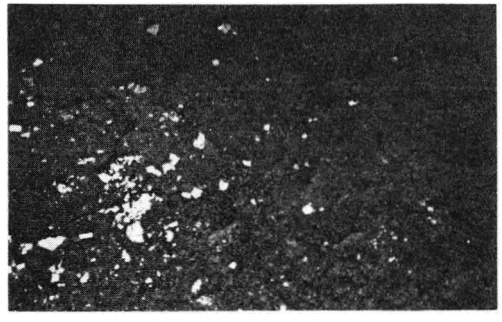
FAIR

60-85% intact. Some material missing. Cracked into sections. Some buckling.

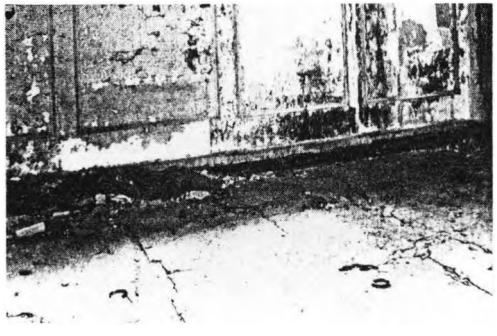
POOR

30-60% intact. Significant amount of material missing. Extensive cracking, buckling, and spalling of material.

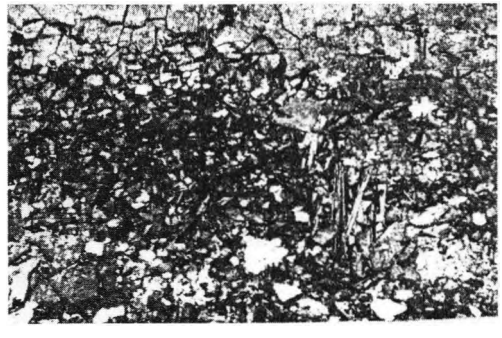
DESTROYED

0-30% intact. Material is completely missing or is destroyed beyond practical retrieval.

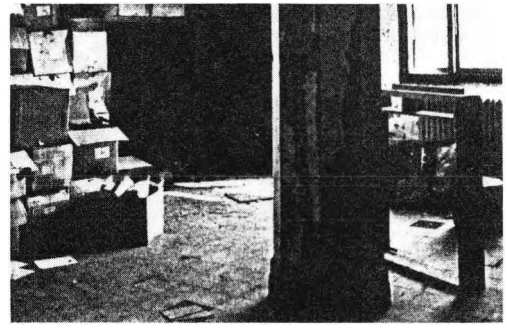
FAIR

60-85% intact. Some material broken, some buckling, some adhesive failure. Exposure of sections of sub-floor.

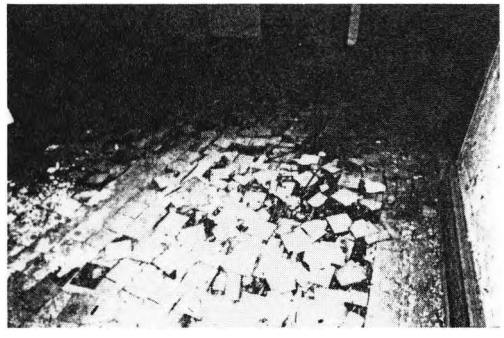
POOR

30-60% intact. Significant amount of material is missing, broken, buckling, loose, no longer adhered.

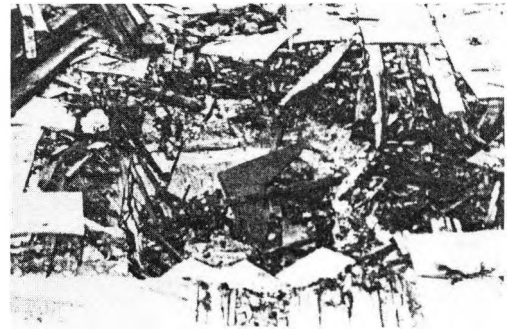
DESTROYED

0-30% intact. Material is completely missing or is destroyed beyond practical retrieval.

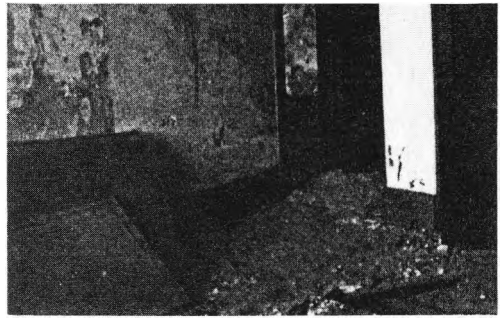
FAIR

75-90% intact. Separated from wall in limited areas. Some deterioration in localized areas (generally along window).

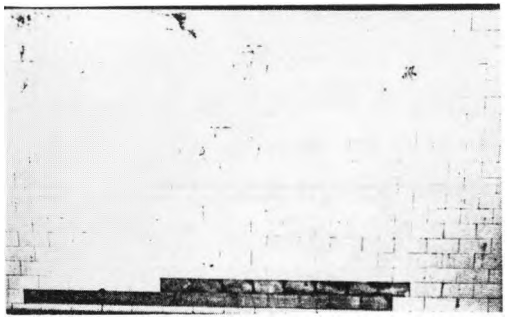
FAIR

60-85% intact. Some cracks in localized areas. Some tiles missing.

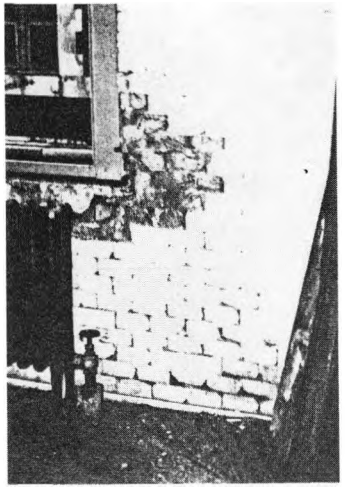
POOR

30-60% intact. Large areas missing, sizable cracks present.

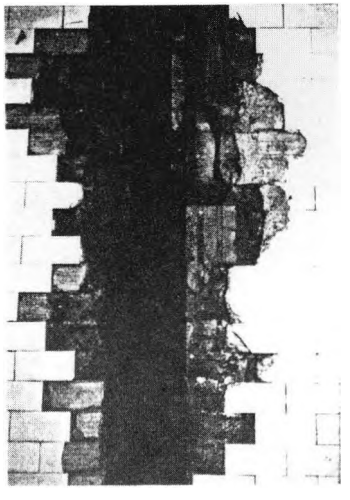
DESTROYED

0-30% intact. Material is completely missing or is destroyed beyond practical retrieval.

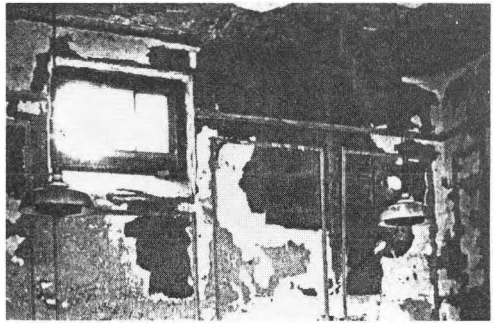
POOR

20-50% intact. Majority of plaster is severely cracked with buckling and spalling. Exposure of significant areas of base surface.

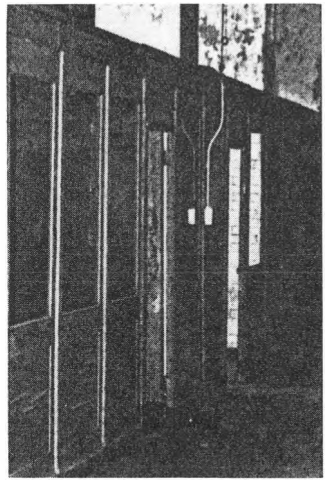
FAIR

50-70% intact. Small holes and cracks. Some missing material. Glass missing.

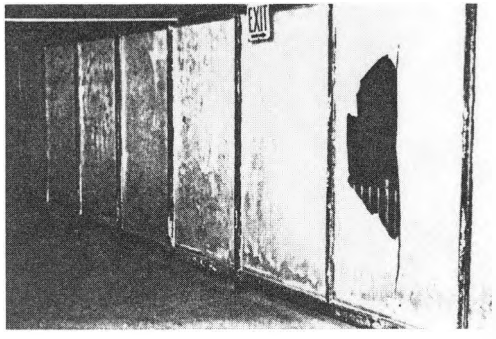
POOR

20-50% intact. Large holes and cracks. Major amount of missing material.

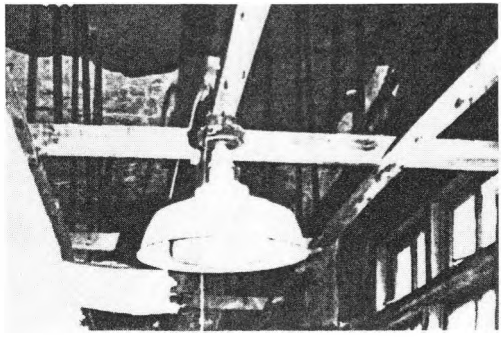
DESTROYED

0-20% intact. Material is completely missing or is destroyed beyond practical retrieval.

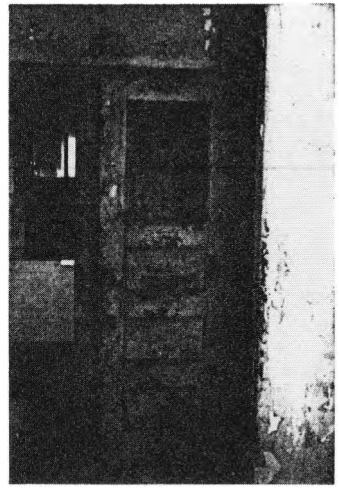
FAIR

Hardware intact, part may be missing. Minor warping of doors. Deteriorated paint finish and/or surface damage.

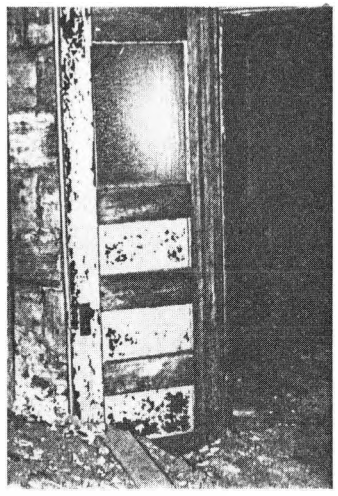
POOR

Severe wood damage, i.e., splitting and missing elements. Glass broken or missing. Extensive deterioration.

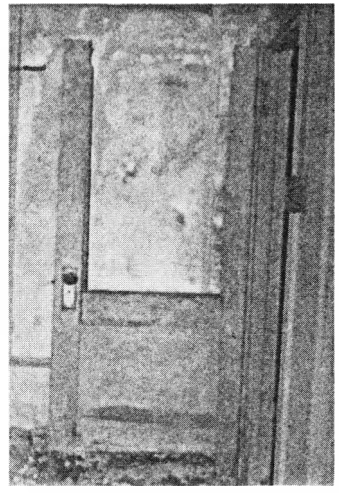
DESTROYED

Door is missing or is destroyed beyond practical retrieval.

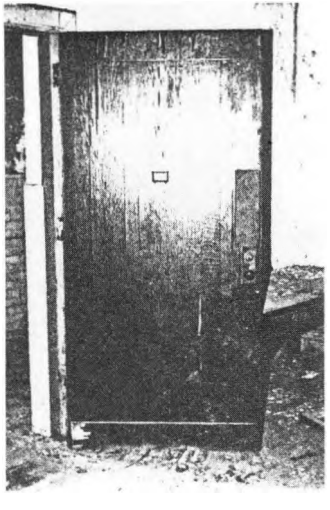
POOR

Hardware missing. Severe splitting and/or delamination.

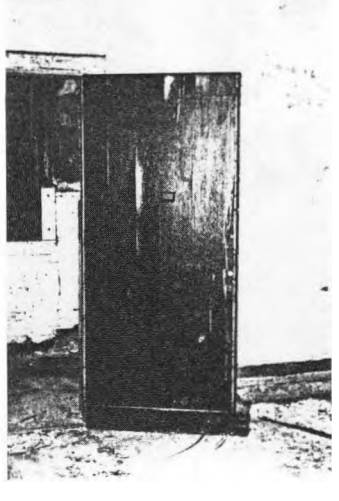
DESTROYED

Door is missing or is destroyed beyond practical retrieval.

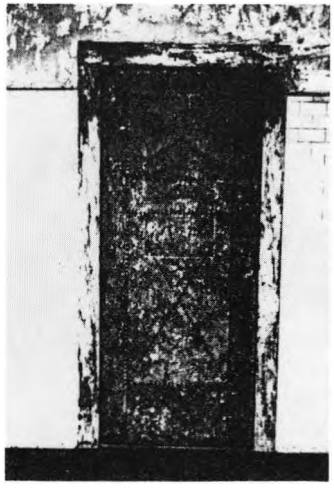
FAIR

Deteriorated paint finish. Small dents to surface. Hardware may have minor damage.

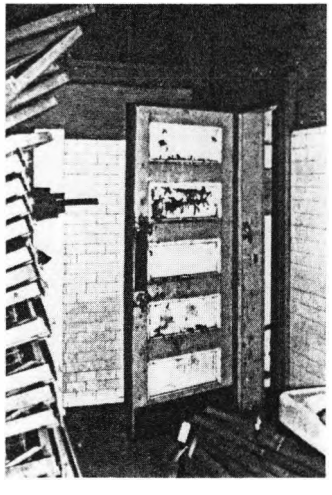
POOR

Deteriorated paint finish. Severe corrosion to surface. Bad dents. Hardware badly damaged or missing.

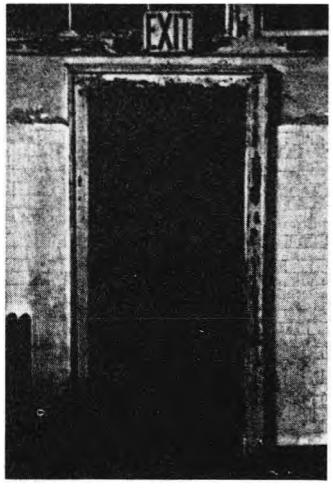
DESTROYED

Door is missing or is destroyed beyond practical retrieval.

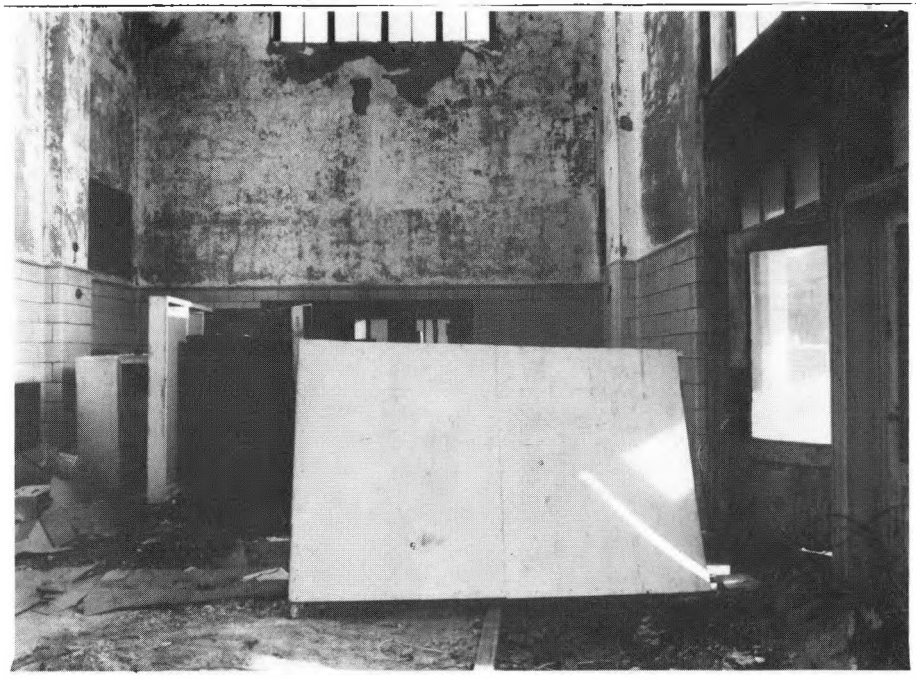
ROOM NO: 101 LAST KNOWN USE: Waiting room SQUARE FEET: 904 CEILING HEIGHT: 36'-1/4" DATE: 9 Dec 1985

| | FINISHES: | CONDITION: | DATE: | NOTES: |
|---|---|---|---|---|
| **WALLS:** | [X] Plaster<br>[ ] Partitions<br>[X] Tile Wainscot<br>[ ] Other: | [X] Good<br>[ ] Fair<br>[X] Poor<br>[ ] Destroyed | [ ] 1911-1923<br>[ ] 1924-1933<br>[X] 1934-present<br>[ ] In question | Beige & pink terra cotta tile. Cracking. S. wall has area of missing tiles. |

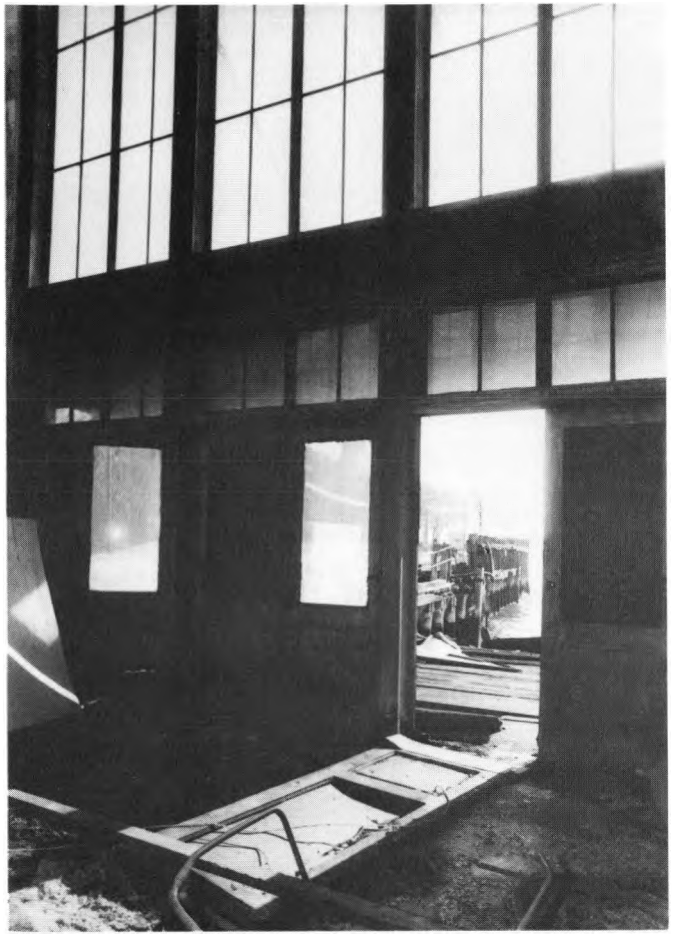
PHOTOGRAPHS: (4) Doors, East wall (5) Doors, West wall ROOM NO. 101

| | FINISHES: | CONDITION: | DATE: | NOTES: |
|---|---|---|---|---|
| **SUMMARY:** | | [ ] Good<br>[ ] Fair<br>[X] Poor<br>[ ] Destroyed | [ ] 1911-1923<br>[ ] 1924-1933<br>[X] 1934-present<br>[ ] In question | **ARCHITECTURAL SIGNIFICANCE:** [X] Most [ ] Some [ ] Minor [ ] Negligible |

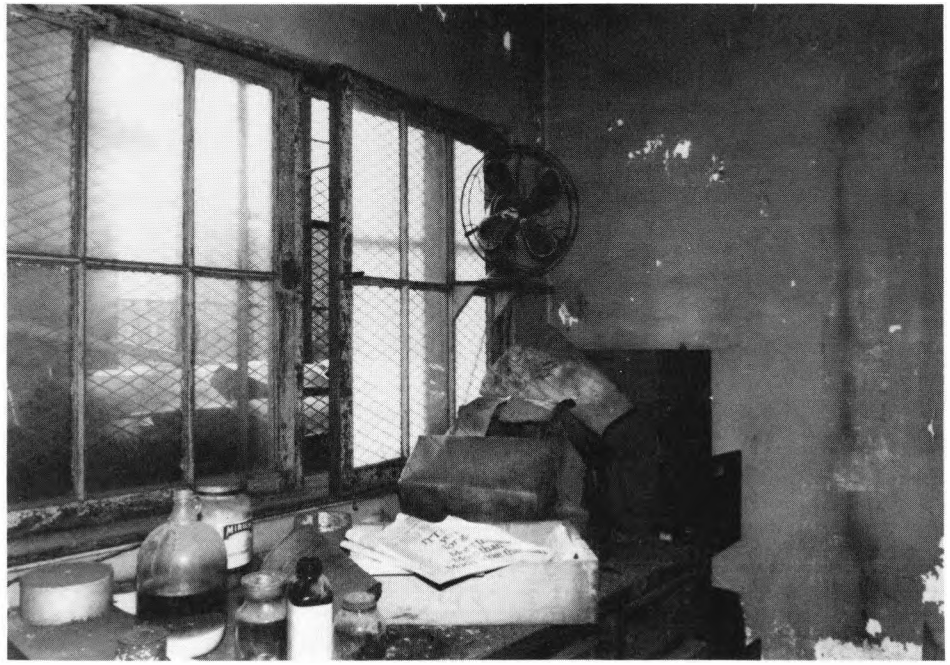
ROOM NO: 101A LAST KNOWN USE: Ferry Boat Engineer's Office SQUARE FEET: 91 CEILING HEIGHT: 10'-6½" DATE: 9 Dec. 1985

| | FINISHES: | CONDITION: | DATE: | NOTES: |
|---|---|---|---|---|
| **LIGHTING:** | [ ] Incandescent/Type A<br>[ ] Incandescent/Type B<br>[ ] CML/Sconce<br>[X] Other: | [ ] Intact [ ] Destroyed<br>[ ] Intact [ ] Destroyed<br>[ ] Intact [ ] Destroyed<br>[ ] Intact [X] Destroyed | [ ] 1911-1923<br>[ ] 1924-1933<br>[X] 1934-present<br>[ ] In question | chain hanging from ceiling, lamp missing. |

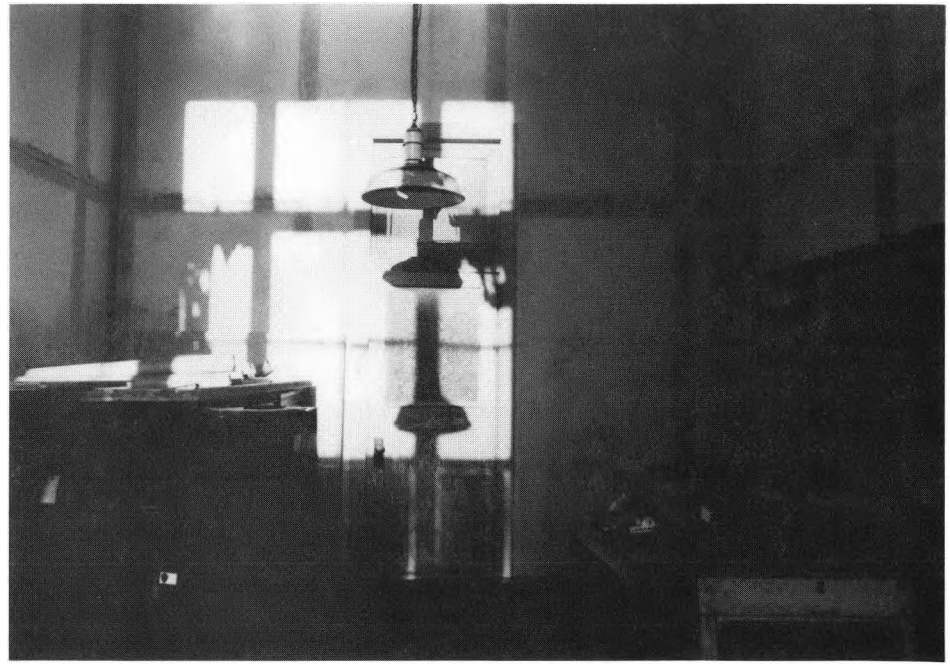
PHOTOGRAPHS: ① View east ② View west ROOM NO. 102C

| | FINISHES: | CONDITION: | DATE: | NOTES: |
|---|---|---|---|---|
| **LIGHTING:** | [ ] Incandescent/Type A<br>[X] Incandescent/Type B<br>[ ] CML/Sconce<br>[ ] Other: | [ ] Intact [ ] Destroyed<br>2 Intact [ ] Destroyed<br>[ ] Intact [ ] Destroyed<br>[ ] Intact [ ] Destroyed | [ ] 1911-1923<br>[ ] 1924-1933<br>[X] 1934-present<br>[ ] In question | Globes missing. |

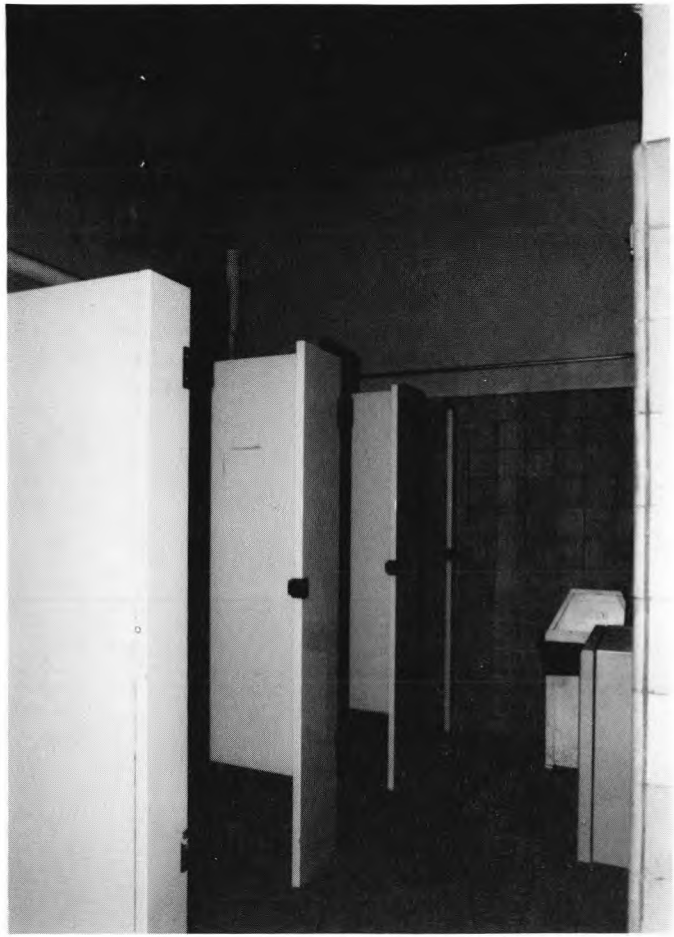
PHOTOGRAPHS: ① View north ② View south ROOM NO. 103

| | FINISHES: | CONDITION: | DATE: | NOTES: |
|---|---|---|---|---|
| **CEILING:** | [ ] Plaster<br>[X] Acoustic ~~panels~~ Tiles<br>[ ] Cove<br>[ ] Other | [ ] Good<br>[X] Fair<br>[ ] Poor<br>[ ] Destroyed | [ ] 1911-1923<br>[ ] 1924-1933<br>[X] 1934-present<br>[ ] In question | Patches of missing acoustic tiles. |
| **SUMMARY:** | | [X] Good<br>[ ] Fair<br>[ ] Poor<br>[ ] Destroyed | [ ] 1911-1923<br>[ ] 1924-1933<br>[X] 1934-present<br>[ ] In question | **ARCHITECTURAL SIGNIFICANCE:** [X] Most [ ] Some [ ] Minor [ ] Negligible |

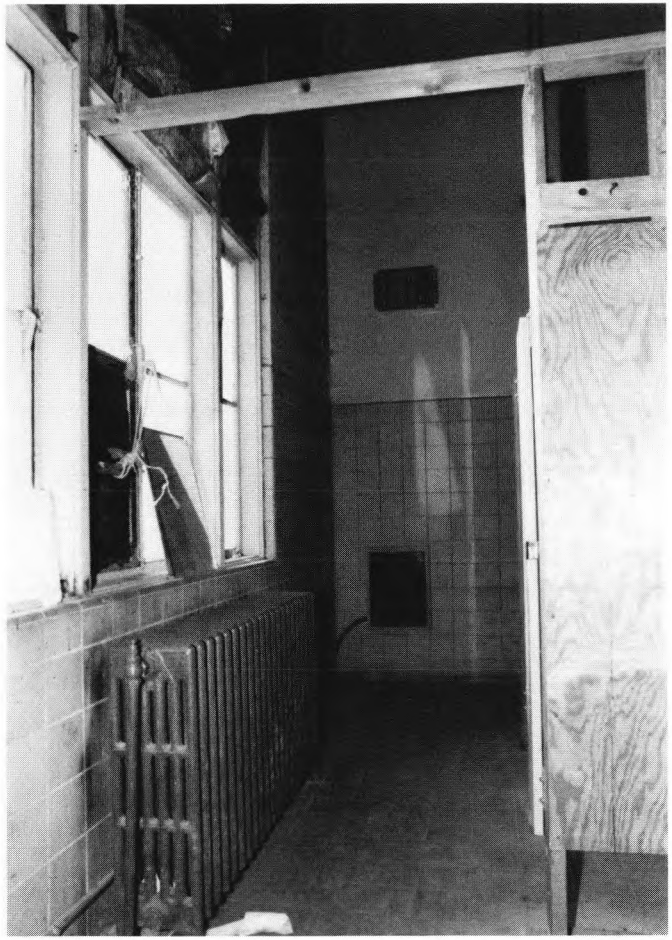
PHOTOGRAPHS: ① View southeast ② View northwest ROOM NO. 105

| | FINISHES: | CONDITION: | DATE: | NOTES: |
|---|---|---|---|---|
| **DOORS/ OPENINGS:** | 1 Wood/Glass Paneled<br>Wood Veneer<br>2 Galvanized Metal<br>Other: | Good<br>X Fair<br>Poor<br>Destroyed | 1911-1923<br>1924-1933<br>X 1934-present<br>In question | glass missing from light of wood door. |
| **SUMMARY:** | | X Good<br>Fair<br>Poor<br>Destroyed | 1911-1923<br>1924-1933<br>X 1934-present<br>In question | **ARCHITECTURAL SIGNIFICANCE:** Most / Some / X Minor / Negligible |

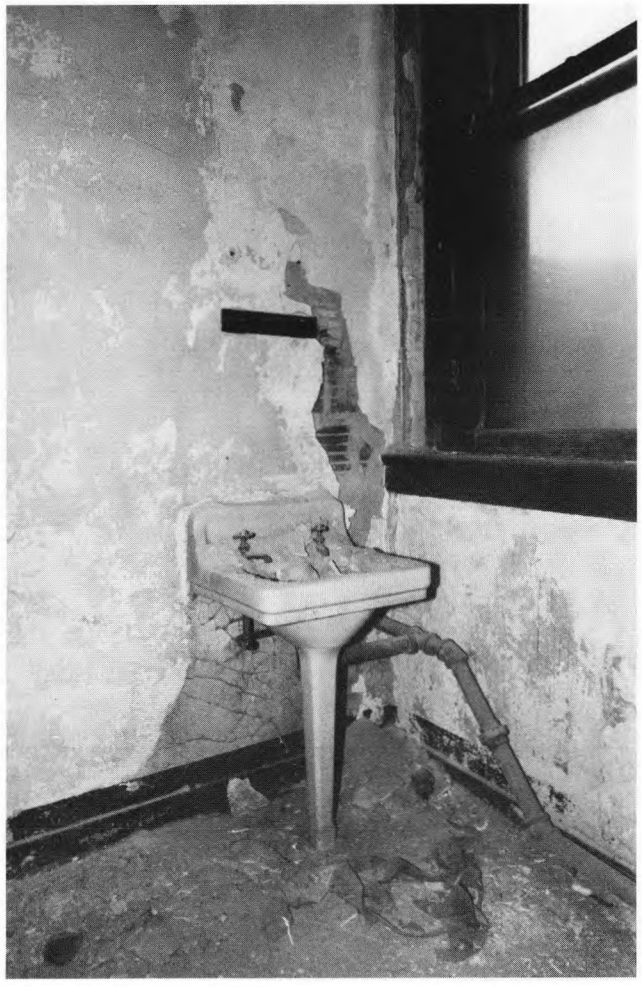
PHOTOGRAPHS: (1) View Southeast (2) View East (3) View North ROOM NO. 303

| | FINISHES: | CONDITION: | DATE: | NOTES: |
|---|---|---|---|---|
| **SUMMARY:** | | [ ] Good<br>[X] Fair<br>[ ] Poor<br>[ ] Destroyed | [X] 1900-1912<br>[ ] 1913-1933<br>[X] 1934-present<br>[X] In question | **ARCHITECTURAL SIGNIFICANCE:** [ ] Most [X] Some [ ] Minor [ ] Negligible |

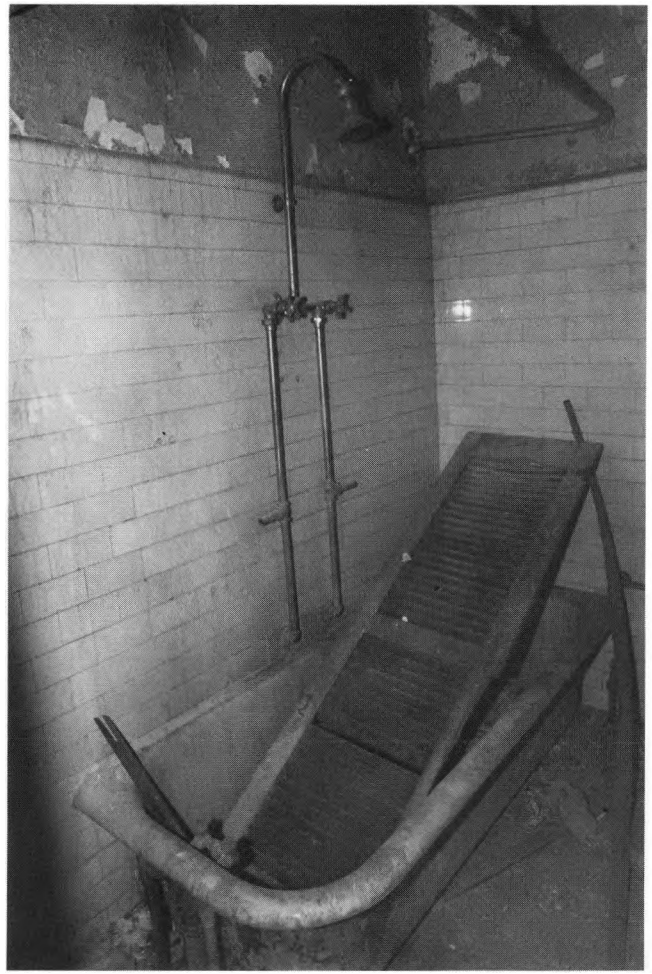
PHOTOGRAPHS: (1) Bathtub, View Northwest (2) View South ROOM NO. 307

| | FINISHES: | CONDITION: | DATE: | NOTES: |
|---|---|---|---|---|
| **MISCELLANEOUS:** | | Good<br>Fair<br>Poor<br>Destroyed | 1900-1912<br>1913-1933<br>1934-present<br>In question | "329" stenciled on door to hall.<br>1 screen door on floor.<br>Mirror in wood frame above sink, 307A.<br>Hook on back of door to hall. |
| **SUMMARY:** | | X Good<br>Fair<br>Poor<br>Destroyed | X 1900-1912<br>X 1913-1933<br>X 1934-present<br>X In question | **ARCHITECTURAL SIGNIFICANCE:** Most / Some / X Minor / Negligible |

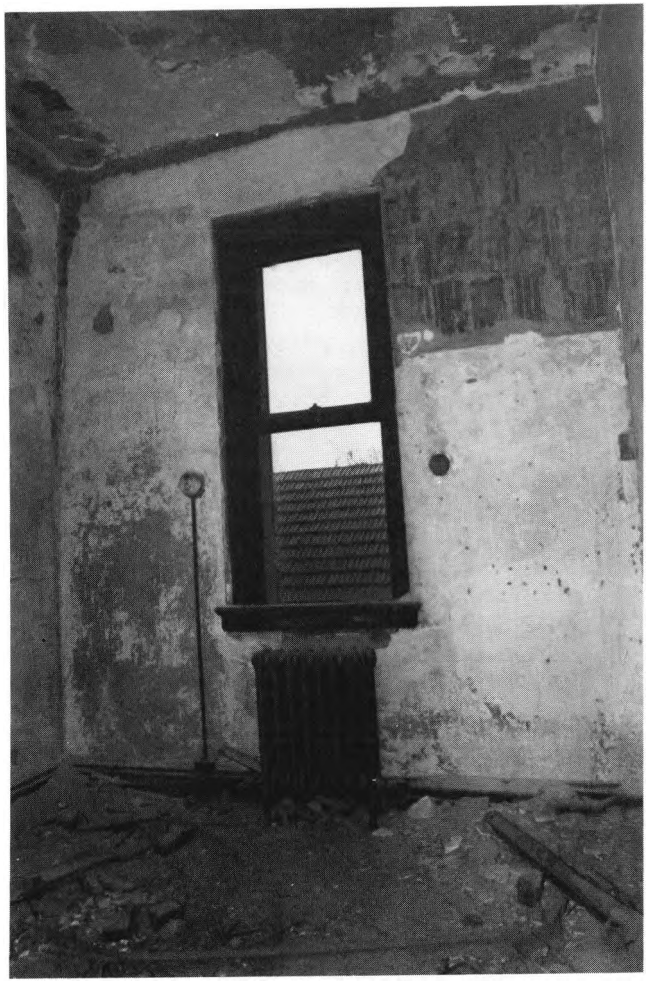
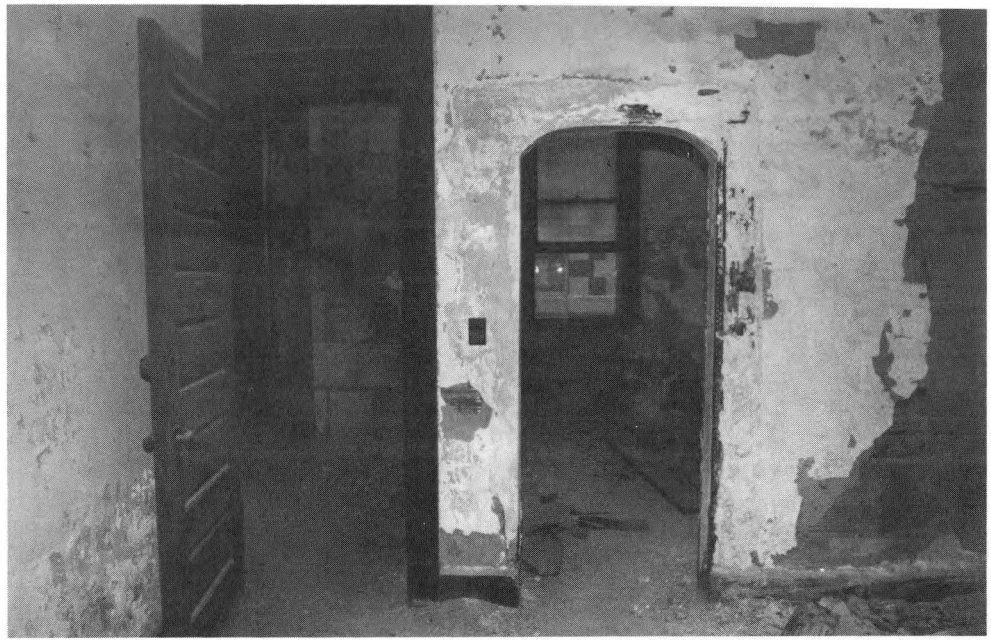
PHOTOGRAPHS: (1) View West (2) View East ROOM NO. 309

| | FINISHES: | CONDITION: | DATE: | NOTES: |
|---|---|---|---|---|
| **SUMMARY:** | | Good<br>X Fair<br>Poor<br>Destroyed | X 1900-1912<br>X 1913-1933<br>X 1934-present<br>X In question | **ARCHITECTURAL SIGNIFICANCE:** Most / Some / X Minor / Negligible |

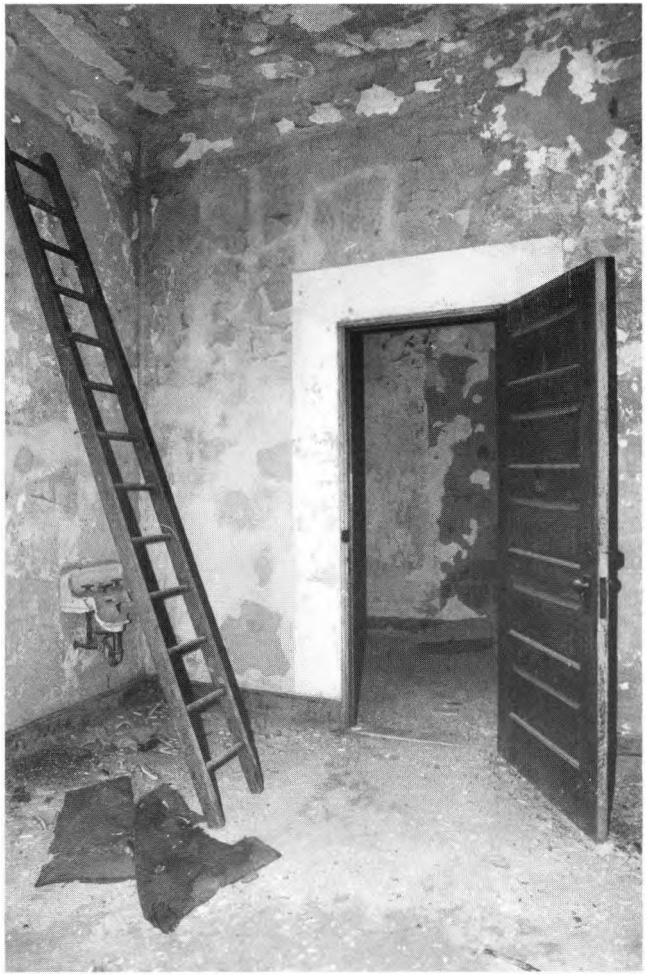
ROOM NO: 312 LAST KNOWN USE: Maternity Ward SQUARE FEET: CEILING HEIGHT: DATE: 15 Nov. 1985

| | FINISHES: | CONDITION: | DATE: | NOTES: |
|---|---|---|---|---|
| **FLOOR:** | [X] Tile/Concrete<br>[ ] Resilient<br>[ ] Wood<br>[ ] Other: | [X] Good<br>[ ] Fair<br>[ ] Poor<br>[ ] Destroyed | [X] 1900-1912<br>[ ] 1913-1933<br>[ ] 1934-present<br>[ ] In question | scored.<br>Marble sill to hall. |

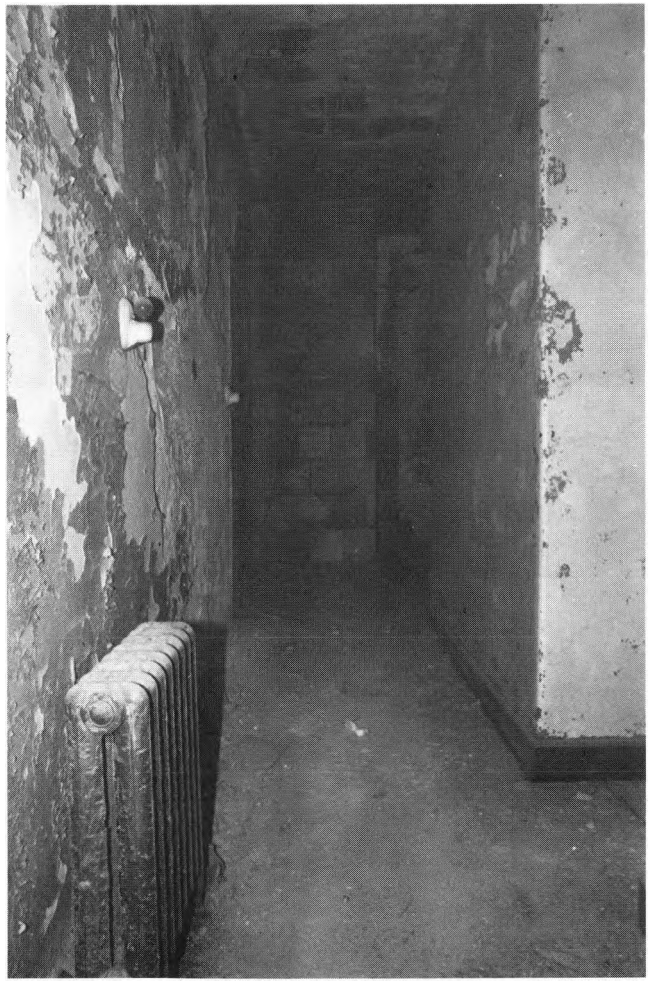
ROOM NO. H304

| | FINISHES: | CONDITION: | DATE: | NOTES: |
|---|---|---|---|---|
| **SUMMARY:** | | ☐ Good<br>☐ Fair<br>☒ Poor<br>☐ Destroyed | ☒ 1900-1912<br>☐ 1913-1933<br>☒ 1934-present<br>☒ In question | **ARCHITECTURAL SIGNIFICANCE:** ☐ Most ☐ Some ☒ Minor ☐ Negligible |

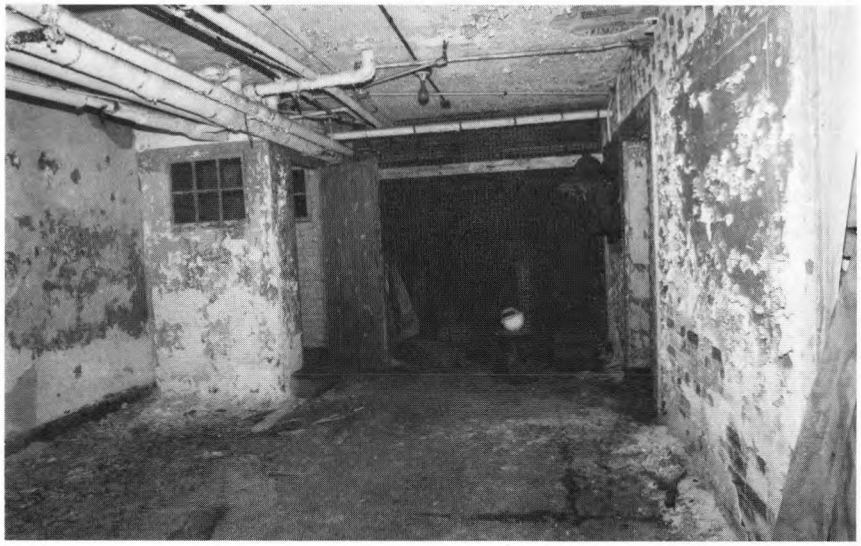
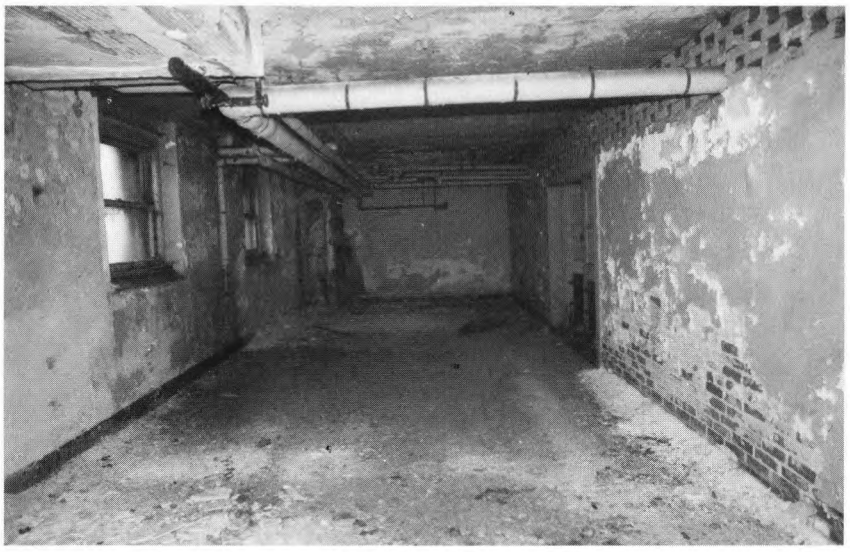
PHOTOGRAPHS: (5) Door to B01 (6) B01, East (7) B11/B12, East (8) HB01 from S02 ROOM NO. Basement

| Walls: | Exterior wall structure is 3'-5" concrete below brick with plaster. Interior walls are wood and glass paneling, plywood, brick and painted plaster over brick. | Condition: | Fair to poor condition. Extensive spalling and loss of plastered surfaces. Wood paneling exhibits deteriorating finishes with some plywood in a destroyed condition. |
| Ceiling: | Plaster over structural tile. | Condition: | Severe deterioration, spalling and loss. |

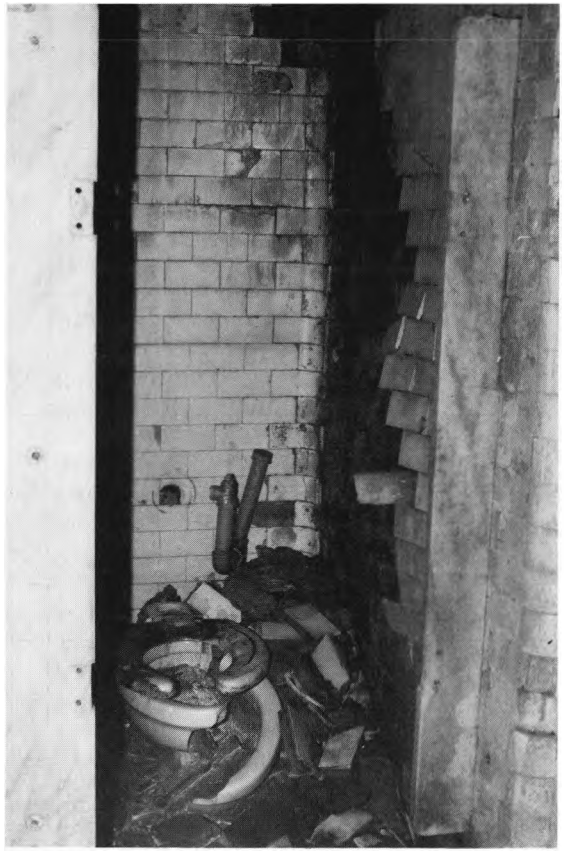
PHOTOGRAPHS: (1) View North (2) View South ROOM NO. 105

| | FINISHES: | CONDITION: | DATE: | NOTES: |
|---|---|---|---|---|
| **CEILING:** | [X] Plaster<br>[ ] Acoustic panels<br>[X] Cove<br>[ ] Other | [ ] Good<br>[ ] Fair<br>[X] Poor<br>[ ] Destroyed | [X] 1900-1912<br>[ ] 1913-1933<br>[ ] 1934-present<br>[ ] In question | Severe deterioration on N. side — exposed structural tiles. |
| **SUMMARY:** | | [ ] Good<br>[ ] Fair<br>[X] Poor<br>[ ] Destroyed | [X] 1900-1912<br>[X] 1913-1933<br>[X] 1934-present<br>[ ] In question | **ARCHITECTURAL SIGNIFICANCE:** [ ] Most [ ] Some [X] Minor [ ] Negligible |

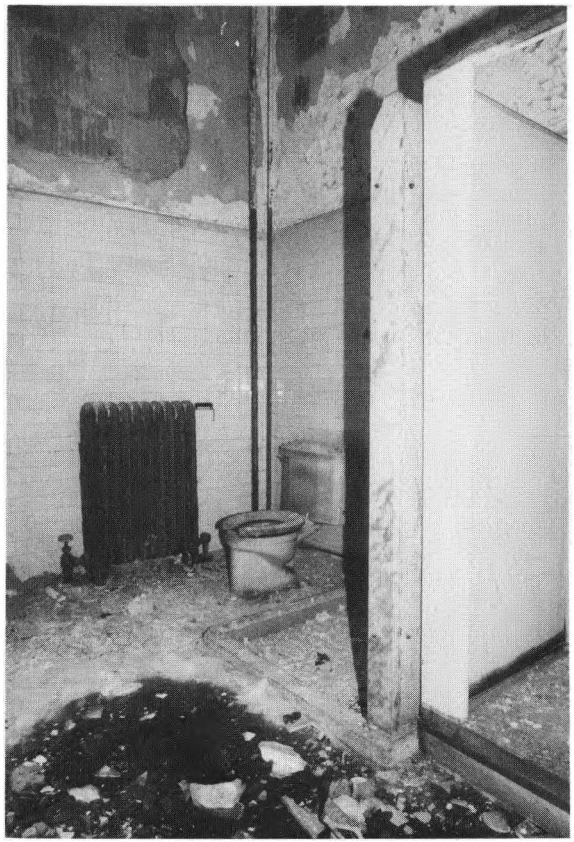
PHOTOGRAPHS: ① View North ② View South ROOM NO. 115

| | FINISHES: | CONDITION: | DATE: | NOTES: |
|---|---|---|---|---|
| **LIGHTING:** | [X] Incandescent/Type A<br>[ ] Incandescent/Type B<br>[X] CML/Sconce<br>[ ] Other: | [ ] Intact [1] Destroyed<br>[ ] Intact [ ] Destroyed<br>[ ] Intact [1] Destroyed<br>[ ] Intact [ ] Destroyed | [ ] 1900-1912<br>[ ] 1913-1933<br>[X] 1934-present<br>[ ] In question | globe missing from Incandescent A.<br>1 broken wall sconce - not standard type. |
| **MISCELLANEOUS:** | | [ ] Good<br>[ ] Fair<br>[ ] Poor<br>[ ] Destroyed | [ ] 1900-1912<br>[ ] 1913-1933<br>[X] 1934-present<br>[ ] In question | stencil on S wall "H53".<br>2 cans of leaking chemicals. |
| **SUMMARY:** | | [ ] Good<br>[ ] Fair<br>[X] Poor<br>[ ] Destroyed | [X] 1900-1912<br>[X] 1913-1933<br>[X] 1934-present<br>[ ] In question | **ARCHITECTURAL SIGNIFICANCE:** [ ] Most [ ] Some [X] Minor [ ] Negligible |

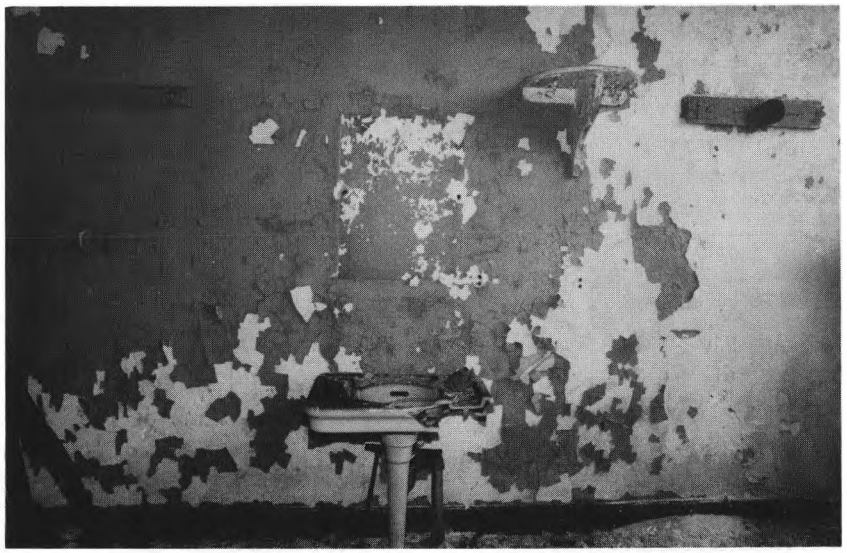
PHOTOGRAPHS: (1) View North. (2) Cabinet, East wall. ROOM NO. 117

| | FINISHES: | CONDITION: | DATE: | NOTES: |
|---|---|---|---|---|
| **CEILING:** | [X] Plaster<br>[ ] Acoustic panels<br>[X] Cove<br>[ ] Other | [ ] Good<br>[ ] Fair<br>[X] Poor<br>[ ] Destroyed | [X] 1900-1912<br>[ ] 1913-1933<br>[ ] 1934-present<br>[ ] In question | Greatest deterioration towards N wall. |
| **HEATING/ VENTILATION PLUMBING:** | [X] Radiators 1<br>[ ] ~~Vents/Fans~~<br>[X] Sink/Toilet/Urinal<br>[ ] Other: | [X] Intact [ ] Destroyed<br>[ ] Intact [ ] Destroyed<br>[ ] Intact [ ] Destroyed<br>[ ] Intact [ ] Destroyed | [X] 1900-1912<br>[X] 1913-1933<br>[ ] 1934-present<br>[ ] In question | 1 unusual wall-mounted sink on brass supports.<br>1 toilet — broken base. |
| **MISCELLANEOUS:** | | [ ] Good<br>[ ] Fair<br>[X] Poor<br>[ ] Destroyed | [X] 1900-1912<br>[ ] 1913-1933<br>[X] 1934-present<br>[ ] In question | 1 large metal cabinet — Rusted.<br>1 original(?) toilet paper holder. |
| **SUMMARY:** | | [ ] Good<br>[ ] Fair<br>[X] Poor<br>[ ] Destroyed | [X] 1900-1912<br>[X] 1913-1933<br>[X] 1934-present<br>[ ] In question | **ARCHITECTURAL SIGNIFICANCE:** [ ] Most [ ] Some [X] Minor [ ] Negligible |

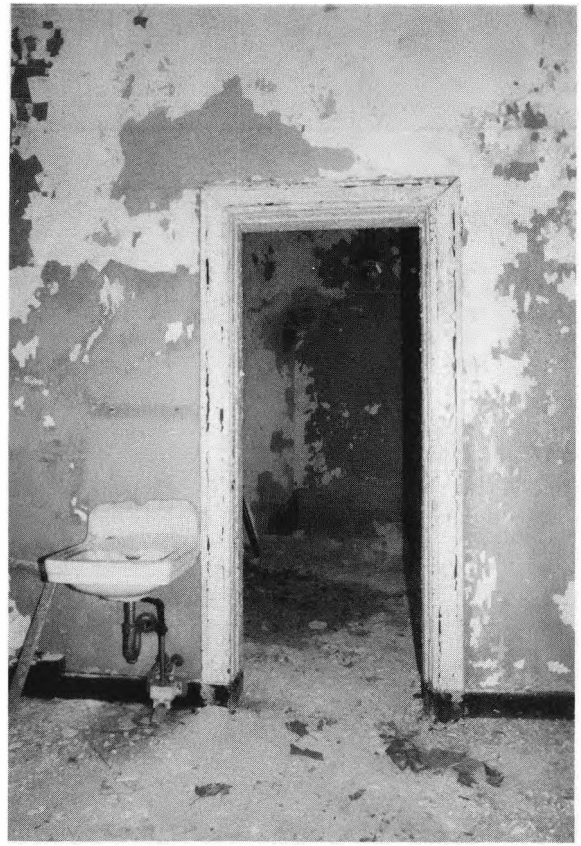
PHOTOGRAPHS: (1) View North (2) View East ROOM NO. 119

| | FINISHES: | CONDITION: | DATE: | NOTES: |
|---|---|---|---|---|
| **CEILING:** | [X] Plaster<br>[ ] Acoustic panels<br>[X] Cove<br>[ ] Other | [ ] Good<br>[X] Fair<br>[ ] Poor<br>[ ] Destroyed | [X] 1900-1912<br>[ ] 1913-1933<br>[ ] 1934-present<br>[ ] In question | structural tile exposed: N. end<br>General surface cracking |
| **HEATING/ VENTILATION PLUMBING:** | [X] Radiators<br>[X] ~~Vents~~/Fans<br>[X] Sink/Toilet/Urinal<br>[ ] Other: | [1] Intact [ ] Destroyed<br>[1] Intact [ ] Destroyed<br>[1] Intact [ ] Destroyed<br>[ ] Intact [ ] Destroyed | [X] 1900-1912<br>[X] 1913-1933<br>[ ] 1934-present<br>[ ] In question | 1 wall-mounted sink: fixtures missing.<br>1 wall-mounted rotary fan w/ cover. (switch on wood plaquide below). |

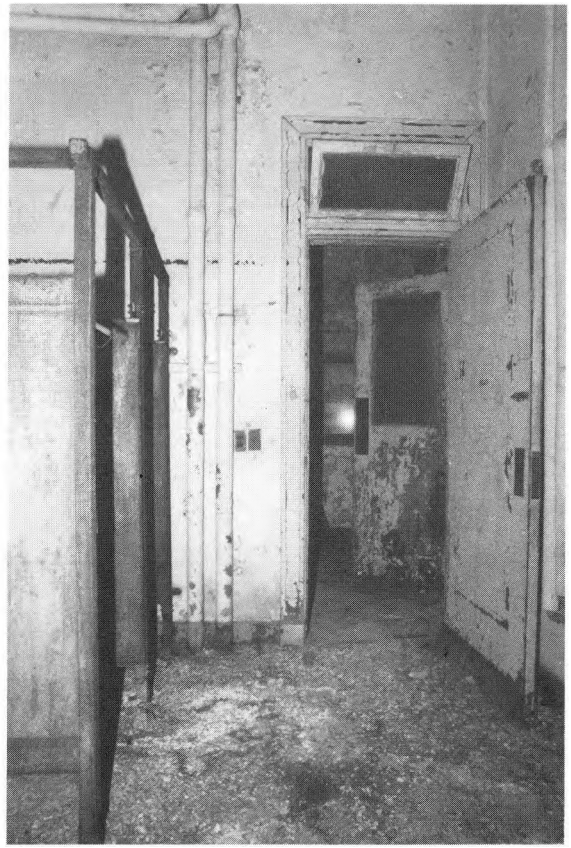
PHOTOGRAPHS: (1) View North (2) View South ROOM NO. 203

| | FINISHES: | CONDITION: | DATE: | NOTES: |
|---|---|---|---|---|
| **MISCELLANEOUS:** | | ☐ Good<br>☐ Fair<br>☐ Poor<br>☐ Destroyed | ☒ 1900-1912<br>☒ 1913-1933<br>☐ 1934-present<br>☐ In question | Metal shower stalls. Toilet stall rusted metal: painted grey. Ghosts of 3 sinks: W. wall. |
| **SUMMARY:** | | ☐ Good<br>☐ Fair<br>☒ Poor<br>☐ Destroyed | ☒ 1900-1912<br>☒ 1913-1933<br>☒ 1934-present<br>☐ In question | **ARCHITECTURAL SIGNIFICANCE:** ☐ Most ☐ Some ☒ Minor ☐ Negligible |

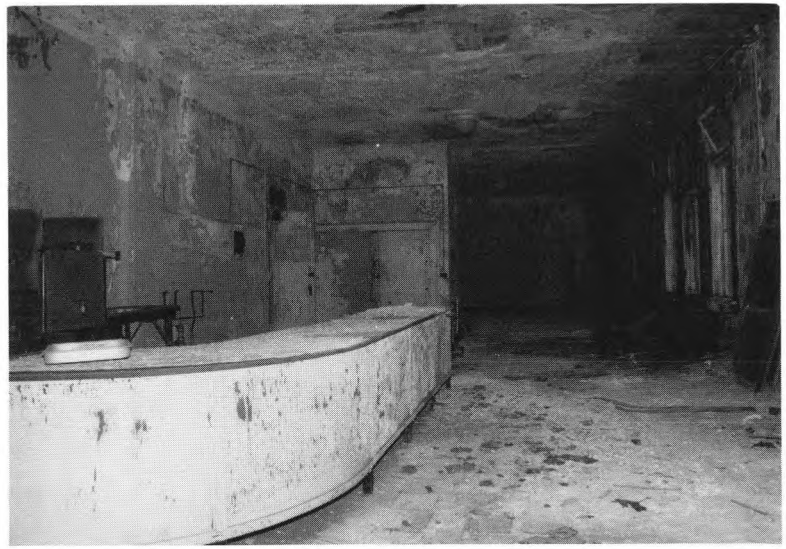
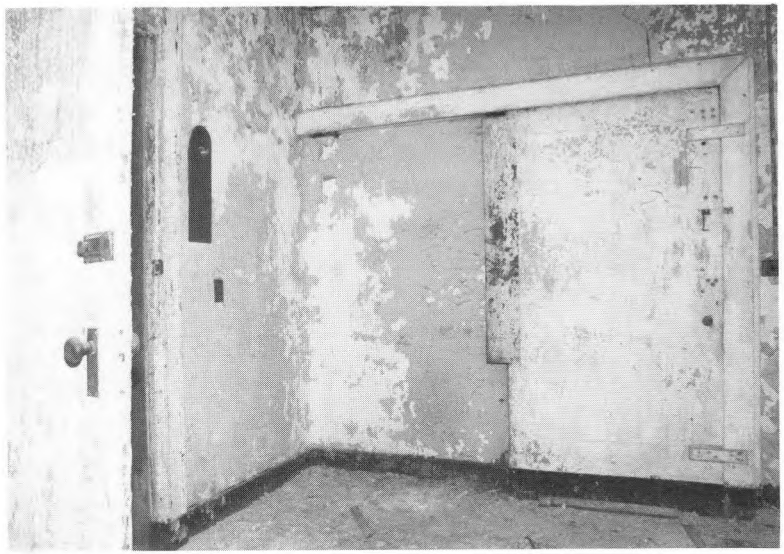
PHOTOGRAPHS: (1) View West (2) View West (3) View East (4) Elevator ROOM NO. 208

- Wood elevator door opens into space.
- Red painted fire extinguisher plaque mounted near elevator.
- Fuse box, N. wall.
- Pipes for sink, N. wall.
- Pipes for gas cooking unit, center of floor.
- Curved wood veneer counter with linoleum top, W. end.
- "Hobart Utensil Sterilizer" dishwasher, with "Allen Bradley" metal box with start/stop push buttons, to left of dishwasher on wall.

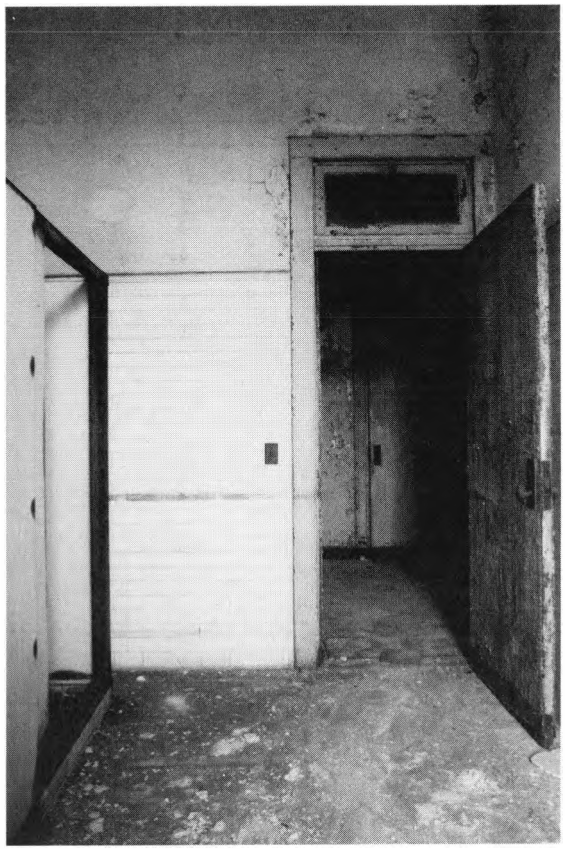
PHOTOGRAPHS: (1) View Northeast (2) View North (3) View South ROOM NO. 211

| | FINISHES: | CONDITION: | DATE: | NOTES: |
|---|---|---|---|---|
| **DOORS/ OPENINGS:** | [ ] Wood/Glass Panelled<br>[X] Wood Veneer<br>[ ] Galvanized Metal<br>[ ] Other: | [ ] Good<br>[ ] Fair<br>[X] Poor<br>[ ] Destroyed | [X] 1900-1912<br>[ ] 1913-1933<br>[ ] 1934-present<br>[ ] In question | Marble door and window surrounds, top sections are missing. |

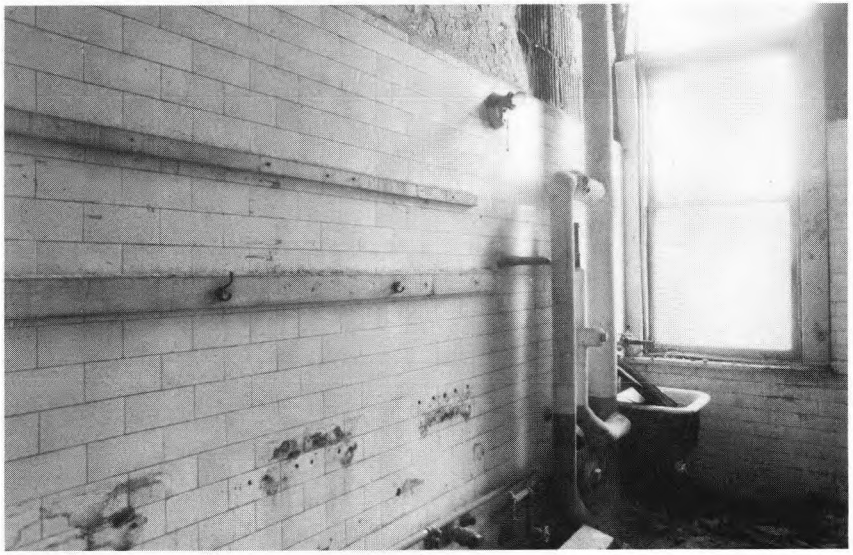
PHOTOGRAPHS: ① View North ② View South ROOM NO. 212

| | FINISHES: | CONDITION: | DATE: | NOTES: |
|---|---|---|---|---|
| **DOORS/ OPENINGS:** | Wood/Glass Panelled<br>X Wood Veneer<br>Galvanized Metal<br>Other: | Good<br>X Fair<br>Poor<br>Destroyed | 1900-1912<br>1913-1933<br>1934-present<br>X In question | 2 hooks on inside of door.<br>Marble door and window surrounds w/ white overpaint. Top of window surround missing. |

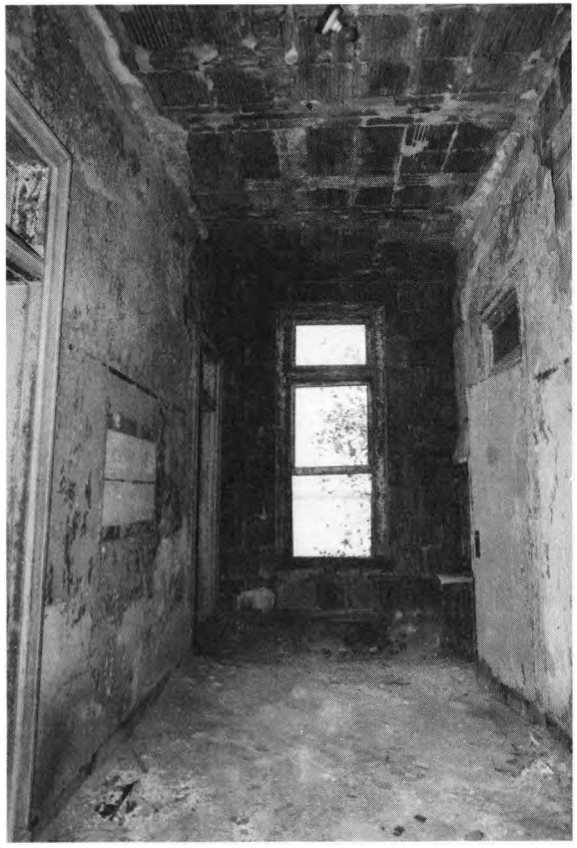
PHOTOGRAPHS: (1) View East (2) View West ROOM NO. H202

| | FINISHES: | CONDITION: | DATE: | NOTES: |
|---|---|---|---|---|
| **LIGHTING:** | Incandescent/Type A<br>Incandescent/Type B<br>X (CML)/Sconce<br>Other: | Intact Destroyed<br>Intact Destroyed<br>Intact Destroyed<br>Intact Destroyed | 1900-1912<br>1913-1933<br>X 1934-present<br>In question | shade missing. |

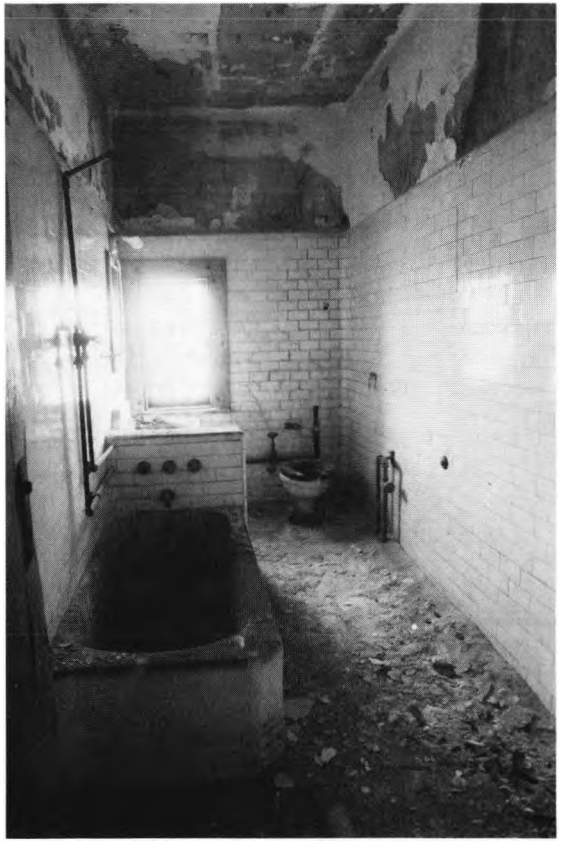
PHOTOGRAPHS: (1) View North (2) View South ROOM NO. 303

| | FINISHES: | CONDITION: | DATE: | NOTES: |
|---|---|---|---|---|
| **MISCELLANEOUS:** | | [ ] Good<br>[ ] Fair<br>[ ] Poor<br>[ ] Destroyed | [ ] 1900-1912<br>[ ] 1913-1933<br>[ ] 1934-present<br>[ ] In question | pipes from removed plumbing fixture: E. wall.<br>"304" stenciled on door. |

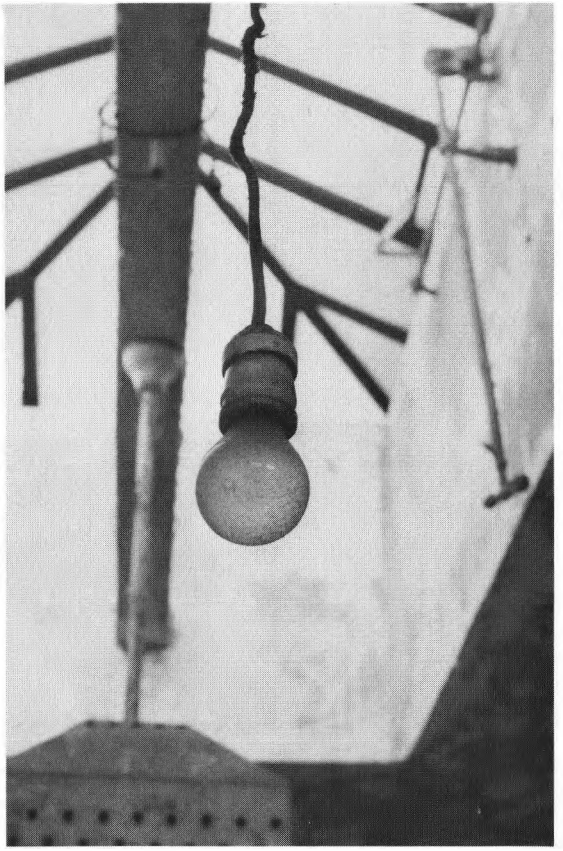
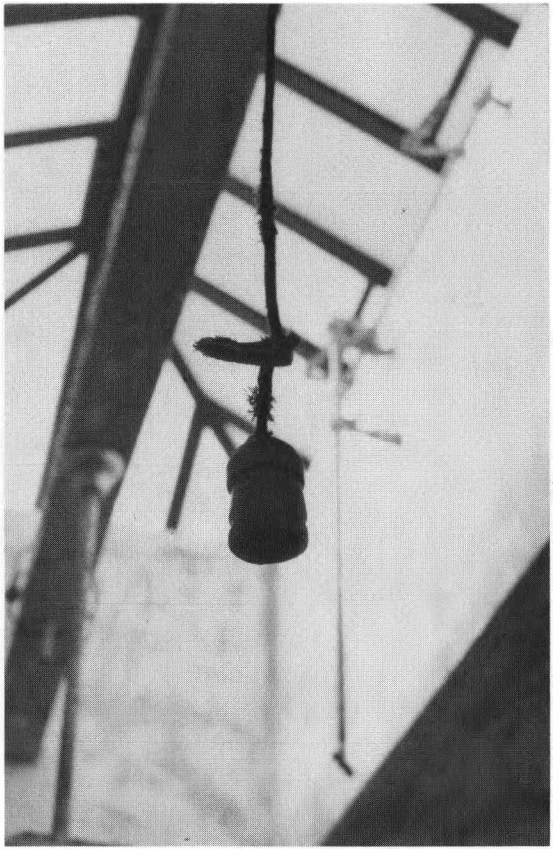
PHOTOGRAPHS: (5) Southwest corner (6) Operating lamp (7) Surgical sink ROOM NO. 306

PHOTOGRAPHS: (8) skylight (9) light fixture (10) light fixture ROOM NO. 306
