existing condition survey

units 2, 3, and 4
volume 4
appendix A
part one

# ELLIS ISLAND
# STATUE OF LIBERTY NATIONAL MONUMENT

## EXISTING CONDITION SURVEY
## UNITS 2, 3 AND 4

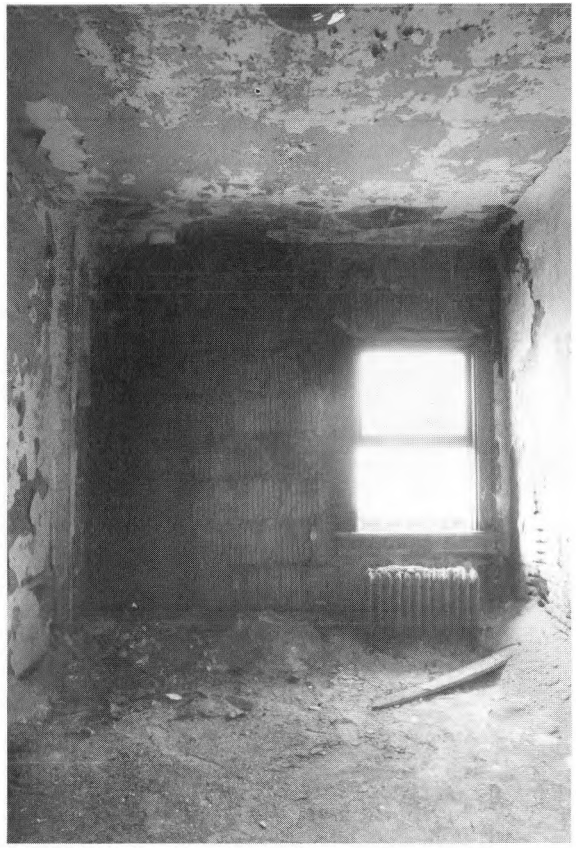
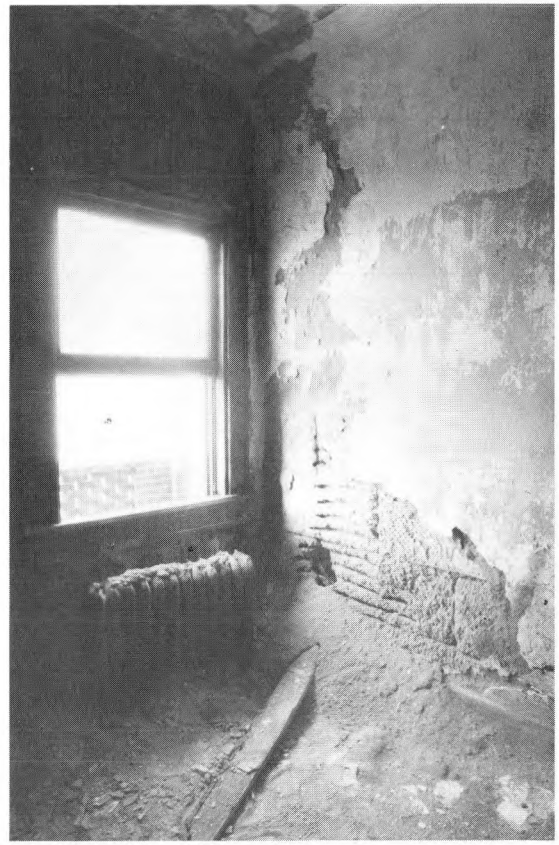
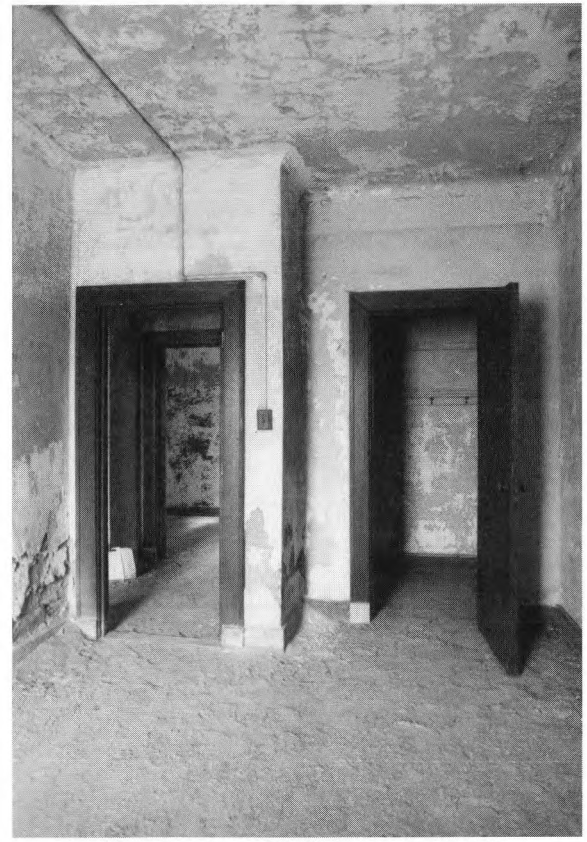
PHOTOGRAPHS: ① View South ② View Southwest ③ View North ROOM NO. 307

| | FINISHES: | CONDITION: | DATE: | NOTES: |
|---|---|---|---|---|
| **MISCELLANEOUS:** | | ☐ Good<br>☐ Fair<br>☐ Poor<br>☐ Destroyed | ☐ 1900-1912<br>☐ 1913-1933<br>☐ 1934-present<br>☒ In question | "305" stencilled on door. |

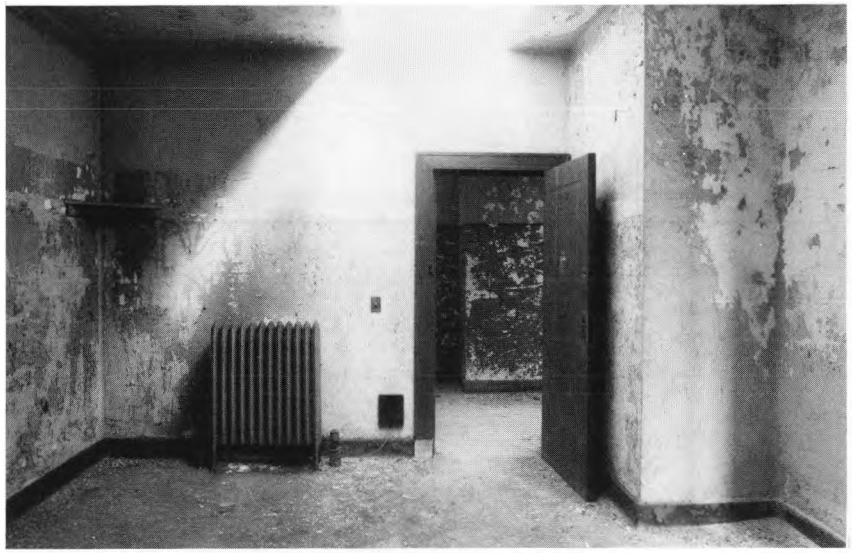
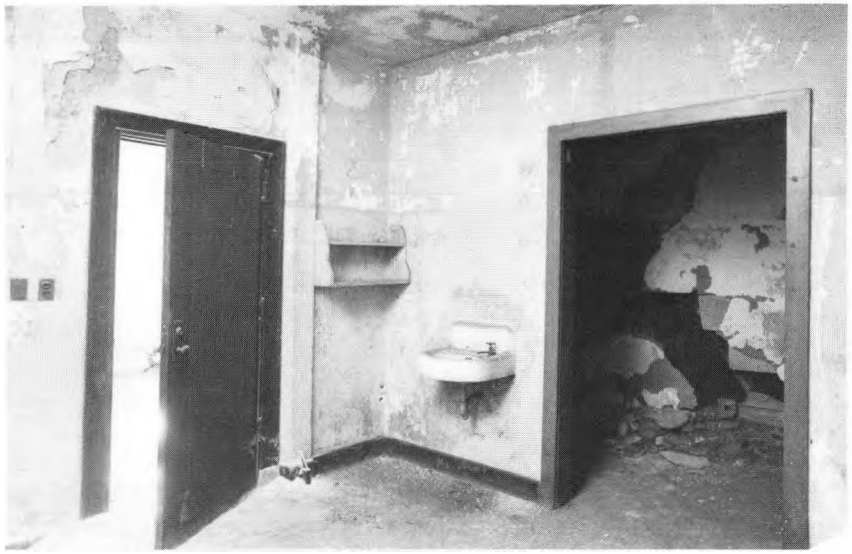
PHOTOGRAPHS: (1) View North (2) View South (3) View South with Skylight ROOM NO. 311

| | FINISHES: | CONDITION: | DATE: | NOTES: |
|---|---|---|---|---|
| **MISCELLANEOUS:** | | Good<br>Fair<br>Poor<br>Destroyed | 1900-1912<br>1913-1933<br>1934-present<br>X In question | door stencil: "317."<br>3 window shades on 3-bay window.<br>Ghosts of shelves in closet. Loose metal pipes stored in closet. |

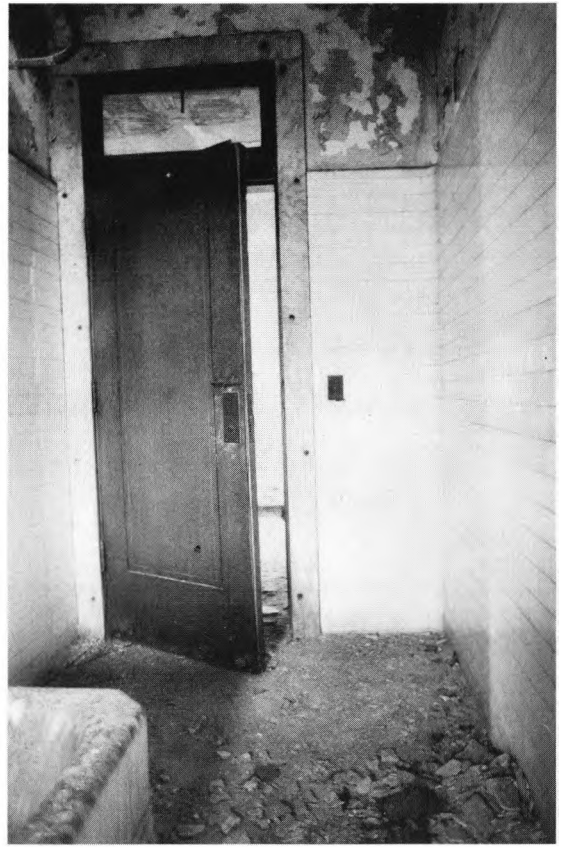
PHOTOGRAPHS: ① View North ② View South ROOM NO. 313

| | FINISHES: | CONDITION: | DATE: | NOTES: |
|---|---|---|---|---|
| **MISCELLANEOUS:** | | Good<br>Fair<br>Poor<br>Destroyed | 1900-1912<br>1913-1933<br>1934-present<br>X In question | 1 Mirror.<br>1 toilet paper holder.<br>1 towel rack. |

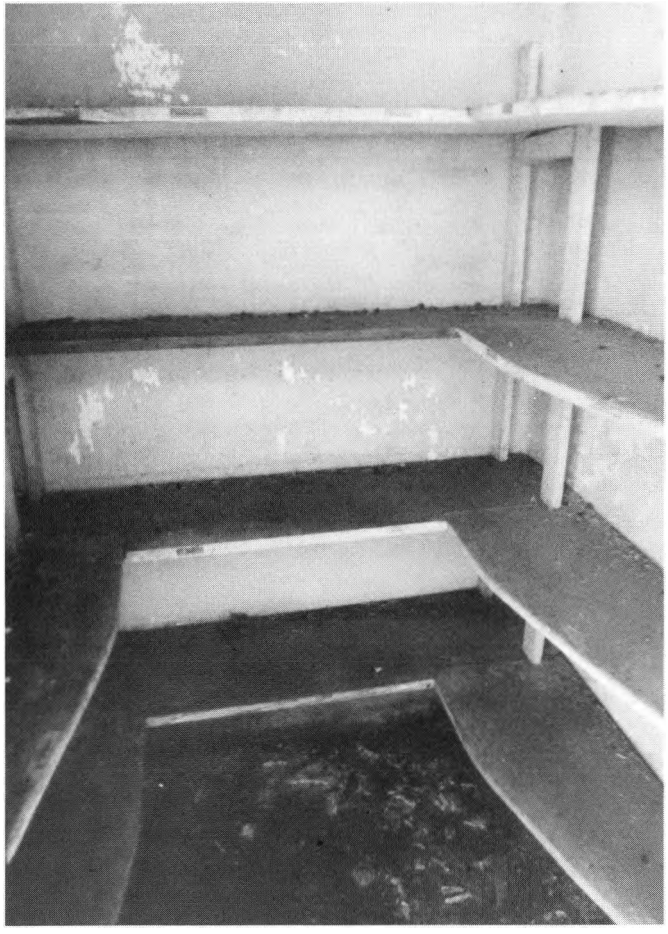
ROOM NO. H303A

PHOTOGRAPHS: (1) View North, into closet

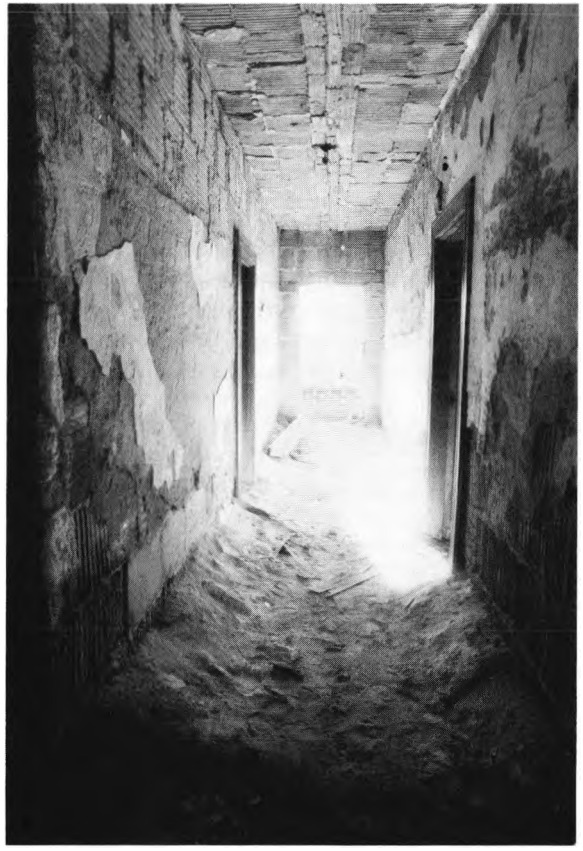
ROOM NO. H304

PHOTOGRAPHS: ① View South

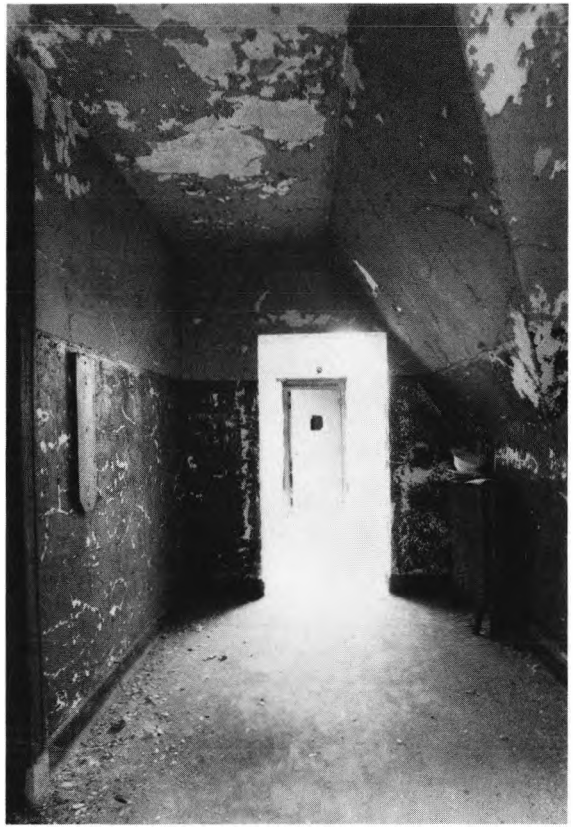
ROOM NO. H306

PHOTOGRAPHS: ① View West

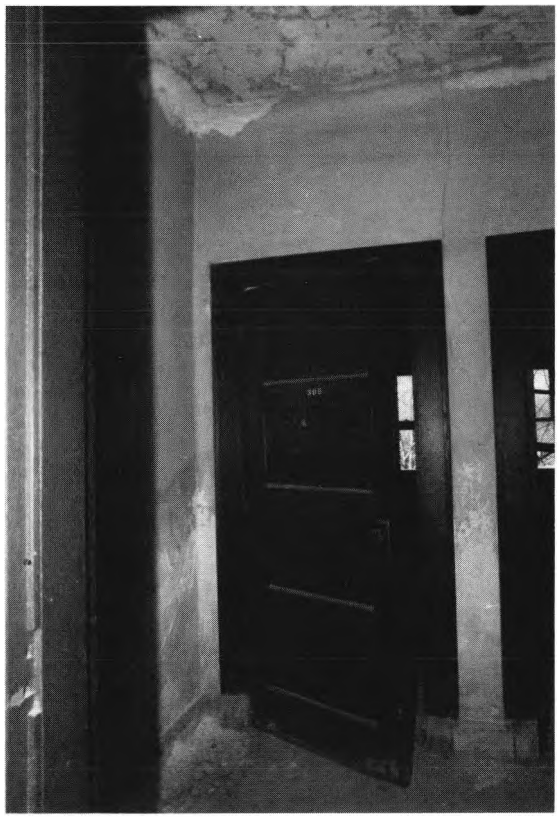
ROOM NO. H307

PHOTOGRAPHS: (1) View Southwest

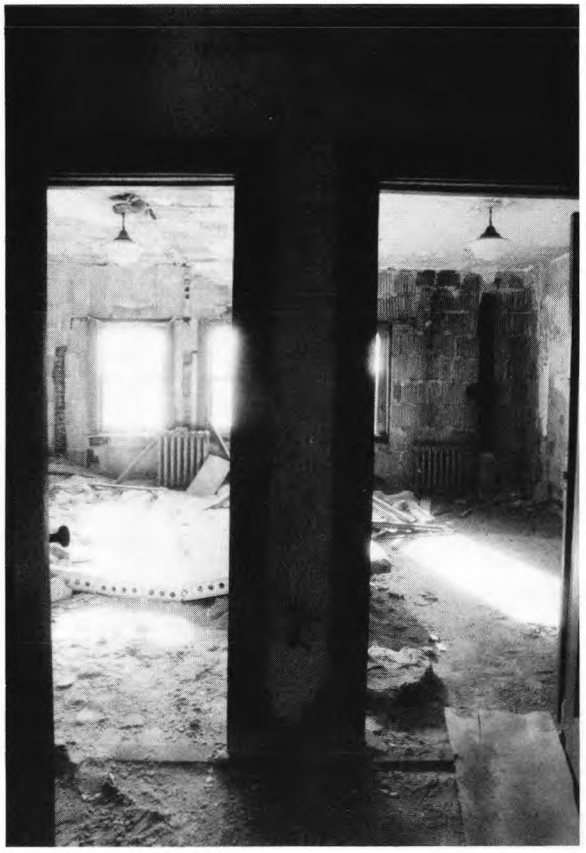
ROOM NO. H308

PHOTOGRAPHS: (1) View South.

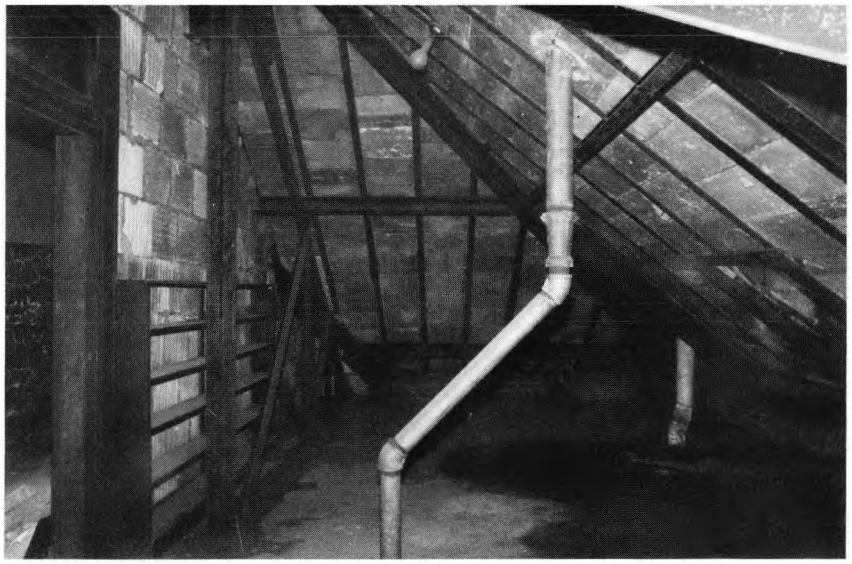
ROOM NO. A3A

PHOTOGRAPHS: (1) View South (2) View North

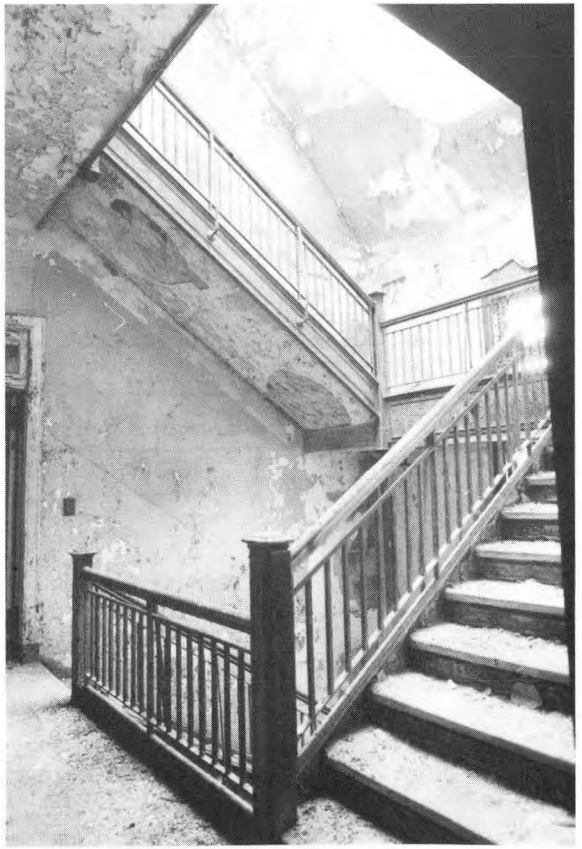
| Doors/ Openings: | One window with wood surround is located at each mid-floor landing. A decorative iron grille covers the upper portion of the window at the third floor mid-landing. A wire-glass and metal skylight lights the stairwell at the third floor roof level. | Condition: | Four panes of glass are missing from the skylight with one having been infilled with wood. Additional panes are cracked. |
