existing condition survey

ELLIS ISLAND

EXISTING CONDITION SURVEY
UNITS 2, 3 AND 4

Volume 4
Appendix A
Part Two

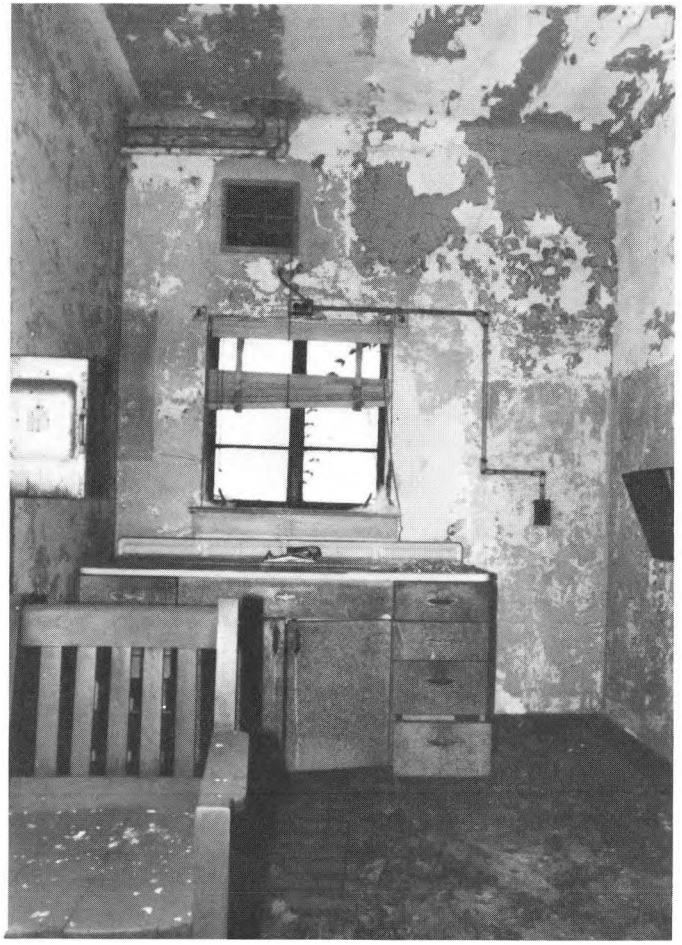
PHOTOGRAPHS: ① View East ② View Northwest ROOM NO. 102A

FINISHES:	CONDITION:	DATE:	NOTES:
FLOOR:	☐ Tile/Concrete ☒ Resilient vinyl tile ☐ Wood ☐ Other:	☒ Good ☐ Fair ☐ Poor ☐ Destroyed	☐ 1911-1923 ☐ 1924-1933 ☒ 1934-present ☐ In question	Adhering to base.
BASE:	☐ Tile/Concrete ☐ Resilient ☐ Wood ☒ Other: vinyl	☒ Good ☐ Fair ☐ Poor ☐ Destroyed	☐ 1911-1923 ☐ 1924-1933 ☒ 1934-present ☐ In question	
WALLS:	☒ Plaster ☐ Partitions ☐ Tile Wainscot ☐ Other:	☐ Good ☒ Fair ☐ Poor ☐ Destroyed	☒ 1911-1923 ☐ 1924-1933 ☒ 1934-present ☐ In question	ghosts of prior walls and shelving.
CEILING:	☒ Plaster ☐ Acoustic panels ☐ Cove ☐ Other	☒ Good ☐ Fair ☐ Poor ☐ Destroyed	☒ 1911-1923 ☐ 1924-1933 ☐ 1934-present ☐ In question	ghosts of prior wall on ceiling.
DOORS/ OPENINGS:	☒ Wood/Glass Panelled ☐ Wood Veneer ☐ Galvanized Metal ☐ Other:	☐ Good ☒ Fair ☐ Poor ☐ Destroyed	☒ 1911-1923 ☐ 1924-1933 ☒ 1934-present ☐ In question	1 5-panel door to central hall. 1 altered 3 panel swinging door to 102, diamond light, off hinges. 1 casement window: alteration.

LIGHTING:	☐ Incandescent/Type A ☐ Incandescent/Type B ☒ CM/Sconce 1 ☐ Other:	☐ Intact ☐ Destroyed ☐ Intact ☐ Destroyed ☒ Intact ☐ Destroyed ☐ Intact ☐ Destroyed	☐ 1911-1923 ☐ 1924-1933 ☒ 1934-present ☐ In question	no shade.
HEATING/ VENTILATION PLUMBING:	☐ Radiators ☒ Vents/Fans ☒ Sink/Toilet/Urinal ☐ Other:	☐ Intact ☐ Destroyed ☒ Intact ☐ Destroyed ☒ Intact ☐ Destroyed ☐ Intact ☐ Destroyed	☐ 1911-1923 ☐ 1924-1933 ☒ 1934-present ☐ In question	1 ceramic sink on "Youngstown" Metal kitchen cabinet base: rusting. 1 exhaust fan over sink.
MISCELLANEOUS:		☐ Good ☐ Fair ☐ Poor ☐ Destroyed	☐ 1911-1923 ☐ 1924-1933 ☒ 1934-present ☐ In question	1 wood counter in corner, on legs. 1 rusted metal wall hung box = switch. 1 circuitry box = N. wall.
SUMMARY:		☒ Good ☐ Fair ☐ Poor ☐ Destroyed	☒ 1911-1923 ☐ 1924-1933 ☒ 1934-present ☐ In question	**ARCHITECTURAL SIGNIFICANCE:** ☐ Most ☐ Some ☒ Minor ☐ Negligible

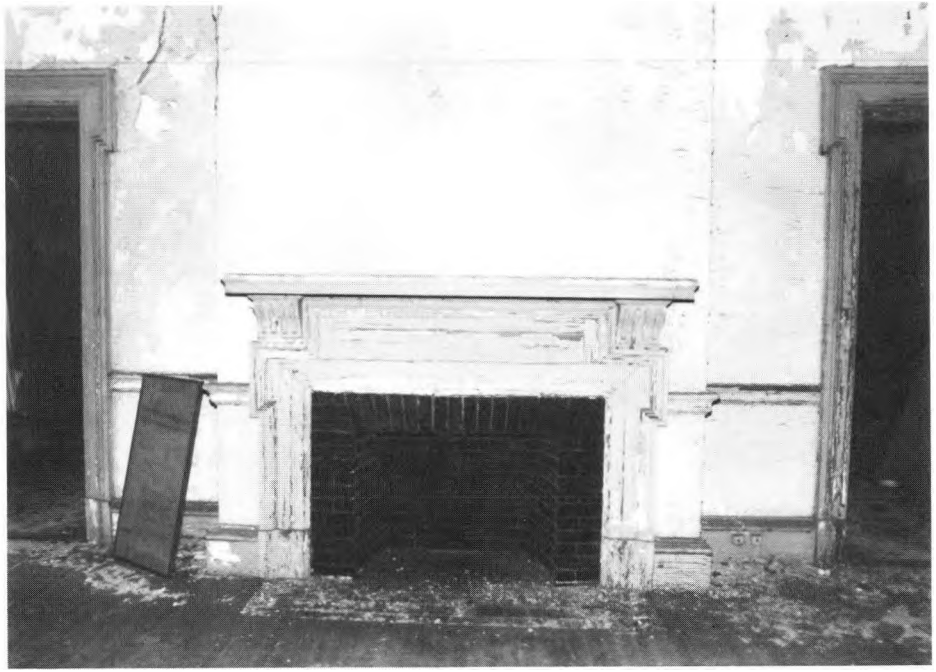
PHOTOGRAPHS: ① View South ② View North ROOM NO. 103

FINISHES:	CONDITION:	DATE:	NOTES:
FLOOR:	[ ] Tile/Concrete [ ] Resilient [X] Wood [ ] Other:	[ ] Good [X] Fair [ ] Poor [ ] Destroyed	[X] 1911-1923 [ ] 1924-1933 [ ] 1934-present [ ] In question	Evidence of brown stain
BASE:	[ ] Tile/Concrete [ ] Resilient [X] Wood [ ] Other:	[ ] Good [X] Fair [ ] Poor [ ] Destroyed	[X] 1911-1923 [ ] 1924-1933 [ ] 1934-present [ ] In question	
WALLS:	[X] Plaster [ ] Partitions [ ] Tile Wainscot [ ] Other:	[ ] Good [X] Fair [ ] Poor [ ] Destroyed	[X] 1911-1923 [ ] 1924-1933 [ ] 1934-present [ ] In question	E. wall - rusting thru of metal subsurface; electric cable to removed sconce. chair rail.
CEILING:	[X] Plaster [ ] Acoustic panels [ ] Cove [ ] Other	[ ] Good [X] Fair [ ] Poor [ ] Destroyed	[X] 1911-1923 [ ] 1924-1933 [ ] 1934-present [ ] In question	Severe crack, SE area - extends down wall.
DOORS/ OPENINGS:	[X] Wood/Glass Panelled [ ] Wood Veneer [ ] Galvanized Metal [ ] Other:	[ ] Good [X] Fair [ ] Poor [ ] Destroyed	[X] 1911-1923 [ ] 1924-1933 [ ] 1934-present [ ] In question	Wood Valence over windows. Evidence of Venetian blinds. Doorways to 104, panelled reveals, no doors. 1 wood 15-panel door to H102A.

LIGHTING:	[ ] Incandescent/Type A [ ] Incandescent/Type B [X] CML/Sconce [X] Other:	[ ] Intact [ ] Destroyed [ ] Intact [ ] Destroyed [ ] Intact [X] Destroyed [ ] Intact [X] Destroyed	[ ] 1911-1923 [ ] 1924-1933 [X] 1934-present [ ] In question	Evidence of 2 removed sconces: E wall. 1 metal rod suspended from ceramic fixture - no shade.
HEATING/ VENTILATION PLUMBING:	[X] Radiators 1 [ ] Vents/Fans [ ] Sink/Toilet/Urinal [ ] Other:	[X] Intact [ ] Destroyed [ ] Intact [ ] Destroyed [ ] Intact [ ] Destroyed [ ] Intact [ ] Destroyed	[X] 1911-1923 [ ] 1924-1933 [ ] 1934-present [ ] In question	
MISCELLANEOUS:		[ ] Good [X] Fair [ ] Poor [ ] Destroyed	[X] 1911-1923 [ ] 1924-1933 [ ] 1934-present [ ] In question	Fireplace: Brick, wood mantel w/ egg + dart molding; brackets
SUMMARY:		[X] Good [ ] Fair [ ] Poor [ ] Destroyed	[X] 1911-1923 [ ] 1924-1933 [X] 1934-present [ ] In question	**ARCHITECTURAL SIGNIFICANCE:** [X] Most [ ] Some [ ] Minor [ ] Negligible

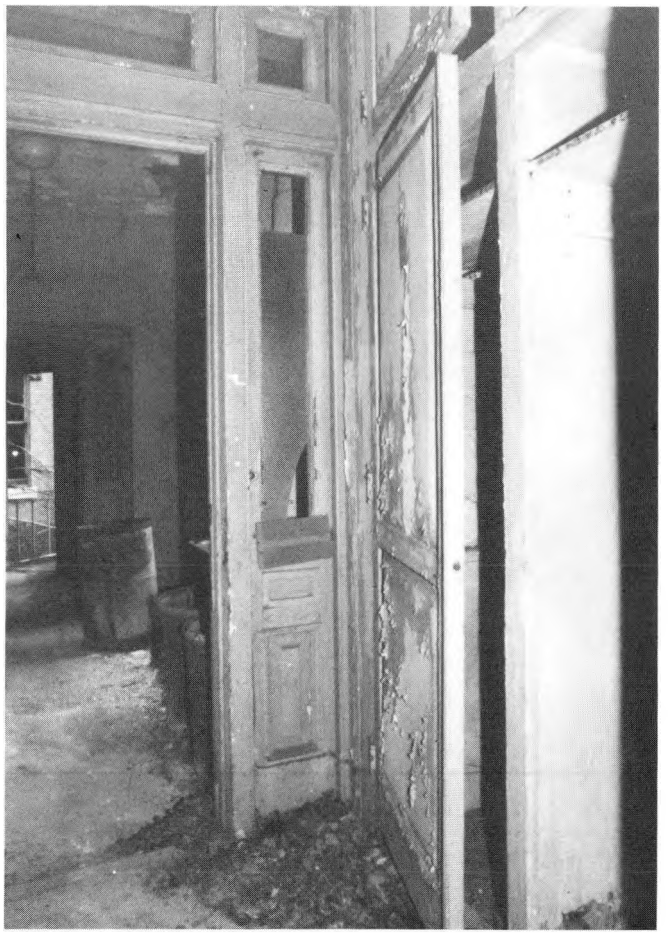
PHOTOGRAPHS: ① view East from covered way. ② view Northwest ROOM NO. H101

FINISHES:	CONDITION:	DATE:	NOTES:
FLOOR:	☐ Tile/Concrete ☐ Resilient ☒ Wood ☐ Other:	☒ Good ☐ Fair ☐ Poor ☐ Destroyed	☐ 1911-1923 ☐ 1924-1933 ☐ 1934-present ☐ In question	
BASE:	☐ Tile/Concrete ☐ Resilient ☐ Wood ☐ Other:	☐ Good ☐ Fair ☐ Poor ☐ Destroyed	☐ 1911-1923 ☐ 1924-1933 ☐ 1934-present ☐ In question	
WALLS:	☐ Plaster ☒ Partitions ☐ Tile Wainscot ☒ Other: door surrounds	☒ Good ☐ Fair ☐ Poor ☐ Destroyed	☐ 1911-1923 ☐ 1924-1933 ☐ 1934-present ☐ In question	Wood partition wall to H101A w/ 3 lights in upper portion: S. wall. N. wall = cupboard : closet. chair rail and floral detail (paint) in closet. E. and W. walls = doorways.
CEILING:	☒ Plaster ☐ Acoustic panels ☐ Cove ☐ Other	☒ Good ☐ Fair ☐ Poor ☐ Destroyed	☐ 1911-1923 ☐ 1924-1933 ☐ 1934-present ☐ In question	
DOORS/ OPENINGS:	☐ Wood/Glass Panelled ☐ Wood Veneer ☐ Galvanized Metal ☐ Other:	☐ Good ☐ Fair ☐ Poor ☐ Destroyed	☐ 1911-1923 ☐ 1924-1933 ☐ 1934-present ☐ In question	E. door: 3-panel w/ upper light (infilled). W. door: 1½ panel w/ upper light; cast iron sill. Dimpled glass sidelights. Transoms have 3 lights.

LIGHTING:	☐ Incandescent/Type A ☐ Incandescent/Type B ☒ CMD/Sconce ☐ Other:	☐ Intact ☐ Destroyed ☐ Intact ☐ Destroyed ☒ Intact ☐ Destroyed ☐ Intact ☐ Destroyed	☐ 1911-1923 ☐ 1924-1933 ☐ 1934-present ☐ In question	
HEATING/ VENTILATION PLUMBING:	☐ Radiators ☐ Vents/Fans ☐ Sink/Toilet/Urinal ☐ Other:	☐ Intact ☐ Destroyed ☐ Intact ☐ Destroyed ☐ Intact ☐ Destroyed ☐ Intact ☐ Destroyed	☐ 1911-1923 ☐ 1924-1933 ☐ 1934-present ☐ In question	
MISCELLANEOUS:		☐ Good ☐ Fair ☐ Poor ☐ Destroyed	☐ 1911-1923 ☐ 1924-1933 ☐ 1934-present ☐ In question	Double door closet w/ double door upper closet area. 1 door of lower section removed.
SUMMARY:		☒ Good ☐ Fair ☐ Poor ☐ Destroyed	☐ 1911-1923 ☐ 1924-1933 ☐ 1934-present ☐ In question	**ARCHITECTURAL SIGNIFICANCE:** ☐ Most ☐ Some ☒ Minor ☐ Negligible

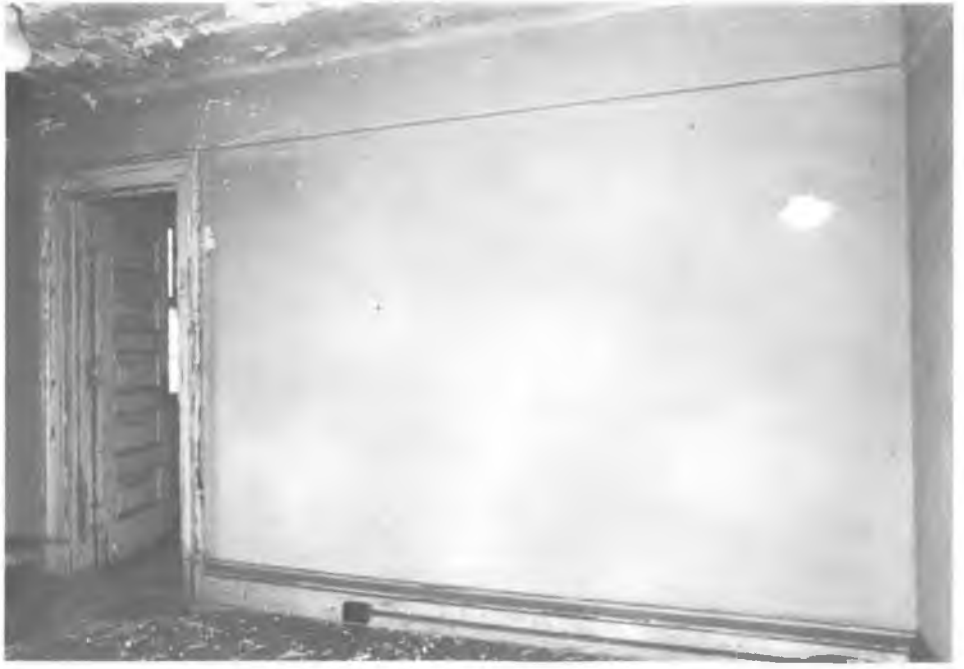
PHOTOGRAPHS: (1) view West (2) view South (3) view North (4) view East ROOM NO. 201

FINISHES:	CONDITION:	DATE:	NOTES:
FLOOR:	☐ Tile/Concrete ☐ Resilient ☒ Wood ☐ Other:	☒ Good ☐ Fair ☐ Poor ☐ Destroyed	☒ 1911-1923 ☐ 1924-1933 ☐ 1934-present ☐ In question	
BASE:	☐ Tile/Concrete ☐ Resilient ☒ Wood ☐ Other:	☒ Good ☐ Fair ☐ Poor ☐ Destroyed	☒ 1911-1923 ☐ 1924-1933 ☐ 1934-present ☐ In question	
WALLS:	☒ Plaster ☐ Partitions ☐ Tile Wainscot ☐ Other:	☒ Good ☐ Fair ☐ Poor ☐ Destroyed	☒ 1911-1923 ☐ 1924-1933 ☐ 1934-present ☐ In question	
CEILING:	☒ Plaster ☐ Acoustic panels ☒ Cove ☐ Other	☒ Good ☐ Fair ☐ Poor ☐ Destroyed	☒ 1911-1923 ☐ 1924-1933 ☐ 1934-present ☐ In question	
DOORS/ OPENINGS:	☒ Wood/~~Glass~~ Panelled ☐ Wood Veneer ☐ Galvanized Metal ☐ Other:	☒ Good ☐ Fair ☐ Poor ☐ Destroyed	☒ 1911-1923 ☐ 1924-1933 ☐ 1934-present ☐ In question	3 wood 5-panel doors.
LIGHTING:	☐ Incandescent/Type A ☐ Incandescent/Type B ☒ CML (Sconce) 2 ☒ Other: 1	☐ Intact ☐ Destroyed ☐ Intact ☐ Destroyed ☐ Intact ☒ Destroyed ☒ Intact ☐ Destroyed	☐ 1911-1923 ☐ 1924-1933 ☒ 1934-present ☐ In question	1 Standard staff House lamp (w/ metal rod and shade) shade is on floor. 2 ghosts removed sconces.

HEATING/ VENTILATION PLUMBING:	☒ Radiators 1 ☐ Vents/Fans ☐ Sink/Toilet/Urinal ☐ Other:	☒ Intact ☐ Destroyed ☐ Intact ☐ Destroyed ☐ Intact ☐ Destroyed ☐ Intact ☐ Destroyed	☒ 1911-1923 ☐ 1924-1933 ☐ 1934-present ☐ In question	
MISCELLANEOUS:		☐ Good ☒ Fair ☐ Poor ☐ Destroyed	☐ 1911-1923 ☐ 1924-1933 ☒ 1934-present ☐ In question	201 B closet: 2 upper shelves. Lower shelves and clothes rod missing.
SUMMARY:		☒ Good ☐ Fair ☐ Poor ☐ Destroyed	☒ 1911-1923 ☐ 1924-1933 ☒ 1934-present ☐ In question	**ARCHITECTURAL SIGNIFICANCE:** ☐ Most ☒ Some ☐ Minor ☐ Negligible

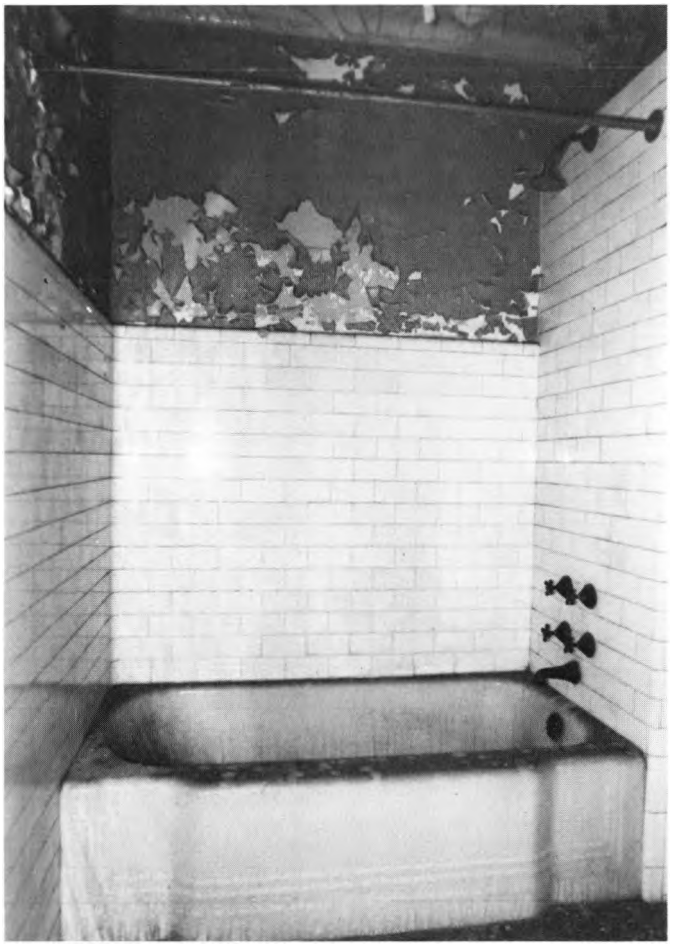
PHOTOGRAPHS: (1) View South (2) View East ROOM NO. 201A

FINISHES:	CONDITION:	DATE:	NOTES:
FLOOR:	[X] Tile/Concrete [ ] Resilient [ ] Wood [ ] Other:	[X] Good [ ] Fair [ ] Poor [ ] Destroyed	[X] 1911-1923 [ ] 1924-1933 [ ] 1934-present [ ] In question	Hexagonal white tile.
BASE:	[X] Tile/Concrete [ ] Resilient [ ] Wood [ ] Other:	[X] Good [ ] Fair [ ] Poor [ ] Destroyed	[X] 1911-1923 [ ] 1924-1933 [ ] 1934-present [ ] In question	
WALLS:	[ ] Plaster [ ] Partitions [X] Tile Wainscot [ ] Other:	[X] Good [ ] Fair [ ] Poor [ ] Destroyed	[X] 1911-1923 [ ] 1924-1933 [ ] 1934-present [ ] In question	Picture rail.
CEILING:	[X] Plaster [ ] Acoustic panels [X] Cove [ ] Other	[X] Good [ ] Fair [ ] Poor [ ] Destroyed	[X] 1911-1923 [ ] 1924-1933 [ ] 1934-present [ ] In question	
DOORS/ OPENINGS:	[X] Wood/~~Glass~~ Panelled [ ] Wood Veneer [ ] Galvanized Metal [ ] Other:	[ ] Good [X] Fair [ ] Poor [ ] Destroyed	[X] 1911-1923 [ ] 1924-1933 [ ] 1934-present [ ] In question	5-panel door

LIGHTING:	[ ] Incandescent/Type A [ ] Incandescent/Type B [X] CML/Sconce [ ] Other:	[ ] Intact [ ] Destroyed [ ] Intact [ ] Destroyed [1] Intact [1] Destroyed [ ] Intact [ ] Destroyed	[ ] 1911-1923 [ ] 1924-1933 [X] 1934-present [ ] In question	1 CML w/ broken shade. 1 oval sconce, no shade. unusual light switch: Knob end.
HEATING/ VENTILATION PLUMBING:	[X] Radiators [ ] Vents/Fans [X] Sink/Toilet/Urinal [ ] Other: tub	[ ] Intact [X] Destroyed [ ] Intact [ ] Destroyed [X] Intact [ ] Destroyed [X] Intact [ ] Destroyed	[X] 1911-1923 [X] 1924-1933 [X] 1934-present [ ] In question	radiator removed. 1 wall mounted sink w/ faucets. 1 toilet w/ tank. 1 tub w/ shower from tile backpiece.
MISCELLANEOUS:		[ ] Good [X] Fair [ ] Poor [ ] Destroyed	[X] 1911-1923 [ ] 1924-1933 [ ] 1934-present [ ] In question	1 cupboard over sink.
SUMMARY:		[X] Good [ ] Fair [ ] Poor [ ] Destroyed	[X] 1911-1923 [X] 1924-1933 [X] 1934-present [ ] In question	**ARCHITECTURAL SIGNIFICANCE:** [ ] Most [ ] Some [X] Minor [ ] Negligible

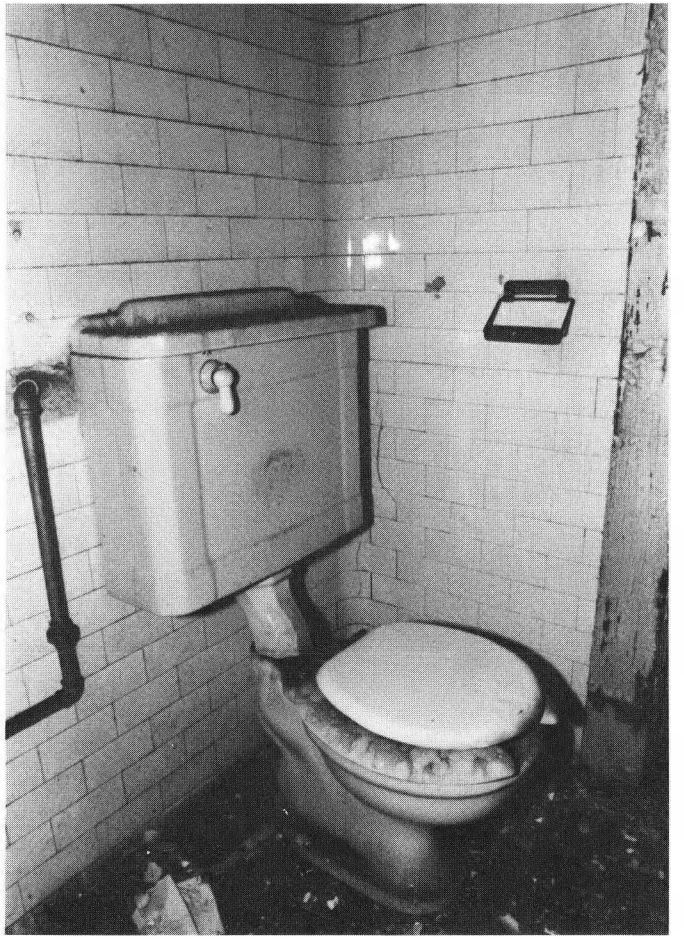
PHOTOGRAPHS: (1) View North (2) toilet, SE corner. ROOM NO. 203

FINISHES:	CONDITION:	DATE:	NOTES:
FLOOR:	[X] Tile/Concrete [ ] Resilient [ ] Wood [ ] Other:	[X] Good [ ] Fair [ ] Poor [ ] Destroyed	[X] 1911-1923 [ ] 1924-1933 [ ] 1934-present [ ] In question	Hexagonal white tiles.
BASE:	[X] Tile/Concrete [ ] Resilient [ ] Wood [ ] Other:	[X] Good [ ] Fair [ ] Poor [ ] Destroyed	[X] 1911-1923 [ ] 1924-1933 [ ] 1934-present [ ] In question	
WALLS:	[ ] Plaster [ ] Partitions [X] Tile Wainscot [ ] Other:	[X] Good [ ] Fair [ ] Poor [ ] Destroyed	[X] 1911-1923 [ ] 1924-1933 [ ] 1934-present [ ] In question	
CEILING:	[X] Plaster [ ] Acoustic panels [X] Cove [ ] Other	[X] Good [ ] Fair [ ] Poor [ ] Destroyed	[X] 1911-1923 [ ] 1924-1933 [ ] 1934-present [ ] In question	cracking, NE corner.
DOORS/ OPENINGS:	[X] Wood/~~Glass~~ Panelled [ ] Wood Veneer [ ] Galvanized Metal [ ] Other:	[X] Good [ ] Fair [ ] Poor [ ] Destroyed	[X] 1911-1923 [ ] 1924-1933 [ ] 1934-present [ ] In question	Marbel window and door sills. Dimpled glass window

LIGHTING:	[ ] Incandescent/Type A [ ] Incandescent/Type B [X] CML/Sconce | [ ] Other:	[ ] Intact [ ] Destroyed [ ] Intact [ ] Destroyed [X] Intact [ ] Destroyed [ ] Intact [ ] Destroyed	[ ] 1911-1923 [ ] 1924-1933 [X] 1934-present [ ] In question	1 oval ceramic sconce, no shade.
HEATING/ VENTILATION PLUMBING:	[X] Radiators | [ ] Vents/Fans [X] Sink/Toilet/Urinal [X] Other: tub	[X] Intact [ ] Destroyed [ ] Intact [ ] Destroyed [X] Intact [ ] Destroyed [X] Intact [ ] Destroyed	[X] 1911-1923 [X] 1924-1933 [X] 1934-present [ ] In question	1 toilet w/ tank. 1 tub w/ shower + tiled back + tiled foot shelf. 1 wall mounted sink w/ faucets.
MISCELLANEOUS:	[ ] [ ] [ ] [ ]	[ ] Good [X] Fair [ ] Poor [ ] Destroyed	[ ] 1911-1923 [ ] 1924-1933 [ ] 1934-present [X] In question	Cream colored cloth window shade. 1 hanging wood cabinet w/ mirror. 1 toilet paper roller.
SUMMARY:		[X] Good [ ] Fair [ ] Poor [ ] Destroyed	[X] 1911-1923 [X] 1924-1933 [X] 1934-present [X] In question	**ARCHITECTURAL SIGNIFICANCE:** [ ] Most [ ] Some [X] Minor [ ] Negligible

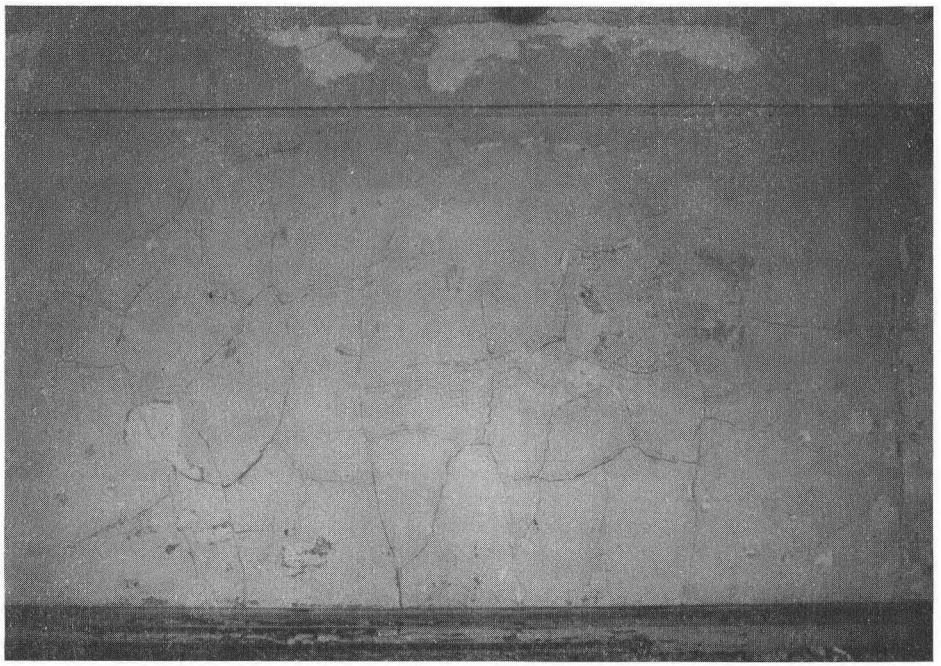
PHOTOGRAPHS: (1) View East (2) View West (3) View North (4) View South ROOM NO. 264

FINISHES:	CONDITION:	DATE:	NOTES:
FLOOR:	☐ Tile/Concrete ☐ Resilient ☒ Wood ☐ Other:	☐ Good ☒ Fair ☐ Poor ☐ Destroyed	☒ 1911-1923 ☐ 1924-1933 ☐ 1934-present ☐ In question	Weathered surface.
BASE:	☐ Tile/Concrete ☐ Resilient ☒ Wood ☐ Other:	☐ Good ☒ Fair ☐ Poor ☐ Destroyed	☒ 1911-1923 ☐ 1924-1933 ☐ 1934-present ☐ In question	Some deterioration due to weathering thru opened windows.
WALLS:	☒ Plaster ☐ Partitions ☐ Tile Wainscot ☐ Other:	☐ Good ☒ Fair ☐ Poor ☐ Destroyed	☒ 1911-1923 ☐ 1924-1933 ☐ 1934-present ☐ In question	
CEILING:	☒ Plaster ☐ Acoustic panels ☒ Cove ☐ Other	☒ Good ☐ Fair ☐ Poor ☐ Destroyed	☒ 1911-1923 ☐ 1924-1933 ☐ 1934-present ☐ In question	
DOORS/ OPENINGS:	☒ Wood/~~Glass~~ Panelled ☐ Wood Veneer ☐ Galvanized Metal ☐ Other:	☒ Good ☐ Fair ☐ Poor ☐ Destroyed	☒ 1911-1923 ☐ 1924-1933 ☐ 1934-present ☐ In question	Door had hinged upper panel. Hooks on back of door. Venetian blinds: E. window. Drapery rod: N. window.

LIGHTING:	☐ Incandescent/Type A ☐ Incandescent/Type B ☒ CML ~~Sconce~~ 2 ☒ Other: 1	☐ Intact ☐ Destroyed ☐ Intact ☐ Destroyed ☐ Intact ☒ Destroyed ☒ Intact ☐ Destroyed	☐ 1911-1923 ☐ 1924-1933 ☒ 1934-present ☐ In question	ghosts of 2 removed sconces. 1 standard fixture – shade detached, on floor.
HEATING/ VENTILATION PLUMBING:	☒ Radiators 1 ☐ Vents/Fans ☐ Sink/Toilet/Urinal ☐ Other:	☒ Intact ☐ Destroyed ☐ Intact ☐ Destroyed ☐ Intact ☐ Destroyed ☐ Intact ☐ Destroyed	☒ 1911-1923 ☐ 1924-1933 ☐ 1934-present ☐ In question	
MISCELLANEOUS:		☐ Good ☐ Fair ☐ Poor ☐ Destroyed	☐ 1911-1923 ☐ 1924-1933 ☐ 1934-present ☐ In question	
SUMMARY:		☒ Good ☐ Fair ☐ Poor ☐ Destroyed	☒ 1911-1923 ☐ 1924-1933 ☒ 1934-present ☐ In question	**ARCHITECTURAL SIGNIFICANCE:** ☒ Most ☐ Some ☐ Minor ☐ Negligible

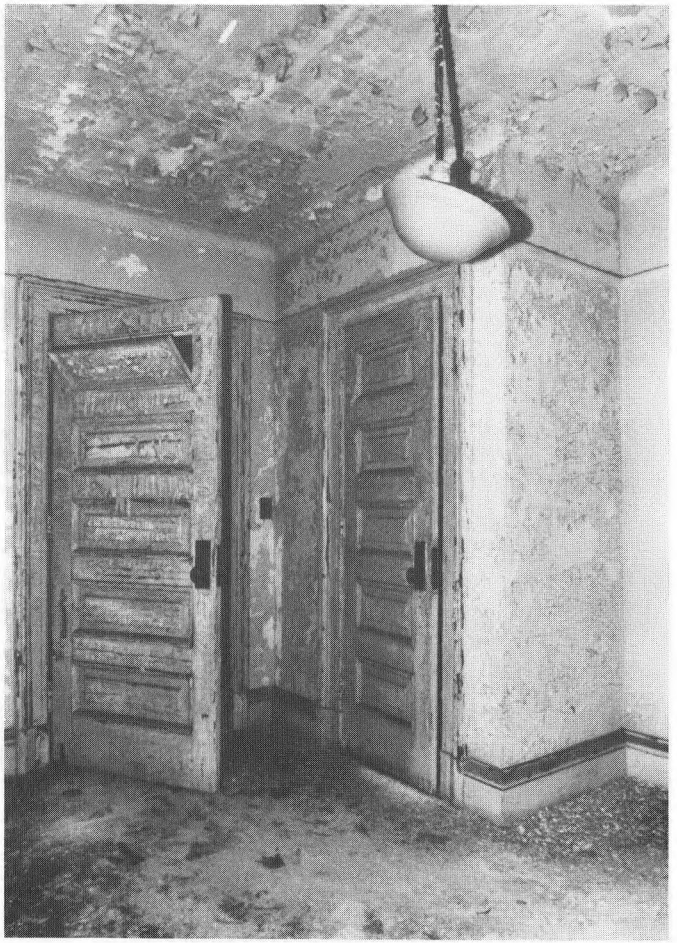
PHOTOGRAPHS: (1) View Northwest (2) View East ROOM NO. 205

FINISHES:	CONDITION:	DATE:	NOTES:
FLOOR:	☐ Tile/Concrete ☐ Resilient ☒ Wood ☐ Other:	☒ Good ☐ Fair ☐ Poor ☐ Destroyed	☒ 1911-1923 ☐ 1924-1933 ☐ 1934-present ☐ In question	
BASE:	☐ Tile/Concrete ☐ Resilient ☒ Wood ☐ Other:	☐ Good ☒ Fair ☐ Poor ☐ Destroyed	☒ 1911-1923 ☐ 1924-1933 ☐ 1934-present ☐ In question	
WALLS:	☒ Plaster ☐ Partitions ☐ Tile Wainscot ☐ Other:	☒ Good ☐ Fair ☐ Poor ☐ Destroyed	☒ 1911-1923 ☐ 1924-1933 ☐ 1934-present ☐ In question	picture rail.
CEILING:	☒ Plaster ☐ Acoustic panels ☐ Cove ☐ Other	☐ Good ☒ Fair ☐ Poor ☐ Destroyed	☒ 1911-1923 ☐ 1924-1933 ☐ 1934-present ☐ In question	Fairly significant exposure of structural tile: E end.
DOORS/ OPENINGS:	☒ Wood/~~Glass~~ Panelled ☐ Wood Veneer ☐ Galvanized Metal ☐ Other:	☒ Good ☐ Fair ☐ Poor ☐ Destroyed	☒ 1911-1923 ☐ 1924-1933 ☐ 1934-present ☐ In question	5-panel door to Hall - w/ hinged top panel. 5-panel door to closet.
LIGHTING:	☐ Incandescent/Type A ☐ Incandescent/Type B ☐ CML/Sconce ☒ Other: 1	☐ Intact ☐ Destroyed ☐ Intact ☐ Destroyed ☐ Intact ☐ Destroyed ☒ Intact ☐ Destroyed	☐ 1911-1923 ☐ 1924-1933 ☒ 1934-present ☐ In question	standard fixture: rod w/ dish.

HEATING/ VENTILATION PLUMBING:	☒ Radiators 1 ☐ Vents/Fans ☐ Sink/Toilet/Urinal ☐ Other:	☐ Intact ☒ Destroyed ☐ Intact ☐ Destroyed ☐ Intact ☐ Destroyed ☐ Intact ☐ Destroyed	☒ 1911-1923 ☐ 1924-1933 ☐ 1934-present ☐ In question	radiator removed.
MISCELLANEOUS:	☐ ☐ ☐ ☐	☒ Good ☐ Fair ☐ Poor ☐ Destroyed	☐ 1911-1923 ☒ 1924-1933 ☐ 1934-present ☐ In question	closet: clothes rod; hooks on door. Removed lower rod. Removed upper shelf. (205A)
SUMMARY:		☒ Good ☐ Fair ☐ Poor ☐ Destroyed	☒ 1911-1923 ☒ 1924-1933 ☒ 1934-present ☐ In question	**ARCHITECTURAL SIGNIFICANCE:** ☐ Most ☒ Some ☐ Minor ☐ Negligible

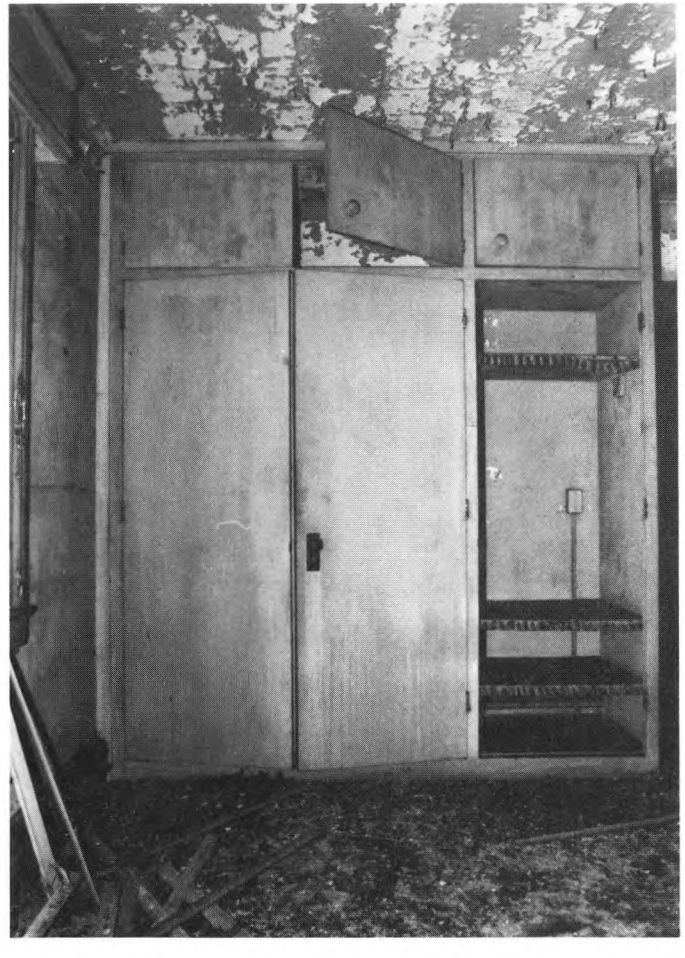
PHOTOGRAPHS: (1) View North (2) View South ROOM NO.

FINISHES:	CONDITION:	DATE:	NOTES:
FLOOR:	[ ] Tile/Concrete [ ] Resilient [X] Wood [ ] Other:	[ ] Good [X] Fair [ ] Poor [ ] Destroyed	[X] 1911-1923 [ ] 1924-1933 [ ] 1934-present [ ] In question	joint where wall was removed.
BASE:	[ ] Tile/Concrete [ ] Resilient [X] Wood [ ] Other:	[ ] Good [X] Fair [ ] Poor [ ] Destroyed	[X] 1911-1923 [ ] 1924-1933 [ ] 1934-present [ ] In question	
WALLS:	[X] Plaster [ ] Partitions [ ] Tile Wainscot [ ] Other:	[ ] Good [X] Fair [ ] Poor [ ] Destroyed	[X] 1911-1923 [ ] 1924-1933 [ ] 1934-present [ ] In question	E. Wall – cloth wall covering, "Wall-Tex" Type. Overpainted w/ blue.
CEILING:	[X] Plaster [ ] Acoustic panels [X] Cove [ ] Other	[ ] Good [X] Fair [ ] Poor [ ] Destroyed	[X] 1911-1923 [ ] 1924-1933 [ ] 1934-present [ ] In question	ghost of removed wall.
DOORS/ OPENINGS:	[X] Wood/~~Glass~~ Panelled [ ] Wood Veneer [ ] Galvanized Metal [ ] Other:	[ ] Good [X] Fair [ ] Poor [ ] Destroyed	[X] 1911-1923 [ ] 1924-1933 [ ] 1934-present [ ] In question	1 5-panel door, W. wall.

LIGHTING:	[ ] Incandescent/Type A [ ] Incandescent/Type B [ ] CML/Sconce [ ] Other:	[ ] Intact [ ] Destroyed [ ] Intact [ ] Destroyed [ ] Intact [ ] Destroyed [ ] Intact [ ] Destroyed	[ ] 1911-1923 [ ] 1924-1933 [ ] 1934-present [ ] In question	
HEATING/ VENTILATION PLUMBING:	[X] Radiators 2 [ ] Vents/Fans [ ] Sink/Toilet/Urinal [ ] Other:	[X] Intact [ ] Destroyed [ ] Intact [ ] Destroyed [ ] Intact [ ] Destroyed [ ] Intact [ ] Destroyed	[X] 1911-1923 [ ] 1924-1933 [ ] 1934-present [ ] In question	
MISCELLANEOUS:		[ ] Good [X] Fair [ ] Poor [ ] Destroyed	[ ] 1911-1923 [ ] 1924-1933 [X] 1934-present [ ] In question	Built-in closet w/ cupboards above and side cupboard: S.W. Wall. (207A).
SUMMARY:		[X] Good [ ] Fair [ ] Poor [ ] Destroyed	[X] 1911-1923 [ ] 1924-1933 [X] 1934-present [ ] In question	**ARCHITECTURAL SIGNIFICANCE:** [ ] Most [X] Some [ ] Minor [ ] Negligible

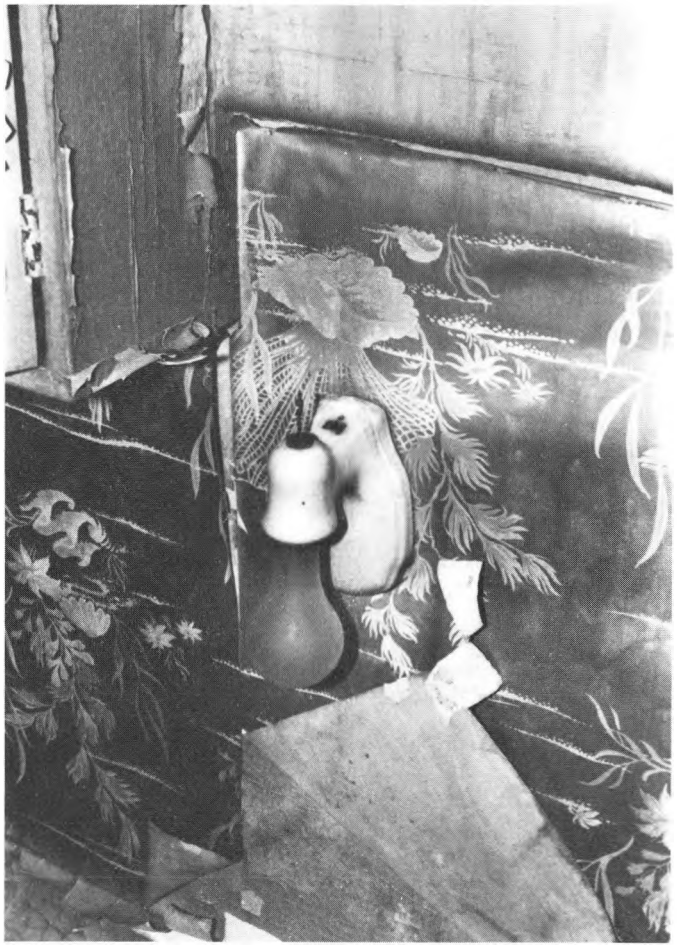
PHOTOGRAPHS: (1) view South (2) wallpaper + sconce, E. wall ROOM NO. 208

FINISHES:	CONDITION:	DATE:	NOTES:
FLOOR:	(Tile/Concrete) X Resilient Wood Other:	Good X Fair Poor Destroyed	1911-1923 1924-1933 X 1934-present In question	
BASE:	Tile/Concrete X Resilient Wood Other:	Good X Fair Poor Destroyed	1911-1923 1924-1933 X 1934-present In question	
WALLS:	X Plaster Partitions X Tile Wainscot Other:	Good X Fair Poor Destroyed	X 1911-1923 1924-1933 1934-present In question	wallpaper: silver and cream underwater design. Tile painted over.
CEILING:	X Plaster Acoustic panels Cove Other	Good X Fair Poor Destroyed	X 1911-1923 1924-1933 1934-present In question	
DOORS/ OPENINGS:	X Wood/~~Glass~~ Panelled Wood Veneer Galvanized Metal Other:	Good X Fair Poor Destroyed	X 1911-1923 1924-1933 1934-present In question	5-panel door window has marble sill and dimpled glass.
LIGHTING:	Incandescent/Type A Incandescent/Type B X CML/(Sconce) Other:	Intact Destroyed Intact Destroyed X Intact Destroyed Intact Destroyed	1911-1923 1924-1933 X 1934-present In question	wall-mounted fixture, bulb points downward.

HEATING/ VENTILATION PLUMBING:	X Radiators Vents/Fans X (Sink)/(Toilet)/Urinal X Other: tub	Intact Destroyed Intact Destroyed X Intact Destroyed X Intact Destroyed	X 1911-1923 X 1924-1933 X 1934-present In question	1 wall-hung sink w/ faucets. 1 toilet base - no tank. 1 tub w/ tile back area.
MISCELLANEOUS:		Good Fair Poor Destroyed	1911-1923 1924-1933 1934-present X In question	shelves hung over sink. 2 metal drinking glass holders on each side of sink (deteriorated chrome finish over brass).
SUMMARY:		X Good Fair Poor Destroyed	X 1911-1923 X 1924-1933 X 1934-present X In question	**ARCHITECTURAL SIGNIFICANCE:** Most / Some / X Minor / Negligible

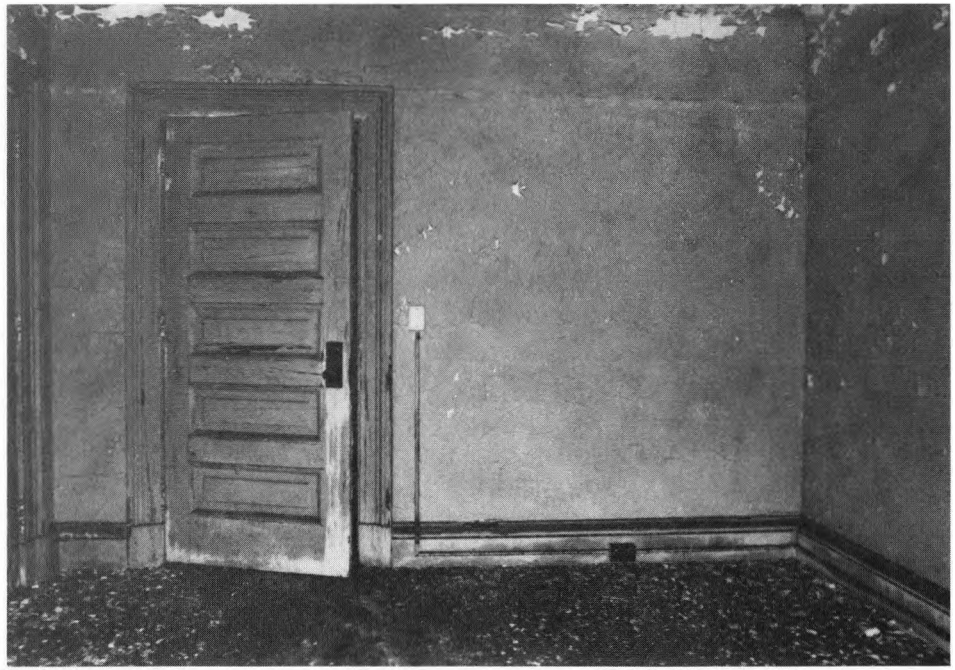
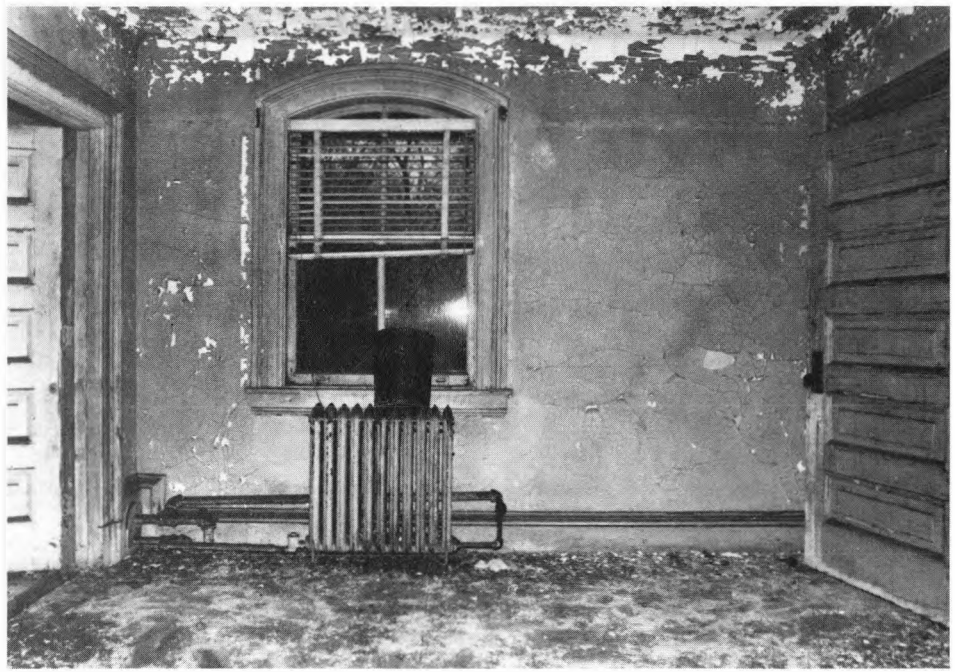
PHOTOGRAPHS: (1) View North (2) View South (3) View East (4) View West ROOM NO. 210

FINISHES:	CONDITION:	DATE:	NOTES:
FLOOR:	☐ Tile/Concrete ☐ Resilient ☒ Wood ☐ Other:	☒ Good ☐ Fair ☐ Poor ☐ Destroyed	☒ 1911-1923 ☐ 1924-1933 ☐ 1934-present ☐ In question	
BASE:	☐ Tile/Concrete ☐ Resilient ☒ Wood ☐ Other:	☐ Good ☒ Fair ☐ Poor ☐ Destroyed	☒ 1911-1923 ☐ 1924-1933 ☐ 1934-present ☐ In question	Corner raised where pipe for radiator enters room.
WALLS:	☒ Plaster ☐ Partitions ☐ Tile Wainscot ☐ Other:	☒ Good ☐ Fair ☐ Poor ☐ Destroyed	☒ 1911-1923 ☐ 1924-1933 ☐ 1934-present ☐ In question	Ghost of removed picture rail some delamination of finish coat; s. wall.
CEILING:	☒ Plaster ☐ Acoustic panels ☐ Cove ☐ Other	☒ Good ☐ Fair ☐ Poor ☐ Destroyed	☒ 1911-1923 ☐ 1924-1933 ☐ 1934-present ☐ In question	Crazing/cracking.
DOORS/ OPENINGS:	☒ Wood/~~Glass~~ Panelled ☐ Wood Veneer ☐ Galvanized Metal ☐ Other:	☐ Good ☒ Fair ☐ Poor ☐ Destroyed	☒ 1911-1923 ☐ 1924-1933 ☐ 1934-present ☐ In question	3 5-panel doors. Venetian blinds.

LIGHTING:	☐ Incandescent/Type A ☐ Incandescent/Type B ☒ CML/(Sconce) ☐ Other:	☐ Intact ☐ Destroyed ☐ Intact ☐ Destroyed ☐ Intact ☒ Destroyed ☐ Intact ☐ Destroyed	☐ 1911-1923 ☐ 1924-1933 ☐ 1934-present ☒ In question	Ghosts of 2, possibly 3 sconces.
HEATING/ VENTILATION PLUMBING:	☒ Radiators \ Vents/Fans ☐ Sink/Toilet/Urinal ☐ Other:	☒ Intact ☐ Destroyed ☐ Intact ☐ Destroyed ☐ Intact ☐ Destroyed ☐ Intact ☐ Destroyed	☐ 1911-1923 ☐ 1924-1933 ☒ 1934-present ☐ In question	
MISCELLANEOUS:		☐ Good ☐ Fair ☐ Poor ☐ Destroyed	☐ 1911-1923 ☐ 1924-1933 ☒ 1934-present ☐ In question	210 B: Addition of closet w/ 2 upper shelves and 1 lower shelf for shoes, clothes rods and hooks.
SUMMARY:		☒ Good ☐ Fair ☐ Poor ☐ Destroyed	☒ 1911-1923 ☐ 1924-1933 ☒ 1934-present ☒ In question	**ARCHITECTURAL SIGNIFICANCE:** 210 ☐ Most ☒ Some ☐ Minor 210B ☐ Negligible ☒

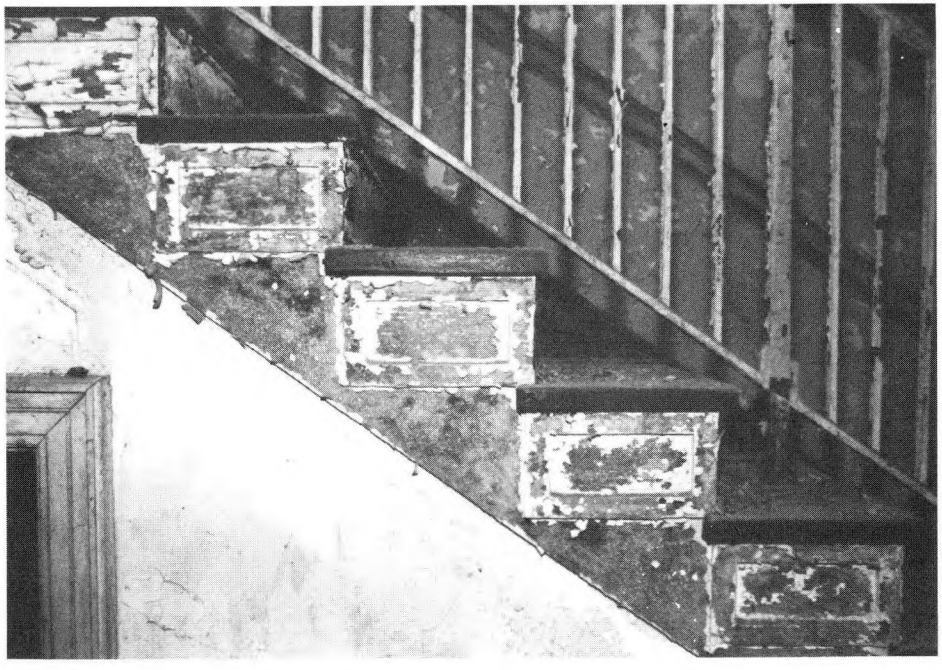
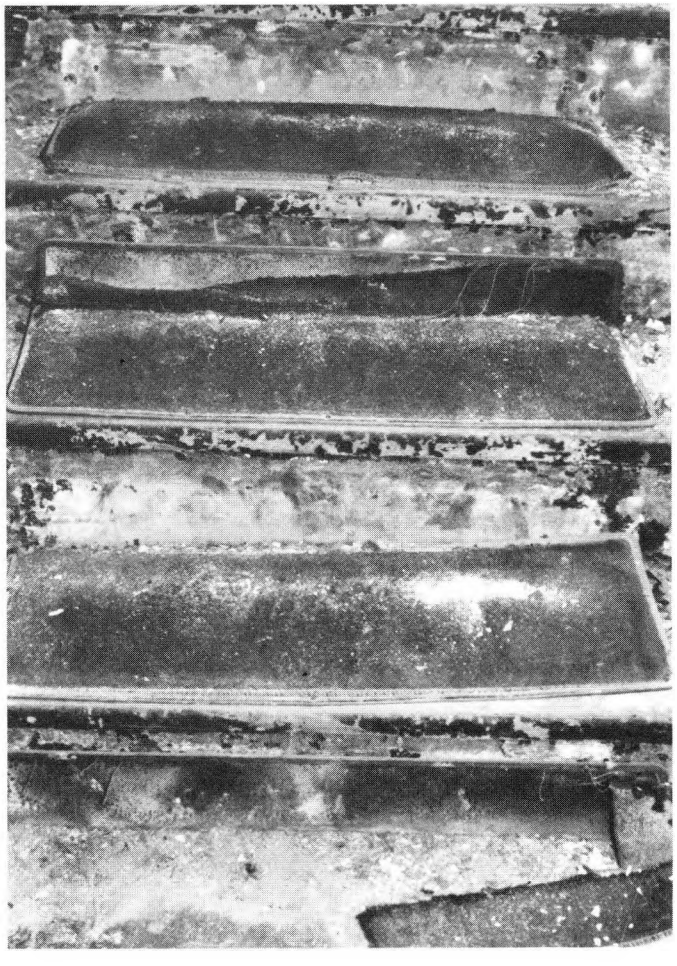
SUMMARY:		(XX) Good ( ) Fair ( ) Poor ( ) Destroyed	ARCHITECTURAL SIGNIFICANCE:	( ) Most (XX) Some ( ) Minor ( ) Negligible

PHOTOGRAPHS: (1) View East (2) Newel post ROOM NO. 501

PHOTOGRAPHS: (3) panelled stringer. (4) carpeted treads ROOM NO. 501

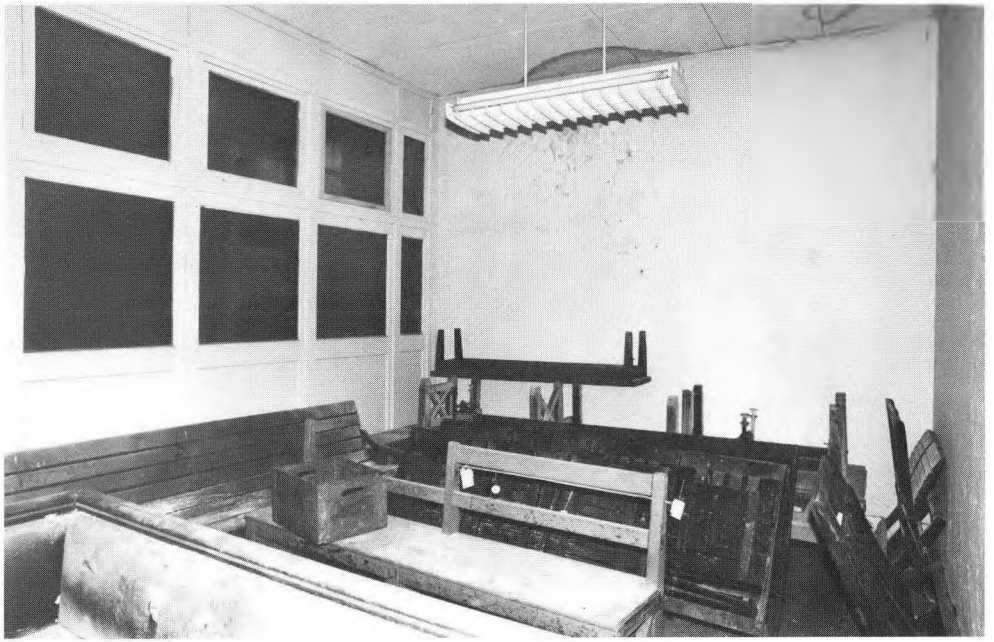
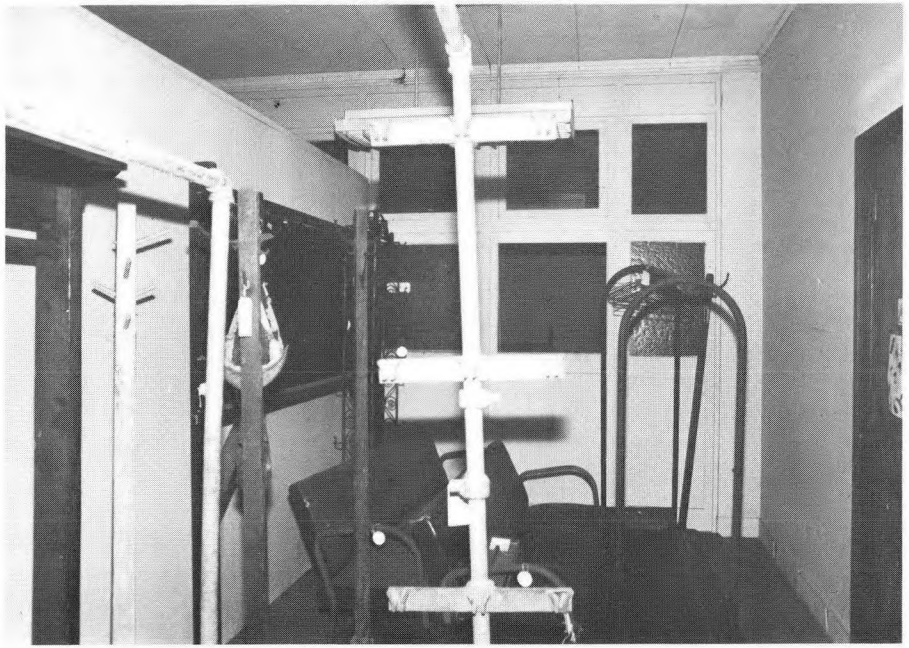
FINISHES:	CONDITION:	DATE:	NOTES:
FLOOR:	☐ Tile/Concrete ☐ Resilient ☐ Wood ☒ Other:	☐ Good ☒ Fair ☐ Poor ☐ Destroyed	☐ 1911-1923 ☐ 1924-1933 ☒ 1934-present ☐ In question	Carpet over composite sheet-board. Remains in place.
BASE:	☐ Tile/Concrete ☐ Resilient ☐ Wood ☒ Other: asphalt	☐ Good ☐ Fair ☒ Poor ☐ Destroyed	☐ 1911-1923 ☐ 1924-1933 ☒ 1934-present ☐ In question	Not on partition walls.
WALLS:	☒ Plaster ☒ Partitions ☐ Tile Wainscot ☐ Other:	☒ Good ☐ Fair ☒ Poor ☐ Destroyed	☐ 1911-1923 ☐ 1924-1933 ☒ 1934-present ☐ In question	101A, E wall: severe surface chemical reaction and deterioration (white crusting, possible efflorescence). All partitions, good cond.
CEILING:	☐ Plaster ☒ Acoustic panels ☐ Cove ☐ Other	☒ Good ☐ Fair ☐ Poor ☐ Destroyed	☐ 1911-1923 ☐ 1924-1933 ☒ 1934-present ☐ In question	
DOORS/ OPENINGS:	☐ Wood/Glass Panelled ☒ Wood Veneer ☐ Galvanized Metal ☐ Other:	☒ Good ☐ Fair ☐ Poor ☐ Destroyed	☐ 1911-1923 ☐ 1924-1933 ☒ 1934-present ☐ In question	Doors removed from partition walls to 101C and 101D.

LIGHTING:	☐ Incandescent/Type A ☐ Incandescent/Type B ☐ CML/Sconce ☒ Other: fluorescent	☐ Intact ☐ Destroyed ☐ Intact ☐ Destroyed ☐ Intact ☐ Destroyed ☒ Intact ☐ Destroyed	☐ 1911-1923 ☐ 1924-1933 ☒ 1934-present ☐ In question	
HEATING/ VENTILATION PLUMBING:	☒ Radiators ☐ Vents/Fans ☐ Sink/Toilet/Urinal ☐ Other:	☐ Intact ☐ Destroyed ☐ Intact ☐ Destroyed ☐ Intact ☐ Destroyed ☐ Intact ☐ Destroyed	☐ 1911-1923 ☐ 1924-1933 ☒ 1934-present ☐ In question	
MISCELLANEOUS:		☐ Good ☐ Fair ☐ Poor ☐ Destroyed	☐ 1911-1923 ☐ 1924-1933 ☒ 1934-present ☐ In question	Door signage from H101: "VOCATIONAL"
SUMMARY:		☐ Good ☒ Fair ☐ Poor ☐ Destroyed	☐ 1911-1923 ☐ 1924-1933 ☒ 1934-present ☐ In question	**ARCHITECTURAL SIGNIFICANCE:** ☐ Most ☐ Some ☒ Minor ☐ Negligible

PHOTOGRAPHS: ① 101A, View SW. ② 101B View S. ③ 101D, View S. ④ 101D, NE ROOM NO. 101/A,B,C,D

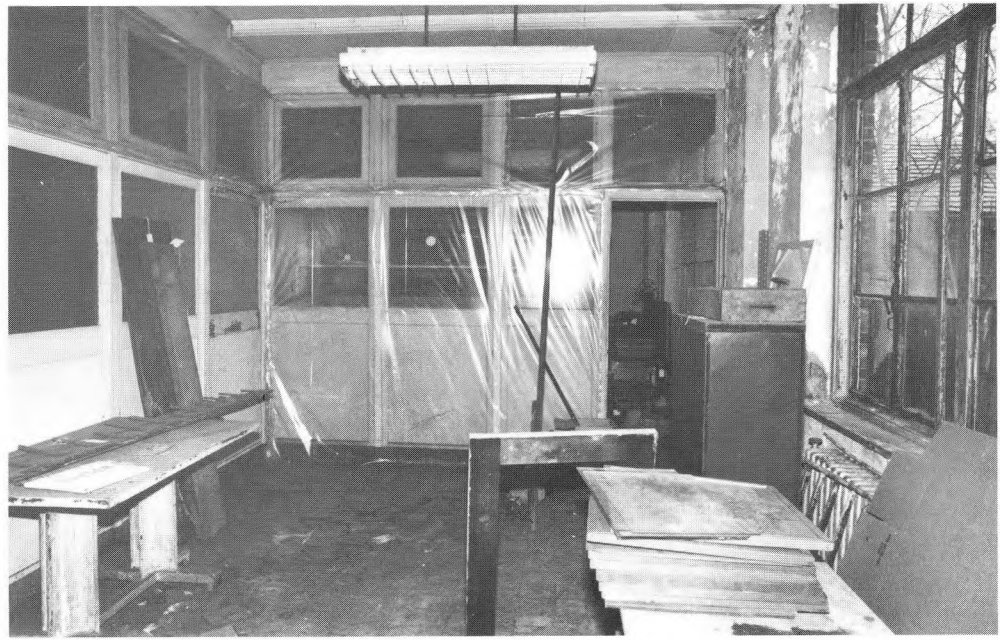
PHOTOGRAPHS: (5) 101C, view S.E. (6) 101C, South (7) 101C, North ROOM NO. 101C

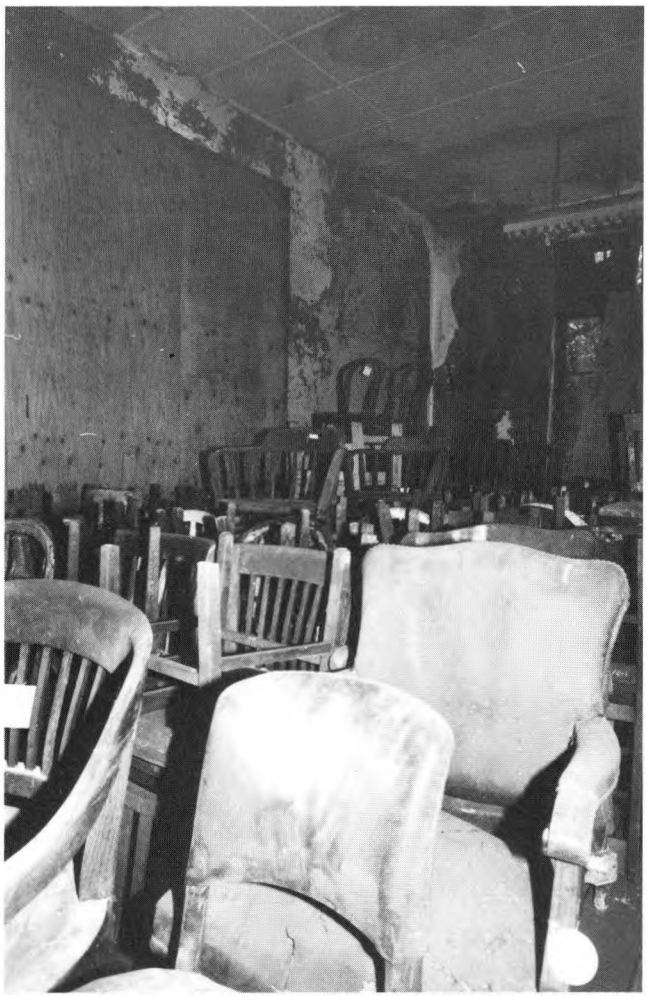
FINISHES:	CONDITION:	DATE:	NOTES:
FLOOR:	☐ Tile/Concrete ☒ Resilient rolled ☐ Wood ☐ Other:	☐ Good ☒ Fair ☐ Poor ☐ Destroyed	☐ 1911-1923 ☐ 1924-1933 ☒ 1934-present ☐ In question	
BASE:	☒ Tile/Concrete ☐ Resilient ☐ Wood ☐ Other:	☒ Good ☐ Fair ☐ Poor ☐ Destroyed	☐ 1911-1923 ☐ 1924-1933 ☒ 1934-present ☐ In question	
WALLS:	☒ Plaster ☐ Partitions ☐ Tile Wainscot ☐ Other:	☒ Good ☐ Fair ☐ Poor ☐ Destroyed	☐ 1911-1923 ☐ 1924-1933 ☒ 1934-present ☐ In question	
CEILING:	☐ Plaster ☒ Acoustic panels ☐ Cove ☐ Other	☐ Good ☒ Fair ☐ Poor ☐ Destroyed	☐ 1911-1923 ☐ 1924-1933 ☒ 1934-present ☐ In question	
DOORS/ OPENINGS:	☐ Wood/Glass Panelled ☐ Wood Veneer ☐ Galvanized Metal ☐ Other:	☐ Good ☐ Fair ☐ Poor ☐ Destroyed	☐ 1911-1923 ☐ 1924-1933 ☒ 1934-present ☐ In question	windows covered with plywood.
LIGHTING:	☐ Incandescent/Type A ☐ Intact ☐ Destroyed ☐ Incandescent/Type B ☐ Intact ☐ Destroyed ☐ CML/Sconce ☐ Intact ☐ Destroyed ☒ Other: fluorescent 2 ☐ Intact ☐ Destroyed		☐ 1911-1923 ☐ 1924-1933 ☒ 1934-present ☐ In question

HEATING/ VENTILATION PLUMBING:	☒ Radiators 2 ☐ Intact ☐ Destroyed ☐ Vents/Fans ☐ Intact ☐ Destroyed ☐ Sink/Toilet/Urinal ☐ Intact ☐ Destroyed ☐ Other: ☐ Intact ☐ Destroyed		☐ 1911-1923 ☐ 1924-1933 ☒ 1934-present ☐ In question	
MISCELLANEOUS:		☐ Good ☐ Fair ☐ Poor ☐ Destroyed	☐ 1911-1923 ☐ 1924-1933 ☒ 1934-present ☐ In question	small wood panel in N. wall, lower right-hand corner - behind tub in 102.
SUMMARY:		☐ Good ☒ Fair ☐ Poor ☐ Destroyed	☐ 1911-1923 ☐ 1924-1933 ☒ 1934-present ☐ In question	**ARCHITECTURAL SIGNIFICANCE:** ☐ Most ☐ Some ☒ Minor ☐ Negligible

PHOTOGRAPHS: ① View North ② View Southeast ROOM NO. 103

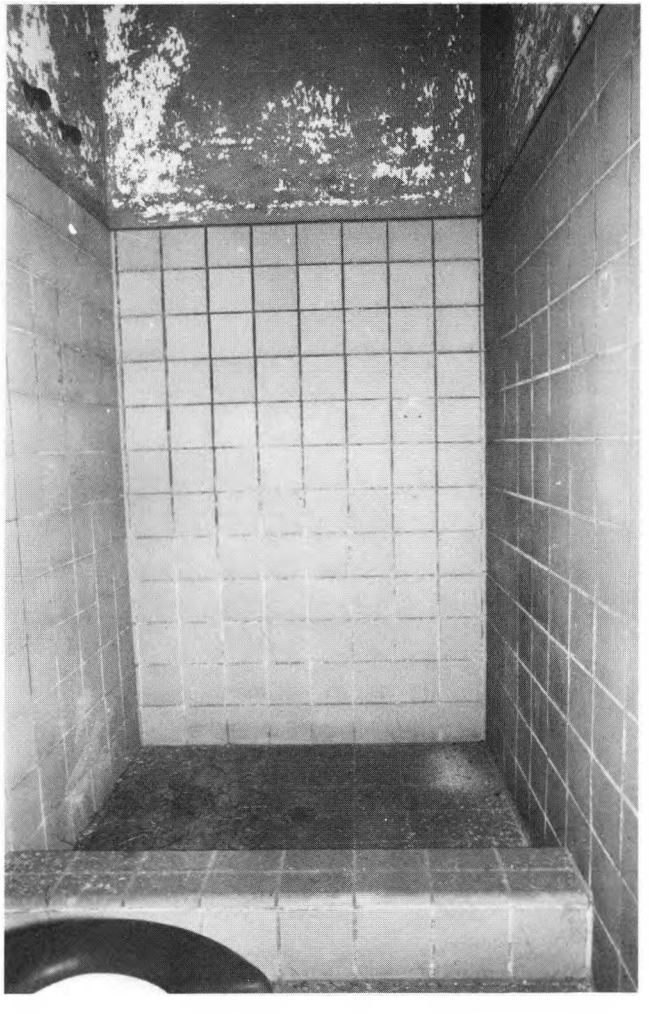
FINISHES:	CONDITION:	DATE:	NOTES:
FLOOR:	[X] Tile/Concrete [ ] Resilient [ ] Wood [ ] Other:	[X] Good [ ] Fair [ ] Poor [ ] Destroyed	[ ] 1911-1923 [ ] 1924-1933 [/] 1934-present [ ] In question	
BASE:	[X] Tile/Concrete [ ] Resilient [ ] Wood [ ] Other:	[X] Good [ ] Fair [ ] Poor [ ] Destroyed	[ ] 1911-1923 [ ] 1924-1933 [X] 1934-present [ ] In question	
WALLS:	[ ] Plaster [ ] Partitions [X] Tile Wainscot [ ] Other:	[X] Good [ ] Fair [ ] Poor [ ] Destroyed	[ ] 1911-1923 [ ] 1924-1933 [/] 1934-present [ ] In question	
CEILING:	[ ] Plaster [X] Acoustic panels [ ] Cove [ ] Other	[X] Good [ ] Fair [ ] Poor [ ] Destroyed	[ ] 1911-1923 [ ] 1924-1933 [X] 1934-present [ ] In question	
DOORS/ OPENINGS:	[ ] Wood/Glass Panelled [X] Wood Veneer [ ] Galvanized Metal [ ] Other:	[ ] Good [X] Fair [ ] Poor [ ] Destroyed	[ ] 1911-1923 [ ] 1924-1933 [X] 1934-present [ ] In question	
LIGHTING:	[ ] Incandescent/Type A [ ] Incandescent/Type B [ ] CML/Sconce [X] Other:	[ ] Intact [ ] Destroyed [ ] Intact [ ] Destroyed [ ] Intact [ ] Destroyed [1] Intact [ ] Destroyed	[ ] 1911-1923 [ ] 1924-1933 [X] 1934-present [ ] In question	Standard Immigrant Building bathroom light fixture w/ fluted glass shade.

HEATING/ VENTILATION PLUMBING:	[X] Radiators [ ] Vents/Fans [X] Sink/Toilet/Urinal [X] Other: shower	[1] Intact [ ] Destroyed [ ] Intact [ ] Destroyed [X] Intact [ ] Destroyed [ ] Intact [ ] Destroyed	[ ] 1911-1923 [ ] 1924-1933 [X] 1934-present [ ] In question	1 toilet. 1 slop sink: wall mounted. 1 shower: plumbing destroyed.
MISCELLANEOUS:		[ ] Good [ ] Fair [ ] Poor [ ] Destroyed	[ ] 1911-1923 [ ] 1924-1933 [X] 1934-present [ ] In question	2 mirrors w/ wood frames. 1 metal paper towel dispenser.
SUMMARY:		[X] Good [ ] Fair [ ] Poor [ ] Destroyed	[ ] 1911-1923 [ ] 1924-1933 [X] 1934-present [ ] In question	**ARCHITECTURAL SIGNIFICANCE:** [ ] Most [ ] Some [X] Minor [ ] Negligible

PHOTOGRAPHS: (1) View South (2) View North ROOM NO. 104B

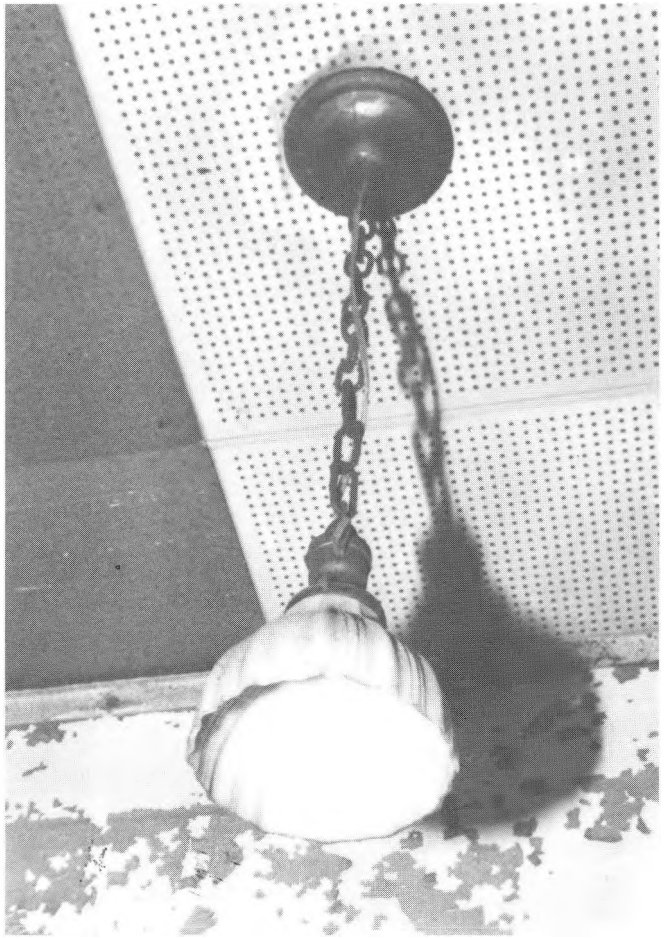
PHOTOGRAPHS: (3) Standard Immigrant Building bathroom light fixture. ROOM NO. 104B

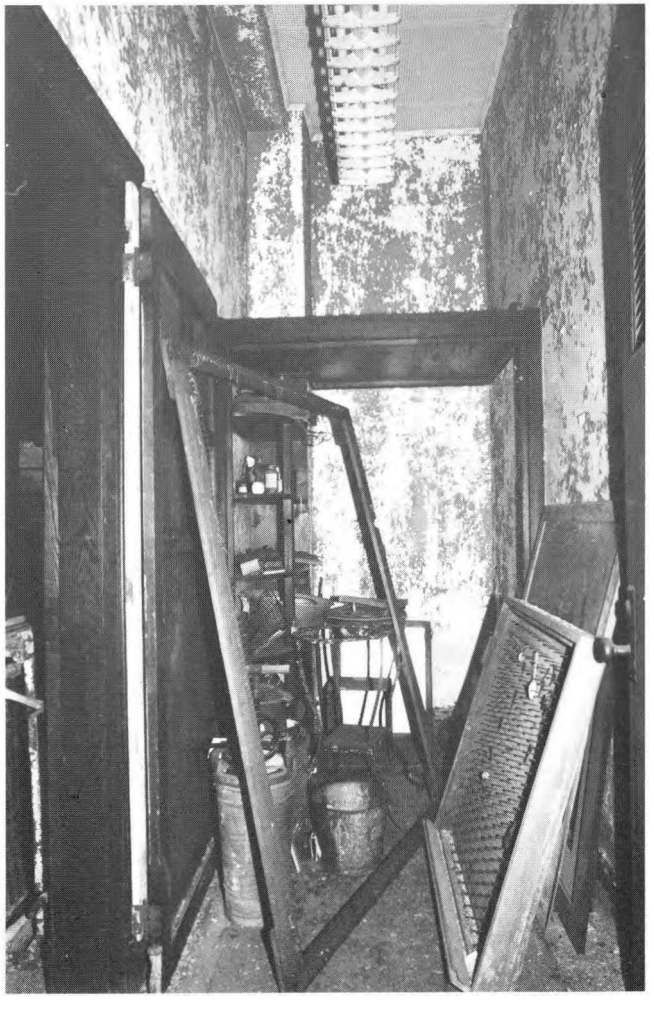
ROOM NO. 106A

HEATING/ VENTILATION PLUMBING:	☐ Radiators ☐ Vents/Fans ☐ Sink/Toilet/Urinal ☐ Other:	☐ Intact ☐ Destroyed ☐ Intact ☐ Destroyed ☐ Intact ☐ Destroyed ☐ Intact ☐ Destroyed	☐ 1911-1923 ☐ 1924-1933 ☐ 1934-present ☐ In question	
MISCELLANEOUS:		☒ Good ☐ Fair ☐ Poor ☐ Destroyed	☐ 1911-1923 ☐ 1924-1933 ☒ 1934-present ☐ In question	Built-in loft w/ shelves.
SUMMARY:		☒ Good ☐ Fair ☐ Poor ☐ Destroyed	☐ 1911-1923 ☐ 1924-1933 ☐ 1934-present ☐ In question	**ARCHITECTURAL SIGNIFICANCE:** ☐ Most ☐ Some ☒ Minor ☐ Negligible

PHOTOGRAPHS: (1) View South

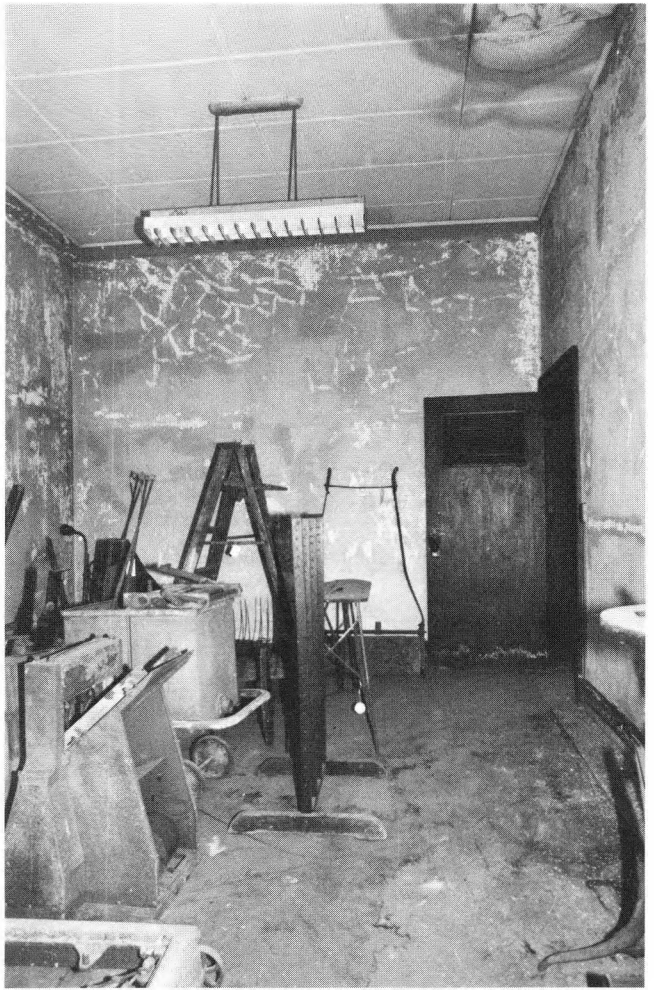
FINISHES:	CONDITION:	DATE:	NOTES:
FLOOR:	☐ Tile/Concrete ☒ Resilient rolled ☐ Wood ☐ Other:	☐ Good ☒ Fair ☐ Poor ☐ Destroyed	☐ 1911-1923 ☐ 1924-1933 ☒ 1934-present ☐ In question	
BASE:	☒ Tile/Concrete ☐ Resilient ☐ Wood ☐ Other:	☒ Good ☐ Fair ☐ Poor ☐ Destroyed	☐ 1911-1923 ☐ 1924-1933 ☒ 1934-present ☐ In question	
WALLS:	☒ Plaster ☐ Partitions ☐ Tile Wainscot ☐ Other:	☒ Good ☐ Fair ☐ Poor ☐ Destroyed	☐ 1911-1923 ☐ 1924-1933 ☒ 1934-present ☐ In question	
CEILING:	☐ Plaster ☒ Acoustic panels ☐ Cove ☐ Other	☒ Good ☒ Fair ☐ Poor ☐ Destroyed	☐ 1911-1923 ☐ 1924-1933 ☒ 1934-present ☐ In question	Water stains.
DOORS/ OPENINGS:	☐ Wood/Glass Panelled ☒ Wood Veneer ☐ Galvanized Metal ☐ Other:	☐ Good ☒ Fair ☐ Poor ☐ Destroyed	☐ 1911-1923 ☐ 1924-1933 ☒ 1934-present ☐ In question	2" plywood 5 point star nailed to outside of door.
LIGHTING:	☐ Incandescent/Type A ☐ Incandescent/Type B ☐ CML/Sconce ☒ Other: fluorescent 2	☐ Intact ☐ Destroyed ☐ Intact ☐ Destroyed ☐ Intact ☐ Destroyed ☐ Intact ☐ Destroyed	☐ 1911-1923 ☐ 1924-1933 ☒ 1934-present ☐ In question

HEATING/ VENTILATION PLUMBING:	☒ Radiators ☐ Vents/Fans ☐ Sink/Toilet/Urinal ☐ Other:	☐ Intact ☐ Destroyed ☐ Intact ☐ Destroyed ☐ Intact ☐ Destroyed ☐ Intact ☐ Destroyed	☐ 1911-1923 ☐ 1924-1933 ☒ 1934-present ☐ In question	
MISCELLANEOUS:		☐ Good ☐ Fair ☐ Poor ☐ Destroyed	☐ 1911-1923 ☐ 1924-1933 ☐ 1934-present ☐ In question	
SUMMARY:		☒ Good ☐ Fair ☐ Poor ☐ Destroyed	☐ 1911-1923 ☐ 1924-1933 ☒ 1934-present ☐ In question	**ARCHITECTURAL SIGNIFICANCE:** ☐ Most ☐ Some ☒ Minor ☐ Negligible

PHOTOGRAPHS: (1) View South (2) View North ROOM NO. 107
