existing condition survey

ELLIS ISLAND

EXISTING CONDITION SURVEY
UNITS 2, 3 AND 4

Volume 4
Appendix A
Part Two

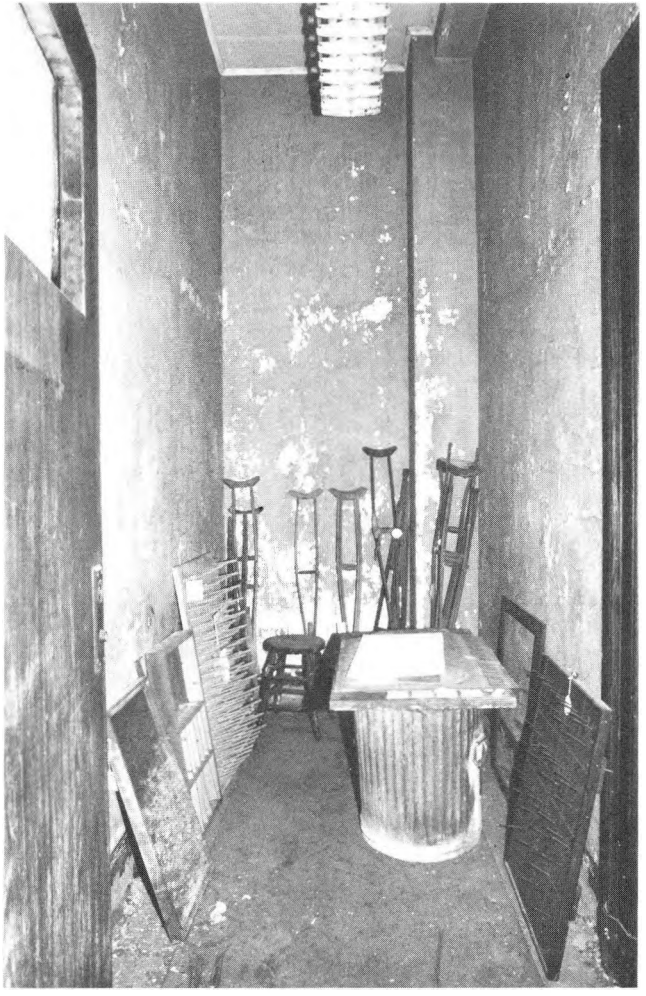
ROOM NO. 107A

LIGHTING:	[ ] Incandescent/Type A [ ] Incandescent/Type B [ ] CML/Sconce [X] Other: fluorescent	[ ] Intact [ ] Destroyed [ ] Intact [ ] Destroyed [ ] Intact [ ] Destroyed [1] Intact [ ] Destroyed	[ ] 1911-1923 [ ] 1924-1933 [ ] 1934-present [ ] In question	
HEATING/ VENTILATION PLUMBING:	[ ] Radiators [ ] Vents/Fans [ ] Sink/Toilet/Urinal [ ] Other:	[ ] Intact [ ] Destroyed [ ] Intact [ ] Destroyed [ ] Intact [ ] Destroyed [ ] Intact [ ] Destroyed	[ ] 1911-1923 [ ] 1924-1933 [ ] 1934-present [ ] In question	
MISCELLANEOUS:		[ ] Good [ ] Fair [ ] Poor [ ] Destroyed	[ ] 1911-1923 [ ] 1924-1933 [ ] 1934-present [ ] In question	
SUMMARY:		[X] Good [ ] Fair [ ] Poor [ ] Destroyed	[ ] 1911-1923 [ ] 1924-1933 [ ] 1934-present [ ] In question	**ARCHITECTURAL SIGNIFICANCE:** [ ] Most [ ] Some [X] Minor [ ] Negligible

PHOTOGRAPHS: ① View South

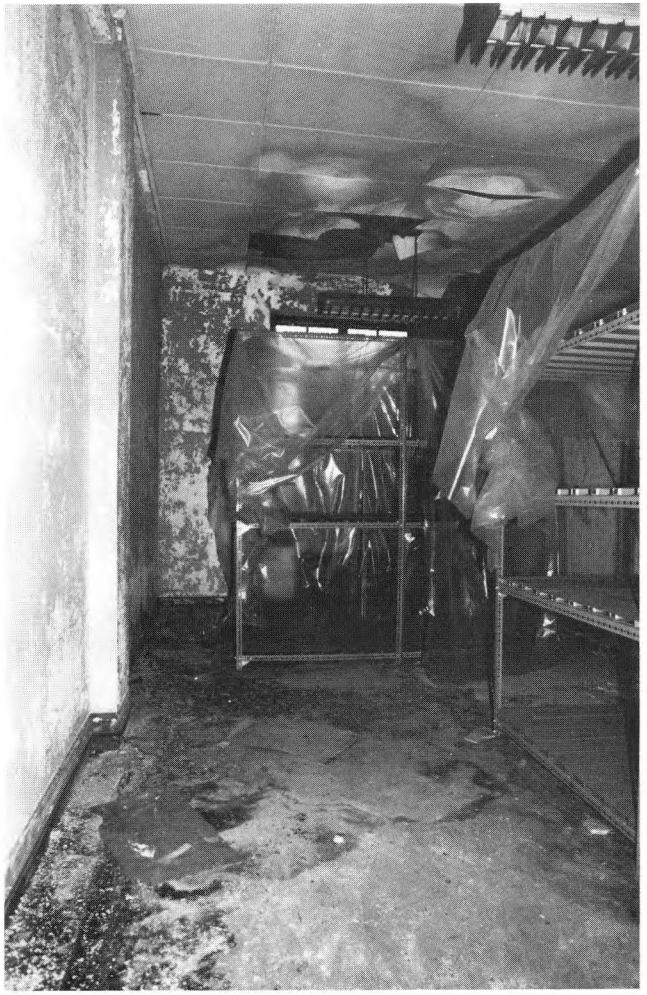
FINISHES:	CONDITION:	DATE:	NOTES:
FLOOR:	☐ Tile/Concrete ☒ Resilient ☐ Wood ☐ Other:	☐ Good ☐ Fair ☒ Poor ☐ Destroyed	☐ 1911-1923 ☐ 1924-1933 ☒ 1934-present ☐ In question	
BASE:	☒ Tile/Concrete ☐ Resilient ☐ Wood ☐ Other:	☒ Good ☐ Fair ☐ Poor ☐ Destroyed	☐ 1911-1923 ☐ 1924-1933 ☒ 1934-present ☐ In question	
WALLS:	☒ Plaster ☐ Partitions ☐ Tile Wainscot ☐ Other:	☒ Good ☐ Fair ☐ Poor ☐ Destroyed	☐ 1911-1923 ☐ 1924-1933 ☒ 1934-present ☐ In question	
CEILING:	☐ Plaster ☒ Acoustic panels ☐ Cove ☐ Other	☐ Good ☐ Fair ☒ Poor ☐ Destroyed	☐ 1911-1923 ☐ 1924-1933 ☒ 1934-present ☐ In question	
DOORS/ OPENINGS:	☐ Wood/Glass Panelled ☐ Wood Veneer ☐ Galvanized Metal ☐ Other:	☐ Good ☐ Fair ☐ Poor ☐ Destroyed	☐ 1911-1923 ☐ 1924-1933 ☐ 1934-present ☐ In question	No doors. Windows broken and boarded over.
LIGHTING:	☐ Incandescent/Type A ☐ Intact ☐ Destroyed ☐ Incandescent/Type B ☐ Intact ☐ Destroyed ☐ CML/Sconce ☐ Intact ☐ Destroyed ☒ Other: fluorescent 2 ☐ Intact ☐ Destroyed		☐ 1911-1923 ☐ 1924-1933 ☒ 1934-present ☐ In question

HEATING/ VENTILATION PLUMBING:	☒ Radiators 2 ☐ Intact ☐ Destroyed ☐ Vents/Fans ☐ Intact ☐ Destroyed ☐ Sink/Toilet/Urinal ☐ Intact ☐ Destroyed ☐ Other: ☐ Intact ☐ Destroyed		☐ 1911-1923 ☐ 1924-1933 ☒ 1934-present ☐ In question	
MISCELLANEOUS:		☐ Good ☐ Fair ☐ Poor ☐ Destroyed	☐ 1911-1923 ☐ 1924-1933 ☐ 1934-present ☐ In question	
SUMMARY:		☒ Good ☐ Fair ☐ Poor ☐ Destroyed	☐ 1911-1923 ☐ 1924-1933 ☒ 1934-present ☐ In question	**ARCHITECTURAL SIGNIFICANCE:** ☐ Most ☐ Some ☒ Minor ☐ Negligible

PHOTOGRAPHS: (1) View South (2) View Southwest ROOM NO. 108

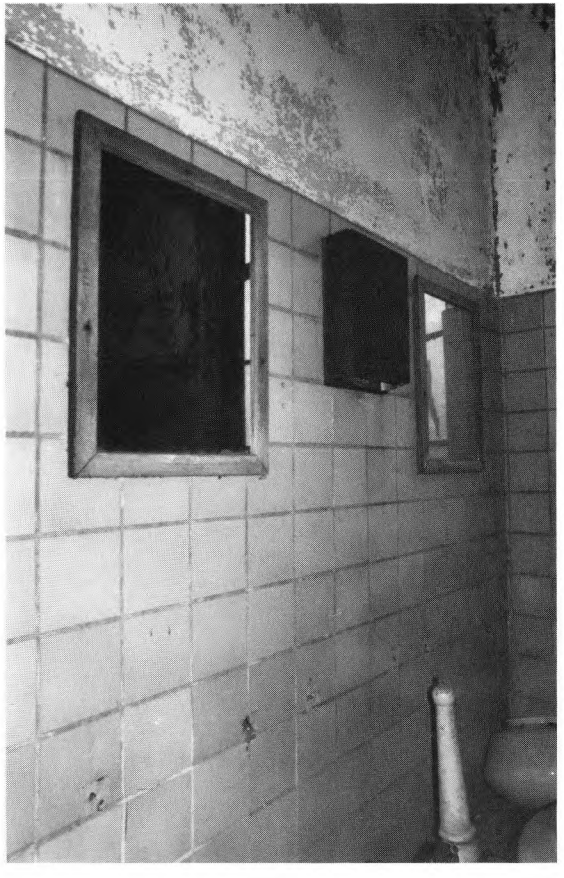
FINISHES:	CONDITION:	DATE:	NOTES:
FLOOR:	X Tile/Concrete Resilient Wood X Other:	X Good Fair Poor Destroyed	1911-1923 1924-1933 X 1934-present In question	Vestibule floor = poured stone, at hallway, 110 = tile.
BASE:	X Tile/Concrete Resilient Wood X Other:	X Good Fair Poor Destroyed	1911-1923 1924-1933 X 1934-present In question	Vestibule = poured stone, 110 = tile.
WALLS:	X Plaster Partitions Tile Wainscot Other:	X Good Fair Poor Destroyed	1911-1923 1924-1933 X 1934-present In question	
CEILING:	Plaster X Acoustic panels Cove Other	X Good Fair Poor Destroyed	1911-1923 1924-1933 X 1934-present In question	
DOORS/ OPENINGS:	Wood/Glass Panelled X Wood Veneer Galvanized Metal Other:	Good X Fair Poor Destroyed	1911-1923 1924-1933 X 1934-present In question	Vestibule door - plain veneer, no louvre Door to 110 standard, louvre missing.
LIGHTING:	Incandescent/Type A Incandescent/Type B X (CMD)/Sconce X Other: fluorescent	Intact / Destroyed Intact / Destroyed 1 Intact / Destroyed 1 Intact / Destroyed	1911-1923 1924-1933 X 1934-present In question

HEATING/ VENTILATION PLUMBING:	Radiators Vents/Fans X Sink/Toilet/~~Urinal~~ Other:	1 Intact / Destroyed Intact / Destroyed Intact / Destroyed Intact / Destroyed	1911-1923 1924-1933 X 1934-present In question	Sinks removed. Toilets may be missing - obscured by storage of artifacts.
MISCELLANEOUS:		Good Fair Poor Destroyed	1911-1923 1924-1933 X 1934-present In question	2 mirrors. 1 rusted paper towel dispenser. Structural glass toilet stalls (white).
SUMMARY:		X Good Fair Poor Destroyed	1911-1923 1924-1933 X 1934-present In question	**ARCHITECTURAL SIGNIFICANCE:** Most / Some / X Minor / Negligible

PHOTOGRAPHS: ① 110A, View West ② 110, View West ③ 110, View North ROOM NO. 110/110A

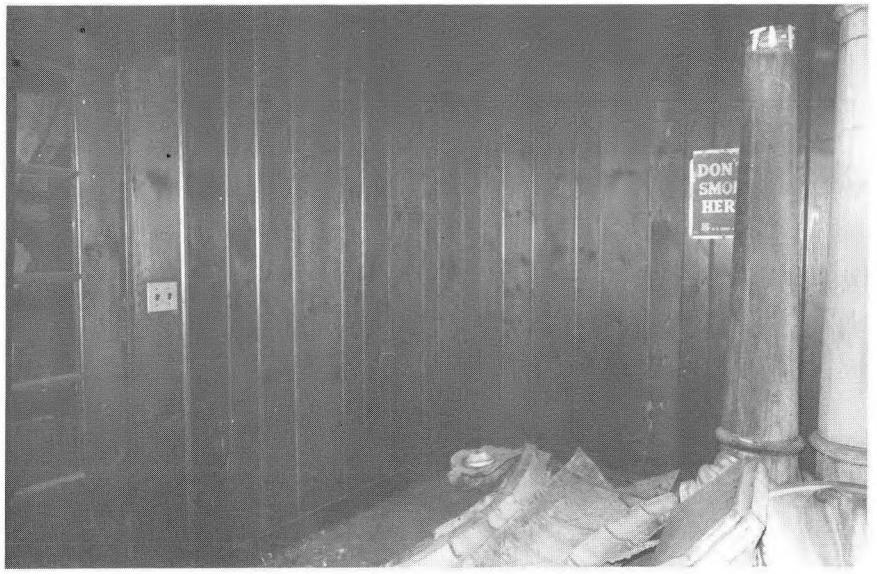
FINISHES:	CONDITION:	DATE:	NOTES:
FLOOR:	☐ Tile/Concrete ☐ Resilient ☒ Wood ☐ Other:	☒ Good ☐ Fair ☐ Poor ☐ Destroyed	☐ 1911-1923 ☐ 1924-1933 ☒ 1934-present ☐ In question	finish gone, some warping and staining. Appears struct. sound. Patch in NE section (approx. 5½'×2½') wood infill?
BASE:	☐ Tile/Concrete ☐ Resilient ☒ Wood ☐ Other:	☒ Good ☐ Fair ☐ Poor ☐ Destroyed	☐ 1911-1923 ☐ 1924-1933 ☒ 1934-present ☐ In question	5½" flat base, stained dark brown, as panelling.
WALLS:	☐ Plaster ☐ Partitions ☐ Tile Wainscot ☒ Other: wood panel	☒ Good ☐ Fair ☐ Poor ☐ Destroyed	☐ 1911-1923 ☐ 1924-1933 ☒ 1934-present ☐ In question	Red brown stain, vertical panelling varied widths.
CEILING:	☐ Plaster ☒ Acoustic panels ☐ Cove ☐ Other	☒ Good ☐ Fair ☐ Poor ☐ Destroyed	☐ 1911-1923 ☐ 1924-1933 ☒ 1934-present ☐ In question	some loss N/W corner. staining, W. wall along windows. wood encased beams.
DOORS/ OPENINGS:	☒ Wood/Glass Panelled ☐ Wood Veneer ☐ Galvanized Metal ☐ Other:	☐ Good ☐ Fair ☐ Poor ☐ Destroyed	☐ 1911-1923 ☐ 1924-1933 ☒ 1934-present ☐ In question	3 pairs double doors. Center doors: South door removed - replaced w/ ½ door with mid-shelf.

LIGHTING:	☐ Incandescent/Type A ☐ Incandescent/Type B ☒ CML/Sconce 4 ☒ Other: Fluorescent 20	☐ Intact ☐ Destroyed ☐ Intact ☐ Destroyed Intact ☐ Destroyed Intact ☐ Destroyed	☐ 1911-1923 ☐ 1924-1933 ☒ 1934-present ☐ In question	
HEATING/ VENTILATION PLUMBING:	☒ Radiators 5 ☐ Vents/Fans ☐ Sink/Toilet/Urinal ☐ Other:	Intact ☐ Destroyed Intact ☐ Destroyed Intact ☐ Destroyed Intact ☐ Destroyed	☐ 1911-1923 ☐ 1924-1933 ☒ 1934-present ☐ In question	
MISCELLANEOUS:		☐ Good ☐ Fair ☐ Poor ☐ Destroyed	☐ 1911-1923 ☐ 1924-1933 ☒ 1934-present ☐ In question	2 fireplaces: N. and S. considerable soot staining.
SUMMARY:		☒ Good ☐ Fair ☐ Poor ☐ Destroyed	☐ 1911-1923 ☐ 1924-1933 ☒ 1934-present ☐ In question	**ARCHITECTURAL SIGNIFICANCE:** ☒ Most ☐ Some ☐ Minor ☐ Negligible

PHOTOGRAPHS: (1) View South (2) View North (3) View South (4) paneling ROOM NO. 111

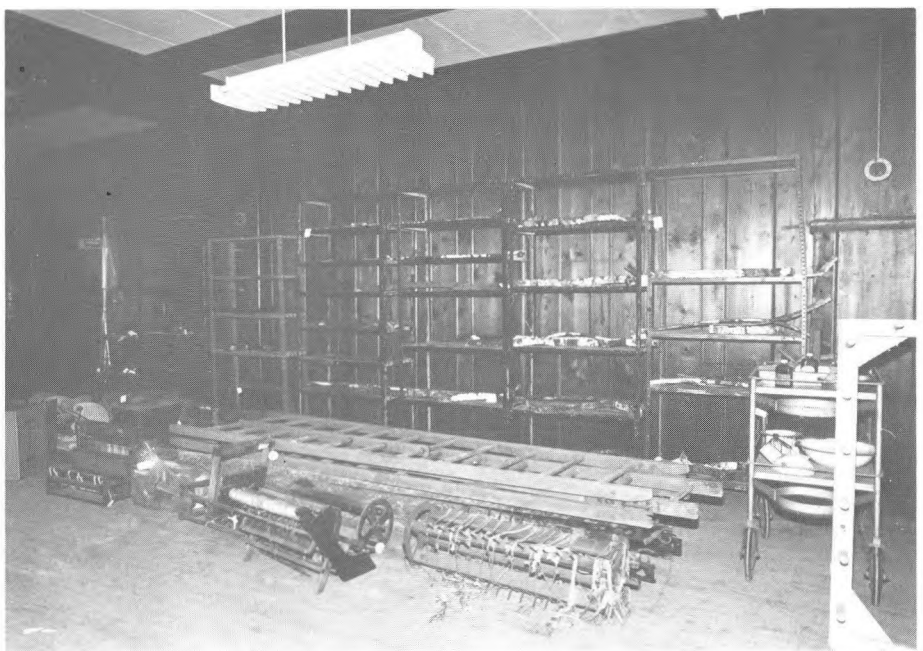
PHOTOGRAPHS: (5) Door, North end. (6) East wall ROOM NO. 111

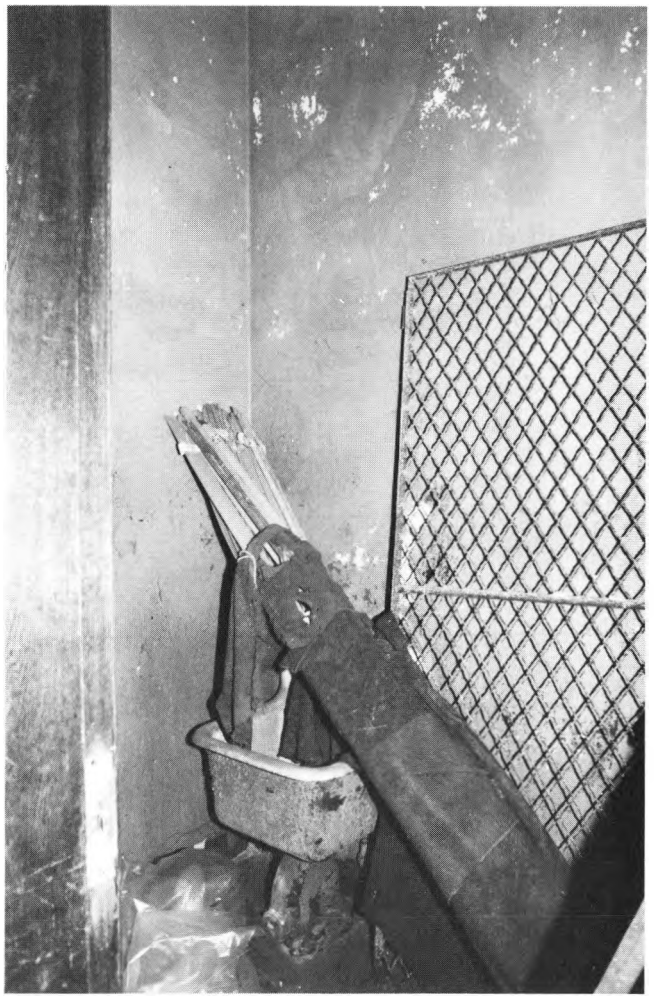
ROOM NO. 112A

HEATING/ VENTILATION PLUMBING:	[ ] Radiators [ ] Vents/Fans [X] Sink/Toilet/Urinal [ ] Other:	[ ] Intact [ ] Destroyed [ ] Intact [ ] Destroyed [ ] Intact [ ] Destroyed [ ] Intact [ ] Destroyed	[ ] 1911-1923 [ ] 1924-1933 [X] 1934-present [ ] In question	1 slop sink.
MISCELLANEOUS:		[ ] Good [ ] Fair [ ] Poor [ ] Destroyed	[ ] 1911-1923 [ ] 1924-1933 [ ] 1934-present [ ] In question	
SUMMARY:		[X] Good [ ] Fair [ ] Poor [ ] Destroyed	[ ] 1911-1923 [ ] 1924-1933 [X] 1934-present [ ] In question	**ARCHITECTURAL SIGNIFICANCE:** [ ] Most [ ] Some [ ] Minor [X] Negligible

PHOTOGRAPHS: ① View Southwest

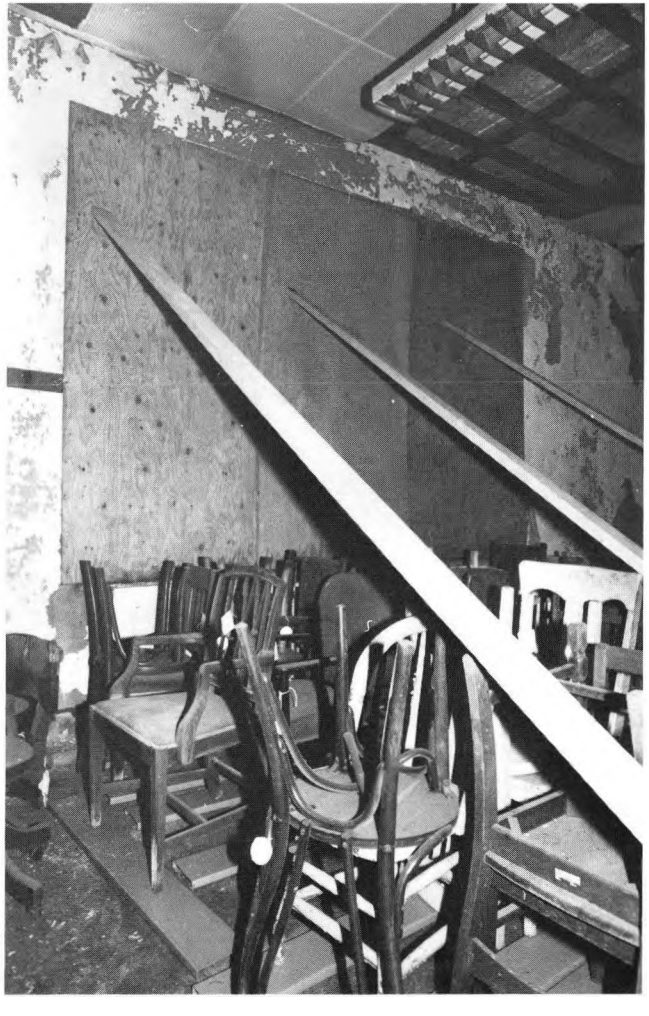
FINISHES:	CONDITION:	DATE:	NOTES:
FLOOR:	☐ Tile/Concrete ☒ Resilient ☐ Wood ☐ Other:	☐ Good ☒ Fair ☐ Poor ☐ Destroyed	☐ 1911-1923 ☐ 1924-1933 ☒ 1934-present ☐ In question	
BASE:	☒ Tile/Concrete ☐ Resilient ☐ Wood ☐ Other:	☒ Good ☐ Fair ☐ Poor ☐ Destroyed	☐ 1911-1923 ☐ 1924-1933 ☒ 1934-present ☐ In question	
WALLS:	☒ Plaster ☐ Partitions ☐ Tile Wainscot ☐ Other:	☐ Good ☒ Fair ☐ Poor ☐ Destroyed	☐ 1911-1923 ☐ 1924-1933 ☒ 1934-present ☐ In question	N. wall, plaster poor—destroyed.
CEILING:	☐ Plaster ☒ Acoustic panels ☐ Cove ☐ Other	☐ Good ☐ Fair ☒ Poor ☐ Destroyed	☐ 1911-1923 ☐ 1924-1933 ☒ 1934-present ☐ In question	Water damage. Panels missing in center of ceiling.
DOORS/ OPENINGS:	☐ Wood/Glass Panelled ☐ Wood Veneer ☐ Galvanized Metal ☐ Other:	☐ Good ☐ Fair ☐ Poor ☐ Destroyed	☐ 1911-1923 ☐ 1924-1933 ☐ 1934-present ☐ In question	No doors. Windows broken and boarded over.
LIGHTING:	☐ Incandescent/Type A ☐ Incandescent/Type B ☐ CML/Sconce ☒ Other: fluorescent	☐ Intact ☐ Destroyed ☐ Intact ☐ Destroyed ☐ Intact ☐ Destroyed 2 Intact ☐ Destroyed	☐ 1911-1923 ☐ 1924-1933 ☒ 1934-present ☐ In question

HEATING/ VENTILATION PLUMBING:	☒ Radiators ☐ Vents/Fans ☐ Sink/Toilet/Urinal ☐ Other:	2 Intact ☐ Destroyed ☐ Intact ☐ Destroyed ☐ Intact ☐ Destroyed ☐ Intact ☐ Destroyed	☐ 1911-1923 ☐ 1924-1933 ☒ 1934-present ☐ In question	
MISCELLANEOUS:		☐ Good ☐ Fair ☐ Poor ☐ Destroyed	☐ 1911-1923 ☐ 1924-1933 ☒ 1934-present ☐ In question	Strips of flue wood with clothes hooks on West wall.
SUMMARY:		☐ Good ☒ Fair ☐ Poor ☐ Destroyed	☐ 1911-1923 ☐ 1924-1933 ☒ 1934-present ☐ In question	**ARCHITECTURAL SIGNIFICANCE:** ☐ Most ☐ Some ☒ Minor ☐ Negligible

PHOTOGRAPHS: (1) View North (2) View Northwest ROOM NO. 113

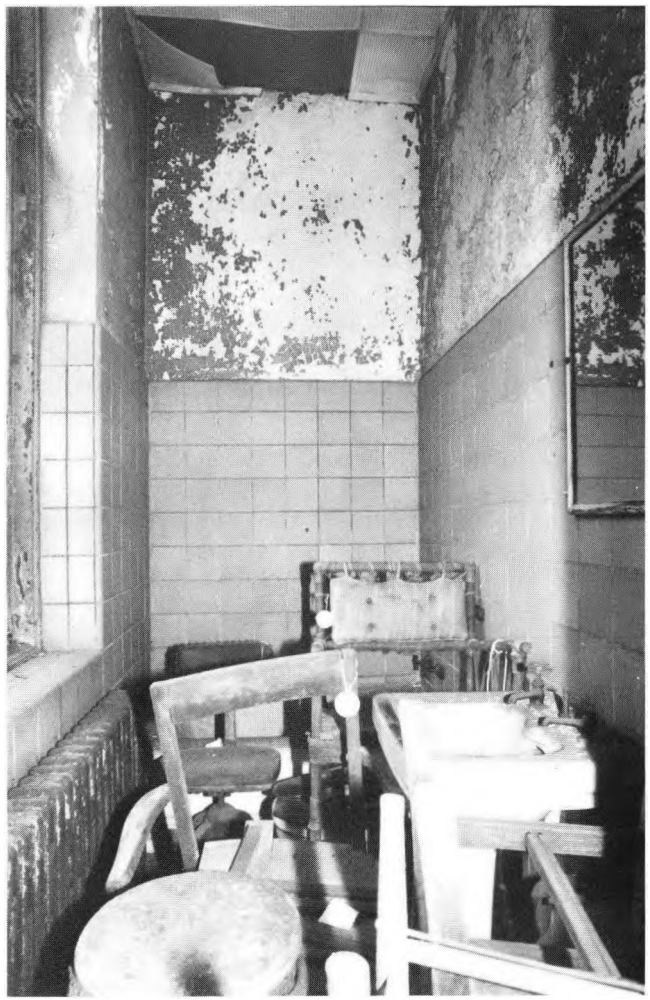
ROOM NO. 113A

HEATING/ VENTILATION PLUMBING:	[X] Radiators [ ] Vents/Fans [X] Sink/Toilet/Urinal [X] Other: Tub	[1] Intact [ ] Destroyed [ ] Intact [ ] Destroyed [X] Intact [ ] Destroyed [X] Intact [ ] Destroyed	[ ] 1911-1923 [ ] 1924-1933 [X] 1934-present [ ] In question	1 sink 1 toilet 1 tub.
MISCELLANEOUS:		[ ] Good [ ] Fair [ ] Poor [ ] Destroyed	[ ] 1911-1923 [ ] 1924-1933 [X] 1934-present [ ] In question	1 mirror w/ white wood frame.
SUMMARY:		[X] Good [ ] Fair [ ] Poor [ ] Destroyed	[ ] 1911-1923 [ ] 1924-1933 [X] 1934-present [ ] In question	**ARCHITECTURAL SIGNIFICANCE:** [ ] Most [ ] Some [X] Minor [ ] Negligible

PHOTOGRAPHS: ① View West

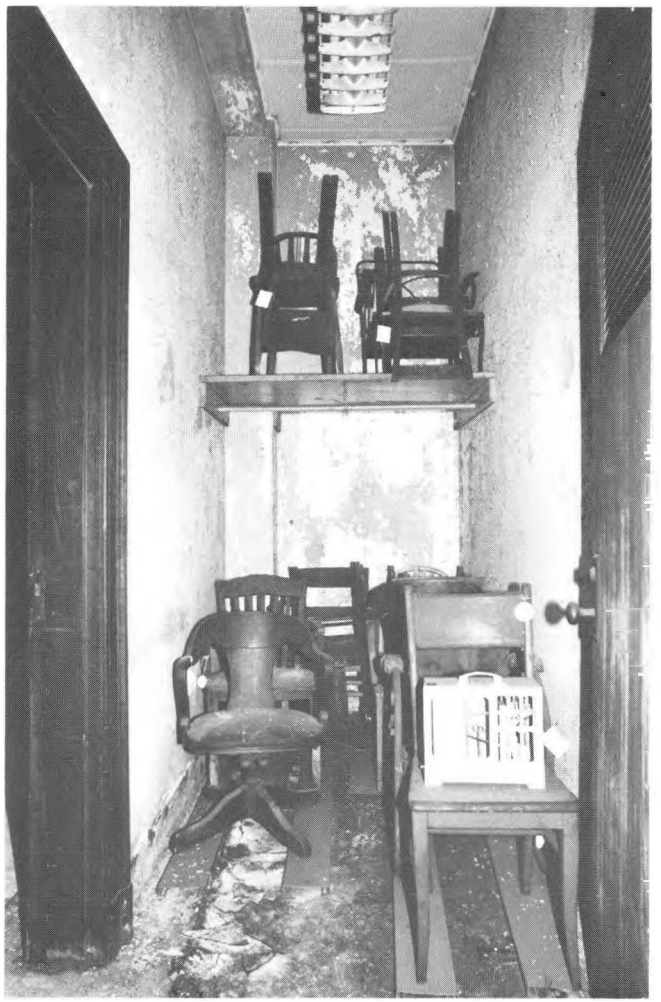
ROOM NO. 114A

HEATING/ VENTILATION PLUMBING:	[ ] Radiators [ ] Vents/Fans [ ] Sink/Toilet/Urinal [ ] Other:	[ ] Intact [ ] Destroyed [ ] Intact [ ] Destroyed [ ] Intact [ ] Destroyed [ ] Intact [ ] Destroyed	[ ] 1911-1923 [ ] 1924-1933 [X] 1934-present [ ] In question	
MISCELLANEOUS:		[ ] Good [ ] Fair [ ] Poor [ ] Destroyed	[ ] 1911-1923 [ ] 1924-1933 [X] 1934-present [ ] In question	1 shelf w/ clothes rod underneath.
SUMMARY:		[X] Good [ ] Fair [ ] Poor [ ] Destroyed	[ ] 1911-1923 [ ] 1924-1933 [X] 1934-present [ ] In question	**ARCHITECTURAL SIGNIFICANCE:** [ ] Most [ ] Some [X] Minor [ ] Negligible

PHOTOGRAPHS: (1) View North

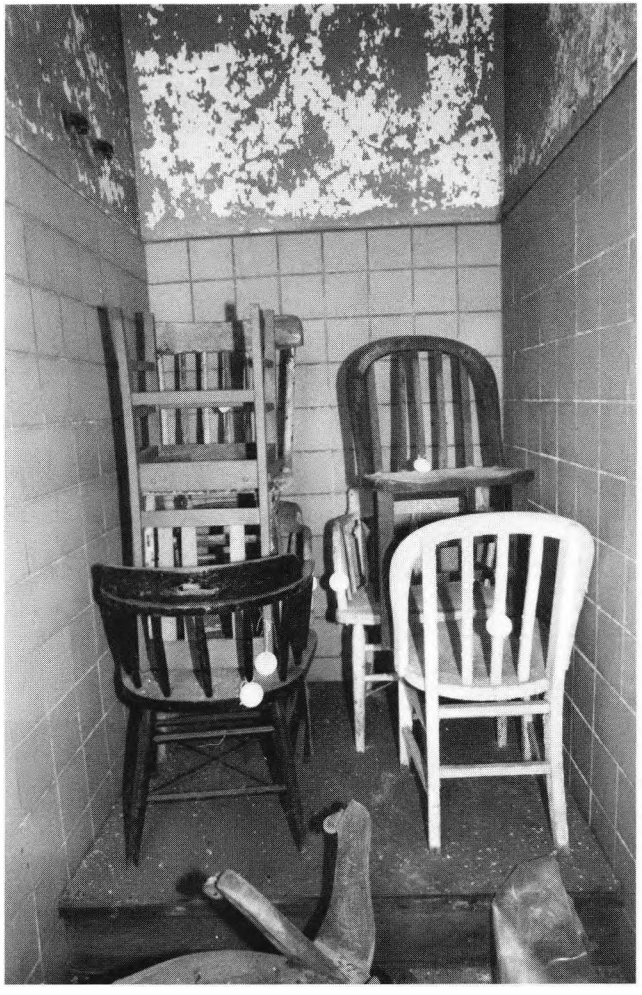
FINISHES:	CONDITION:	DATE:	NOTES:
FLOOR:	[X] Tile/Concrete [ ] Resilient [ ] Wood [ ] Other:	[X] Good [ ] Fair [ ] Poor [ ] Destroyed	[ ] 1911-1923 [ ] 1924-1933 [X] 1934-present [ ] In question	
BASE:	[X] Tile/Concrete [ ] Resilient [ ] Wood [ ] Other:	[X] Good [ ] Fair [ ] Poor [ ] Destroyed	[ ] 1911-1923 [ ] 1924-1933 [X] 1934-present [ ] In question	
WALLS:	[ ] Plaster [ ] Partitions [X] Tile Wainscot [ ] Other:	[X] Good [ ] Fair [ ] Poor [ ] Destroyed	[ ] 1911-1923 [ ] 1924-1933 [X] 1934-present [ ] In question	
CEILING:	[ ] Plaster [X] Acoustic panels [ ] Cove [ ] Other	[X] Good [ ] Fair [ ] Poor [ ] Destroyed	[ ] 1911-1923 [ ] 1924-1933 [X] 1934-present [ ] In question	
DOORS/ OPENINGS:	[ ] Wood/Glass Panelled [X] Wood Veneer [ ] Galvanized Metal [ ] Other:	[ ] Good [ ] Fair [ ] Poor [1] Destroyed	[ ] 1911-1923 [ ] 1924-1933 [X] 1934-present [ ] In question	door missing.
LIGHTING:	[ ] Incandescent/Type A [ ] Incandescent/Type B [ ] CML/Sconce [X] Other:	[ ] Intact [ ] Destroyed [ ] Intact [ ] Destroyed [ ] Intact [ ] Destroyed [ ] Intact [1] Destroyed	[ ] 1911-1923 [ ] 1924-1933 [X] 1934-present [ ] In question	standard bathroom fixture.

HEATING/ VENTILATION PLUMBING:	[X] Radiators [ ] Vents/Fans [X] Sink/Toilet/~~Urinal~~ [ ] Other:	[1] Intact [ ] Destroyed [ ] Intact [ ] Destroyed [ ] Intact [ ] Destroyed [ ] Intact [ ] Destroyed	[ ] 1911-1923 [ ] 1924-1933 [X] 1934-present [ ] In question	1 sink, square, central pedestal. 1 toilet. – shower boxed over + made into platform
MISCELLANEOUS:	[ ]	[ ] Good [ ] Fair [ ] Poor [ ] Destroyed	[ ] 1911-1923 [ ] 1924-1933 [ ] 1934-present [ ] In question	1 mirror w/ white wood frame. 1 metal paper towel dispenser.
SUMMARY:		[X] Good [ ] Fair [ ] Poor [ ] Destroyed	[ ] 1911-1923 [ ] 1924-1933 [X] 1934-present [ ] In question	**ARCHITECTURAL SIGNIFICANCE:** [ ] Most [ ] Some [X] Minor [ ] Negligible

PHOTOGRAPHS: ① View South ② View North ROOM NO. 114-B

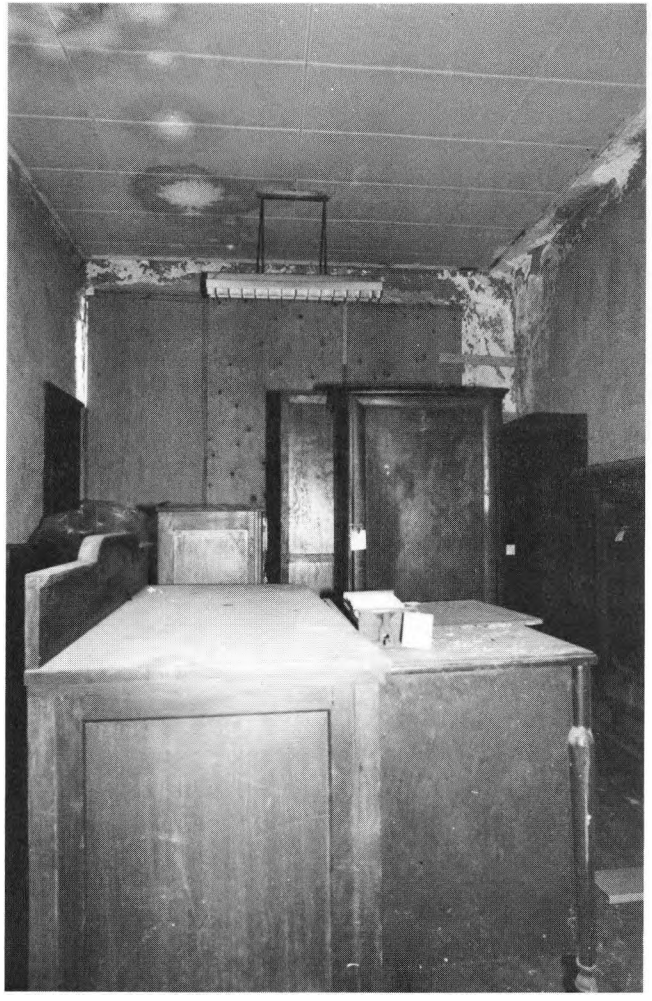
FINISHES:	CONDITION:	DATE:	NOTES:
FLOOR:	[ ] Tile/Concrete [X] Resilient [ ] Wood [ ] Other:	[ ] Good [X] Fair [ ] Poor [ ] Destroyed	[ ] 1911-1923 [ ] 1924-1933 [X] 1934-present [ ] In question	
BASE:	[X] Tile/Concrete [ ] Resilient [ ] Wood [ ] Other:	[X] Good [ ] Fair [ ] Poor [ ] Destroyed	[ ] 1911-1923 [ ] 1924-1933 [X] 1934-present [ ] In question	
WALLS:	[X] Plaster [ ] Partitions [ ] Tile Wainscot [ ] Other:	[X] Good [ ] Fair [ ] Poor [ ] Destroyed	[ ] 1911-1923 [ ] 1924-1933 [X] 1934-present [ ] In question	
CEILING:	[ ] Plaster [X] Acoustic panels [ ] Cove [ ] Other	[X] Good [ ] Fair [ ] Poor [ ] Destroyed	[ ] 1911-1923 [ ] 1924-1933 [X] 1934-present [ ] In question	some water stains.
DOORS/ OPENINGS:	[ ] Wood/Glass Panelled [X] Wood Veneer 2 [ ] Galvanized Metal [ ] Other:	[X] Good [X] Fair [ ] Poor [ ] Destroyed	[ ] 1911-1923 [ ] 1924-1933 [X] 1934-present [ ] In question	windows boarded over.

LIGHTING:	[ ] Incandescent/Type A [ ] Incandescent/Type B [ ] CML/Sconce [X] Other: Fluorescent 2	[ ] Intact [ ] Destroyed [ ] Intact [ ] Destroyed [ ] Intact [ ] Destroyed [X] Intact [ ] Destroyed	[ ] 1911-1923 [ ] 1924-1933 [X] 1934-present [ ] In question	
HEATING/ VENTILATION PLUMBING:	[X] Radiators 1 [ ] Vents/Fans [ ] Sink/Toilet/Urinal [ ] Other:	[X] Intact [ ] Destroyed [ ] Intact [ ] Destroyed [ ] Intact [ ] Destroyed [ ] Intact [ ] Destroyed	[ ] 1911-1923 [ ] 1924-1933 [X] 1934-present [ ] In question	
MISCELLANEOUS:		[ ] Good [ ] Fair [ ] Poor [ ] Destroyed	[ ] 1911-1923 [ ] 1924-1933 [ ] 1934-present [ ] In question	
SUMMARY:		[X] Good [ ] Fair [ ] Poor [ ] Destroyed	[ ] 1911-1923 [ ] 1924-1933 [X] 1934-present [ ] In question	**ARCHITECTURAL SIGNIFICANCE:** [ ] Most [ ] Some [X] Minor [ ] Negligible

PHOTOGRAPHS: ① View North ② View East ROOM NO. 115

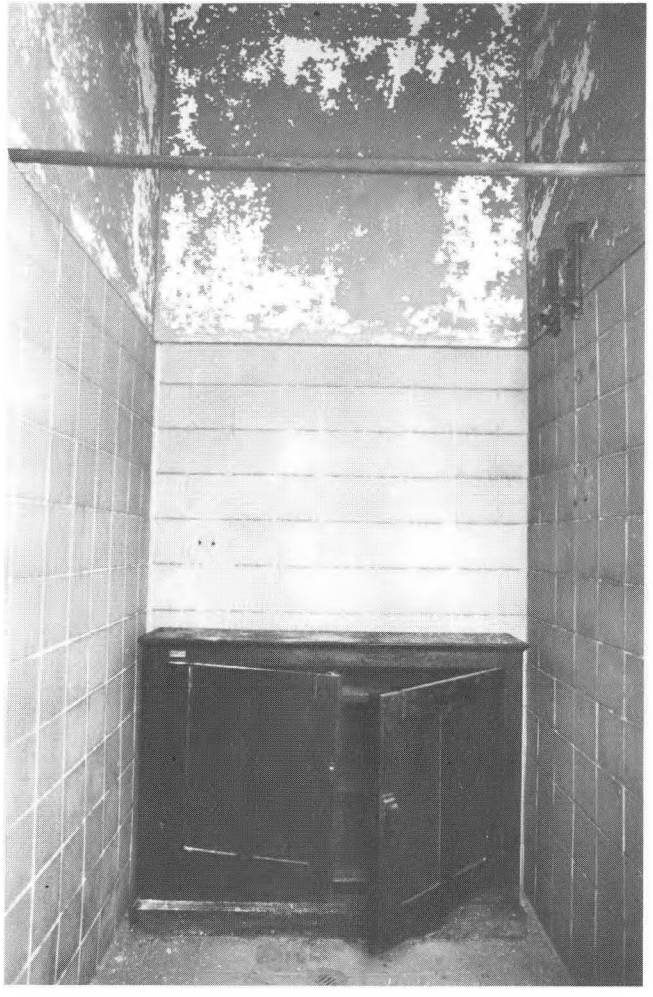
FINISHES:	CONDITION:	DATE:	NOTES:
FLOOR:	[X] Tile/~~Concrete~~ [ ] Resilient [ ] Wood [ ] Other:	[X] Good [ ] Fair [ ] Poor [ ] Destroyed	[ ] 1911-1923 [ ] 1924-1933 [/] 1934-present [ ] In question	
BASE:	[X] Tile/~~Concrete~~ [ ] Resilient [ ] Wood [ ] Other:	[X] Good [ ] Fair [ ] Poor [ ] Destroyed	[ ] 1911-1923 [ ] 1924-1933 [X] 1934-present [ ] In question	
WALLS:	[ ] Plaster [ ] Partitions [X] Tile Wainscot [ ] Other:	[X] Good [ ] Fair [ ] Poor [ ] Destroyed	[ ] 1911-1923 [ ] 1924-1933 [X] 1934-present [ ] In question	
CEILING:	[ ] Plaster [X] Acoustic panels [ ] Cove [ ] Other	[X] Good [ ] Fair [ ] Poor [ ] Destroyed	[ ] 1911-1923 [ ] 1924-1933 [X] 1934-present [ ] In question	
DOORS/ OPENINGS:	[ ] Wood/Glass Panelled [X] Wood Veneer [ ] Galvanized Metal [ ] Other:	[X] Good [ ] Fair [ ] Poor [ ] Destroyed	[ ] 1911-1923 [ ] 1924-1933 [X] 1934-present [ ] In question	
LIGHTING:	[ ] Incandescent/Type A [ ] Incandescent/Type B [ ] CML/Sconce [X] Other:	[ ] Intact [ ] Destroyed [ ] Intact [ ] Destroyed [ ] Intact [ ] Destroyed [1] Intact [ ] Destroyed	[ ] 1911-1923 [ ] 1924-1933 [X] 1934-present [ ] In question	Standard bathroom light: glass shade destroyed!

HEATING/ VENTILATION PLUMBING:	[X] Radiators [ ] Vents/Fans [X] Sink/Toilet/~~Urinal~~ [X] Other:	[1] Intact [ ] Destroyed [ ] Intact [ ] Destroyed [X] Intact [ ] Destroyed [X] Intact [ ] Destroyed	[ ] 1911-1923 [ ] 1924-1933 [X] 1934-present [ ] In question	shower has curtain rod - unusual for Immigrant Bldg.
MISCELLANEOUS:		[ ] Good [ ] Fair [ ] Poor [ ] Destroyed	[ ] 1911-1923 [ ] 1924-1933 [ ] 1934-present [ ] In question	
SUMMARY:		[X] Good [ ] Fair [ ] Poor [ ] Destroyed	[ ] 1911-1923 [ ] 1924-1933 [X] 1934-present [ ] In question	**ARCHITECTURAL SIGNIFICANCE:** [ ] Most [ ] Some [X] Minor [ ] Negligible

PHOTOGRAPHS: (1) View South (2) View North ROOM NO. 115B

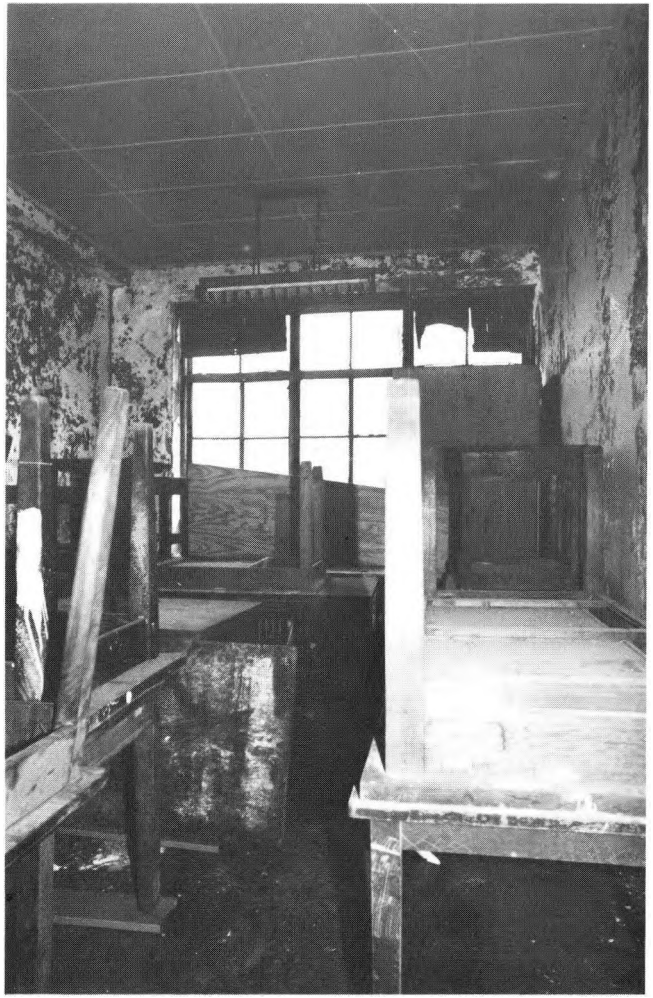
PHOTOGRAPHS: (1) View North (2) Standard louvred door. ROOM NO. 116

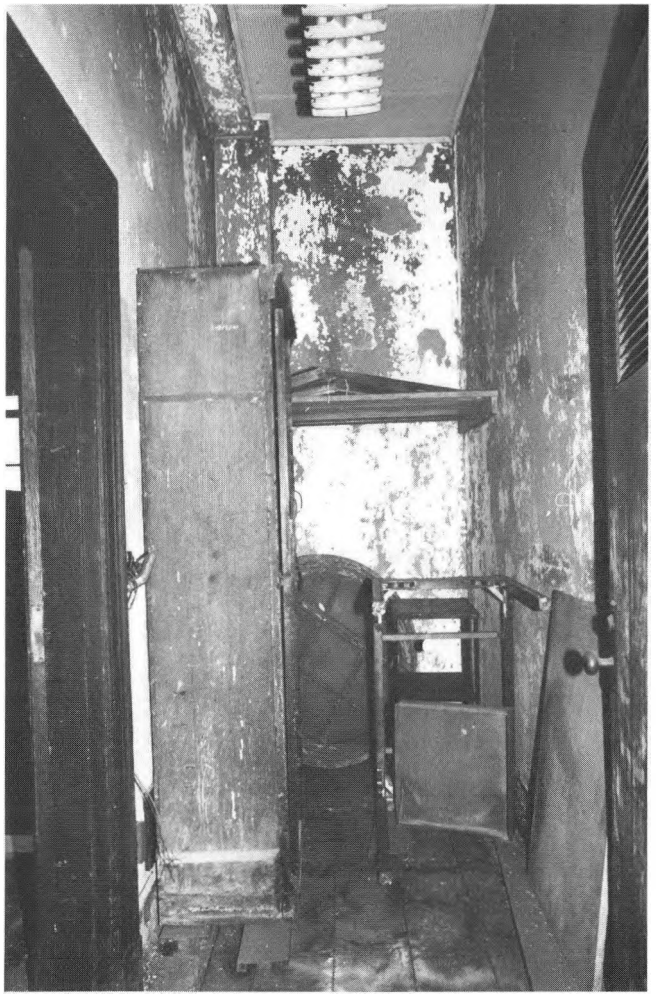
ROOM NO. 116A

PHOTOGRAPHS: (1) View North

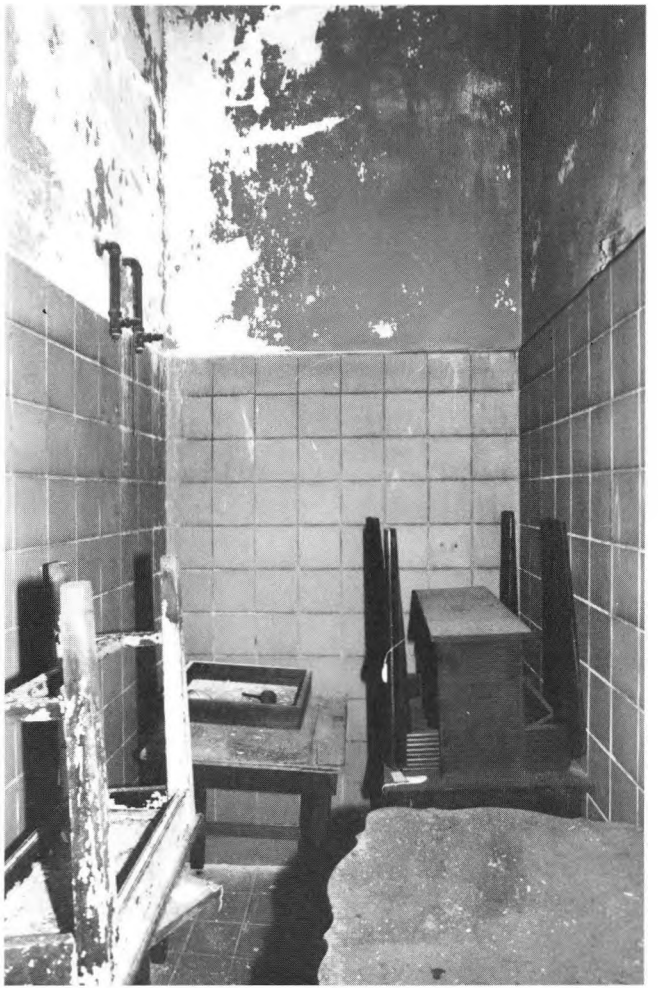
LIGHTING:	[ ] Incandescent/Type A [ ] Incandescent/Type B [ ] CML/Sconce [X] Other:	[ ] Intact [ ] Destroyed [ ] Intact [ ] Destroyed [ ] Intact [ ] Destroyed [1] Intact [ ] Destroyed	[ ] 1911-1923 [ ] 1924-1933 [X] 1934-present [ ] In question	chain with bulb, shade destroyed.
HEATING/ VENTILATION PLUMBING:	[X] Radiators [ ] Vents/Fans [X] Sink/Toilet/~~Urinal~~ [X] Other: shower	[1] Intact [ ] Destroyed [ ] Intact [ ] Destroyed [X] Intact [ ] Destroyed [1] Intact [ ] Destroyed	[ ] 1911-1923 [ ] 1924-1933 [X] 1934-present [ ] In question	
MISCELLANEOUS:	[ ]	[ ] Good [ ] Fair [ ] Poor [ ] Destroyed	[ ] 1911-1923 [ ] 1924-1933 [X] 1934-present [ ] In question	mirror with wood frame, over sink. Paper towel dispenser- rusted.
SUMMARY:		[X] Good [ ] Fair [ ] Poor [ ] Destroyed	[ ] 1911-1923 [ ] 1924-1933 [X] 1934-present [ ] In question	**ARCHITECTURAL SIGNIFICANCE:** [ ] Most [ ] Some [X] Minor [ ] Negligible

PHOTOGRAPHS: ① View East ② View South ROOM NO. 116B

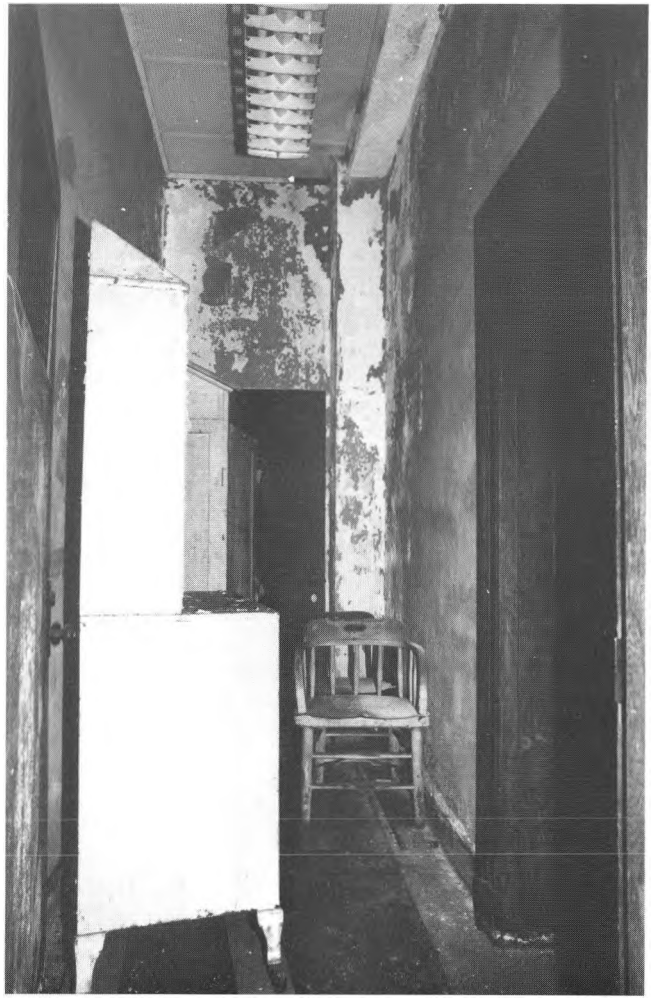
ROOM NO. 117A

PHOTOGRAPHS: (1) View North

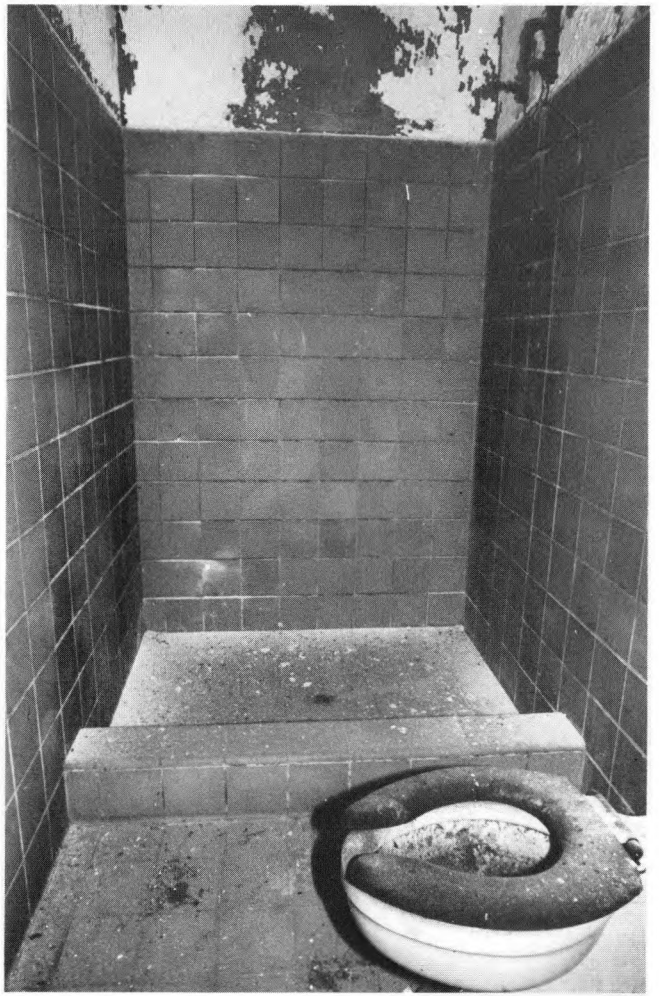
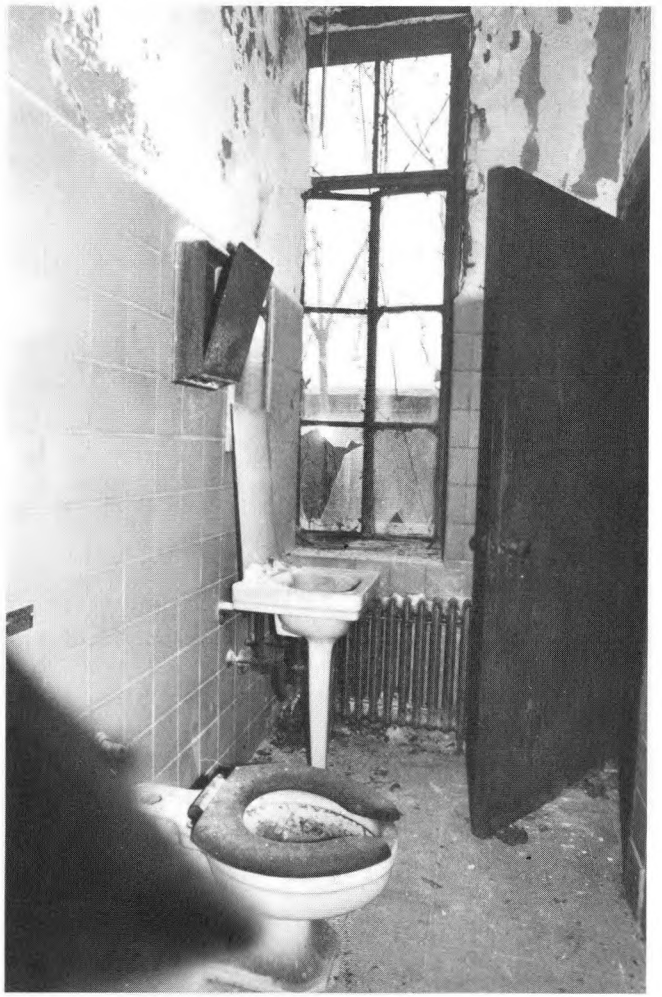
LIGHTING:	[ ] Incandescent/Type A [ ] Incandescent/Type B [ ] CML/Sconce [X] Other:	[ ] Intact [ ] Destroyed [ ] Intact [ ] Destroyed [ ] Intact [ ] Destroyed [ ] Intact [X] Destroyed	[ ] 1911-1923 [ ] 1924-1933 [X] 1934-present [ ] In question	chain with bulb – shade missing.
HEATING/ VENTILATION PLUMBING:	[X] Radiators [ ] Vents/Fans [X] Sink/Toilet/~~Urinal~~ [X] Other: shower	[ ] Intact [ ] Destroyed [ ] Intact [ ] Destroyed [X] Intact [ ] Destroyed [ ] Intact [ ] Destroyed	[ ] 1911-1923 [ ] 1924-1933 [X] 1934-present [ ] In question	square central pedestal sink.
MISCELLANEOUS:		[ ] Good [ ] Fair [ ] Poor [ ] Destroyed	[ ] 1911-1923 [ ] 1924-1933 [X] 1934-present [ ] In question	Stencil under light switch: "22 V.D.C". Paper towel dispenser. Mirror.
SUMMARY:		[ ] Good [X] Fair [ ] Poor [ ] Destroyed	[ ] 1911-1923 [ ] 1924-1933 [X] 1934-present [ ] In question	**ARCHITECTURAL SIGNIFICANCE:** [ ] Most [ ] Some [X] Minor [ ] Negligible

PHOTOGRAPHS: (1) View South (2) View North ROOM NO. 117B

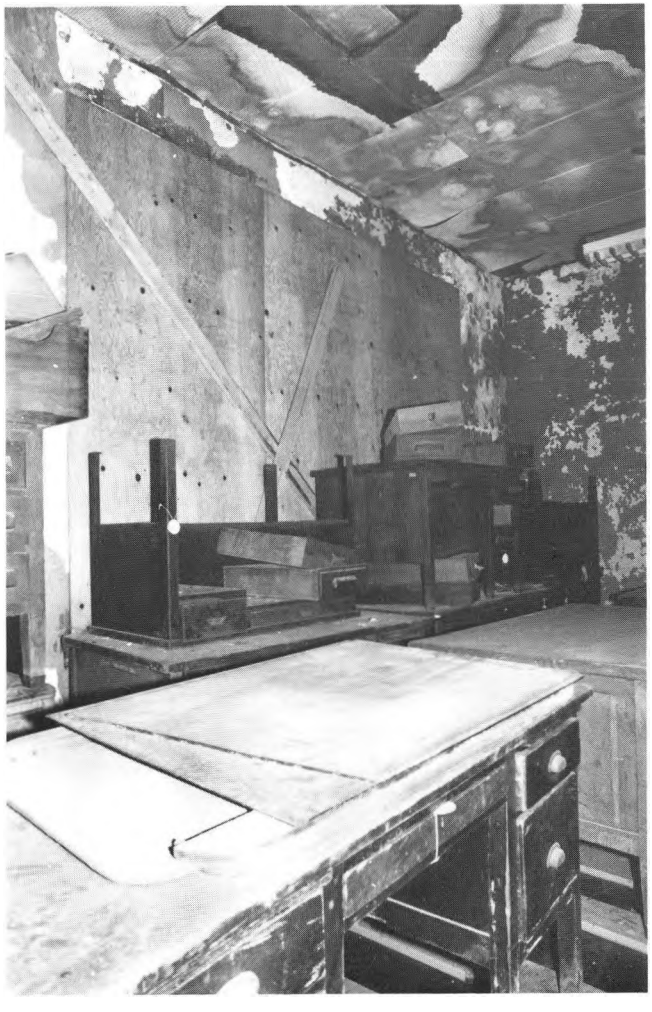
FINISHES:	CONDITION:	DATE:	NOTES:
FLOOR:	[ ] Tile/Concrete [X] Resilient rolled [ ] Wood [ ] Other:	[X] Good [ ] Fair [ ] Poor [ ] Destroyed	[ ] 1911-1923 [ ] 1924-1933 [X] 1934-present [ ] In question	
BASE:	[X] ~~Tile~~ Concrete [ ] Resilient [ ] Wood [ ] Other:	[X] Good [ ] Fair [ ] Poor [ ] Destroyed	[ ] 1911-1923 [ ] 1924-1933 [X] 1934-present [ ] In question	
WALLS:	[X] Plaster [ ] Partitions [ ] Tile Wainscot [ ] Other:	[ ] Good [X] Fair [ ] Poor [ ] Destroyed	[ ] 1911-1923 [ ] 1924-1933 [X] 1934-present [ ] In question	Small area of structural tile exposed NW. and NE. corner.
CEILING:	[ ] Plaster [X] Acoustic panels [ ] Cove [ ] Other	[ ] Good [ ] Fair [X] Poor [ ] Destroyed	[ ] 1911-1923 [ ] 1924-1933 [X] 1934-present [ ] In question	water damage - areas of tiles missing.
DOORS/ OPENINGS:	[ ] Wood/Glass Panelled [X] Wood Veneer [ ] Galvanized Metal [ ] Other:	[ ] Good [X] Fair [ ] Poor [ ] Destroyed	[ ] 1911-1923 [ ] 1924-1933 [X] 1934-present [ ] In question	windows boarded over with plywood.

PHOTOGRAPHS: (1) View North (2) View South ROOM NO. 118

PHOTOGRAPHS: (3) View Northeast (4) View Northeast ROOM NO. 118

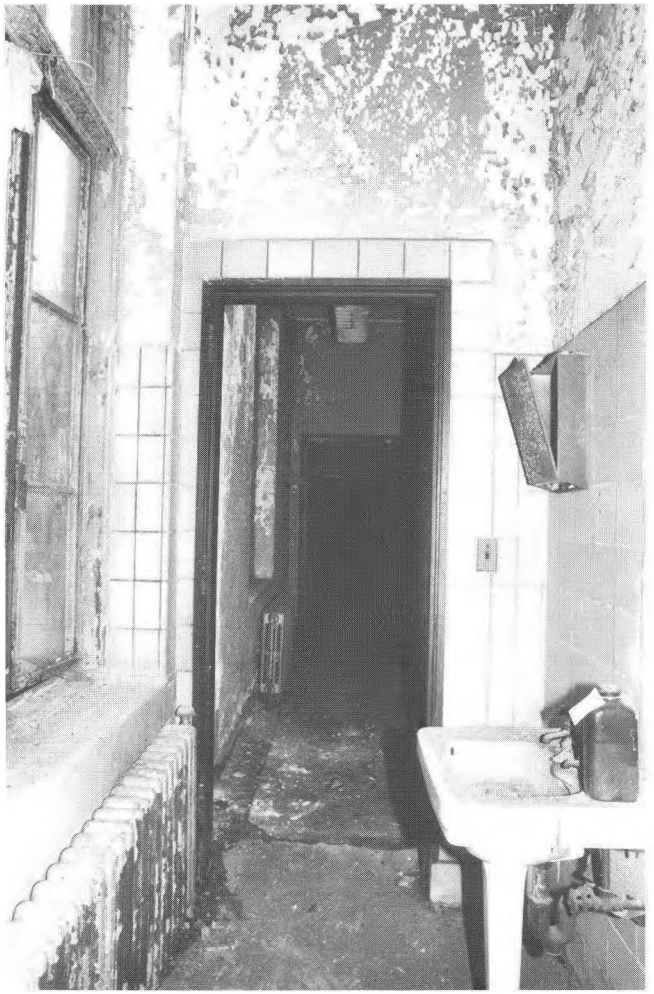
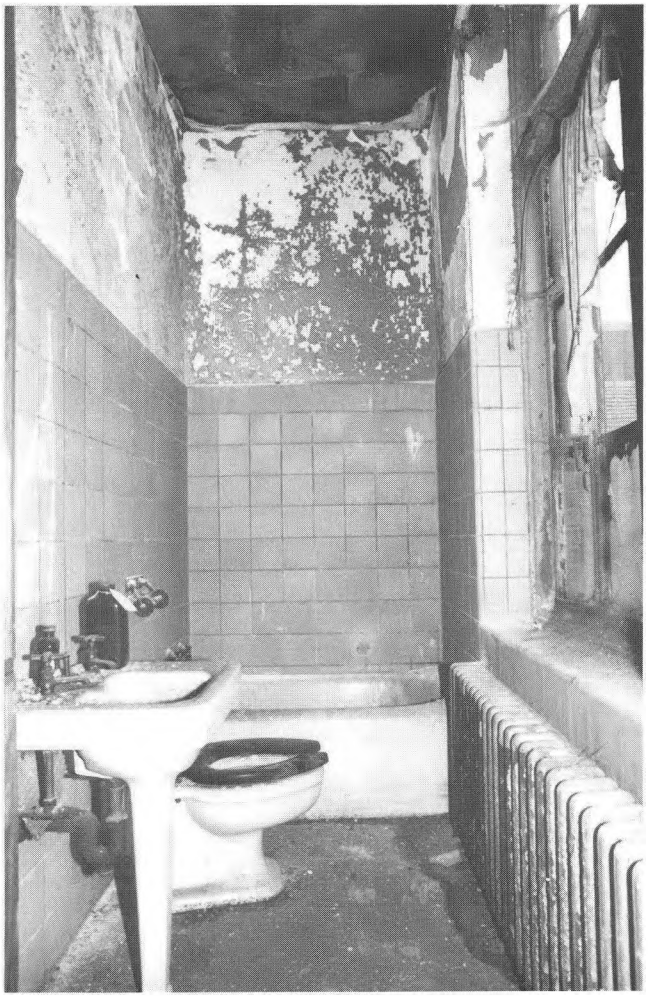
LIGHTING:	[ ] Incandescent/Type A [ ] Incandescent/Type B [ ] CML/Sconce [X] Other:	[ ] Intact [ ] Destroyed [ ] Intact [ ] Destroyed [ ] Intact [ ] Destroyed [ ] Intact [ ] Destroyed	[ ] 1911-1923 [ ] 1924-1933 [X] 1934-present [ ] In question	chain w/ bulb. shade missing.
HEATING/ VENTILATION PLUMBING:	[X] Radiators [ ] ~~Vents/Fans~~ [X] ~~Sink/Toilet/Urinal~~ [X] Other: tub	[1] Intact [ ] Destroyed [ ] Intact [ ] Destroyed [X] Intact [ ] Destroyed [X] Intact [ ] Destroyed	[ ] 1911-1923 [ ] 1924-1933 [X] 1934-present [ ] In question	square central pedestal sink.
MISCELLANEOUS:		[ ] Good [ ] Fair [ ] Poor [ ] Destroyed	[ ] 1911-1923 [ ] 1924-1933 [X] 1934-present [ ] In question	Toilet paper roller. Paper towel dispenser, (rusted). floral print cloth @ window.
SUMMARY:		[X] Good [ ] Fair [ ] Poor [ ] Destroyed	[ ] 1911-1923 [ ] 1924-1933 [X] 1934-present [ ] In question	**ARCHITECTURAL SIGNIFICANCE:** [ ] Most [ ] Some [X] Minor [ ] Negligible

PHOTOGRAPHS: (1) View East (2) View West ROOM NO. 119

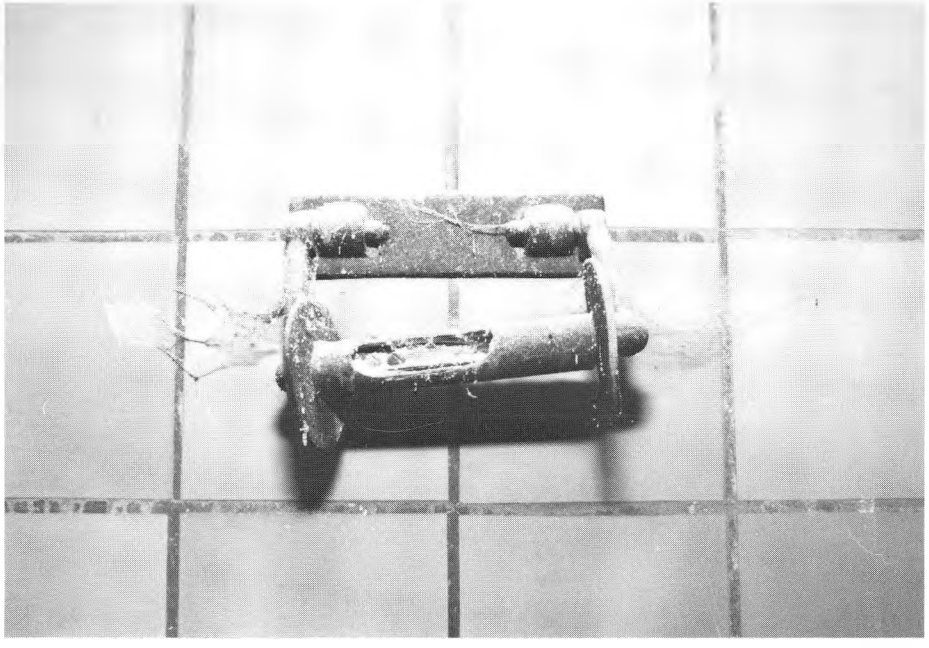
PHOTOGRAPHS: (3) Toilet paper roller ROOM NO. 119

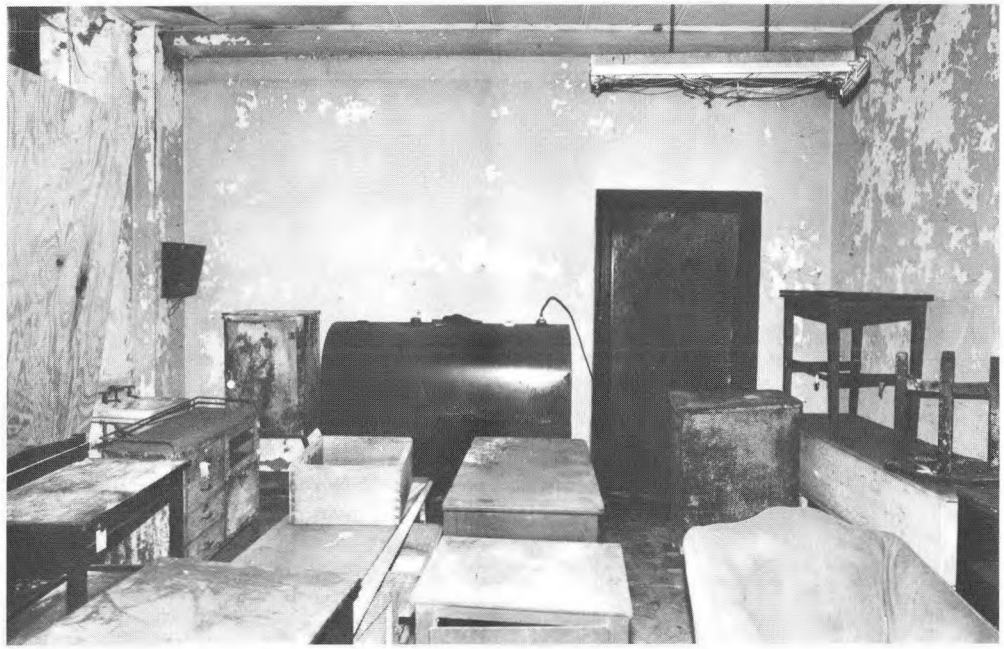
PHOTOGRAPHS: ① View East ② View West ③ View South ④ View North ROOM NO. 120

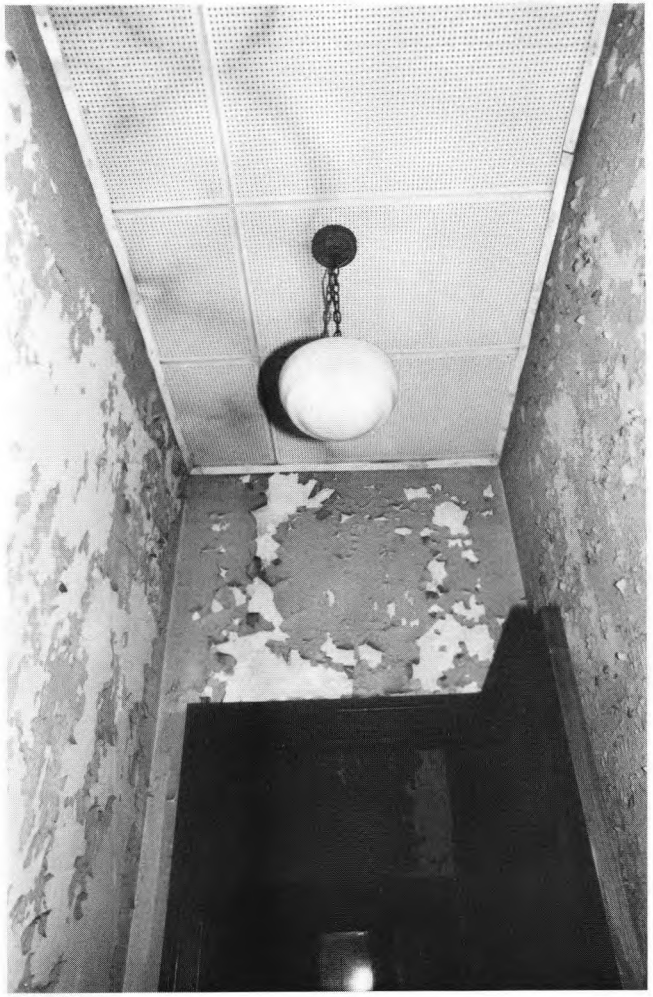
FINISHES:	CONDITION:	DATE:	NOTES:
FLOOR:	X ~~Tile~~ Concrete (circled) Resilient Wood Other:	X Good Fair Poor Destroyed	Pre-1911 1911-1923 1924-1933 X 1934-present In question	
BASE:	Tile/Concrete X Resilient Wood Other:	Good Fair Poor X Destroyed	1911-1923 1924-1933 X 1934-present In question	
WALLS:	X Plaster Partitions Tile Wainscot Other:	Good X Fair Poor Destroyed	1911-1923 1924-1933 X 1934-present In question	
CEILING:	Plaster X Acoustic panels Cove Other	Good Fair X Poor Destroyed	1911-1923 1924-1933 X 1934-present In question	
DOORS/ OPENINGS:	Wood/Glass Panelled X Wood Veneer Galvanized Metal Other:	Good X Fair Poor Destroyed	1911-1923 1924-1933 X 1934-present In question	
LIGHTING:	X Incandescent/Type A Incandescent/Type B CML/Sconce X Other: fluorescent	1 Intact Destroyed Intact Destroyed Intact Destroyed 2 Intact Destroyed	1911-1923 1924-1933 X 1934-present In question	1 incandescent w/ white glass globe, possibly original fixture.

HEATING/ VENTILATION PLUMBING:	X Radiators Vents/Fans X Sink/~~Toilet/Urinal~~ Other:	2 Intact Destroyed Intact Destroyed X Intact Destroyed Intact Destroyed	1911-1923 1924-1933 X 1934-present In question	1 wall-mounted sink.
MISCELLANEOUS:		Good Fair X Poor Destroyed	1911-1923 1924-1933 X 1934-present In question	Rusted paper towel dispenser.
SUMMARY:		Good X Fair Poor Destroyed	1911-1923 1924-1933 X 1934-present In question	**ARCHITECTURAL SIGNIFICANCE:** Most / Some / X Minor / Negligible

PHOTOGRAPHS: (5) sink, southeast corner. (6) Light fixture ROOM NO. 120

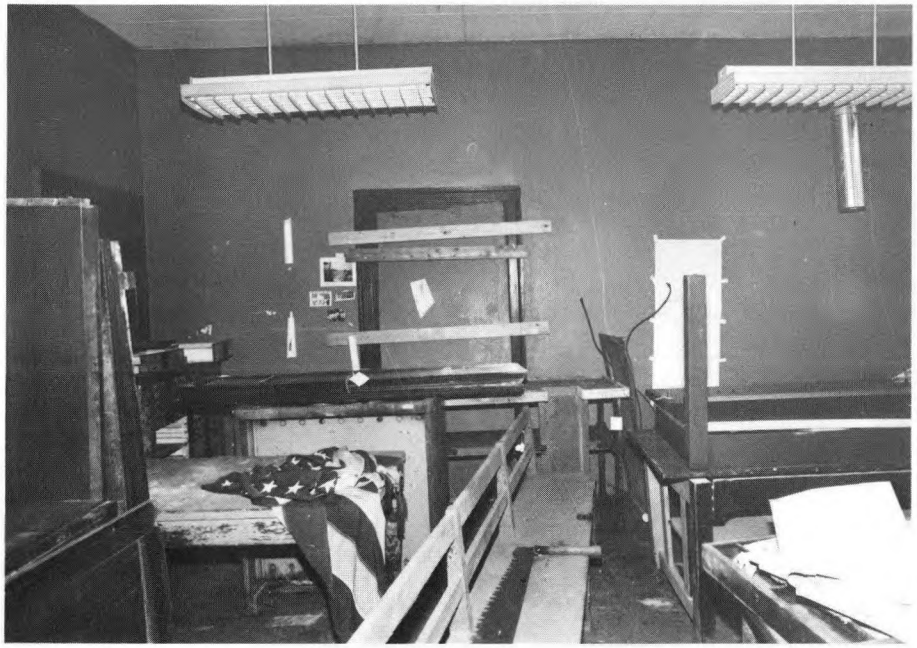
FINISHES:	CONDITION:	DATE:	NOTES:
FLOOR:	Tile/Concrete X Resilient rolled Wood Other:	Good X Fair Poor Destroyed	1911-1923 1924-1933 X 1934-present In question	
BASE:	X ~~Tile~~/Concrete Resilient Wood Other:	X Good Fair Poor Destroyed	1911-1923 1924-1933 X 1934-present In question	
WALLS:	X Plaster Partitions Tile Wainscot Other:	X Good Fair Poor Destroyed	1911-1923 1924-1933 X 1934-present In question	
CEILING:	Plaster X Acoustic panels Cove Other	X Good Fair Poor Destroyed	1911-1923 1924-1933 X 1934-present In question	
DOORS/ OPENINGS:	Wood/Glass Panelled X Wood Veneer Galvanized Metal Other:	Good X Fair Poor Destroyed	1911-1923 1924-1933 X 1934-present In question	4 extant, 1 removed and infilled to 120. "Office" stenciled on door from H101.
LIGHTING:	Incandescent/Type A Incandescent/Type B CML/Sconce X Other:	Intact Destroyed Intact Destroyed Intact Destroyed 4 Intact 1 Destroyed	1911-1923 1924-1933 X 1934-present In question	4 fluorescent. 1 chain w/ base, no shade.

HEATING/ VENTILATION PLUMBING:	X Radiators Vents/Fans X Sink/~~Toilet/Urinal~~ Other:	1 Intact Destroyed Intact Destroyed X Intact Destroyed Intact Destroyed	1911-1923 1924-1933 X 1934-present In question	1 wall-mounted sink w/ faucets.
MISCELLANEOUS:		Good Fair Poor Destroyed	1911-1923 1924-1933 1934-present In question	Closet: door blocked by furniture.
SUMMARY:		X Good Fair Poor Destroyed	1911-1923 1924-1933 X 1934-present In question	**ARCHITECTURAL SIGNIFICANCE:** Most / Some / X Minor / Negligible

PHOTOGRAPHS: (1) View North (2) View Northwest (3) View East ROOM NO. 122
