existing condition survey

ELLIS ISLAND

EXISTING CONDITION SURVEY
UNITS 2, 3 AND 4

Volume 4
Appendix A
Part Two

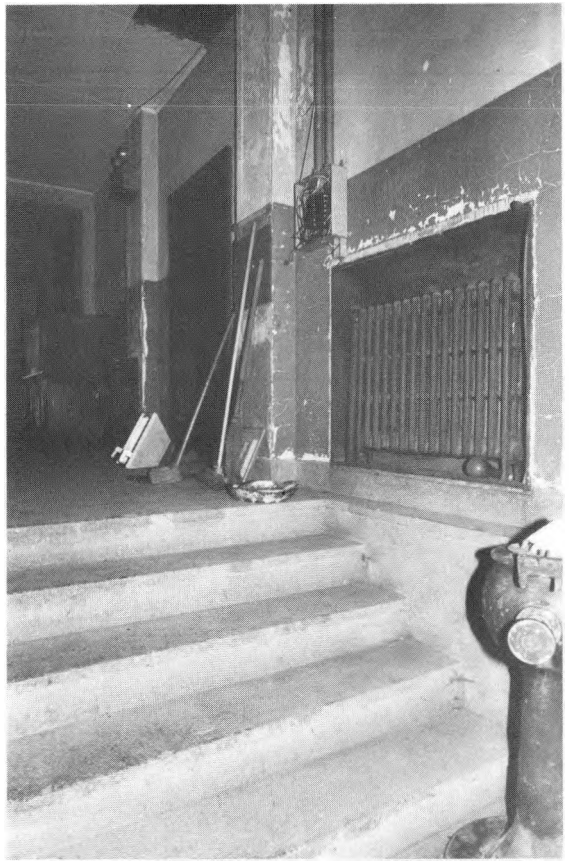
PHOTOGRAPHS: (5) View Northwest, radiator niche ROOM NO. H101

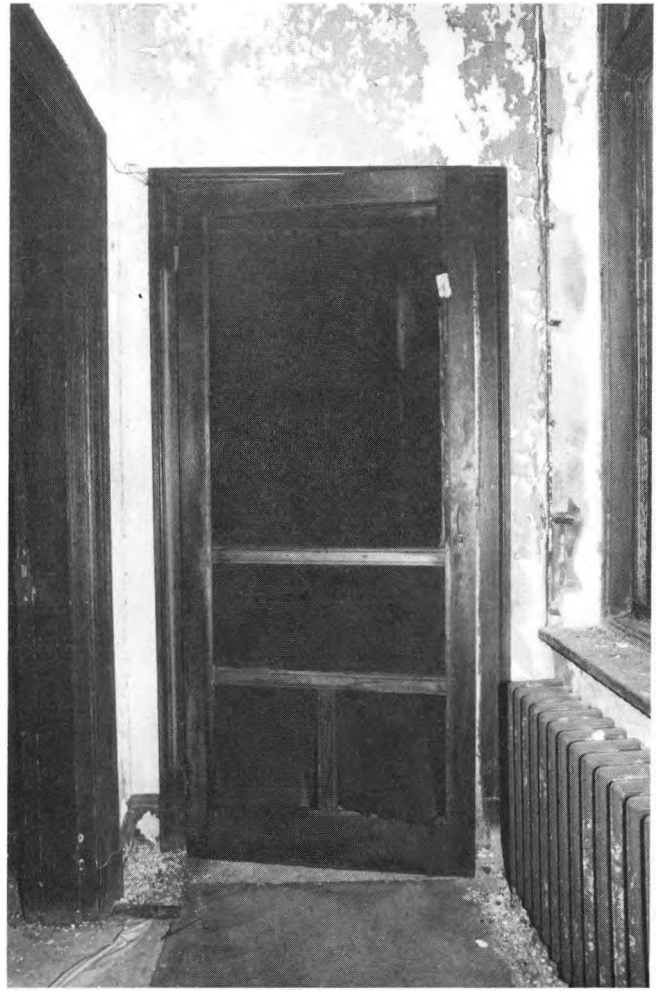
PHOTOGRAPHS: (1) View West (2) View West, screen door ROOM NO. H104

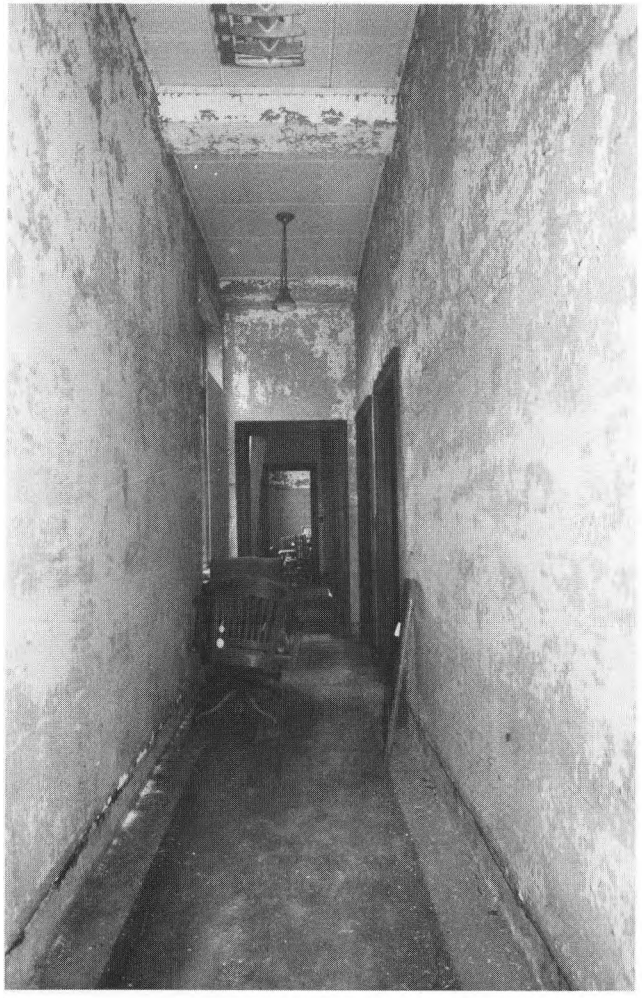
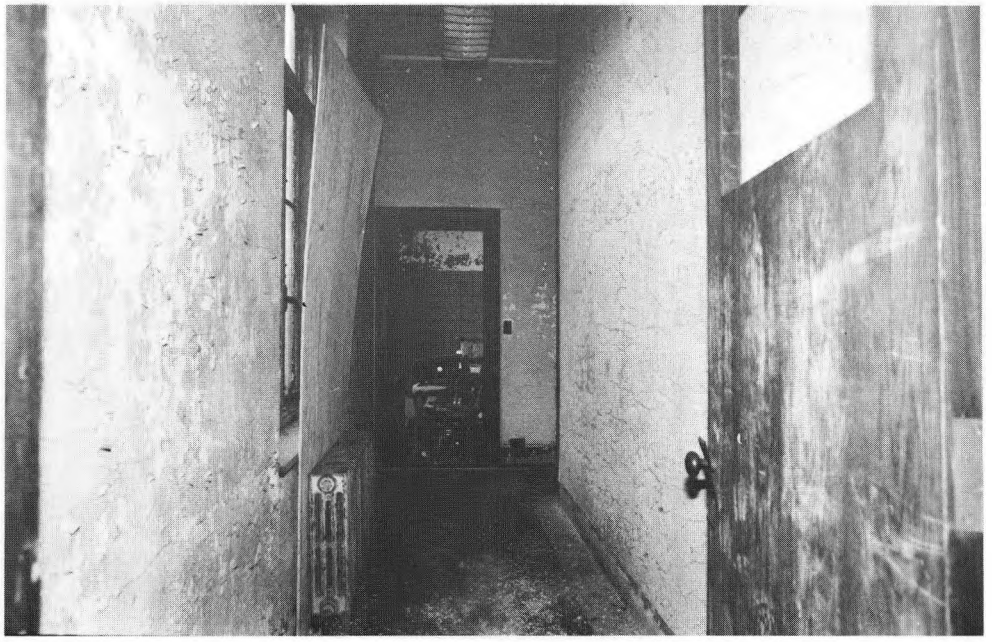
FINISHES:	CONDITION:	DATE:	NOTES:
FLOOR:	[ ] Tile/Concrete [X] Resilient rolled [ ] Wood [ ] Other:	[ ] Good [X] Fair [ ] Poor [ ] Destroyed	[ ] 1911-1923 [ ] 1924-1933 [X] 1934-present [ ] In question	
BASE:	[X] Tile/Concrete [ ] Resilient [ ] Wood [ ] Other:	[X] Good [ ] Fair [ ] Poor [ ] Destroyed	[ ] 1911-1923 [ ] 1924-1933 [X] 1934-present [ ] In question	
WALLS:	[X] Plaster [ ] Partitions [ ] Tile Wainscot [ ] Other:	[X] Good [ ] Fair [ ] Poor [ ] Destroyed	[ ] 1911-1923 [ ] 1924-1933 [X] 1934-present [ ] In question	
CEILING:	[ ] Plaster [X] Acoustic panels [ ] Cove [ ] Other	[X] Good [ ] Fair [ ] Poor [ ] Destroyed	[ ] 1911-1923 [ ] 1924-1933 [X] 1934-present [ ] In question	
DOORS/ OPENINGS:	[ ] Wood/Glass Panelled [X] Wood Veneer [ ] Galvanized Metal [ ] Other:	[X] Good [ ] Fair [ ] Poor [ ] Destroyed	[ ] 1911-1923 [ ] 1924-1933 [X] 1934-present [ ] In question	
LIGHTING:	[ ] Incandescent/Type A [ ] Incandescent/Type B [ ] CML/Sconce [X] Other:	[ ] Intact [ ] Destroyed [ ] Intact [ ] Destroyed [ ] Intact [ ] Destroyed 3 Intact [ ] Destroyed	[ ] 1911-1923 [ ] 1924-1933 [X] 1934-present [ ] In question	2 fluorescent 1 chain w/ fluted glass shade (bathroom st.).

PHOTOGRAPHS: (1) H107, View West (2) H107A, View West ROOM NO. H107/107A

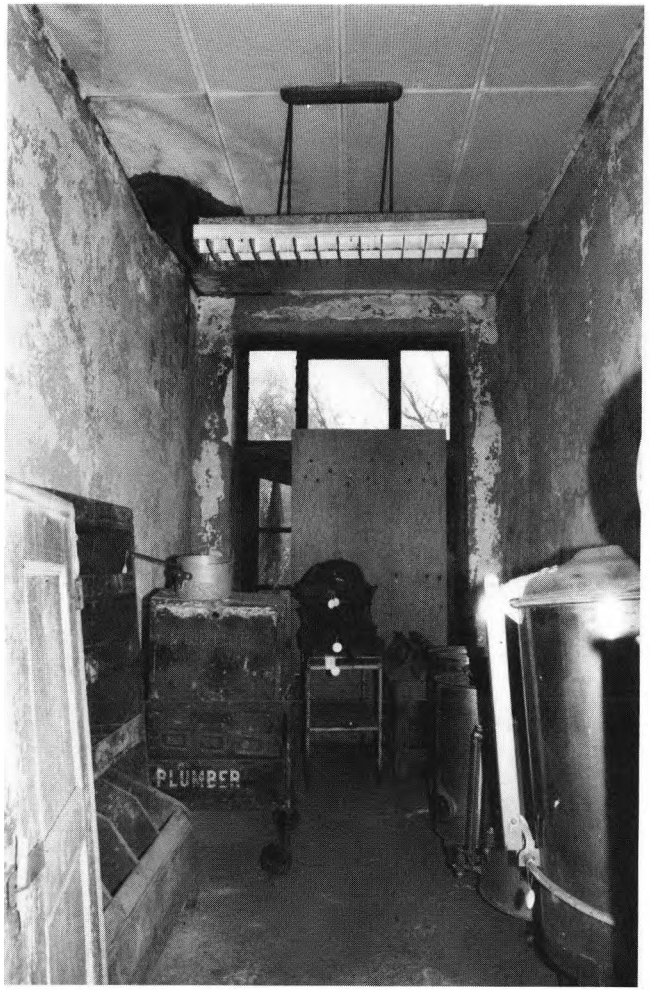
PHOTOGRAPHS: (1) View West (2) View East ROOM NO. H108

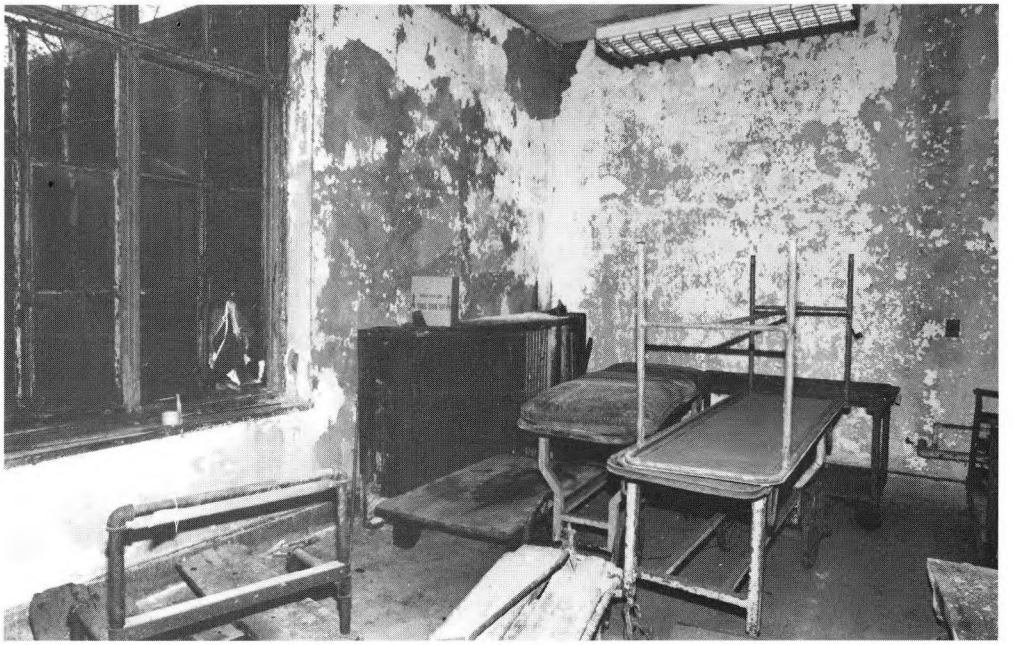
FINISHES:	CONDITION:	DATE:	NOTES:
FLOOR:	☐ Tile/Concrete ☐ Resilient ☐ Wood ☒ Other: Terrazzo poured stone	☒ Good ☐ Fair ☐ Poor ☐ Destroyed	☐ 1911-1923 ☐ 1924-1933 ☒ 1934-present ☐ In question	As in hallways, beige, black + white chips, 2'6½" X 2'3¼" sections, Brass dividing strips.
BASE:	☐ Tile/Concrete ☐ Resilient ☒ Wood ☒ Other: Terrazzo	☒ Good ☐ Fair ☐ Poor ☐ Destroyed	☐ 1911-1923 ☐ 1924-1933 ☒ 1934-present ☐ In question	Wood @ partition wall (W). Terrazzo @ other 3 walls.
WALLS:	☒ Plaster ☒ Partitions ☐ Tile Wainscot ☐ Other:	☒ Good ☐ Fair ☐ Poor ☐ Destroyed	☐ 1911-1923 ☐ 1924-1933 ☒ 1934-present ☐ In question	West wall - bet. 501 and Hallway Wood partition. E., N., S. walls plaster.
CEILING:	☐ Plaster ☒ Acoustic panels ☐ Cove ☐ Other	☒ Good ☐ Fair ☐ Poor ☐ Destroyed	☐ 1911-1923 ☐ 1924-1933 ☒ 1934-present ☐ In question	
DOORS/ OPENINGS:	☐ Wood/Glass Panelled ☐ Wood Veneer ☐ Galvanized Metal ☐ Other:	☐ Good ☐ Fair ☐ Poor ☐ Destroyed	☐ 1911-1923 ☐ 1924-1933 ☒ 1934-present ☐ In question	Framed square opening (approx. 2'X2') in partition wall (window, no glass).

PHOTOGRAPHS: (1) View North (2) View Southeast (3) View South ROOM NO. 501

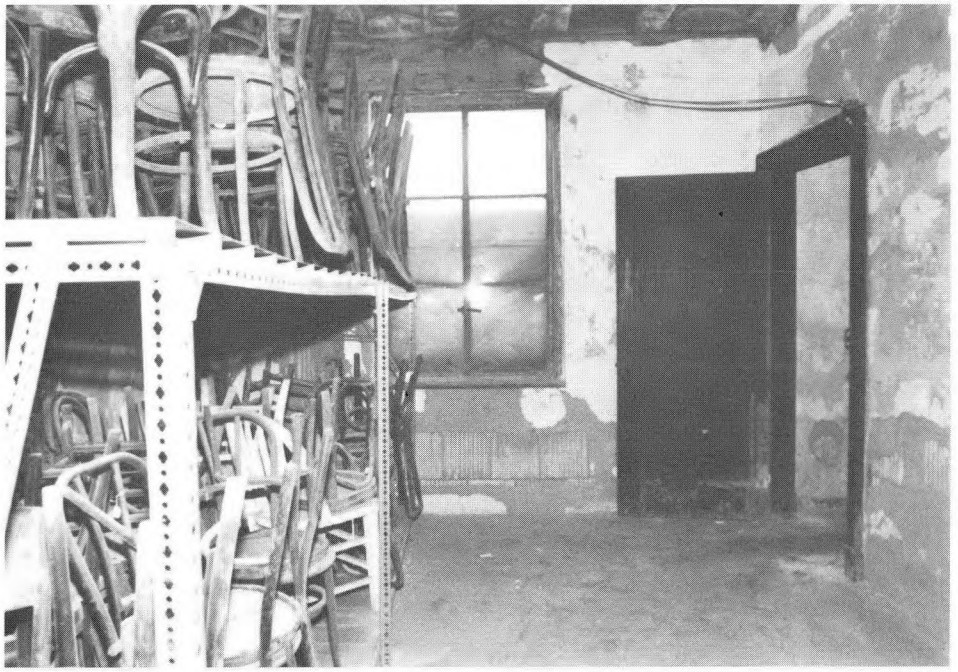
PHOTOGRAPHS: ① View South ② View North ③ View West ROOM NO. 103

FINISHES:	CONDITION:	DATE:	NOTES:
FLOOR:	[X] Tile/Concrete [ ] Resilient [ ] Wood [ ] Other:	[X] Good [ ] Fair [ ] Poor [ ] Destroyed	[ ] 1911-1923 [ ] 1924-1933 [X] 1934-present [ ] In question	
BASE:	[ ] Tile/Concrete [ ] Resilient [ ] Wood [ ] Other:	[ ] Good [ ] Fair [ ] Poor [ ] Destroyed	[ ] 1911-1923 [ ] 1924-1933 [X] 1934-present [ ] In question	
WALLS:	[X] Plaster [ ] Partitions [ ] Tile Wainscot [ ] Other:	[ ] Good [ ] Fair [X] Poor [ ] Destroyed	[ ] 1911-1923 [ ] 1924-1933 [X] 1934-present [ ] In question	
CEILING:	[X] Plaster [ ] Acoustic panels [ ] Cove [ ] Other	[ ] Good [ ] Fair [ ] Poor [X] Destroyed	[ ] 1911-1923 [ ] 1924-1933 [X] 1934-present [ ] In question	
DOORS/ OPENINGS:	[ ] Wood/Glass Panelled [X] Wood Veneer 2 [ ] Galvanized Metal [ ] Other:	[ ] Good [ ] Fair 1 Poor 1 Destroyed	[ ] 1911-1923 [ ] 1924-1933 [X] 1934-present [ ] In question	2 6-light casement windows.
LIGHTING:	[ ] Incandescent/Type A [ ] Incandescent/Type B [X] CML/Sconce [ ] Other:	[ ] Intact [ ] Destroyed [ ] Intact [ ] Destroyed [ ] Intact [X] Destroyed [ ] Intact [ ] Destroyed	[ ] 1911-1923 [ ] 1924-1933 [X] 1934-present [ ] In question

HEATING/ VENTILATION PLUMBING:	[X] Radiators 1 [ ] Vents/Fans [X] Sink/Toilet/Urinal [ ] Other:	[X] Intact [ ] Destroyed [ ] Intact [ ] Destroyed [X] Intact [ ] Destroyed [ ] Intact [ ] Destroyed	[ ] 1911-1923 [ ] 1924-1933 [X] 1934-present [ ] In question	1 wall-mounted sink.
MISCELLANEOUS:		[ ] Good [ ] Fair [ ] Poor [ ] Destroyed	[ ] 1911-1923 [ ] 1924-1933 [X] 1934-present [ ] In question	signage on door in gold stencil: "HOSPI" R
SUMMARY:		[ ] Good [X] Fair [ ] Poor [ ] Destroyed	[ ] 1911-1923 [ ] 1924-1933 [X] 1934-present [ ] In question	**ARCHITECTURAL SIGNIFICANCE:** [ ] Most [ ] Some [X] Minor [ ] Negligible

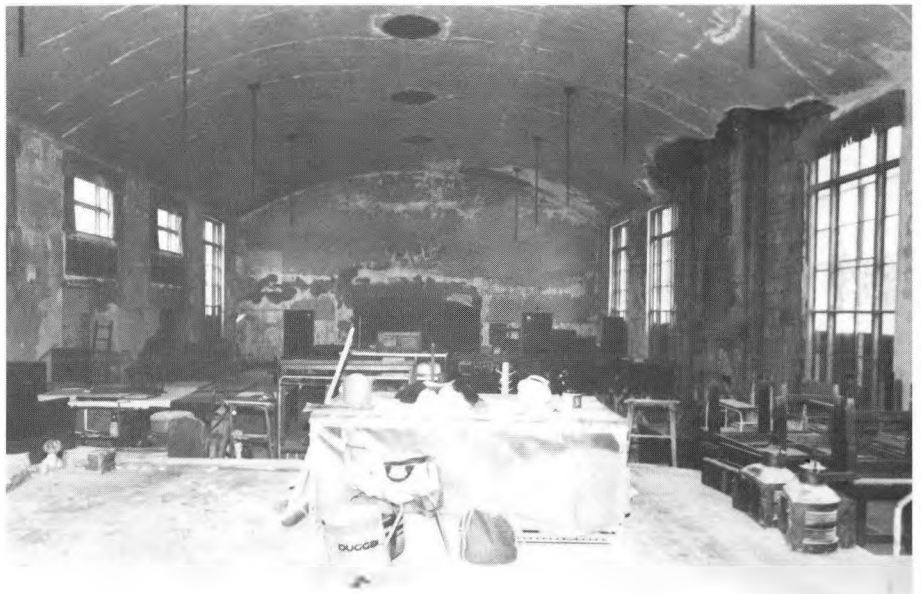
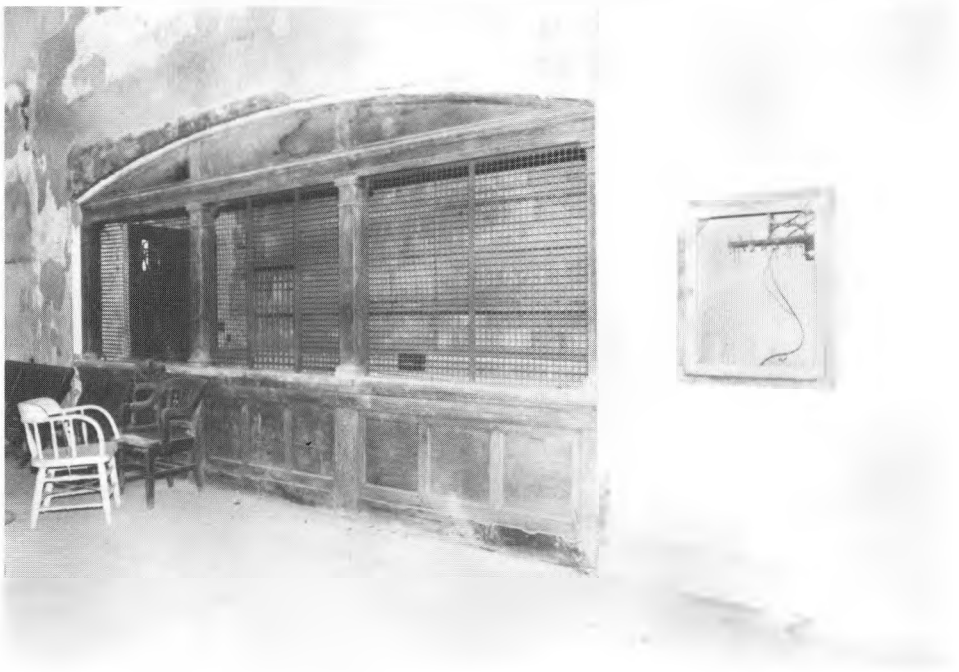
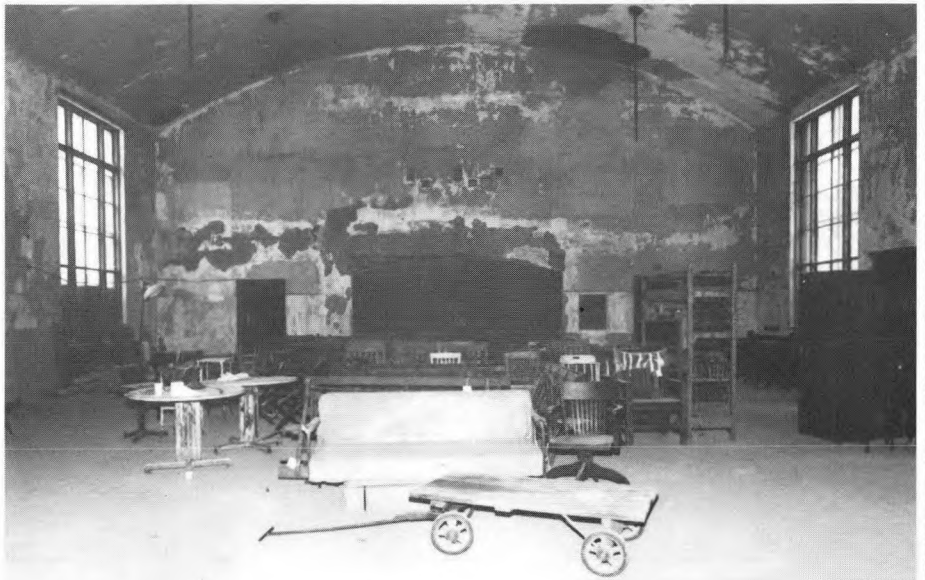
PHOTOGRAPHS: (1) View North (2) View North (3) canteen (4) View Southwest ROOM NO. 105

FINISHES:	CONDITION:	DATE:	NOTES:
FLOOR:	[X] Tile/Concrete [ ] Resilient [ ] Wood [ ] Other:	[X] Good [ ] Fair [ ] Poor [ ] Destroyed	[ ] 1911-1923 [ ] 1924-1933 [X] 1934-present [ ] In question	Stage floor - resilient Tile, good cond. Main space - concrete w/ evidence of Tile overlay. 2 cracks in west end.
BASE:	[ ] Tile/Concrete [X] Resilient [X] Wood [X] Other:	[ ] Good [ ] Fair [X] Poor [X] Destroyed	[ ] 1911-1923 [ ] 1924-1933 [X] 1934-present [ ] In question	Probable wood base. Slate base on stage. Asphalt base w/ cove in area of wood paneling.
WALLS:	[X] Plaster [ ] Partitions [ ] Tile Wainscot [ ] Other:	[ ] Good [X] Fair [ ] Poor [ ] Destroyed	[ ] 1911-1923 [ ] 1924-1933 [X] 1934-present [ ] In question	Exposure of structural tile in some areas.
CEILING:	[X] Plaster [ ] Acoustic panels [ ] Cove [ ] Other	[X] Good [ ] Fair [ ] Poor [ ] Destroyed	[ ] 1911-1923 [ ] 1924-1933 [X] 1934-present [ ] In question	Barrel vault. Hole in NE. section - exposure of steel framing + support. Hole over fireplace.

DOORS/ OPENINGS:	[ ] Wood/Glass Panelled [X] Wood Veneer [ ] Galvanized Metal [ ] Other:	[ ] Good [X] Fair [X] Poor [X] Destroyed	[ ] 1911-1923 [ ] 1924-1933 [X] 1934-present [ ] In question	6 wood veneer doors; 1 removed, 1 destroyed. Iron casement windows.
LIGHTING:	[X] Incandescent/Type A [ ] Incandescent/Type B [X] CML/Sconce [ ] Other:	[ ] Intact [X] Destroyed [ ] Intact [ ] Destroyed [X] Intact [ ] Destroyed [ ] Intact [ ] Destroyed	[ ] 1911-1923 [ ] 1924-1933 [X] 1934-present [ ] In question	10 central Type AS. Bases + chains extant, globes removed. 2 wall-mounted fixtures over doors to 105A + 105B - Brass base, red bulb.
HEATING/ VENTILATION PLUMBING:	[X] ~~Radiat~~ors [X] Vents/Fans [ ] Sink/Toilet/Urinal [ ] Other:	[X] Intact [ ] Destroyed [X] Intact [ ] Destroyed [ ] Intact [ ] Destroyed [ ] Intact [ ] Destroyed	[ ] 1911-1923 [ ] 1924-1933 [X] 1934-present [ ] In question	6 radiators w/ screened covers. 3 screened vents. 4 circular vents in ceiling.

MISCELLANEOUS:		[X] Good [ ] Fair [ ] Poor [ ] Destroyed	[ ] 1911-1923 [ ] 1924-1933 [X] 1934-present [ ] In question	Fireplace - E. Wall. Canteen - N. Wall. Stage - S. end.
SUMMARY:		[X] Good [ ] Fair [ ] Poor [ ] Destroyed	[ ] 1911-1923 [ ] 1924-1933 [X] 1934-present [ ] In question	**ARCHITECTURAL SIGNIFICANCE:** [X] Most [ ] Some [ ] Minor [ ] Negligible

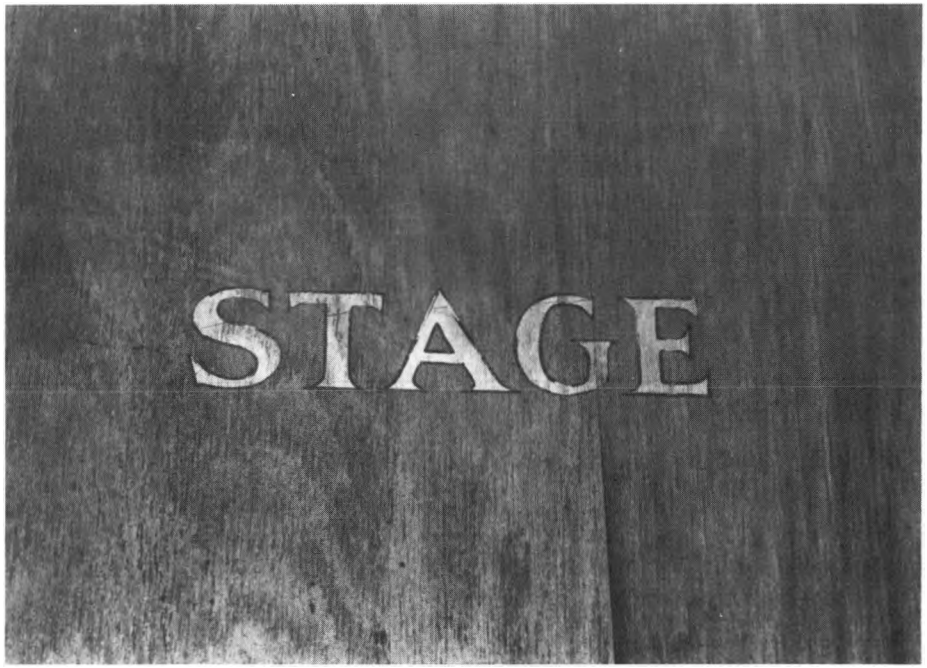
ROOM NO. 1050

FINISHES:	CONDITION:	DATE:	NOTES:
FLOOR:	[X] Tile/Concrete [ ] Resilient [ ] Wood [ ] Other:	[X] Good [ ] Fair [ ] Poor [ ] Destroyed	[ ] 1911-1923 [ ] 1924-1933 [X] 1934-present [ ] In question	
BASE:	[X] Tile/Concrete [ ] Resilient [ ] Wood [ ] Other:	[X] Good [ ] Fair [ ] Poor [ ] Destroyed	[ ] 1911-1923 [ ] 1924-1933 [X] 1934-present [ ] In question	flush w/ wall.
WALLS:	[X] Plaster [ ] Partitions [ ] Tile Wainscot [ ] Other:	[X] Good [ ] Fair [ ] Poor [ ] Destroyed	[ ] 1911-1923 [ ] 1924-1933 [X] 1934-present [ ] In question	
CEILING:	[X] Plaster [ ] Acoustic panels [ ] Cove [ ] Other	[X] Good [ ] Fair [ ] Poor [ ] Destroyed	[ ] 1911-1923 [ ] 1924-1933 [X] 1934-present [ ] In question	
DOORS/ OPENINGS:	[ ] Wood/Glass Panelled [X] Wood Veneer [ ] Galvanized Metal [ ] Other:	[ ] Good [X] Fair [ ] Poor [ ] Destroyed	[ ] 1911-1923 [ ] 1924-1933 [X] 1934-present [ ] In question	Signage on exterior of door: "STAGE" Gold w/ black lined edge. Iron window sills. Circular window w/ screen.

PHOTOGRAPHS: (1) Door Signage

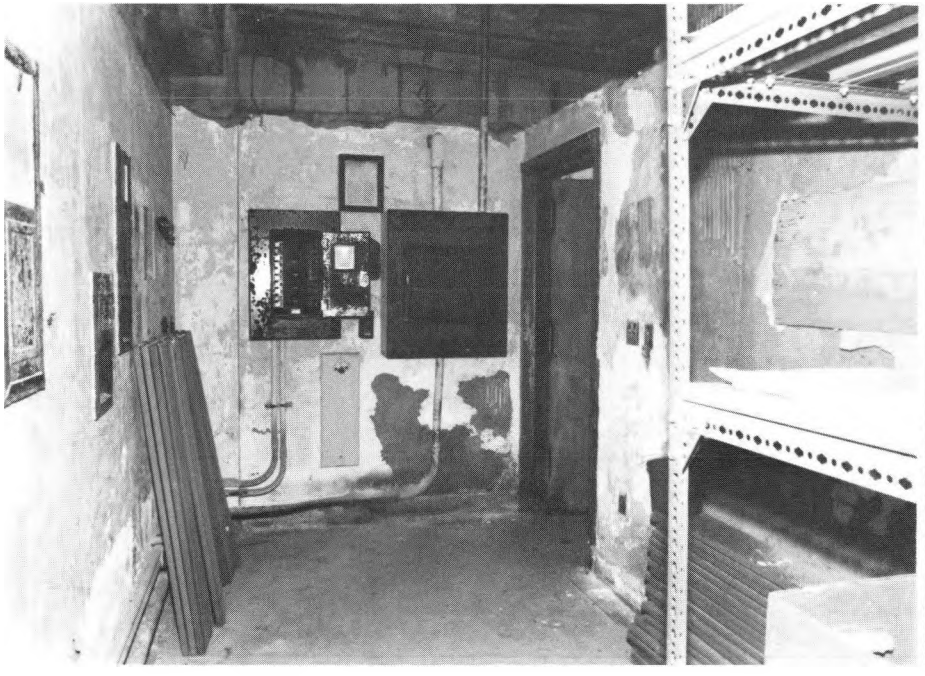
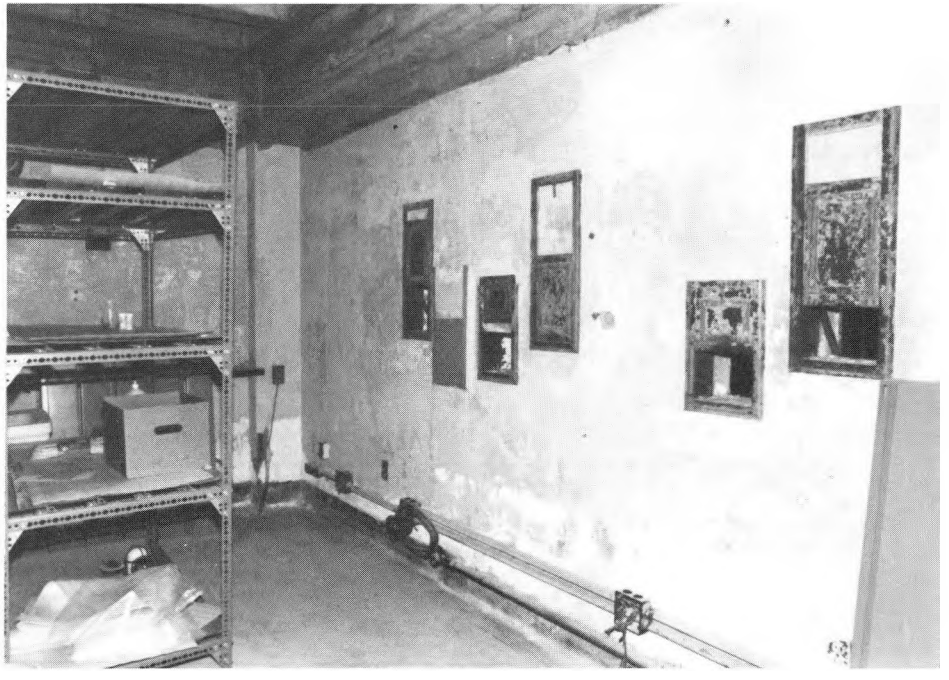
PHOTOGRAPHS: ① View West ② View East ROOM NO. 202

FINISHES:	CONDITION:	DATE:	NOTES:
FLOOR:	[X] Tile/Concrete [ ] Resilient [ ] Wood [ ] Other:	[X] Good [ ] Fair [ ] Poor [ ] Destroyed	[ ] 1911-1923 [ ] 1924-1933 [X] 1934-present [ ] In question	
BASE:	[X] Tile/Concrete [ ] Resilient [ ] Wood [ ] Other:	[X] Good [ ] Fair [ ] Poor [ ] Destroyed	[ ] 1911-1923 [ ] 1924-1933 [X] 1934-present [ ] In question	flush w/ wall.
WALLS:	[X] Plaster [ ] Partitions [ ] Tile Wainscot [ ] Other:	[ ] Good [X] Fair [ ] Poor [ ] Destroyed	[ ] 1911-1923 [ ] 1924-1933 [X] 1934-present [ ] In question	Wall signage: "STAGE LIGHT" "HOUSE LIGHT" Projection openings w/ sliding metal doors. Structural tile visible on N. wall + near ceiling.
CEILING:	[X] Plaster [ ] Acoustic panels [ ] Cove [ ] Other	[ ] Good [ ] Fair [ ] Poor [X] Destroyed	[ ] 1911-1923 [ ] 1924-1933 [X] 1934-present [ ] In question	
DOORS/ OPENINGS:	[ ] Wood/Glass Panelled [ ] Wood Veneer [X] Galvanized Metal [ ] Other:	[ ] Good [X] Fair [ ] Poor [ ] Destroyed	[ ] 1911-1923 [ ] 1924-1933 [X] 1934-present [ ] In question	rusting metal door - signage: in Gold - "PROJECTION ROOM"

LIGHTING:	[ ] Incandescent/Type A [ ] Incandescent/Type B [X] CML/Sconce I [ ] Other:	[ ] Intact [ ] Destroyed [ ] Intact [ ] Destroyed [X] Intact [ ] Destroyed [ ] Intact [ ] Destroyed	[ ] 1911-1923 [ ] 1924-1933 [X] 1934-present [ ] In question	
HEATING/ VENTILATION PLUMBING:	[ ] Radiators [X] Vents/Fans ([X] Sink/Toilet/Urinal [ ] Other:	[X] Intact [ ] Destroyed [X] Intact [ ] Destroyed [X] Intact [ ] Destroyed [ ] Intact [ ] Destroyed	[ ] 1911-1923 [ ] 1924-1933 [X] 1934-present [ ] In question	1 wall mounted sink Metal shelf on brackets: E. Wall. Generator.
MISCELLANEOUS:		[ ] Good [ ] Fair [ ] Poor [ ] Destroyed	[ ] 1911-1923 [ ] 1924-1933 [ ] 1934-present [ ] In question	
SUMMARY:		[ ] Good [X] Fair [ ] Poor [ ] Destroyed	[ ] 1911-1923 [ ] 1924-1933 [X] 1934-present [ ] In question	**ARCHITECTURAL SIGNIFICANCE:** [ ] Most [X] Some [ ] Minor [ ] Negligible

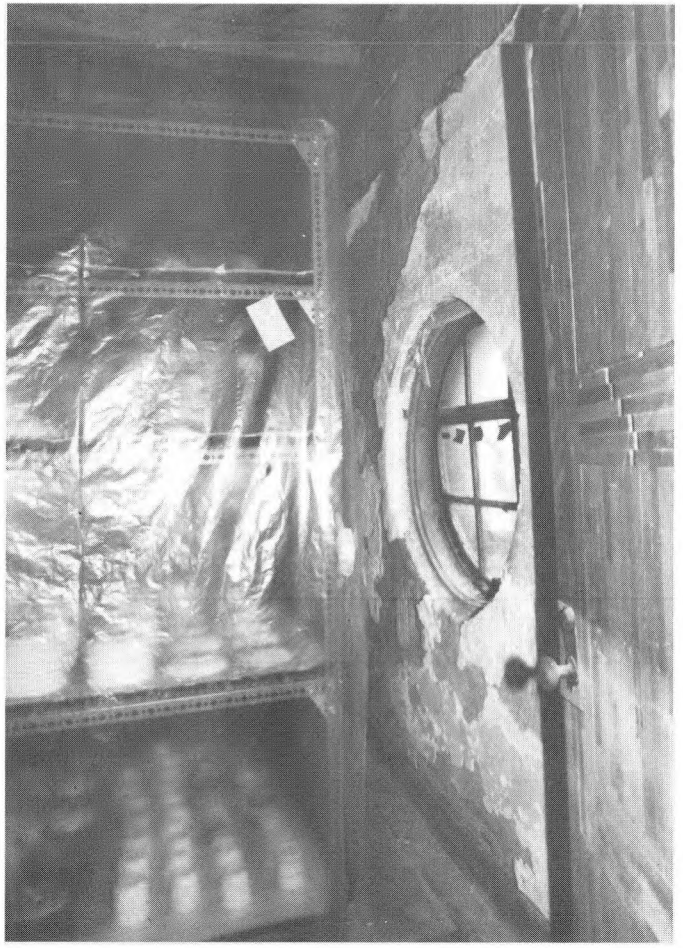
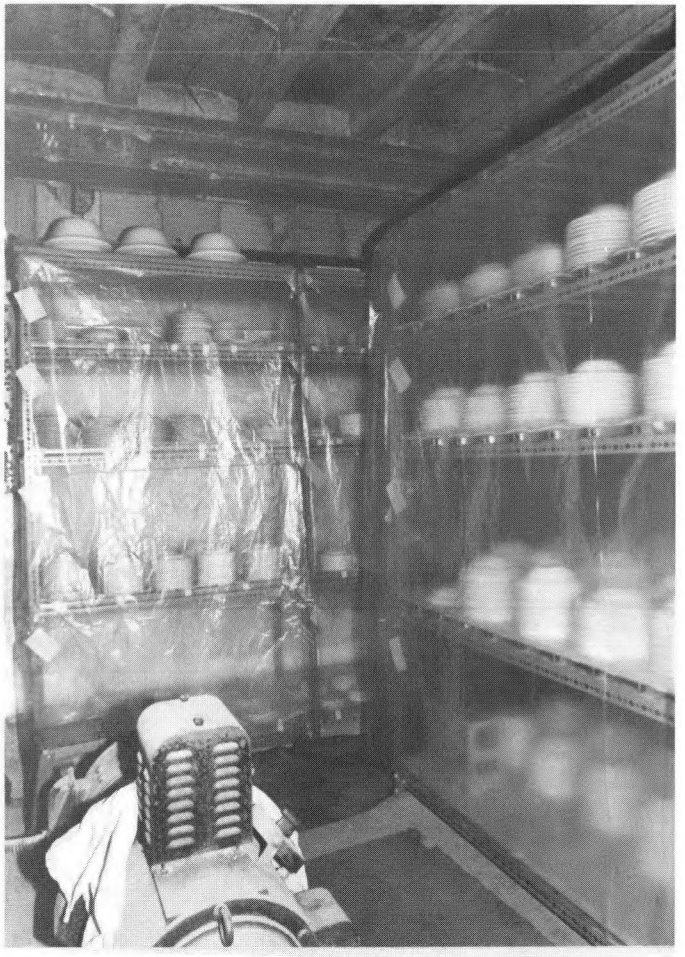
PHOTOGRAPHS: (1) View West (2) View Southeast ROOM NO. 203

FINISHES:	CONDITION:	DATE:	NOTES:
FLOOR:	[X] Tile/Concrete [ ] Resilient [ ] Wood [ ] Other:	[X] Good [ ] Fair [ ] Poor [ ] Destroyed	[ ] 1911-1923 [ ] 1924-1933 [ ] 1934-present [ ] In question	
BASE:	[X] Tile/Concrete [ ] Resilient [ ] Wood [ ] Other:	[X] Good [ ] Fair [ ] Poor [ ] Destroyed	[ ] 1911-1923 [ ] 1924-1933 [X] 1934-present [ ] In question	flush w/ wall.
WALLS:	[X] Plaster [ ] Partitions [ ] Tile Wainscot [ ] Other:	[ ] Good [X] Fair [ ] Poor [ ] Destroyed	[ ] 1911-1923 [ ] 1924-1933 [X] 1934-present [ ] In question	
CEILING:	[X] Plaster [ ] Acoustic panels [ ] Cove [ ] Other	[ ] Good [ ] Fair [ ] Poor [X] Destroyed	[ ] 1911-1923 [ ] 1924-1933 [X] 1934-present [ ] In question	
DOORS/ OPENINGS:	[ ] Wood/Glass Panelled [X] Wood Veneer [ ] Galvanized Metal [ ] Other:	[ ] Good [ ] Fair [X] Poor [ ] Destroyed	[ ] 1911-1923 [ ] 1924-1933 [X] 1934-present [ ] In question	2 round windows w/ screens. Veneer of doors destroyed.

LIGHTING:	[ ] Incandescent/Type A [ ] Incandescent/Type B [ ] CML/Sconce [ ] Other:	[ ] Intact [ ] Destroyed [ ] Intact [ ] Destroyed [ ] Intact [ ] Destroyed [ ] Intact [ ] Destroyed	[ ] 1911-1923 [ ] 1924-1933 [ ] 1934-present [ ] In question	
HEATING/ VENTILATION PLUMBING:	[X] Radiators [ ] Vents/Fans [X] Sink/Toilet/Urinal [ ] Other:	[X] Intact [ ] Destroyed [ ] Intact [ ] Destroyed [ ] Intact [ ] Destroyed [ ] Intact [ ] Destroyed	[ ] 1911-1923 [ ] 1924-1933 [X] 1934-present [ ] In question	1 wall-mounted sink w/ faucets
MISCELLANEOUS:		[ ] Good [ ] Fair [ ] Poor [ ] Destroyed	[ ] 1911-1923 [ ] 1924-1933 [ ] 1934-present [ ] In question	
SUMMARY:		[X] Good [ ] Fair [ ] Poor [ ] Destroyed	[ ] 1911-1923 [ ] 1924-1933 [X] 1934-present [ ] In question	**ARCHITECTURAL SIGNIFICANCE:** [ ] Most [X] Some [ ] Minor [ ] Negligible

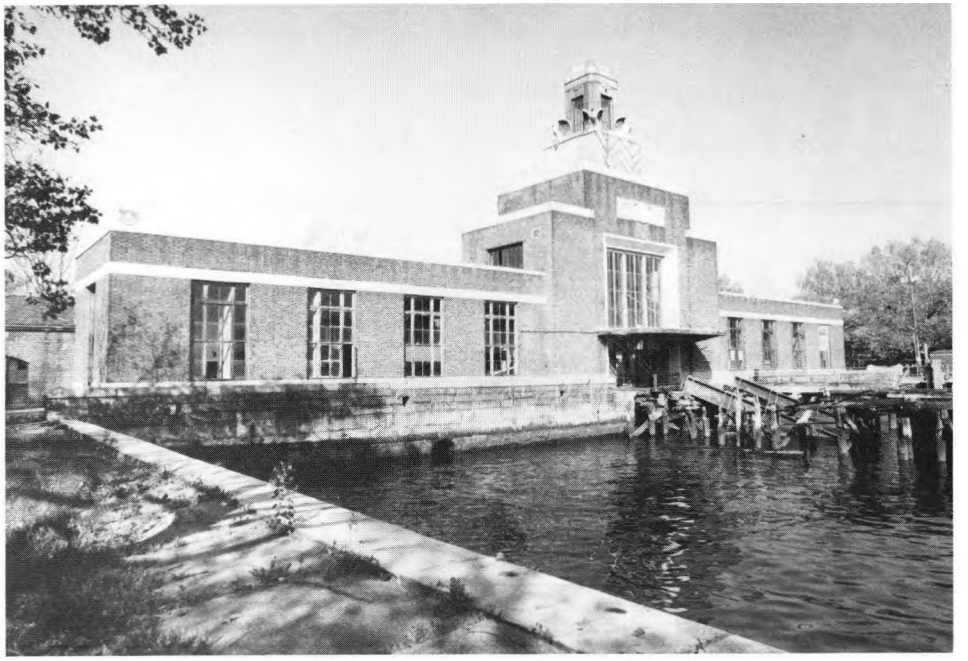
SUMMARY:	**CONDITION:**	XXX	**GOOD** **FAIR** **POOR** **DESTROYED**

Ferry, east elevation, view southwest.

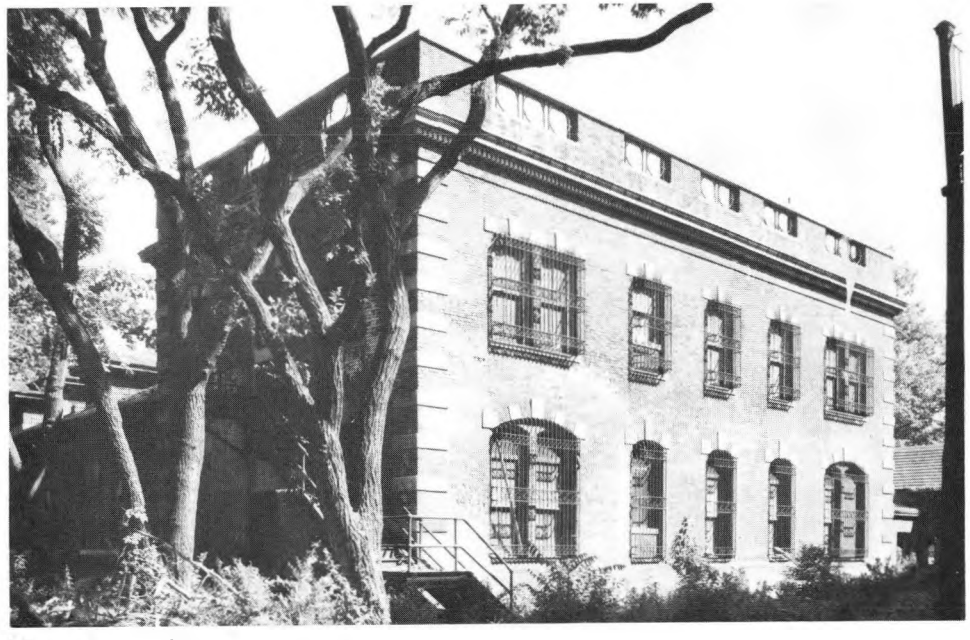
SUMMARY:	**CONDITION:**	XXX	**GOOD**
			FAIR
		XXX	**POOR** (south elevation)
			DESTROYED

South elevation, View northeast.

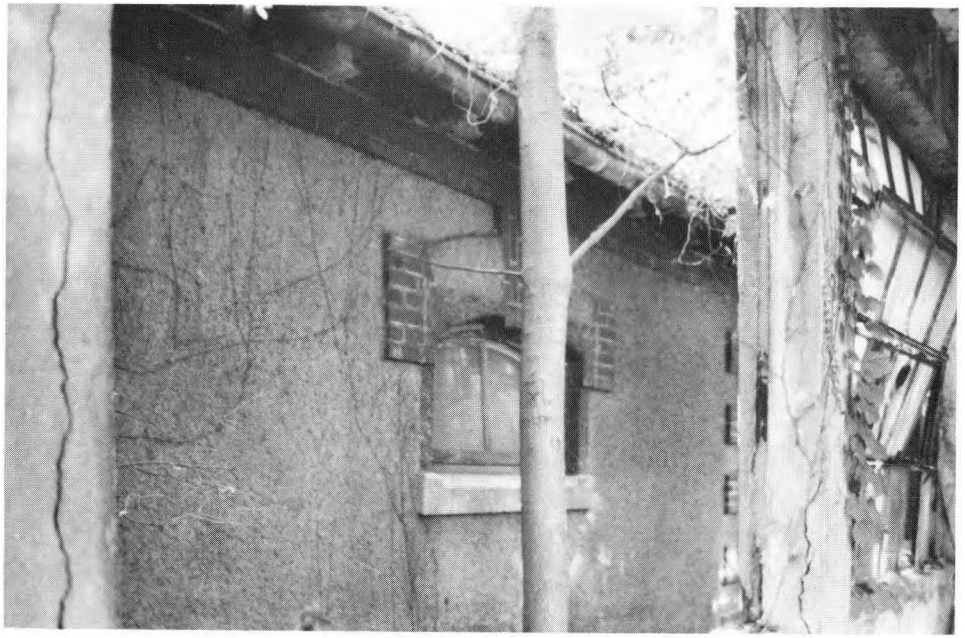
GOOD
XXX	**FAIR**
	POOR
	DESTROYED

West elevation, view from covered way 9A.

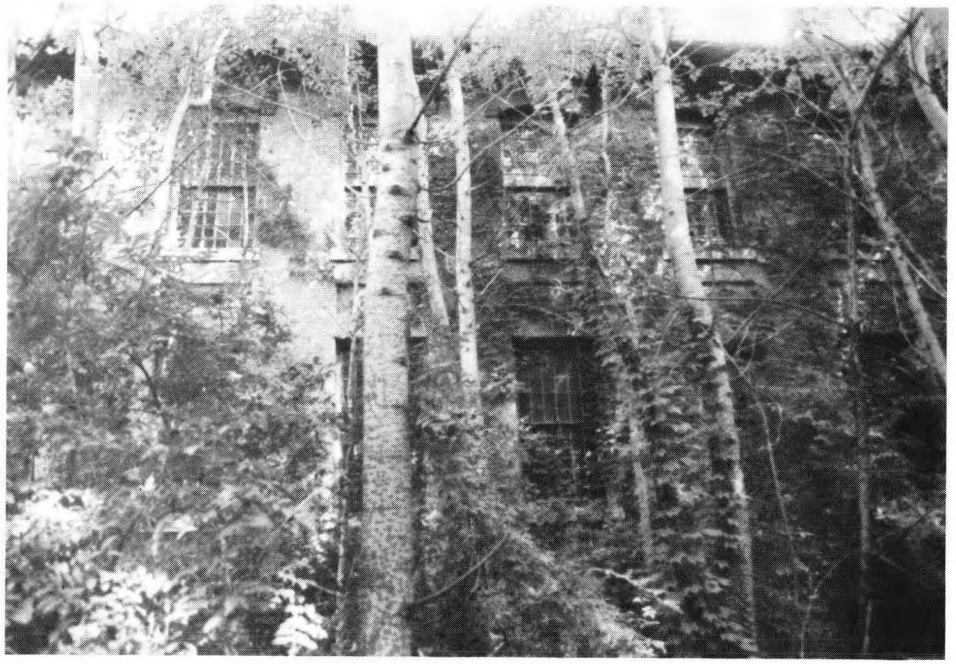
SUMMARY:	**CONDITION:**	XXX	**GOOD** **FAIR** **POOR** **DESTROYED**

South elevation.

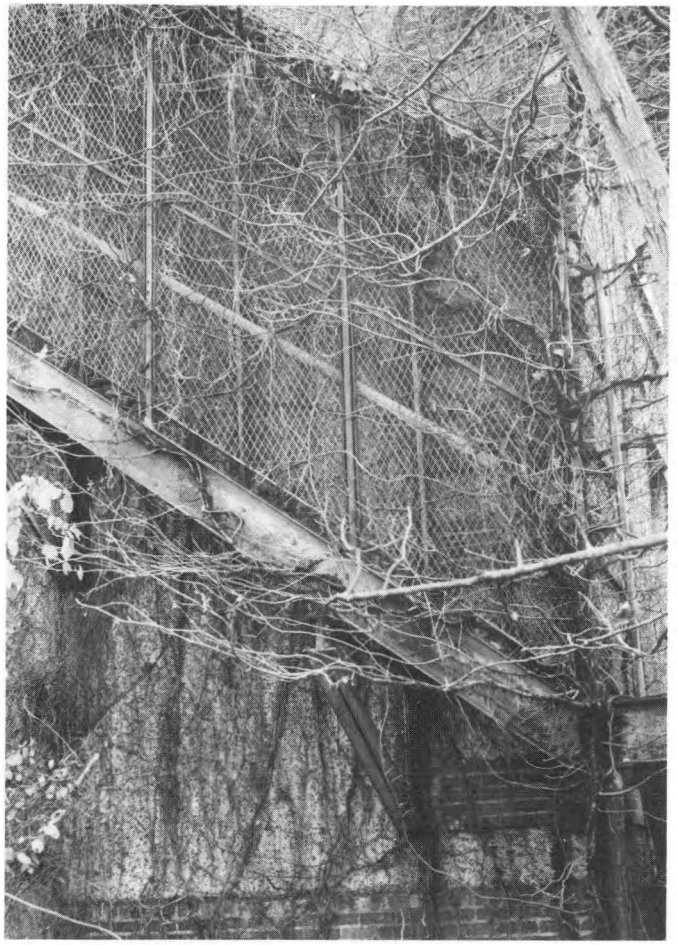
MATERIALS:	CONDITIONS:
FACADE FOUNDATION/ BASE:	Pebble dash stucco. Brick. Granite.	Vine cover. Carbon soot staining: under eaves, undersurfaces. Green biological staining. Random loss. Area of exposed brick under surface: west elevation. Some efflorescence of brick base. Severe green biological staining: protected areas.
TRIM:	Brick. Concrete stair balustrades. Limestone.	Cracked, rust stained. North elevation: rust staining of some window sills.
ROOF:	Clay tile. Wood. Copper.	Loss of several roof tiles: west elevation. General weathering. General weathering. Random gutter perforations. Loss of downspouts. Some crushing of gutter.
WINDOWS/ DOORS:	Steel sash. Glass.	Surface rusting. Random broken glass. Installation of metal grilles: second floor windows, west and south elevations.
MISC.:	Metal stair with wire enclosure: to second level, north elevation.	Rusting. Detachment of sections of stair enclosure.

North elevation, exterior stair.

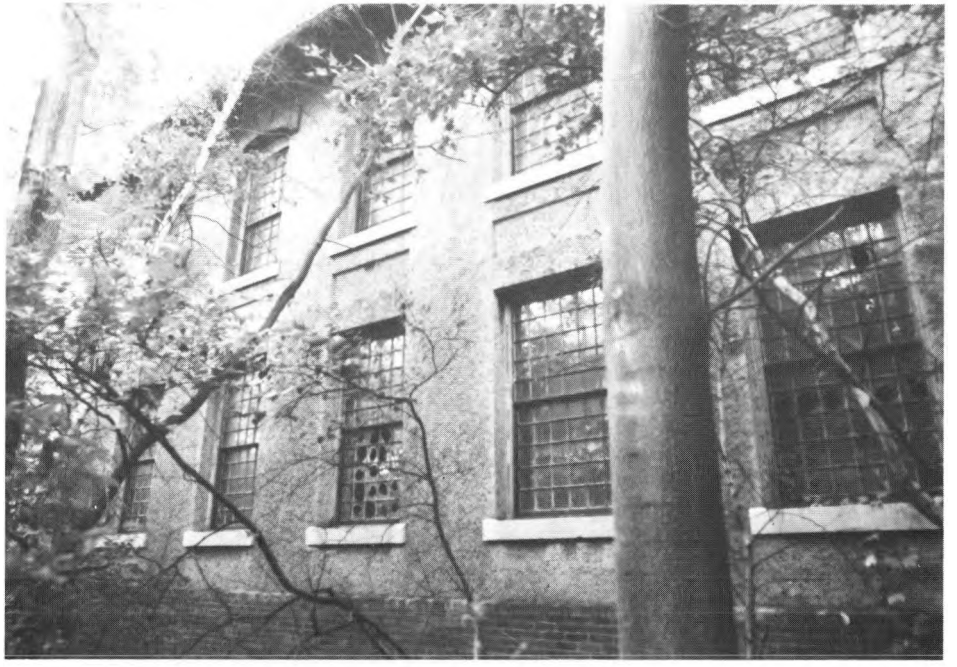
North elevation, view south.

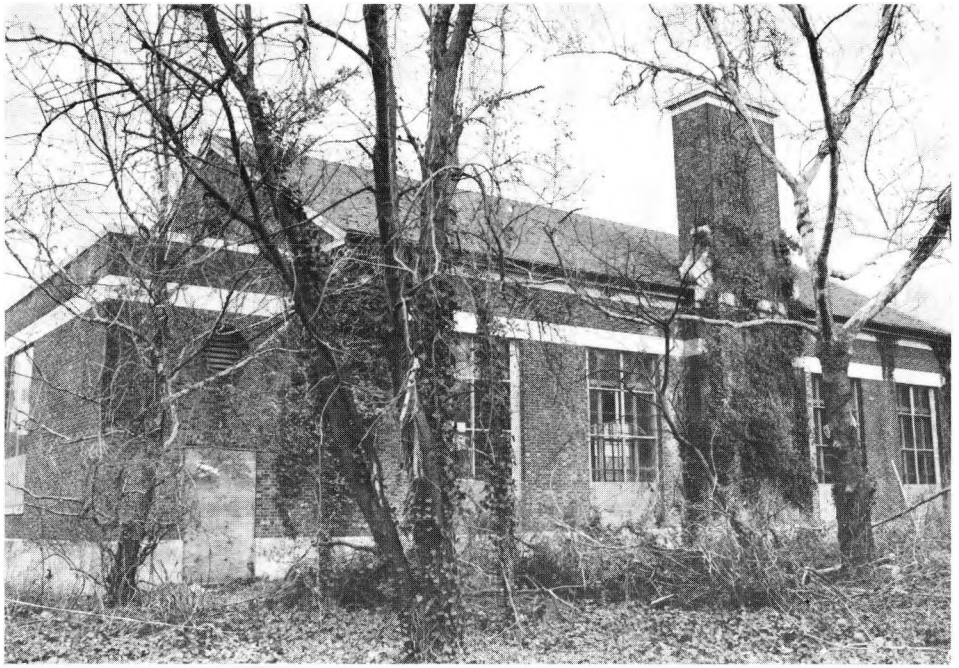
MATERIALS:	CONDITIONS:
FACADE FOUNDATION/ BASE:	Brick. Limestone.	Vertical cracking and bulging: east elevation. Some flaking loss and fine cracking of surfaces. Random mortar loss. Vine growth: east elevation. Efflorescence: all elevations. Green biological staining. Copper staining. General weathering. Black crust in protected areas.
TRIM:	Terra cotta. Limestone.	Horizontal cracking: east elevation. Carbon soot staining: protected areas. Chipping and flaking loss. Mortar loss. Surface weathering. Black crust: protected areas. Some iron staining: north and west elevations.
ROOF:	Clay tile. Roof felt/asphalt/ballast. Copper.	Intermittant loss of tile with 4 foot wide swath of loss: east elevation. Gutters and downspouts: clogging, damage and loss of parts.
WINDOWS/ DOORS:	Steel/metal. Wood. Glass.	Surface corrosion. Plexiglass and wood window infill.
MISC.:

East elevation.

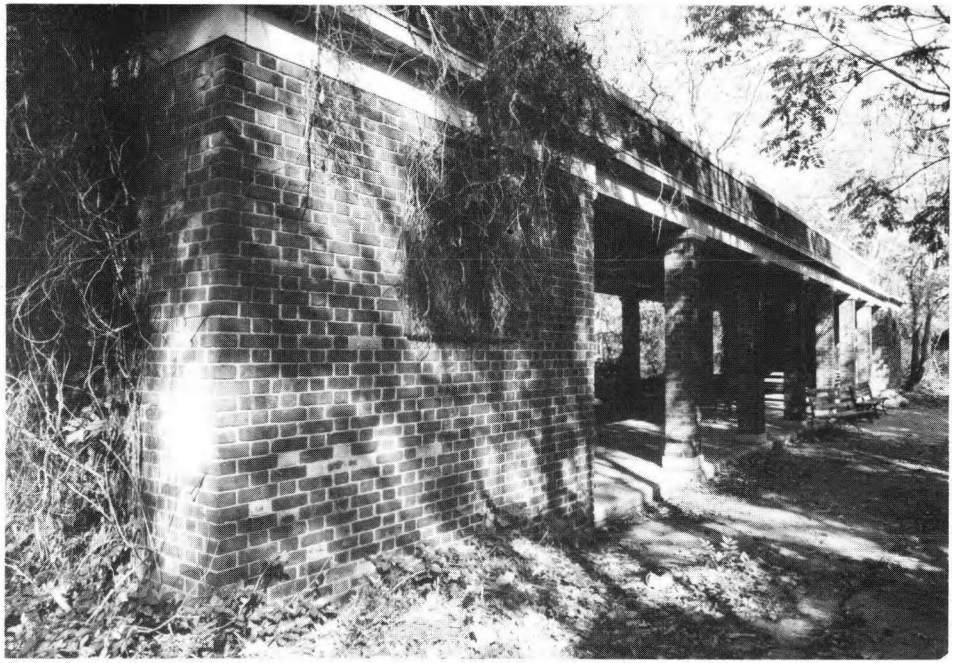
MATERIALS:	CONDITIONS:
FACADE FOUNDATION/ BASE:	Brick	Areas of mortar loss: north and west elevations. Efflorescence: all elevations. Vine cover. Green biological staining: upper areas of west and north elevations.
TRIM:	Terra cotta	General surface weathering, chipping, spalling and some breakage. Mortar disintegration. Carbon soot staining.
ROOF:	Roof felt /asphalt/ballast	
WINDOWS/ DOORS:	Steel Wood Glass	General surface rusting. Some breakage of window glass: east facade.
MISC.:

East elevation, view northwest.

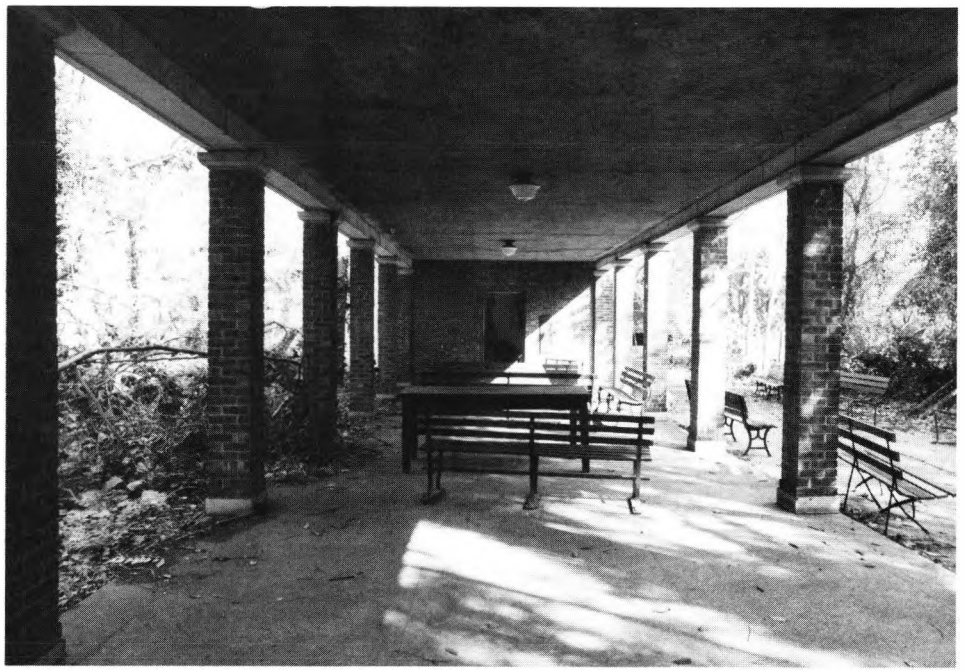
View south, inside pavilion.
