List of Classified Structures

Thomas Stone
National Historic Site

List of Classified Structures
Thomas Stone National Historic Site
Park Index

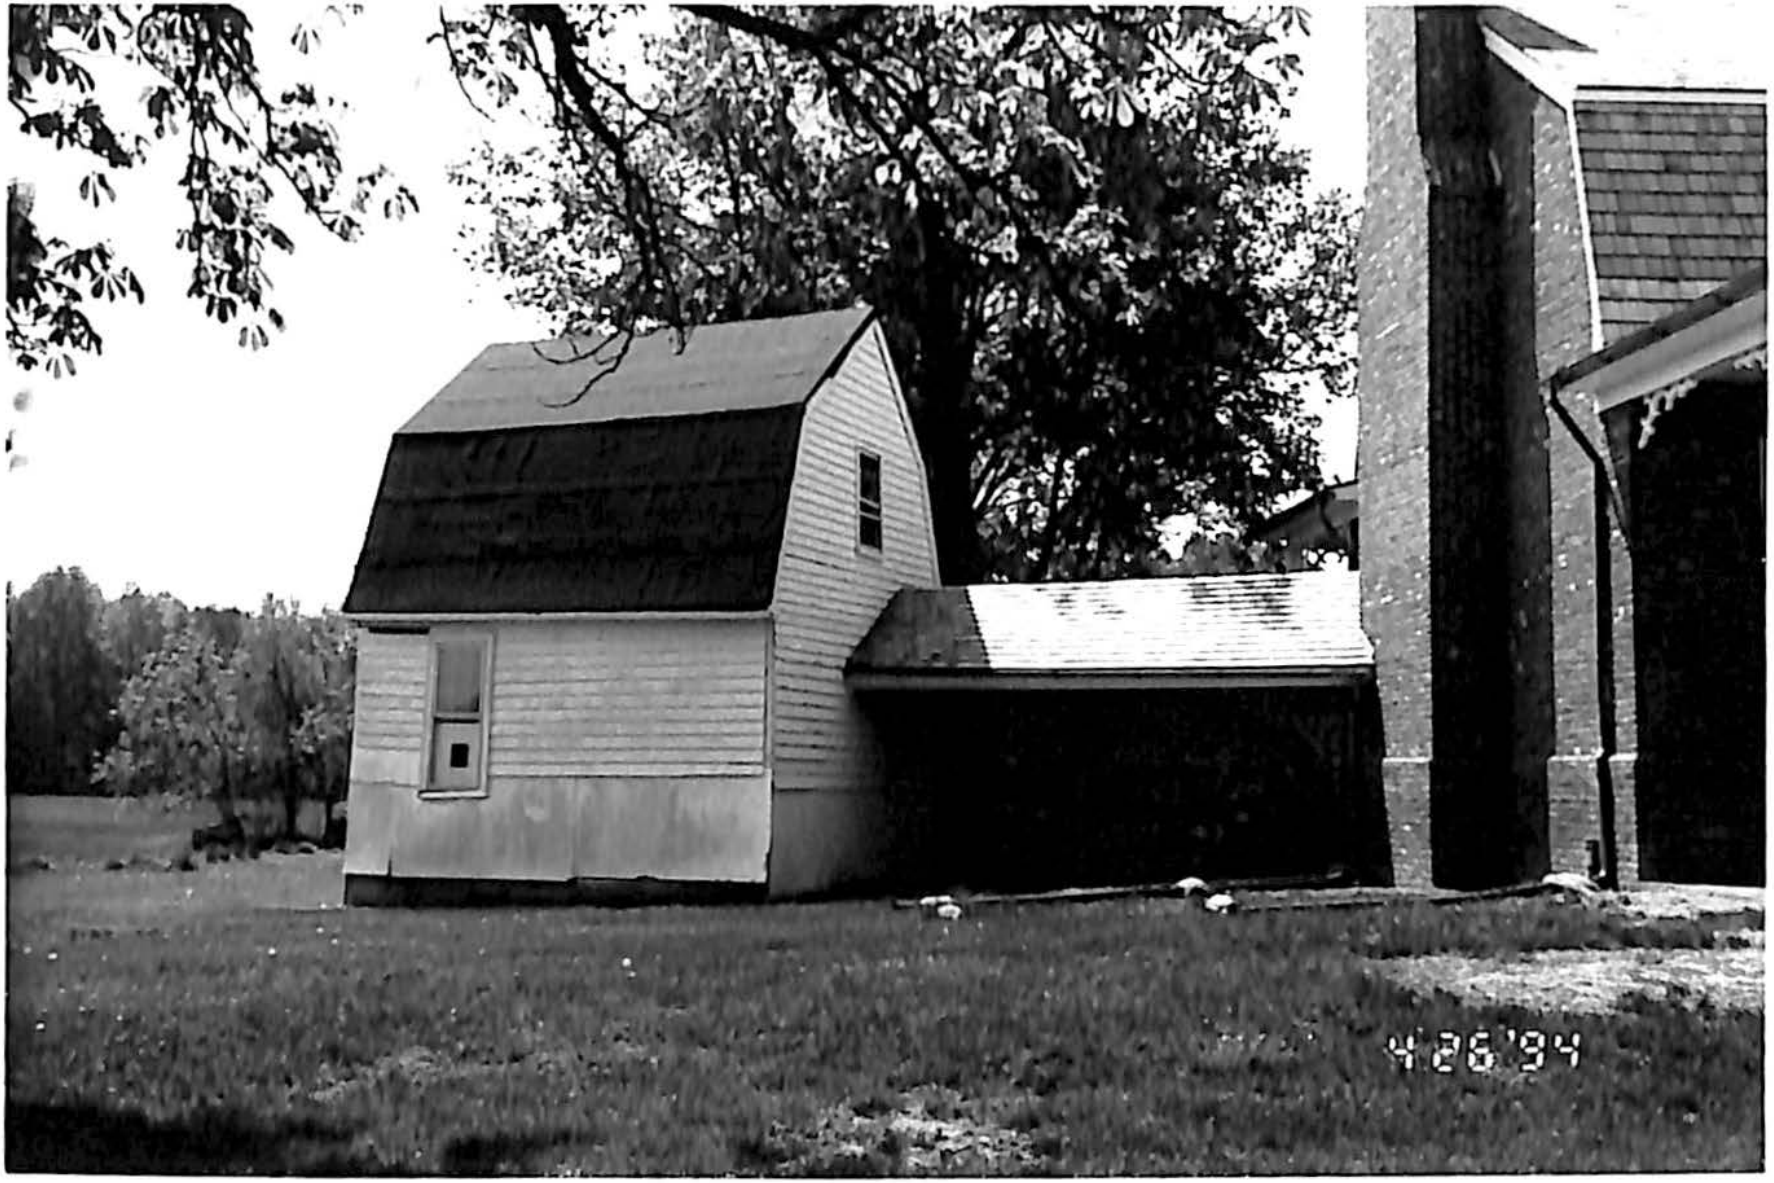
NEG #
LCS THST 006

Thomas Stone House
View from W
May 1994

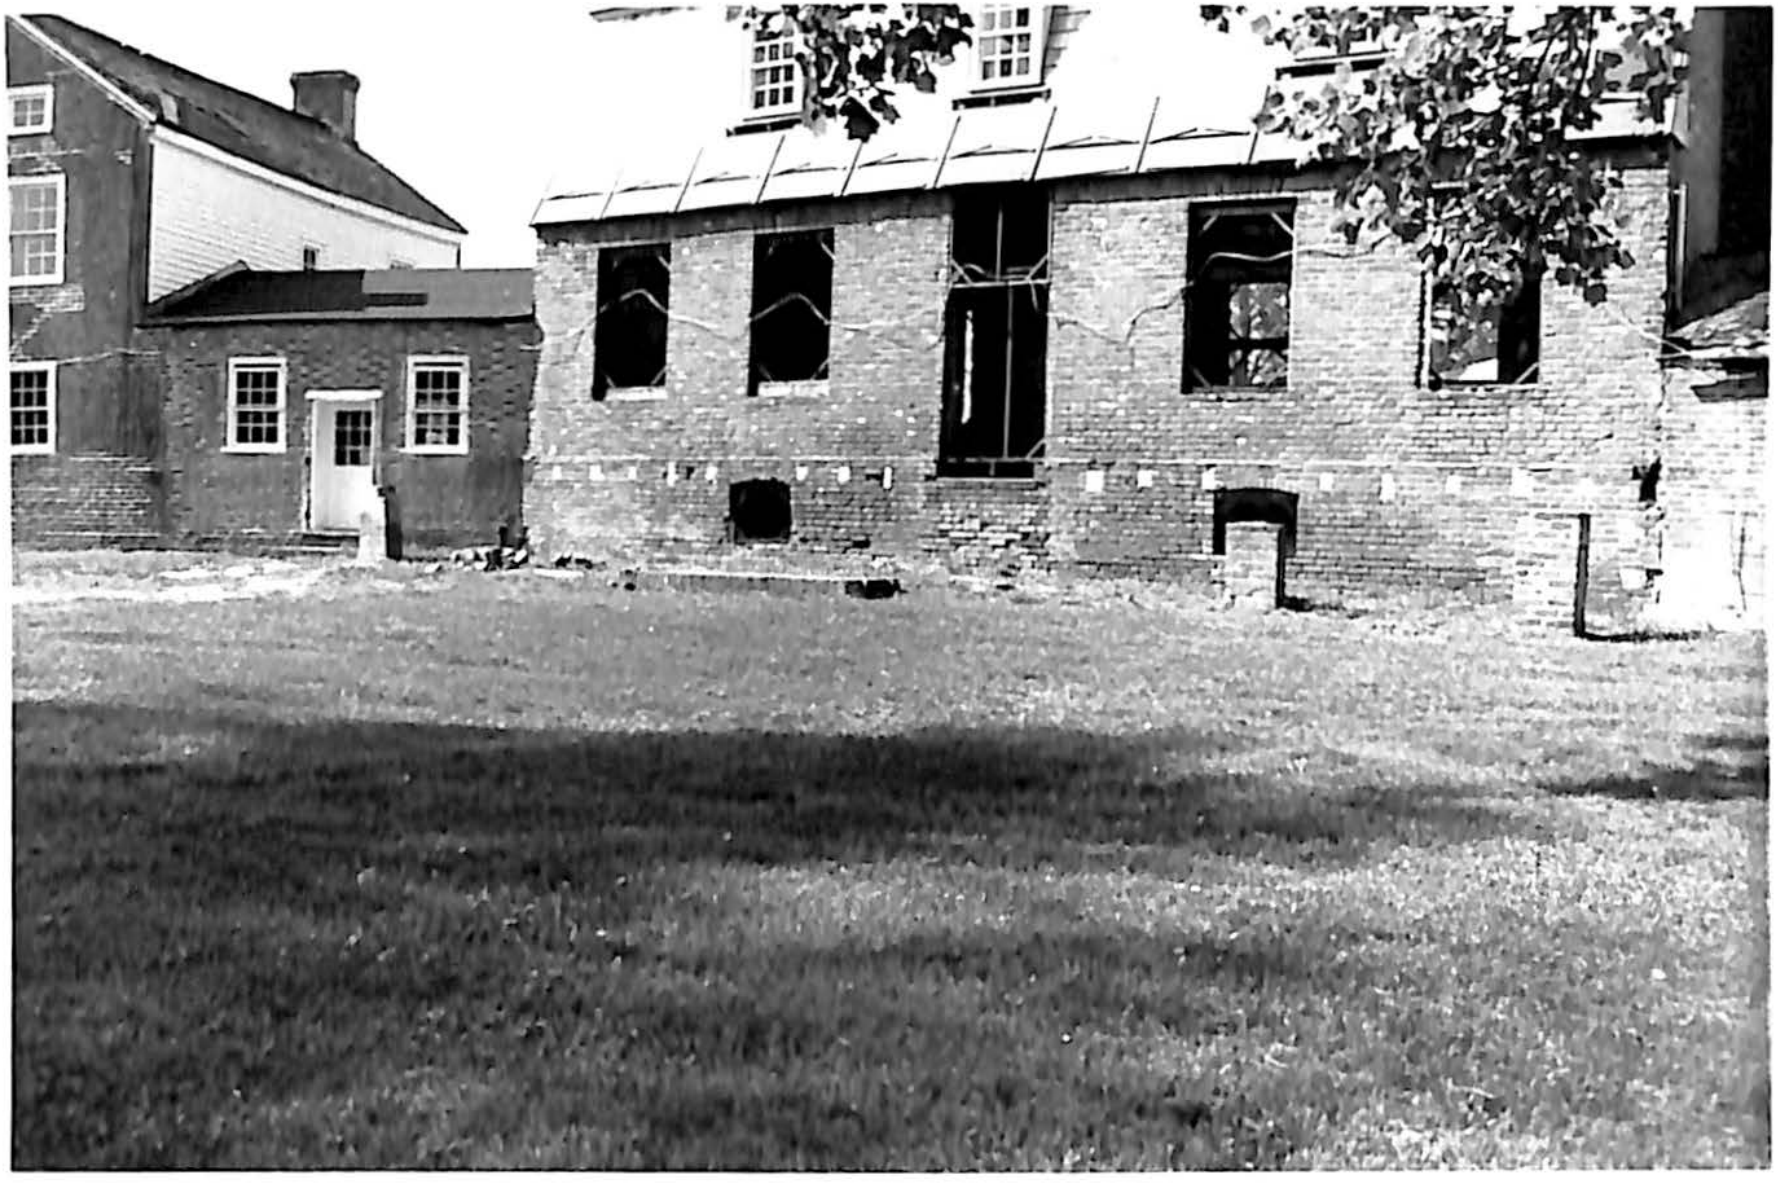
NEG #
LCS-THST-001

Thomas Stone House
View from south
May 1992

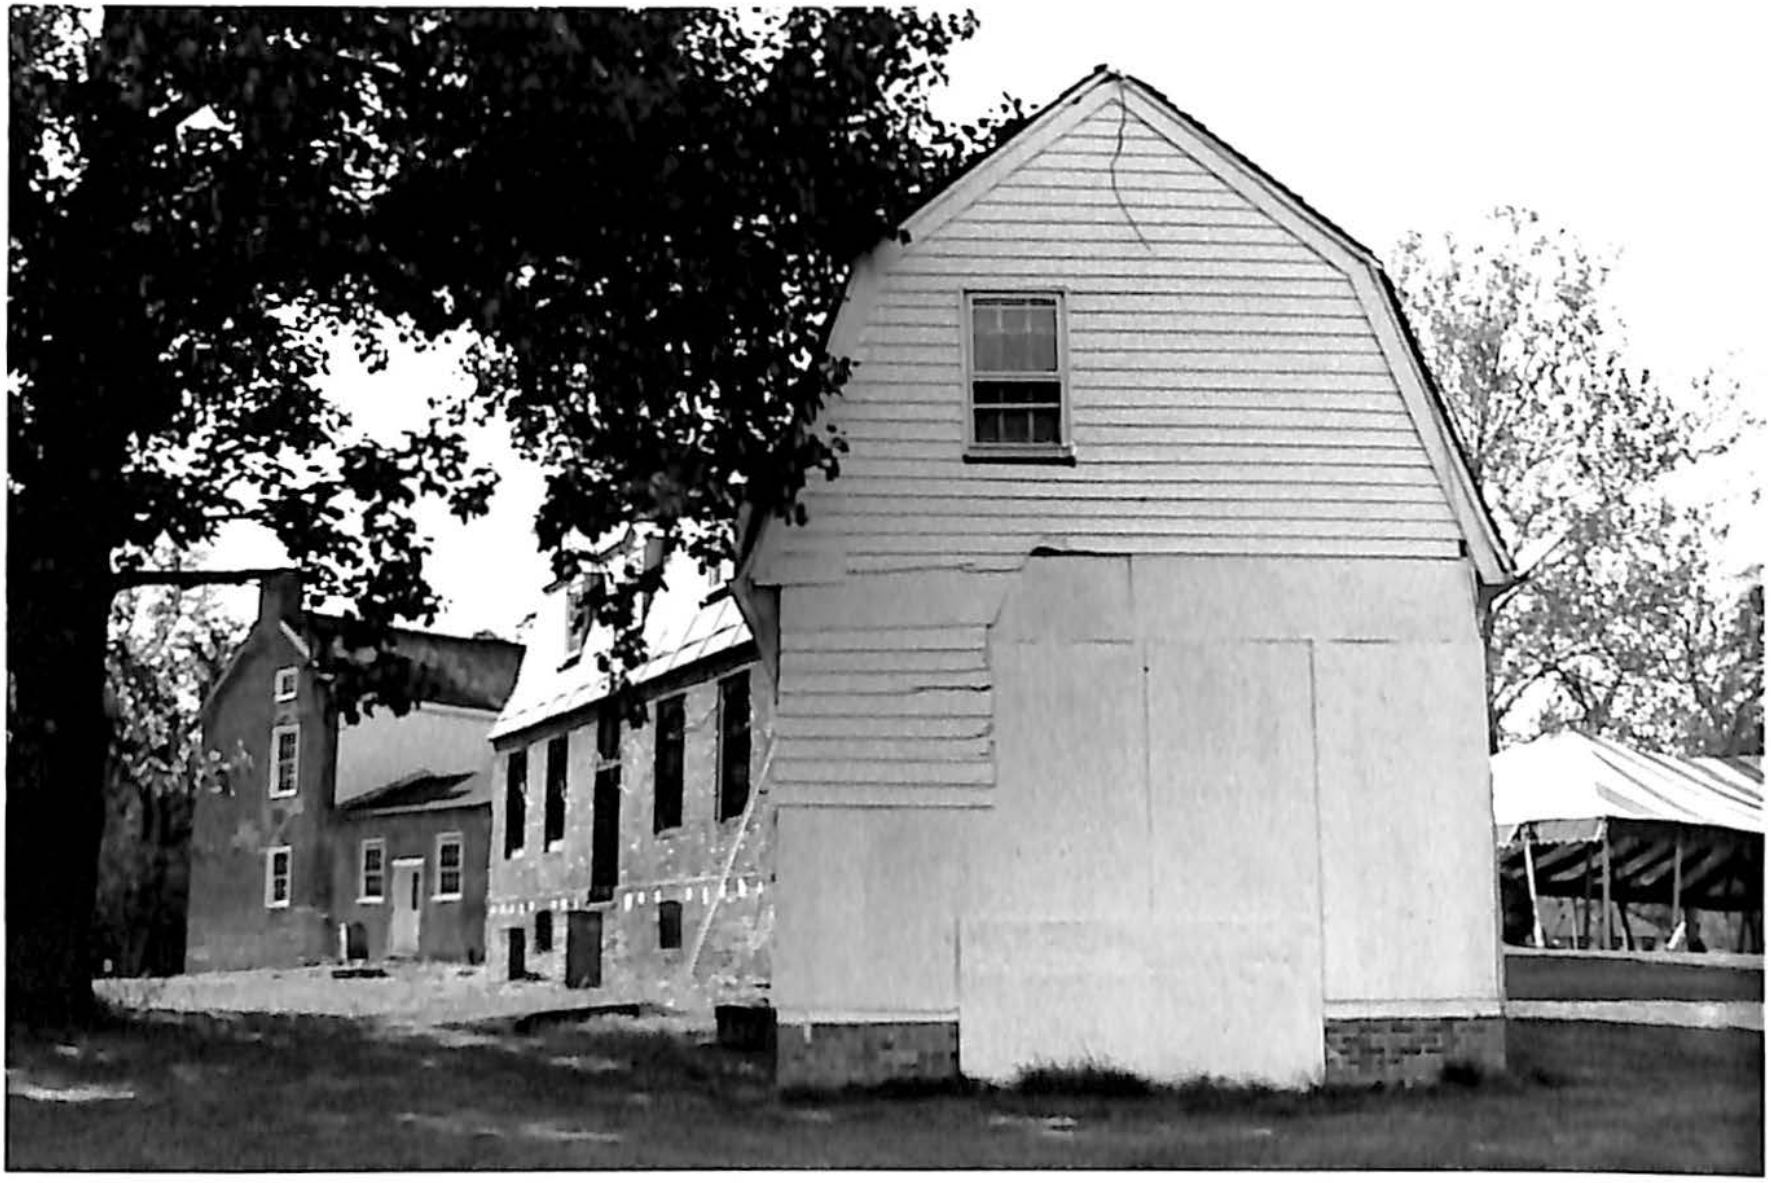
NEG #
LCS-THST-001

Thomas Stone House
View from southwest
May 1992

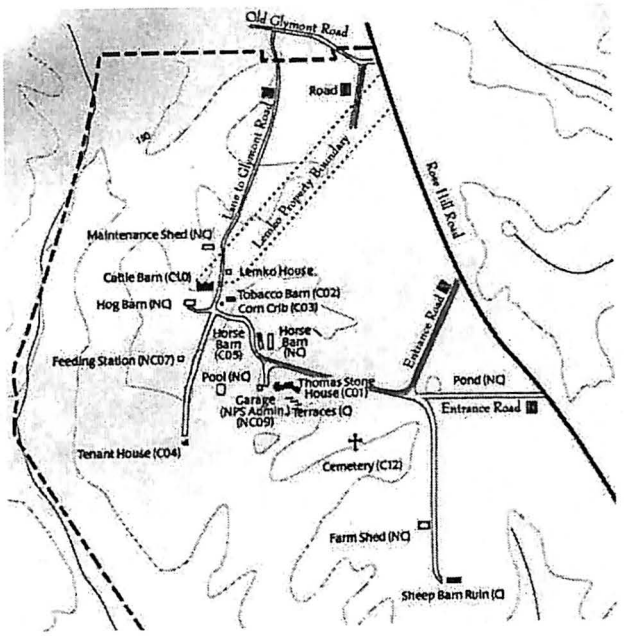
Graphic	Caption	Graphic Date/Year	Sequence
1.		Formal Garden Terrace from CLR, 02/01/1996	August 2002	1

2.		Formal Garden Terraces, view from South	August 2002	2
3.		Formal Garden Terraces, view from SE	August 2002	3

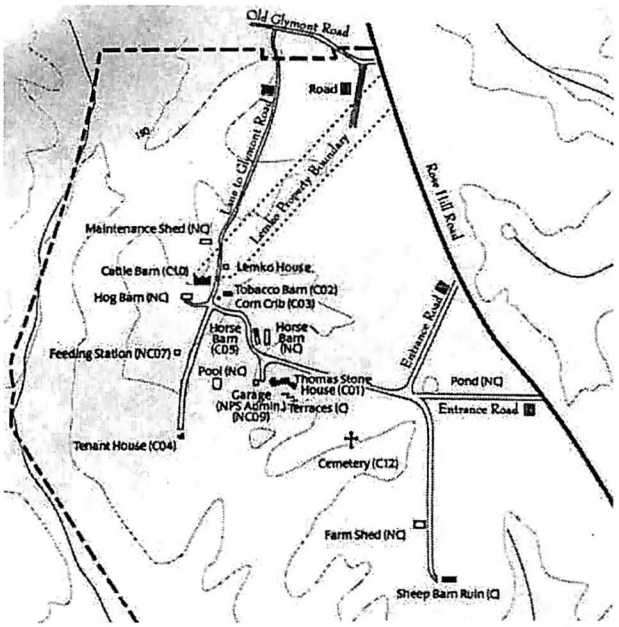
Graphic	Caption	Graphic Date/Year	Sequence
1.		Entrance Road A	2002	1
2.		1937 Aerial with roads & lanes	August 2002	2

3.		Thomas Stone Entrance Rd A, view from NE	August 2002	3

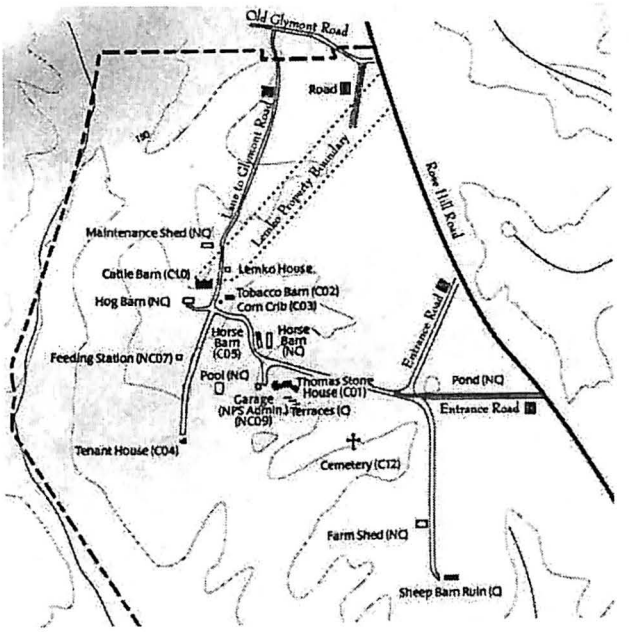
Graphic	Caption	Graphic Date/Year	Sequence
1.		Map taken from CLR, 2/1/96	August 2002	1
2.		Formal Entrance Trace, view from South	August 2002	2

3.		1937 Aerial, Formal Road @ Top (north)	Sept 2002	3

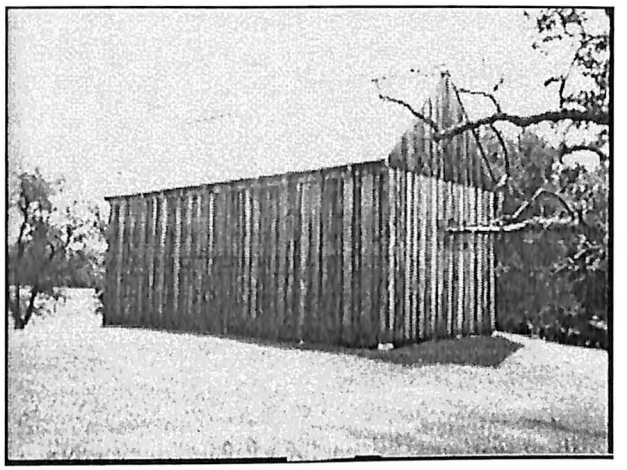
Graphic	Caption	Graphic Date/Year	Sequence
1.		Sheep Barn Farm Lane	August 2002	1
2.		1937 aerial, road @ E, lower right of Photo	August 2002	2

Figure 27: 1937 aerial photograph. (National Archives)			
3.		Sheep Barn Road, view from S	August 2002	3
4.		Sheep Barn Road, view from N	August 2002	4

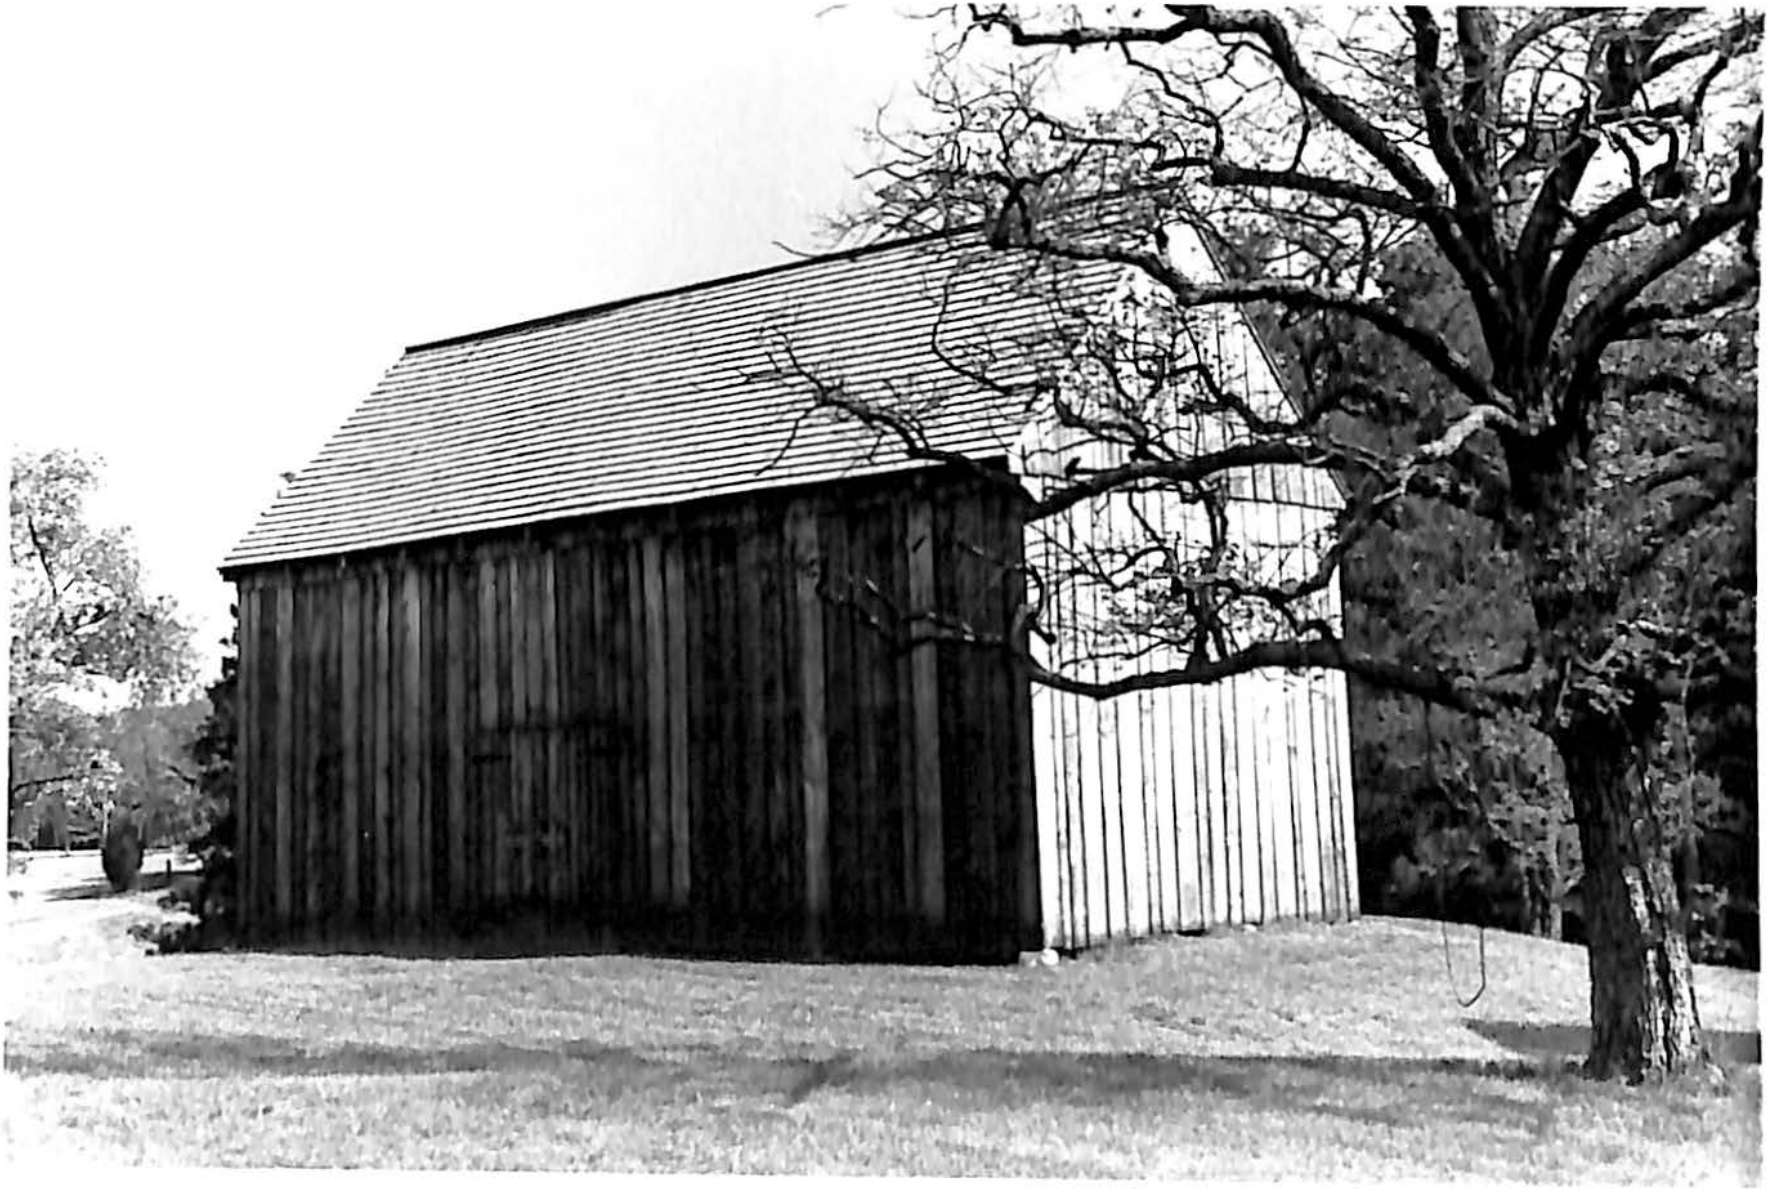
NEG #
LCS THST 001

Tobacco Barn
View from northwest
May 1992

MAJOR ROT DAMAGE TO SILLS AND FRAMING. SOME POSTS COMPLETELY HANGING FROM FRAME. SIGNIFICANT TIMBERS REMOVED FOR STORAGE OF FARM MACHINERY NEEDS ENGINEERING EVALUATION FOR STABILIZATION.

13. PARTS NEEDING SPECIAL ATTENTION: SILLS AND FRAME NEED REPAIR/SHEATHING NEEDS REPAIR.

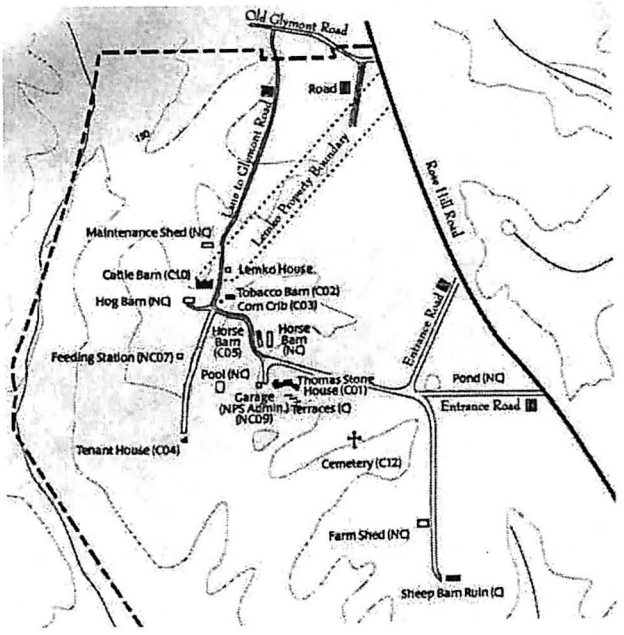
Structure Condition:	Unknown
Year Condition Assessed:	2002
Impact Level:	Severe
Primary Impact:	Vegetation

Graphic	Caption	Graphic Date/Year	Sequence
1.		Glymont Road within park boundaries	August 2002	1

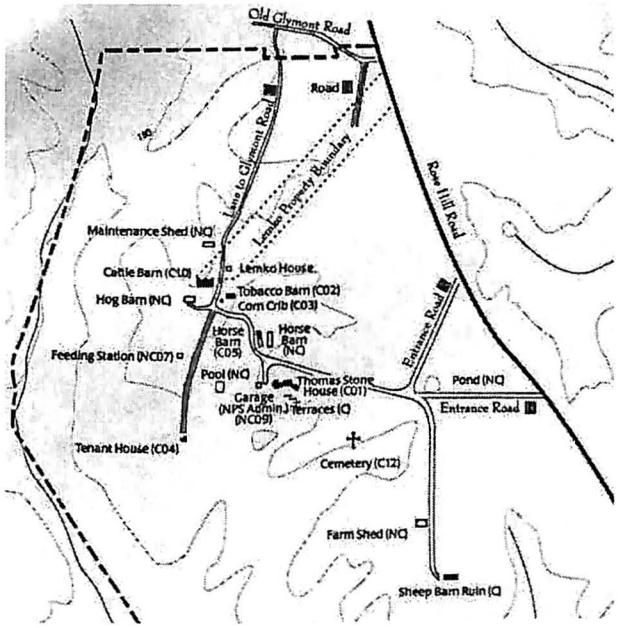
Graphic	Caption	Graphic Date/Year	Sequence
1.		Farm Lane	August 2002	1
2.		Note Farm Lane to right of Barn, vw frm east	August 2002	2

3.	 Figure 27: 1937 aerial photograph. (National Archives)	1937 Aerial of Farm Roads & Entrance Lanes	August 2002	3

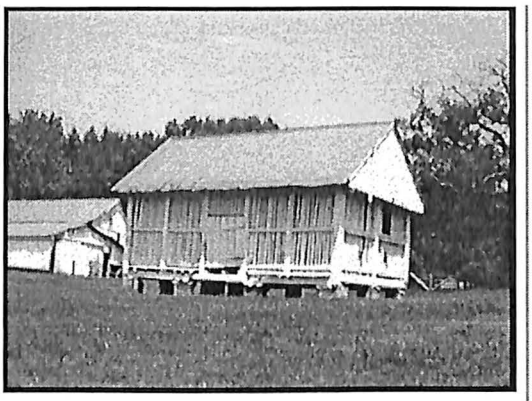
Short Management Text: Roof has suffered wind damage from Tornado in late April 2002. Needs replacement. Remainder of structure in good condition excluding missing slats. Paint stable, foundation appears sound.

2.		Corn Crib, view from SE	July 2002	1
3.		Corn Crib, view from NW, Note roof damage	July 2002	2

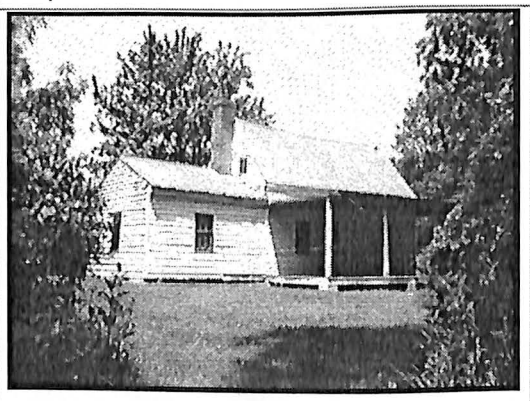
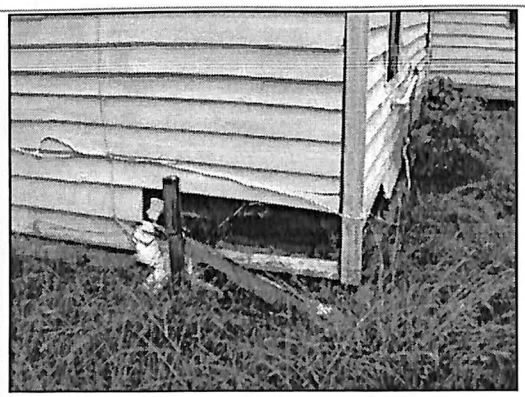
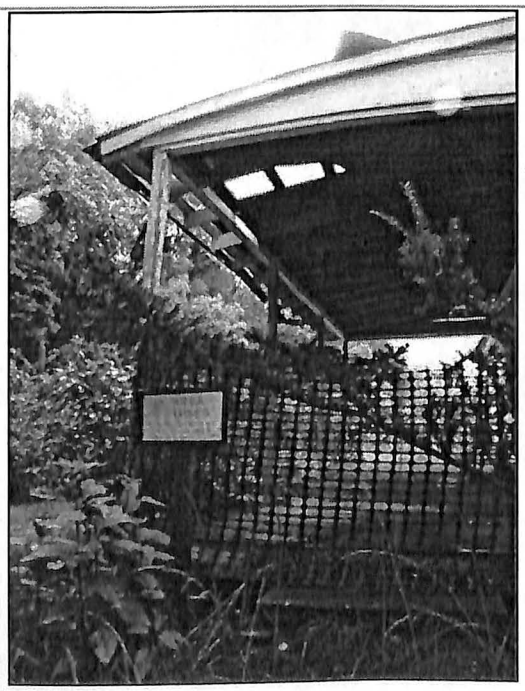
Structure Condition: Poor

Graphic	Caption	Graphic Date/Year	Sequence
1.				1
2.		Tenant House, view from SE	July 2002	2
3.		Tenant Hse, vw frm NW, note missing chimney	July 2002	3
