An Investigation of the Painted Finishes of Mission San José de Tumacácori's Façade: At the Interface of Materials Analysis, Conservation, and Cultural Confluence

Jocelyn Chan
University of Pennsylvania

A THESIS

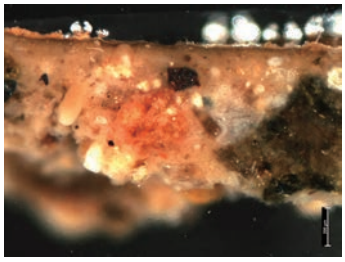
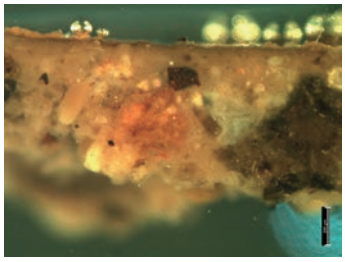
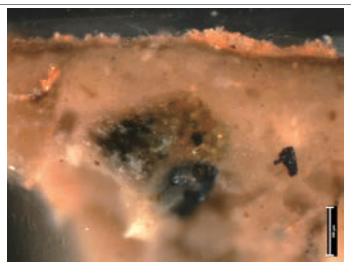
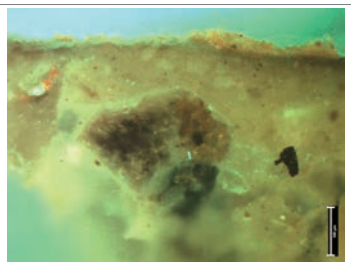
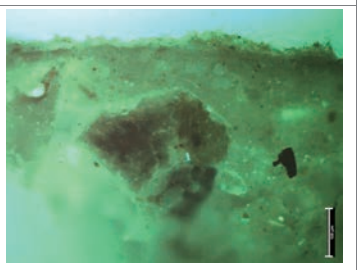
Table 8.3: Stratigraphic Analysis of TUMA_06 (Yellow)			
	Visible	Ultraviolet/Visible	Ultraviolet
40x			
100x

Microscopy Metadata			
Location	Sampled By	Sampled On	Analyzed By
Upper fact (left) above nicho	F. Matero, J. Chan	1/9/15	J. Chan
Microscope	**Light Source**	**Filters**	**Camera**
Nikon Alphaphot-2	Visible (fiber optics), UV (mercury lamp)	Daylight	Nikon DS Fi-1 camera NIS Elements BR software
Ocular mag	**Trinocular mag**	**Objective mag**	**Zoom**
10.0x	1.0x	4.0x, 10.0x.	-

- Brownish-yellow layer appears more organic
- To be used for subsequent analyses as sample of potential limewash staining (e.g. to test for application of ferrous sulfate) or application of organic layer

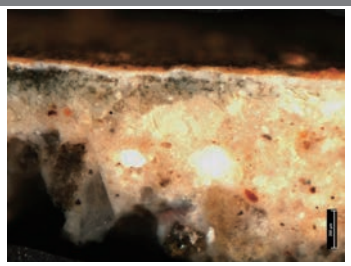
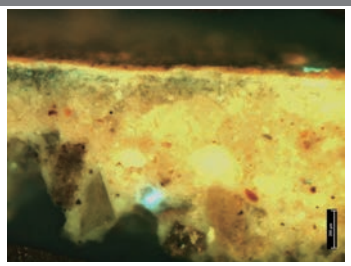
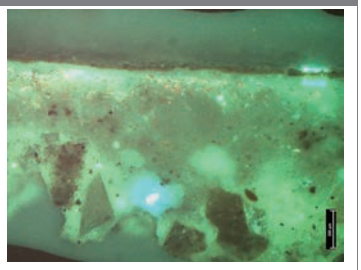
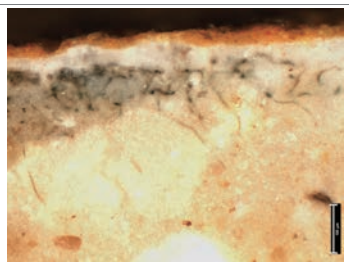
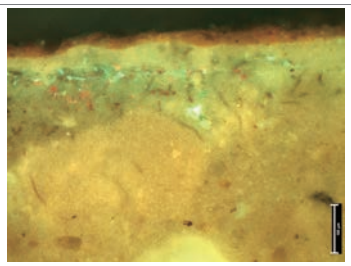
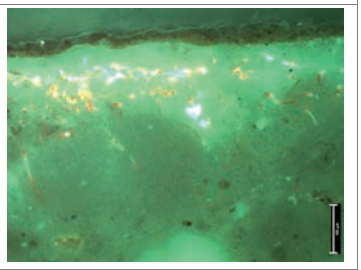
Table 8.4 Stratigraphic Analysis of TUMA_11 (Yellow)

- Very clear, discrete layering
- White preparatory finish layer appears to be on very weathered white substrate, suggested that it was applied atop an already dried surface
- Black tendrils appear to be some type of biological microflora

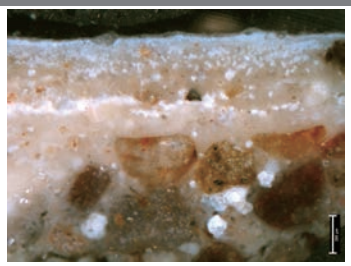
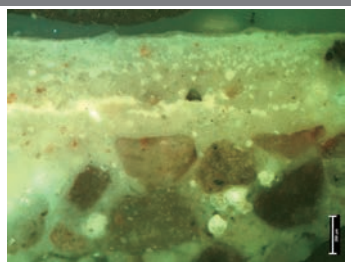
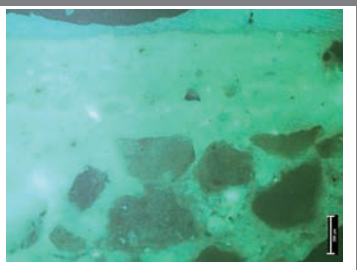
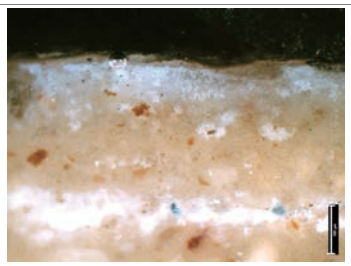
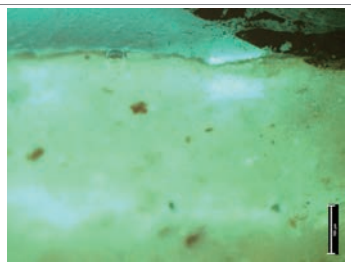
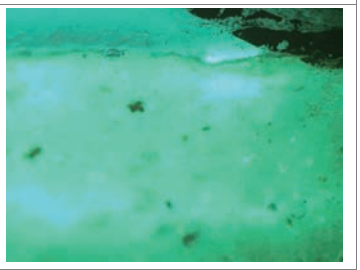
Table 8.5 Stratigraphic Analysis of TUMA_03 (White)			
	Visible	Ultraviolet/Visible	Ultraviolet
40x			
100x

Microscopy Metadata			
Location	Sampled By	Sampled On	Analyzed By
Upper, outer left capital (west side)	F. Matero, J. Chan	1/9/15	J. Chan
Microscope	**Light Source**	**Filters**	**Camera**
Nikon Alphaphot-2	Visible (fiber optics), UV (mercury lamp)	Daylight	Nikon DS Fi-1 camera NIS Elements BR software
Ocular mag	**Trinocular mag**	**Objective mag**	**Zoom**
10.0x	1.0x	4.0x, 10.0x.	-

- Very clear, discrete layering

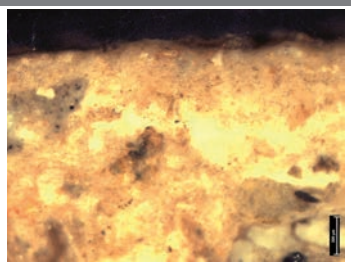
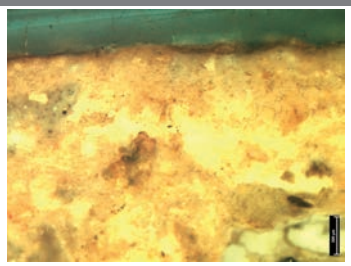
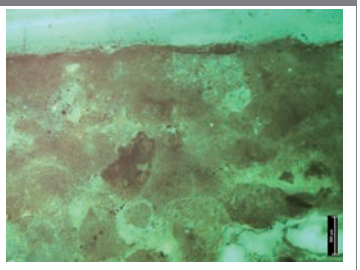
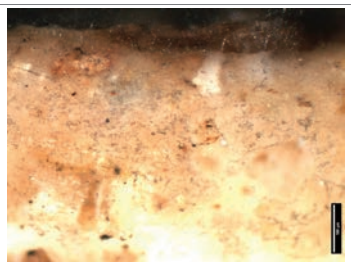
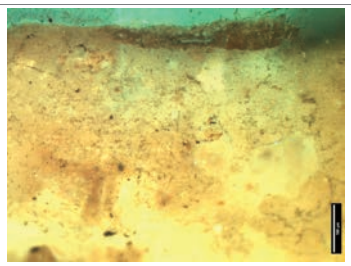
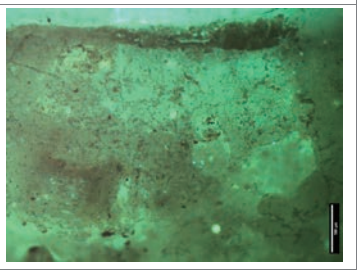
Table 8.6 Stratigraphic Analysis of TUMA_14 (Orange)			
	Visible	Ultraviolet/Visible	Ultraviolet
40x			
100x

Microscopy Metadata			
Location	Sampled By	Sampled On	Analyzed By
Intradose voussoir	F. Matero, J. Chan	1/9/15	J. Chan
Microscope	**Light Source**	**Filters**	**Camera**
Nikon Alphaphot-2	Visible (fiber optics), UV (mercury lamp)	Daylight	Nikon DS Fi-1 camera NIS Elements BR software
Ocular mag	**Trinocular mag**	**Objective mag**	**Zoom**
10.0x	1.0x	4.0x, 10.0x.	-

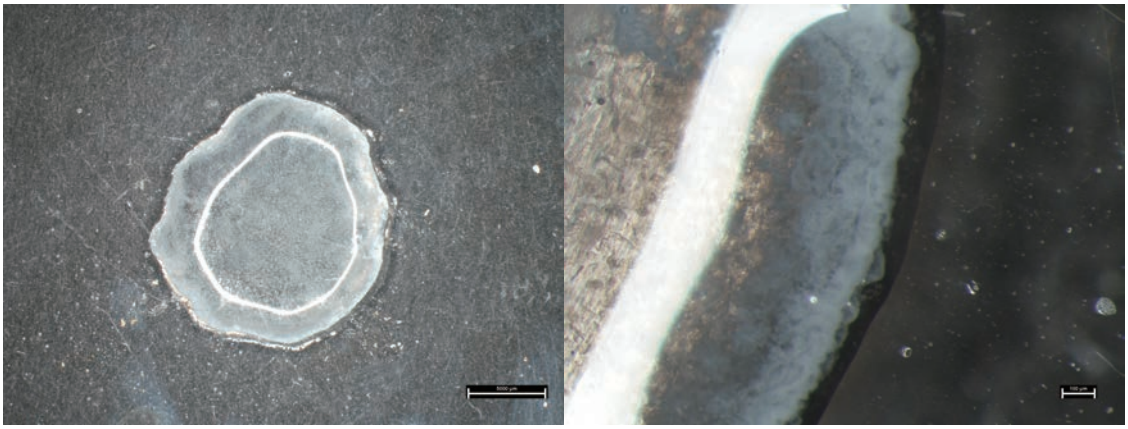
Figure 9.5: Sample of TUMA_25 preparatory layer after preliminary nitric acid treatment, heat, and addition of sulfuric acid. Left shows sample under reflected light stereomicroscope at 0.5x magnification and right shows sample at 5x magnification. Sample behavior appears more close to that of the chalk standard sample, with conglomerated crystals and the formation of some thin-needle like crystals in solution.

Table 9.2: Identification of White Preparatory Pigments				
Reagents used	Ion	Chalk	Gypsum	TUMA_25
Nitric acid (HNO_3)	CO_3^{2-}	Gas evolution	No gas evolution	Gas evolution, less violent than sample of pure chalk
Heat	SO_4^{2+}	No discernable change other than evaporation	Formation of needle-like crystals when viewed under stereomicroscope	No discernable change other than evaporation
Sulfuric Acid (H_2SO_4)	SO_4^{2+}	Slight reaction upon addition of sulfuric acid, conglomeration of crystals	NA	Appears more similar to chalk standard, conglomeration of crystals on edge, appears some thin needle-like crystals in solution

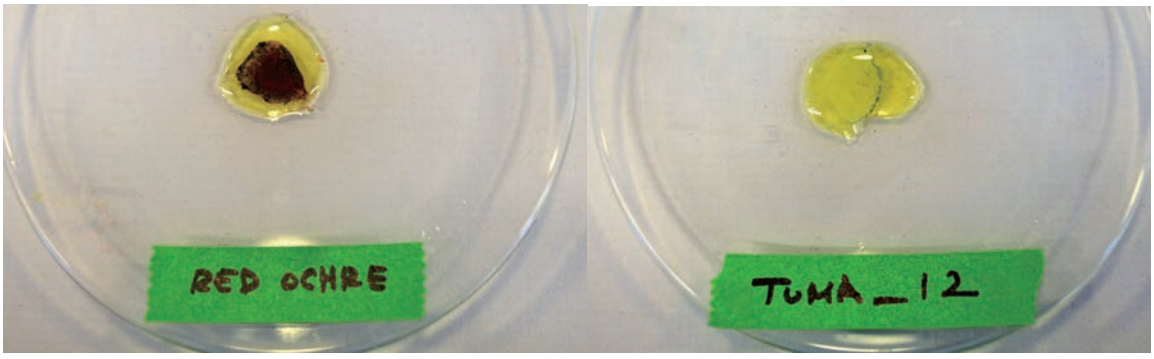
Figure 9.8: Standard sample of red ochre and TUMA_12 sample after HCl-treated sample was redissolved in distilled water and addition of a drop of potassium ferrocyanide. Note formation of thin blue ring around the sample area in TUMA_12.

Table 9.3: Identification of Iron in Red Pigment layer			
Reagents used	Ion	Red Ochre (Hematite)	TUMA_12
Hydrochloric Acid (HCl) + H_2O	Cl^-	Reaction upon addition of HCl	Slight reaction upon addition of HCl
HCl + H_2O + Potassium ferrocyanide	Fe^{3+}	Darkened maroon reaction with dark purple-blue ring around edge of sample	Formation of thin dark blue ring around edge of sample

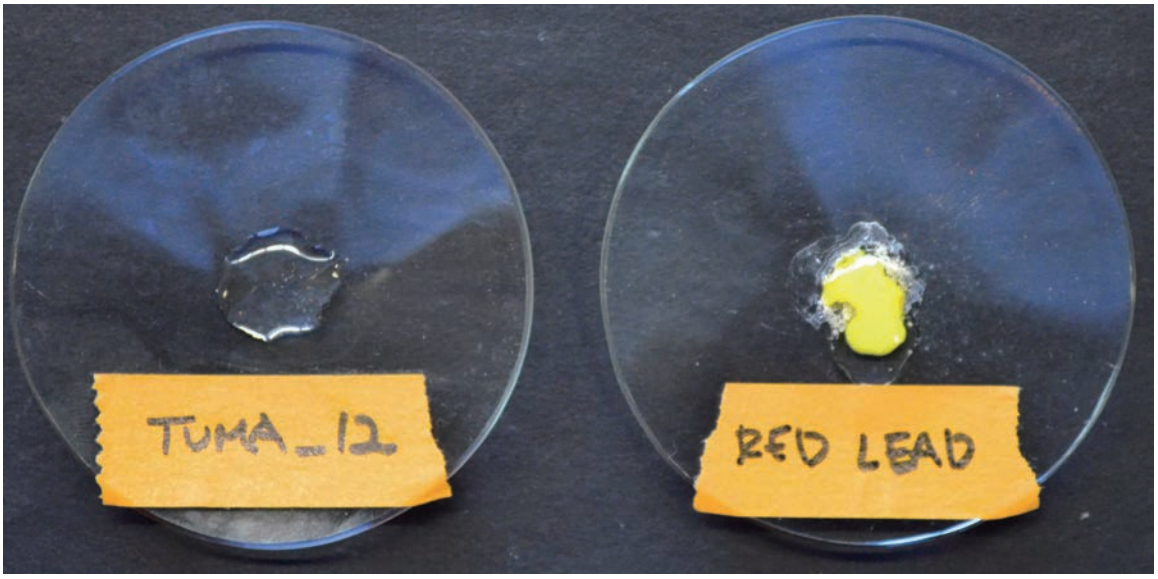
Figure 9.10: Standard samples of red lead tested alongside sample scraped from TUMA_12 after acid-treated sample was heated, crystals redissolved with distilled water, and one crystal of potassium iodide was added. Note the formation of a characteristic bright yellow precipitate indicating presence of lead in red lead standard.

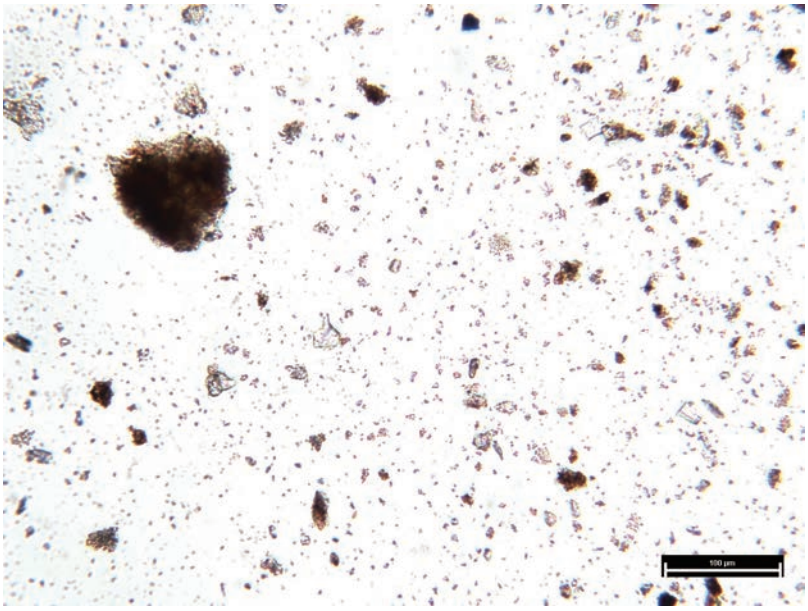
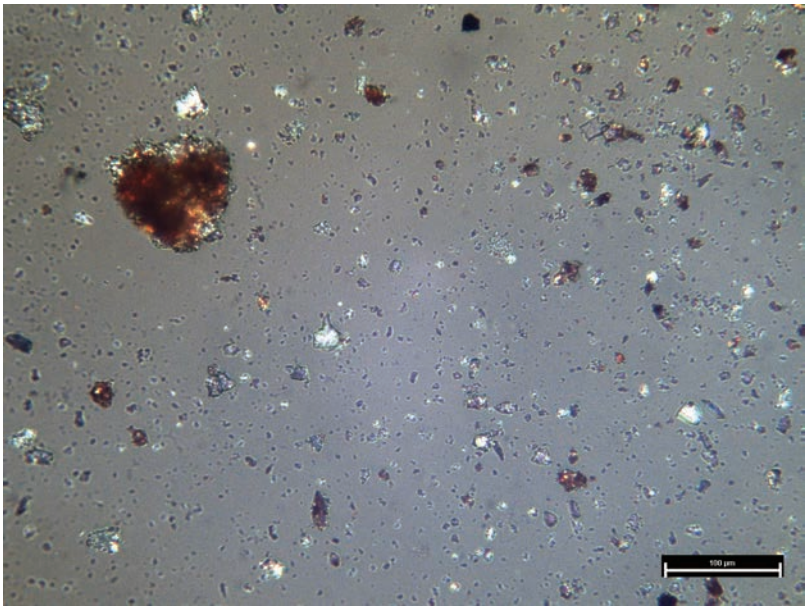
TABLE 10.2: PARTICLE DISPERSION OF TUMA_12 (RED) IN PPL AND XPL

-Dull red coarse grain particles
-High birefringence
-Mixture of grain sizes, some more opaque red
-Several clear particles that appear to be quartz coated in red pigment, similar to hematite standard in Pigment Compendium

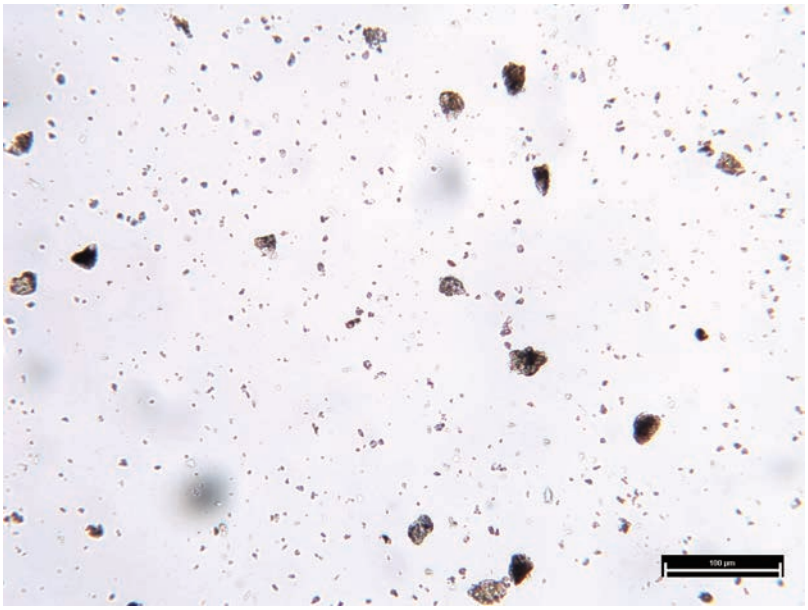
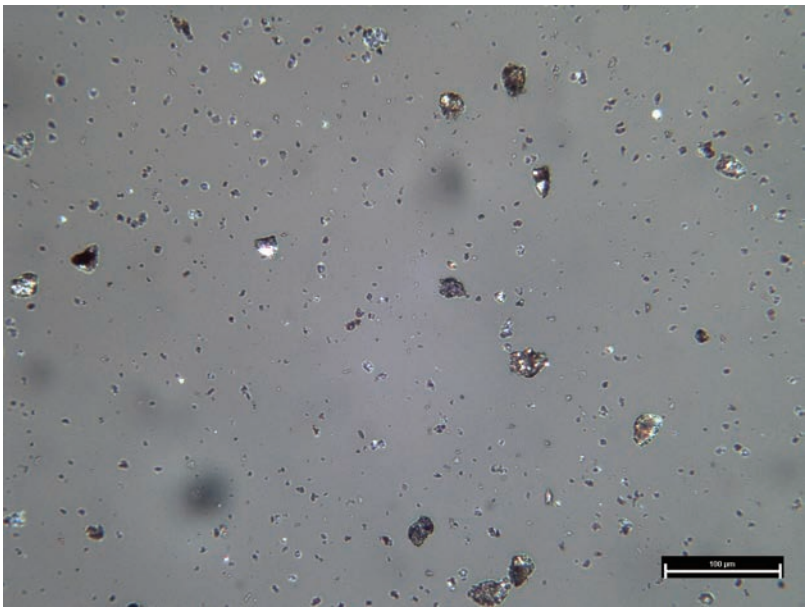
Table 10.3: Particle Dispersion of TUMA_11 (Yellow) in PPL and XPL

-Dull yellow-brown coarse grain particles
-High birefringence
-Mixture of grain sizes, some more opaque
-Presence of some red particles within the dispersion
-Appear similar to goethite standard in Pigment Compendium

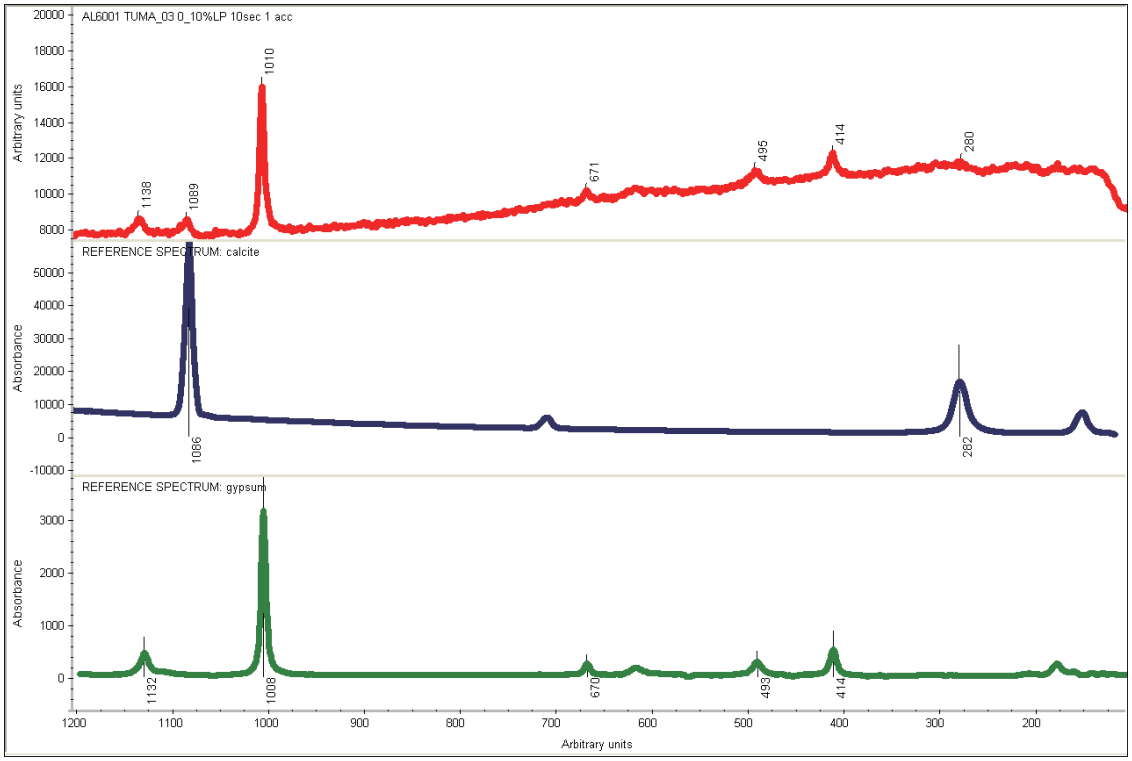
Raman Analysis of TUMA_03 White Finish Layer

Figure 12.1: Raman spectral data showing presence of both calcite and gypsum within the white finish layer of TUMA_03

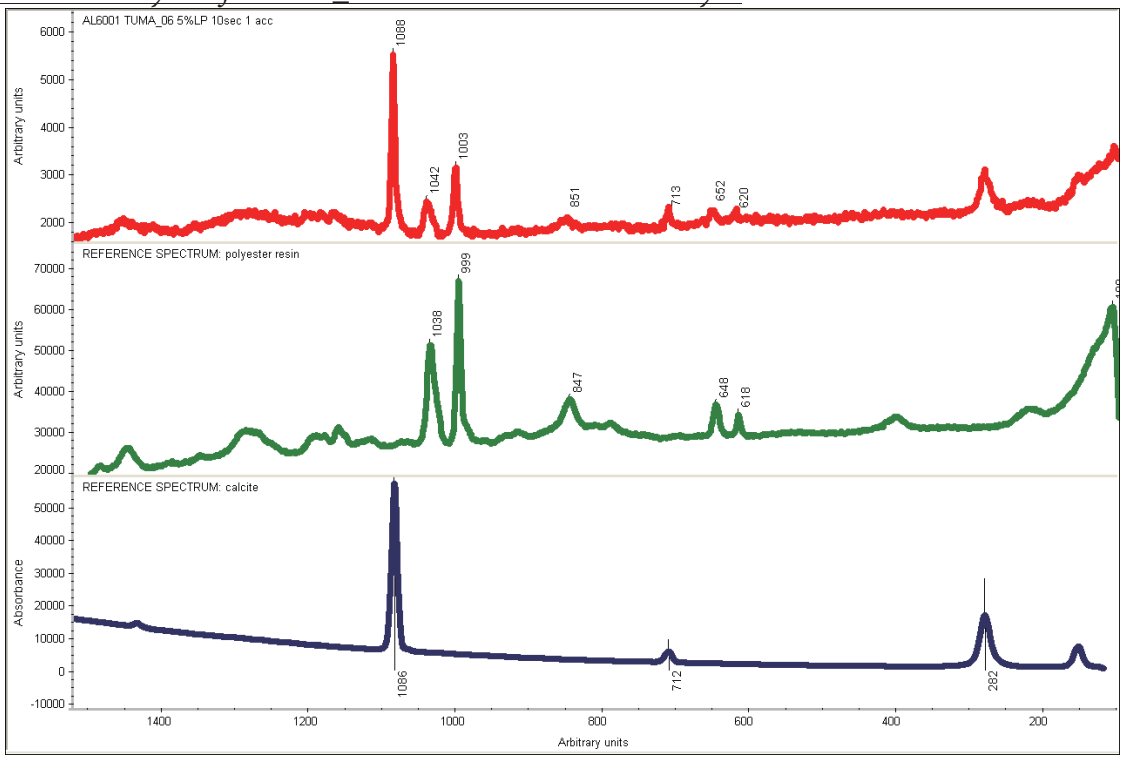
Raman Analysis of TUMA_06 Yellow-Brown Finish Layer

Figure 12.2: Raman spectral data showing presence of calcite and polyester resin, likely the embedding medium, within the yellow-brown finish layer of TUMA_06 (suspected organic)

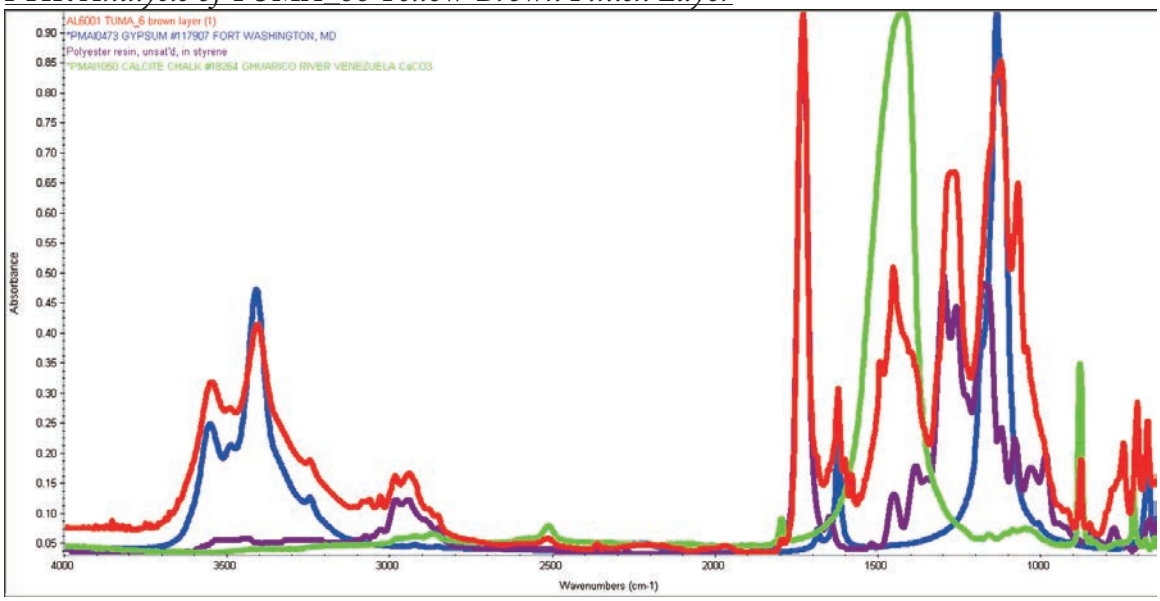
One particular sample, TUMA_06, exhibited characteristics under both SEM-EDS as well as Raman microscopy that suggested that an observed polychromatic layer was composed

Figure 12.3: FTIR spectral data showing presence of calcite, gypsum, and polyester resin, likely the embedding medium, within the yellow-brown finish layer of TUMA_06 (suspected organic)

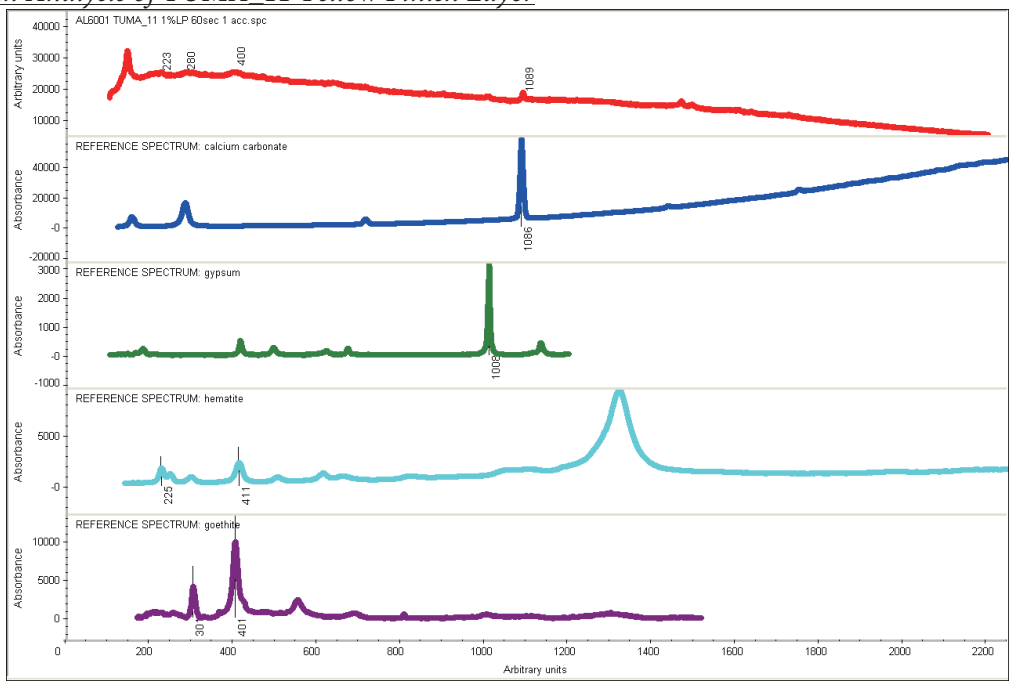
Figure 12.4: Raman spectral data showing presence of goethite, hematite, calcium carbonate, and gypsum within the bright yellow finish layer of TUMA_11

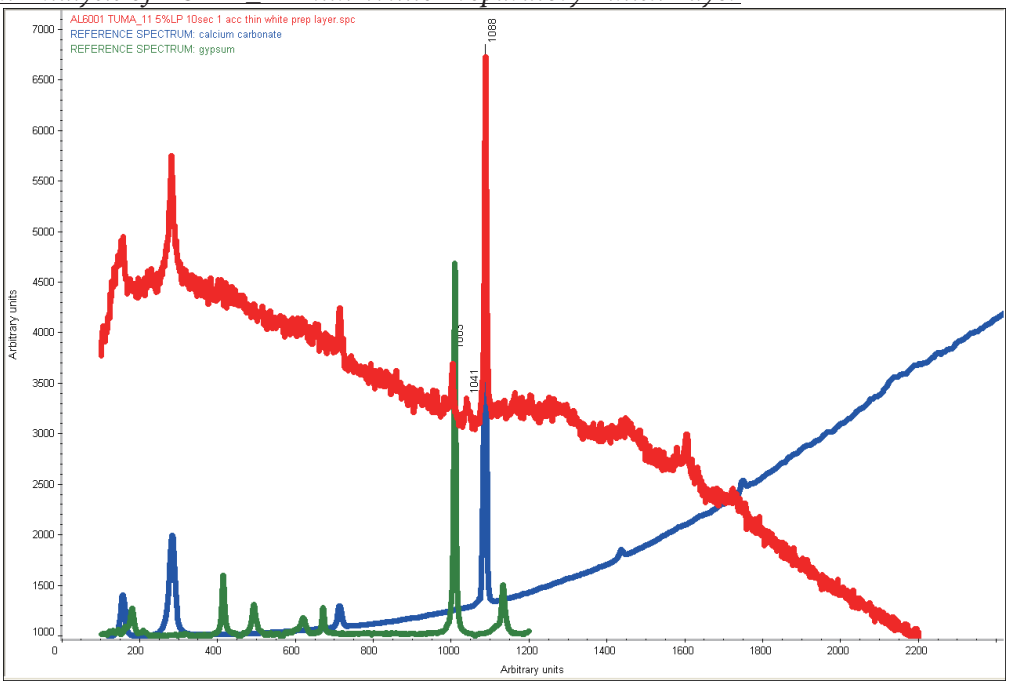
Figure 12.5: Raman spectral data showing presence of both calcium carbonate and gypsum within the thin white preparatory finish layer of TUMA_11

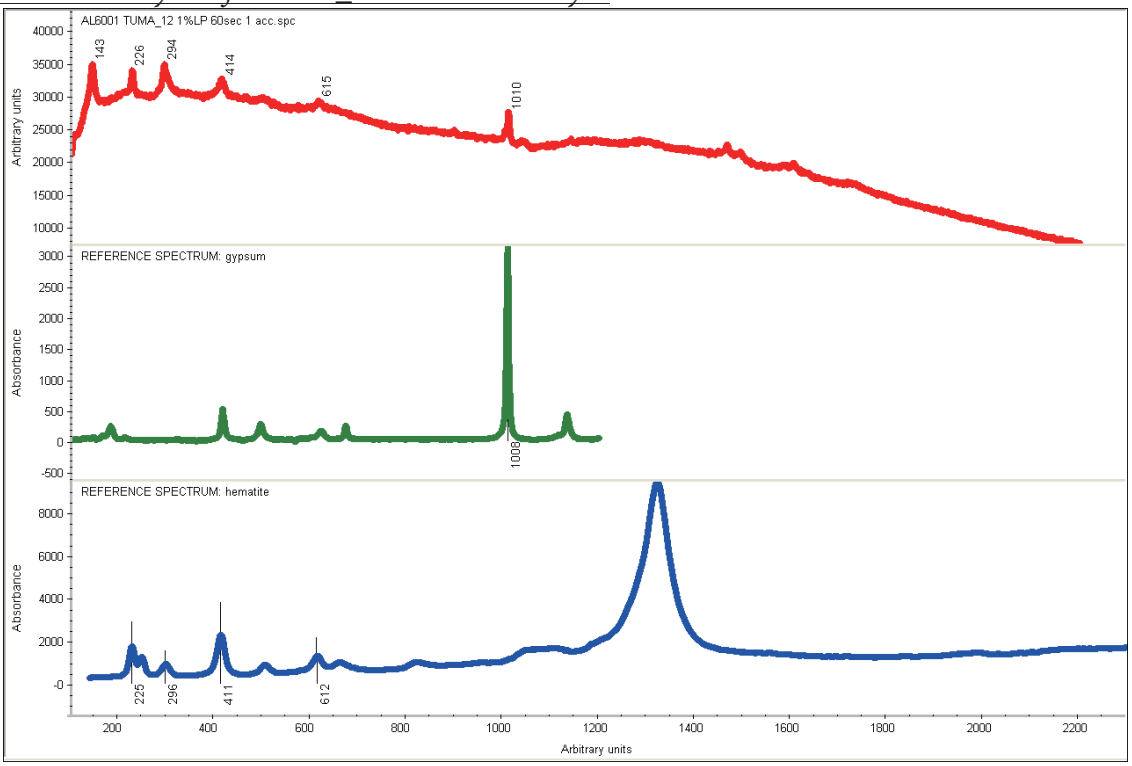
Raman Analysis of TUMA_12 Red Finish Layer

Figure 12.6: Raman spectral data showing presence of hematite and gypsum within the bright red finish layer of TUMA_12

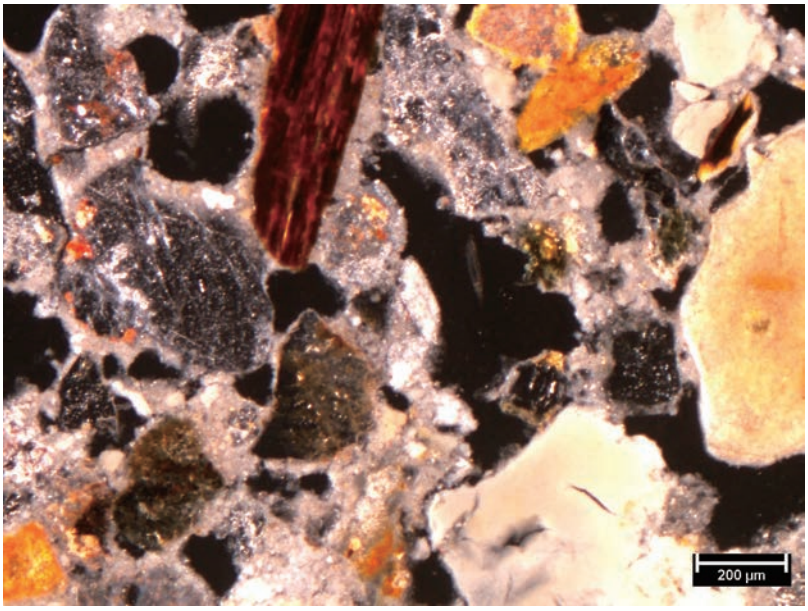
Figure: Thin-section of TUMA_25 viewed under pseudo dark field, note white preparatory paste to the left of the sample image

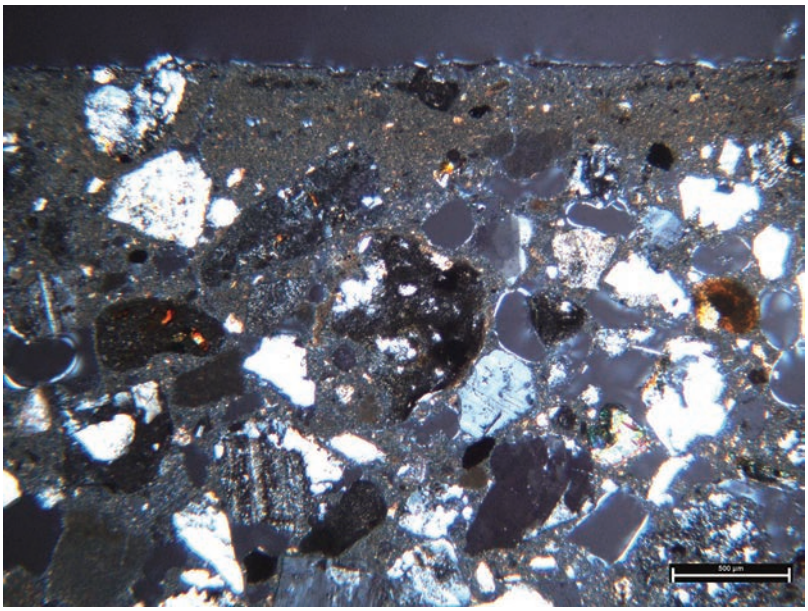
Figure: Thin-section of TUMA_25 viewed under plane-polarized light, sample oriented with the preparatory paste on top and substrate on bottom

While the bulk sample seemed fairly homogenous and exhibited extremely low snap strength, thin-section microscopy indicated that the mineral constituents of the stucco used on the façade of the Mission San José de Tumacácori are much more varied than originally anticipated. Overall, the sample appears quite coarse grained and porphyritic, with several rock fragments that appear to be of igneous nature. Mineralogically, there is a high degree of alteration and a large range of mineral types and rock fragments. However the minerals present within the TUMA_25 sample appear very felsic with not very many mafic components present. Indeed, this would corroborate SEM-EDS findings that indicated a general scattered presence of elements such as potassium, aluminum, silica, oxygen, calcium – elements that are all primary constituent of feldspars. Dr. Boileau confirmed the presence of quartz and feldspar, of varying degrees of clarity and alteration. Other specific minerals identified include zoned plagioclase, oxidized and elongated biotite mica, and calcite grains that were noted for their high twinning and relief. Many rock fragments of both fine and coarse-grained nature were also noted, including what appeared to be andesite due to its fine-grained rock matrix with some inclusions, and chert. However the chert appeared to be seen with epidote, an occurrence that is rarely seen together.

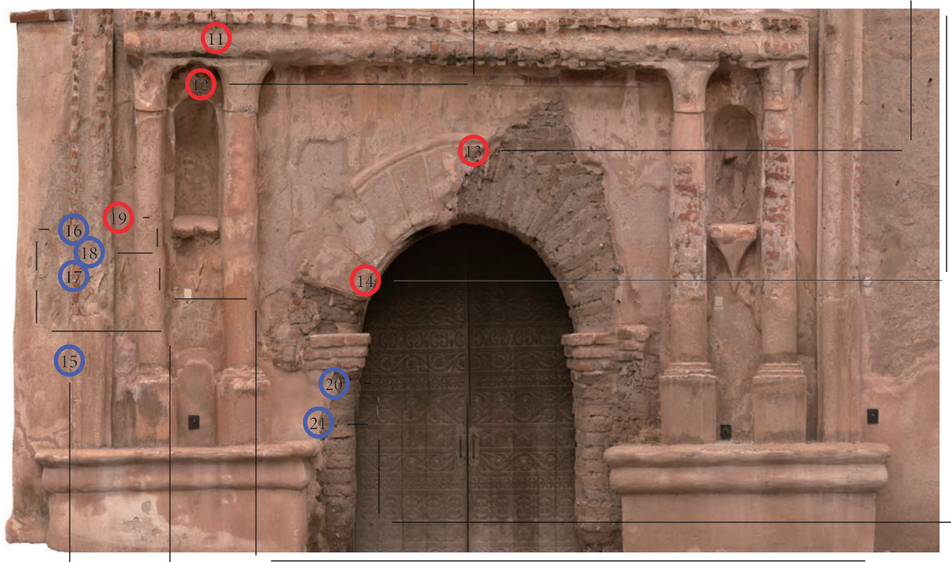
TUMA_14
Dark orange voussoir with pencilled white joints and black border

Photographs show location of samples acquired while the colored rectangles indicate approximate area of sampling.

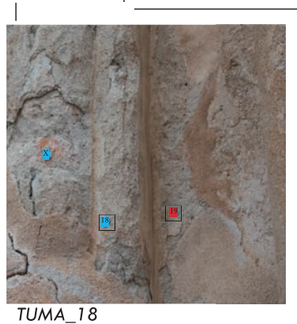
TUMA_15
Repair

TUMA_16
May be similar to TUMA_15
TUMA_17
Repair to TUMA_15

TUMA_18
Repair to TUMA_15
TUMA_19
Original finish

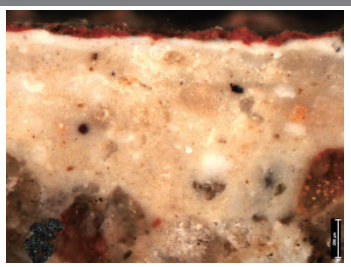
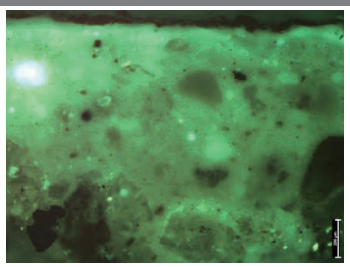
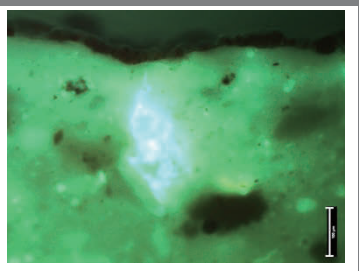
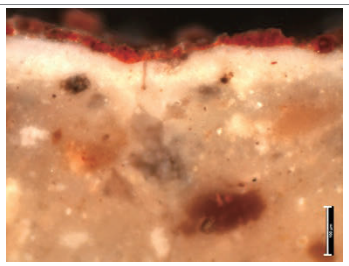
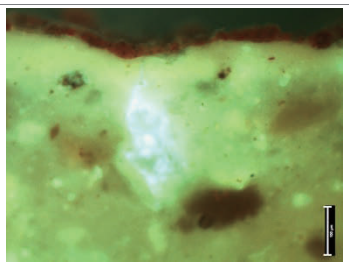
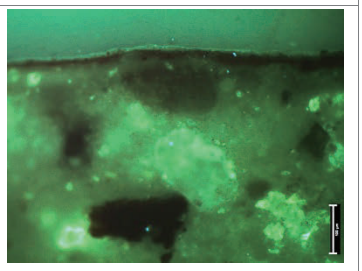
Stratigraphic Analysis of TUMA_01 (Red)

Unmounted, 1.6x total magnification	Cross section, 2.0x total magnification
Examination date	February 22, 2015	March 22, 2015
Analyzed by	Jocelyn Chan	Jocelyn Chan
Microscope & Software	Leica MZ16a stereoscope Nikon DS Fi-1 camera with NIS Elements BR software	Leica MZ16a stereoscope Nikon DS Fi-1 camera with NIS Elements BR software
Description	Red on white undercoat, fired brick substrate	Red on white preparatory layer with initial plaster scratch coat visible. Initial coat contains a variety of large inclusions.

- Substrate: coarse aggregate paste with extremely varied mineral constituents
- Layer 1: thin preparatory white finish layer
- Layer 2: bright red pigmented finish, discrete particles visible suggesting inorganic pigment

- Very clear, discrete layers
- Can see what may potentially be indication of lime laitance (more visible in ultraviolet light)
- Good candidate for subsequent analyses be used for subsequent analyses as representative red pigment sample

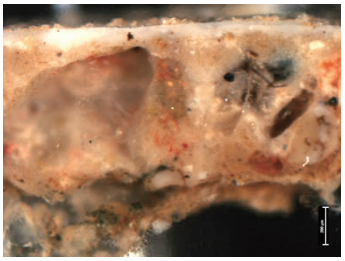
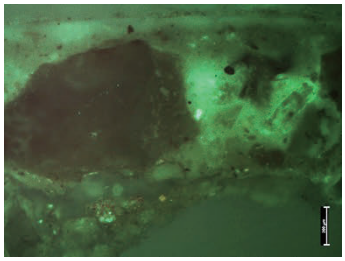
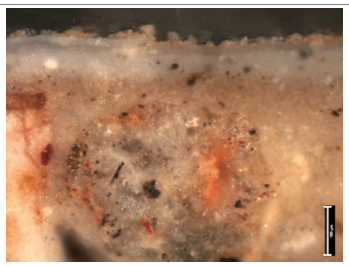
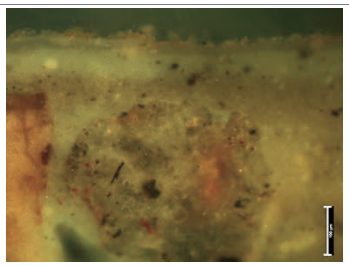
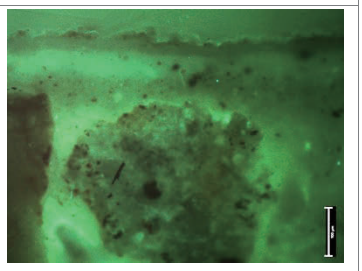
Stratigraphic Analysis of TUMA_02 (White)

Unmounted, 1.6x total magnification	 Cross section, 2.0x total magnification
Examination date	February 22, 2015	March 22, 2015
Analyzed by	Jocelyn Chan	Jocelyn Chan
Microscope & Software	Leica MZ16a stereoscope Nikon DS Fi-1 camera with NIS Elements BR software	Leica MZ16a stereoscope Nikon DS Fi-1 camera with NIS Elements BR software
Description	White, substrate unknown	White preparatory layer, sample has lost a lot of the finish. Yellowish cream intermittent?

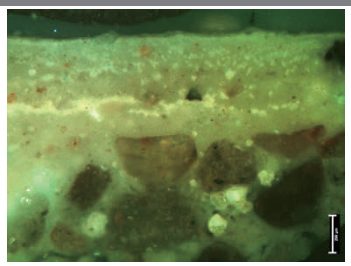
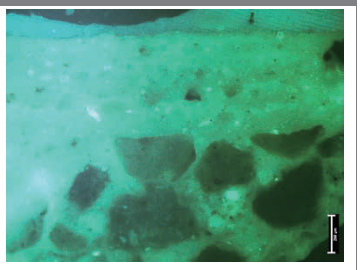
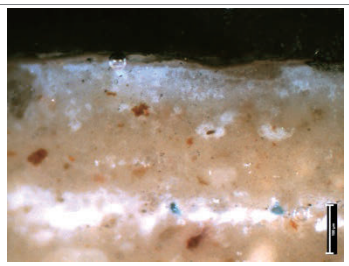
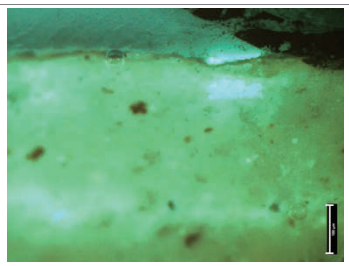
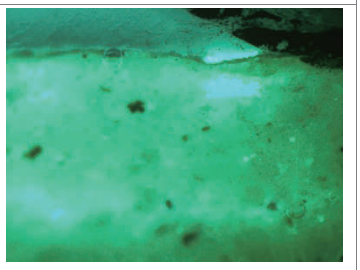
Stratigraphic Analysis of TUMA_03 (White)

Unmounted, 1.6x total magnification	Cross section, 2.0x total magnification
Examination date	February 22, 2015	March 22, 2015
Analyzed by	Jocelyn Chan	Jocelyn Chan
Microscope & Software	Leica MZ16a stereoscope Nikon DS Fi-1 camera with NIS Elements BR software	Leica MZ16a stereoscope Nikon DS Fi-1 camera with NIS Elements BR software
Description	White, brick substrate	Thick white preparatory layer, white finish layer

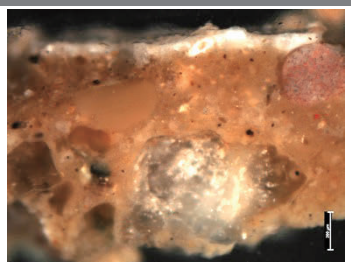
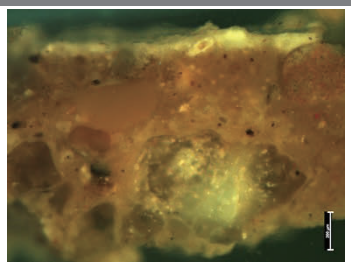
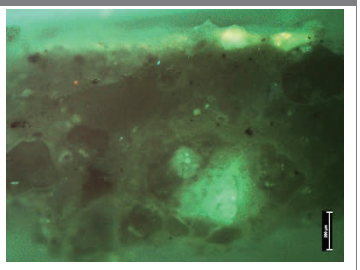
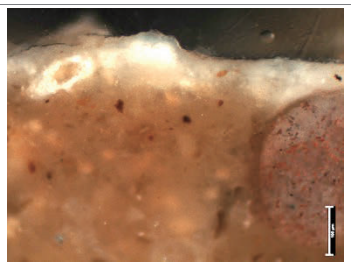
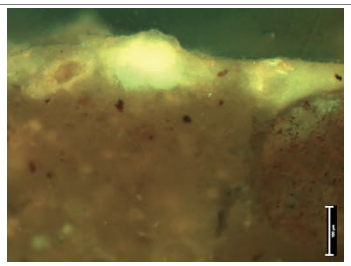
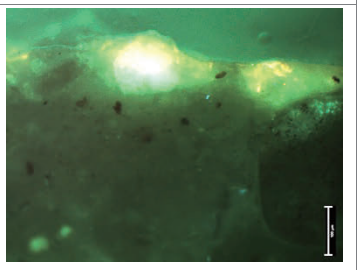
Stratigraphic Analysis of TUMA_04 (White)

Unmounted, 1.6x total magnification	Cross section, 2.0x total magnification
Examination date	February 22, 2015	March 22, 2015
Analyzed by	Jocelyn Chan	Jocelyn Chan
Microscope & Software	Leica MZ16a stereoscope Nikon DS Fi-1 camera with NIS Elements BR software	Leica MZ16a stereoscope Nikon DS Fi-1 camera with NIS Elements BR software
Description	White, substrate unknown	Not as good as other samples, missing a lot of surface. Does not appear to be in the same plane appears cream colored

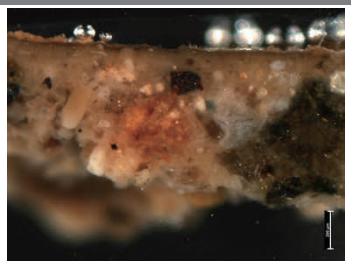
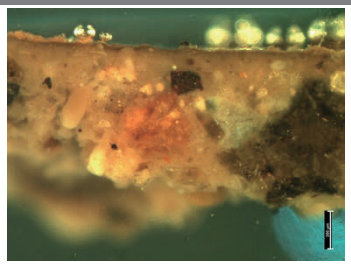
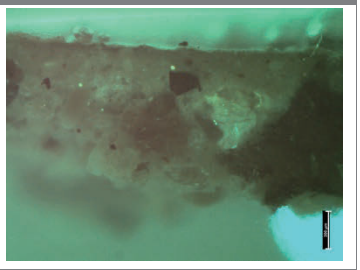
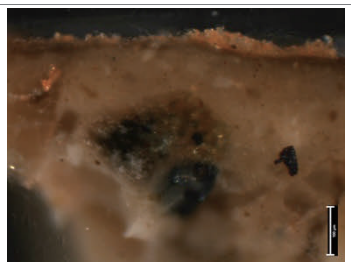
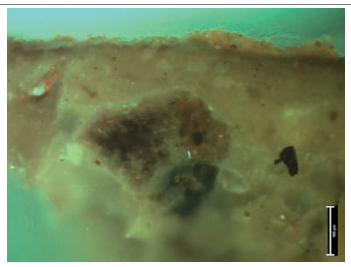
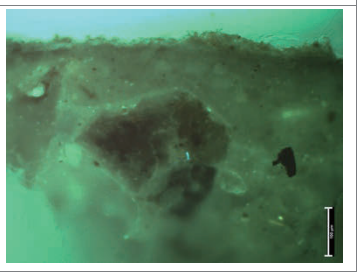
Stratigraphic Analysis of TUMA_06 (Yellow)

Unmounted, 1.6x total magnification	Cross section, 2.0x total magnification
Examination date	February 22, 2015	March 22, 2015
Analyzed by	Jocelyn Chan	Jocelyn Chan
Microscope & Software	Leica MZ16a stereoscope Nikon DS Fi-1 camera with NIS Elements BR software	Leica MZ16a stereoscope Nikon DS Fi-1 camera with NIS Elements BR software
Description	Yellow, substrate unknown	Very thick yellow layer, bubbles on surface, yellow does not appear to be applied on a preparatory layer

- Brownish-yellow layer appears more organic
- To be used for subsequent analyses as sample of potential limewash staining (e.g. to test for application of ferrous sulfate) or application of organic layer

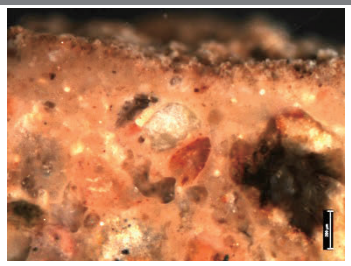
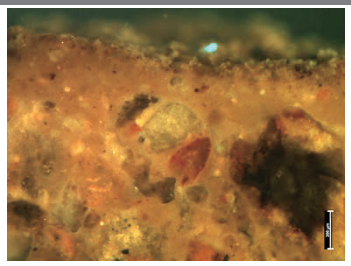
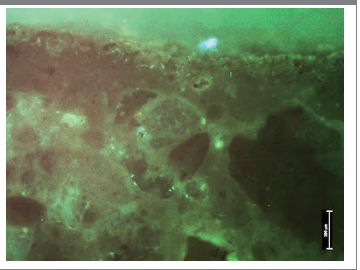
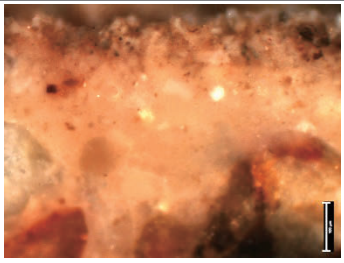
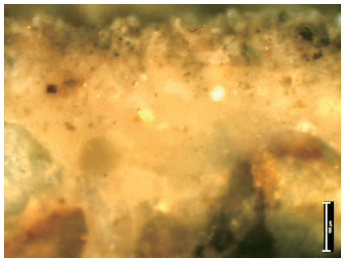
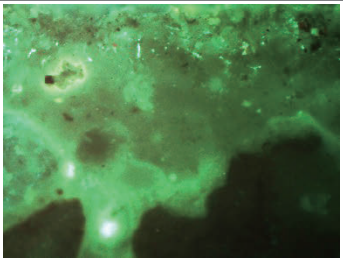
Microscopic Analysis of TUMA_07 (Yellow)

Unmounted, 1.6x total magnification	 Cross section, 2.0x total magnification
Examination date	February 22, 2015	March 22, 2015
Analyzed by	Jocelyn Chan	Jocelyn Chan
Microscope & Software	Leica MZ16a stereoscope Nikon DS Fi-1 camera with NIS Elements BR software	Leica MZ16a stereoscope Nikon DS Fi-1 camera with NIS Elements BR software
Description	Yellow, substrate unknown	Yellow thick layer

- Substrate: coarse aggregate paste with extremely varied mineral constituents
- Layer 1: brownish-yellow with mixed particles, does not appear to be on a preparatory layer
- Similar to TUMA_06 to test for application of a stain?

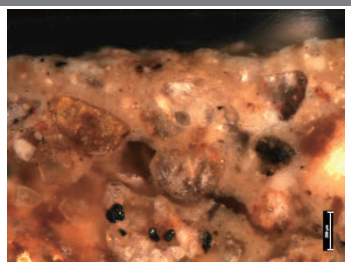
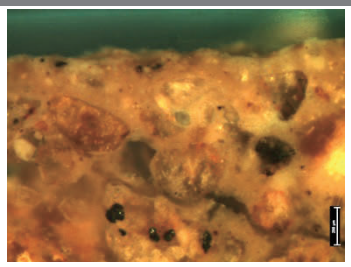
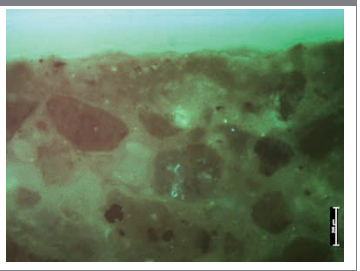
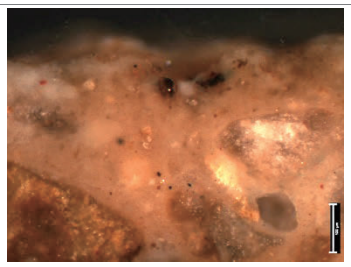
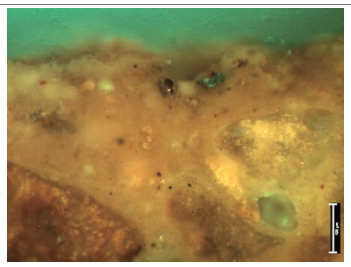
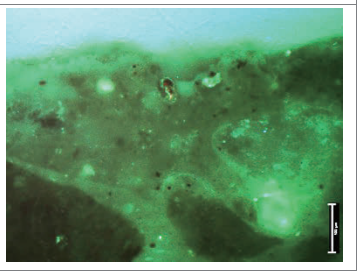
Microscopic Analysis of TUMA_08 (White)

Unmounted, 1.6x total magnification	 Cross section, 2.0x total magnification
Examination date	February 22, 2015	March 22, 2015
Analyzed by	Jocelyn Chan	Jocelyn Chan
Microscope & Software	Leica MZ16a stereoscope Nikon DS Fi-1 camera with NIS Elements BR software	Leica MZ16a stereoscope Nikon DS Fi-1 camera with NIS Elements BR software
Description	White, substrate unknown	Appears there was a white finish, gone? Distressed surface

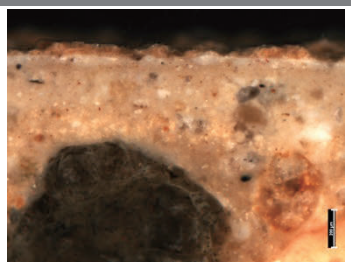
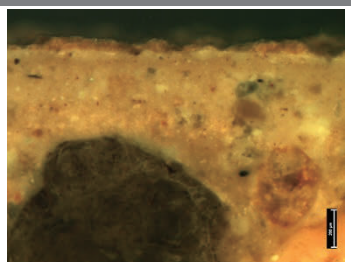
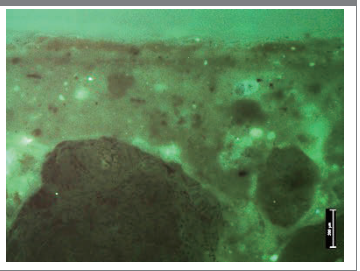
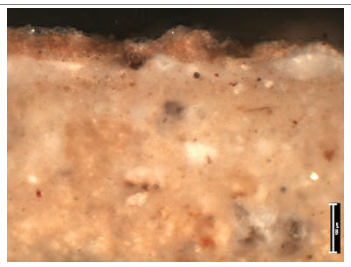
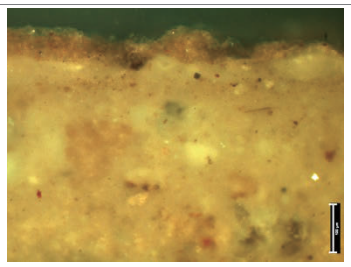
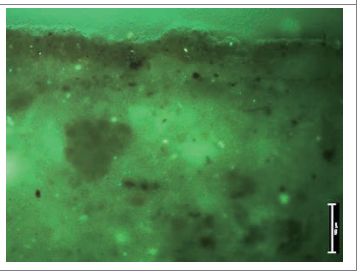
Microscopic Analysis of TUMA_09 (Yellow)

Unmounted, 1.6x total magnification	**Cross section, 2.0x total magnification**
Examination date	February 22, 2015	March 22, 2015
Analyzed by	Jocelyn Chan	Jocelyn Chan
Microscope & Software	Leica MZ16a stereoscope Nikon DS Fi-1 camera with NIS Elements BR software	Leica MZ16a stereoscope Nikon DS Fi-1 camera with NIS Elements BR software
Description	Yellow on white, substrate unknown	Paste of substrate, white, yellow, small red and black particles in mixture bulk. Discrete layers.

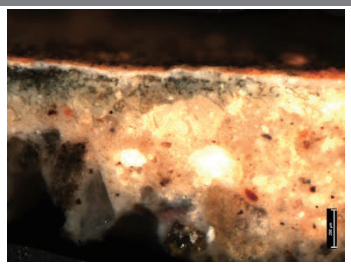
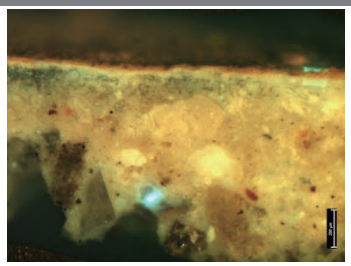
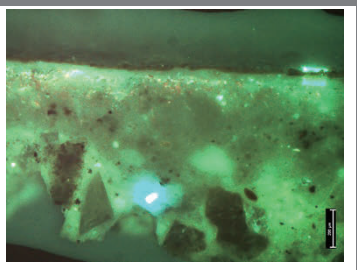
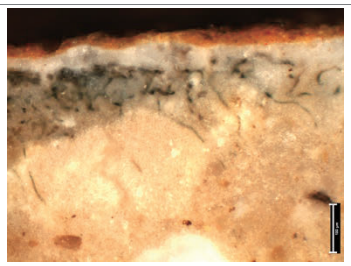
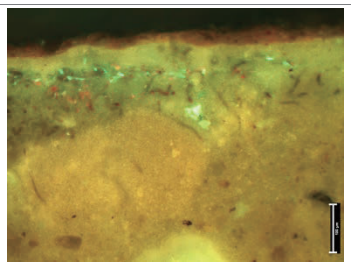
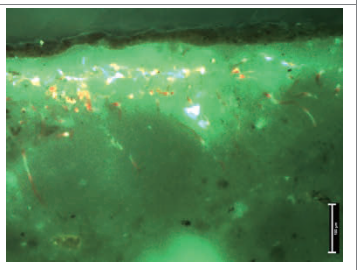
Microscopic Analysis of TUMA_11 (White)

Unmounted, 1.6x total magnification	Cross section, 2.0x total magnification
Examination date	February 22, 2015	March 22, 2015
Analyzed by	Jocelyn Chan	Jocelyn Chan
Microscope & Software	Leica MZ16a stereoscope Nikon DS Fi-1 camera with NIS Elements BR software	Leica MZ16a stereoscope Nikon DS Fi-1 camera with NIS Elements BR software
Description	Yellow, first scratch coat appro. 1/8", 2nd scratch coat approx ¼", 3rd coat thick limewash, 4th coat color	Very clear, pigmented with red and yellow on white preparatory layer. White layer appears to be on a very weathered white substrate, black appears to be biological microflora

- Substrate: coarse aggregate paste with extremely varied mineral constituents
- Layer 1: thick preparatory white finish layer
- Layer 2: orange-yellow pigmented finish, discrete particles visible suggesting inorganic pigment; some red pigment particles visible in upper finish layer

- Very clear, discrete layering
- White preparatory finish layer appears to be on very weathered white substrate, suggested that it was applied atop an already dried surface
- Black tendrils appear to be some type of biological microflora

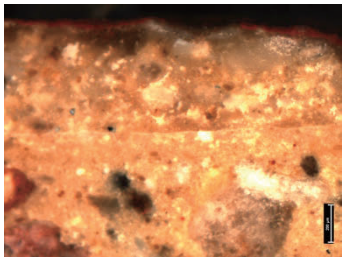
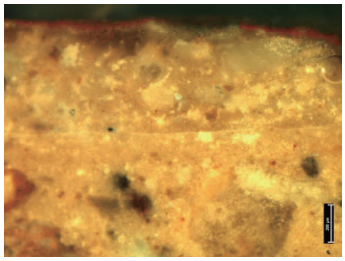
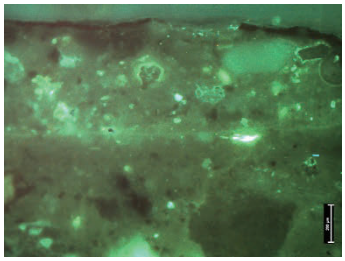
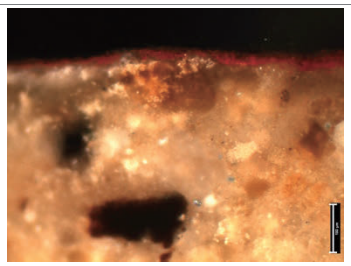
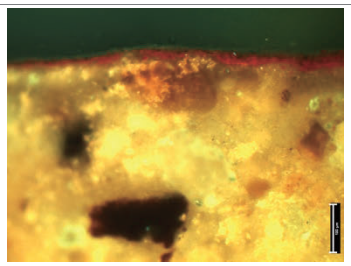
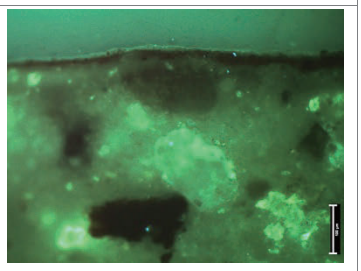
Microscopic Analysis of TUMA_12 (Red)

Unmounted, 1.6x total magnification	**Cross section, 2.0x total magnification**
Examination date	February 22, 2015	March 22, 2015
Analyzed by	Jocelyn Chan	Jocelyn Chan
Microscope & Software	Leica MZ16a stereoscope Nikon DS Fi-1 camera with NIS Elements BR software	Leica MZ16a stereoscope Nikon DS Fi-1 camera with NIS Elements BR software
Description	Red, substrate unknown	Red on white preparatory, very clear – can see lines suggesting lime laitance

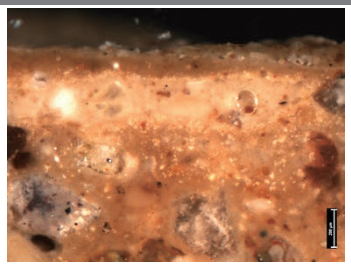
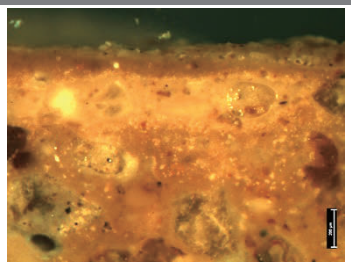
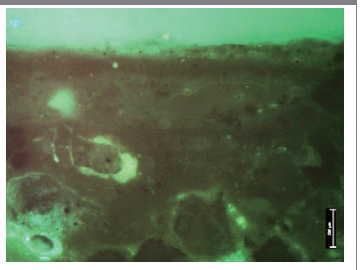
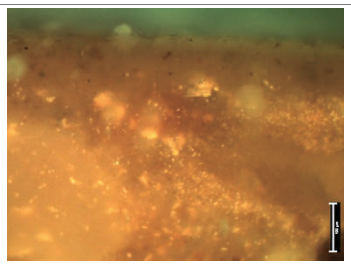
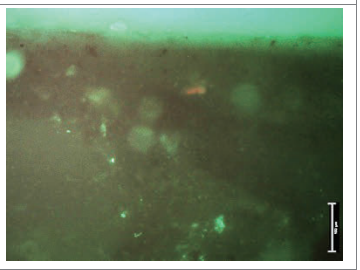
Stratigraphic Analysis of TUMA_13A (White)

Unmounted, 1.6x total magnification	Cross section, 2.0x total magnification
Examination date	February 22, 2015	March 22, 2015
Analyzed by	Jocelyn Chan	Jocelyn Chan
Microscope & Software	Leica MZ16a stereoscope Nikon DS Fi-1 camera with NIS Elements BR software	Leica MZ16a stereoscope Nikon DS Fi-1 camera with NIS Elements BR software
Description	TUMA_13A is white of scored joint (TUMA_13B yellow of extradose molding)	Very thin white layer on top of yellow layer

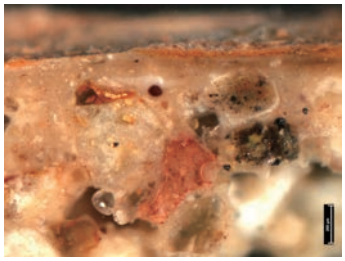
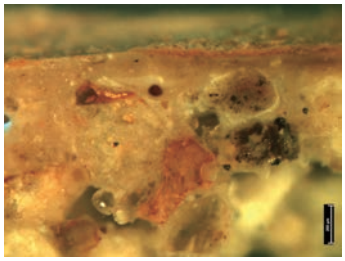
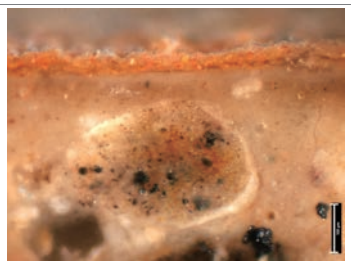
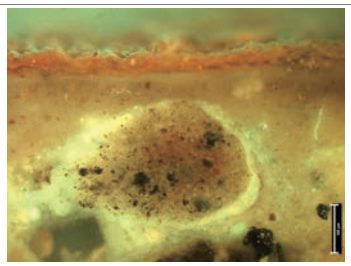
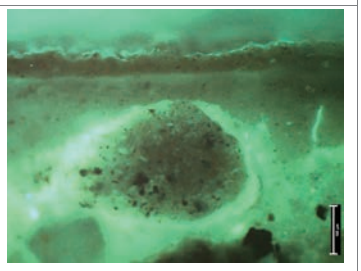
Stratigraphic Analysis of TUMA_13B (Yellow)

Unmounted, 1.6x total magnification	 Cross section, 2.0x total magnification
Examination date	February 22, 2015	March 22, 2015
Analyzed by	Jocelyn Chan	Jocelyn Chan
Microscope & Software	Leica MZ16a stereoscope Nikon DS Fi-1 camera with NIS Elements BR software	Leica MZ16a stereoscope Nikon DS Fi-1 camera with NIS Elements BR software
Description	TUMA_13A is white of scored joint (TUMA_13B yellow of extradose molding)	Thin preparatory layer, yellow layer mixed with red pigment
