An Investigation of the Painted Finishes of Mission San José de Tumacácori's Façade: At the Interface of Materials Analysis, Conservation, and Cultural Confluence

Jocelyn Chan
University of Pennsylvania

A THESIS

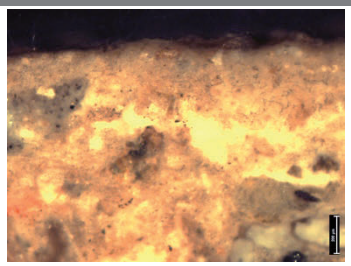
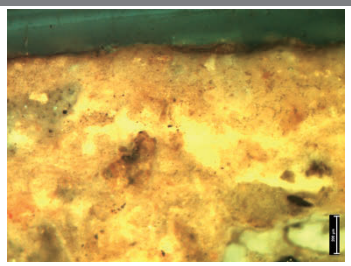
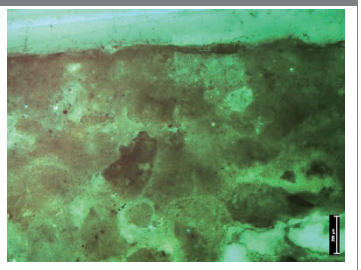
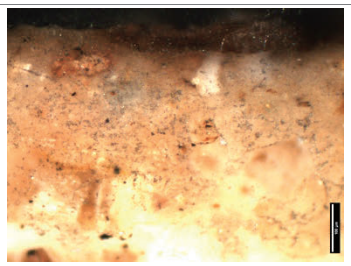
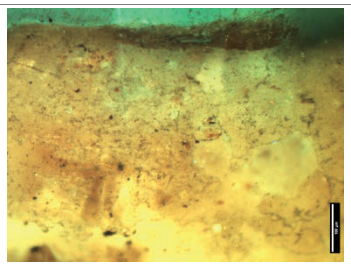
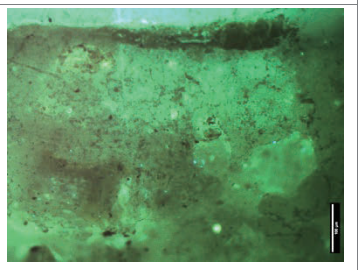
Stratigraphic Analysis of TUMA_14 (Orange)

Unmounted, 1.6x total magnification	**Cross section, 2.0x total magnification**
Examination date	February 22, 2015	March 22, 2015
Analyzed by	Jocelyn Chan	Jocelyn Chan
Microscope & Software	Leica MZ16a stereoscope Nikon DS Fi-1 camera with NIS Elements BR software	Leica MZ16a stereoscope Nikon DS Fi-1 camera with NIS Elements BR software
Description	Dark orange voussoir with penciled white joints and black border	Layer appears distressed, pigment darker than in other examples. Presence of what appears yellow stained upper zone

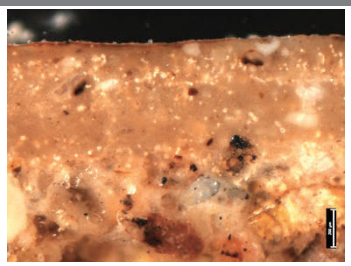
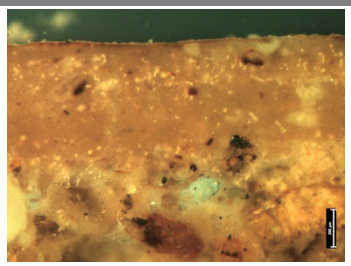
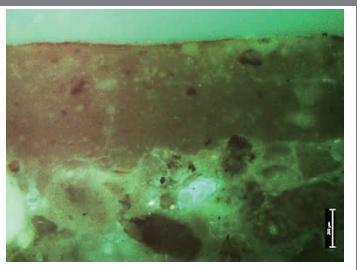
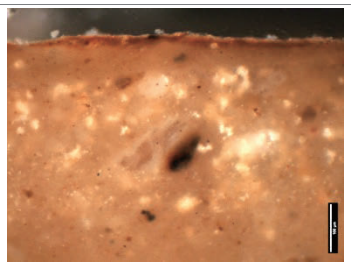
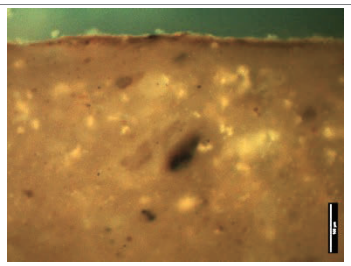
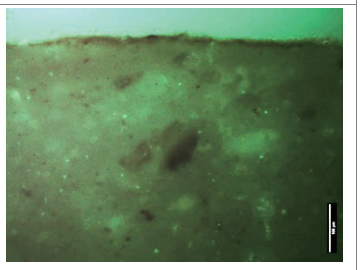
Stratigraphic Analysis of TUMA_19 (Yellow)

Unmounted, 1.6x total magnification	Cross section, 2.0x total magnification
Examination date	February 22, 2015	March 22, 2015
Analyzed by	Jocelyn Chan	Jocelyn Chan
Microscope & Software	Leica MZ16a stereoscope Nikon DS Fi-1 camera with NIS Elements BR software	Leica MZ16a stereoscope Nikon DS Fi-1 camera with NIS Elements BR software
Description	Somewhat distressed surface, yellow and cream pigments

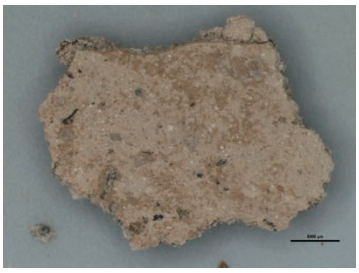
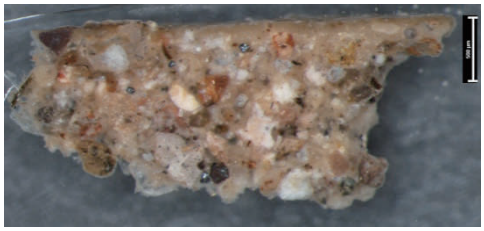
Sample Location for TUMA_25 (White)

Site	Mission San José de Tumacácori façade, Tucson Arizona
Sampling date	Unknown
Sample name	TUMA_25
Sampled by	Alex Lim (NPS)
Sample location	From collection of fallen fragments (potentially lower right column)

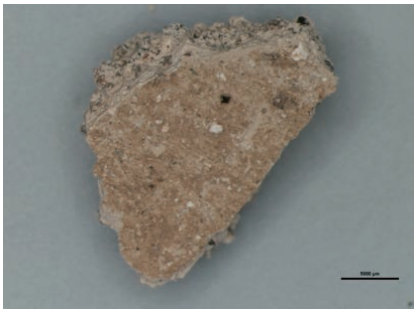
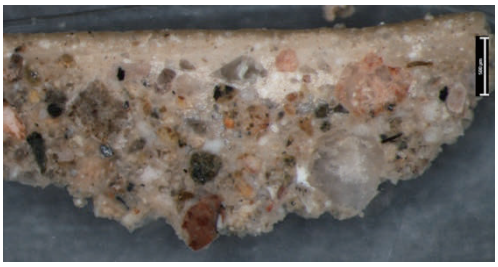
Sample Location for TUMA_26 (Yellow)

Site	Mission San José de Tumacácori façade, Tucson Arizona
Sampling date	Unknown
Sample name	TUMA_26
Sampled by	Alex Lim (NPS)
Sample location	From collection of fallen fragments (potentially lower right column)

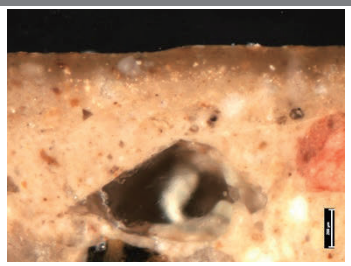
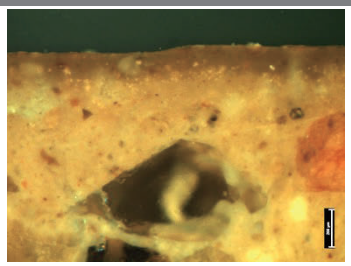
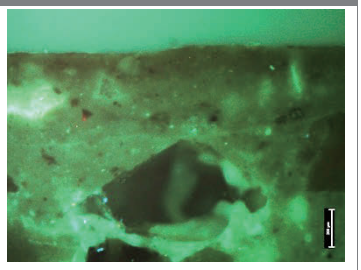
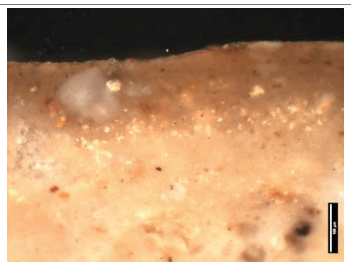
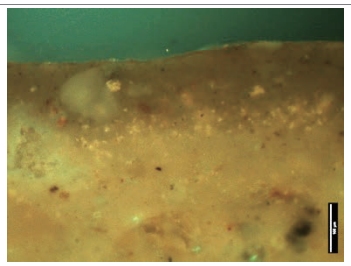
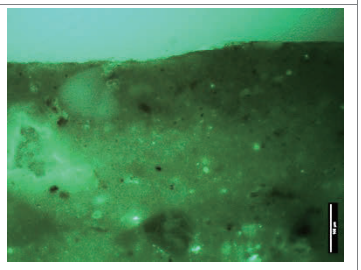
Stratigraphic Analysis of TUMA_26 (Yellow)

Unmounted, 1.6x total magnification	Cross section, 2.0x total magnification
Examination date	February 22, 2015	March 22, 2015
Analyzed by	Jocelyn Chan	Jocelyn Chan
Microscope & Software	Leica MZ16a stereoscope Nikon DS Fi-1 camera with NIS Elements BR software	Leica MZ16a stereoscope Nikon DS Fi-1 camera with NIS Elements BR software
Description	Yellow-cream layer, not as brightly pigmented as other yellow examples	Discrete layering with yellow-cream finish – laitance visible under UV

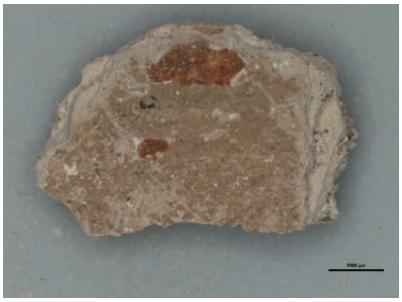
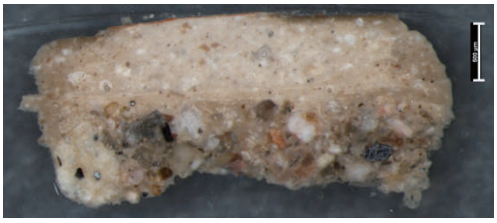
Sample Location for TUMA_27 (Red)

Site	Mission San José de Tumacácori façade, Tucson Arizona
Sampling date	Unknown
Sample name	TUMA_27
Sampled by	Alex Lim (NPS)
Sample location	From collection of fallen fragments (potentially lower right column)

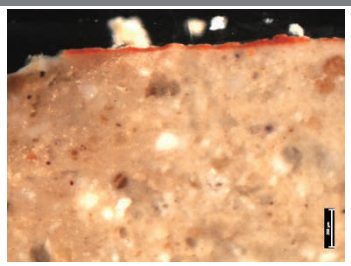
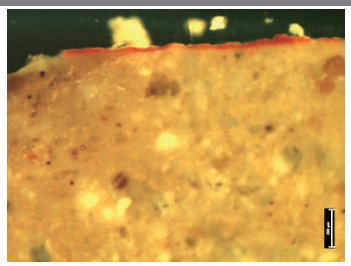
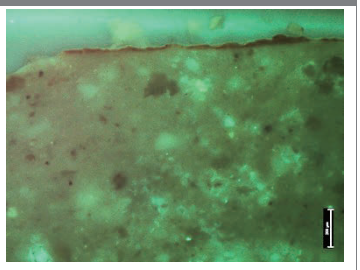
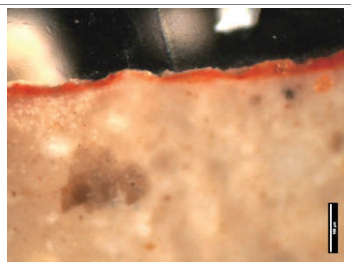
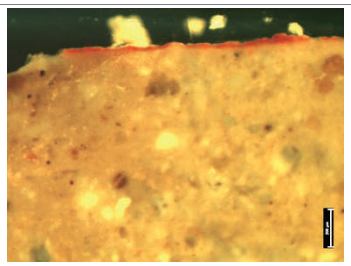
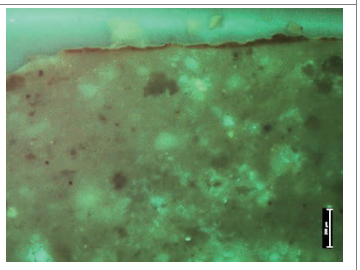
Microscopic Analysis of TUMA_27 (Red)

- Substrate: coarse aggregate paste with extremely varied mineral constituents
- Layer 1: thick cream-white preparatory layer
- Layer 2: traces of orange-red pigment, brightly pigmented like in other cases of red finish

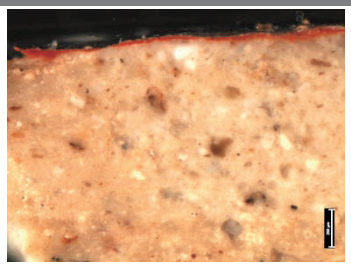
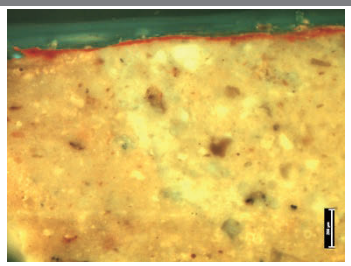
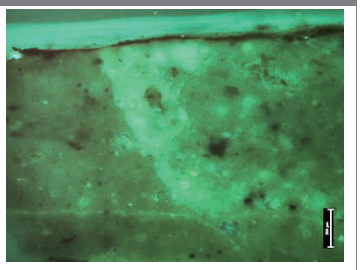
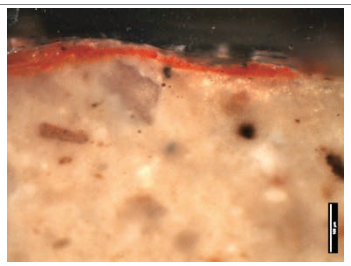
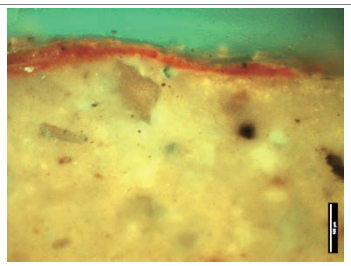
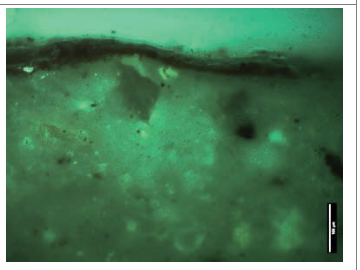
Microscopic Analysis of TUMA_28 (Red)

Unmounted, 1.6x total magnification	Cross section, 2.0x total magnification
Examination date	February 22, 2015	March 22, 2015
Analyzed by	Jocelyn Chan	Jocelyn Chan
Microscope & Software	Leica MZ16a stereoscope Nikon DS Fi-1 camera with NIS Elements BR software	Leica MZ16a stereoscope Nikon DS Fi-1 camera with NIS Elements BR software
Description	Red finish on weathered preparatory	Traces of red over thick white preparatory layer – lime laitance visible in UV

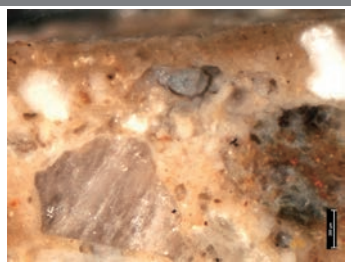
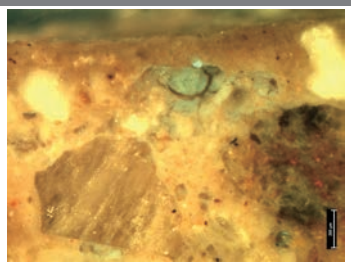
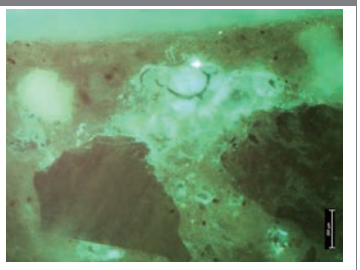
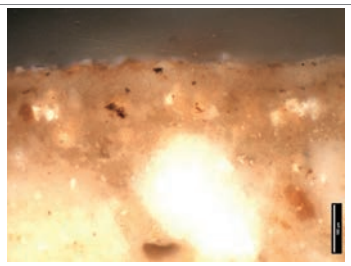
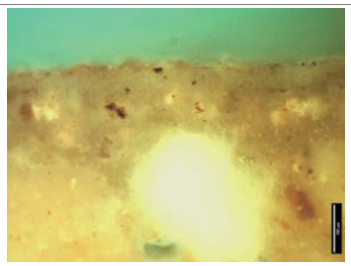
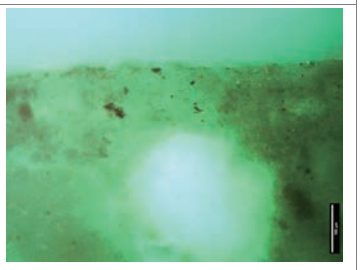
Microscopic Analysis of TUMA_30 (White)

- Substrate: coarse aggregate paste with extremely varied mineral constituents
- Layer 1: cream-white layer that appears darkened/weathered – potentially a preparatory layer?

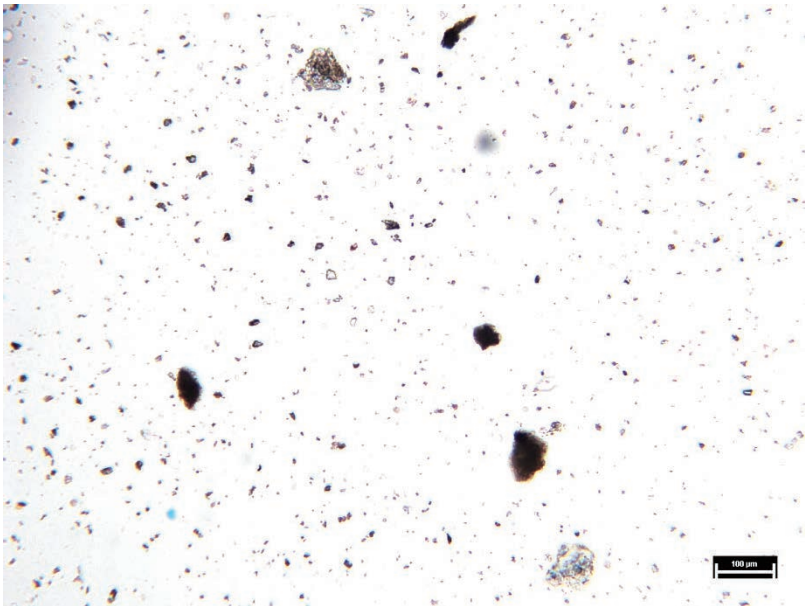
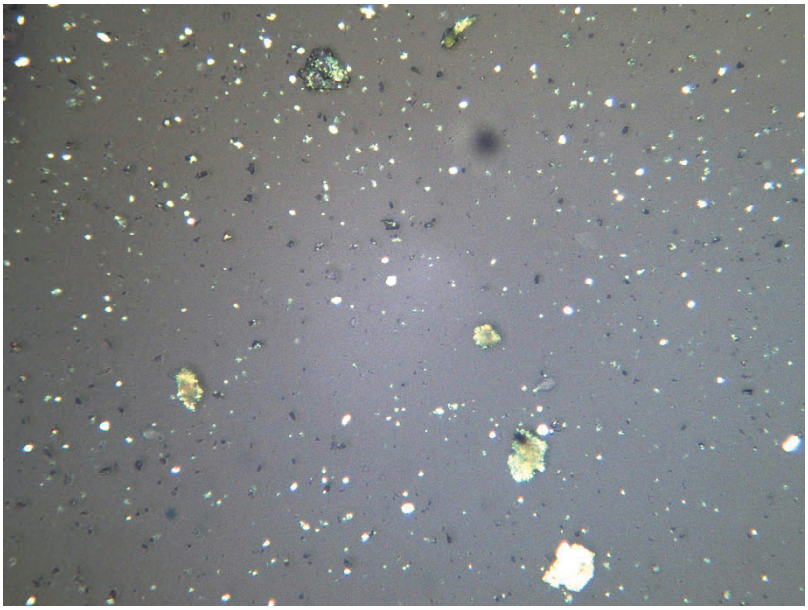
-Dull red coarse grain particles
-High birefringence
-Mixture of grain sizes, some more opaque red
-Several clear particles that appear to be quartz coated in red pigment, similar to hematite standard in Pigment Compendium

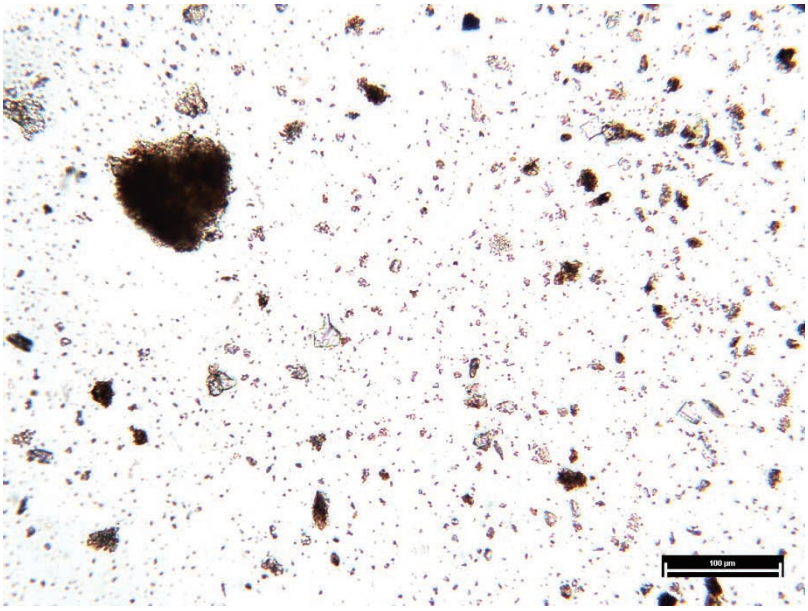
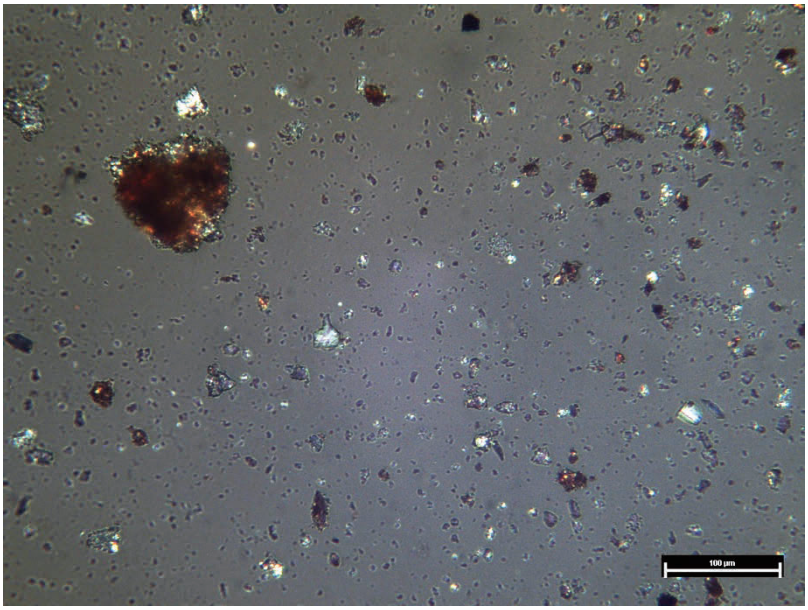
Two particles both from TUMA_12 at 400x magnification showing what appears to be quartz crystals covered in a red globular pigment – this is consistent with standards shown in Pigment Compendium

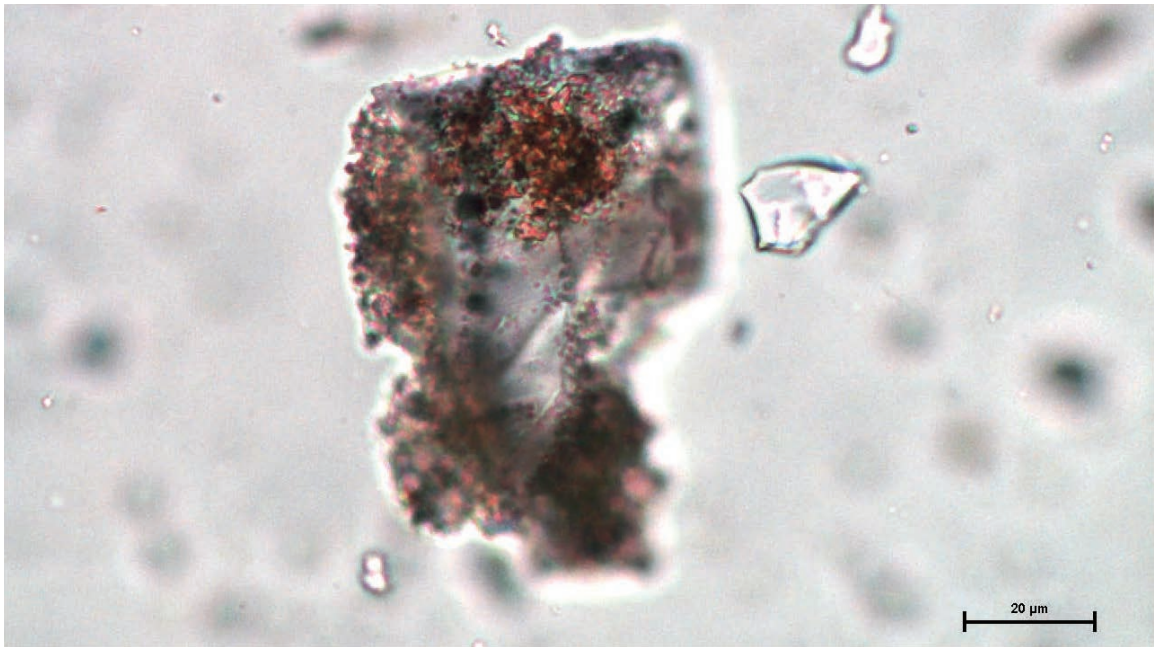
-Dull red coarse grain particles
-High birefringence
-Mixture of grain sizes, some more opaque red
-Several clear particles that appear to be quartz coated in red pigment, similar to hematite standard in Pigment Compendium

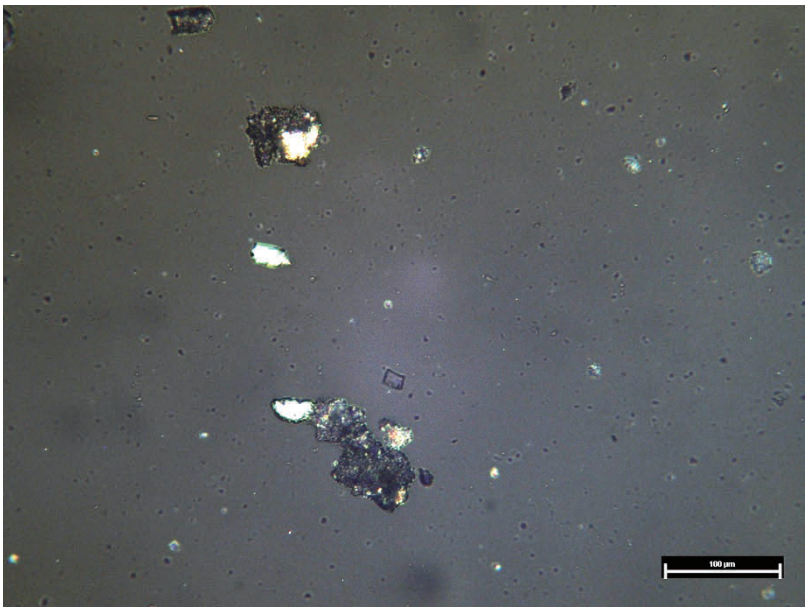
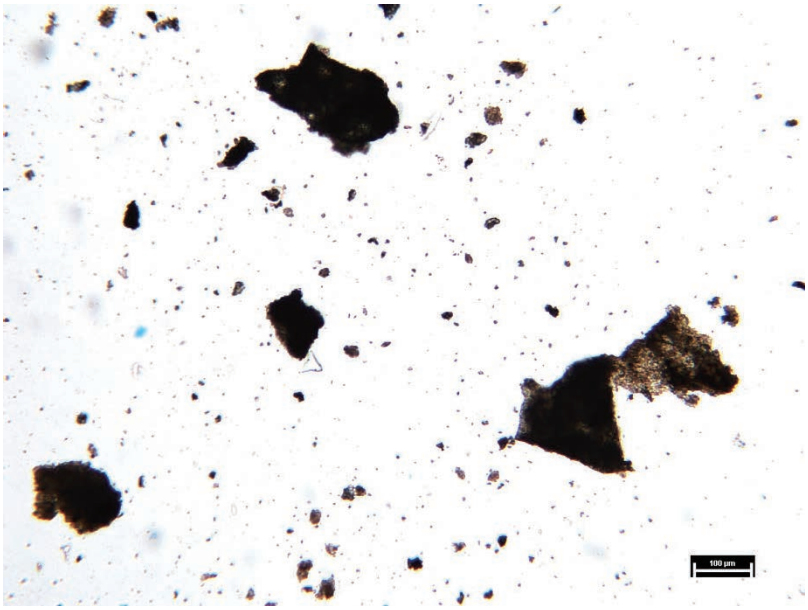
Particle Dispersion of TUMA_06 (Yellow) in PPL and XPL at 200x

-Dull yellow-brown coarse grain particles
-High birefringence
-Mixture of grain sizes, some more opaque
-Not as well dispersed as other yellow samples
-More cases of pigments that perhaps were not well ground or dispersed enough in preparation

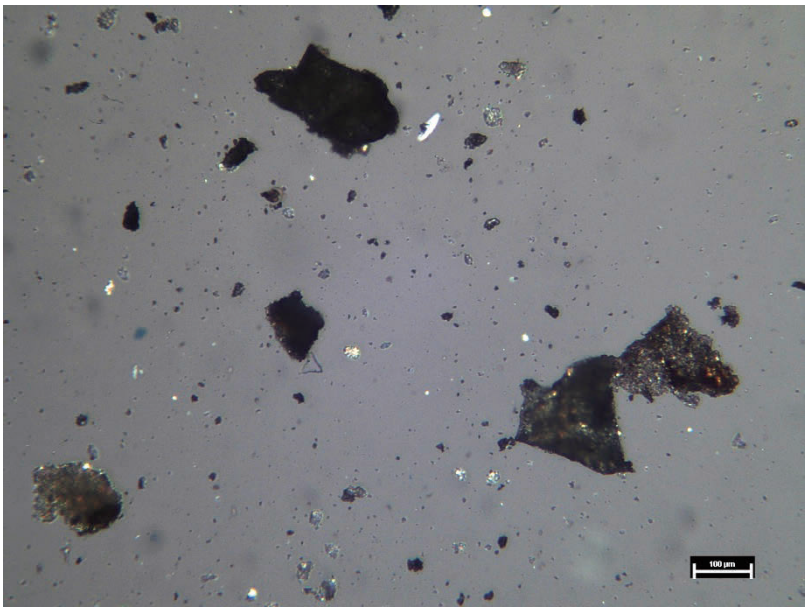
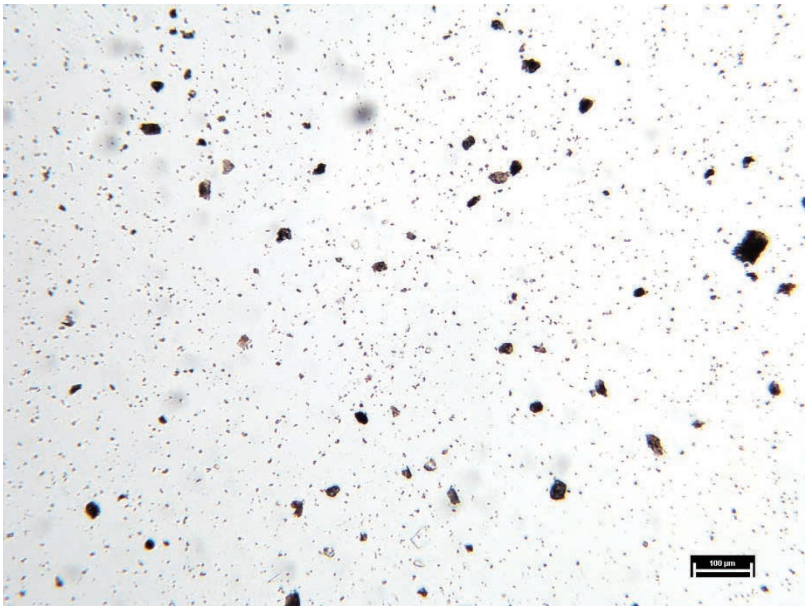
Particle Dispersion of TUMA_09 (Yellow) in PPL and XPL at 100x

-Dull yellow-brown coarse grain particles
-High birefringence
-Mixture of grain sizes, more opaques or large chunks of pigment noted than in other samples
-Presence of some red particles within the dispersion
-Appear similar to goethite standard in Pigment Compendium

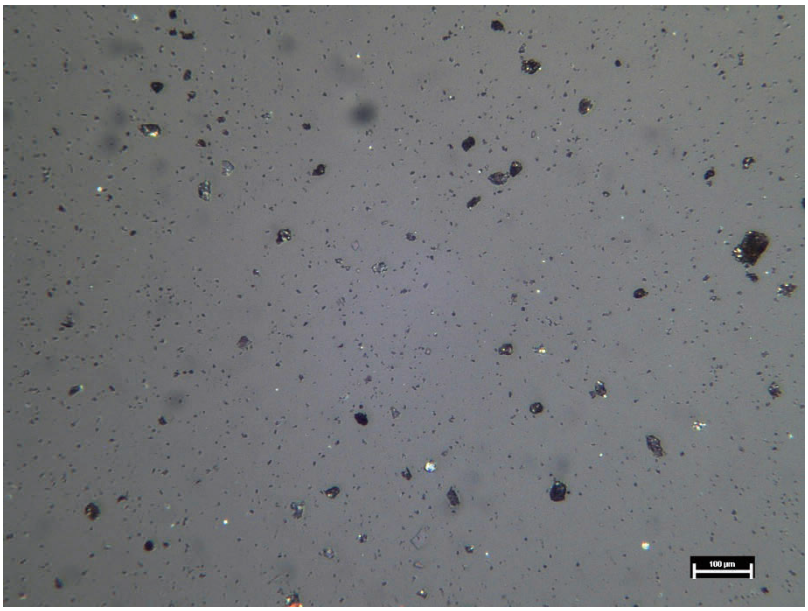
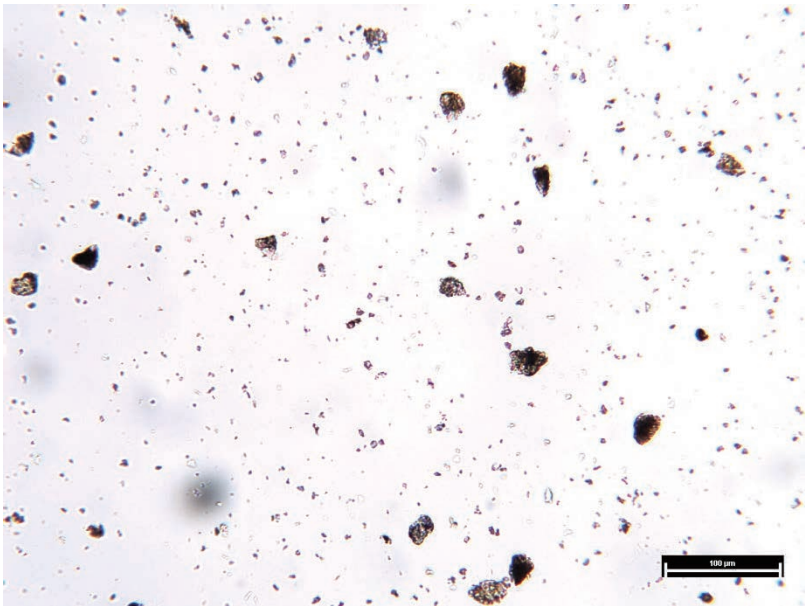
Particle Dispersion of TUMA_11 (Yellow) in PPL and XPL at 100x

-Dull yellow-brown coarse grain particles, mixture of grain sizes, some more opaque
-High birefringence
- Most well dispersed sample of the three yellow samples
-Presence of some red particles within the dispersion
-Appear similar to goethite standard in Pigment Compendium

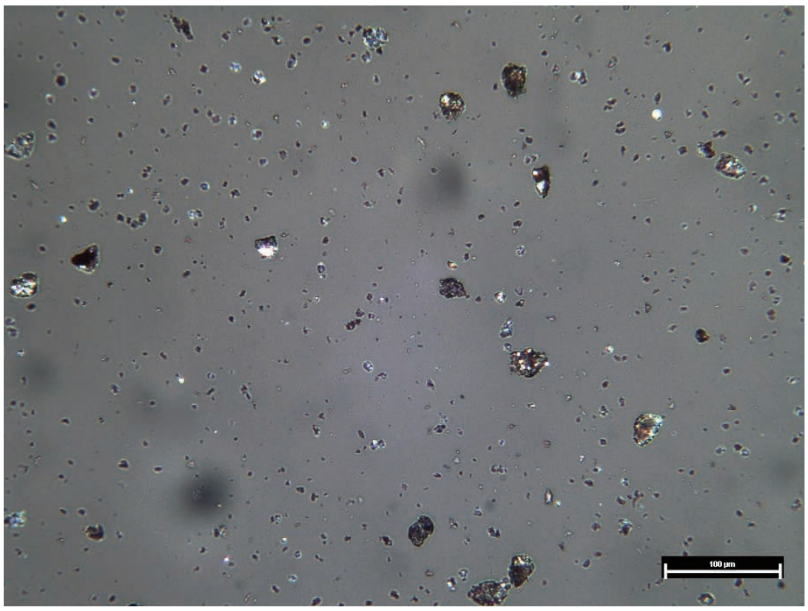
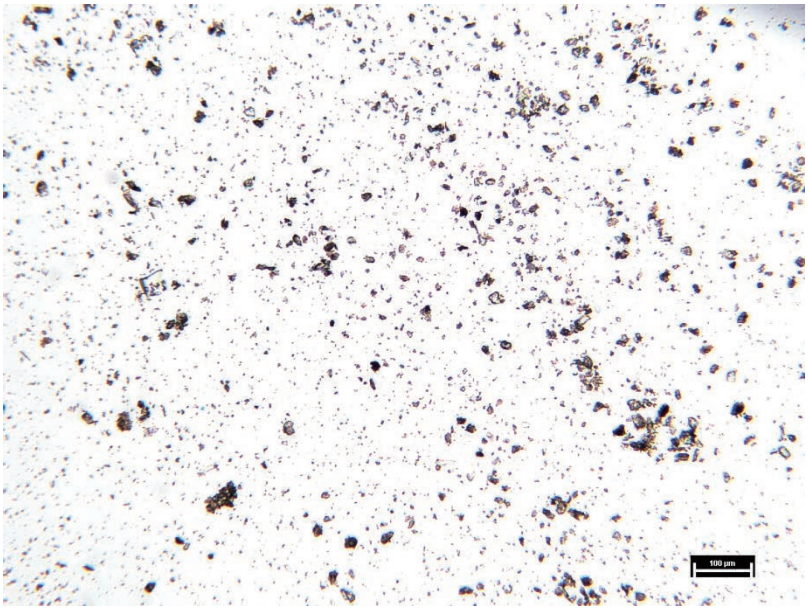
Particle Dispersion of TUMA_11 (Yellow) in PPL and XPL at 200x

-Dull yellow-brown coarse grain particles, mixture of grain sizes, some more opaque
-High birefringence
- Most well dispersed sample of the three yellow samples
-Presence of some red particles within the dispersion
-Appear similar to goethite standard in Pigment Compendium

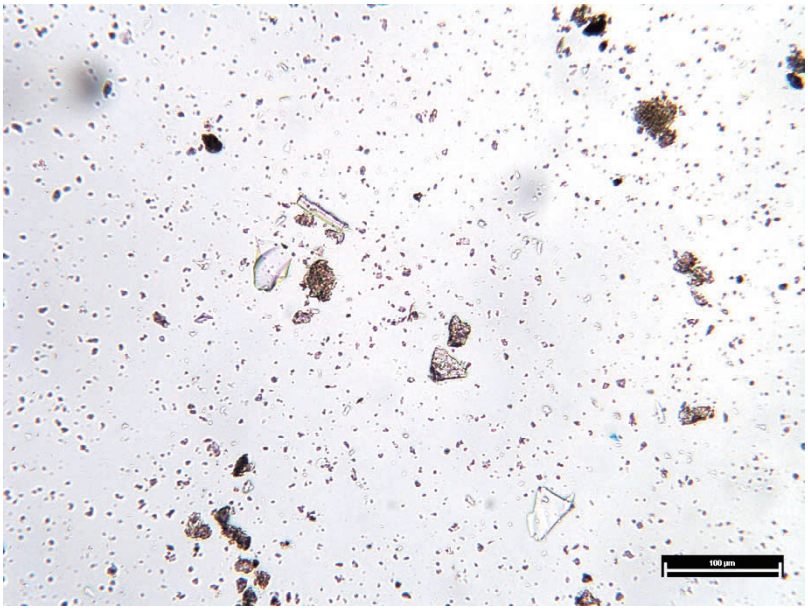
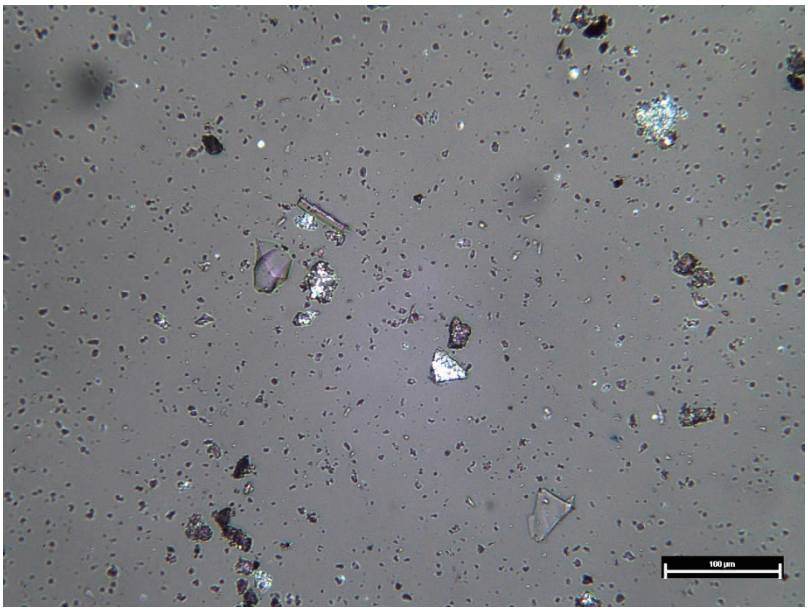
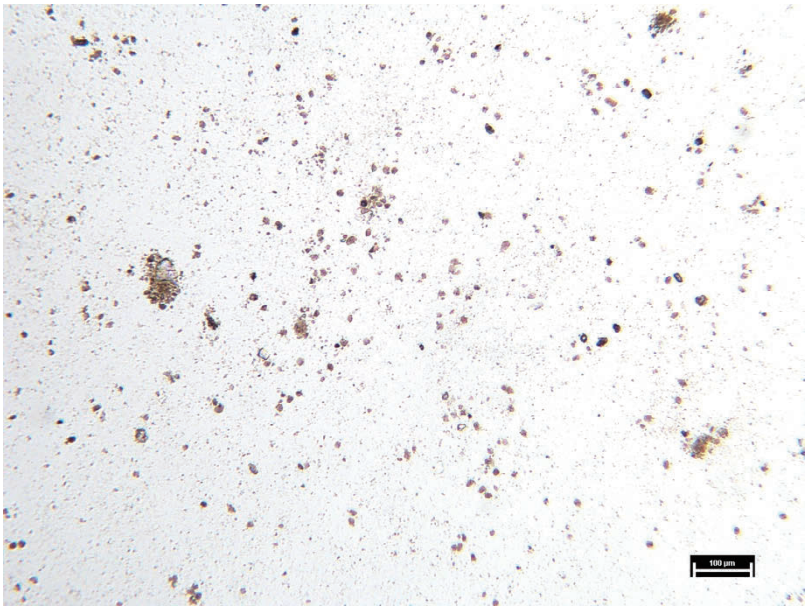
Particle Dispersion of TUMA_03 (White) in PPL and XPL in 200x

-Irregularly shaped white/clear crystals, mixture of grain sizes
-High birefringence
- More angular than TUMA_25
-Similar to chalk standard in Pigment Compendium, potential presence of microfossils?

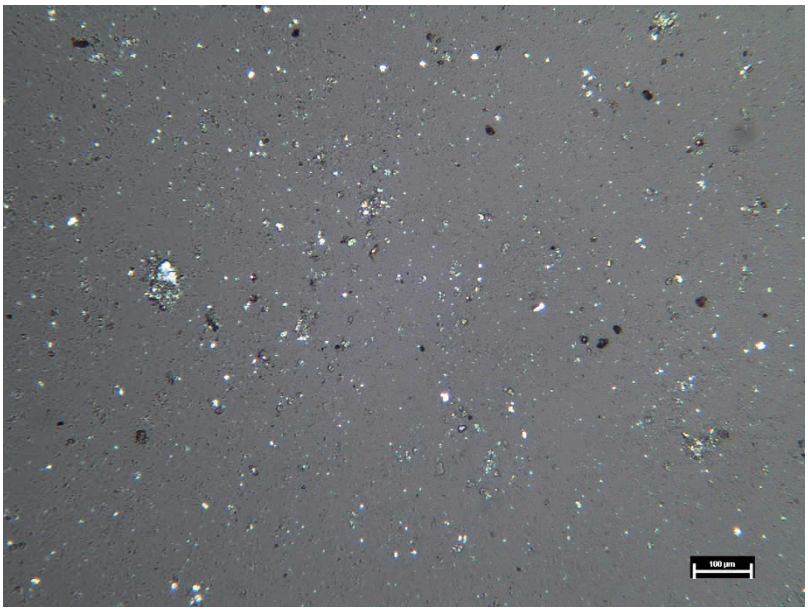
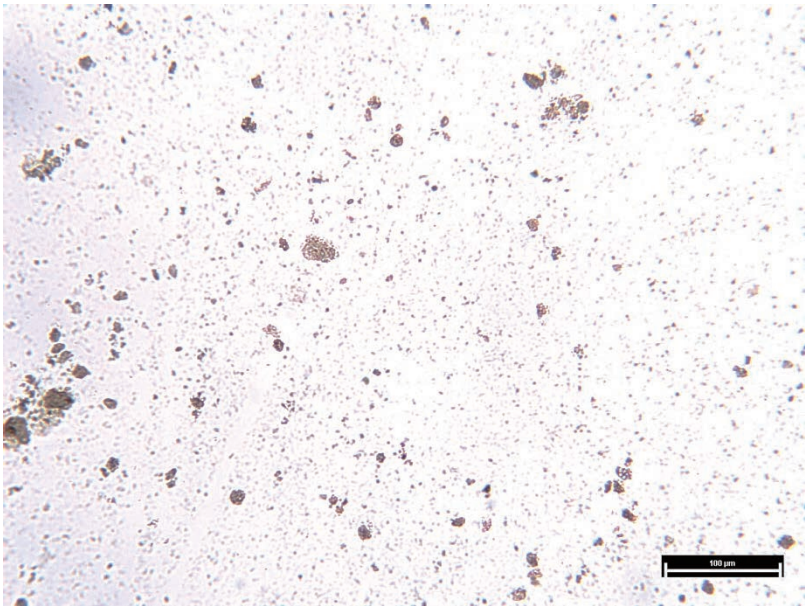
Particle Dispersion of TUMA_25 (White) in PPL and XPL in 100x

-Irregularly shaped white/clear crystals, mixture of grain sizes
-High birefringence
-More well dispersed than TUMA_03
-Similar to chalk standard in Pigment Compendium, potential presence of microfossils?

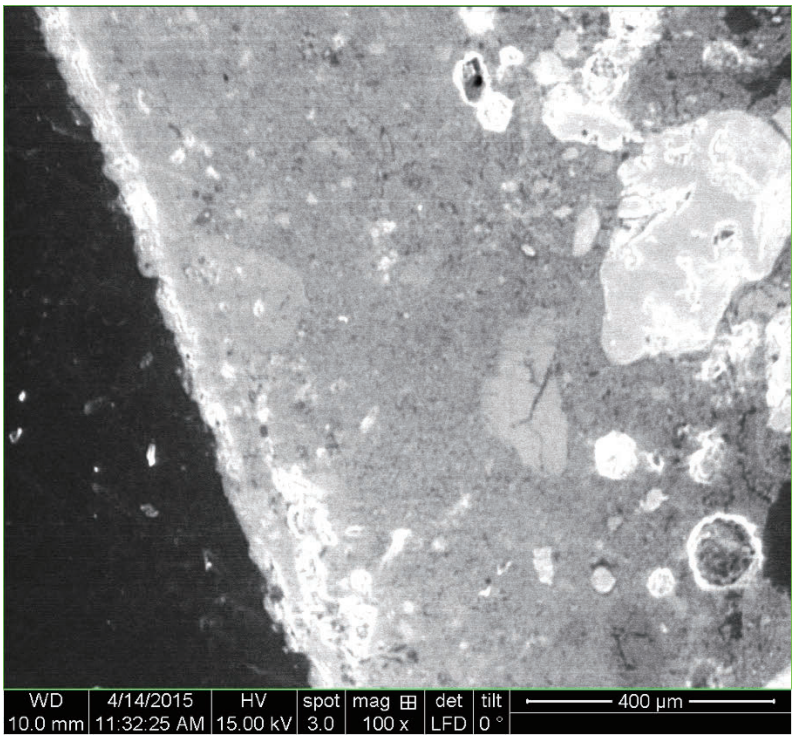
TUMA_14 backscattered electron image from SEM, note finish layer rotation

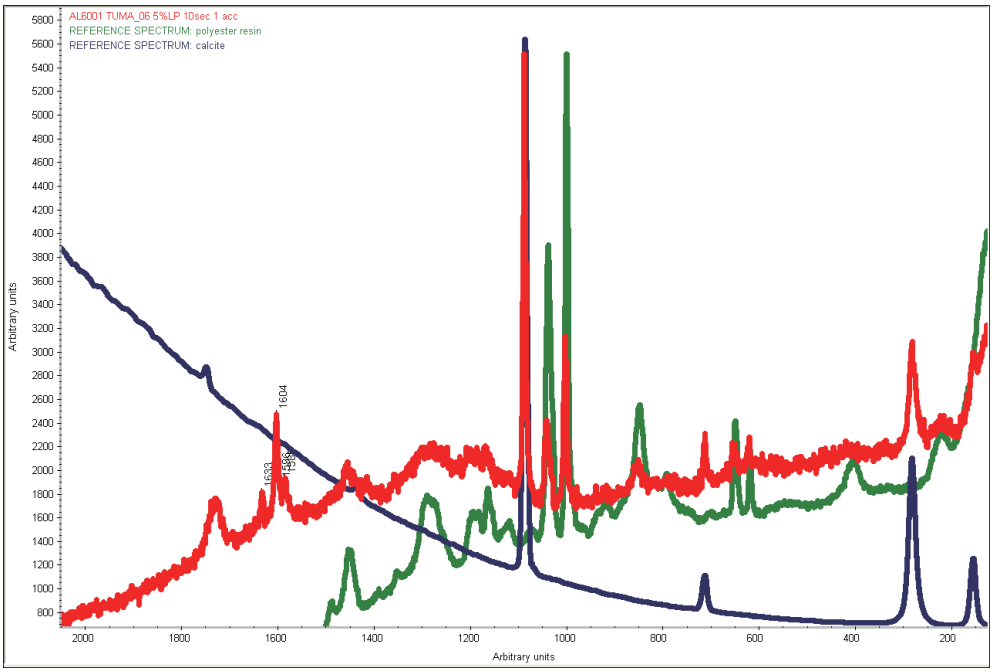
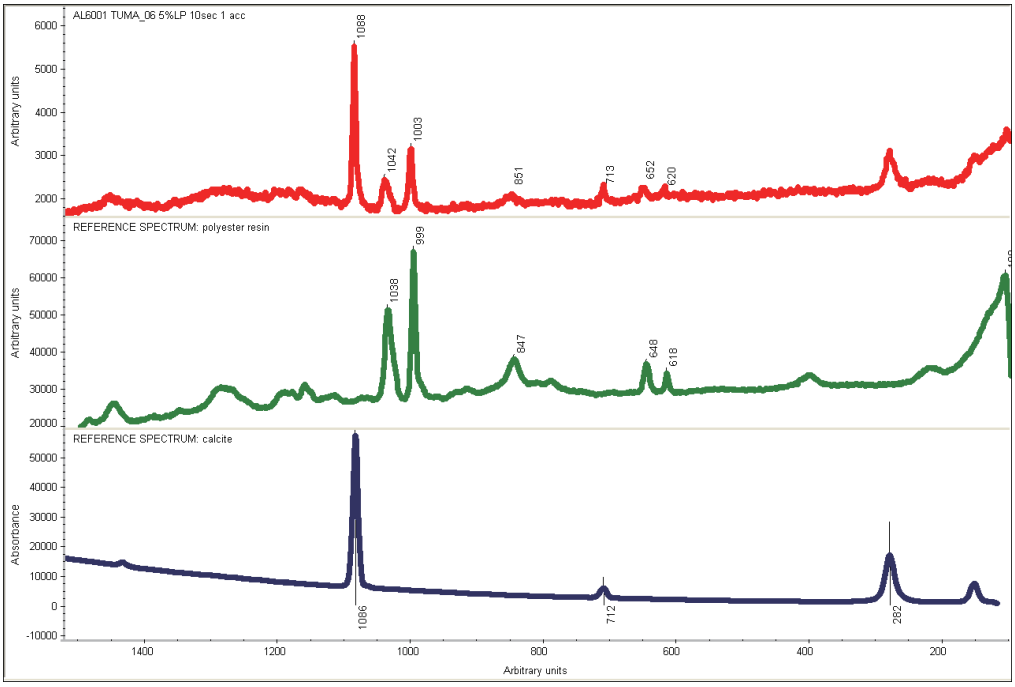
Scientific Research & Analysis Laboratory, Winterthur Museum
TUMA_06 Raman Microscopy Data

- Brownish-yellow layer appears more organic
- To be used for subsequent analyses as sample of potential limewash staining (e.g. to test for application of ferrous sulfate) or application of organic layer
