HISTORIC STRUCTURE REPORT

TUMACACORI NATIONAL MONUMENT
Arizona

by
Anthony Crosby

September 1985

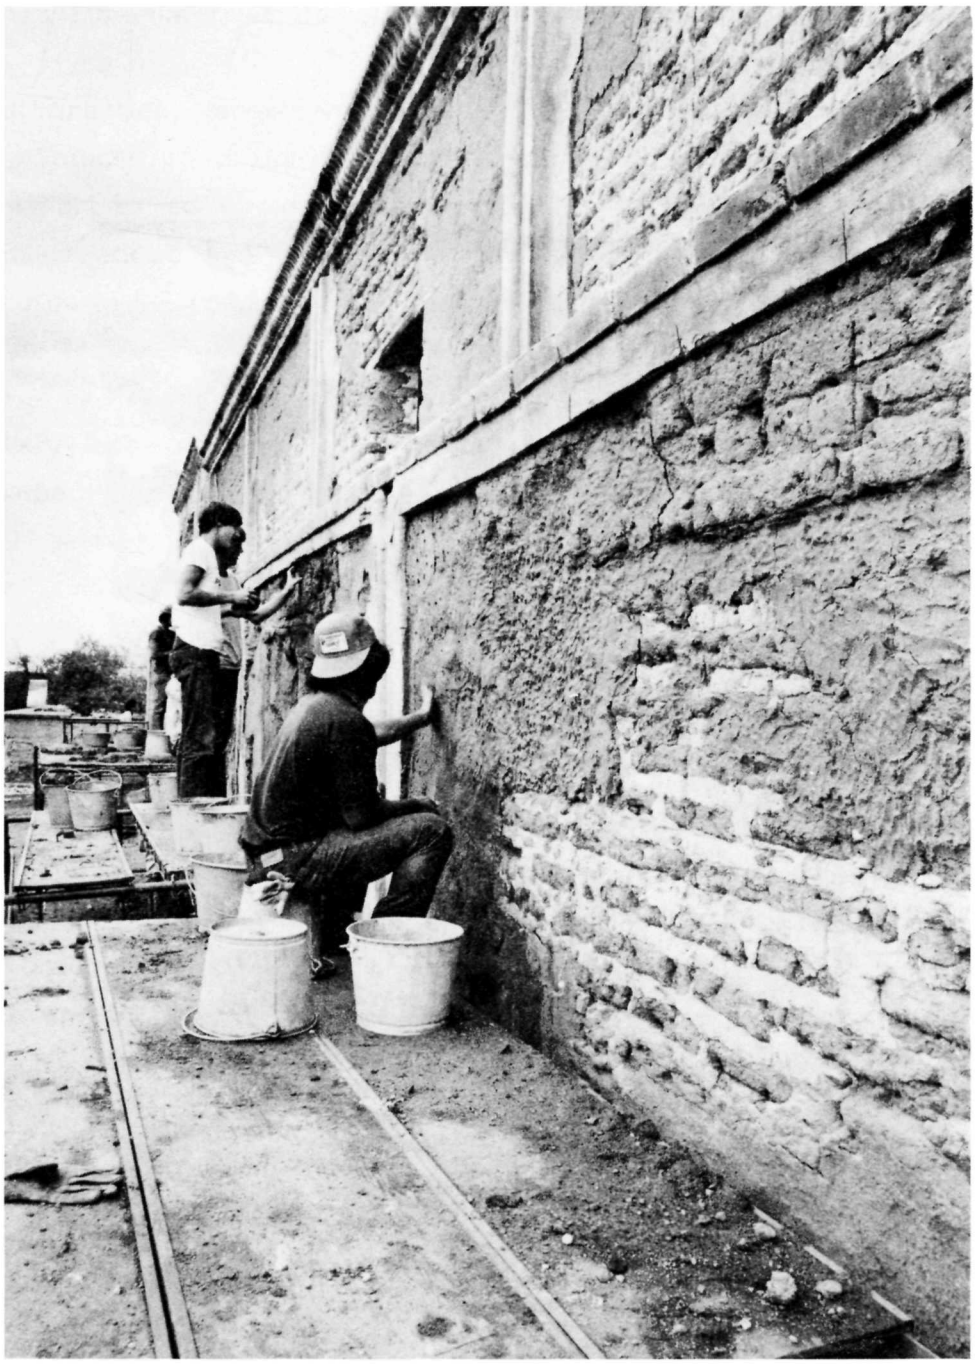
1. West church wall during the filling of voids.

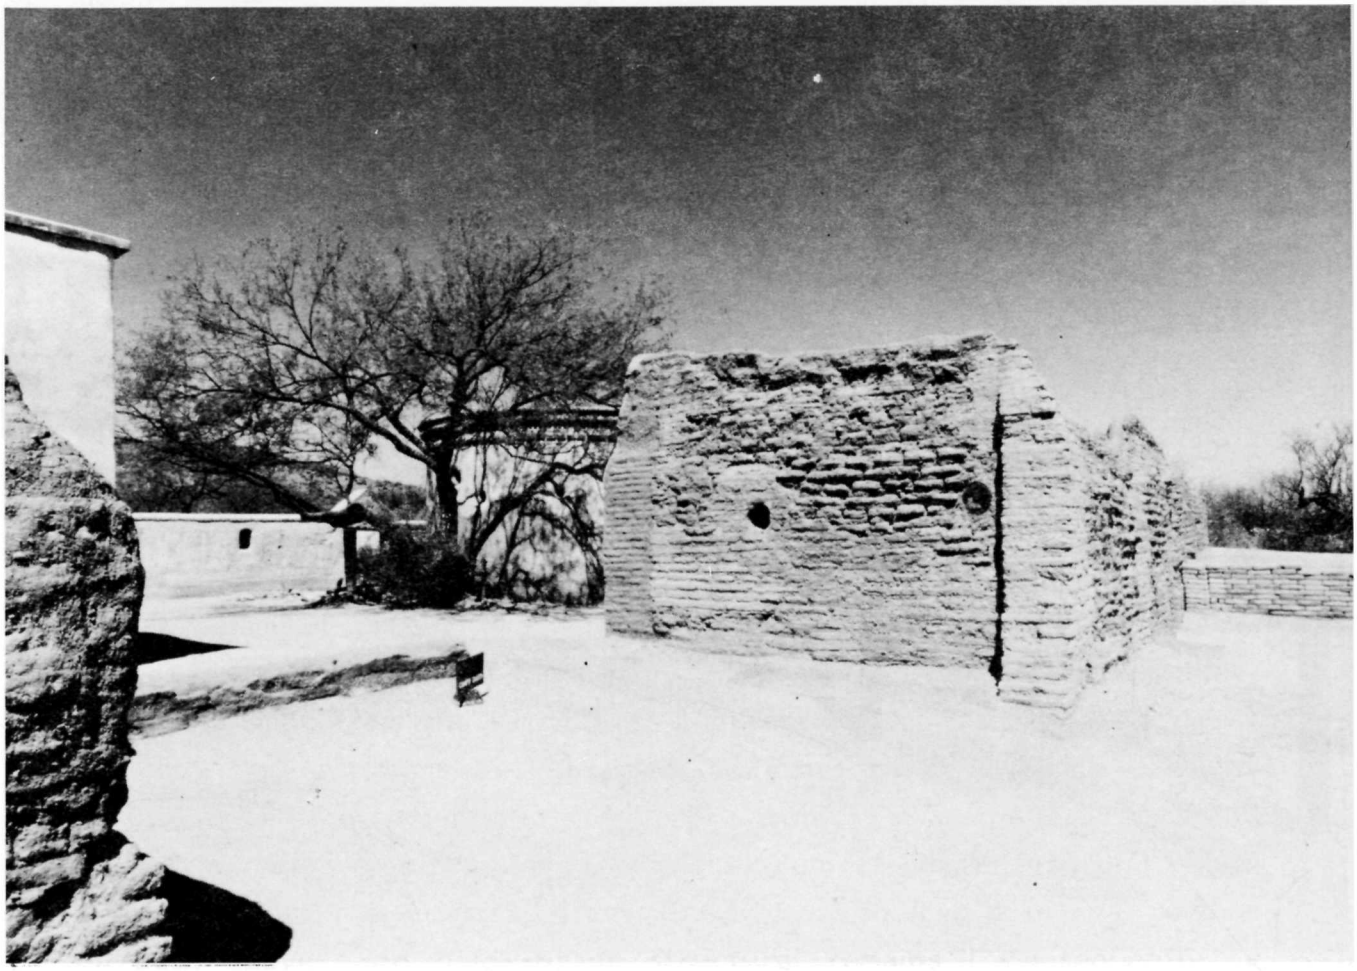
7. The granary from the southeast after the removal of the protective roof.

In retrospect, the dry well would have probably been the best solution. And, in fact, it is probably the solution that should be employed in the future. A recommendation for the development of a solution of this problem is included in "Chapter VIII: General Conclusions and Recommendations."

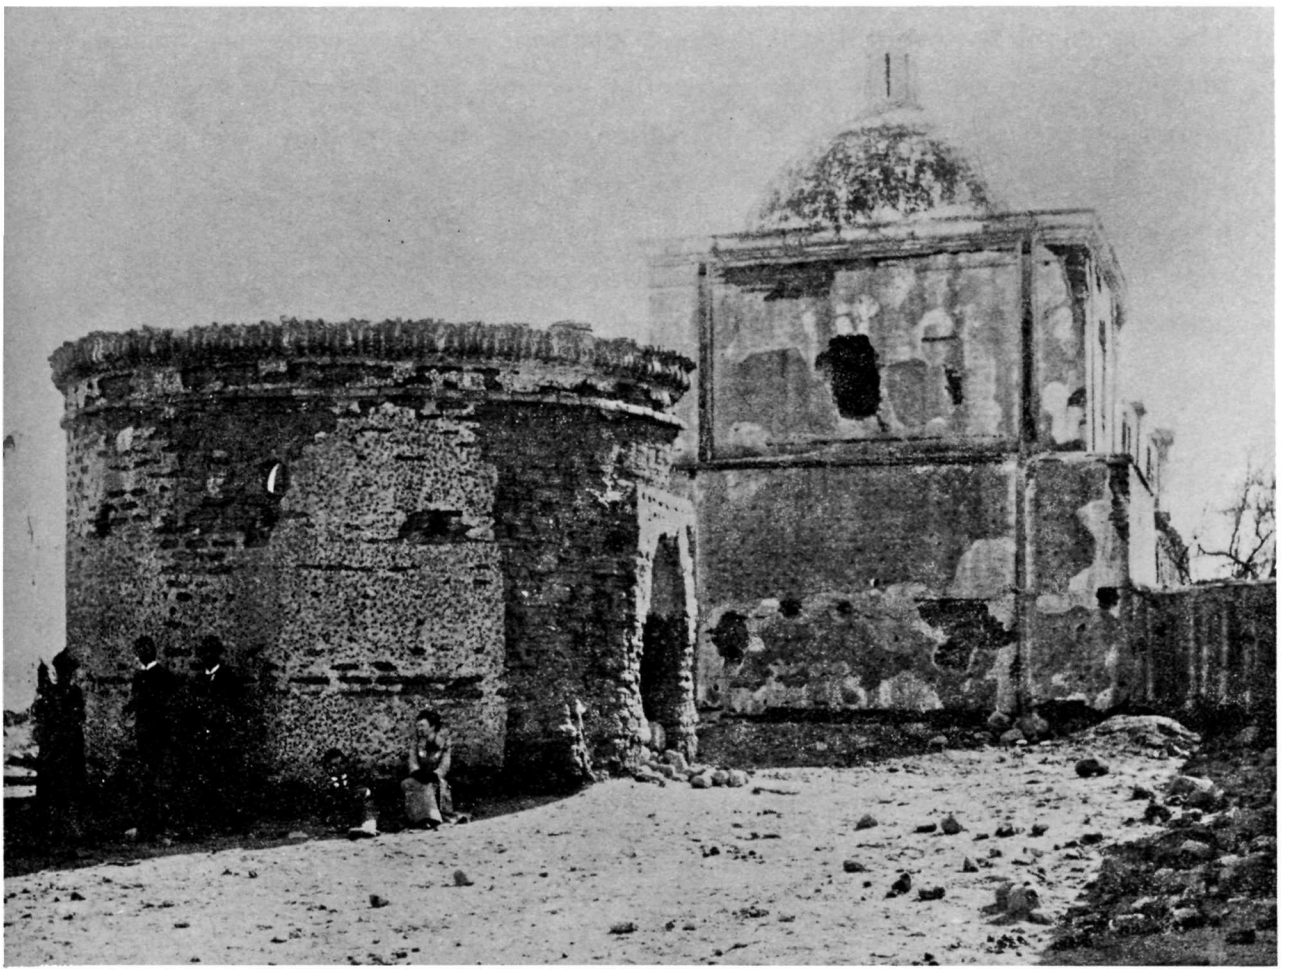
The interior surfaces had been completely replastered with a tinted cement plaster. Much of the exterior surface had also been replastered with the same tinted plaster, but some of the surface of the exterior had been replastered with a cement plaster that attempts to duplicate the

8. A view of the mortuary chapel from the northwest. 1892 International Boundary Resurvey photograph, No. JM-22/3275, Arizona Historic Foundation, Arizona State University Library, Tempe, Arizona.

original finish coat. The original finish coat had small pieces of crushed brick set into the plaster in a random fashion. The physical technique was certainly much the same as was used on the exterior of the camp santo wall and the lower portions of the church, but the result was completely different. It probably reflects a somewhat hurried approach by a less skilled craftsman to a method that had been used previously.

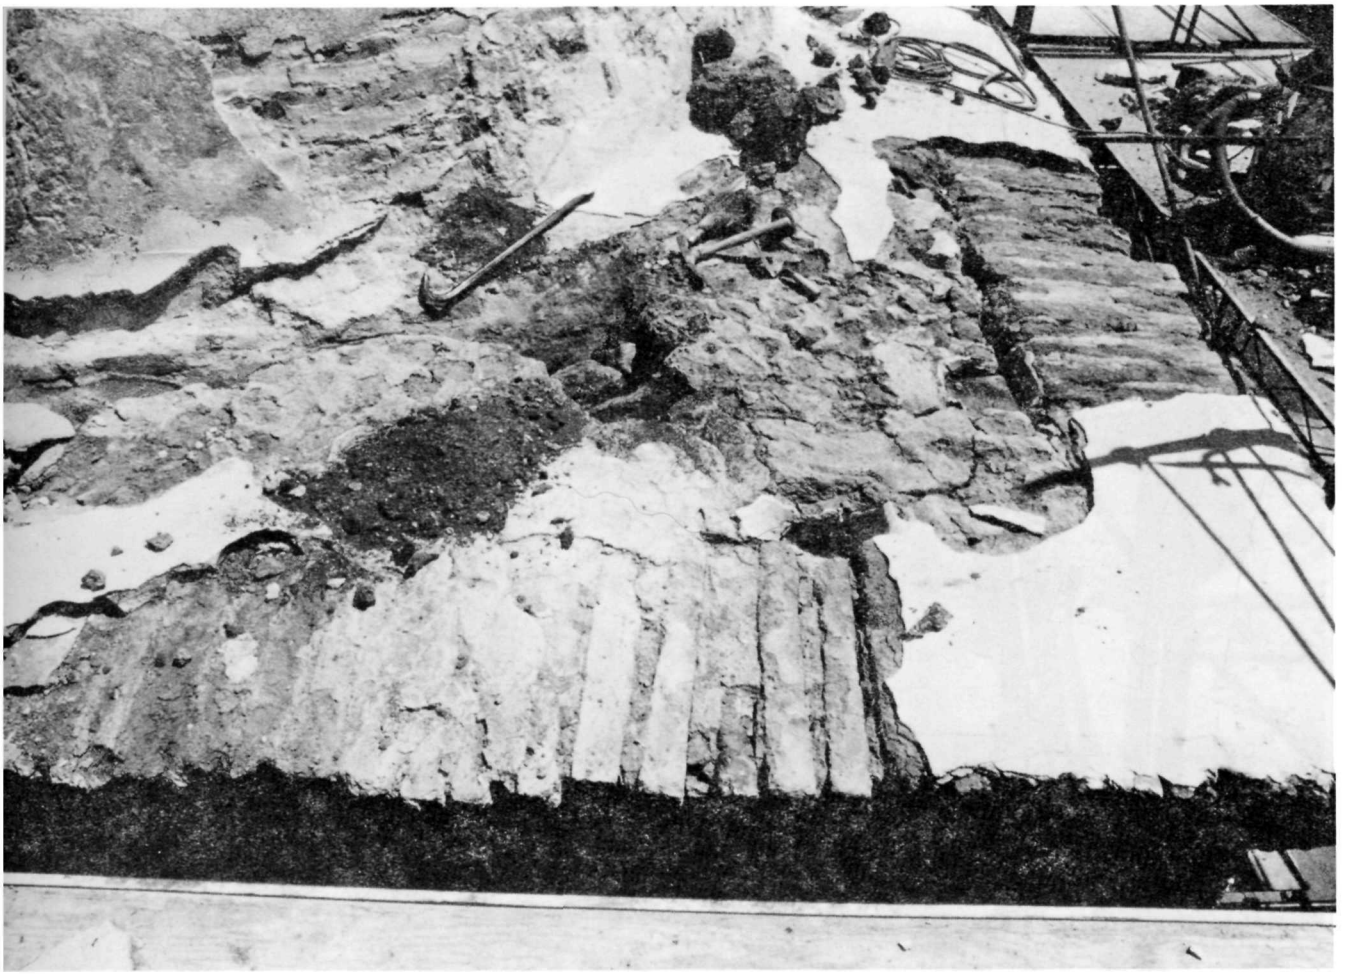
12. A view of the northwest flat portion of the sanctuary adjacent to the dome after removal of the cement stucco. Photograph taken in August 1979.

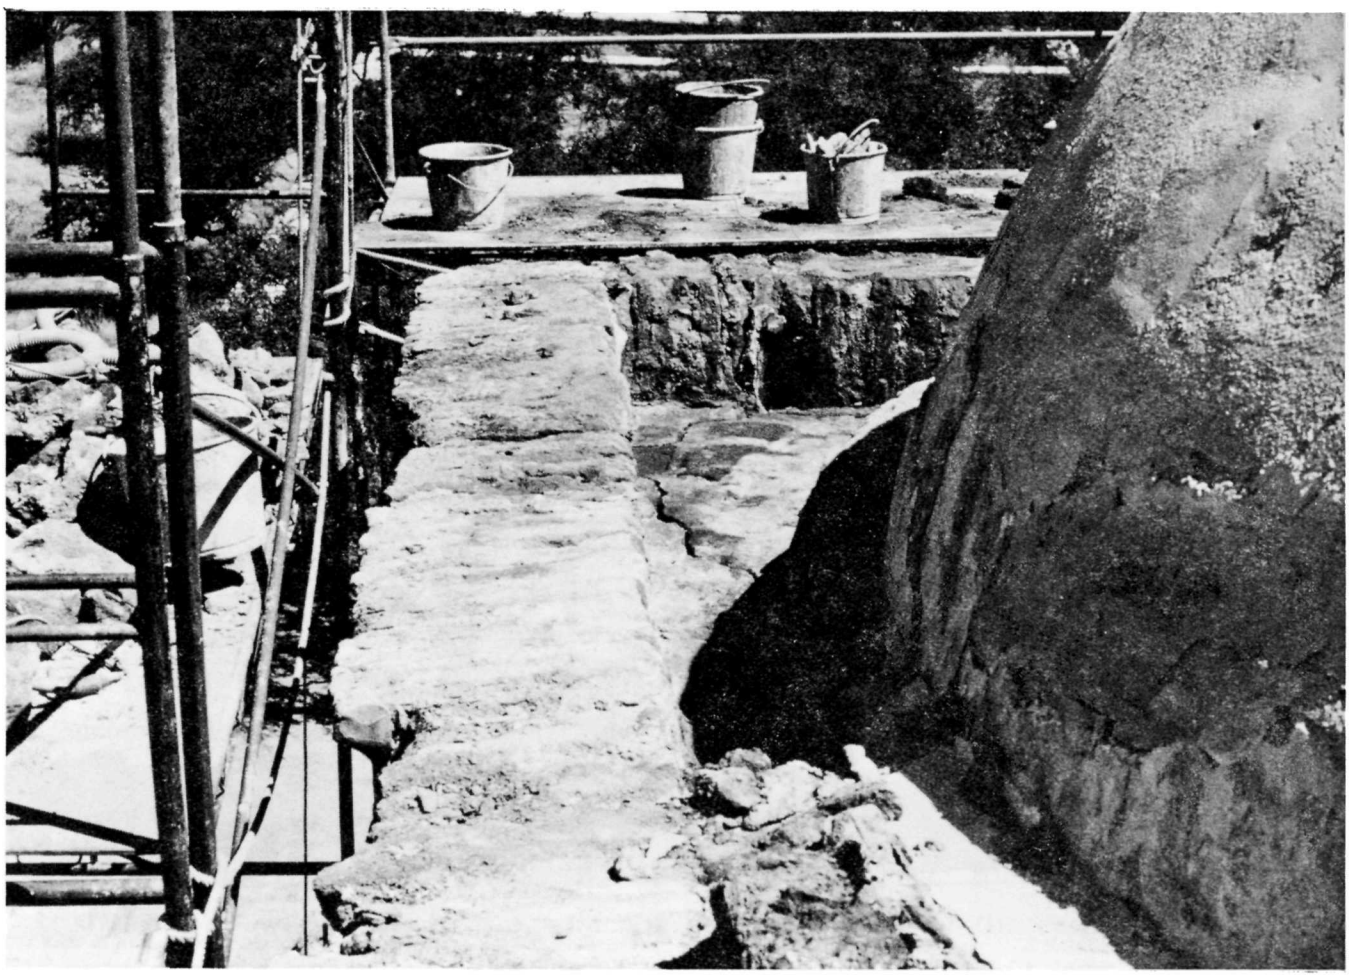
13. A view of the west side of the dome and top of the sanctuary from the south after the removal of the dirt fill.

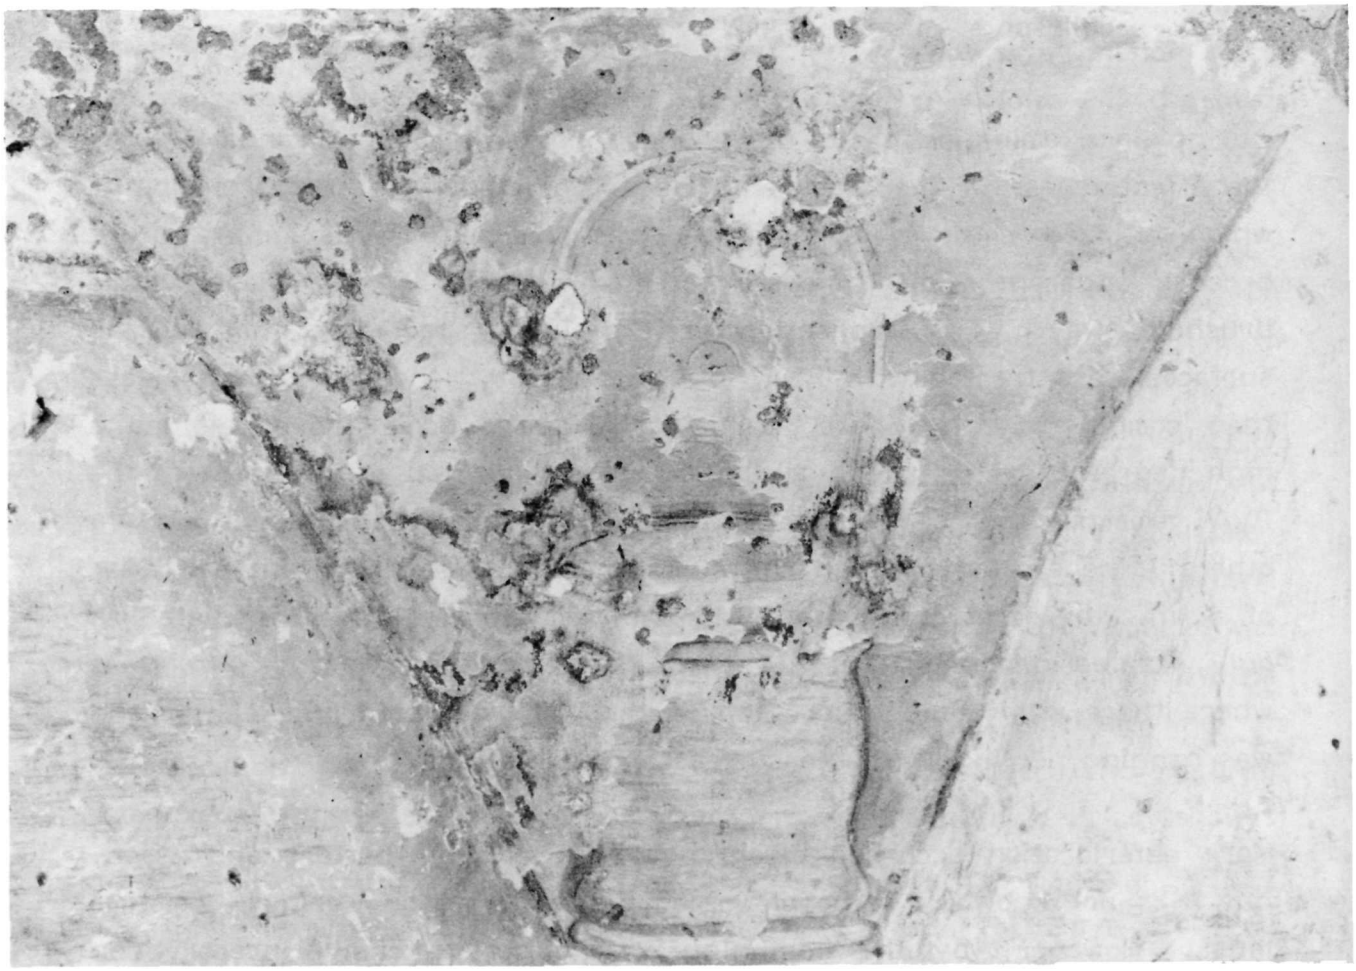
The affected area that had suffered the most was the northwest pendentive (illustration 15). Walter Nitkiewicz, painting conservator with the National Park Service's Harpers Ferry Center, evaluated the

15. View of the northwest pendentive.

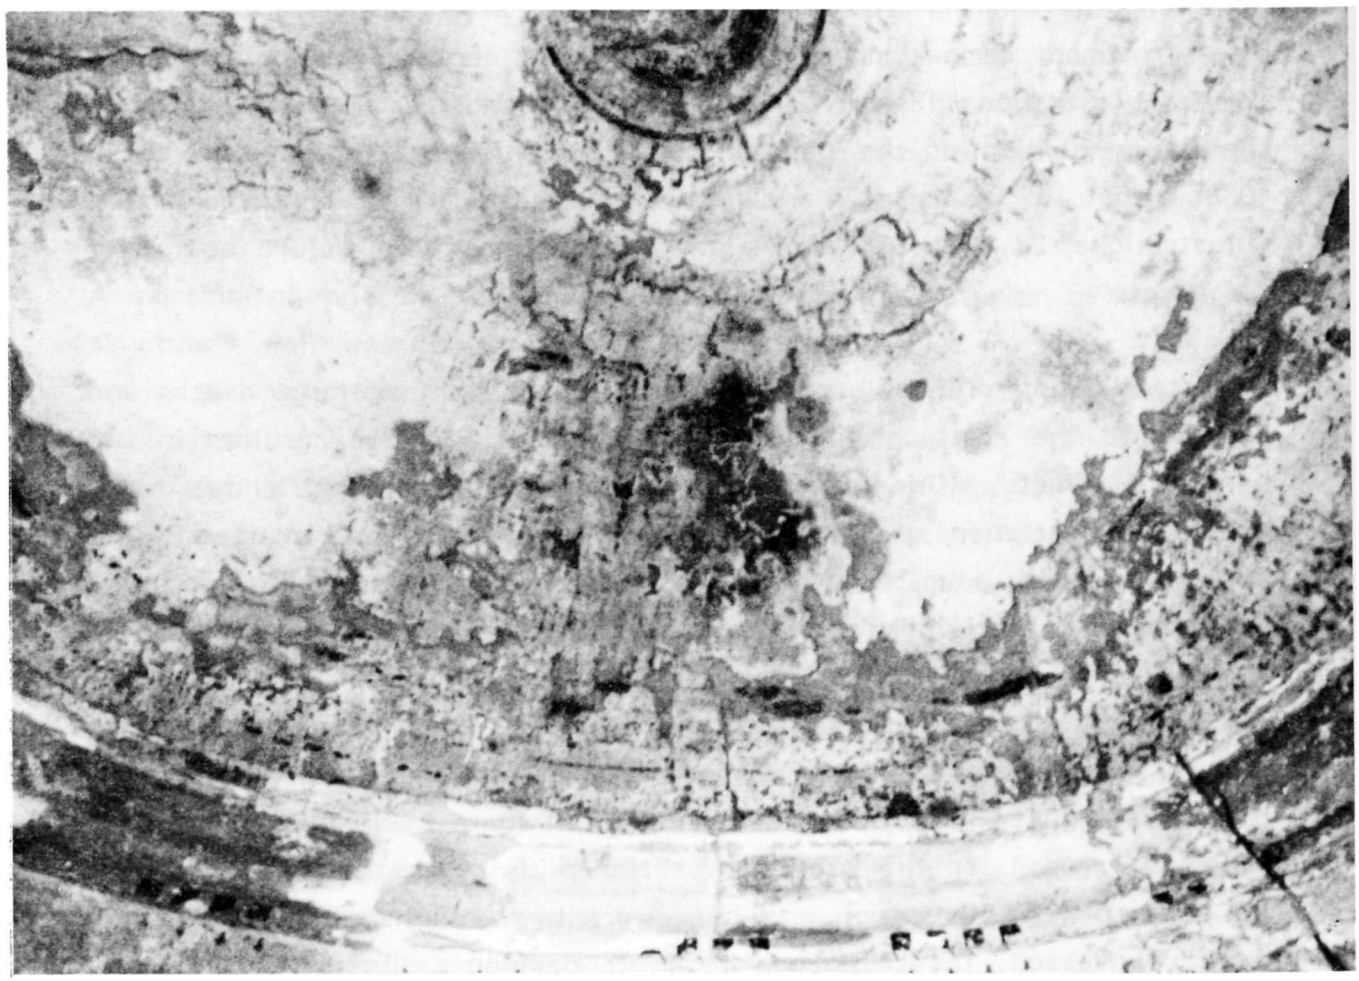
16. South side of the sanctuary dome before treatment, 1981.

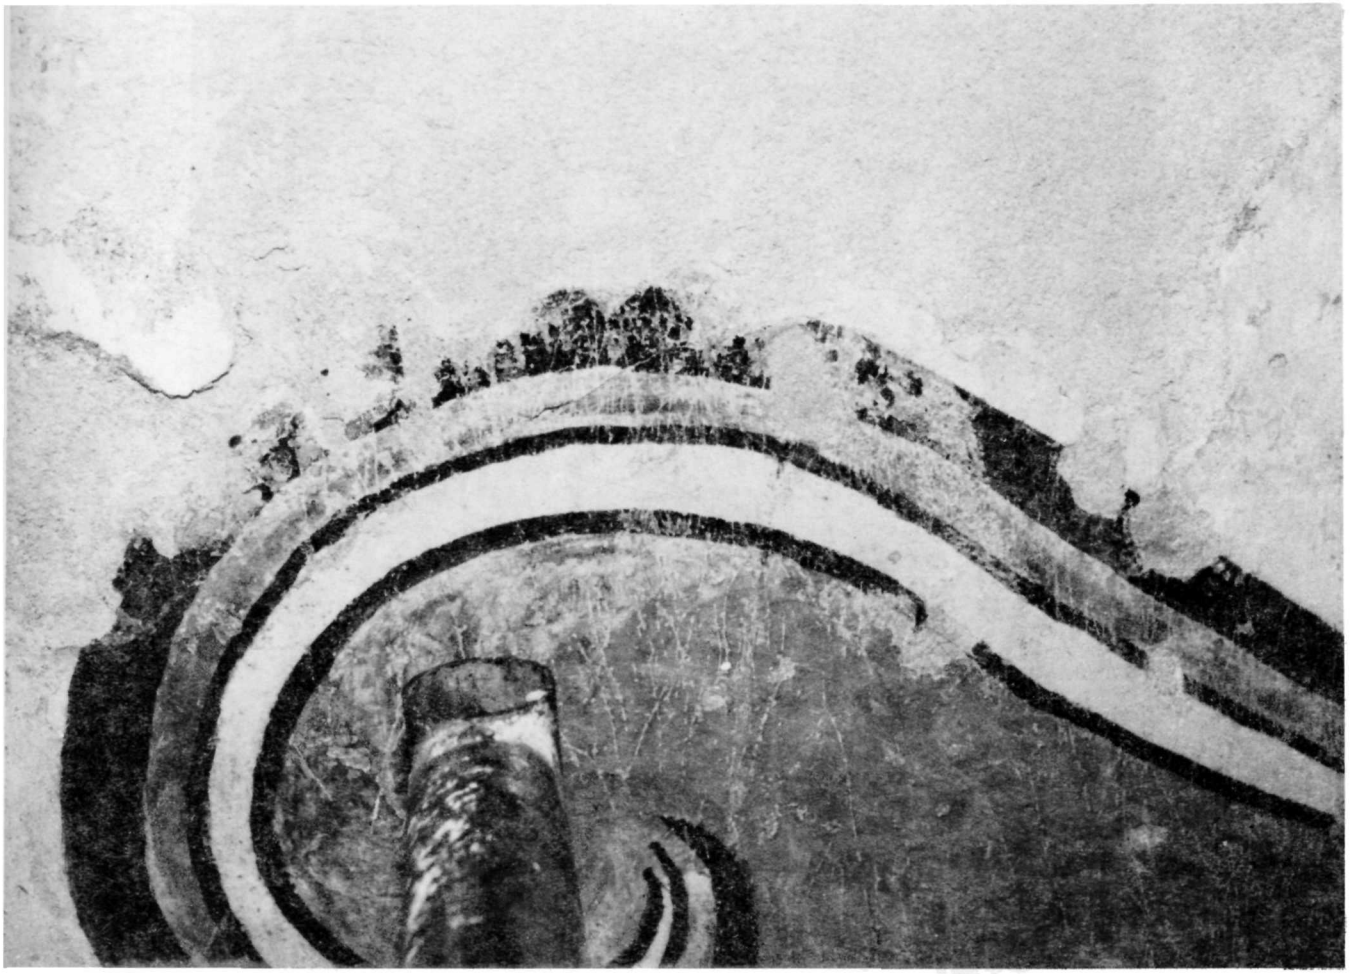
19. Painted volute on the sanctuary's north wall after treatment, August 1982.

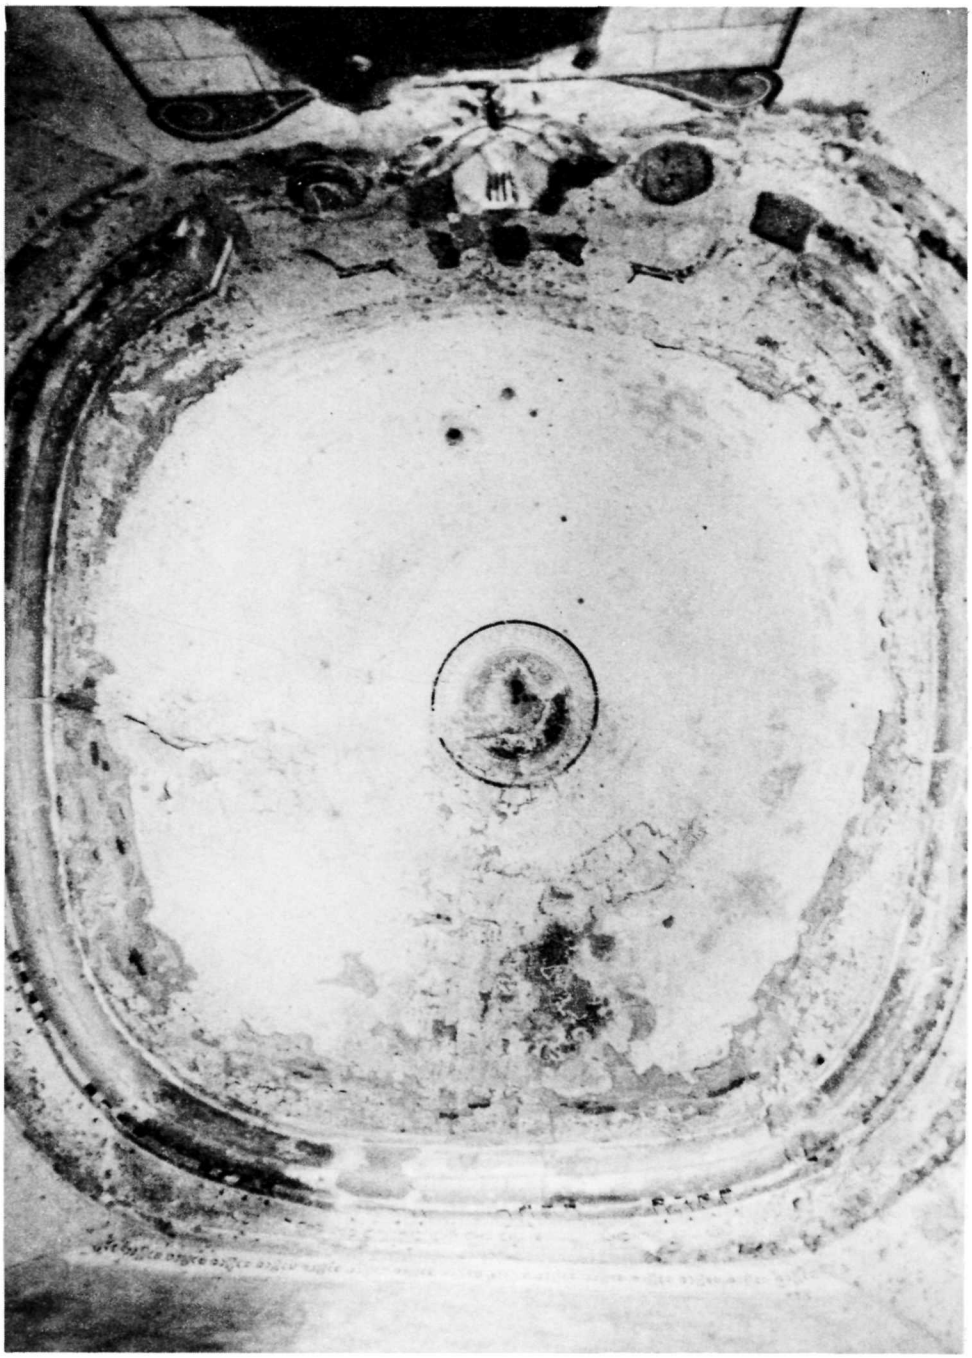
20. Interior of the dome before treatment, 1979.

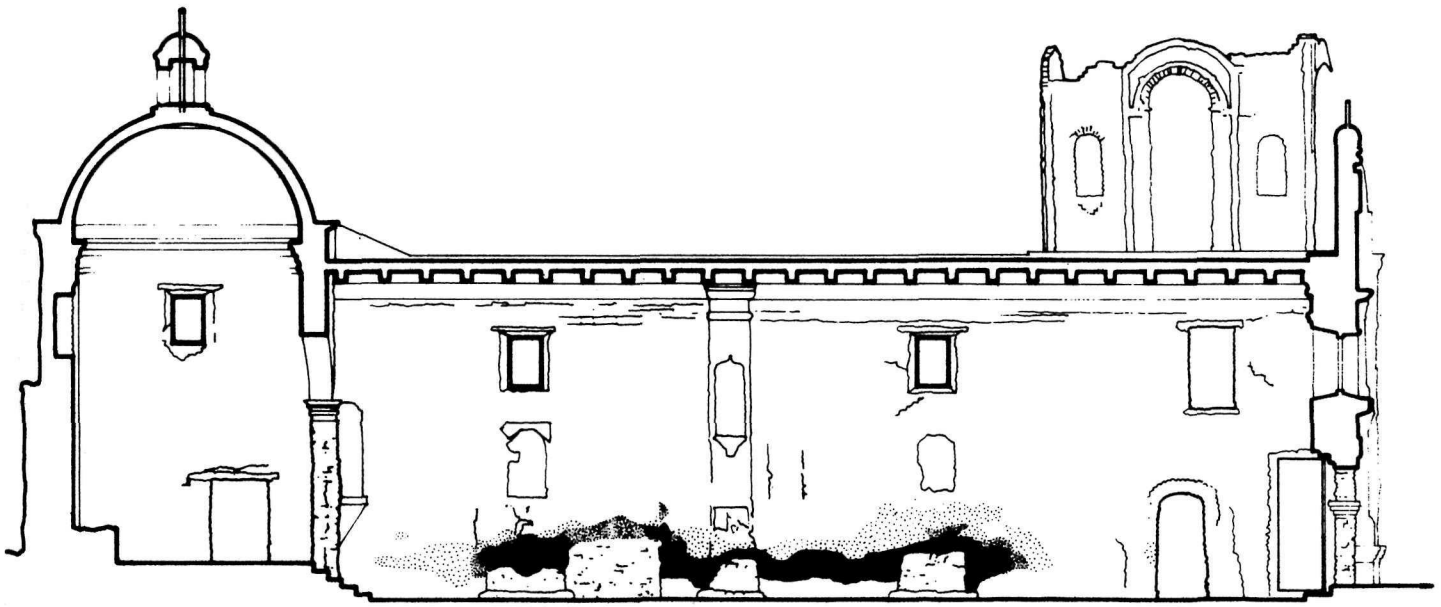
SURFACE MOISTURE SURVEY: EAST NAVE WALL

Dec. 1, 1976 reading ☐ 0-30 ▒ 30-60 ▓ 60-85 ■ 85-100

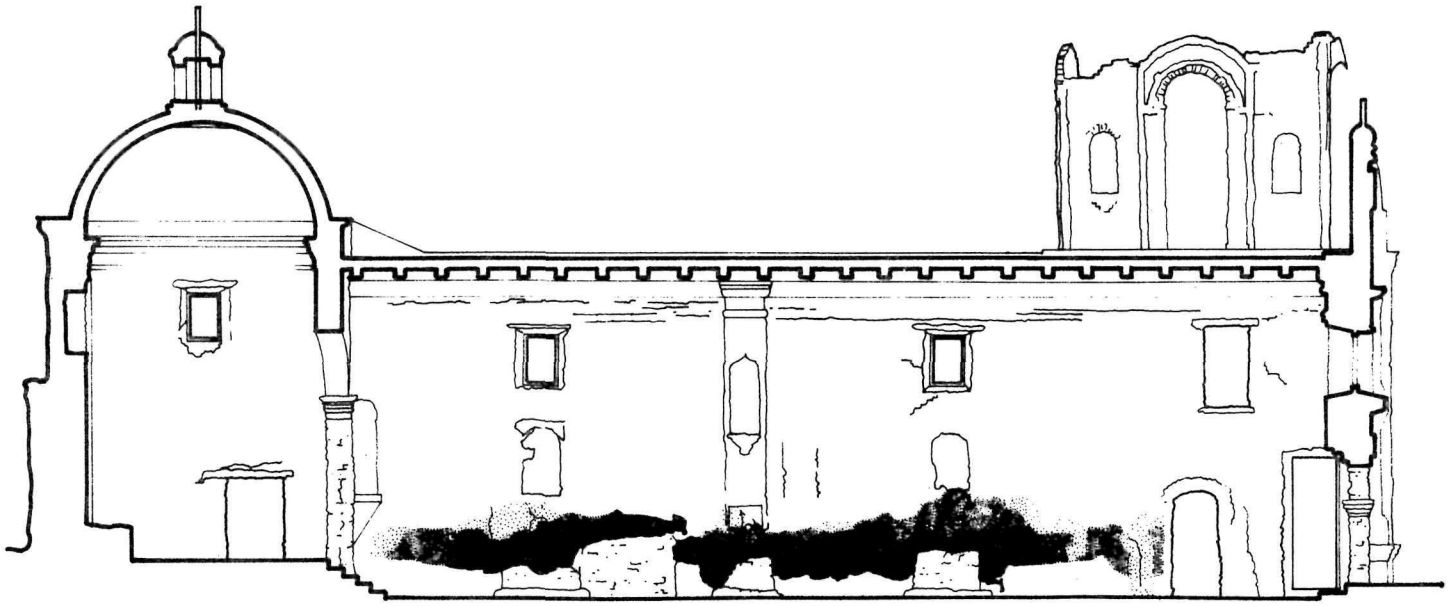
ILLUSTRATION 28.

SURFACE MOISTURE SURVEY: EAST NAVE WALL
Feb. 11, 1977 reading ☐ 0-30 ▒ 30-60 ▓ 60-85 ■ 85-100
Readings taken with Protimeter Mini.

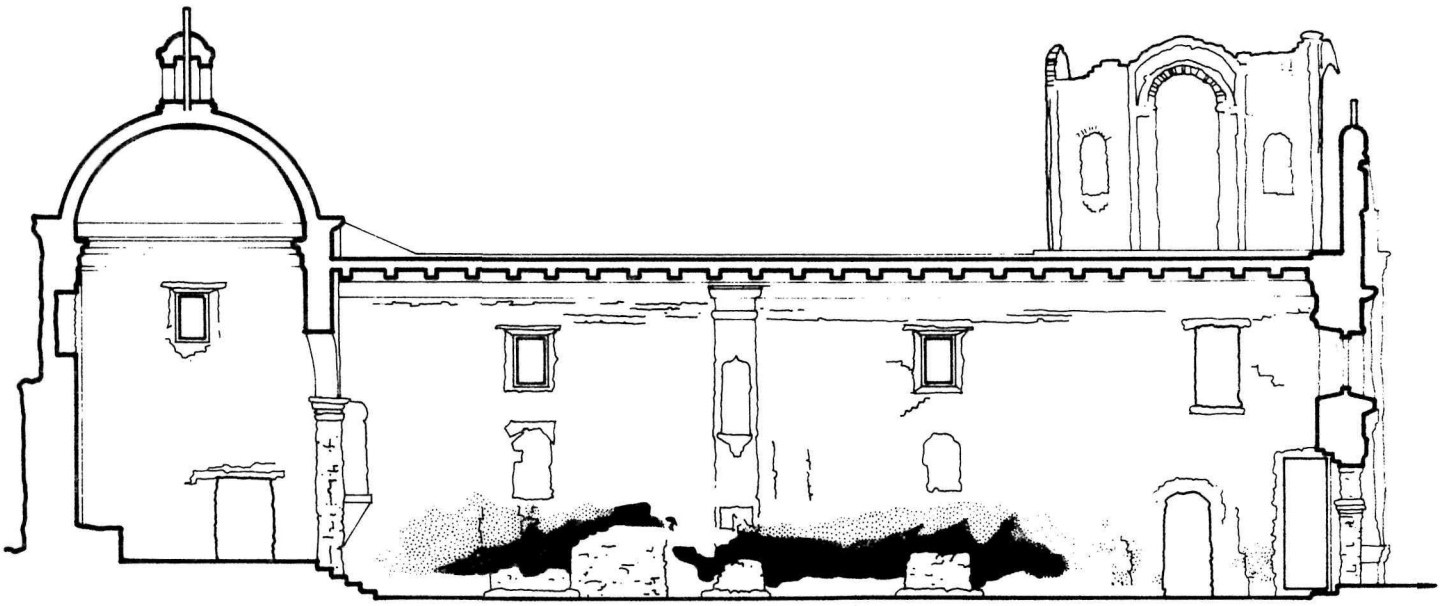
ILLUSTRATION 29.

SURFACE MOISTURE SURVEY: EAST NAVE WALL
April 1977 reading ☐ 0-30 ▒ 30-60 ▓ 60-85 ■ 85-100
Readings taken with Protimeter Mini.

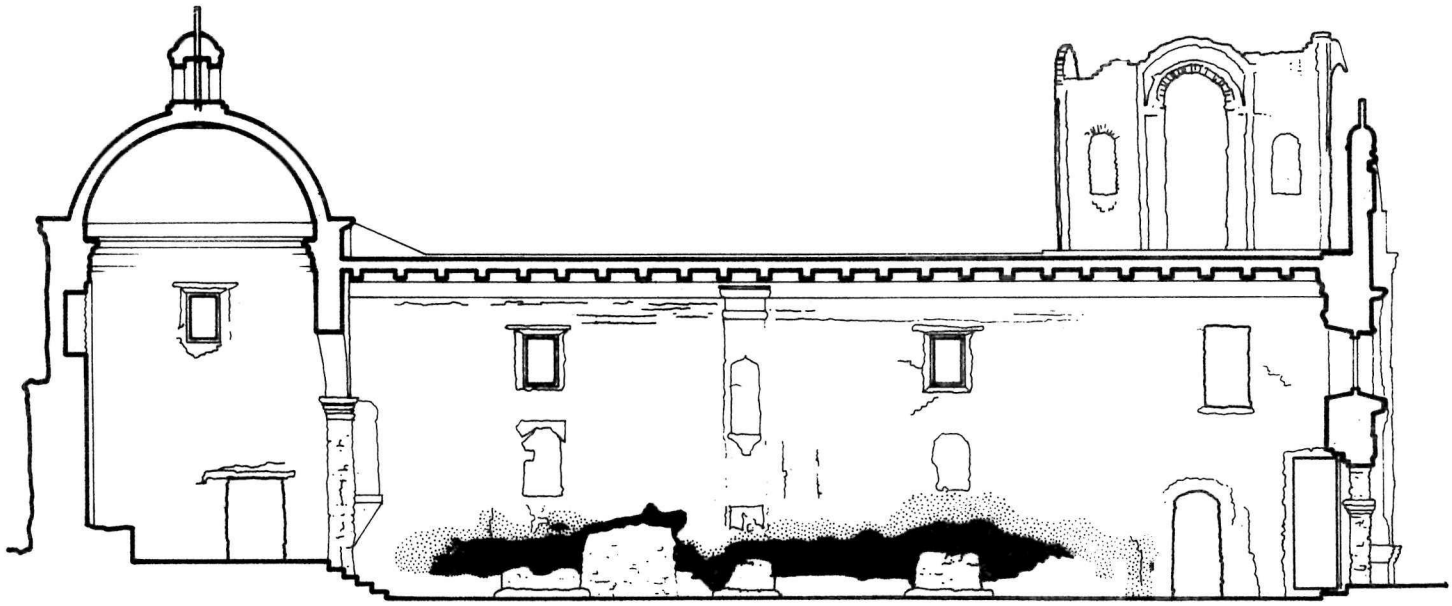
ILLUSTRATION 30.

SURFACE MOISTURE SURVEY: EAST NAVE WALL
May 14, 1977 reading ☐ 0-30 ▒ 30-60 ▓ 60-85 ■ 85-100
Readings taken with Protimeter Mini.

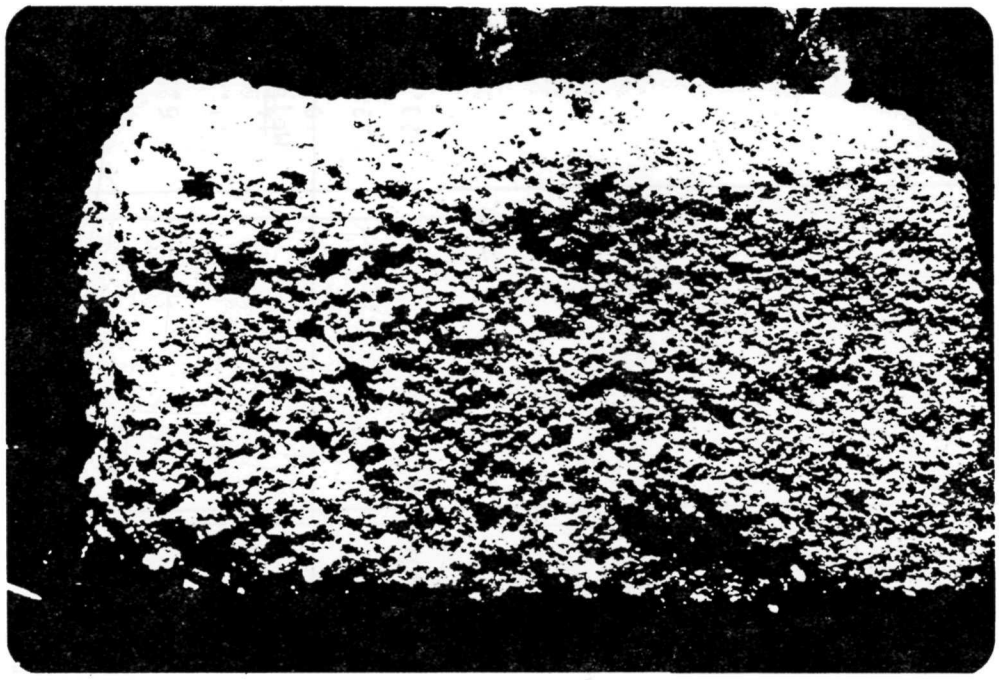
Figure 1a: Rear or unfinished side of Sample B after the drying associated with test 3. Three-treatment area is on the upper right and the one-treatment area is below it. Scale: approximately actual size.

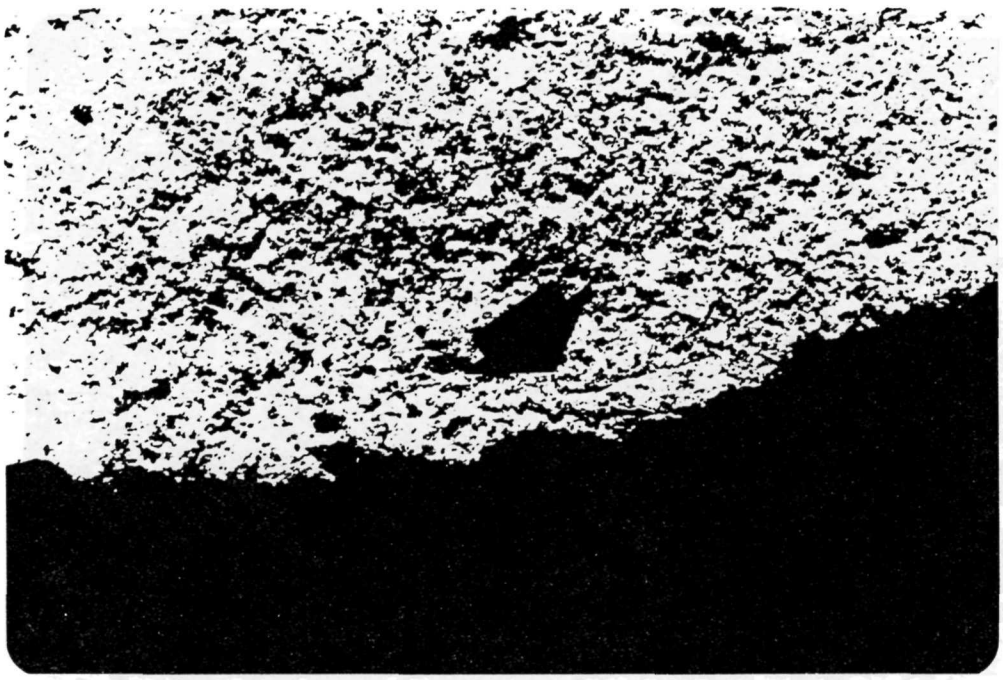
Figure 3: Detail of plaster Sample B showing edge fractures. Scale: approximately five times actual size.

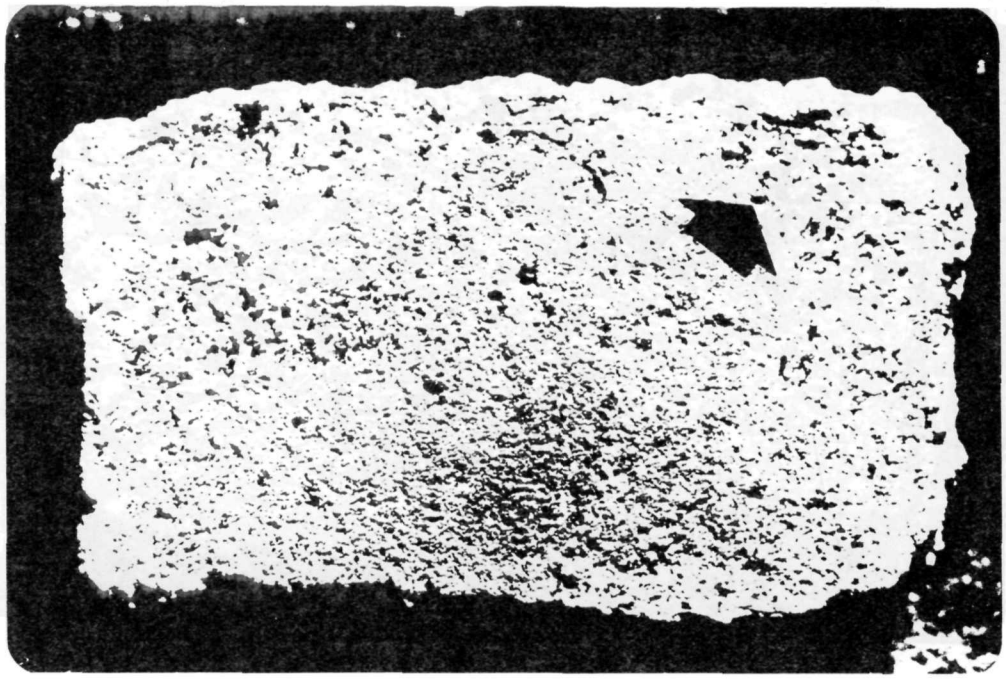
Figure 4a: Surface deterioration of plaster Sample B. Scale: actual size.

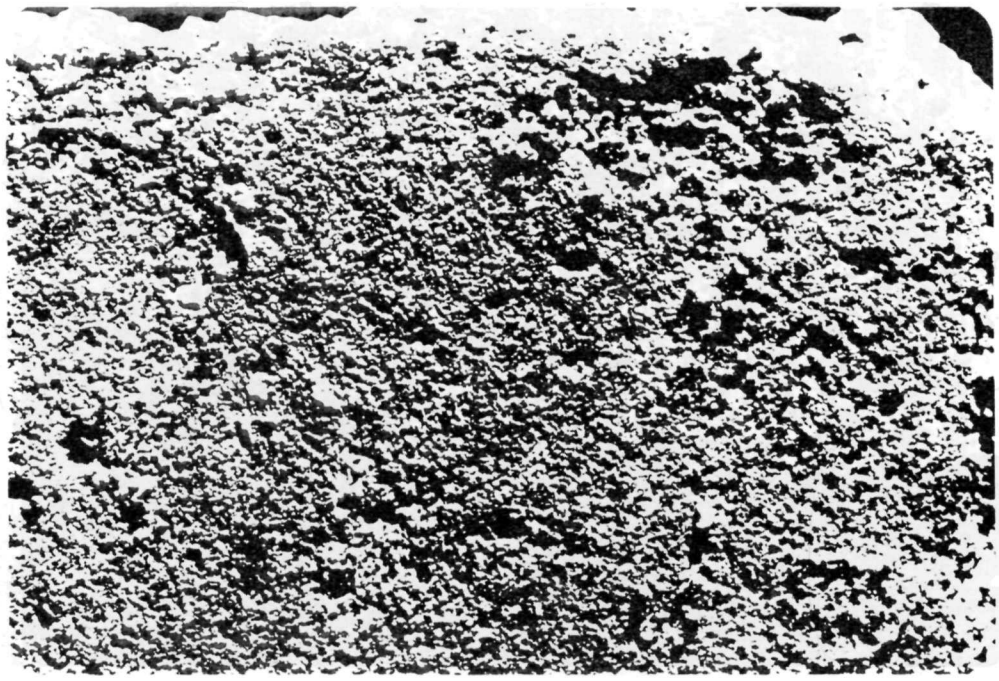
Figure 4b: Detail of Figure 4a. Scale: approximately two times actual size.

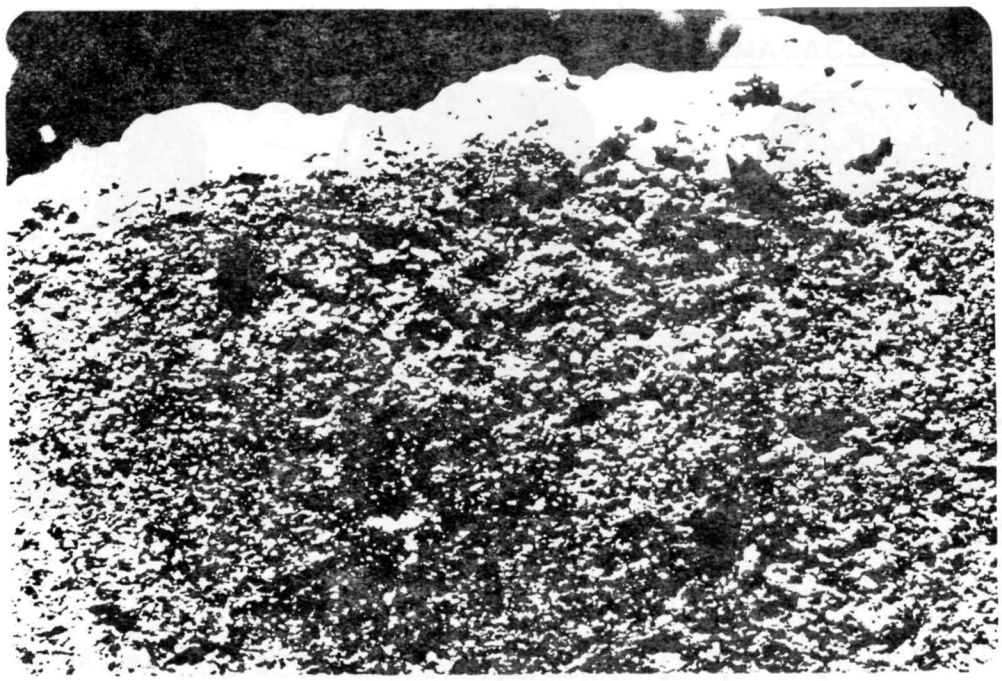
Figure 5: Detail of the upper right of plaster Sample B where small sections have lifted from the finished surface. Scale: approximately four times actual size.

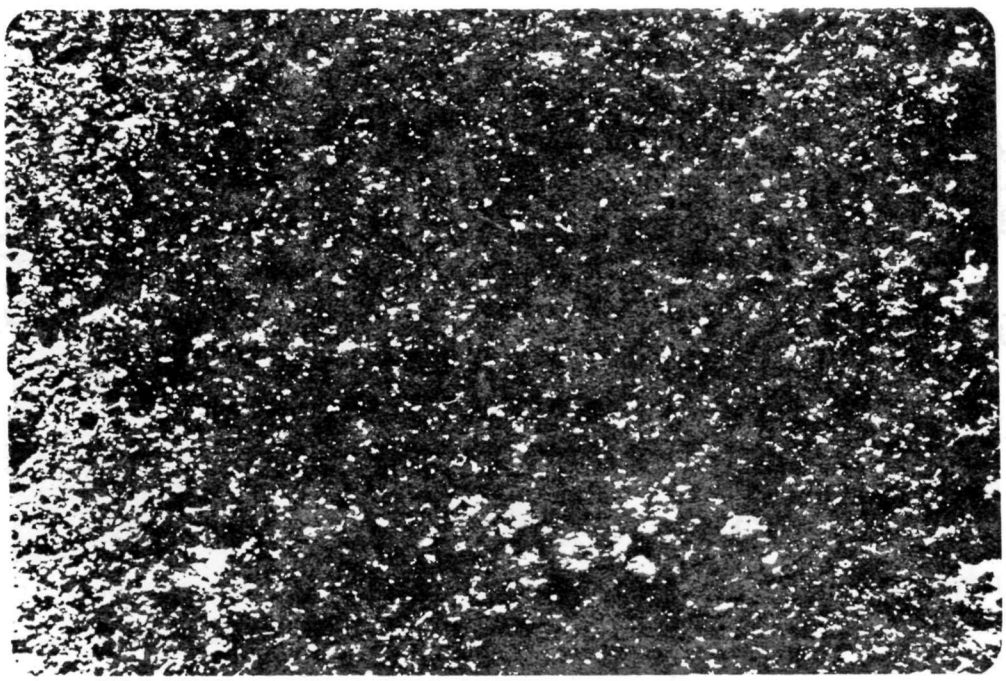
After test 3, the Acryloid B-72 was clearly visible on the surface. After test 4 the B-72 appears to have been pushed from the surface, was somewhat fuzzy, and some had disappeared. It remained clearly visible after the subsequent tests in the three-treatment area. One of these is pointed out in the detailed photograph of Figure 6.

Figure 6: Detail of the center right portion of plaster Sample B showing the remains of some Acryloid B-72 which remained on the surface. Scale: approximately four times actual size.

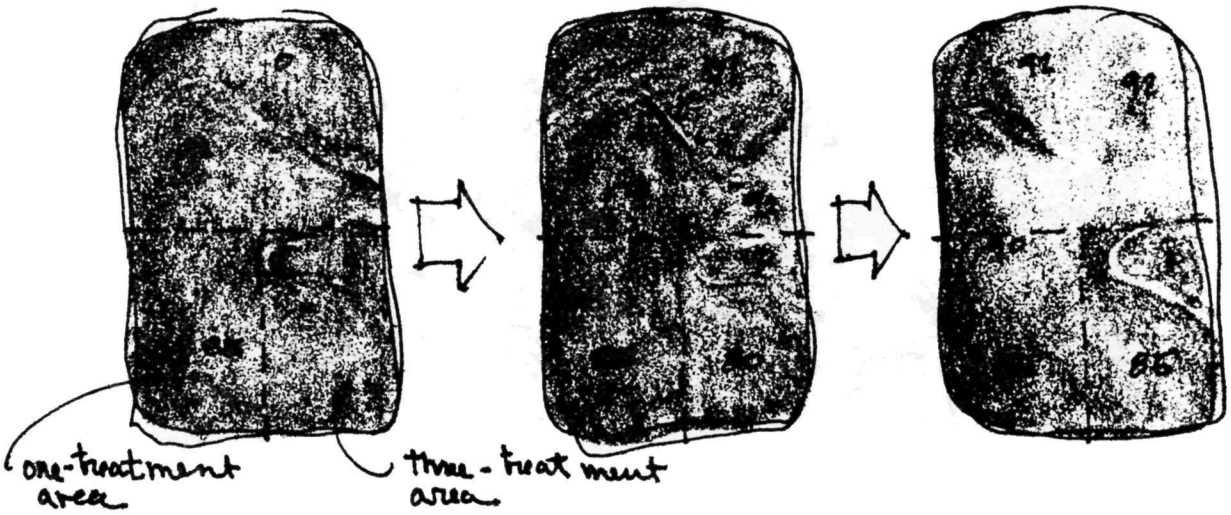
Figure 7: Back side of plaster Sample B showing visable capillary rise and relative surface moisture readings after 1 1/2, 2 1/2, and 4 hours, respectively. The blue areas are those which appear to be wet.

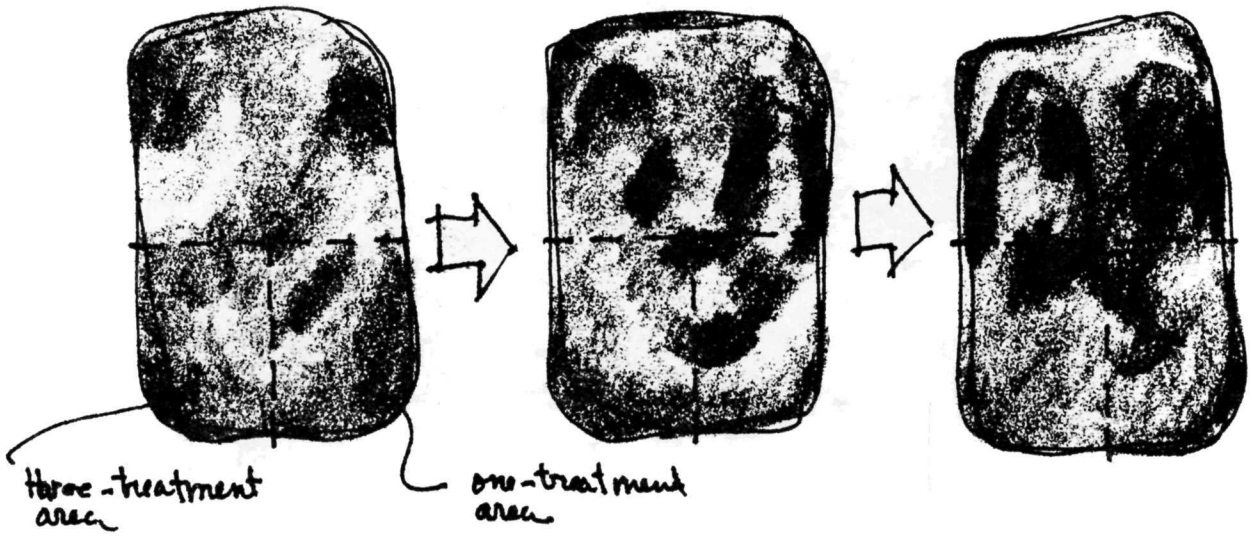
Figure 8: Front side, or finished surface of plaster Sample B showing the formation of efflorescence after 2, 3, and 18 hours respectively. The intensity of the gray areas represents the amount of efflorescence.
