HISTORIC STRUCTURE REPORT

TUMACACORI NATIONAL MONUMENT
Arizona

by
Anthony Crosby

September 1985

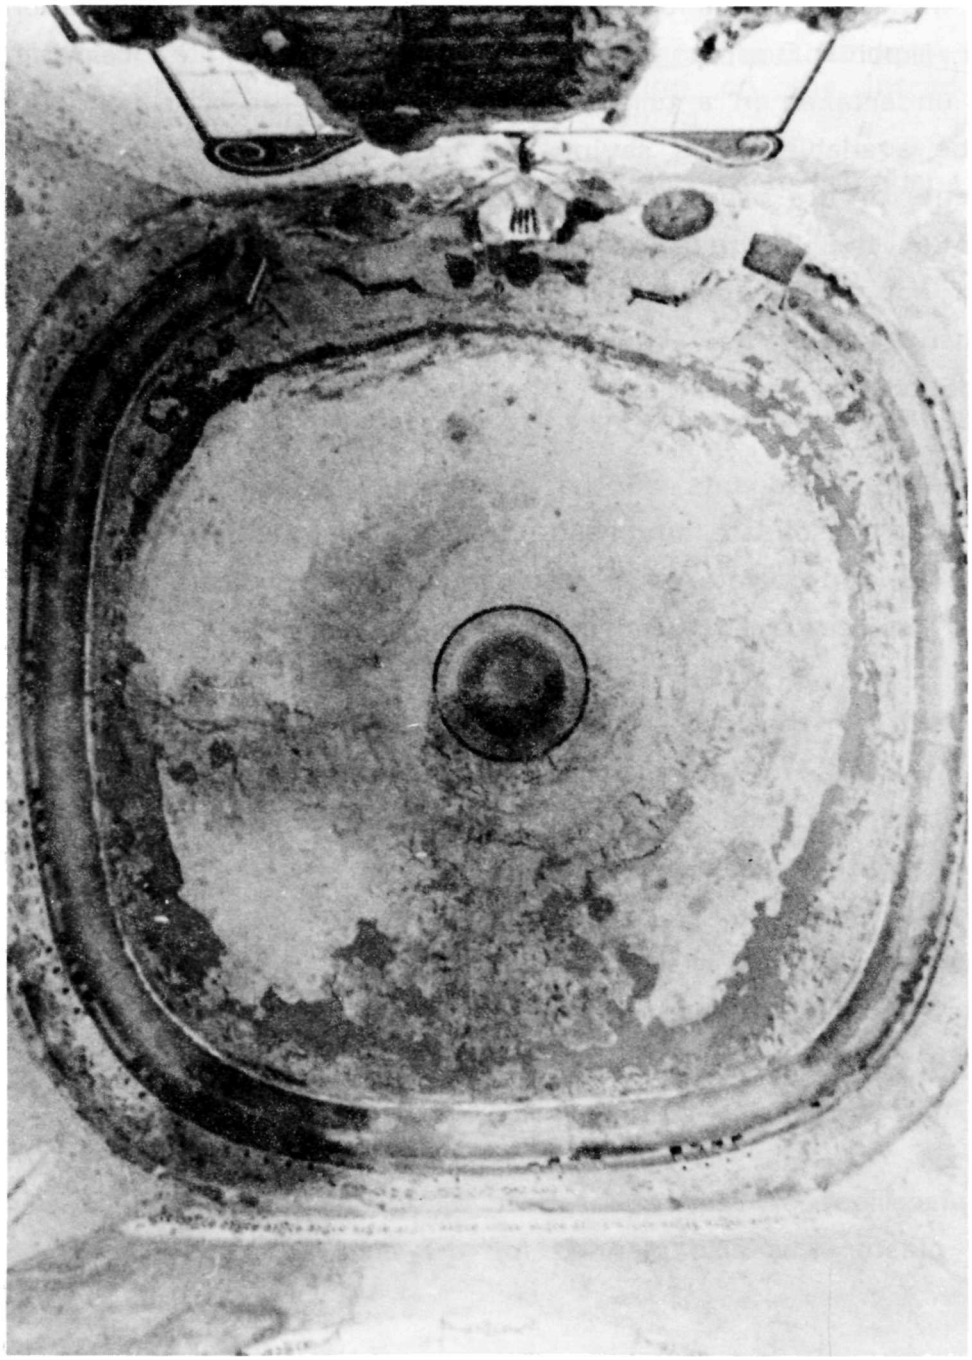
21. Interior of the dome after treatment, August 1982.

The general components of the remaining conservation work are listed below: (1) consolidate and reattach paint and plaster, (2) clean plaster surfaces as appropriate, (3) reconstruct missing plaster as appropriate, and (4) replace cement bead in lower plaster edge.

The reconstruction of missing plaster will also be less extensive than was necessary during the summer of 1982, but some is needed on the original plaster in specific locations on both the interior and exterior of the building.

The replacement of the cement bead along the lower edge of all original interior plaster was also planned for the summer of 1982, but it was not begun.

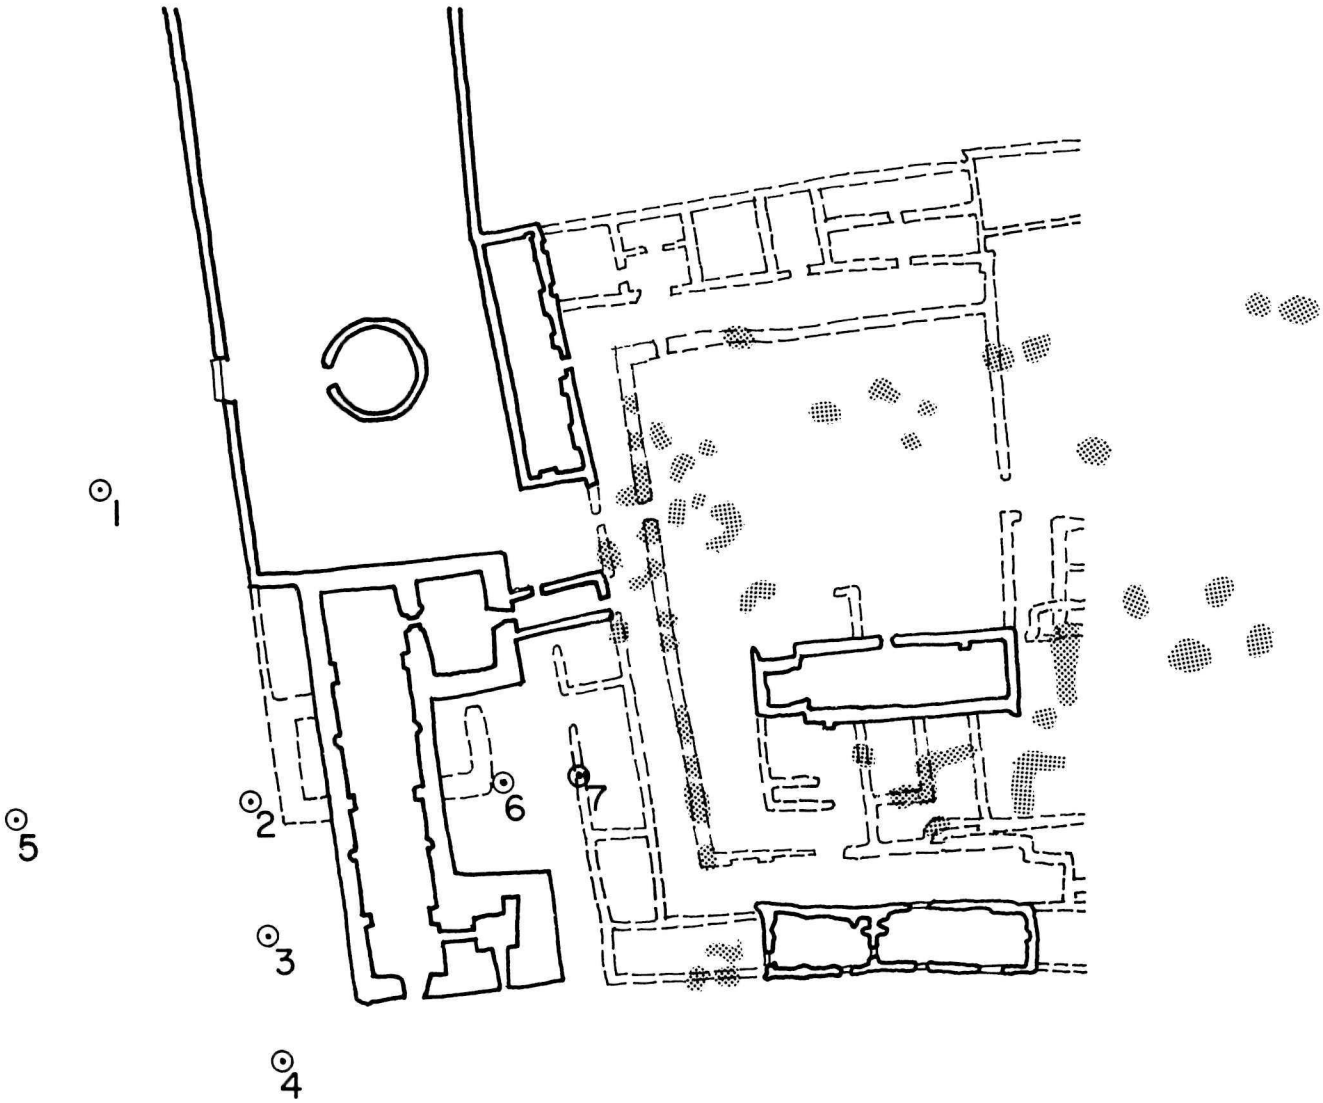
SOIL MOISTURE MAP

At the time of the subsurface investigation, Doug McCollough, chief of maintenance at Tumacacori, pointed out several spots in the area of the convento patio that appeared to be wet (illustration 22). A continuous monitoring of these spots indicated they remained dark, or stained, and at relatively high moisture contents throughout the year. On May 26, 1977, after a period of two months without rain, the moisture content by weight of the soil only 1 inch below the ground surface in two of these dark spots was 8.6 percent and 6.2 percent. A nonstained area used as a control contained 1.5 percent moisture.

The darkest areas were approximately 40 feet east of the east nave wall of the church, just to the west of the paved walk, southeast of the granary, and just east of the concrete block foundations that mark the apparent foundations of an earlier Jesuit church. The architectonic quality of these stained spots seems to indicate some direct relationship to subsurface architectural remains. The one area that extends parallel to

the church is near the foundations of the original convento arcade. Also, the dark spot just south of the Jesuit church foundation formed a perfect right angle being approximately 2 feet wide, the normal single wall thickness. However, when compared with an archeological map of this same area, this particular feature was not indicated.

These dark spots contain a much higher salt content than the surrounding soil, and it seems possible that the spots themselves were the results of salt being leached out of subsurface architectural features and migrating to the surface of the ground. There existed, however, a relationship between portions of buildings affected by capillary moisture, the abnormal subsurface condition southwest and east of the church, and these dark stained areas. A relationship that did not exist in other areas of abundant subsurface remains. Consequently, while the stained areas probably did relate to subsurface features, an abnormal amount of subsurface moisture affected them, causing them to show up in this area. In addition, this same abnormal subsurface moisture condition probably contributed to the capillary moisture of the building aboveground.

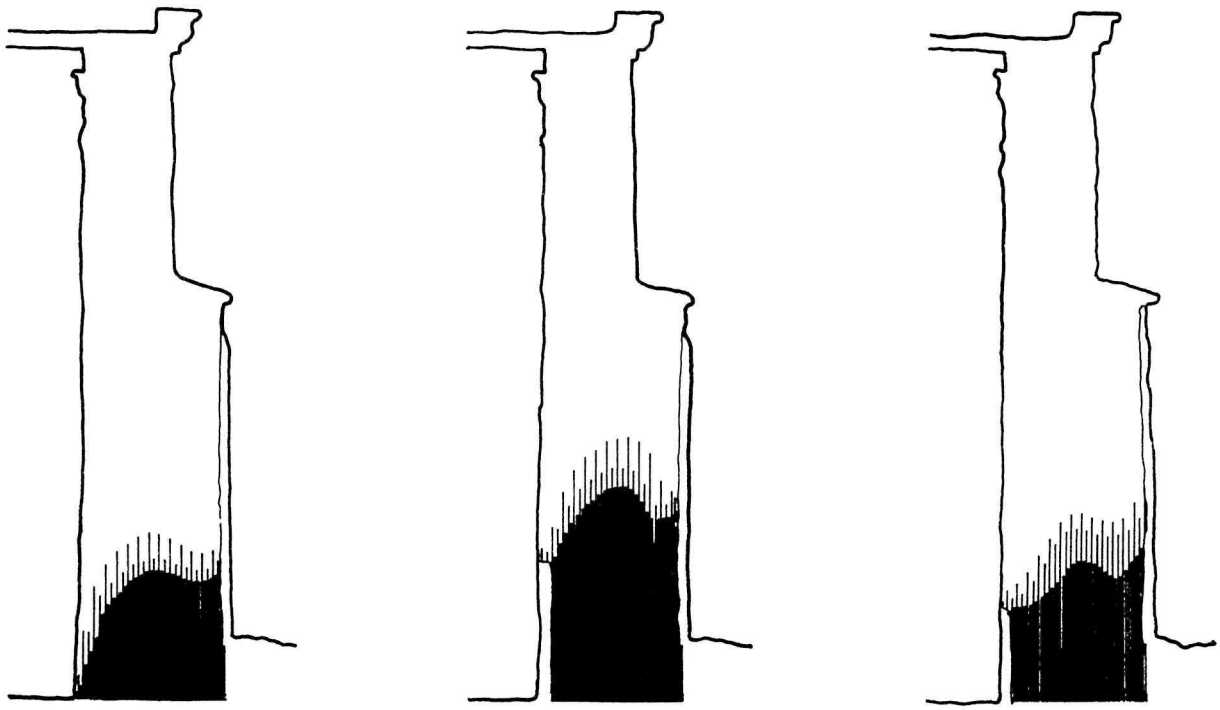
ILLUSTRATION 23.

MOISTURE PROFILES: EAST NAVE WALL
Based on samples taken 1976.
% Moisture ☐ 0-3 ▥ 3-6 ▥ 6-8 ▥ 8-11 ■ 11+

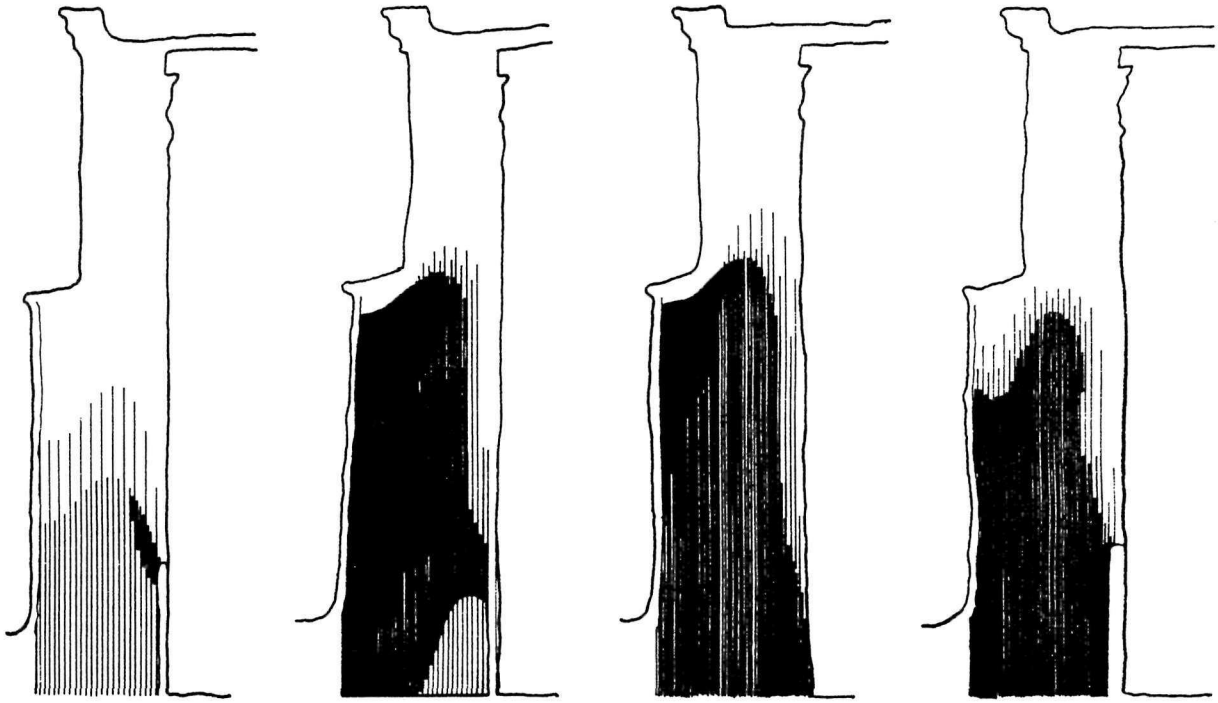
ILLUSTRATION 24

MOISTURE PROFILES: WEST NAVE WALL
Based on samples taken 1976.
% Moisture □ 0-3 ▥ 3-6 ▥ 6-8 ▩ 8-11 ■ 11+

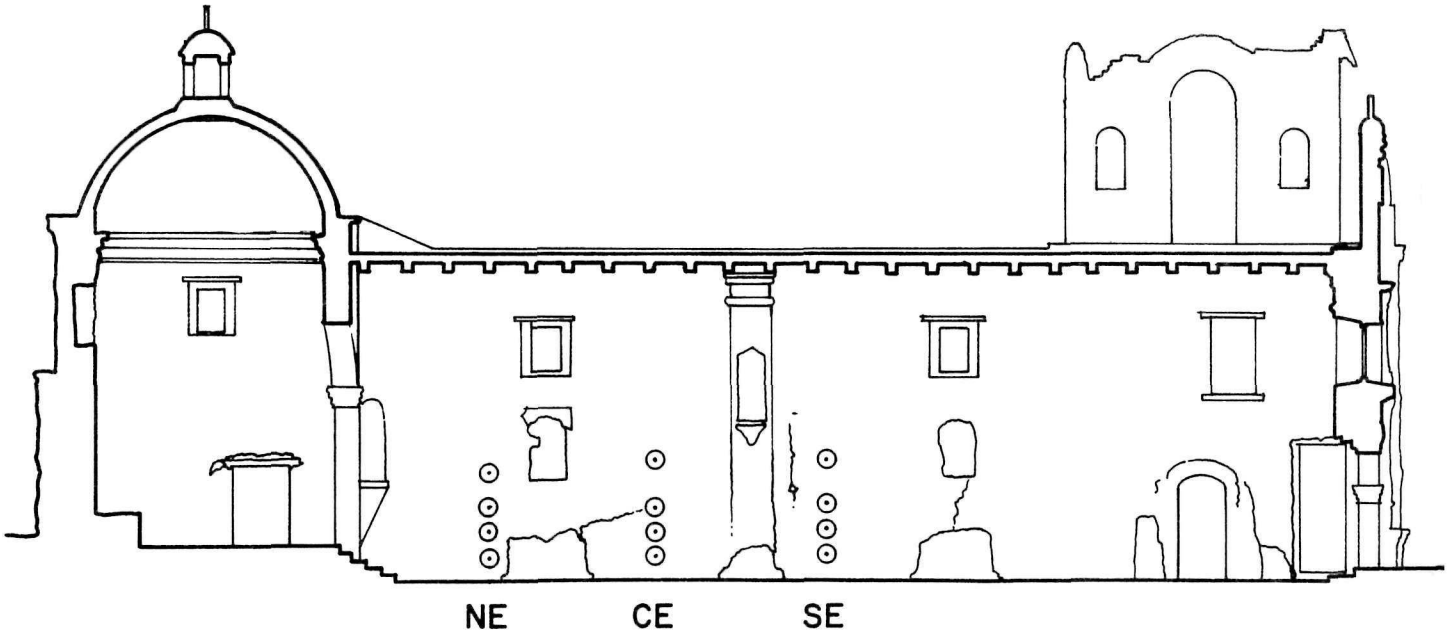
ILLUSTRATION 25.

The initial testing directed to determining the source of the moisture that was visible along the tower portion of the east nave wall of the church consisted of taking material samples along the upper several feet of wall both before and after the roof and exterior upper walls had been subjected to water (NPS 1976). The results of this testing indicated that, except in the area of the third canale from the south on the west church wall, water was not penetrating down from the top of the walls. While the moisture content near this canale was not excessively high, 4 to 5 percent by weight compared to 1 to 2 percent of other samples, the

higher reading did indicate at least that water had probably entered the wall via a leaking drain box sometime in the past. Samples taken after rains and artificial flooding showed no significant change in this area, probably indicating that the leak, if still active, was slight. A significant amount of deterioration of the exterior cement stucco in the area was visible, causing concern that even a small amount of moisture might be building up behind the stucco and not being removed from the wall by evaporative processes.

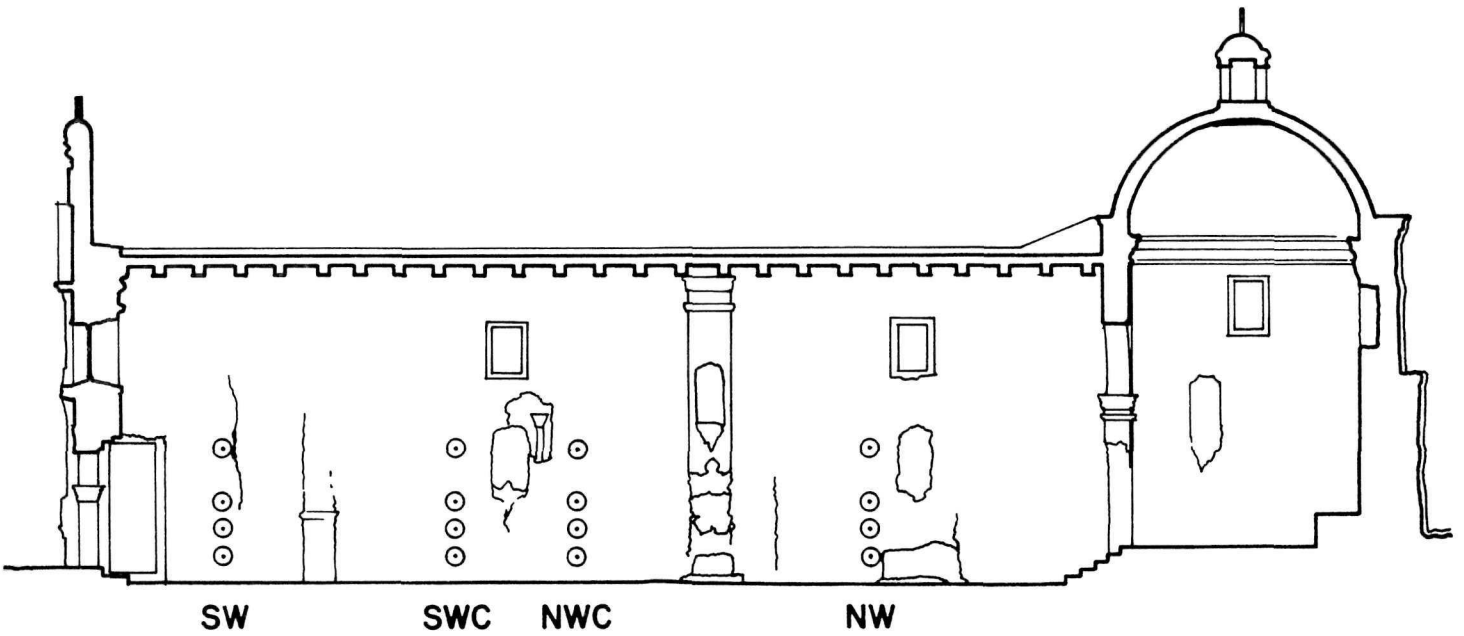
ILLUSTRATION 26.

The areas in the church that appear to have been affected by capillary moisture occur all along the east nave wall, north of the bell tower, a small spot on the south wall of the sacristy, the south end of the west nave wall, and possibly one other spot farther north along the west nave wall.
