Wolfe Ranch
Historic Structures Report
Arches National Park

Prepared for Arches National Park

by
James R. McDonald Architects
Historical Research Associates, Inc.
October, 1999

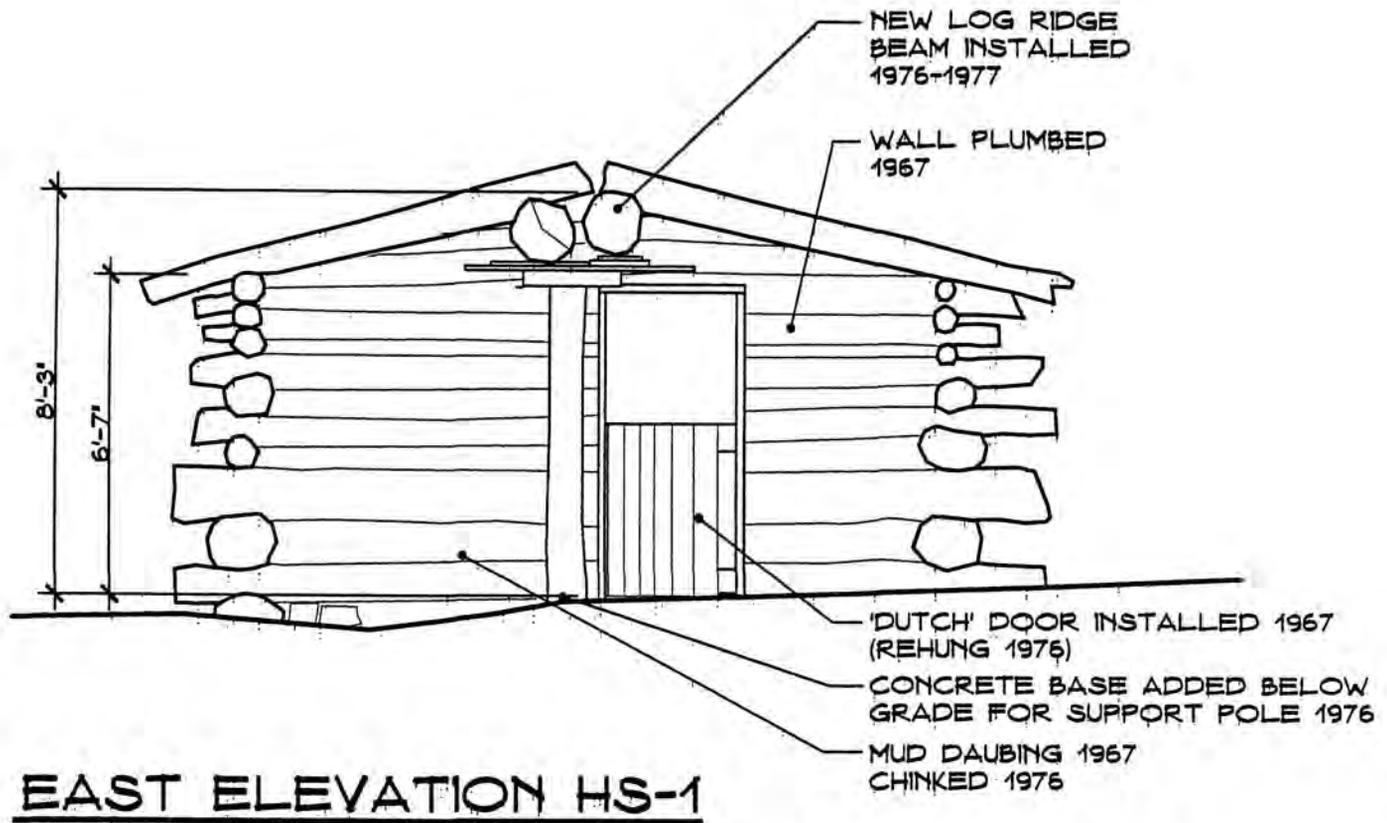
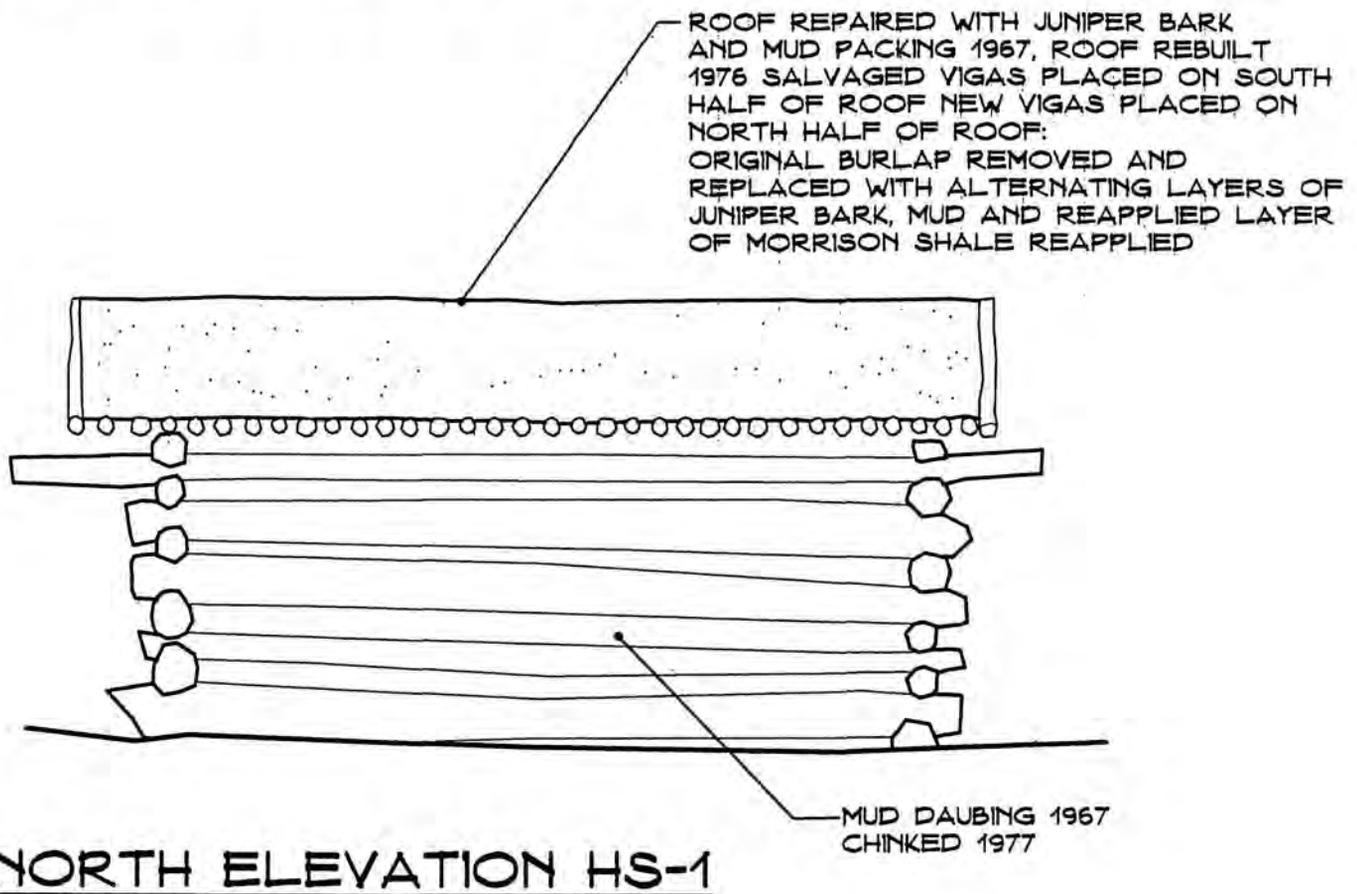
FIGURE 8
CHRONOLOGY OF CONSTRUCTION
WOLFE CABIN HS-1 ELEVATIONS

CHIMNEY PARTS REPLACED
1967 AND 1977

ROOF REPAIRED WITH JUNIPER BARK
AND MUD PACKING 1967, ROOF REBUILT
1976 SALVAGED VIGAS PLACED ON SOUTH
HALF OF ROOF NEW VIGAS PLACED ON
NORTH HALF OF ROOF:
ORIGINAL BURLAP REMOVED AND
REPLACED WITH ALTERNATING LAYERS OF
JUNIPER BARK, MUD AND REAPPLIED LAYER
OF MORRISON SHALE REAPPLIED

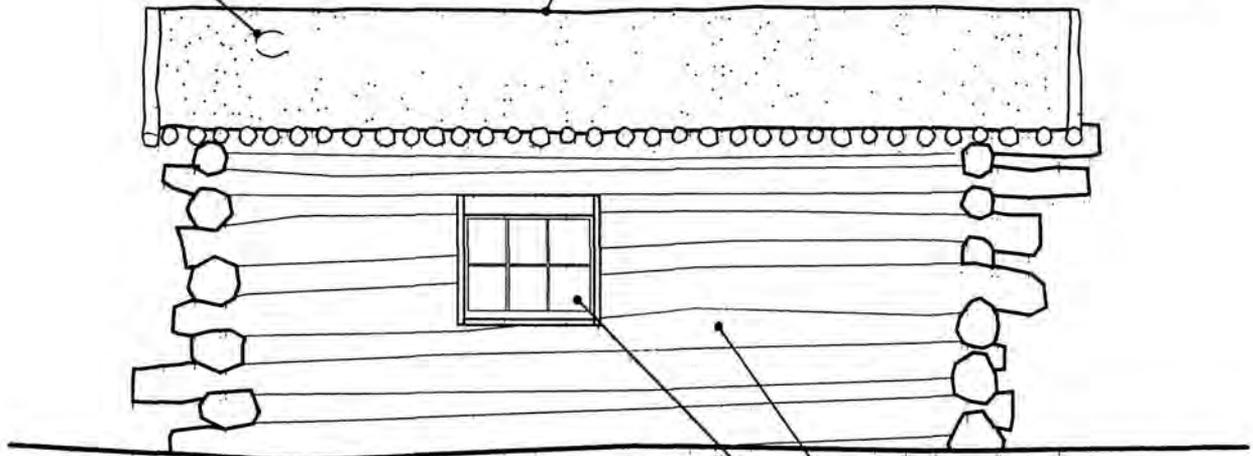
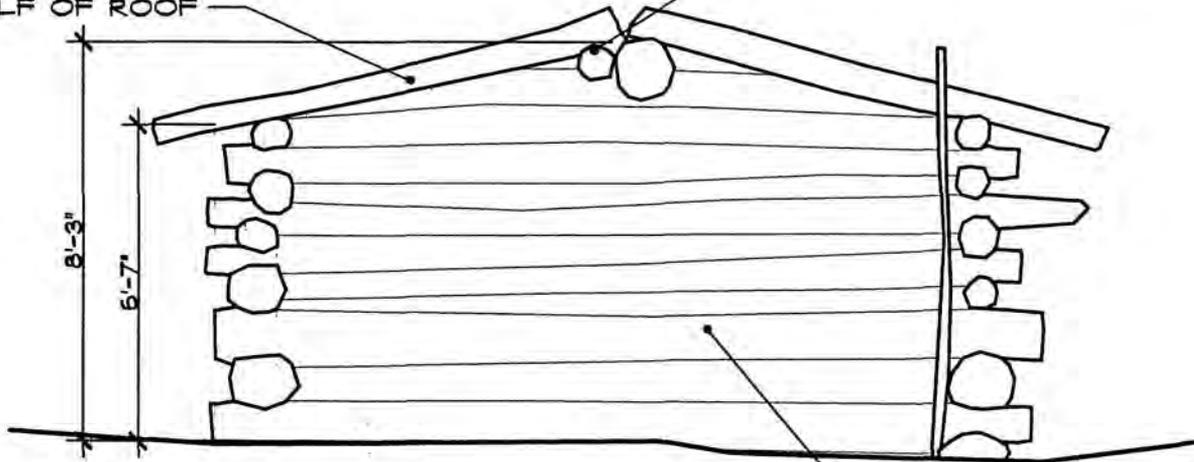
FIGURE 9
CHRONOLOGY OF CONSTRUCTION
WOLFE CABIN HS-1 ELEVATIONS

MUD DAUBING 1967
CHINKED 1976

NEW GLASS
1976

1976 NEW OAK VIGAS
INSTALLED ON NORTH
HALF OF ROOF

NEW LOG RIDGE
BEAM INSTALLED 1976

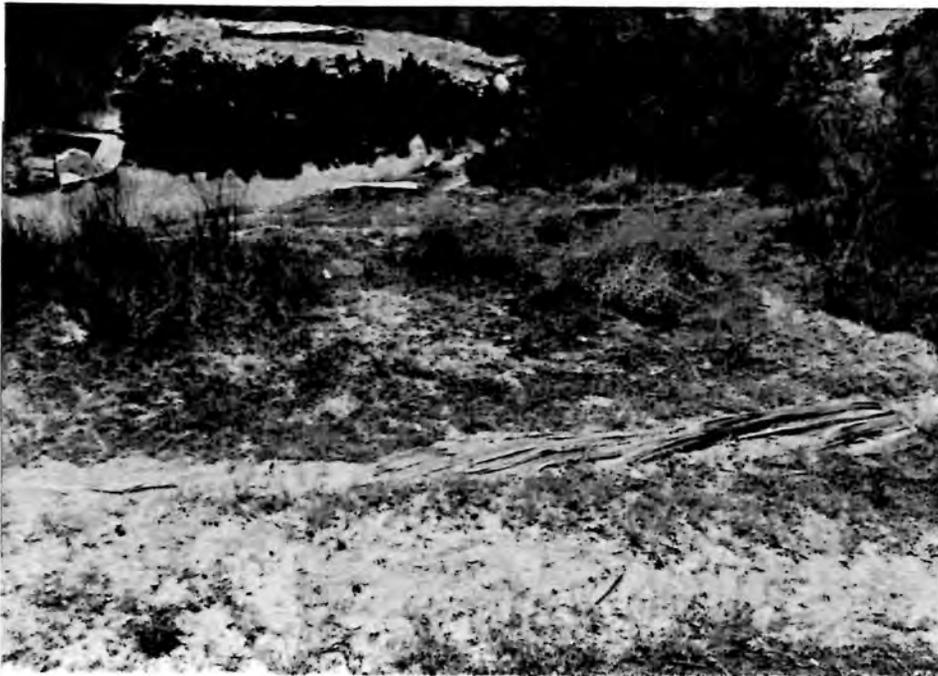
Figure 16. Looking west at remains of the second dugout located adjacent to the east side of HS-2. (1998 photo)

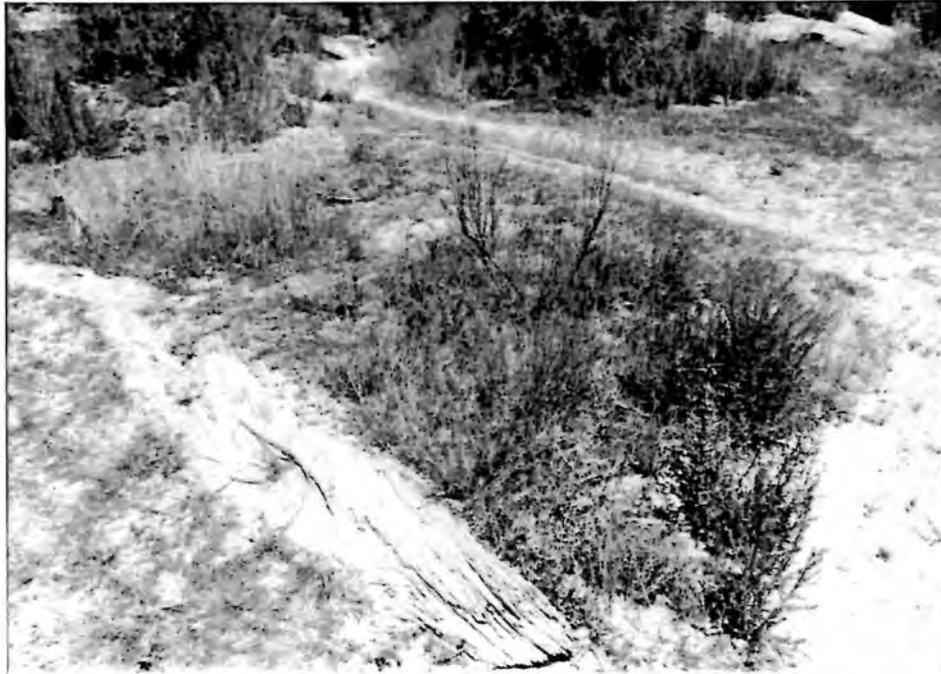
Figure 17. Looking northeast at the remains of the second dugout. (1998 photo)

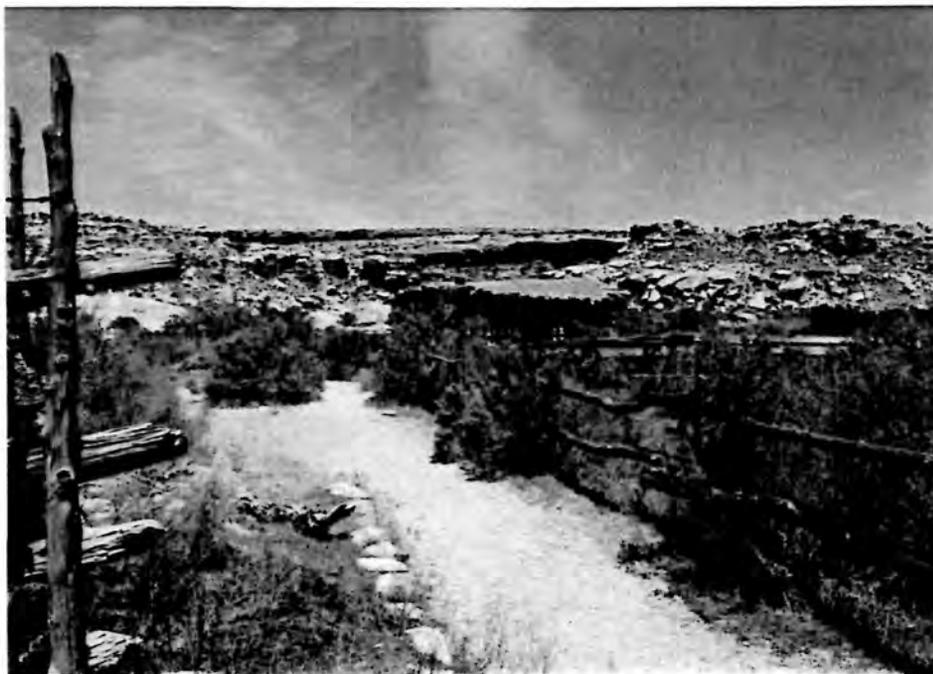
Figure 22. Looking northeast at the interpretive trail between the corral (HS-3) and the cabin (HS-1). The fence to the right was added to protect the vegetation in front of the cabin. (1998 photo)

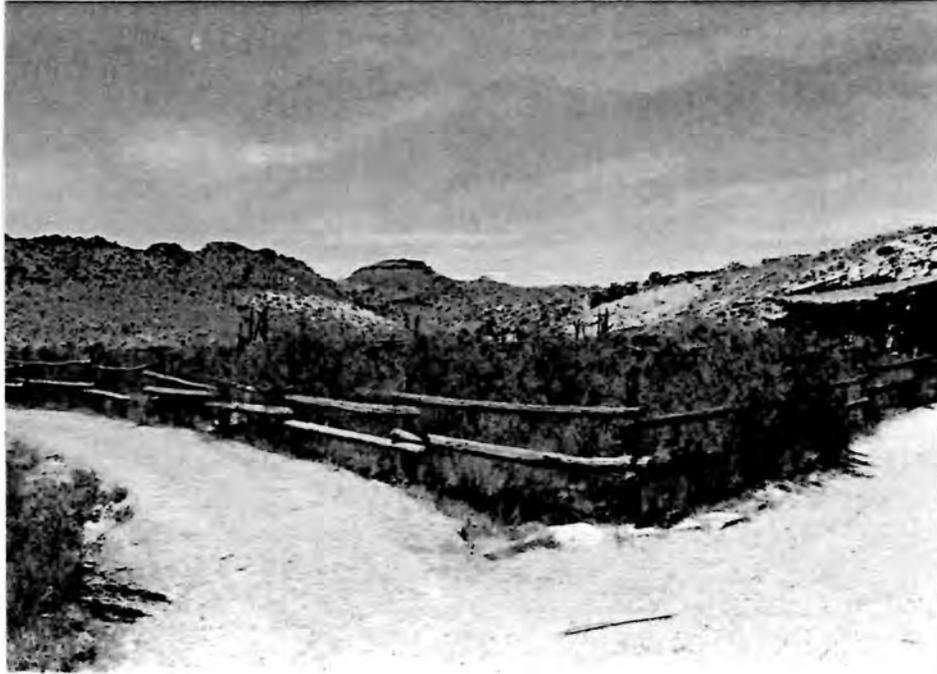
Figure 23. Looking northwest at the site with the main trail from the bridge to the parking lot to the left. The post and pole fence was added to help protect vegetation around the south side of the cabin. (1998 photo)

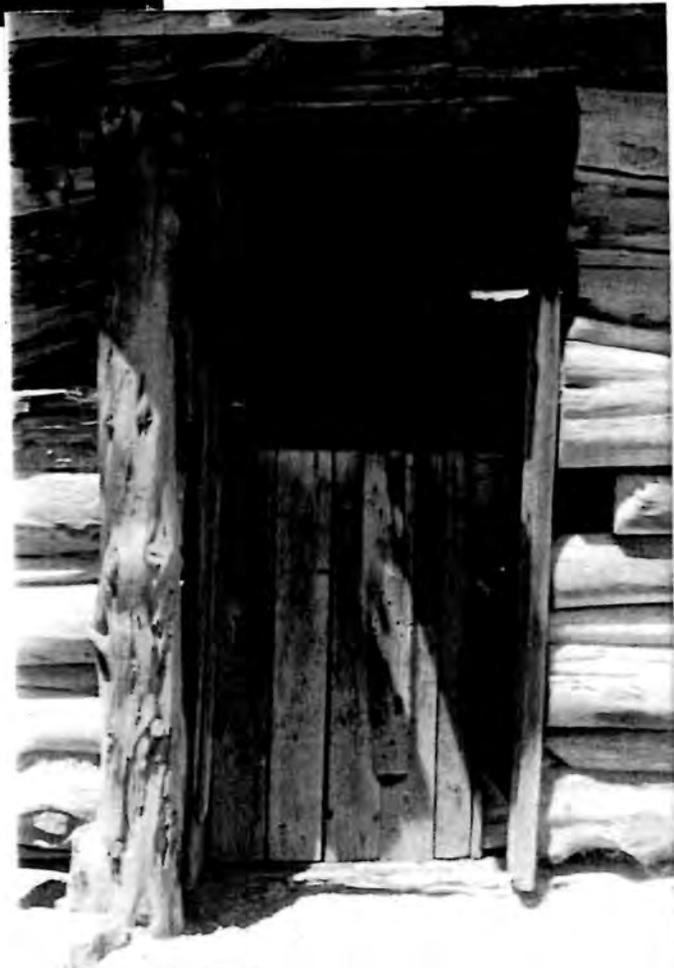
Figure 32. Looking northwest at the cabin (HS-1). Note the fence to keep people out of this side of the site. Also, note that the stones along the base of the cabin have fallen away. (1998 photo)

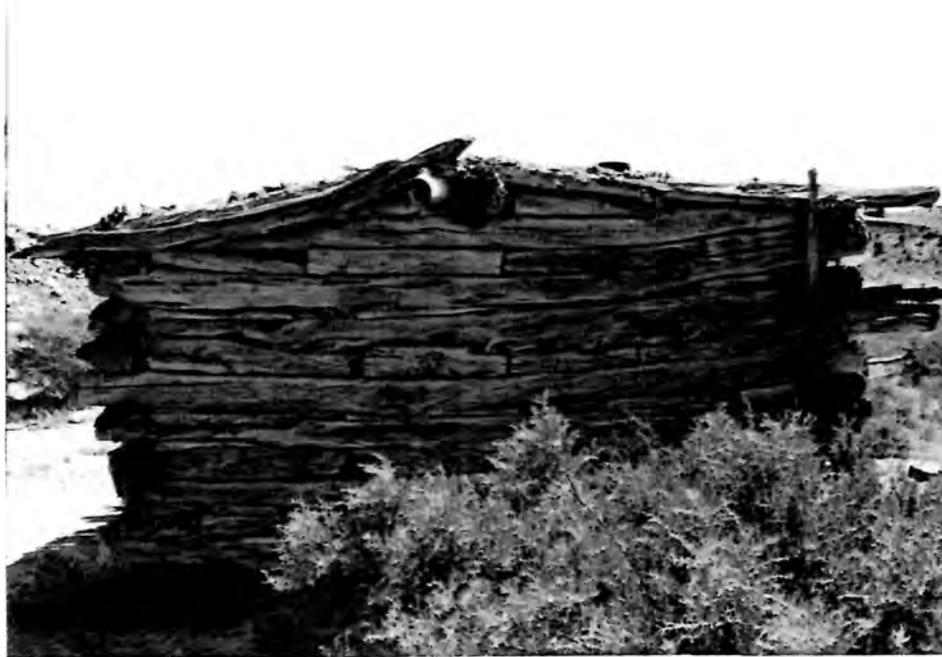
Figure 36. Looking east at the rear of the cabin (HS-1). Note the short sections of logs and chinking used to fill the spaces between the wall logs. (1998 photo)

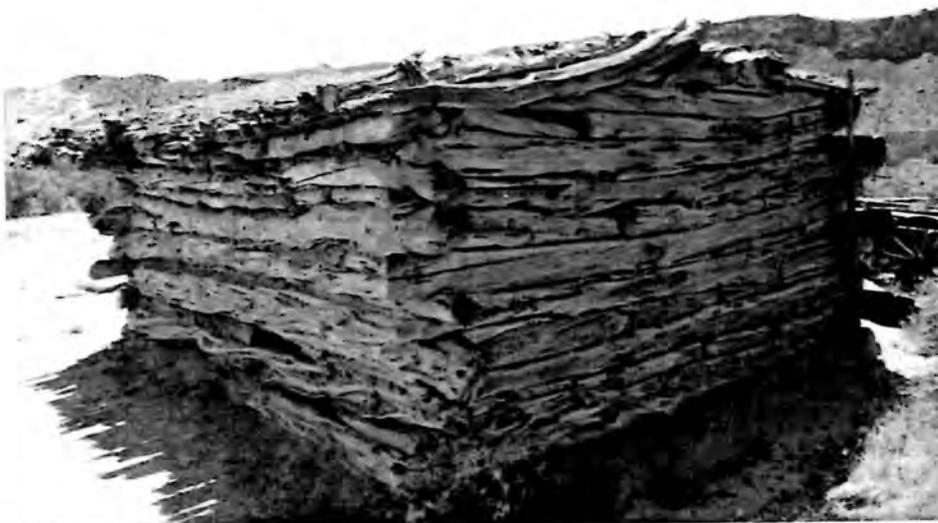
Figure 37. Looking southeast at the cabin (HS-1). Note the bent logs at the edge of the roof and the opening that lets water onto the wall logs. The grade is better on this side of the building, although earth has accumulated against the sill log. (1998 photo)

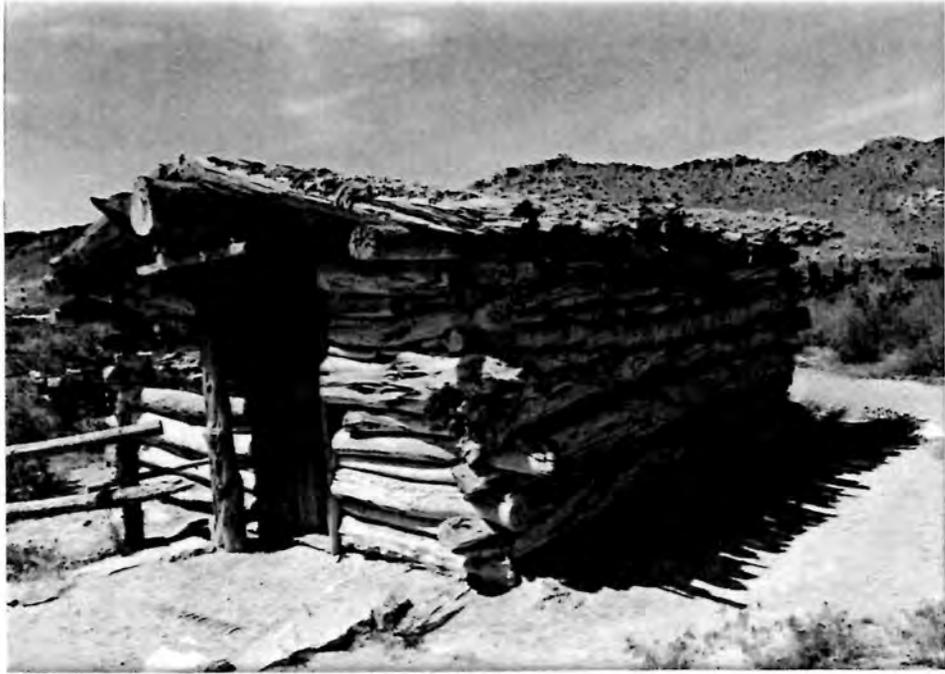
Figure 40. Looking southwest at the cabin (HS-1). The purlin along this side was replaced along with the roof. (1998 photo)

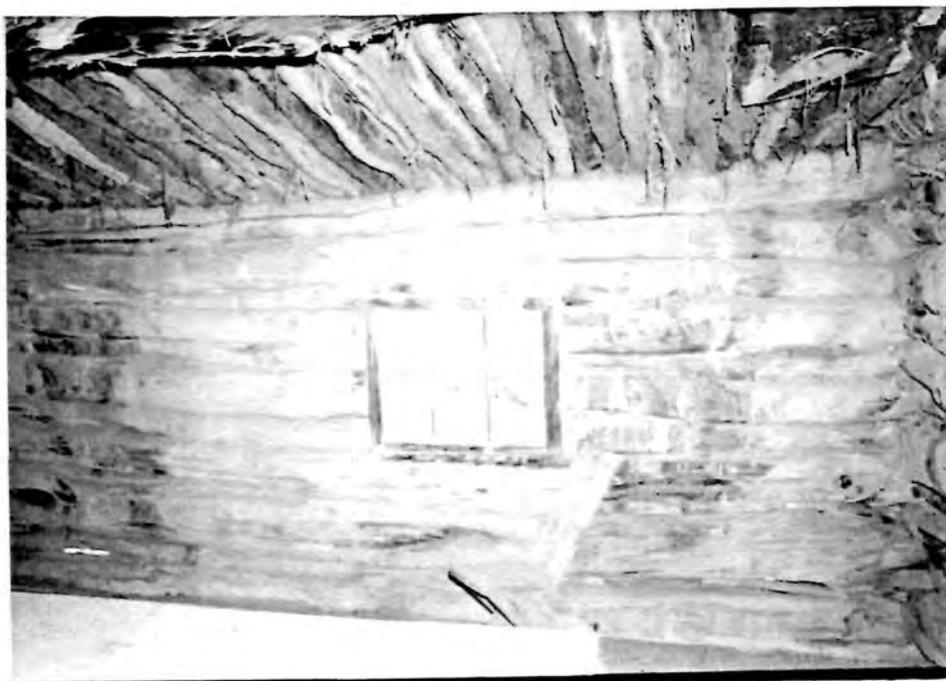
Figure 44. Looking south at the interior. Note the roof logs and stove pipe surround. (1998 photo)

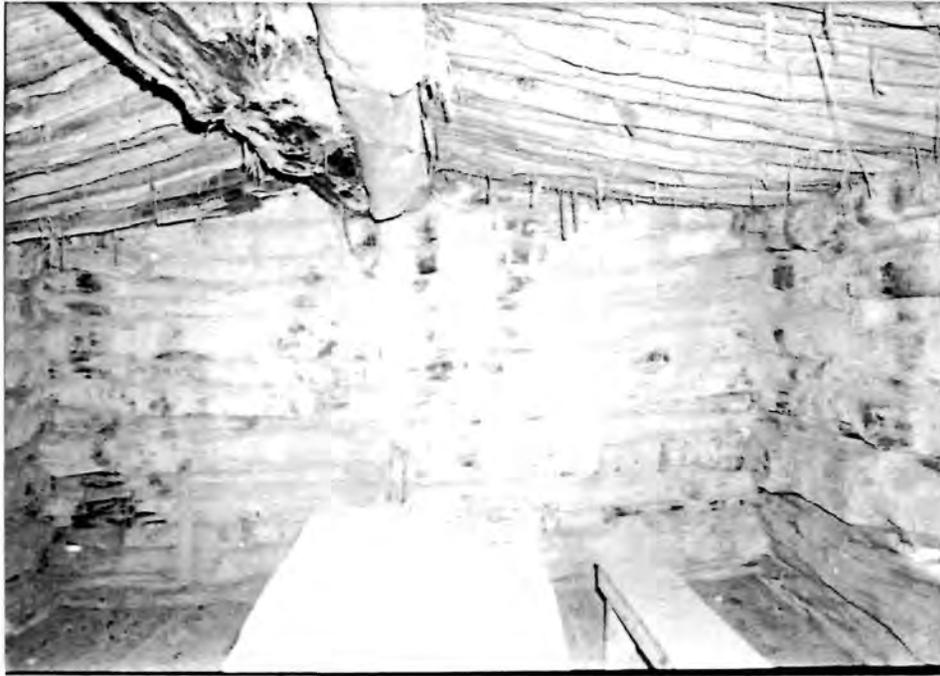
Figure 48. Looking west at the interior showing the roof structure and the wood floor to the left of the table. (1998 photo)

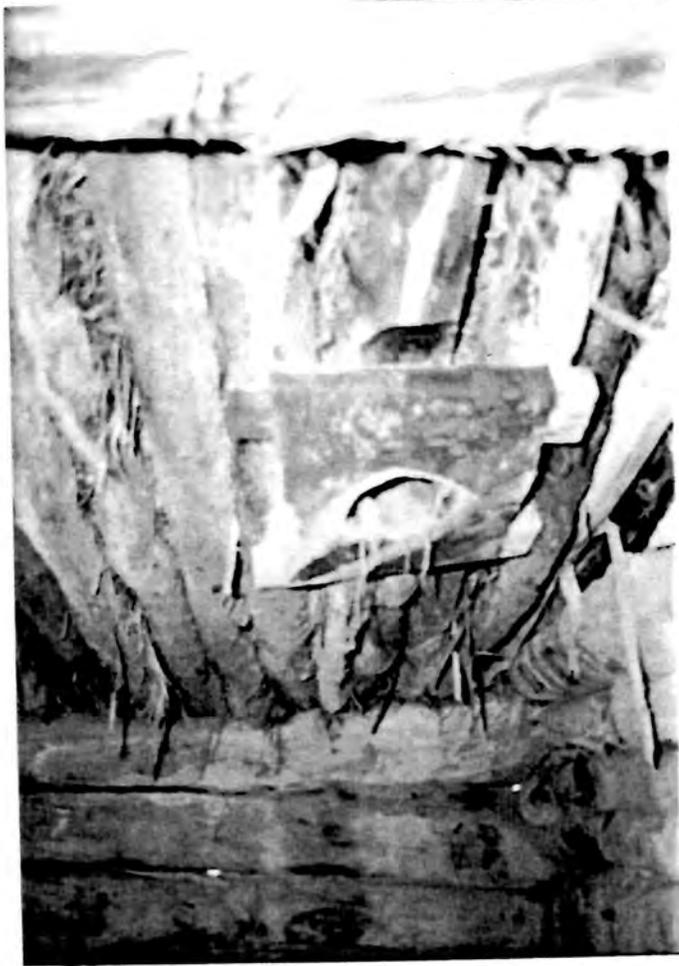
Figure 50. Detail of the opening for a metal stove pipe. (1998 photo)

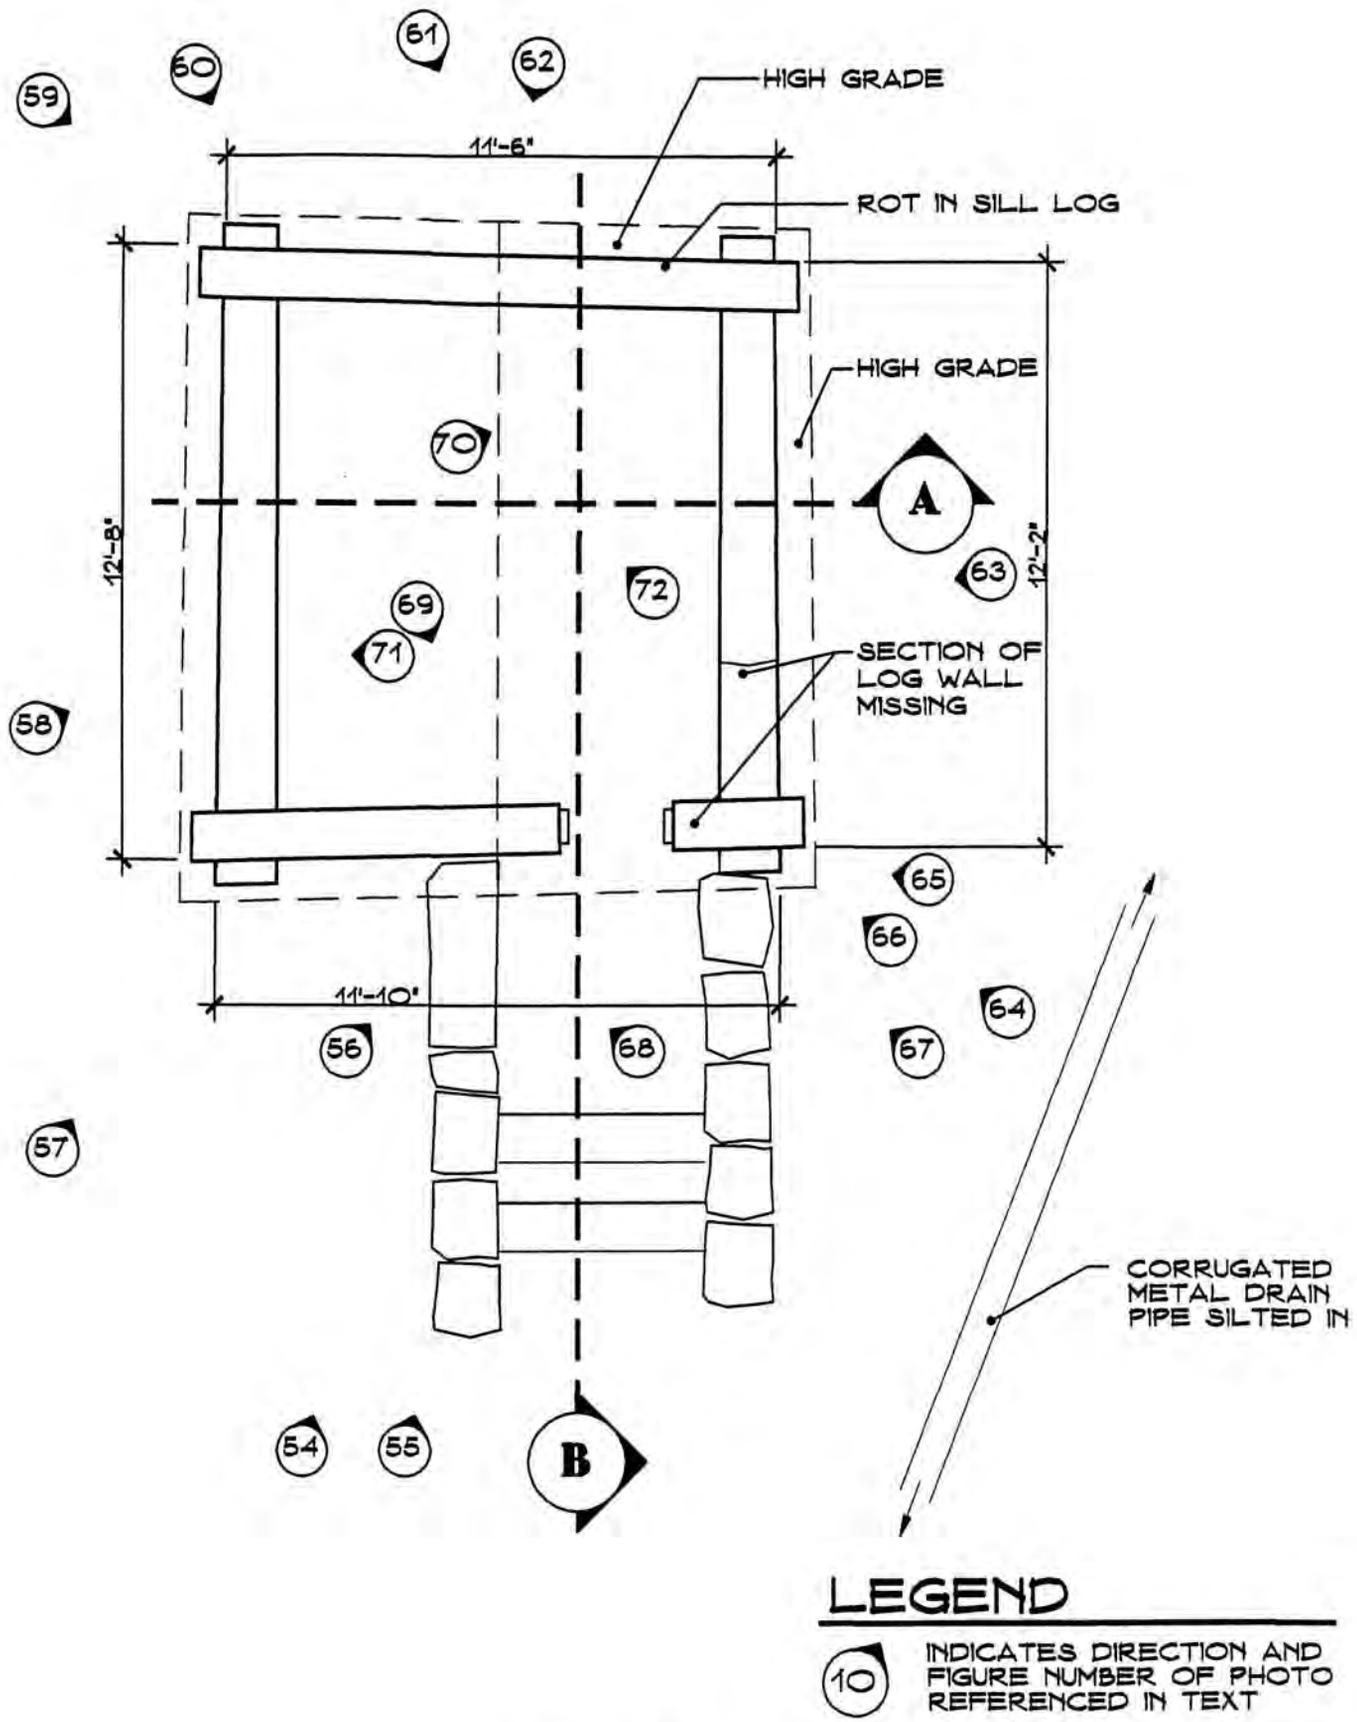
FIGURE 51
CONDITION ASSESSMENT
DUGOUT HS-2 FLOOR PLAN

Based upon the LCS condition definitions, the dugout is in poor condition. Specific problems include the following:

Walls: The wall logs on the north and west sides are in such poor condition that they are beginning to fall apart; on the southeast corner there is hardly any material holding the corner together. Also, some of the logs are missing.

Ceiling: The ridge beams and *vigas* are water-stained and rotted from water leaking inside.

Walls: Some of the chinking and daubing has fallen out on the interior wall surface. Also, a few of the wall logs are missing.

Windows and Doors: The building is once again out of plumb causing the door frame to pull apart.

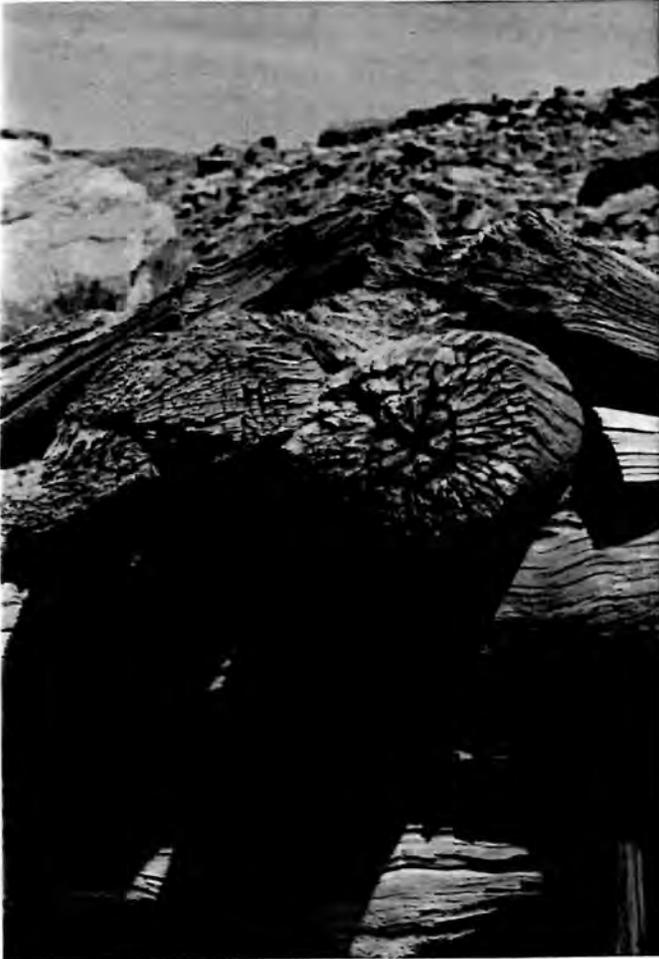
Figure 56. Looking north at the ridge beams and the roof material. Note the checked and weathered wood and separation of the ridge poles. (1998 photo)

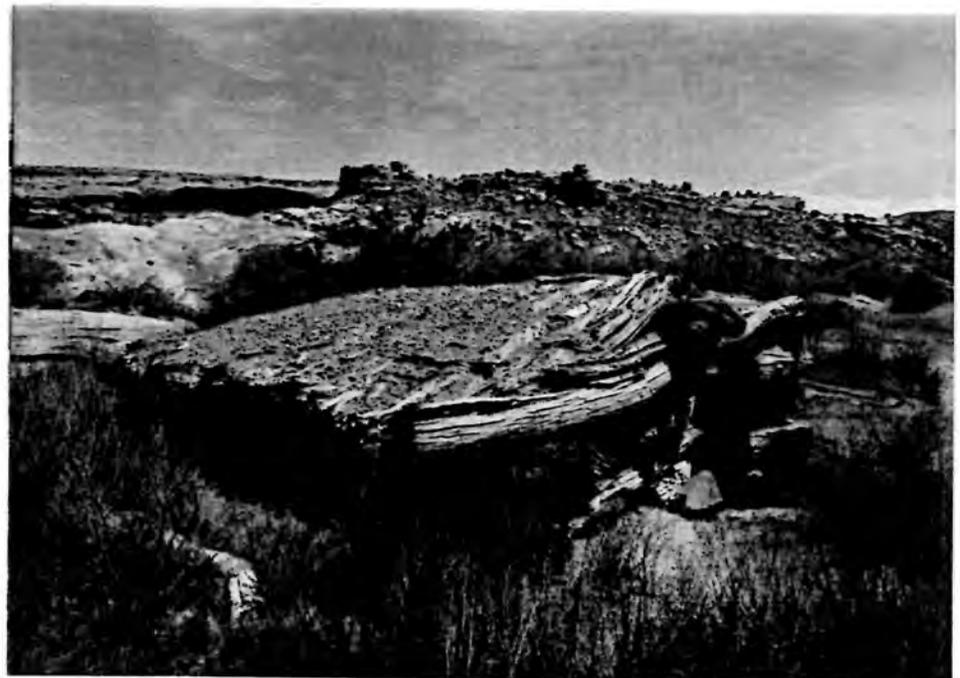
Figure 57. Looking northeast at the dugout (HS-2). Note the roof with the juniper bark covering. This is in poor condition. (1998 photo)

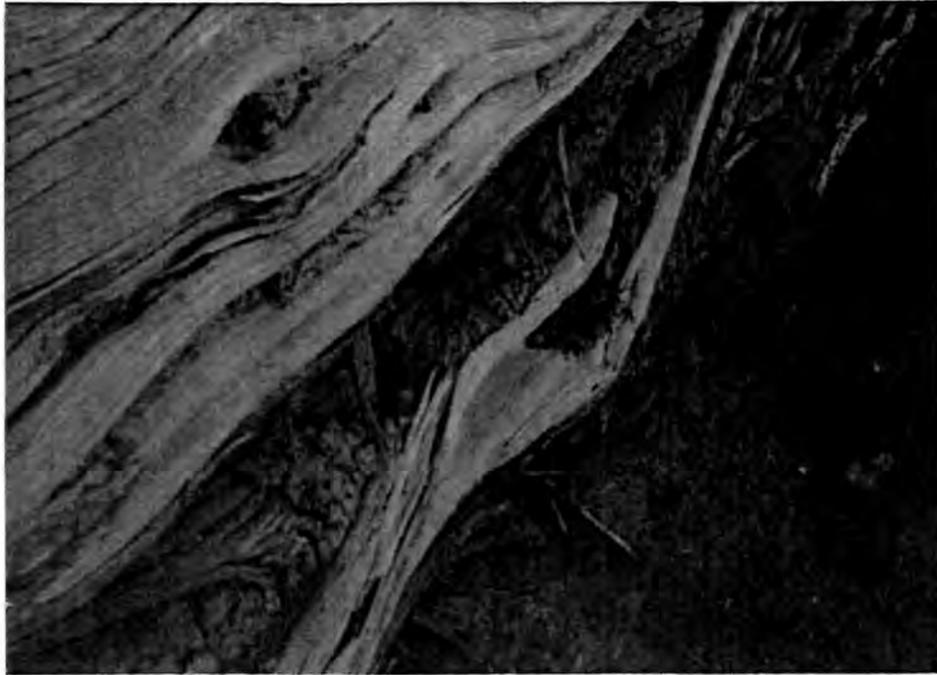
Figure 60. Looking southeast along the base of the structure where the bottom log is rotted. (1998 photo)

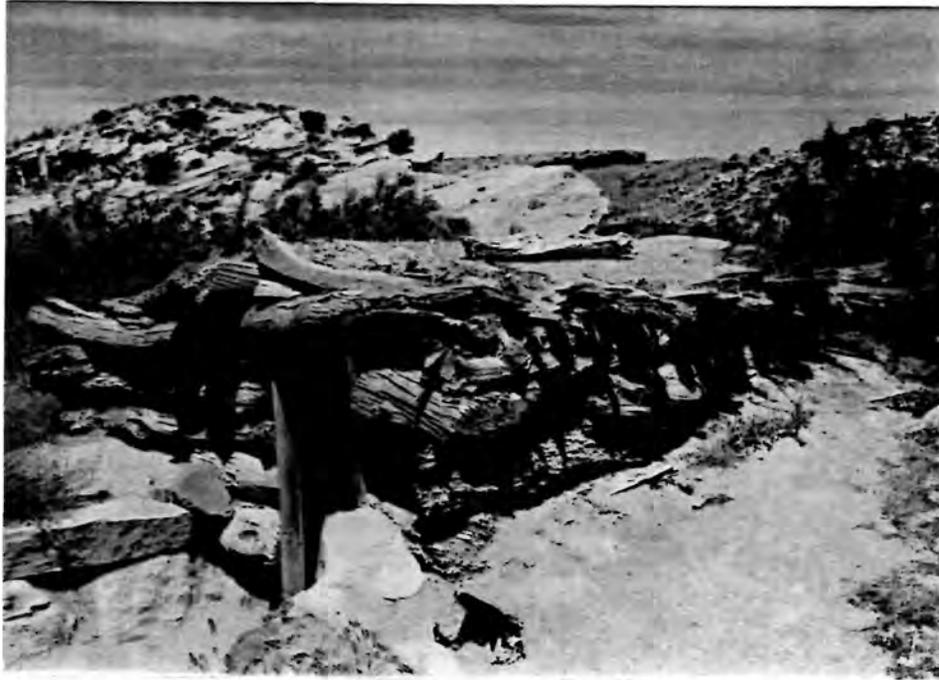
Figure 64. Looking northwest at the dugout. (1998 photo)

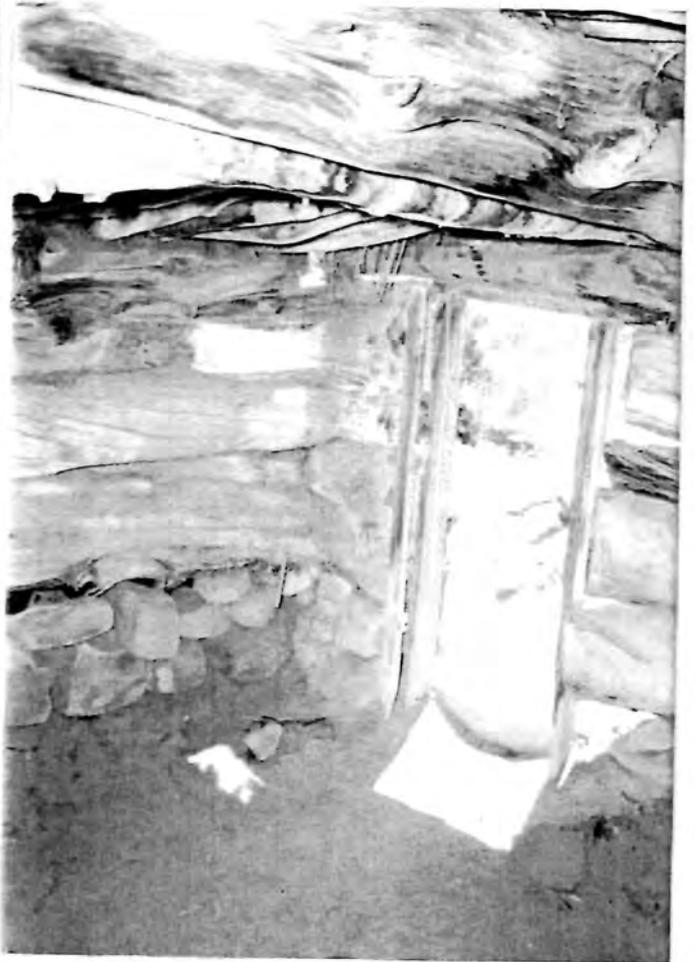
Figure 69. Looking southeast towards the entrance opening from the interior of the dugout. Note the stone foundation. (1998 photo)

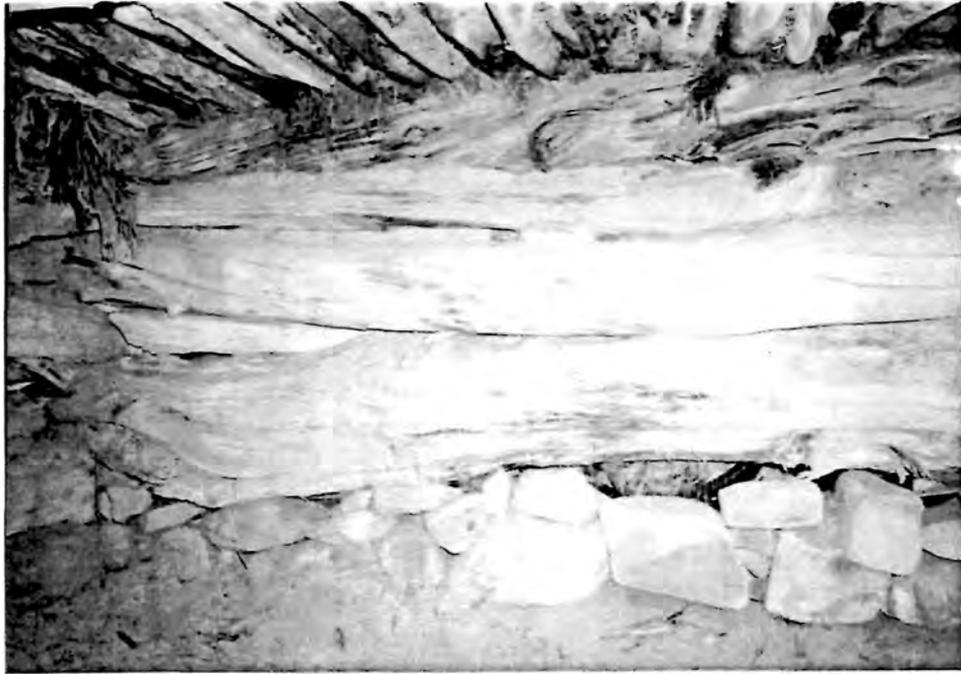
Figure 70. Looking east at the log wall with the stone foundation. A plastic membrane has been added on the outside of the logs to keep the moisture from penetrating to the interior of the building. (1998 photo)

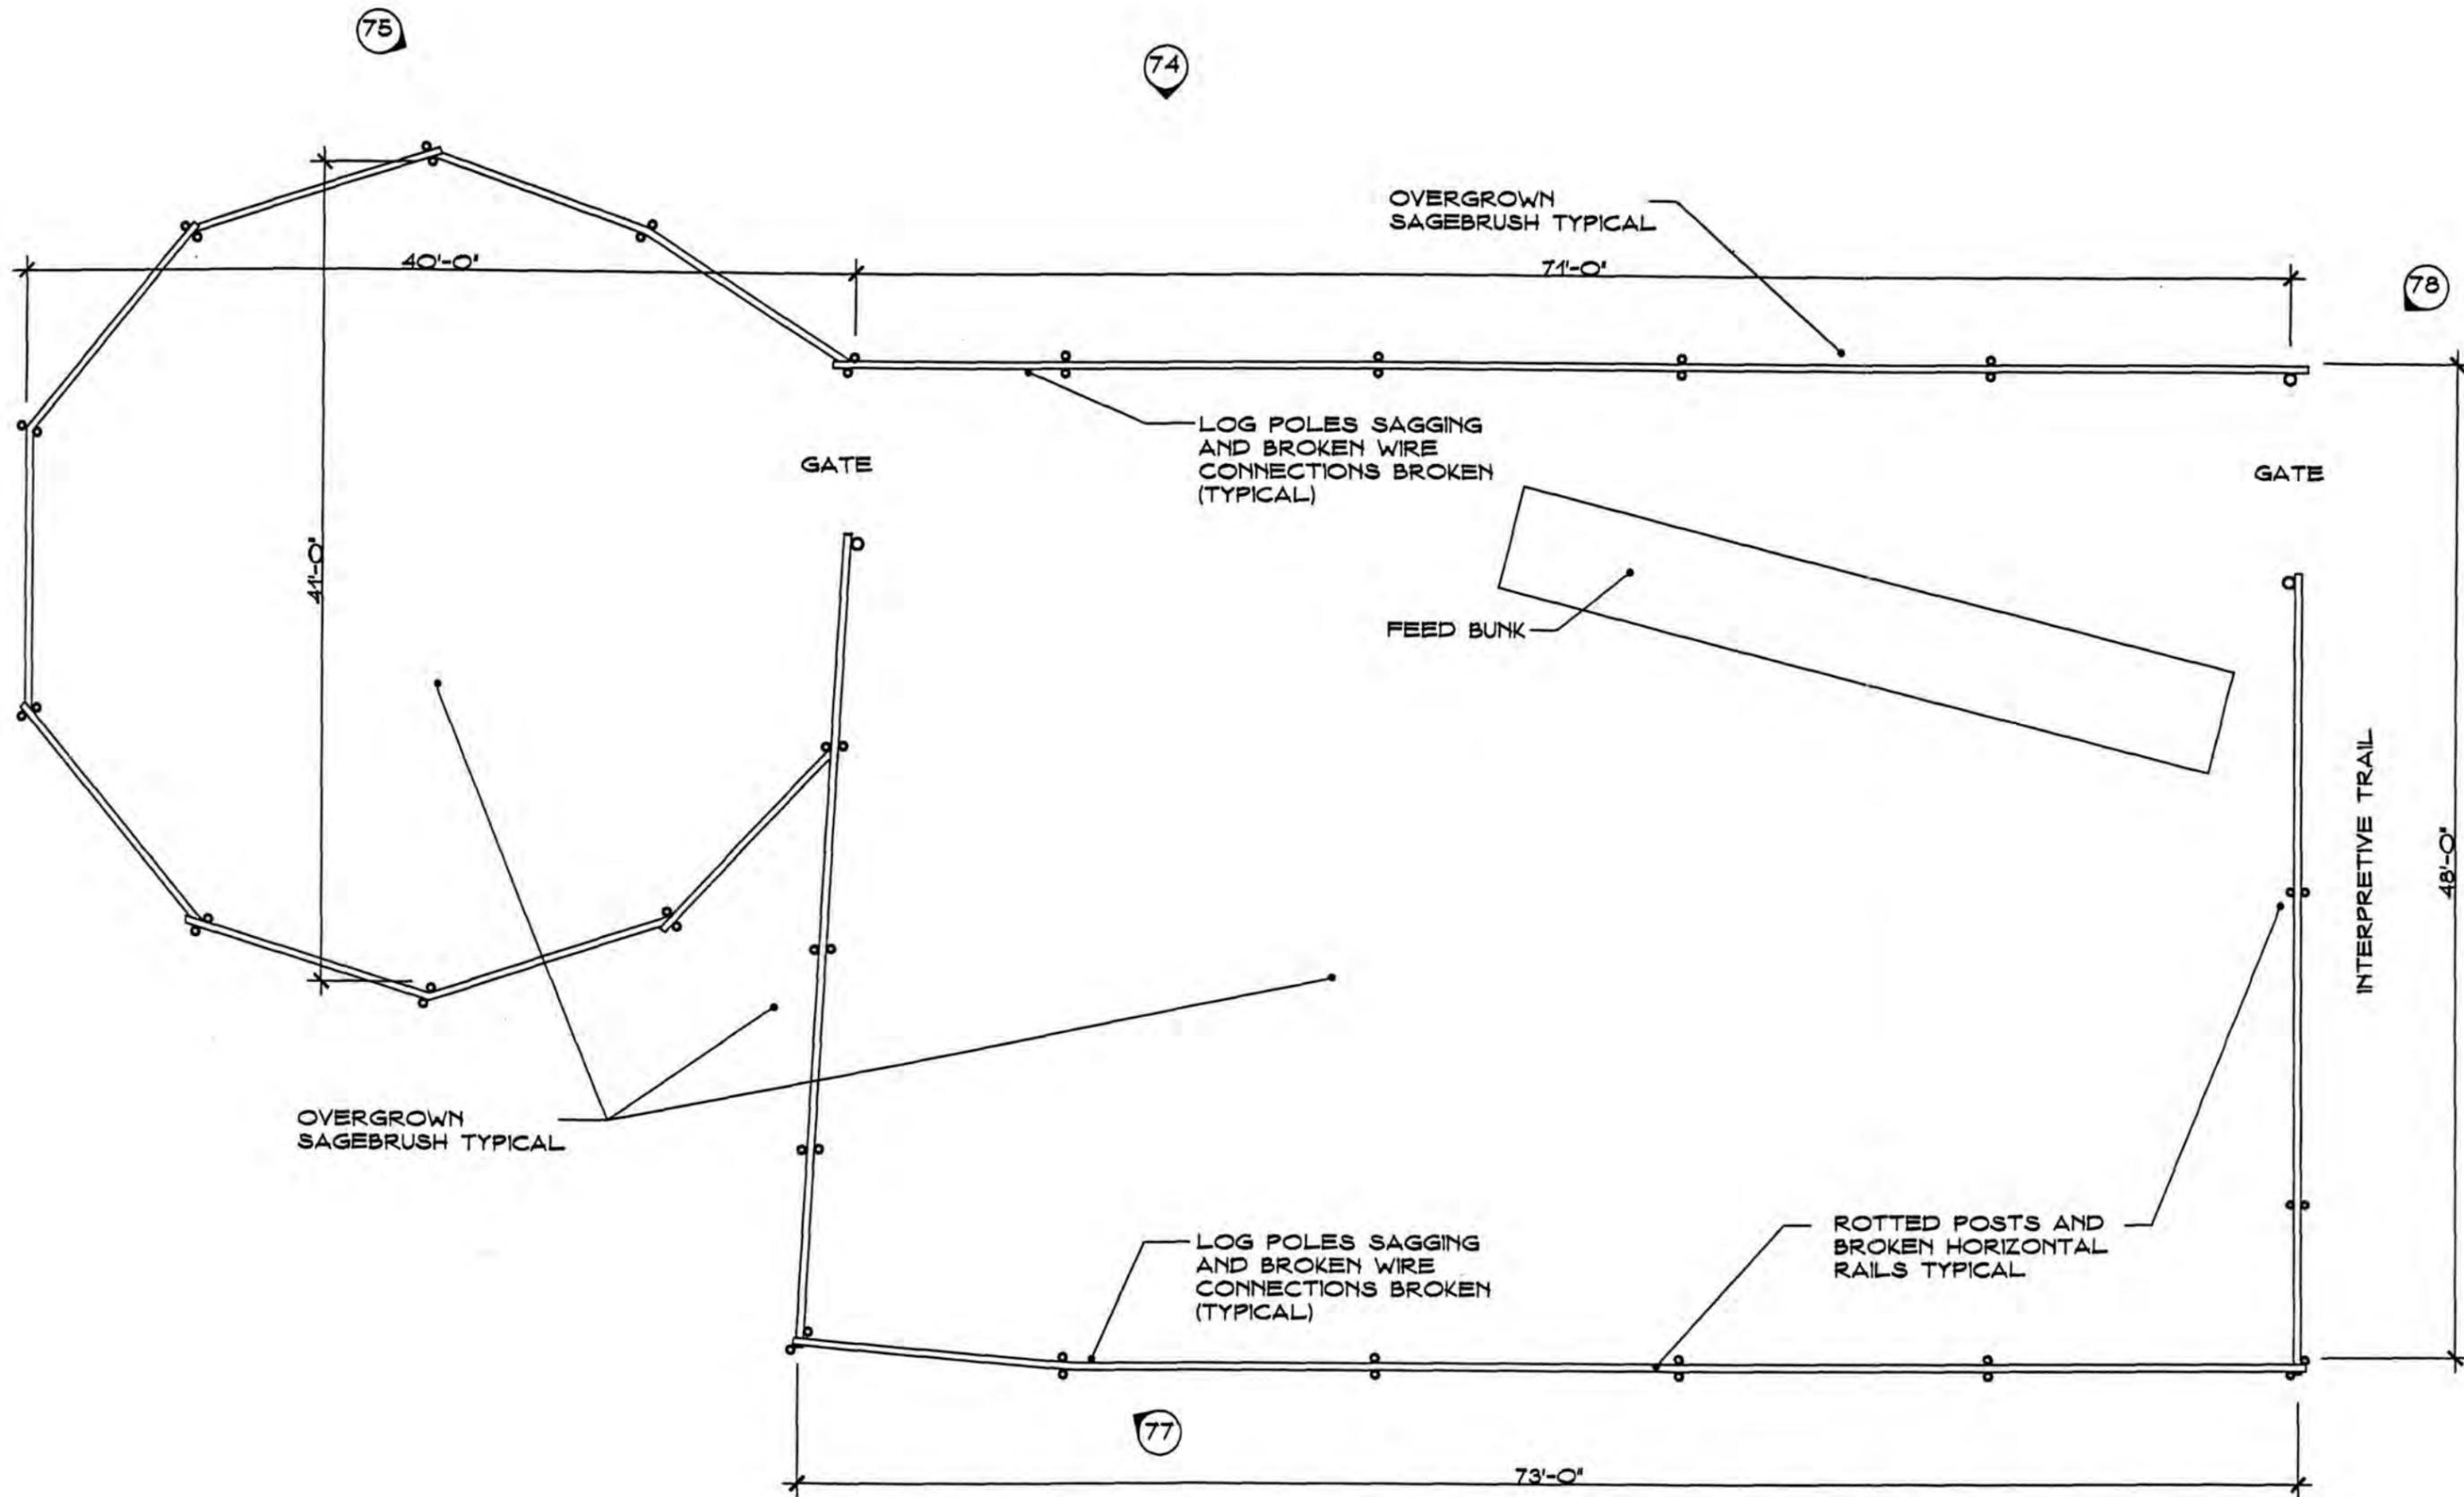
**FIGURE 73
CONDITION ASSESSMENT
CORRAL PLAN HS-3**

The corrals were completely rebuilt during the 1967 restoration effort. Although salvageable material was reused, currently there is no way to determine which material is new and which material came from the cannibalized BLM corral. Currently, the corrals are once again in poor condition with rotted posts, broken horizontal rails, and broken wire connections. The deterioration appears to be due to a simple lack of maintenance.

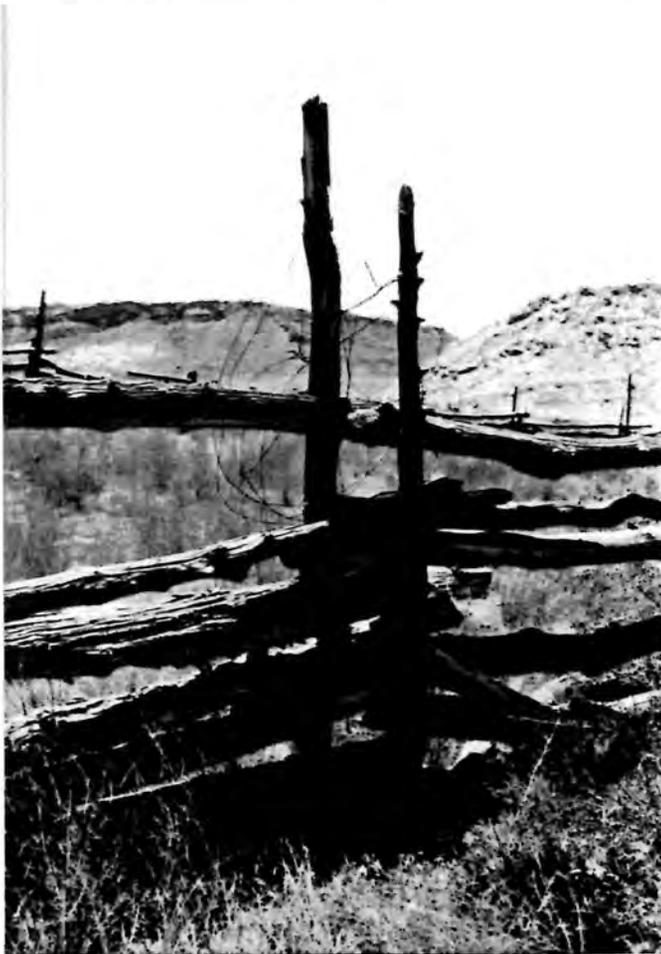
Figure 77. Looking northwest at structural detail typical in this corral; horizontal rails wired between two vertical posts. (1998 photo)

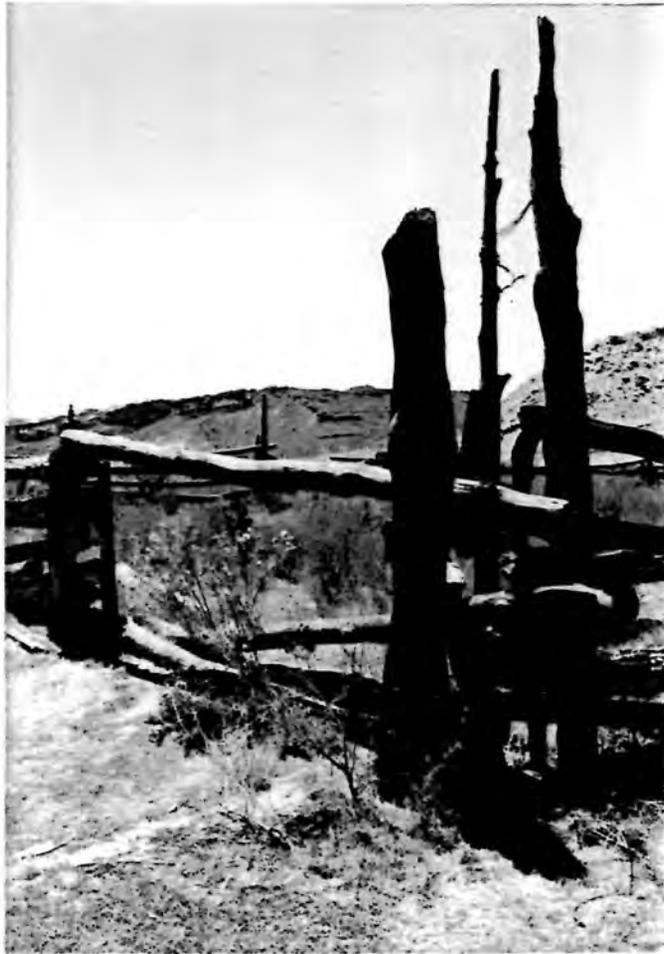
Figure 78. Looking southwest at a gate detail where poles are laid between the corral fence to close the opening. (1998 photo)
