HISTORIC STRUCTURES REPORT  
NORTH SERVANTS' QUARTERS  
CUSTIS-LEE MANSION, VA.  
(Part II)

HISTORIC STRUCTURES REPORT

NORTH SERVANTS' QUARTERS,

CUSTIS-LEE MANSION, VA.

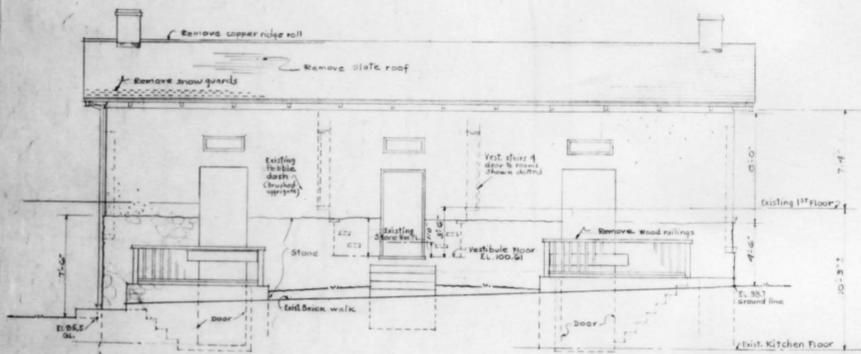
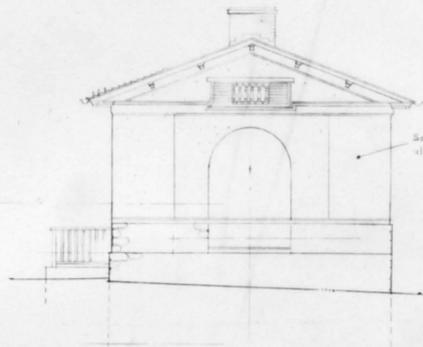
EXISTING SOUTH ELEVATION

EXISTING EAST ELEVATION

- NOTE:-
1. Repair entire stone foundation & water table.
  2. Replace and match all pebble dash where necessary.
  3. All wood work shall be carefully removed, protected until used as directed.
  4. All wood work which has been removed and found decayed shall be securely replaced with new members of the same dimension.
  5. Remove all miscellaneous excess hardware and repair holes & etc.

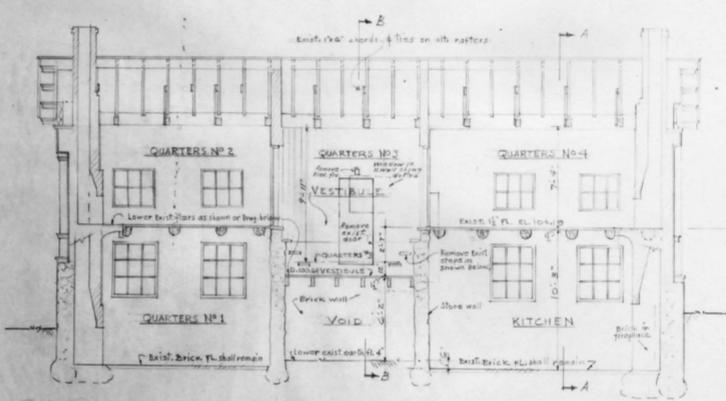
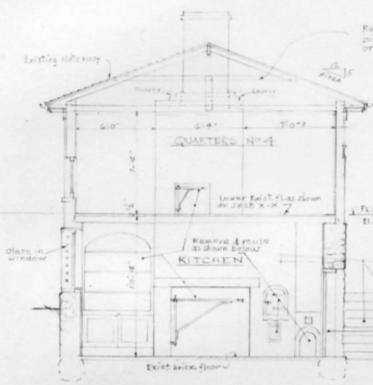
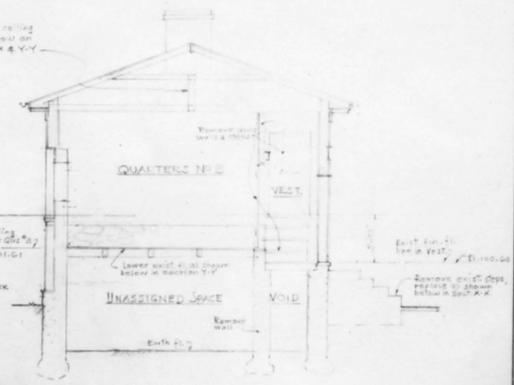
LONGITUDINAL SECTION (EXISTING CONDITIONS)

CROSS SECTION A-A THRU KITCHEN (EXISTING CONDITION)

CROSS SECTION B-B THRU CENTER (EXISTING CONDITION)

Check condition 'C' on job & call architect for a field inspection.
