Fort Point National Historic Site  
Golden Gate National Recreation Area

# Abbreviated Fort Point Historic Structure Report

September 2006

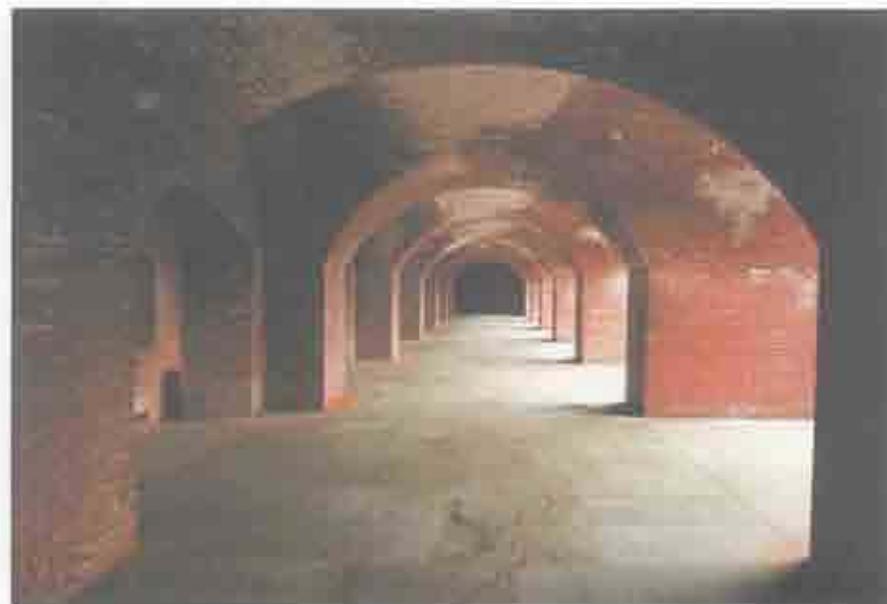
Each casemate has brick walls, laid in an English bond (alternating courses of headers and stretchers), and a brick barrel-vaulted ceiling. The mortar is deteriorated in many places; green algae and efflorescence is present as well. There is an arched opening from the parade into most of the casemates and all of the casemates have a cannon embrasure at the opposite end. The walls between the casemates on the 1st tier are constructed of 18" high granite blocks. Connecting each of the casemates is a 12 ft. wide arched opening with a brick arched header, 7'-6" high at the spring point and 9'-2" at the high point.

Typical brick casemate with arched ceilings and granite floors. (John Martini, 2005)

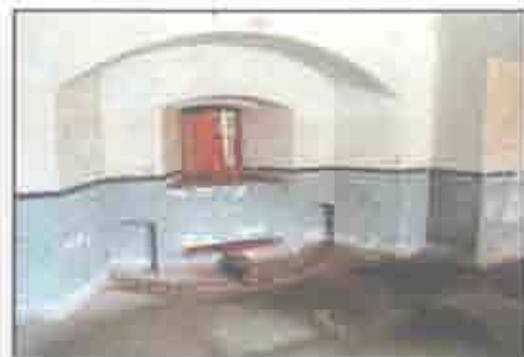
Typical cannon embrasure. This embrasure in casemate 2 still retains part of its original front pintle carriages. (John Martini, 2005)

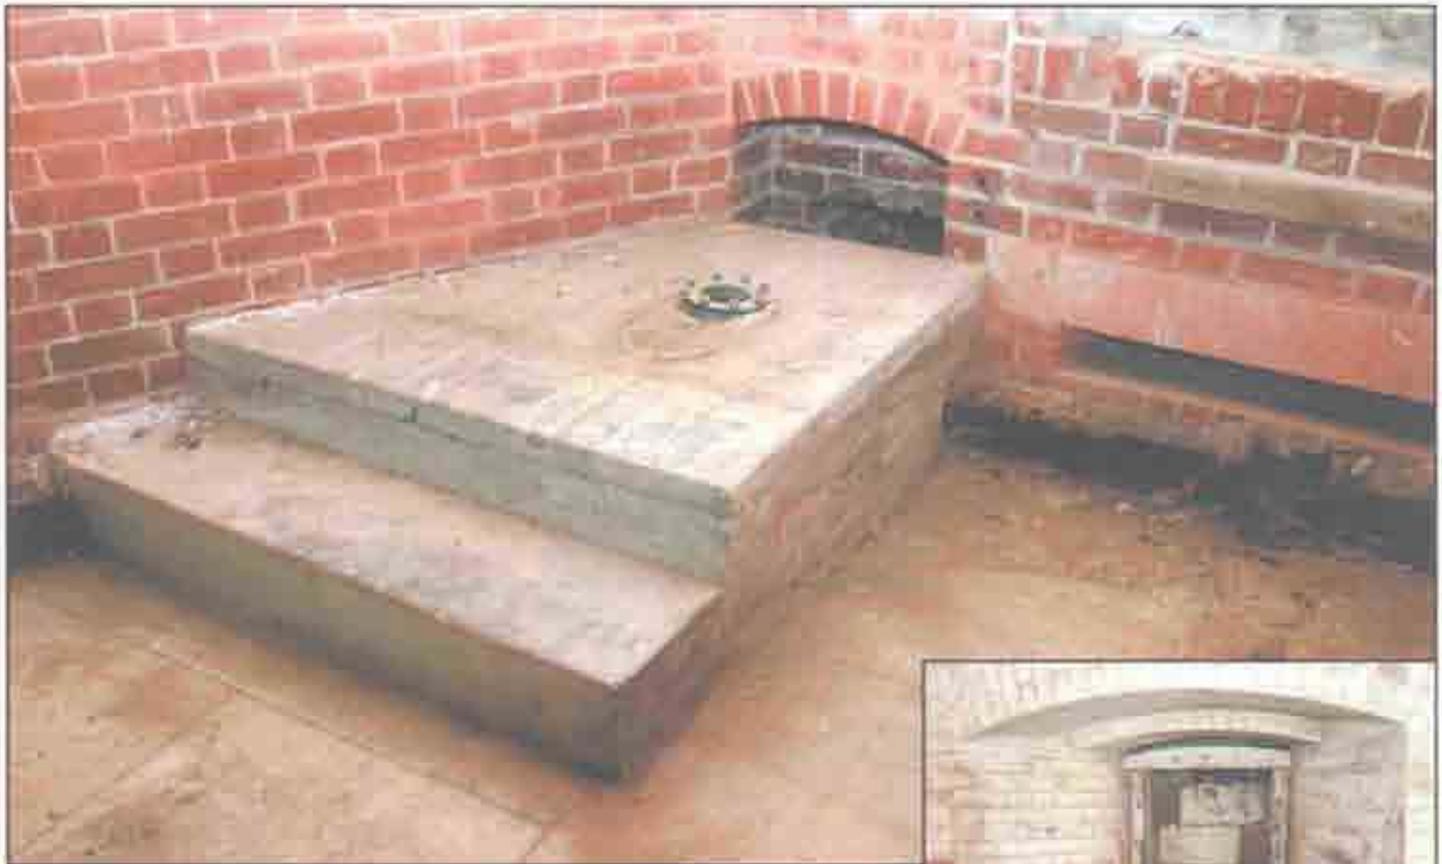
These concrete platforms for plumbing fixtures remain from the 1914 attempted remodel of the fort into a disciplinary barracks. (John Martini, 2005)

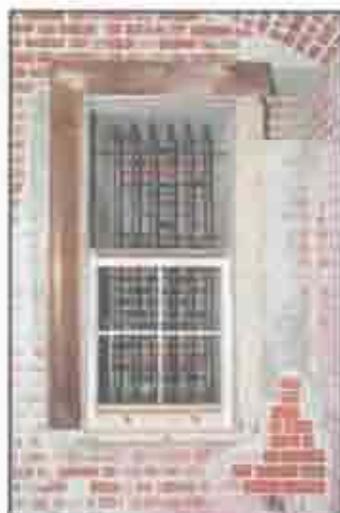
Rifle slit openings were enlarged and then bricked up leaving various building components. (John Martini, 2005)

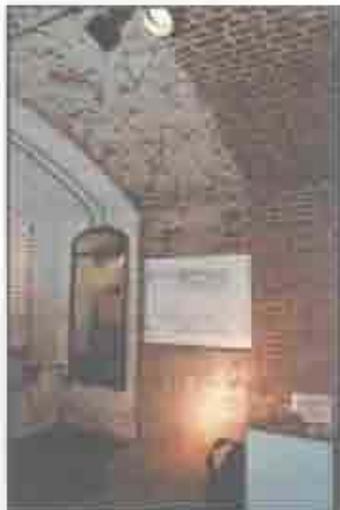
The original 4 1/2 ft. thick wall between magazine 1 and the corridor was also removed in 1914. In this area the floor is patched with concrete and the cut bricks are visible on the walls and ceiling. Only part of the wall between magazine 1B and

Walls were removed in the magazines during the conversion of the fort to a disciplinary barracks in 1914. Half of the 4-foot thick brick and rubble wall remains at right, while only the outline of a wall remains above. (John Martini, 2005)

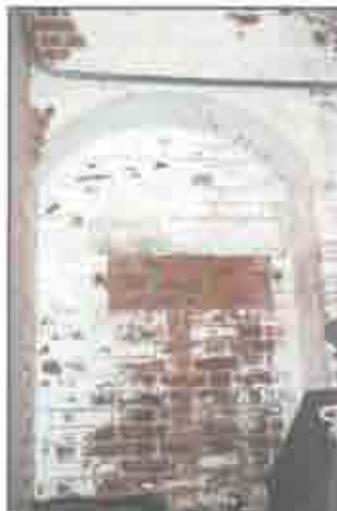
The rifle slit in the corridor of the jail area has been infilled with brick. (John Martini, 2005)

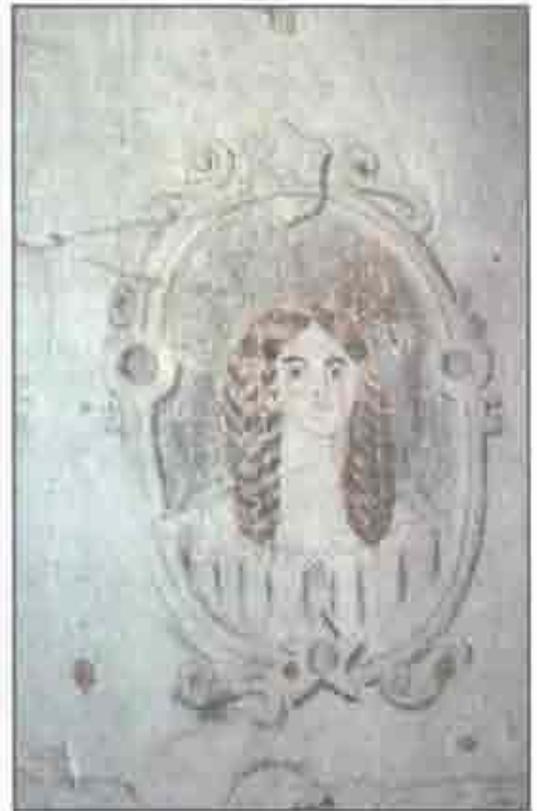
In the north jail cell, there is a drawing on the wall that was done by a prisoner in the 1860s. It is fair condition now, but should be preserved. The drawing depicts an oval portrait hung on a nail of a young woman with Victorian dress.

The drawing on the wall of one of the jail cells was done by a long ago prisoner. (John Martini, 2005)

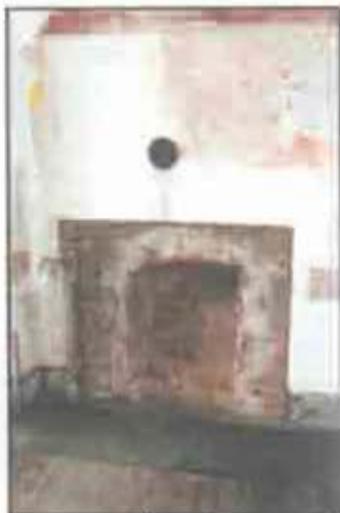
It is apparent from the remnants in this non-commissioned officer's room that the fireplaces were not part of the fort's original construction. (John Martini, 2005)

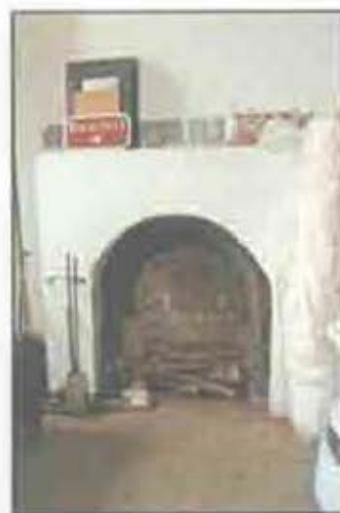
arched opening over the firebox. The bricks in the firebox are rough and appear to be carved out of the masonry wall as well. There is a remaining flue and no evidence of another flue hole in the wall above the fireplace. There is also a decorative iron insert remaining, although this is heavily rusted and broken in places.

One of the older style fireplaces in non-commissioned officer's quarters E. (John Martini, 2005)

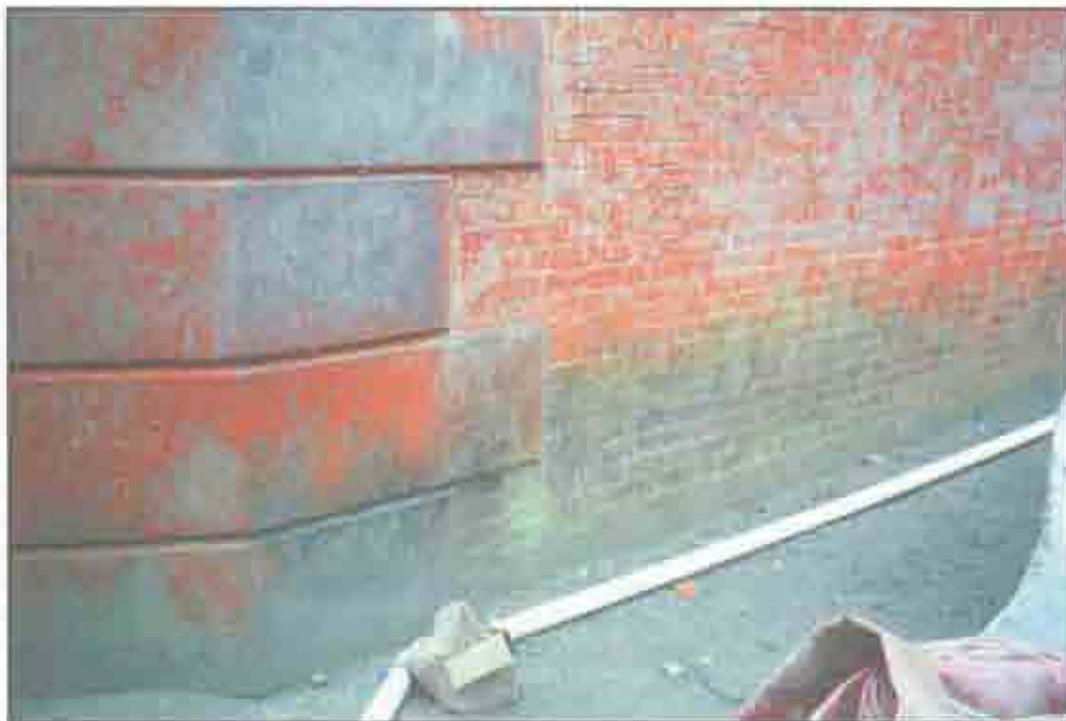
Condition Photo 1:  
Northwest Face Elevation; Biological  
growth located on brick wall and  
granite quoin surfaces. Exfoliation  
on granite quoin is due to the  
growth. (Courtesy of ARG, 2003)

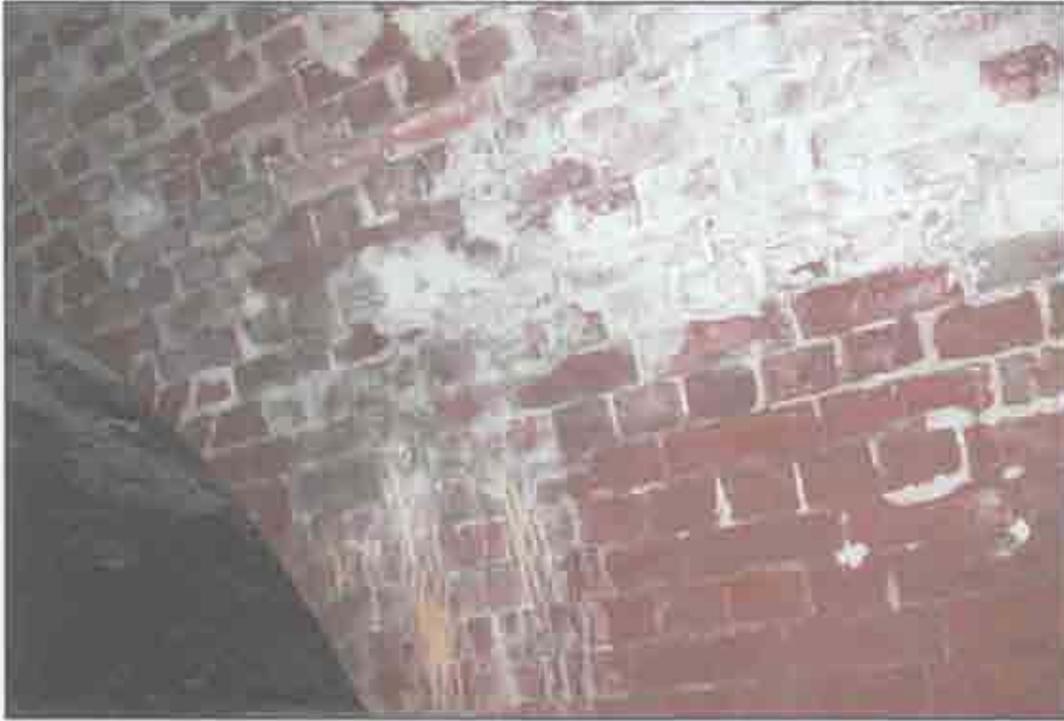
Condition Photo 2:  
Intersecting Arch of Casements  
98 and 99; Biological growth and  
efflorescence settle on masonry  
surfaces. (Courtesy of ARG, 2003)

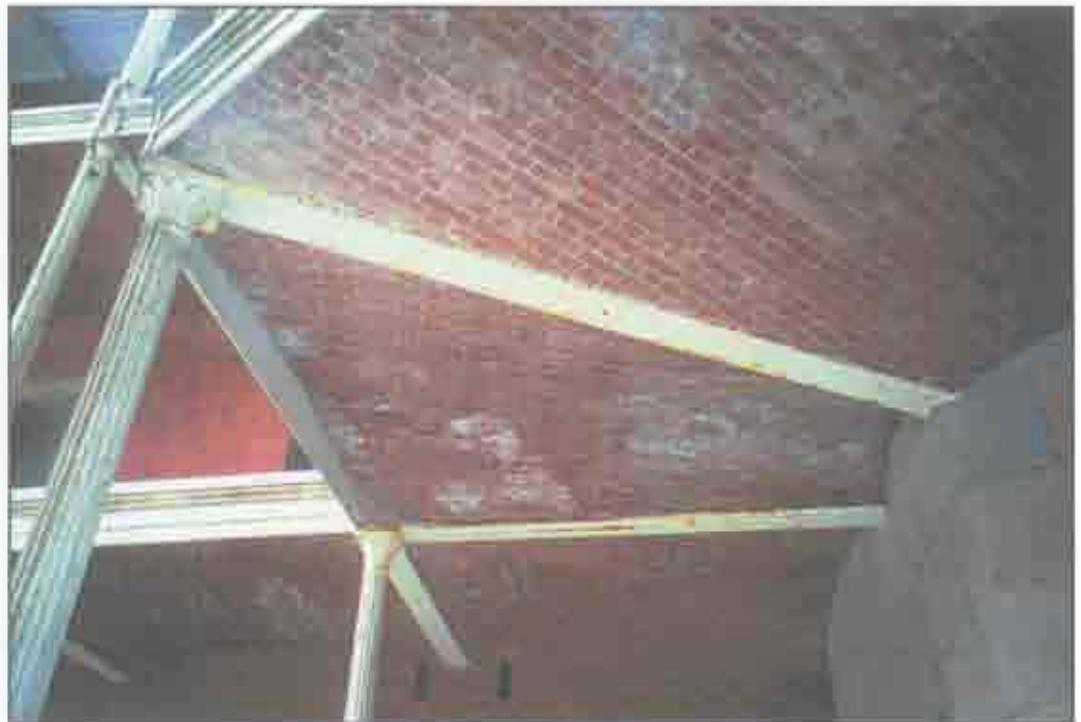
Condition Photo 9:  
Southeast Courtyard—Underside of Walkway at Tier One; Metal corrosion and staining of the granite walls. The brick facing is spalling. Efflorescence occurs on the brick and granite masonry.  
(Courtesy of ARG, 2003)

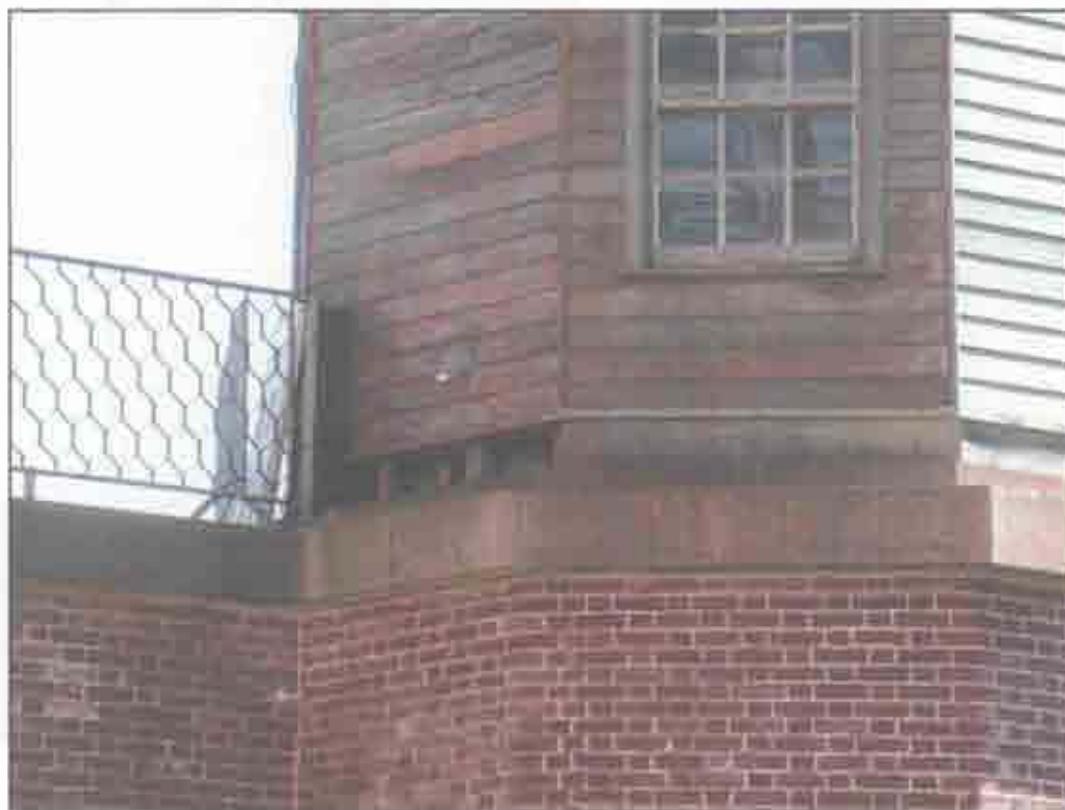
Condition Photo 13:  
Stair 3; Missing siding exposes the  
structural framing. (Courtesy of ARG,  
2003)

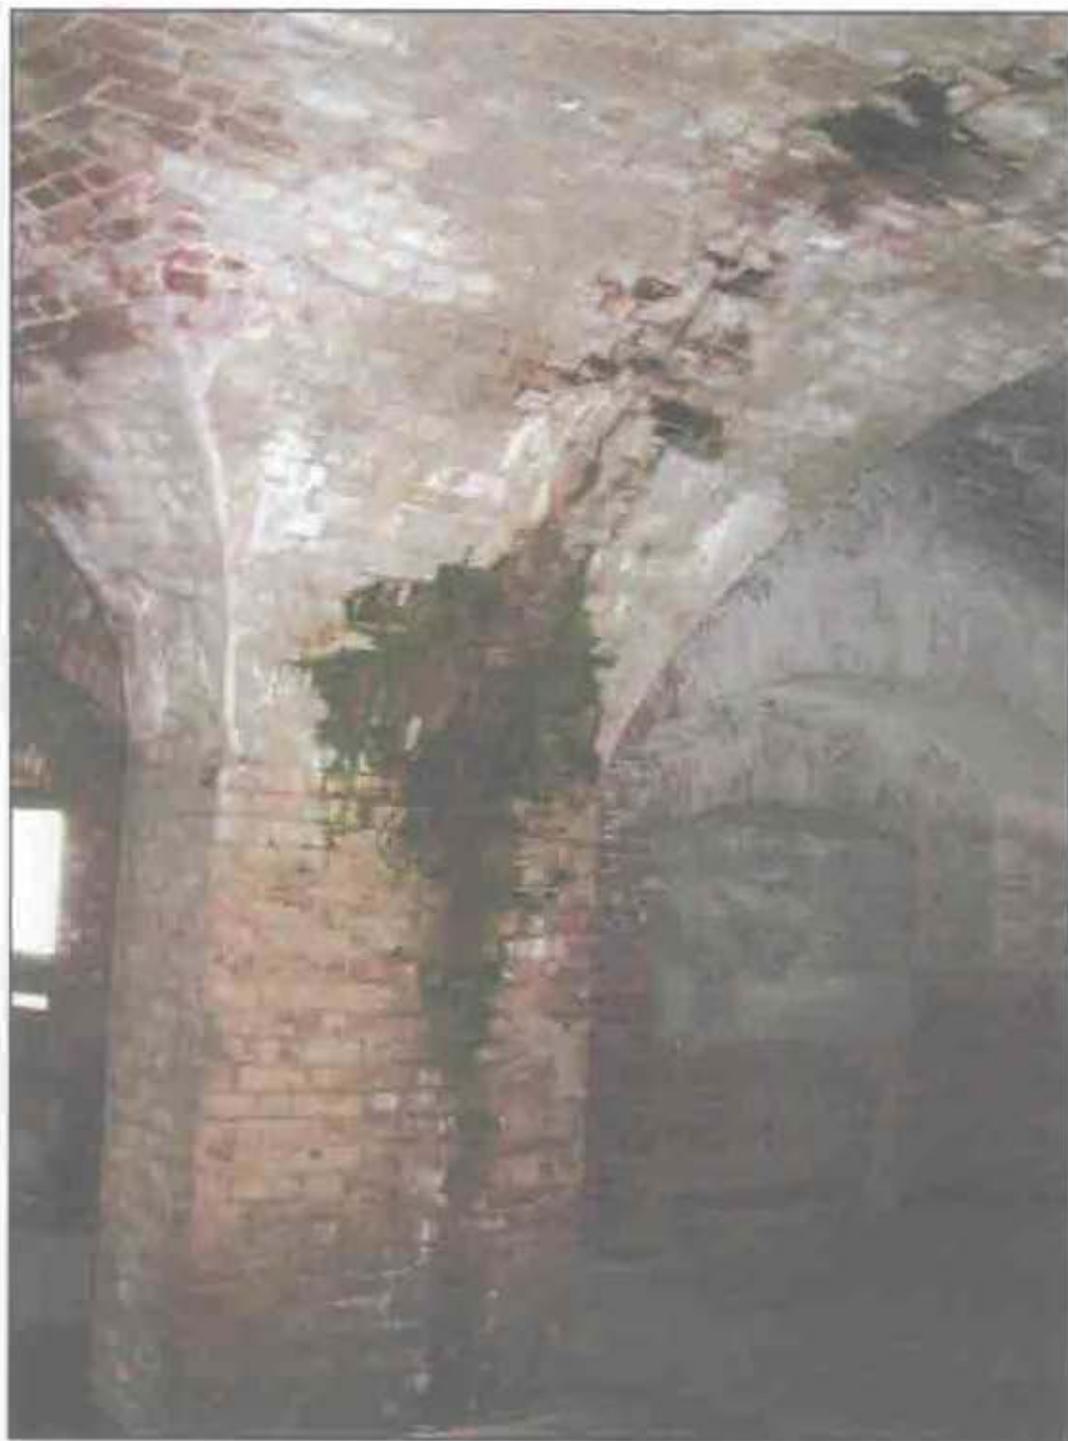
Condition Photo 17:  
Casemate 68A- Third Tier; Crack  
spanning the arch of a casemate,  
typical at the intersection of the east  
barrion and arch of the adjacent  
walkway. Extensive water damage,  
biological growth and efflorescence  
of masonry. (Courtesy of ARG, 2003)

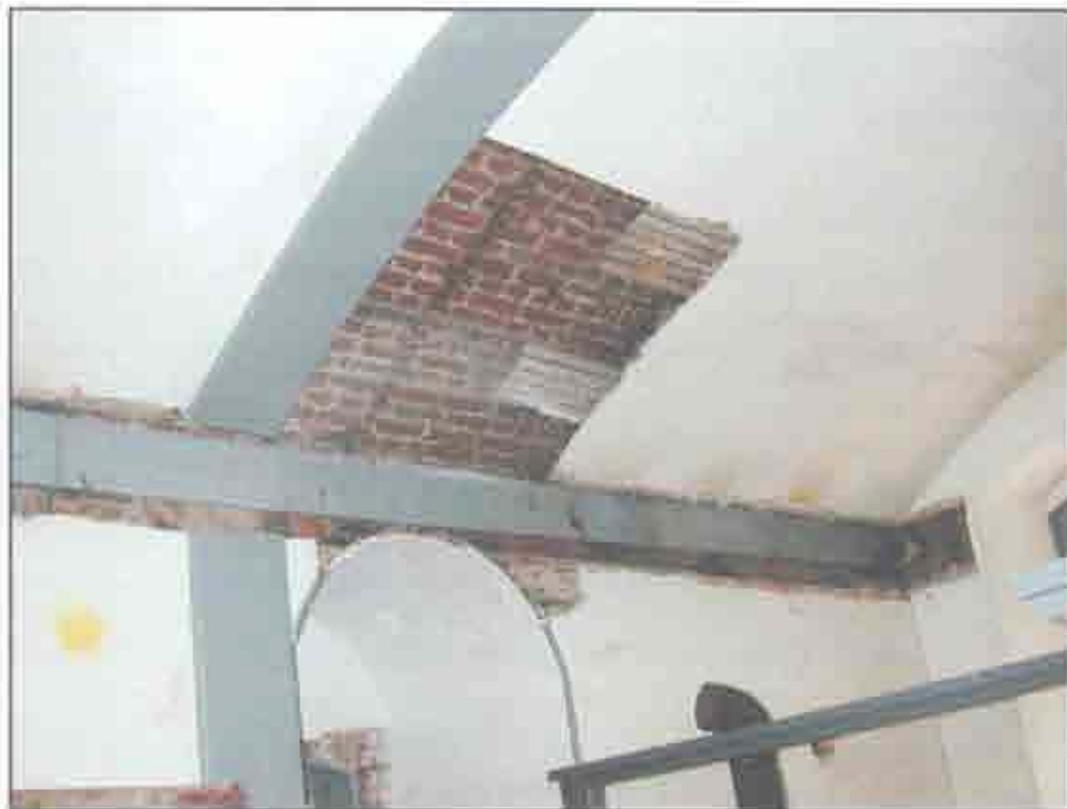
Condition Photo 20:  
Photo shows interior plaster  
patching at 2<sup>nd</sup> tier.  
(Courtesy of ARG, 2003)

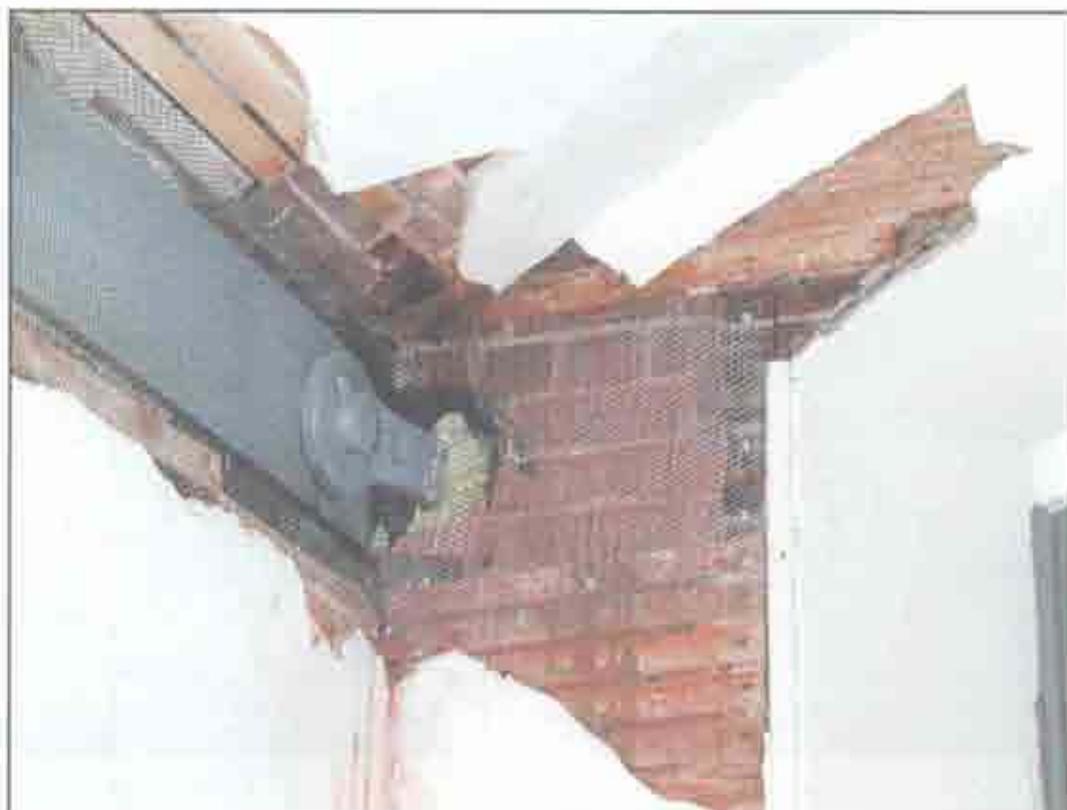
Condition Photo 21:  
Detail of brick lath, wire mesh, and  
plaster layers. (Courtesy of ARG,  
2003)
