Historic Structures Report

Fort Point US Coast Guard Station
Gulf of the Farallones National Marine Sanctuary

April 1, 2008

by
Carey & Co. Inc.

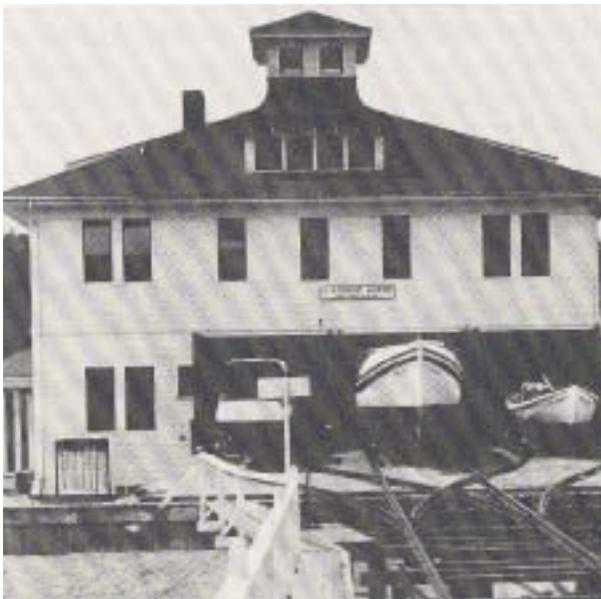
Fig. 37 : North elevation, the original window configuration of the Life Safety Station, 1919.

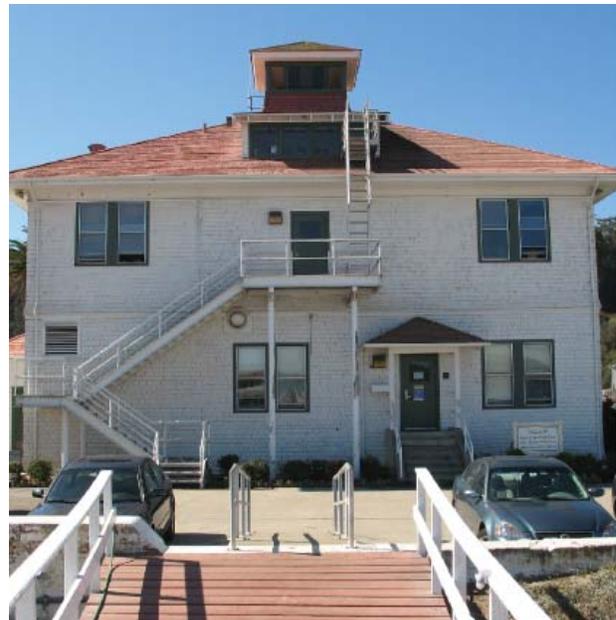
Fig. 38 :North elevation, the current window configuration of the Life Safety Station.

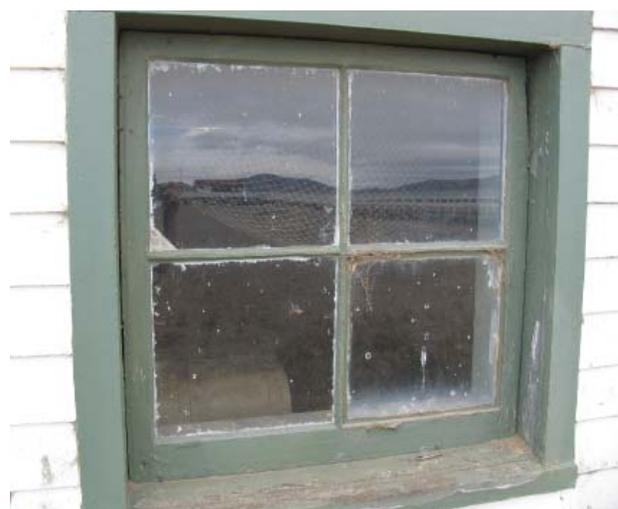
Condition: The paint has deteriorated, and is alligatored, peeling, or missing over the majority of all five structures primarily on the window elements (see figure 52).

Fig. 52: Four-lite awning window at the Shop & Garage.

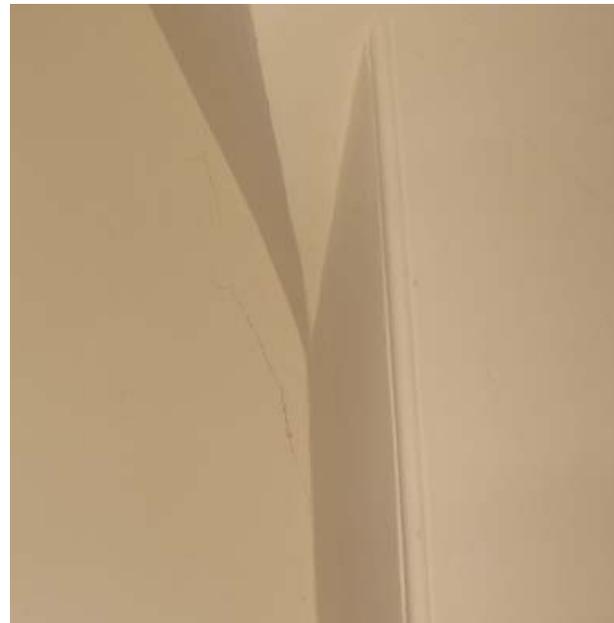
Fig. 60 :Flat plaster wall and corner bead at the interior of the Officer in Charge Quarters.

Condition: The conditions of the plaster walls is generally good. Some areas have been damaged by water infiltration.

Recommendation: Replace missing or debonded flat plaster. Refer to Preservation Brief 21: Repairing Historic Flat Plaster.¹⁰ Where plaster is damaged due to natural, structural or any other occurrence, repair as follows:

- Repair hairline cracks with no debonded material with commercial patching material.
- Cut plaster back in larger cracks and around debonded areas to sound material.
- Install new three-coat plaster over expanded galvanized metal lath.
- Finish plaster to match existing adjacent surfaces.
- Prepare and paint to match adjacent surfaces or historic condition. See Paint Analysis report in the appendix for color recommendations.

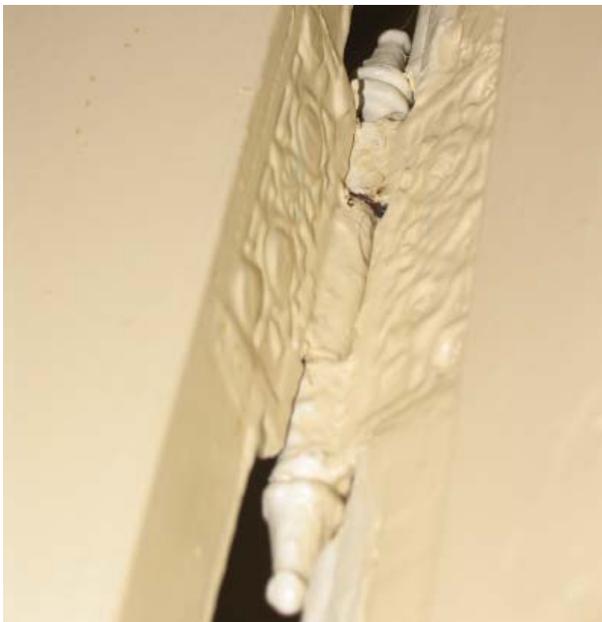
Fig. 69 : Original hardware at the Officer in Charge Quarters.

Condition: Most interior doors appear to be in good condition, with normal wear and tear such as finish abrasion in evidence, and only minor repairs needed. Hardware is also in good condition, although in most cases in need of reconditioning (see below).

Description: The majority of the hardware is original and intact. It consists of bronze doorknobs, bronze faceplates and hinges, and bronze window catches (see figures 69 & 70). Several locks on the exterior doors have been replaced with modern dead bolt locks.

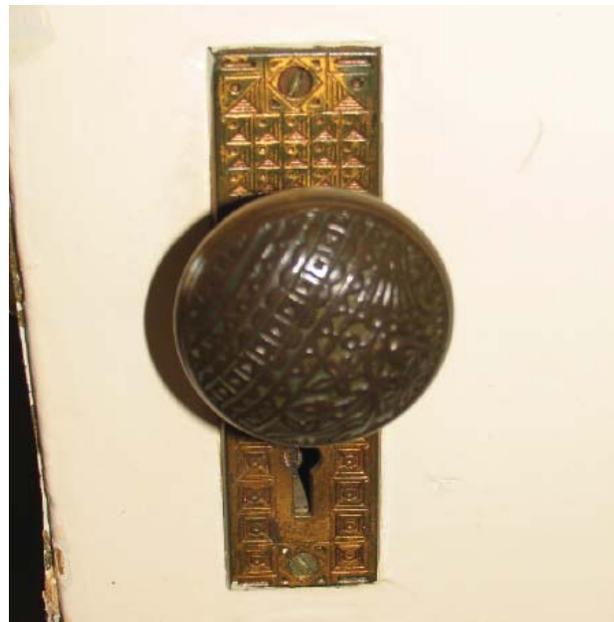
Fig. 70 :Original hardware at the Officer in Charge Quarters.

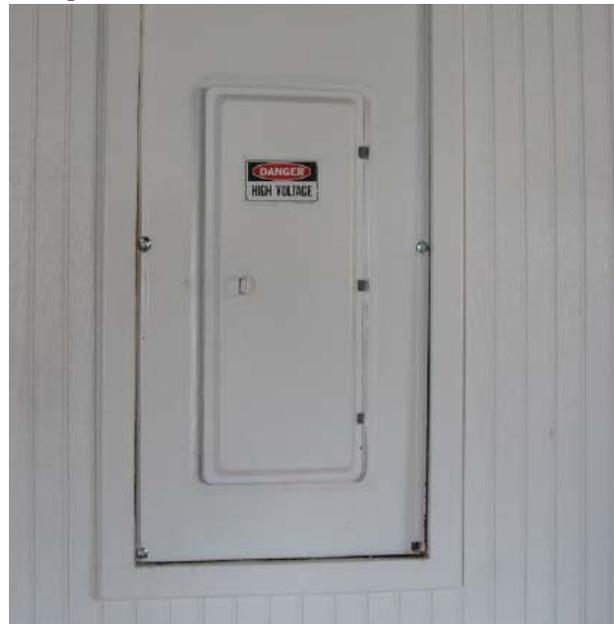
Fig. 72 : Electrical box at the Buoy Shack.

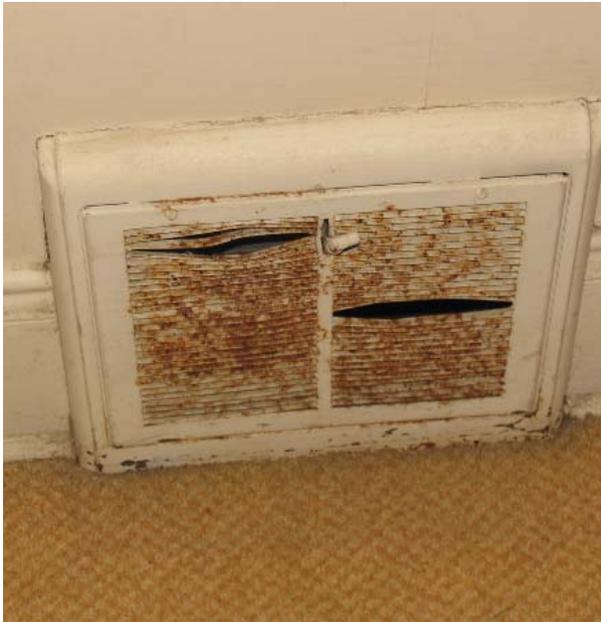
Fig. 73 : Heater vents at the Officer in Charge Quarters.

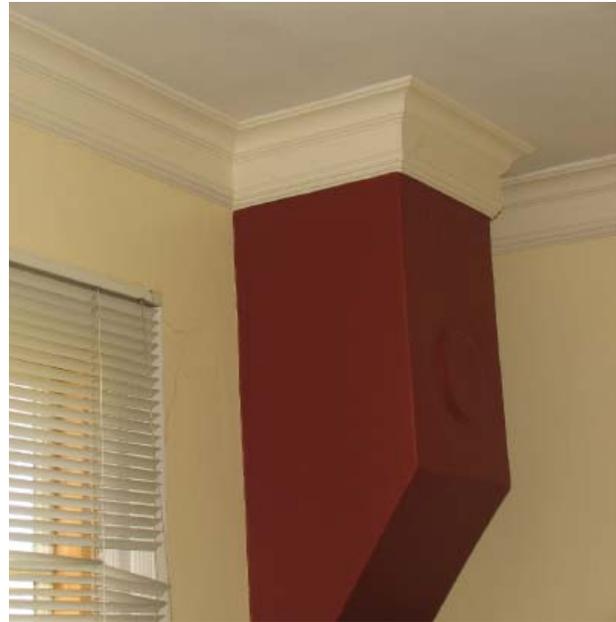
Fig. 74 : Flue and flue cover at the Officer in Charge Quarters, remnant of earlier stove heating system.

Description: The Officer in Charge Quarters was originally heated by stoves. Flue holes, covered over by plates, survive in many rooms, as do fireplaces in the parlors and dining rooms (see figure 74). A propane-fueled forced air system has been installed in the house, and grates are visible in the majority of the rooms. It is unknown whether or not any of the other structures were heated. The Officer in Charge Quarters appears to be heated by a propane-fueled forced air system.
