HISTORIC STRUCTURES REPORT  
for  
VANCOUVER BARRACKS, WEST BARRACKS  
Vancouver National Historic Reserve

**PART II: TREATMENT AND USE**

Leavengood Architects  
Seattle, Washington

November 15, 2002

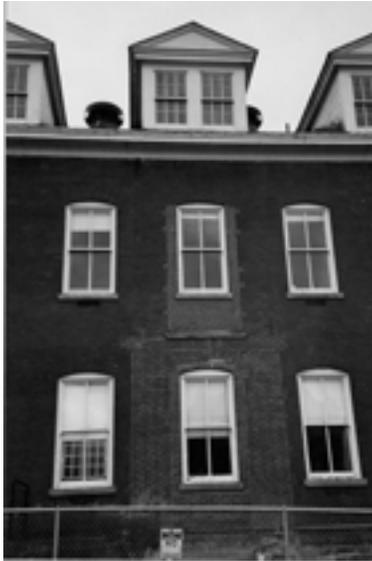
- **Foundation:** The foundation is brick and rubble stone with rusticated ashlar sandstone facing laid in a four-height pattern. A heavy, rusticated sandstone belt course circles the building above the foundation. In general, the foundation is in fair condition with some biological growth near grade and some red staining from the brick deteriorating above.

The west elevation of the hospital shows the location of the walkways to the Annex building.

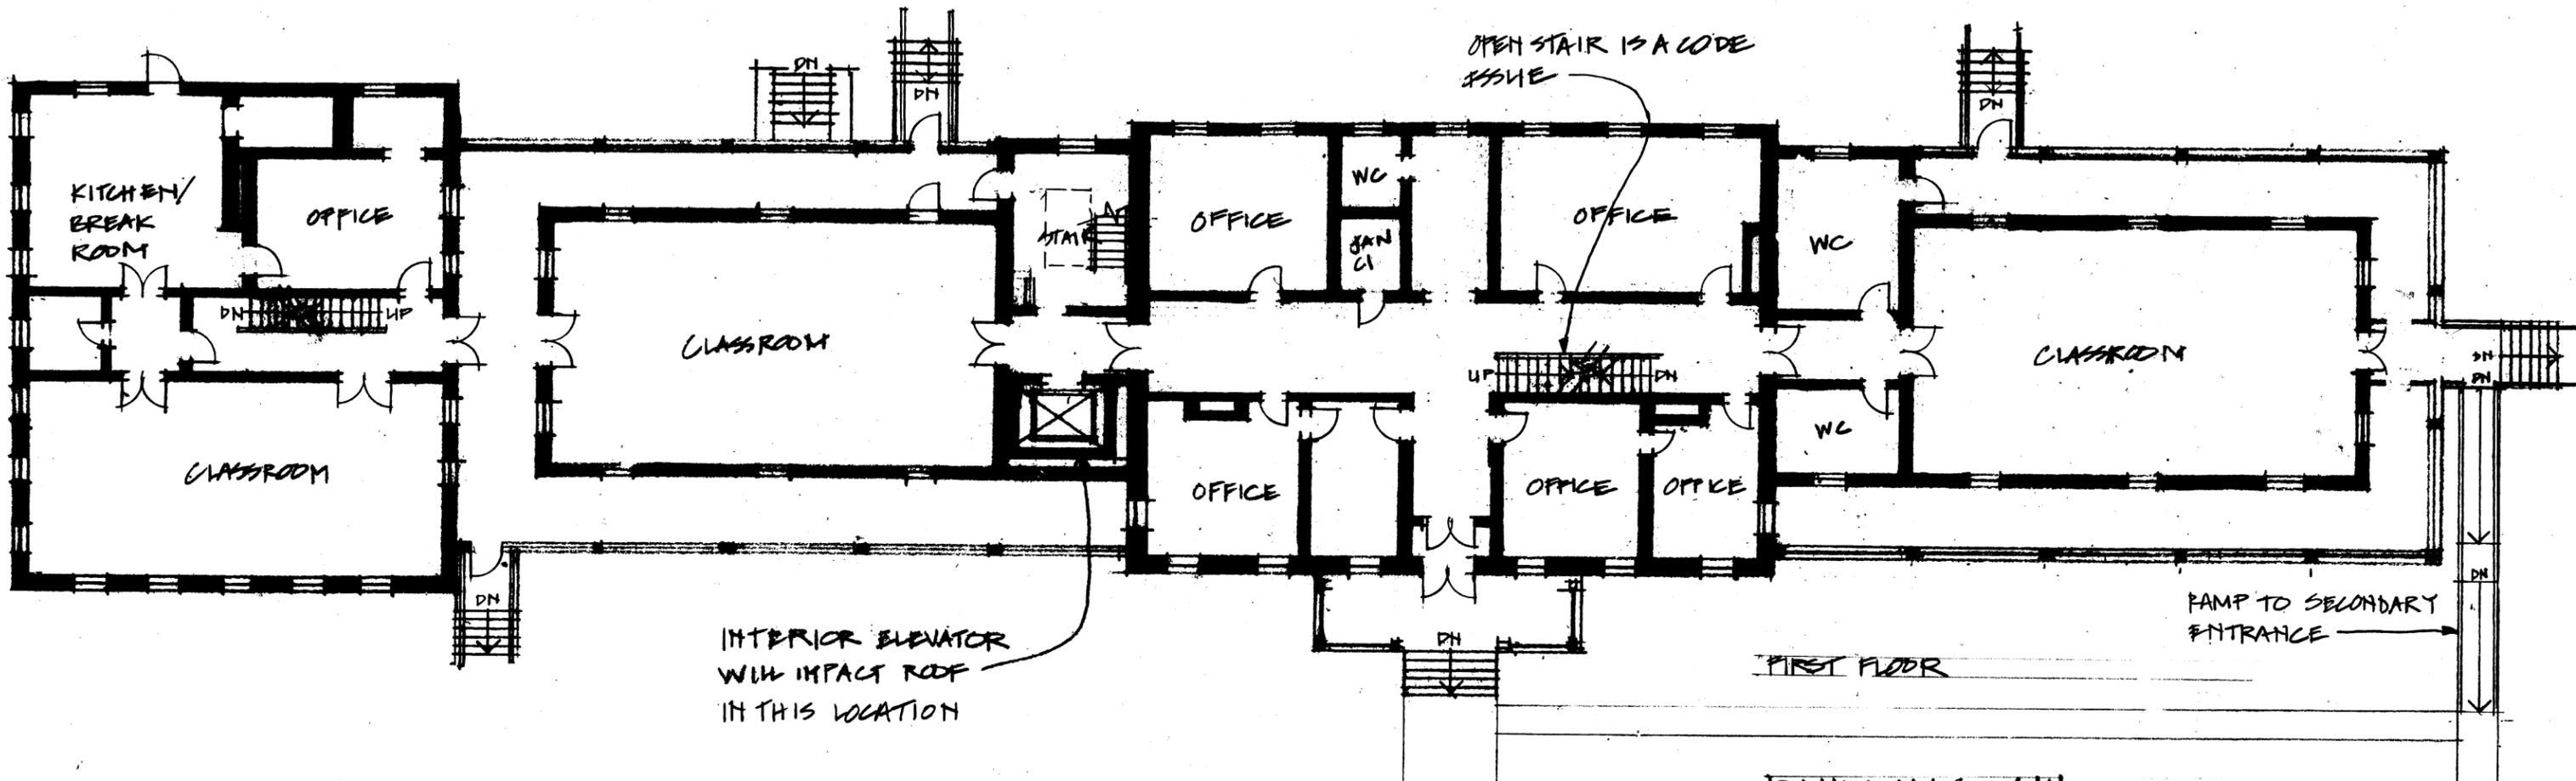
BUILDING 014  
SCALE: 1/16" = 1'-0"

OPEN STAIR IS A CODE ISSUE

INTERIOR ELEVATOR WITH IMPACT ROOF IN THIS LOCATION

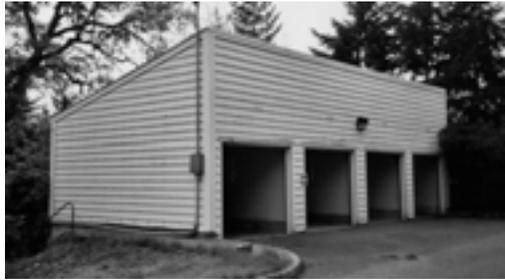
**Building Number:** 602, 676, 673  
**Area:** West Barracks  
**Date of Construction:** 1982  
**Historic Use:** None  
**Current/Recent Use:** Garages

These buildings are in relatively poor shape for being so recently constructed. They are not historic structures and therefore do not fit in to the overall West Barracks historic district. The only feature that ties them into their surroundings is the exterior finish material. However, in the short term they will be useful to tenants of the Duplexes and should be retained until the wherewithal to demolish them and build more compatible buildings is found.

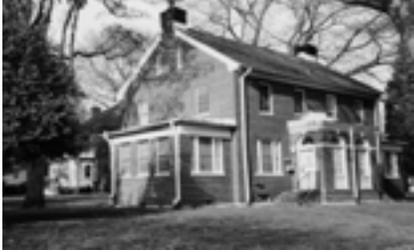
<b>Building Number:</b>	<b>635, 641, 642, 643, 644, 664, 665 Duplexes</b>

- **Summary**: The units are in good overall condition. Wooden trim, porches, windows, and other elements have varying degrees of deterioration that will require attention. This constitutes the worst of the damage on these buildings except for units #643 and #664 that were relocated in 1952 and have suffered some settlement of their foundations. Few changes have been made to these buildings, apart from the kitchen remodels and the conversion of the back porches to bathrooms.

- **Foundation**: The concrete foundations are in good condition.
- **Walls**: The exterior walls are in good condition with plain wire-cut brick laid in a common bond and sixth course headers. Conduit and other items have been attached to the brick wall at the mortar joints.

- **Windows**: The windows are wood six-over-six lite double hung units in fair condition. The paint is peeling on the sashes. The sidelights are wood two-over-two lite double hung units in fair condition that also have some damage to the sashes. The rear porch windows are wood four-over-four lite that are non-contributing, but are in good condition as they were installed in 1994. The wood casements and fanlights at the brick front porches are in good condition. The basement windows are three-lite hoppers; quite a few have been modified for dryer vents. Aluminum-frame screens at the hoppers have replaced the original wood screens.

- Trim: The wood trim at the rear porches is in fair to poor condition probably due to inadequate preparation before painting.
- Roof, Gutters and Eaves: The wood at the eaves has been stained by water from overflowing gutters. The damage may not be limited to surface staining. The gutters fill quickly and easily with debris. Several roof leaders are damaged or blocked. The roofs are slate in either a gable or a hipped configuration. There is some biological growth but no immediate indications of waterproofing problems. There are copper roofs on the porches and the sun room that are covered with an elastomeric coating that is failing. No damage is visible, however, on the interior finishes that would indicate failure in the waterproofing. The flashing at the junction of roof and brick is loose.

- Porches and Stairs: The brick at the entry porches is in good condition. The French doors were modified and the metal railings in front of them removed in 1994. The concrete stairs have some biological growth on them and the metal railing connections are in good condition. The wood at the front entry porches has not fared so well. The wood trim is in fair to poor condition and the base elements in particular are deteriorating where they are in contact with the concrete slab. The rear porches have been modified for powder rooms in 1994 and are not aging well. The wood trim, in particular, is deteriorating. The back porch stairs were also reconfigured in 1994. They are in good condition. The concrete stairs to the basement collect debris and the drainage could be blocked. There is no handrail.

- Miscellaneous: The existing mailboxes are modern and should be replaced. Light fixtures at exterior porches are also inappropriate in style and the surface mounted conduit is intrusive. The coal chute cover was modified to allow for a vent insert that was installed poorly and has deteriorated over the years. There are temporary exhaust fans installed in the upper story windows.

- Site: Re-grading should be explored for Buildings #643 and #664 and the settlement of these two building evaluated by a structural engineer.
- Foundations: They are generally in good condition except for Buildings #643 and #664.

- Walls: Remove conduit and other intrusive surface mounted items and re-point the brick as required.
- Windows: Scrape and paint sash and trim. Repair sashes that have been damaged by squirrels.
