**1998 Summary Report:  
Archaeological Site Monitoring and Management  
Along the Colorado River  
Corridor Below Glen Canyon Dam**

Submitted by  
Grand Canyon National Park/Northern Arizona University  
Glen Canyon National Recreation Area

September, 1998

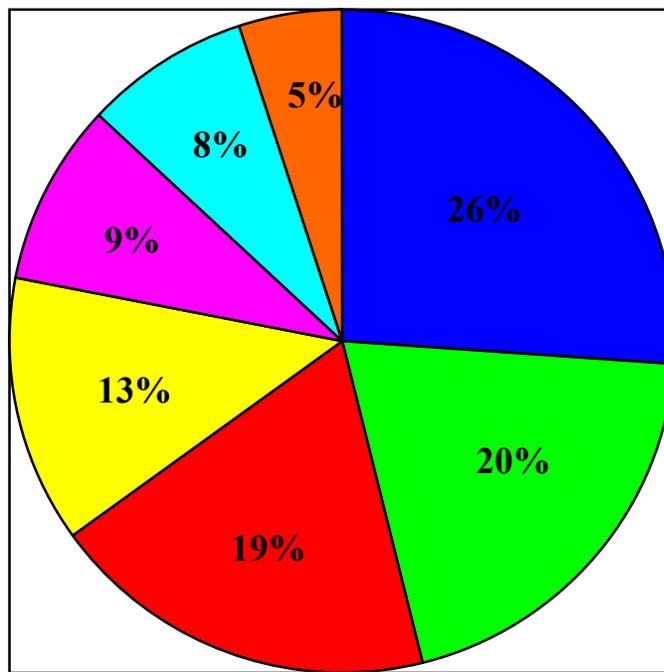
Figure 1 shows the relative frequency of physical impacts (N = 456 observations). The 456 observations refer to the number of times monitors identified any form of physical impact, or each individual occurrence recorded during FY98. It is important to understand that more than one type of physical impact may be occurring simultaneously within a site boundary or to the same cultural feature. Remedial action assessments and recommendations for treatment are grounded in the identification and understanding of how multiple physical impacts may be related.

Figure 1. Relative frequency of physical impacts in FY98.  
(N = 456 Observations)

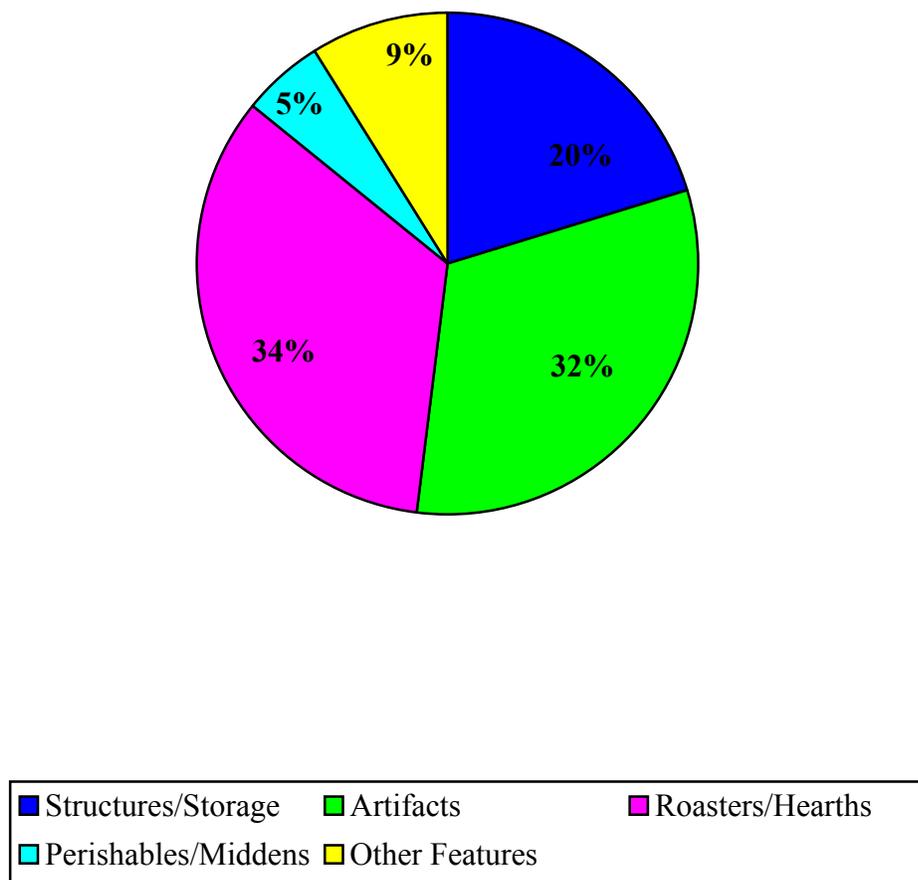
Identification of impacts on-site aids monitors in understanding the nature and severity of the observed impacts. Locational data leads to the formulation of a ranking of impacts at sites which have been selected for remediation. Figure 2 shows the relative frequency of physical impacts to specific cultural features on-site. The highest frequency of physical impact occurs at roasters/hearths, artifacts and structure/storage features. These features are also the most common cultural feature observed along the river corridor in Grand Canyon.

Figure 2. Physical impacts to features in FY98.  
(N = 456 observations)

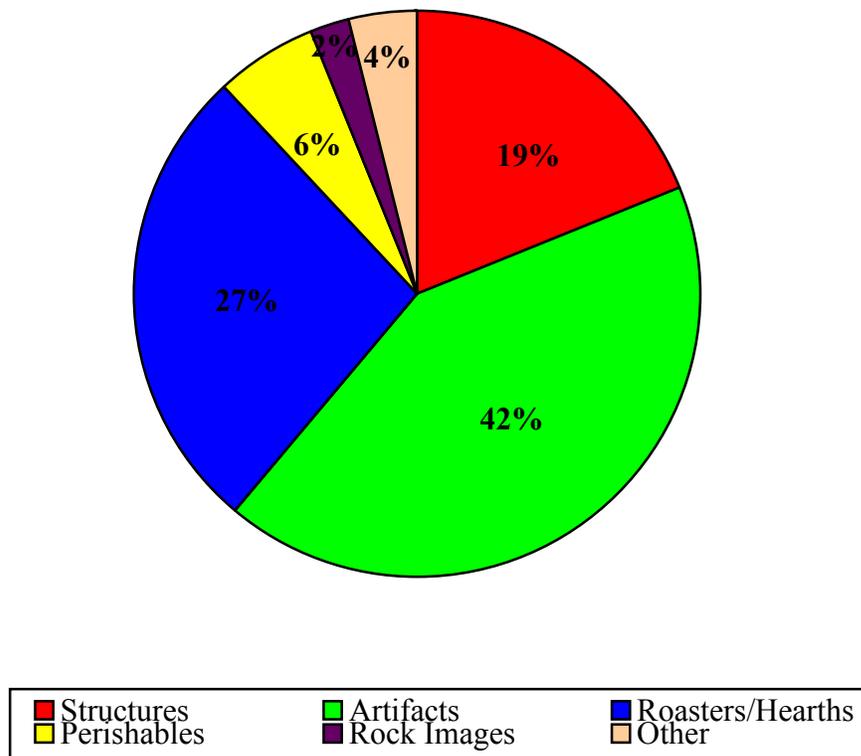
Figure 3. illustrates the relative frequency of visitor-related impacts at various features. As in past years, artifact scatters (42%), roasters/hearths (27%) and, structure/storage (19%) features receive the highest number of visitor-related disturbances. One occurrence of rock art vandalism occurred at C:02:094, where new graffiti was discovered by monitors. The new graffiti is most likely from fishermen due to the associated trash and proximity to Lees Ferry.

Figure 3. Visitor-related impacts to features in FY98.  
(N = 48 Observations)

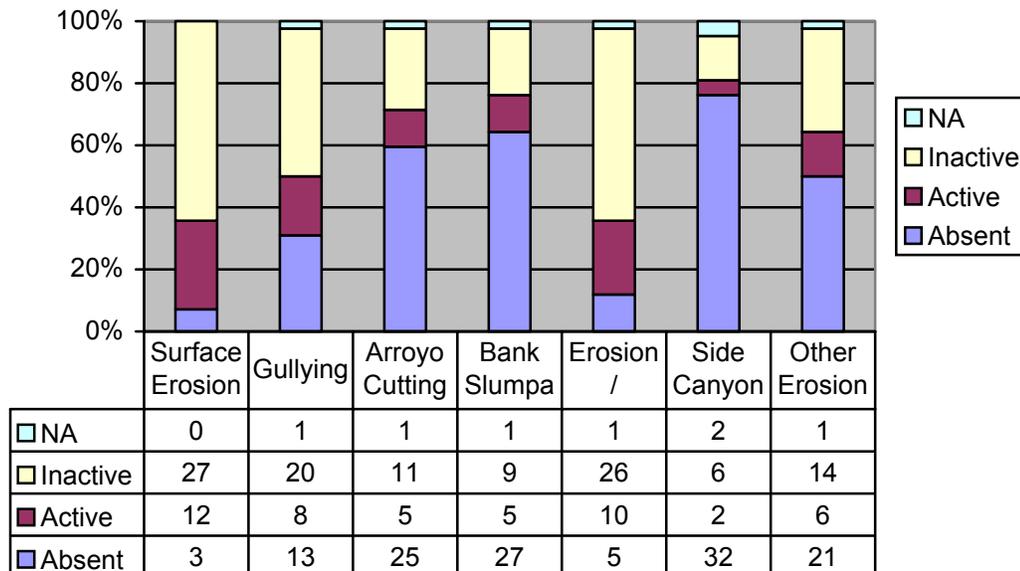
In Glen Canyon NRA, one site (C:02:105 [2% of the 42 sites monitored in FY98]) exhibited no physical impacts. This is the "Hislop 1889" historic inscription inside Hislop Cave. Figure PI summarizes the frequency of physical impact types within Glen Canyon NRA in FY98. Of the 42 sites monitored, active physical impacts are generally exhibited at less than half of the sites with any particular physical impact type. For example, active surface erosion is present at 29% (N = 12) of the sites, while surface erosion is inactive at 64% (N=27) of the sites. Gullying is active at 19% (N = 8) of the sites, and is inactive at 48% (N = 20). Arroyo cutting is active at 12% (N = 5), and is inactive at 26% (N = 11) of the sites. Figure 8 also indicates that surface erosion is present most often, followed by eolian erosion/deposition, gullying, other erosion, and finally by arroyo cutting and bank slumpage.

Figure 8. Frequency of physical impact types within Glen Canyon NRA in FY98.

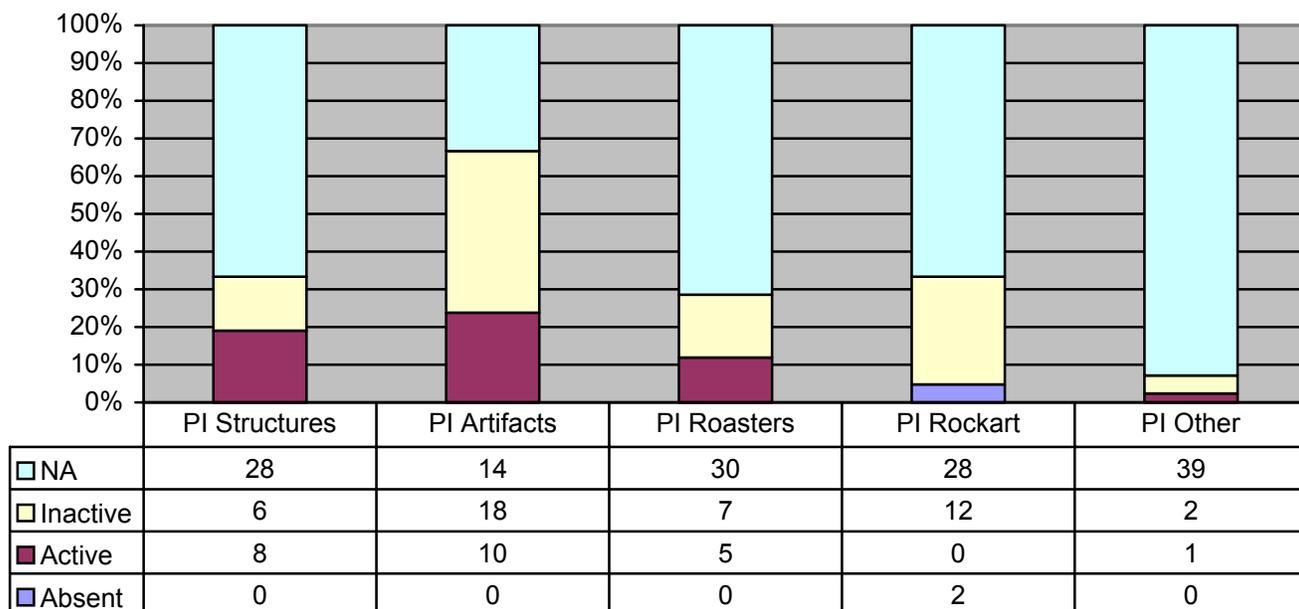
Figure 9 summarizes the frequency of physical impacts to features within Glen Canyon NRA in FY98. Of the 42 sites monitored, those consisting solely of artifact scatters (24%, N = 10) and those containing structures (19%, N = 8) more frequently exhibited active erosion than did sites with roasters (12%, N = 5). Rock image panels exhibited no active erosion. The active erosion of the Bureau of Reclamation Trail was also noted (PI Other).

Figure 9. Frequency of physical impacts to features within Glen Canyon NRA in FY98.
