Fiscal Year 2002
Archaeological Site Monitoring and Management
Activities Along the Colorado River in Grand Canyon
National Park.

CHAPTER ONE

EXECUTIVE SUMMARY

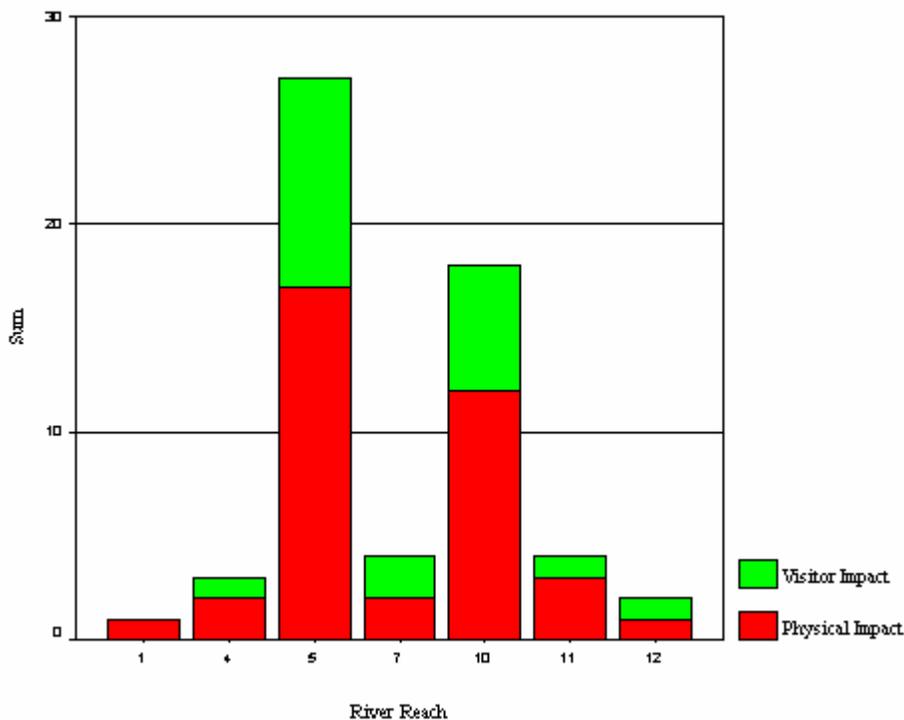
Figure 3 shows the distribution of physical and visitor-related impacts by reach at the 42 monitored sites. It is apparent from this stacked bar graph that (1) sites within reaches 5 and 10 continue to experience the majority of both physical and visitor-related impacts, and (2) physical impact frequency exceeds visitor impact frequency in 4 of the 7 reaches (reaches 4, 5, 10, and 11).

Figure 3. Visitor and Physical Impact Frequencies at 42 Monitored Sites

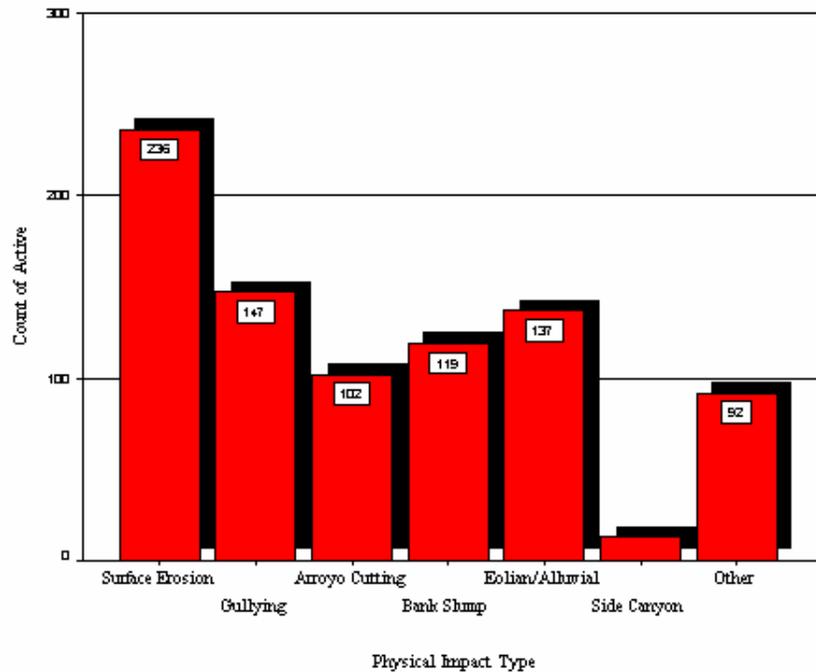
Figure 4 (Count of Active Erosion FY1991-2001) indicates the frequency of active physical impacts observed at the 42 sites over an eleven-year period (from FY1991-2001). The bottom graph depicts the same information, but for a single year (FY2002). Surface erosion, gullyng, and eolian/alluvial erosion or deposition remain the most frequently observed active impacts over time and in the present fiscal year. The rank order of impact type, however, is different for the two time periods. When comparing the previous eleven years to the current year it is apparent that arroyo cutting and bank slump have “switched places” in the rank order. The observed frequency of active arroyo cutting exceeded the observed frequency of active bank slump in FY2002, unlike the pattern for the previous eleven years. The reason for this change has yet to be determined. Additionally, the proportionate increase in eolian/alluvial erosion or deposition in FY2002 as compared to the previous eleven years is significant. It is possible that this phenomenon is related to drought conditions, less vegetation, and subsequent active eolian processes.

Figure 4. Count of Active Erosion at 42 Sites Monitored from FY1991 – 2001
(N = 42 Sites and 378 Observations)

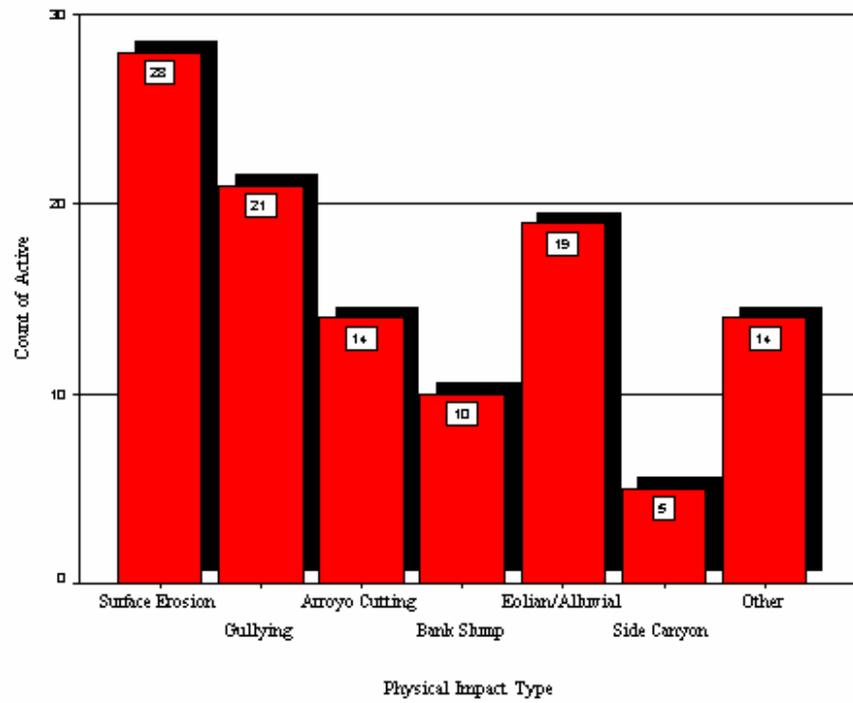
Figure 5. Count of Active Erosion at 42 Sites Monitored in FY2002
(N = 42 Sites and 42 Observations)

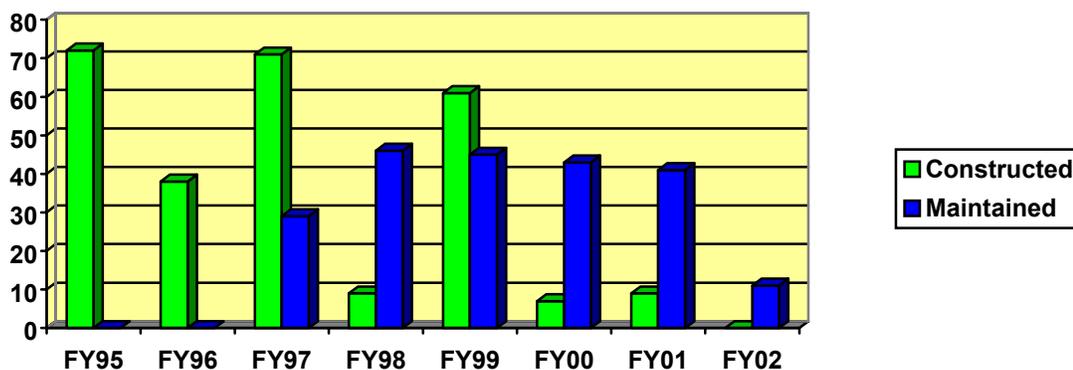
Erosion control structures are monitored annually. In the course of monitoring, ZCP staff determine whether or not maintenance or additional construction is necessary. Figure 13 presents the 254 existing checkdams as they were constructed in each fiscal year and the number of checkdams where maintenance was required. It should be noted that in FY95, all checkdam construction occurred at two sites, C:13:099 and C:13:100 [Leap, 1995 #27].

Figure 13. Number of Checkdams Constructed and Maintained by Fiscal Year.

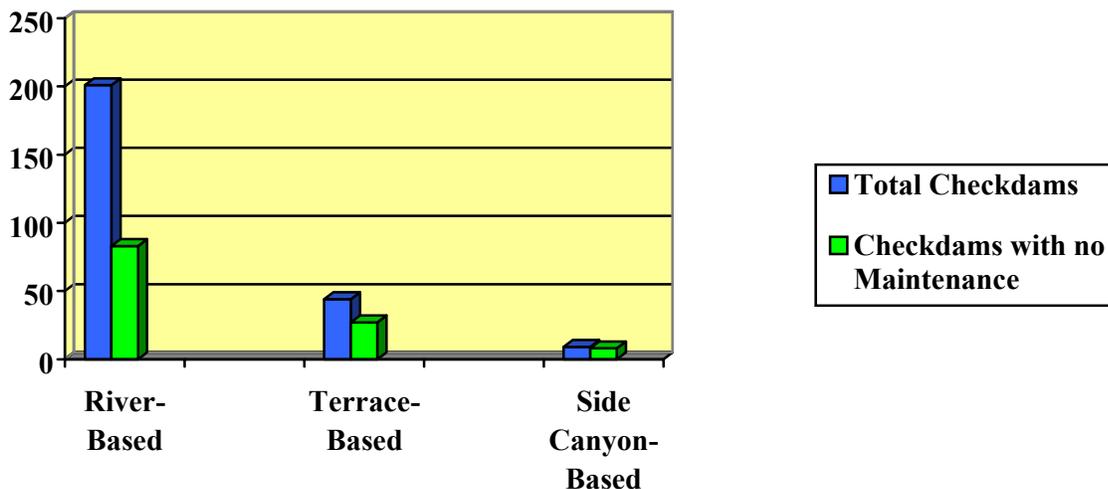
Since initial construction, 119 of the 254 checkdams, or 47% have required no maintenance of any sort. Figure 14 shows the total number of checkdams and the number of checkdams without maintenance, by drainage type. It is anticipated that current research relating to checkdams will provide additional support for the construction and maintenance of certain checkdam types in specific contexts. Until this research is completed in April 2003, maintenance of existing checkdams and new construction at nine specific locations has been halted.

It should be expected that checkdams located in river-based drainages require the most amount of maintenance. River-based drainages are actively eroding to the lowered base-level of the Colorado River [Hereford, 1993 #20]. The presence of nickpoints, or changes in elevation within the drainage channel, indicates active channel deepening and widening. Twenty-one nickpoint treatments have been required at eight sites. No nickpoint treatments have occurred at terrace or side canyon-based drainages.

Figure 14. Number of Checkdams Constructed and Maintained by Drainage Type.

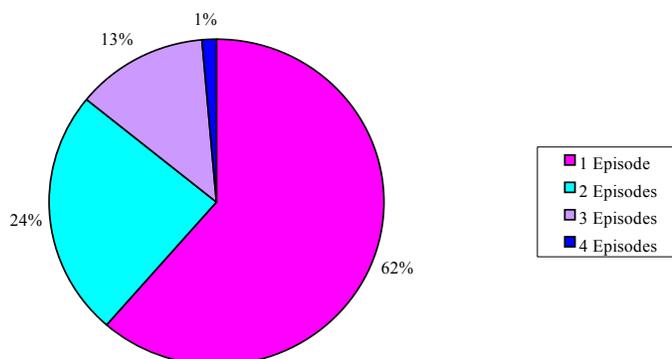
Of the existing 254 checkdams, a total of 135 existing checkdams have required maintenance at some point since their original construction. Figure 15 shows the percentage of sites with maintenance episodes. The majority of checkdams, 83, have needed only one maintenance episode. Two maintenance episodes have occurred at 33 checkdams, three maintenance episodes at 17 checkdams, and two checkdams have required four maintenance episodes, one at Palisades, the other at Granite Park.

Figure 15. Percentage of Checkdams Maintained by Number of Maintenance Episodes.

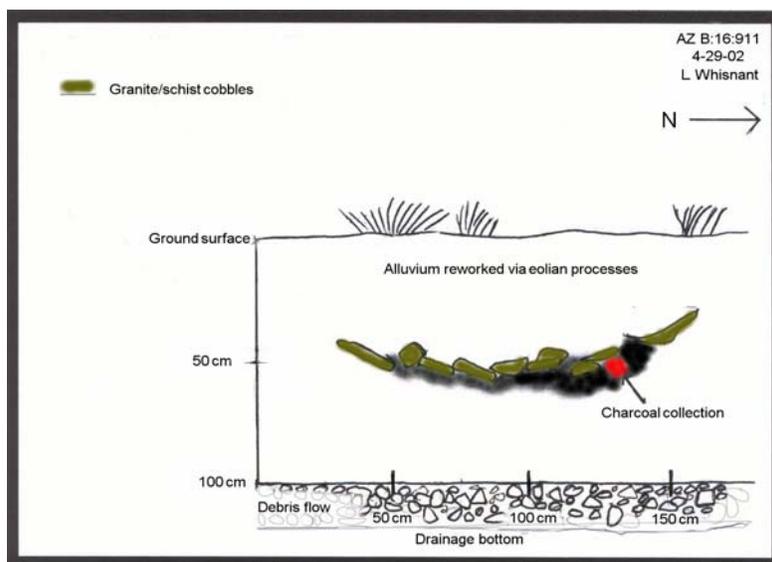
Figure 18 . Site Map/Profile of B:16:911.

B:16:911, a single roasting feature, is located in an alluvial deposit reworked via eolian processes. This site was recently exposed by a flash flood at Monument Creek (see Figure 17). The roasting feature is situated approximately 40 centimeters below the ground surface. It is composed of charred granite and schist cobbles, which form a shallow basin. The cobbles are burnt to varying degrees and average a size of 10 centimeters. The charcoal is mainly ashy with some larger pieces on the north end of the feature. A charcoal sample was collected from this location (see Figure 18). This date will provide a timeframe for when the feature was used and the fuel type, assuming there is no "old wood" problem. No artifacts are associated with this feature.
