Addicks Cabin and Adamless Eden
Elkmont Historic District
Great Smoky Mountains National Park

Historic Structure Report

September 2010
for
Great Smoky Mountains National Park
Southeast Region, National Park Service
by
Joseph K. Oppermann–Architect, P.A.
539 N. Trade Street Winston-Salem, NC 27101

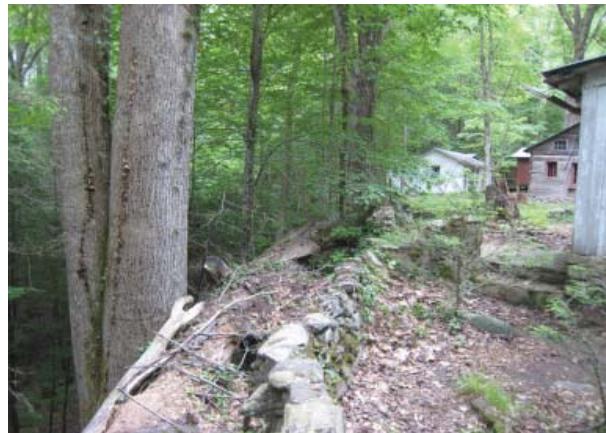
Figure 4, Stone retaining wall at back edge of property.

A field stone wall follows the property line just north of Adamless Eden. At its west terminus, it intersects perpendicularly with the front retaining wall. At its east terminus, it intersects a wall along a steep bluff. That wall continues north behind other cabins and south past Adamless Eden, the Addicks Cabin, the Mayo Cabin, Trentham Cabin, the Mayo Servants' Quarters and beyond. Additional low, stone garden walls and a low stone planter edge the property to the south of Addicks Cabin.

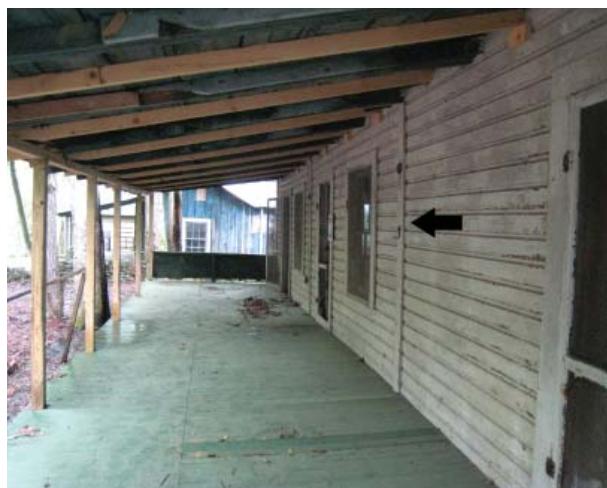
Figure 9, Front (west) elevation of main block of Addicks Cabin with plank boards covering seams in German siding.

The front elevation has three matching four-panel apparently original entrance doors; the doors at either end are currently inoperable and covered over on the interior. Each door is located next to an apparently original six-over-six double-hung sash window. There are a total of six such double-hung windows in the main block; three are on the west, or main elevation, with one on the south and two on the north.

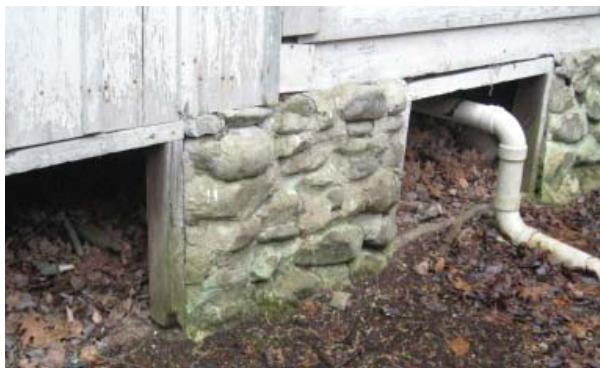
Figure 14. Stone foundation pier at north elevation spans between Northeast Bathroom on left and main block on right.

The foundation wall of the cabin is constructed of local stone. It is continuous around the perimeter of the cabin except for the north side where there are four openings for access to the crawl space. On the east elevation the finished walls are at grade.

The stone perimeter foundation wall extends beneath the front porch. In areas where the wall has deteriorated, modern wood temporary shoring has been installed to help provide support. The porch floor framing is made up of 1½" by 5½" wood boards that run north-south at 20" on center. The ¾" wide floor boards on the front porch measure 1" thick at the back of the porch and ¾" thick to the west of the floor seam where the porch was extended.

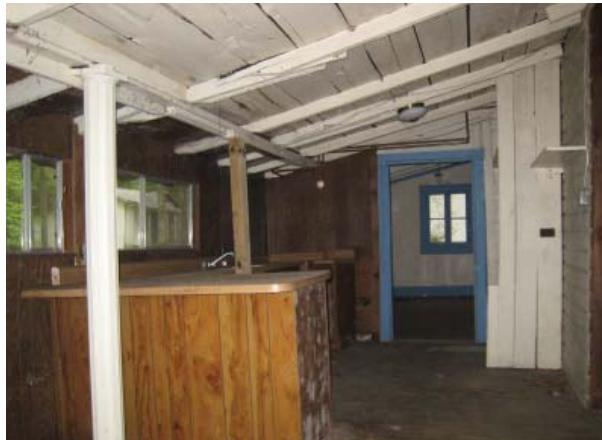
Figure 16, Kitchen with four generations of rafters.

At the east side of the cabin several generations of rafters have been scabbed onto the main block's original roof rafters as various additions were constructed. At what is now the kitchen, the original rafters have a 9" to 10" overhang. A second generation of rafters extended the space 6'-0". Later another 2'-0" were added with a third generation of rafters; and again later another 2'-0" were added on to allow for the depth of the current kitchen cabinets and countertops. Makeshift

posts and beams were added to support the third generation of rafters, though the overall roof structure at the back of the cabin does not appear to be completely sound.

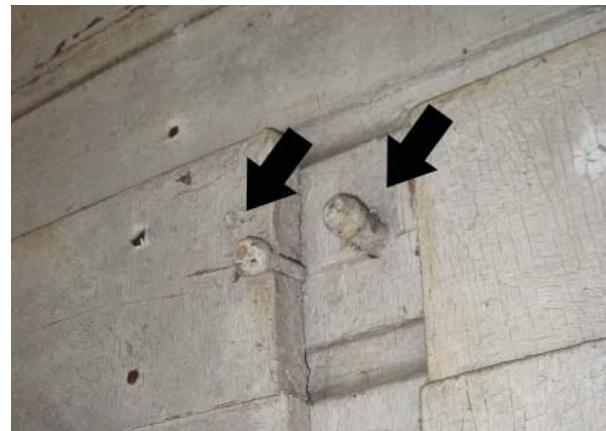
Figure 17, Two porcelain tubes in west wall are remnants of early knob-and-tube wiring.

The earliest electrical distribution system for the main block of the cabin appears to have been knob-and-tube wiring. Developed in the 1880s and remaining in use until the 1940s, knob-and-tube wiring utilized ceramic knobs mounted on the surface along with ceramic tubes drilled through framing and walls to separate the hot and neutral wires by 4" to 6", and also insulate the wires away from the structure. Remnants of these porcelain tubes or sleeves can be seen in several places on the walls where wiring was routed through the structure.

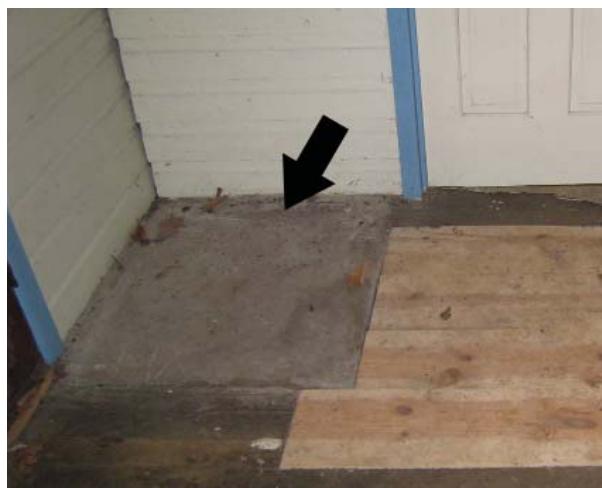
Figure 19, Concrete pad in kitchen floor, presumably for a hot water heater.

There is a concrete pad located in the northwest corner of the kitchen where a hot water heater probably once sat. Three holes in the floor to the south of the concrete pad indicate where pipes once ran.

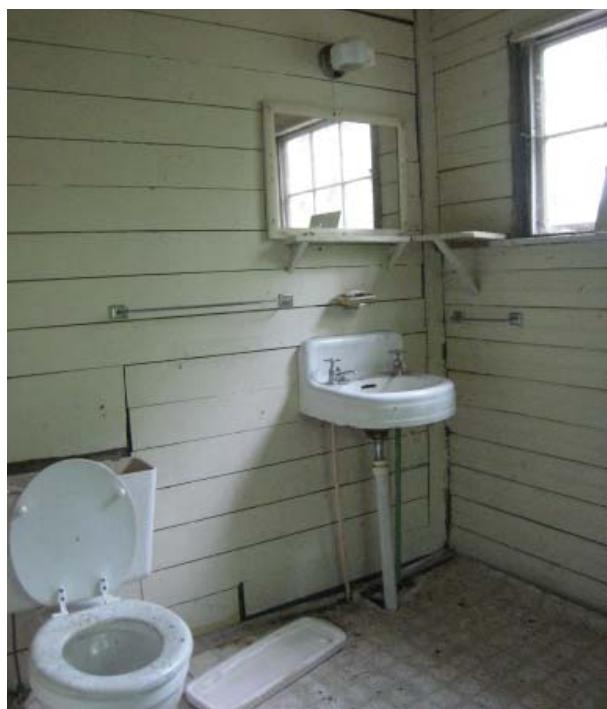
Figure 20, Room 108 northeast bathroom with c. 1920 fixtures.

Room 108, the bathroom, which probably dates back to the 1920s, has original fixtures including toilet, sink and a claw-foot tub. At the sink, modern PVC pipes are exposed.

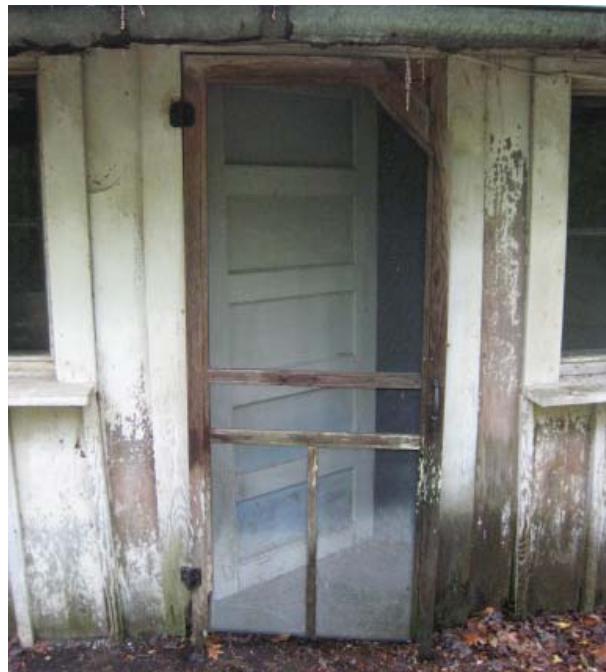
Figure 23, Five-panel rear entrance door at dining room, Room 106.

Another door type is located at the southeast addition. It is a five-panel wood door, measuring 2'-6½" wide by 6'-½" tall. The upper right hand corner has been clipped so that the door can open under the gutter. The door has two five-knuckle,

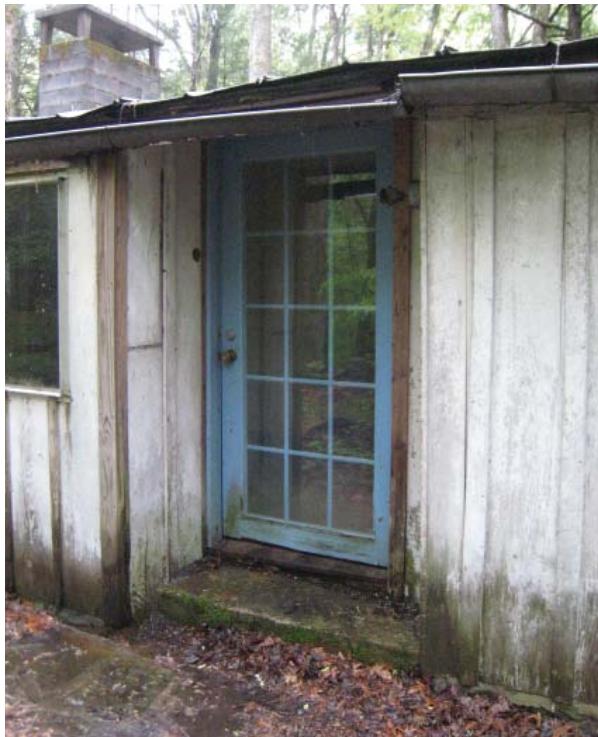
Figure 24, C. 1970 fifteen-light door at kitchen, Room 107.

The kitchen's fifteen-light door dates to c. 1970. It has a 2" modern brass-plated doorknob and three five-knuckle 4" brass-plated hinges.

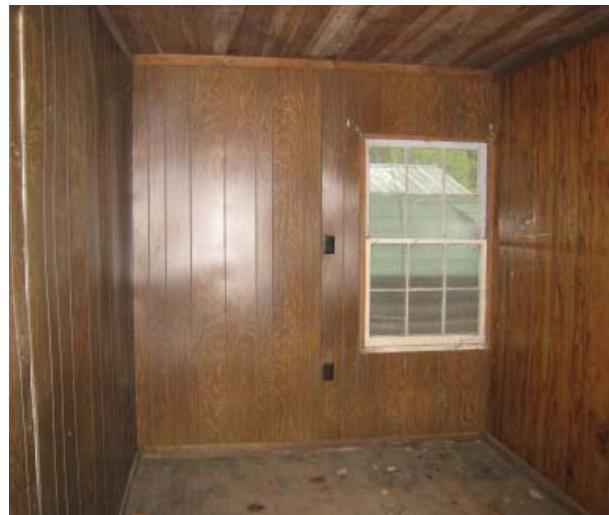
Figure 38, Northeast oblique of Room 101 with modern veneered wall panels. Note that window casing has been removed to install wall panels.

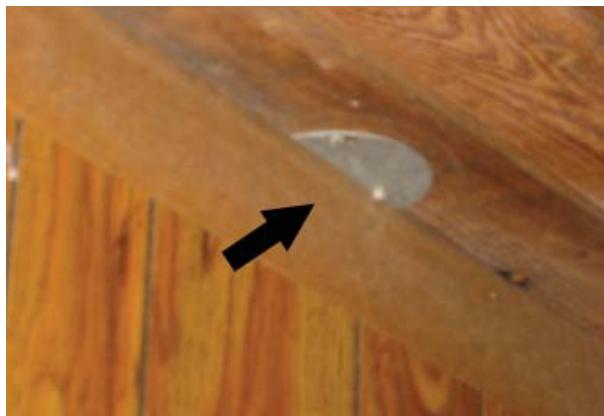
Figure 45, Metal cover for earlier ceiling fixture at wall between Room 101 and Room 102.

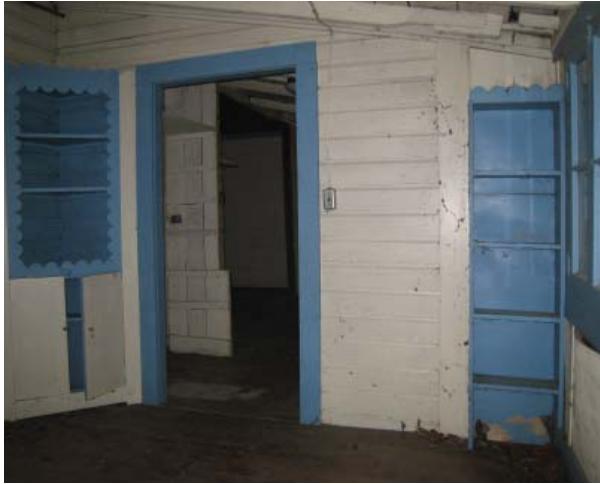
The wood floor boards, probably dating to c. 1950 when remodeled for a dining room with cabinets, measure 3½" in width and are laid east-west. There is a seam in the flooring approximately 4'-3" off of the west wall. The floor shows signs of rotting and has a slope to the east.

Figure 56, North wall of dining room looking through doorway into kitchen, Room 107.

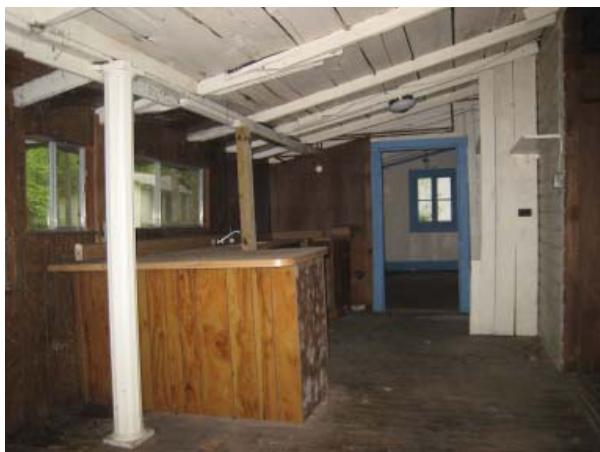
Figure 59, Southeast oblique of kitchen and dining room, Room 106, beyond.

width and are laid east-west. There is a seam in the flooring approximately 2'-3 $\frac{1}{2}$ " off of the east wall where the kitchen was extended. The wood floor is in poor condition and at the north end of the kitchen several feet of flooring has been removed and patched with new pieces of wood. In the northeast corner of the kitchen floor there is an exposed concrete slab that is flush with the wood flooring where at one time a hot water heater probably sat.

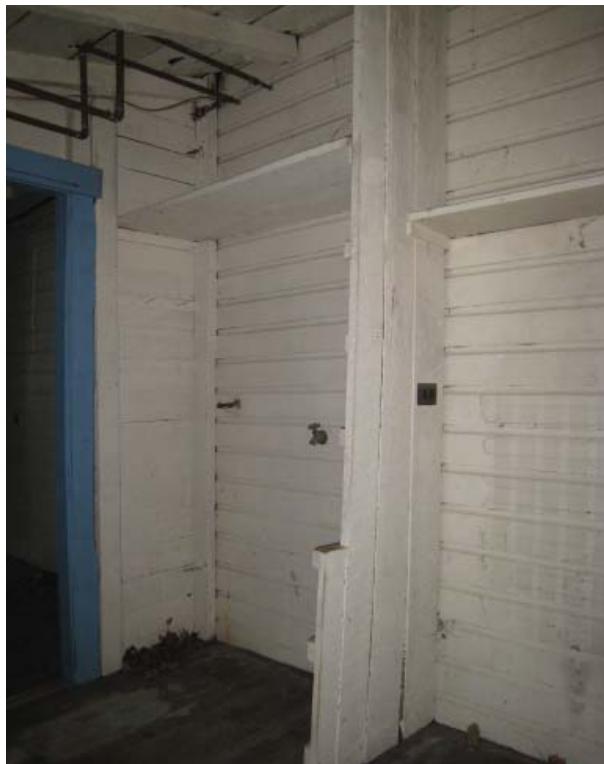
Copper plumbing pipes enter the kitchen through the south wall from Room 106. The pipe that runs along the south wall was probably a water line for the kitchen sink and the pipe on the west wall was probably a water line for a washing machine that is no longer present.

Figure 61, Southwest corner of kitchen configured for washing machine or other appliances.

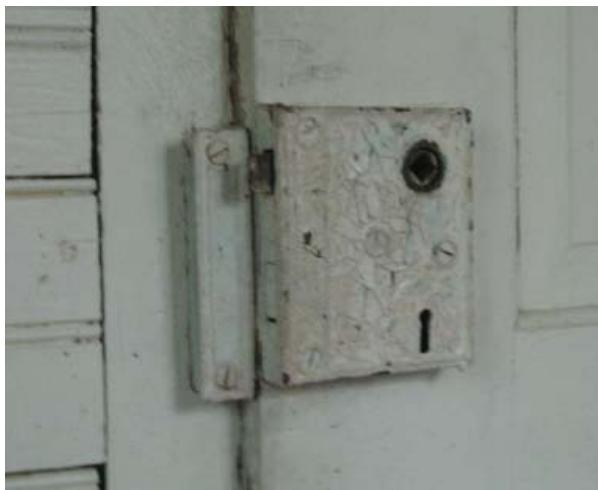
The bathroom door is a four-panel wood door measuring 2'-6" by 6'-6". The door has the original rim lock and key escutcheon but is missing the knobs on both sides.

Figure 63, Original rim lock of northeast bathroom door.

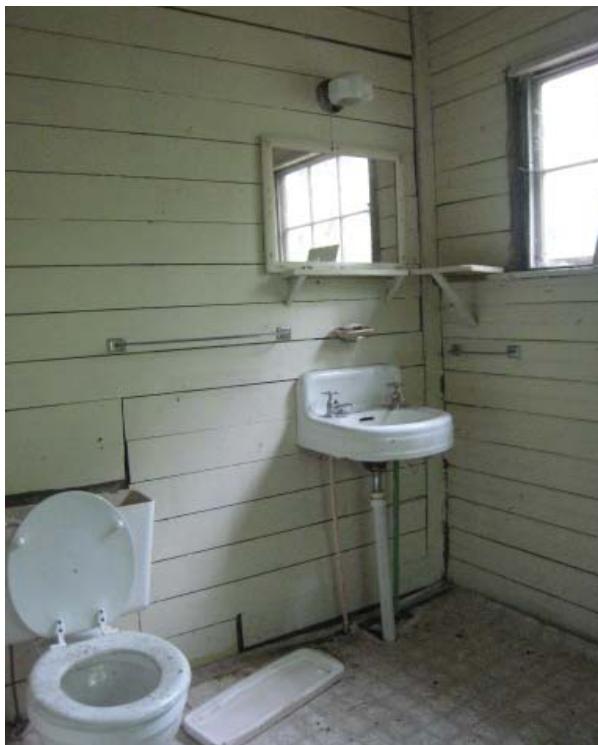
Figure 64, Northwest oblique of Room 108, northeast bathroom with early plumbing and lighting fixtures.

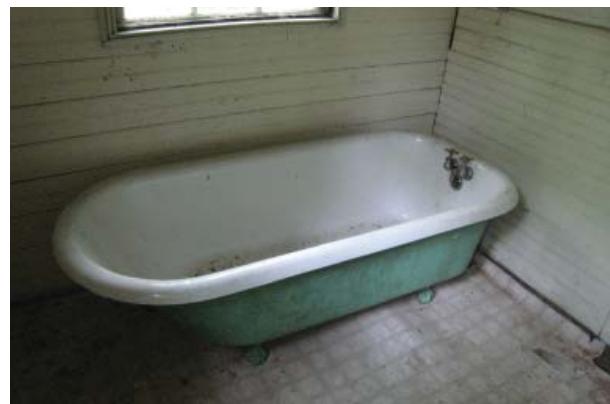
The bathroom fixtures include a sink, toilet and an original claw-footed bathtub. The exposed supply lines and sink drain are made of PVC pipes.

Figure 65, C. 1920 claw-foot porcelain-on-iron bathtub.

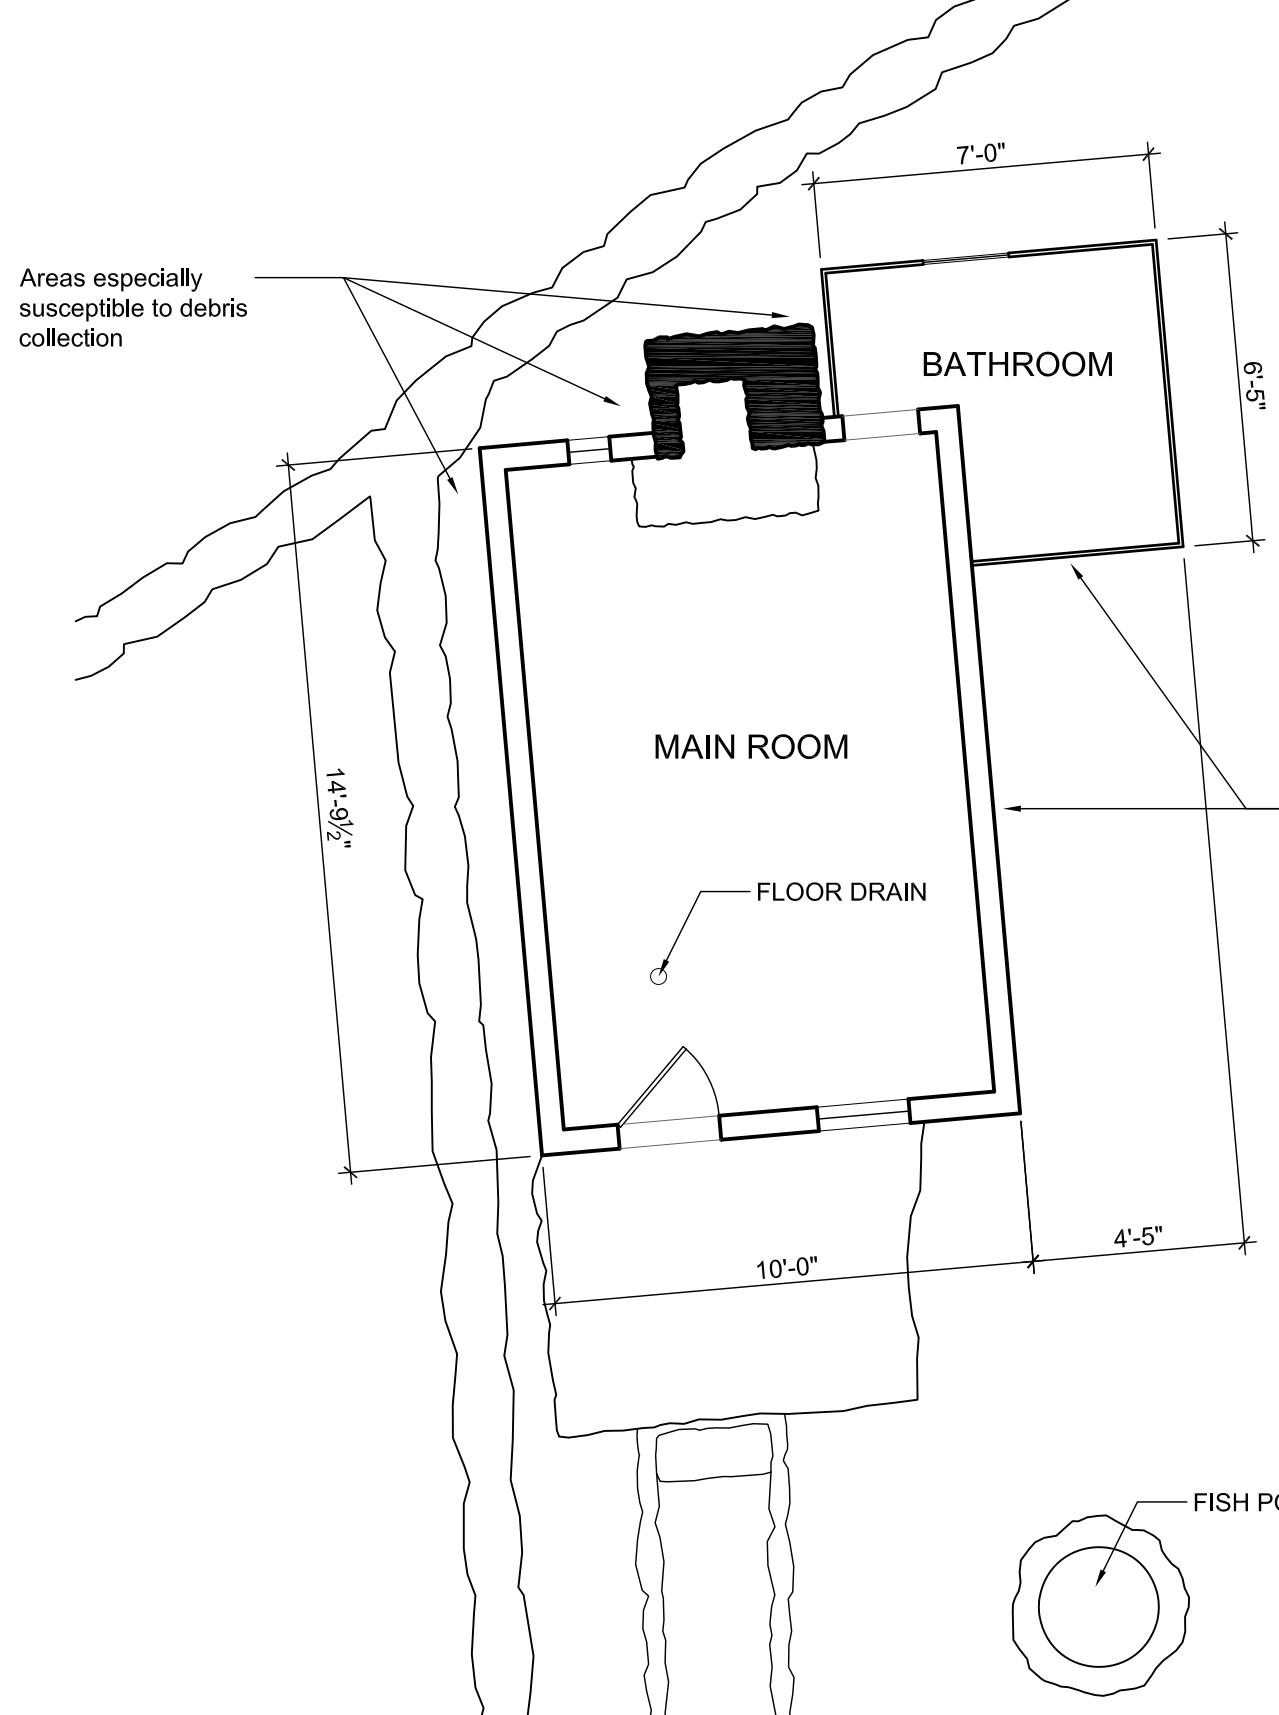
ADAMLESS EDEN FLOOR PLAN
SCALE: $\frac{1}{4}$ " = 1'-0"

Adamless Eden suffers from poor site drainage. Several logs close to grade have advanced deterioration.

- Reuse the historic culvert shared with the Mayo Cabin property.
- Install French drain between Addicks Cabin and Adamless Eden as indicated on *Repair & Maintenance: Schematic Plans*; carefully select and remove trees that interfere with drainage.
