CHAPMAN-BYERS CABIN

**Great Smoky Mountains National Park
Elkmont Historic District
Sevier County, TN**

HISTORIC STRUCTURE REPORT

February 17, 2009

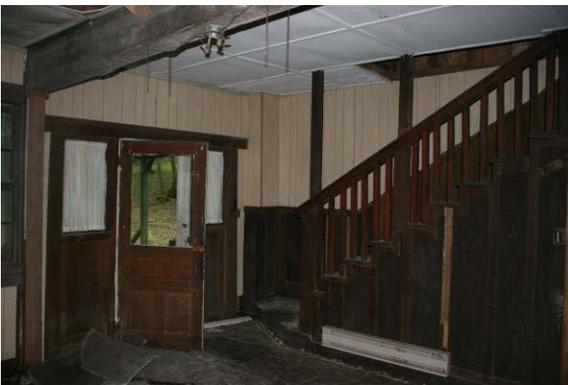
Figure B- 4. Room 101 showing remnants of the Craftsman interior.

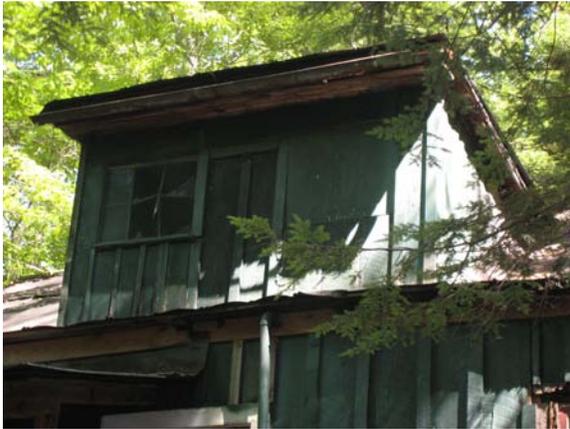
Room 203 Window: Based on observations of the exterior, it appears that there was a window of the same size and type as the existing one. Evidence for this window can be seen on the exterior where there is a

wood panel covering the previous opening. Behind the removed window is the present shower-stall which appears to date from the last quarter of the twentieth-century. It seems likely that the window was removed when the shower was installed.

Figure B- 6. West elevation dormer showing wood panel covering previous window opening.

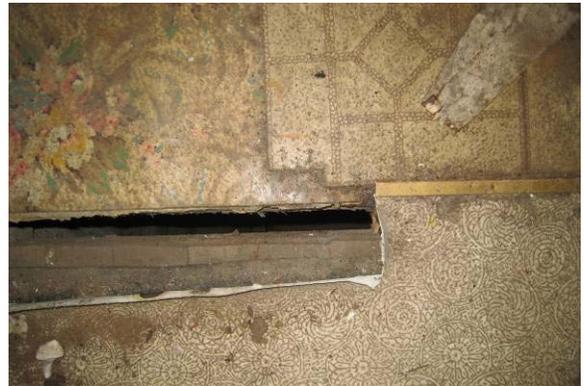
Figure B- 7. Multiple layers of flooring.

When this flooring was put in is hard to determine given that vinyl flooring has been popular for most of the last half of the twentieth century. The vinyl flooring in the kitchen, Room 103, however, is a different matter. Underneath the earlier vinyl (top left in *Figure B- 7*), newspapers were laid down and used as a kind of subfloor or cushion. The year of the newspapers is 1967, indicating that the vinyl flooring in this room is a later addition.

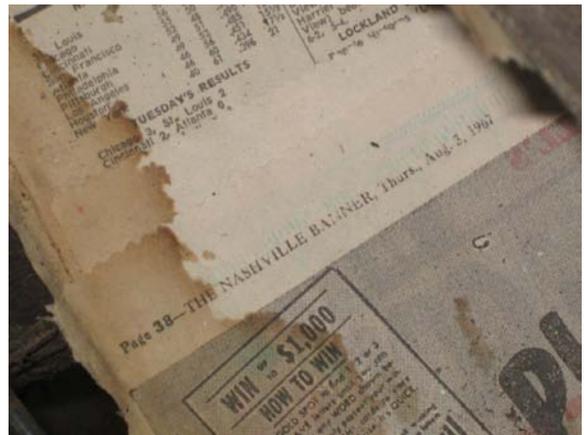
Figure B- 8. Newspaper, dated August 3, 1967, found under earliest vinyl flooring in Room 103, the kitchen.

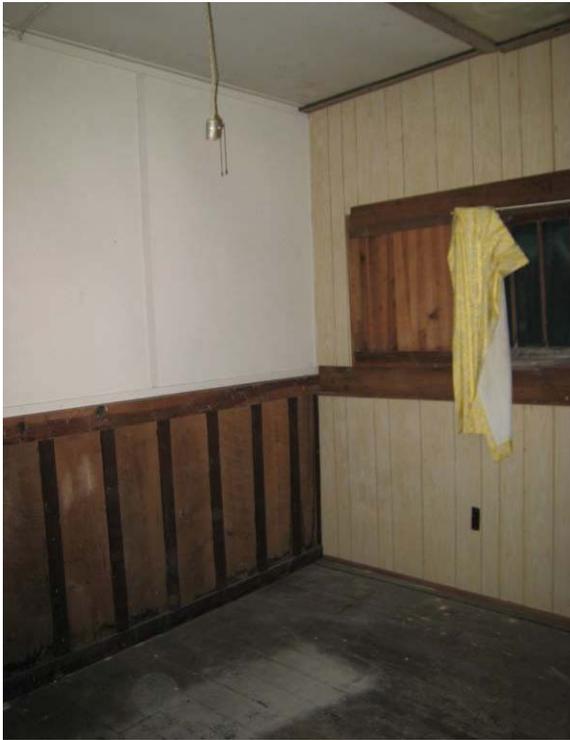
Figure B- 9. Early board-and-batten wainscot on the left wall with later gypsum board-and-battens above. The right wall has been covered with 1/8" laminated hardboard paneling. The ceiling is likewise covered with later gypsum board-and-battens.

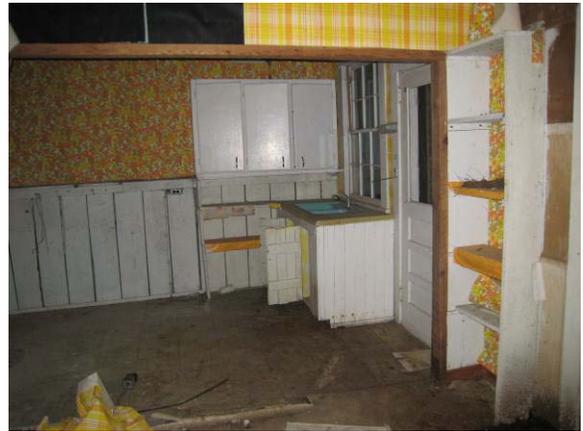
In addition to the later wall, ceiling, and floor coverings, it appears that the opening in the wall separating Rooms 102 and 103 has been enlarged. Previously there was a smaller doorway at the west end of the dividing wall. The extent of the old wall and width of the doorway is evident at the floor, where the underlying wood floor is exposed in the area of the previous wall and the earlier doorway is marked by a thin metal threshold (*Figure B- 7*). The date for when this opening has been enlarged is not certain but it appears that it was in the last half of the twentieth century.

Figure B- 10. Enlarged opening between Rooms 102 and 103.

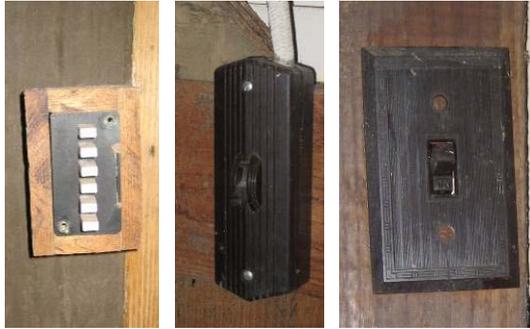
Examples of early electrical devices include the light switches and their cover plates. There is a six-button switch in Room 101. This switch would appear to be the oldest since push-button switches became outmoded by the 1930s but it is not the only early switch. Throughout the Cabin there are brown plastic toggle switches and molded-plastic cover plates. The molded plastic cover plates may be Bakelite which was a synthetic plastic marketed during the 1930s for use in many products, including electrical devices because of its heat resistance and electrically non-conductive

Figure B- 11. Variety of light switches found in the Cabin.

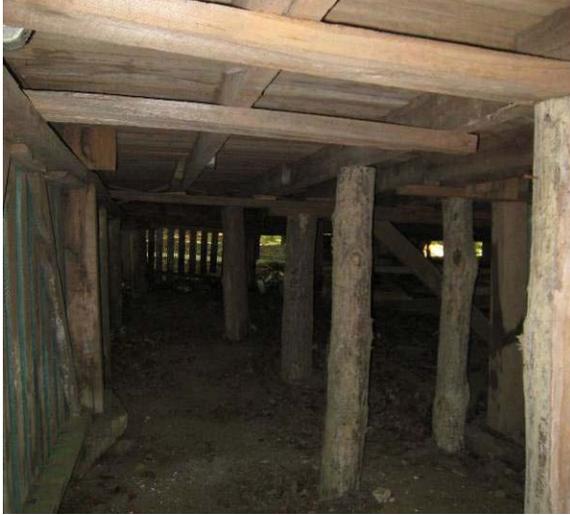
At the time this report was being prepared, many of the presumably original posts along the north and east extremities were severely damaged by rot where the posts come into contact with grade. Treated wood posts measuring 5½" x 5½", each sitting on a 4" x

Figure C- 4. Log posts set in the ground, support girders and joists.

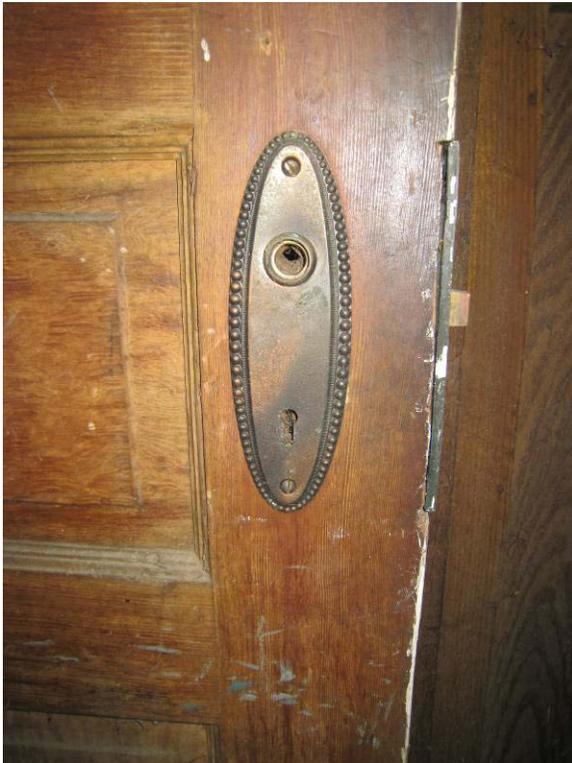
The exterior door has two five-knuckle, 3½" high, steel, butt-hinges with a ball at both ends of the pin. At the interior face there is an oval decorative bronze escutcheon, but no knob. The escutcheon is approximately 7" high. Above the escutcheon is a later deadbolt lock. A ghost mark at the exterior face indicates that the same escutcheon was used but it is now missing. Above the ghost mark is a later deadbolt lock and padlock.

Figure C- 8. Decorative escutcheon and dead bolt at interior face of front exterior door.

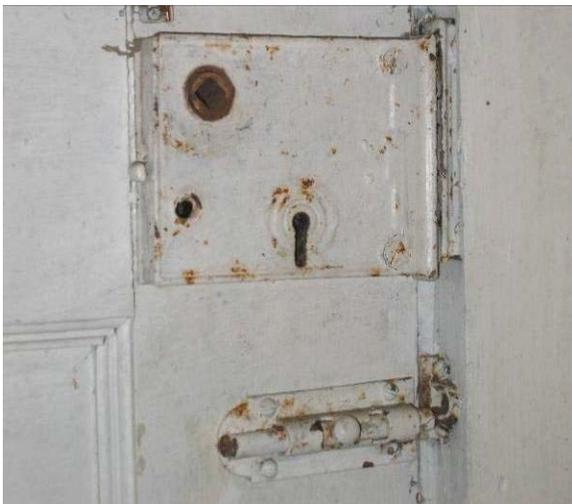
The exterior door has two, five-knuckle, steel, butt-hinges with a ball at either end of the pin, a barrel bolt, and a rim lock. The door knob is missing. The hinges and both locks have been painted.

Figure C- 11. Rim lock and barrel bolt on door in Room 103.

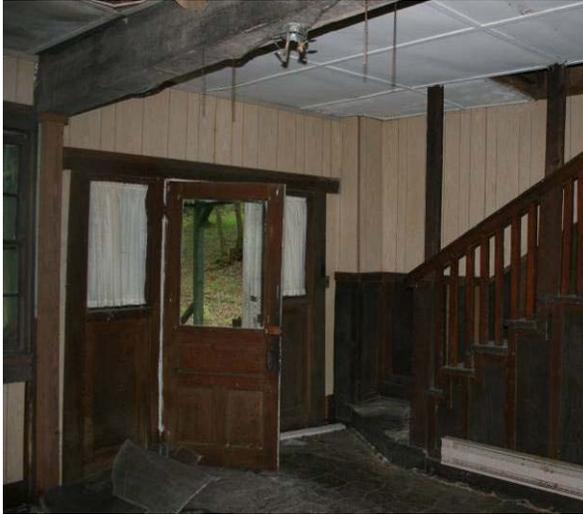
Figure C- 16. Room 101 looking toward the southeast.

Flooring: The floor surface is sheet vinyl, with a stone pattern laid over tongue-and-groove wood boards of random width (4 $\frac{1}{4}$ ", 4 $\frac{1}{2}$ ", 5" x $\frac{7}{8}$ ") and there is no sub-floor. The boards run north-to-south. A metal threshold separates Room 101's floor from Room 102's. The sheet vinyl is in poor condition being well worn, buckling in areas, and has generally lost its adhesion to the underlying wood floor. It appears to

date from the last quarter of the twentieth century. Based on areas where the wood floor is exposed, it appears in good condition.

Overall the wall sheathing appears to be in fair to good condition. There are signs of water staining, loose or missing battens, and some loose paneling.

Ceiling: The ceiling is 9'-2" above finished floor and consists of 4'-0" x 4'-0" x 3/8" drywall panels and 1 1/2" x 1 1/4" wood battens. Above the drywall, the joists and floor decking are painted white indicating the floor flaming was previously left exposed. The joists measure 2" x 4" and are 24" o.c. while the floor deck boards are either 5", 5 3/4" or 6" x 1". A wood 6" x 12" wood beam runs east-to-west approximately in the middle of the room. The ceilings are in fair to poor condition with many panels suffering water damage.

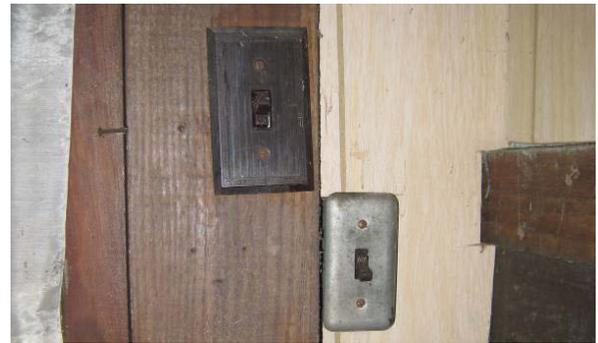
A push-button light switch is at the west end of the south stair wall and two toggle switches are just south of the doorway assembly. One toggle switch has an early molded-plastic cover while the other has a mid-century metal cover.

Figure C- 18. Toggle light switches in Room 101.

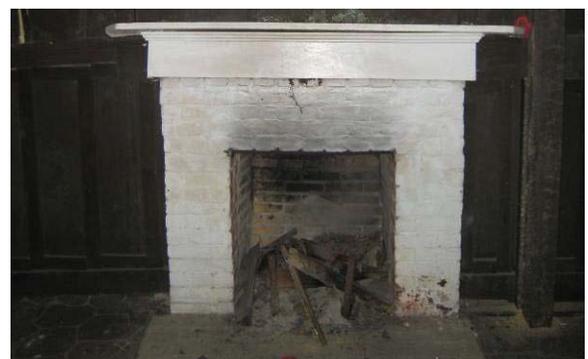
Figure C- 19. Fireplace in Room 101.

Other Features: There is a masonry wood-burning fireplace with wood mantel along the west wall. The firebox opening is 2'-6" wide x 2'-7 1/2" high and 1'-8" deep. In front of the fireplace is a brick hearth 1'-6" deep x 4'-10" wide. The masonry and wood

mantel appear to be generally in good condition although worn and the mantel shelf is loose.

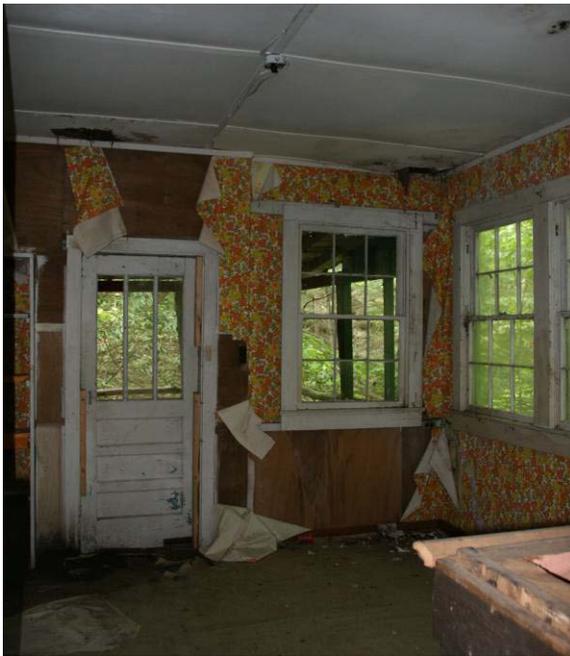
Figure C- 22. Room 102, looking northeast.

Flooring: The floor surface is sheet vinyl over the original wood floor boards which run north-to-south. An aluminum threshold separates Rooms 101 and 103. Between Rooms 102 and 103, there is a gap in the flooring indicating a previous partition wall, and a thin strip of aluminum threshold remains marking the location of the previous doorway. The vinyl flooring is in fair condition being quite worn and stained. Where water has leaked from above, the flooring is loose and badly stained. The earlier wood floor boards are not exposed and could not be evaluated.

The wall covering is in generally fair to poor condition with much of the wallpaper either loose or missing. The cause of the problem appears to be exposure to the elements and water damage due to ceiling leaks.

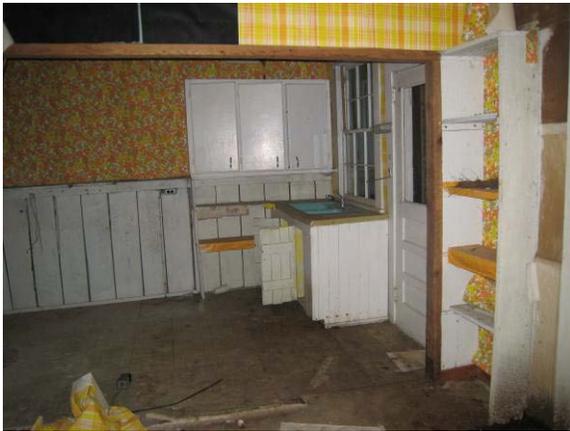
Figure C-25. Room 103, or the kitchen, looking south from Room 102.

Flooring: Tongue-and-groove floor boards, that run north-to-south, are covered by a couple layers of vinyl flooring. The bottom, floral patterned, vinyl flooring dates from to or after 1967 based on newspaper remnants that were laid between the wood and vinyl flooring. The vinyl flooring appears to be in fair condition with considerable staining and some of the tiles are loose or missing.

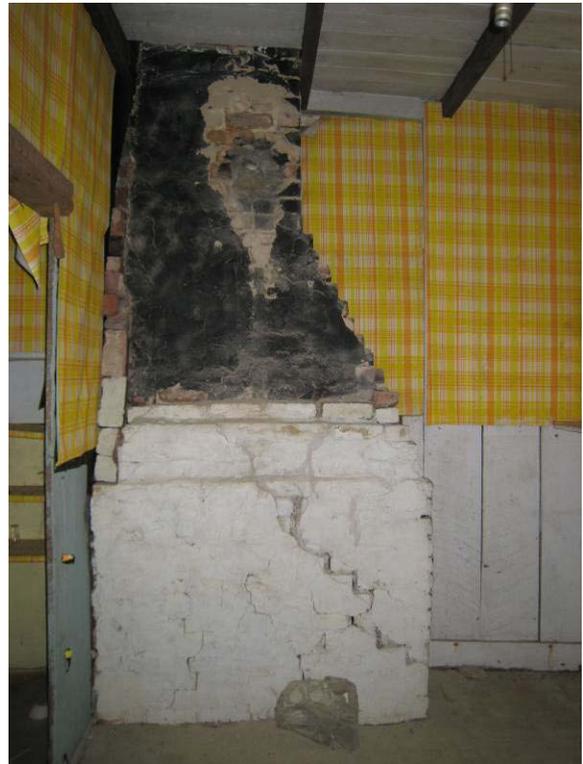
Figure C-27. East wall of Room 103.

The wall sheathing is in typically fair condition. All surfaces appear quite worn and some of the wallpaper is peeling. The masonry chimney has quite a few cracks, some loose brick, and the plaster over the upper portion is discolored and spalling.

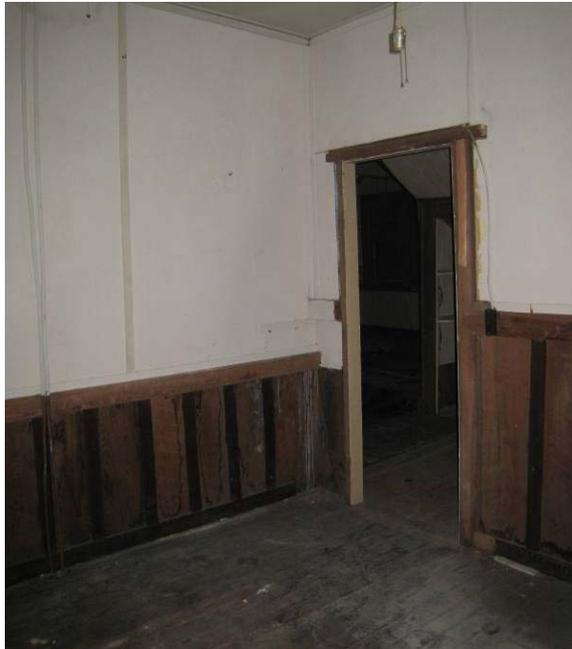
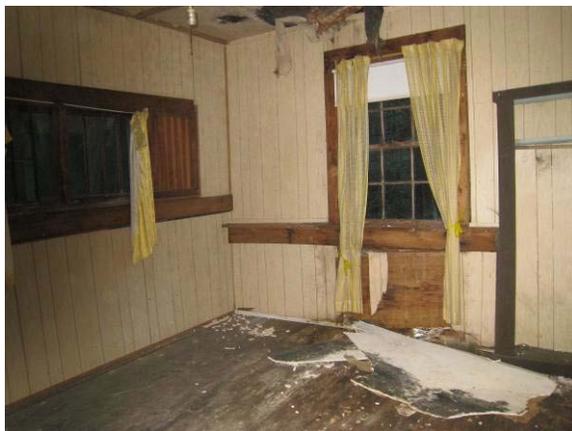
Figure C- 29. Room 104 looking northeast.

Figure C- 30. Room 104 looking southwest.

Flooring: The floor is tongue-and-groove boards that run east-to-west. Along the western third, a 6'-0" x 9'-7" patch of new flooring has been installed to replace rotted

or damaged floor boards. The new boards measure 9¼" x ¾".

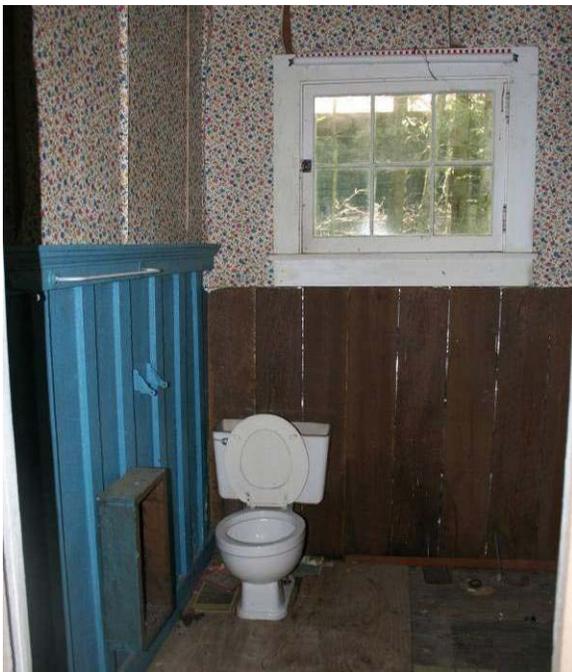
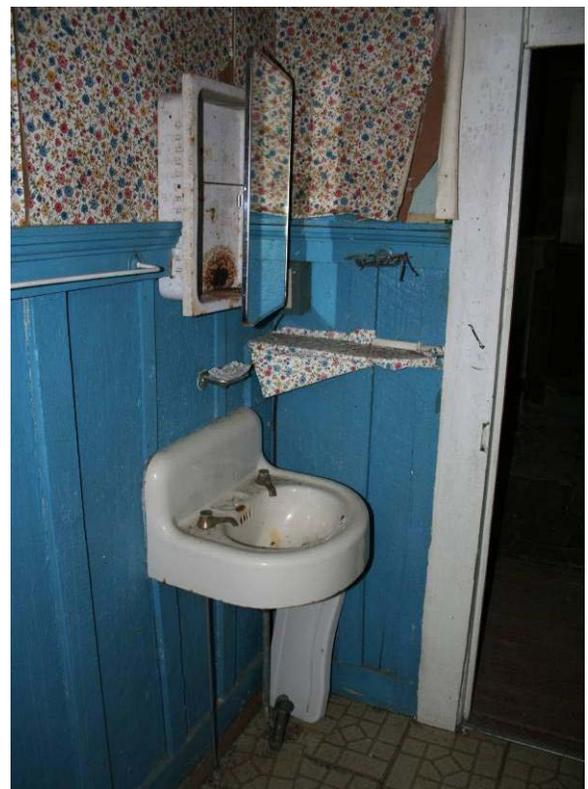
Figure C- 34. Room 105 looking south.

Figure C- 35. Room 105, looking northwest.

The wainscot is generally in good condition while many areas of the wall paper are loose or peeling.

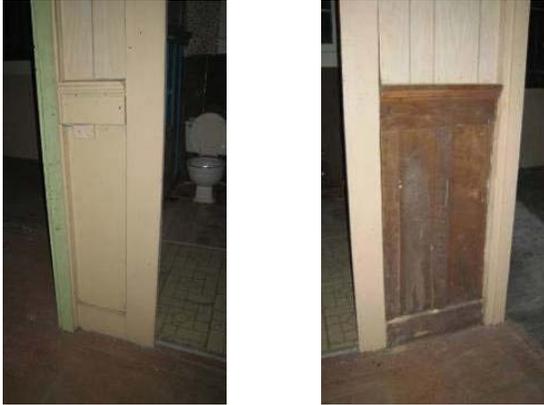
century, laminated, 1/8" hardboard paneling is used to cover the board walls. The chair rail appears to have the same profile and dimensions as in Room 105. To the west of the doorway the wainscot and chair rail are unfinished but to the east they are painted a cream color. There is no batten on the wainscot to the east of the doorway.

Figure C- 36. South wall of Room 106, showing different wainscot on either side of Room 105 doorway.

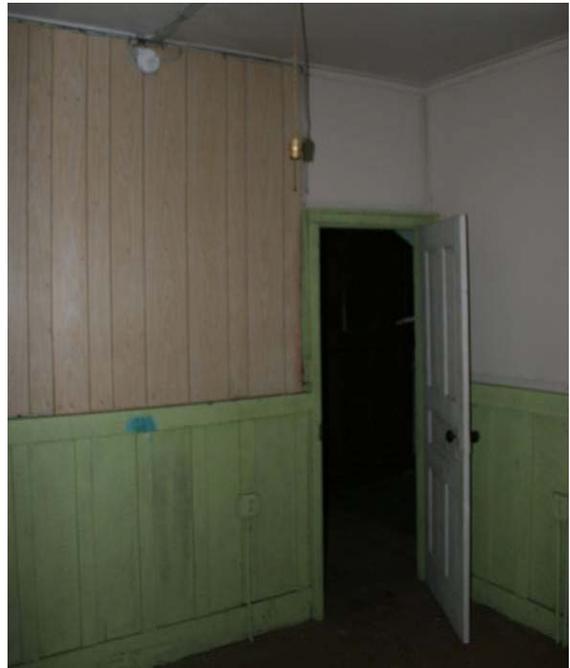
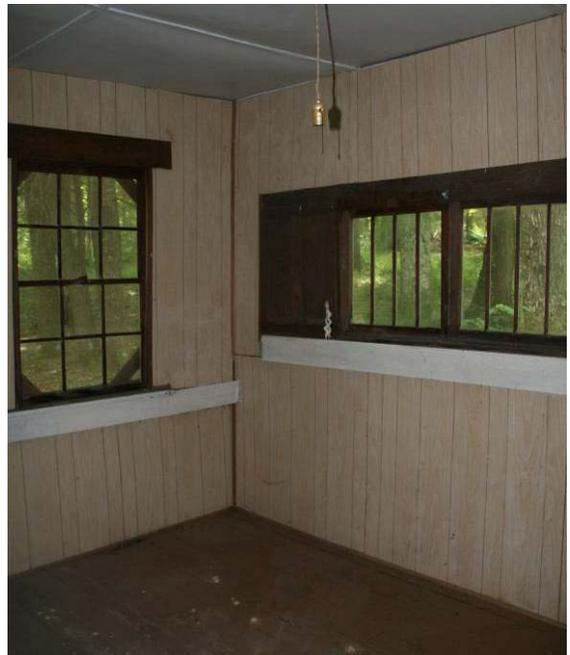
Figure C- 40. Room 107, looking northwest.

Flooring: The floor consists of painted tongue-and-groove floorboards that run east-to-west. The board width changes approximately 4'-8" off the north wall from 3½" to boards varying from 5" to 5½" wide. It is in fair to good condition.

Figure C- 41. Room 107, looking southeast.

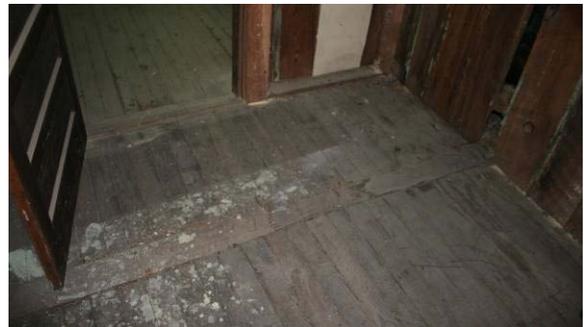
Figure C- 46. Transverse floorboard in Rm. 201.

Flooring: The floor consists of 3⅝" tongue-and-groove floorboards running in a east-to-west direction. The boards all appear to be circular-sawn. Approximately 2'-8" from the east wall there is a break in the floor pattern by two boards running north-to-south. These transverse boards continue to the north and south and appear to provide a top plate on which the gable roof joists rest. The southern board is 4½" wide and the northern board is 5" wide. The boards are generally in fair condition and appear quite worn. At the northwest corner of the room,

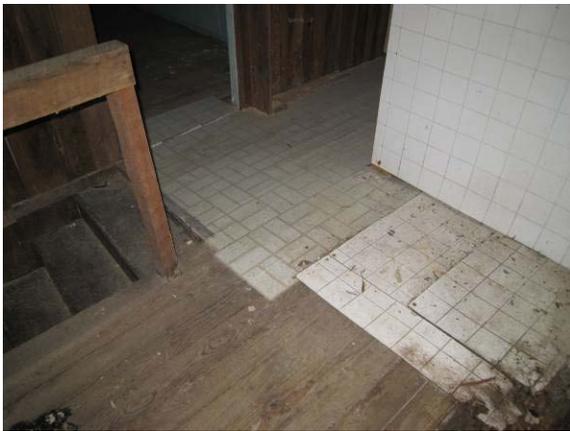
12" x 12" vinyl floor tile covers the original wood floor at the western edge of the room. The tile is the same as used in Room 203. The tile is in fair condition.

The floor appears to slope down and away to the east and south from the chimney in the northwest corner.

Figure C- 47. Vinyl floor tile at west end of the room.

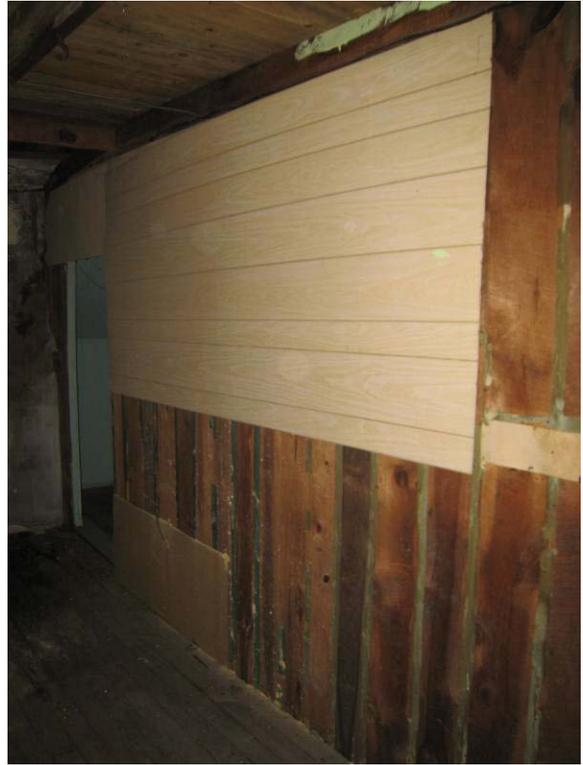
Figure C- 48. Room 201, north wall.

Walls: The north and south walls consist of vertical board walls. The boards vary in width from 1" x 5½" to 1" x 10". A horizontal board was used to provide lateral support. It remains only along the eastern end of the north wall. At the south wall, only a ghost mark indicates the horizontal board's previous presence. At the western half of the north wall the late twentieth-century, laminated, ⅛" hardboard paneling is present. Approximately 1½" wide adhesive paper strips were used to cover the vertical joints which partially remain.

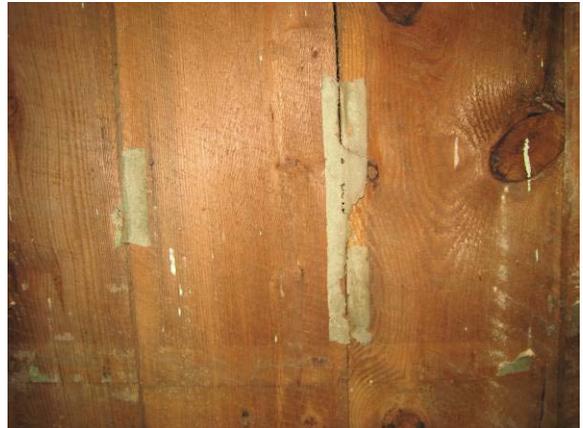
Figure C- 49. Paper fragments on Room 201 walls.

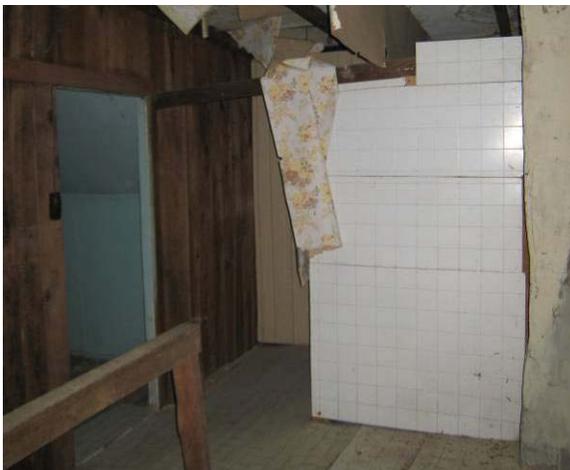
Figure C- 51. Room 201, west wall.

The west wall is crudely constructed and only a partial-height wall that abuts the masonry chimney. The partial-height wall is approximately 6'-0" above the finished floor and is consists of unfinished vertical boards over which are tile panels with a modular brick pattern. The masonry chimney appears to be covered in painted plaster and shows signs of water damage.

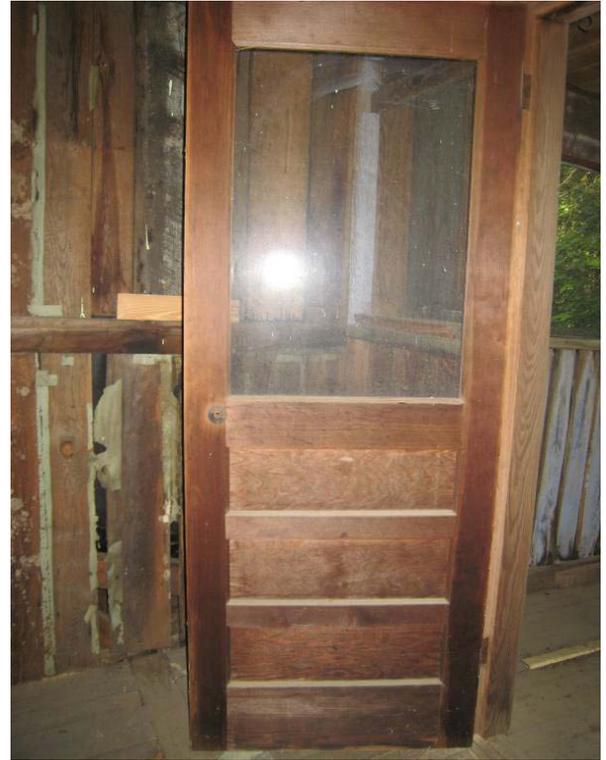
Figure C- 52. Sash-door at east wall of Room 201.

A varnished wood single-light sash door with three recessed panels below is located at the east wall. The door opens into Room 201 from 205 and measures 2'-8" x 6'-8" x 1 3/8". It appears to be in good condition.

The door is hinged at the north jamb and has two five-knuckle, 3 1/2" high metal hinges with a ball at either end of the pin. Based on the ghost lines, the door also had a knob and rim lock, both of which are missing. The ghost line for the rim lock measures approximately 3" high x 4" wide. The keeper remains at the south jamb.

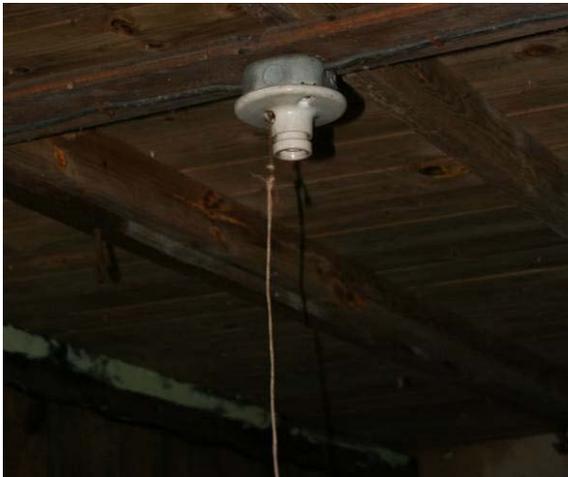
Figure C- 53. Ceramic light socket in Room 201.

Electrical Systems: A ceramic light socket is attached to the underside of a beam. The base has a ridge by the socket and a rope pull.

The wiring is not run in any conduit but rather anchored directly to the wall and beam.

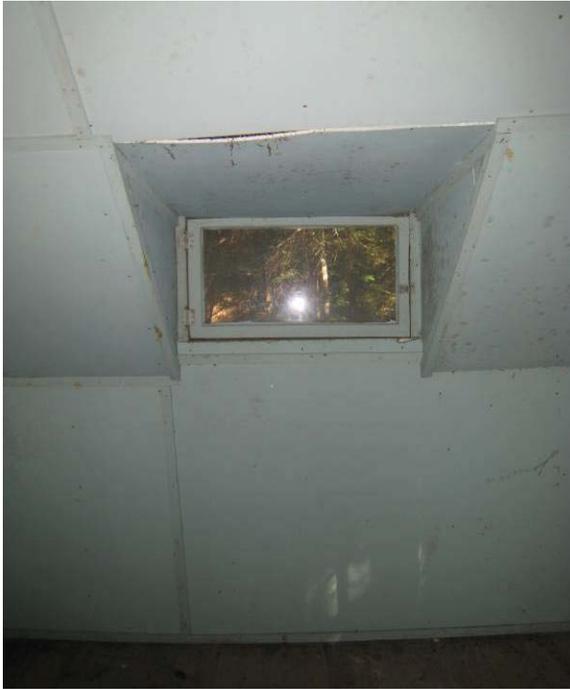
Figure C- 55. Room 202, looking east.

Walls: The walls are sheathed with painted $\frac{3}{8}$ " drywall panels with $\frac{1}{4}$ " x $1\frac{1}{2}$ " wood battens over the seams. Some of the wall surfaces appear blotchy which may be staining from water infiltration.

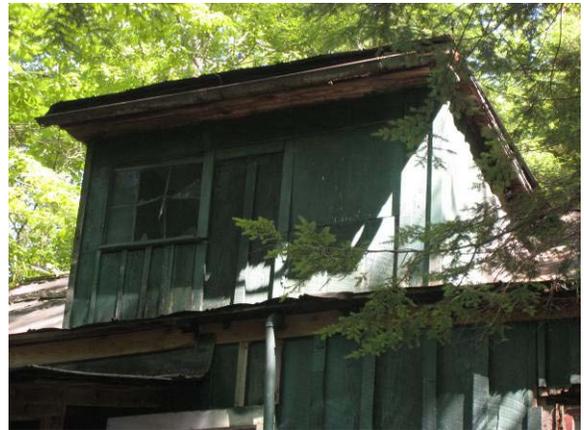
Figure C- 59. West dormer, showing in-filled window opening (right).

It appears that another window, most likely a type W-5, was located where the present shower. The exterior board-and-battens stop in the area of the window and a solid

wood panel encloses the opening. Any evidence for this window on the interior is covered by the shower stall unit.

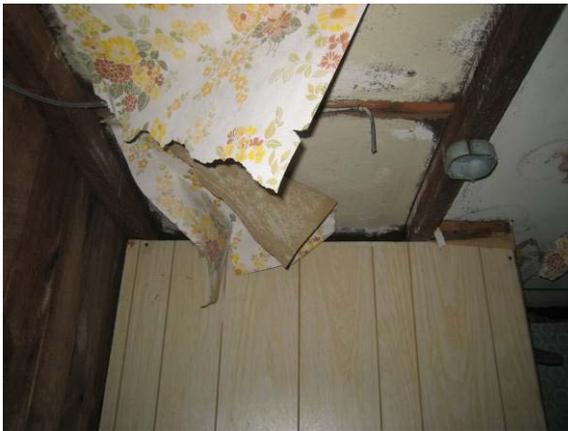
Figure C- 60. Ceiling in Room 203.

Ceiling: The ceiling is approximately 7'-0" above the finished floor consists of ½" insulation board, with wallpaper, between the joists. The northern joist measures 2" x 3¼", the southern is a true 2" x 4" while the two inner ones measure 2" x 3½". The ceiling is in fair to poor condition with much of the wallpaper peeling or missing and there are stains and mold on the ceiling panels due to water infiltration.

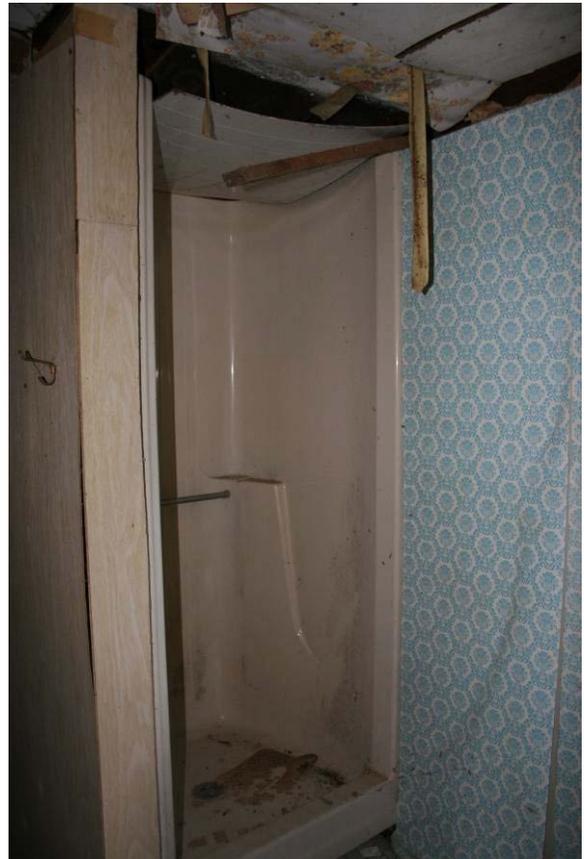
Figure C- 61. Prefabricated shower stall unit in Room 203.

Plumbing Systems: A pre-fabricated, either acrylic or fiberglass, shower stall unit is located at the southwest corner. The mixing valve and shower head are located at the eastern shower wall.

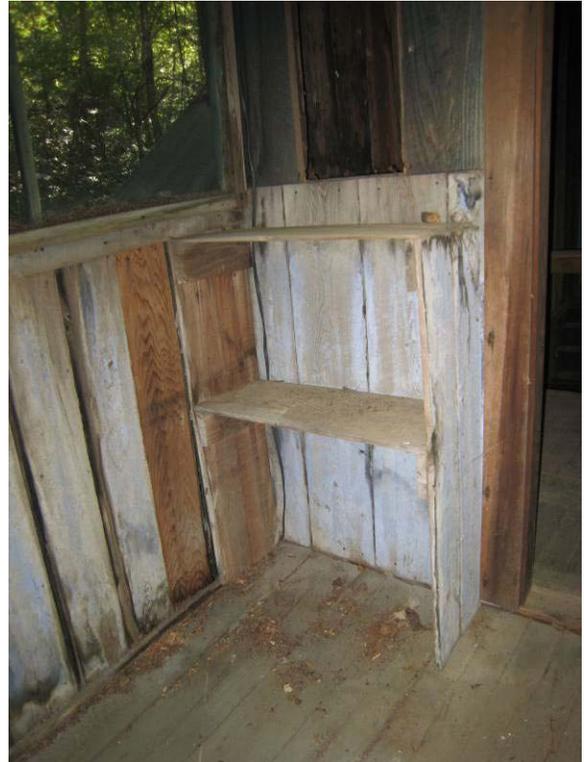
Figure C- 65. Room 205, looking southwest.

The west wall has a doorway opening and the two flanking walls consist of unfinished 1" x 9" and 1" x 10" vertical boards at the lower two-thirds. Above the vertical boards, there appears to have been an opening which is now mostly filled in by vertical boards. The infill boards, like those at the eastern portion of the north and south walls in Room 201, have a dark stain. The wall boards are generally worn and there are some signs of water staining near their bottom.

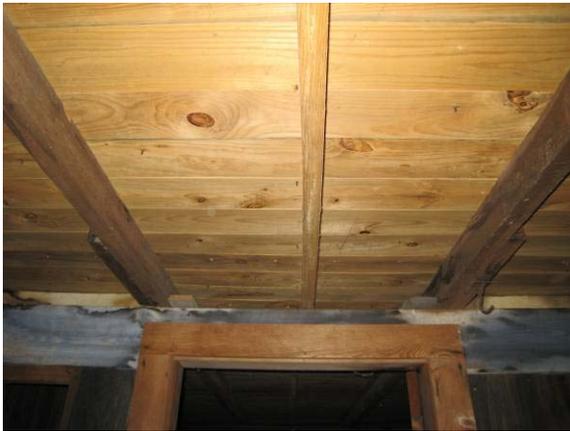
Ceiling: The rafters and deck boards for the shed roof above are left exposed. The two inner rafters are true 2" x 4" boards while the middle and outers rafters measures 1 $\frac{1}{2}$ " x 3 $\frac{1}{2}$ ". The inner rafters extend approximately 2'-4" into Room 201. The deck boards are 5 $\frac{1}{2}$ " wide. At the west wall, the deck boards are 7'-9" above finished floor. At the southeast corner, there have been some previous roof repairs. The deck boards appear lighter and are generally in good condition. Their color and condition may suggest that they were added later.

Figure C- 66. Looking west at the exposed rafters and deck boards in Room 205.

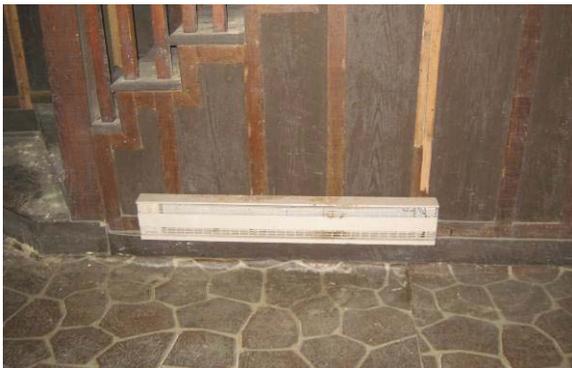
Limited heating could have been provided by the wood-burning fireplace, apparently a feature since the initial construction of the house. Later, probably in the third quarter of the twentieth century, electrical baseboard heaters were installed to provide additional heating; these heaters should not be considered for reuse.

Figure C- 70. Mid-century baseboard heater.

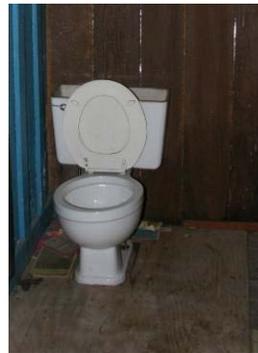
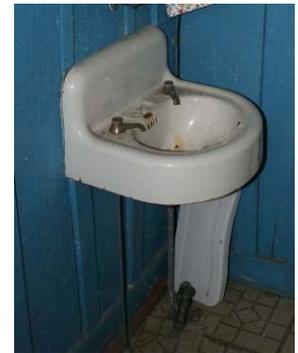
Figure C- 71. Early, if not original, toilet and lavatory.

An early if not original toilet and lavatory remain in the first floor bathroom. Imprints in the floor indicate a claw-foot bath tub was once present also.

The plumbing lines and fixtures are important interpretive features and their retention and reuse are desirable when possible. All portions should be disconnected and retained in place if the plumbing is not put to use. If plumbing is needed, the fixtures are likely candidates for reuse; supply and waste lines are not likely candidates for reuse.

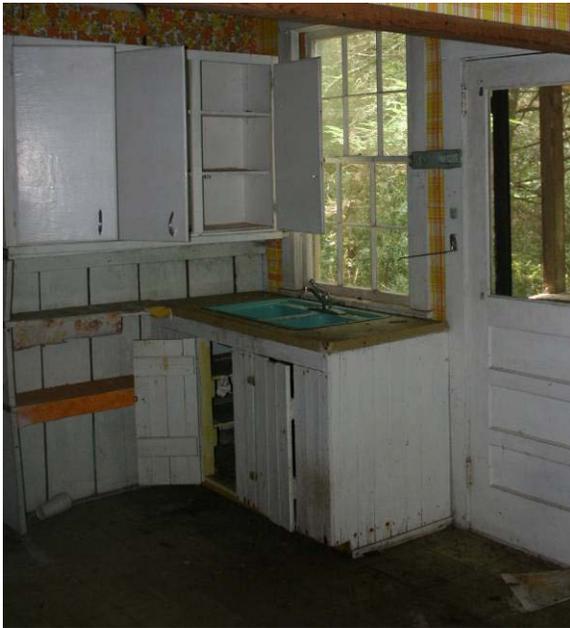
At the first floor kitchen, there is a turquoise-colored, drop-in, ceramic lavatory. The color was extremely popular for a short period of time, during the 1960s primarily. (Cabinet hardware suggests approximately the same date of installation.) Discovery of newspapers from the summer of 1967 beneath the kitchen flooring would further suggest a major kitchen remodeling that year.

Figure C- 72. Mid-century cabinets and sink.
