**Cook Cabin
Elkmont Historic District
Great Smoky Mountains National Park
Historic Structure Report**

March 2016

The Jaeger Company

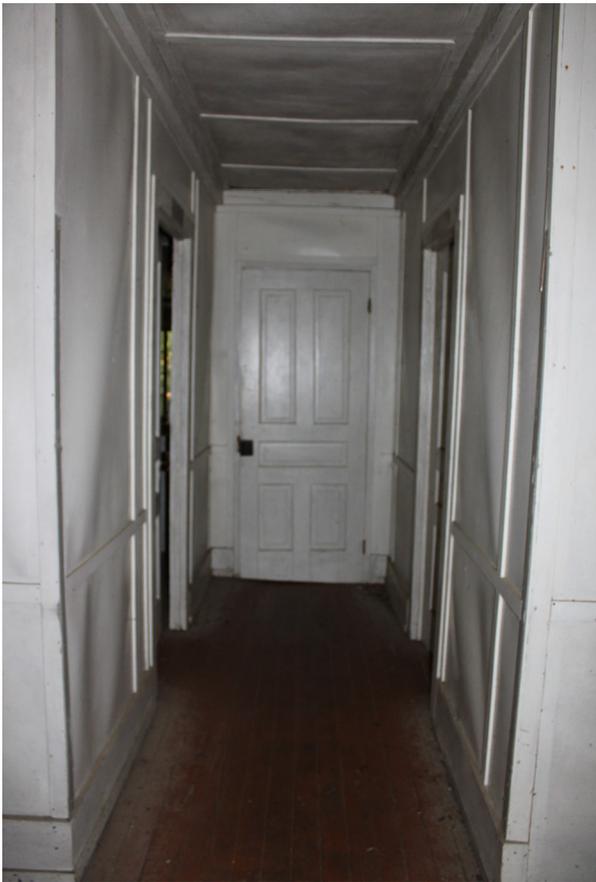
Figure 34: Room 102, hallway.

The hallway extends east-west from Room 101 to the rear of the main core and measures 3'-10" by 9'-11". (Figure 34) One bedroom flanks each side of the hallway.

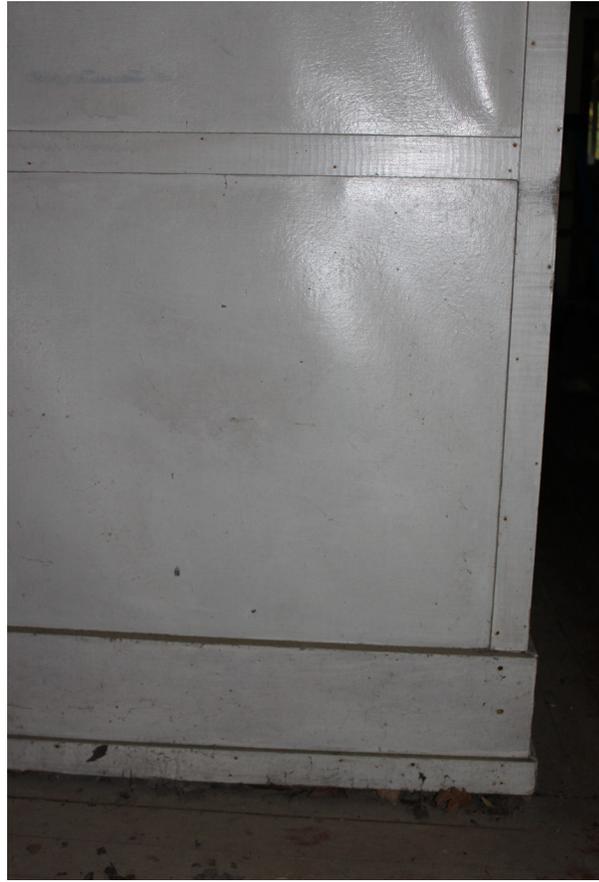
Figure 35: Fiberboard panel wall and ceiling finish materials.

Walls—The walls are finished with $\frac{1}{8}$ " thick fiberboard panels with 2" wide by $\frac{1}{8}$ " thick wood strips covering the edges and seams between panels. (Figure 35)

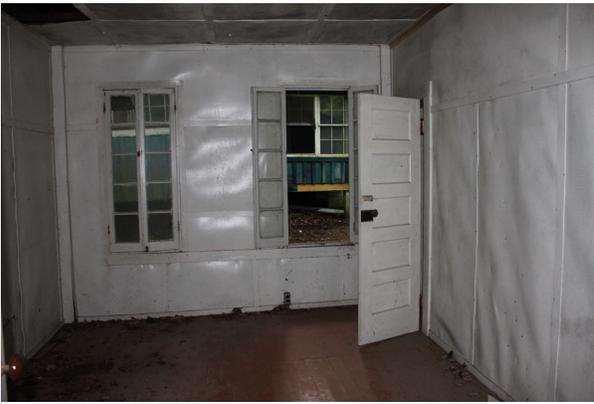
Figure 36: Room 103 looking south toward closet.

Room 103 is on the south side of the hallway and in the southeast corner of the main core; it served as a bedroom. The room was extended to the south and a closet added at some point. The room measures 13'-10" by 9'-9". (Figure 36)

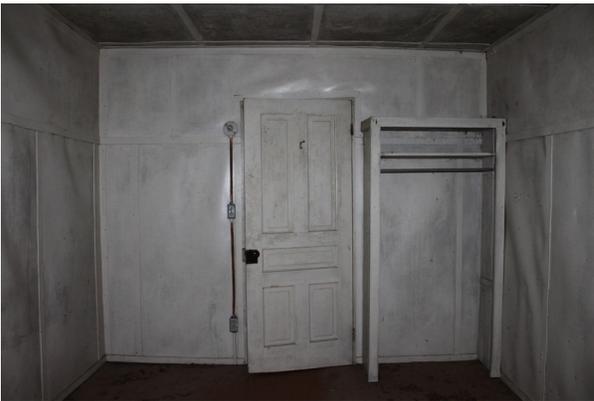
Figure 37: Room 103 looking north toward hallway.

Doorways—Two doorways enter into Room 103. The doorway into the hallway has 2" wide strips around the opening. (See *Room 102*.) (Figure 37)

An open closet constructed of beaded boards is located in the northeast corner of the room adjacent to the door. A mounted hanging rod is in the closet, and the top boards form a shelf. (See *Figure 37*.)

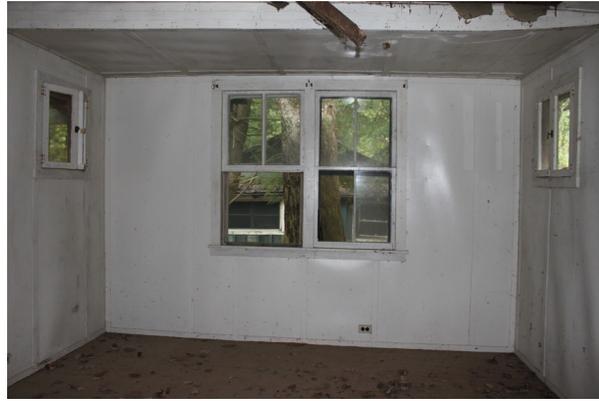
Figure 39: Room 104 looking north toward room extension.

Room 104 is on the north side of the hallway and in the northeast corner of the main core; it served as a bedroom. The room was extended to the north and east to form a larger room and measures 14'-8" by 11'-9". (Figure 39)

Flooring—The flooring is 3 ¼" tongue-and-groove wood flooring extending east-west. A portion of the flooring has been replaced. A seam extending north-south marks the location of the room extension to the east. This area of flooring is 4 ¼" wide tongue-and-groove and slopes downward.

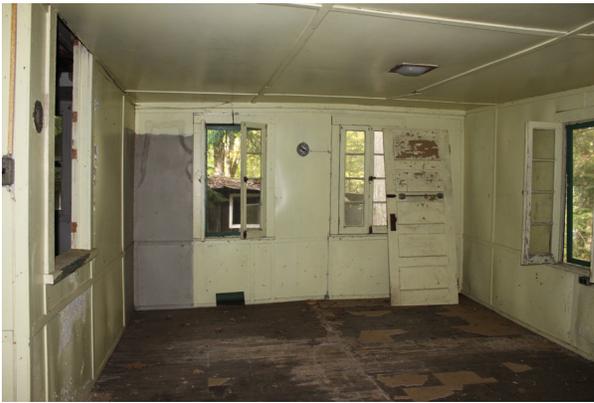
Figure 41: Room 105 looking north toward casement windows.

Room 105 is east of the main core and measures approximately 18'-3" by 11'-11". The room's construction probably occurred in two sections. The west half may have been part of an open shed-roof porch on the rear of the main core. The room may have been used as a dining room due to its close proximity to the kitchen; it may also have served as a bedroom. (Figure 41)

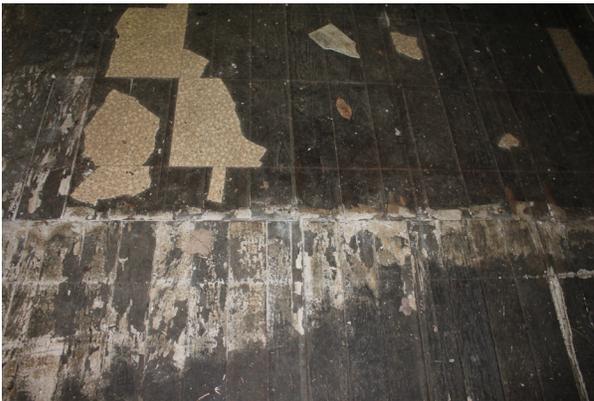
Figure 42: Seam in flooring in Room 105.

Flooring—The flooring in the west half of the room is 3 $\frac{1}{4}$ " tongue-and-groove wood flooring running east-west. The east half of the room has 4 $\frac{1}{4}$ " tongue-and-groove extending east-west. A distinct seam in the flooring extends north-south and marks the division in the room. Remnants of linoleum squares and asbestos tiles are present over the wood flooring. (Figure 42)

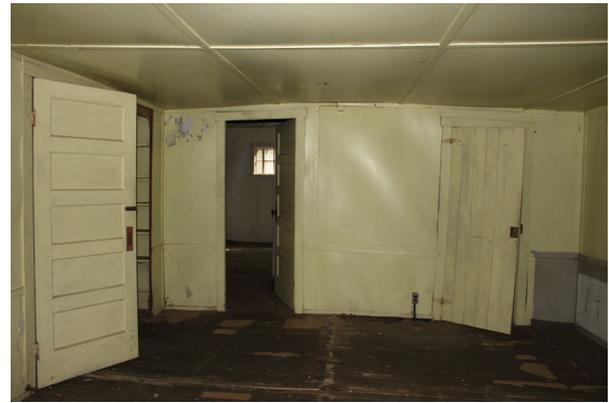
Figure 43: Room 105 looking south toward Rooms 106 and 107.

The door into Room 106 is constructed of $9 \frac{3}{8}$ " wide beaded boards with two $2 \frac{3}{4}$ " wide beveled boards across the Room 106 side. It measures $2'-4"$ wide by $6'-4"$ tall and is attached with $1 \frac{5}{8}$ " metal strap hinges. The metal box lock, knobs, and keyhole no longer remain. The doorway has a $3 \frac{5}{8}$ " casing. (Figure 43)

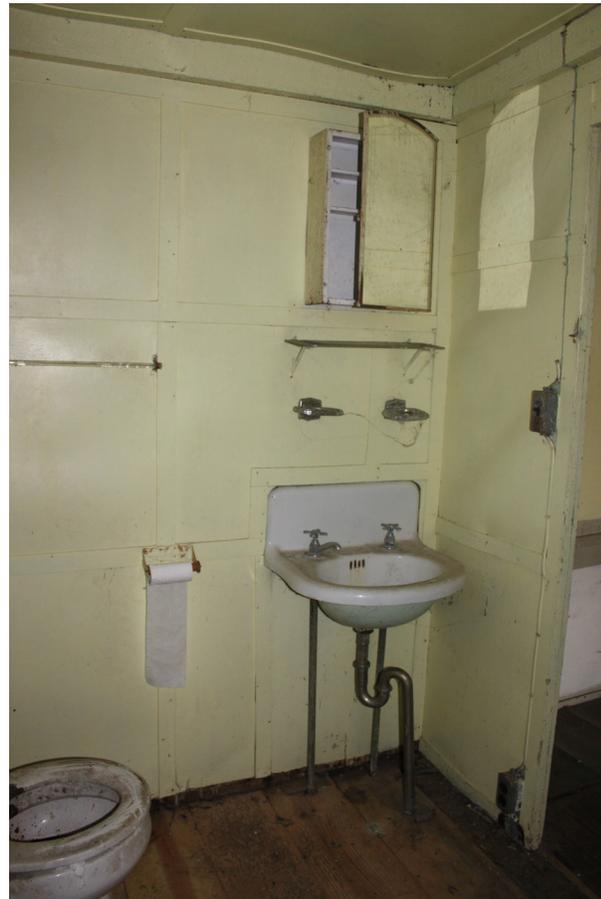
Figure 45: Room 106, bathroom fixtures and doorway .

The bathroom is located at the southeast rear corner of the main core. This room may have been the “bath” included in the 1931 description of the house. The room measures approximately $5'-7"$ by $7'-10"$. (Figure 45)

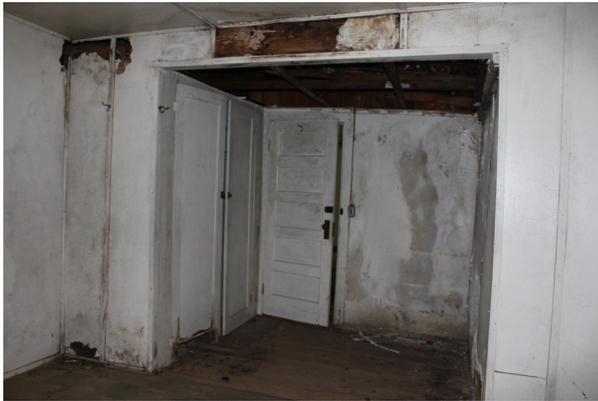
Figure 47: Room 107, entrance door and closet.

Room 107 is an addition on the southeast rear of the house. The construction of the entrance area with closet probably occurred before the rest of the room. This room was used as a bedroom. It measures approximately 16’-6” from the entrance door to the south wall by approximately 12’ across the wider part of the room from east wall to west wall. (Figure 47)

area the ceiling is lower and measures 7’-0 1/2”. The ceiling panels in this area have fallen off due to moisture deterioration.

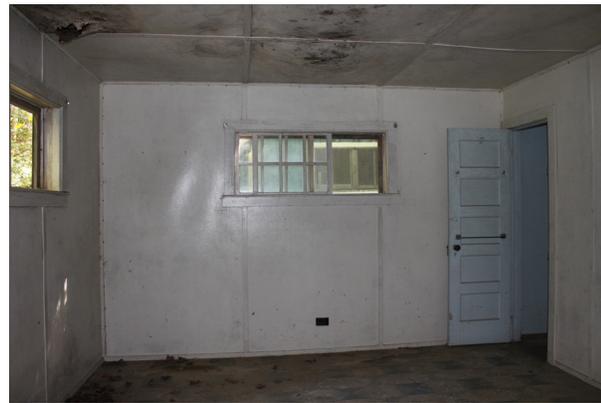
Figure 48: Room 107 looking south toward windows and Room 108.

The door into Room 108 has five horizontal panels and measures 2’-0 1/4” wide by 6’-6 1/8” tall. The casing in Room 107 is 3 1/4” wide. Door hardware includes a metal box lock with metal knobs, keyhole escutcheon, strike plate, and catch. The door is attached with 3” hinges. Mounted on the bathroom side are a towel bar and hook. (*Figure 48*)

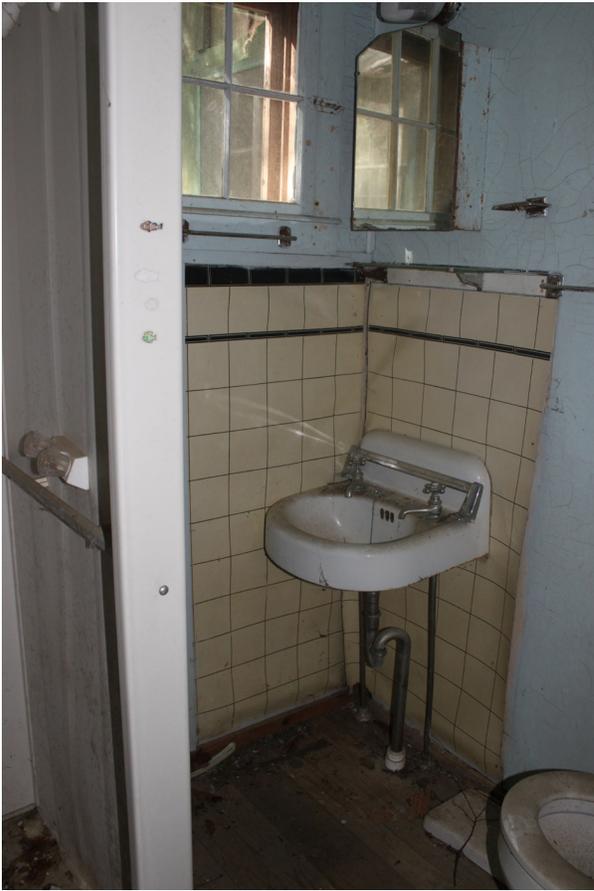
Figure 49: Room 108, bathroom fixtures and window.

Room 108 is a bathroom located at the west side of Room 107. The room was clearly an addition to Room 107. It measures approximately 5’-11” by 5’-3”. (*Figure 49*)

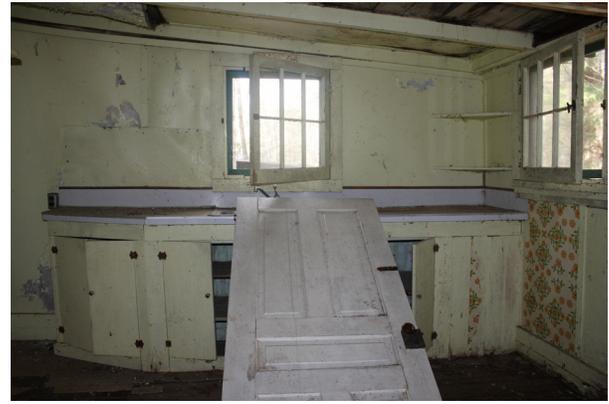
Figure 50: Room 109, kitchen cabinet and casement windows.

The kitchen is at the east rear of the house and is clearly an addition. The room measures approximately 11’-11” from the entrance door to the east wall and approximately 10’-7” from the north wall to the south wall. (*Figure 50*)

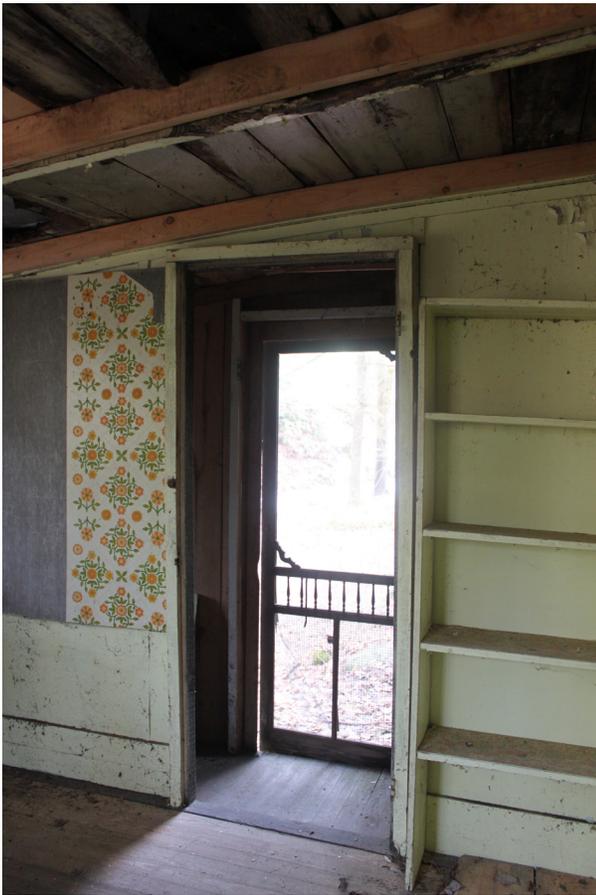
Figure 51: South wall of Room 109 with rear entrance door

The doorway into Room 110 contains a frame and a door detached from its hinges. (The door is currently stored in Room 105.) The door measures 2’-6 ¼” wide by 6’-3 ¾” tall; the 3” hinges remain on the door. Door hardware includes metal knobs and surrounds with strike plate and a deadbolt. A mounted towel bar is on the kitchen side of the door. (Figure 51)

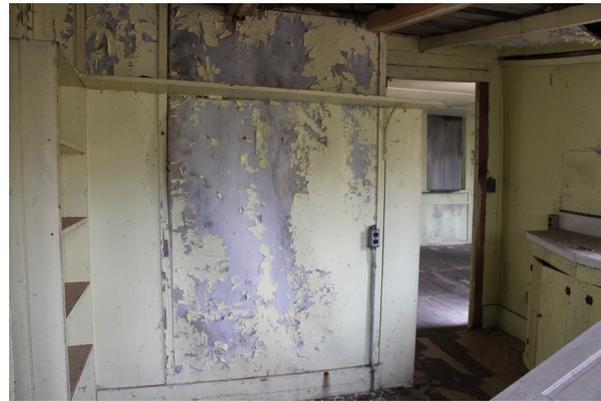
Figure 52: Shelving at the west end of Room 109

Two wood shelves are at the west end of the room along the south wall. Mounted angled shelves are in the northeast corner of the room. (Figure 52) A five panel wood door is stored in the room; it matches the other doors in the main core but its original location is unknown.

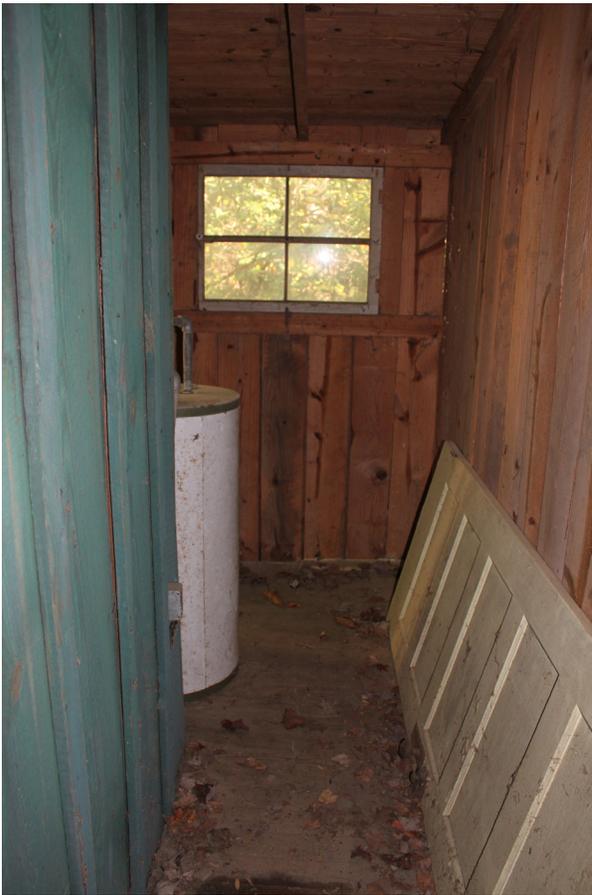
Figure 53: Room 110, hot water heater.

Room 110 is located at the rear of the kitchen and is clearly an addition. A 6 ¼” step-down leads from the kitchen doorway into 110. The room contains the hot water heater and a rear exterior entrance door. It measures approximately 4’-5” at the widest part and approximately 12’-2” from the east wall to the west wall. (*Figure 53*)

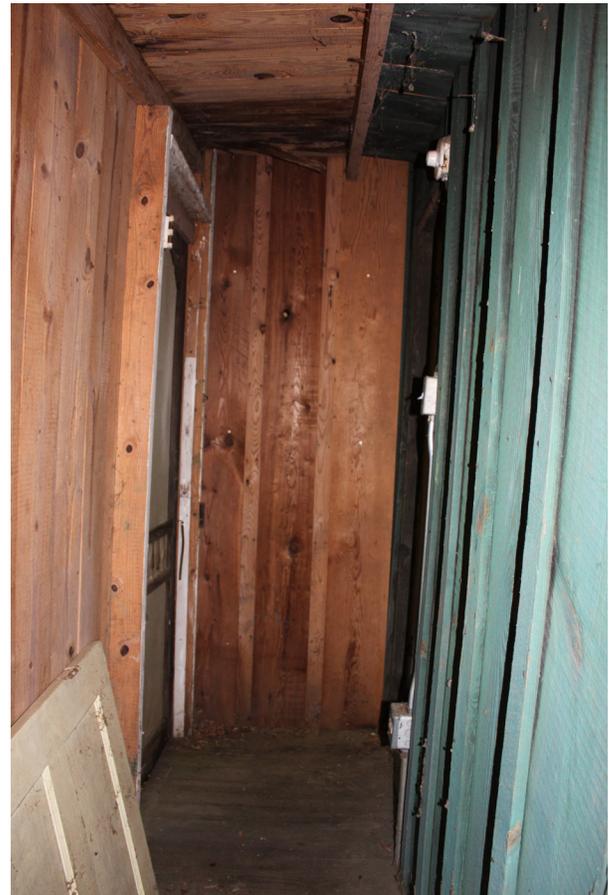
Figure 54: Room 110 looking west toward rear exterior entrance door (left).

The rear exterior entrance door has a frame but no casing; this door has been removed from its hinges. (*See Exterior Doors.*) (*Figure 54*)
