Smith Cabin
Elkmont Historic District
Great Smoky Mountains National Park
Historic Structure Report

September 2014

JOSEPH K. OPPERMAN-ARCHITECT, P.A.
539 N. Trade Street Winston-Salem, NC 27101
www.jkoa.net office@jkoa.net

Historic Structure Report

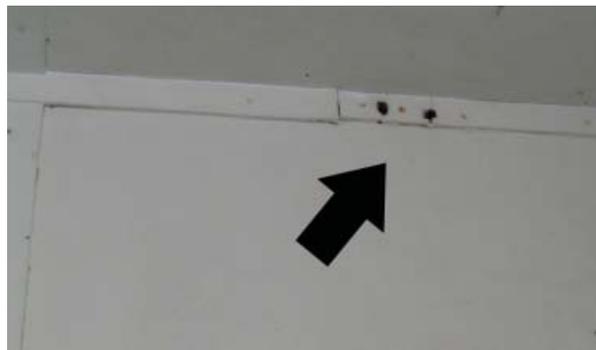
The earliest electrical distribution system for the Smith Cabin appears to have been knob-and-tube wiring. Developed in the 1880s and remaining in use until the 1940s, knob-and-tube wiring was made up of ceramic knobs mounted on wood surfaces, along with ceramic tubes drilled through framing and walls. The system separated the hot and neutral wires by 4” to 6”, and insulates the wires away from the wood structural members. Remnants of these porcelain tubes or sleeves can be seen in several places on the walls where wiring was routed through the original main block.

Figure 41. Holes near ceiling for early knob-and-tube wiring.

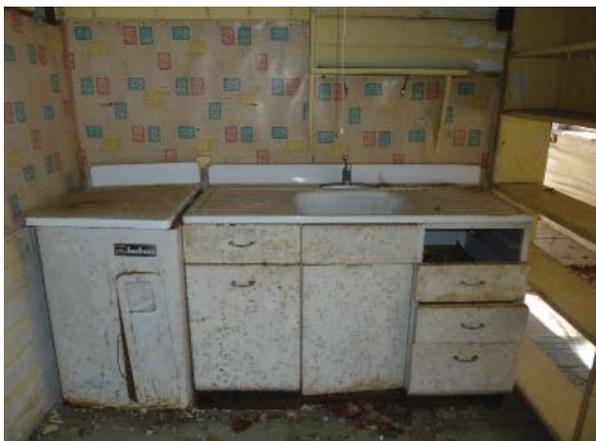
Figure 43. Sink in Kitchen (Room 106).

An inoperable gas-powered hot water heater remains in the Kitchen (Room 106) inside a metal cabinet. The 30 gallon 240 volt water heater was manufactured by W. L. Jackson Manufacturing, Inc. There is a 3" diameter flue in the wall above the cabinet. The Kitchen (Room 106) also has a 2'-0" deep by 4'-6" wide glazed cast-iron sink that is integral to the countertop (*Fig. 43*).

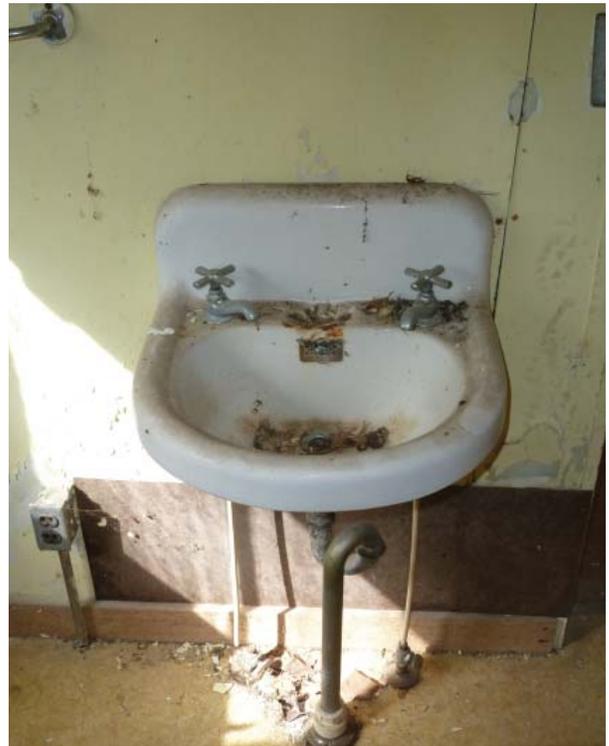
Figure 44. Ceramic sink in West Bathroom (Room 105).

There are two full bathrooms in the cabin, though the tub is missing from the West Bathroom (Room 105). Existing plumbing fixtures in that bathroom include a ceramic toilet with a missing tank top and a ceramic sink. The sink measures 1'-6" wide by 1'-4" deep and has two chrome-plated cross-handled faucets (*Fig. 44*). The $\frac{3}{8}$ " water supply lines are PVC and the $\frac{1}{4}$ " drain pipe is chrome plated.

Holes in the floor for plumbing lines indicate that a tub sat in the southeast corner of the room, but is now missing. There is a ceramic toilet on the south wall missing its top. The ceramic sink on the north wall measures 1'-6" wide by 1'-4" deep and has two chrome-plated cross-handled faucets (*Fig. 44*). The $\frac{3}{8}$ " water supply lines are PVC and the $\frac{1}{4}$ " drain pipe is chrome plated.

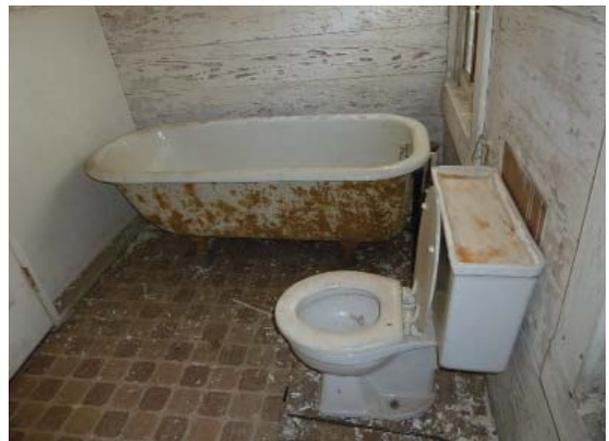
Figure 45. Toilet and tub in South Bathroom (Room 107b).

The South Bathroom (Room 107b) has a toilet, claw-foot tub, and a sink. The ceramic toilet is dated March 29, 1982. The tub measures 2'-6" wide by 5'-6" long and has chrome-plated fixtures. The $\frac{1}{2}$ " cold water supply line is PVC and the $\frac{1}{2}$ " hot water supply is a galvanized pipe. The sink and its faucets match that of the West Bathroom (Room 105). Its $\frac{1}{4}$ " supply lines and drain line are PVC.

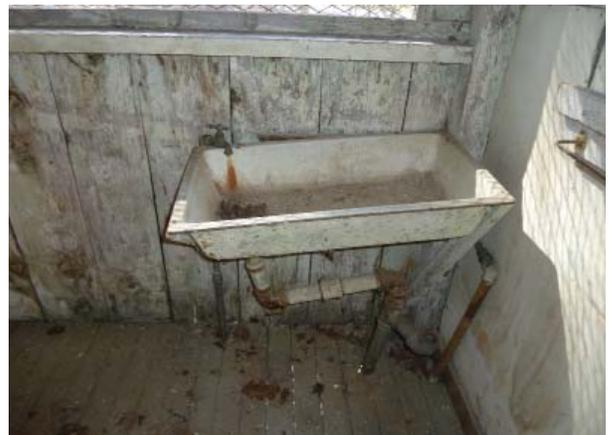
Figure 46. Sink in Enclosed Porch (Room 104).

There is an additional sink in the Enclosed Porch (Room 104) (Fig. 46). The galvanized iron basin measures 1'-6" by 2'-6" and is 5½" deep. There are two 1" galvanized supply pipes, a galvanized drain pipe, and one brass faucet and handle. The sink is supported on two wood brackets measuring 1" by 2".

A galvanized iron sink basin is located in the northwest corner of the room; it measures 1'-6" by 2'-6" and is 5½" deep (Fig. 46). There are two 1" galvanized supply pipes, a galvanized drain pipe, and one brass faucet and handle. The sink is supported on two wooded brackets measuring 1" by 2"

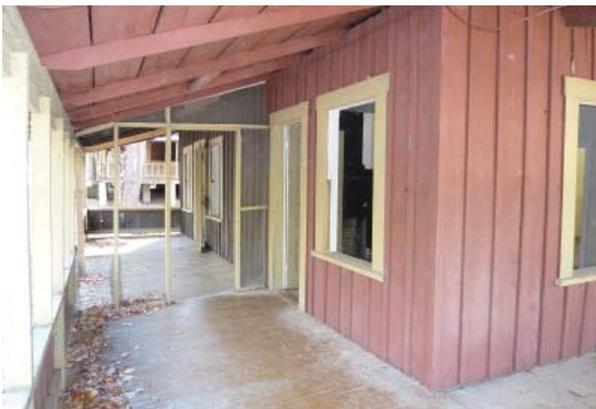
The porch of the main block is L-shaped and wraps the cabin on the east and part of the north elevations. It is approximately 8 feet deep and in the north-south direction measures 40'-5" and in the east-west direction measures 25'-3". The north side of the porch has remnants of screened panels; the screening extends across the east elevation approximately mid way and turns west dividing the porch in half. The remains of the east-west dividing wall indicate that there was once a screen door measuring 2'-8" wide by 6'-10" tall. The porch framing and flooring is described above in the *Structural Systems* section.

Figure 48. Front porch with remnants of screened panels.

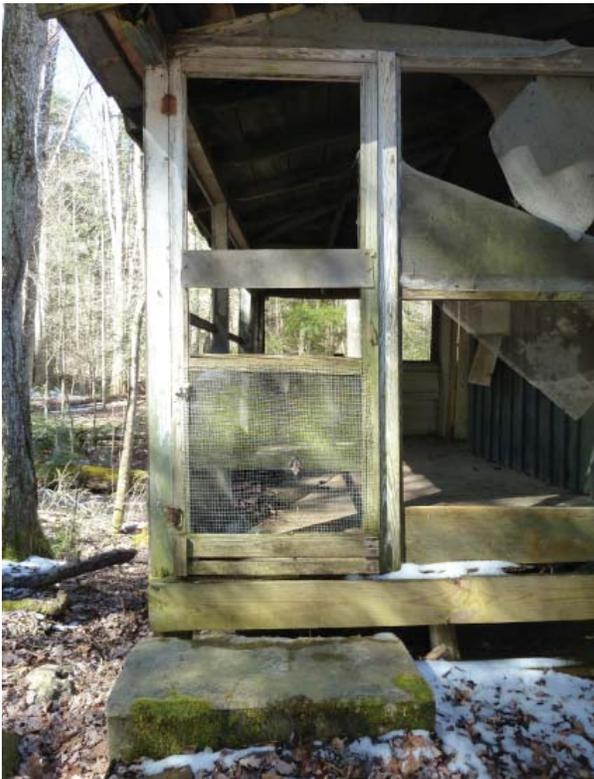
Figure 50. East elevation of south porch.

The south porch has two cast concrete steps on the east elevation that provide access from grade. The steps are approximately 3'-6" wide (*Fig. 50*).

handle, and a 2½” wire hook and eye (Fig. 50). The porch framing and flooring are described above in the *Structural Systems* section.

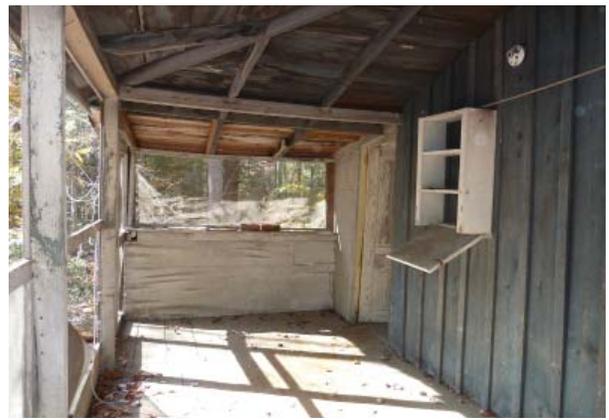
Figure 53. South porch looking west.

A wood cabinet is mounted on the north wall east of the doorway (Fig. 53). It measures 1'-8½” wide by 2'-6½” tall by 8¾” deep. The bottom of the cabinet can be lifted to form a shelf. A 3” galvanized vent pipe is located in the north wall; it was installed to vent the gas water heater in the kitchen. A wall-mounted 4½” ceramic lamp base is on the north wall.

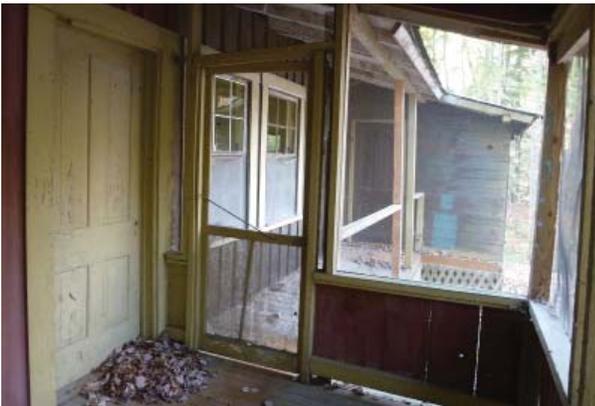
Figure 55. Screened door between wraparound porch and north porch.

knuckle hinges that measure 2½” tall by 1¾” wide, a 2” wire hook and eye, a wire handle that is 3” tall, and a spring closer (Fig. 55). The porch posts are paired 2” by 4” wood studs, another 2” by 4” wood studs runs horizontally forming the porch railing. The porch framing and flooring is described above in the *Structural Systems* section.

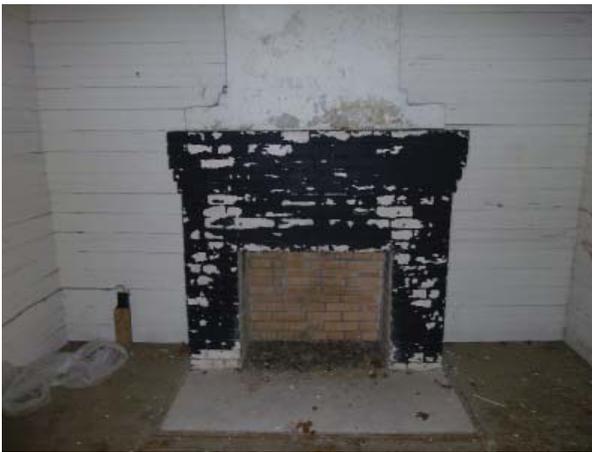
Figure 68. Fireplace and exposed chimney centered on north elevation.

A fireplace and its exposed chimney are centered on the north wall (*Fig. 68*). The firebox, which measures 3'-0" wide by 1'-4" deep by 2'-5" tall, is made of yellow firebrick and the mantel is smooth painted brick. The mantel measures 5'-4" wide by 10½" deep and the top of the shelf is 4'-11" above the floor. The brick of the mantel corbels out towards the top of the shelf with a ½" corbel for each of the three courses of brick and an additional ½" for the top two courses. The exposed chimney is covered in stucco and painted; it measures 3'-4" wide and 8" deep and has a patch for a flue. The poured concrete hearth is 5'-1" wide by 1'-11½" deep and has wood edge strips that measure 1½" by ⅝".

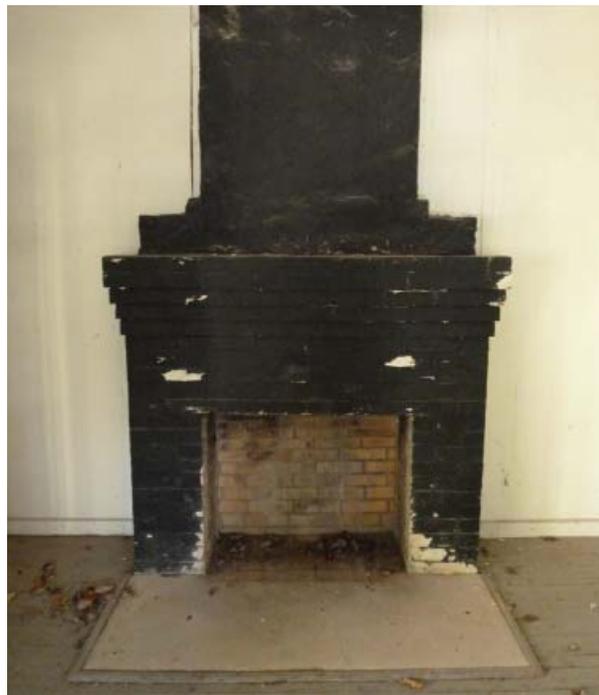
Figure 72. Fireplace and exposed chimney on south elevation.

Bedroom (Room 101) (*Fig. 72*). The firebox, made of yellow firebrick, measures 3'-0" wide by 1'-4" deep by 2'-5" tall and has a 2" by $\frac{3}{8}$ " steel bar across the top. The mantel is smooth painted brick measuring 5'-6" wide by 11½" deep and the top of the shelf is 4'-8" above the floor. The brick of the mantel corbels out towards the top of the shelf with a $\frac{1}{2}$ " corbel for each of the three courses of brick and an additional $\frac{1}{2}$ " for the top two courses. The exposed chimney is covered in stucco and painted; it measures 3'-3" wide and 6" deep. The poured concrete hearth is 5'-1½" wide by 2'-1" deep and has wood edge strips that measure 1½" by $\frac{5}{8}$ ".

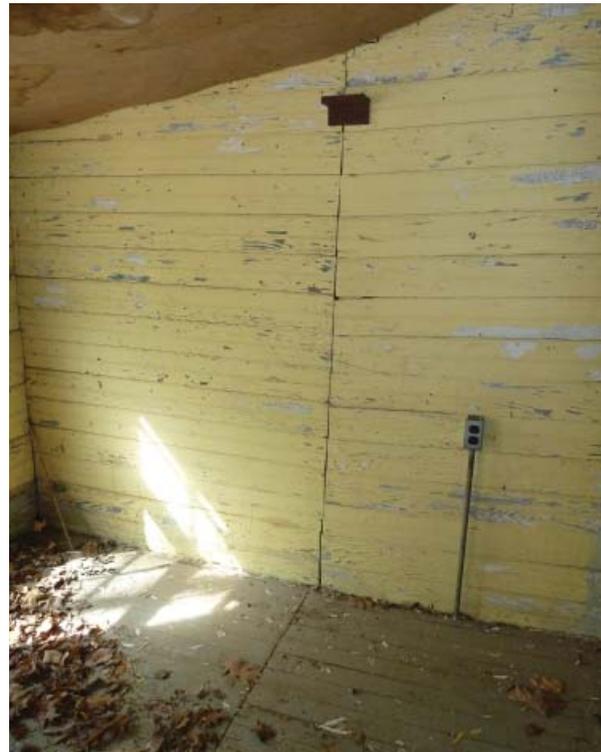
There is a mixture of two different size tongue-and-groove wood floor boards in this room. Some measure 3¼” in width and others measure 2¼” in width, and all are laid east-west. A seam runs north-south across the floor boards approximately 7’10” west of the east wall; the floor seam aligns with a seam in the north wall where the room was expanded.

Figure 87. Vertical seam in north wall.

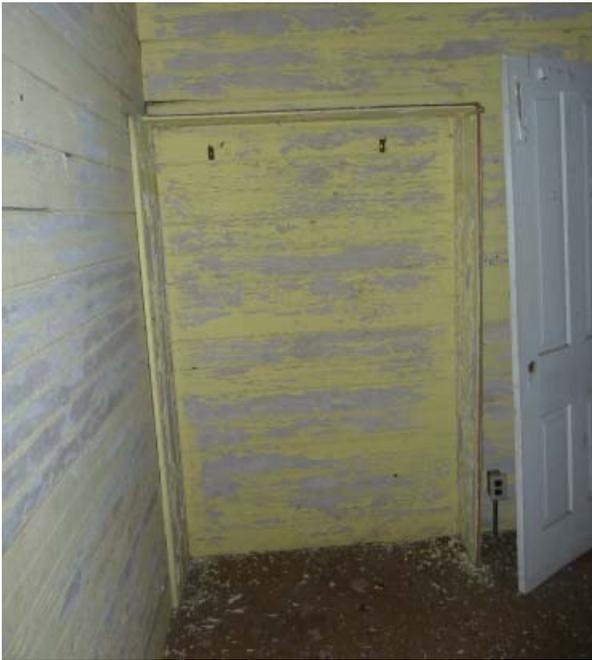
Figure 93. Closet on east wall.

There is a closet on the east wall that is constructed of leftover beaded boards. The closet measures approximately 6'-1" tall by 4'-2" wide and projects 1'-2" from the wall; it does not have any doors. Two brass hooks are mounted near the top of the closet on the east wall (Fig. 93).

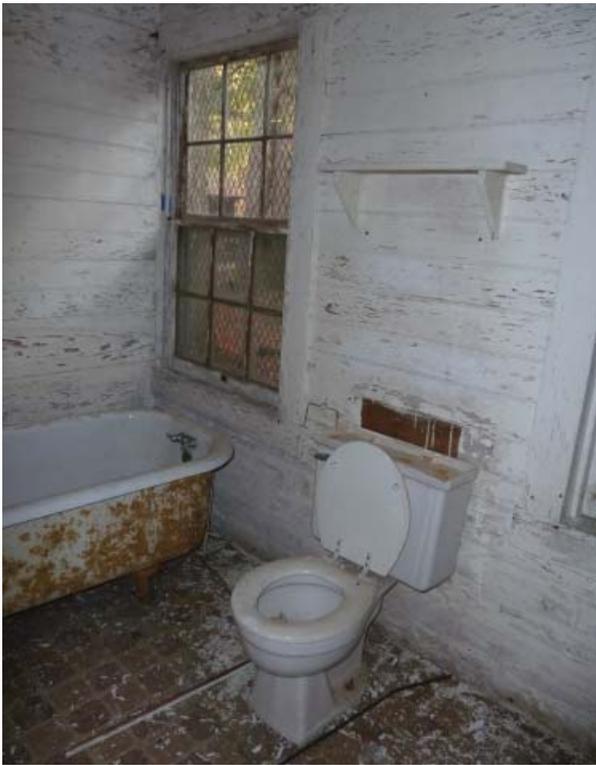
Figure 94. Southeast oblique of South Bathroom (Room 107b).

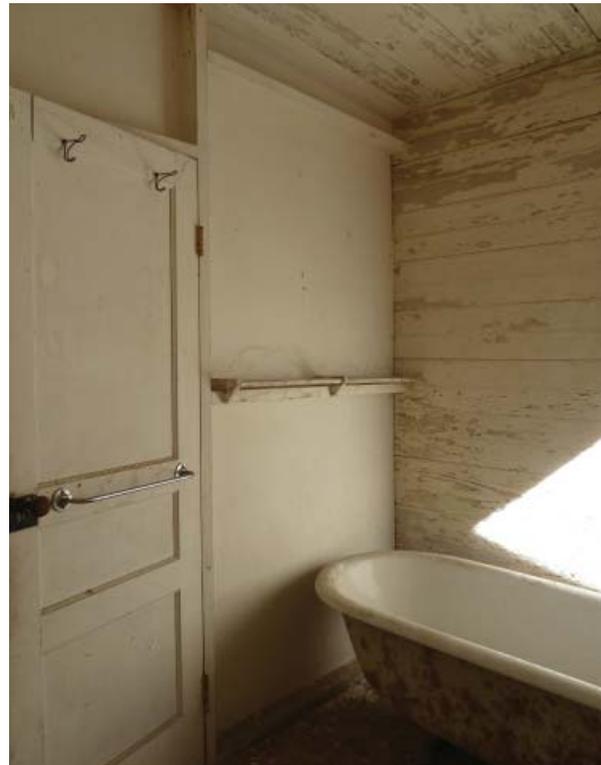
Figure 96. Northeast oblique of South Bathroom (Room 107b).

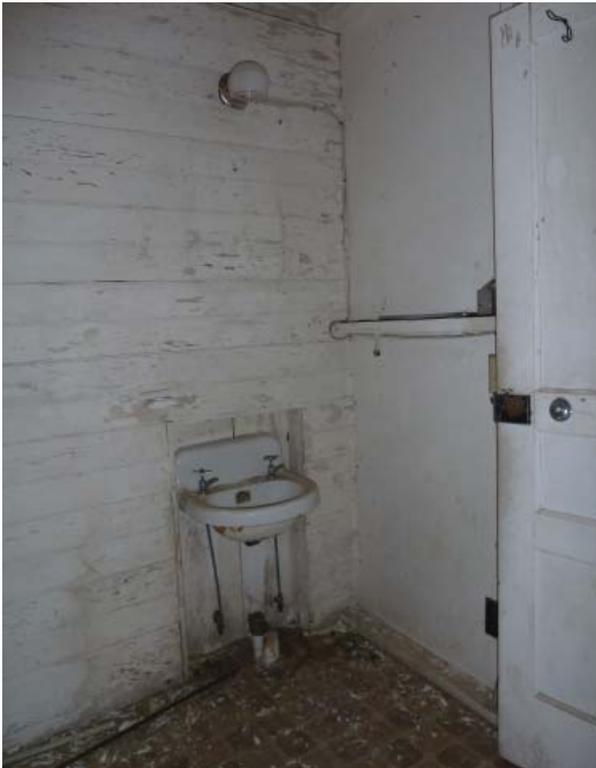
Figure 95. Northwest oblique of South Bathroom (Room 107b).

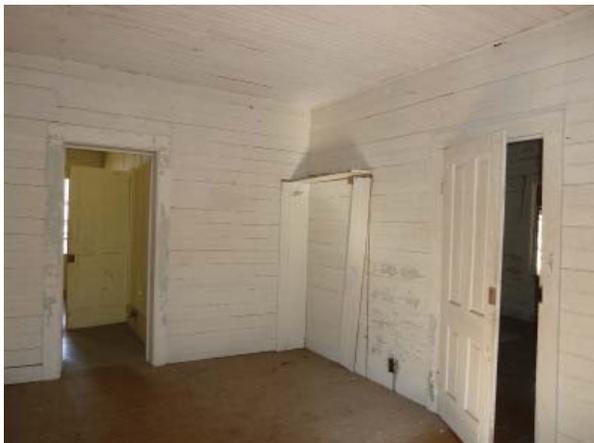
Figure 97. Northeast oblique of Middle Bedroom (Room 108).

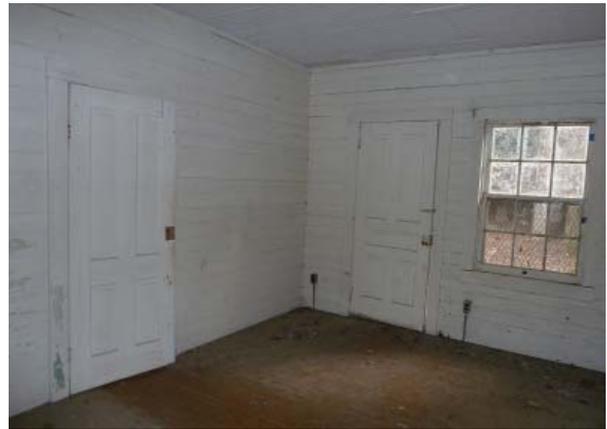
Figure 98. Southeast oblique of Middle Bedroom (Room 108).

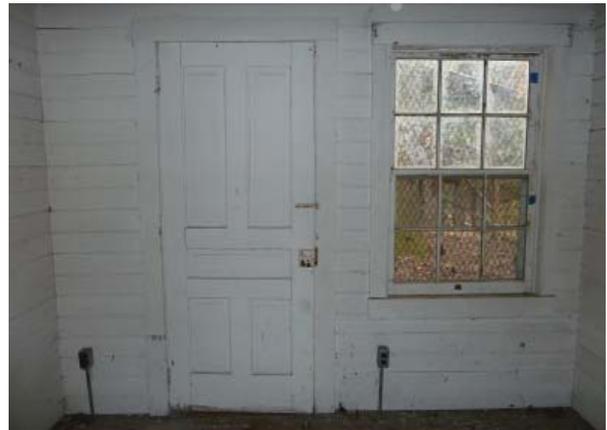
Figure 99. South elevation of Middle Bedroom (Room 108).

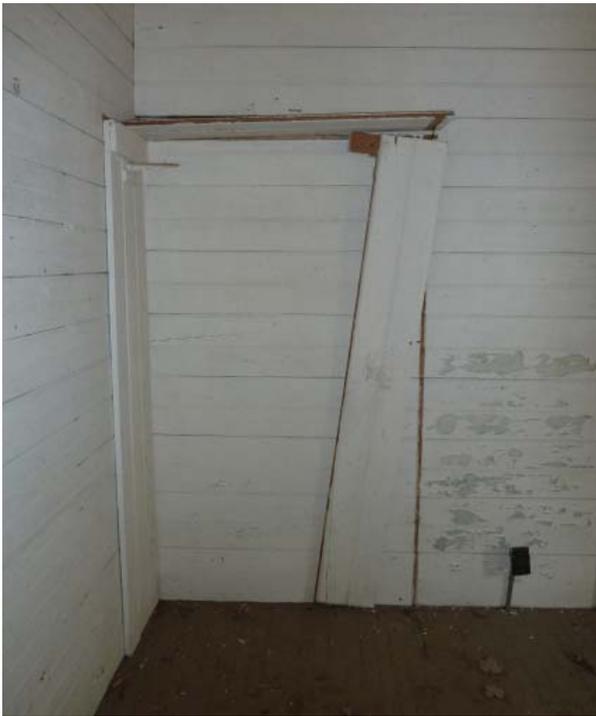
Figure 100. Closet on east wall of Middle Bedroom (Room 108).

There is a closet on the east wall north of the doorway constructed of leftover beaded boards. The closet measures approximately $6'-0$ " tall by $3'-8$ " wide and projects $1'-2$ " from the wall; it does not have any doors. A remnant from a wooden hanging rod is mounted on the north side of the closet (*Fig. 100*).
