SPENCE CABIN

**Great Smoky Mountains National Park
Elkmont Historic District
Sevier County, TN**

HISTORIC STRUCTURE REPORT

February 17, 2009

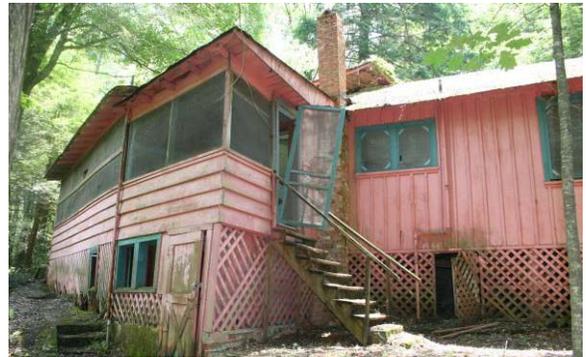
In the original house, the bathroom 112, the west end of the west hall (Room 110), bedroom 113 and its walk-in closet (Room 114) did not exist. Nor did the screened porch extension (Room 107) and the ground floor rooms below exist. In place of the screened porch extension there was a small open porch as evidenced by the framing members.

Figure B-2. Screen porch addition.

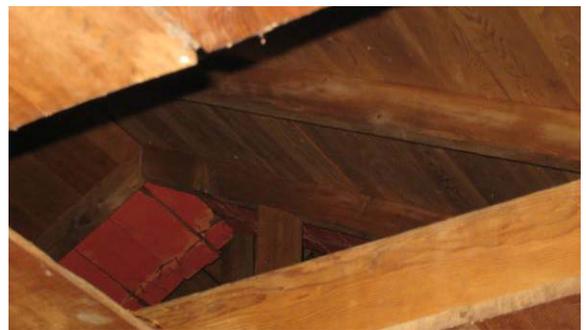
Confirmation of the initial west end of the house can be seen from the ceiling hatch in bedroom 111. From the attic above, one can see remnants of the painted soffit of the original west exterior wall.

Figure B-3. Painted roof soffit visible through ceiling hatch in Room 111.

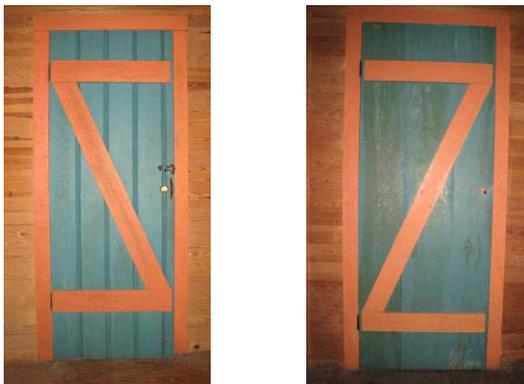
Still other evidence of the west addition can be found in the doors of bathroom 112, bedroom 113 and walk-in closet 114. These board-and-batten doors, though similar to the board-and-batten doors elsewhere in the house, are constructed with a slight difference; the long dimension of the boards of these doors is beveled, not squared.

Figure B-4. Beveled vertical boards on west wing addition door compared to squared boards at typical interior doors (right).

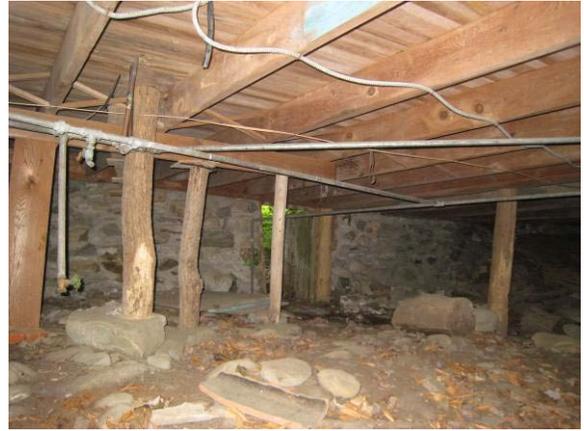
Figure C- 15. Crawl space showing wood posts and perimeter stone foundation wall.

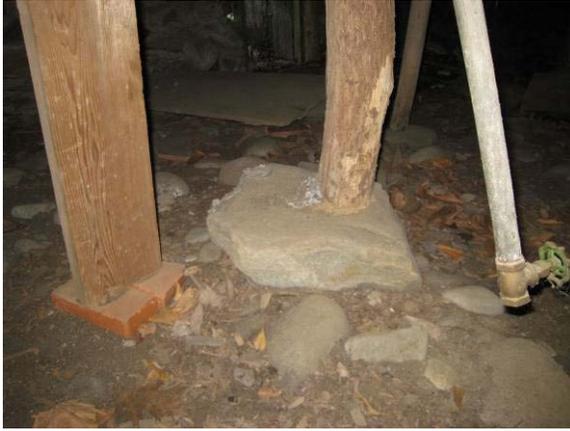
Along the north or rear elevation of each section of the cabin, a series of cut but not shaped locust posts with bark, typically about 6" in diameter, sitting on a flat stone on grade, provide the support. Each post has

Y-bracing of 2x4s (dimensionally 1¾" x 3¾") under the sill. All appear to be original.

Figure C- 17. Locust post sitting on a flat stone. Next to it is a later wood support resting on bricks.

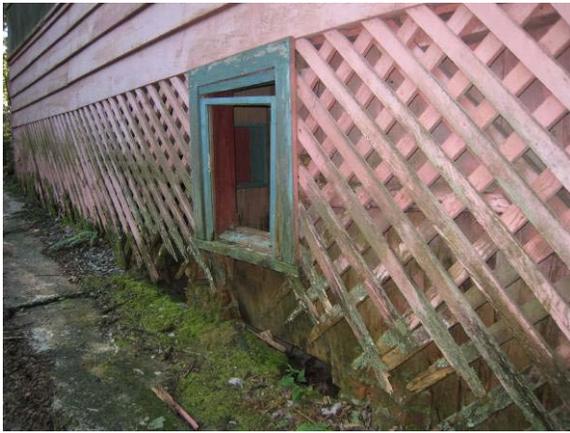
Figure C- 21. Lattice work along the north side of the cabin.

The enclosing lattice work at grade along the north side of the cabin also varies according to these construction periods. The dimensions of the lattice for the original construction period is $\frac{3}{4}$ " x $1\frac{7}{8}$ " the same as its batten. The dimensions of the lattice at the extensions is $\frac{3}{4}$ " x 2" the same as its batten.

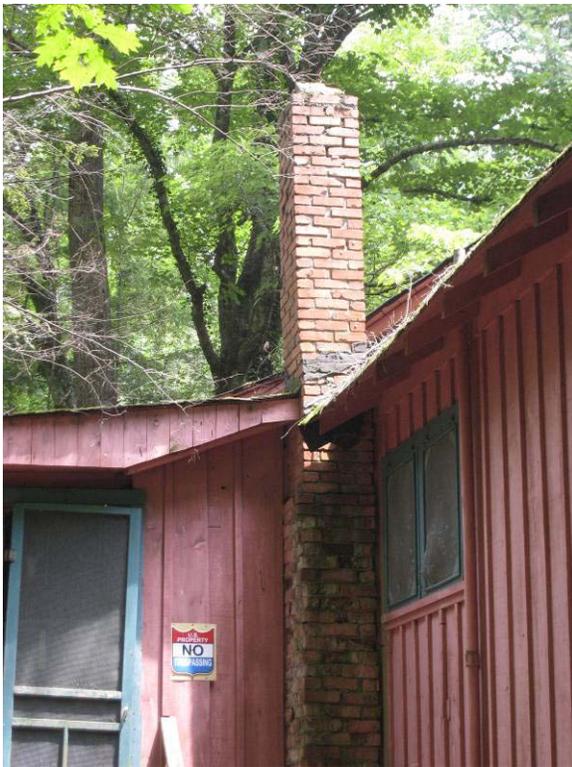
Figure C- 24. Brick chimney at the north side of the cabin.

There is a brick chimney to the east of window in Room 109. This chimney was added when the screen porch was extended and the dressing room was constructed at grade. There is no apparent connection to the kitchen. There is a 6" diameter clay flue however, at the west wall of Room 001 which likely served a wood burning stove.

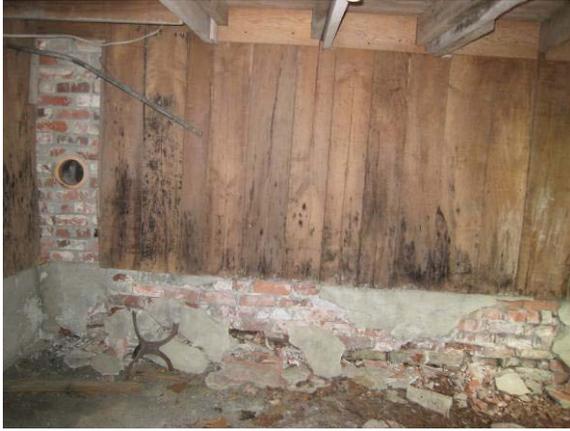
Walls: The bottom two feet of the four perimeter walls are made of brick and parged with a cement stucco. Above, are wood boards of varying widths set vertically. A narrow strip at the south end of the west wall has not been covered with

wood boards and has the remains of a 6" diameter clay flue embedded in the chimney wall.

Figure C- 38. West wall of Room 001.

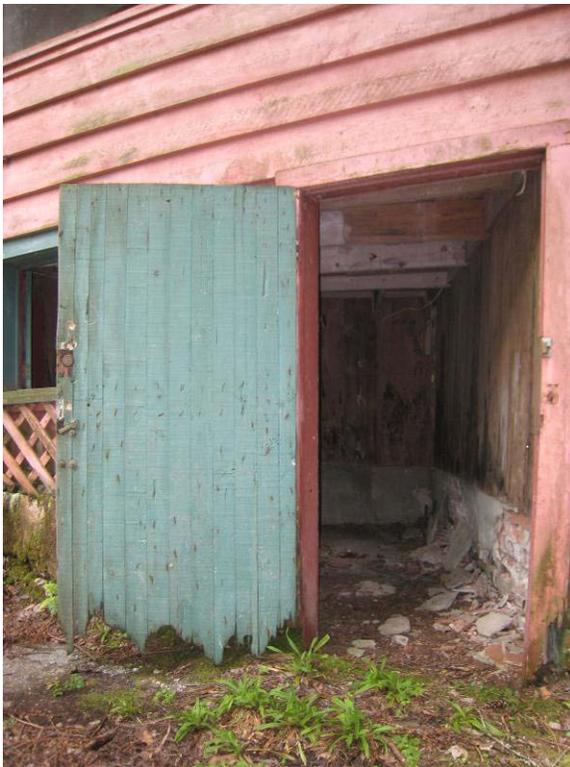
Figure C- 39. Door to Room 001 at north elevation.

Doors: One Type D-1 door is located at the north wall and measures 2'-11" wide by 6'-0" high by 1¾" thick. The door consists of vertical wood boards that are either 2¼" or 3¼" wide. At the exterior the door has been subdivided into two panels by large 5" x 7/8"

A variety of locks and pulls have been added to the exterior door over the years. At the exterior side, there is an older pull, back plate, and latch which may all be original. The pull appears to have been removed from the back plate and relocated next to it. Above the latch is a padlock and above the padlock is a later deadbolt. A ghost line of a previous lock can be observed around the keyhole. Above the deadbolt are also patched holes from earlier hardware.

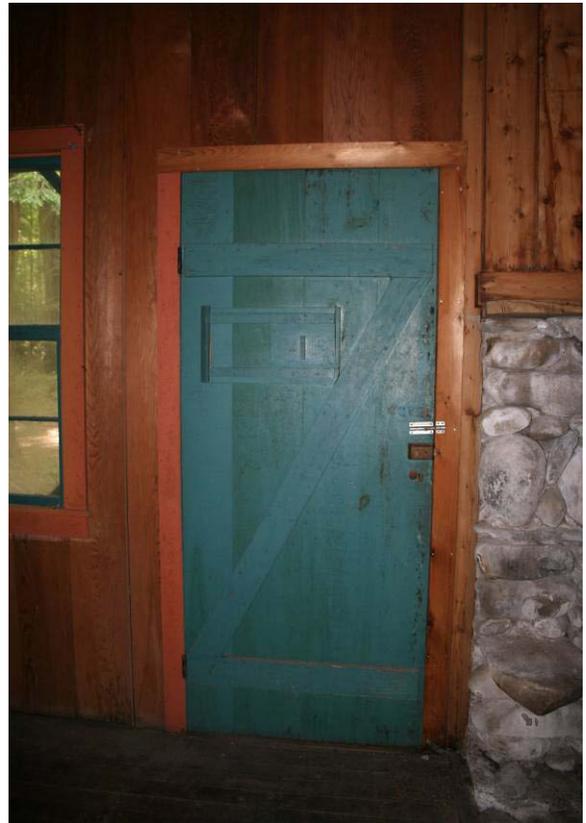
Figure C- 43. Entry door into Room 101.

The main entrance door has two, five-knuckle, 3½" high, painted steel, butt hinges by Hager. The hinge pins have rounded ends. On the interior side of the door is a deadbolt lock with a sliding bolt lock above. There are ghost lines above the bolt lock indicating that another type of bolt lock was once installed.

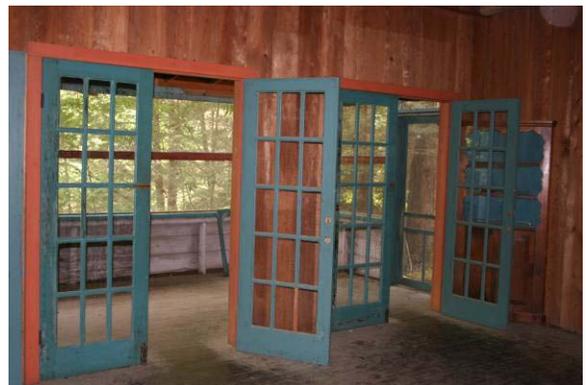
Figure C- 44. French doors at north wall of Room 101.

On the French doors, there are two five-knuckle, 3½" high, painted steel, butt-hinges by Hager per leaf. The left leaf (looking from the inside) of each pair also has a newer sliding bolt lock and an early, if not original, floor bolt. The hinge pins have rounded ends. In addition, the French doors also had pull handles but they are now missing.

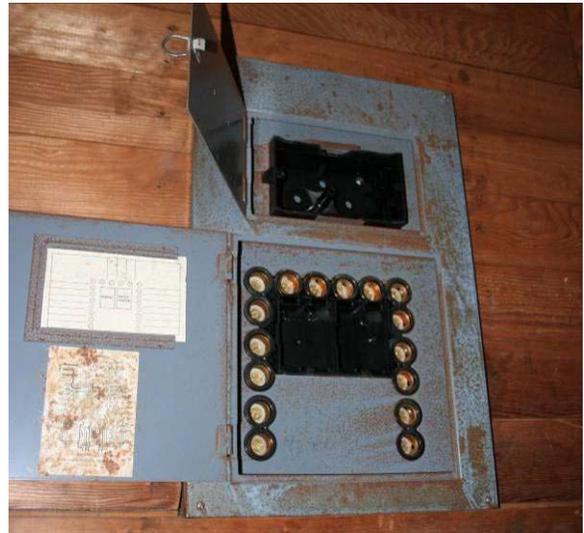
Electrical Systems: There is a 100 amp. electrical panel by "Wadsworth" and evidence of a sconce light, now missing, at the north wall.

Figure C- 49. Fuse panel at north wall.

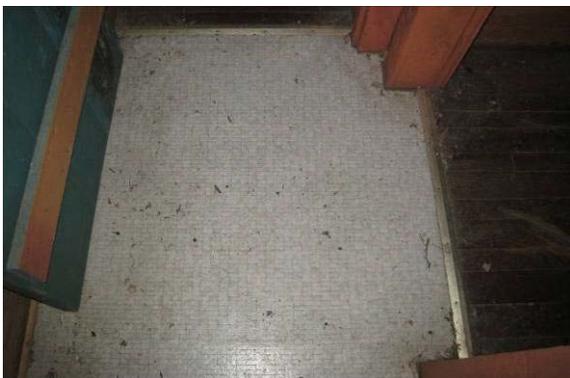
Figure C- 53. Sheet vinyl floor and aluminum thresholds in Room 103, the east wing bathroom.

Flooring: The floor is sheet vinyl with a wood shoe mold over the original wood floor. There is an aluminum threshold at each of the door openings.

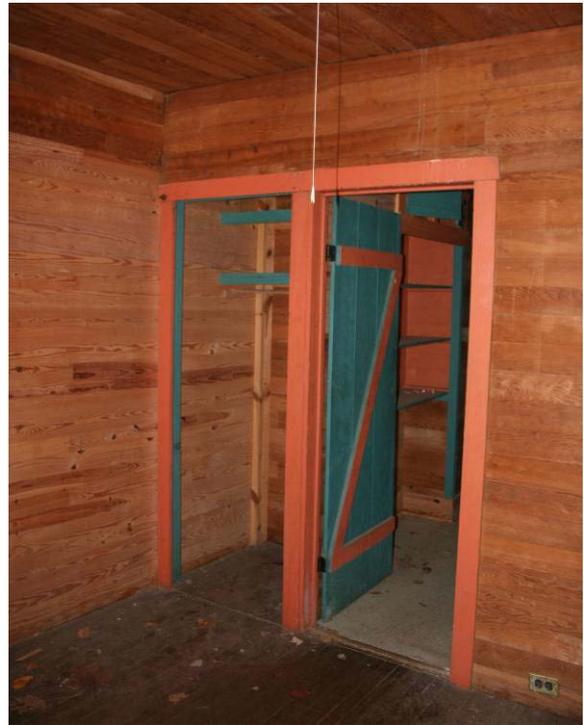
There is a seam in the floor at the closet opening as well as at the bathroom doorway, the former west end of the wing. In the closet, the floor boards are all 3¼" wide. There is an aluminum threshold at the entry to Room 112.

Figure C- 65. Room 111 looking toward southwest corner. Note seam in wood floor by closet and aluminum threshold at door to Room 112, the bathroom.

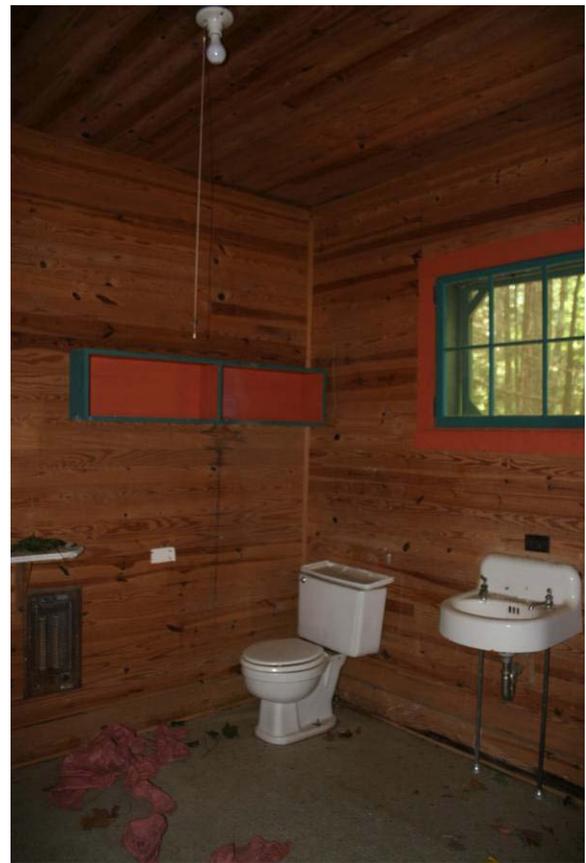
Figure C- 66. Room 112 looking toward northwest corner.

Flooring: The flooring consists of sheet vinyl with aluminum thresholds at the door openings. A wood floor is believed to be under the vinyl.

appearances in good repair. It is further recommended that for its use as a public rental facility a unisex, handicapped-accessible restroom be located in the west restroom (Room 112) with connection through the adjoining bedroom (Room 111) to the west hall (Room 110.) Further, limit food preparation to those of a warming kitchen located in the current kitchen (Room 109).

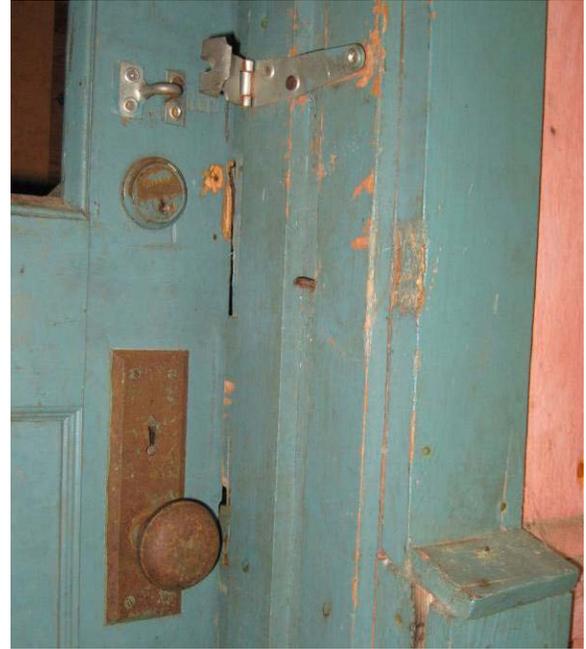
Figure C- 68. Early door knob and Yale deadbolt above at door leading to Room 113.

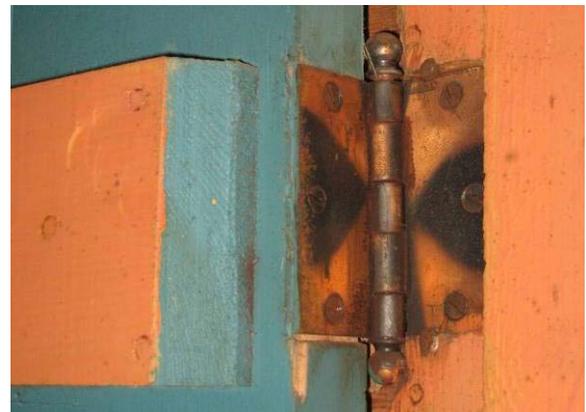
Figure C- 69. Brass butt hinge by Lawrence at door leading to Room 113.

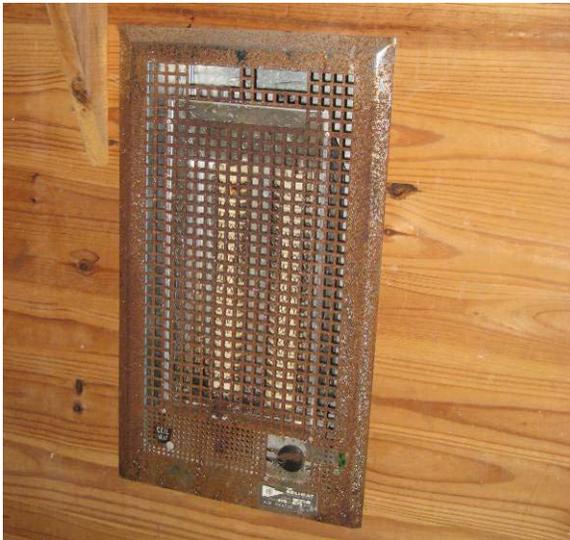
Mechanical Systems: A "Ceilheat" 240 volt (1500 watt) air heater is located under the shelf on the west wall. Ceilheat doesn't appear to be in business anymore but was located in Knoxville, TN. The model number is 21 AB 15.

Figure C- 70. Wall heater in Room 112.

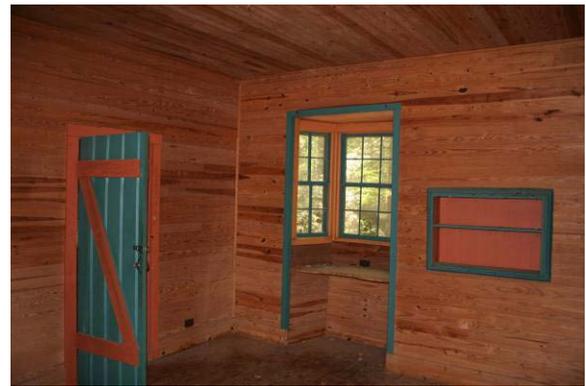
Figure C- 71. Room 113 looking toward the southwest.

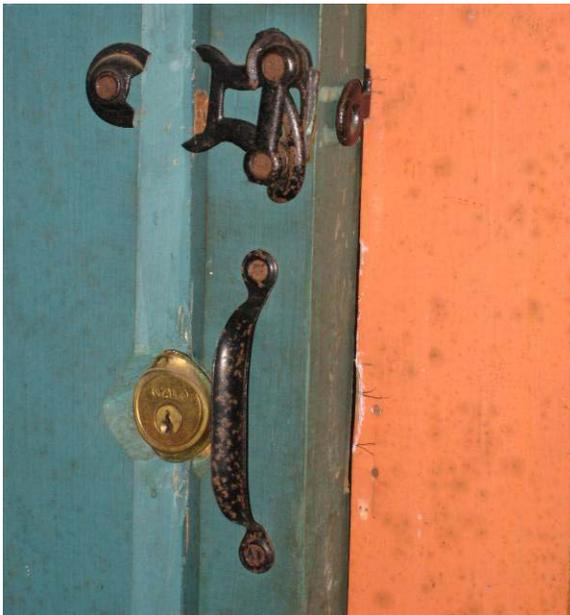
Figure C- 72. Early pull handle and latch above on door to Room 114.

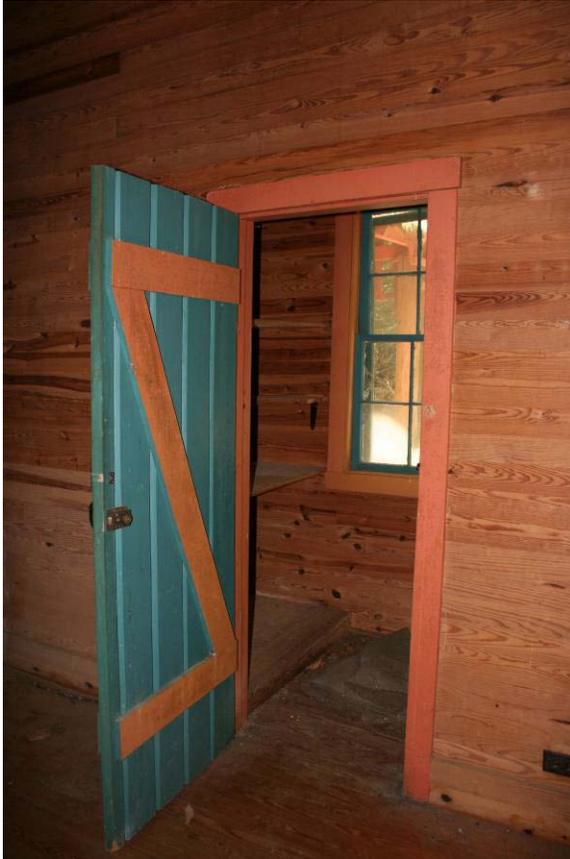
Figure C- 73. Looking into Room 114.

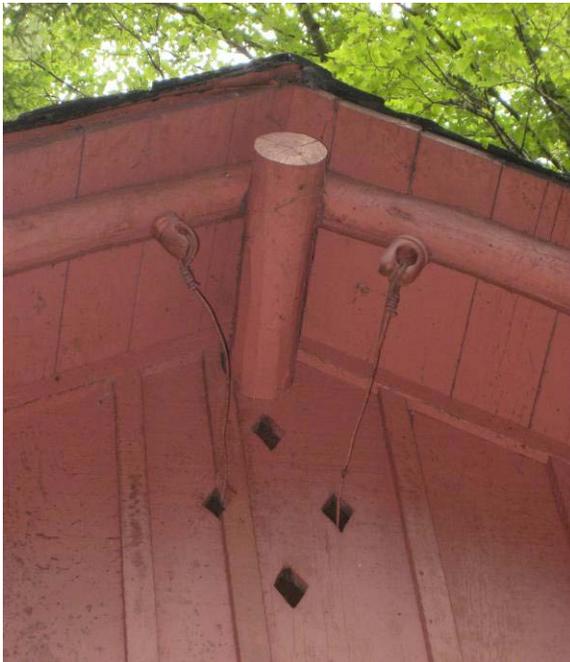
Figure C-74. Diamond-pattern gable vent and electrical supply lines.

There are some issues that need to be addressed. Certainly, these electrical and plumbing lines have been out of service and should not be trusted; a complete replacement of both will be necessary if these services are to be available again.

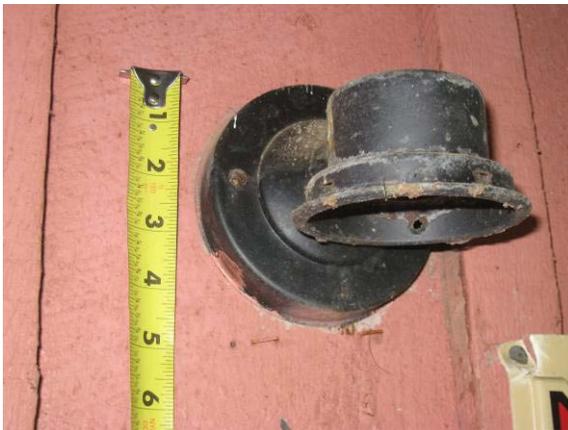
Figure C- 75. Wall-mounted c. 1950s pendant light fixture at west wing addition south entrance.
