Harry S Truman National Historic Site Truman Farm

Cultural Landscape Report Historic Structure Report & Environmental Assessment

1, DEZ, 2013

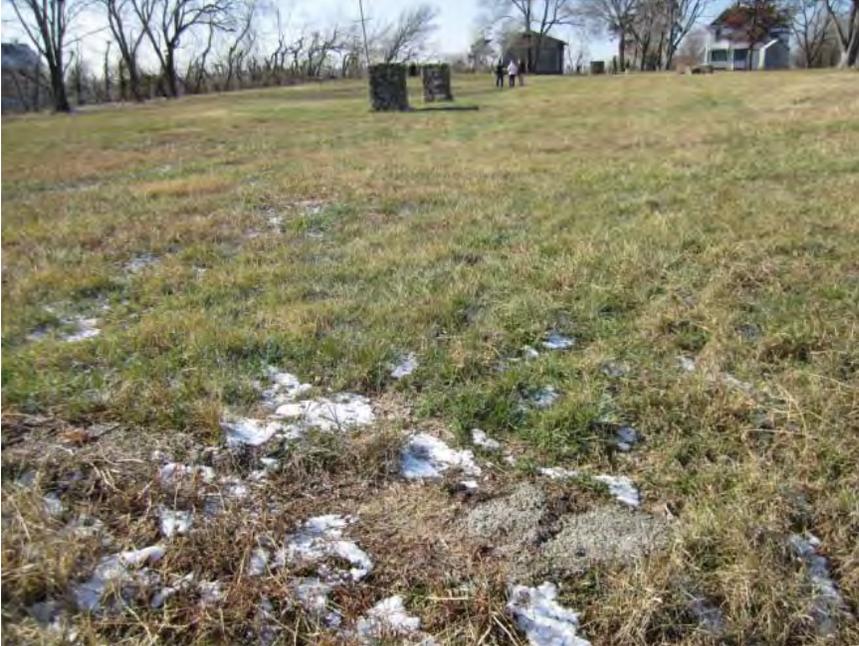
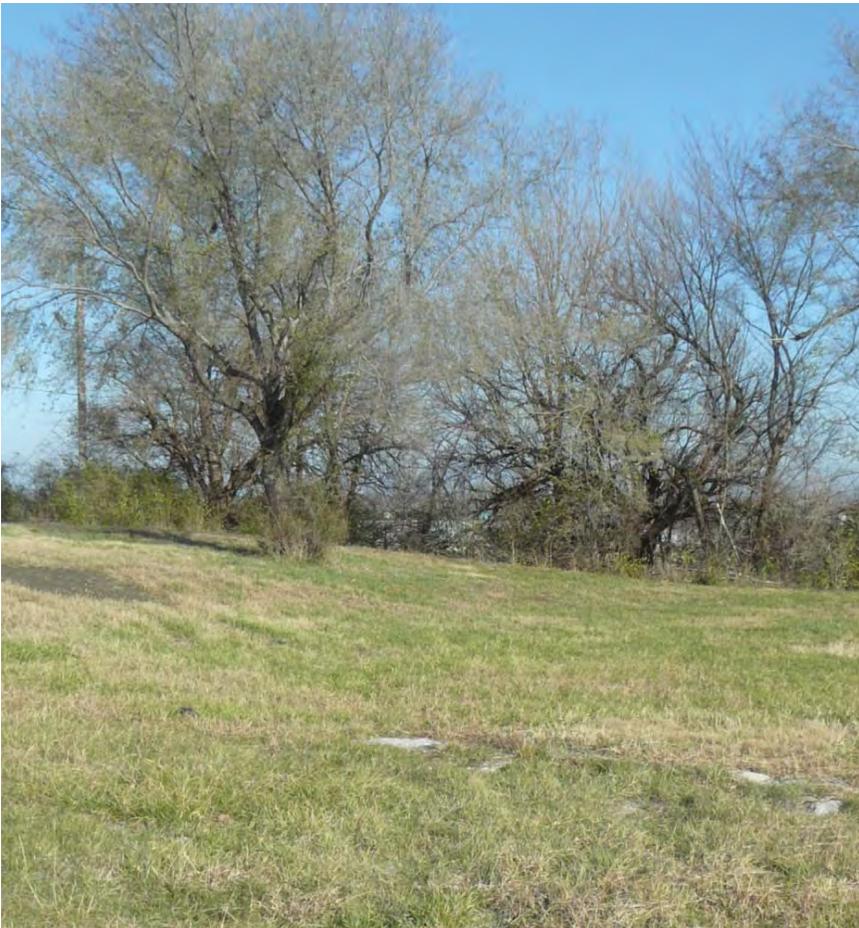
Figure 3-3. The concrete foundation in the east field. It was possibly poured as a foundation for a hog house and is a contributing feature. SS 12/6/11

foundation was filled with a pavement of rocks. “Function of the structure was uncertain, but it was probably a hog house. Time of use was almost certainly Truman period.”¹⁵

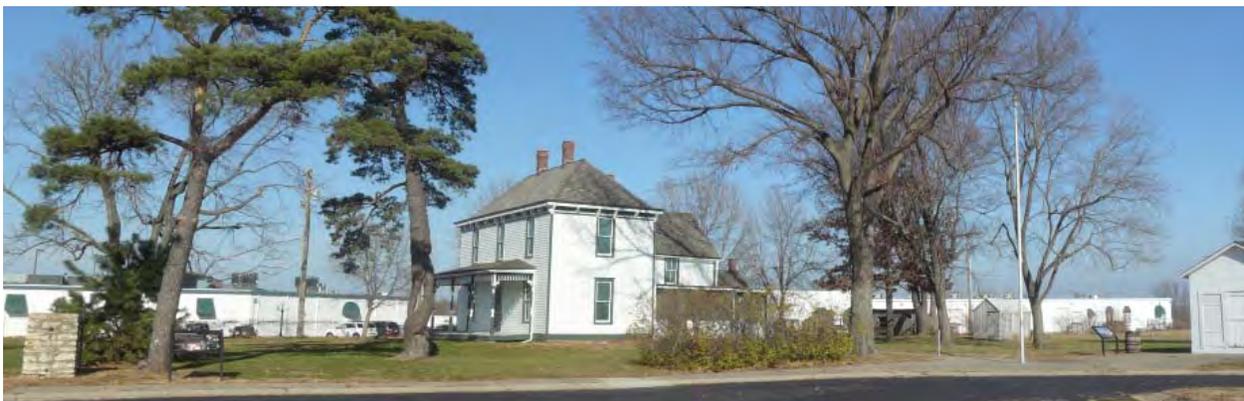
Figure 3-8. The Farm Home yard remains similar to its appearance during the period of significance, with mown lawn and few ornamental plantings. However, the fence that once separated the space from other farm spaces is gone and the division of space between Farm Home yard, garden, and barnyard have become blurred. SS 12/6/11

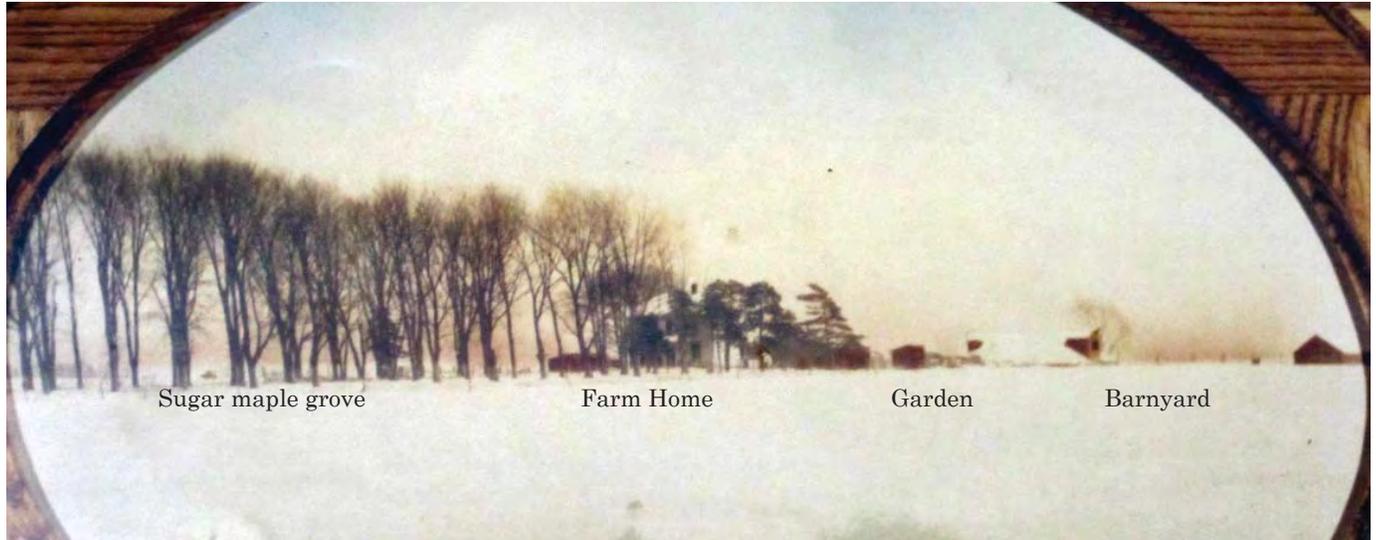
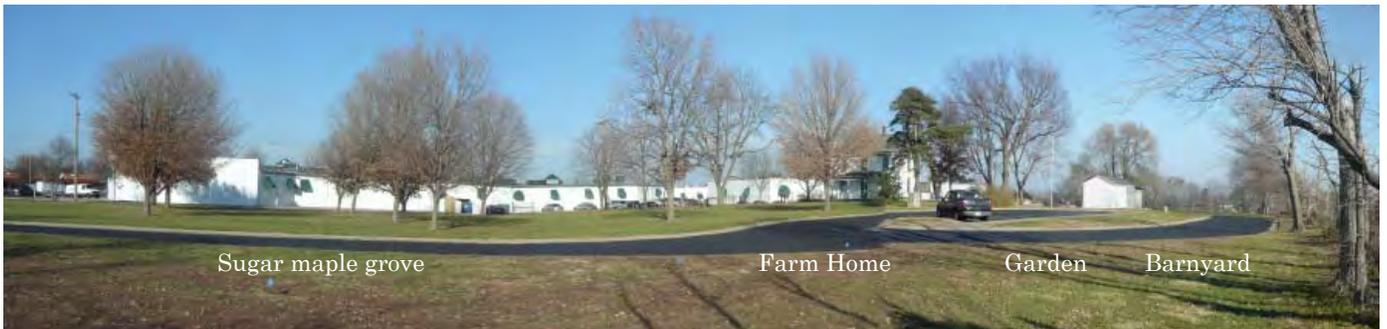
Figure 3-9. The farm historically was divided into discrete spaces. The sugar maple grove is the furthest west, then the Farm Home yard, garden, and barnyard on the east. The sugar maple grove was replanted in 1984 and retains a similar spatial orientation to the Farm Home; other spatial relationships have become diminished due to the loss of the garden and its vegetation and fences which helped to define spaces. Today, it is difficult to distinguish the barnyard, particularly since none of the barns are extant. HSTL 83-127, c.1920/1930; SS 12/6/11

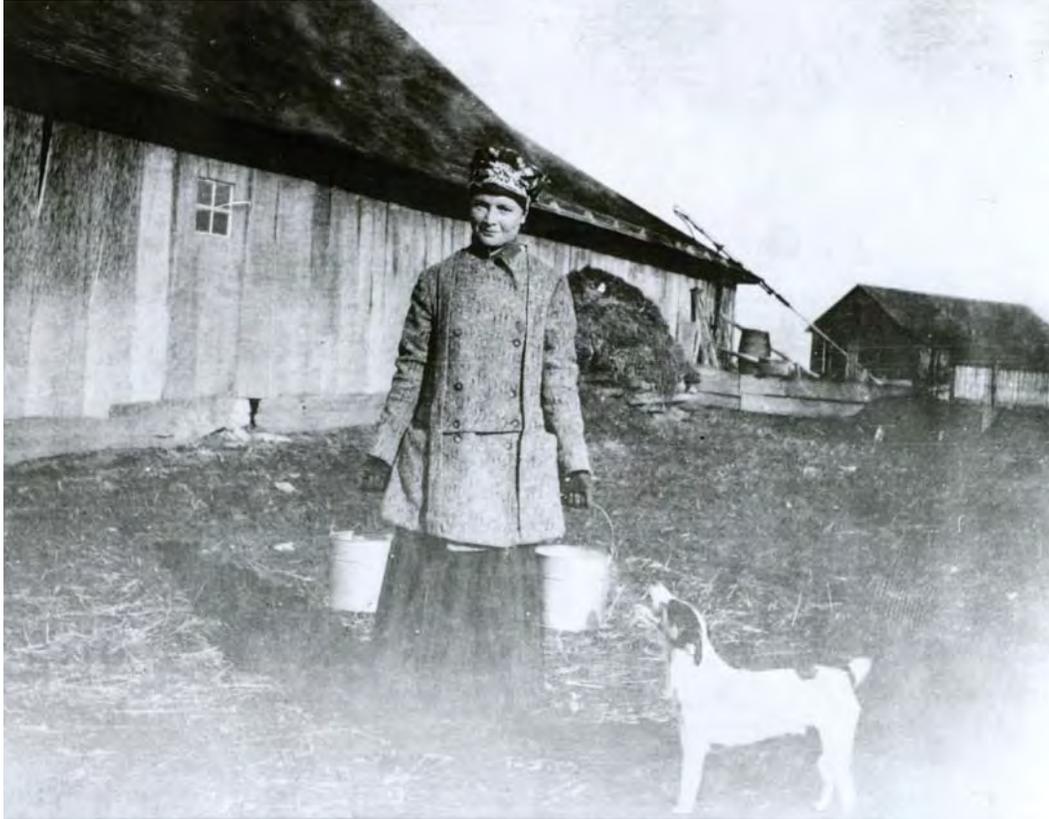
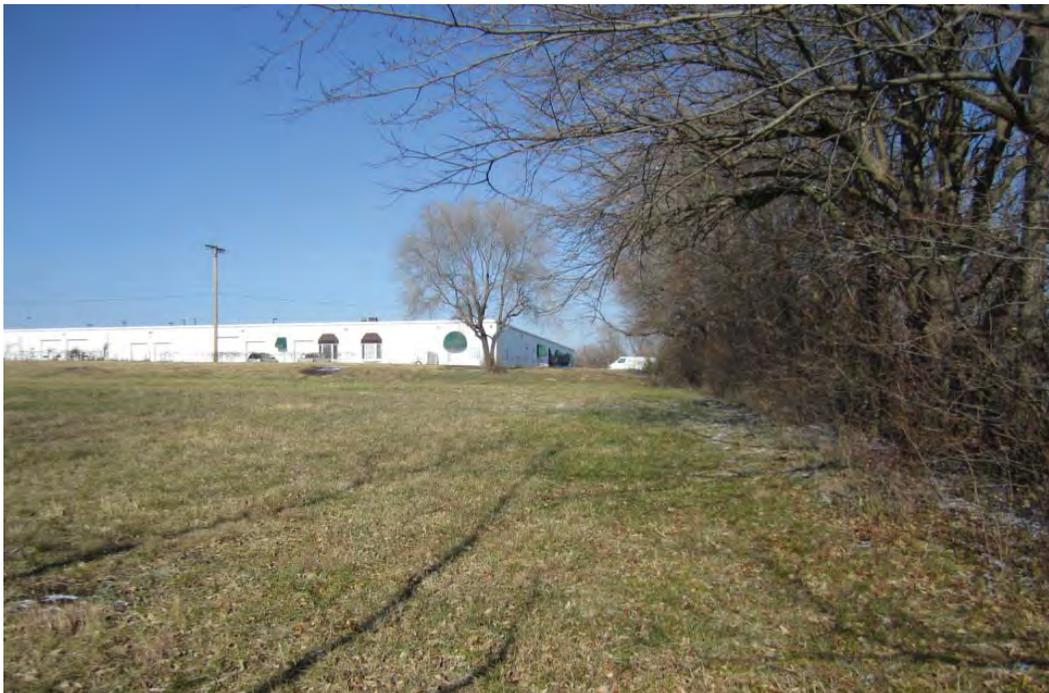
The barnyard is the easternmost space of the Truman Farm. During the period of significance, it was filled by the Solomon Young Barn which was built in 1867 and burned in 1966. The barnyard was defined on the southeast corner by the granary, and was enclosed by fences and stone columns. The barnyard space remains, but the loss of the Solomon Young Barn, granary, fencing, and one of the stone posts, makes it difficult to distinguish it as a space. Other changes to the space include trees and native understory vegetation that have naturalized on the east boundary, which was not there historically. The vegetation encloses the barnyard, which was historically open on all sides with views to the surrounding land.

Figure 3-10. The barnyard is the easternmost space on the Truman Farm today. Historically, the barnyard was dominated on the north by the Solomon Young Barn (top) built in 1867 which burned in 1966 and was removed. Today, the space remains, however the loss of the barn, granary, and fencing makes it difficult to identify the space as a barnyard (bottom). Trees and native understory vegetation have naturalized along the east boundary. HSTL 84-17, c.1906; SS 12/6/11

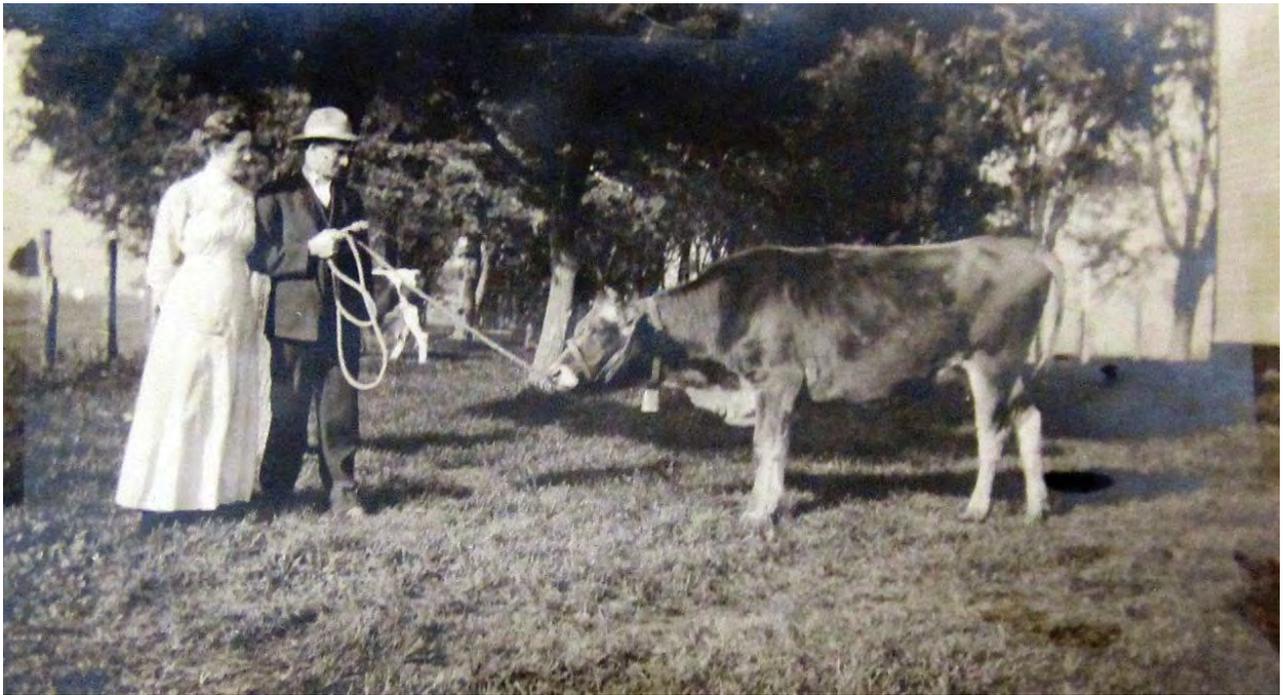
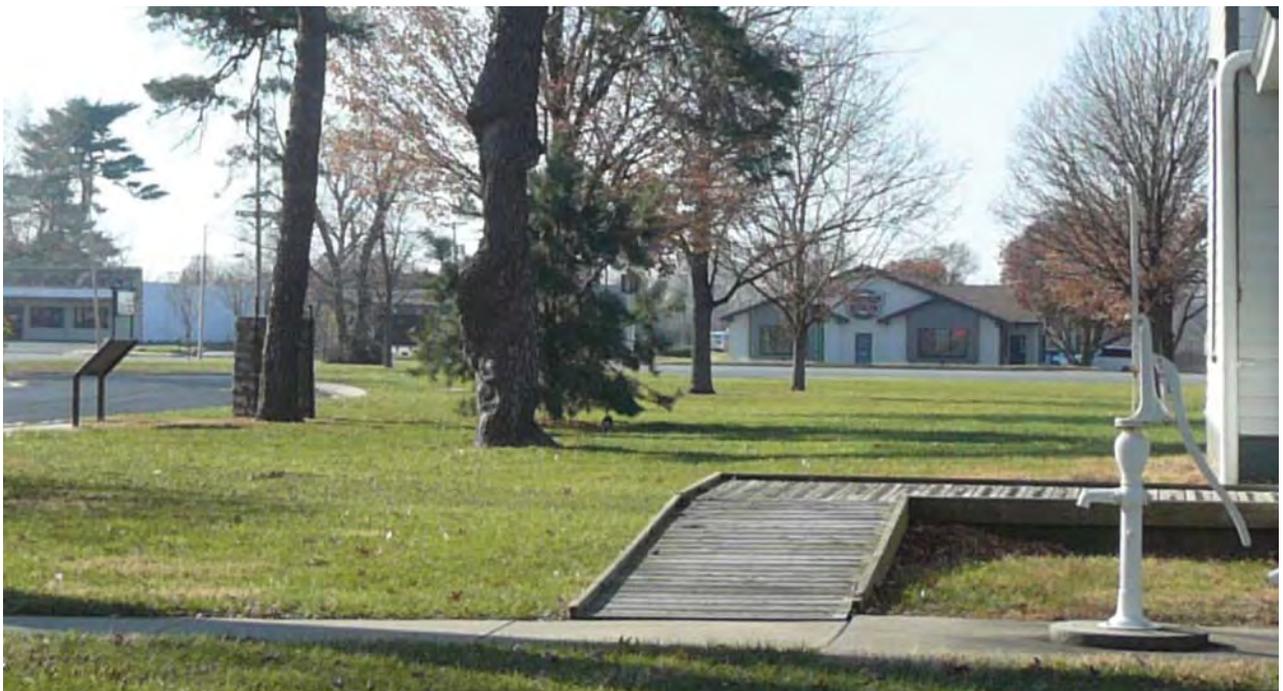
Figure 3-11. The Farm Home yard space remains, defined by the sugar maple grove on the west, Poultry House on the east, and evergreen trees on the south. At the center, is the Farm Home. Missing is the fencing that enclosed the yard. HSTL 72-3594, c.1911; SS 12/6/11

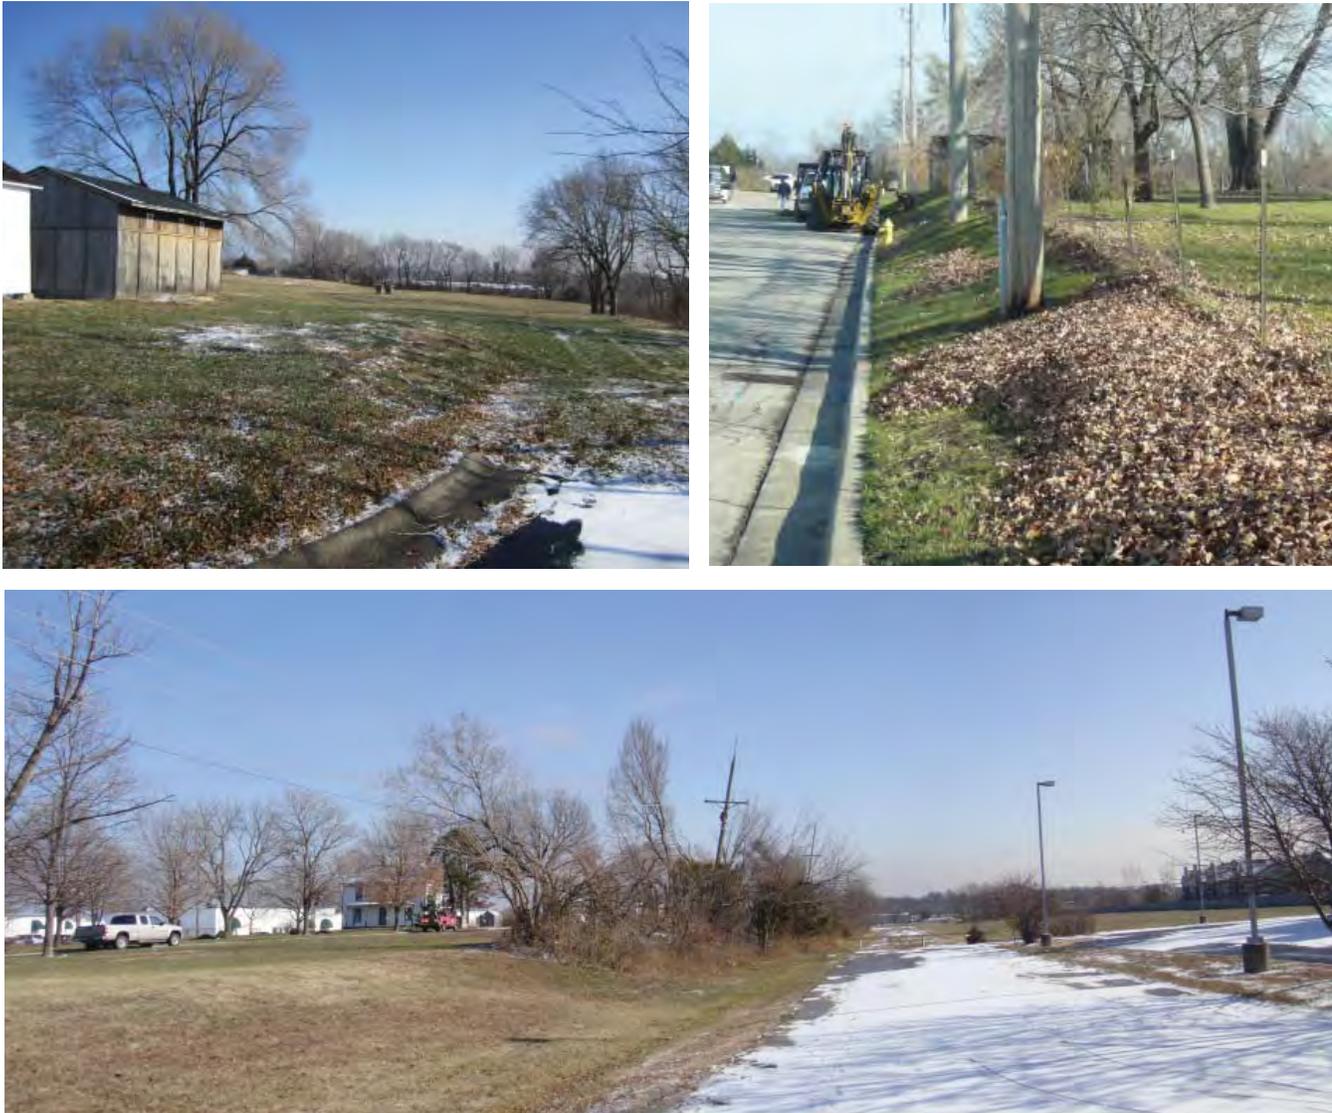
Figure 3-13. A slight roadway trace exists between the parking area and the eastern field (upper left). The north portion of the property is level with its edges sloping down significantly. On the south, this slope connects to the south field. On the north and east, it slopes down to adjacent properties. The slope at the north edge of the site was built in the late 1980s with adjacent commercial development (upper right). A steep slope was built in the late 1950s separating the farm from the future development (bottom). SS 12/6/11

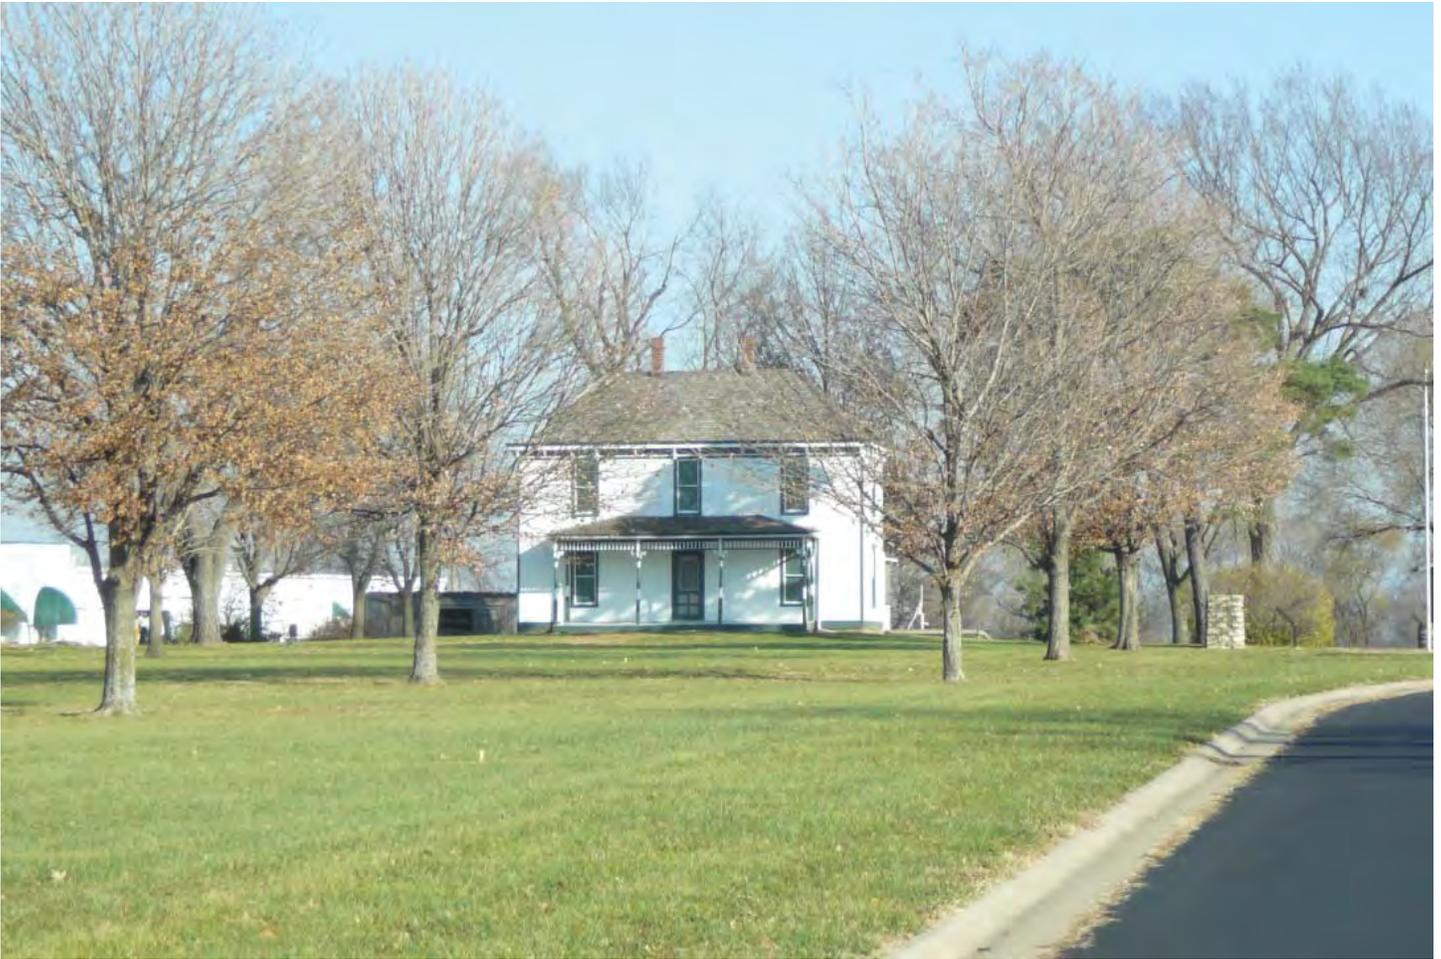
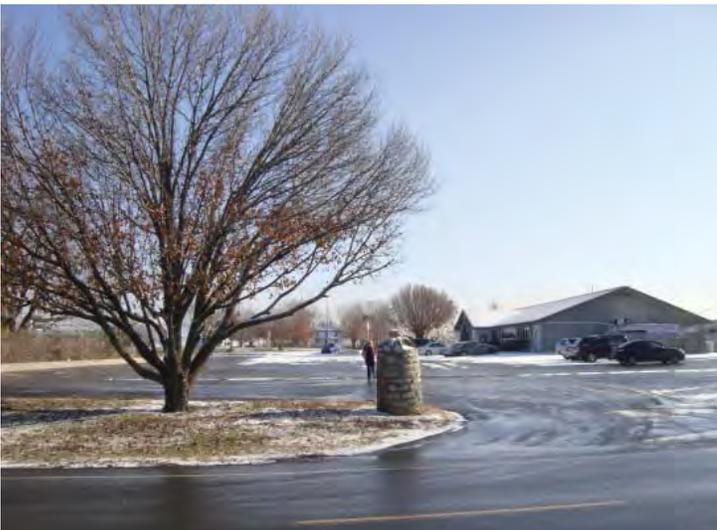
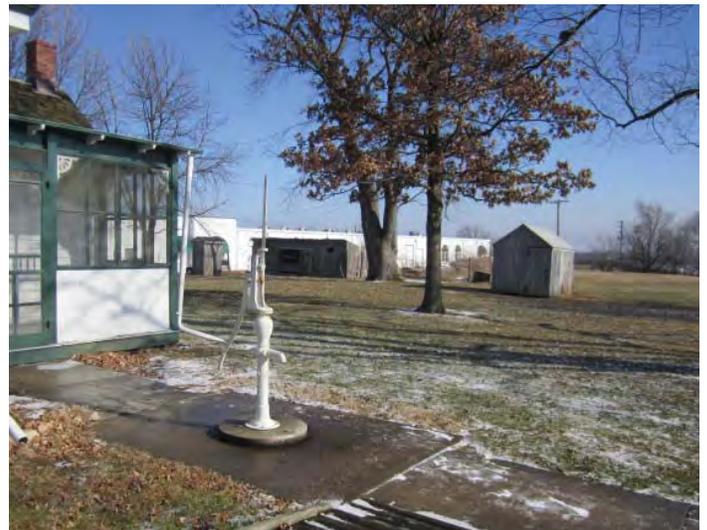
Figure 3-14. The view of the Farm Home from the entrance drive (top) and Grandview Road (bottom left) is similar to how it appeared during the period of significance, however adjacent development and the realignment of the entrance drive have altered portions of the view. The view from the Farm Home and the well and pump historically offered expansive views of the surrounding countryside. Today it retains an openness across the site but views are truncated by adjacent vegetation along the site's perimeter. BN 11/23/11; TB 12/6/11; SS 12/6/11

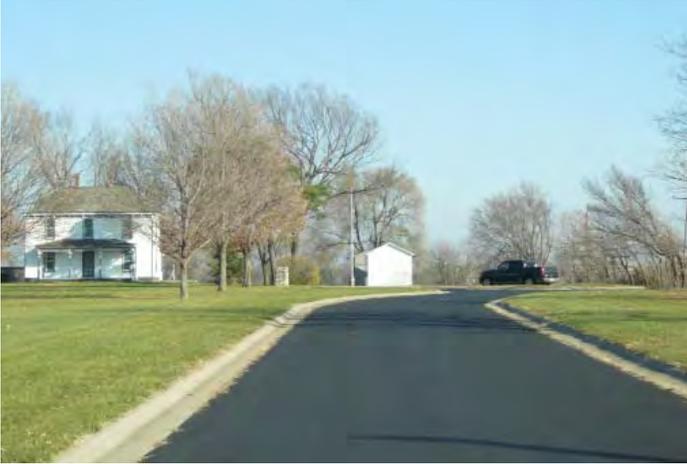
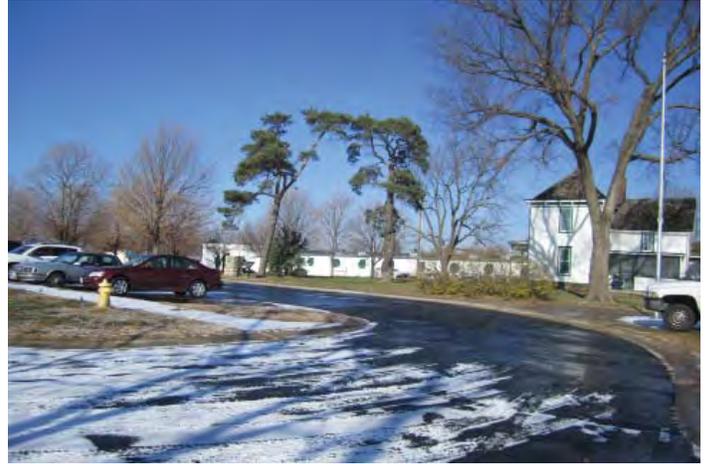
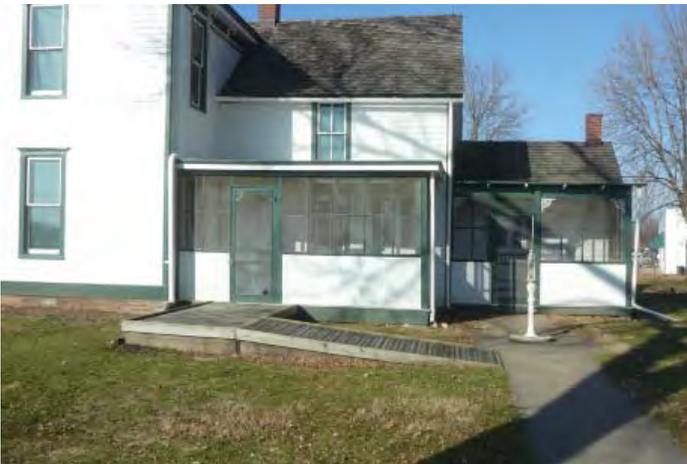
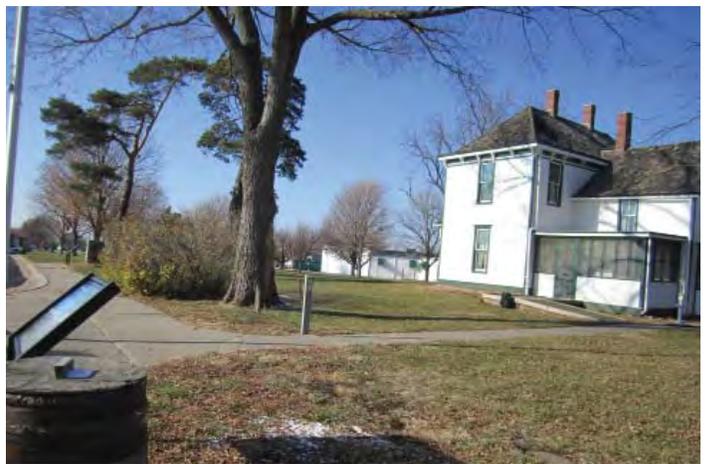
Figure 3-17. Vehicular access to the property is from Blue Ridge Boulevard, via a 20-foot wide asphalt entrance drive that leads to a parking area located just southwest of the Farm Home (top). Concrete paths connect the parking area with the Farm Home. A wood accessible ramp provides access into the Farm Home. SS 12/6/11

entering into the dining room. The ramp is in good condition, as are the concrete paths. The remainder of the pedestrian circulation is informal throughout most of the site and no other developed paths exist.

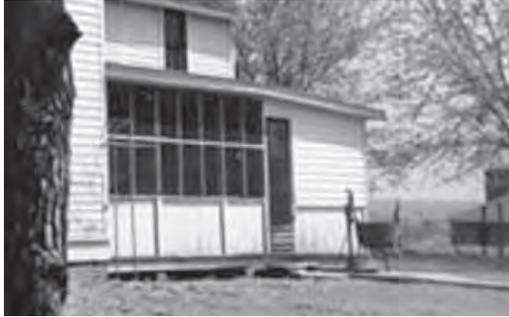
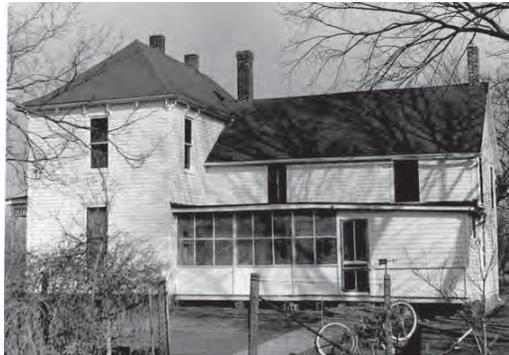
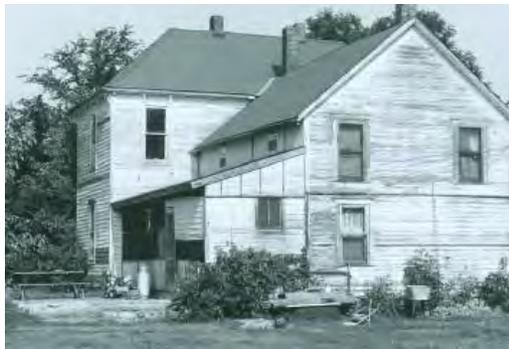
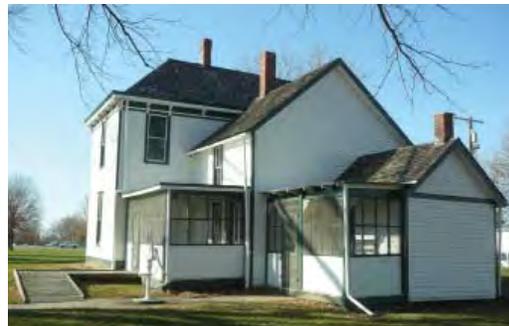
Figure 3-19. Historically, a path connected the Garage to the Farm Home (top). By c.1960, a raised, likely paved, pathway connected the two. Later a concrete pad occurred directly south of the Farm Home (middle photos). The concrete pad is now gone. The path from the parking area to the back door of the Farm Home remains in essentially its historic alignment (bottom). HSTL 029005, c.1940; HSTL 61-66-02, c.1961; Al O'Bright 8/83; SS 12/6/11

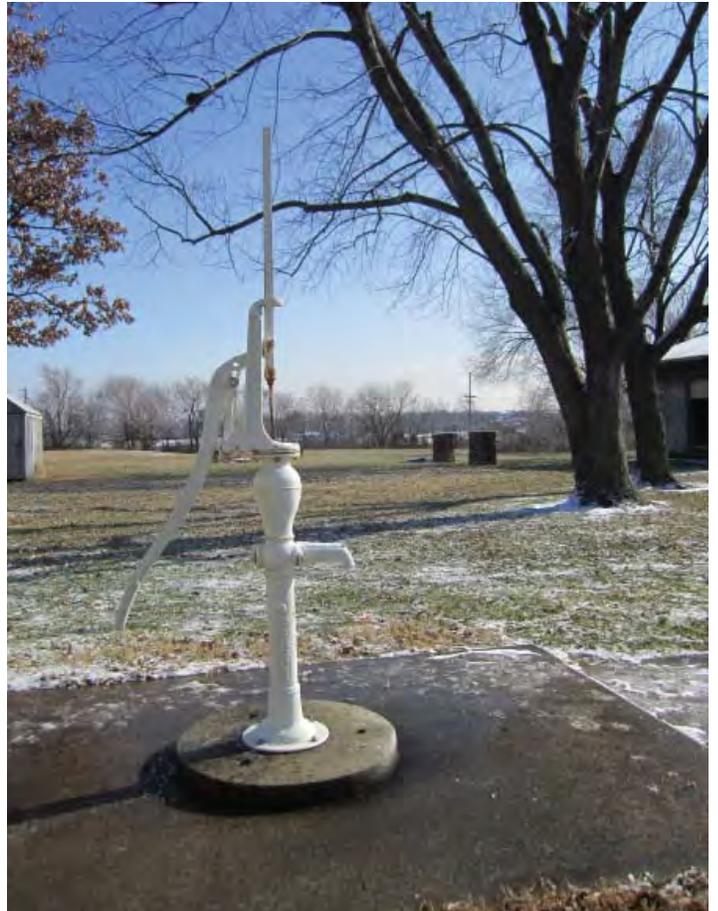
Figure 3-23. The Truman Farm Well and Pump is immediately south of the Farm Home. The pump is not original, is of a slightly different style and faces a different direction from the one that stood in this location historically. SS 12/6/11

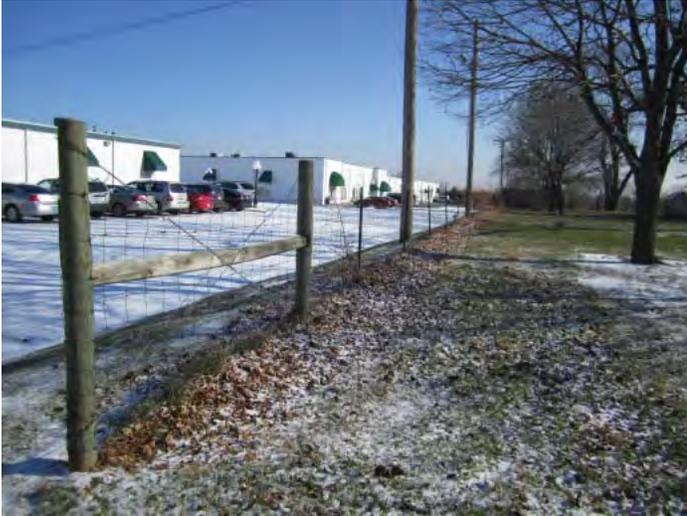
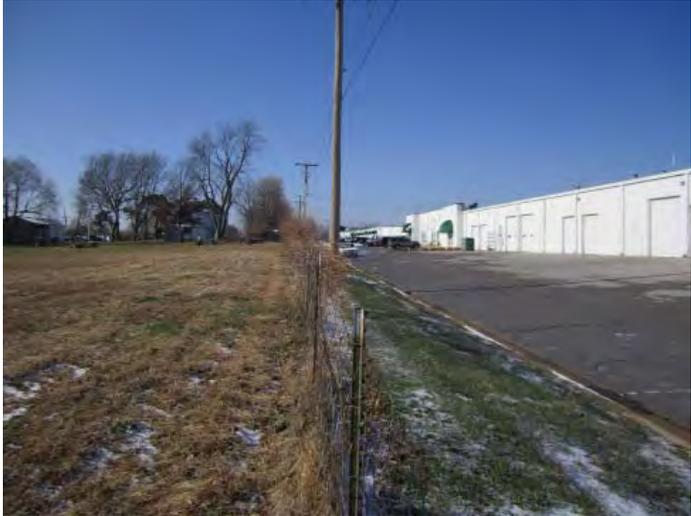
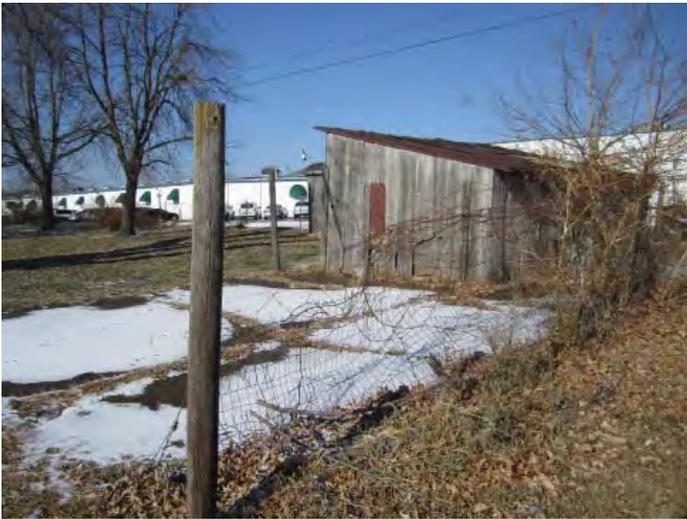
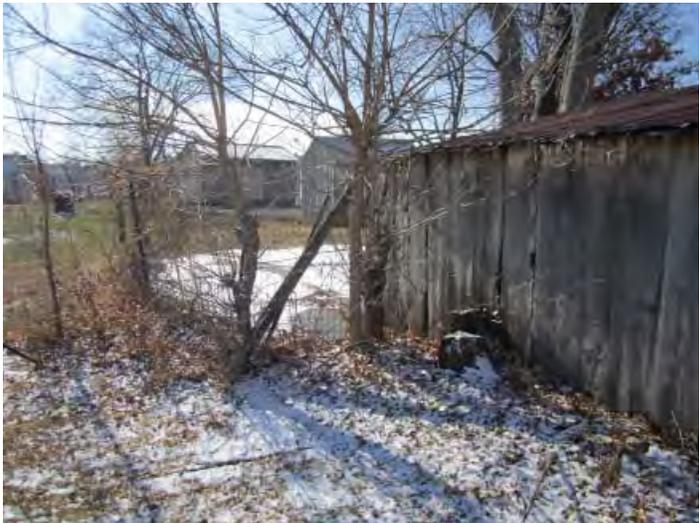
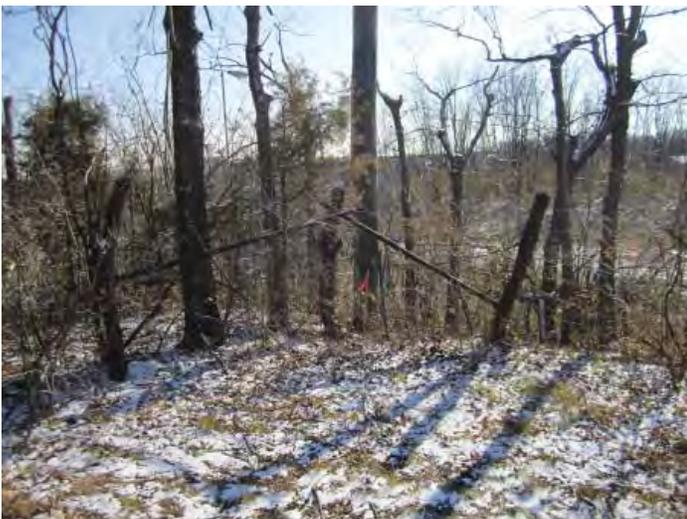
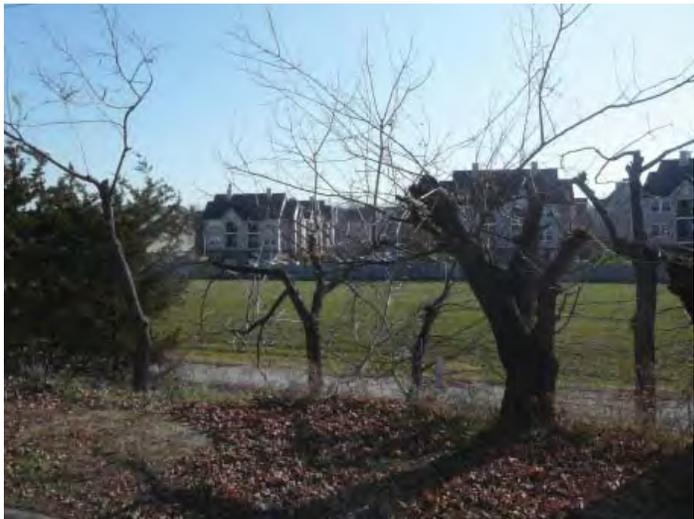
Figure 3-24. Fences enclose three sides of the Truman Farm and include three fence types. A post and wire fence is on the north edge (top), and around the Poultry House (middle); a post, mesh, and barbwire fence occurs at the east and southeast edges (bottom left), and post and barbwire fence at the south edge (bottom right). SS 12/6/11

Fence 1 was installed after the 1994 transfer of property to the NPS. The post and wire fence along the north property boundary separates the farm from the shopping center. The fence is supported by wood posts and rails at the corners and where adjacent to the Poultry House with regularly spaced metal posts in between. The wood posts are 62-inches in height, and the wire mesh fence is approximately 50-inches tall. This fence extends from approximately 130 feet northwest of the Farm Home to the northeast corner of the property for a total length of 625 feet. It is interrupted by the Poultry House as this structure extends across the property boundary for about one foot. The fence is in good condition.

House. This fence is 28-feet long and is supported by two wooden posts, one at the south end, one at the northwest corner. The east end of the fence connects to the Poultry House. Another wood post is located across the concrete pad from the fence with only a set of metal hinges on its west side. This wire fence is of a denser weave than others on the property. In several places it does not reach its full height, likely damaged due to overgrown vegetation. There are three small trees (likely volunteers) at the northeast corner, and they are displacing the wood post. This fence is in poor condition.

Fence 3 is a wood post, wire mesh and barbwire fence that defines the east and southeast boundary of the Truman Farm. This fence is supported by wooden posts at property corners, and has wire mesh at the bottom with barbed wire strands at the top. Metal posts support this fence at regular intervals. Portions have fallen or have been damaged by falling tree branches and dense volunteer overgrown vegetation. The corner posts at the southeast property corner differ from others on site. They are not turned posts, but are untreated, natural wood, reinforced with two metal cross-pipes.

Fence 4 is a post and barbwire fence that occurs between the north portion of the property where the Farm Home is set and the south portion that is a field. It is also overgrown with dense vegetation and portions of it have been damaged. It extends for approximately 470 feet.

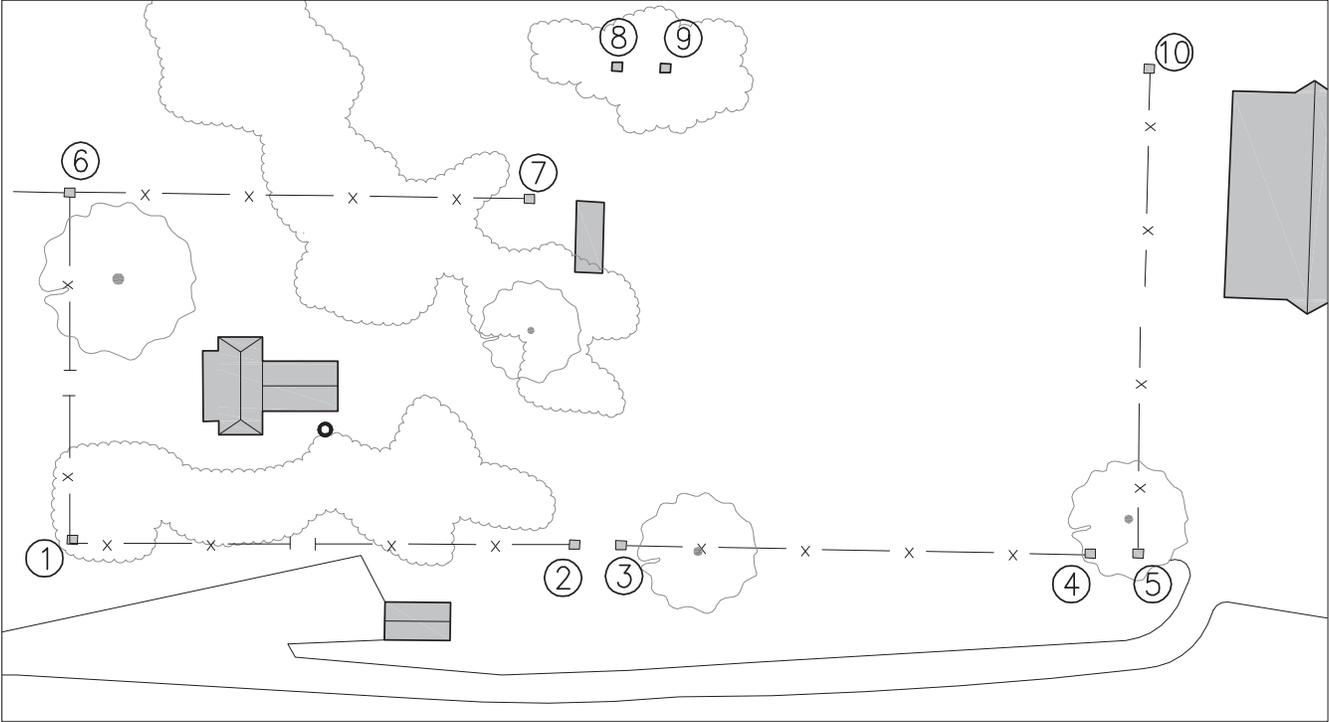
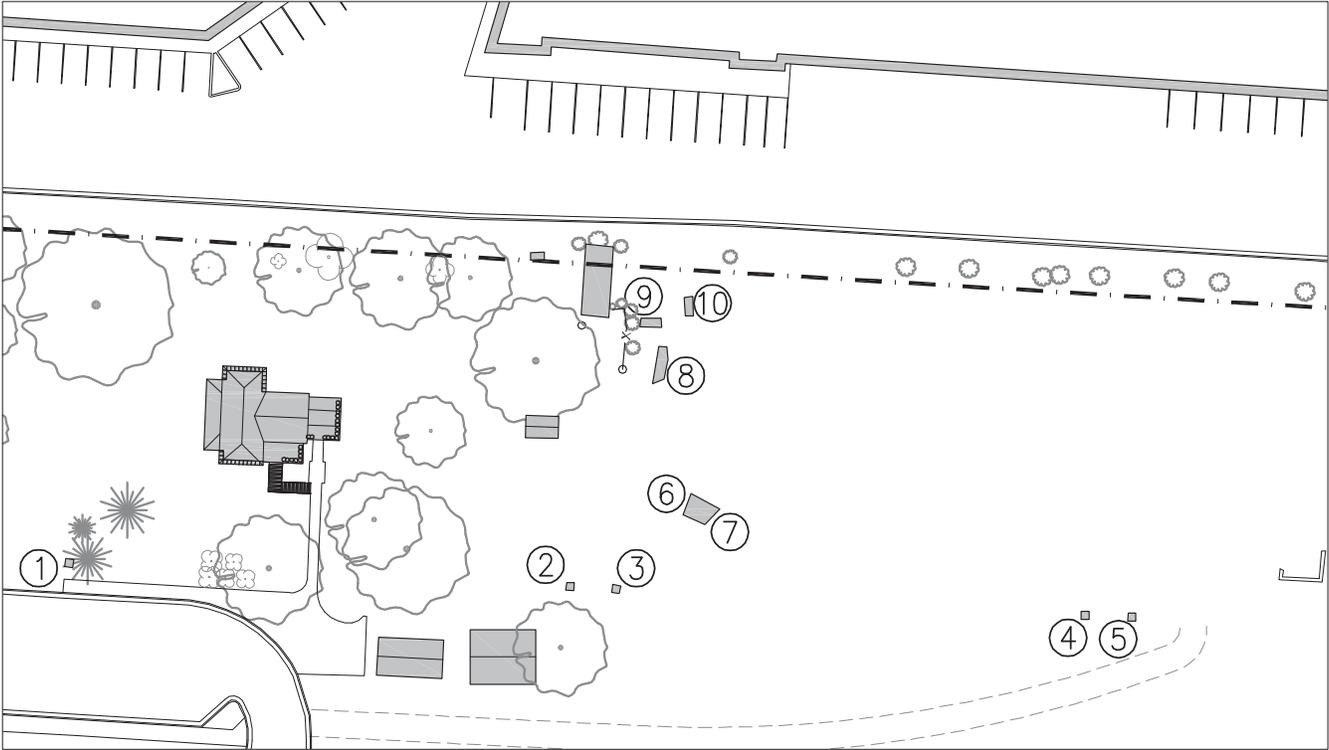
Figure 3-28. The stone posts at the Truman farm likely date from c.1920 to 1930. After the shopping center to the north of the farm was developed in 1987, several of the stone posts (Posts 6 through 10) were removed and placed, on their sides, on the farm property. MBD

Posts 1 to 5 are in their original locations. The other five posts (Posts 6 to 10) were removed during the 1987 construction of the Truman Farm Shopping Center on land that was historically Vivian Truman's farm. These posts were placed in the field east of the Farm Home. Posts 6 through 10 are broken and lying on their sides and it is somewhat difficult to distinguish one post from another. The posts are contributing features of the farm landscape.

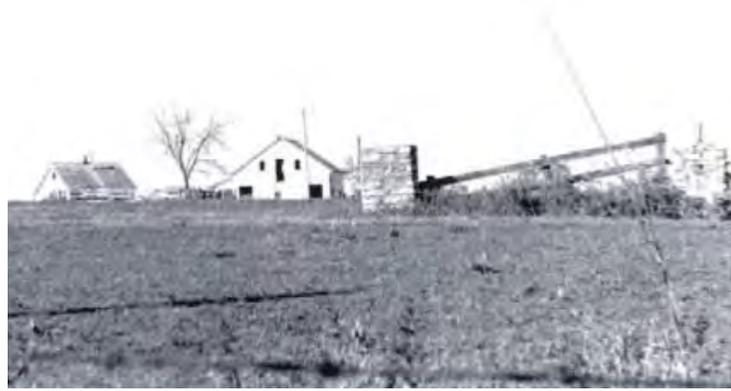
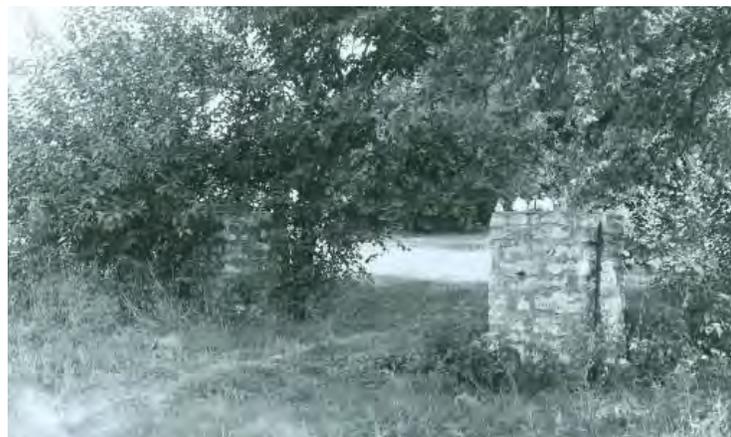
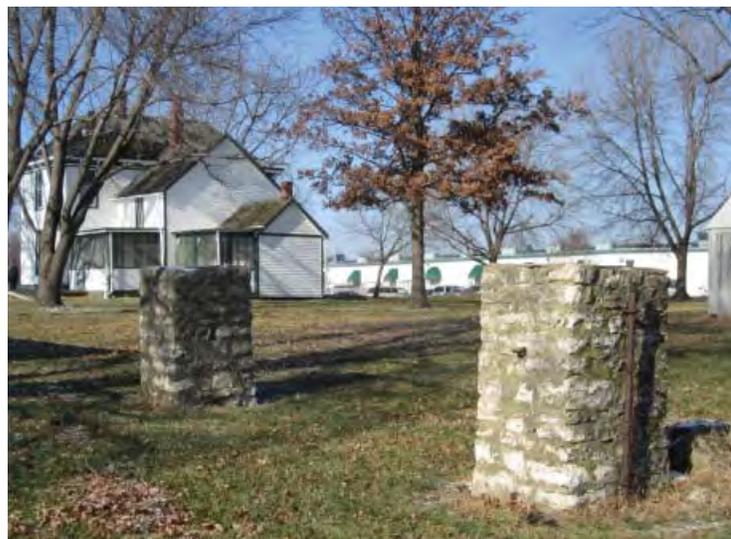
Figure 3-32. The stone posts were placed to anchor the corners of fences which distinguished the Farm Home yard, garden, and barnyard spaces. As farming activities ceased, fences were not maintained and eventually were removed and (Posts 8 and 9, top). After the period of significance, Posts 2 and 3 remained but were obscured by overgrown vegetation (middle). The extant Posts 2 and 3 are a striking component of the cultural landscape but their context and association with fences and the spaces that they denoted has been lost (bottom). Bill Curtis 1974; Al O’Bright 8/83; SS 12/6/11

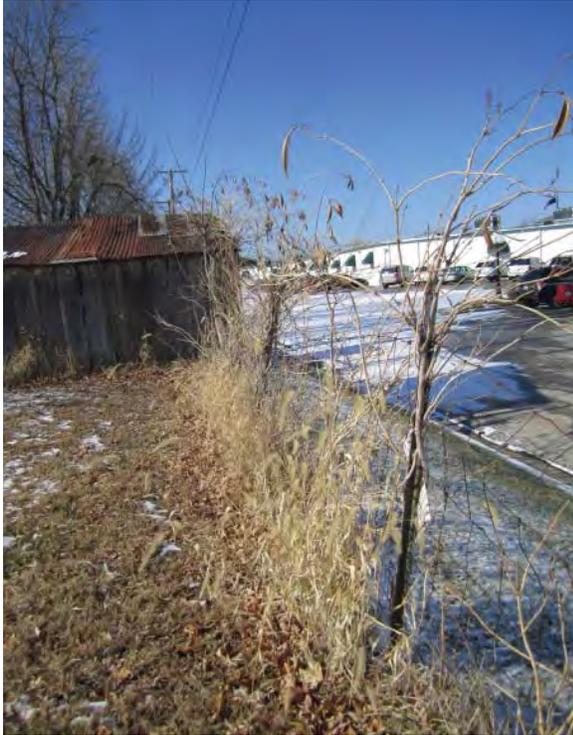
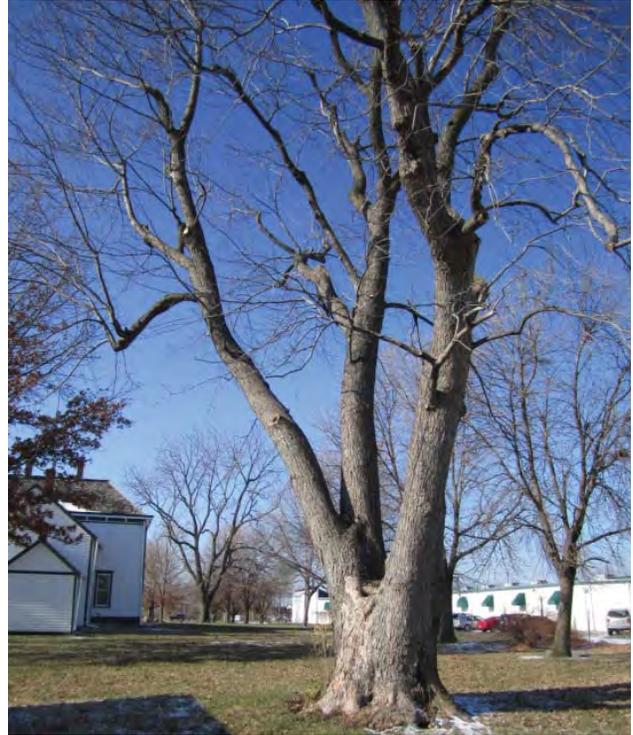
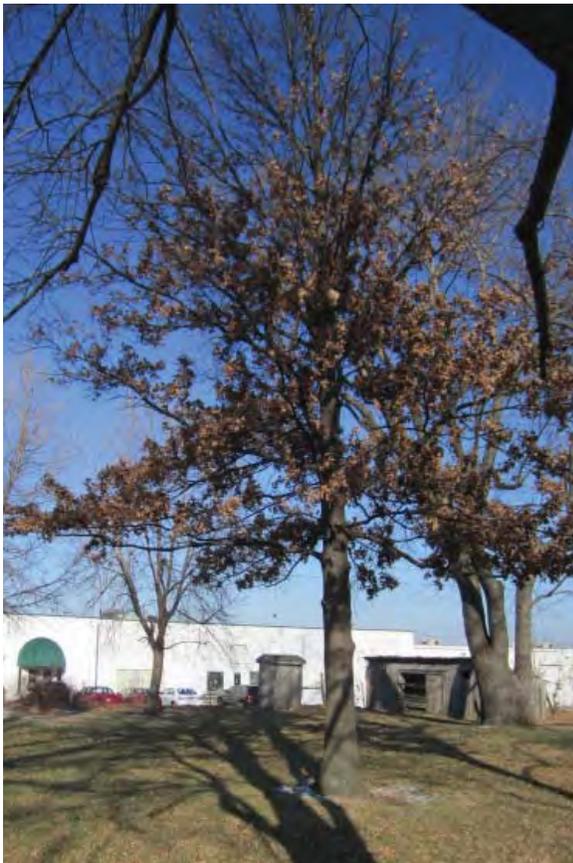
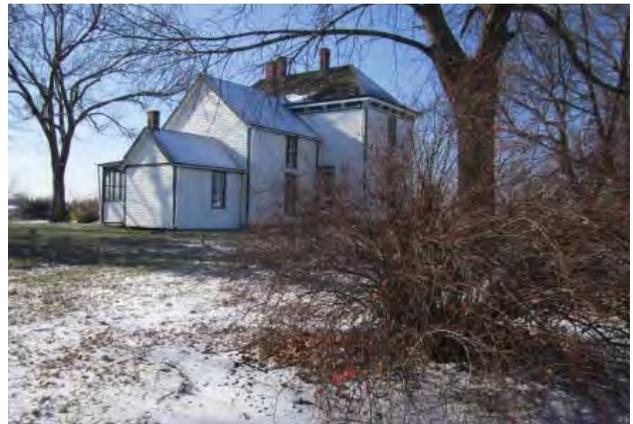
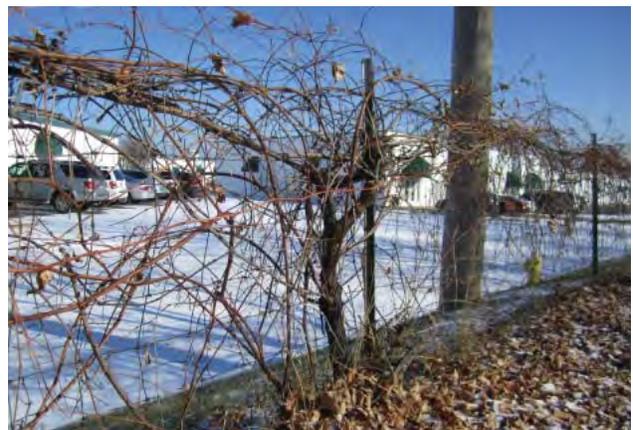
Figure 3-33. Volunteer grasses grow taller along the north boundary fence (upper left). A few trees remain from the period of significance, including a 72" maple (upper right), while the few ornamental plantings include spirea (middle right) and grapevines along the north fence (lower right). A native pin oak is located just behind the Farm Home, planted in 1987 (lower left). SS 12/6/11

The other trees are in fair to poor condition. The 72-inches in diameter maple near the Poultry House, likely established during the period of significance, is in fair condition. A native pin oak is east of the Farm Home, planted by the National Association of Retired Federal Employees in 1987 and is in good condition.
