Harry S Truman National Historic Site Truman Farm

Cultural Landscape Report Historic Structure Report & Environmental Assessment

1, DEZ, 2013

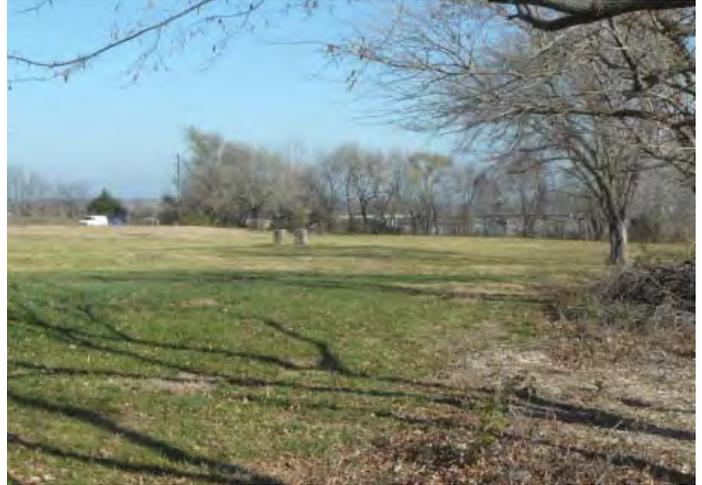
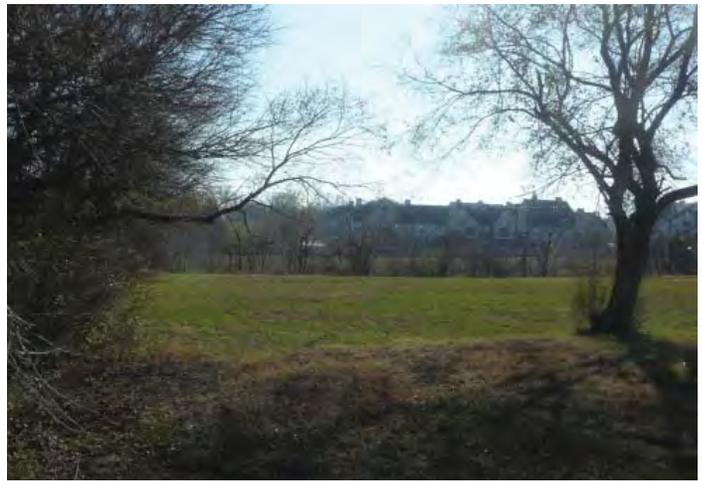
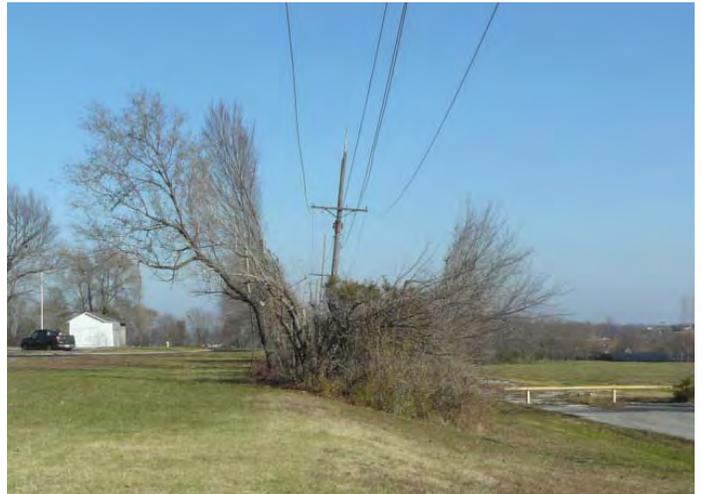
Figure 3-34. Mown lawn covers most of the property. Volunteer vegetation grows along fence lines (top and middle). A thick line of trees that have been extensively pruned to accommodate power lines occur along the fence line between the north and south portions of the property (bottom). SS 12/6/11; BN 11/23/11

Naturalized, volunteer vegetation grows along the east boundary of the property and continues down the slope to Turman Corners. This area is dense with undergrowth and overcrowded tall trees. Along the fence to the south of the Farm Home dense brush is accompanied by a thick line of trees runs east west. These trees have been extensively pruned to accommodate overhead power lines. As a result, these trees are in poor condition.

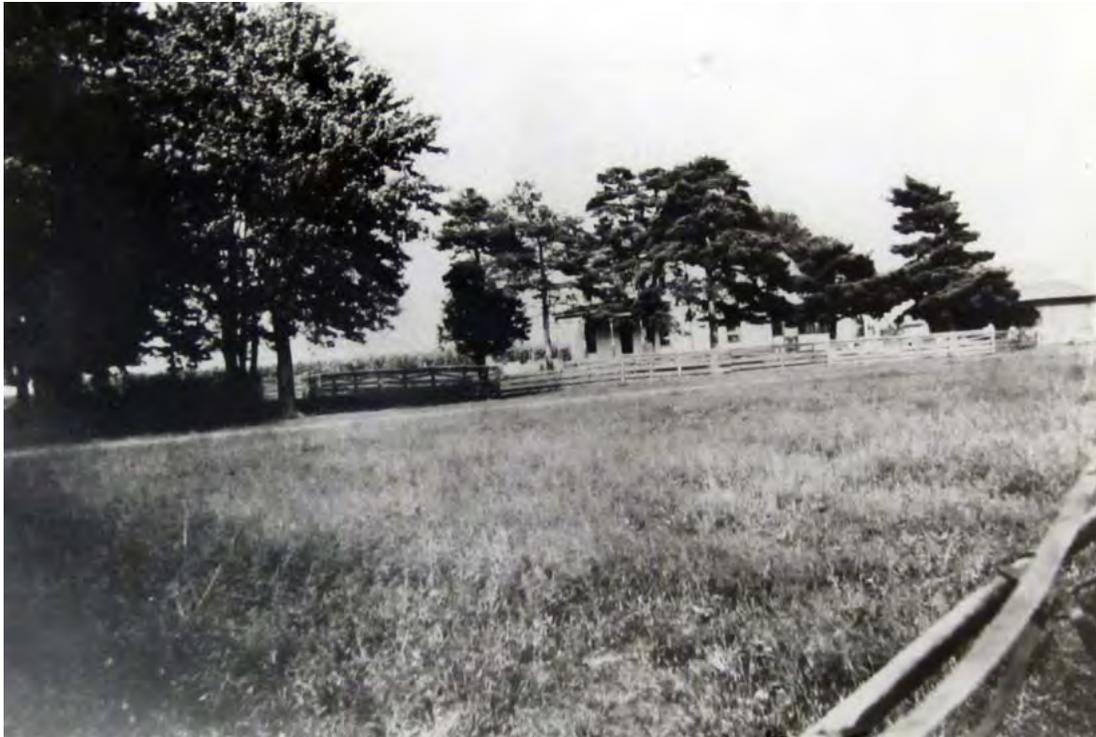
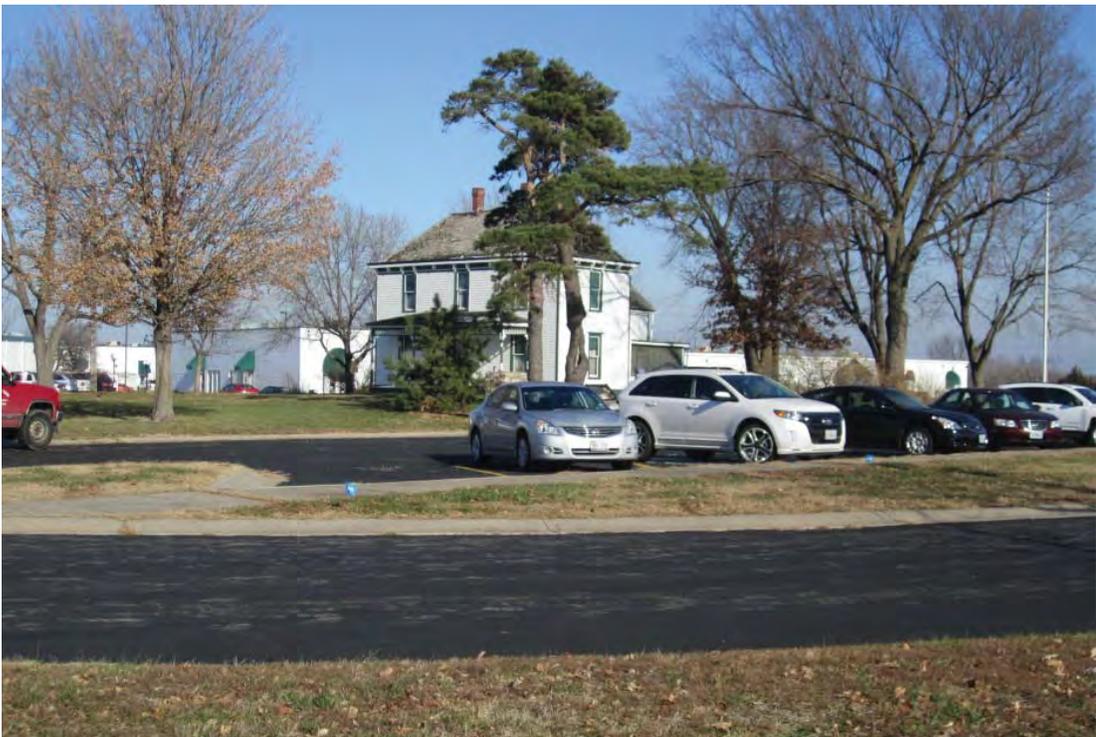
Figure 3-35. During the period of significance, the adjacent land was under agricultural use and the vegetation varied from season to season and mostly consisted of cereal crops and pasture grass, which contrasted with the vegetation planted around the Farm Home - the maple grove and pine trees - which were both northwest and southwest of the Farm Home (top). Today, the agricultural land with its low-growing grasses and crops is gone, while the trees around the Farm Home have been replanted and reflect the historic planting pattern (bottom). HSTL 72-3585, c.1912-1920; SS 12/6/11

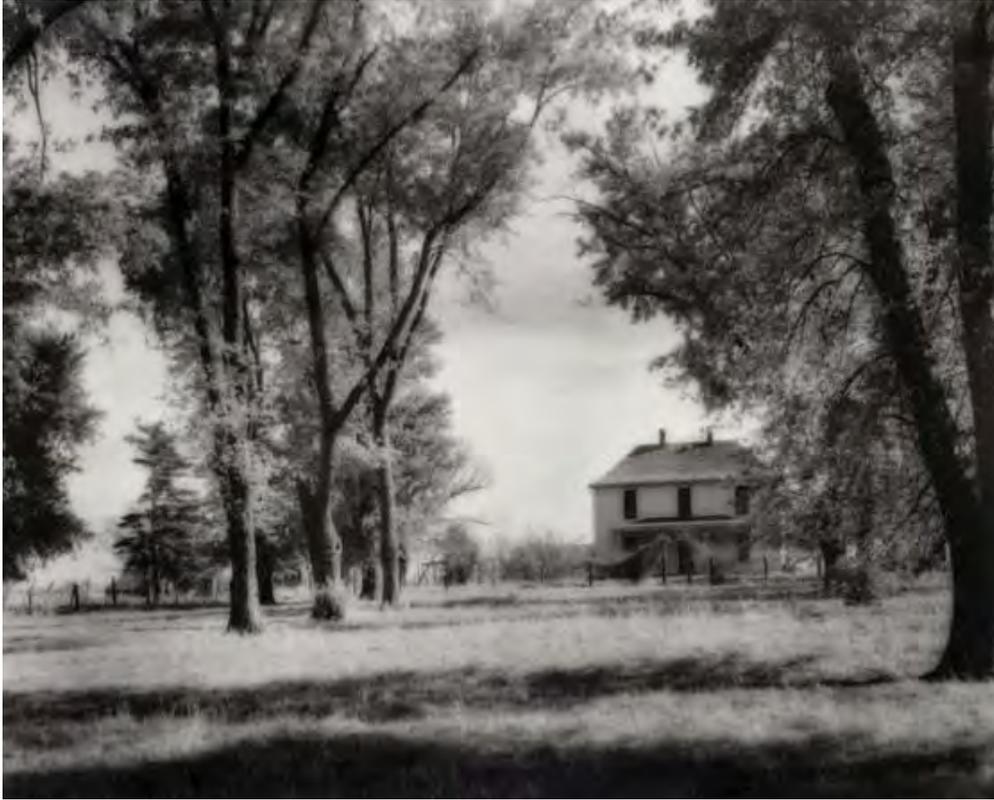
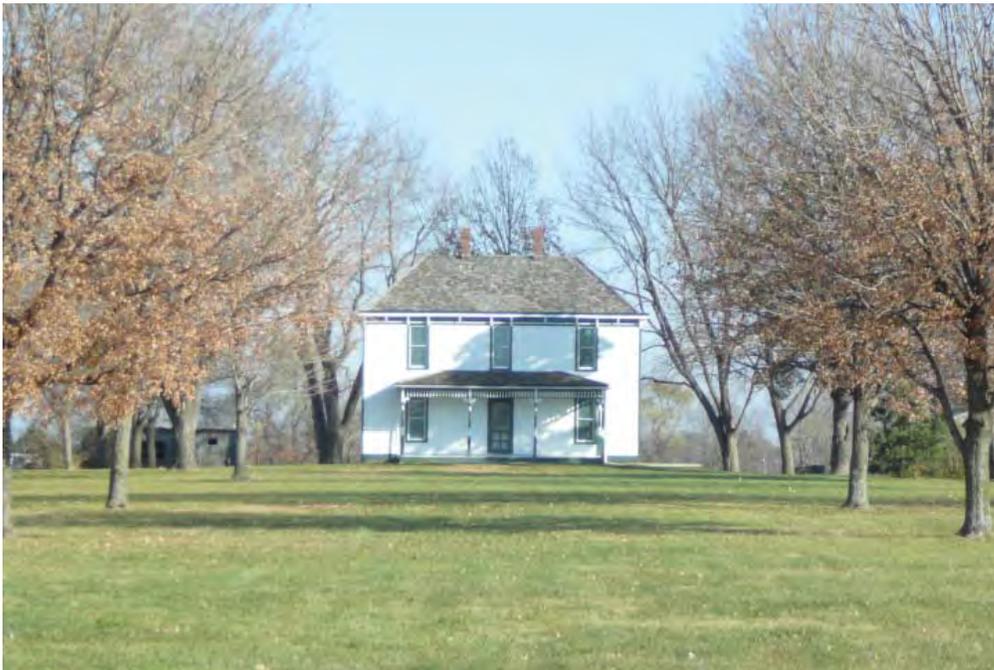
Figure 3-36. In 1867, Solomon Young planted a large sugar maple grove to the west of the Farm Home that extended along the entrance drive to Grandview Road. This grove of trees was destroyed in 1957 by a tornado and was replanted in 1984. Although none of the original maple trees planted by Solomon Young remain, the trees that currently stand resemble the design of the original grove. HSTL 84-9, c.1940; BN 11/23/11

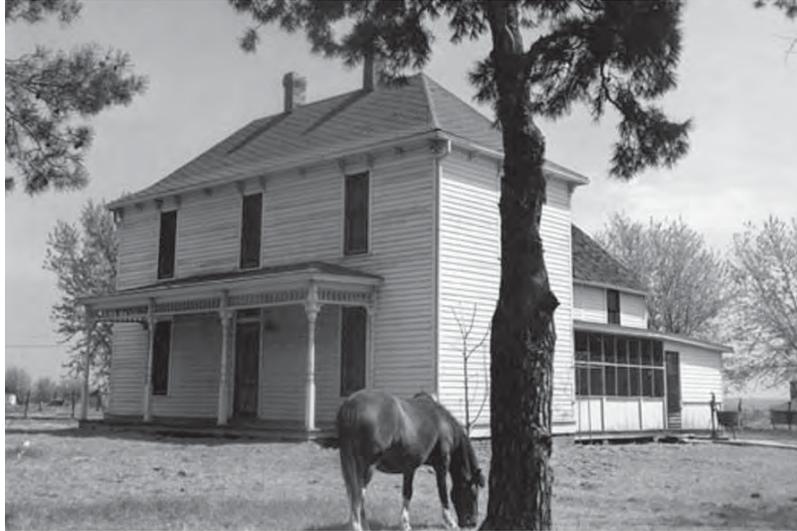
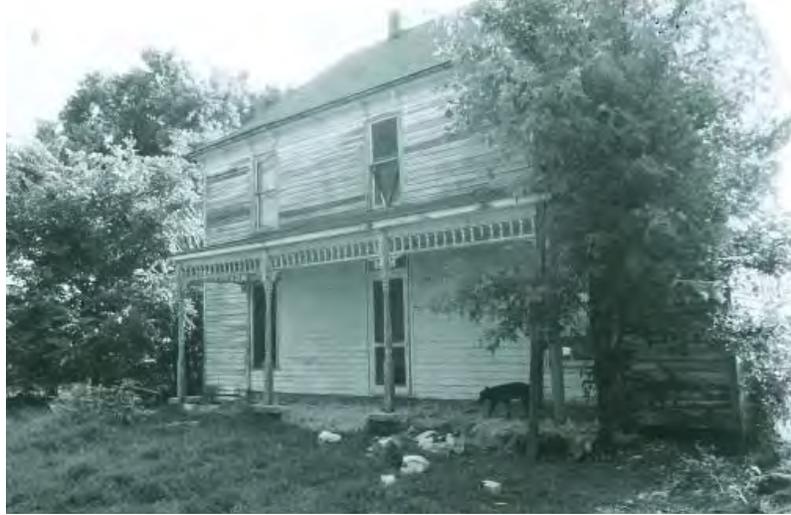
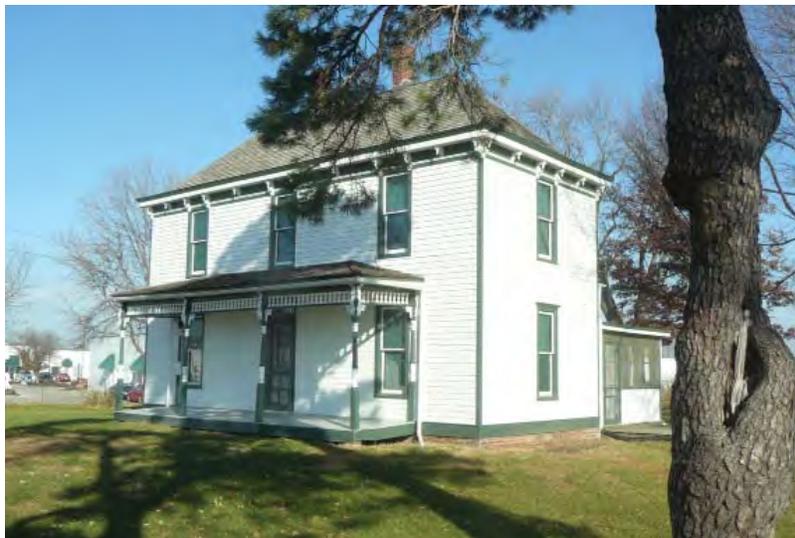
Figure 3-38. The Farm Home yard historically had of short mown grass with few ornamental plantings. Pine trees grew in the front and shade trees grew in the back (top). By the 1980s vegetation was overgrown and enclosed the Farm Home yard (middle). Today the yard is clear of brush and the vegetation more closely resembles the period of significance. HSTL 029005, c.1940; Al O'Bright 8/83; BN 11/23/11

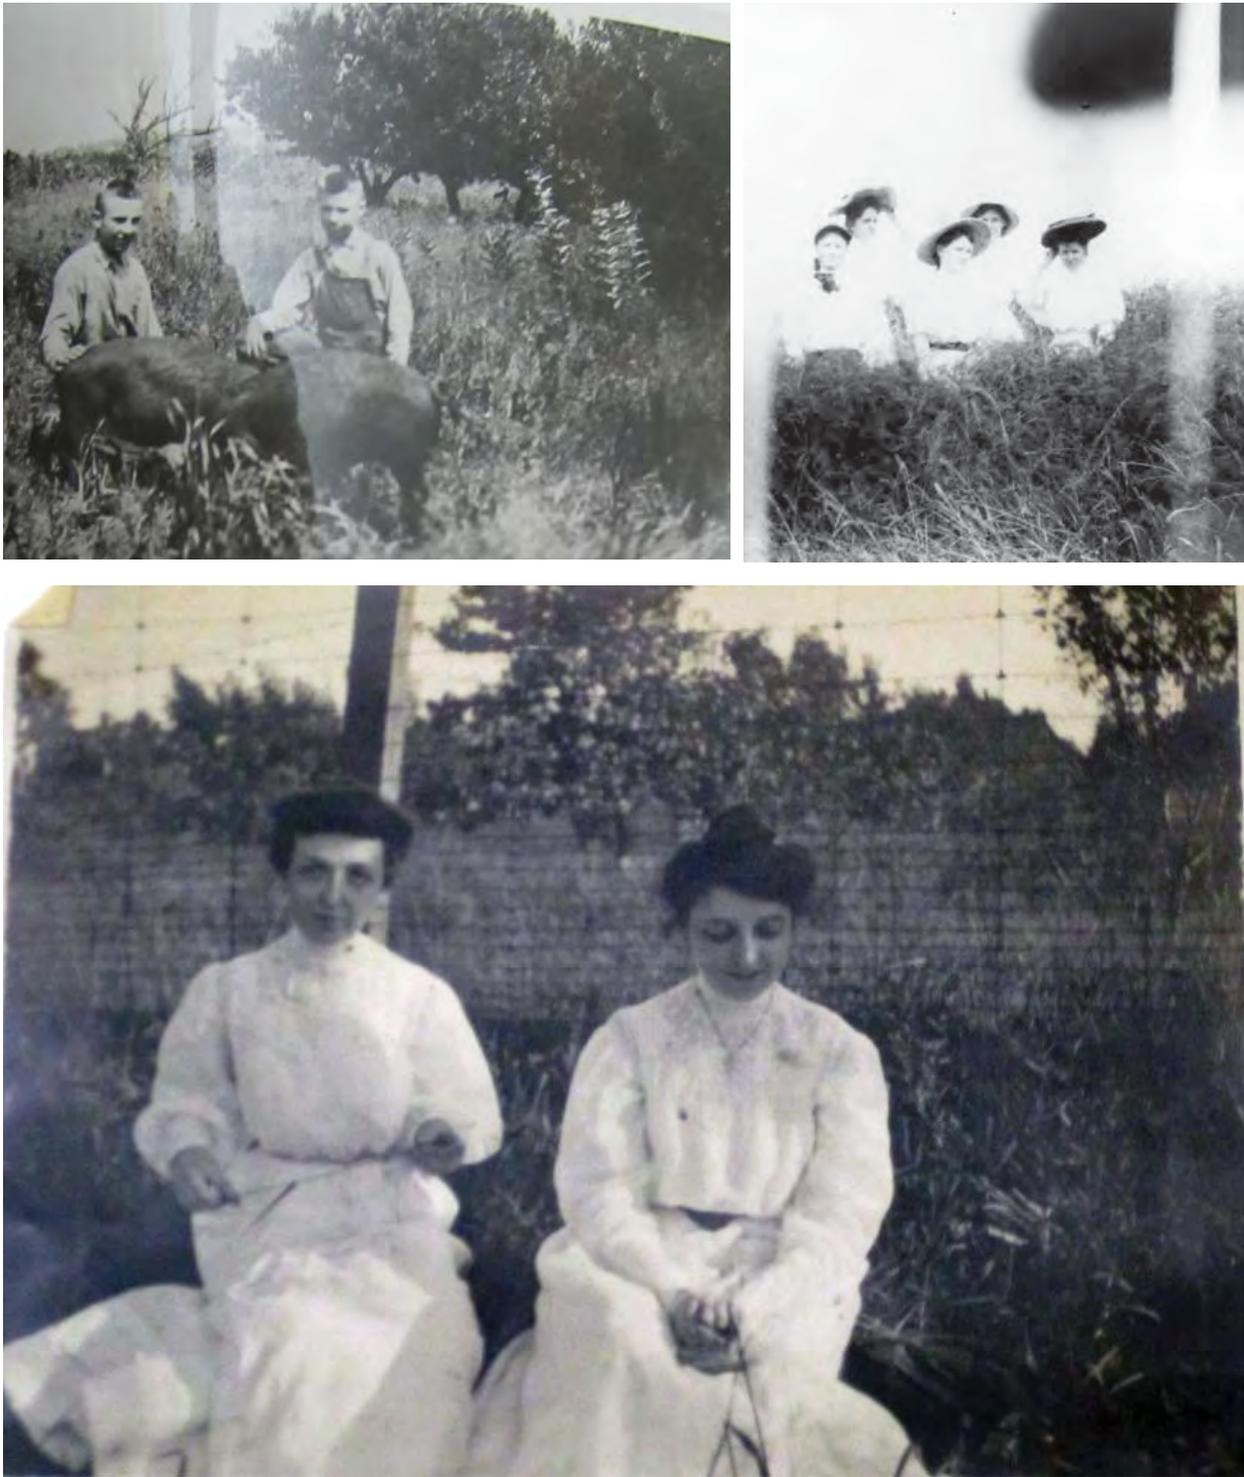
Figure 3-39. A few historic photographs indicate that the garden had an orchard and asparagus patch (top right). The garden was fenced between the Farm Home yard and barnyard. Today, there is no surface evidence of the garden or the orchard. HSTL 62-290, c.1920; HSTL 84-12-10, c.1906; HSTL 72-3577, c.1906

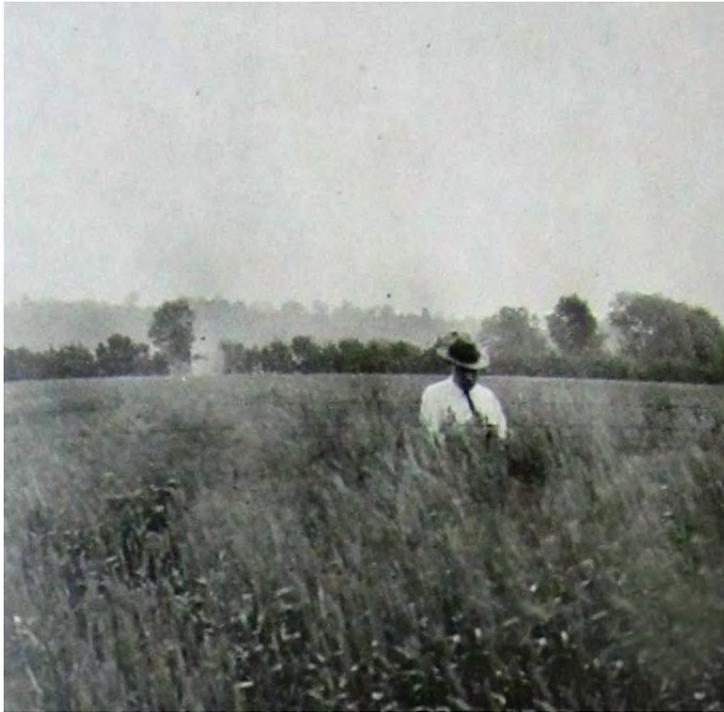
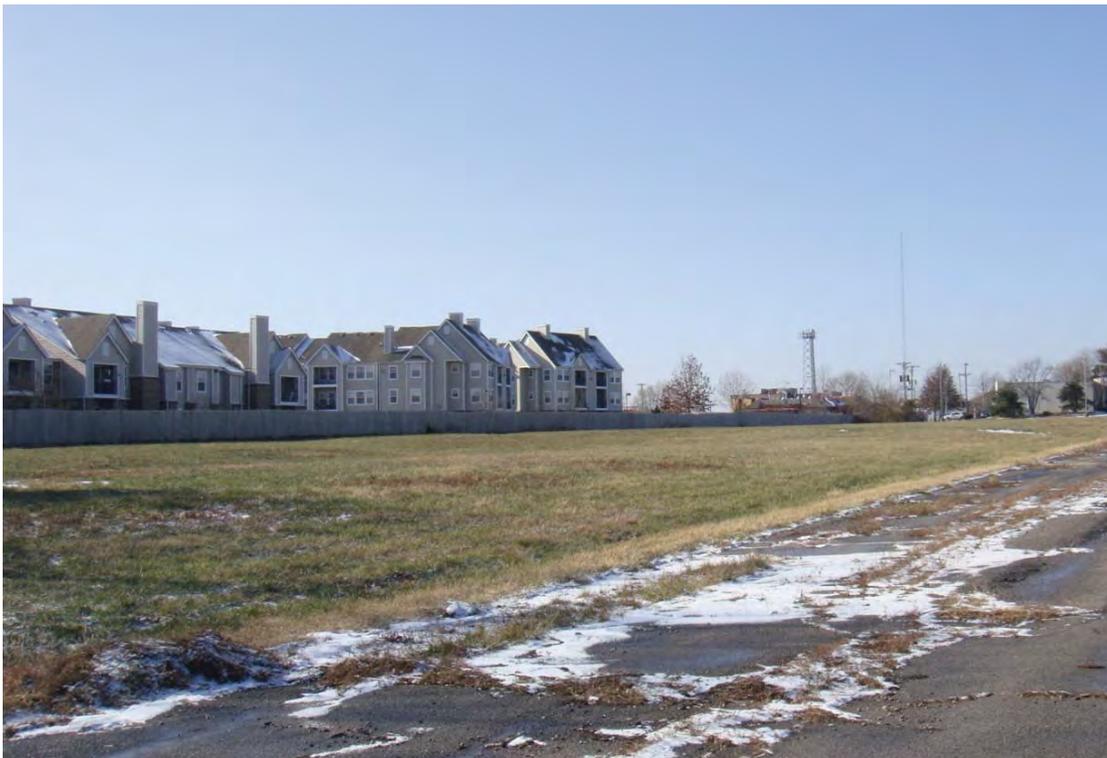
Figure 3-40. Historically, vegetation varied from season to season, mostly consisting of crops such as oats, wheat, corn, clover, as well as pasture grass. Naturalized vegetation likely grew along fences, natural drainages, and roadways. Today, mown lawn covers most of the property, and is similar in appearance to the short crops that once covered the landscape. The seasonality associated with the cropland is no longer apparent. HSTL 62-288, c. 1940; TB 12/6/11

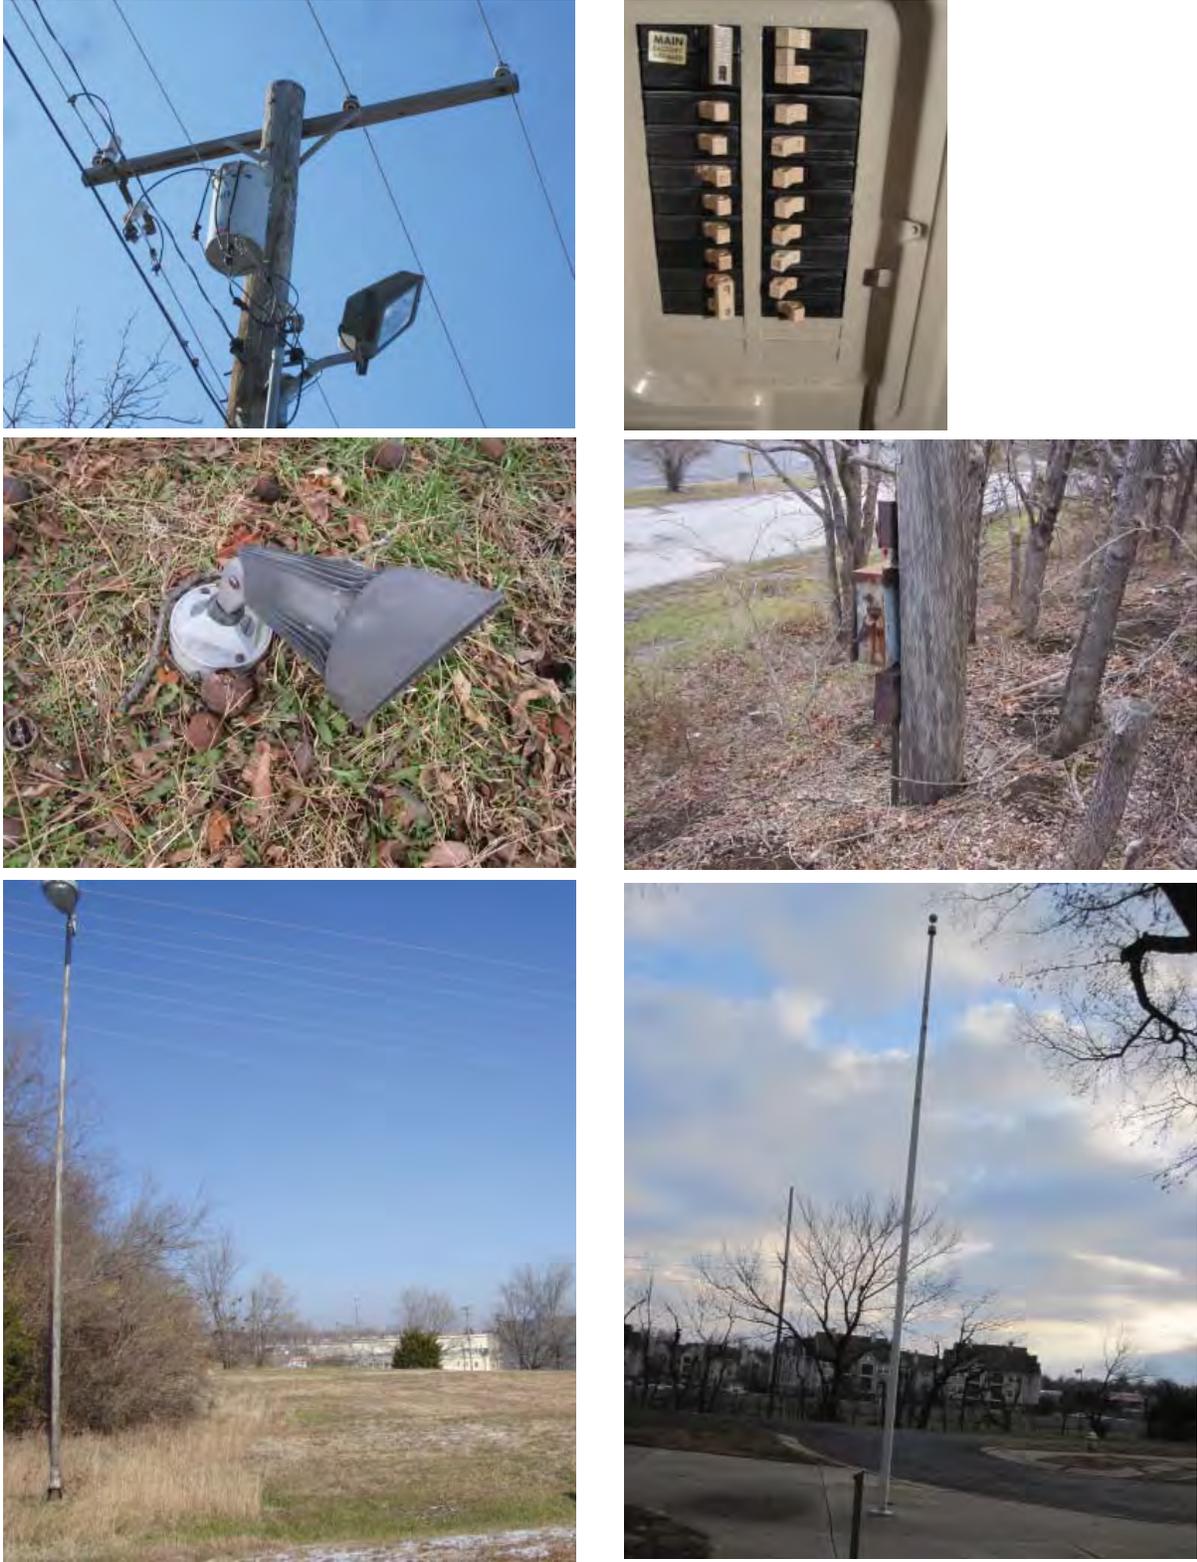
Figure 3-41. Photographs noted the following from top left clockwise to lower right: Existing Pole Mounted Transformer; Existing Main Electrical Panel; Existing Building Floodlight; Existing Abandoned Electrical Service; late 1950s Historic Cobra Head Light; Existing Flagpole. JB 12/6/11; TB 12/6/11

An abandoned rusted electrical exterior disconnect and meter socket located at the base of a utility pole exists between Tract 1 and Tract 3.

Existing electrical infrastructure appears to be sized appropriately for the loads served, and the equipment is in fair condition with another 10 to 15 years of remaining useful life.

The existing photocell that controls the exterior lighting could be removed, and the lighting fixtures could be controlled with a new digital astronomical timeclock that would not require any exterior equipment for control.

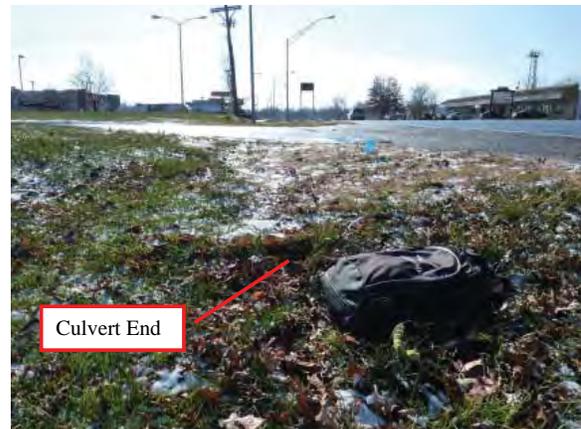
Figure 3-43. Existing culvert beneath the entrance drive at Blue Ridge Boulevard. MT 12/6/11

Poultry House does not have positive drainage in all directions away from its perimeter. The storm culvert beneath the entrance drive is clogged and does not convey stormwater from one side of drive to the other. The following recommendations should be considered for the on-site storm drainage.

The existing drainage culvert located beneath the entrance drive, within the city Right of Way, has not been maintained and is partially buried at both ends. Since the culvert has a limited amount of cover, remediation could include replacement with a new 12-inch Class V reinforced concrete pipe.

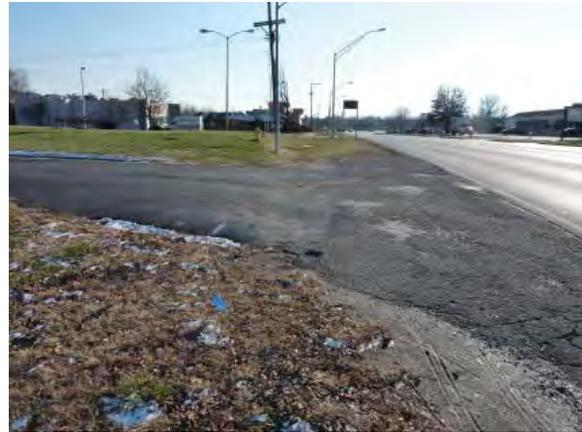
Figure 3-44. Entrance drive at Blue Ridge Boulevard. MT 12/6/11

The existing entrance drive, is in poor condition and is showing signs of severe deterioration. Existing concrete sidewalks are in good to moderate condition. The 1950s roadway is also in a poor condition with multiple areas that have degraded over time, exposing the top course and sub-grade materials. Asphalt and concrete within Tract 3 is also in poor condition. Most of the parking area is displaying alligator cracking and severe spalling near the building entrance.

The entrance drive has wide cracks and alligator cracking along most areas which indicates poor sub-grade preparation. If this drive remains, the asphalt will need to be fully removed and replaced, and consultations with a geotechnical engineer will be necessary for proper reconditioning of the sub-grade along with a new asphalt design section. If this paving were to be removed, consultation with a geotechnical engineer will be needed for best practices in protecting the below-grade geothermal system.

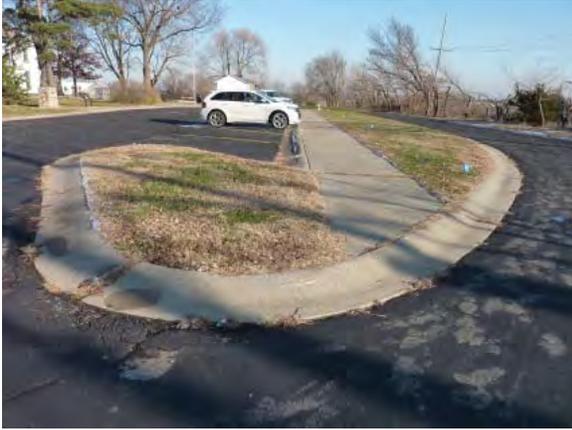
The parking area and drive aisle shed stormwater to the east toward a grassed area. This grassy area drains south over a steep hill into the south field. Higher velocity flows down this hill are eroding the hillside. If the parking area were to remain, water quality measures and erosion control would be necessary and would likely negatively impact the historic setting and topography. A small water quality pond near the east end of the drive could be considered with a small release outlet and installation of riprap armoring down the hillside to mitigate additional erosion. If this parking area was removed, these measures would not be required.

Figure 3-47. Parking area. MT 12/6/11

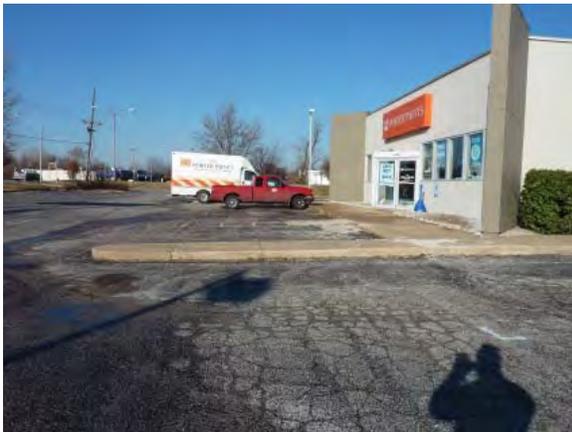
Figure 3-48. Parking area in Tract 3. MT 12/6/11

If Tract 3 becomes new park facilities, the asphalt parking and concrete sidewalks should be fully replaced as they are in poor condition. The sidewalks exhibit severe spalling and deterioration.

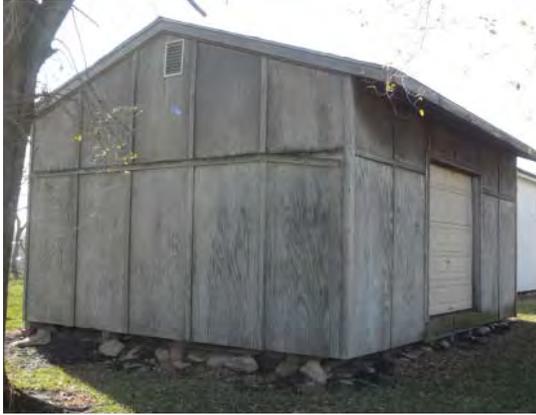
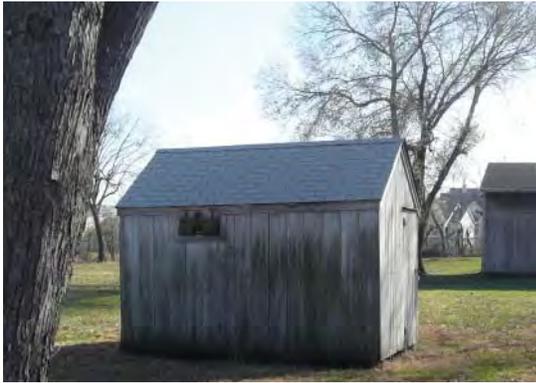
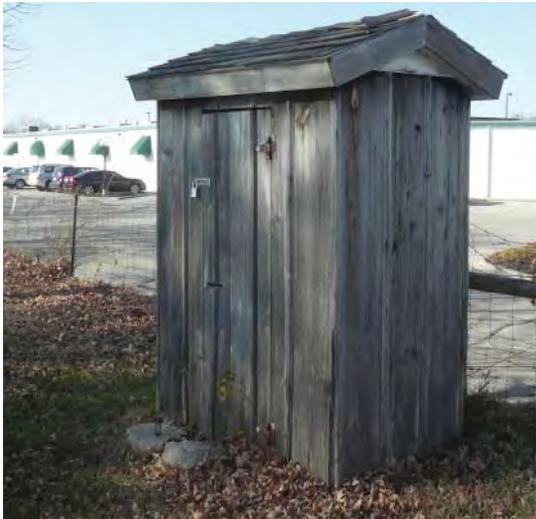
Figure 3-50: Three non-contributing structures exist on the Truman Farm. The maintenance shed was added by the NPS in 1995 (top). The smokehouse was moved to the Truman Farm by the Truman Farm Home Foundation in 1985 (middle), and the outhouse was placed on the property c.1985 (bottom). SS 12/6/11

The shed is in good condition. It is not a historic structure and its presence detracts from the historic setting. The shed is to be removed once storage for maintenance equipment is provided at Tract 3 or an alternate facility.

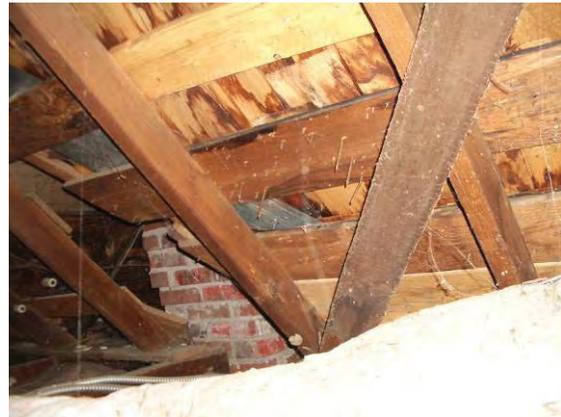
From the underside of the attic it was determined that the sheathing consists of 1 x 6 boards with approximately 3" spacing with the exception of +/- 2' from the eave which is newer solid sheathing. The spaced sheathing indicates that wood shingles were the original roofing and is consistent with historic photographs. Park records indicate that the original roof remained the base layer for succeeding roofs until 1984 when it was all removed along with three layers of subsequent composition shingle above it.

Figure 3-55: Underside of the roof, as viewed from the attic, EMH 12/6/11

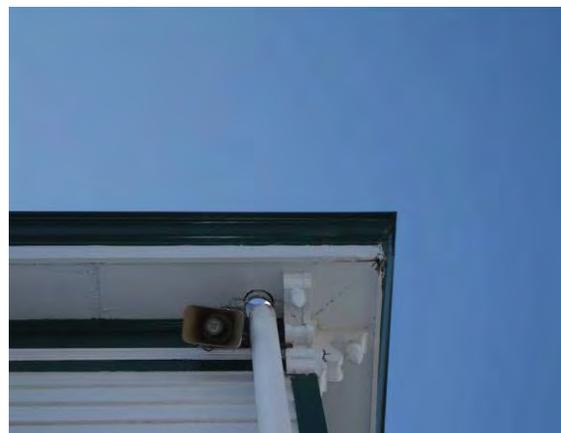
The gutter of the main roof consists of a newer stainless steel integral gutter c. 1984. This system drains to two 4" round downspouts on the east side – at the north and south ends, each with a 10' extension at grade. The north downspout is currently disconnected at the top.

Figure 3-56: Detached north downspout , EMH 12/6/11

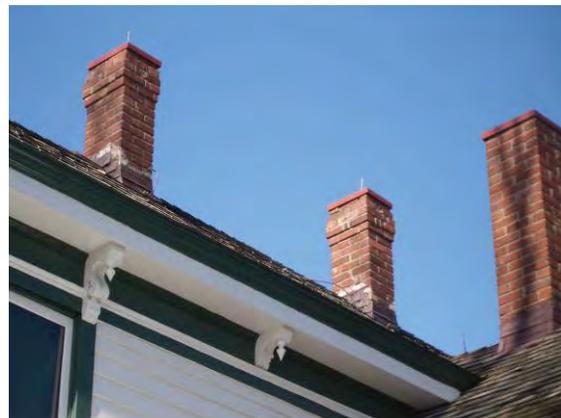
There are four red brick running bond chimneys on the house; two at the west wing of the house with corbelled detailing at the upper portion, one at the two-story central wing and one newer chimney at the east wing. All have newer prefinished red caps and all have prefinished brown stepped flashing at the roof intersections. The two chimneys at the west wing roof and the one chimney on the central wing are connected to the lightning protection system. There is minor face of brick spalls at the corbelled coursing of the two west wing chimneys.

Figure 3-59: Chimneys, as viewed looking northeast, EMH 12/6/11

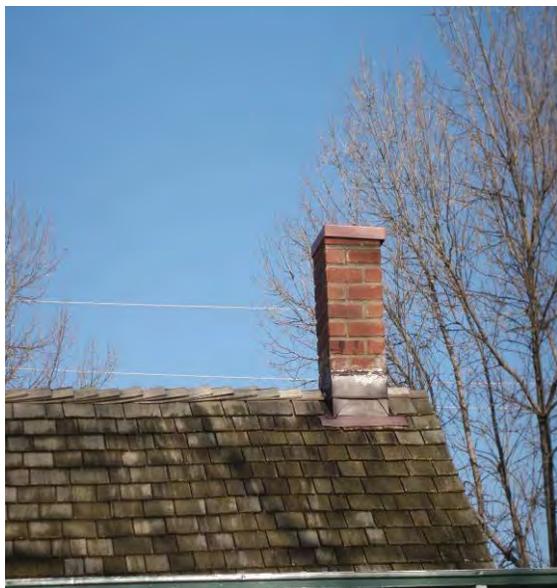
The east wing chimney is currently in a different location (offset of the main east ridge) than can be seen in the historic photograph below, c. 1935, when the east chimney aligned with the ridge.

The 12"x 12" exterior dimensions also indicate it was rebuilt inaccurately because the interior allowable fire area would be virtually non-functional historically.

Figure 3-61: East chimney existing location, EMH 12/6/11

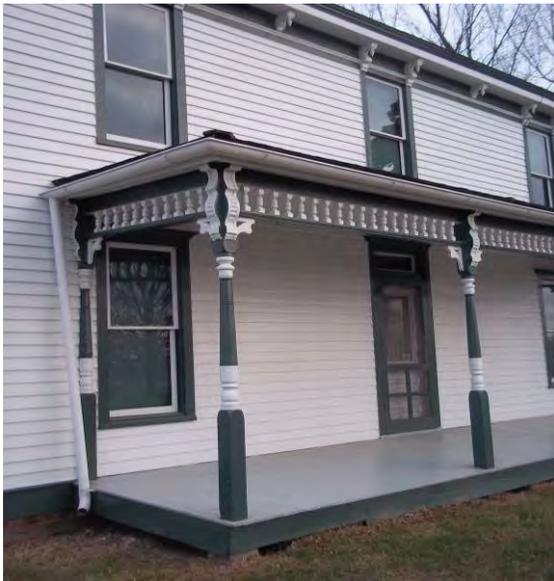
The front porch has a hipped roof and is open. It is approximately 13” above grade with no steps. The existing porch framing and flooring was replaced between 1994 and 2009, per park records. The porch is supported by six wood turned posts, the western four of which have been replaced. The 1984 work indicated that the porch was shored up, so it is possible the roof framing is original. The smaller spindle and bracket work below the porch eave was also reported to have been replaced in 1984.

Figure 3-62: Front porch, ABA 12/6/11

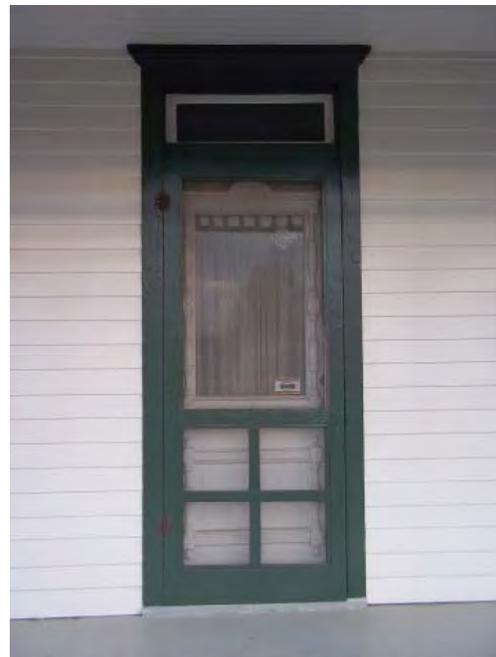
West Wing: The entry screen door is 2'-10" x 6'-11" (door 101A), half-lite screen over four equal screen panels. The wood frame and 1 x 4 trim are painted. Hardware consists of a spring closer and two surface mounted hinges. There is no handle on the exterior. The door does not match any of the historic photos and appears to be a recent construction. The screen door style varied as per historic documents and photographs.

Figure 3-70: West entry screen door 101A, main door 101 and transom, NAA 12/6/11

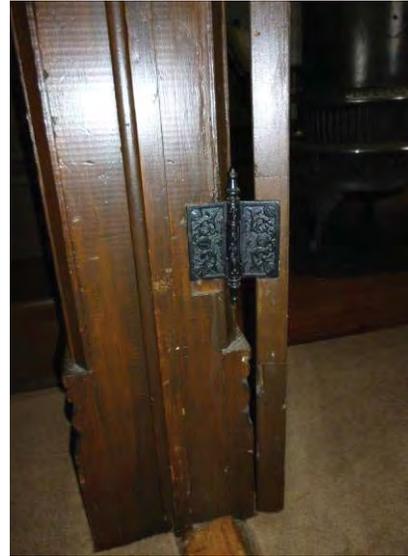
Figure 3-78: West wing trim profile, ABA 12/6/11

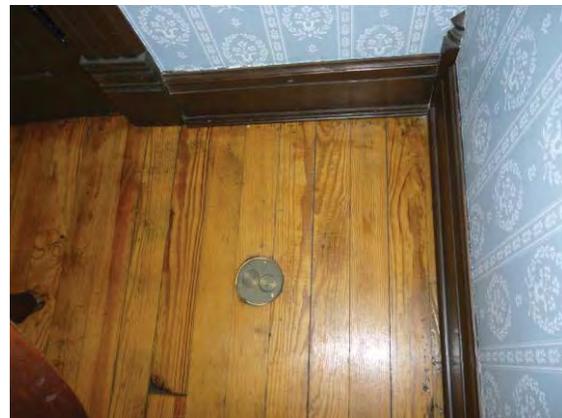
Figure 3-79: West wing room 103 base trim and floor, ABA 12/6/11

West Wing: The flooring in this portion of the Farm Home is 3-3 ¼" wide varnished wood tongue and groove, laid running north-south. The floor is continuous through the closets and to the main stair. Most of this portion of the Farm Home has a carpet runner protecting the wood floors. (See figure 3-79: West wing room 103 base trim and floor.)

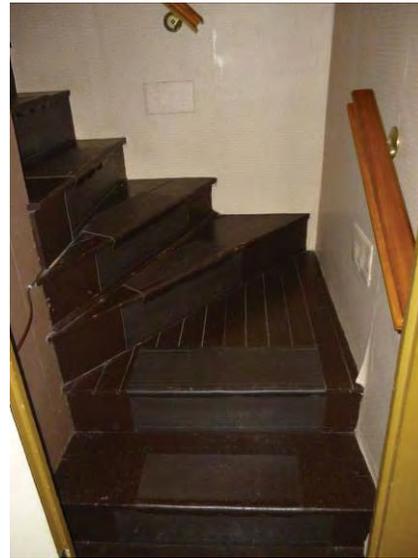
Central Wing: The winder stair up to room 204 has 12 risers 7-7 ½” high and is 3’-1” wide. It has tread and riser rubber protectors installed over the painted wood stairs and no base trim. The stair has a contemporary handrail along the exterior walls which is 2” wide and 30” above finished floor. It is discontinuous and does not have any extensions.

Figure 3-84: Central wing stair and handrails to room 204, ABA 12/6/11

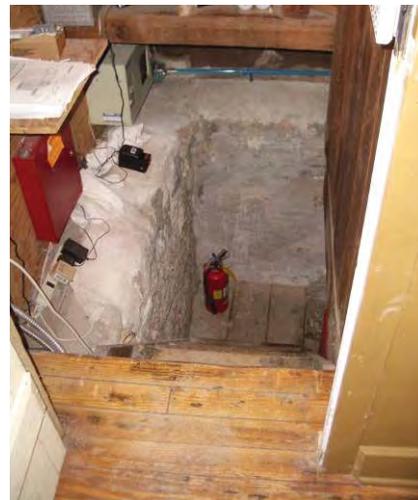
The basement stair has six open risers at 10” high and one open riser at 6” high. The width of the stair is 2’-3” and there are no handrails.

Figure 3-85: Central wing basement stair, ABA 12/6/11

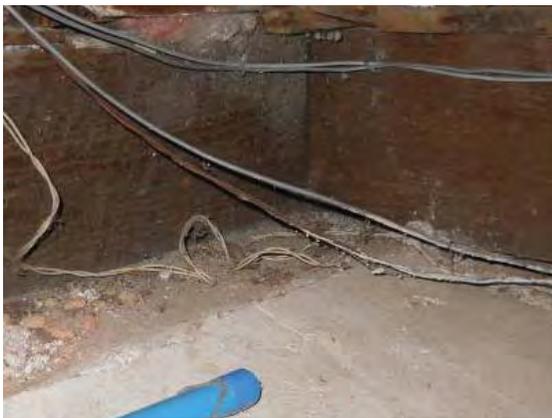
The first floor framing over the basement consists of 1 1/2" x 7 1/2" wood joists spaced at about 24" on center (o.c.). The joists span east-west a distance of approximately 16' and are sheathed with solid 3/4" thick tongue and groove wood flooring. The joists are supported on the perimeter foundation walls by bearing on an embedded wood sill plate (following figure). The basement floor framing at the stair opening is supported by 2 x 4 propped posts which extend from the underside of the floor framing and bear on the slab on grade. Likewise the stair to the basement has framing that bears directly on the slab on grade and is decaying.

Figure 3-86: Embedded wood sill plate on the stone foundation wall, northeast corner of the basement, PD 12/6/11

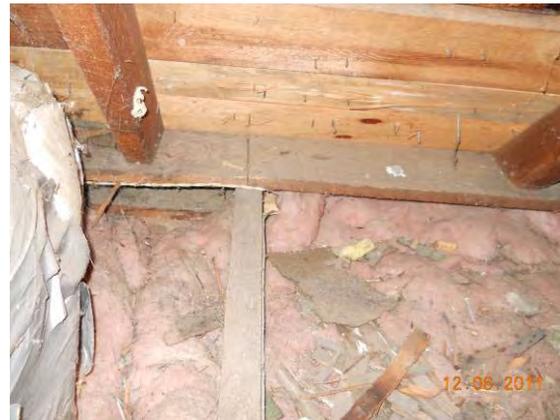
nominal 1 x 4 ridge board. The rafters are sheathed with spaced 1 x 6 (nominal) solid wood underlayment spaced at 10" o.c. The hip roofs are framed in the same manner with nominal 2 x 4 rafters spanning from the exterior wall to the hip ridge. The hip ridge member is a single nominal 2 x 4. All the rafters are supported by a nominal 1 x 6 flat board at the exterior wall, and the rafters do not line up with the ceiling joists (figure 3-87). The 1 x 6 flat board supports the rafter and the 1x board spans to the ceiling joists. The hip roofs do not have ceiling joists or blocking to resist thrust from the rafters.

Figure 3-87: West wing attic, rafters do not align with ceiling joists, PD 12/6/11

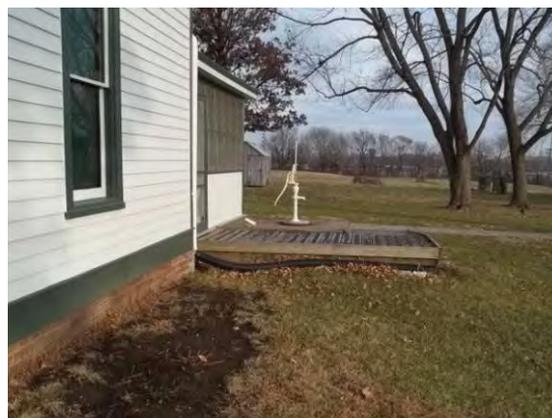
Figure 3-90: Disturbed ground on south side of building where geothermal lines enter building, DMD 12/6/11

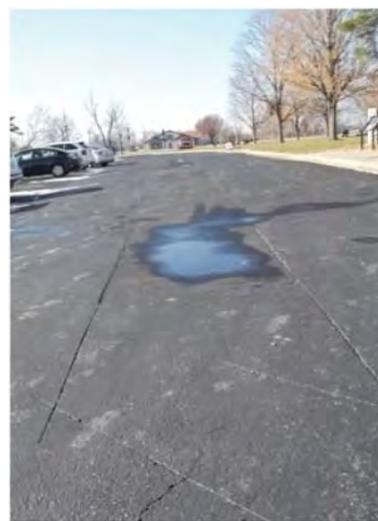
Figure 3-91: Patched asphalt where geothermal wells installed in parking lot, DMD 12/6/11

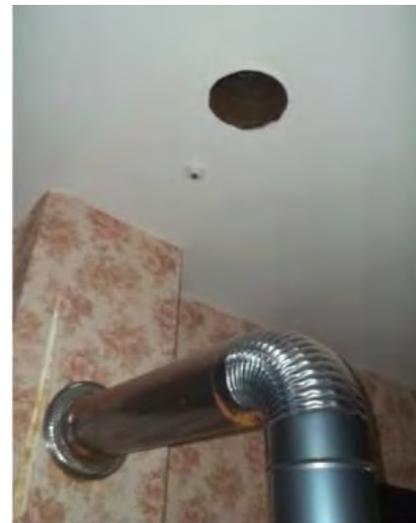
opening is covered with a decorative cover. The cooking stove in kitchen 105 and the two heating stoves in rooms 102 and 103 are connected to adjacent chimneys via single wall flue venting. Room 202 also has a hole in the ceiling that appears to have been for a heating stove at some point. This opening is not covered.

Figure 3-103: Room 202 vent opening in ceiling, DMD 12/6/11

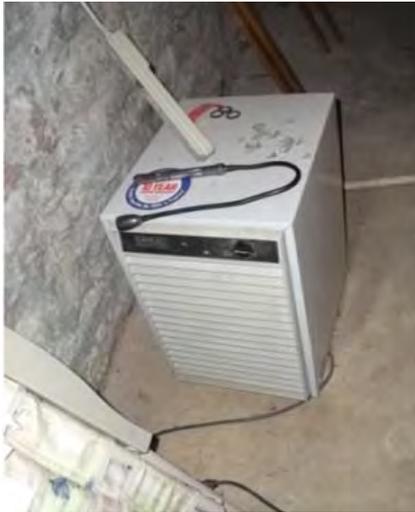
Throughout the Farm Home are signs of humidity control problems including the peeling of wallpaper. This is also evident by a stand alone portable dehumidification unit that is located in the basement. This unit sits at the

bottom of the basement stairs and can be transported and plugged in to help control the humidity level in the house. The park staff monitors the humidity level in the Farm Home and plug-in and unplug the dehumidifier as needed. This dehumidification control is not automated and requires manual interaction to start and stop the unit.

Figure 3-104: Portable dehumidifier in basement, DMD 12/6/11

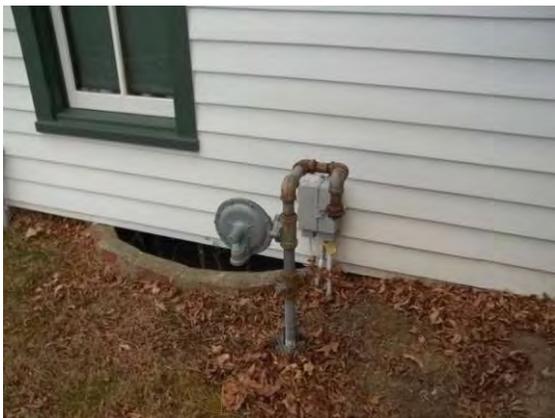
In 2007 when the geothermal system was installed, the natural gas line for the house was abandoned. Currently there is no gas piping in the house and the natural gas line is stubbed up outside on the north side of the house and contains a pressure regulator, but no meter.

Figure 3-107: Gas line stubbed up with pressure regulator and no meter, DMD 12/6/11

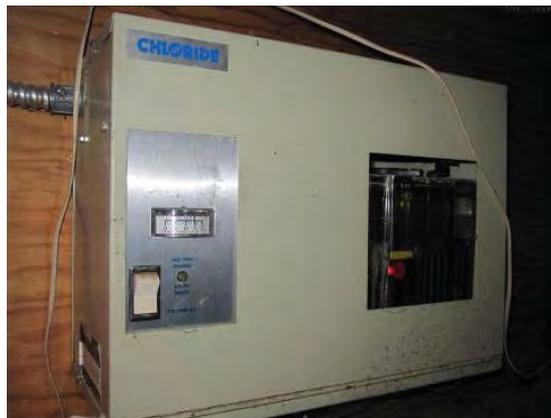
Battery backed up egress lighting is provided by a Chloride 250 watt battery backup inverter which is connected to four incandescent step lights, two located at the main stair and two located at the secondary stair. These fixtures are operated by a standard toggle light switch located near the electrical panel within the stair access down to the basement. The battery system was functional at the time of the site observation (however, it was not tested for a full 90 minutes of backup). These lights only provide egress illumination along the stair treads, supplemental egress lighting in other areas of the Farm Home may be needed for proper egress illumination in the event of a power failure. If it is agreed that the Farm Home is not to be utilized during hours of darkness and the existing light levels provided by daylighting are adequate for egress, supplemental battery powered egress illumination may not be required.

Figure 3-113: Existing battery backup system, Jon Brooks 12/6/11

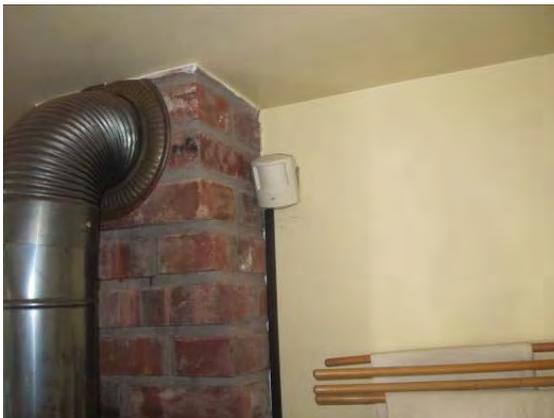
Smoke and heat detector devices are located within the basement, each bedroom, entry hall 101, dining room 104, kitchen 105, and stair landing. The majority of all security and fire alarm system wiring is concealed within the walls of the first and second floors; however, the cabling to the occupancy sensor within kitchen 105 is routed within surface mounted Wiremold.

Figure 3-115: Surface mounted conduit in kitchen 105, Jon Brooks 12/6/11

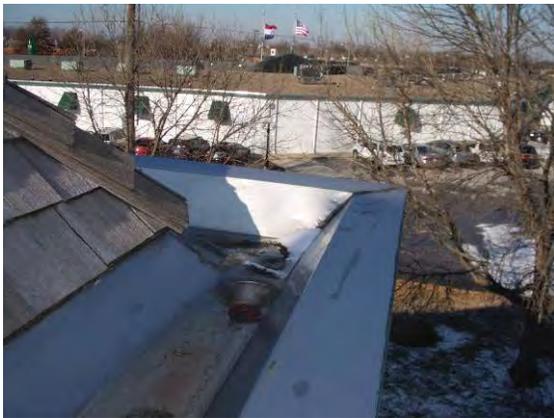
All are in good condition. However, the fascia at each integral gutter corner of the west wing exhibits some minor damage at the vertical joint at each corner. It is unknown what is causing the damage but it could possibly be from differentiation of expansion between the wood and stainless steel gutter, causing a gap at the end grain of the fascia members.

Figure 3-117: c.1984 stainless steel integral gutter, minor damage at corner joint, EMH 12/6/11

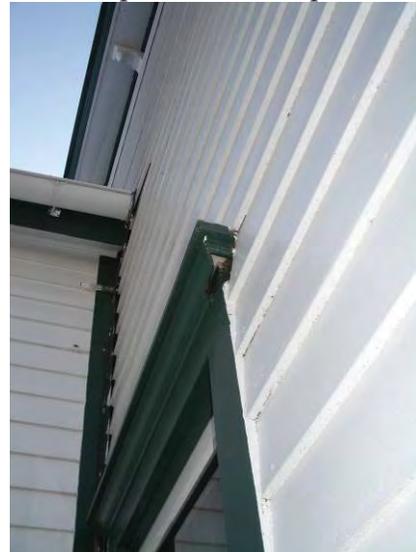
All appear to be in good condition, with the exception of the separation issue.

Figure 3-118: Separation of central and east wing, EMH 12/6/11

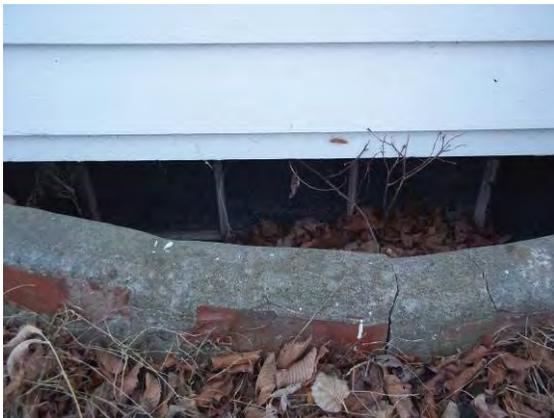
Central Wing: The first and second floor wood windows are in good condition. The basement windows are in fair to poor condition. Debris has covered a portion of the exterior and has trapped moisture against the windows. The window wells themselves are small, with minimal air circulation or space for maintenance.

Figure 3-119: Basement window well condition, NAA 12/6/11

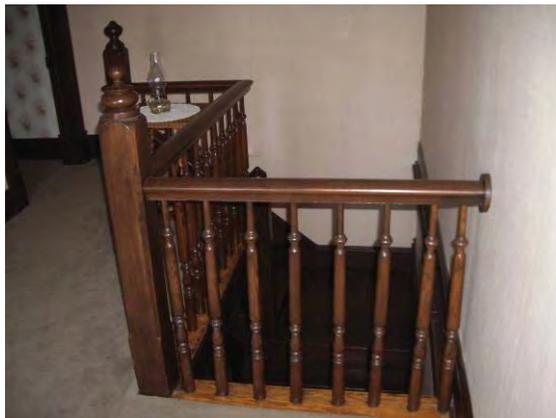
West Wing: The primary staircase leading to the two bedrooms is in good condition. However, it does not have sufficient handrails and railing height at the second floor to meet current code requirements of 42”.

Figure 3-120: Primary staircase railing in hall 201, ABA 12/6/11

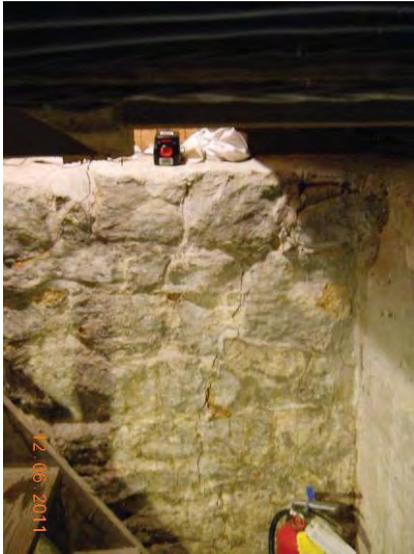
The perimeter foundation walls in the basement are in good condition although

they are cracked and have cracked recently due to foundation movement. The wall cracks are about 1/8" wide (following figure). The slab on grade in the basement has also cracked recently and the crack is sizable, about 1/8" to 3/16" wide.

Figure 3-121: Basement wall crack, PD 12/6/11
