Harry S Truman National Historic Site Truman Farm

Cultural Landscape Report Historic Structure Report & Environmental Assessment

1, DEZ, 2013

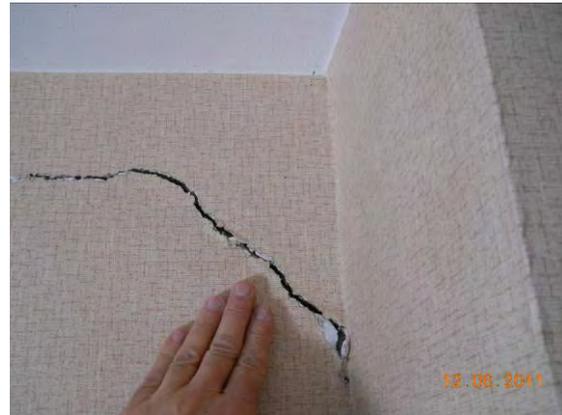
The shallow foundations under the west wing and kitchen 105 move with moisture changes in the soil at the depth of the foundations as discussed in the 2005 report by Quinn Evans Architects and Fitzpatrick Structural Engineering P.C. This is causing distress in the foundations and cracking in the walls of the west wing, and separation of the west wing and kitchen 105 from the center portion of the house (figures 3-122 and 123).

Figure 3-122: West wing wall cracking, second floor hall 201 adjacent to north chimney, PD 12/6/11

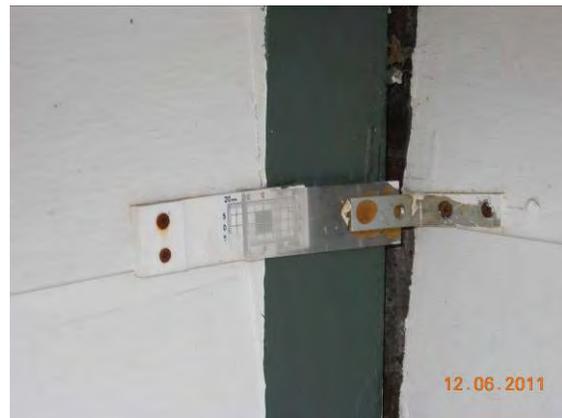
Figure 3-123: Separation of west wing from center of house as measured by crack monitor installed in 2004, PD 12/6/11

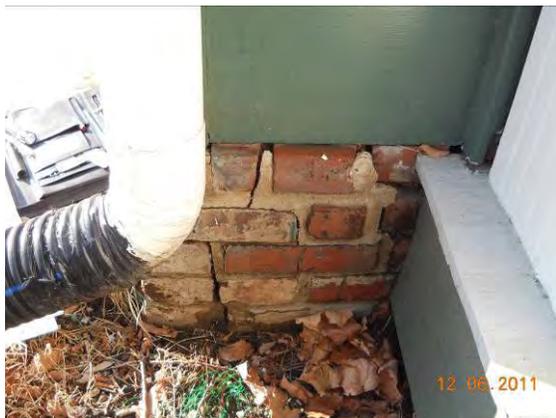
The brick grade beams under the west wing are in poor condition. Bricks and mortar are cracking (figures 3-124 and 125). A large section of the north grade beam is unstable when the soil dries and the grade drops. Repairs have been made and need to be made again. A brick was easily removed to provide viewing of the crawl space.

Figure 3-124: Deteriorated bricks and mortar, brick grade beam, southeast corner of west wing, PD 12/6/11

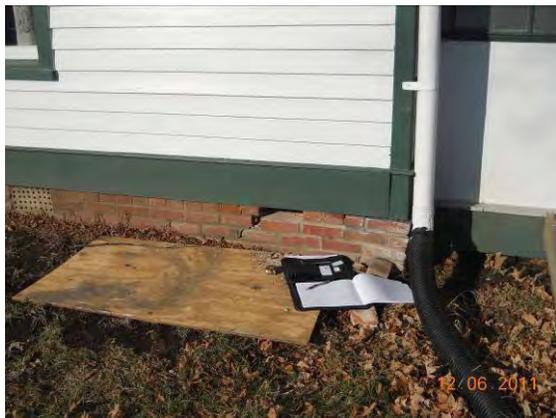
Figure 3-125: Cracking and Rowlock brick easily removed from south grade beam of west wing, PD 12/6/11

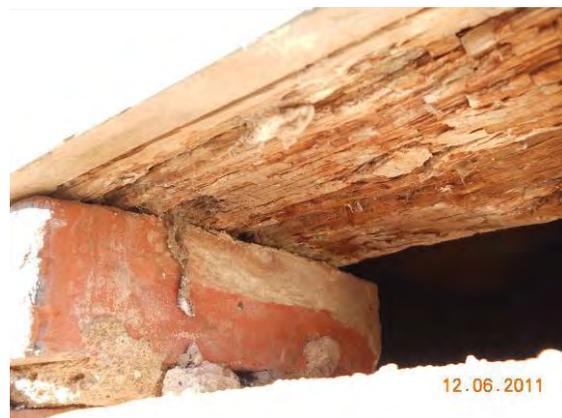
First floor framing for the west wing is generally in fair condition. The crawl space under this framing is not adequately vented, but the wood joist moisture content as measured in December near the southern edge was not excessive. It's possible the mechanical ductwork in the crawl space is providing some air movement and contributing to the favorable environment. It's also likely the moisture content increases during times of wet weather. The venting should be improved. The wood sill plate or beam that bear on the brick grade beams are decayed (figure 3-126). The wood rim joist bearing on masonry is also likely decayed.

Figure 3-126: Decayed wood sill plate (or beam?) on brick grade beam, south wall west wing, PD 12/6/11

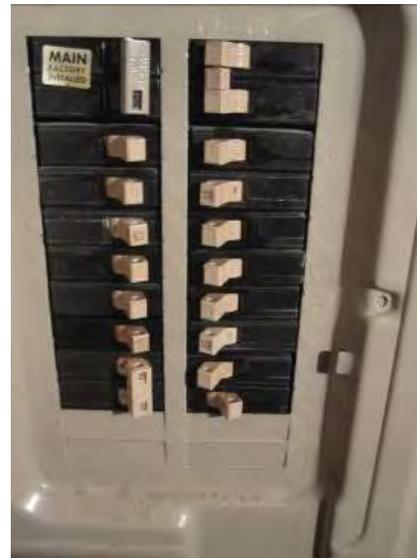
Existing infrastructure appears to be sized appropriately for the loads served, equipment is in fair condition with 10-15 years of remaining useful life.

Figure 3-127: Existing main electrical panel, Jon Brooks 12/6/11

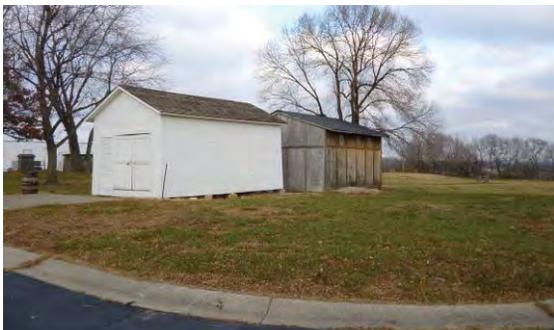
Figure 3-135: Exterior of Garage, west elevation and barn doors, ABA 12/6/11

The barn doors are in fair condition with weathered paint and misaligned hinges that affect the angle in which the doors operate. The 1x wood infill of missing doors is poor.

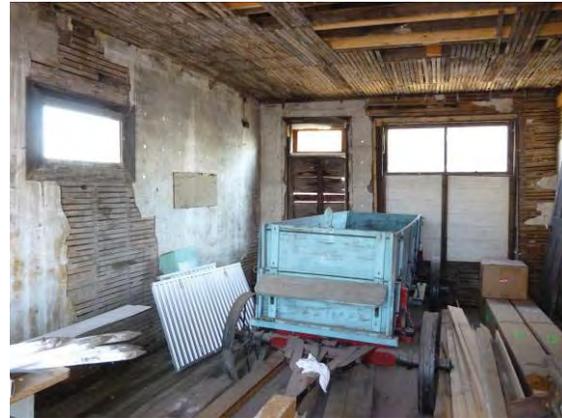
Portions of the original plaster are attached to the remaining lath along the wood frame walls. Plaster sample number 5 was taken of this wall plaster and showed a skim coat of lime and a plaster composed of horse hair (see Appendix F for in-depth analysis of the results).

Figure 3-136: Interior Garage wall finishes, ABA 12/6/11

The remaining lath and plaster are in poor condition.

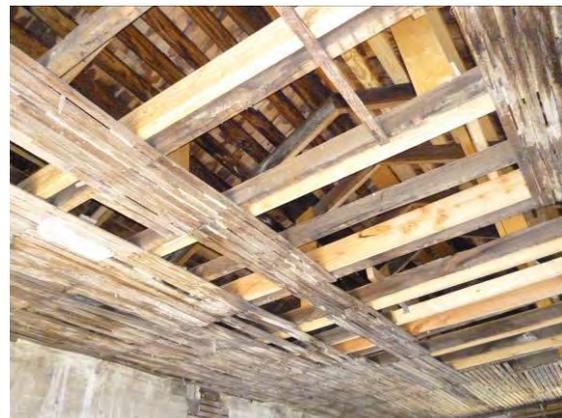
The ceiling retains small areas of the original lath. Remnants of plaster remain (typically between the lath and roof framing).

Figure 3-137: Interior Garage ceiling and roof structure, ABA 12/6/11

The remaining lath and minimal plaster are in poor condition.

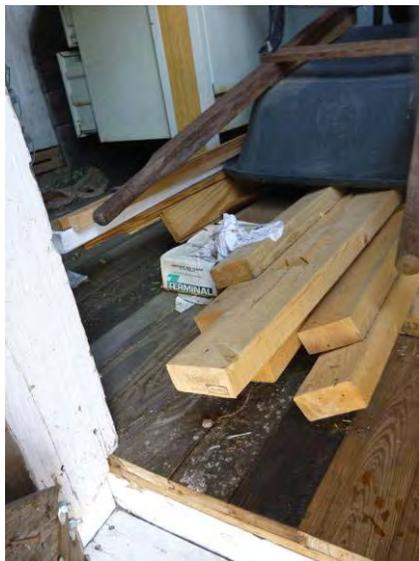
The tongue and groove wood flooring runs east-west and shows obvious signs of large portions having been replaced. It is assured this floor is not original due to its previous use for car storage.

Figure 3-138: Interior Garage tongue and groove flooring, ABA 12/6/11

There historic wood floor is heavily worn and stained; it is clear to see where newer flooring has been installed.

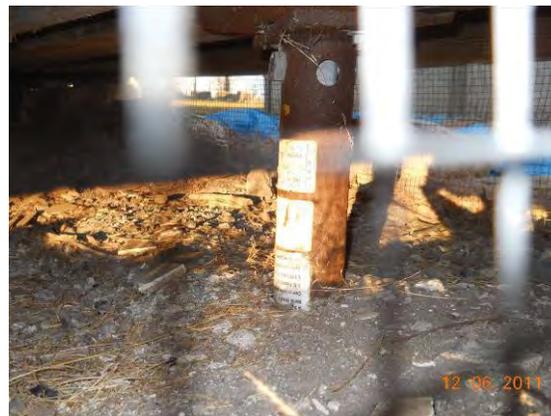
Garage is now supported on six helical piles (Chance C150-0132). The helical piers are unfinished steel and show signs of surface rust (figure 3-139).

Figure 3-139: Helical pile, PD 12/6/11

The six helical piles appear to be performing fine. The piles are not galvanized and show signs of rusting. It's unknown whether the piles were designed to accommodate corrosion.

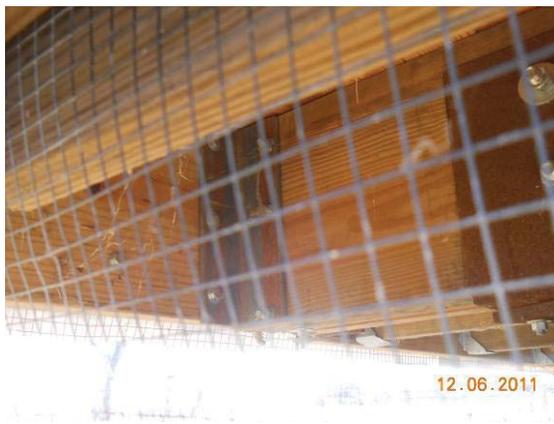
thru bolts and connect to the rim joist with 3 approximately 3/8" diameter lag screws. On the north side the rim joist is continuous and rests on top of the built-up beams. The rim joists support 2x12 floor joists that span north-south approximately 14' between rim joists. A 3/4" solid tongue and groove (T&G) flooring spans 16" to the 2x12 joists. The T&G flooring is about 50% original reused wood and 50% new wood.

Figure 3-140: Angle connecting rim joist to build-up beam, PD 12/6/11

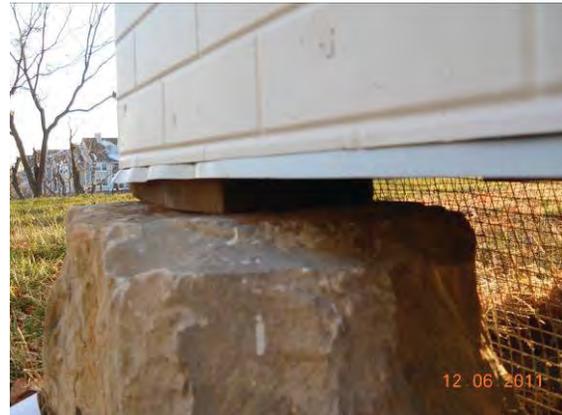
The floor joists between the last built-up beam and the east wall are supported by a 2'-6" length of rim joist on the south side. This rim joist cantilevers off the steel angle connection at the built-up beam. This construction is very weak. A stone has been placed under the corner of the Garage and offers support for the weak framing (following figure). The same condition occurs at the southwest corner.

Figure 3-141: Stone supporting Garage corner, PD 12/6/11

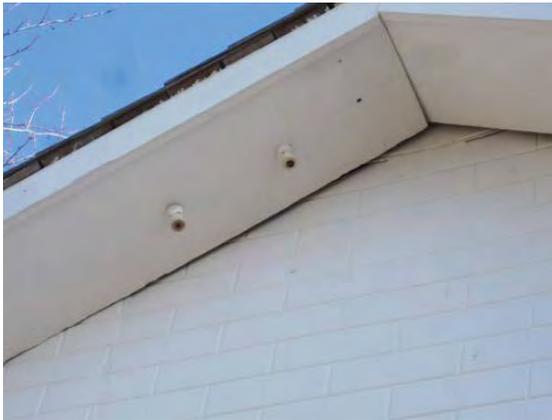
No electrical systems exist on this building. It appears that there was electrical connected to this building near its original construction as is evidenced by the existing porcelain knob and tube connectors located under the roof eave above the Garage entry door.

Figure 3-142: Garage Building Knob and Tube Connectors, Jon Brooks 12/6/11

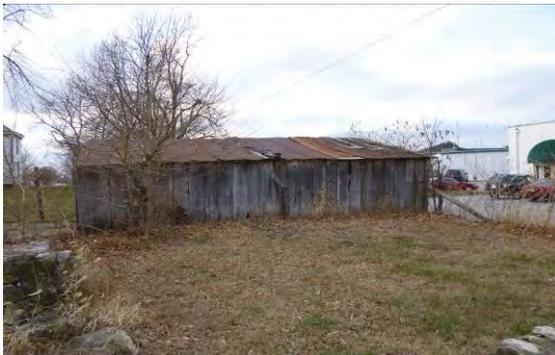
The roof consists of corrugated metal panels (1'-10" wide) replaced in 2005, per park records. Sheathing is 1x10 boards with tar paper.

Figure 3-147: Poultry House east elevation, ABA 12/6/11

The corrugated metal panel roof is weathered and rusted.

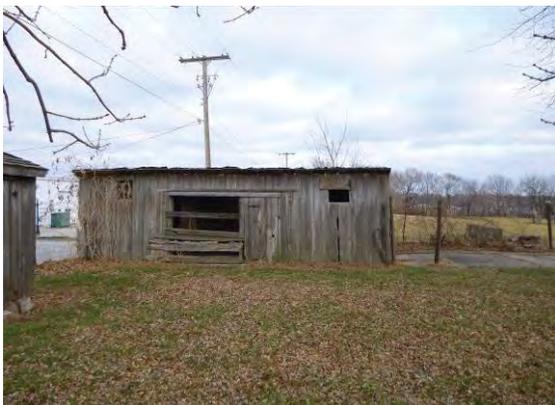
The Poultry House has board (10 ¼" wide) and batten (2 ¼" wide) siding. The west wall is approximately 3" out of plumb per field documentation. There are various gaps and holes in the boards.

Figure 3-148: Poultry House west elevation, ABA 12/6/11

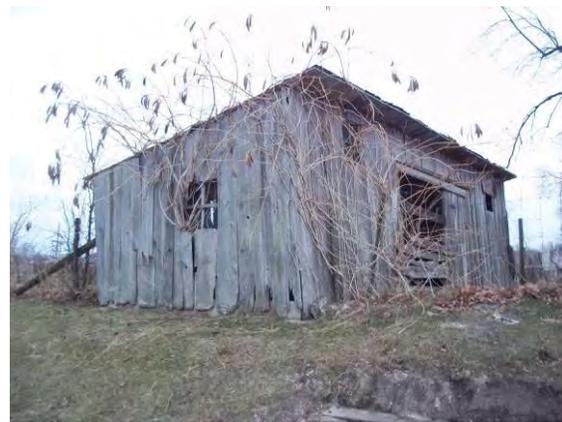
There are four openings in this structure – three are approximately 1'-10" x 1'-5" and the remaining opening is a large expanse measuring 5'-11" x 5'-9 ½". None of the openings have glazing but all have chicken wire covering most of the openings. Two of the windows have muntins (north window on the west elevation and window on the north elevation).

Figure 3-149: Poultry House north elevation, ABA 12/6/11

The window openings are in poor condition with dry rot. Without glazing, there is no protection of the building from weather and vermin.

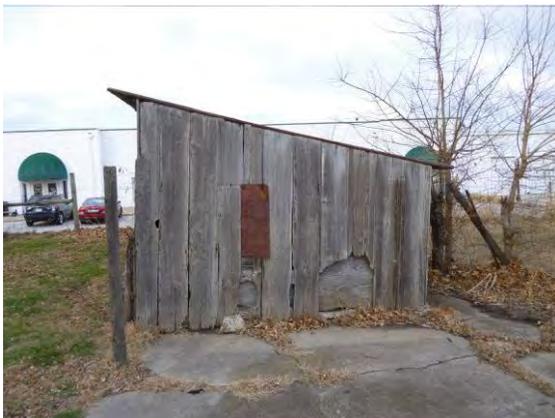
Approximately 2/3 of the interior of the structure has a concrete pad. The concrete pad extends past the south elevation of the structure to provide an exterior pad area. The one portion of the structure (northern portion) which does not have the concrete floor has a packed earth floor.

Figure 3-151: Poultry House south elevation and concrete floor extension, ABA 12/6/11

The concrete pad is in poor condition as it has large cracks running throughout.

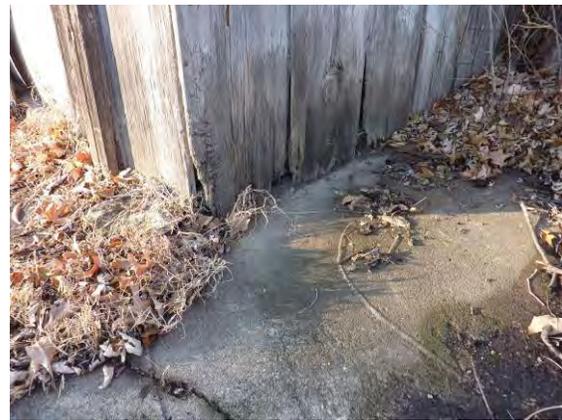
The building does not appear to have a foundation. The wood members appear to be embedded in the ground or simply resting on the ground.

Figure 3-152: Bottom of wall showing decay and no foundation, PD 12/6/11

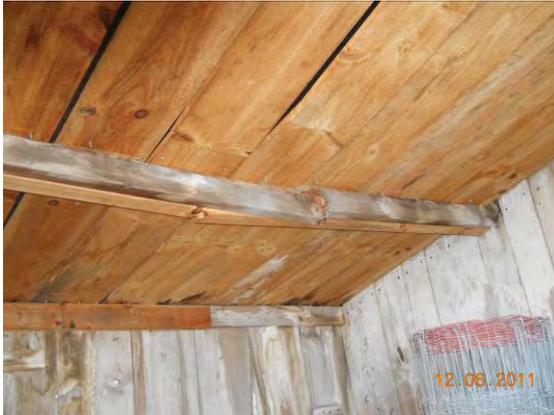
The recently replaced wood sheathing is in good condition other than the damage caused by the tree limb that broke through the roof. The sheathing boards though are not adequately supported. The 2x4 purlins are severely overstressed and are cracked in places (figure 3-153) and are not adequately anchored. There is a noticeable sag in the roof plane.

Figure 3-153: Cracked original and new 2x4 purlins, PD 12/6/11

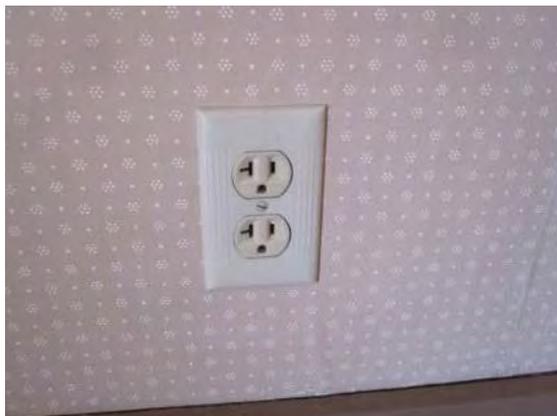
All existing wire and devices appear to be in good condition. Existing, recently updated connections to mechanical heat pump unit appear to be in good condition.

Figure 5-12. Existing receptacle, JB 12/6/11

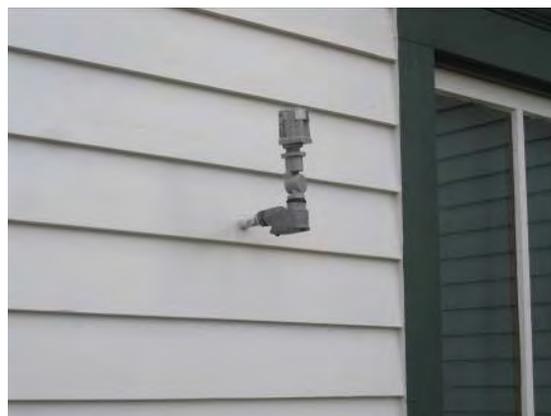
Figure 5-13. Existing exterior photocell, JB 12/6/11

- Insulate cold water line
- Camera scope sanitary sewer line
- Provide power to humidity control system
- Replace <e> photocell controls to exterior lights with new digital time clock

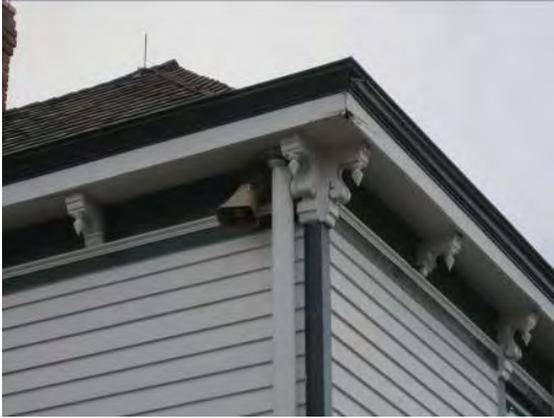
Figure 5-14. Existing exterior horn, JB 12/6/11

Provide a new flow and tamper switch at the new sprinkler water entry location. Tie the flow and tamper switches into the existing fire alarm control panel. Provide a single exterior horn/strobe device located on the south exterior wall and provide a new horn/strobe device on the interior of the Farm Home at a centralized location in the entry hall. These horn/strobe devices are to be connected to the existing fire alarm

panel within this building and are to be activated upon fire sprinkler system flow

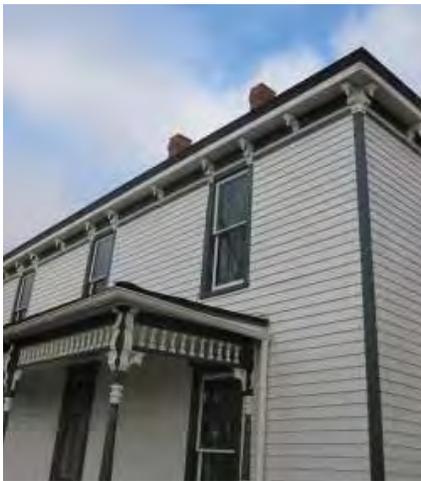
Figure 5-15. Lightning protection downloads, JB 12/6/11

The existing lightning system shall be tested to ensure LPI-175 compliance. Existing downloads that are not neatly routed down the façade and are not securely fastened shall be reconnected in a tight and orderly fashion.
