GRIST MILL
Historic Structure Report

San Antonio Missions
National Historical Park
San Antonio, Texas

Mission San José

October 1997

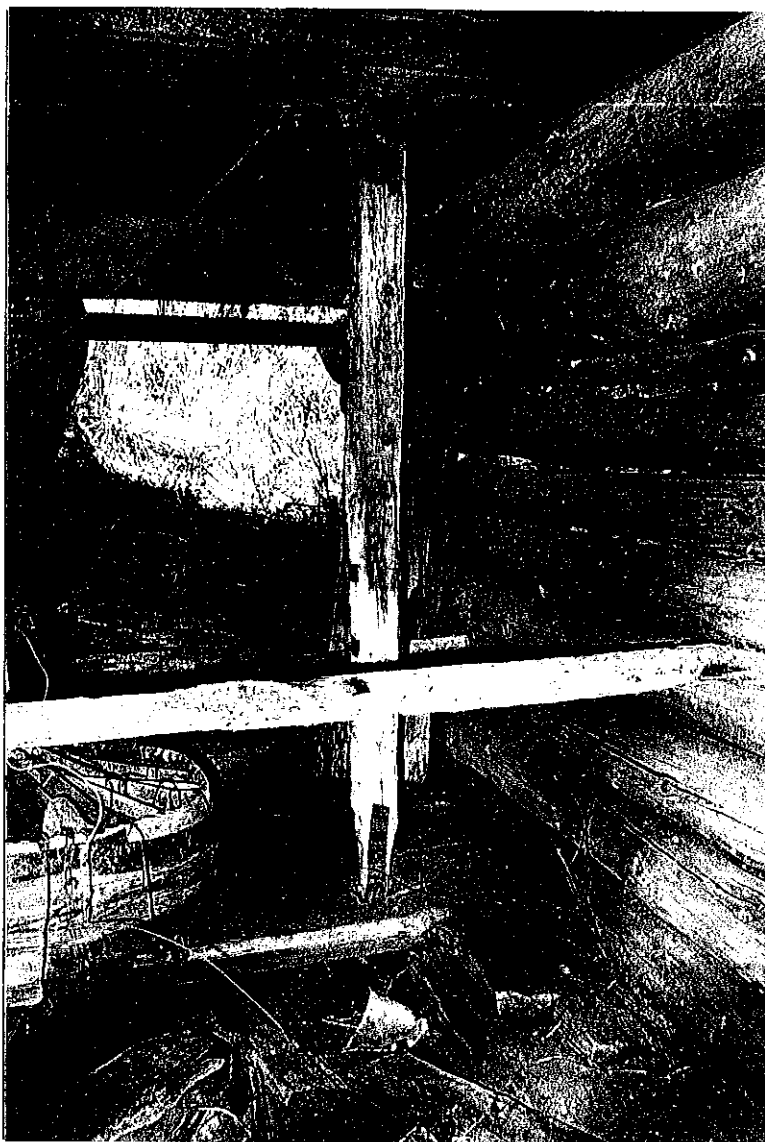
Figure 1-16 November 1990. Truchas mill during initial investigations (prior to relocation to El Rancho de las Golondrinas, and subsequent restoration). Lower wheel room: Detail of tram rod and its connection to the bridge tree. Truchas, New Mexico.

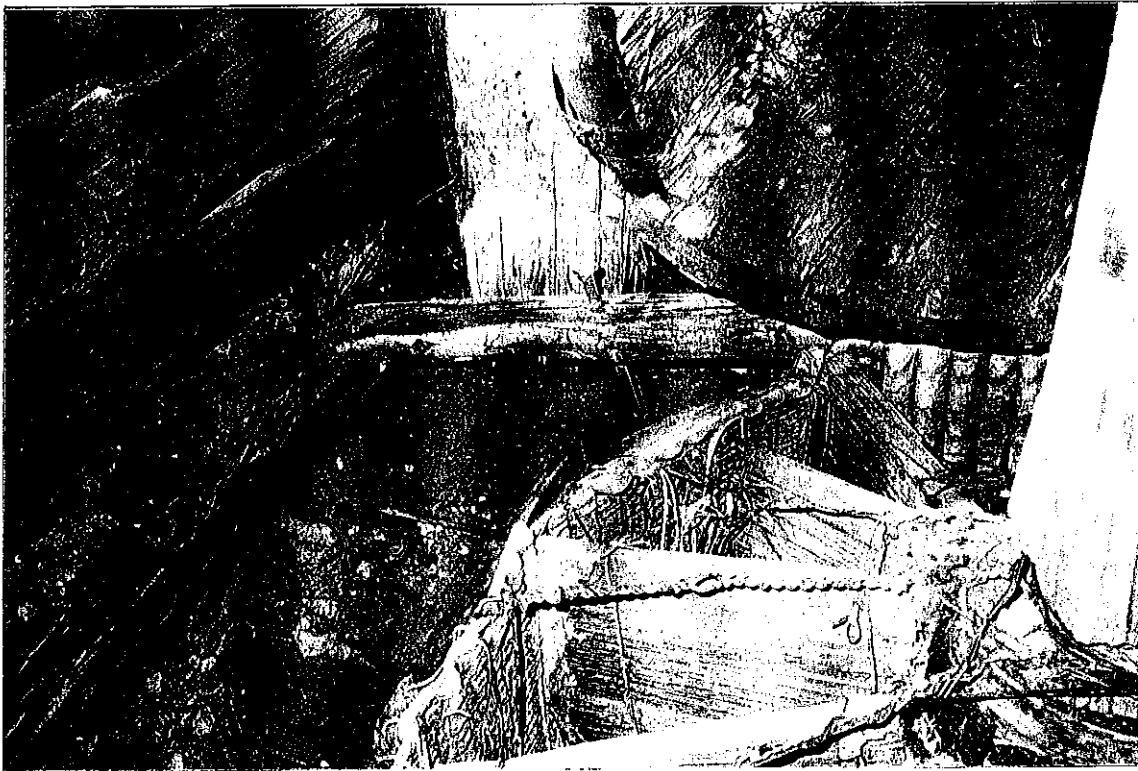
Figure 1-17 November 1990. Truchas mill during initial investigations. Lower wheel room: Detail of previous wheel (note grooved wood band). Truchas, New Mexico.

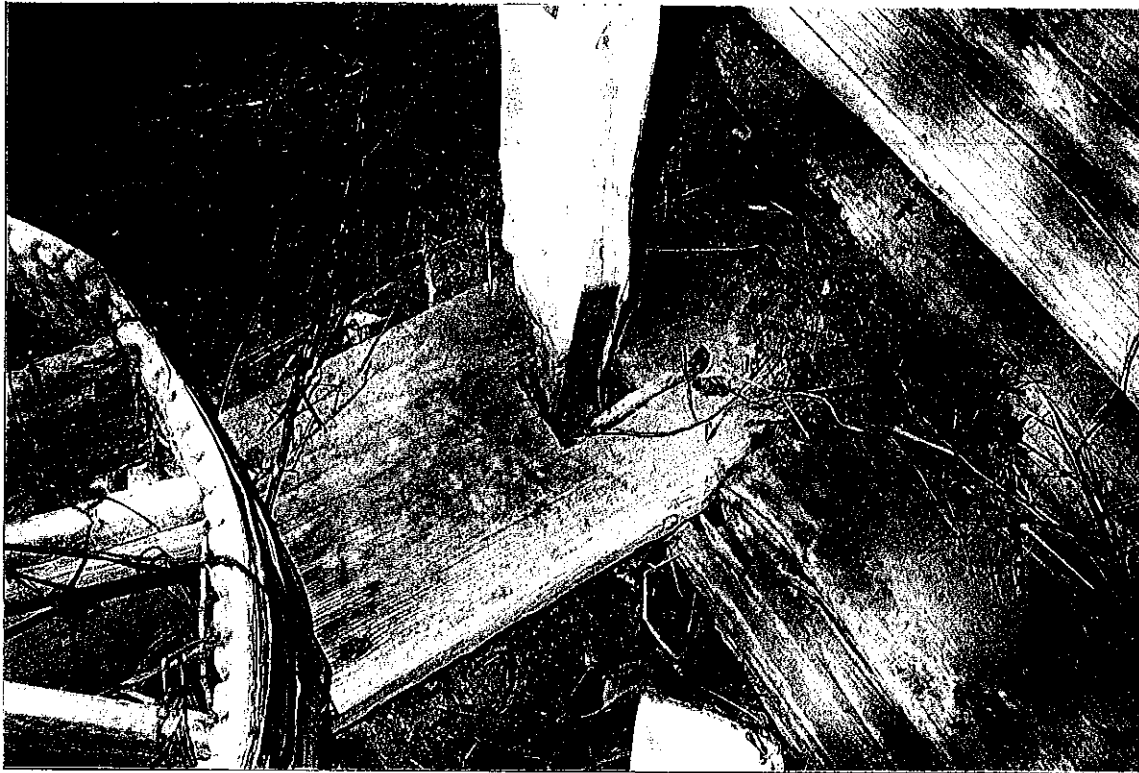
Figure 1-18 November 1990. Truchas mill during initial investigations. Lower wheel room: Detail of previous wheel, tram rod and bridge tree. Truchas, New Mexico.

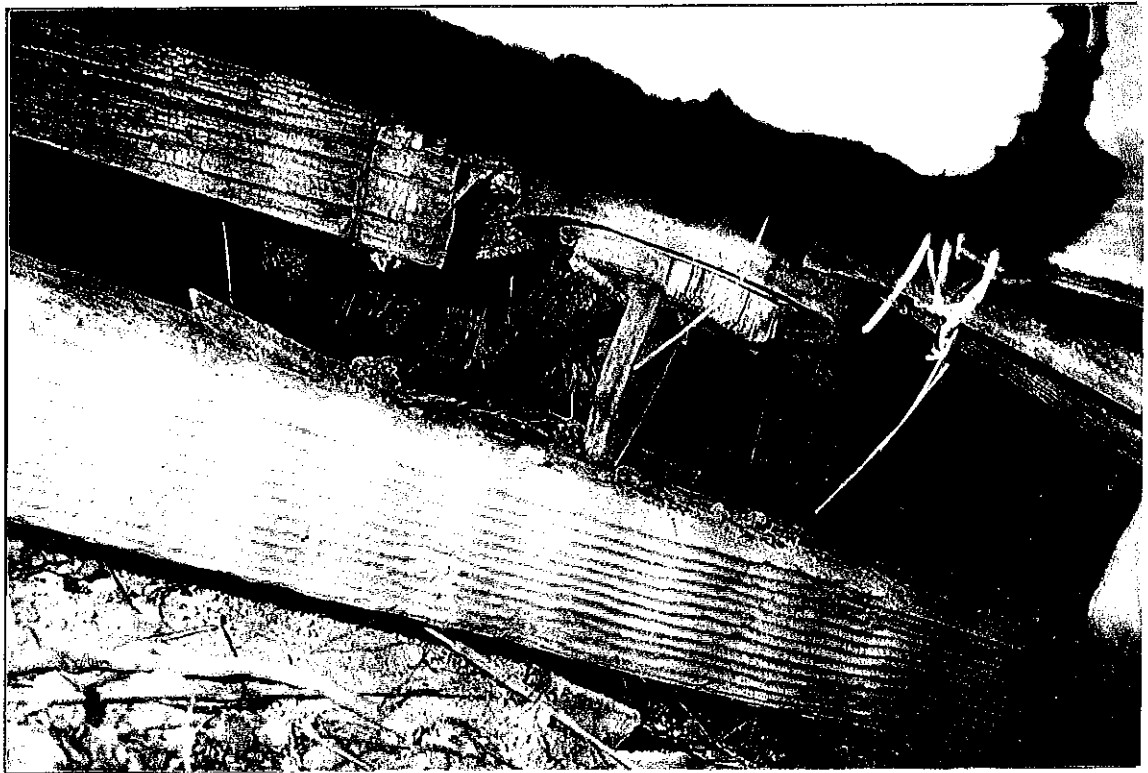
Figure 1-19 November 1990. Truchas mill during initial investigations. Lower wheel room: Detail of previous bridge tree, bottom of main shaft, and thrust bearing. Truchas, New Mexico.

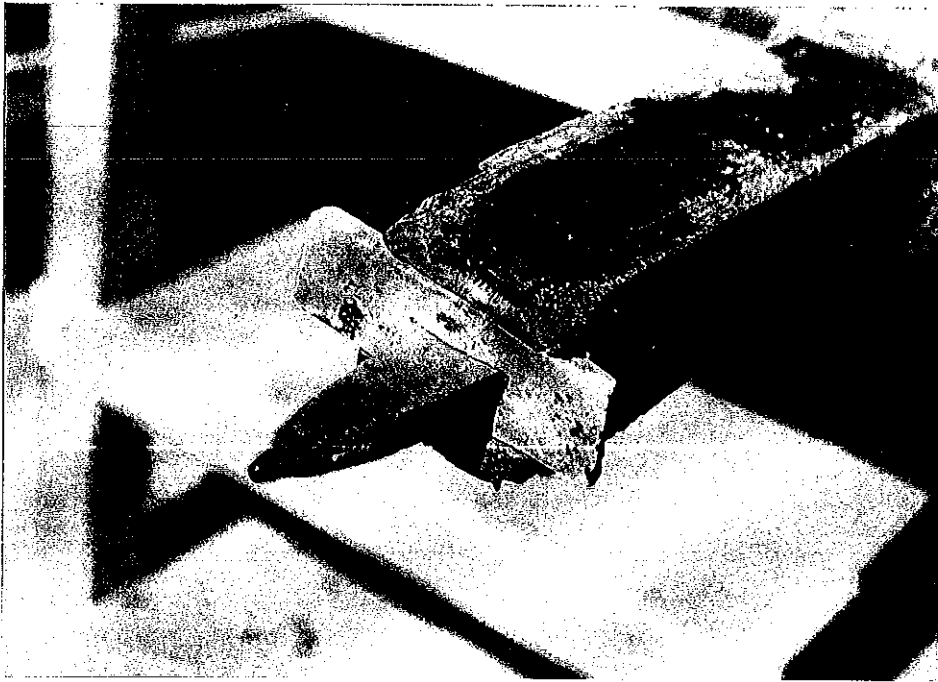
Figure 1-22
Fall 1990
Detail of historic metal pivot point which has been re-inserted into the bottom of the epoxy-stabilized historic main shaft. El Rancho de las Golondrinas, Santa Fe, New Mexico.

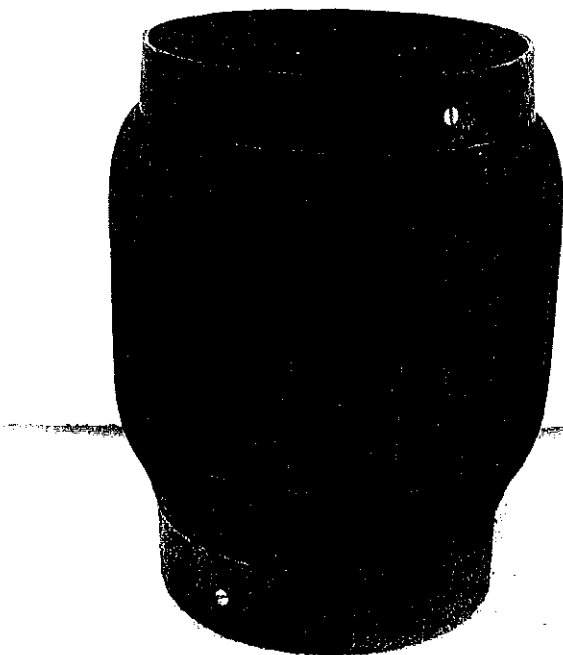
Figure 1-23
Fall 1990
Detail of replacement wagon wheel hub. "Recycled" wagon wheel hubs became convenient replacements for new or rebuilt water wheels in New Mexico mills. El Rancho de las Golondrinas, Santa Fe, New Mexico.

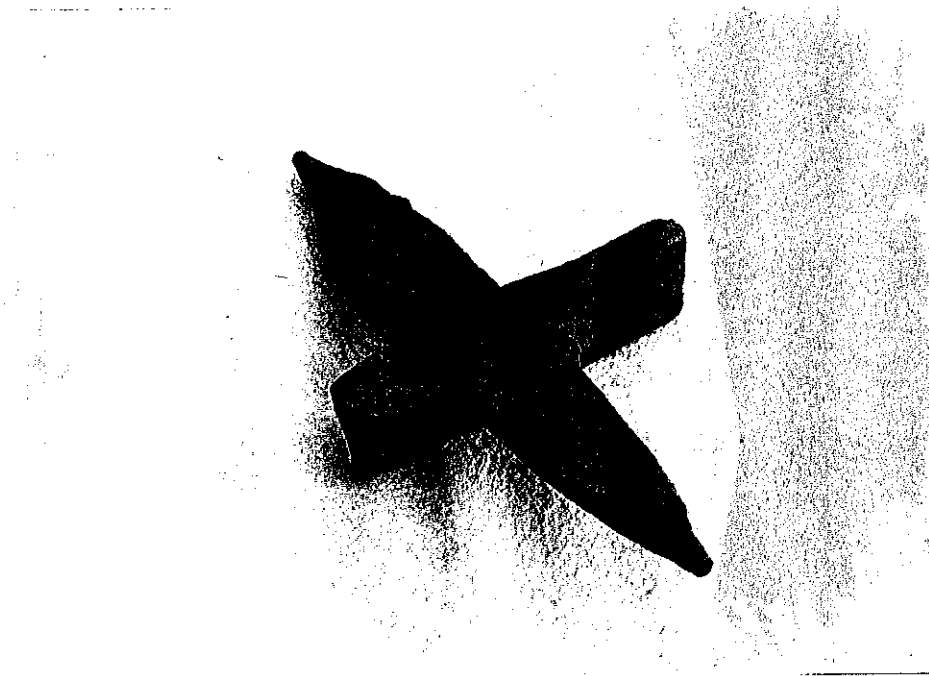
Figure 1-21 Fall 1990. Detail of historic metal pivot point (which is inserted into the bottom of the main shaft). El Rancho de las Golondrinas, Santa Fe, New Mexico.

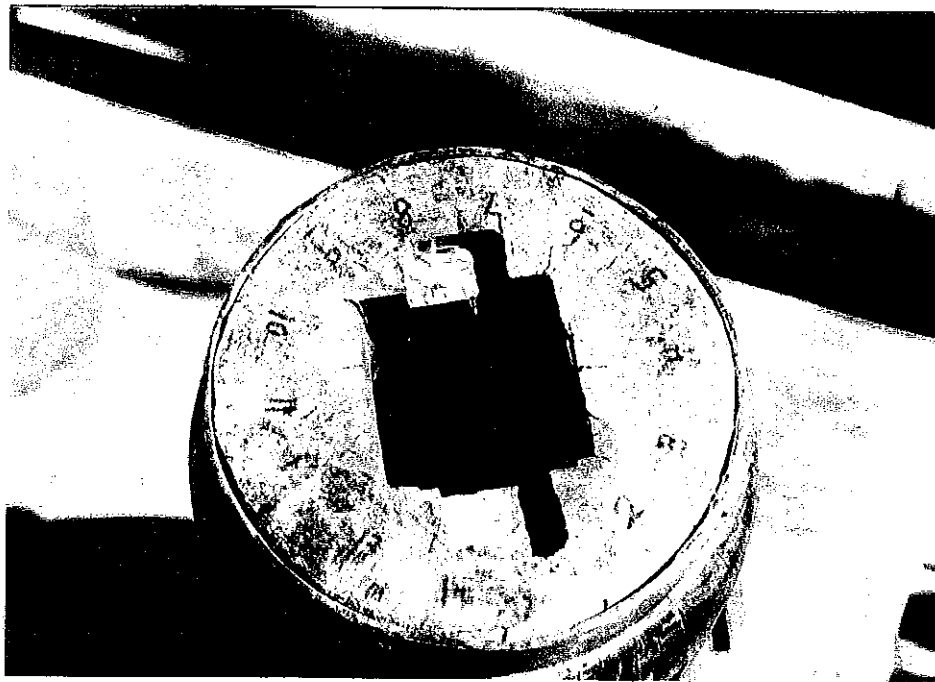
Figure 1-25 Fall 1990. Detail of bottom of replacement water wheel hub. The hub has been notched to accept the horizontal plate from the pivot point. El Rancho de las Golondrinas, Santa Fe, New Mexico.

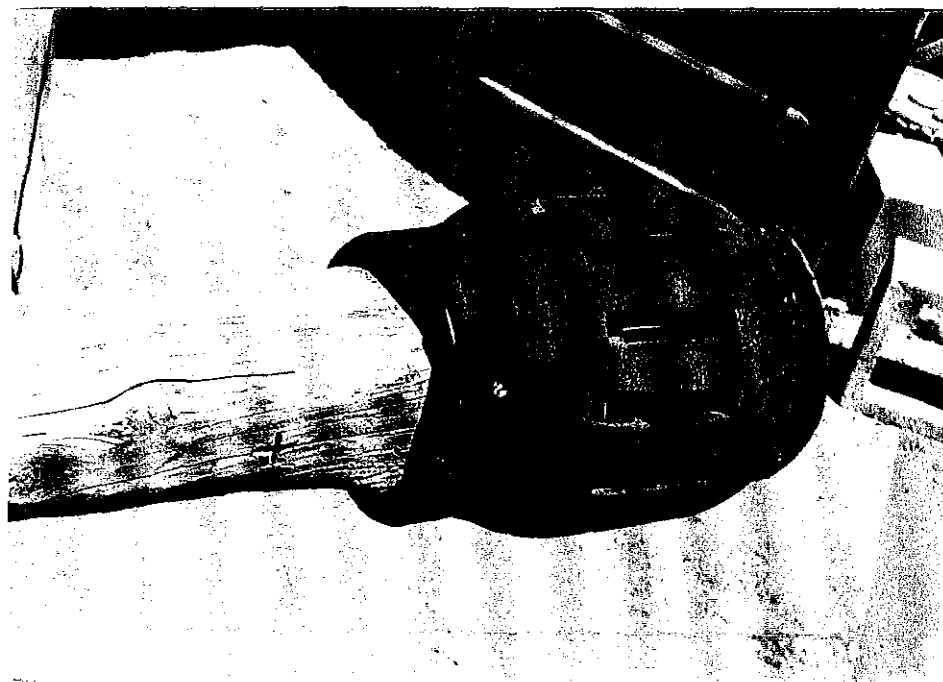
Figure 1-26 Fall 1990. Detail of bottom of replacement water wheel hub. The stabilized main shaft has been inserted into the new hub. El Rancho de las Golondrinas, Santa Fe, New Mexico.

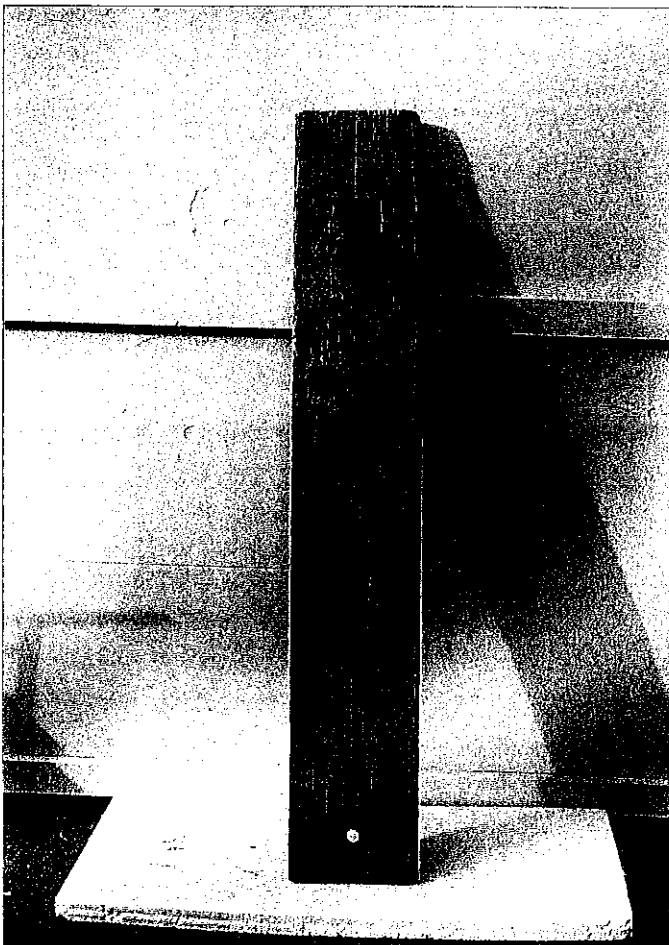
Figure 1-29
Fall 1990
Detail of historic bridge tree (from Truchas mill). The tree was pinned with a spike or peg (location at bottom of photo). At the center of the tree the thrust bearing plate can be seen, notched into the top of the tree. At the top of the photo is the notch for the tram rod. El Rancho de las Golondrinas, Santa Fe, New Mexico.

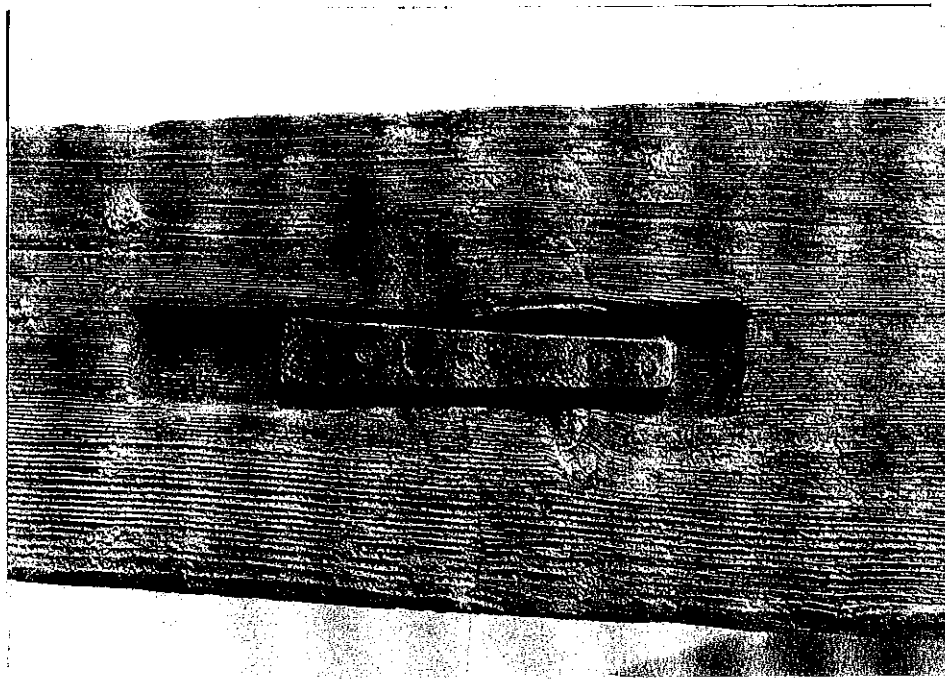
Figure 1-30 Spring 1991. Historic bridge tree (from Truchas mill). Detail of the historic wrought iron thrust bearing plate, notched into the top of the tree. A couple of indentations can be seen indicating that the pivot point (bearing) had been moved a couple of times. Also, this was not the original thrust bearing plate, as the notch was somewhat larger. El Rancho de las Golondrinas, Santa Fe, New Mexico.

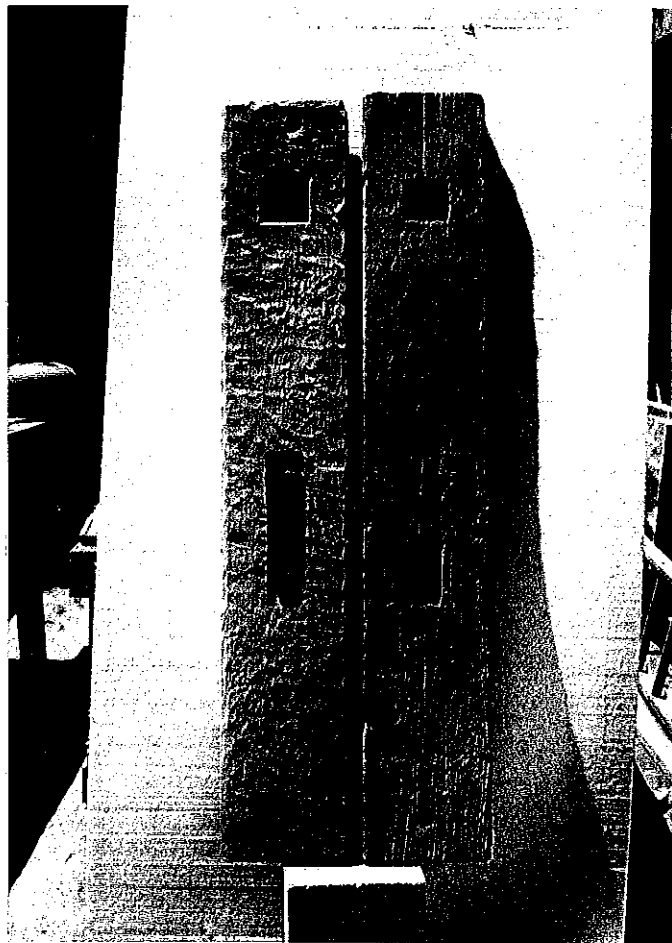
Figure 1-31 Spring 1991. Juxtaposition between the historic bridge tree (at the right) and the re-fabricated tree. The new bridge tree has been carefully tooled to resemble the historic tree. El Rancho de las Golondrinas, Santa Fe, New Mexico.

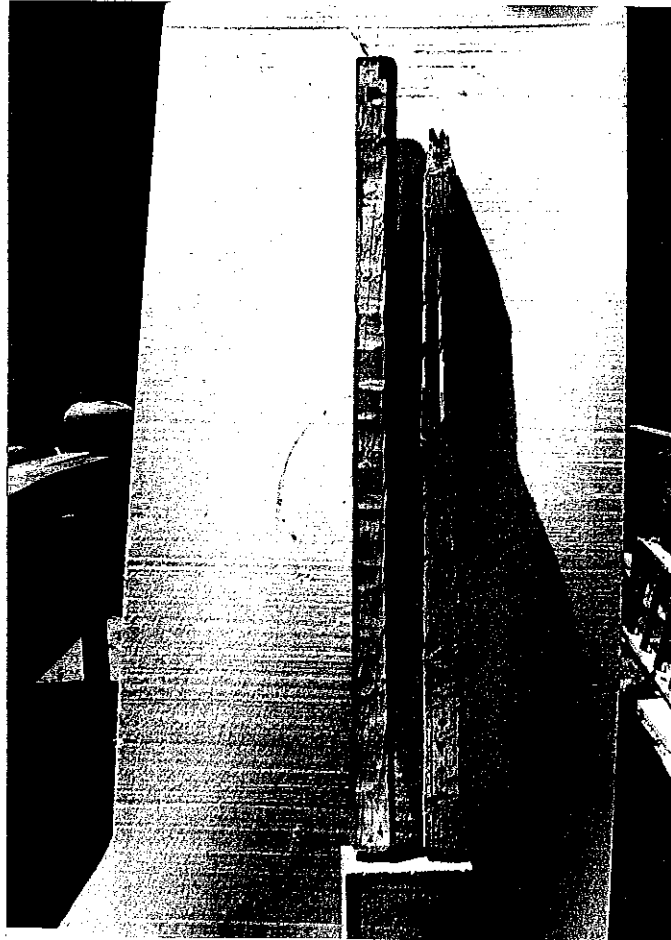
Figure 1-34 Spring 1991. Juxtaposition between the historic tram rod (at the right) and the re-fabricated tram rod (left). The new tram rod has been tooled to resemble the historic pole; and has been treated with wood preservatives and drilled to the same configuration as the historic pole. El Rancho de las Golondrinas, Santa Fe, New Mexico.

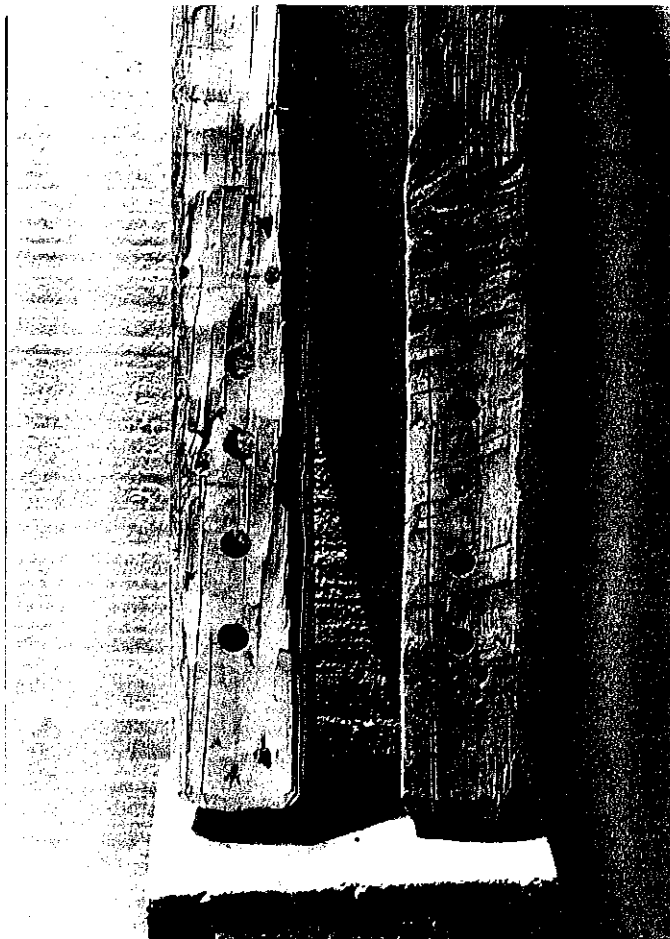
Figure 1-35 Spring 1991. Detail of upper section of the historic tram rod (right) and the re-fabricated tram rod (left). The new tram rod has been tooled to resemble the historic tram rod; and has been treated with wood preservatives and drilled to the same configuration as the historic tram rod. El Rancho de las Golondrinas, Santa Fe, New Mexico.

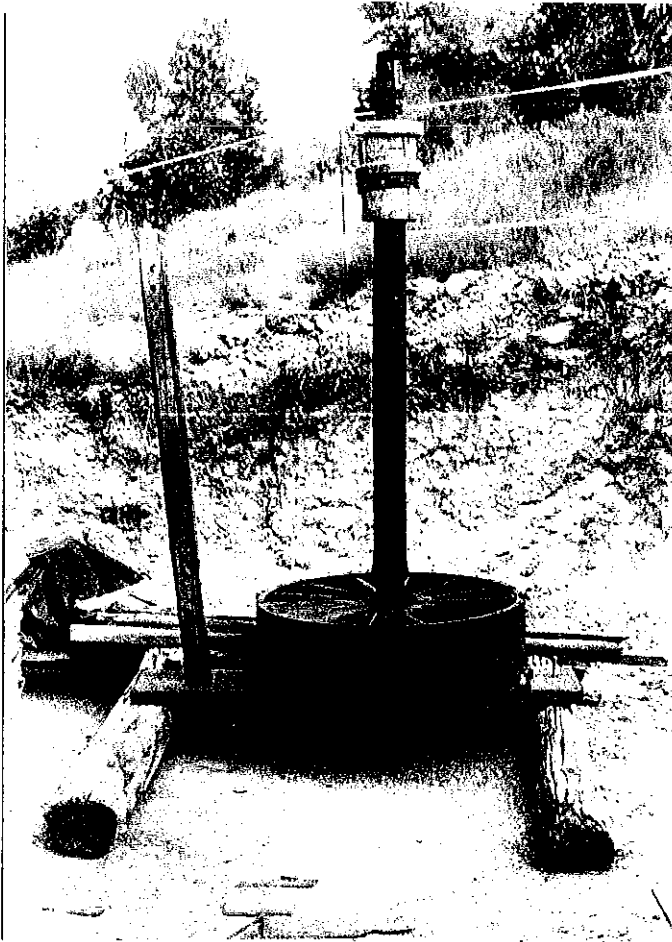
Figure 1-36
March 1991
The completed (re-fabricated) wheel and associated assemblies for the Truchas mill. El Rancho de las Golondrinas, Santa Fe, New Mexico.

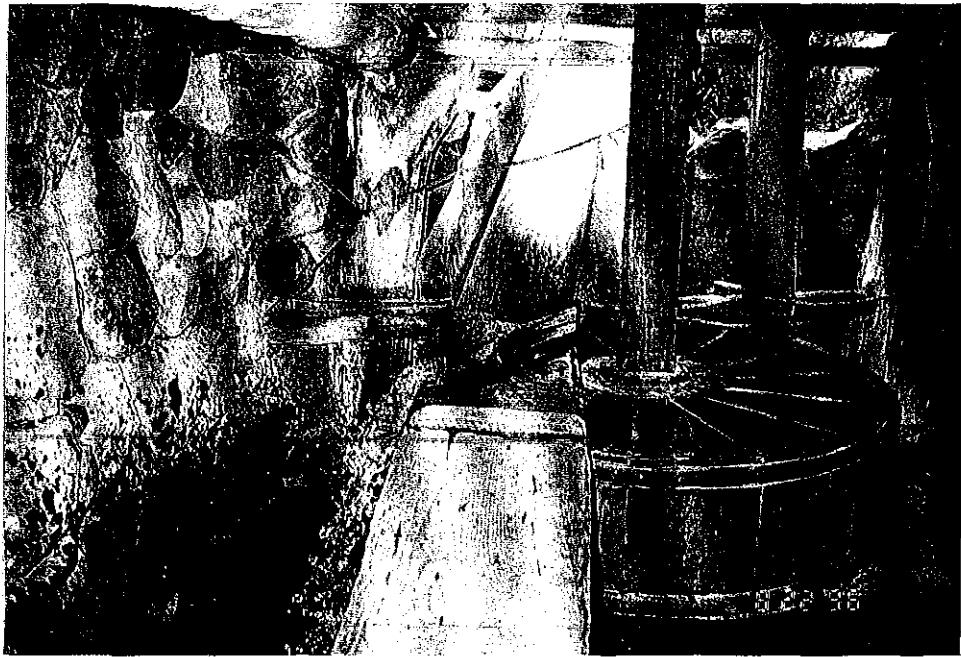
Figure 1-41 August 22, 1996. Water has been introduced into the acequia and wooden aqueduct for a demonstration. Here it is being diverted via the diverter board, away from the wheel (the "on-off" water control for the restored Truchas mill). One of the two pulleys which control the diverter board can also be seen at the left center of the photograph. El Rancho de las Golondrinas, Santa Fe, New Mexico.

The flow of water to the mill wheel was always controlled. Waterwheel, axle, and runner (upper millstone) were a fused unit. The millstone could not remain stationary while the waterwheel continued to rotate, as in mills with gear mechanisms and a clutch. Continued rotation when not in use would have caused the rapid deterioration of both stones. The flow was controlled by diversion at the ditch head or at some point along its course above the mill or, if the mill were on a ditch which was also used for irrigation, the water was diverted from the waterwheel itself. This diversion was accomplished by using a moveable sluice, or by securing a horizontal diversion board atop the mill wheel if the sluice itself was stationary [see Figures 1-41 and 1-42, page 1-40].

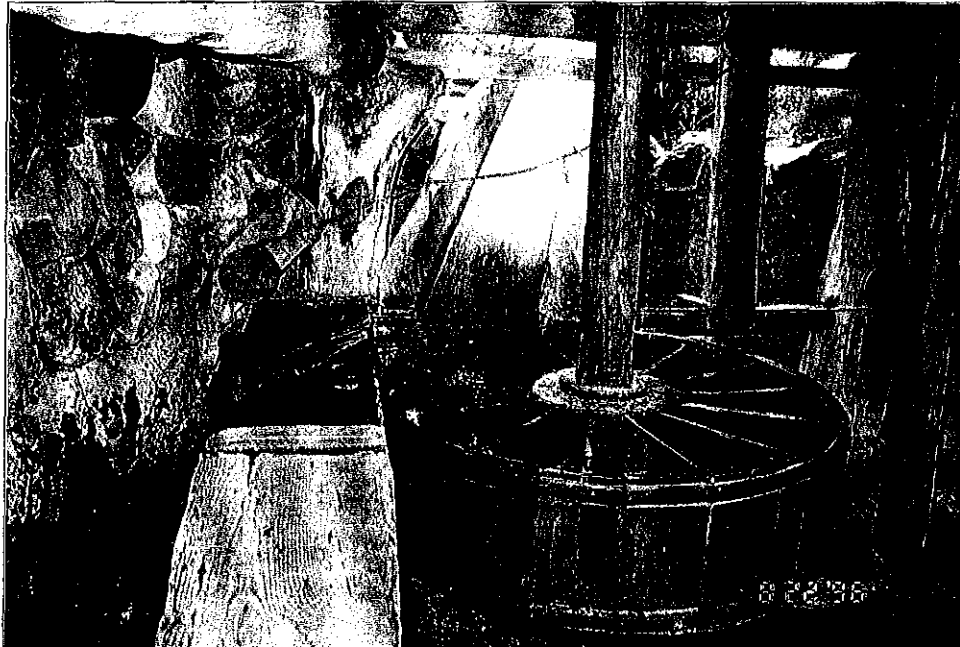
Figure 1-42 August 22, 1996. Water has been diverted to the wheel for the demonstration. El Rancho de las Golondrinas, Santa Fe, New Mexico.

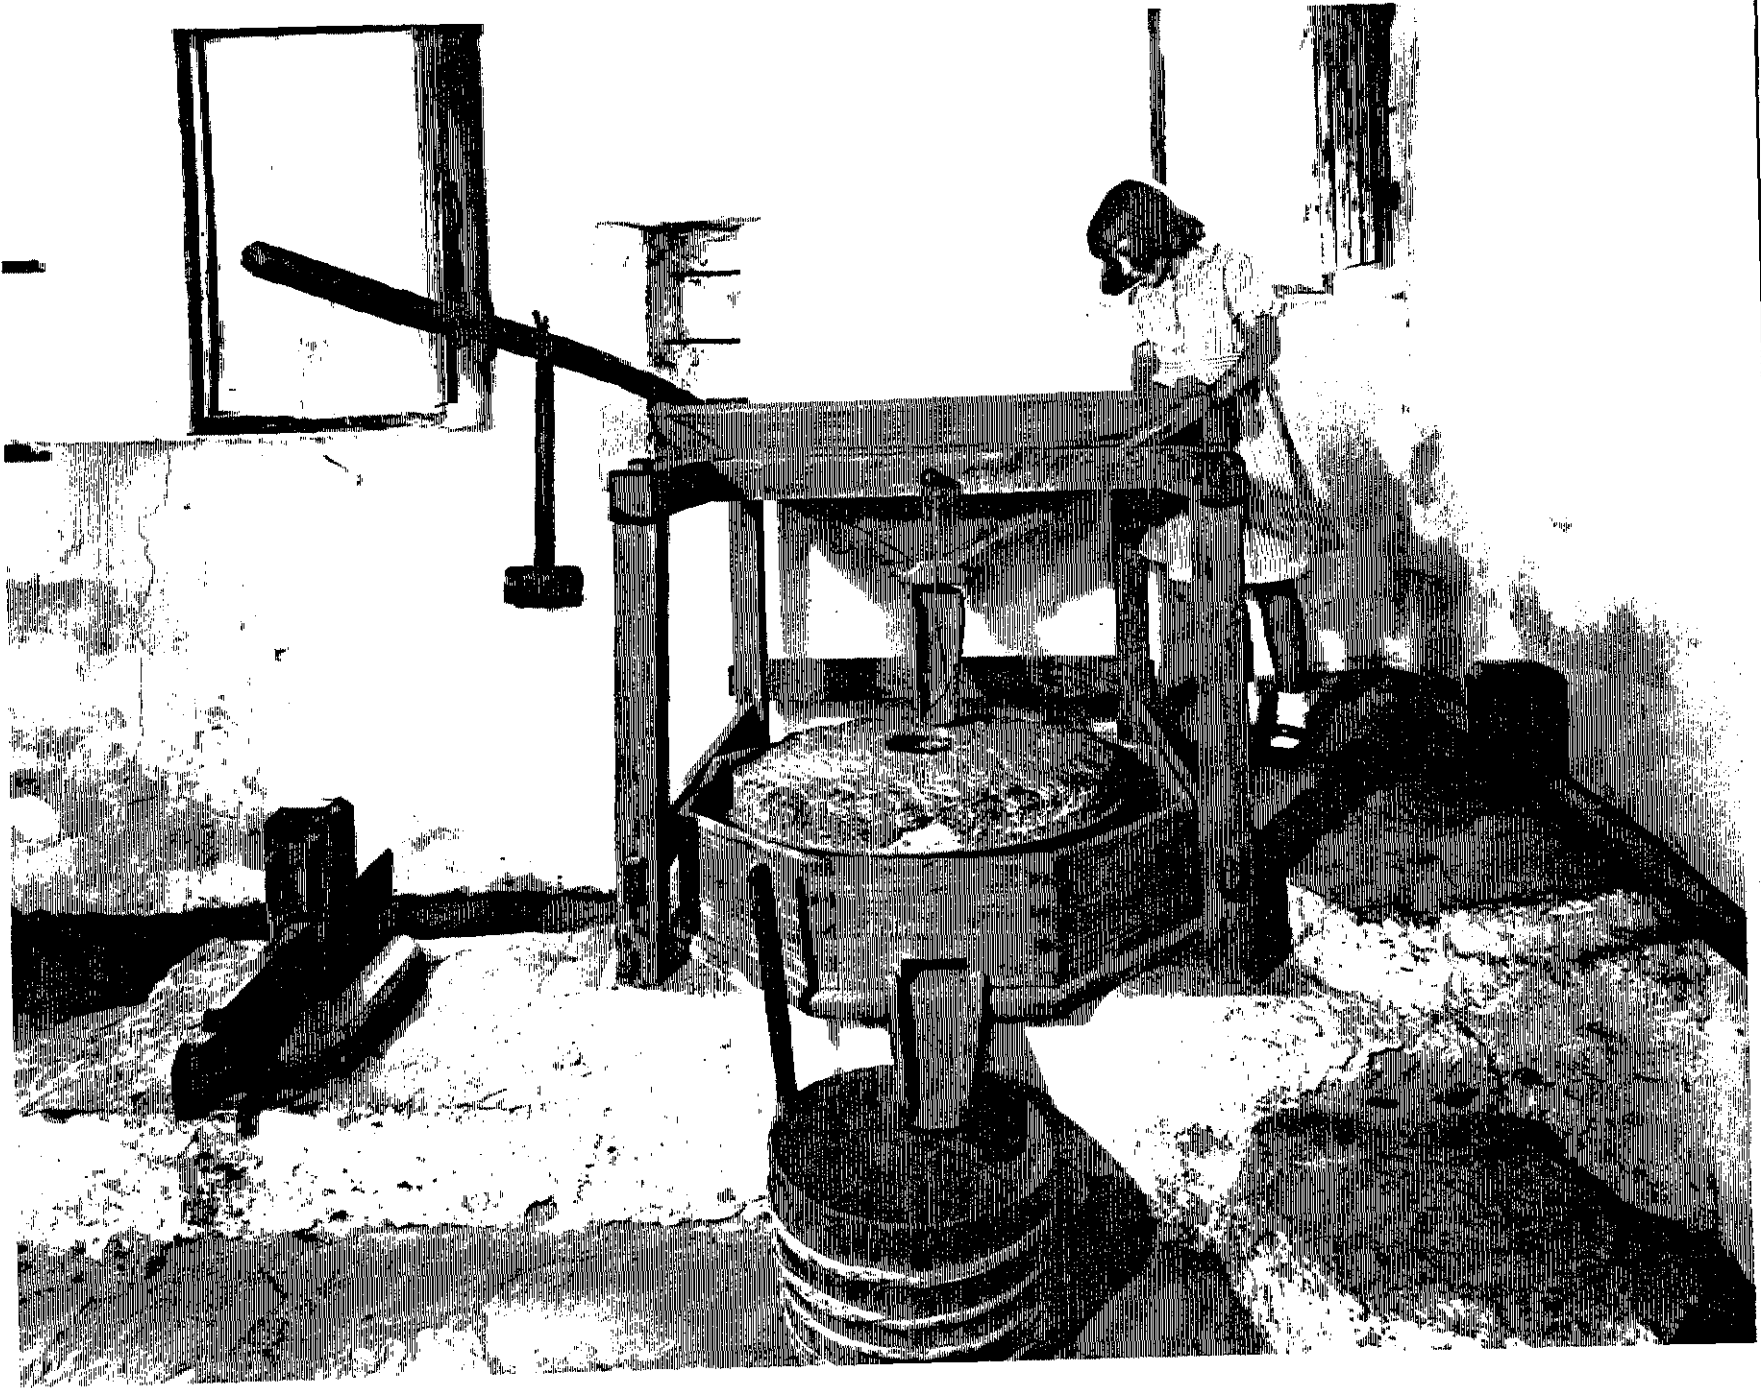
Figure 2-41 (Facing Page) ca. 1937. Looking south inside the milling room. This photo gives perhaps the best documentary evidence for replication of the various missing milling apparatus. One detail which has changed is the absence of a masonry block immediately north of the hole for the west tram rod (see Figure 3-95). Courtesy of the Daughters of the Republic of Texas Library.

1) Most of the extant apparatus sits on a masonry "table" (Figures 3-26, 3-94, 3-108, and 3-109). The table holds the lower milling stone in place and contains two sets of approximately 9-inch square holes from which the two tram rods enter the milling room from the lower level turbine room. Historical photograph 2-41 shows the two tram rods in place: the east rod was the adjustment rod, the west basically held the bridge tree in place. Figure 3-96 show details of the west opening; Figures 3-26, 3-94, 3-108, and 3-109 show details of the east opening. A masonry block which does not show up in Figure 2-41, but was in place as early as 1942 (see Figure

2) Immediately atop the masonry table is an oak casing for the mill stones seen in Figures 3-26, 3-94, and 3-97. This casing kept grain from flying loose around the milling room and also directed ground flour through a wooden chute (see Figures 2-40 and 2-41) to be collected. The chute, plus the wooden dowel and wire or cord holding it in place, are missing and must be re-created.

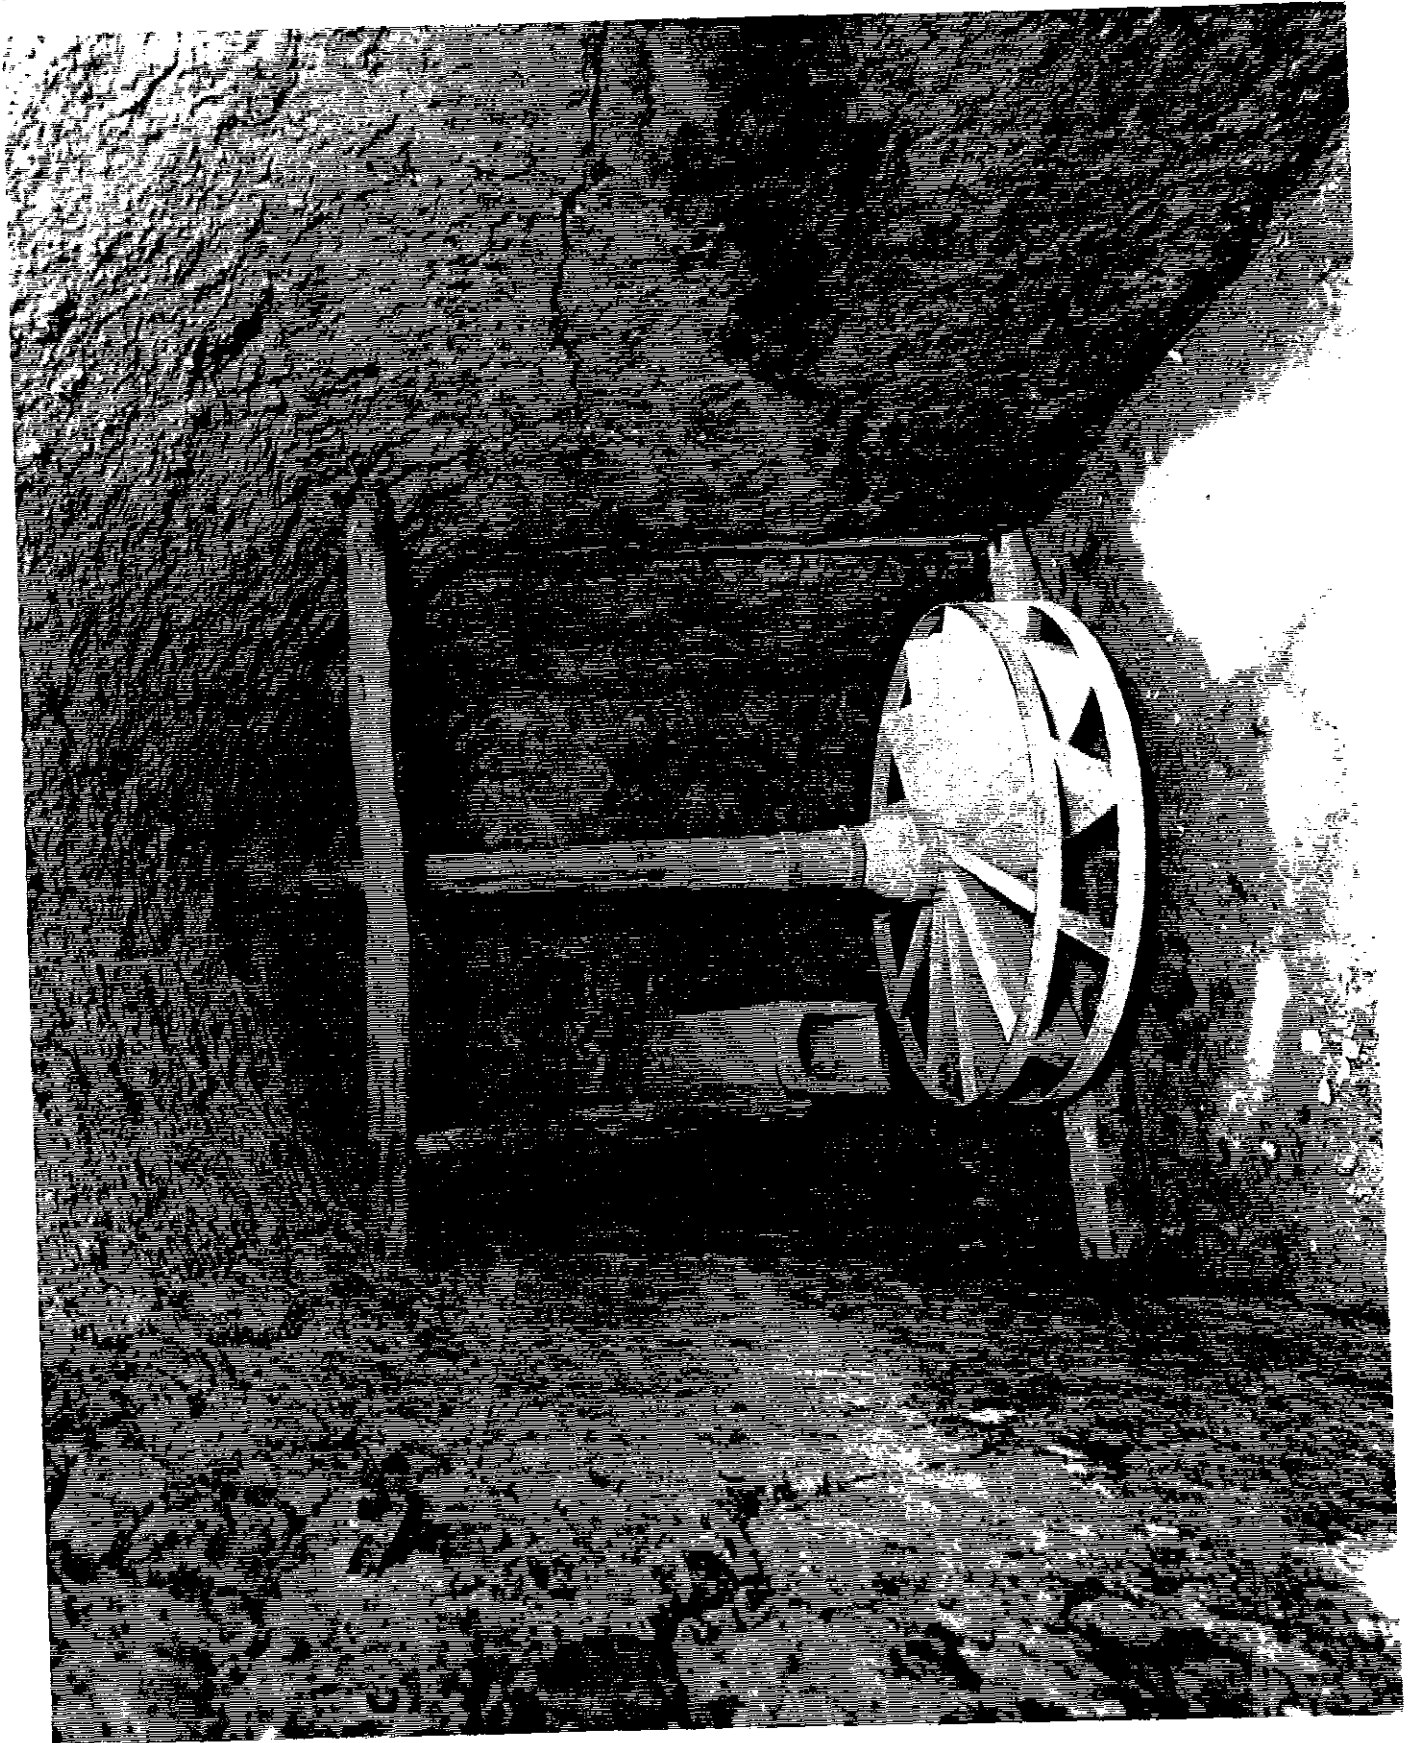
Figure 2-43 (Facing Page) ca. 1937. Looking south into the newly restored wheel room. All of the components of the milling mechanism: The restored wheel and main shaft, the two tram rods; the supported wooden water chute, and the bridge tree are all clearly visible. It is interesting and curious to note that the bridge tree looks as if it is resting on soil, not suspended from the tram rods as one would suspect. Courtesy of the Daughters of the Republic of Texas Library.

d. Bridge tree: Attempts were made in December of 1996 to locate the 1937 restored bridge tree (seen in Figure 2-43). Remnants were located and

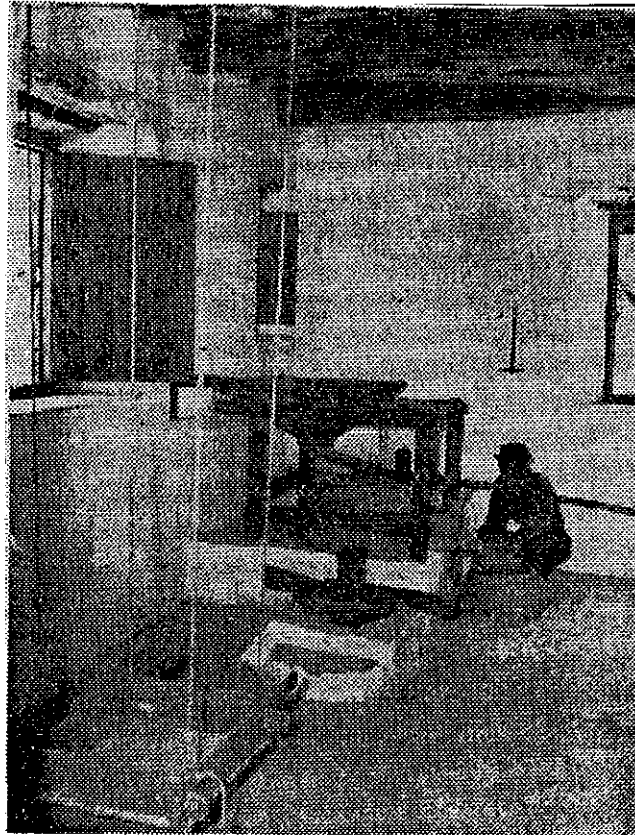
Figure 2-45 July 23, 1937. Photo from the *San Antonio Express* of the newly restored mill, looking south into the wheel room. Note the metal gate which has been installed, most likely for safety and security. If we assume a 4-inch spacing of the vertical bars, the gate would have been about 30 inches wide. A second section appears at the extreme top of the photo indicating that the upper section of the vault was closed in above the gate (presumably enclosing the semicircular section of the vault above the gate). Hardware for this gate was located during existing conditions investigations in 1996 (see Figures 3-66 and 3-67). Courtesy of the Daughters of the Republic of Texas Library.

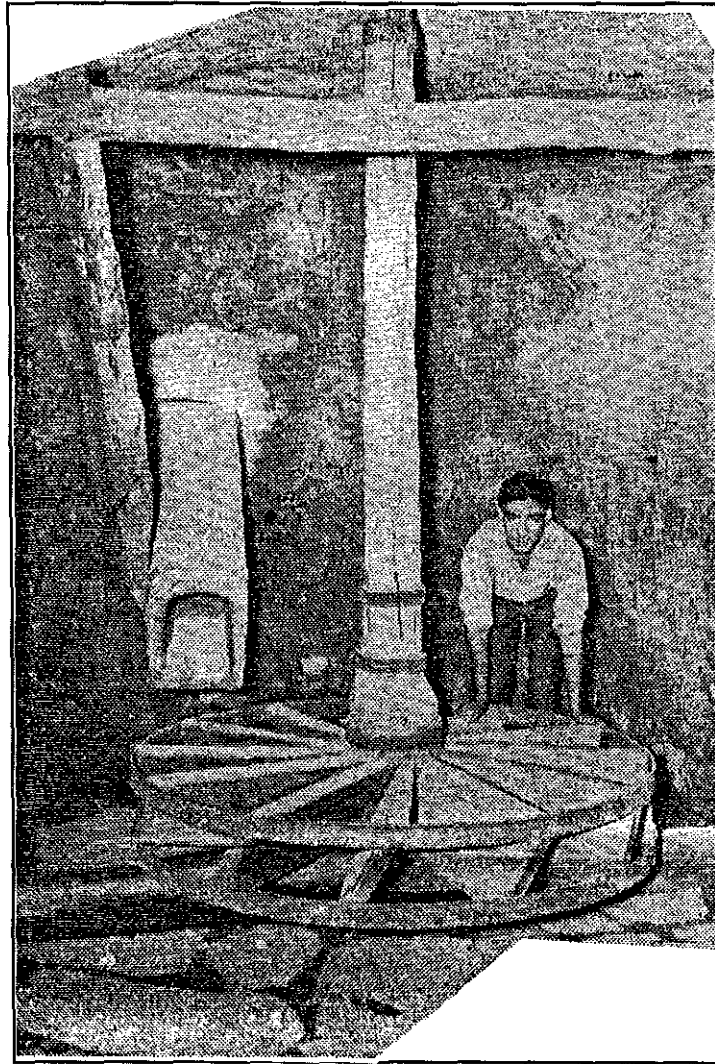
Figure 2-48 March 18, 1938. Photo from the *San Antonio Light* of the newly restored mill, looking into the forebay. The caption read, "B. Vallejo in sluice pit raises sluice gate letting water into bottom of mill through wooden pipe." (If this was true, Mr. Vallejo would be standing in water). This photo does give a good view of some of the operating mechanism particularly the forebay gate and attached control arm. Courtesy of the Daughters of the Republic of Texas Library. (The photo was cropped in the newspaper article).

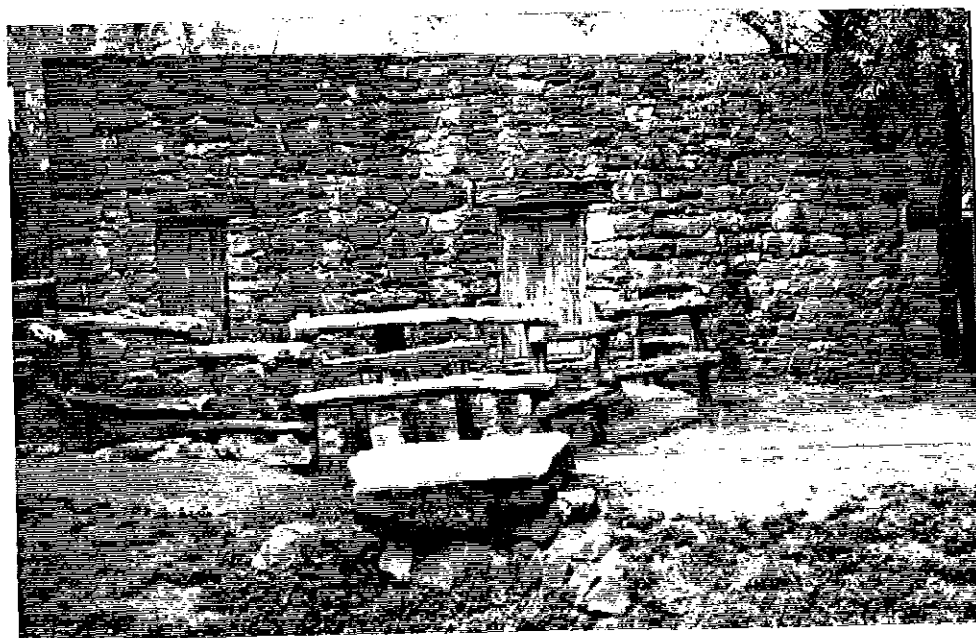
Figure 2-68 1981. South elevation. Note that the lower copper plaque described in Chapter 3 (Figure 3-41) is missing.

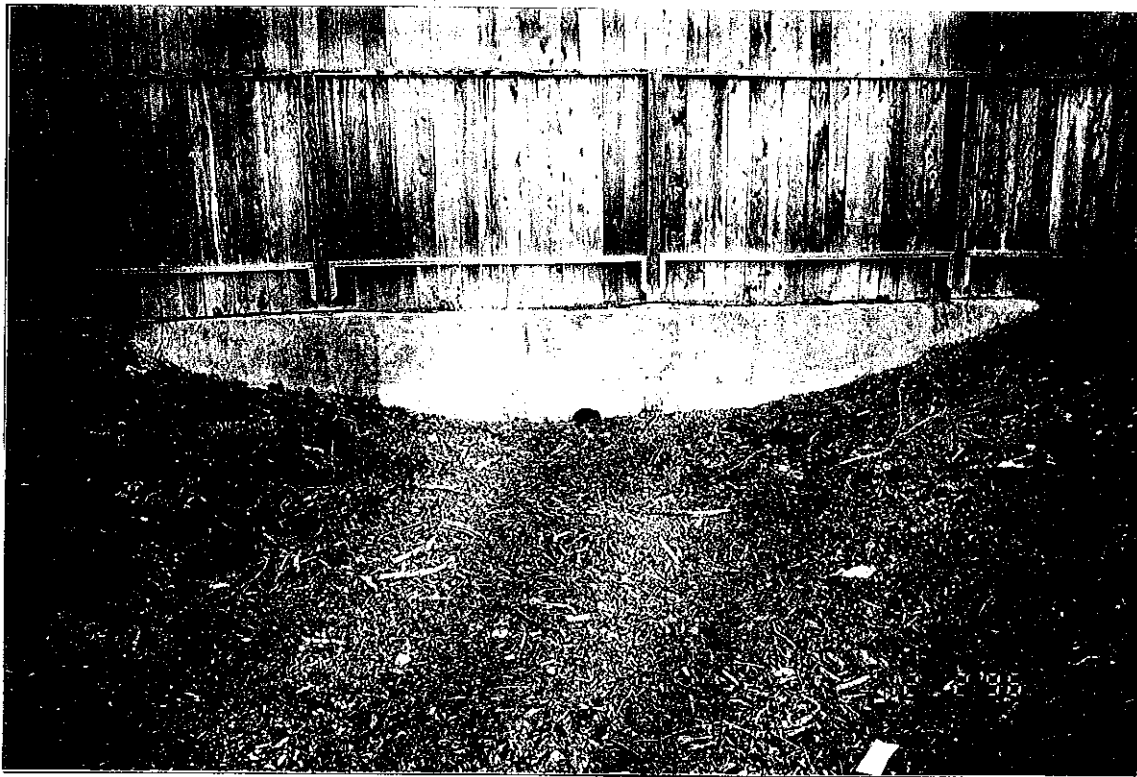
2. The stone-faced concrete wall below the board fence seen in Figures 3-6 through 3-8 was apparently constructed after 1951, as it does not show up on the "Topographic Map" prepared by the NPS in May 1951 (see Figure 3-5). A six-inch pipe goes through the wall connecting both sides of the *acequia madre*. Condition is very good.

Figure 3-7 December 2, 1996. Detail of the *acequia madre* near the conversation pit, the board fence, and the stone-faced concrete wall (the opposite side is stone-faced) beneath with embedded pipe.

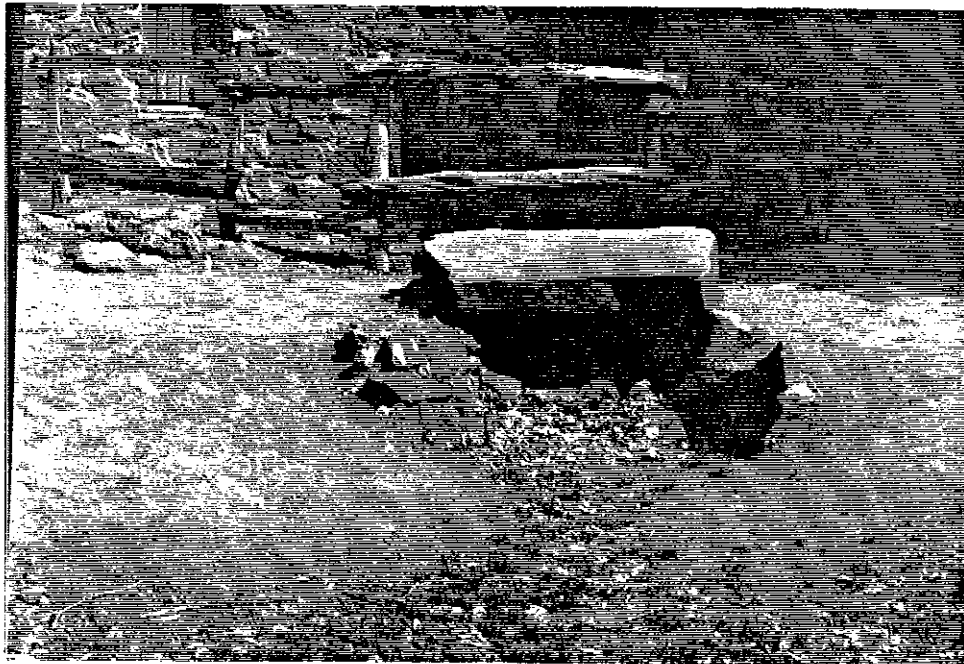
A stone-lined sluice constructed as part of the 1930s reconstruction (Figure 3-13) fed water from the *acequia madre* to the forebay of the mill. This sluice has a large slab of sandstone spanning it just south of the forebay. A similar arrangement is detailed on Harvey Smith's site plan of the amphitheater/mill complex (Figure 3-4). Archeology performed in December 1996 disclosed the full extent of the sluice (Figures 3-156 through 3-159). From historical photograph 2-47, the frame and lifting arm for the gate, which terminated the sluice immediately before the forebay, were identified. Three of the wooden pieces recovered from the turbine room and forebay in September 1996 matched the two grooved side channels and the top member (Figures 3-68 and drawings Figures 3-76 and 3-77). Mortise and tenon joints, and their respective peg holes matched exactly. Missing is an assumed bottom member, which would also have been grooved to accept the gate, would have been mortised to the two side rails, and set into a notch (see Figure 3-159) in the bottom of the masonry and cement sluice. Condition of the sluice is good, however, the stone at the inlet from the *acequia madre* and lining the bottom should be repaired. Several stones have come loose and the entire structure requires pointing.

Figure 3-13 June 1996. Detail of the stone lined and stone covered sluice from the acequia to the forebay in front of the mill (prior to excavation).
