GRIST MILL
Historic Structure Report

San Antonio Missions
National Historical Park
San Antonio, Texas

Mission San José

October 1997

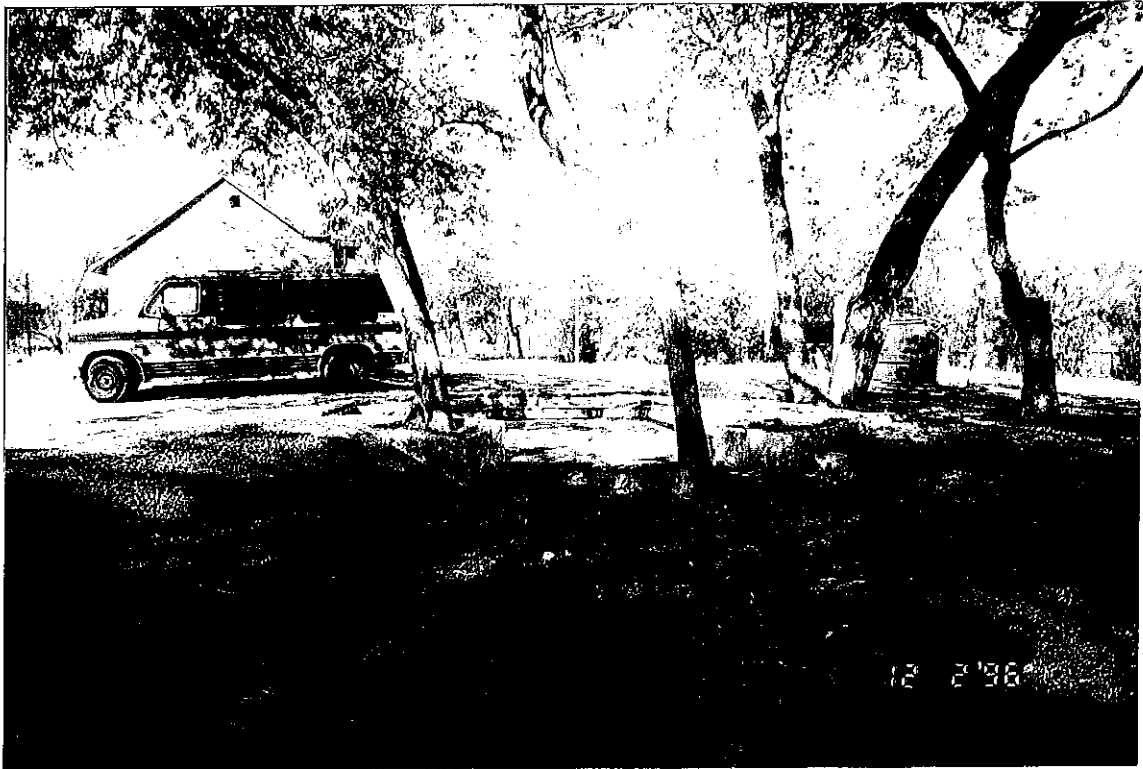
3. A real curiosity is the stone and concrete "conversation pit" (Figures 3-6, 3-14, and 3-15) which sits outside the board fence west of the mill. This structure forms the beginning of the extant portion of the *acequia madre* since it appears to sit right in the *acequia's* profile, but its exact use is thus far unknown. It, too, appears to have been constructed during the WPA period (see detail of flagstones in Figure 3-15). Condition is fair--portions of the "pit" have settled, and cracking is very obvious. There are no plans to restore this feature as an adjunct to the mill.

Figure 3-14 June 1996. View looking northwest toward the stone and concrete "conversation pit," which is situated just outside the board fence on the alignment of the acequia which fed the grist mill.

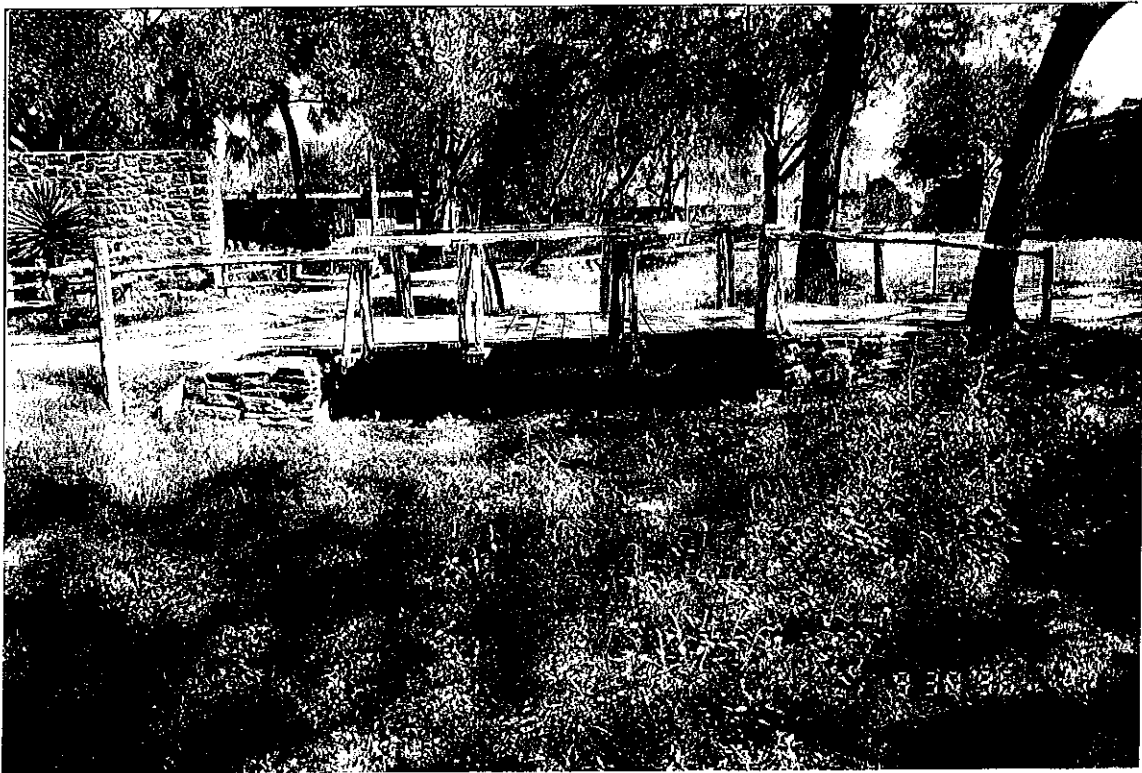
5. A wooden footbridge (Figures 3-18 and 3-19) crosses the *acequia madre* northwest of the mill. This footbridge apparently did not exist prior to the excavations and eventual reconstruction of the mill in 1937. The historical bird's-eye view (Figure 2-14) of the excavations indicate the stone steps mentioned above, but no bridge. Harvey Smith's designs for a bridge very similar to the existing bridge can be seen in his 1937 drawing, Figure 3-4. Two wooden footbridges were designed by Smith: One crossing the *acequia madre*, the second crossing the newly (in 1937) constructed mill race. Although existing construction is similar,

both bridges have been rebuilt over the years, and in the process, Smith's original detailing has changed (compare Smith's details in Figure 3-4, and Figures 3-18 and 3-140). Existing construction is 2x12 treated joists supported on masonry abutments with 2x10 treated decking. Rails are of cedar. Condition is good.

Figure 3-18 September 30, 1996. Detail of the wooden bridge which crosses the acequia just southwest of the mill (looking east).

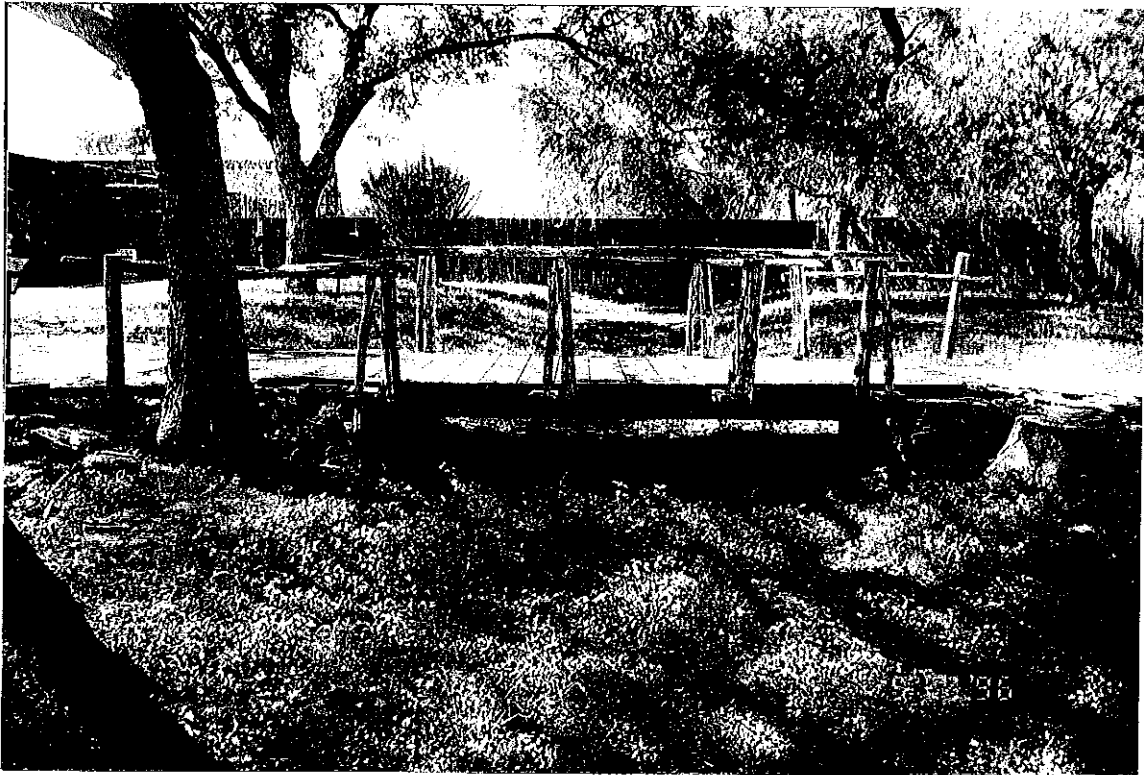
Figure 3-19 September 30, 1996. Detail of the wooden bridge which crosses the acequia just southwest of the mill (looking west).

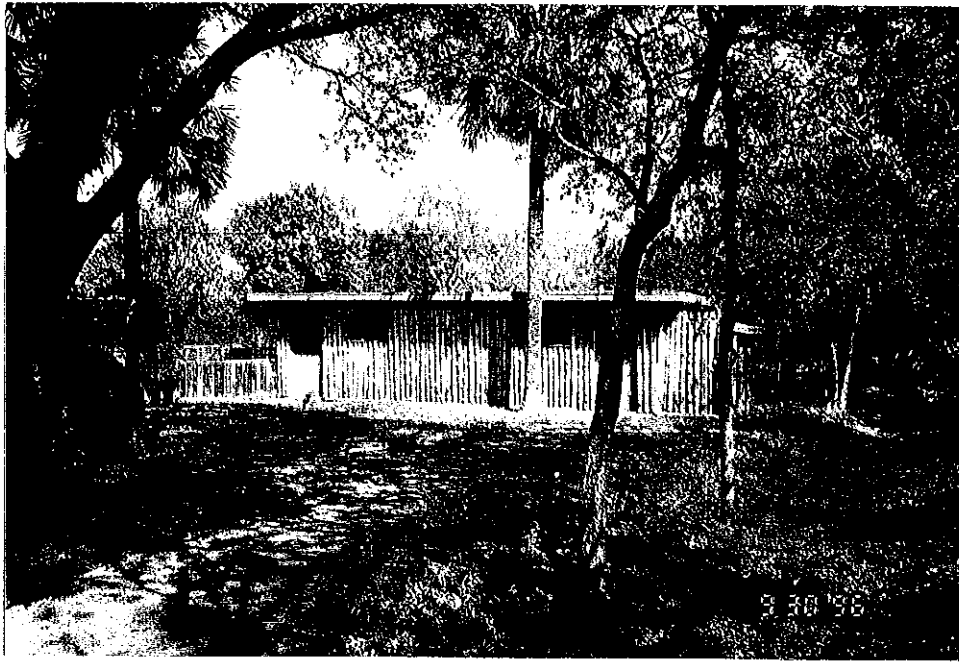
Figure 3-22 September 1996. Modern (ca. 1970) concrete block dressing room which has been sheathed in halved cedar logs in an attempt to help blend the structure with its surroundings. This structure sits almost due east of the mill and is a modern intrusion into the historic scene. The acequia, which terminates just south of the building, can be seen in the lower right corner of the photograph.

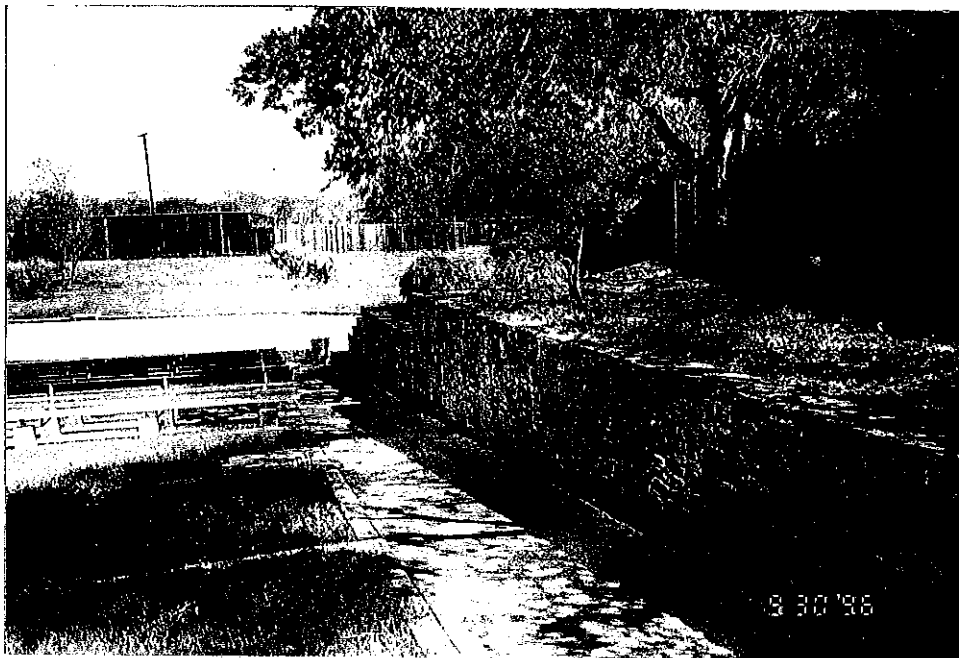
Figure 3-23 September 1996. View of the modern amphitheater, looking east toward the stage.

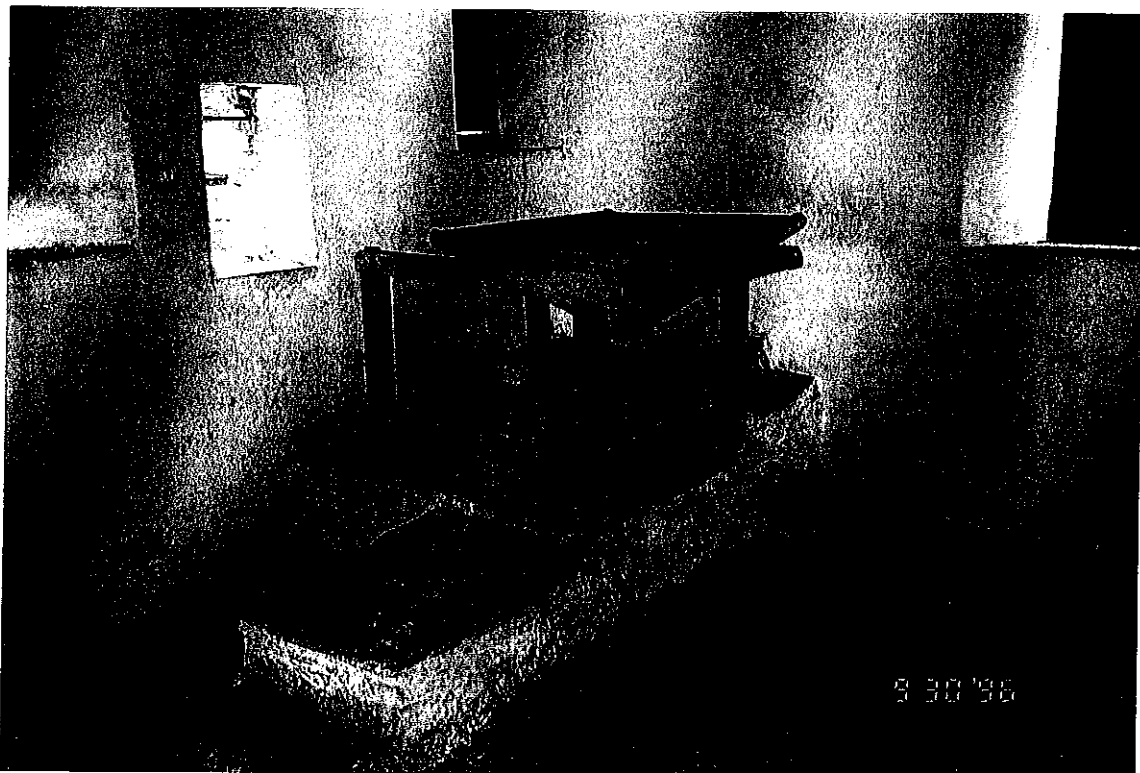
Figure 3-26 September 30, 1996. View into the milling room looking southwest.

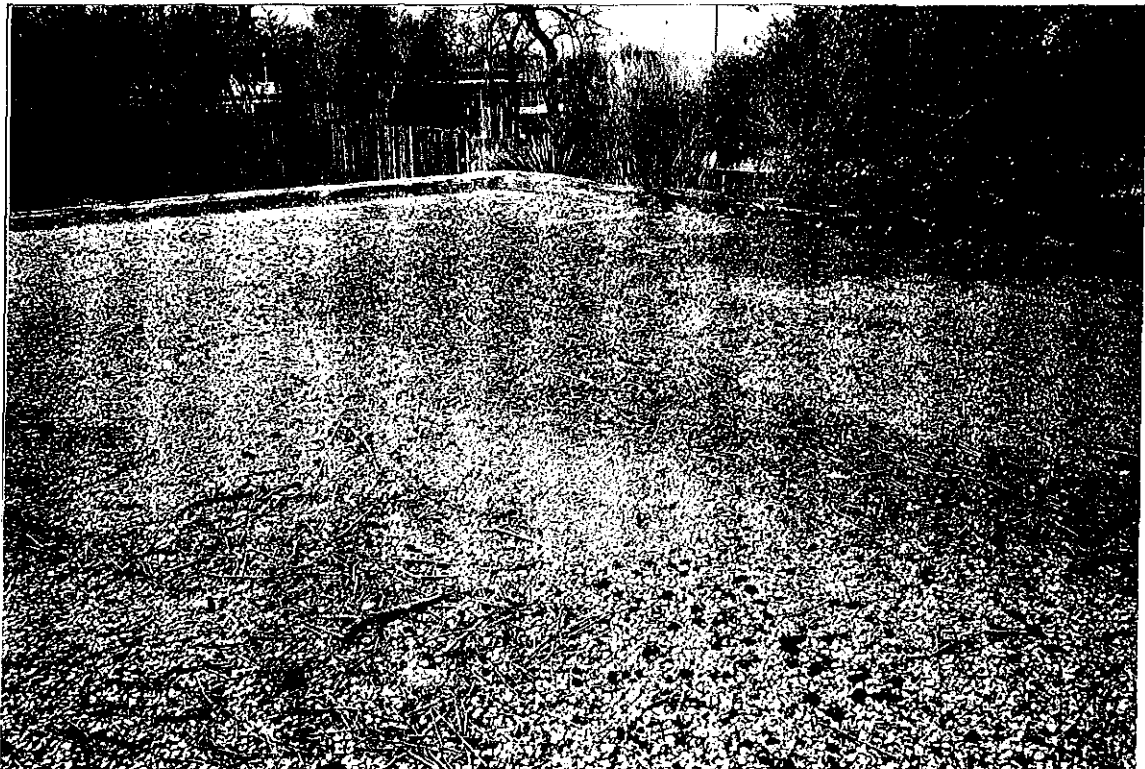
1. Roof (Figures 3-27 through 3-35): The roof is a modern built-up system with a very shallow parapet and asbestos-laden, asphalt impregnated flashings. The roof slopes gently north to a single *canal* (drain), Figure 3-35. Looking at three historical illustrations: the ca. 1937 Historic American Buildings Survey (HABS) photo (Figure 2-39); the *San Antonio Express* July 23, 1937 newspaper article (Figure 2-44); and the 1937 sketch of the mill by "E.F.S." (Ernst F. Schuchard)--see Figure 2-53, it appears that the roof system installed during the 1936-1937 restoration may have been lower, given the placement of the drains in these historical illustrations. In the case of Figure 2-39, the wooden drains (the existing single drain is concrete formed to resemble a hollowed log) is shown approximately 24 inches down from the edge of the parapet. Contemporary evidence (Figures 3-29 through 3-35, and 2-70) has disclosed location of all three wooden drains installed in the 1930s. Condition of the roof is very good; removal and proper disposal of asbestos-laden flashings will need to be considered in the future (they are not currently in a friable condition).

Figure 3-27 January 17, 1997. Roof of mill looking northwest. The surface is built up with gravel ballast and one drain formed of concrete to resemble a hollowed out log. The parapet is only two to three inches high, and is composed of asphalt impregnated asbestos fabric flashing.

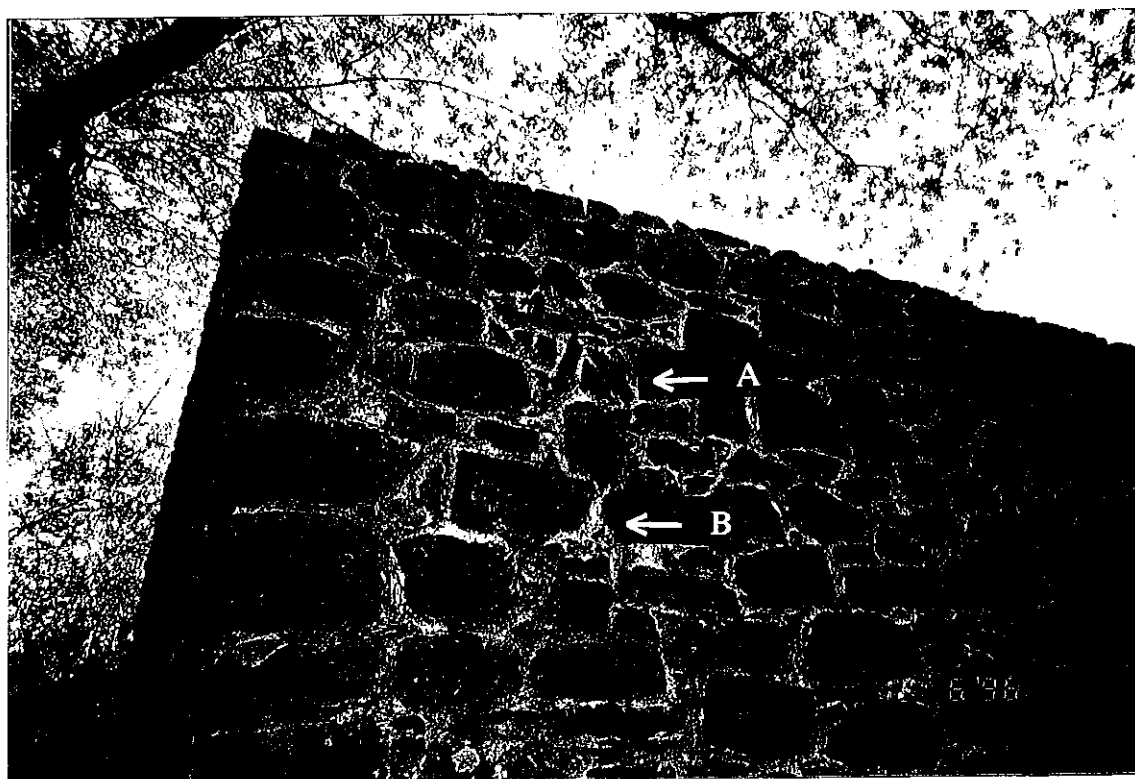
Figure 3-29 December 6, 1996. Detail of upper northeast elevation indicating possible presence of removed wooden drain in this location. Arrow "A" points to inverted "V" arrangement of flagstones used in the 1930s to form a lintel-arrangement above all wooden drains installed at that time (see Figure 3-34). In the 1960s, during the re-roofing of the mill and Indian quarters at Mission San José, all wooden drains were closed off (the mill's were also removed) and concrete drains formed to resemble wood, were installed. Arrow "B" points to tar drips immediately below this inverted "V" indicating that a drain did indeed exist at this location.

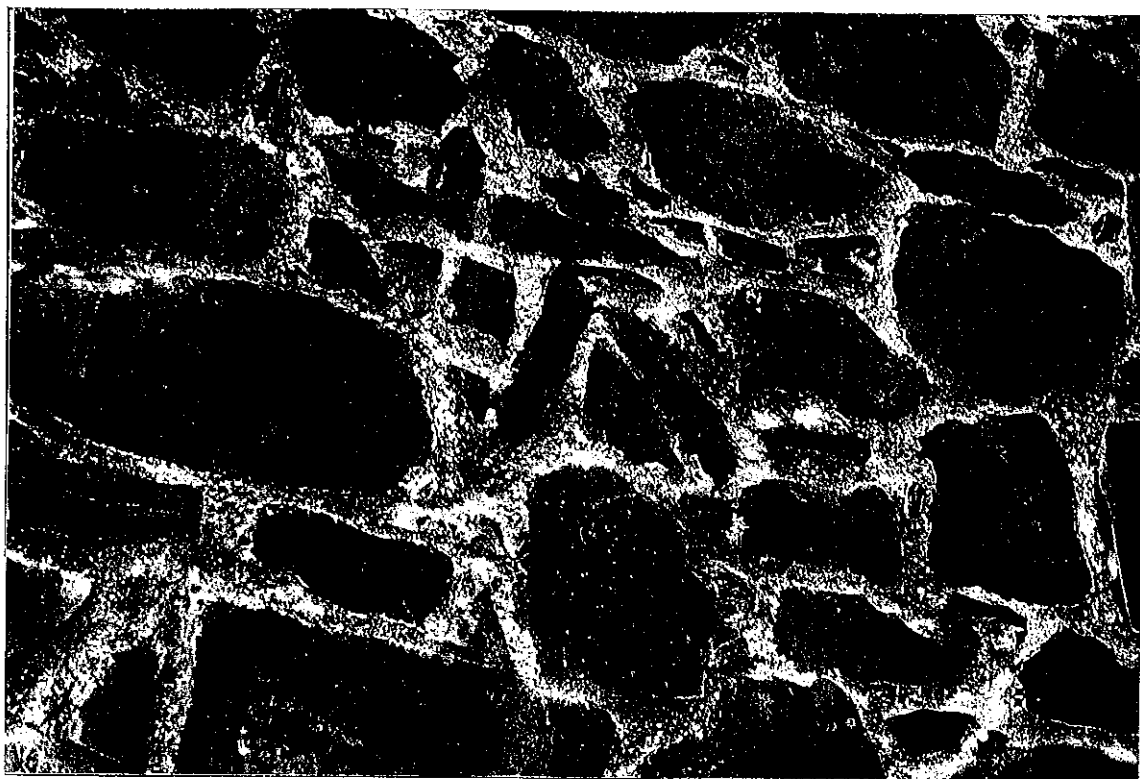
Figure 3-30 December 6, 1996. Enlarged view of inverted "V" arrangement of flagstones described in Figure 3-29.

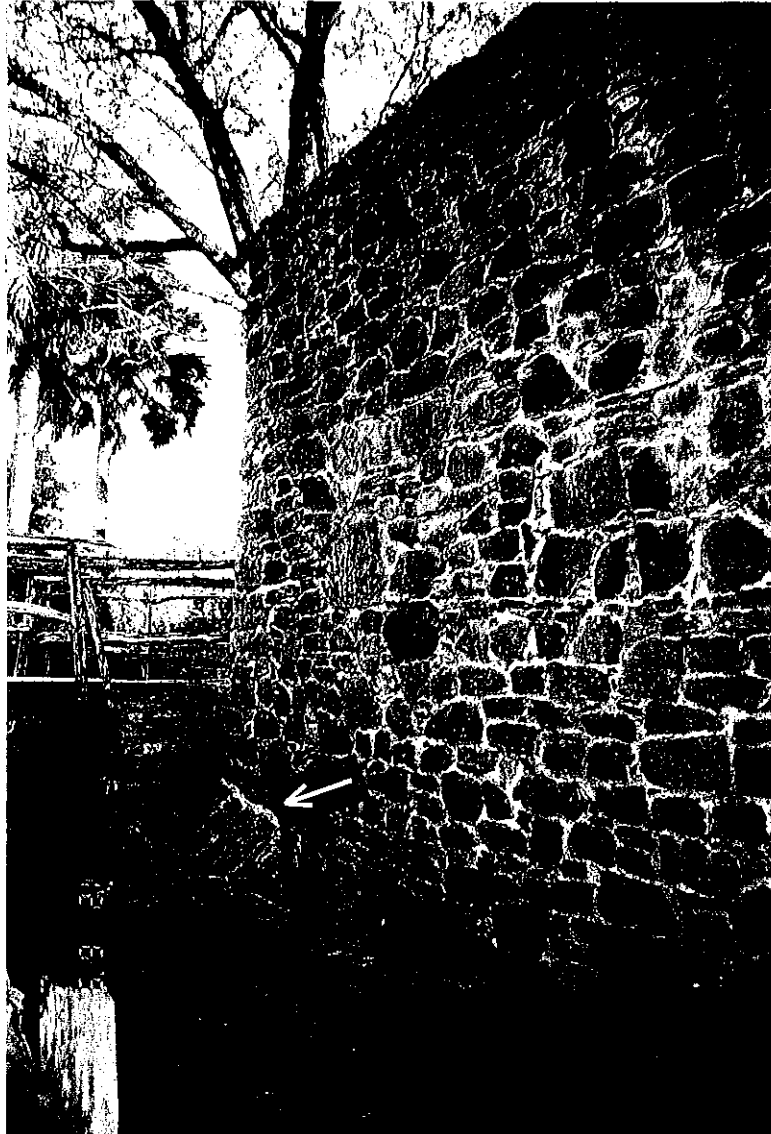
Figure 3-31 December 6, 1996. Detail of eastern end of north elevation. Arrow points to the "stone-and-cement catchment apron" described in Chapter 2 (page 2-19), which was apparently enlarged per Erik Reed's 1946-47 Annual Report for the Mission San Jose National Historic Site (NHS).

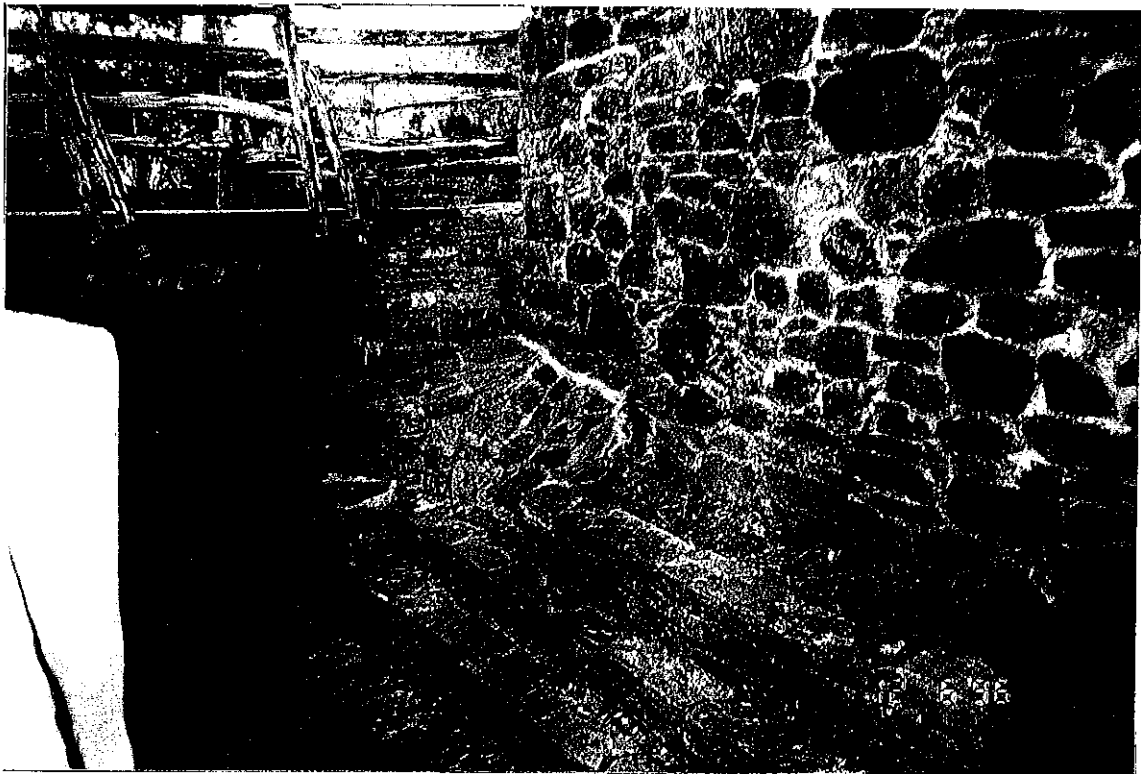
Figure 3-32 December 6, 1996. Enlarged view of "catchment apron" described in Figure 3-31.

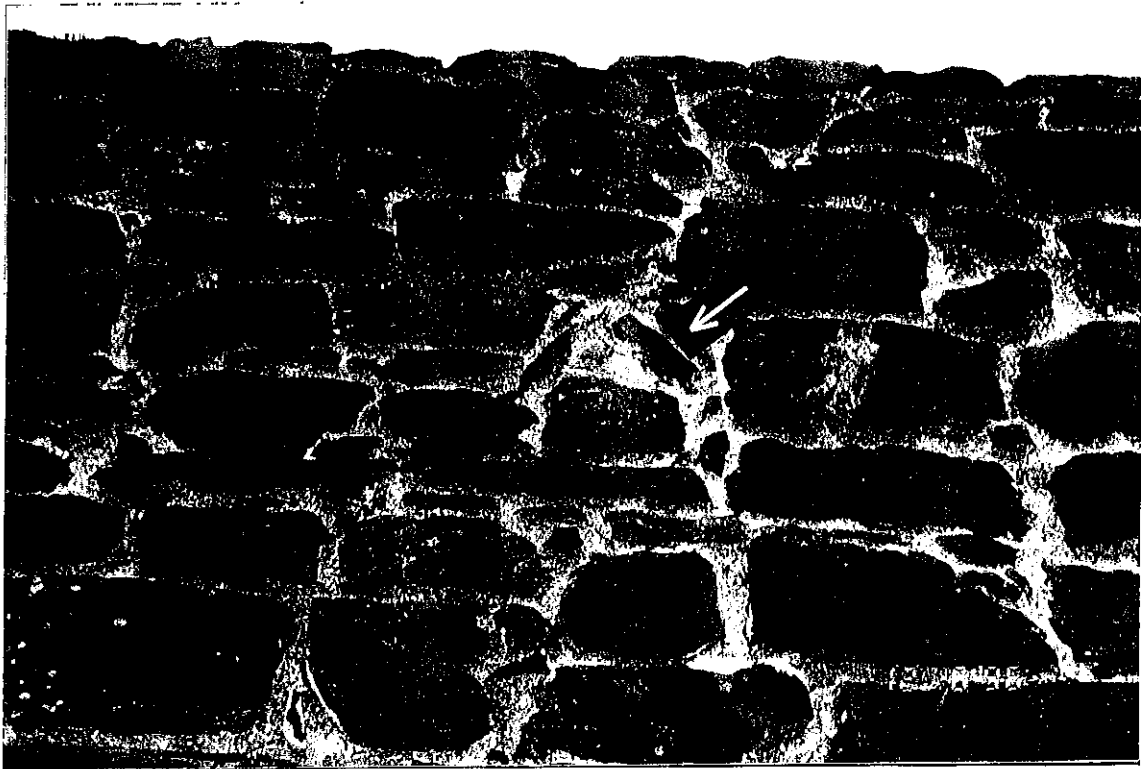
Figure 3-33 December 6, 1996. Detail of upper northwest elevation indicating possible presence of removed wooden drain in this location. Arrow points to inverted "V" arrangement of flagstones used in the 1930s to form a lintel-arrangement above all wooden drains installed at that time (see Figure 3-34).

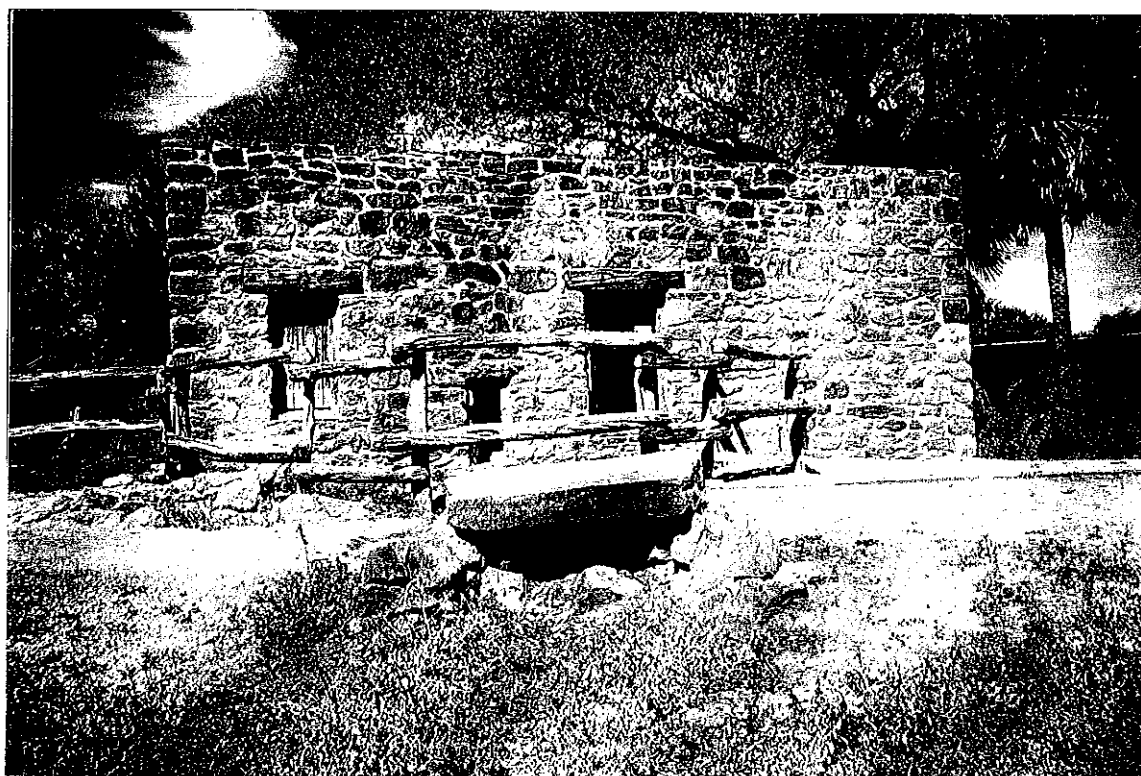
Figure 3-36 September 30, 1996. Overall south elevation. Note the huge slab of sandstone spanning the sluice. This stone (or one similar) is indicated in Smith's 1937 site plan of the mill area (Figure 3-4).

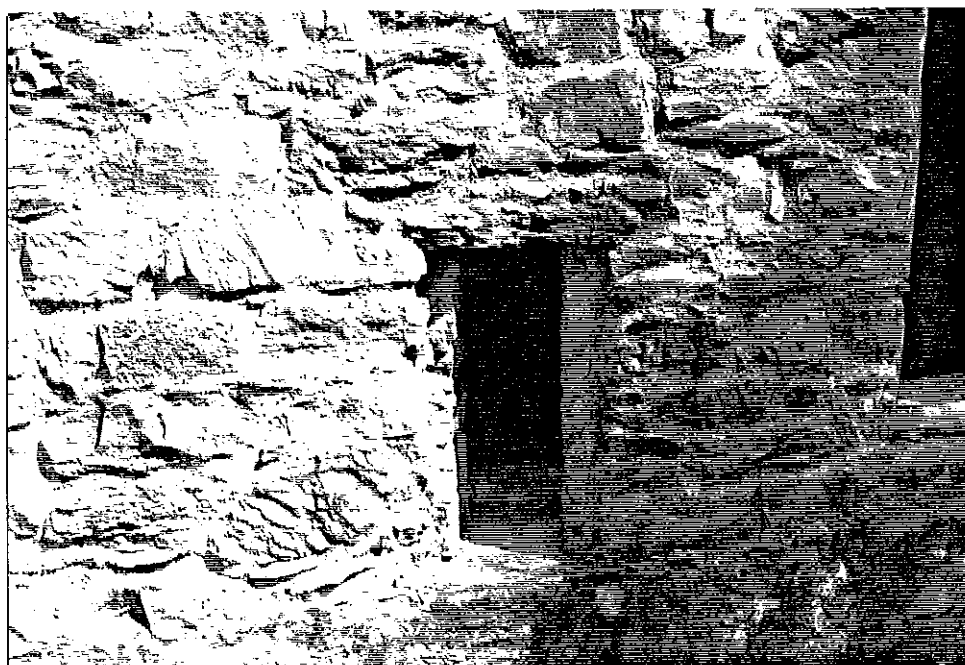
Figure 3-38
June 1996.
Angled Window immediately above the forebay, which held the lifting arm for the gate chute inside the forebay. The angle is toward the west.

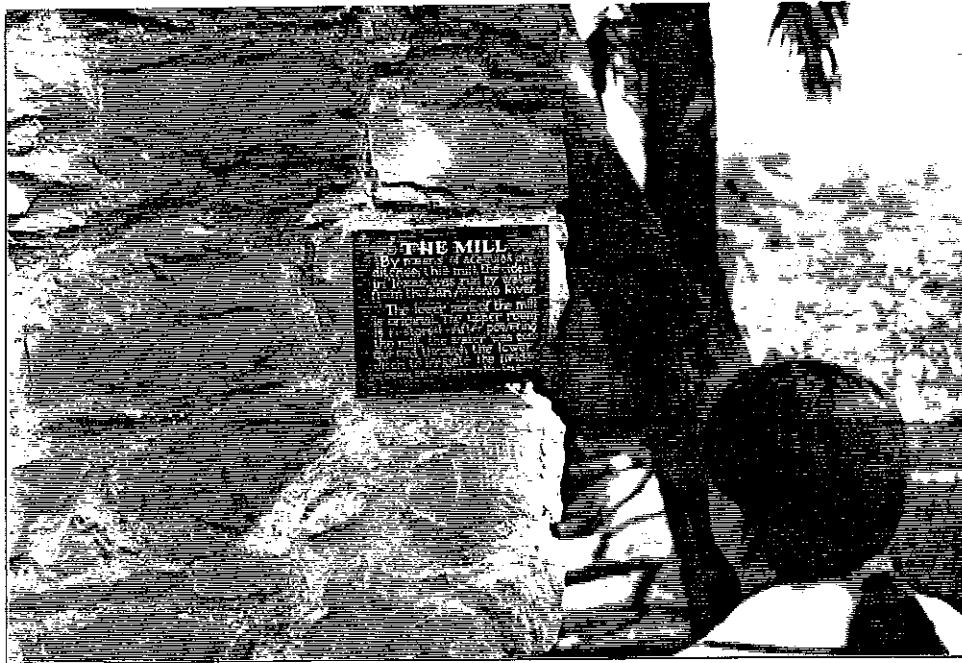
Figure 3-41 June 1996. Detail of the mill plaque, south exterior elevation.

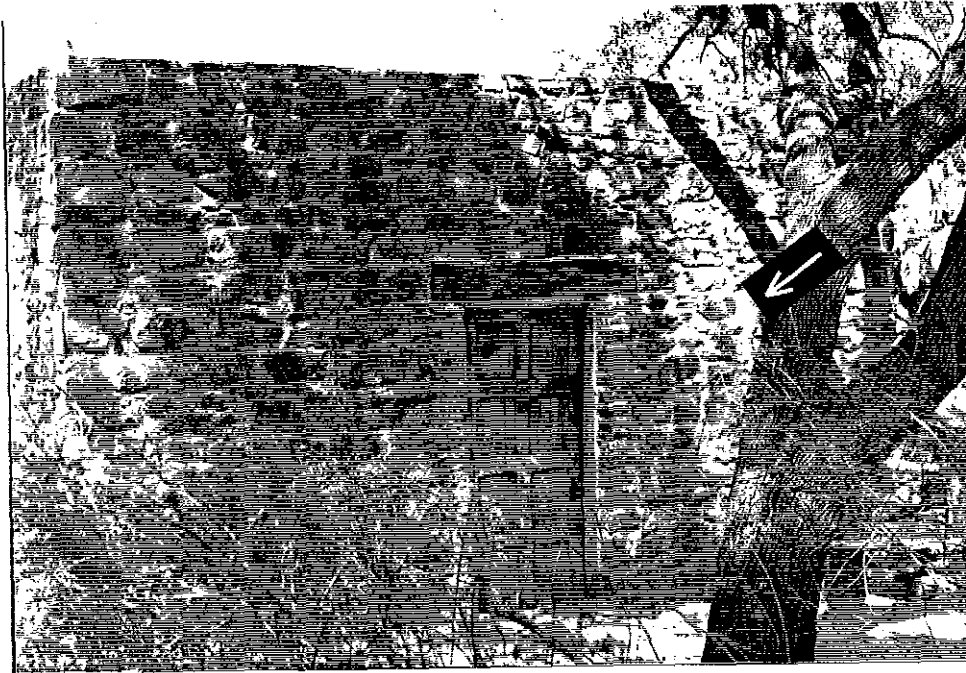
Figure 3-43
June 1996
East exterior
elevation. The
arrow points to the
covered junction
box seen in Figure
3-46.

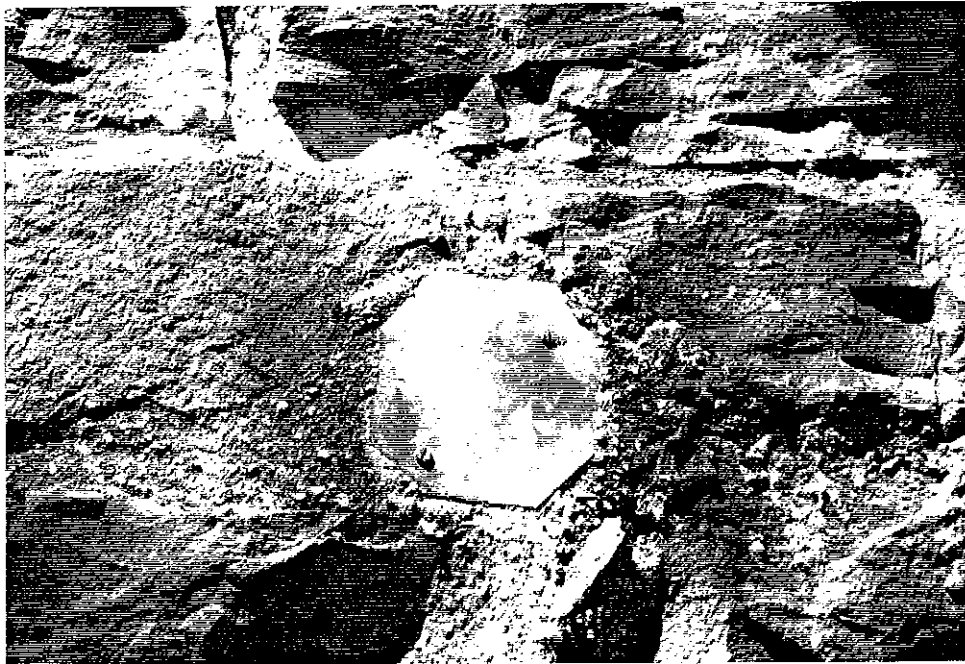
Figure 3-46 June 1996. Detail of an embedded electrical box with a cover on it on the east exterior elevation.

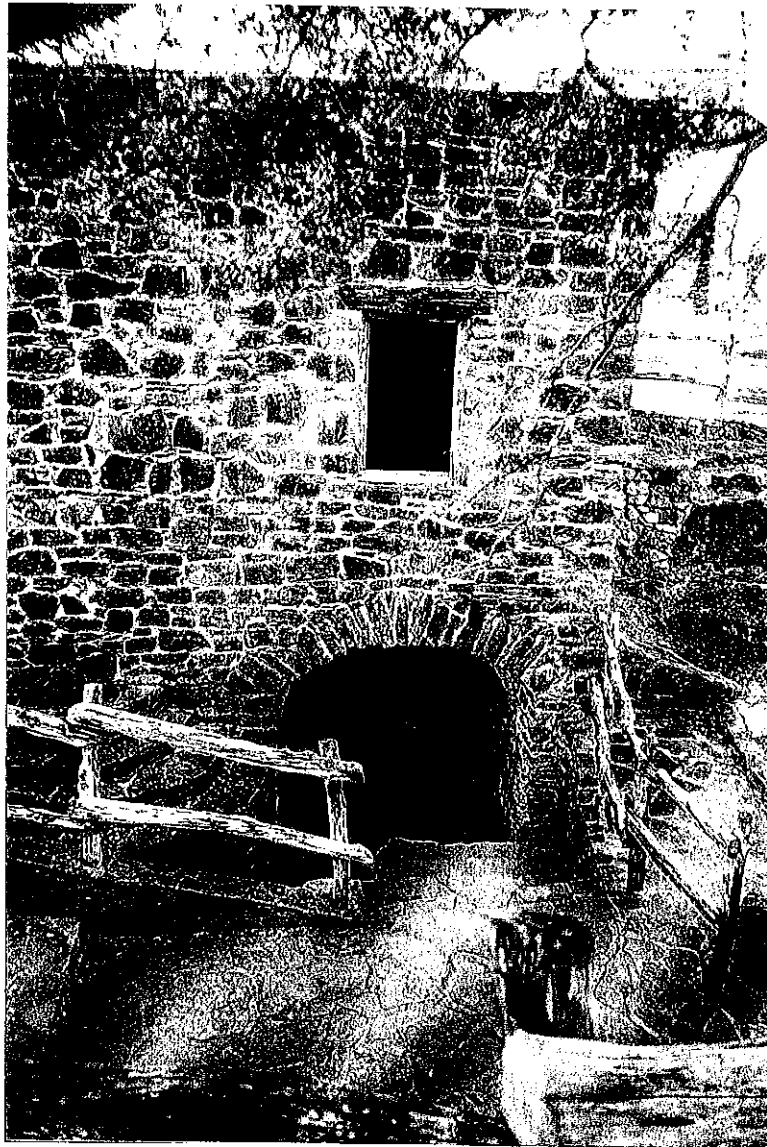
Figure 3-47 June 1996. Overall north elevation of the mill. There is one shuttered window at the northwest corner. The arched stonework above the wheel room vault can be seen at the lower right of the photograph.

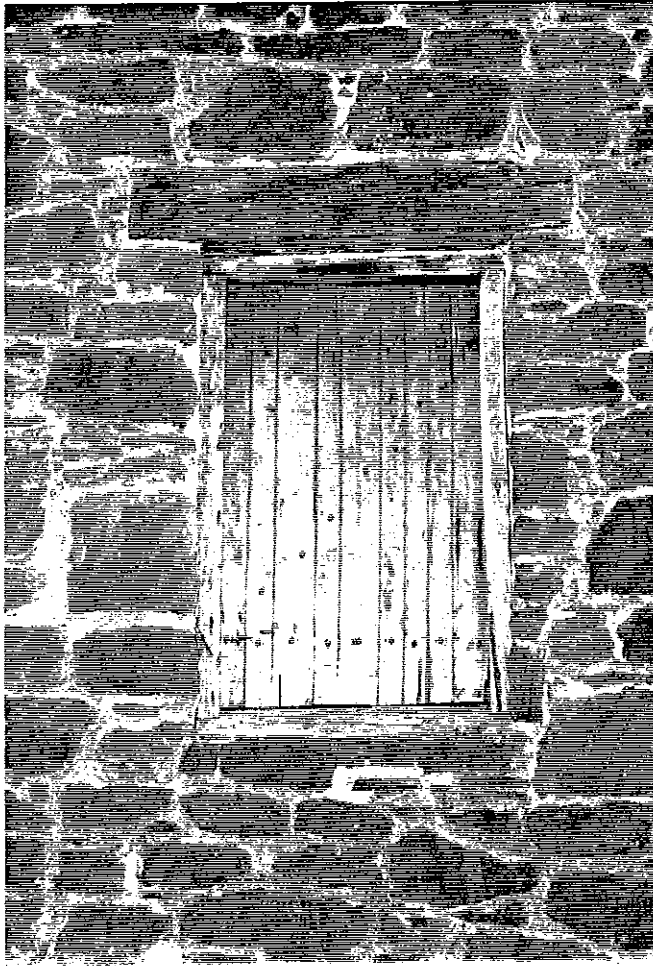
Figure 3-48 June 1996. Detail of the window/shutter in the north elevation.

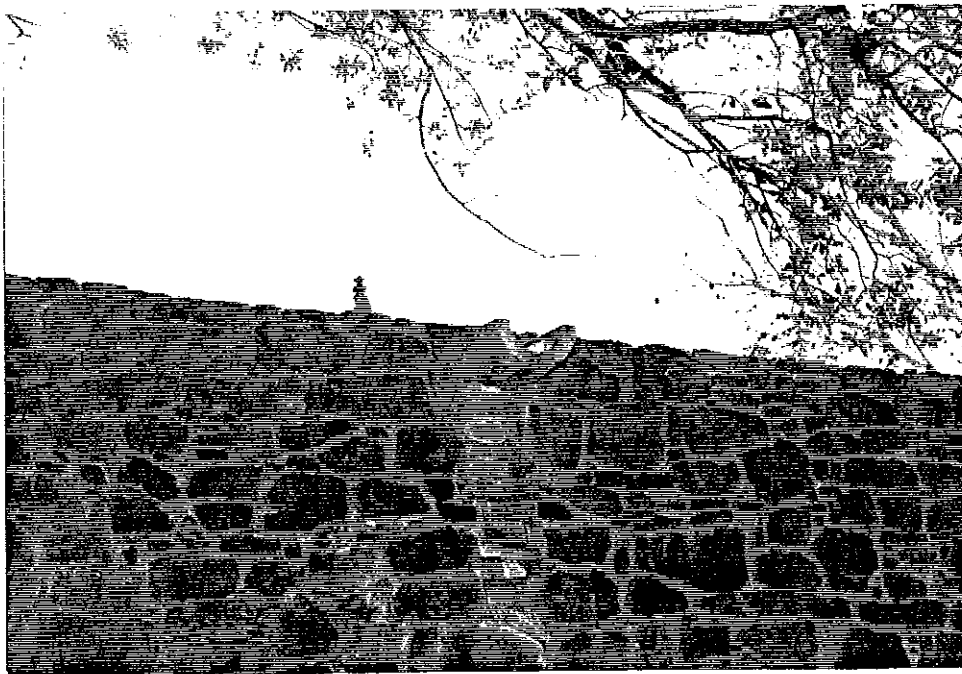
Figure 3-49
June 1996.
Detail on the north elevation of the simulated wood drain, fashioned out of concrete. Many of these drains were installed by the State on the Indian quarters of the San Jose compound in the 1960s.

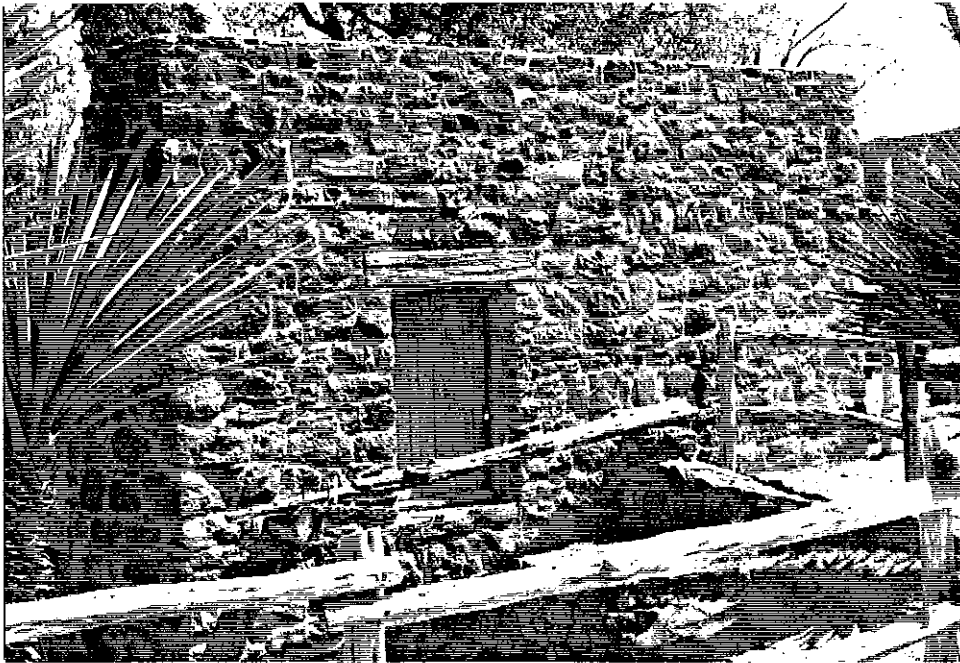
Figure 3-50
June 1996.
Overall west elevation. Timber at base of window is a remnant of the "shed" roof which was installed in the late 1940s or early 1950s.

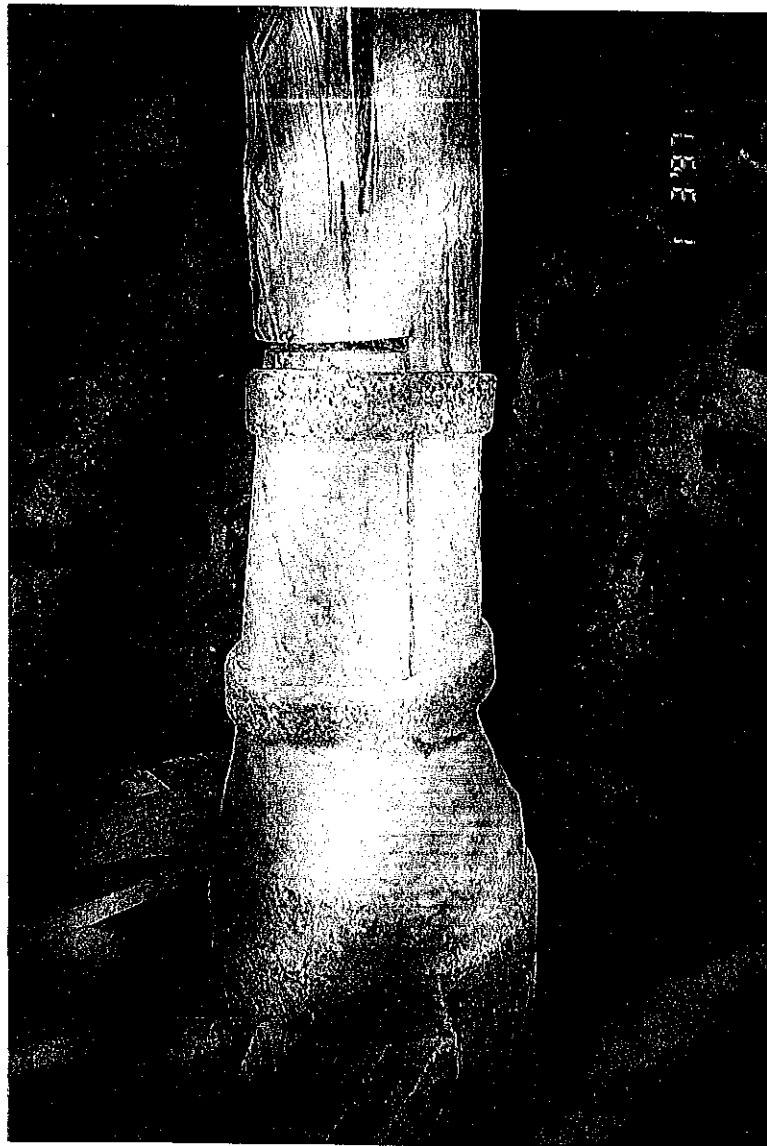
Figure 3-55 January 3, 1997. Detail of the main shaft - splice just above the water wheel held together by two metal bands would have allowed for ease of removing and maintaining either the wheel or shaft.

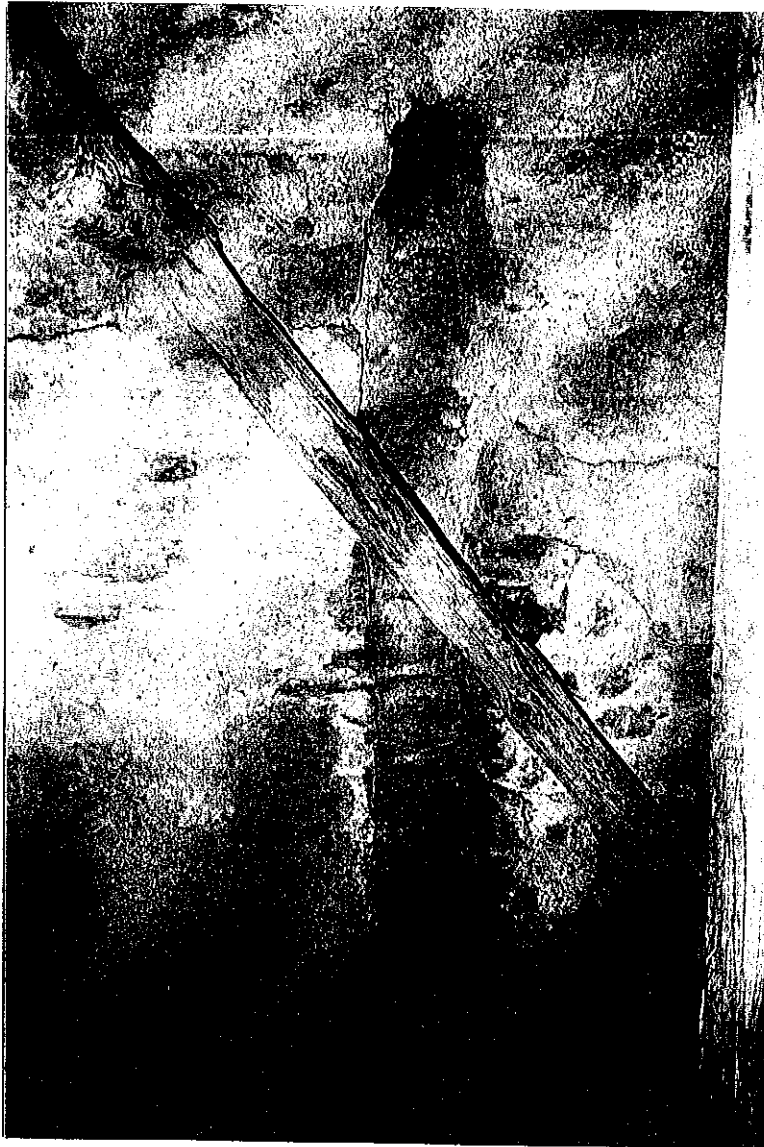
Figure 3-61 September 25, 1996. Detail of the east wall notch with the tram rod removed (all wooden members were removed for storage in September 1996 for safe-keeping, and detailed measuring and analysis), see Figures 3-68 through 73.

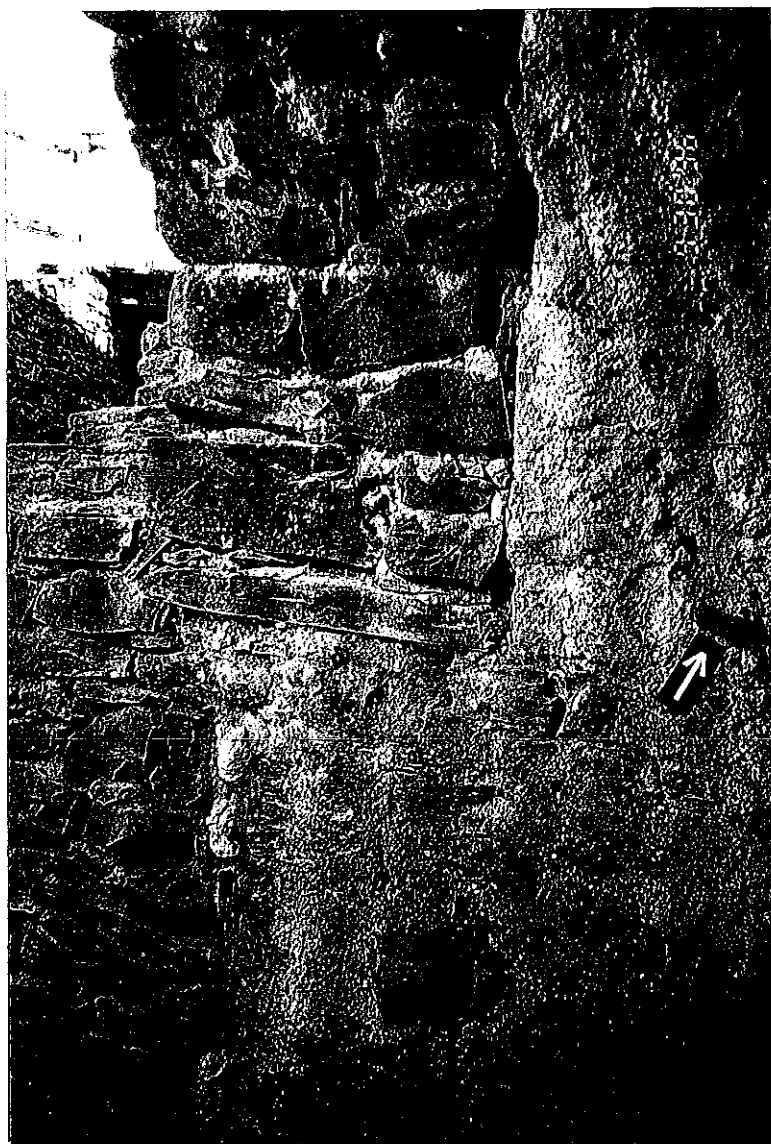
Figure 3-66 September 30, 1996. Looking southeast along the junction of the historic wall/parging (at the right of the photograph) and the 1930s restoration masonry. The joint between old and new is obvious. The arrow points to what looks to have been a hinge pin for a metal gate which shows up in one of the historical photographs associated with the San Antonio Express newspaper article, July 23, 1937 (Figure 2-45). There are four pieces of metal sticking out of the wall, two on either side that would have held the gate.

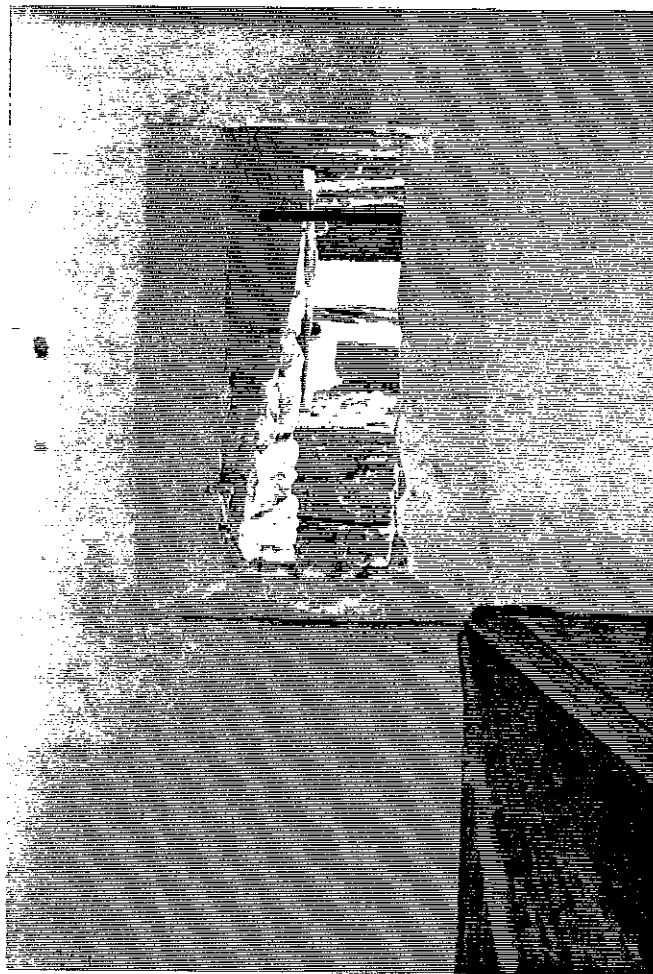
Figure 3-89 June 1996. Detail of the oblique opening in the center of the south elevation which held the lifting arm for the forebay sluice gate (see Figure 2-36). Note the horizontal metal rod spanning the opening at the top -- Figure 2-36 shows two metal rods. Figure 3-90 shows evidence of the second rod which was missing in 1996.

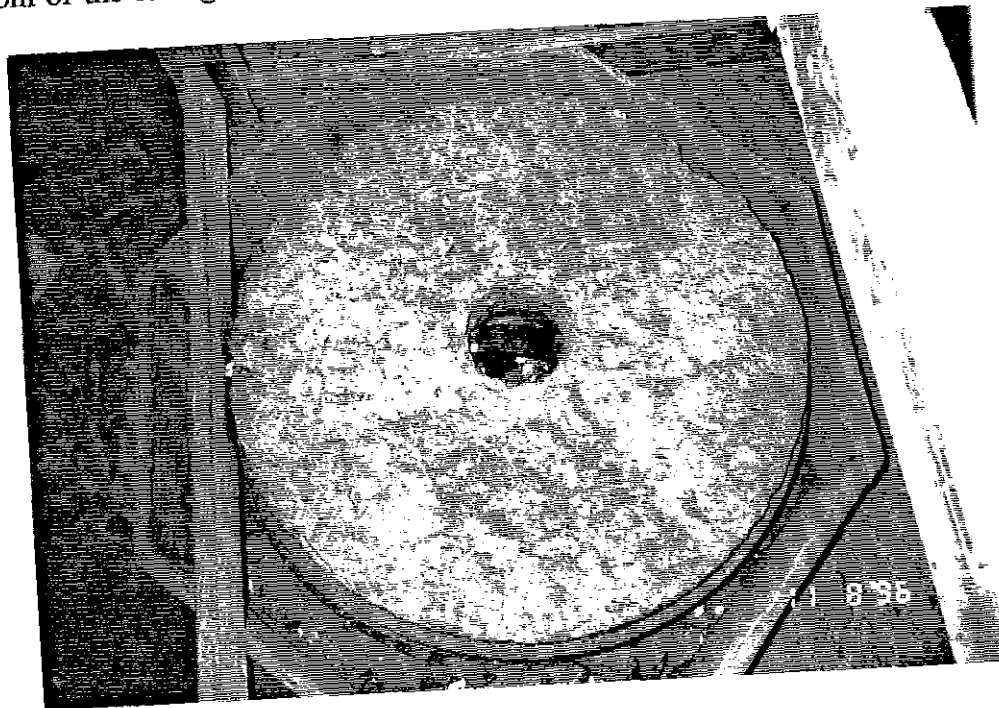
Figure 3-98 November 8, 1996. Detail of top mill stone. The stones are not basalt as those viewed during research for this report, but instead a composite of quartzite and silica cement.
