GRIST MILL
Historic Structure Report

San Antonio Missions
National Historical Park
San Antonio, Texas

Mission San José

October 1997

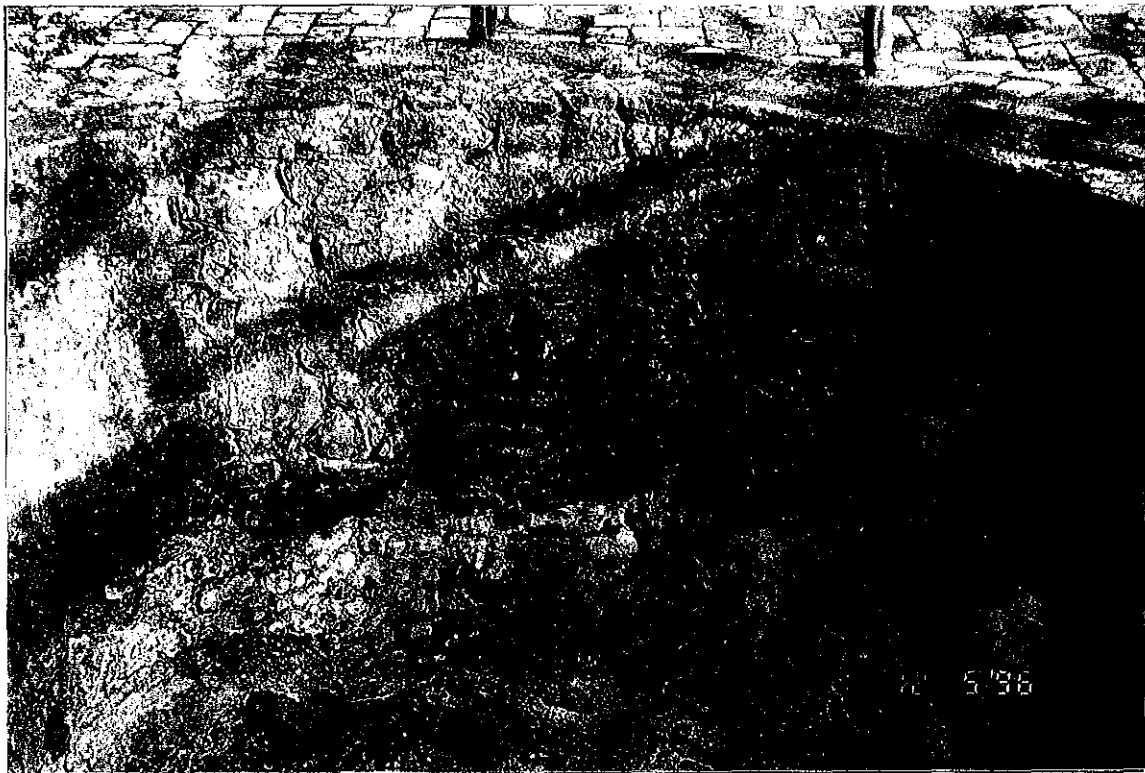
Figure 3-118 November 8, 1996. Looking due east down the millrace, where at the bottom level of the millrace the quality of the masonry in this area is quite spectacular. At the very eastern end of the millrace there is a more contemporary wall (Figure 3-120) which was put in, not historic, to basically block off the millrace from going future towards the northeast and north toward the amphitheater.

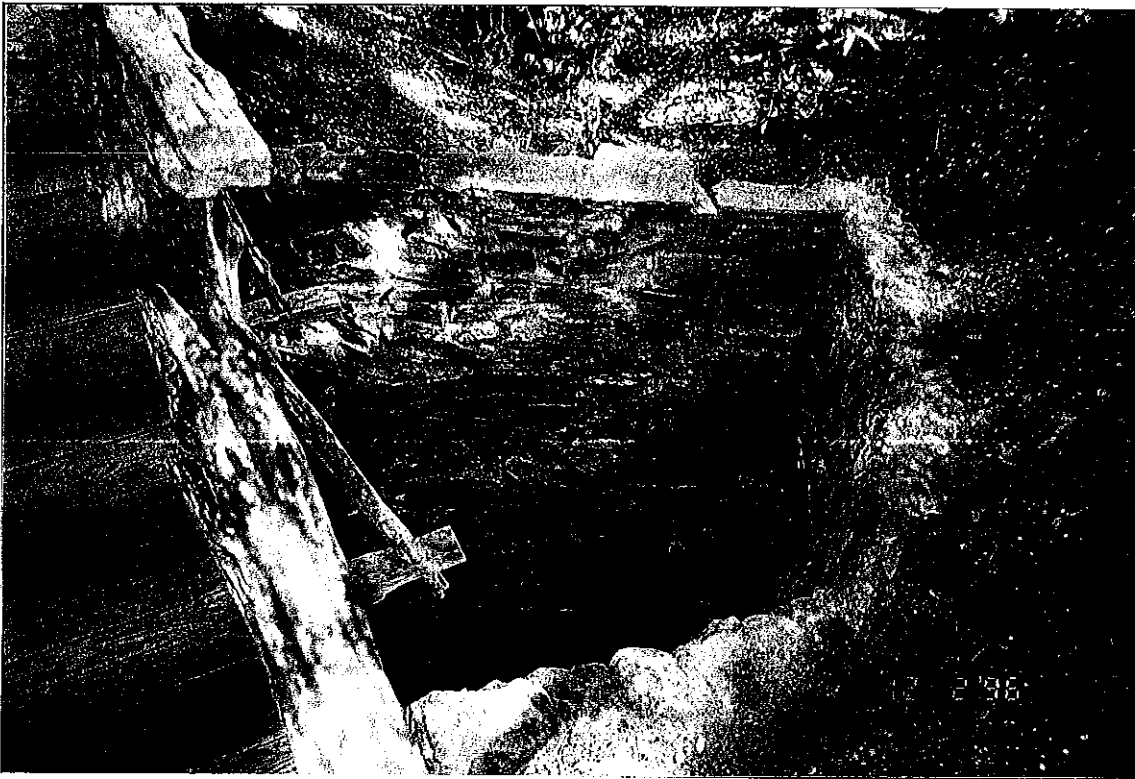
Figure 3-121
June 1996
Looking west
toward the mill at
the back (east) side
of an obviously
later wall that was
installed in the
mill race, cutting
it off immediately
south of the
amphitheater.

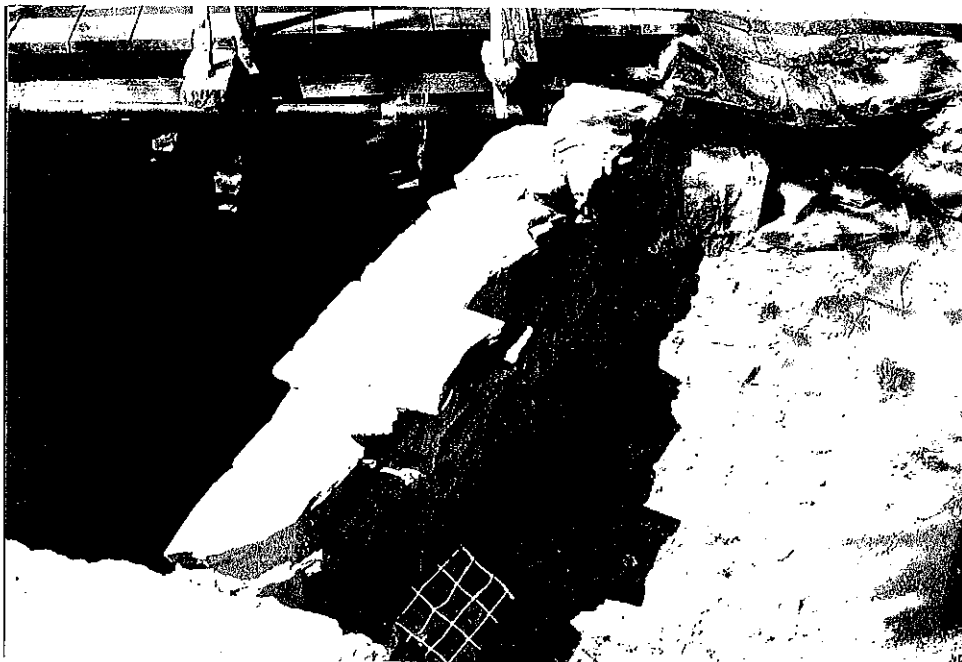
3. Stepped masonry retaining wall and flagstone-paved landing (Figures 3-122 through 3-129): Sometime in the late 1940s (see discussion in Chapter 2), the area around the mill race, immediately north of the mill, was constructed using a series of bench-like structures, all forming an elaborate masonry retaining wall system. Sandstone pavers were also installed providing a completely hard-surfaced lower landing as one descends to the turbine room. The stone used for the mill race retaining wall and this area match--indicating that all of this work was accomplished at approximately the same time. A set of masonry steps is a part of this construction, and can be seen in Figures 3-124 and 3-129. Cedar handrails complete the installation. Condition is very good with minor pointing required.

Figure 3-124 December 2, 1996. Looking north towards the amphitheater at the same retaining wall, stepped arrangement, and stone steps up from the turbine room.

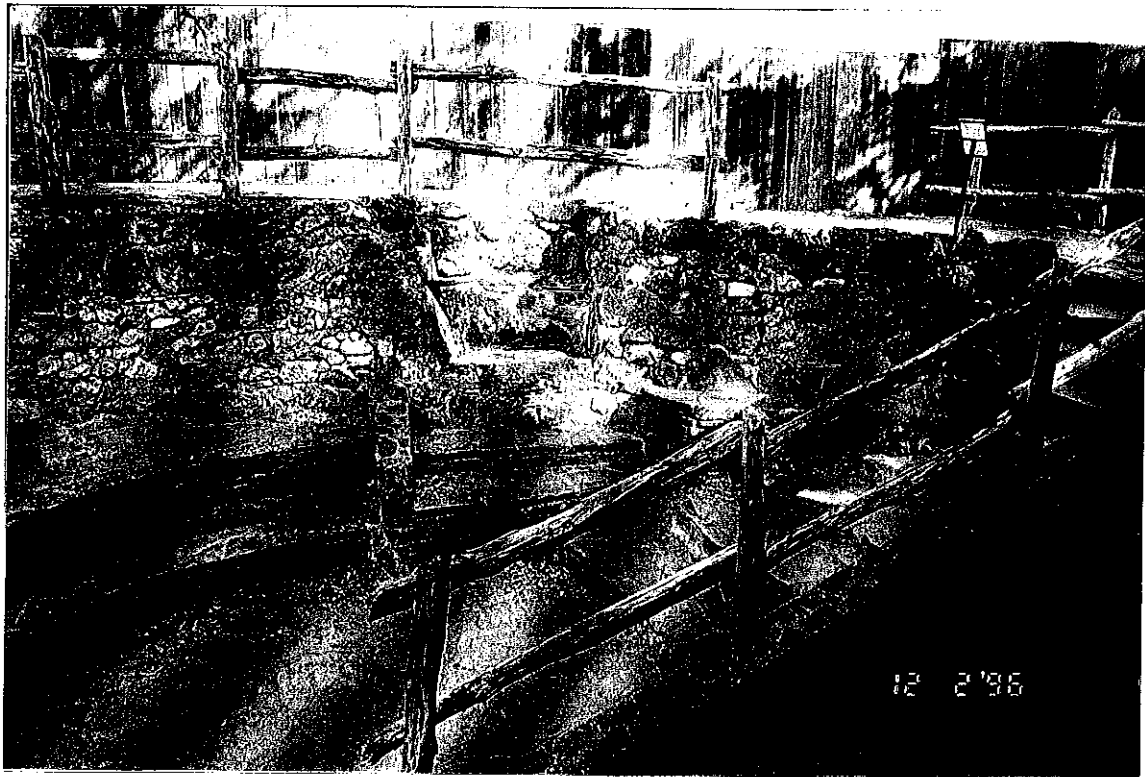
Figure 3-127 November 8, 1996. Blown-up detail of an end wall showing a round impression for a second post--most likely for the lamp which shows up in Figure 3-140.

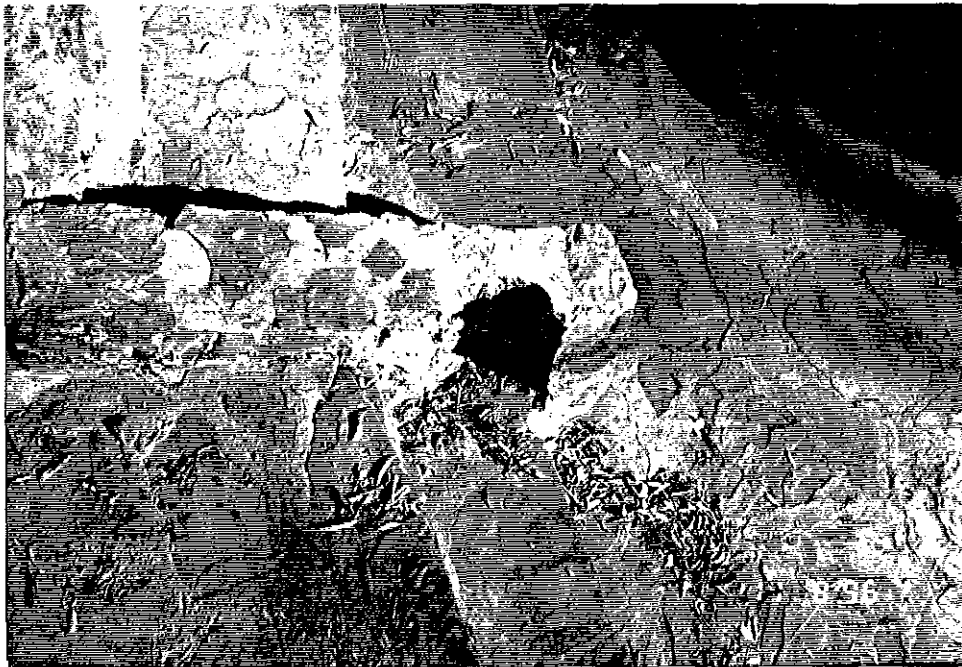
Figure 3-128 June 1996. Looking northeast towards the last of these stepped masonry arrangements before the steps. This is one of the more curious features and appears to be a "seat" formed out of masonry.

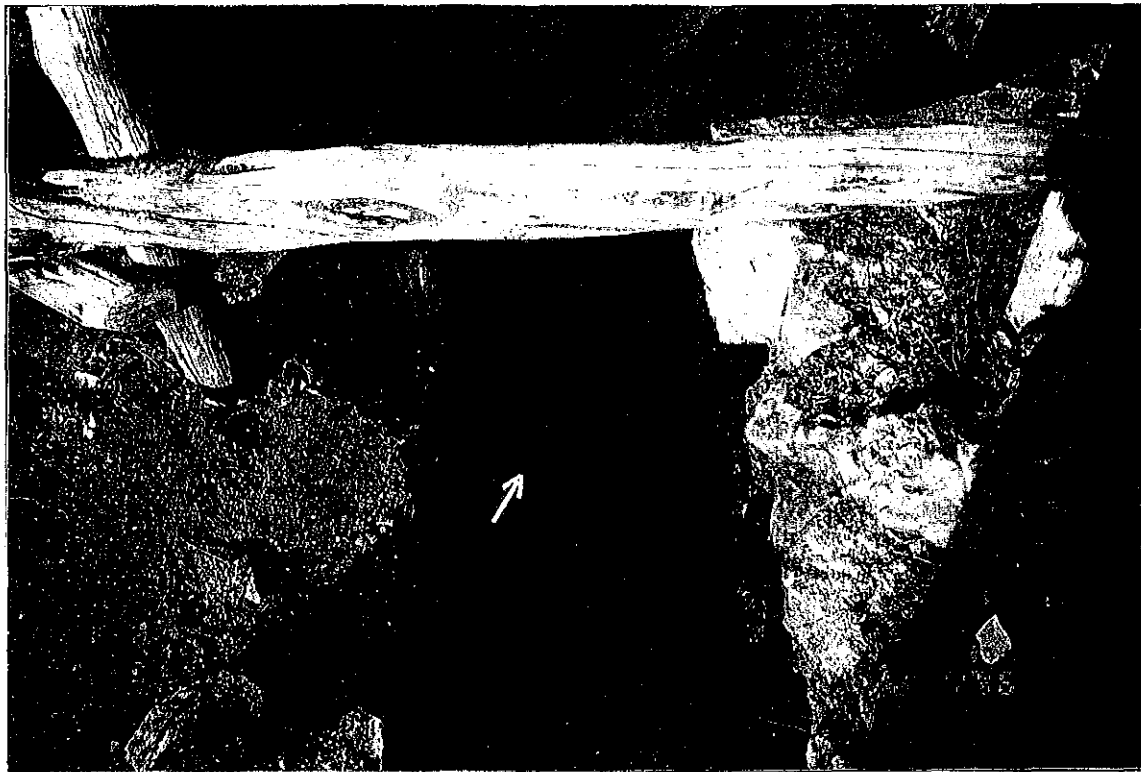
Findings: Three wood remnants were located, excavated, and removed (see Figures 3-157 and 3-74). It was assumed these three members belonged to a wooden gate dating to the 1930s restoration, but they could also have just been placed in the sluice to prevent soil and debris from falling into the forebay. The entire sluice was excavated (Figures 3-156 through 3-160). A notch formed into the sides and bottom of the sluice (Figure 3-159) was uncovered. This notch held the wooden sluice gate frame (Figure 3-73). While excavating this feature, archeologists located remnants of a low masonry wall (see #8 below).

Figure 3-157 December 1996. Detail of remnants of what was assumed to be a wooden gate which date to the 1936 restoration.

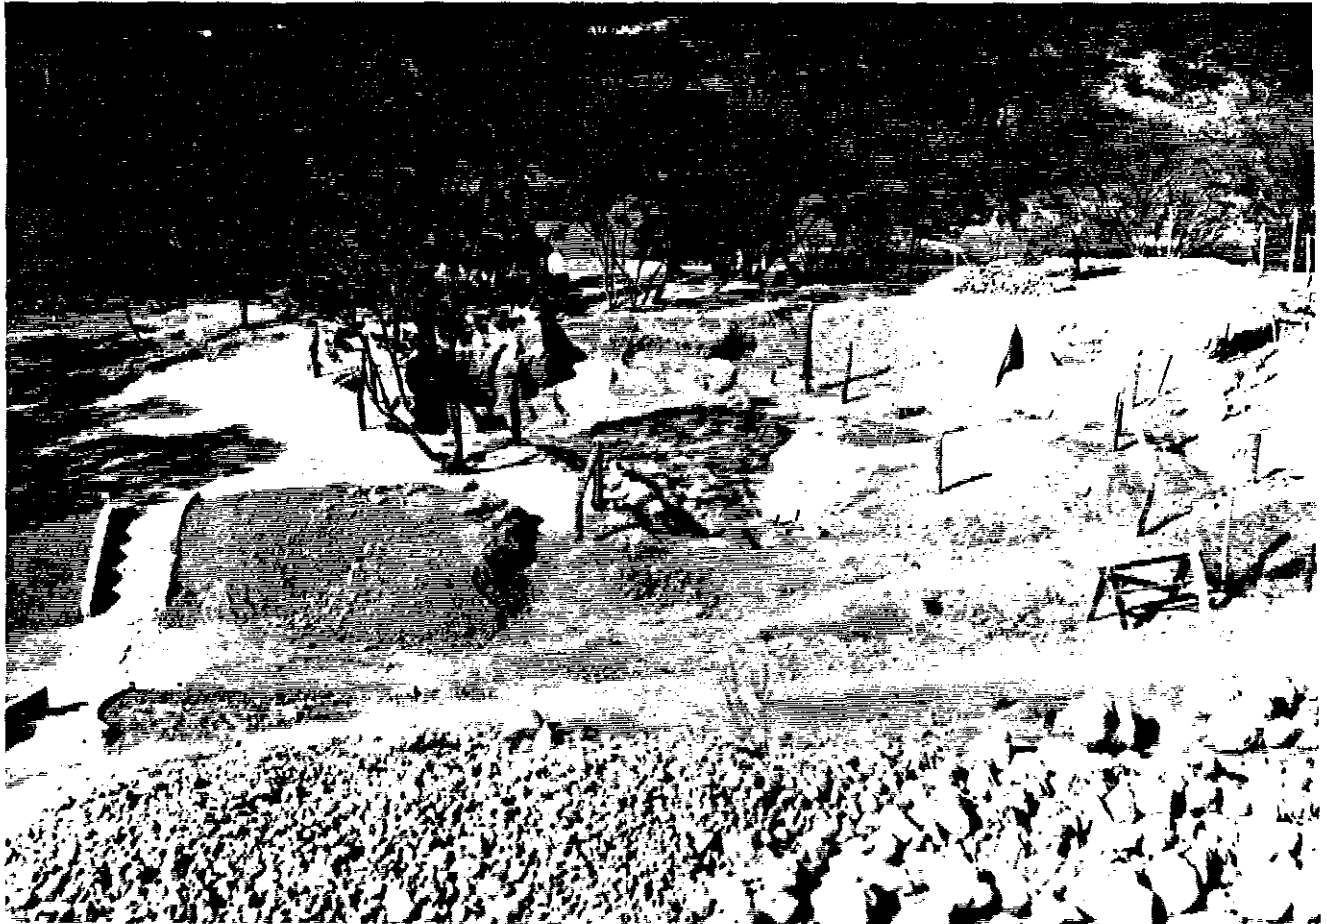
Figure 3. Gristmill reconstruction, facing north. *Courtesy San Antonio Missions NHP.*

Figure 3 reveals that a large portion of the acequia's north bank immediately south of the mill was removed during restoration. Figures 2 and 4 show that the forebay and vaulted turbine room were intact under the surface.

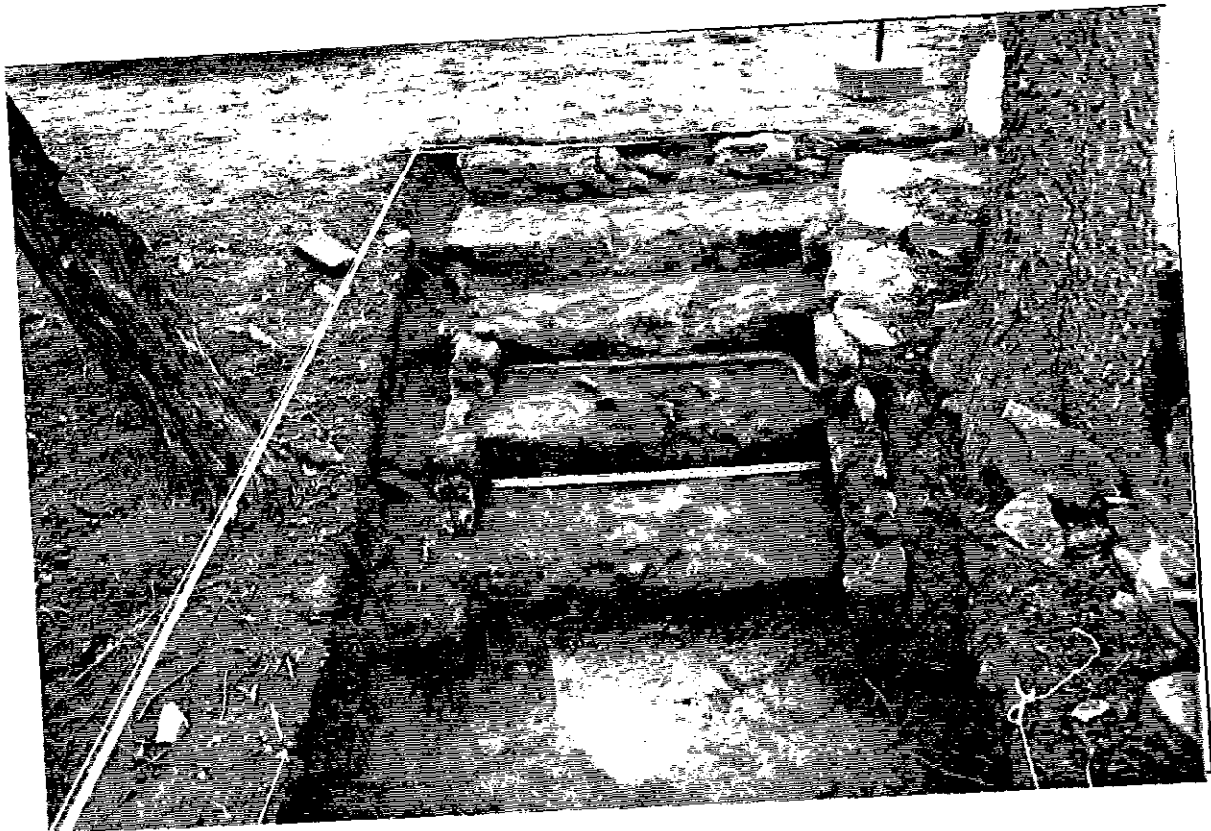
Figure 5. South stairway, Area A.

The first two steps on the south side were fragmented; the first step apparently as the result of grounds-keeping activities and erosion, and the second from erosion only (Figure 5). The next three steps were better preserved, showing only slight damage from erosion. A triangular flagstone, with a maximum width of 27 inches and a maximum length of 24 inches, was identified after the last step at the bottom of the south stairs.

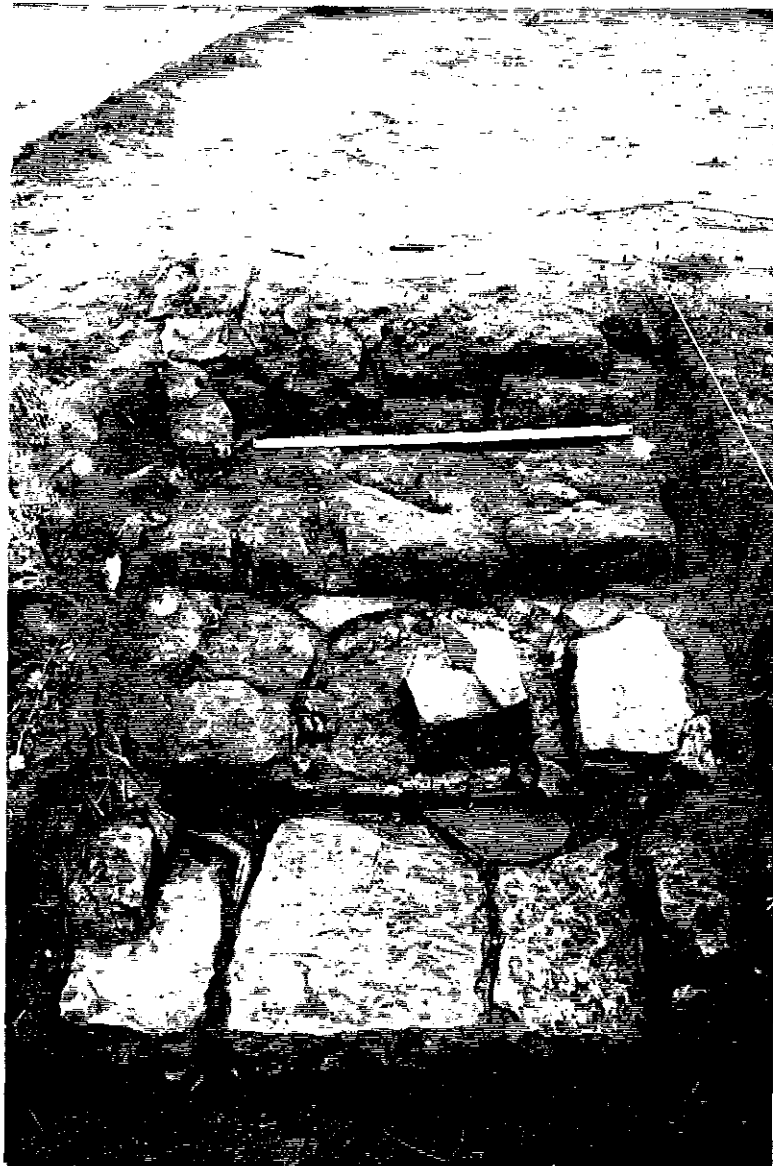
Figure 6. North stairway, Area A.

The stairs on the north side of the acequia were also cleared of overburden. Only four steps were identified on this side (Figure 6). A photograph taken during the WPA reconstruction (Figure 3) suggests that in ca. 1934 there were five steps, so it appears the topmost step is missing. The northern staircase was relatively less intact and less uniform than the southern staircase. The intrusion of large roots from a nearby hackberry tree are probably responsible for the fragmentation of the north stairs. The topmost remaining step had been repaired at an unknown time with portland cement. The other steps were in pieces, with 50 percent of the third step missing. Except for the topmost step, all the steps on the north side of the acequia were constructed with the same loose, sandy mortar found in the south stairs.

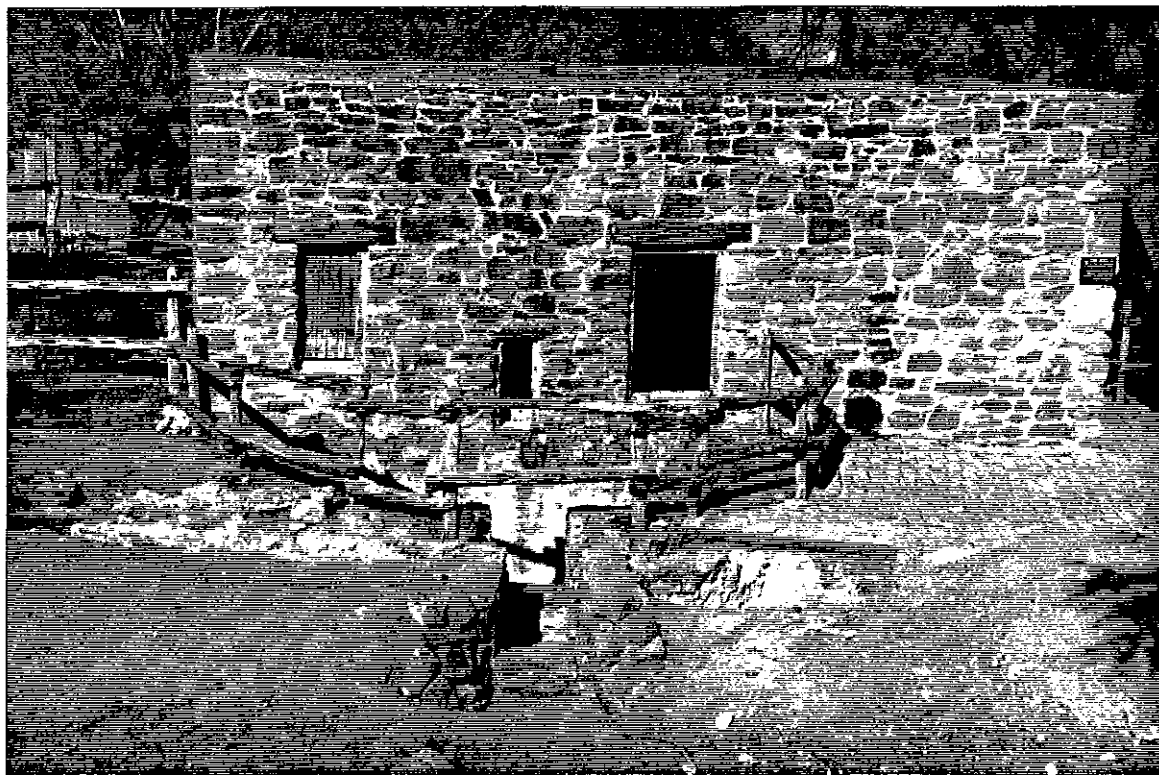
Figure 9. Area B, after excavation, looking north from the mission wall.

Unit H, measuring 2.5 x 3 ft, was adjacent to the east wall of the sluice. The northern edge of the unit is delineated by the south wall of Feature 5. Zone 1 is similar to Zone 1 in Unit E, with pea-sized gravel to a depth of 3–5 inches below the surface. Directly under this zone was a layer of sandy clay mixed with limestone cobbles up to six inches in diameter. This second zone continued to the bottom of the wall, 20–23 inches below the top of the wall. As with Feature 3, the limestone cobbles were mortared with a loose, sandy mortar and showed no formal coursing (Figure 9).

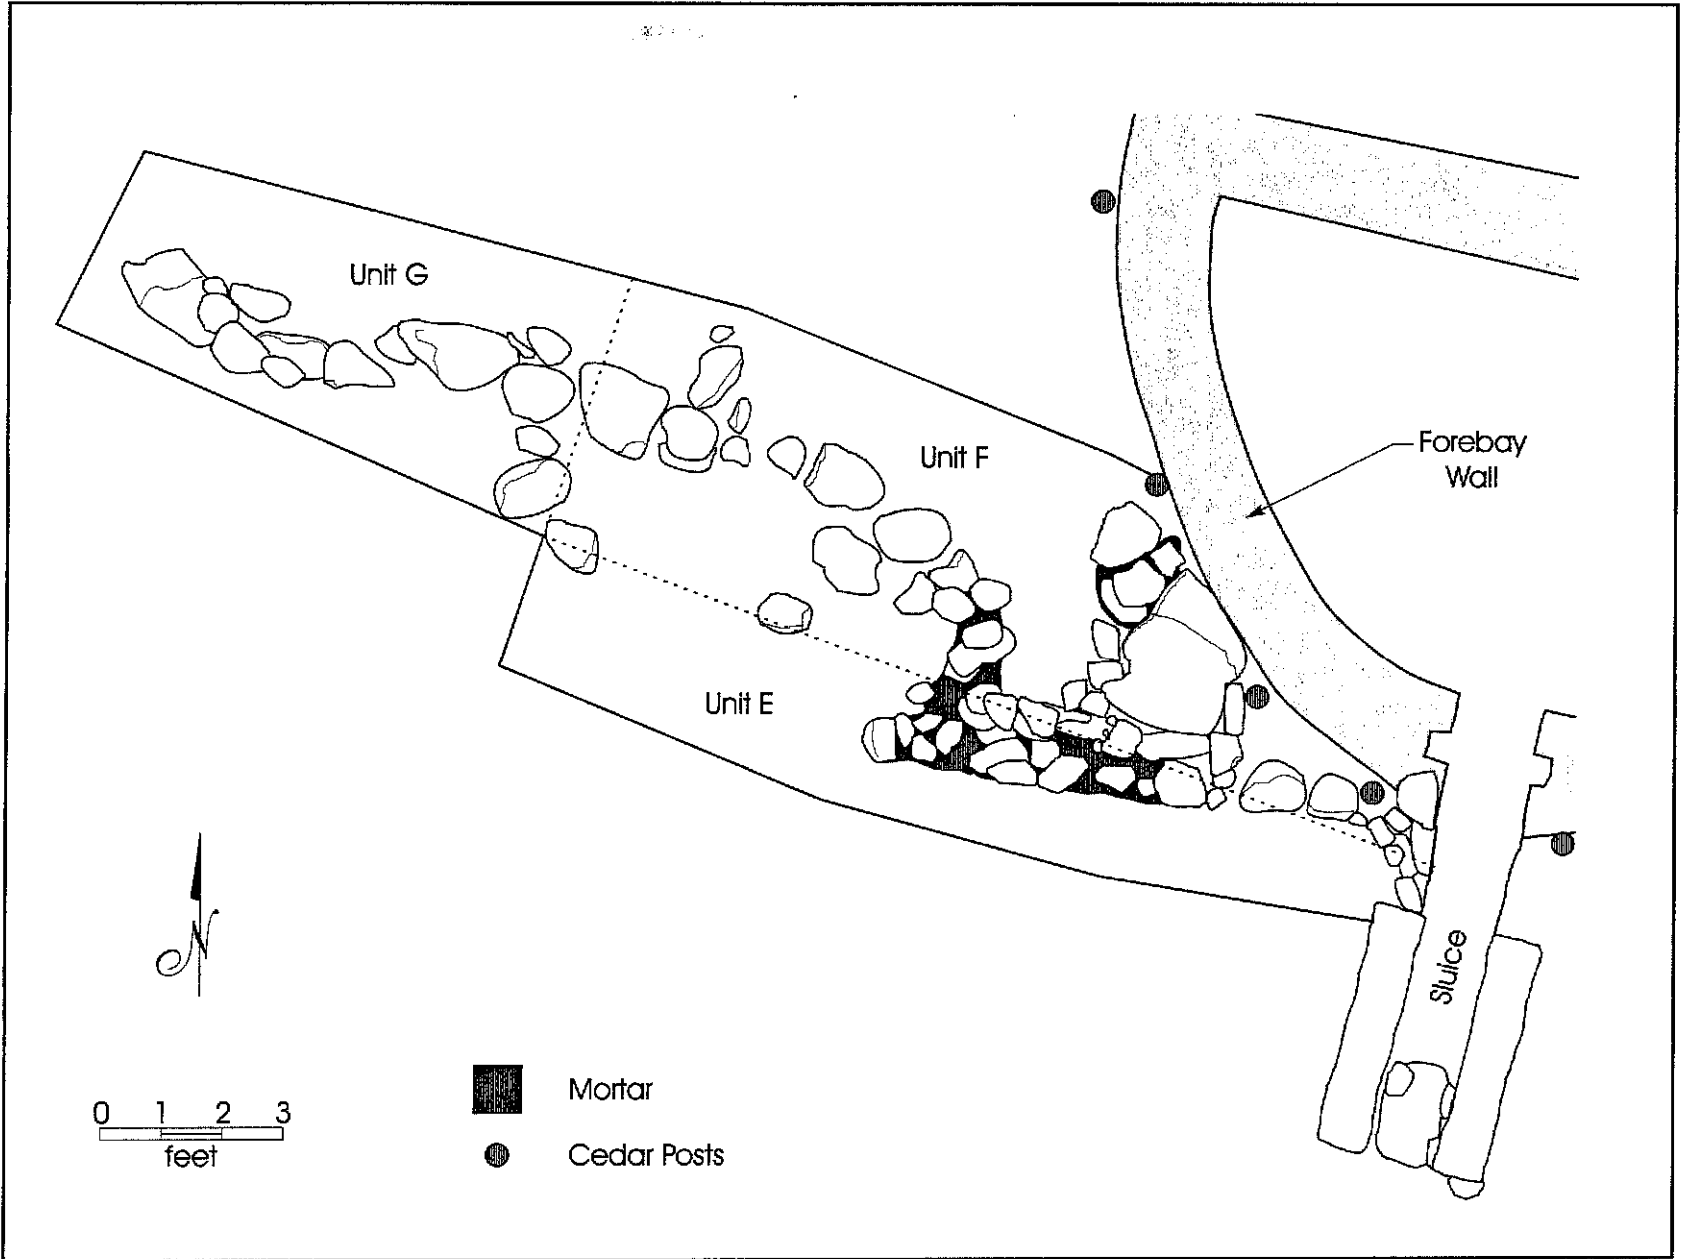
Figure 10. Units E, F, and G, Feature 3, plan view.

Remnants of a wall, Feature 3 (see Figure 10), were observed running perpendicular to the west wall of the sluice. The top of this wall was cleaned, and excavation on both the north and south sides (Units E and F, respectively) was undertaken to determine how much, if any, of the structure remained in situ. An alignment of limestone cobbles adjacent to Units E and F was designated Feature 4. The datum established for the sluice was used for both Units E, F, and H. Feature 5 consisted of a low, semi-circular wall abutting the eastern wall of the sluice (see Figures 11 and 12).

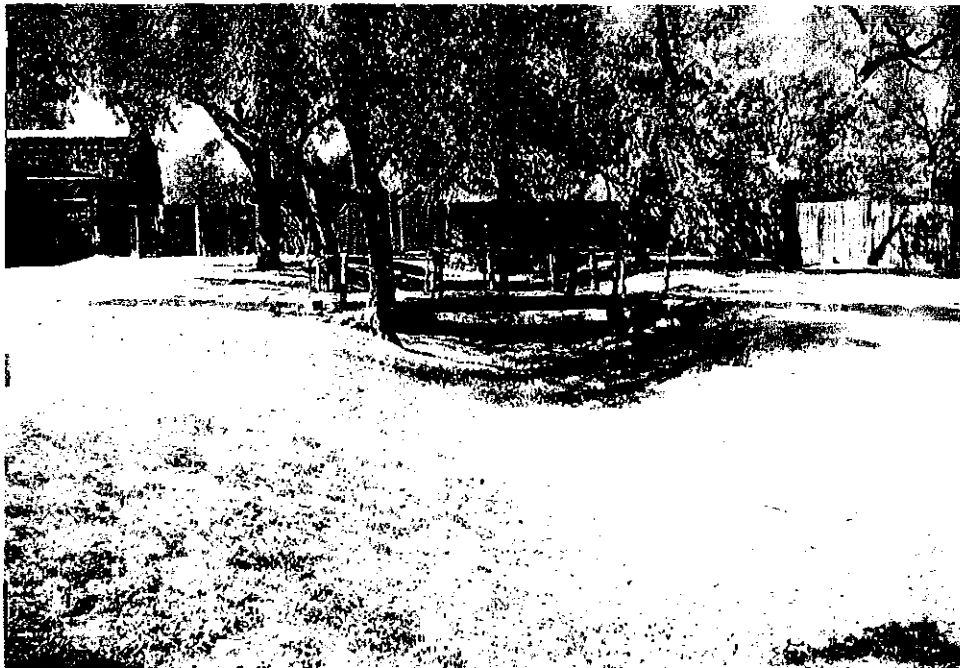
Figure 3. Acequia Madre from Fence at Parking Lot to Grist Mill.

The completed topographic survey of the mill and surroundings is shown in Exhibit A. What remains of the Acequia Madre begins at the parking lot of the service drive. It is currently grass lined and has a slope of 0.48% up to a small stone drain (Figure 3). Beyond the stone drain approximately 95 feet, the channel makes a 90 degree turn and runs north. After 120 feet the channel comes to a fence for a storage yard. At this point the channel ceases to exist.

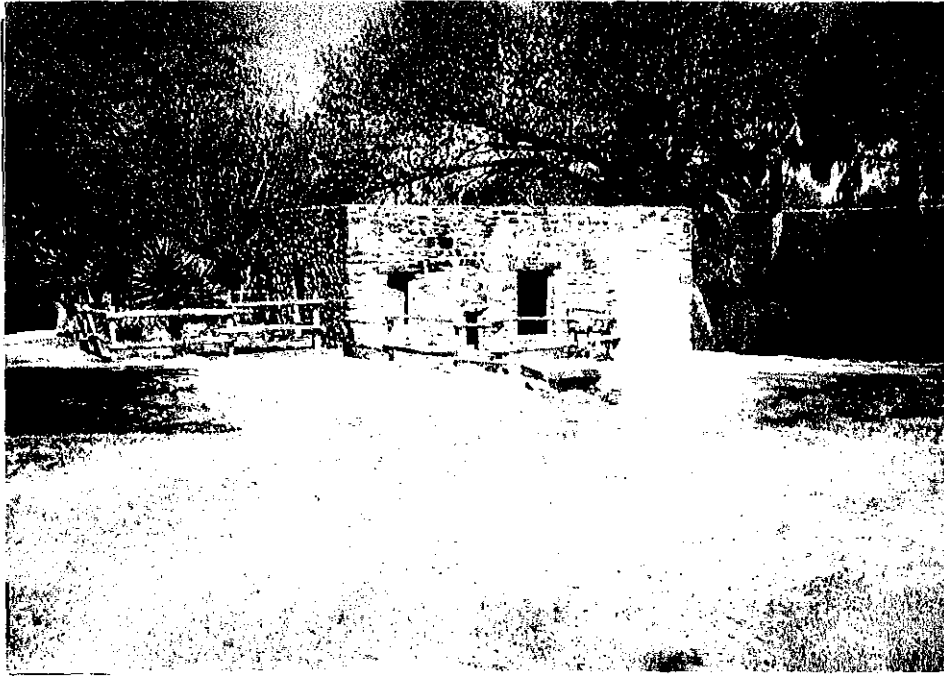
Immediately before the small stone drain is a rock lined channel, 2 feet wide and perpendicular to the Acequia Madre, that connects the Acequia Madre with a reservoir (forebay) adjoining the mill (Figure 4). At the base of this reservoir is a flume that discharges water from the reservoir onto the turbine (Figure 5). Water flows from the turbine room into the mill race. The mill race is rock lined and has a rock wall at the end with an 8" clay pipe at the bottom.

Figure 4. Channel from Acequia Madre to Reservoir.

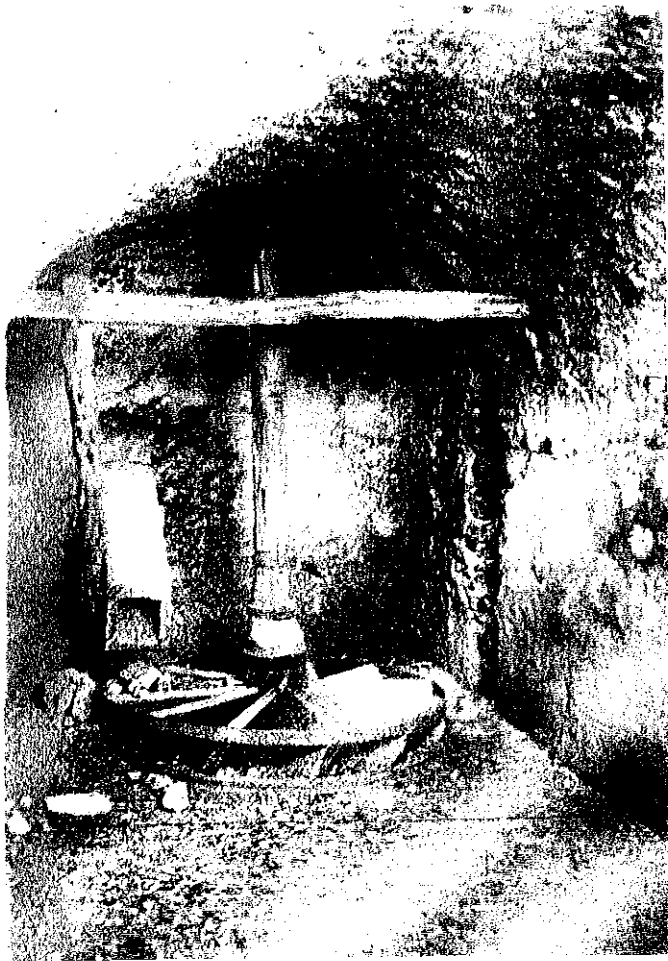
Figure 5. Turbine Room.
