**THE M'CLINTOCK HOUSE**  
**HISTORIC STRUCTURE REPORT**

**Women's Rights National Historical Park**  
**Waterloo, New York**

Barbara A. Yocum  
Architectural Conservator

1993

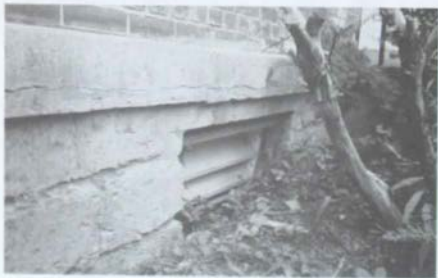
Figure 42. M'Clintock House: North (Front) Foundation [1988].

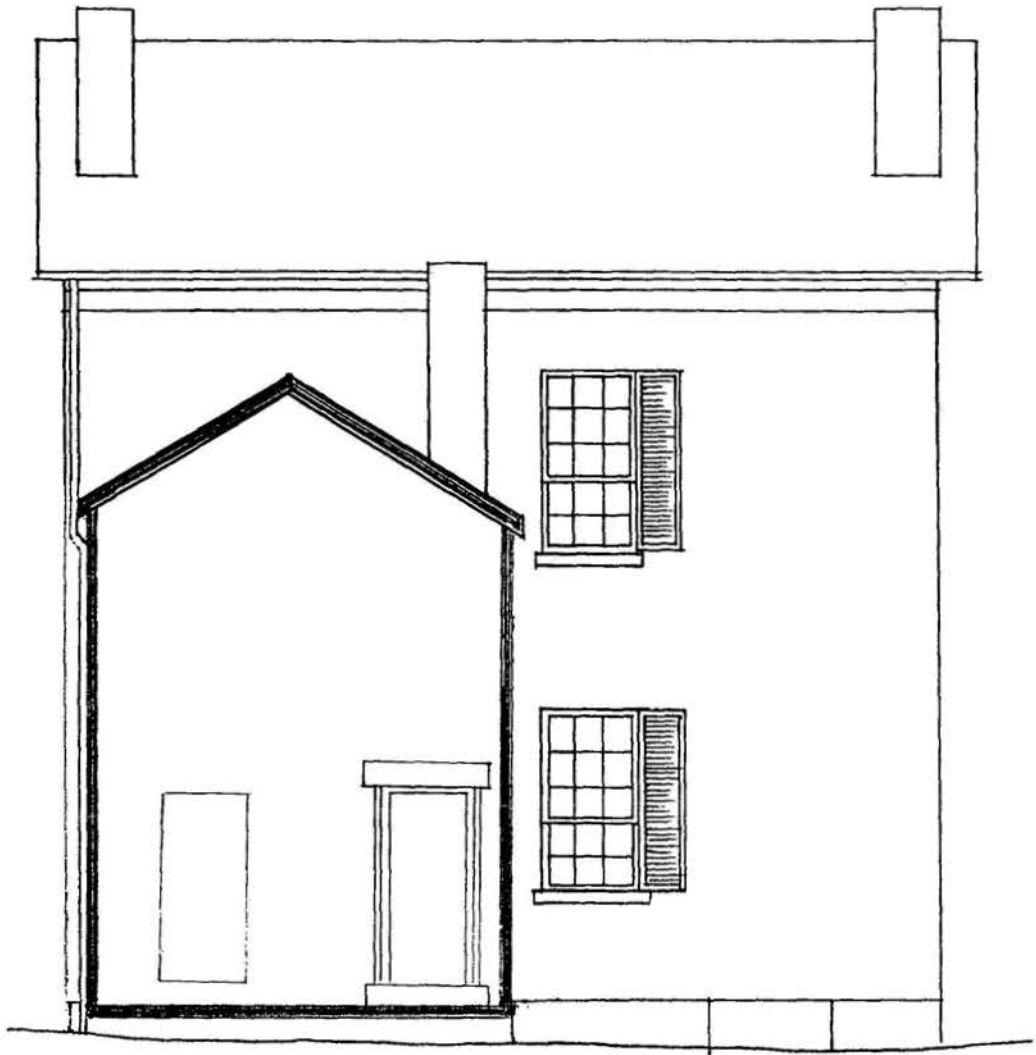
Figure 54. M'Clintock House: Physical Evidence Discovered on South Wall of Main House in May 1990.

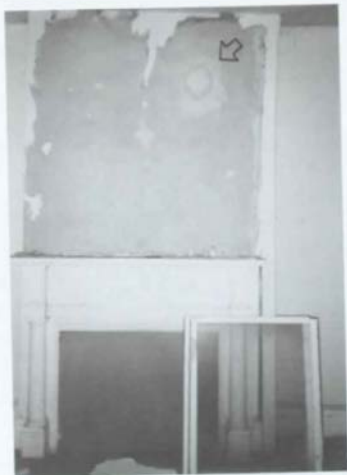
Figure 77. M'Clintock House: Room 102 (Parlor), Patch in Chimney Breast at Former Stovepipe Hole [1988].

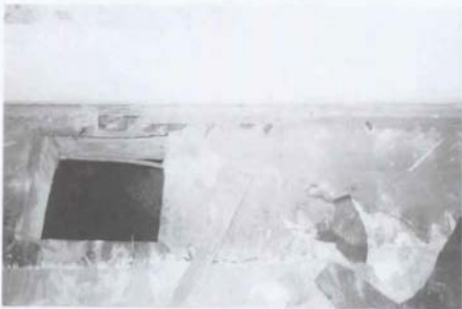
There are two floor registers in the parlor. One is in the northwest corner of the room, while the other is located along the south wall (fig. 78). Both appear to have been part of the gas-fired central-heating system installed in or shortly after 1958.

Figure 78. M'Clintock House: Room 102 (Parlor), Floor at South Wall, in Location of Former Doorway [1988].

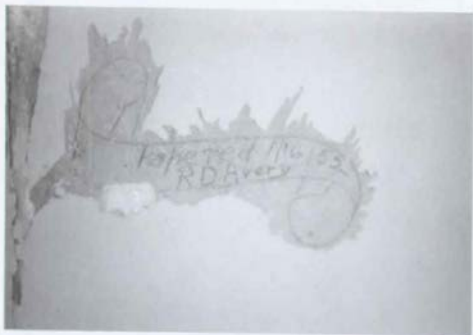
Figure 83. M'Clintock House: Room 103 (Southeast Room), Writing Found Beneath Wallpaper on East Wall [1988].

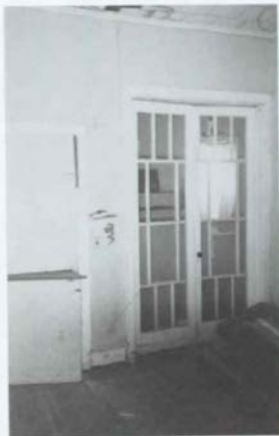
Figure 90. M'Clintock House: Room 104 (Kitchen/Dining Room), North Wall, East End [1988].

As in Room 103, examination of the floor in Room 104 was complicated by the fact that attic floorboards have been stored along the east wall since 1986 (see figure 90). The floor is now covered with the same type of oak strip flooring as used elsewhere on the first story. Some of these boards are buckling and in poor condition; others were removed for the architectural investigation in the vicinity of the northeast doorway. It was thereby observed that the original floorboards survive beneath the oak floor. These floorboards are similar to those in Rooms 101, 102, and 103, being butt-edged pine boards of random width that are secured with cut nails.

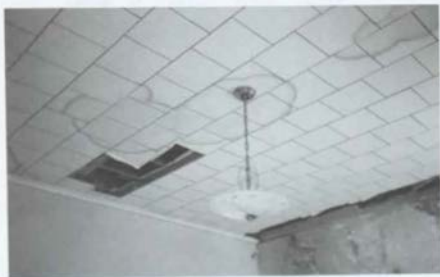
Figure 91. M'Clintock House: Room 104 (Kitchen/Dining Room), Ceiling Looking Southeast [1988].

The condition of this nonhistoric ceiling is poor. It is discolored by water stains, and ceiling tiles are missing both along the south wall and in the center of the room. Where the tiles are missing, it is possible to see that the earlier ceiling plaster and most of the lath has been removed.

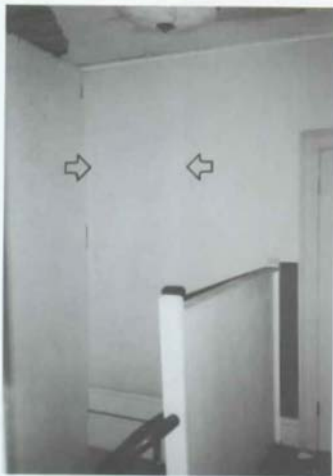
Figure 95. M'Clintock House: Room 201 (Upper Stair Hall), North Wall (arrows show remnant of original closet partition) [1988].

The plaster ceiling in the hall may be original. This ceiling is in poor to fair condition, with a small area of plaster loss exposing the wood lath along the west wall (fig. 95).

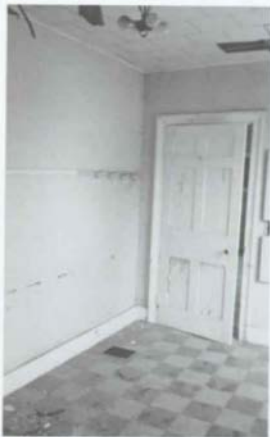
Figure 108. M'Clintock House: Room 203 (Southeast Bedroom), Looking Northwest [1988].

All four walls are original and mostly covered with original plaster. The plaster on the north half of the west wall was removed by the park’s Chief of Maintenance in 1993. Two deep cracks are evident at the east wall in the vicinity of the southeast window. One is above the upper right (south) corner of the window, while the other is below the lower left (north) corner of the window. Both are now being monitored with crack gauges. A horizontal plaster patch about 3 inches wide is centered at the east wall, in the location of a former historic partition. The west wall to the south of center has a patch of plasterboard (fig. 108) that was used to close

A floor register with metal grille is in the northwest corner of the room (fig. 108). It was installed when the gas-fired central-heating system was installed, in or shortly after 1958.

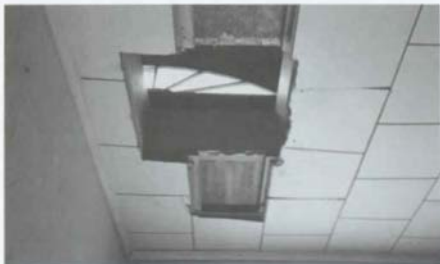
Figure 109. M'Clintock House: Room 203 (Southeast Bedroom), Ceiling at Attic Hatch [1988].

The ceiling is covered with acoustical ceiling tiles that are 12 inches square (fig. 109). A wood molding that is contemporary with the tiles borders the ceiling where it meets the walls. Both were probably installed in the late 1950's.

A framed opening, or hatch, is in the northeast corner of the ceiling (fig. 109). This hatch is the only entrance to the attic. It is small, measuring about 18 inches square. There are no steps or built-in ladder; a portable ladder is needed to reach the opening. This is assumed to be the original means of access to the attic.

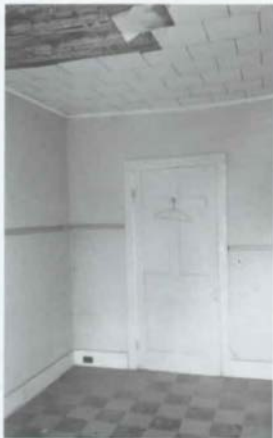
Figure 110. M'Clintock House: Room 204 (Southwest Bedroom), East Half Looking Northwest [1988].

The floors of both the west and the east halves of the room are covered with asphalt tiles that are 9 inches square and laid in alternating colors of brown and tan (fig. 110). These are believed to date to the late 1950's. No tiles have yet been removed, but they probably were laid on top of the original floorboards, as was done in Room 203. The only area where the old floorboards are exposed is the closet in the southwest corner of the west half of the original room. The floor itself has a noticeable slope from south to north, with the lowest point being at the north wall.

North Doorway, East End of Wall. The doorway in the north wall of the east half of the room (fig. 110) leads to Room 202. The architrave consists of plain boards. The six-panel door swings into Room 204. It is original and of mortised construction. It measures 33 1/2 inches wide by 80 1/2 inches high by 1 1/4 inches thick, and has six panels that are recessed and unmolded on both sides.

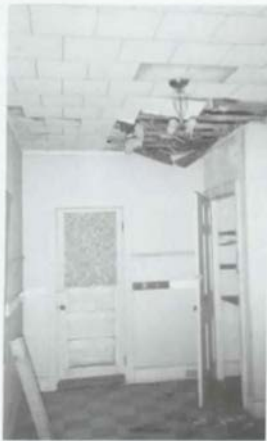
Figure 116. M'Clintock House: Room 204 (Southwest Bedroom), West Half Looking South [1988].

South Doorway. This doorway (fig. 116), in the south wall of the west half of the room, is now an exterior doorway that leads to a metal stairway. It was created as an interior doorway, probably circa 1894, to access the upper story of the enlarged south wing.

Two ceiling fixtures are in Room 204: one in the west half of the room (fig. 116), the other in the east half of the room. The west fixture has four bulbs and is identical in design to the other circa-1950's light fixtures in the house. It is missing its shade, which was undoubtedly a glass saucer similar to the other shades in the house. The east fixture is in poor condition. It was damaged along with the ceiling in that part of the room, and is now stuffed into the attic space. Presumably it also is a four-bulb fixture similar to those used elsewhere in the house. Each fixture was operated by its own light switch. The switch for the west fixture is on the north wall to the left (west) side of the original doorway. The switch for the east fixture is on the north wall to the right (east) side of the later doorway.

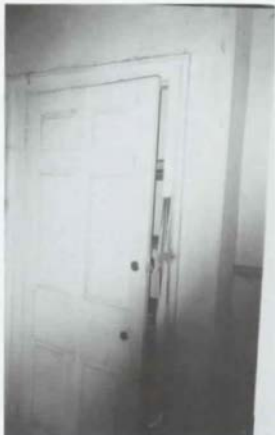
Figure 118. M'Clintock House: Room 204 (Southwest Bedroom), West Half, Closet Doorway [1988].

West Closet Doorway. Like the closet, the closet doorway (fig. 118) appears to be original. It survives in remarkably unaltered condition. The architrave is original and identical in design to that of the north doorway to Room 201, with a Grecian ogee molding, no plinth blocks, and no corner blocks. Its right (north) side is damaged where a large section of the wood has been split away. This appears to have been caused by the door having been forced open while the modern dead bolt was engaged. The threshold survives in place.
