Reference: Apostle Islands National Lakeshore, Package No. 150,
Little Sand Bay, Historic Structure Report, Hokenson
Fish Dock Buildings

HISTORIC STRUCTURE REPORT

ARCHITECTURAL DATA SECTION

HOKENSON FISH DOCK BUILDINGS

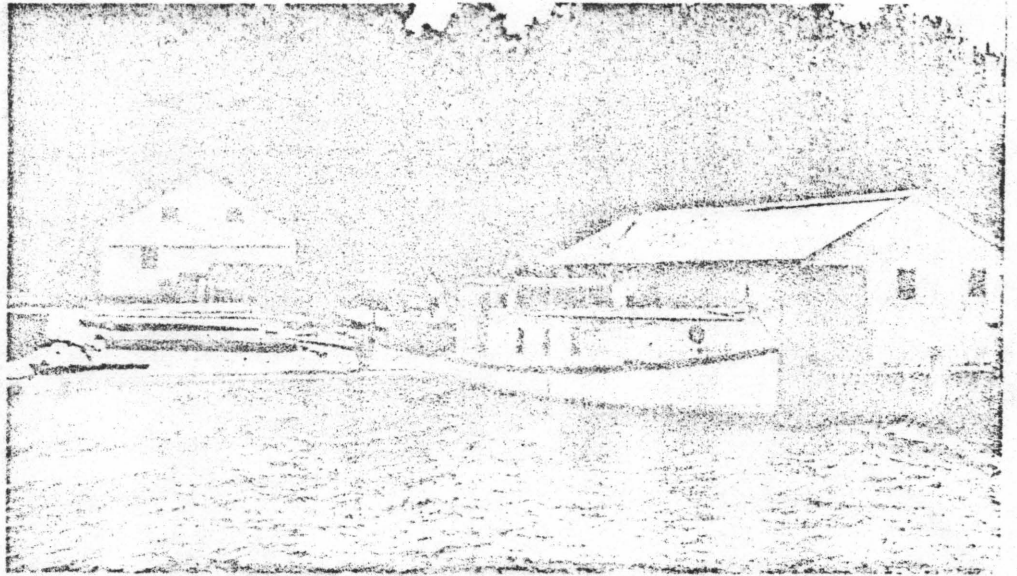
#12

Phase 1 - Fish House 1937

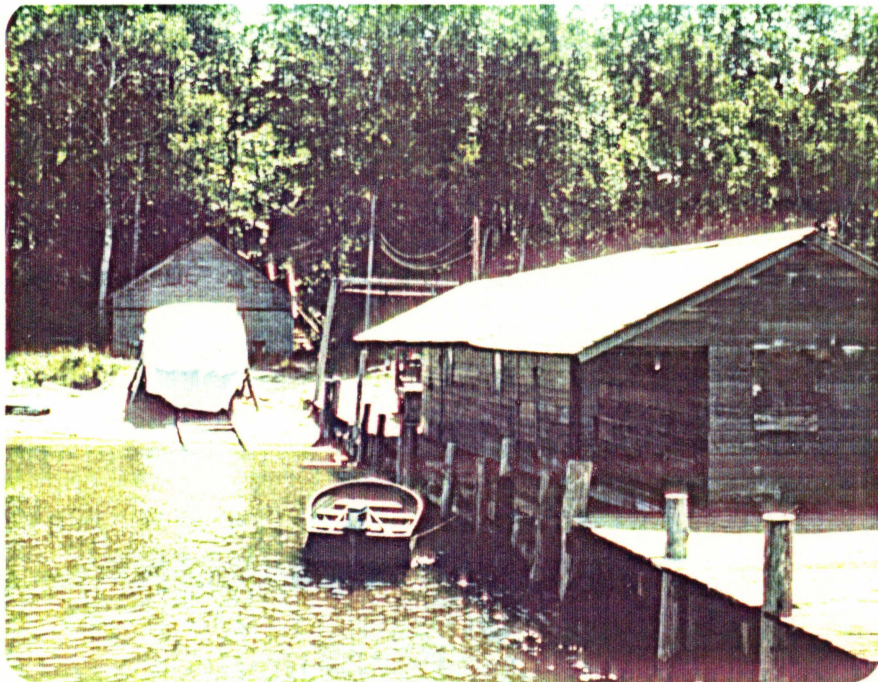
The fish house is in very good condition. The siding is also in good condition with very little damage. The structure was historically painted although presently the paint has weathered off and the structure has been treated by the Park with a water resistive preservative. Due to the work on the dock which raised its level, the doors can not open all the way. The windows are in fair condition although some window units are no longer in place. The muntins & rails have dried out severely on some windows and many have cracked. Some of the glass panes have also cracked.

Existing Fish House - Phase III Complete 1978

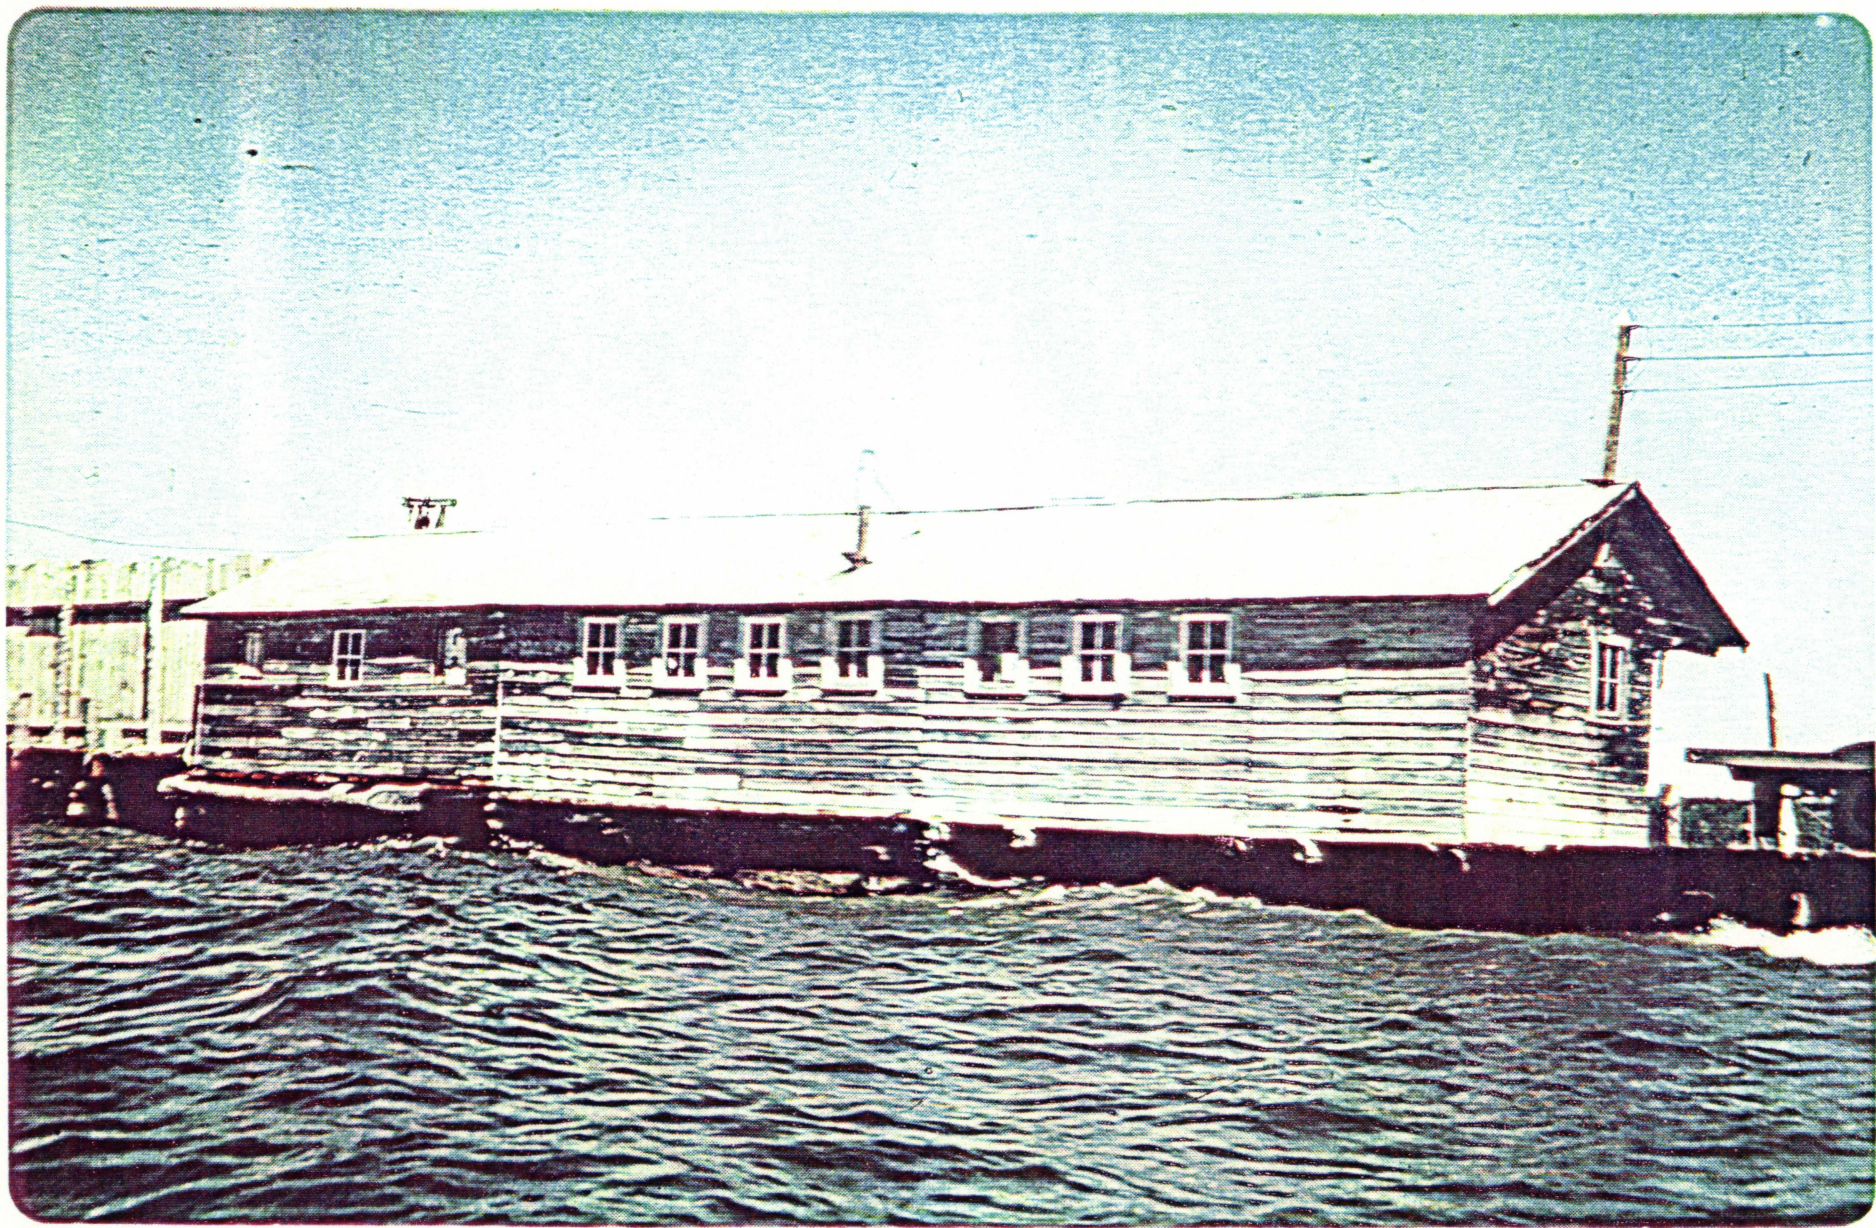
#16

Existing Fish House- 1978 - East Fascade

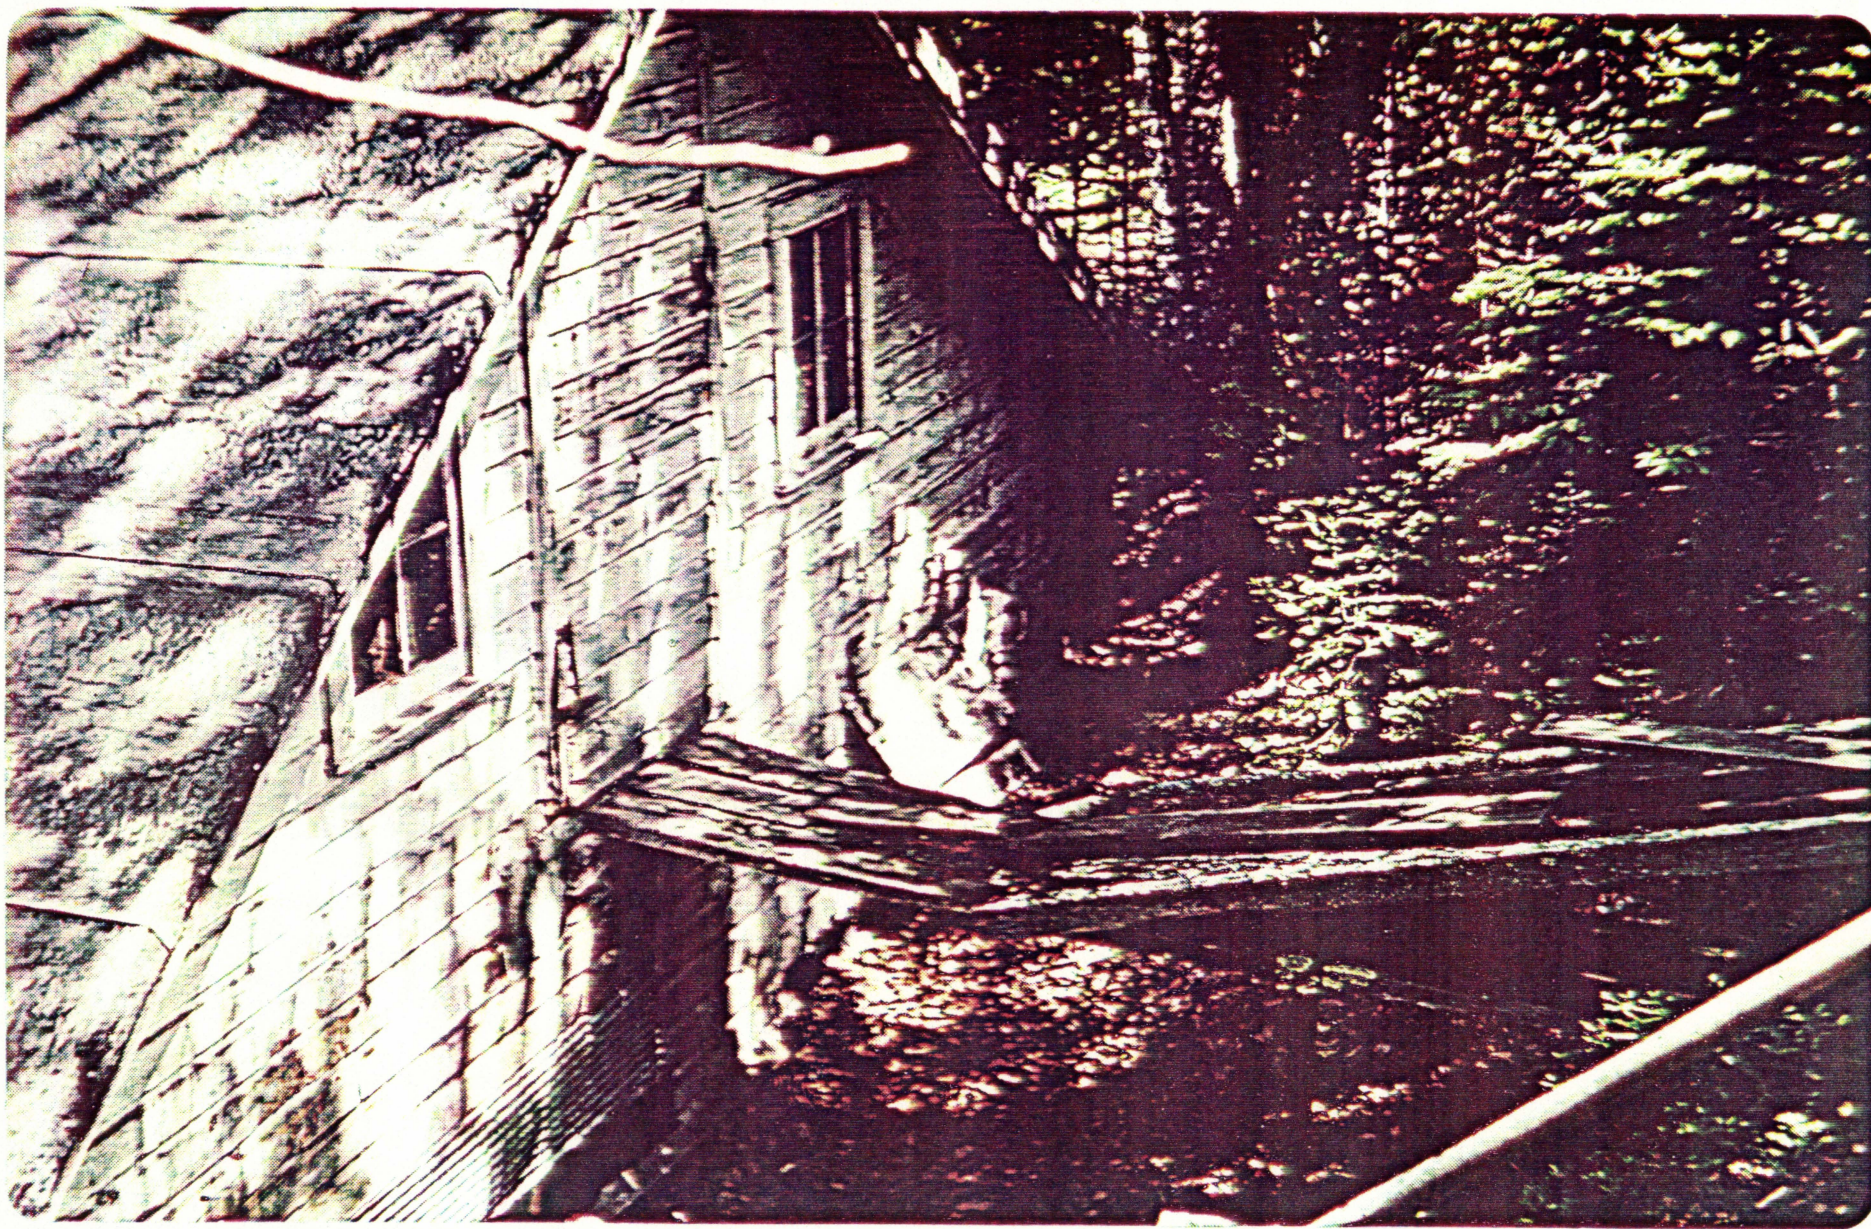
#21

Structurally, the building is in very poor condition, due to wood rot and earth pressure exerted against the building from the shifting hill. Many of the framing members and much of the lower siding on the east and south walls is severely rotted.

Ice House - South Fascade

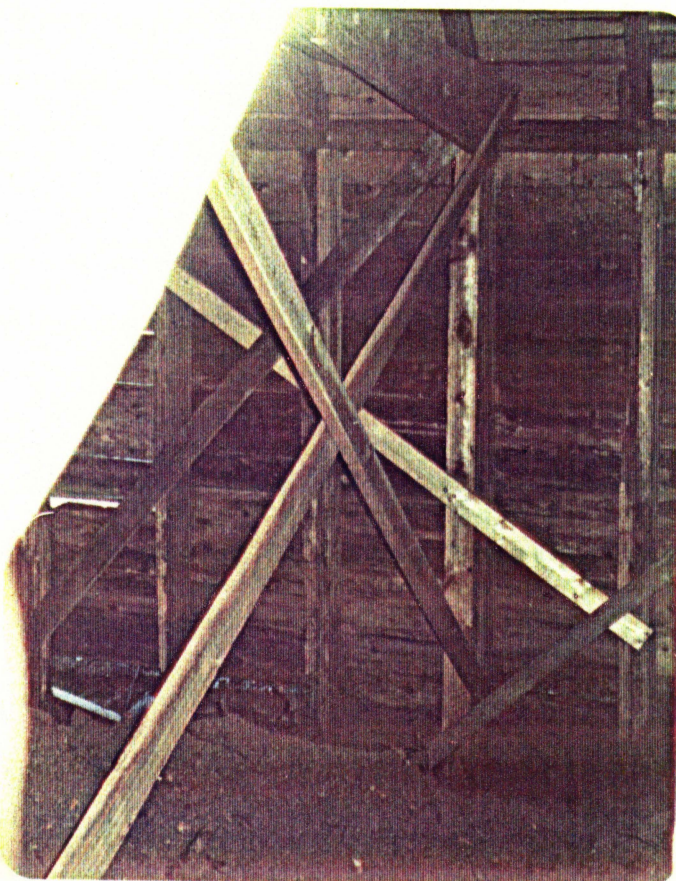
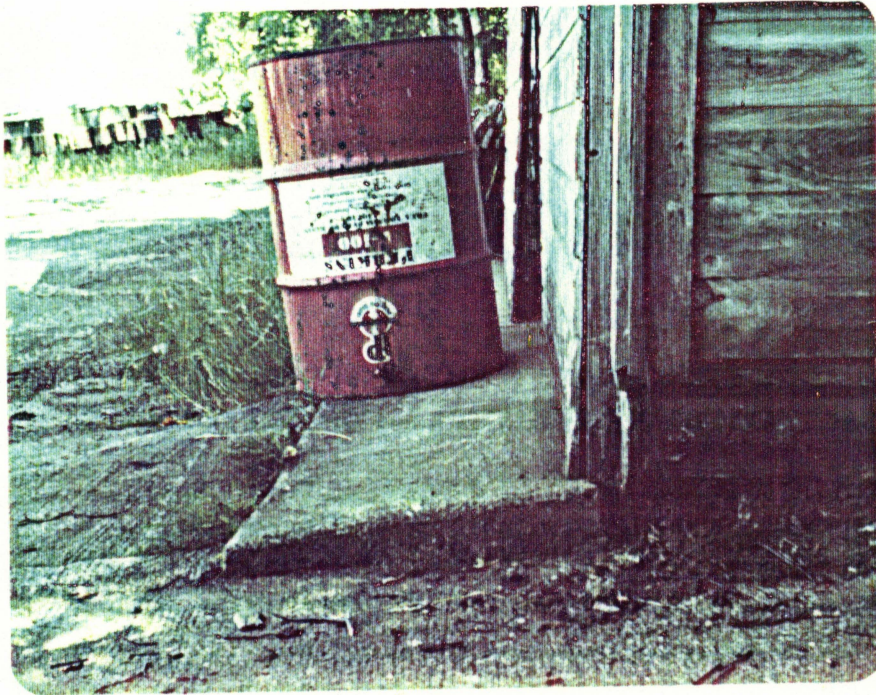
#25 Existing Temporary Bracing

added pressure has caused the structure to be racked to the north and east. For this reason, many new braces have been added to the interior in order to attempt to temporarily stabilize the structure (see photographs 25 and 26).

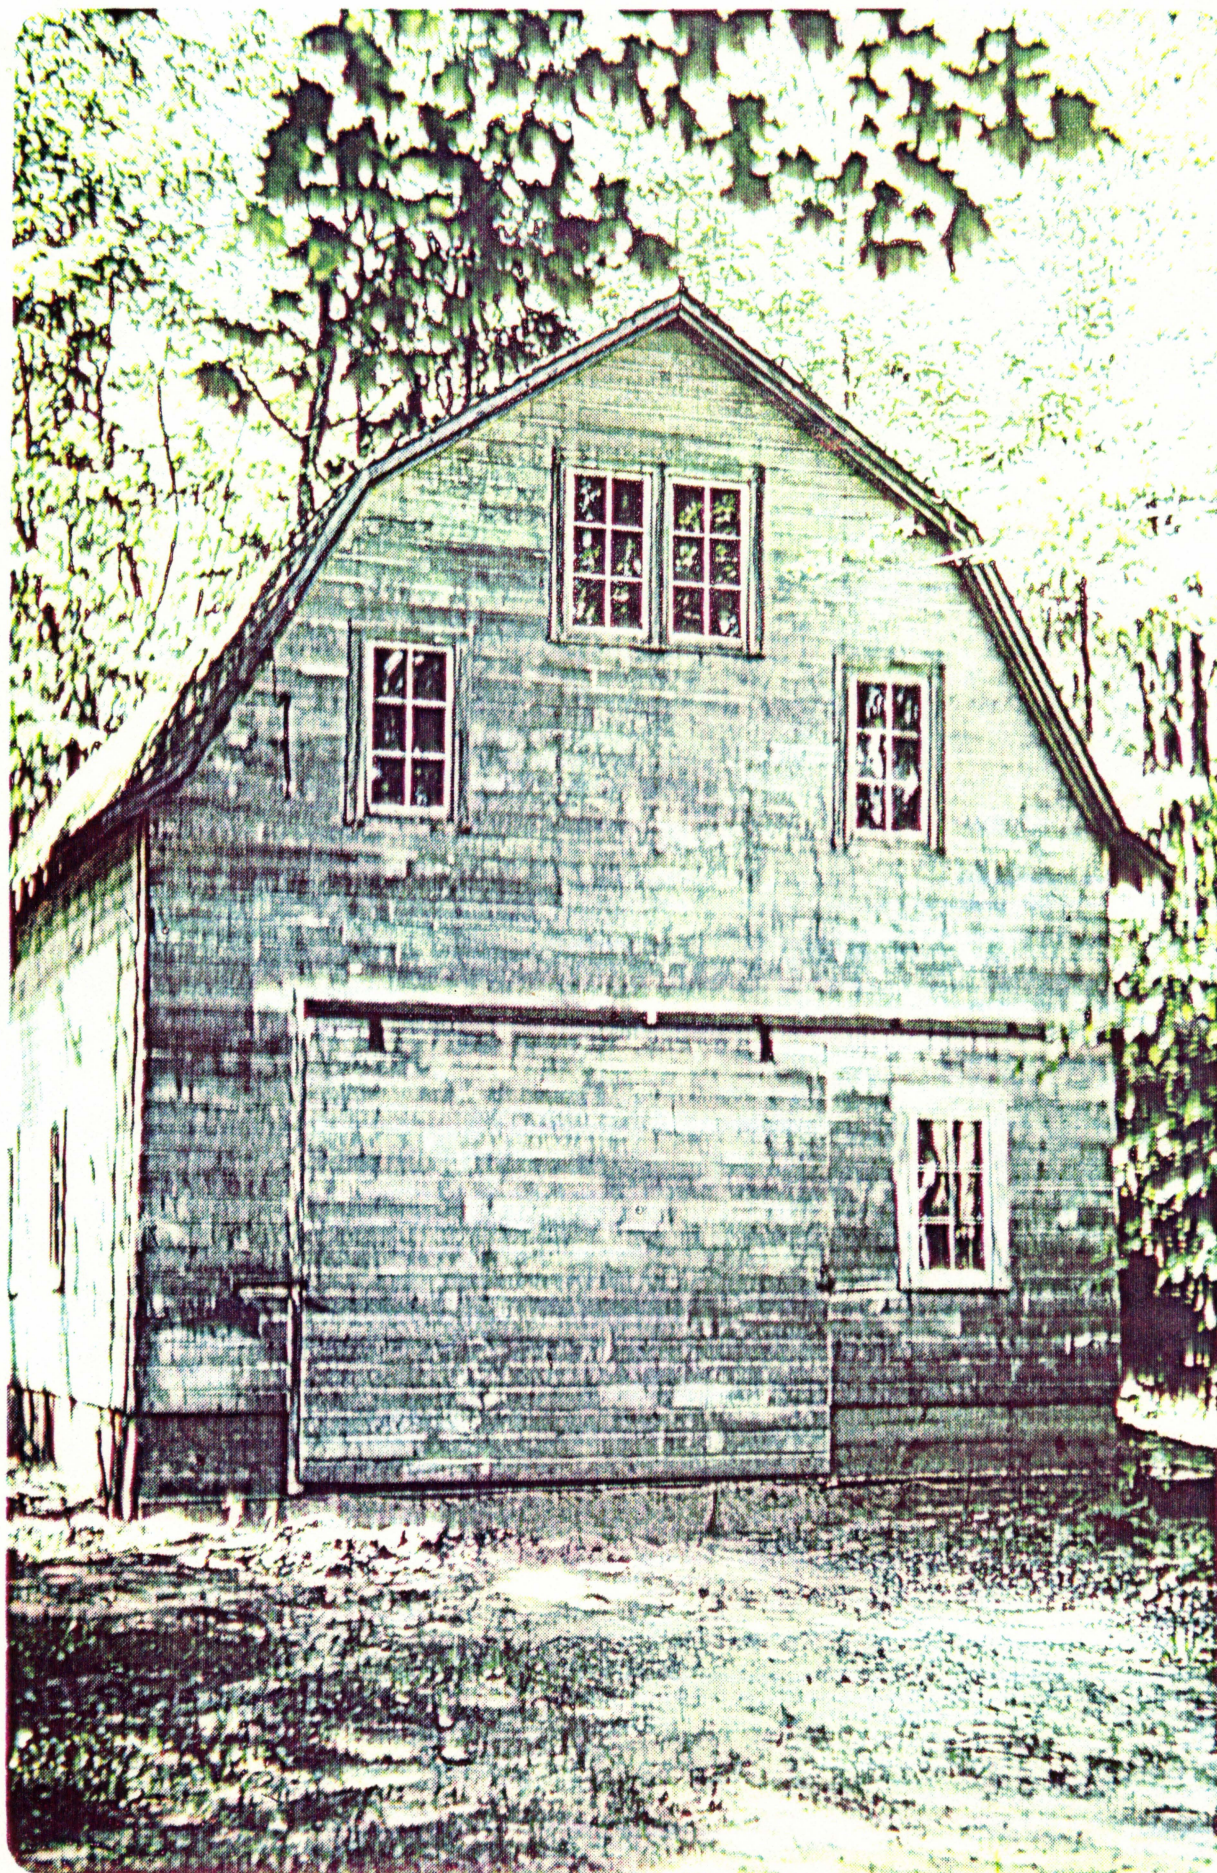
#32

From the southwestern corner of this structure rises a stairway which climbs the bluff to the Twine Shed. This stairway (see photo 30) is new, installed August 1978, which replaced an older interior stairway which had rotted (see photo 31). The older stairway had been put in place about 15 years before, and had come from a church in Bayfield. Running along side this stairway are two narrow rails which were used to slide the packing boxes down the hill to the ice house from the bluff area where they were stored. These boxes, large wooden crates, were stored on the hill in order to minimize water damage to them in case the lake rose and to keep them sand-free. The boxes were sent down as needed. The rails are presently rusting and in poor condition. (See photographs 30 - 32).

Existing stair to Twine Shed and box rails

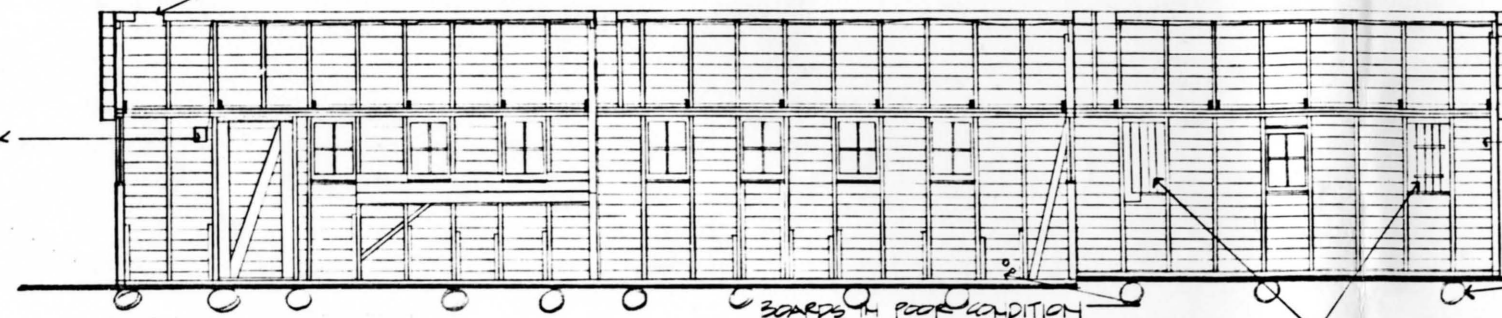
SECTION A-A

The roof is sheathed in 1-inch boards of various widths, and although there is a new cedar shingle roof, there are water stains on the sheathing from previous roof deterioration. There are 2 by 4 collar ties at every alternate rafter except for at the building ends of each room where the collar beams are notched 2 by 6 members (see section AA - Fish House).

wall's siding. Some means of laterally tying the hip joints of each pair of rafter together will be necessary. Either 2 x 6 cross-ties at the hip joints or collar ties at the midspan of each rafter would be effective. If neither of these systems fits into the structure's proposed function, another means of lateral support should be considered. After the walls are reframed and sided, the roof could be lifted back onto the walls' top plates and the two top plates could be nailed back together. Wood used to rebuild the walls need not be treated, but protection from moisture and insects should be provided.

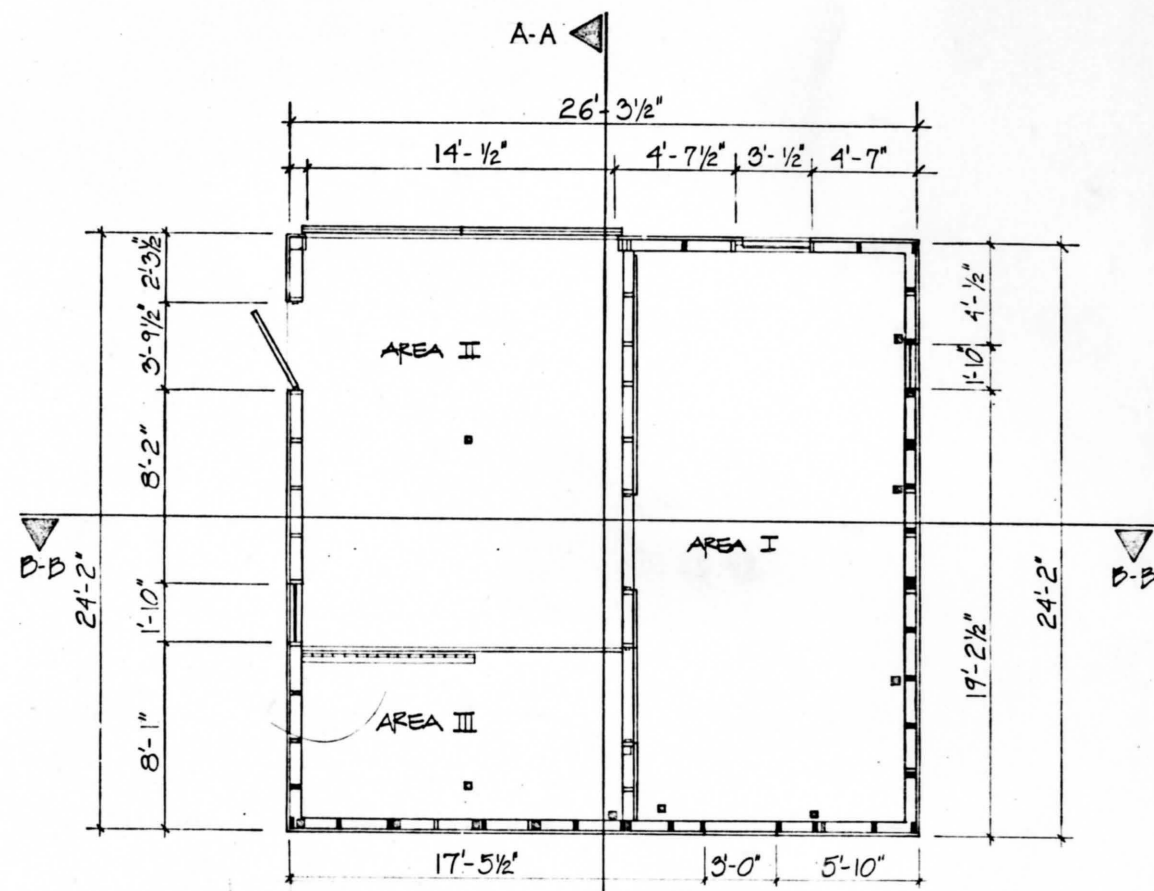
GROUND LEVEL PLAN

- ROTTED WOOD
- NEW MATERIAL

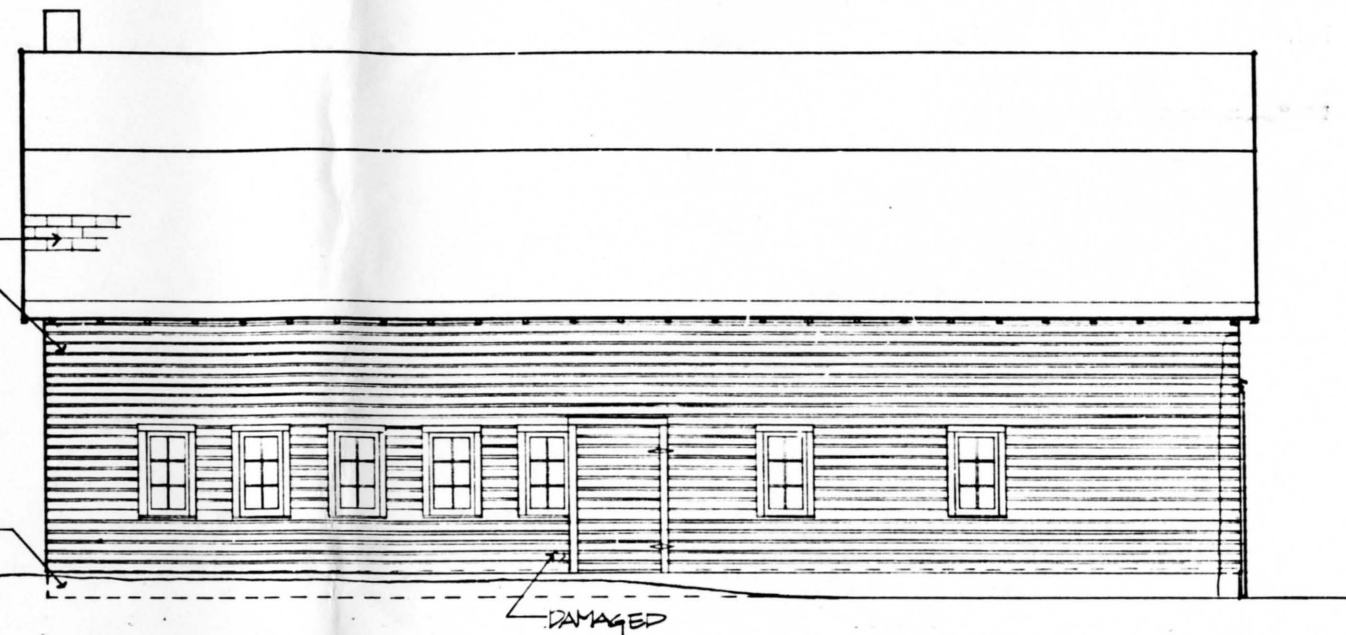
EAST ELEVATION
DRAWN AT 1/4" = 1'-0"

DAMAGED

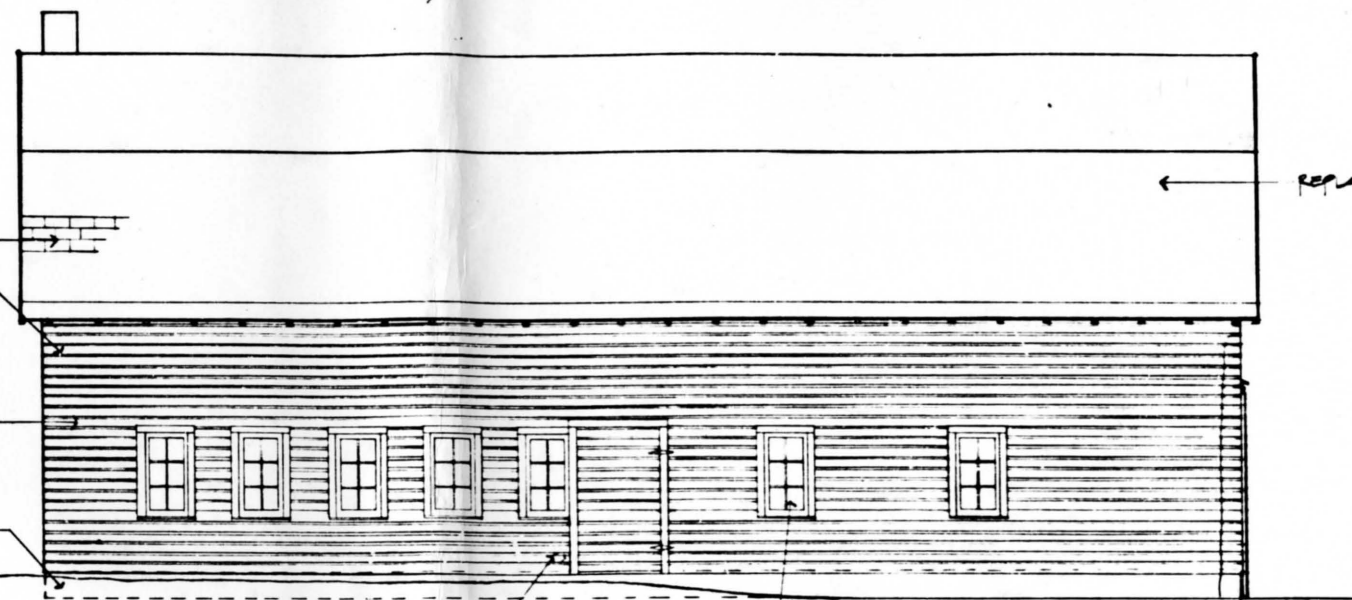
EAST ELEVATION

DAMAGED

REPLACE DAMAGED SIDING W/
LIKE KIND WHERE NEEDED

CLEAN & CAULK WINDOWS AS NEEDED (TYP)
REPLACE BROKEN LIGHTS WHERE NECESSARY (TYP)

← REPLACE ROOF W/ LIKE KIND
