HISTORIC STRUCTURE REPORT

Raspberry Island Lighthouse

(Historic Structure 08-103A)

Apostle Islands National Lakeshore
Wisconsin

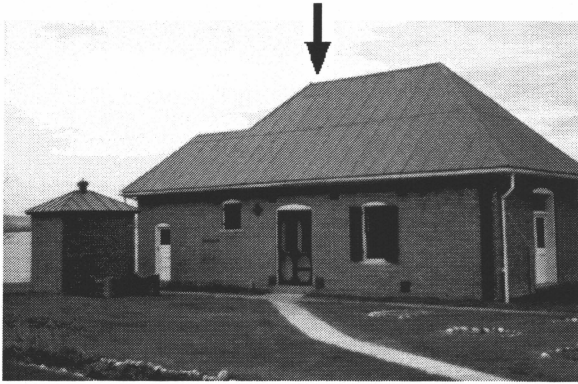
Illustration 21

View looking southwest of the fog signal building and brick oil house, 1995. Note the patch in the fog signal building's corrugated metal roof at the former chimney opening.

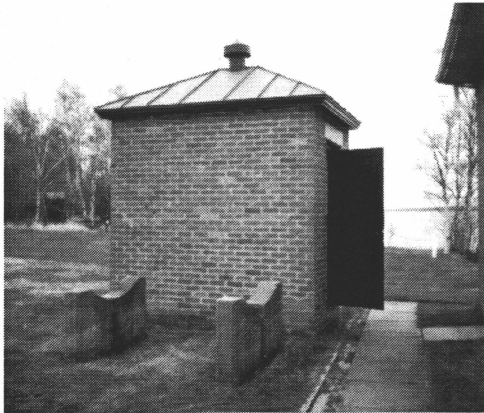
Illustration 23

In addition, there are two concrete saddles on both the north and south side of the brick oil house. The tanks they once supported are no longer extant. They may have held the fuel that generated the diesel-powered engines of the air diaphone fog signal. Illustration 19b shows the large concrete saddles just north of the brick oil house.

Brick Oil House, Raspberry Island Light Station, Lake Superior, 1995. Note the concrete saddles..

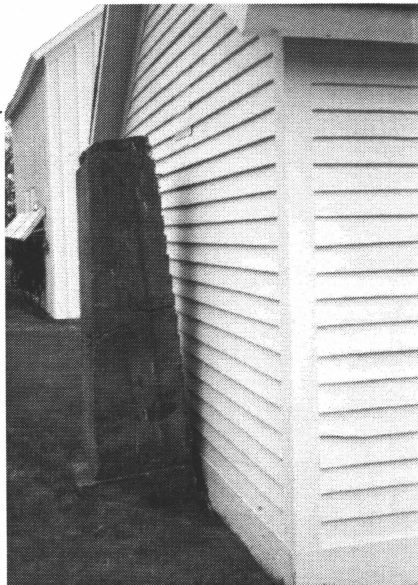
Illustration 26

View of the concrete chimney constructed alongside the rear (east) wall of the "shack," 1995. Note that due to excessive settlement, the chimney has pulled away from the wall surface.

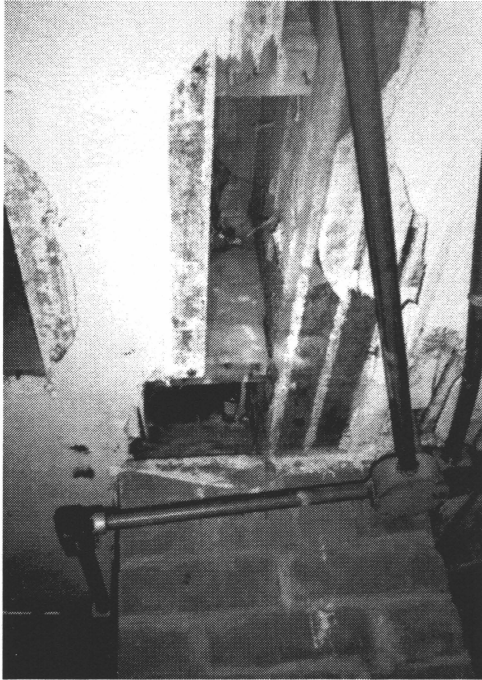
Illustration 1

View looking west at the central protruding wall in the south half of basement, 1995. Note the heavy timber beam with notched floor joists, and the exposed heavy conduit for the electrical system.

A section of missing ceiling plaster revealed a heavy timber beam which spans east-west just south of the central masonry wall in the basement. This beam is directly below the south wall of the tower, and although not visible, it is assumed that a similar beam exists beneath the north wall of the tower. As shown in Illustration 1, the 2" x 10" floor joists spanning north-south at 16" on center are notched into this beam. The 1862 drawing of the original lighthouse (Illustration 2) indicates that there were two beams spanning north-south the entire length of the lighthouse, bearing on the exterior walls and the masonry tower supports, and making it likely that the original joists would have spanned east-west, bearing on these beams. As observed, the existing joists span north-south, therefore parallel to the beams depicted in the original drawing. This conflicting direction suggests that the framing was reconstructed in 1906. However, one idiosyncrasy of this assumption is the presence of this heavy timber beam with floor joists notched into it. The use of heavy timber and joinery is more indicative of 19th rather than 20th century construction techniques. One explanation for why this situation exists may be that portions of the original 1906 heavy timber beams were salvaged and reused in the new framing system. Additionally, the 2" x 10" joists run continuously over, and also bear on the masonry walls enclosing the two stairways.

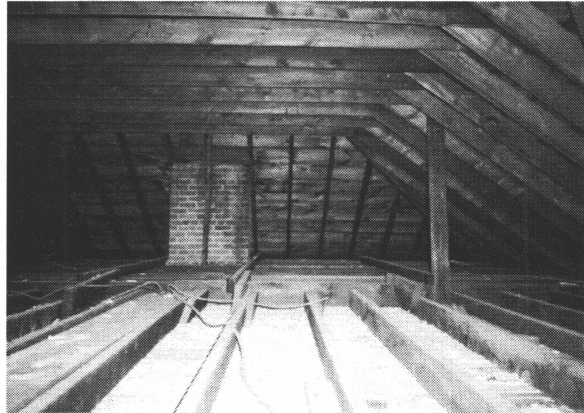
Illustration 3

View in the attic looking east, 1995. Note the change in the height of the floor joists at the division of the 1863 and 1906 construction, and the collar beams tying the rafters over the 1906 section.

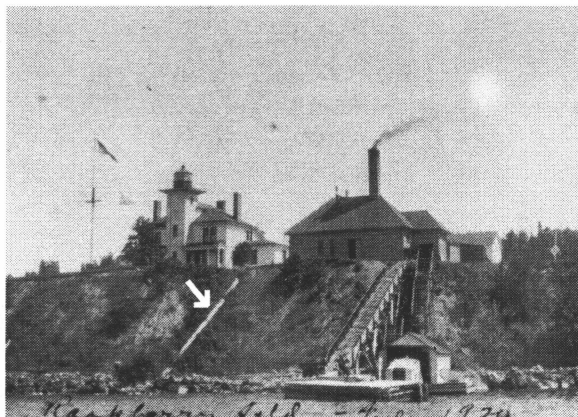
Illustration 8

Photo of the lighthouse site from the water, ca. 1920. Note the trough-type drainage line constructed down the slope of the bluff.

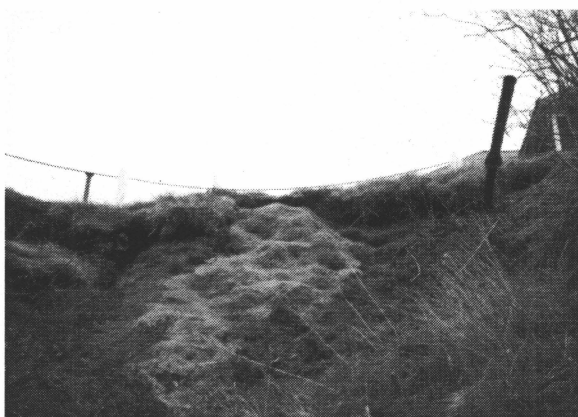
Illustration 9

bluff to the water's edge. The historic drawing (Illustration 6) indicates that this drain was "closed off" or possibly just buried in 1931. Currently, at the location where this drain would have met the bluff edge, there is indication of accelerated erosion, as seen in Illustration 9. This indicates that water may have continued to naturally flow toward this area after the trough was removed.

Photo of the bluff area where the historic drain was originally connected to the trough-type drainage line, 1995.

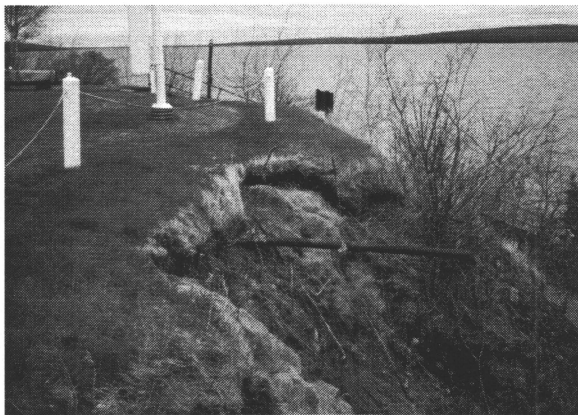
Illustration 10

The fog signal building also has a cistern which collects water from its downspouts. The overflow from the cistern is drained through an underground drain pipe which protrudes from the bluff edge approximately 8," allowing water to drain directly on the side of the bluff. The excessive erosion this has caused is evident in Illustration 10.

Photo showing the severe erosion of the bluff at the drainpipe outlet just north of the tramway, 1995.

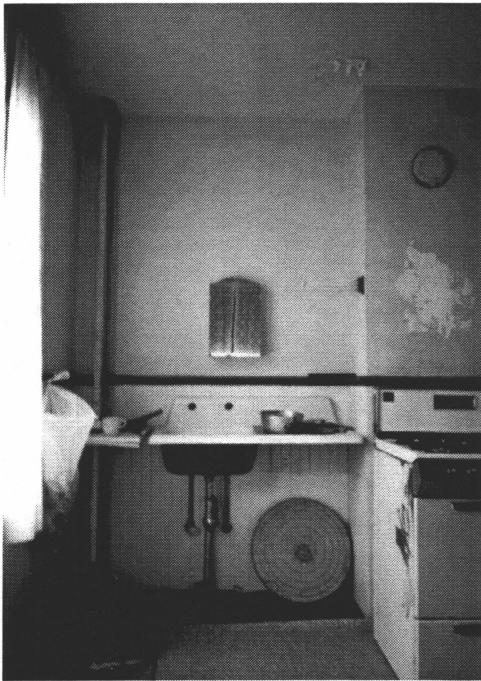
Illustration 11

View of the southeast corner of the assistant keeper's kitchen showing the 1940s cast iron sink, the ghosted image of a former sink at the wainscot, and the cold water pipes leading to the second floor, 1995.

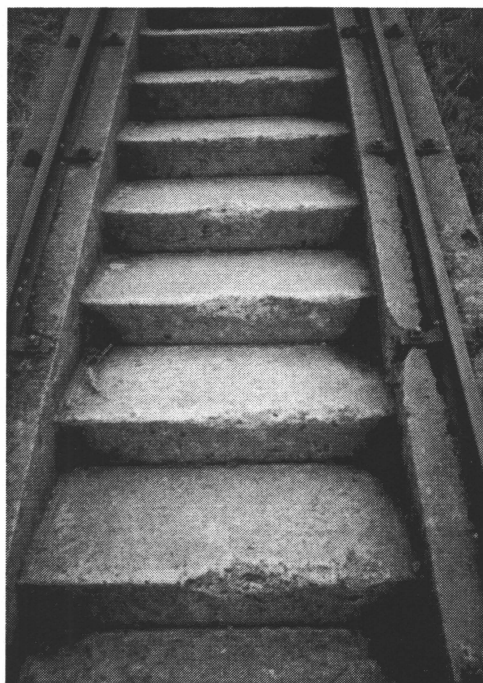
Illustration 14

Detail of the concrete tramway, 1995.

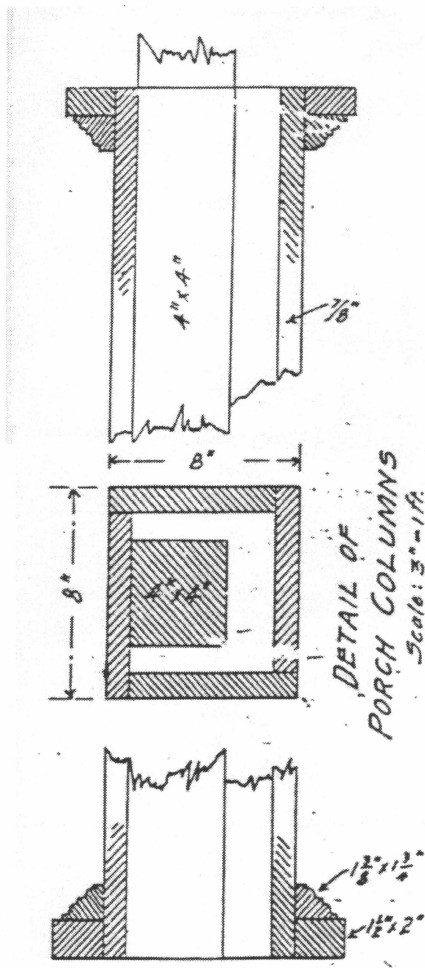
The porch columns are 8" x 8" in plan, comprised of 1" x 8" members nailed square around 4" x 4" solid wood posts, as detailed in the original 1905 construction drawings, Illustration 22. The columns are painted and have an applied molding as a base, except at the two columns of the south porch where there is a solid base member that is beginning to rot and deteriorate. Illustration 22 shows the bases constructed with applied moldings, providing evidence that the solid member bases were added at a later date. At the top of one column on the south porch there is a small piece of extant trim molding directly below the column cap trim (Illustration 23). This molding, which has an ogee profile, appears to be the only extant piece of original trim that was intended to encompass each column, as indicated in Illustration 22.

Porch construction detail taken from the 1906 construction drawings.

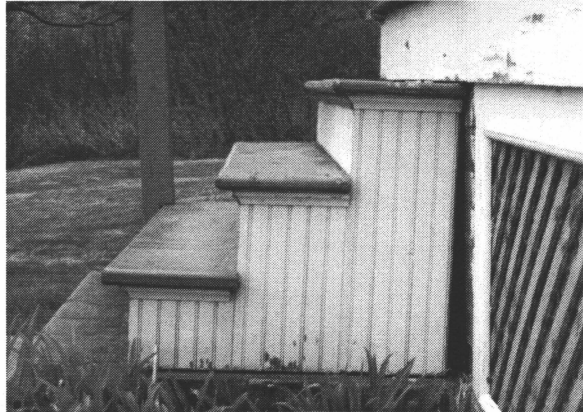
Illustration 24

Historic photos indicate that the concrete base, on which the south steps bear, appears to be the original. Due to ground settlement though, the concrete has cracked and seems to be continually breaking up. The wood treads have been replaced at both stairs, and a non-historic post and handrail has been constructed along the north edge of both stairs as well. The side skirts of the south stair are 2 1/2" vertical beaded boards, which appear relatively new, and do not resemble the skirt boards in the historic photos (Illustration 24).

Photo looking north at the north porch's steps, 1995. Note the non-historic beaded board wood trim.

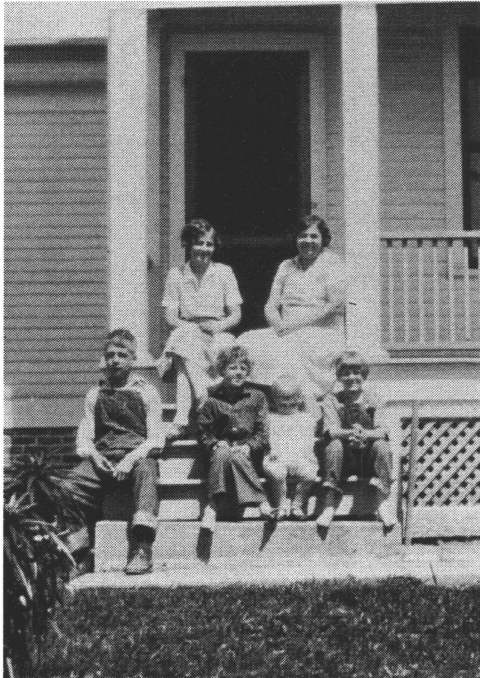
Illustration 25

Photo taken ca. 1924-29. Note that the concrete base of the steps has already significantly settled at the south end.

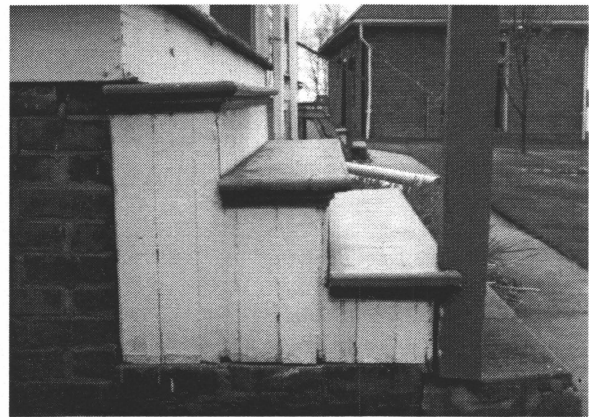
Illustration 27

View looking south at the north porch's steps, 1995. The wide, flat wood boards may be the only extant wood of the original 1906 steps.

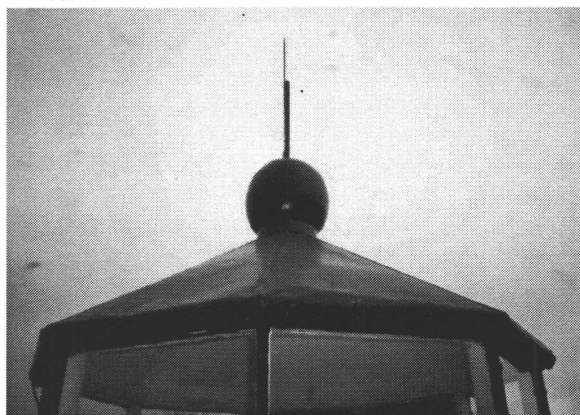
Illustration 30

Detail view of the paint build-up on the lantern's roof, ventilator ball, and lightning rod, 1995.

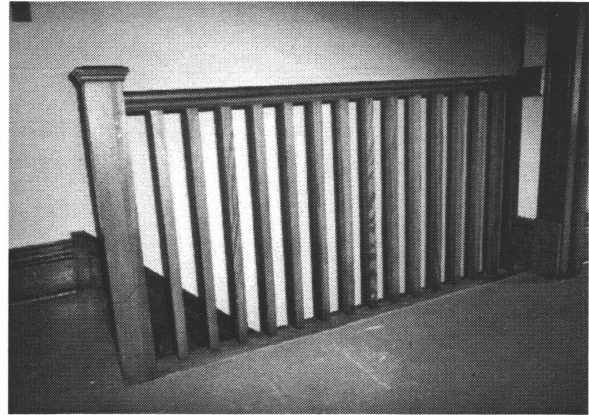
Illustration 35

Photo of the handrail and balustrade at the top of the stair at the north half of the dwelling (Room 213, Stair Hall), 1995. Note the simple profiles including: the square newel post with a simple cap, the square balusters, and the curved handrail.

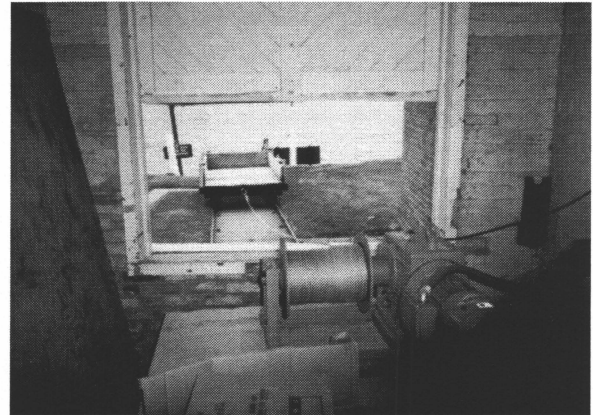
Illustration 39

View of the electrically powered winch, which currently operates the tram, 1995.
