SAND ISLAND WEST BAY CLUB STRUCTURES
APOSTLE ISLANDS NATIONAL LAKESHORE
Historic Structures Report

PMIS #191296
July 5th, 2023

Historic Structures Report

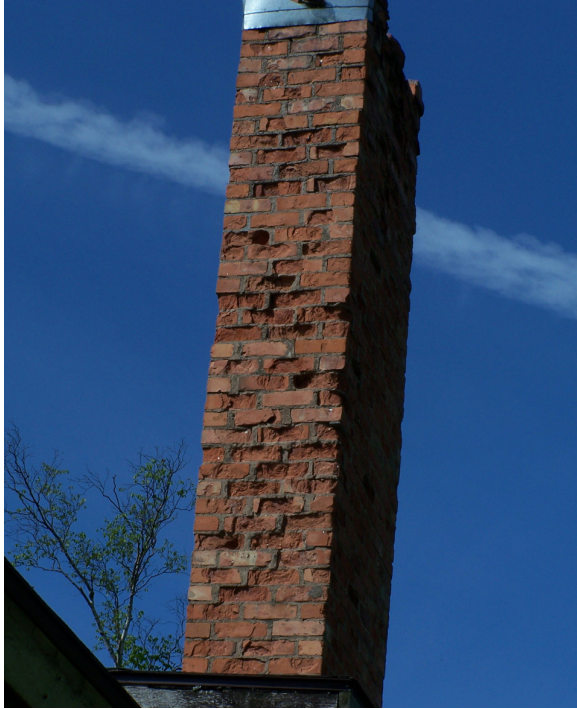
Figure 1-22. Condition of the West Bay Club chimney, 2006 (Source: APIS Library Collection, West Bay Club, 2006 West Bay Club).

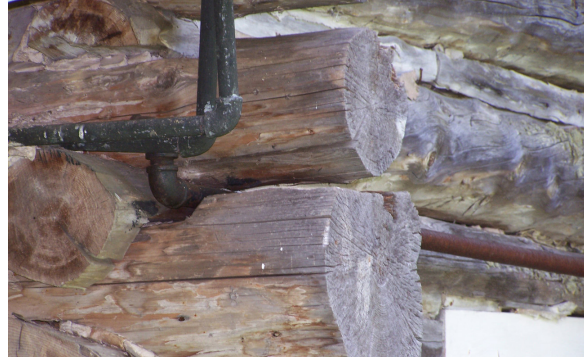
Figure 1-24. Exterior plumbing condition at the West Bay Club, 2006 (Source: APIS Library Collection, West Bay Club, 2006 West Bay Club).

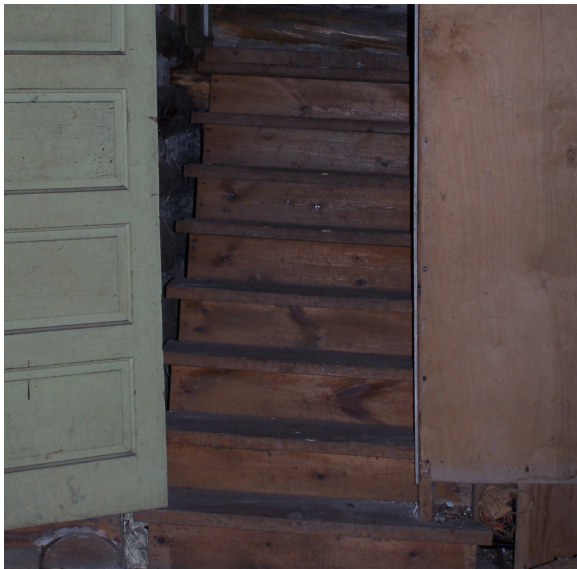
Figure 1-23. Settling of the interior staircase at the West Bay Club, 2006 (Source: APIS Library Collection, West Bay Club, 2006 West Bay Club).

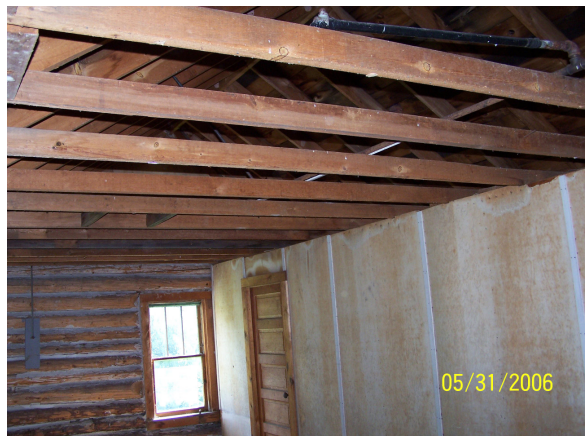
Figure 1-26. Second floor interior finish condition at the West Bay Club, 2006 (Source: APIS Library Collection, West Bay Club, 2006 West Bay Club).

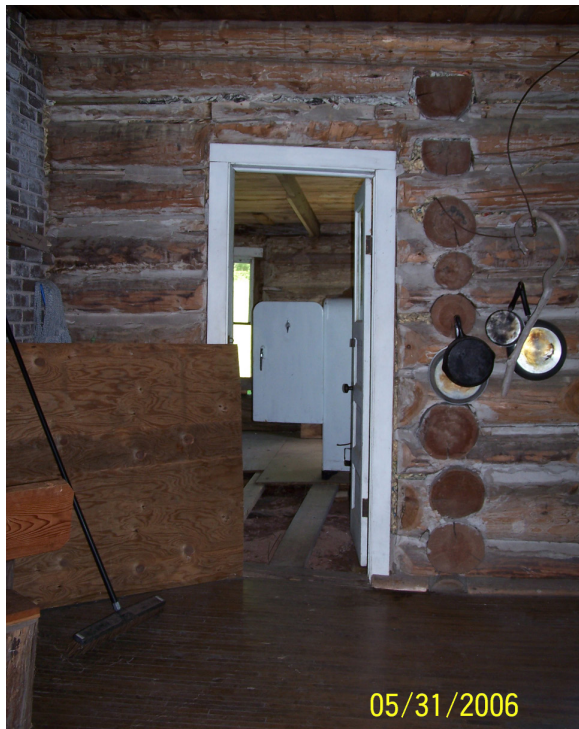
Figure 1-28. Settling observed on a first story doorway of the West Bay Club, 2006 (Source: APIS Library Collection, West Bay Club, 2006 West Bay Club).

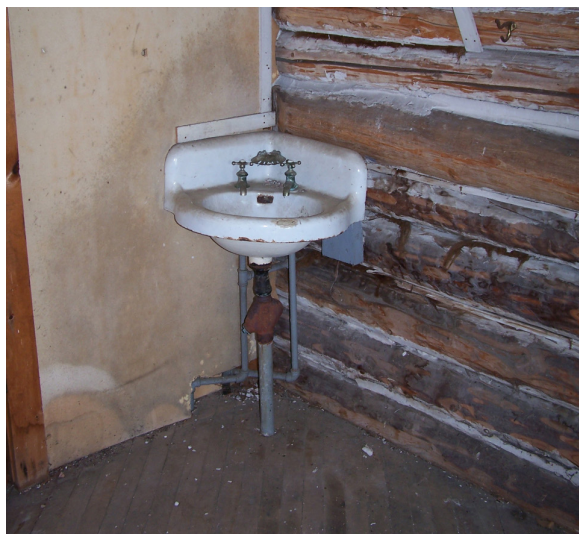
Figure 1-29. Condition of the West Bay Club second-story interior finishes and fixtures, 2006 (Source: APIS Library Collection, West Bay Club, 2006 West Bay Club).

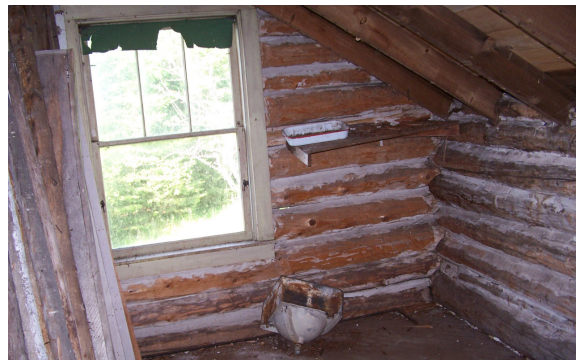
Figure 1-27. Second-floor interior finish condition at the West Bay Club, 2006 (Source: APIS Library Collection, West Bay Club, 2006 West Bay Club)

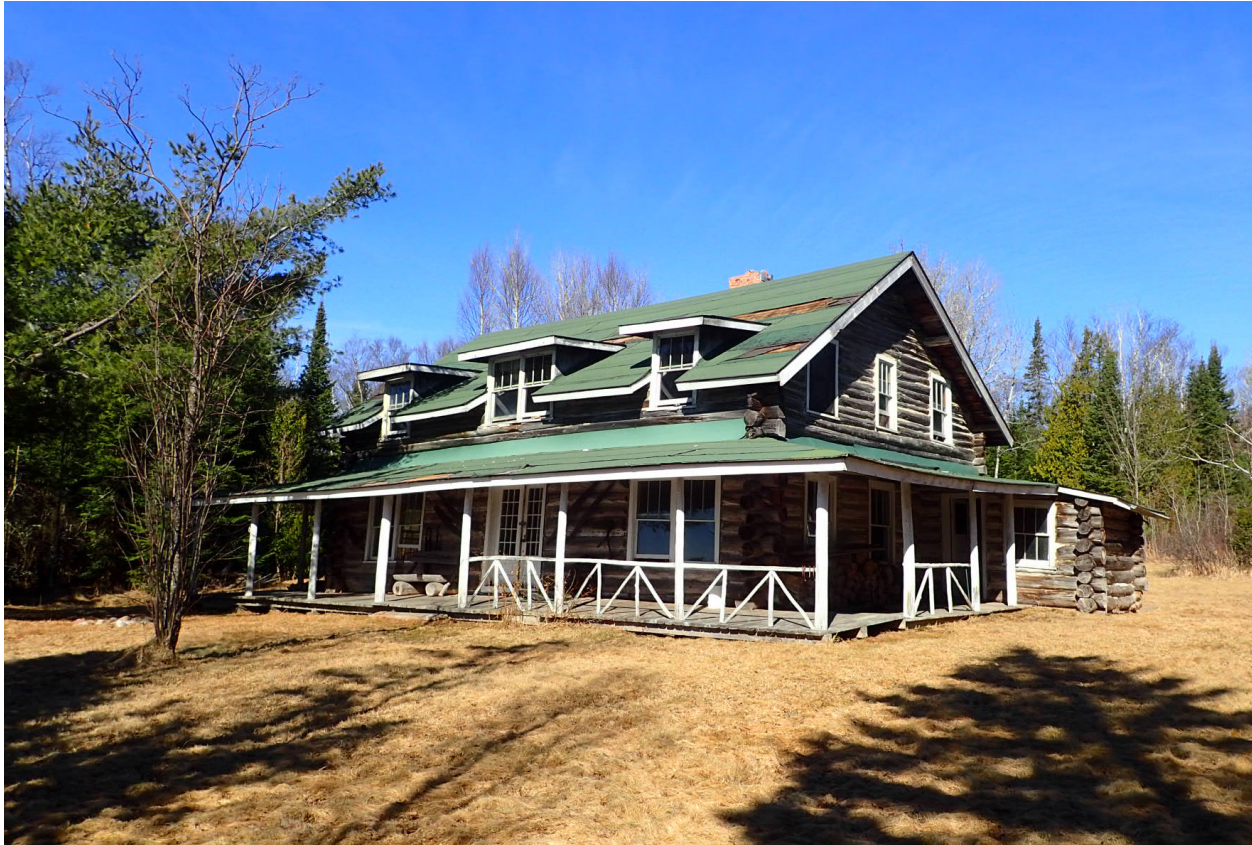
Figure 1-30. Condition of the West Bay Club during the NPS reacquisition site visit, 2017 (Source: APIS Library Collection, West Bay Club, 2017_09 Roofing).

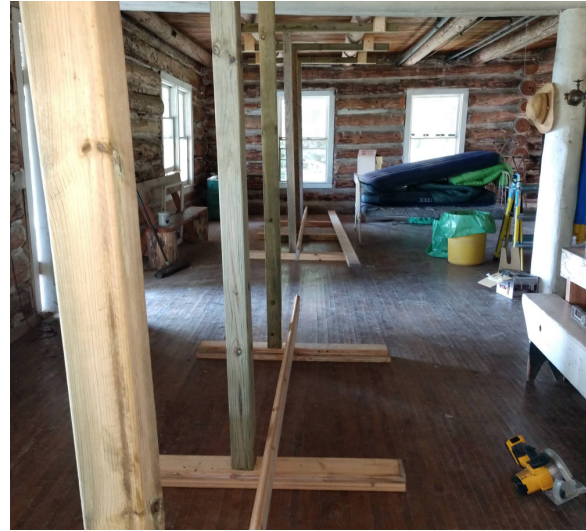
Figure 1-32. Interior shoring of the Lodge, 2017 (Source: APIS Library Collection, West Bay Club, 2017_09 Roofing)).

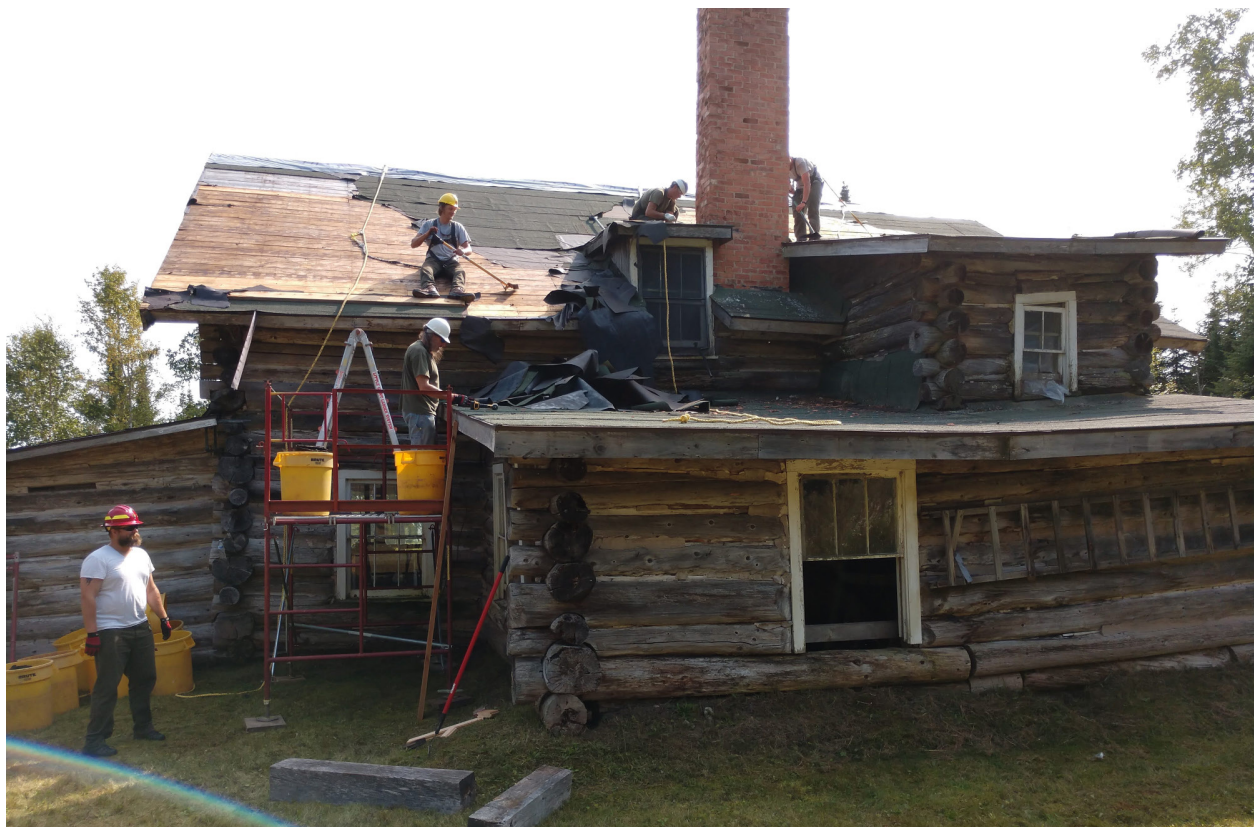
Figure 1-31. Reroofing of the main Lodge roof, 2017 (Source: APIS Library Collection, West Bay Club, 2017_09 Roofing).

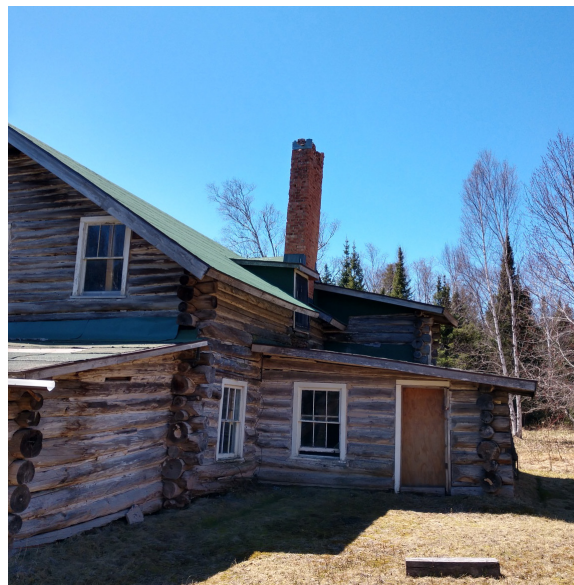
Figure 1-33. West Bay Club Lodge chimney prior to stabilization, 2019 (Source: APIS Library Collection, West Bay Club, 2017_09 Roofing).

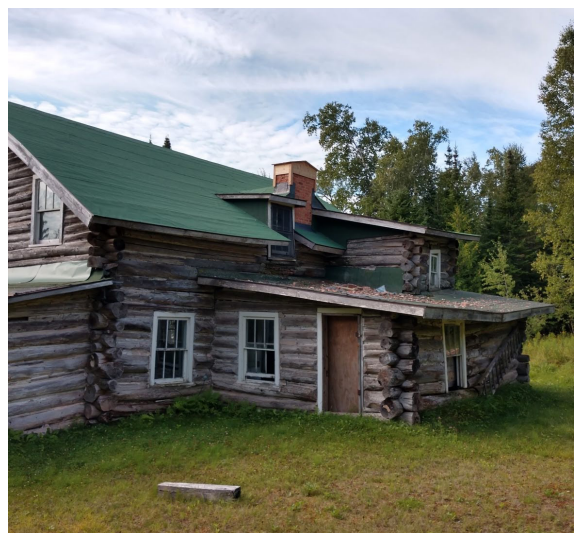
Figure 1-34. West Bay Club Lodge chimney post stabilization, 2019 (Source: APIS Library Collection, West Bay Club, 2017_09 Roofing).

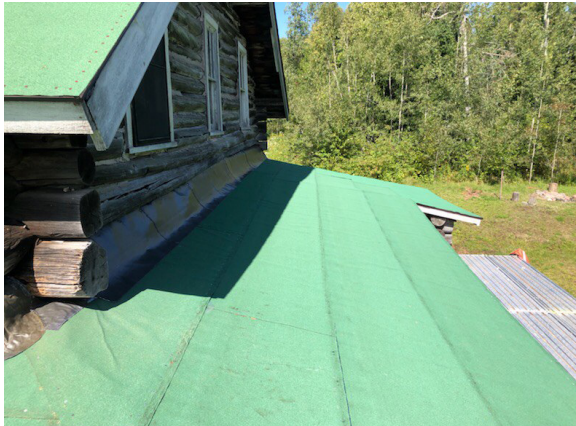
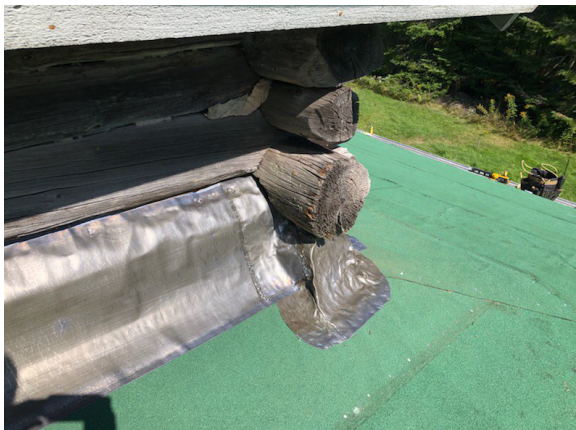
Figure 1-35. Reroofing the porch roof at the West Bay Club, 2020 (Source: APIS Library Collection, West Bay Club, 2020_09 Porch Roof).

Figure 1-36. Reroofing the porch roof at the West Bay Club, 2020 (Source: APIS Library Collection, West Bay Club, 2020_09 Porch Roof).

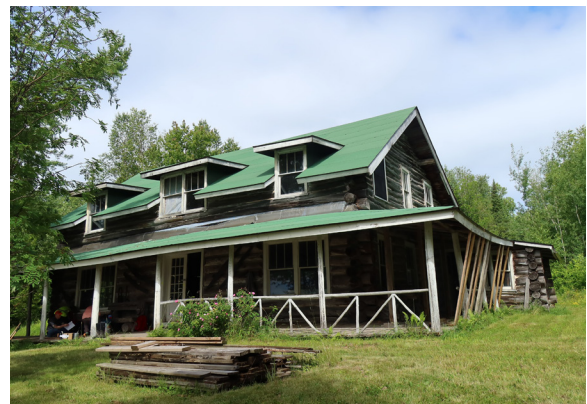
Figure 1-42. South façade of the Lodge, showing temporary supports. (AH, 08/01/2022)

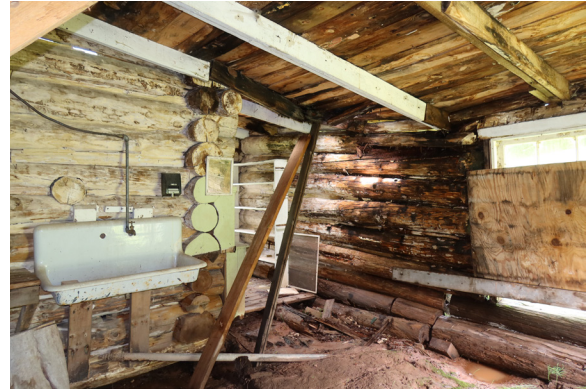
Flooring in the pantry indicates the room was finished similar to Living Room (101) with wood boards. The flooring in the main area of Kitchen (102) has been removed and grade is exposed. Temporary structural shoring spans from the ground to the ceiling.

Figure 1-47. Southeast corner and pantry area of Kitchen (102). (AH, 08/01/2022)

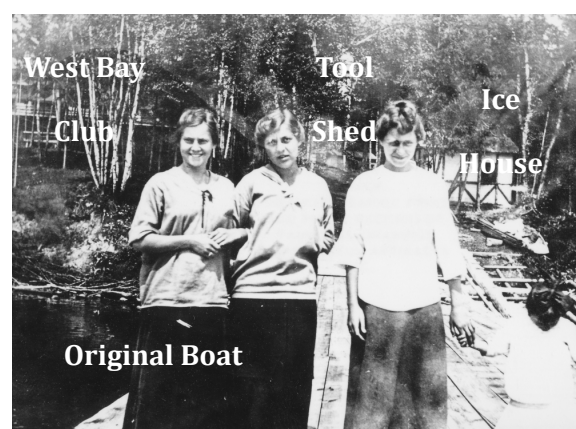
Figure 1-57. Historic physical and visual relationships are altered by the loss of the original dock, the walk from the dock to West Bay Club Lodge, outbuildings, and erosion that continues to modify landform and impact original concrete stairs and Ice House (APIS Library Collection, West Bay Club, IID7g-1915C_01).

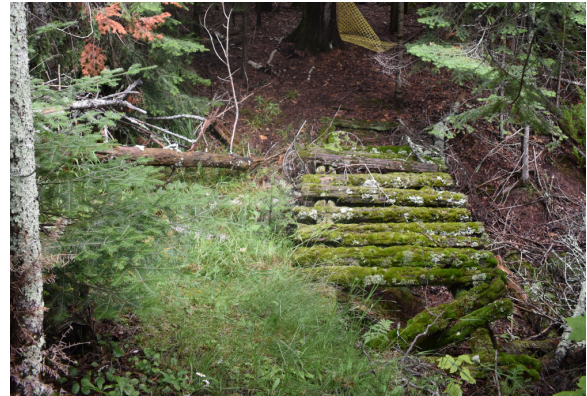
Figure 1-62. The setting is modified by the loss of historic circulation features, including the bridge and road east of Ice House (Mundus Bishop, 2022).

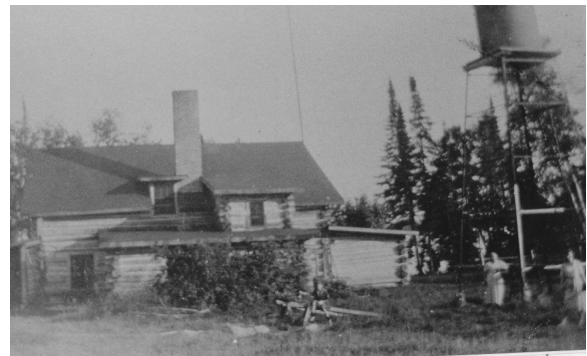
Figure 1-63. Topography slopes from the north to West Bay Club Lodge with stormwater ponding along the hillside and a low point at the kitchen (Mundus Bishop, 2022).

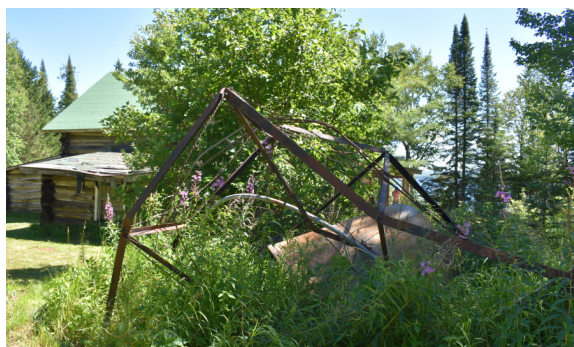
Water tower ruins indicate the location of a collapsed water tank built in 1913. Water tower ruins are in poor condition. Historic concrete stairs are set west of Icehouse to the clearing at the top of the bluff. Concrete stairs mark the historic location of a walk extending from the non-extant, historic dock up the bluff to West Bay Club. Lower stairs are impacted by erosion and are in poor condition. The upper nine stairs, including the “EHA” stair, are in good condition.

Figure 1-66. Water tower ruins indicate the location of the original water tank (Mundus Bishop, 2022).

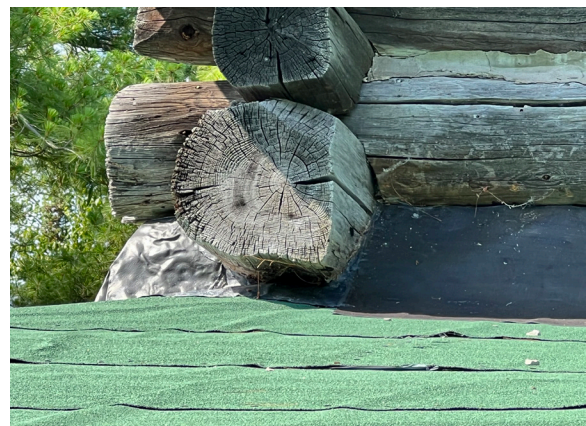
Where the low-slope roofs meet the exterior log walls, approximately 8-to-12-inches of sidewall flashing is exposed. The flashing terminates between two horizontal logs and is hammered to match the profile of the log which it wraps. This condition is present at the shed roofs of the Men's Bath (104), Kitchen (102), and the Stair Hall (105), and at the hipped roof covering the porch. Note that unlike the pre-finished flashing at eaves, this sidewall flashing and all flashing around the chimney appear to be an unfinished softer metal, likely lead. Images from the most recent roofing campaign indicate that the lead sidewall flashing dates to 2017.

Figure 1-72. Flashing terminating over logs onto mineral-surfaced rolled roofing. (AH, 08/01/2022)

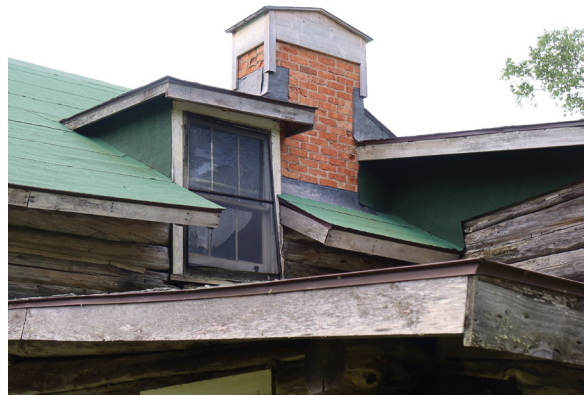
A brick chimney penetrates the gable roof between the north dormer and the Stair Hall (105) roof. This intersection is problematic, as described in the condition assessment below. An over-sized cricket extends along the east and west sides of the chimney onto the adjacent low-slope shed roofs. Limited access precluded verification of wall flashing at the south. Wall flashing on the west and east side of the chimney are not stepped, maintaining the same height and terminating on the adjacent saddle. Front flashing is appropriately tucked into the masonry and terminates on the gable roof below. However, the front flashing appears to be too low on the chimney.

Figure 1-73. The chimney is positioned tightly between a bedroom dormer and stair dormer (AH, 08/01/2022)

Flashing around the chimney appears to be preventing water entry. The chimney is located at a complex joint between two roof dormers and flashing appears to be loosely lapped and contributing to the water intrusion issues at this location.

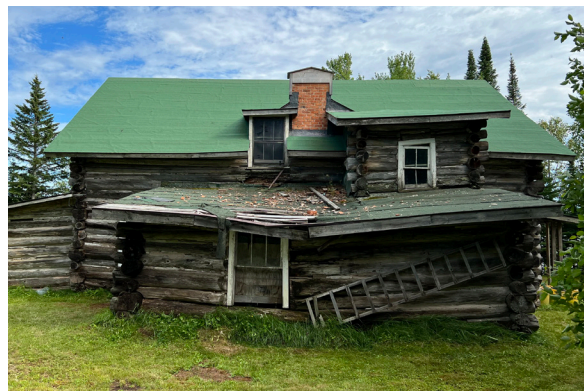
Figure 1-75. Failure of the kitchen wing roof rafters has resulted in noticeable deflection. (AH, 08/01/2022)

Active leaks and severe water damage are concentrated at the Kitchen (102) wing, where roofing was not replaced during the 2017 campaign. This low-slope shed roof and its connection to the north face of the log wall have both failed and are in critical need of repair, although it is structurally unsafe to do roofing work.

Sheathing and roof structure of the Kitchen (102) roof were observed to be deteriorating during Al O'Bright's 1984 visit to the site and have significantly worsened over the intervening thirty years. A hole in the roof, approximately 6-inches in diameter, funnels rainfall directly into the Kitchen (102). See the Structural section for an evaluation of the roof structure.

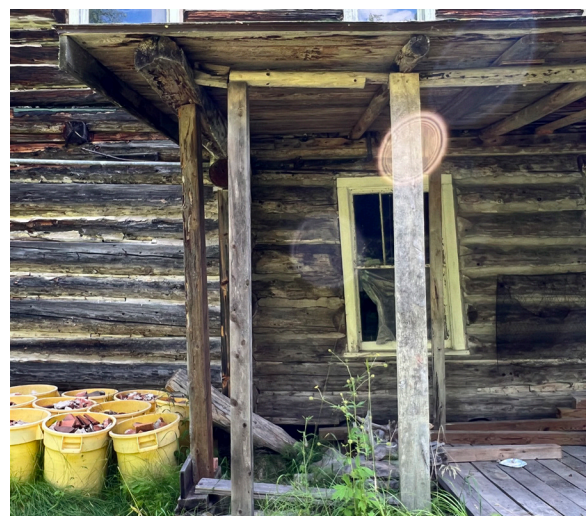
Figure 1-80. Exterior walls are least deteriorated where protected under the porch roof. (AH, 08/01/2022)

The exterior walls are in typically in fair to poor condition. See the Structural section for an assessment of structural logs. Note that logs were generally observed to be in best condition where most protected from weather and elevated from groundwater. Such conditions were observed at the west, south, and east walls beneath the overhanging porch roof.

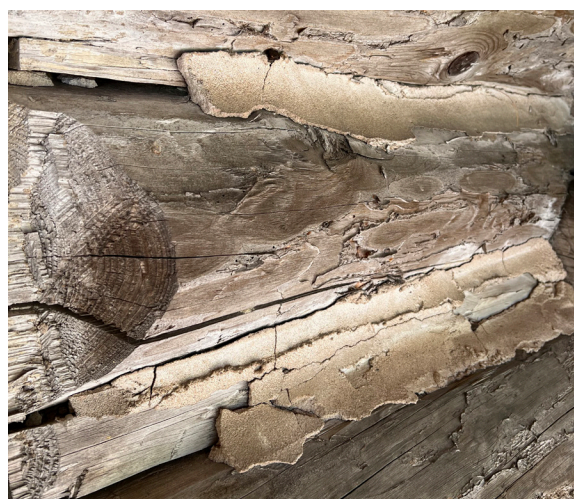
Figure 1-82. Concave profile of exterior daubing, viewed at the south façade. (AH, 08/01/2022)

which thins at the ends. When exposed to temperature swings and weathering, these thin ends can break, as observed across all walls. In some instances, the daubing was observed to flare out at the top, a detail which can lead to water intrusion in the wall assembly and accelerated failure of the daubing. This has likely contributed to the loss of daubing.

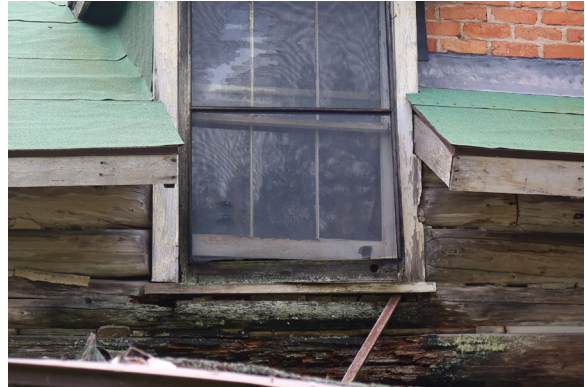
Sills at the second floor windows appear to be in fair condition, except at the two north windows. These two sills are adjacent to saturated, rotted logs and are themselves beginning to show signs of rot. Both sills appeared damp, but could not be inspected up close due to restricted roof access. Light bio-growth was observed on both of the north sills.

Figure 1-89. Deteriorated window sill at the north dormer (second floor). (AH, 08/01/2022)

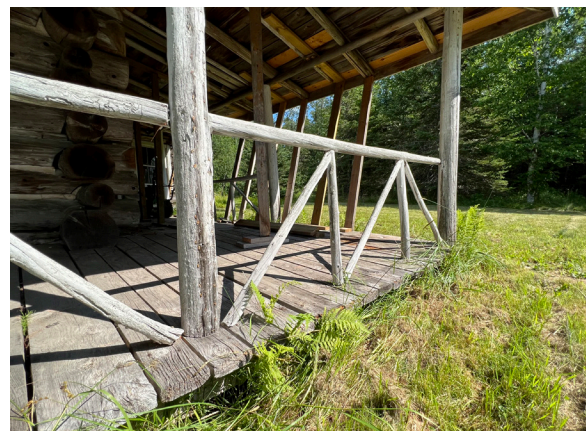
Figure 1-93. Railing and balusters remaining on south façade of porch. (AH, 08/01/2022)

The railing is in poor condition with approximately 60% of the railing and balusters missing. Remaining elements are weathered, cracked, and in fair to poor condition.

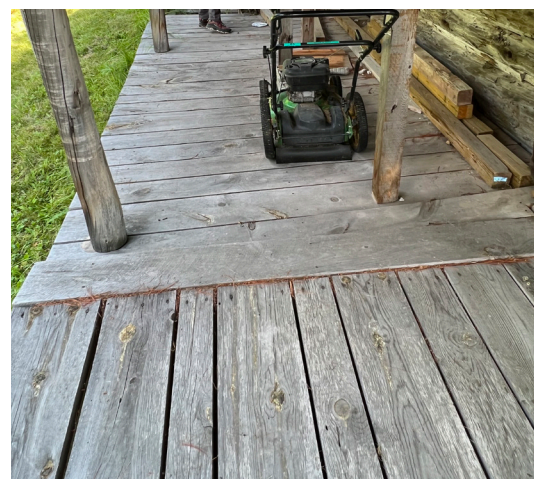
Figure 1-94. Existing wood decking at porch (AH, 08/01/2022)

Wood decking is in fair to poor condition. Boards are weathered. At their ends, boards are cracked and lightly cupped. In various locations along the perimeter, boards are in contact with plants and grade.

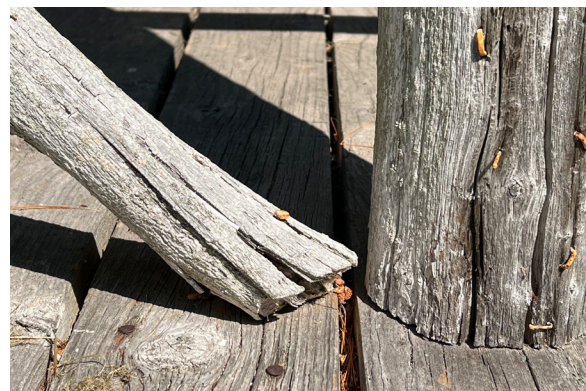
Figure 1-97. Remaining porch elements are weathered and cracked. (AH, 08/01/2022)

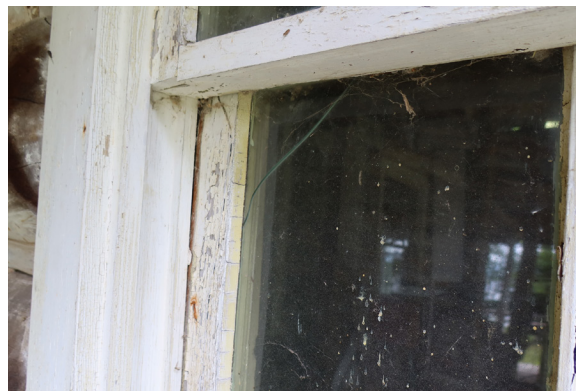
Figure 1-108. Cracked glazing at Men's Room (104), south wall. (AH, 08/01/2022)

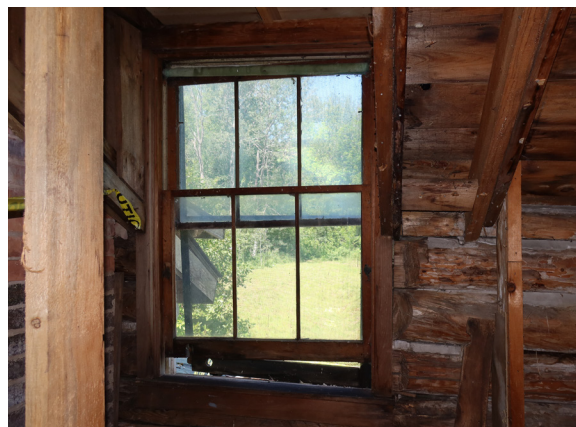
- Hall (201), north wall: The exterior screen is falling off the window. A hole has been drilled in the base of the bottom sash.

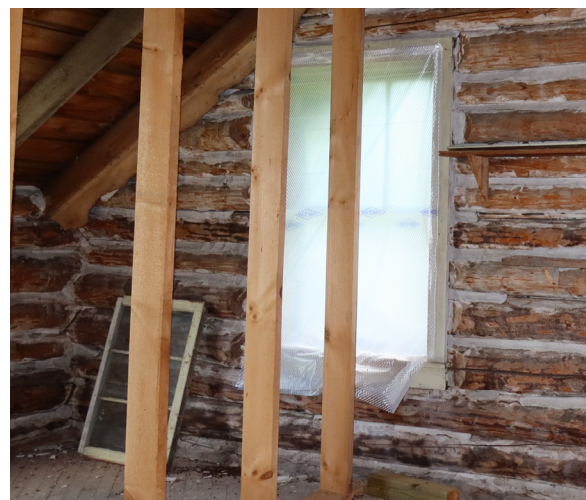
Figure 1-113. Interior of Type B window in Bedroom (203), west wall. Note the plastic film covering window and bottom sash to the left of the window. (AH, 08/01/2022)

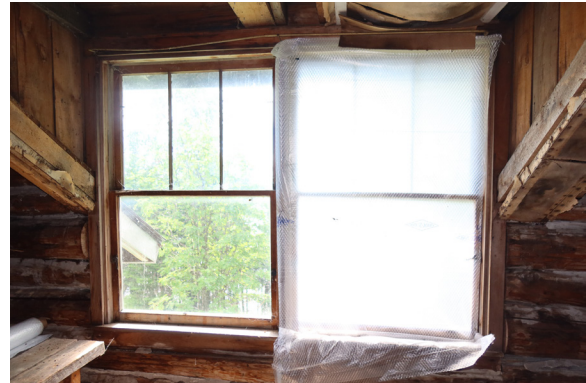
Wood elements of second floor windows are consistently water-stained. This is most severe near the base of the window.

Figure 1-114. Interior of paired Type B windows in Bedroom (204). (AH, 08/01/2022)

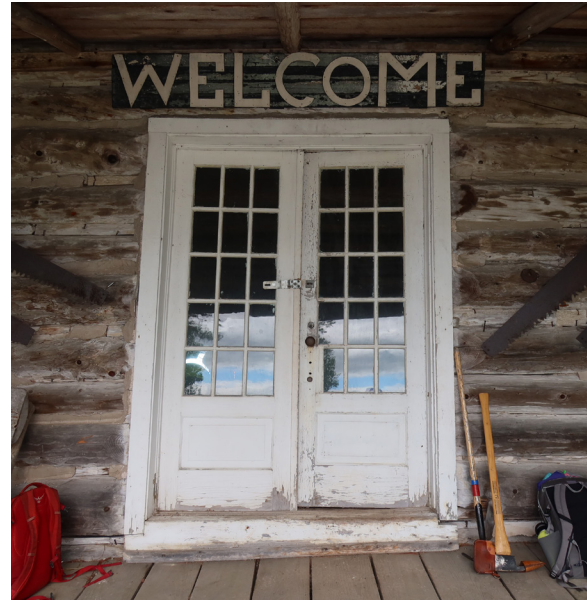
Figure 1-116. Exterior of Type A doors. (AH, 08/01/2022)

The Type A doors are in fair condition. Glazing putty is mostly missing. Approximately 25% of paint is missing on both sides of each door. Operability is difficult. Only the east door is operable and closing it requires excessive force. The integral latch does not meet when closed, requiring use of the padlock-style latch to hold the door closed.

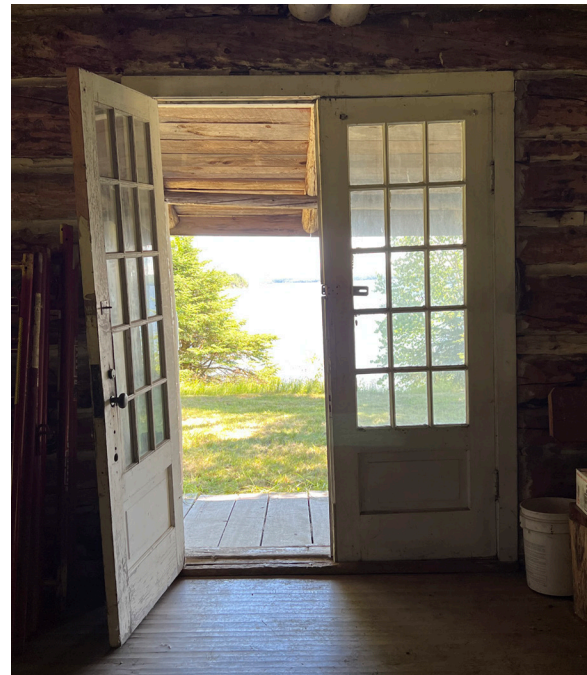
Figure 1-117. Interior of Type A doors. (AH, 08/01/2022)

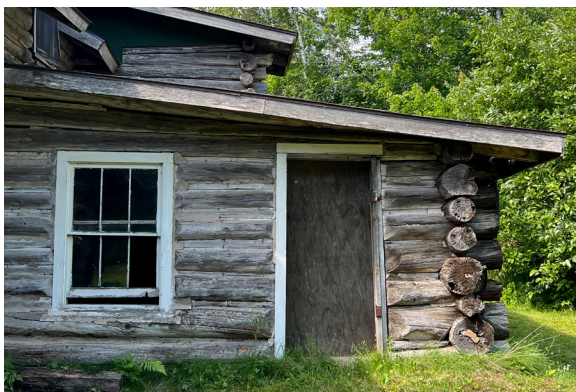
Figure 1-118. Opening for Type B door on east wall of Kitchen (102). (AH, 08/01/2022)

The Type B door at the Kitchen (102) is in poor condition. This door has been removed and is stored in Bedroom (202). The opening is distorted such that it is wider at the base. No threshold remains at this door. A 6x6 wood member has been placed where the threshold belongs and is partially submerged below grade.

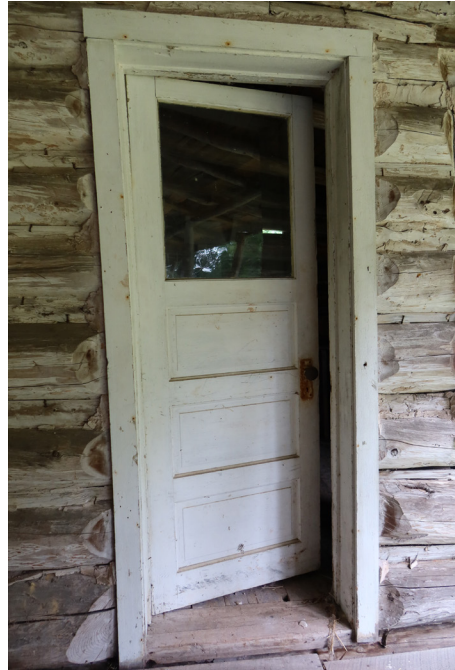
Figure 1-119. Exterior of Type B door at south wall of Men's Bath (104). (AH, 08/01/2022)

The Type B door leading to the Men's Bath (104) is operable and its glazing is intact. Paint is scratched and worn. This door is in fair condition.

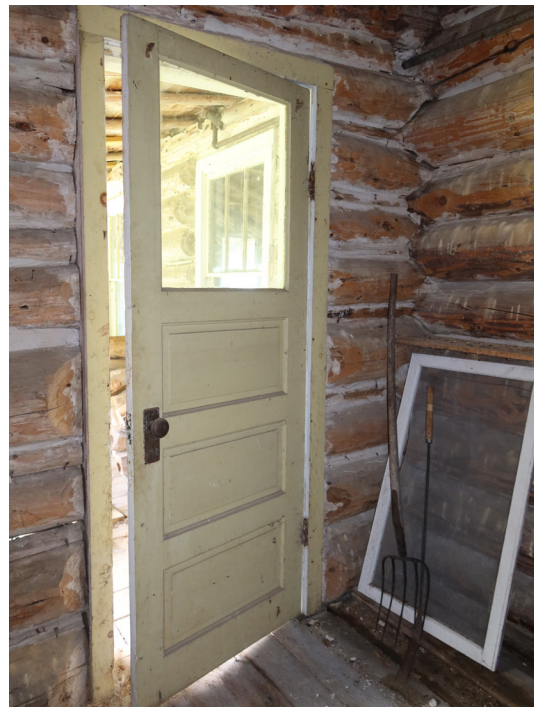
Figure 1-120. Interior of Type B door at south wall of Men's Bath (104). (AH, 08/01/2022)

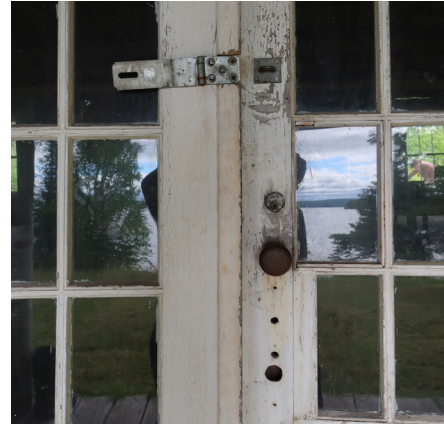
Figure 1-121. Hardware and holes on exterior of Type A doors. (AH, 08/01/2022)

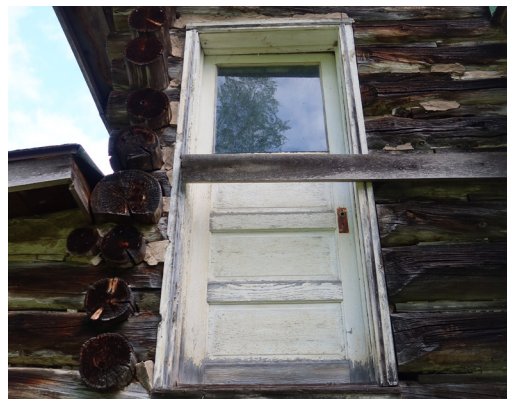
The Type B door at the Stair Hall (105) has been rendered inoperable by a series of modifications. The stairs which served this door (or were intended to be built here, as evidence of their completion has not been uncovered during investigations) do not exist. At the exterior, a wood 1x6 board has been nailed across the opening to prevent its use. Both door knobs have been removed. This door is in poor condition. Approximately 25% of paint is missing at the exterior and the interior face is coated with debris.

Figure 1-122. Exterior of Type B door at Stair Hall (105). (AH, 08/01/2022)

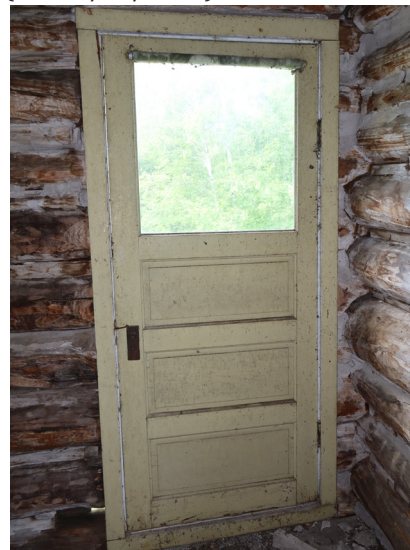
Figure 1-123. Interior of Type B door at Stair Hall (105). Note missing knob. (AH, 08/01/2022)

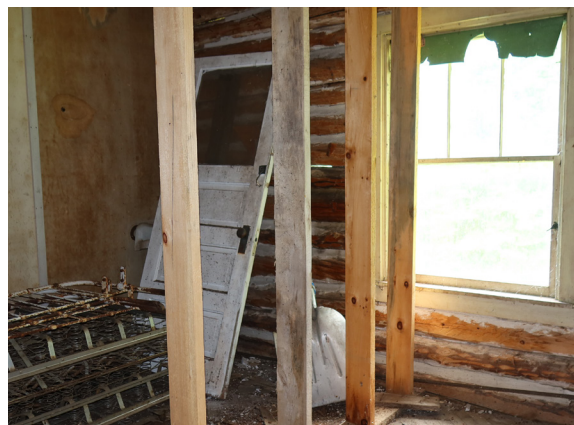
Figure 1-124. The Type B door for the Kitchen (102) have been removed and is stored in Bedroom (202). (AH, 08/01/2022)

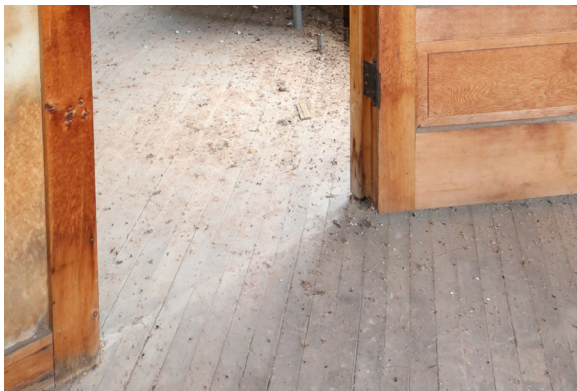
Where doors remain upstairs, debris and staining on the floors indicate threshold strips were previously located under each door but have since been removed.

Figure 1-130. Debris and staining in door openings indicate thresholds previously spanned each door opening. (AH, 08/01/2022)

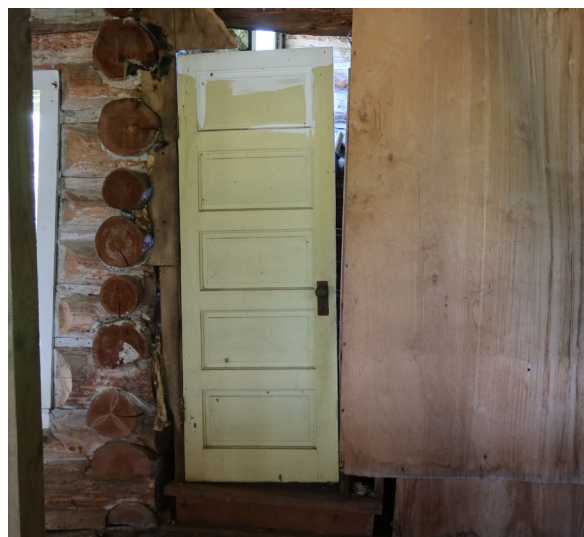
- Living Room (101) to Stair Hall (105): This door is in fair condition. Two coats of roughly applied paint were observed. The door is operable, however the latch does not meet in the closed position as a result of structural shifts distorting the frame.
- Hall (201) to Bedroom (202): This door is in fair condition with some light water-staining near the base, however, temporary structural shoring through the framed opening prevents operation.

Figure 1-132. Type D door leading to Stair Hall (105), viewed from Living Room (101). (AH, 08/01/2022)

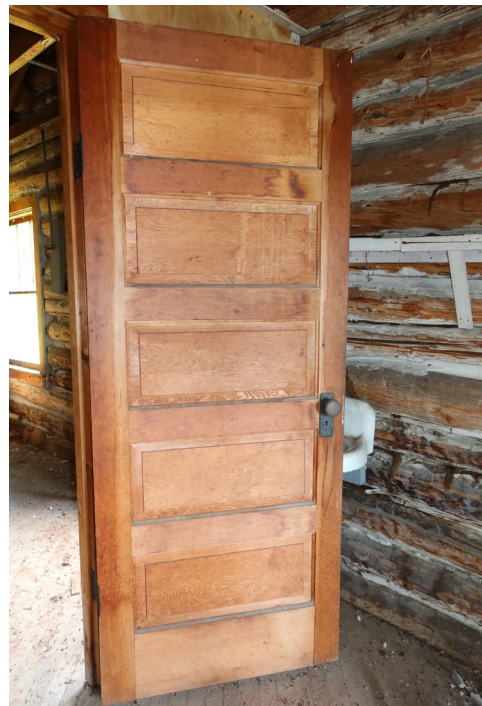
- Hall (201) to Bedroom (203): This door is in poor condition. The door is lightly water-stained, most severely near the base of the door, and does not close. Due to structural settlement, the door binds against the floor when pulled closed.
- Hall (201) to Bedroom (204): This door is in fair condition and is lightly water-stained. Temporary structural shoring through the framed opening prevents operation.
- Hall (201) to Bedroom (205): This door is in fair condition and is lightly water-stained. Operation is difficult.

Figure 1-134. Type D doors from Hall (201) to Bedroom (205). (AH, 08/01/2022)

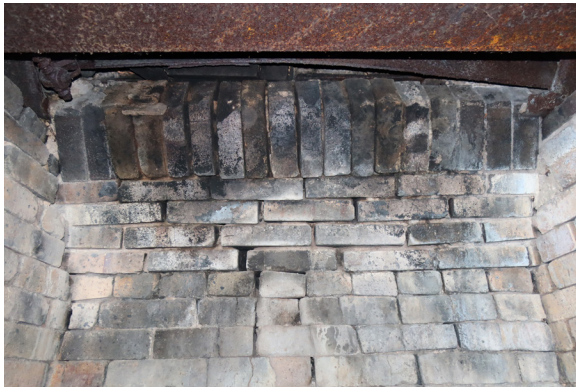
Figure 1-139. Concealed steel lintel and light yellow high-fire bricks lining the firebox. (AH, 08/01/2022)

The firebox is in poor condition. High-fire bricks in the firebox are charred with soot from use. Most joints in the firebox have lost mortar. Debris and brick particles have fallen into the firebox during previous chimney work.

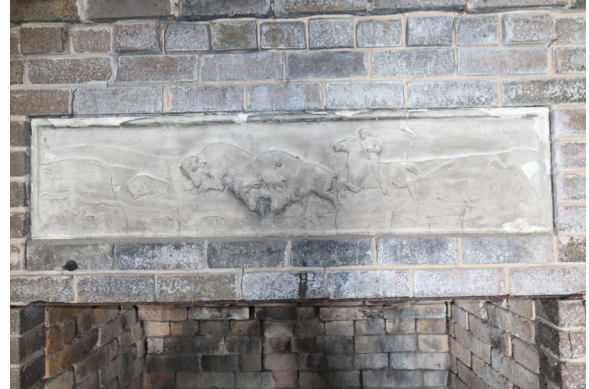
Figure 1-140. Inset plaster relief above the firebox opening. (AH, 08/01/2022)

The plaster relief above the firebox is darkened with soot. White paint, applied over the finish coat, is cracked and peeling.

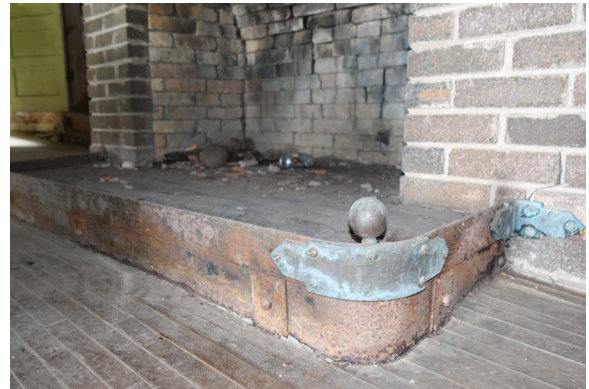
Figure 1-141. A steel skirt wraps the raised brick hearth and cast bronze elements. (AH, 08/01/2022)

Metal elements around the hearth are in fair to poor condition. The steel skirt is rusted and bronze elements are heavily tarnished.

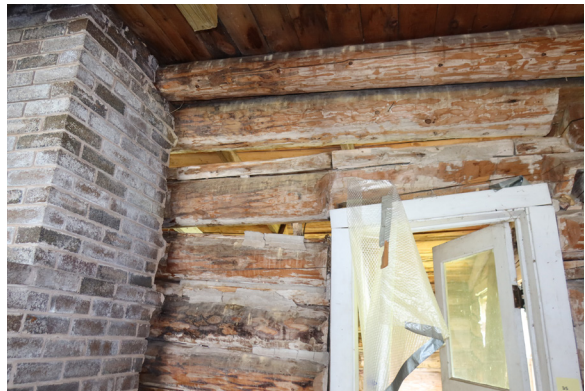
Plywood and fiberboard on the north wall are warped, water-stained and in poor condition. Large gaps in the log wall and significant missing wood strip fill were observed on the north wall, east of the fireplace.

Figure 1-151. North wall of Living Room (101). Note the large gaps in the log wall and missing wood strip fill. (AH, 08/01/2022)

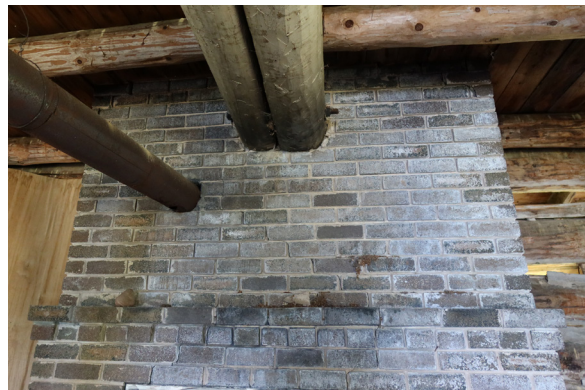
The brick masonry fireplace is in fair condition. Efflorescence due to moisture intrusion is present on all exposed faces. Mortar is roughly applied, with spots on the face of bricks. Mortar joints are overall in good condition. Where the structural beam is pocketed in the face of the chimney, the joint is roughly mortared.

Figure 1-152. Brick masonry fireplace in Living Room (101). Note efflorescence. (AH, 08/01/2022)

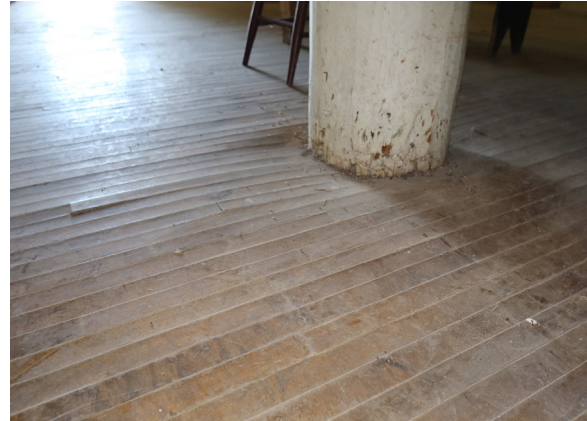
Tongue and groove floorboards are generally in fair condition, exhibiting a light cupping from moisture exposure. Although debris coats the floor, the varnished finish appears to be largely intact. As noted in the Structural section, significant settlement has caused planar distortions across the floor. At the base of the stairs, the wood flooring has split at a joint between boards and those connected to the stairs have risen to form a large gap.

Figure 1-153. Tongue and groove floorboards in Living Room (101). (AH, 08/01/2022)

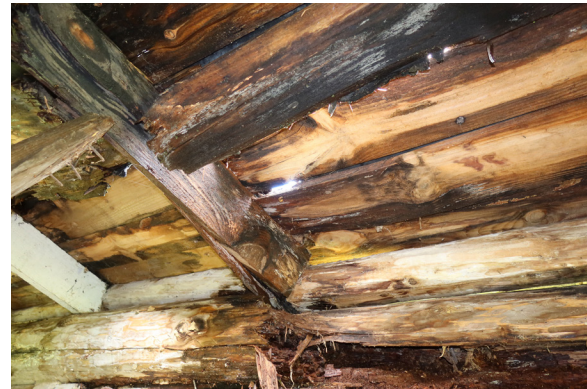
Finishes in the Kitchen (102) are largely missing and where remaining are in poor condition. Significant water intrusion through the north wall and roof has accelerated deterioration of remaining materials.

Figure 1-154. Water intrusion has accelerated deterioration of the roof and walls in Kitchen (102). (AH, 08/01/2022)

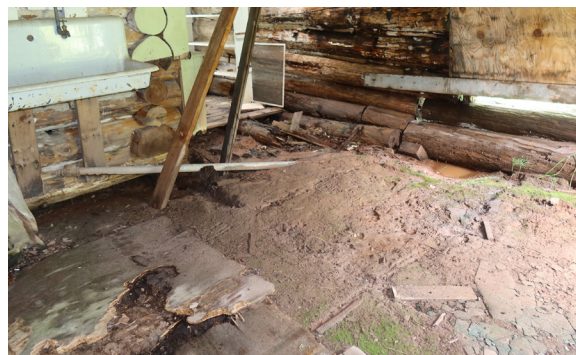
As noted previously, floors remain only in the northwest corner of the room. These boards are significantly deteriorated and in poor condition. Plywood laid directly atop grade in the Kitchen (102) is in an even more advanced state of deterioration. Moss and a large pooling water were observed on the ground in the Kitchen (102). During investigations, heavy rainfall resulted in standing water across much of the room.

Figure 1-157. Deteriorated Kitchen floors have been removed except for a remnant in the northwest corner. (AH, 08/01/2022)

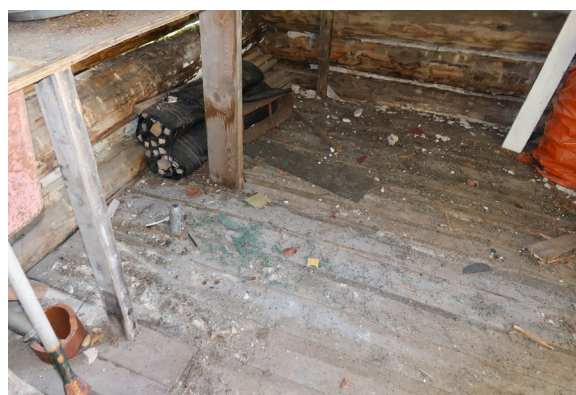
This room is in fair condition. The floor finish is worn and coated with debris. Approximately 40% of paint on floorboards is missing. Two boards closest to the east wall are rotted.

Figure 1-158. Flooring in the Men's Bath (104) is worn, covered with debris, and missing paint. (AH, 08/01/2022)

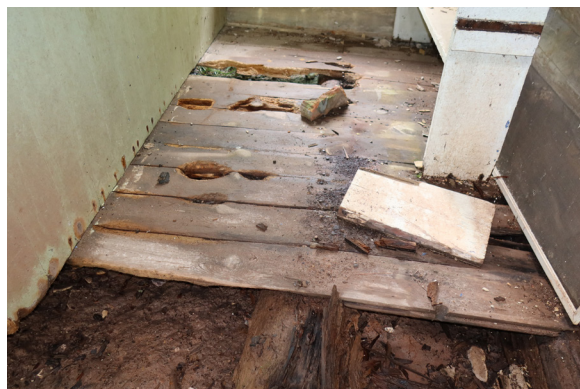
Tongue and groove boards on the west wall are rotted near the ground and coated with debris. Casework is worn, coated with debris, and exhibiting mildew and rot near the ground.

Figure 1-156. Extant floors in the Kitchen (102) are significantly deteriorated. Casework is rotted at the bottom. (AH, 08/01/2022)

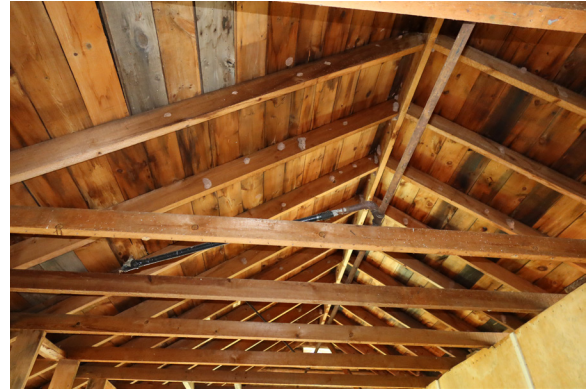
The ceiling finish has been removed in Hall (201), save for a few sheets of fiberboard which rest atop the ceiling framing on the west end of the room. Wall base is missing on the west wall, but remains at the south.

Figure 1-160. Exposed ceiling structure in Hall (201). (AH, 08/01/2022)

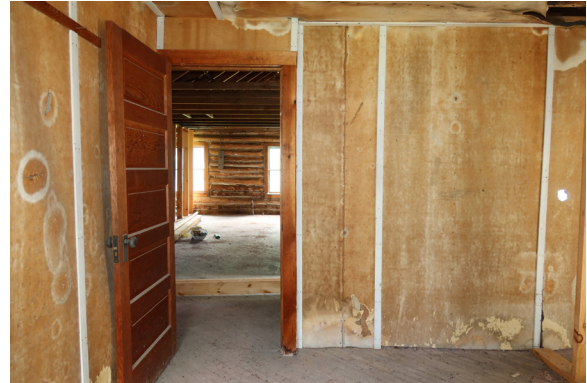
In Bedroom (203) significant debris from mud-dauber insects was found. Several of the insects' mud nests were observed on exposed roof framing near the west gable.

Figure 1-166. Facing east in Bedroom (203). (AH, 08/01/2022)

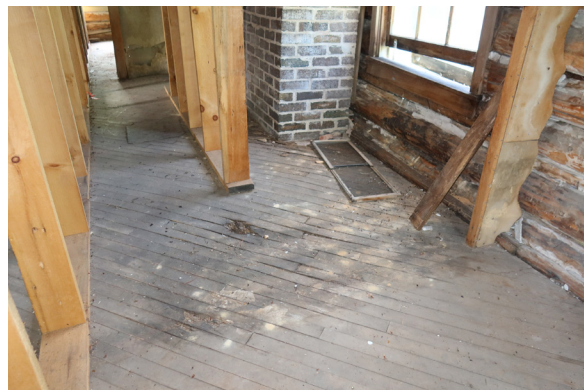
The floors are overall in fair condition with areas of poor condition. Near the chimney on the north side of Hall (201), caution tape has been strung up to deter walking on the significantly deteriorated boards in this area. Water intrusion has left the boards soft and rotted. Similarly, boards near the window on the south end of Bedroom (204) are rotted from water intrusion. Elsewhere, the floor boards are coated with debris and worn, but in fair condition.

Figure 1-172. Water intrusion has significantly damaged the floor boards in Hall (201). (AH, 08/01/2022)

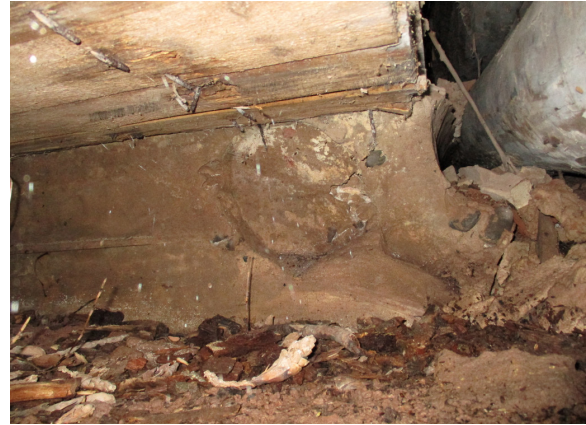
Figure 1-176. Concrete foundation under the chimney (CBB, 08/01/2022)

The chimney is founded on a concrete mass with a footprint matching that of the base of the chimney at 2'-10 ½" by 7'-0 ½". The foundation extends approximately 16" above the current crawlspace grade level and it is unknown how far below grade the footing extends. It is unknown if the footing is reinforced.

The chimney foundation is settling differentially with more settlement towards

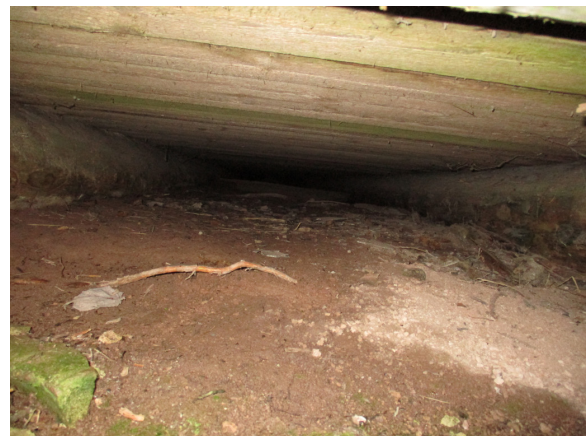
Figure 1-177. Crawlspace under the first floor between two joists (CBB, 08/01/2022)

The foundation of the West Bay Club is in poor condition. Since the perimeter log sills and other wood elements such as some joists, dropped beams, and columns are in direct contact with earth, the soil conducts moisture to the wood causing wood decay fungi to flourish and deteriorate the wood structural elements. This deterioration mechanism is exacerbated by poor site and roof drainage details which cause water to run through and around the crawlspace of the building. Because of this flow of water, the grade level of the crawlspace has built up over time. Now the dropped log beams and the joists in some areas are in direct contact with the soil.

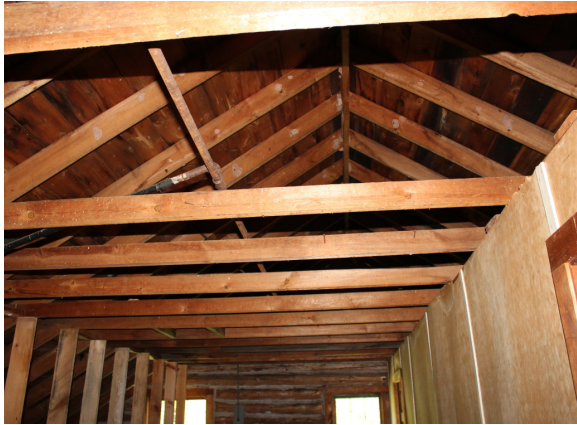
Figure 1-181. Main roof framing. Note the rafters and the collar ties (CBB, 08/01/2022)

The roofs of the West Bay Club are in poor structural condition. The main roof framing does not have the calculated capacity to support the snow load associated with the site. Since there are no elements spanning between the rafter pairs at the top of wall level such as rafter ties, the rafter ends have thrust outwards, rolling the top of the second floor walls slightly outwards. This issue has been temporarily addressed by the installation of the cripple walls where the collar ties meet the rafters, however, this solution renders portions of the second floor unusable, the shoring posts and beams on the first floor are unsightly, and the shoring posts on the first floor bear on the first flooring and framing which is already inadequate (see the Floor Framing section).

There are several other minor issues at the main roof. Some water staining on the rafters indicates previous leaks in the roofing that appear to have been ameliorated. The northeast gable end kicker is missing. One rafter (the 6th rafter from the east wall on the south side of the gable roof) has split.
