SAND ISLAND WEST BAY CLUB STRUCTURES
APOSTLE ISLANDS NATIONAL LAKESHORE
Historic Structures Report

PMIS #191296
July 5th, 2023

Historic Structures Report

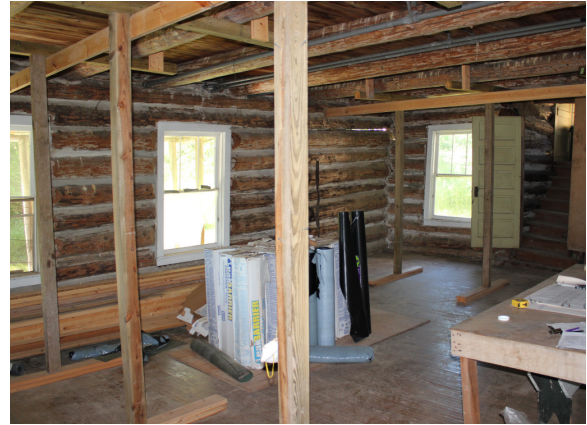
As noted in the Structural section, temporary structural shoring has been erected throughout the second floor.

Figure 1-183. Shoring on the first floor supporting the cripple wall on the second floor (CBB, 08/01/2022)

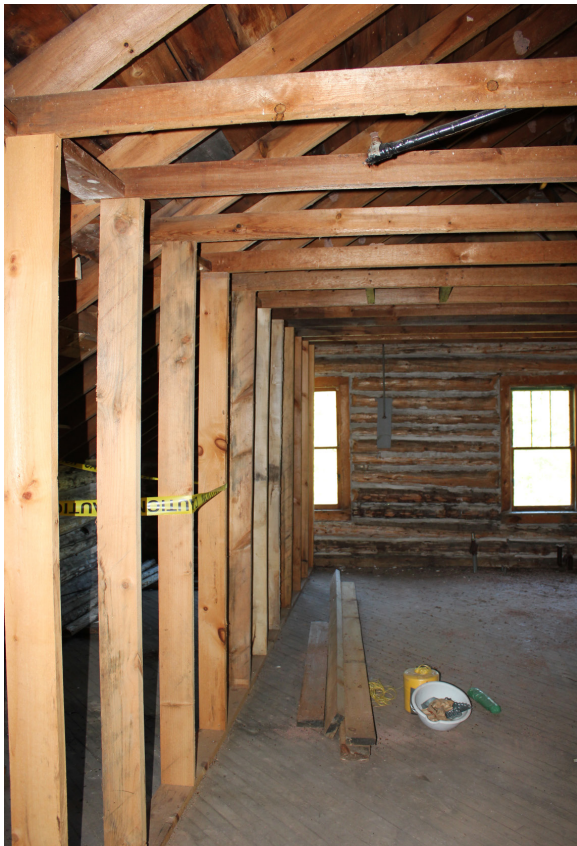
Figure 1-182. Cripple wall installed at the joint of the collar tie and the rafters to strengthen the roof framing (CBB, 08/01/2022)

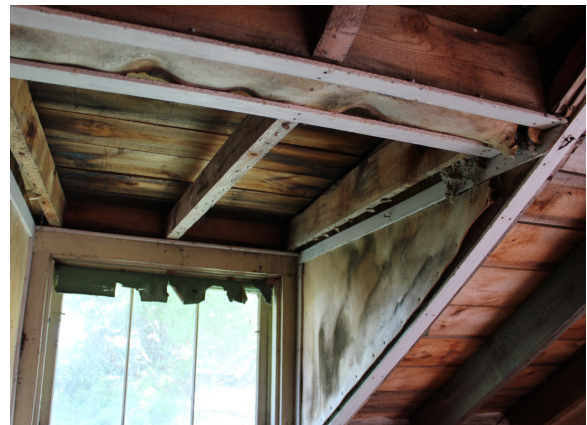
Figure 1-185. Typical dormer framing (CBB, 08/01/2022)

The dormers on the main roof are also in poor condition because they too do not have the calculated capacity to support the snow load associated with the site. This is exacerbated by the flat orientation of some of the dormer rafters and the inadequate or missing support headers between the main roof rafters. The north dormer roof framing recently had to be replaced likely because of water intrusion through a bad drainage detail between the adjacent chimney and the roof.

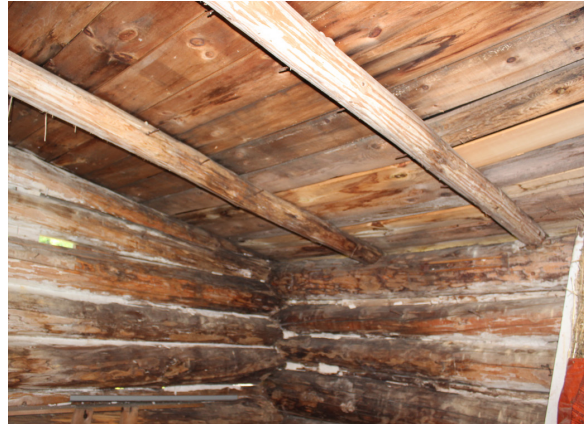
Figure 1-186. Men's Bath (104) roof framing (CBB, 08/01/2022)

The roof of the Men's Bath (104) is in poor condition. The rafters are not adequate to support the snow load associated with the site and the northernmost rafter is deteriorated due to decay fungi infestation.

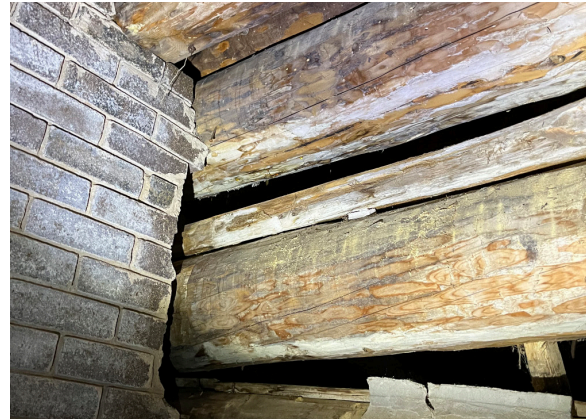
Figure 1-190. Separation of north wall of the Living Room (101) and chimney (CBB, 08/01/2022)

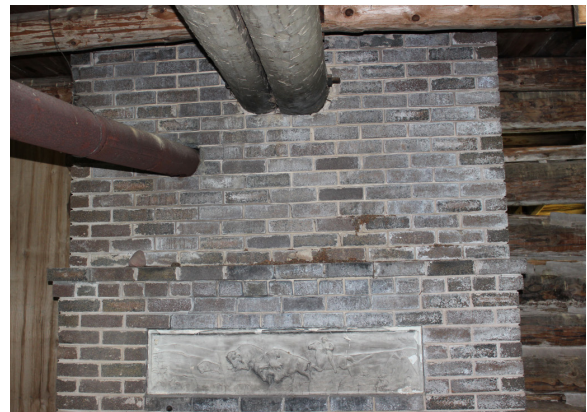
Figure 1-191. South face of the chimney. Note the bearing of the second floor beam, the opening for the barrel stove pipe, and the fireplace opening (CBB, 08/01/2022)

The chimney is in fair condition. Although it is generally showing no widespread signs of distress, the steel lintel over the fireplace opening is inadequate and is corroding. It is likely inadequately sized to support the chimney above the fireplace opening because there is an arched-shaped crack over the opening indicating that the chimney has self-created a load path. Also, the steel lintel is not galvanized or treated in a way to prevent corrosion so overtime, it has started to corrode. As the metal corrodes, it expands via a mechanism called rust jacking. The rust jacking is causing the mortar joints and brick units to crack, especially at the ends of the fireplace opening. There are also some cracks emanating from the opening in the chimney for the barrel stove pipe and the second floor beam pocket.

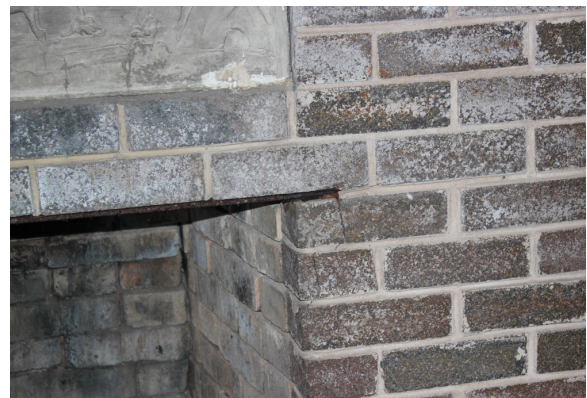
Figure 1-192. Rust jacking of the steel lintel at the fireplace opening (CBB, 08/01/2022)

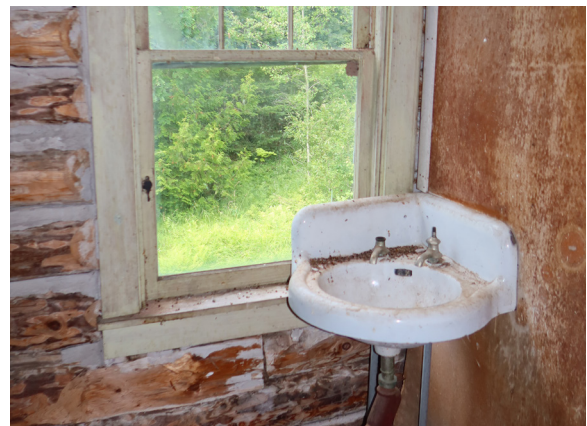
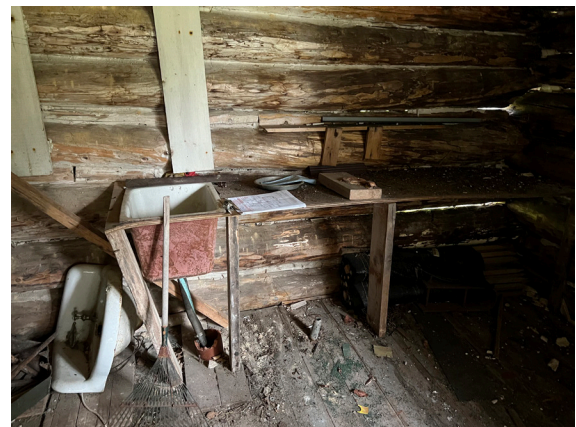
The plumbing fixtures consist of a kitchen sink, four (4) corner lavatories, and a utility sink. The kitchen sink and corner lavatories are in fair condition. The utility sink is in poor condition.

Figure 1-195. Sink in Southwest bedroom (AH, 08/01/2022)

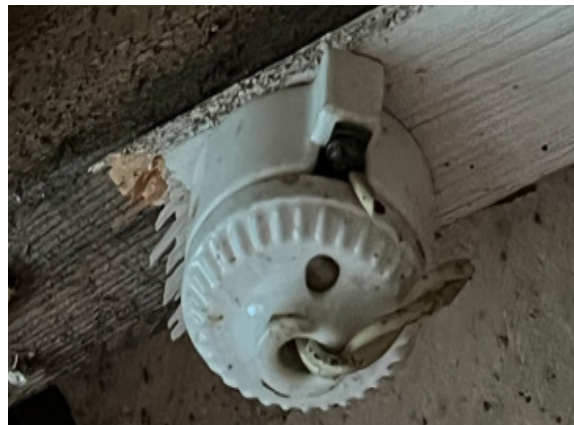
There is one ceiling mounted light fixture and it is inoperable as there is no power source to the fixture. Previous light fixtures were gas powered and have been removed. The surface mounted gas piping remains to the locations of previous gas powered fixtures. A single gas lamp remains in the Living Room (101), which was installed by the Peter's family in the 1970s to replace the historic fixture, which had been removed.

Figure 1-197. Abandoned Light Fixture (AH, August 2022)

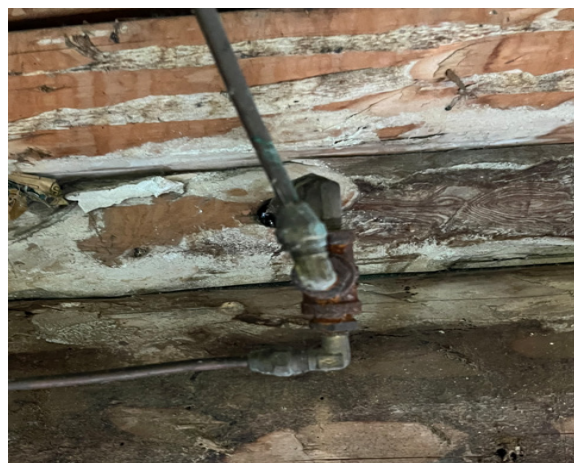
Figure 1-198. Abandoned Gas Piping (AH, August 2022)

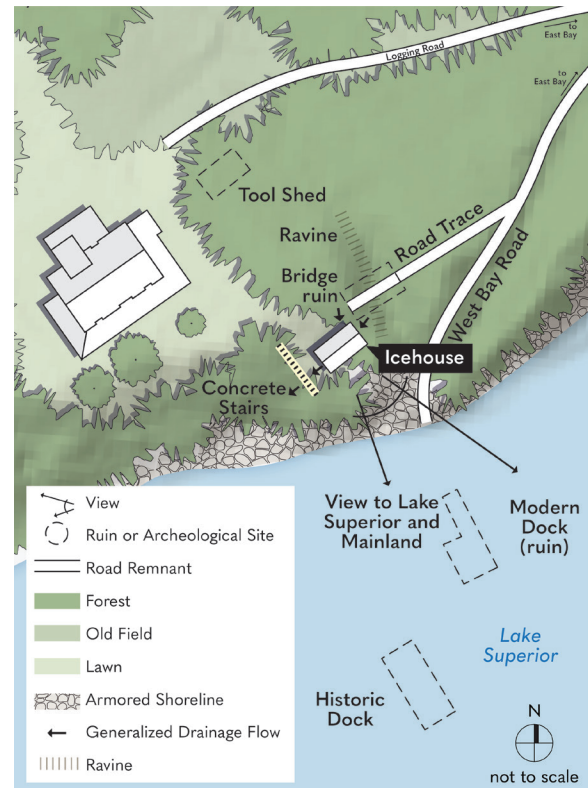
Figure 1-207. Icehouse Existing Condition (Mundus Bishop, adapted from 2019 Sand Island CLR Map).

Condition: *Fair*

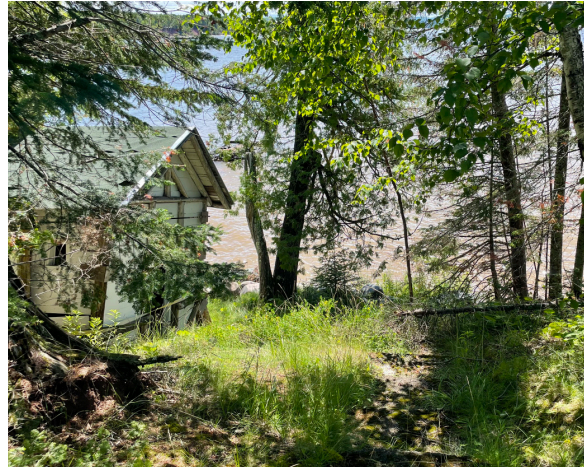
Historic concrete stairs are set west of Icehouse to the clearing at the top of the bluff. Lower stairs are impacted by erosion and are in poor condition. The upper nine stairs, including the "EHA" stair, are in good condition.

Figure 1-208. Icehouse retains its original orientation to Lake Superior and concrete stairs (Mundus Bishop, 2022).

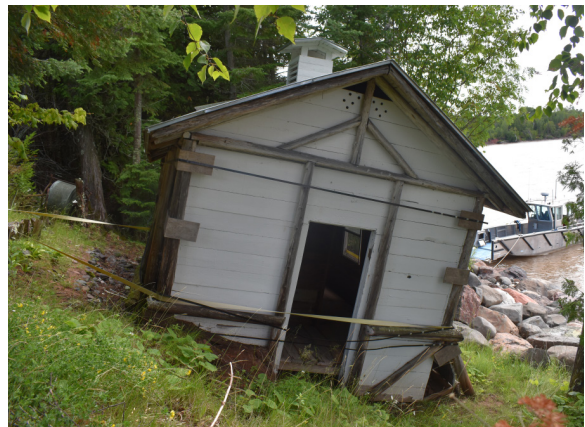
Figure 1-209. Bluff erosion at Icehouse (Mundus Bishop, 2022).

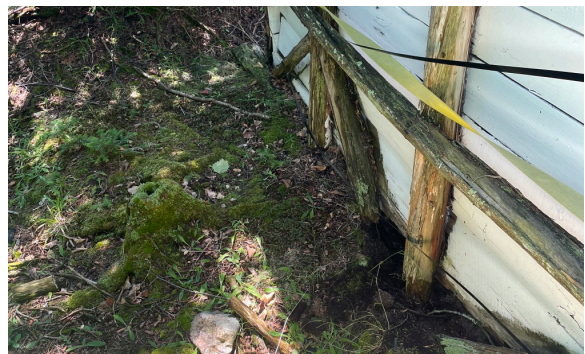
Figure 1-210. Stormwater flow diverted to/below Icehouse (Mundus Bishop, 2022).

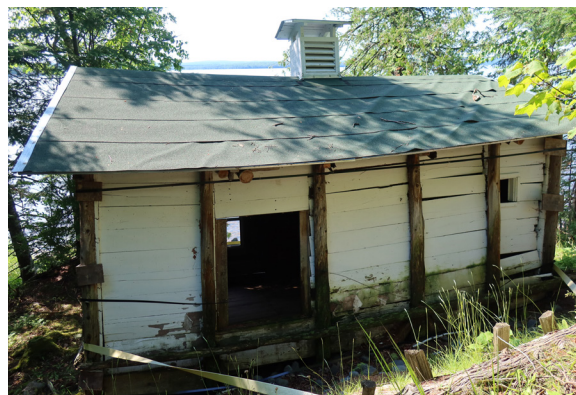
The roofing system is in poor condition. The asphalt roofing is wrinkled, loose, and gapped. Debris has gathered on the north slope of the roof. Ceiling boards are stained, indicating a past roof leak which appears to have been addressed during the most recent re-roofing campaign in 2017. Rolled roofing has a short lifespan, with expected replacement due in approximately 2025.

Figure 1-211. The Icehouse roof and cupola, viewed from north façade. (AH, 08/01/2022)

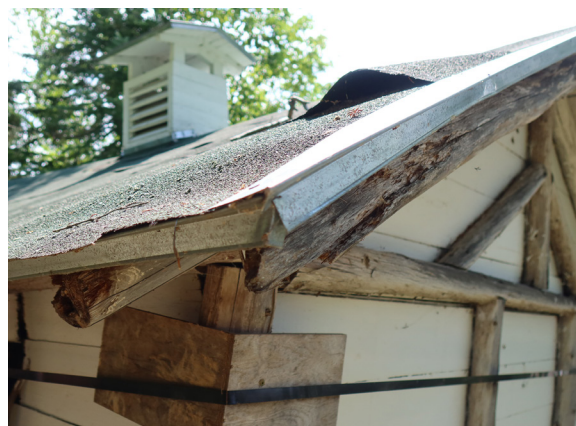
Figure 1-212. Eave condition at the northeast corner showing metal flashing, drip edge, and asphalt roofing, and log fascia on west façade. (AH, 08/01/2022)

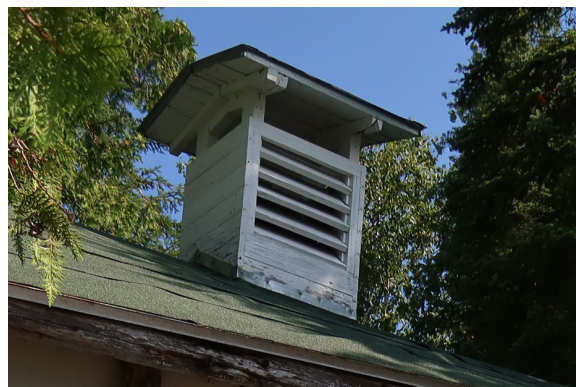
Figure 1-213. Cupola, viewed from south. (AH, 08/01/2022)

The cupola is in fair condition. Paint is worn, particularly near the base of the cupola where exposure is greatest.

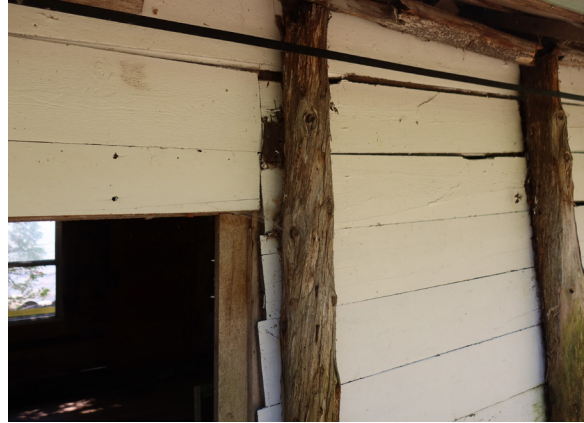
The exterior walls are in fair to poor condition. As the building has shifted, siding boards near or in contact with the ground have been impacted and are now buried, broken, significantly deteriorated, or missing.

Figure 1-214. Exterior wall assembly, viewed on north façade. (AH, 08/01/2022)

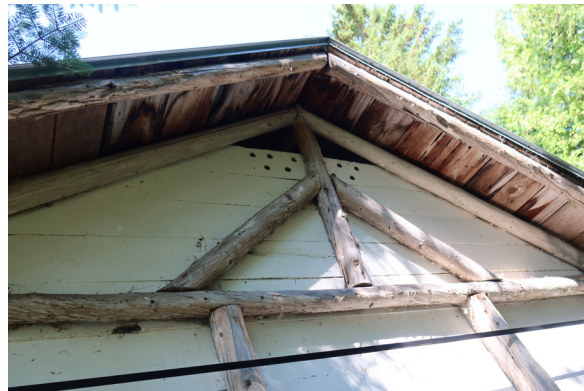
Figure 1-215. Logs at gable ends, viewed on west façade. (AH, 08/01/2022)

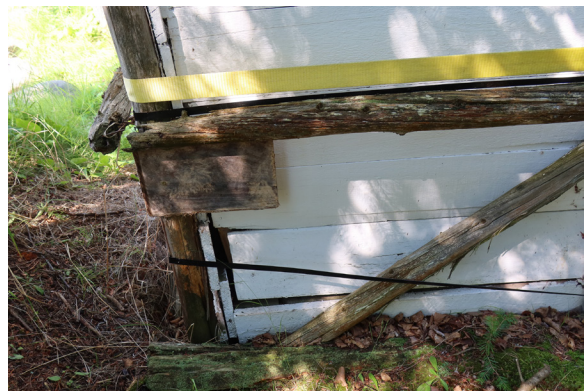
Figure 1-216. Siding boards near the ground have deteriorated as a result from building shifting. (AH, 08/01/2022)

Some boards are cracked and missing paint, especially in boards closer towards the ground. Some boards are bent, broken, and/or rotten. Some boards are buried and cannot be assessed. Significant structural movement has caused some boards to bend, break, and come unattached to the structure.

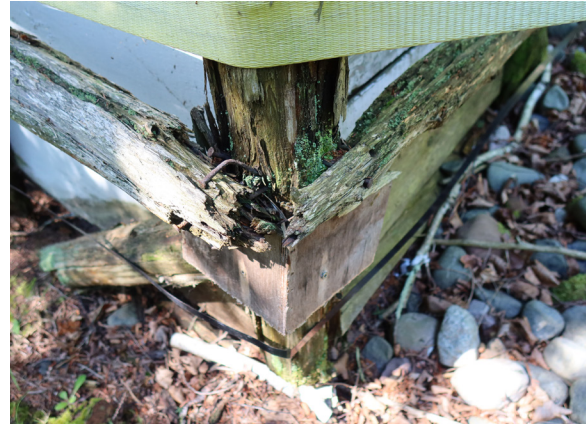
Figure 1-217. Bio-growth and rotting is extant in the bottom half of the south façade. (AH, 08/01/2022)

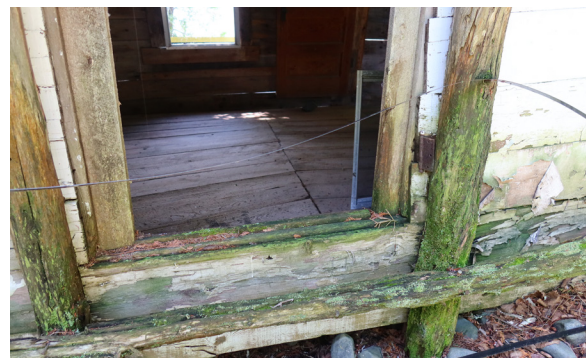
There is significant deterioration in the bottom 3-feet of the north wall. The paint is peeling and missing in some areas. Significant bio-growth is evident. The boards along the ground have rotten.

Figure 1-218. Peeling paint and significant bio-growth is extant on the north façade. (AH, 08/01/2022)

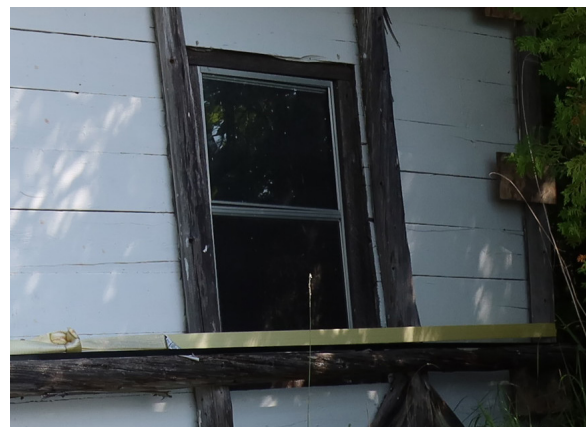
Figure 1-219. Type A window, viewed on south façade. (AH, 08/01/2022)

Windows are in poor condition. Glazing is intact at the Type A window. Unstable structural conditions prevented up-close investigation of this window and operability could not be tested.

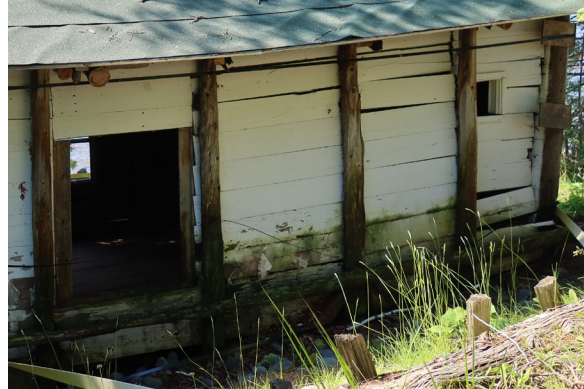
Windows are missing at the Type B and Type C locations. The framing around these two openings are damaged by structural settlement.

Figure 1-220. Type B and Type C windows, viewed from north. (AH, 08/01/2022)

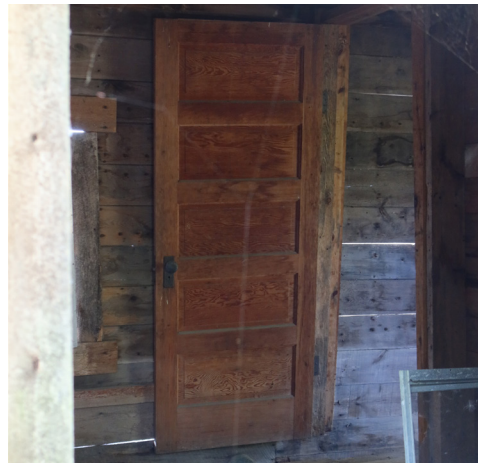
Due to restricted access for safety, this door was assessed from a distance and operability could not be tested. As a result of structural movement, the door does not appear to be operable. However, it otherwise appears to be in fair condition with minor scratches.

Figure 1-221. Type A door, viewed from Type B opening. (AH, 08/01/2022)

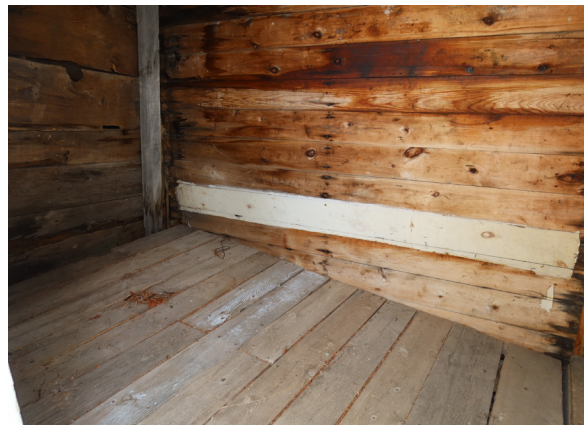
Figure 1-222. Floor and wall finish in Room (100), looking northeast. (AH, 08/01/2022)

Interior finishes in the Icehouse are in poor condition. The ceiling boards are typically water-stained. Gaps visible between wall boards are evidence of the structural movement. Wall boards are also typically water-stained. Floor boards are only lightly stained, however the floor plane is greatly distorted, as noted in the Structural section.

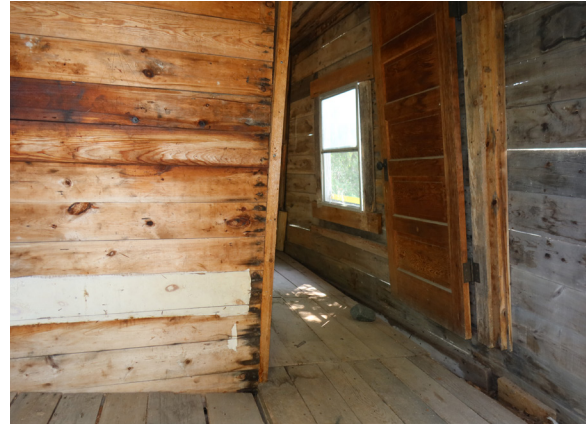
Figure 1-223. Opening between Room (100) and Room (101), looking southeast. (AH, 08/01/2022)

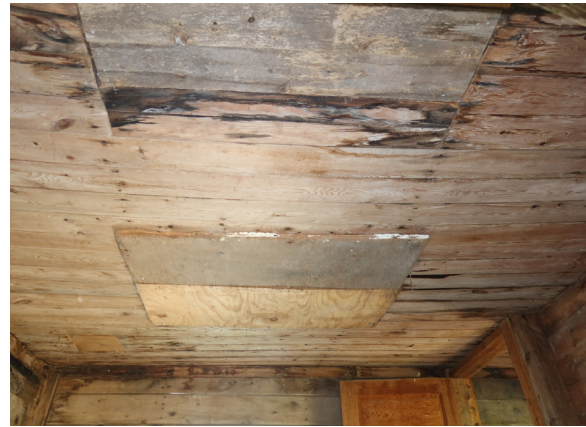
Figure 1-224. Ceiling finish in Room (101). (AH, 08/01/2022)

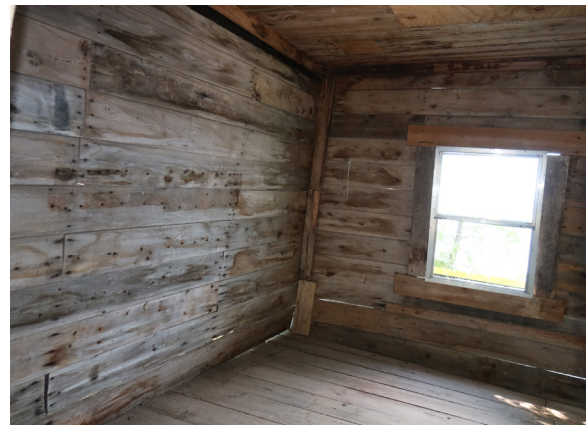
Figure 1-225. Wall finishes looking southeast. (AH, 08/01/2022)

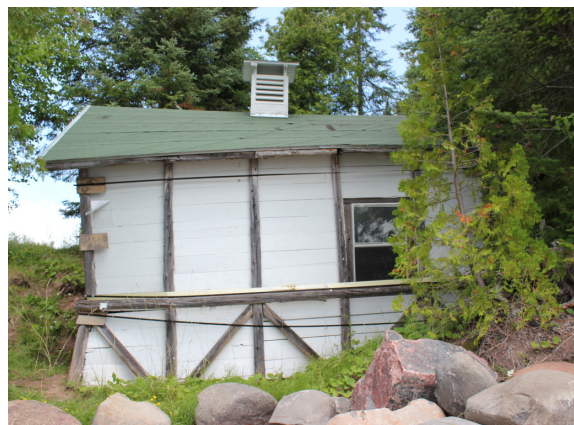
The foundation of the Icehouse is in poor condition. As the hillside has eroded towards the lake over time, the structure has translated downhill sympathetically since there are not any foundation elements in place to resist this movement or force. The Icehouse is currently strapped to trees to the north to keep it from collapsing or translating down the hill into the lake.

Figure 1-226. South wall of Icehouse (CBB, 08/02/2022)

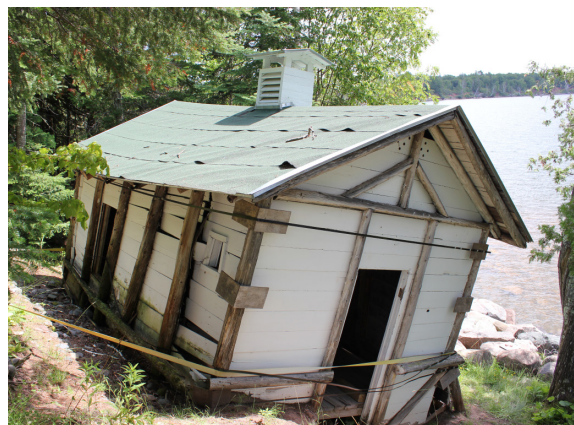
Figure 1-227. Front (West) and North (Side) walls of Icehouse (CBB, 08/02/2022)

contact with earth, the soil harbors moisture against the wood causing wood decay fungi to flourish and deteriorate the wood structural elements. This deterioration mechanism is exacerbated by poor site drainage details which cause water to run through and around the crawlspace of the building.

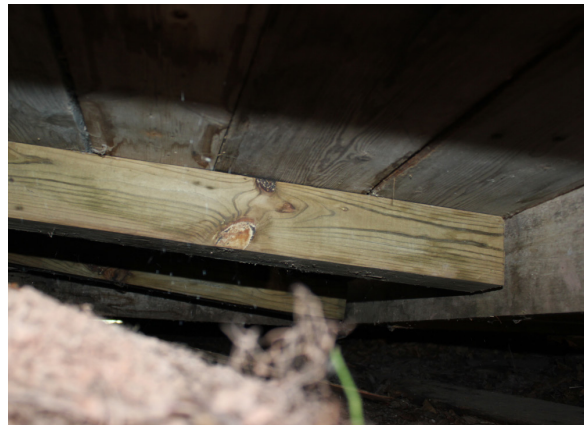
The first floor of the of building is in poor condition. Where visible, at the north end of the building, the joists are in direct contact with the soil floor and are likely deteriorating due to decay fungi infestation. At the south end the floor, the floor framing has separated from the wall and is cantilevering from the north wall of the structure.

Figure 1-229. Floor framing of the Icehouse as seen from the crawlspace (CBB, 08/05/2022)

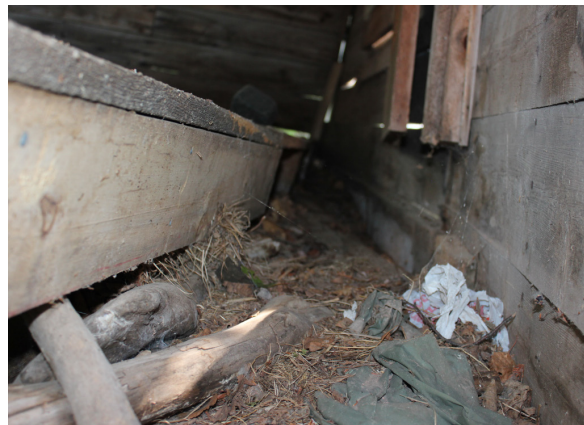
Figure 1-230. Separation between floor and wall framing (CBB, 08/05/2022)

The lateral system is in poor condition and has failed. The walls have racked to the south as the structure translates down the hillside as it erodes. The floor framing has separated from the wall framing causing discontinuities in the LFRS system from the floor diaphragm to the walls and foundations.

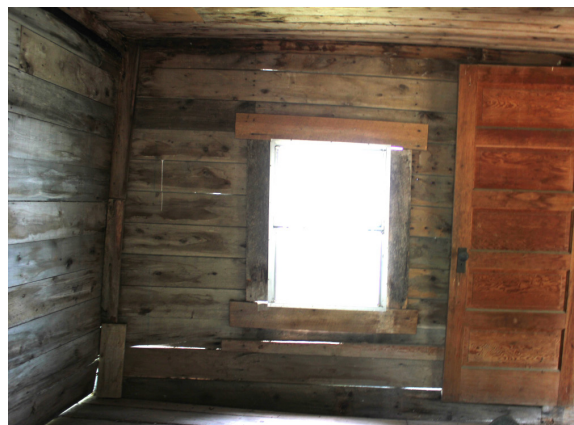
Overall, the roof framing is in poor condition. The ridge has sagged indicating that there is not adequate restraint to keep the roof framing from thrusting. The exposed rafter ends are severely deteriorated due to decay fungi infestation.

Figure 1-231. Interior of the Icehouse. Note that the ceiling finishes are attached to the underside of the rafter ties (CBB, 08/05/2022)

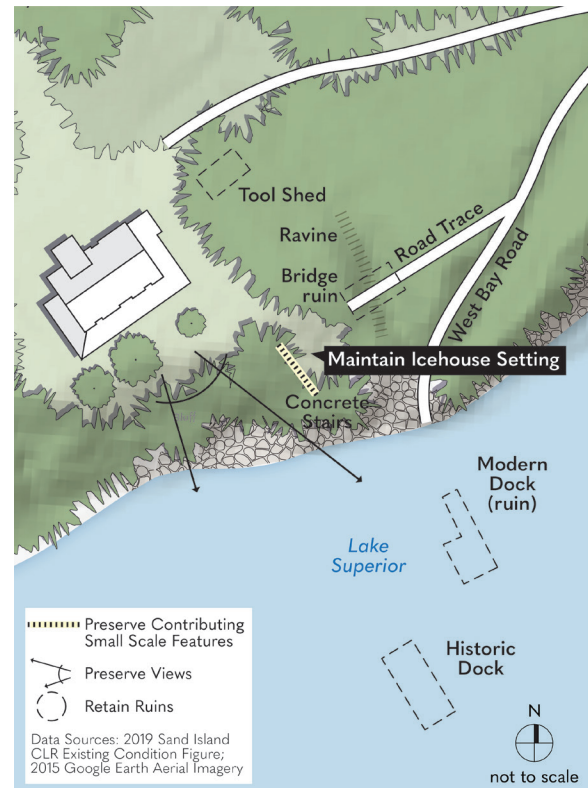
Figure 2-3. Icehouse Site Treatment (Mundus Bishop, adapted from 2019 Sand Island CLR Map).

Provide self-guided interpretive information marking the location of the Icehouse site. Ensure placement does not detract from the historic setting, is subordinate to West Bay Club Lodge, and does not diminish or obstruct historic views.

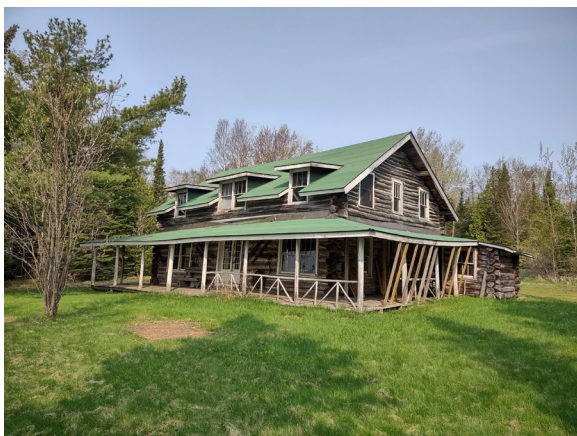
Figure 3-2. Lodge viewed from southeast. No other damage from snow was apparent during the visit. (APIS, 05/23/2023)
