*HISTORIC STRUCTURE REPORT*  
**HISTORIC CEMETERY COMFORT STATION  
(BUILDING #313)**

Kevin Wohlgemuth, Senior Associate, Building Conservation Associates, Inc. (BCA)  
Dorothy Krotzer, Director, BCA  
Michele Boyd, Director of Preservation Services, BCA  
Kate Whitney-Schubb, Staff Conservator, BCA

The following 100% Draft of the Historic Structure Report for the Historic Comfort Station (Building #313) at Arlington National Cemetery represents a synthesis of all research and analysis performed for this project.

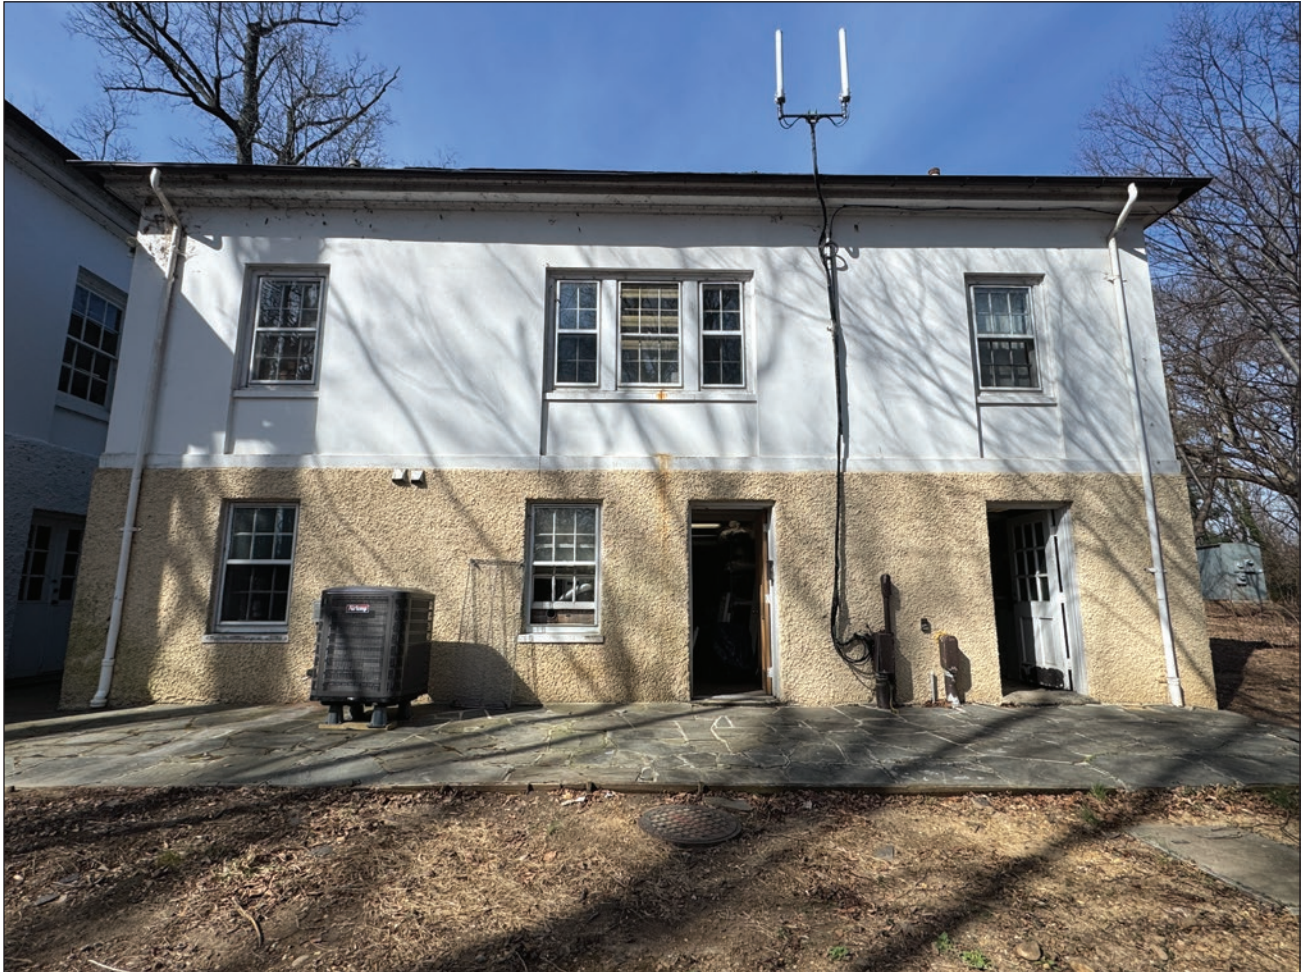
**Figure 142.** East elevation of Building #313. Note the center door that replaced an original window penetration. Building Conservation Associates, 2025.

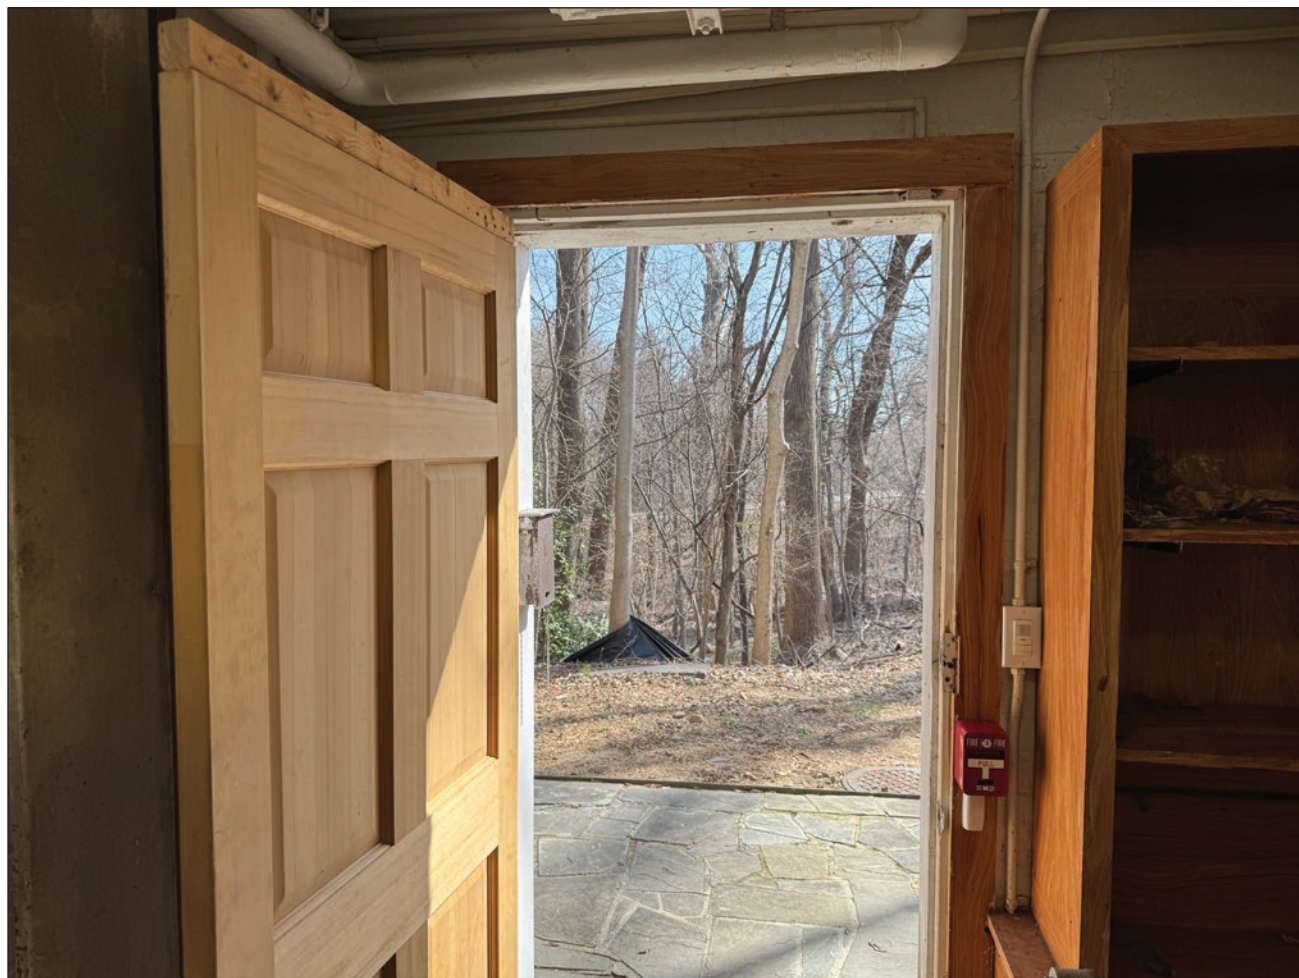
The exterior of Building #313 is distinguished by its two horizontal registers of painted stucco. The lower register, which sits directly on the ground, is faced with pebble dash giving a rough texture beneath cream-colored paint while the upper register is smoother stucco with a sanded finish beneath white paint. The two registers are separated by a smooth-finished stucco belt course. The wall is capped with a cream-painted wood cornice. Many of the doors appear to be original to the building, with the exception of the paneled door to the former segregated men's room—which would have originally matched the existing door to the adjacent former segregated women's room—and the central door on the east elevation, which is a replacement of a former window opening, installed when the former segregated women's toilet room was converted into a storage area. (Figure 145). Nearly all of the doors and frames; windows, frames, and sills; and downspouts and shoes have been painted white. The exception to this is the new door on the east elevation, which is unpainted (Figure 146).

**Figure 146.** Unpainted wood door at center of east elevation. Also note the extra piece of wood to fit the new door to the existing frame.  
Building Conservation Associates, 2025.

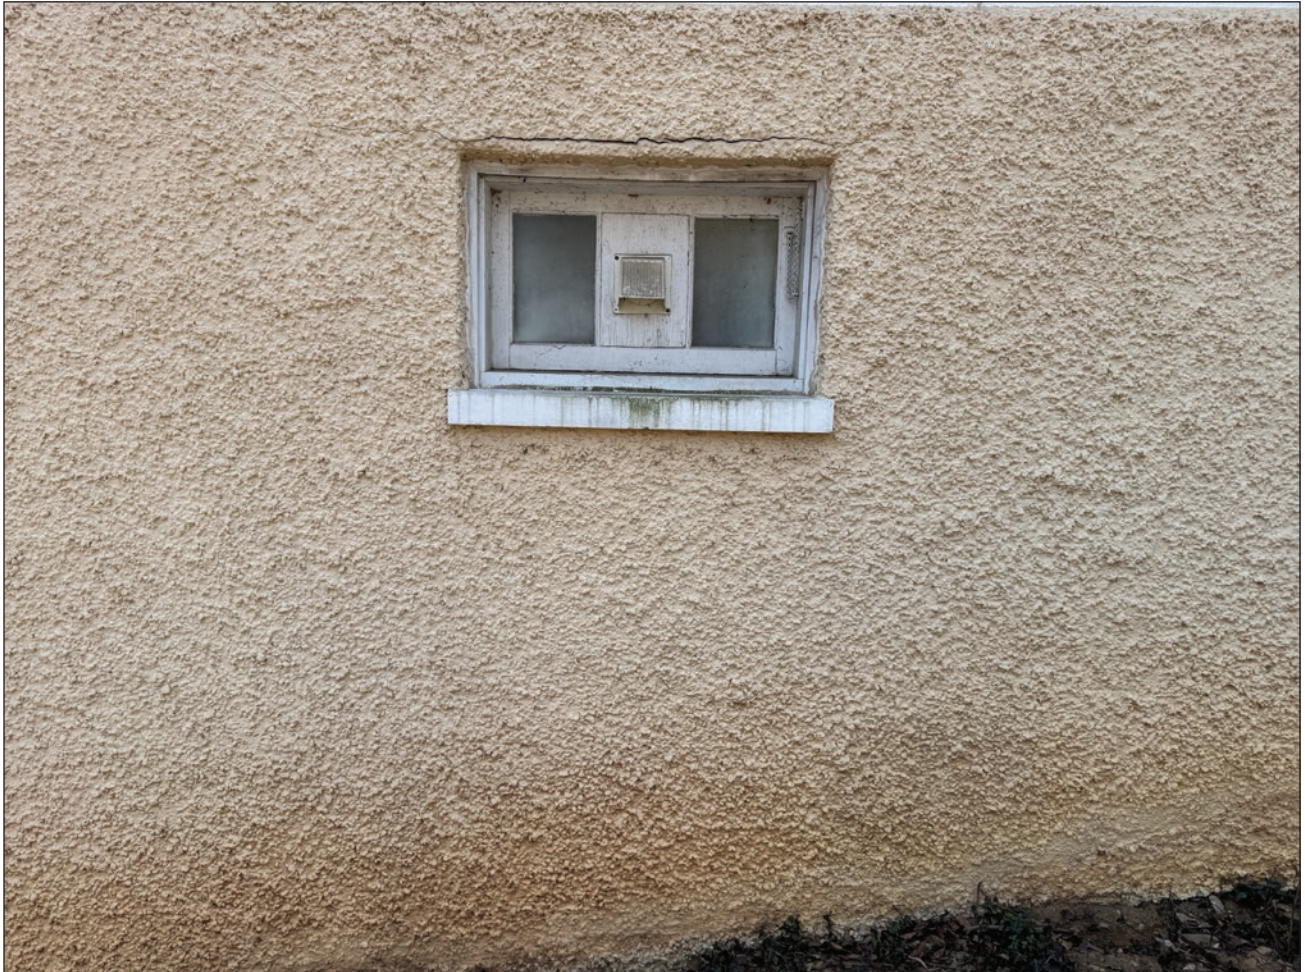
Each of four elevations feature door and/or window penetrations, all of which are recessed slightly into the stucco walls. The basement-level window recesses are framed tight to the penetrations while the upper-level window recesses extend down to the belt course, approximately 27 inches below the windowsills (Figure 129). Two basement-level windows on the west elevation are horizontal three-light, wood-framed hoppers with wide rails and narrow vertical mullions above a stone sill. At the north elevation, one of these same basement windows remains while the easternmost window has been modified with a vent replacing the center lite (Figure 147). At the east elevation, the basement windows are unmodified from the original full-height, double-hung, wood-framed sash over a stone sill (Figure 122). The central window has been modified with a plank and pipe to vent mechanical equipment in the central storage space (Figure 148).

**Figure 147.** Modified basement window at the north elevation. Building Conservation Associates, 2025.

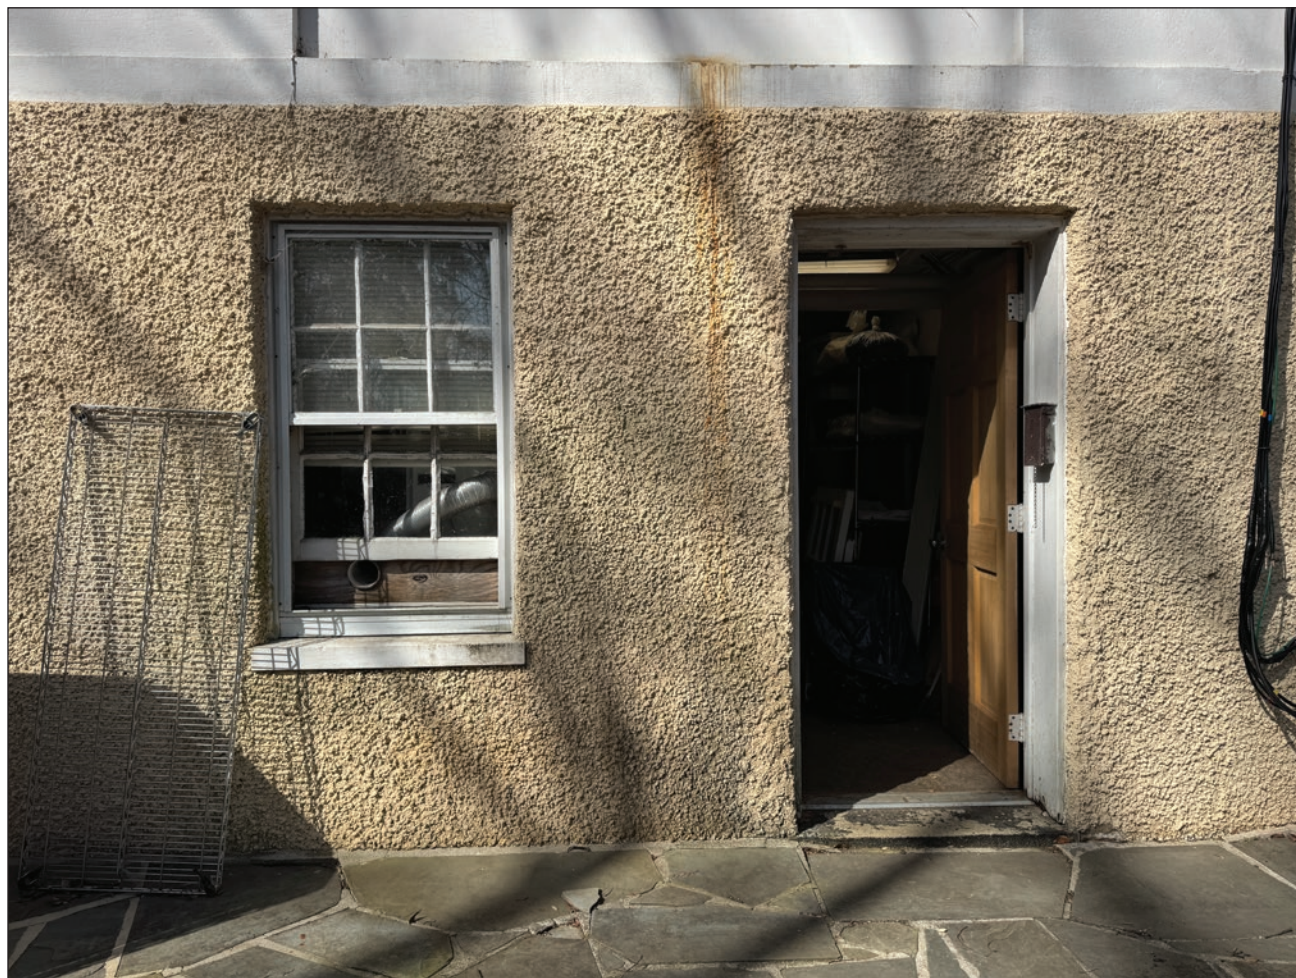
**Figure 148.** The center of the east elevation showing modifications made to the original windows. Building Conservation Associates, 2025.

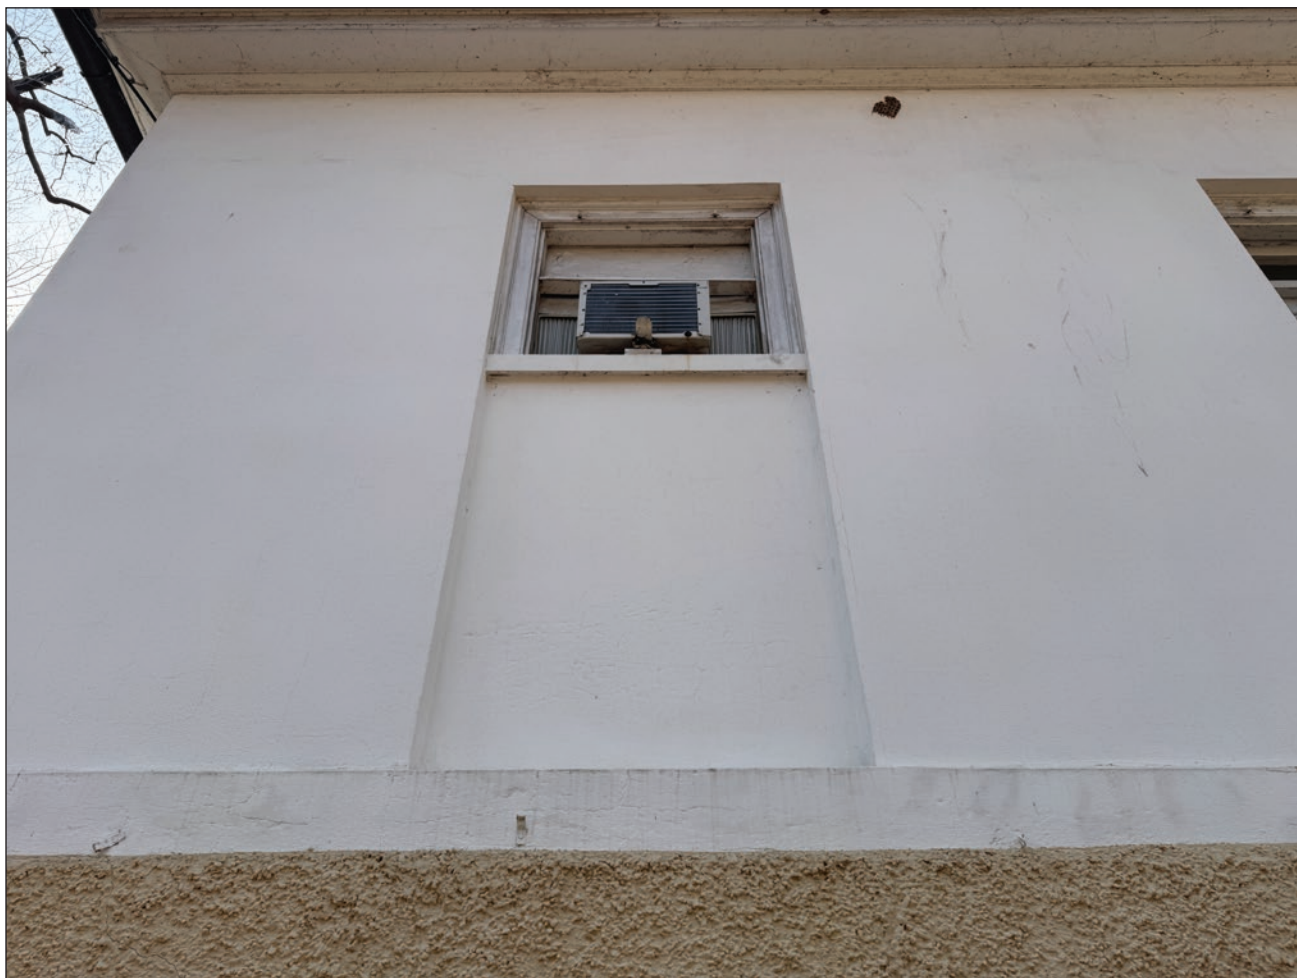
with a central six-over-six double-hung sash and two flanking four-over-four double hung sash (Figure 142). On the north and south elevations, the sash have been replaced with window A/C units and plywood (Figure 150) while the northernmost window on the east elevation has been blocked from the inside by a sheet of plywood (Figure 151).

**Figure 150.** Window A/C unit installed in the east first floor window on the north elevation. Building Conservation Associates, 2025.

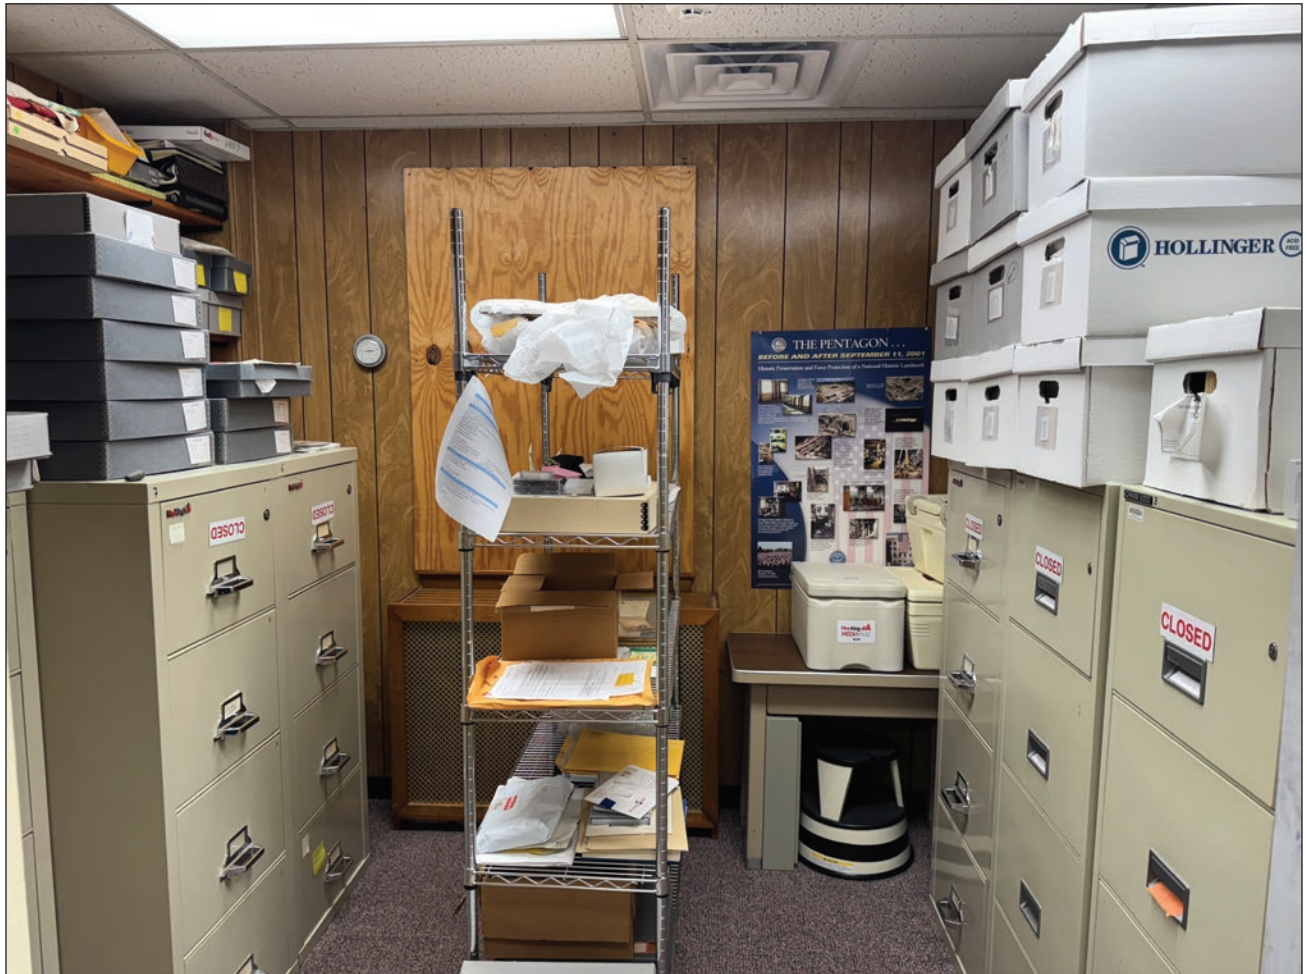
**Figure 151.** Plywood covering the north first floor window on the east elevation. Building Conservation Associates, 2025.

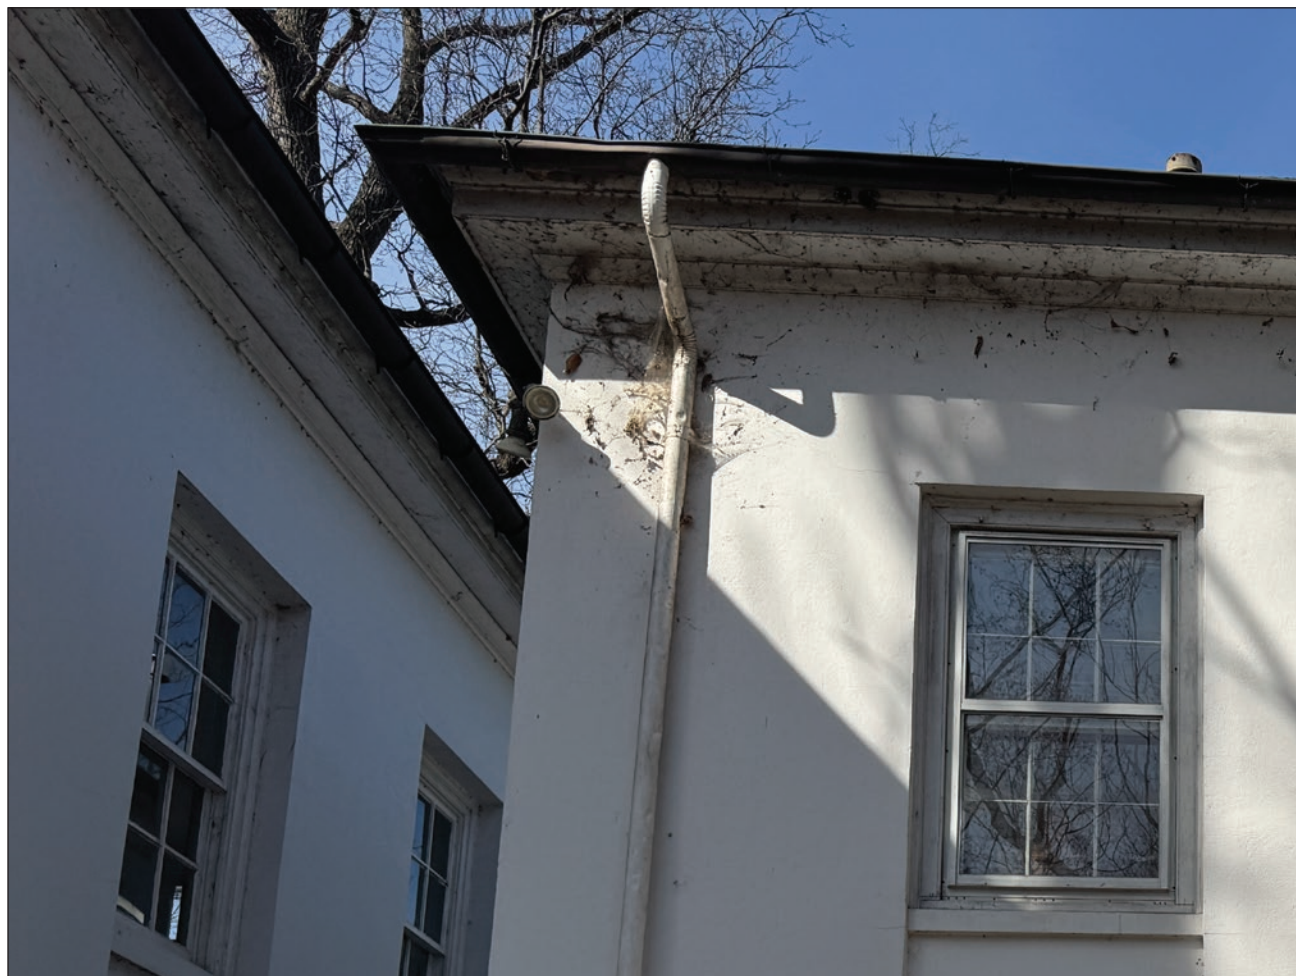
At the south elevation, a single lantern sconce, which matches the fixture in a historical photo, is positioned between the two doors (Figure 158, Figure 116). In addition, above each door is a small metal anchor that formerly supported signage identifying these entrances as the segregated facilities (Figure 159). The signs are no longer extant, but the anchors remain. A small light fixture has been installed at the upper east corner with visible wiring from the floodlight at the west elevation (Figure 160).

**Figure 160.** Small light fixture in upper southeast corner. Building Conservation Associates, 2025.

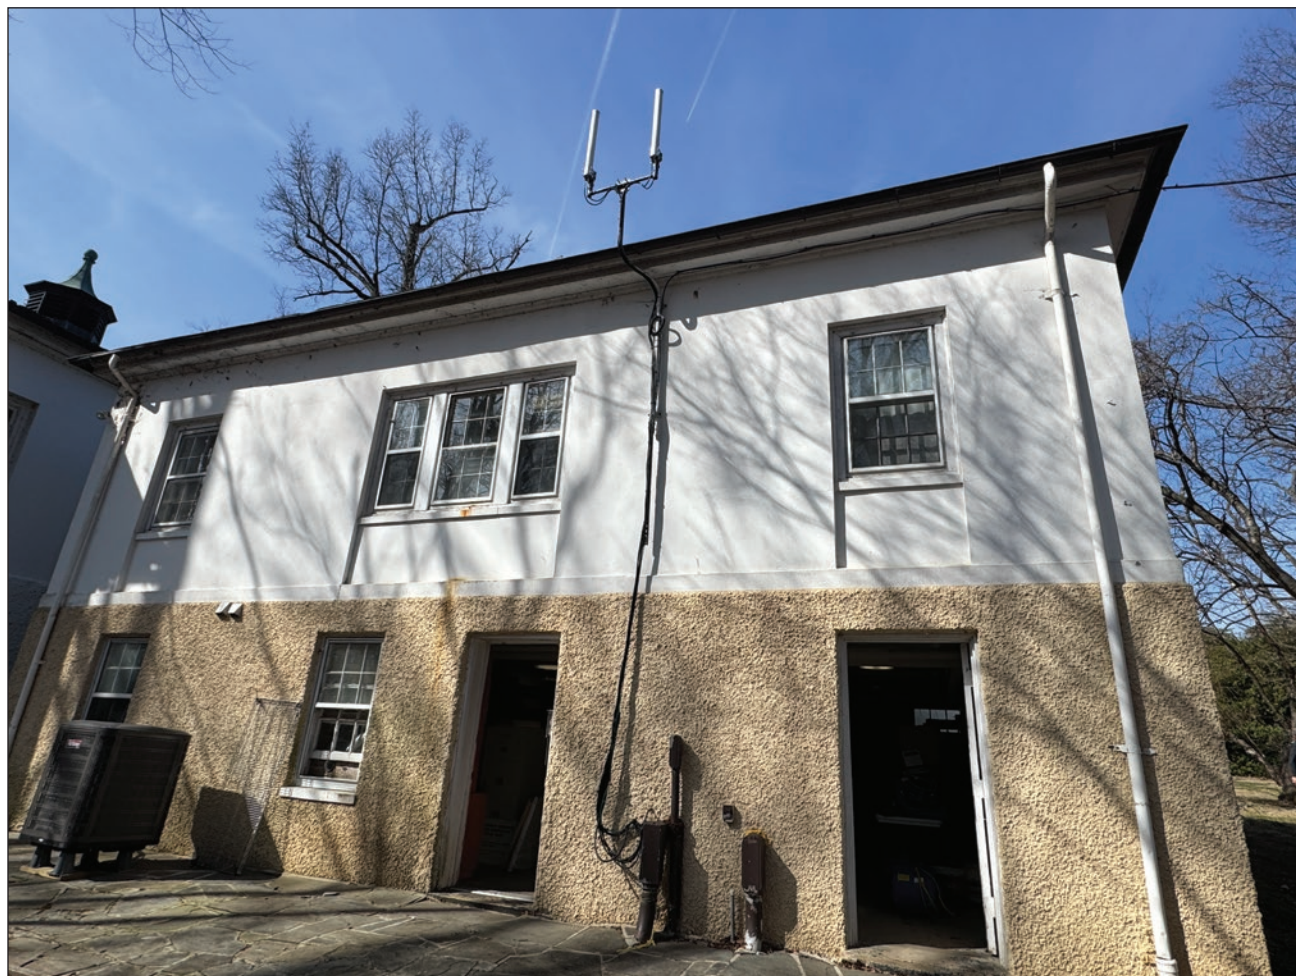
At the east elevation, two small vents are present at the top of the lower register on the south side of the wall; these appear in the original drawings to vent the white men's toilet room (Figure 161). There are also electrical boxes and conduits attached to building on the east elevation that feed underground wiring into the building. These are also connected to wiring and an antenna that rises above the roofline (Figure 162). An air conditioner sits on the flagstone patio with conduit that runs through the wall (Figure 163). On the north elevation, a small antenna rises above the roof line and is connected to a small box at the cornice (Figure 105).

**Figure 162.** Electrical boxes, conduit, wiring, and an antenna on the east elevation. Building Conservation Associates, 2025.

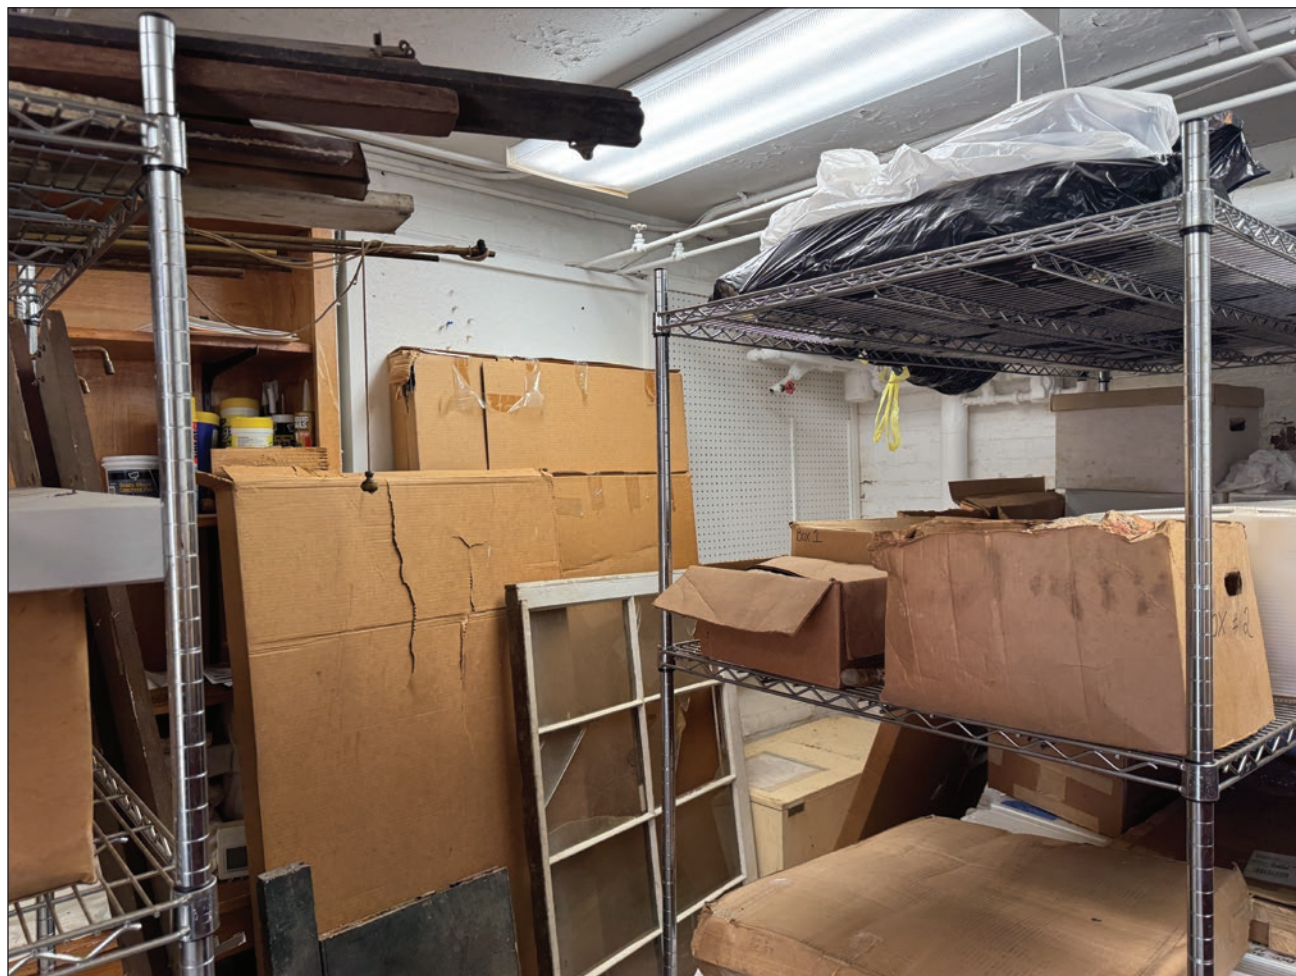
**Figure 166.** Former opening between the segregated women's restroom and toilet room blocked with peg board. View lookout southwest. Building Conservation Associates, 2025.

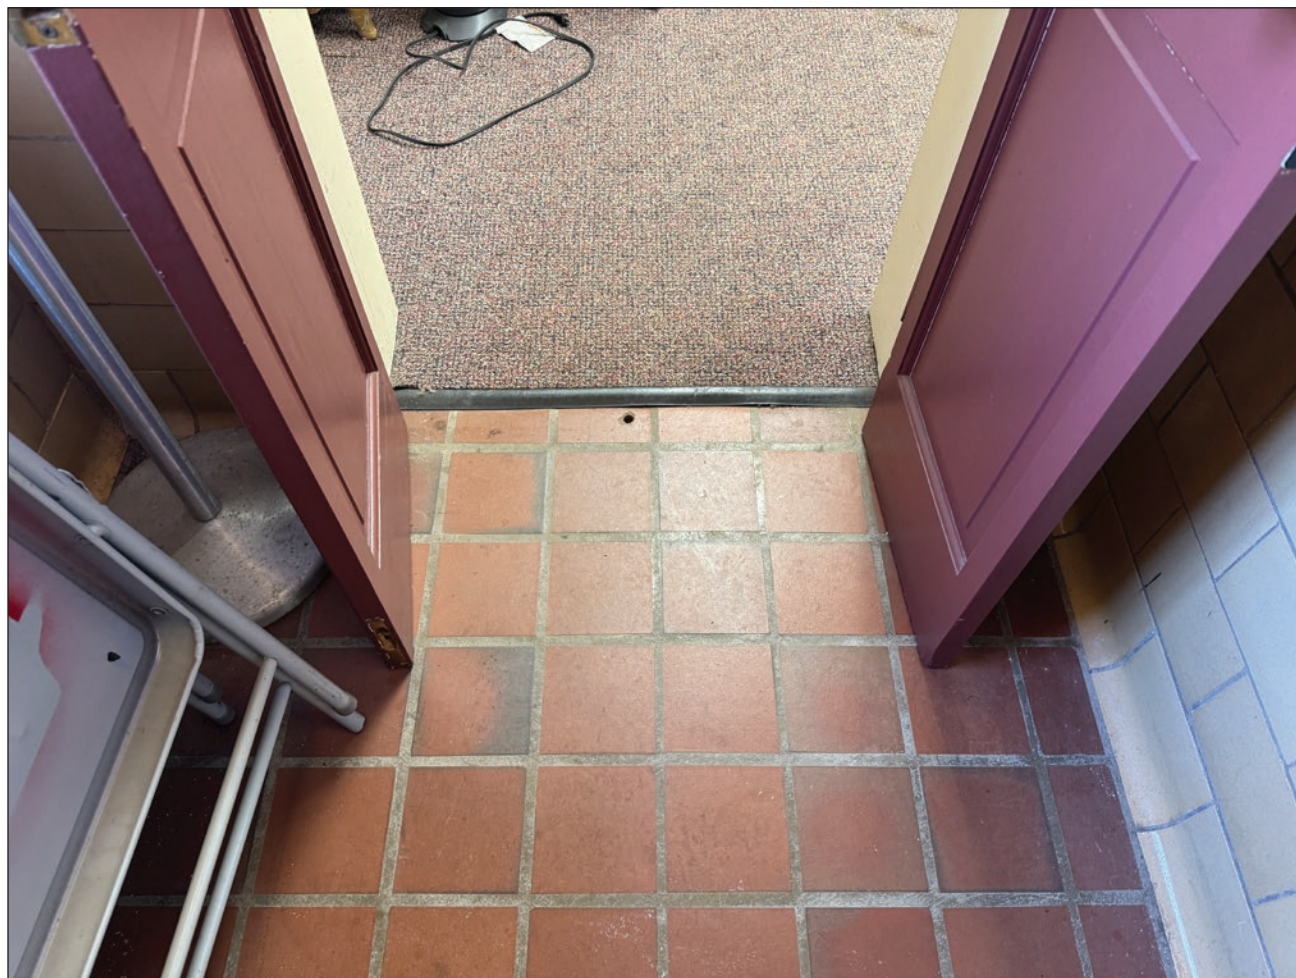
**Figure 179.** Quarry tile floor in vestibule and carpeting in the north room. Note also the hole in the floor for the flush bolt. Building Conservation Associates, 2025.

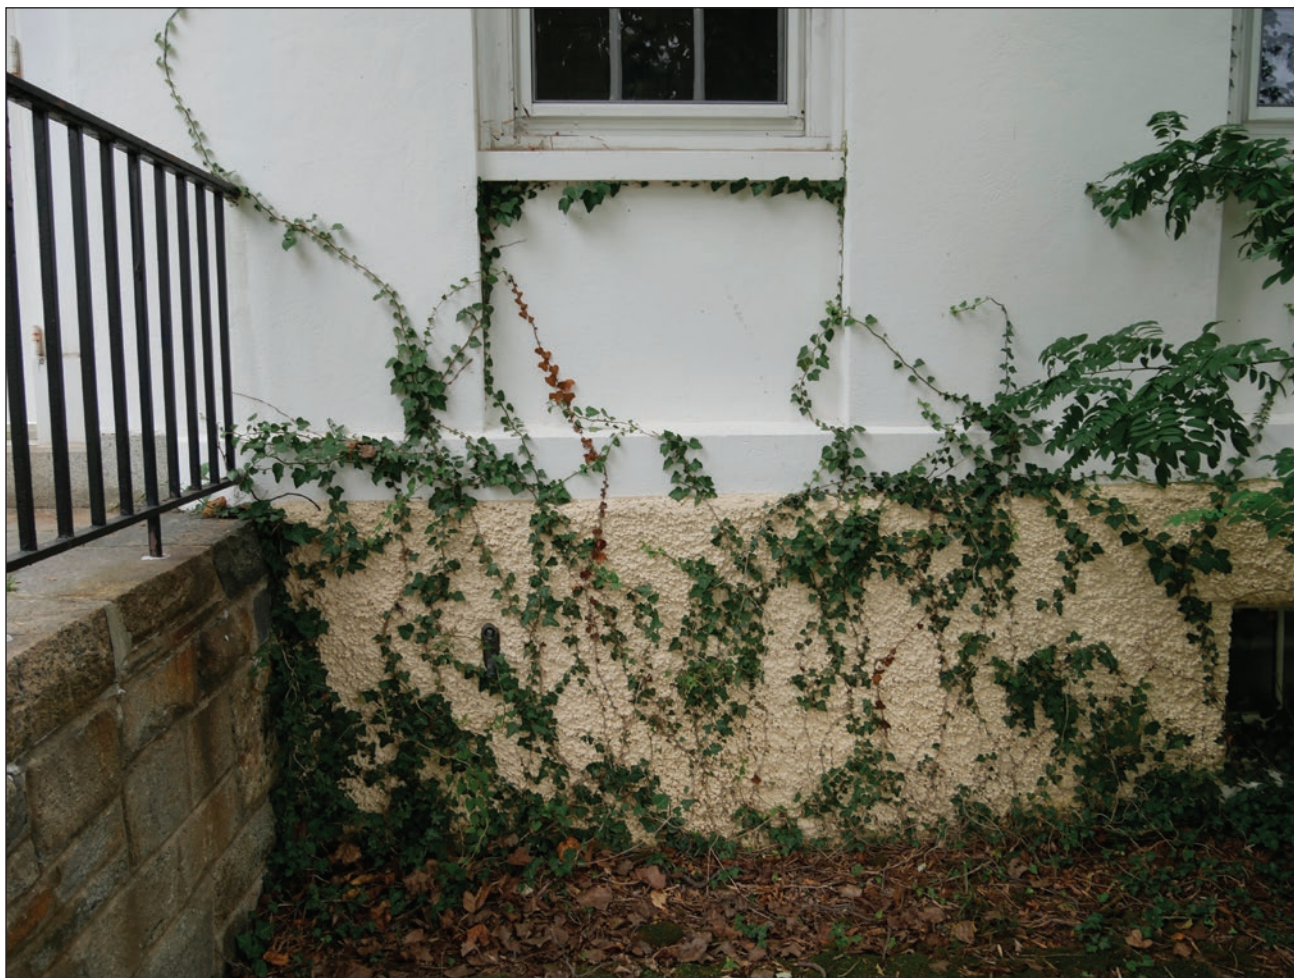
**Figure 203.** Scandent vines climbing the exterior pebble dash and flat stucco at the southwest corner. Building Conservation Associates, 2025.

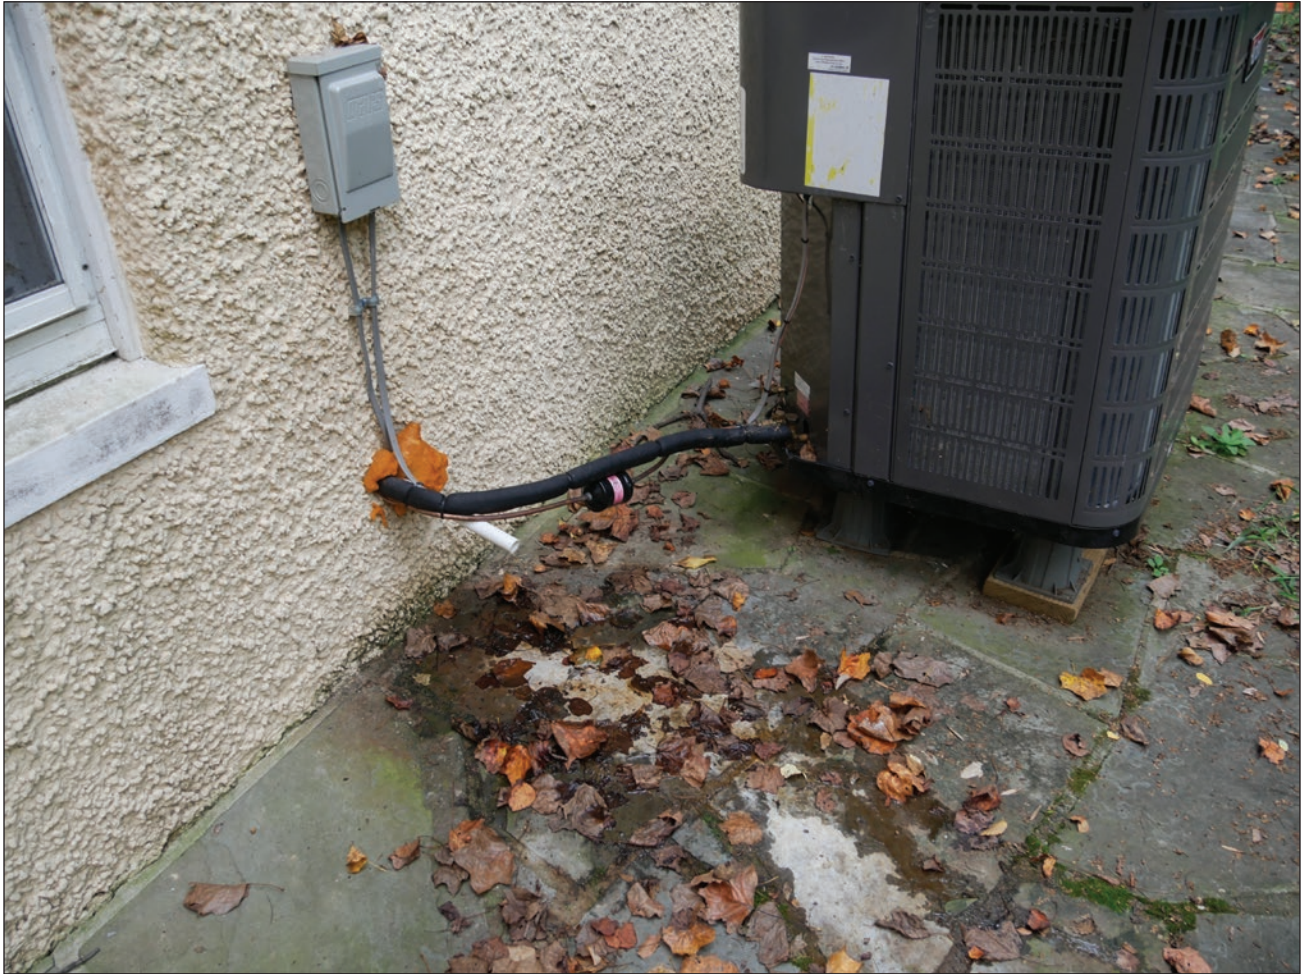
**Figure 204.** Foam sealant at the HVAC penetration in the pebble dash stucco at the east elevation. Building Conservation Associates, 2025.

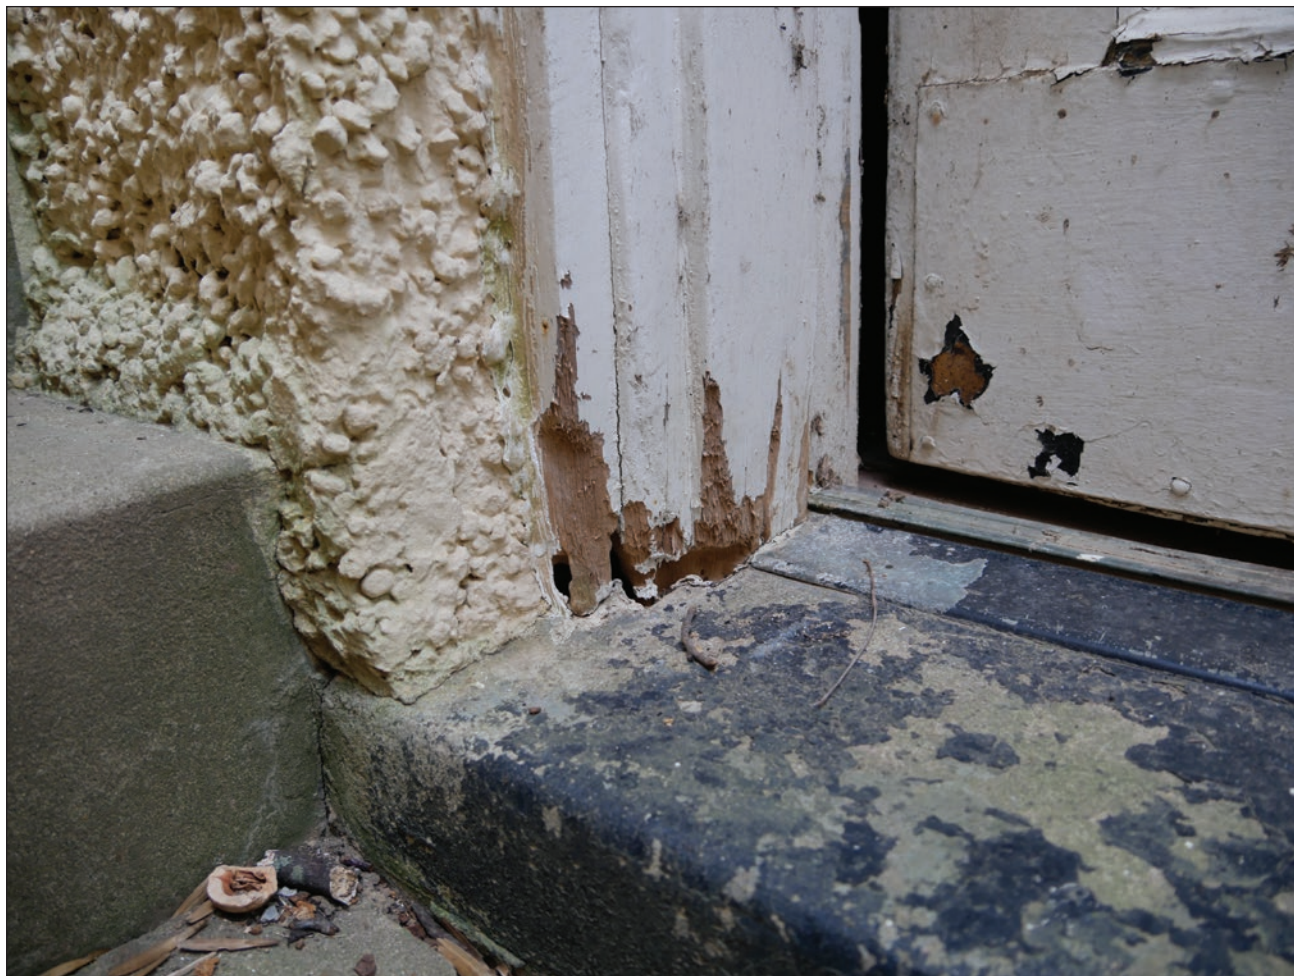
**Figure 207.** Heavy paint at pebble dash and wood loss at southwest basement door surround. Building Conservation Associates, 2025.

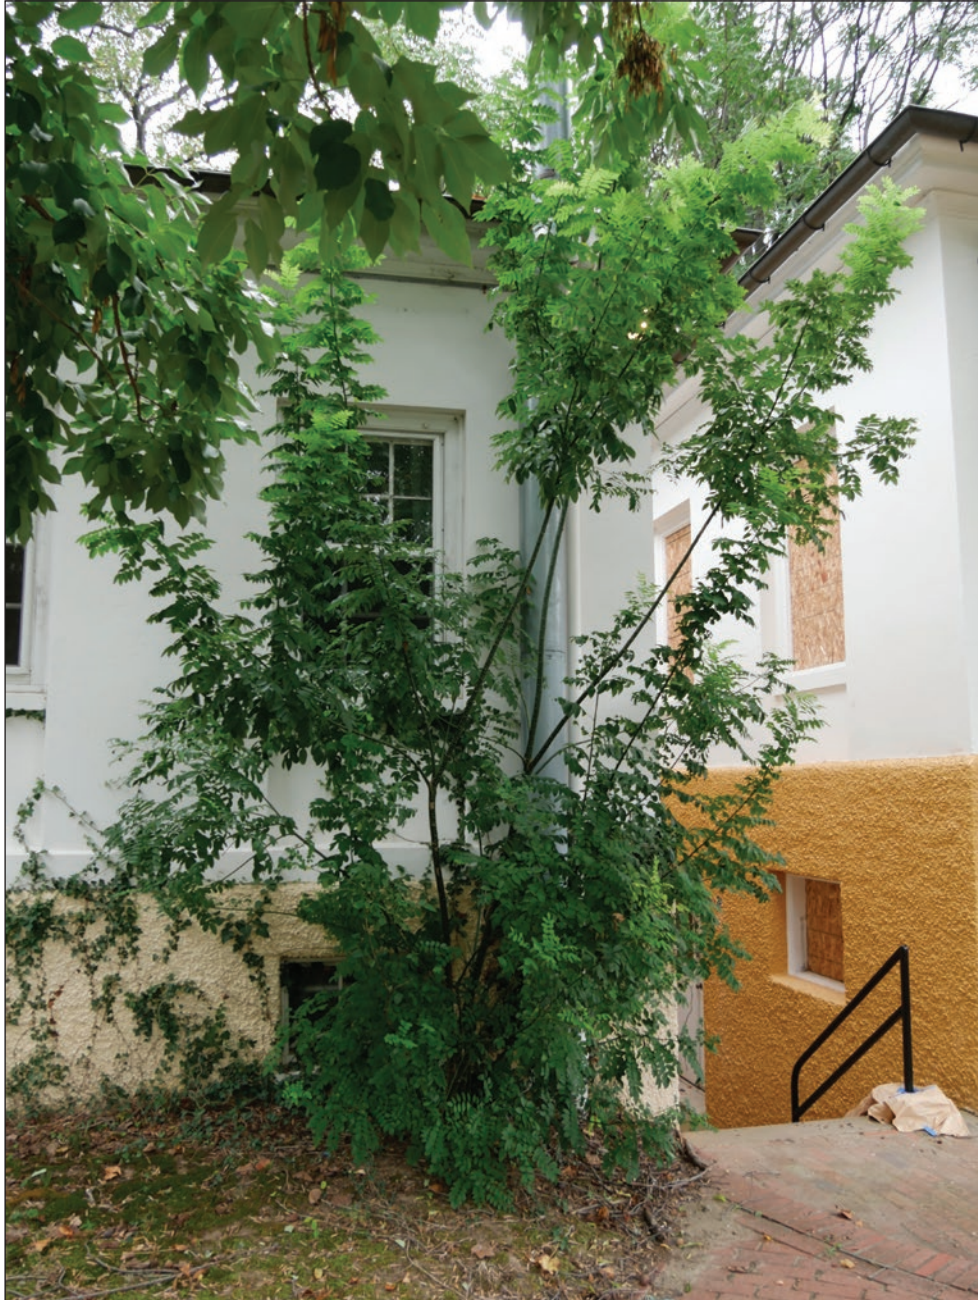
**Figure 208.** Black locust shrub at the southwest corner of the building. Building Conservation Associates, 2025.

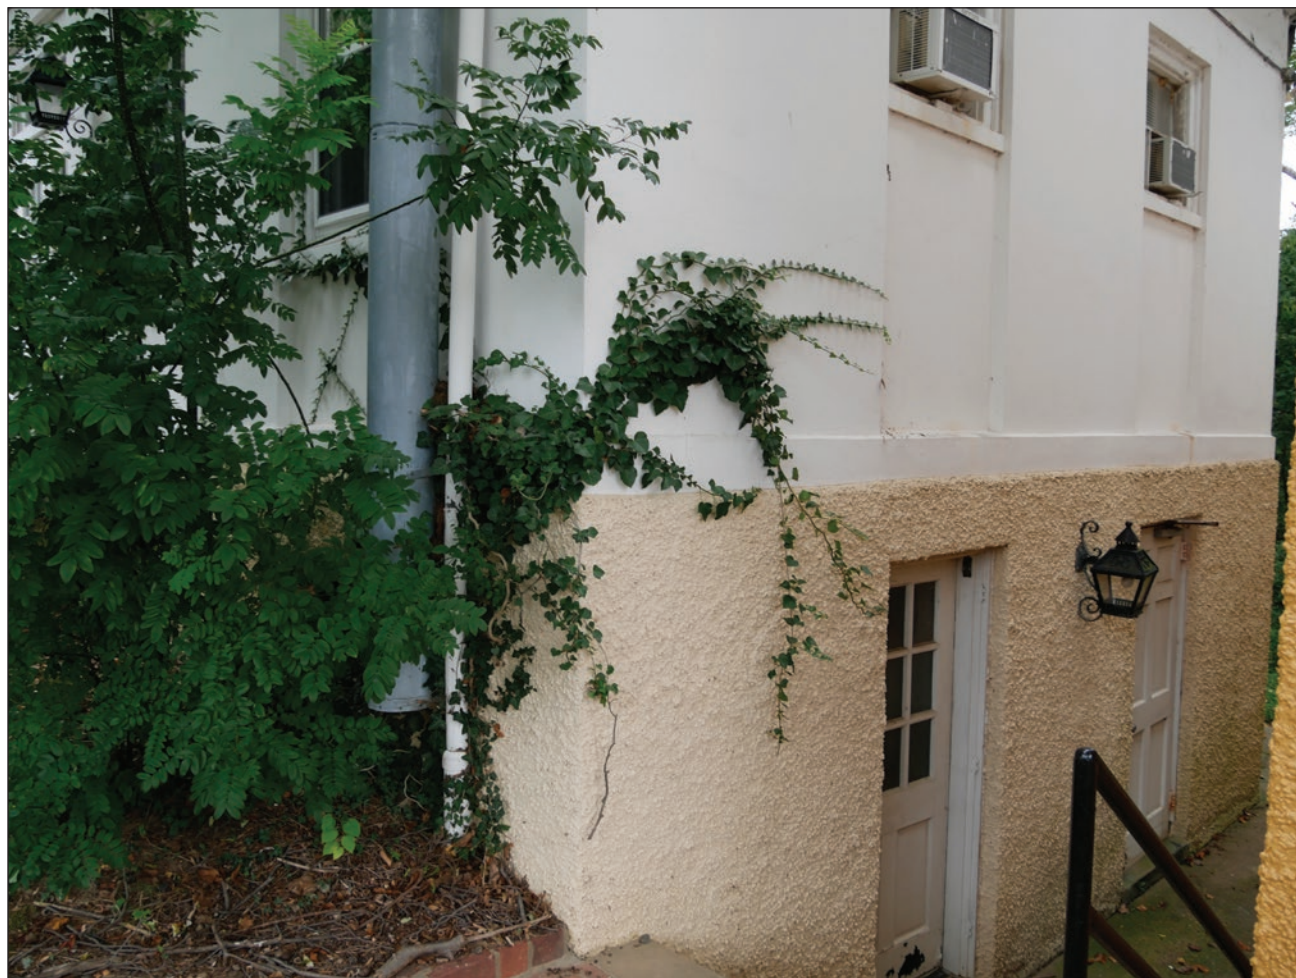
**Figure 209.** Scandent vines climbing the pebble dash and flat stucco at the southwest corner. Building Conservation Associates, 2025.

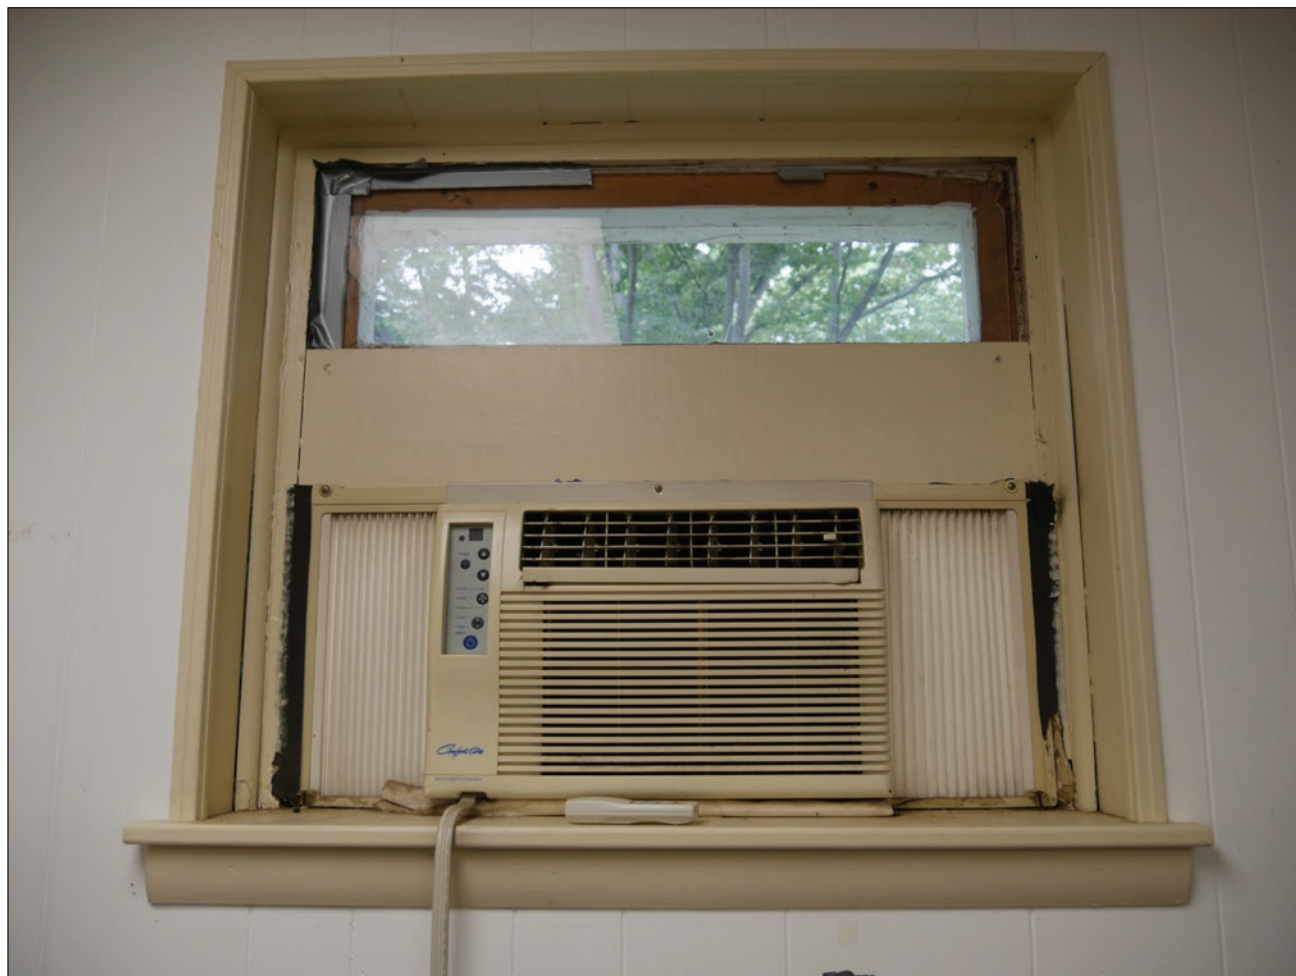
The three-over-three sash windows are present at the first-floor level on the south elevation. Several have been modified to fit window A/C units (Figure 219). The southwest window has been covered at the interior with plastic and tape due to block air and water infiltration (Figure 220).

**Figure 219.** 2-over-3 sash window at north elevation modified for window A/C unit. Building Conservation Associates, 2025.
