*HISTORIC STRUCTURE REPORT*  
**HISTORIC CEMETERY COMFORT STATION  
(BUILDING #313)**

Kevin Wohlgemuth, Senior Associate, Building Conservation Associates, Inc. (BCA)  
Dorothy Krotzer, Director, BCA  
Michele Boyd, Director of Preservation Services, BCA  
Kate Whitney-Schubb, Staff Conservator, BCA

The following 100% Draft of the Historic Structure Report for the Historic Comfort Station (Building #313) at Arlington National Cemetery represents a synthesis of all research and analysis performed for this project.

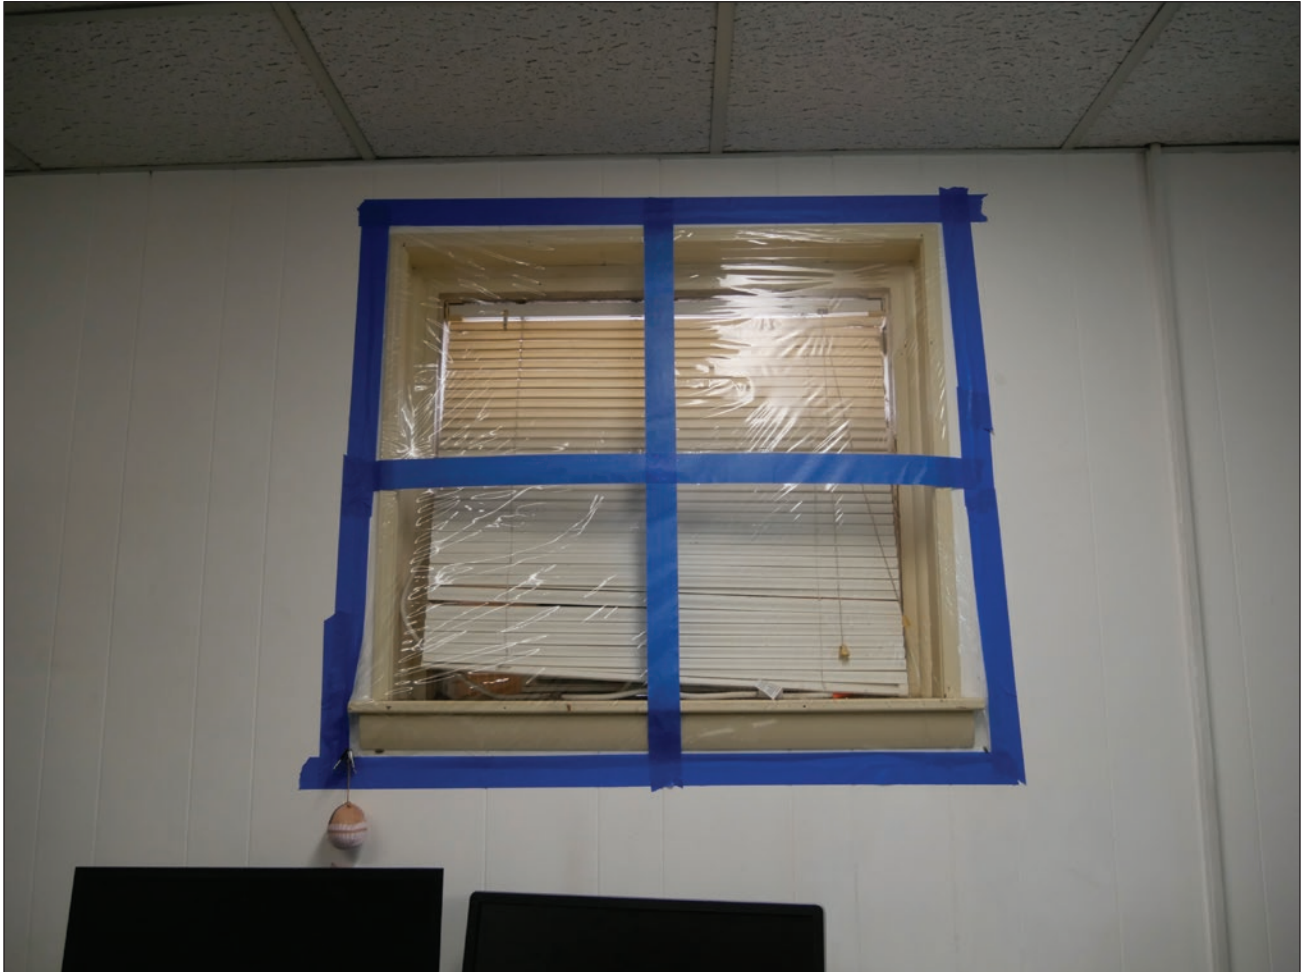
The three-over-three sash windows are present at the first-floor level on the south elevation. Several have been modified to fit window A/C units (Figure 219). The southwest window has been covered at the interior with plastic and tape due to block air and water infiltration (Figure 220).

**Figure 220.** Window at south elevation sealed with plastic and tape. Building Conservation Associates, 2025.

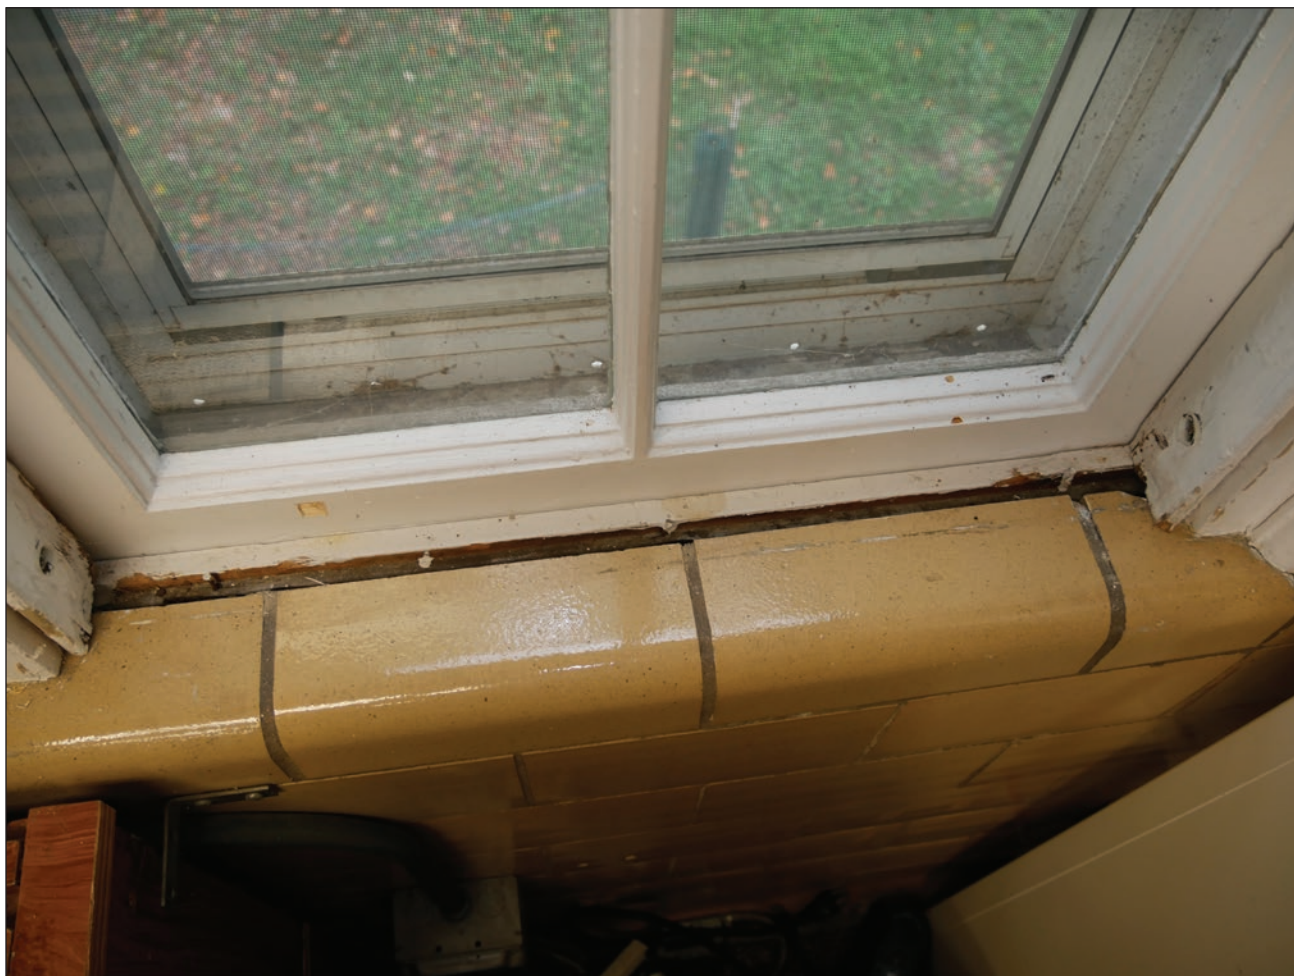
**Figure 221.** Losses in wood frame at tripartite window. Building Conservation Associates, 2025.

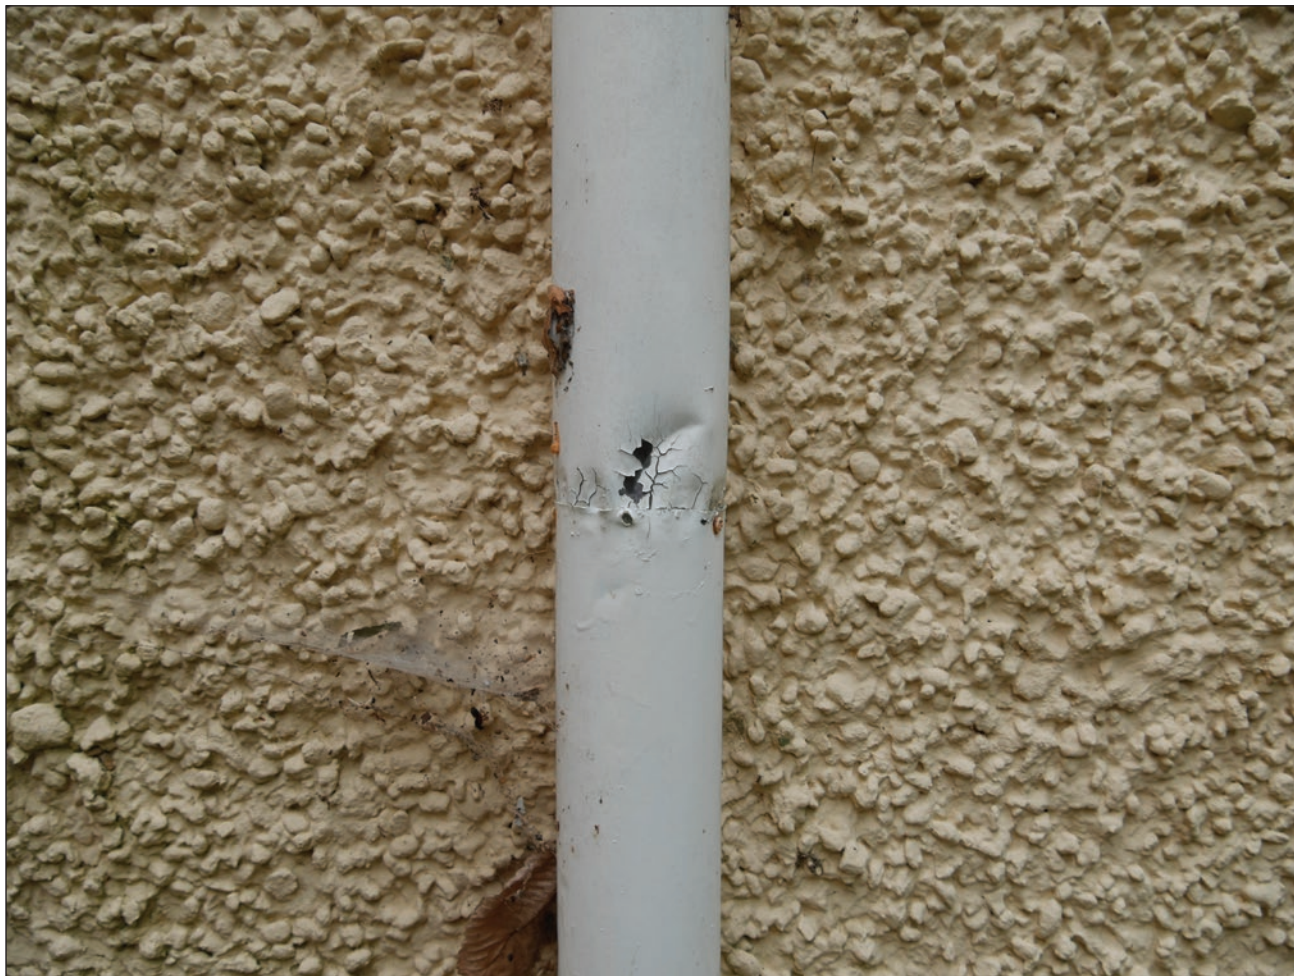
The painted copper downspouts and cast-iron shoes are original to the building's construction. They are in fair condition with minor dents and paint loss at the downspout (Figure 239), paint loss and rusting at the bands (Figure 240), and rusting at the shoes (Figure 241).

**Figure 239.** Dent and paint loss at downspout. Building Conservation Associates, 2025.

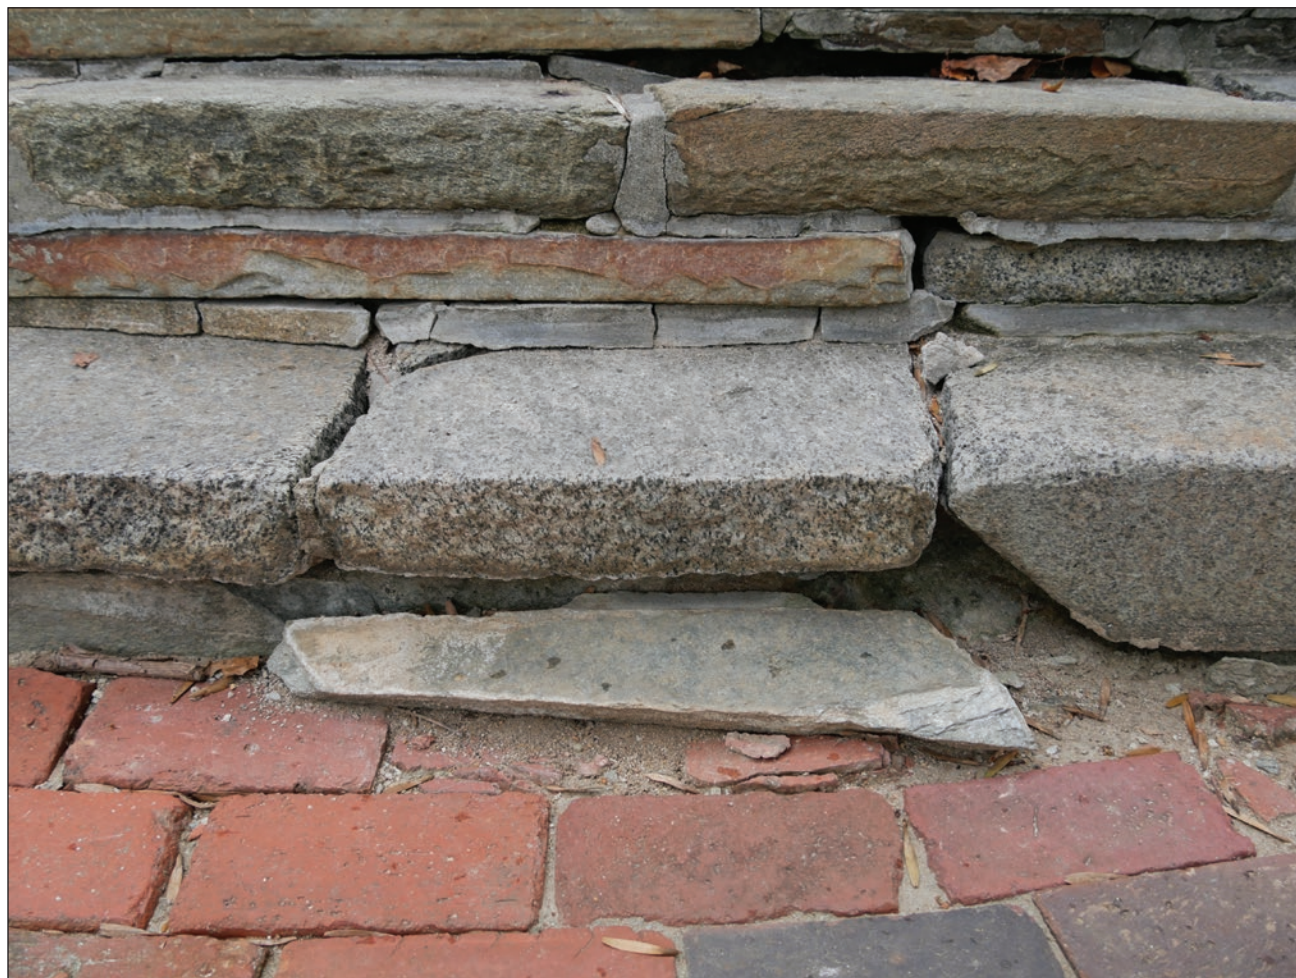
The main entrance stairs on the west side of the building were constructed with granite flag stones and thick, gray mortar, and date to the original construction of the building. The steps are in poor condition and exhibit significant mortar failure and loss (Figure 244), evidence of failed repointing campaigns, stone displacement (Figure 245), cracked stone units (Figure 246), and general soiling (Figure 247).

**Figure 245.** Displaced stone and mortar loss at main entry steps. Building Conservation Associates, 2025.

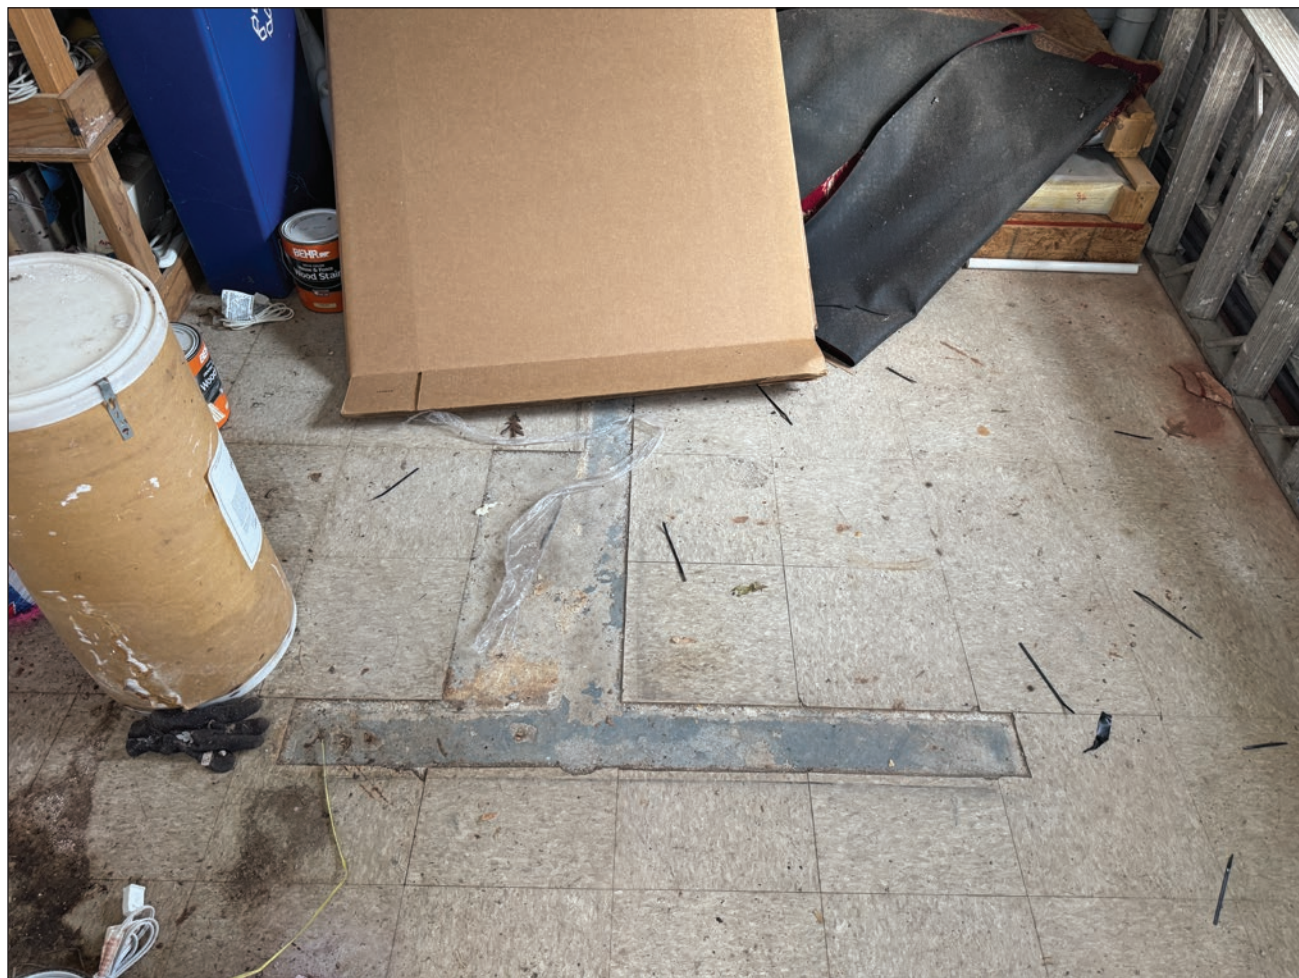
The concrete floors are currently in poor condition, and in all but the southwest room they have been mostly covered by vinyl tiles (Figure 255). Where they are exposed, they exhibit heavy soiling, water staining, and paint loss (Figure 256).

**Figure 255.** Vinyl floor tile in southeast basement room. Building Conservation Associates, 2025.

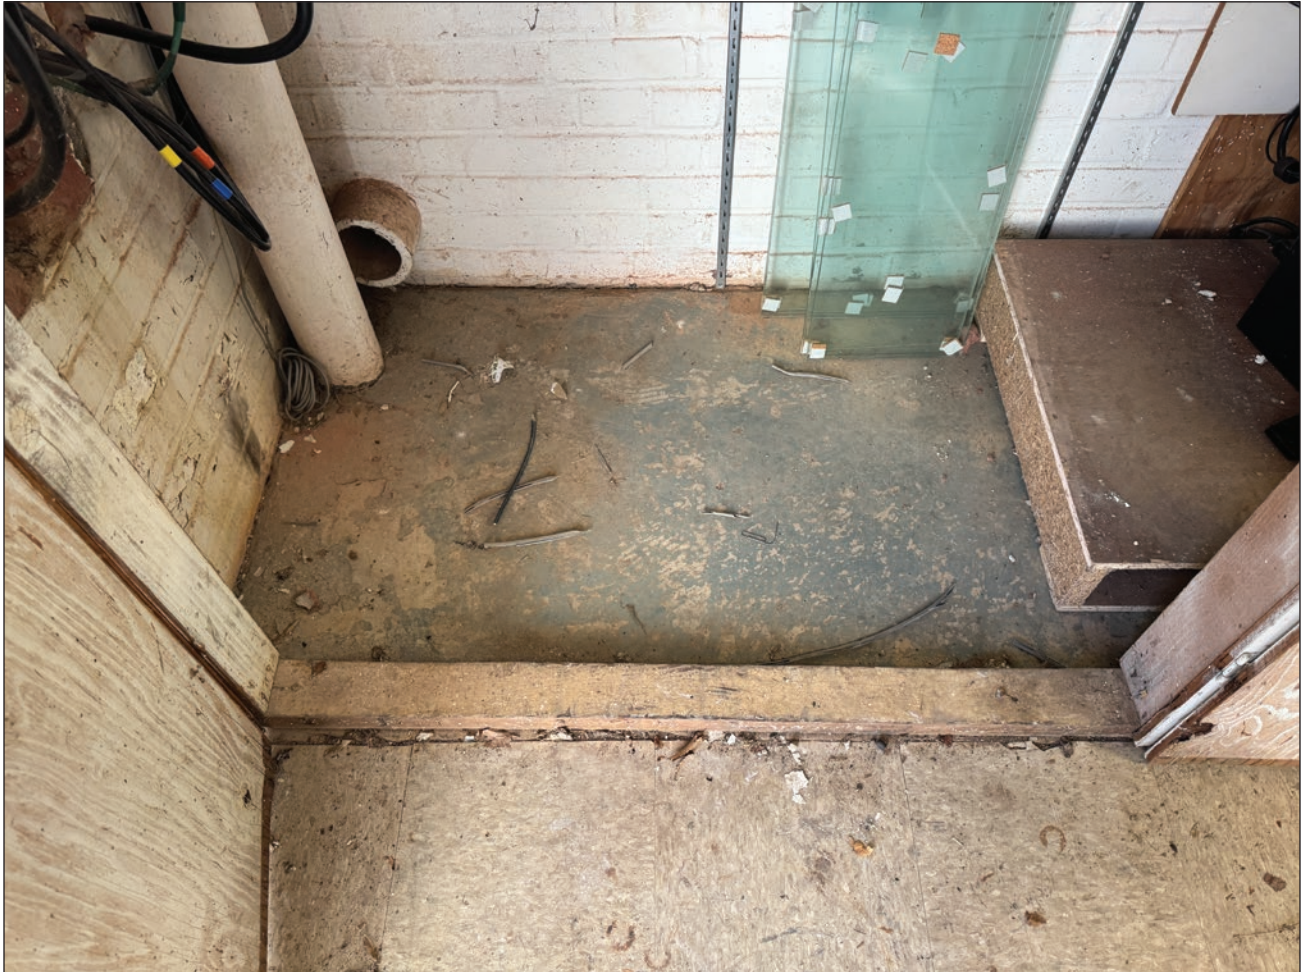
**Figure 256.** Exposed concrete floor in north basement room. Building Conservation Associates, 2025.

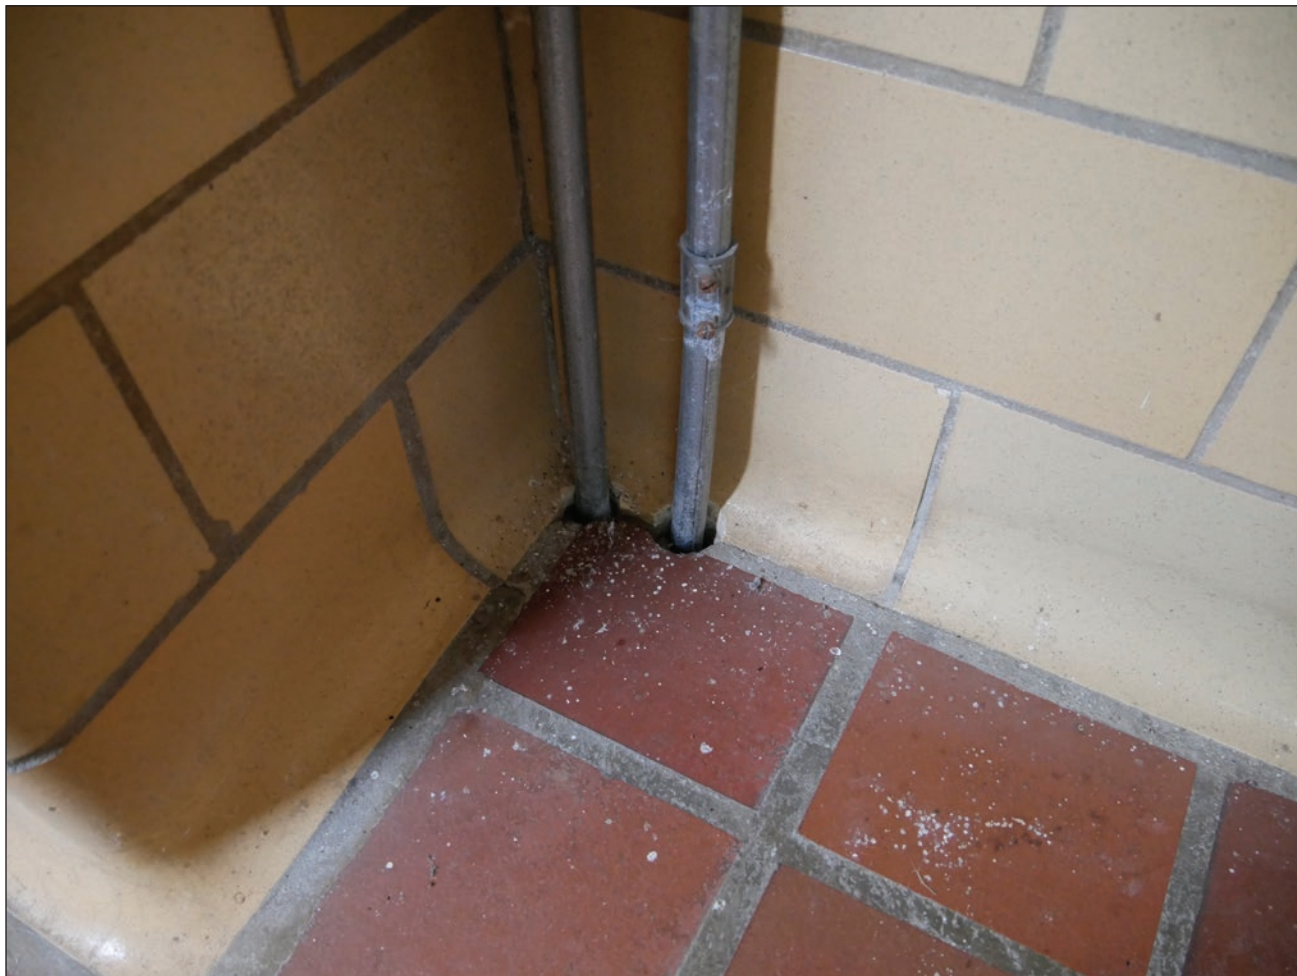
The quarry tile floor in the first-floor spaces was originally exposed; it has been covered by carpeting in the north, south, and east spaces. Where it is still exposed, it appears to be in fair condition, with general soiling and drilled holes for conduits and the flush bolt for replacement doors (Figure 179, Figure 257).

**Figure 257.** Holes for conduit in tile floor in vestibule. Building Conservation Associates, 2025.

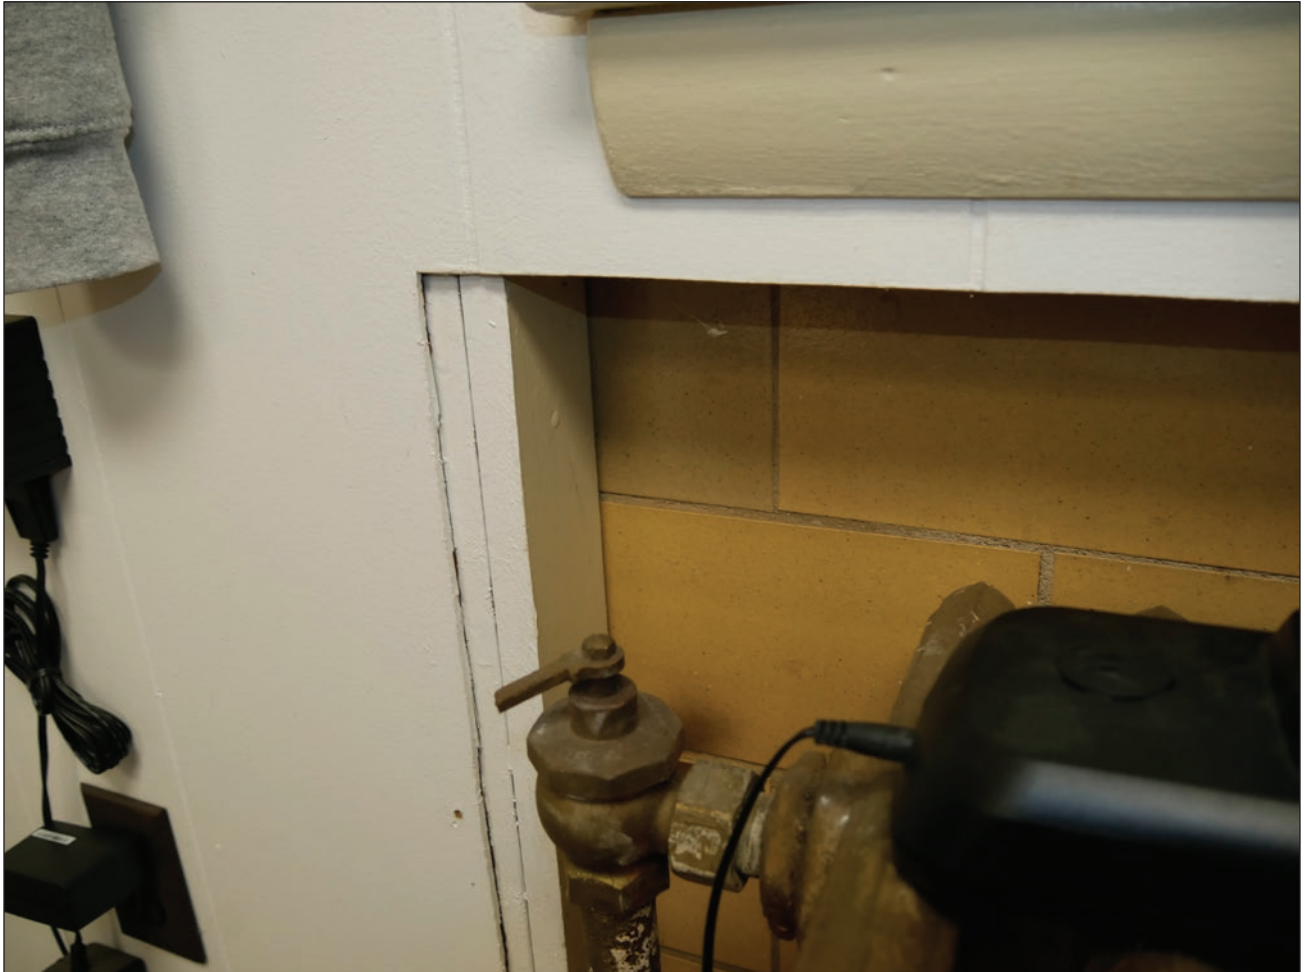
The glazed tile walls in the first-floor spaces were originally exposed in all rooms. When the building was converted into office space after 1982, the tile walls in the north and south toilet room spaces were covered with HDF paneling (Figure 258). Where the tile is still exposed—at the vestibule and west room—it is in fair condition with observed conditions including: hairline cracks in the glazing (Figure 259), abandoned anchor holes (Figure 260), surface marks and adhesive residue (Figure 261), grout loss (Figure 262), and overpaint from the radiators (Figure 263).

**Figure 258.** HDF paneling in north office. Building Conservation Associates, 2025.

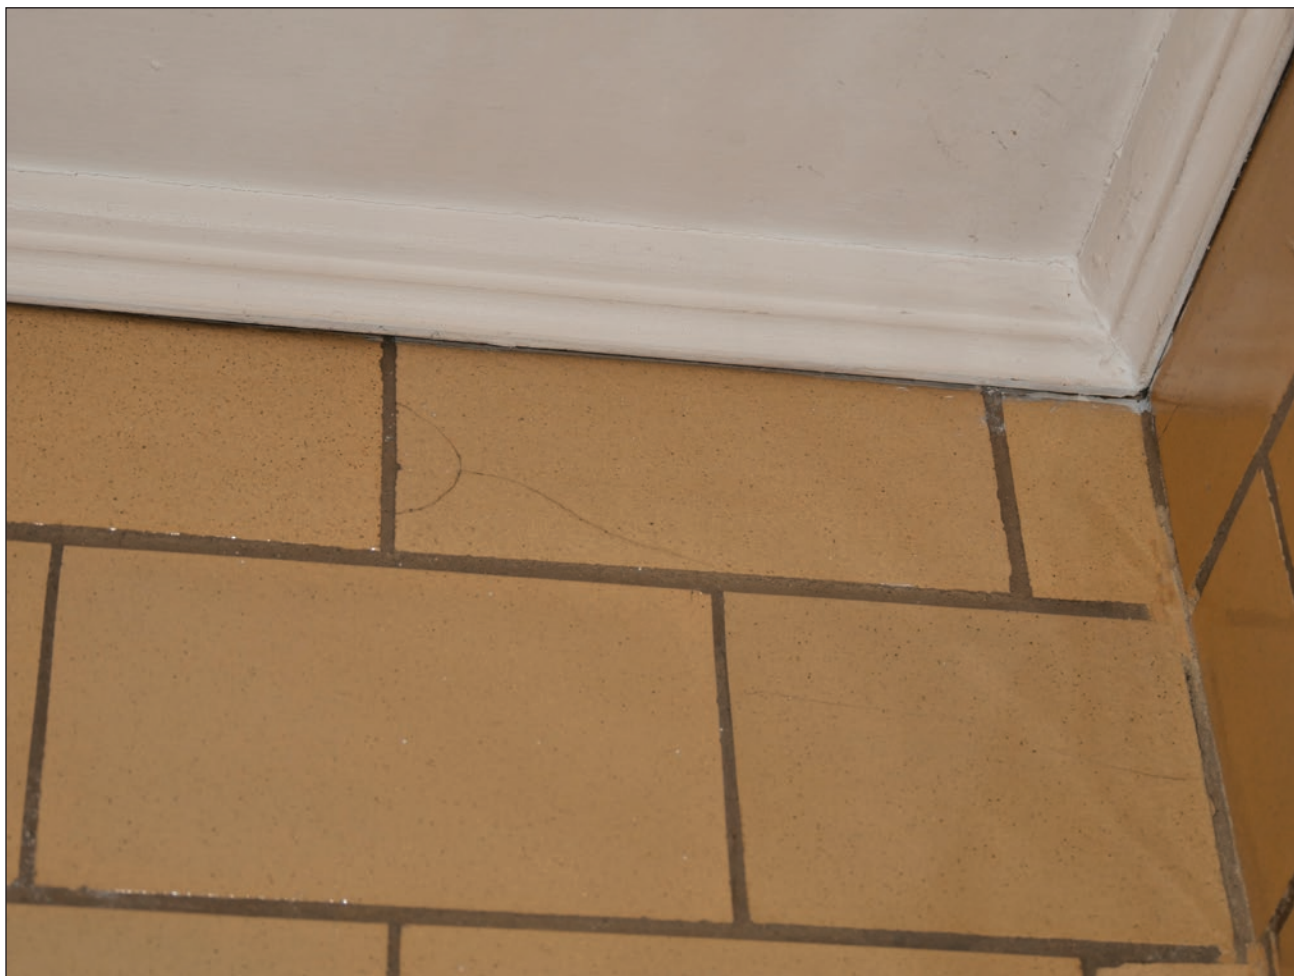
**Figure 259.** Crack in vestibule glazed tile wall. Building Conservation Associates, 2025.

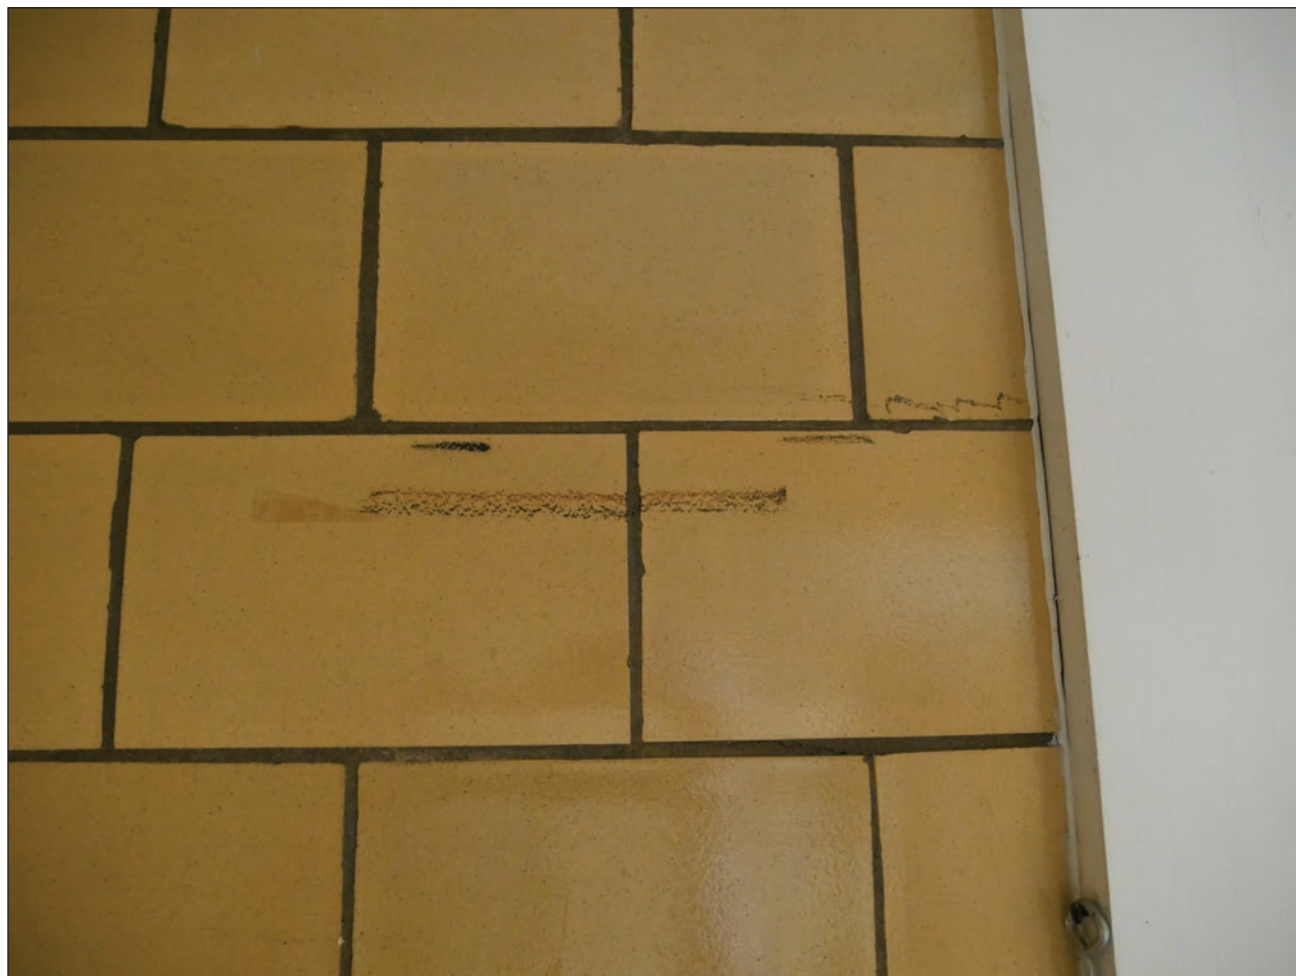
**Figure 261.** Surface marks and adhesive residue on glazed tile wall in vestibule. Building Conservation Associates, 2025.

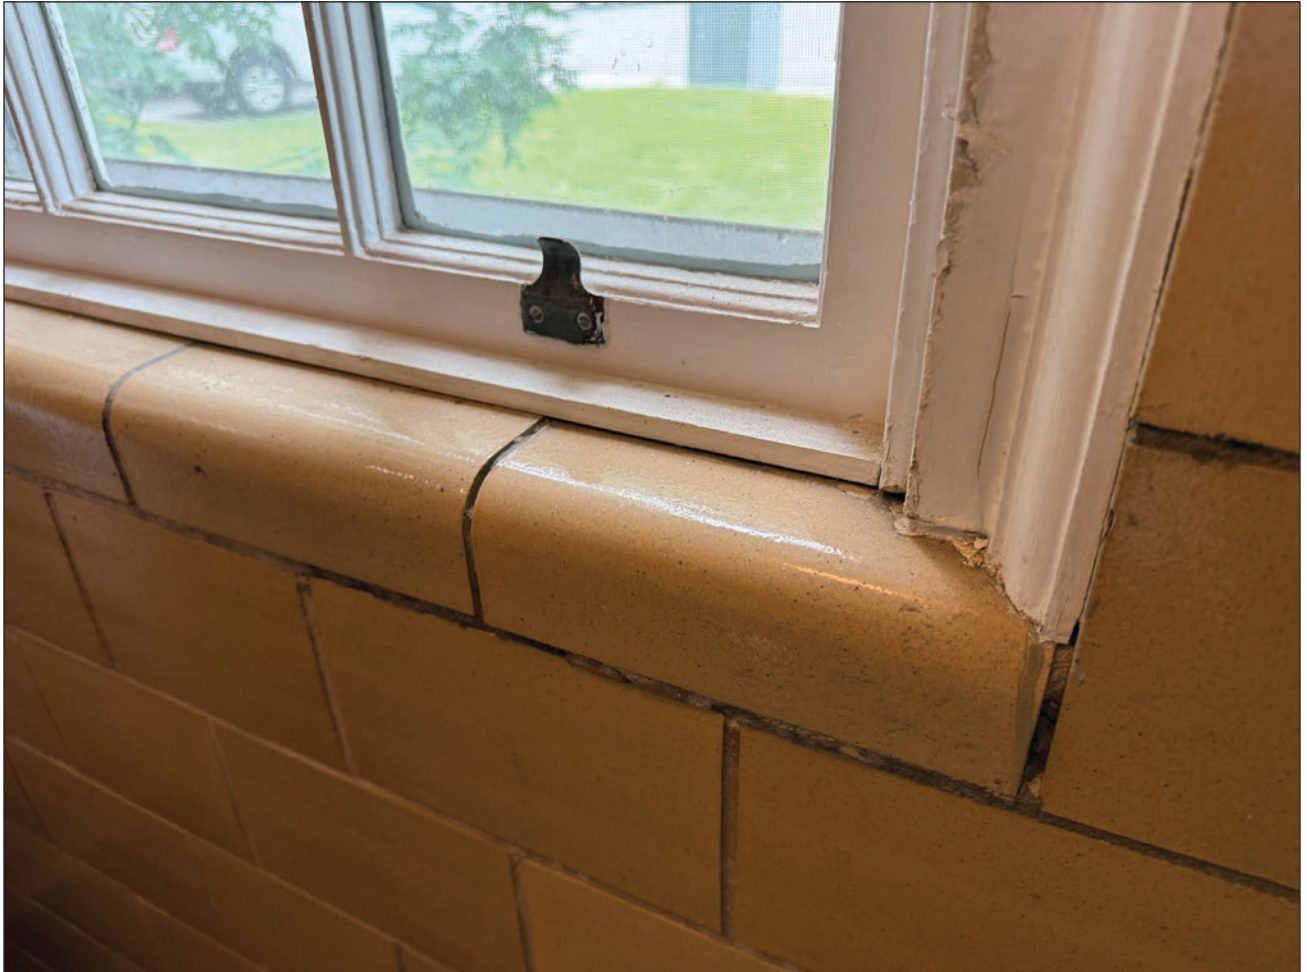
**Figure 262.** Grout loss at glazed tile in vestibule. Building Conservation Associates, 2025.

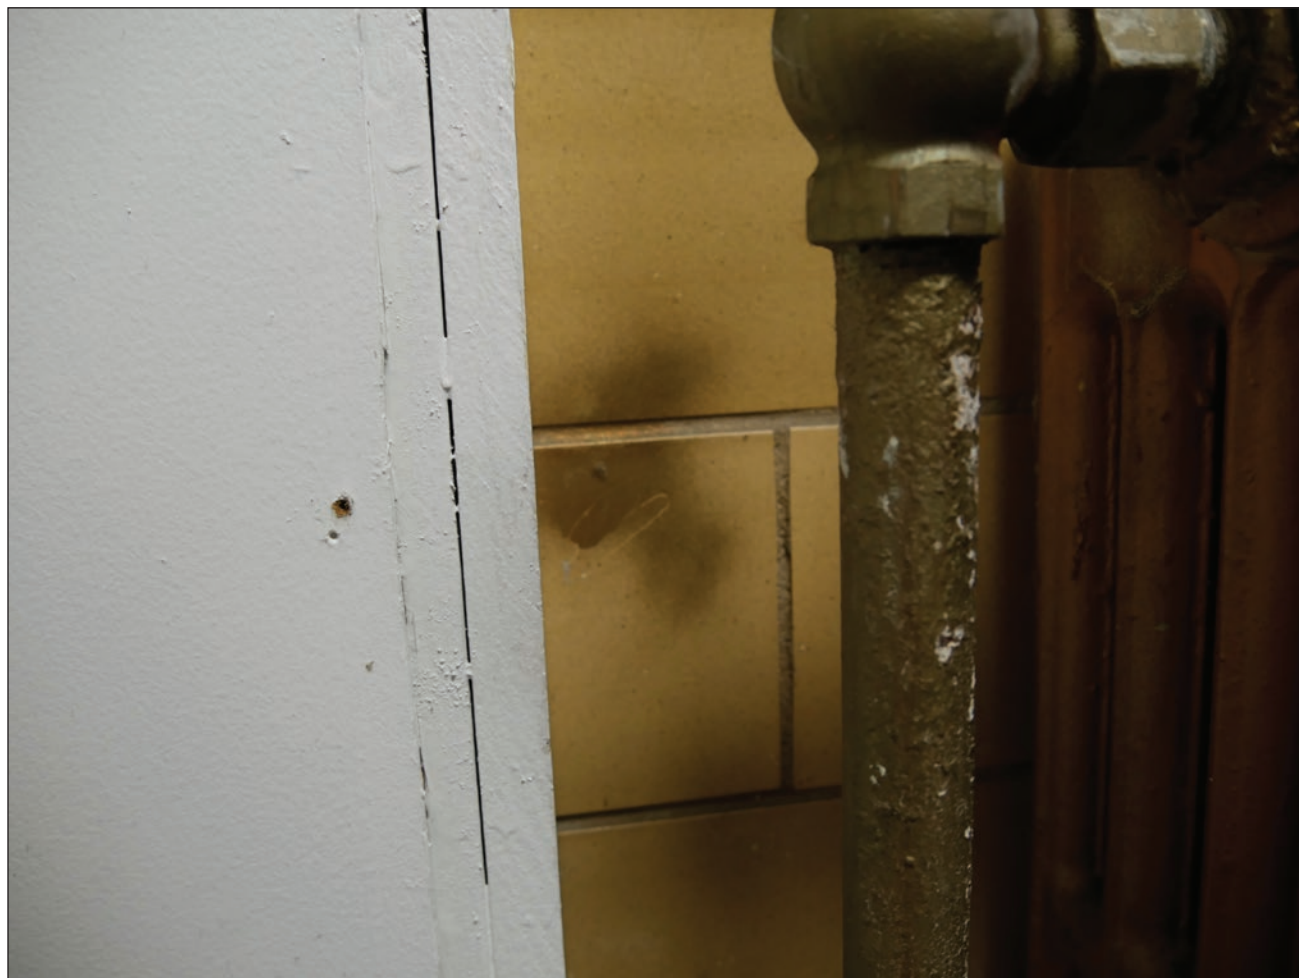
**Figure 263.** Overpaint on glazed tile wall in north office. Building Conservation Associates, 2025.

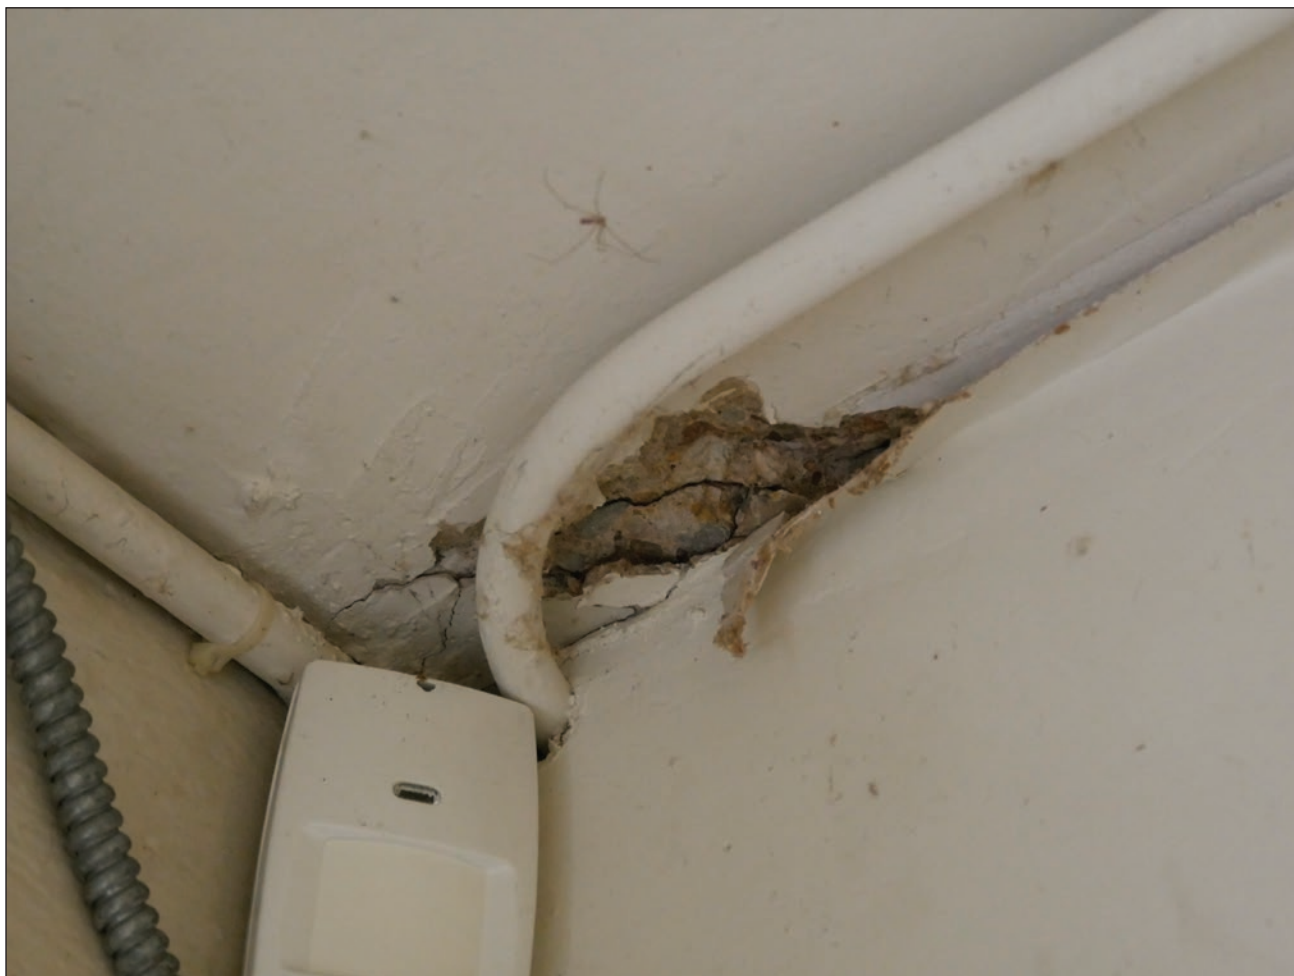
**Figure 265.** Cracked plaster ceiling in basement. Building Conservation Associates, 2025.

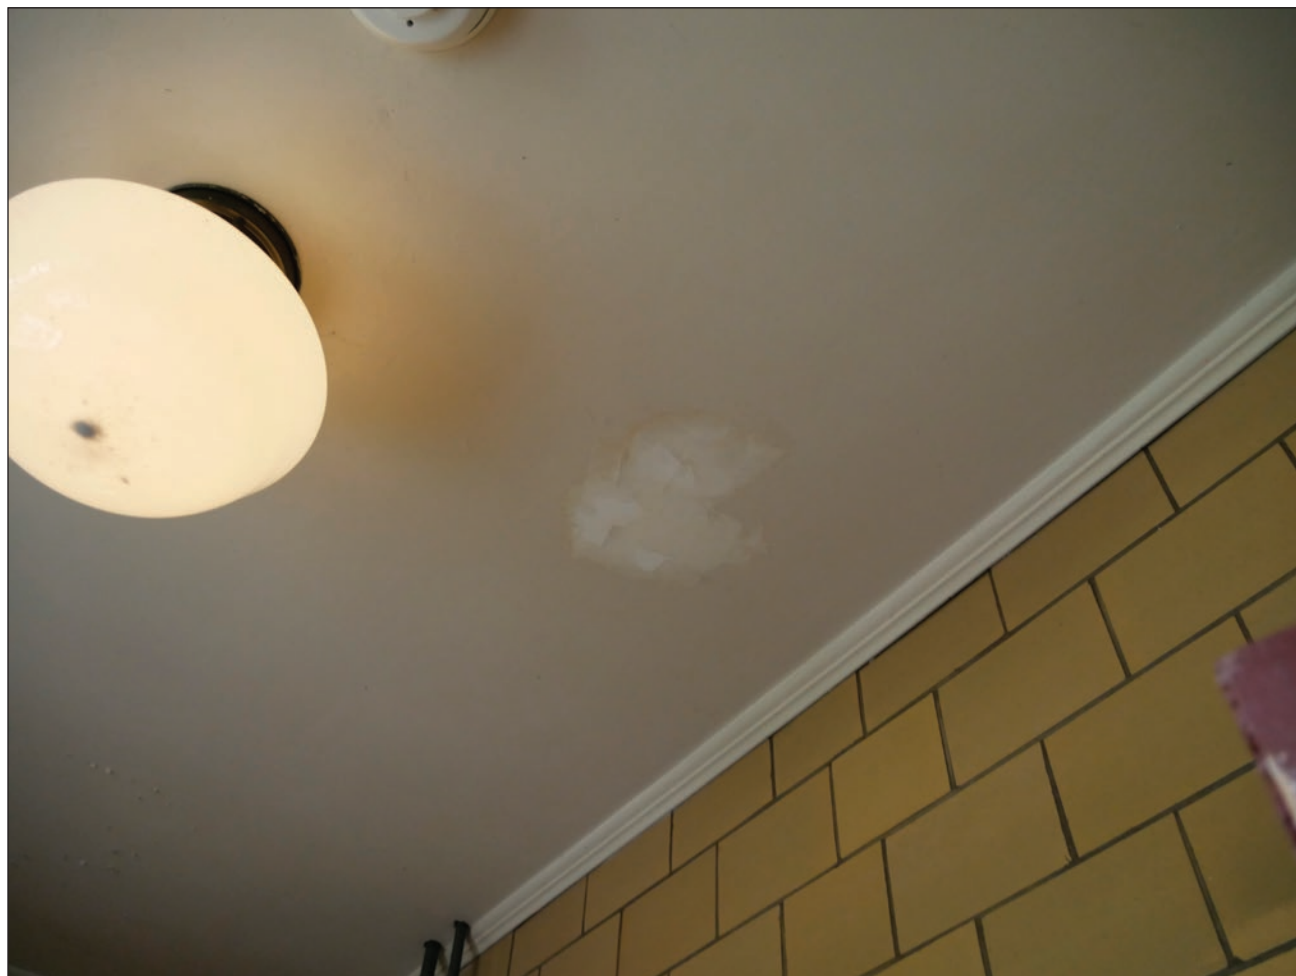
At the first floor, the plaster ceilings have been partially covered by a suspended ceiling with acoustic ceiling tile (ACT) (Figure 181). Where the original plaster ceiling is still exposed, it appears to be in fair condition with evidence of some previous water damage and failing paint (Figure 267, Figure 268), new penetrations for vents and returns (Figure 269), and cracks in the plaster and at the edges where it intersects with wood trim (Figure 270, Figure 271). The ACT also exhibits previous water damage (Figure 272).

**Figure 267.** Water damage and paint loss at vestibule ceiling. Building Conservation Associates, 2025.

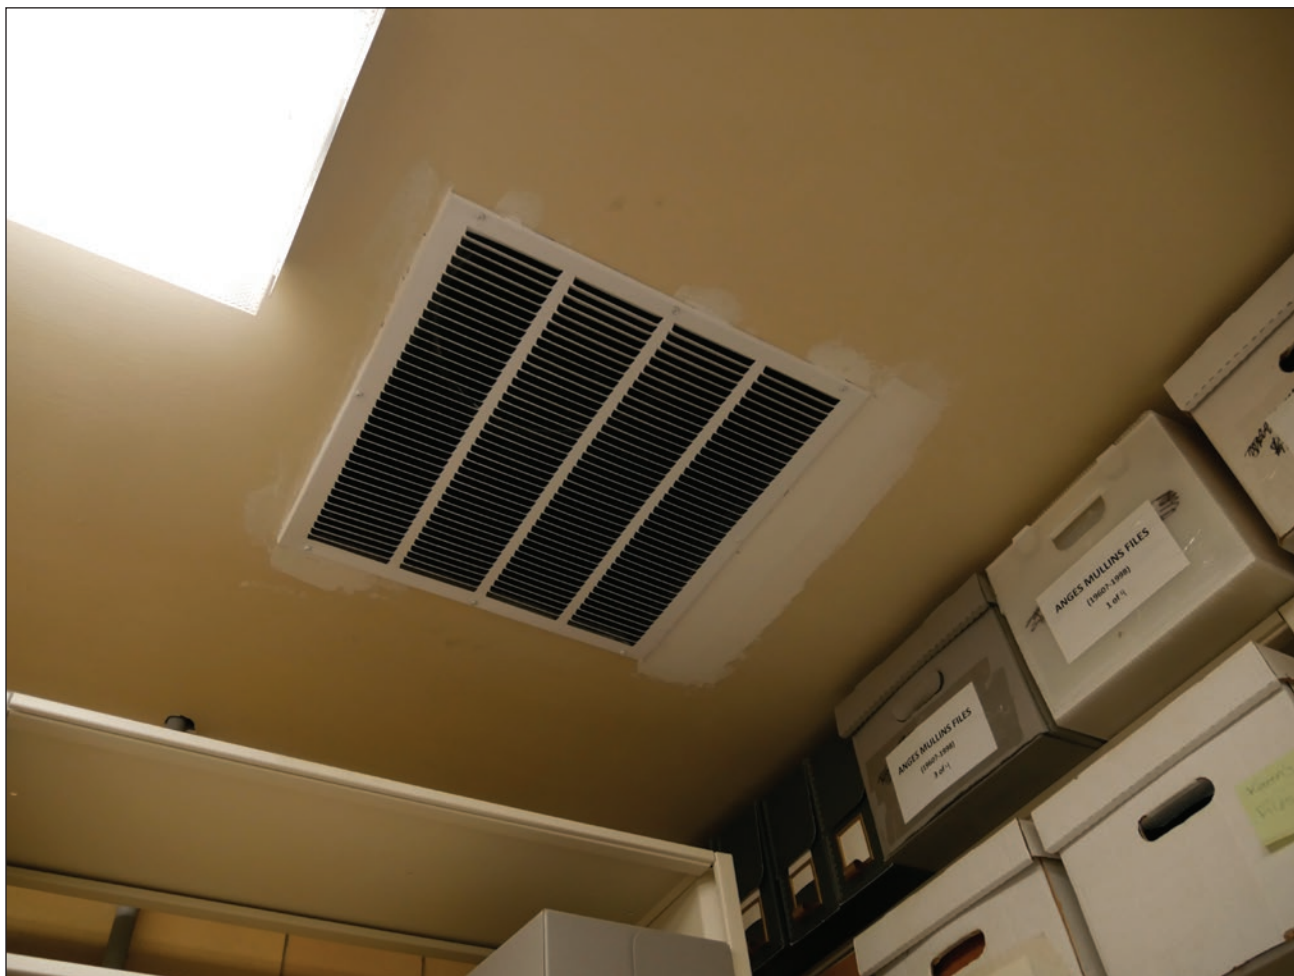
**Figure 269.** Modern air return in first floor east room. Building Conservation Associates, 2025.

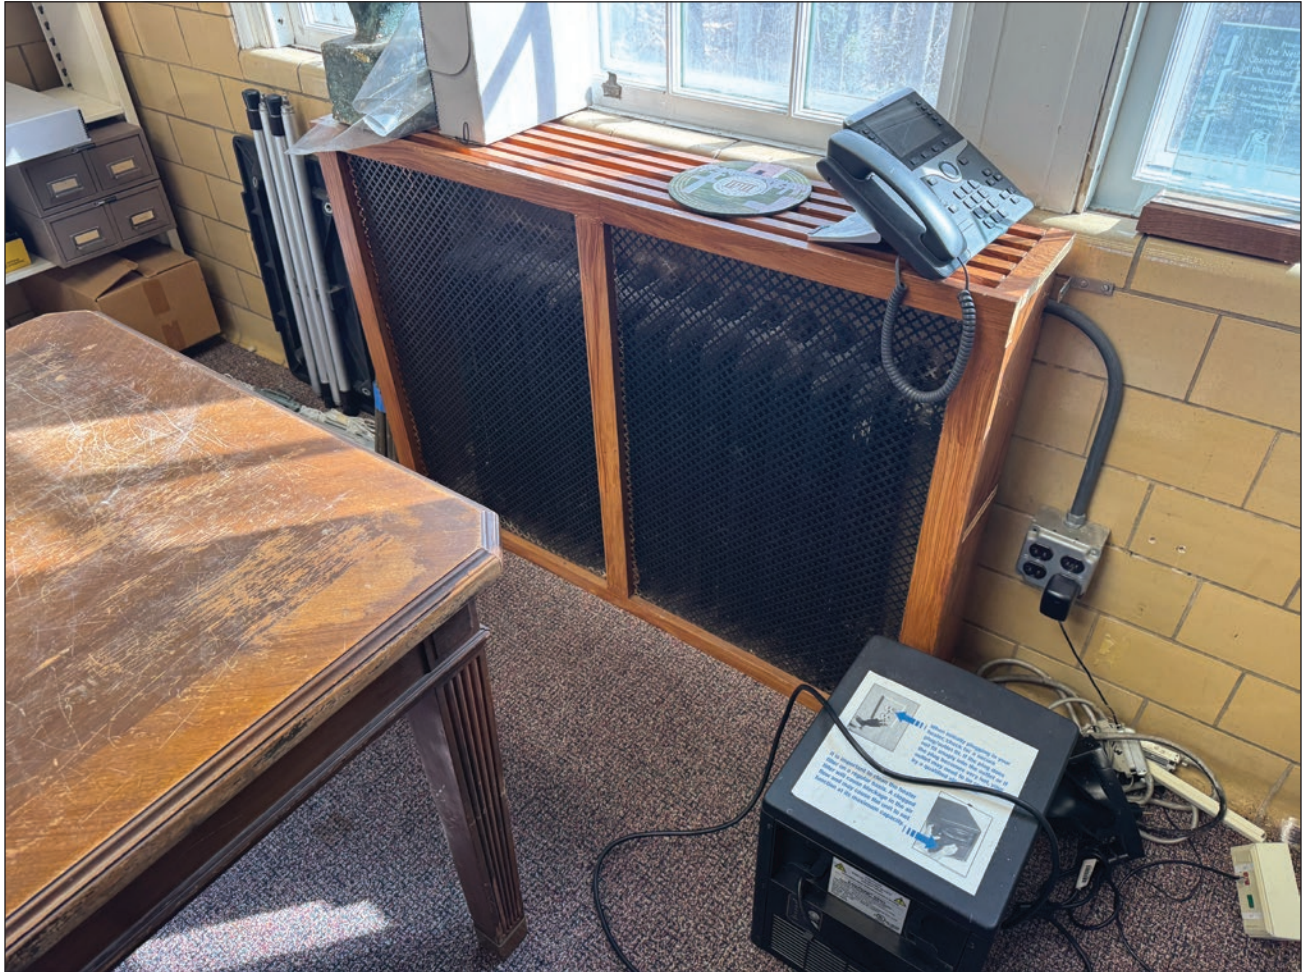
The cast-iron, floor-mounted radiators are present on the first floor, although they are no longer operable. Several have been covered with wood and metal mesh enclosures—particularly in the curatorial spaces—although those in the vestibules and offices are still exposed (Figure 273). These radiators are in fair condition with some paint loss visible (Figure 274).

**Figure 273.** Wood and metal mesh radiator enclosure in first-floor east room. Building Conservation Associates, 2025.

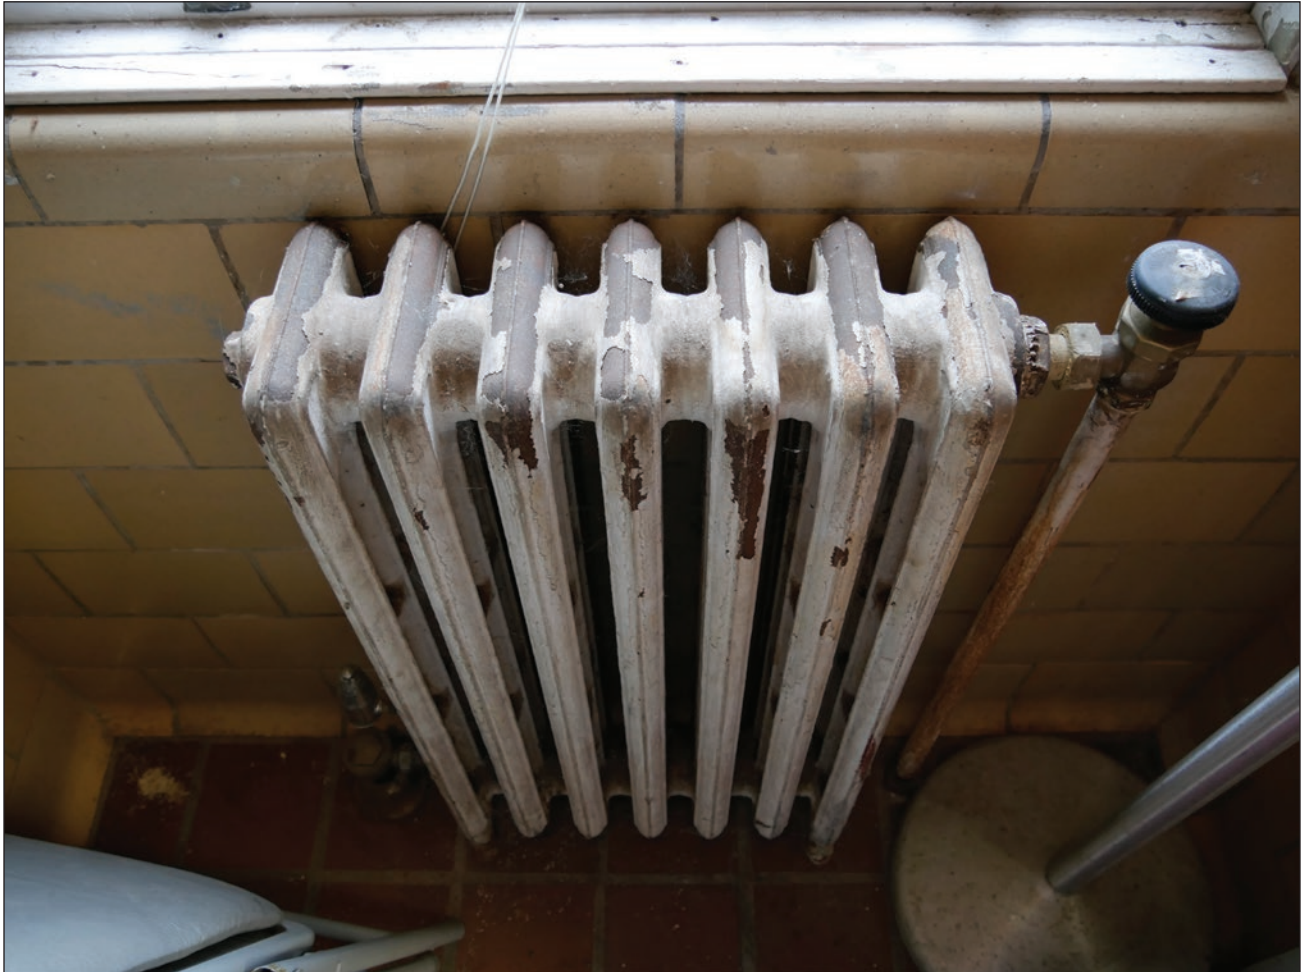
**Figure 274.** Paint loss at radiator in vestibule. Building Conservation Associates, 2025.
