*HISTORIC STRUCTURE REPORT*  
**HISTORIC CEMETERY COMFORT STATION  
(BUILDING #313)**

Kevin Wohlgemuth, Senior Associate, Building Conservation Associates, Inc. (BCA)  
Dorothy Krotzer, Director, BCA  
Michele Boyd, Director of Preservation Services, BCA  
Kate Whitney-Schubb, Staff Conservator, BCA

The following 100% Draft of the Historic Structure Report for the Historic Comfort Station (Building #313) at Arlington National Cemetery represents a synthesis of all research and analysis performed for this project.

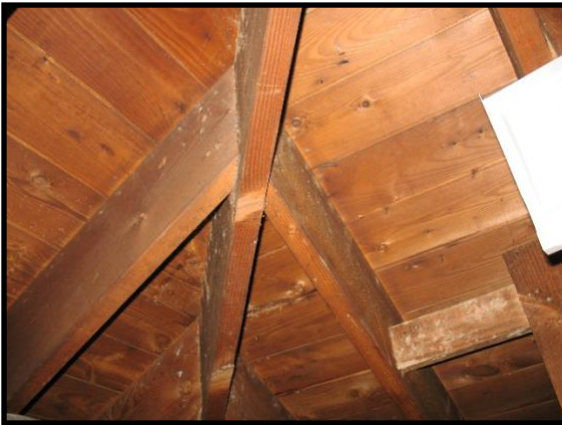
**Photo P-6:** Roof rafter and tie beam framing

The rafters bear on a double 2x8 continuous top plate that is anchored to the brick walls with 5/8-inch diameter anchor bolts spaced at 2'-0" on centers. The inside face of the top plate aligns with the inside face of the brick wall. Spanning between the east and west walls and fastened to the rafters are 2x8 horizontal tie beams. The tie beams are supported at midspan by 1x6 hangers connected to the rafters above, at the ridge beam elevation. A plaster ceiling, supported by 2x4 joists spaced at 2'-0" on centers, is suspended from the horizontal tie beams with 2x2 hangers located along alternate beams (see Photos P-6 to P-8, P-10, P-11, and Figure 2).

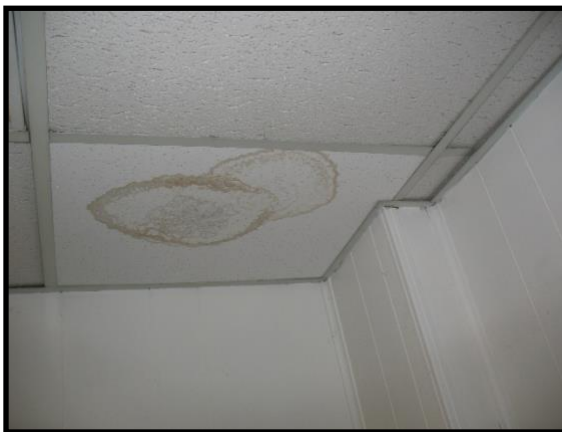
- The Museum Curator pointed out the location of a previously repaired roof leak above a water-stained ceiling tile in the southeast, first floor office (see Photo P-15). Water stains on the wood roof framing and wall top plate above were observed but appeared to be surficial and not a structural issue (see Photo P-16).

**Photo P-15:** Ceiling tile below location of repaired roof leak

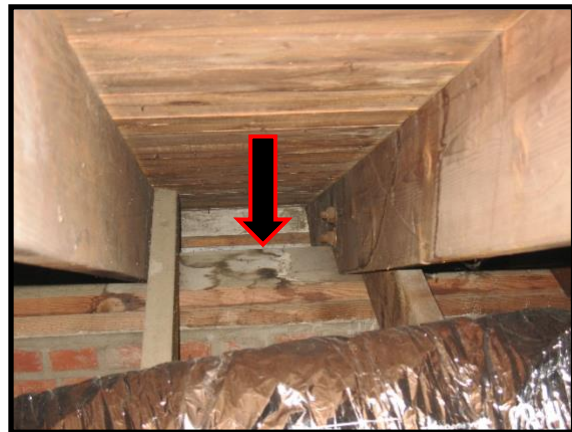
**Photo P-16:** Water stains on framing at location of repaired roof

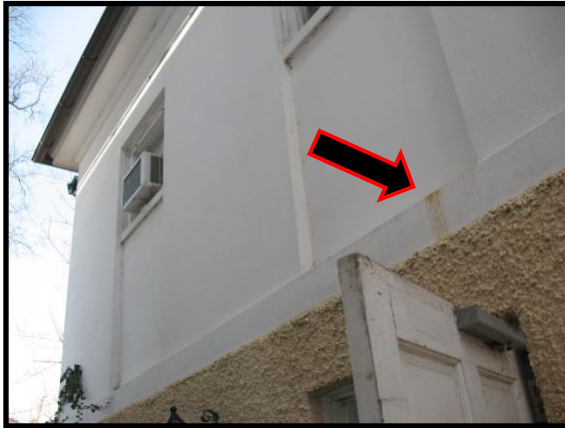
- Water stains were observed along the east and south exterior building elevations. The source of the stains is not clear but may have been caused by leaks in the rain gutters above. This is not a structural issue (see Photos P-17 and P-18).

**Photo P-17:** South building elevation water stains

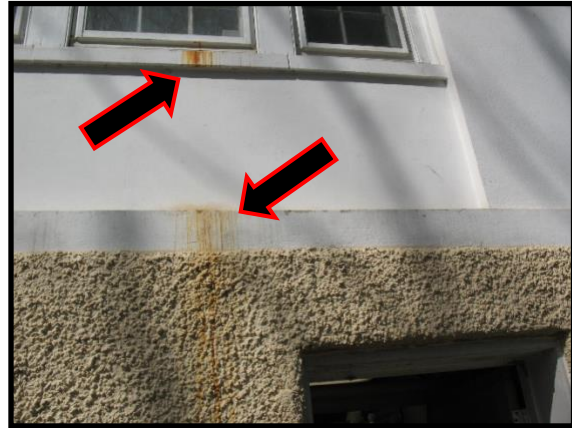
**Photo P-18:** East building elevation water stains

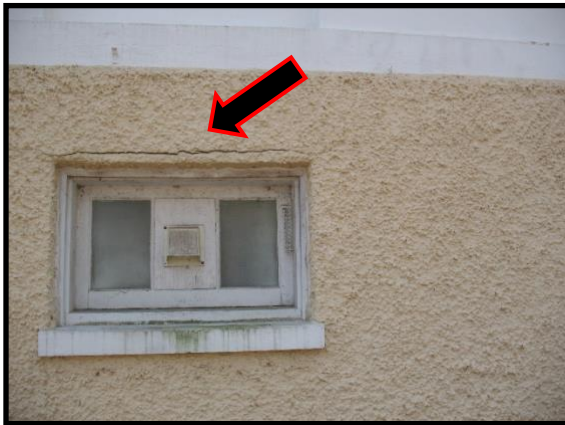
- Cracks in the pebble dash finish of the first story exterior walls were observed at the heads of windows on the west and north building elevations (see Photos P-19 and P-20). Though the cause of the cracks is not known, water infiltration and possible corrosion of the steel lintel angles are suspected (see Figure 5).

**Photo P-19:** Crack above window – north building elevation

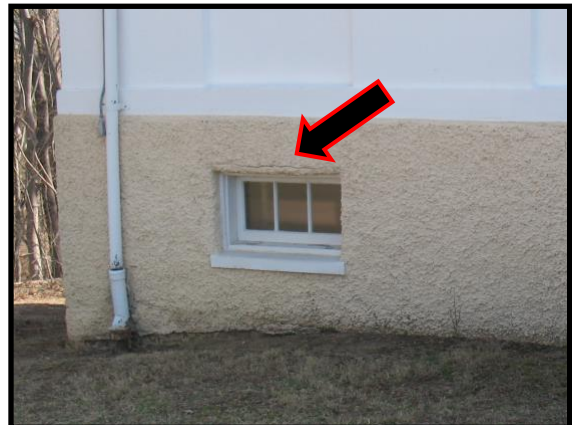
**Photo P-20:** Crack above window – west building elevation

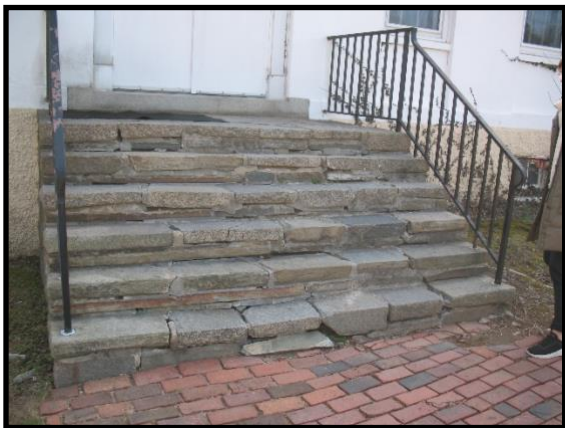
**Photo P-21:** Deterioration at main entrance stair

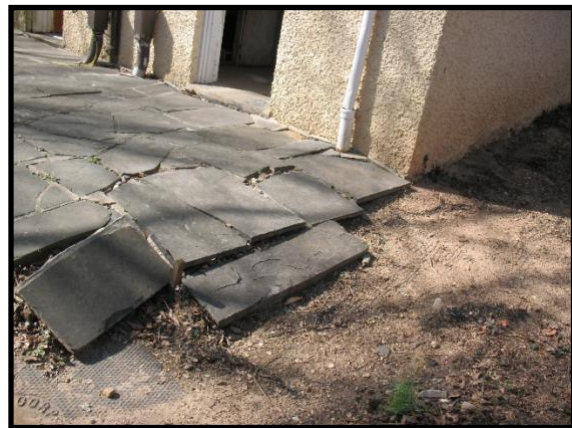
- The flagstone patio along the east side of the building is in poor condition (see Photo P-22) and is extensively so at the north edge. The cause may be due to the degrading of the soil sub-base from water penetration, possibly related to the nearby building downspout.

**Photo P-22:** Deterioration at rear flagstone patio

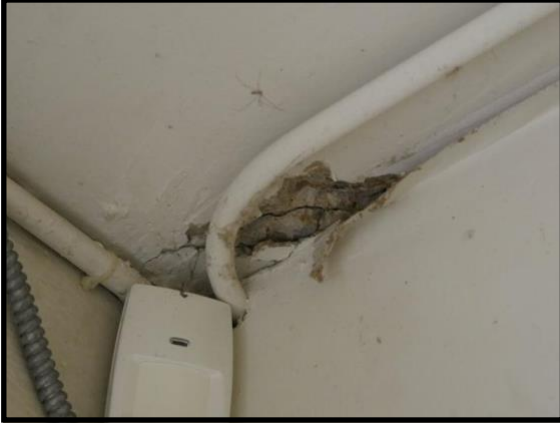
- A small spall and crack in the underside of the first-floor slab was observed near the electrical closet in the north basement room, at the east exterior wall. It is possibly the result of water penetration coupled with thermal movement over time (see Photo P-23).

**Photo P-23:** First floor slab spall above north basement room

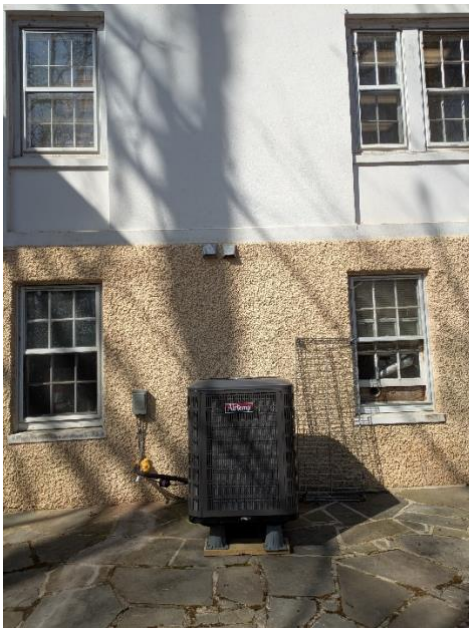
**Photo M 001: Heat Pump Unit**

Only the first floor of the Comfort Station is currently conditioned, which is by a direct expansion (DX) split system heat pump. The split system was installed in 2024. The split system has a cooling capacity of 2.5-tons. The heat pump unit is located outdoors on grade on the east side of the building. The heat pump is in good condition. A set of refrigerant lines run from the outdoor heat pump unit to the indoor fan coil unit. The refrigerant piping is insulated with elastomeric insulation and is in good condition.

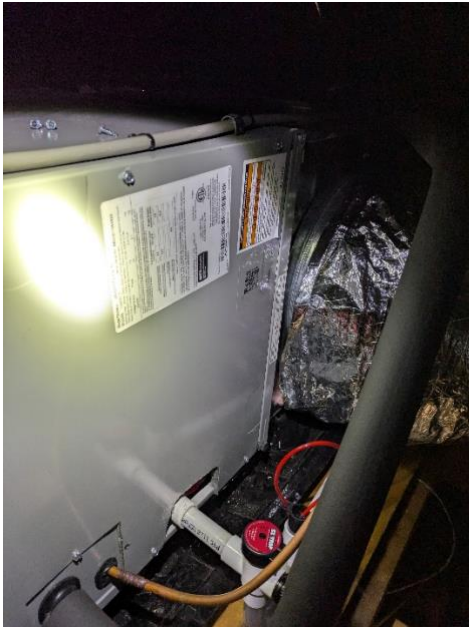
**Photo M 003: Fan Coil Unit**

The fan coil unit is located in the attic. The fan coil unit consists of filters, DX coil, and a supply fan. There is a drain pan with liquid level sensor beneath the unit. The fan coil unit is in good condition but is very difficult to access and change filters. The fan coil unit is ducted to ceiling mounted diffusers and registers. The ductwork is routed through the attic. The supply branch ducts are insulated, but the supply main is not insulated. The ductwork and insulation are in good condition. The diffusers and registers are in good condition.

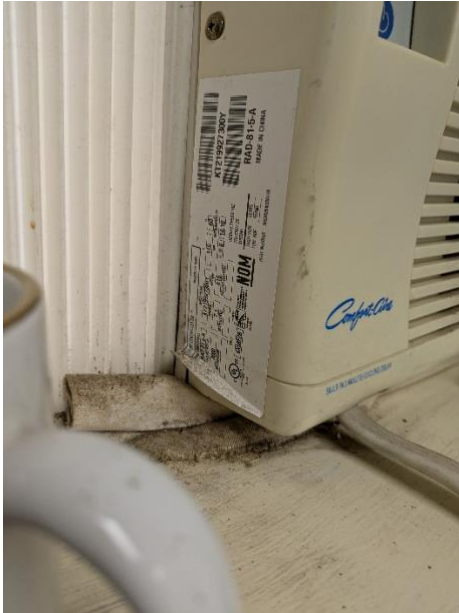
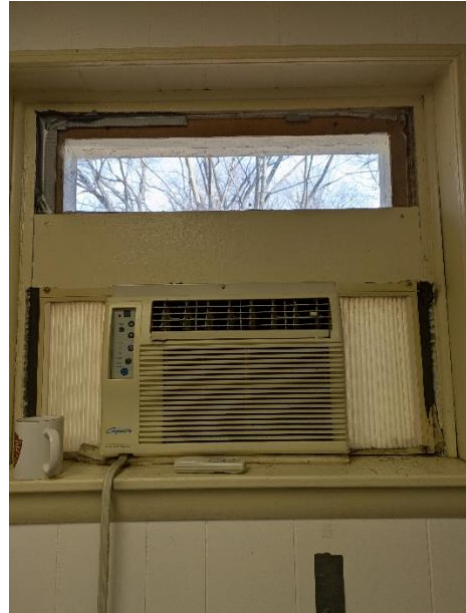
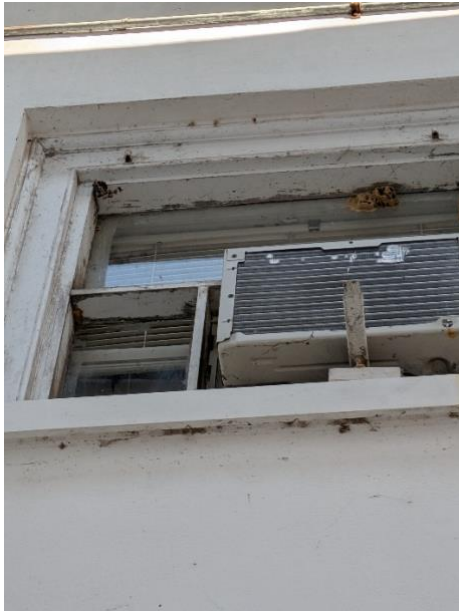
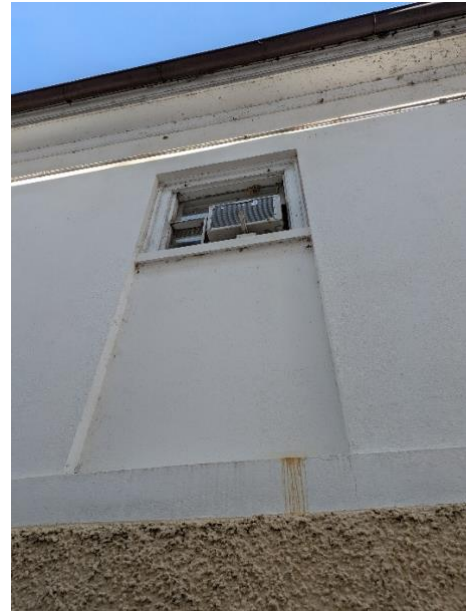
There are multiple window air conditioning units located throughout the first floor. The exact date of installation is not known, but they appear to be pretty old and in poor condition. There doesn't appear to be a good seal around the window units and that air/water can get in. There are a lot of locations where there are signs of water damage/mold around a lot of the window units. There also seems to be issues with condensate running down the exterior of the building. According to the Park Staff, these units can still operate, but they normally don't. The only reason that the Park has not removed the window units is

because they would need to replace the entire window as well and the Park does not have any more of these exact windows in storage on site for any easy replacement. The windows can be rebuilt, but that would be a larger effort.

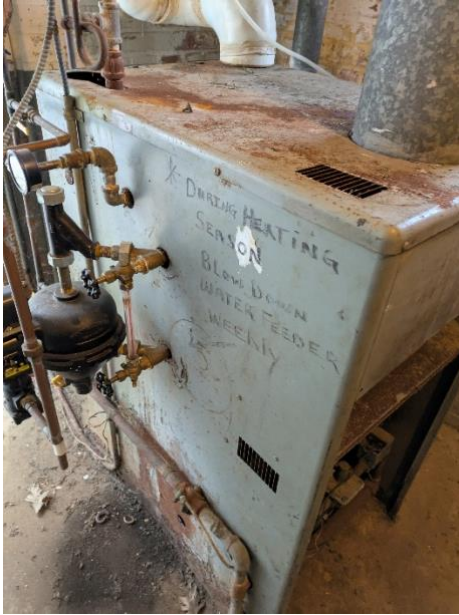
**Photo M 011: Boiler**

There is an abandoned fuel-oil fired boiler located in the basement. The boiler is very old, falling apart and in very poor condition. It appears that it was a steam boiler. The galvanized steel boiler flue is routed up the west exterior of the building and terminates above the roof. It is in poor condition and starting to

show some rust. There are no louvers in this space, so it does not appear that there was a way to get sufficient combustion air to the boiler.

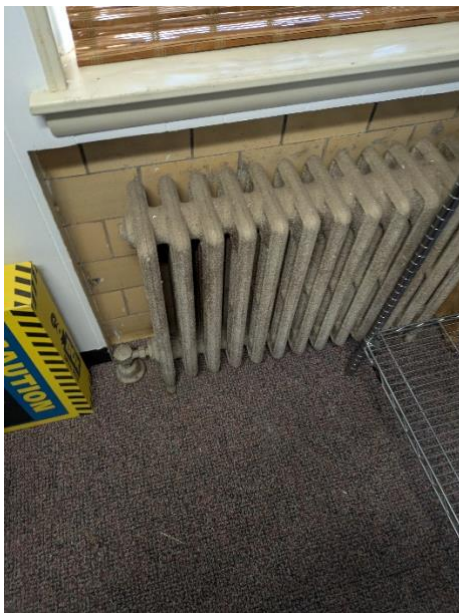
**Photo M 013: First Floor Radiator**

Piping is routed from the boiler to floor mounted radiators throughout the first floor and ceiling mounted radiators in the basement spaces, although it is all abandoned and non-operational. Since the boiler system is non-operational that means there is no heating to the Basement spaces. The piping is insulated with fiberglass insulation. It is in poor condition as it is very dirty and has a lot of instances of staining from possible leaks. The basement and first floor radiators are in fair condition.

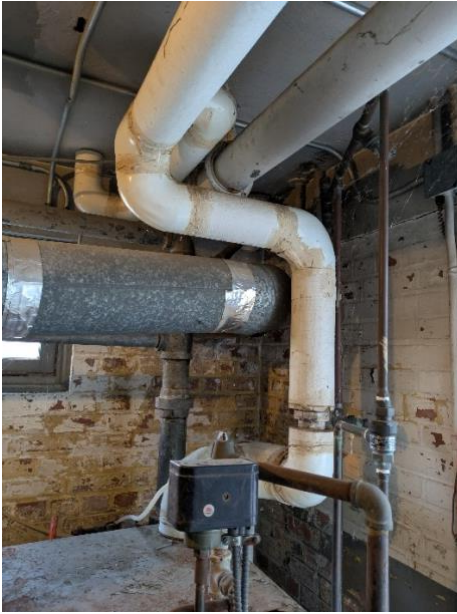
**Photo M 015: Boiler Piping**

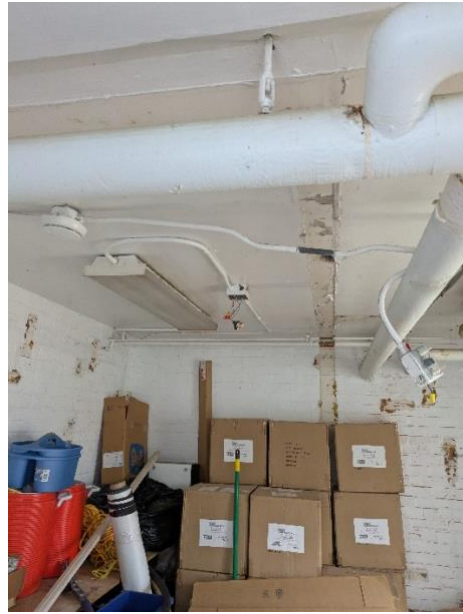
**Photo M 016: Boiler Piping**

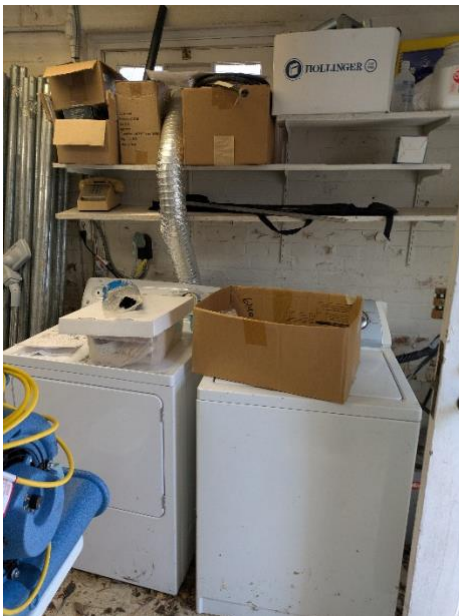
There is a clothes dryer in the north basement room. The dryer exhaust terminates through the window opening. There are two abandoned exhaust wall vents on the east basement wall. Nothing is currently connected to these.

**Photo M 017: Clothes Dryer**

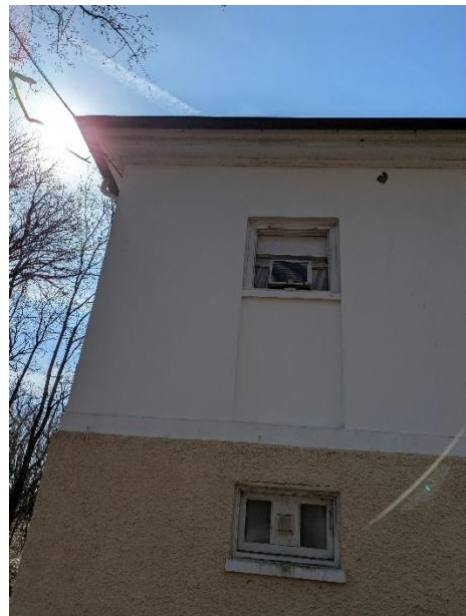
**Photo M 018: Dryer Exhaust**

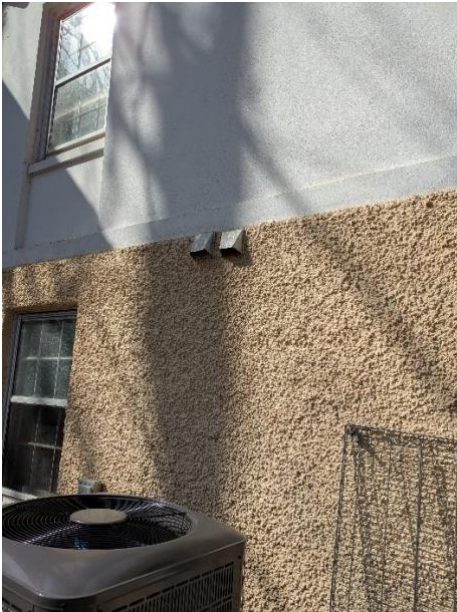
**Photo M 019: Abandoned Exhaust Vents**

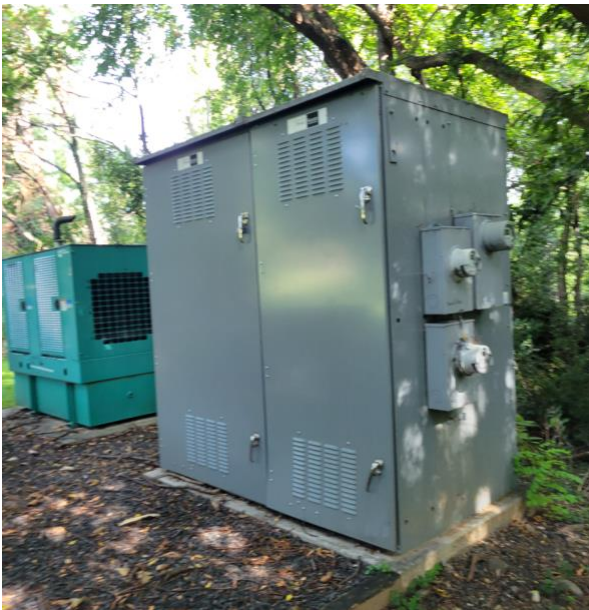
**Photo E02: Generator and utility switchboard with attached electrical meters.**

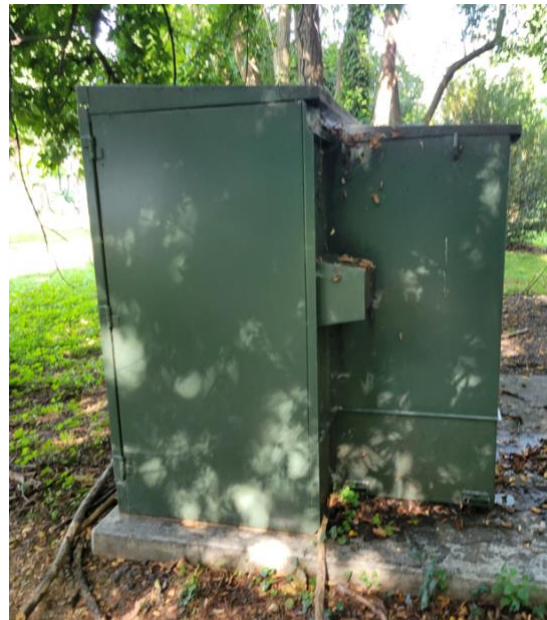
**Photo E03: Dominion Energy pad-mounted transformer serving the building.**

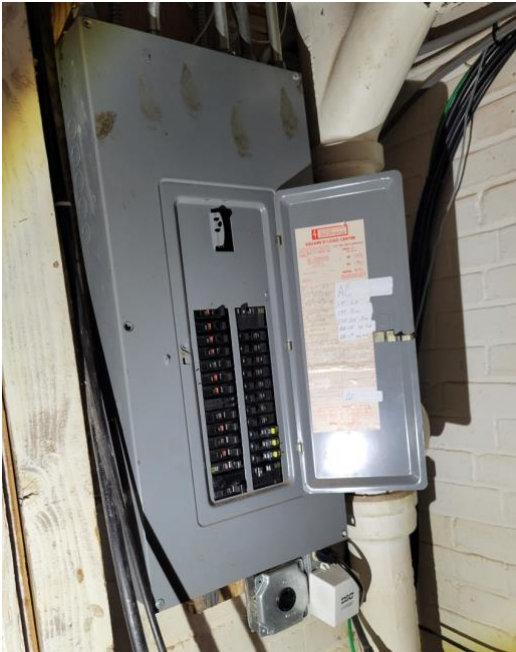
Within the equipment closet, the main distribution equipment consists of the 200A, 120/240V, 1-phase, 3-wire Square D load center with a 200A main circuit breaker. The load center contains single-pole and two-pole branch circuit breakers with no remaining spaces for additional circuit breakers. Overall condition is fair; however, the load center does not have voltage, phase, and feeder identification labeling which is required by NFPA 70, Section 408.4. The load center has 30 poles with the following branch circuit breakers:

**Photo E04: Interior equipment closet showing Square D 200-amp load center.**

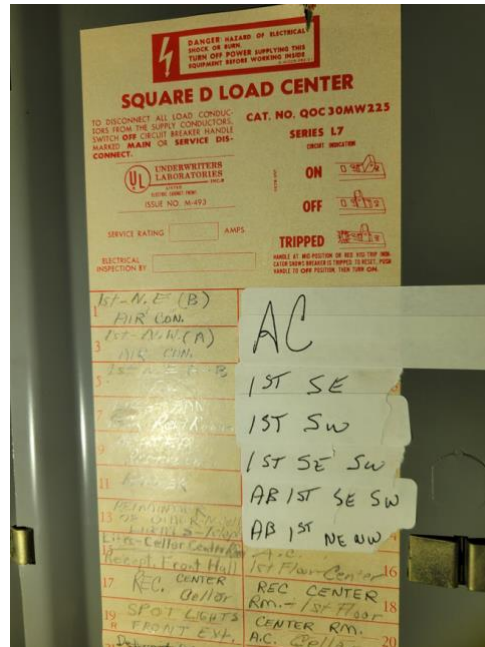
**Photo E05: Load center lacking required voltage and phase labeling.**

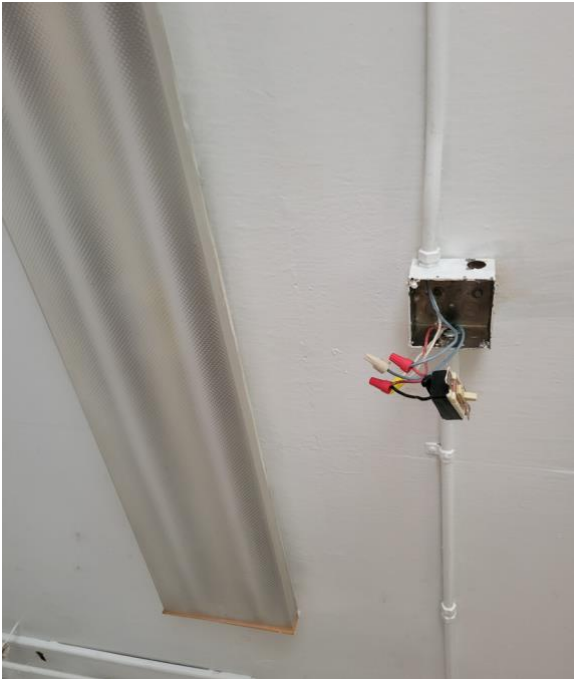
- Missing covers on junction boxes,
- Exposed splices,
- Surface-mounted receptacles with direct NM entry,
- Painted conductors,
- Wiring routed alongside water piping.

**Photo E06: Storage room wall with exposed junction box and toggle switch.**

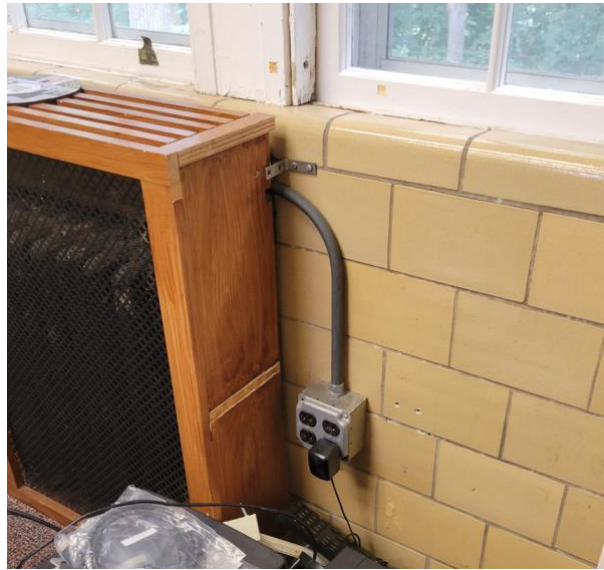
**Photo E07: Surface-mounted receptacle installed on finished wall.**

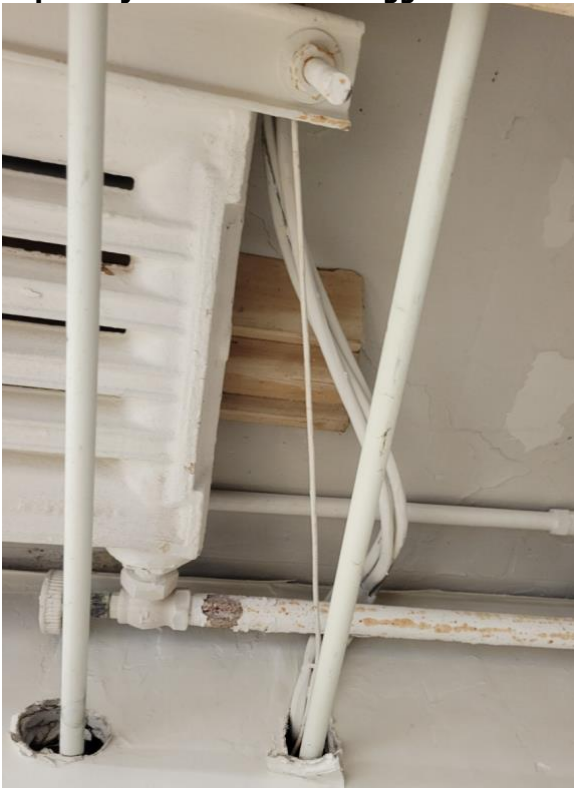
**Photo E08: Painted non-metallic conductors along wall surface.**

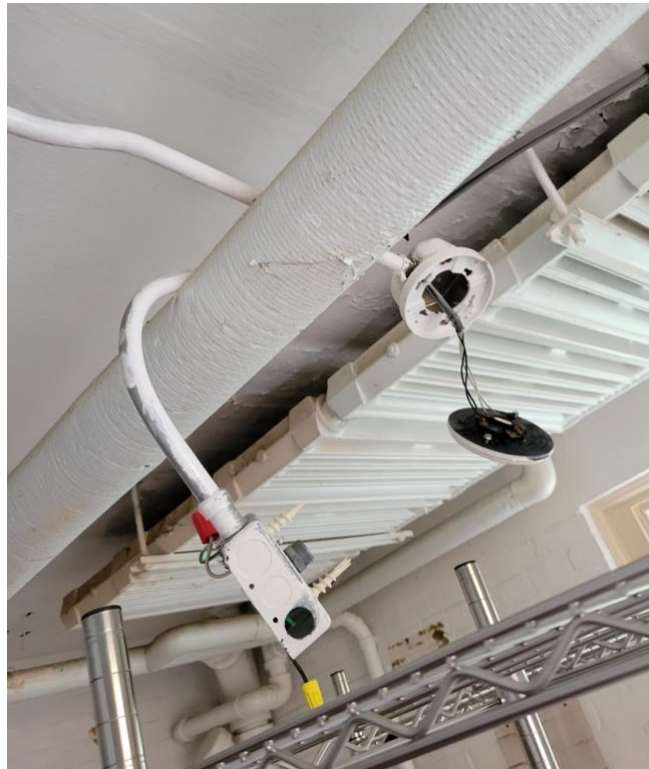
**Photo E09: Loose junction boxes with visible conductors.**

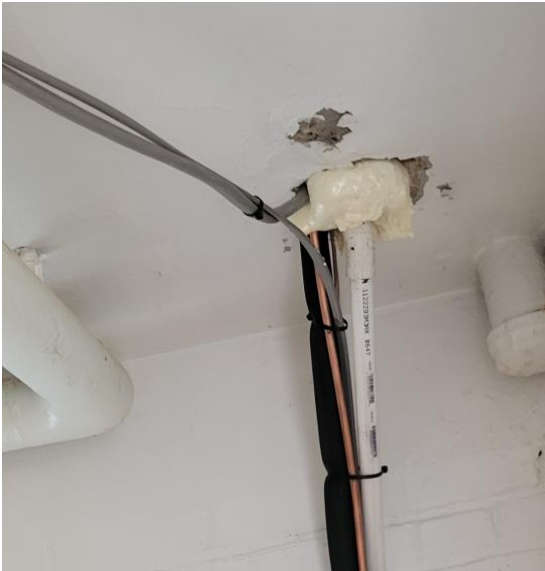
**Photo E10: Electrical wiring improperly secured to building water pipe.**

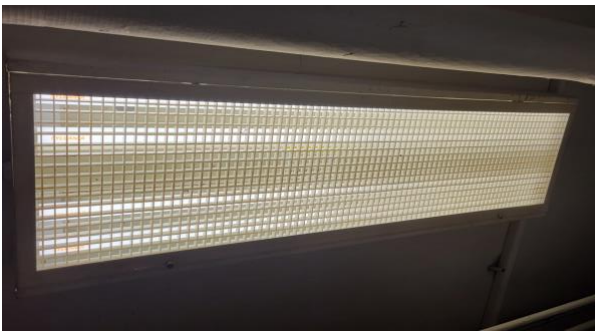
Interior lighting is primarily composed of outdated fluorescent troffers in both surface-mounted and recessed arrangements, supplemented by pendant luminaires in certain spaces. Many of these luminaires have T12 or T8 lamps with magnetic ballasts, which are obsolete and inefficient. Several luminaires have discolored or brittle diffusers. Although occupancy sensors are present, there is no evidence of daylight harvesting or advanced automatic lighting control integration. Luminaire performance is inconsistent, with degraded light output and poor color rendering across the building. A critical life-safety deficiency is the absence of illuminated exit signs and dedicated emergency lighting.

**Photo E11: Storage room ceiling with surface-mounted fluorescent light fixture.**

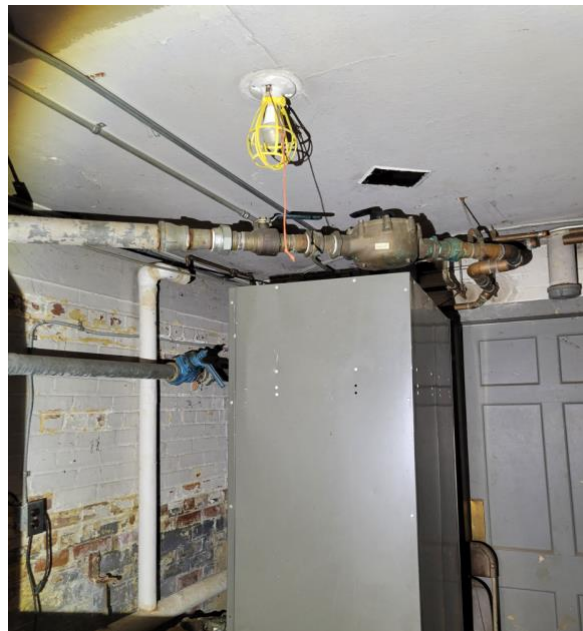
**Photo E12: Mechanical room ceiling containing a single lamp-holder fixture.**

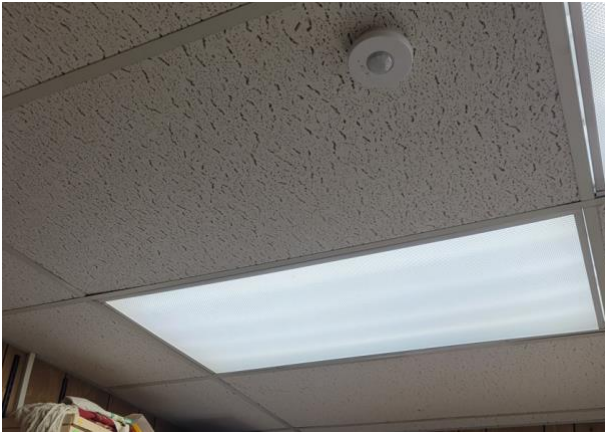
**Photo E13: Accession room ceiling with recessed fluorescent light and occupancy sensor.**

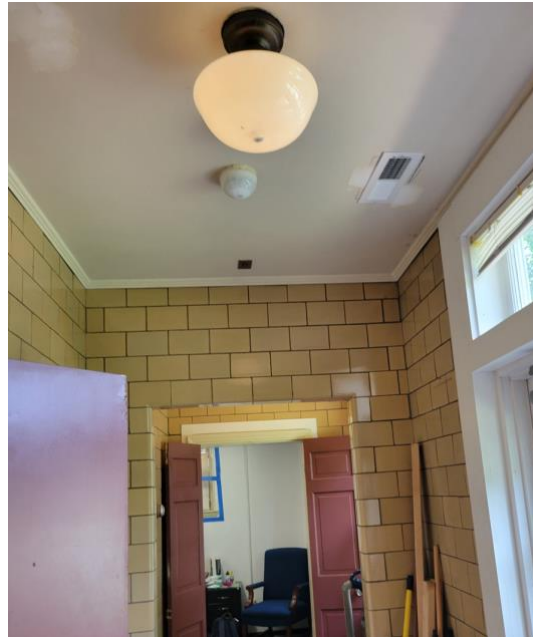
**Photo E14: Vestibule area showing pendant-mounted luminaires.**

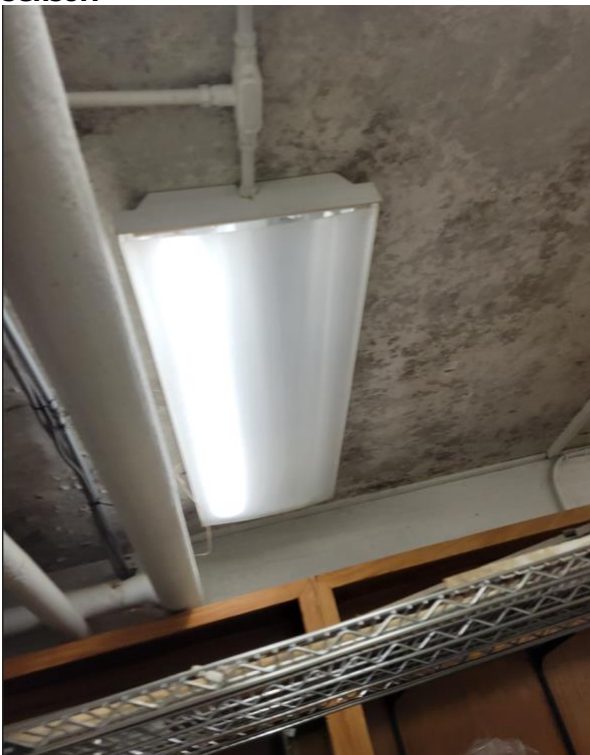
**Photo E15: Storage area ceiling with rows of 1x4 fluorescent fixtures.**

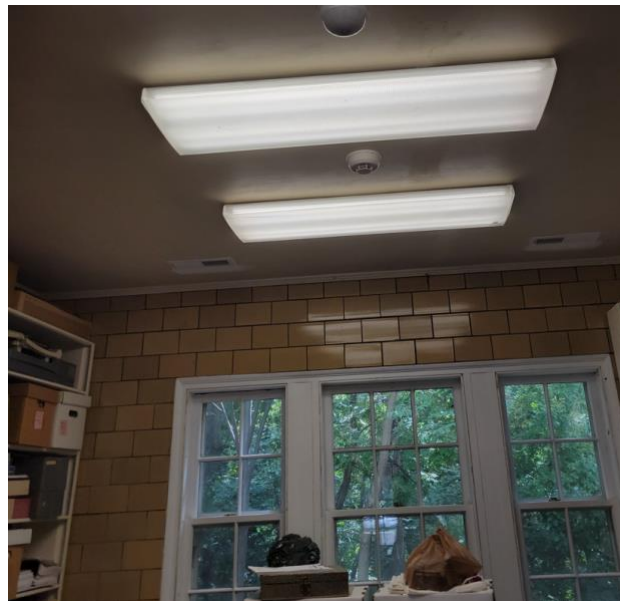
**Photo E16: Library ceiling containing surface-mounted fluorescent luminaires.**

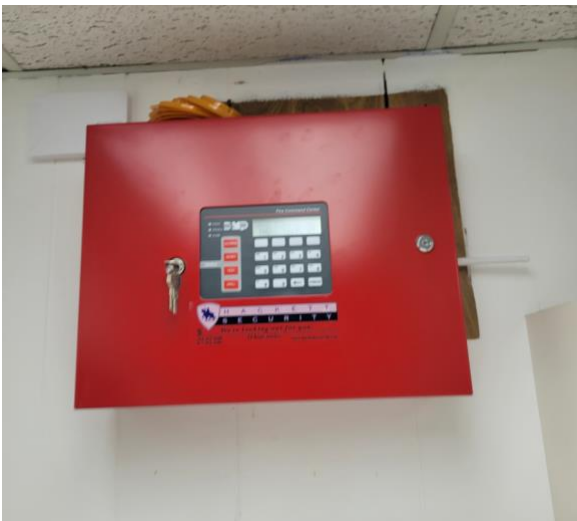
The manual fire alarm boxes are properly located at exits, and smoke detectors of varying generations are installed throughout the building. The control equipment includes a primary red DMP fire alarm control panel, legacy Pyrotronics System 3 equipment, and Monaco Enterprises interface modules and cabinets providing remote monitoring connectivity. While functional, the mix of legacy and modern hardware introduces reliability and maintainability concerns.

**Photo E17: Curator's Office wall with red DMP fire alarm control panel.**

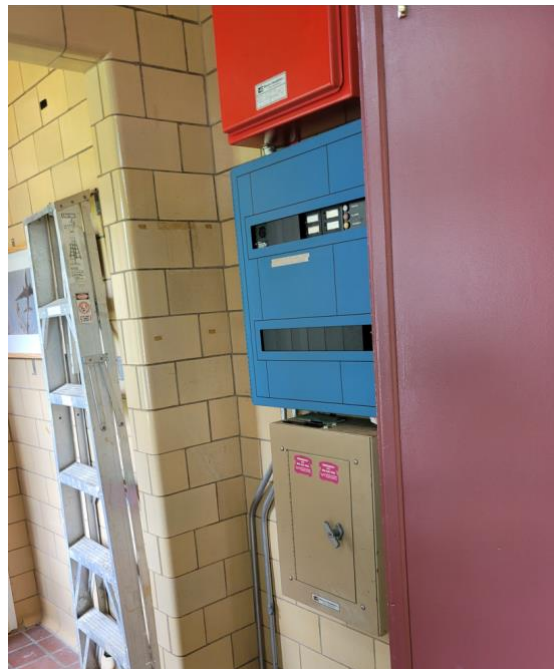
**Photo E18: Vestibule wall with Monaco and Pyrotronics fire alarm cabinets.**

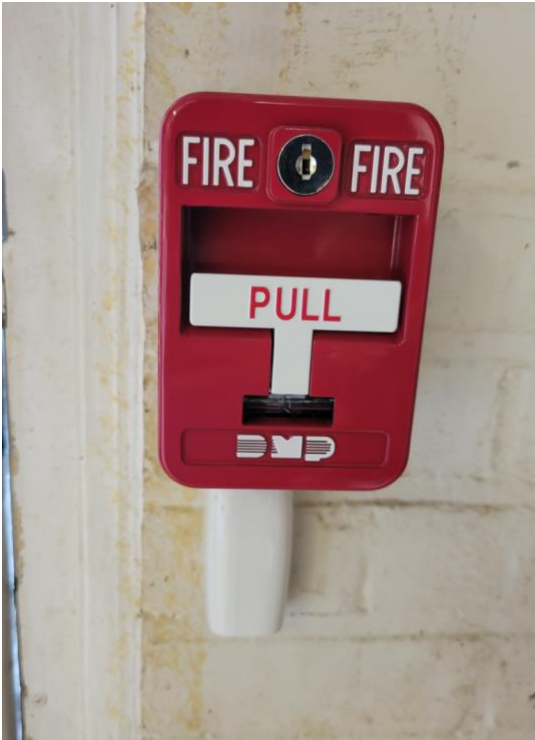
**Photo E19: Manual fire alarm pull station mounted near exit door.**

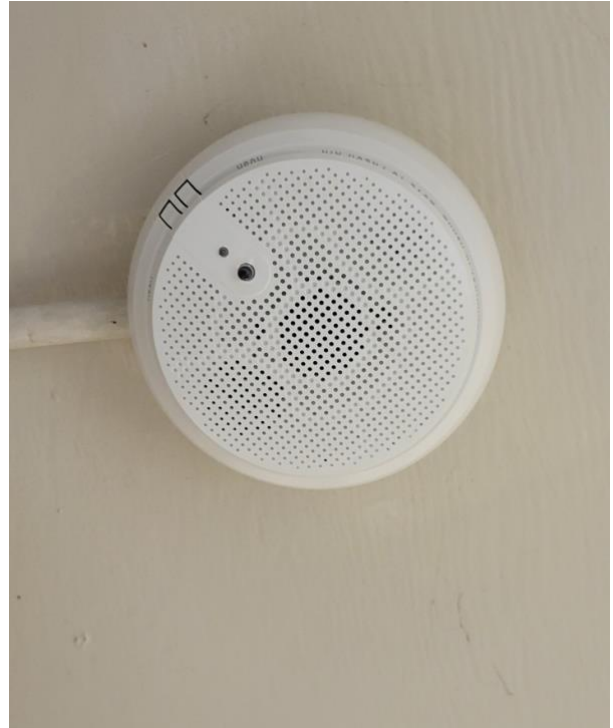
**Photo E20: Ceiling-mounted smoke detector with integrated sounder.**

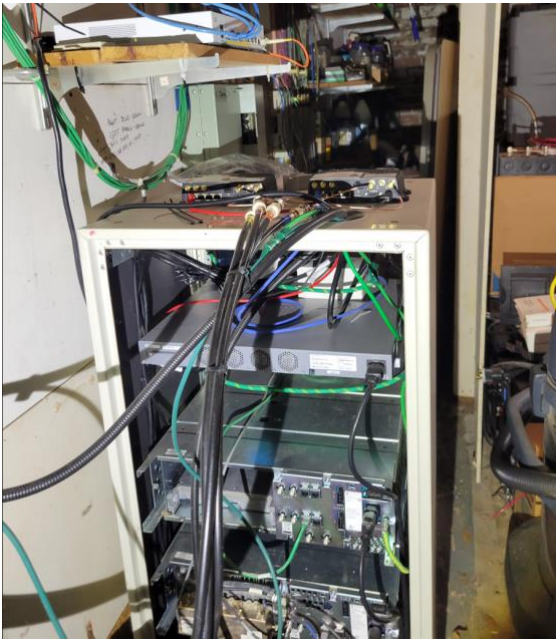
A legacy telephone backboard that is no longer active has been abandoned in place. Current communications infrastructure is supported by a data rack connects to roof mounted- and pole-mounted antennas, indicating reliance on wireless. The rack is minimally outfitted, lacking redundancy and UPS-backed power. Data outlets in upper-level rooms are surface-mounted with exposed cabling, again reflecting retrofit installation practices rather than protected conduit systems.

**Photo E21: Data rack containing network cables and electronic components.**

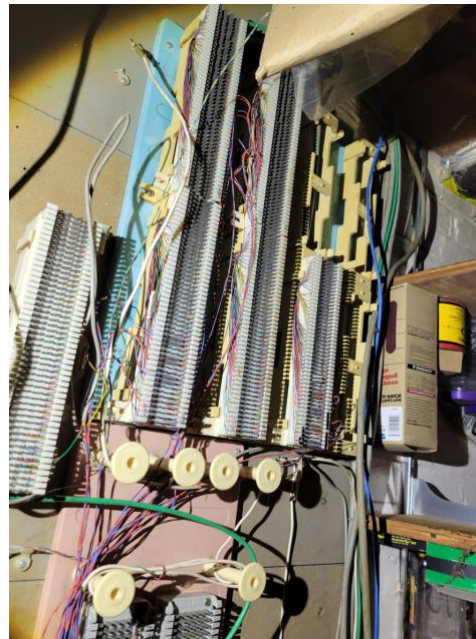
**Photo E22: Wall-mounted inactive telephone backboard.**

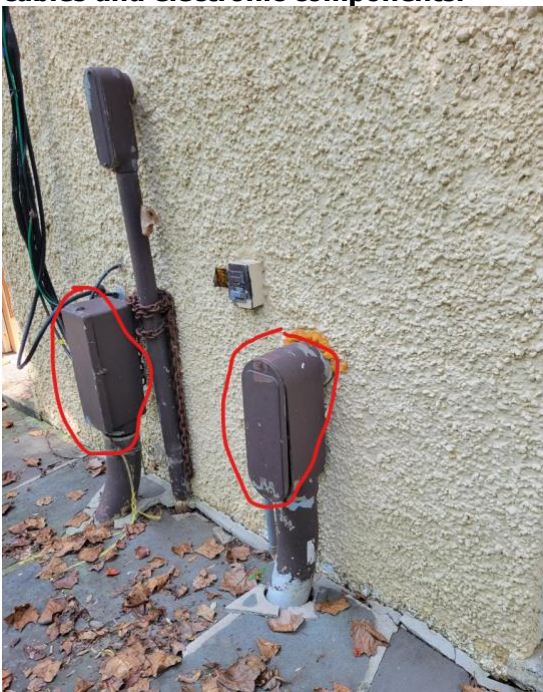
**Photo E23: Underground conduit for inactive data service entry.**

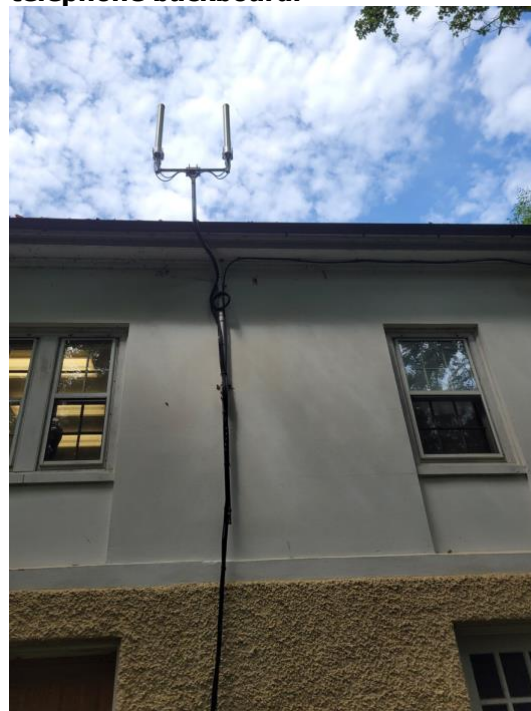
**Photo E24: Roof and pole-mounted antennas providing building data service.**

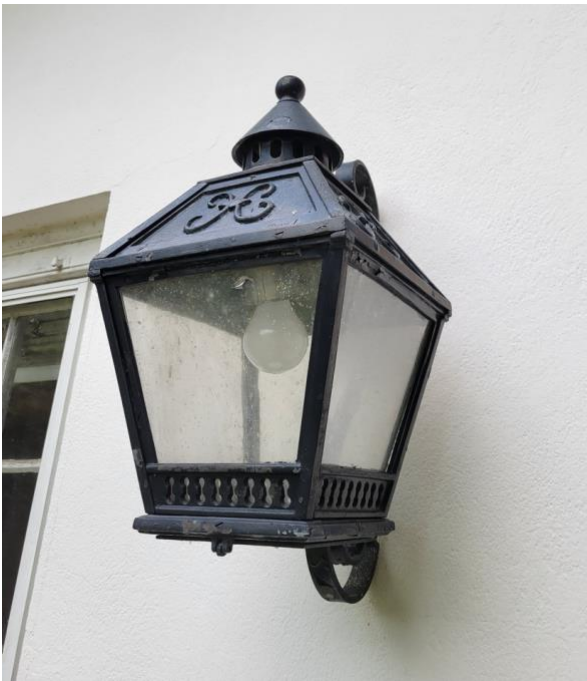
Exterior lighting includes wall sconces at the front and side entrances that were retrofitted with LED lamps. These luminaires are now corroded, weathered, and the lenses are discolored. High-intensity discharge floodlights at the front building corners were observed operating during daylight, suggesting photocell or other automatic lighting control failure. A rear wall-mounted security light is an older model luminaire without motion detection or photocell capability.

**Photo E25: Front entrance wall sconces retrofitted with LED lamps.**

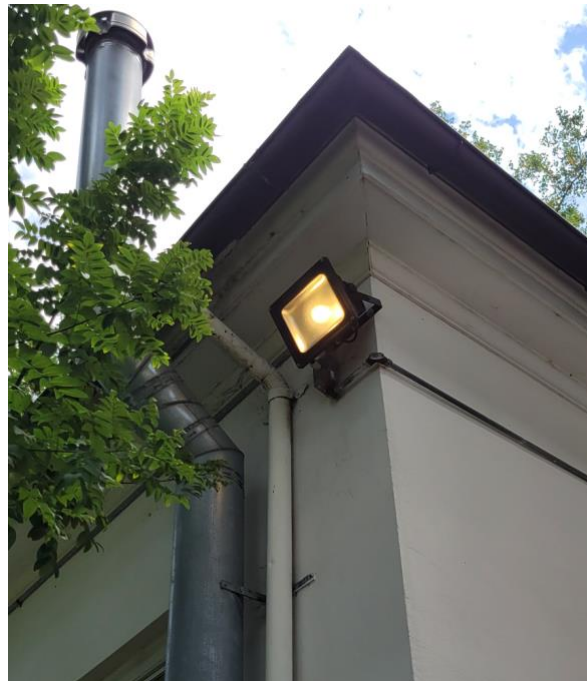
**Photo E26: Exterior HID floodlights operating during daytime hours.**

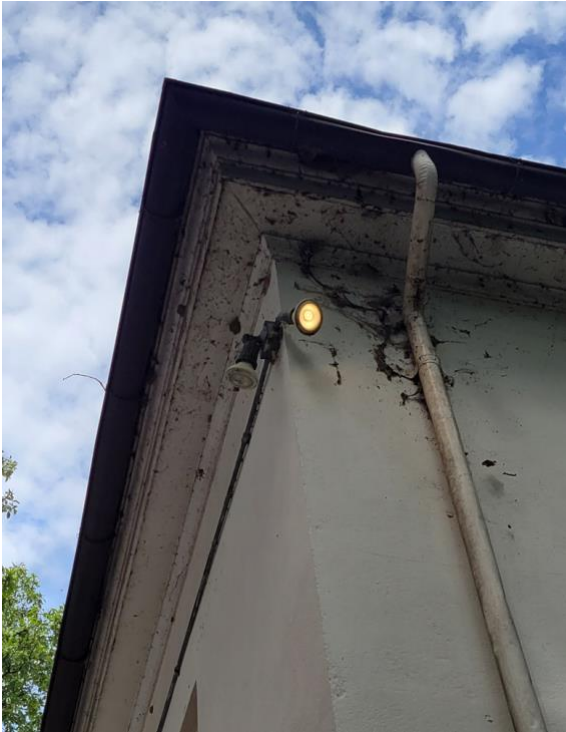
**Photo E27: Rear wall security light without motion or photocell control.**

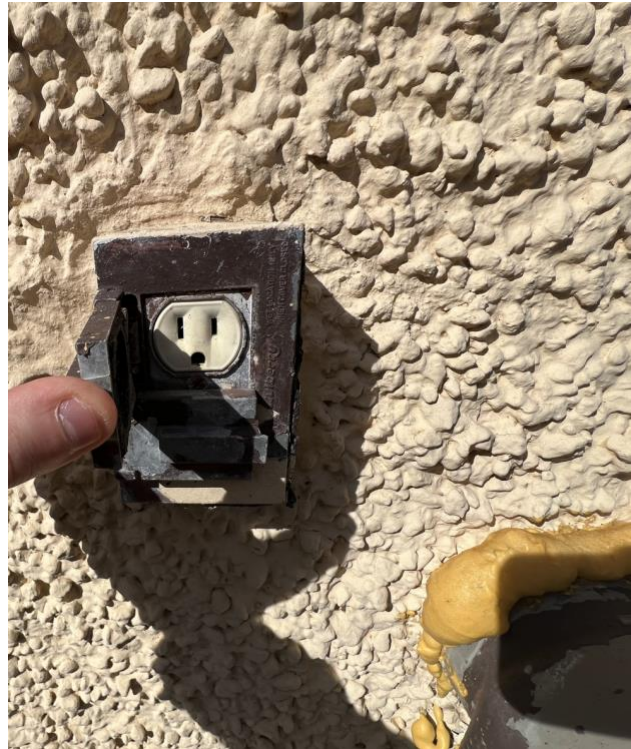
Exterior wiring deficiencies are evident where nonmetallic sheathed cable has been installed on or within wall assemblies, which is not code-compliant. A rear receptacle was identified as non-GFCI, however the it is protected by a GFCI circuit breaker. Similar to the building interior, no emergency lighting is provided at exterior egress points.

**Photo E28: Rear exterior wall receptacle lacking GFCI protection.**

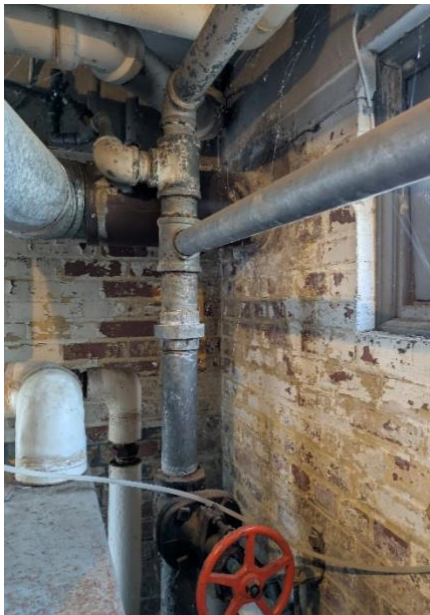
The domestic water service enters the Comfort Station within the mechanical room in the basement. The incoming service is 2-1/2 inches. The domestic water is distributed throughout the basement to the remaining plumbing fixtures. The first 10-15 ft of piping is galvanized and then the rest is copper. The piping is not insulated. The galvanized piping is in fair condition. It is starting to show signs of rust/corrosion. The copper piping is also in fair condition and has many instances where joints are corroded. There is a water meter, but no backflow preventer. It was noted by the Park Staff that since there is no heat in the basement, they shut off the water during the winter.

**Photo P 001: Incoming Domestic Water Service**

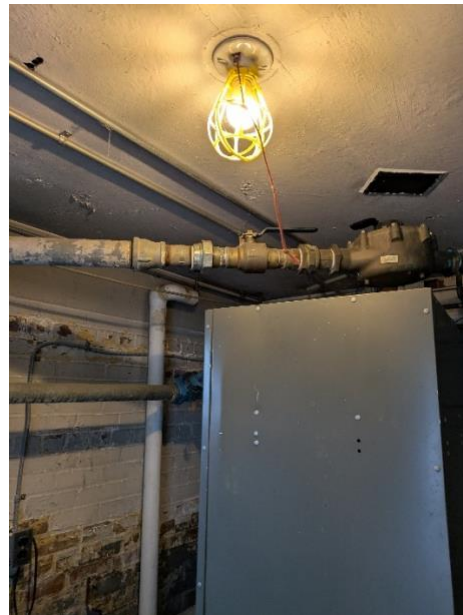
**Photo P 002: Water Meter**

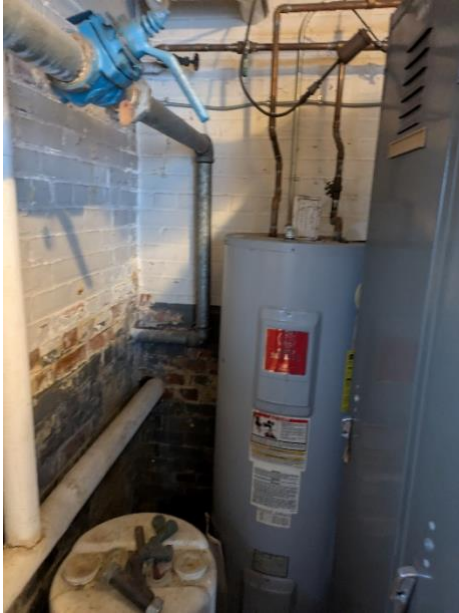
There is a 4.5 kw electric tank type domestic water heater located in the mechanical room in the Basement. The water heater serves the washing machine and laundry sink in the north basement room. The water heater appears to have been installed in 2010 and is in fair condition. The water heater is past its life expectancy, and the tank is starting to rust. There is also no drain pan beneath the water heater, and the relief valve is just piped to the floor. The Park staff indicated that they are not sure if it is operational.

**Photo P 003: Domestic Water Heater**

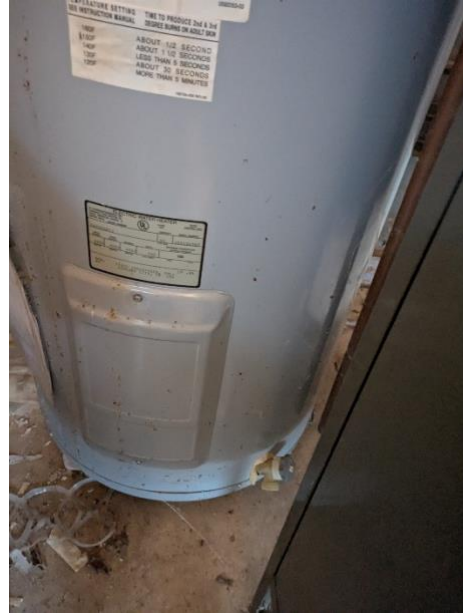
**Photo P 004: Domestic Water Heater**

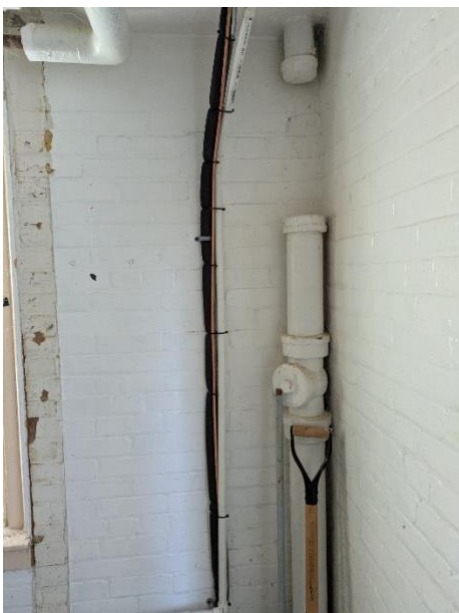
The sanitary piping collects below the basement slab. It is not known exactly where the sanitary main exits the building, but the assumption is the east side of the building because there is a manhole on this side of the building. There are a few abandoned sanitary stacks visible in the basement rooms. This piping is cast iron and in fair condition.

**Photo P 005: Abandoned Sanitary Stack**

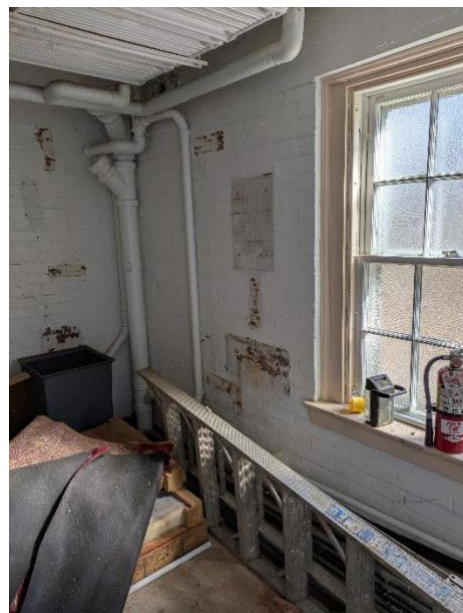
**Photo P 006: Abandoned Sanitary Stack**

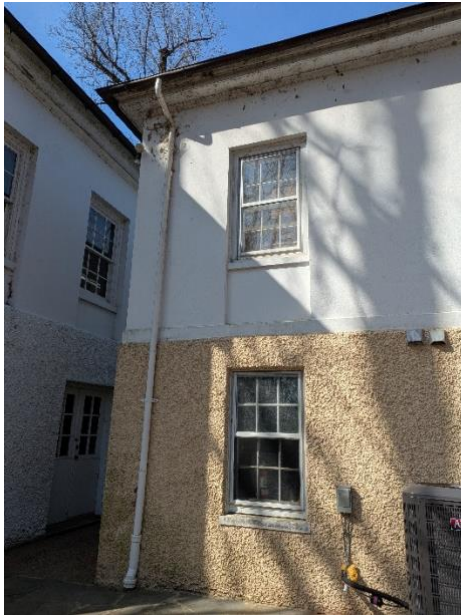
The roof drainage is via gutters and downspouts. There is a downspout at each corner of the building. Each downspout connects to a cast iron storm water pipe which is routed below grade. It is not known where the storm water piping discharges to. The downspouts are in fair condition as there are some minor dents. The cast iron storm water pipes are also in fair condition with some rust.

**Photo P 007: Downspout**

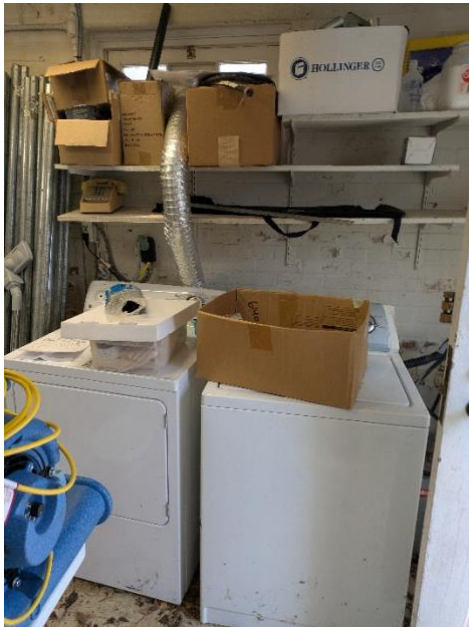
**Photo P 009: Washing Machine**

There are no plumbing fixtures on the first floor. There is a washing machine and a wall mounted laundry sink in the north room of the basement. The washing machine is in good condition. The laundry sink is in poor condition as it is very dirty and the faucet is very corroded. There is a hose bibb on the west exterior wall of the building.
