*HISTORIC STRUCTURE REPORT*  
**HISTORIC CEMETERY COMFORT STATION  
(BUILDING #313)**

Kevin Wohlgemuth, Senior Associate, Building Conservation Associates, Inc. (BCA)  
Dorothy Krotzer, Director, BCA  
Michele Boyd, Director of Preservation Services, BCA  
Kate Whitney-Schubb, Staff Conservator, BCA

The following 100% Draft of the Historic Structure Report for the Historic Comfort Station (Building #313) at Arlington National Cemetery represents a synthesis of all research and analysis performed for this project.

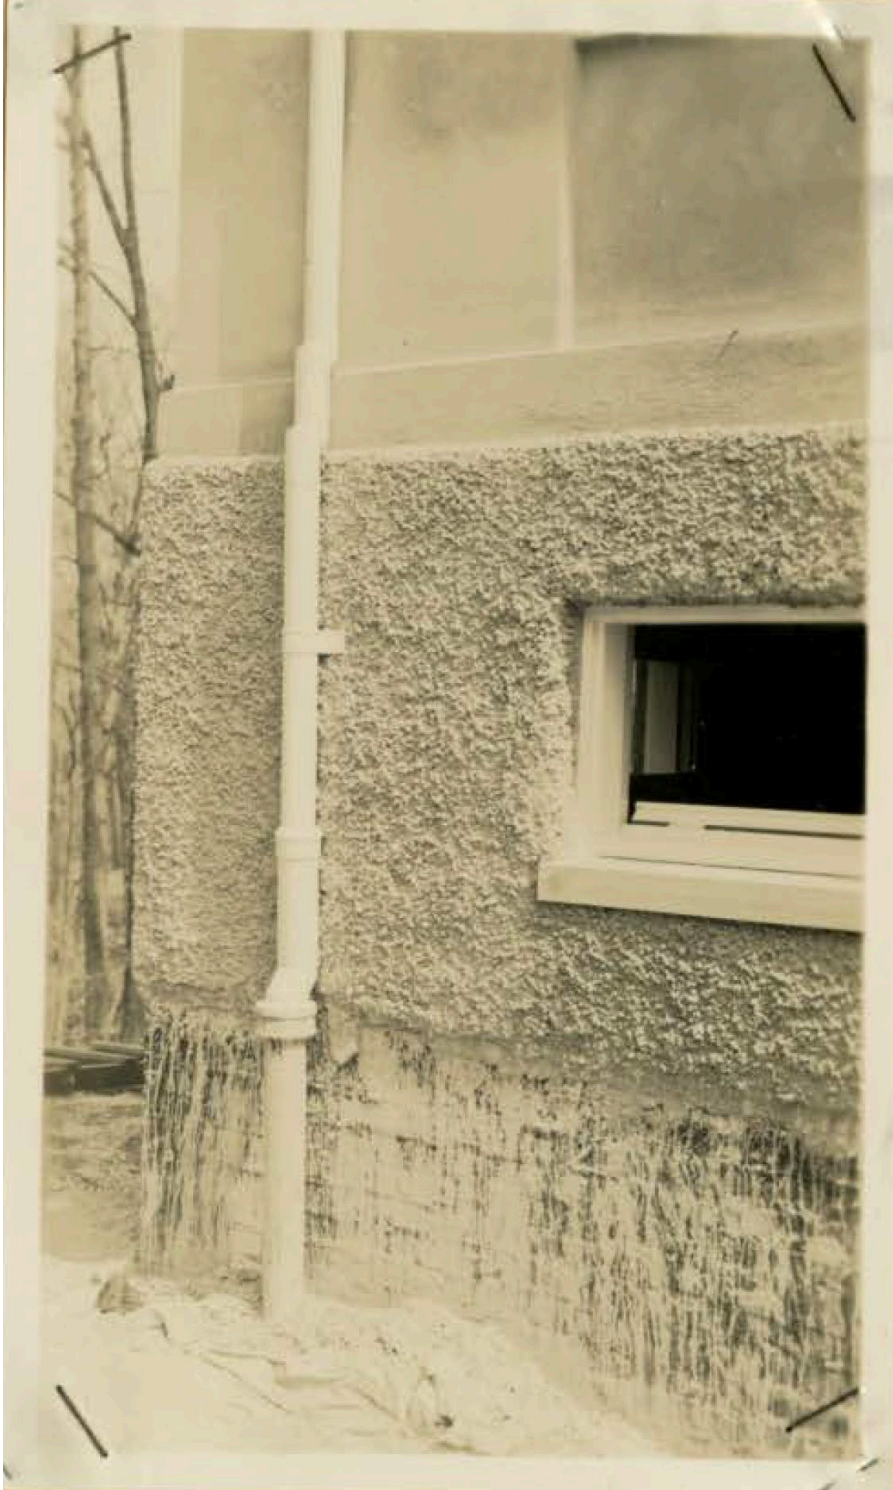
and the present tan finish (Figure 8). The dark yellow paint is not interpreted as the original finish on the pebble dash, however, for three reasons: 1) the appearance of the pebble dash stucco in the 1941 photograph is light and the dark yellow paint has more of a moderate tone that would have appeared darker than the pigmented stucco above; 2) the original description of the building refers to it as “pale yellow” with no mention of a darker yellow pebble dash water table; and 3) the dark yellow paint was found on both the pebble dash water table and the pigmented beige belt course, which we know was intended to be exposed/unpainted. While this evidence might suggest that the pebble dash water table was unpainted originally, the 1941 photograph clearly shows the pebble dash as painted (note the drip marks on the foundation under the pebble dash).

**Figure 5.** Photograph of exterior pebble dash finish after construction in 1941. Note the painted appearance of the pebble dash and the drip marks on the foundation below the pebble dash water table. (First Lt. Howard D. Nottingham, QMC, Completion Report for the Construction and Completion of the Comfort Station at Arlington National Cemetery, Fort Myer, Virginia, War Department, 1941, appendix.)

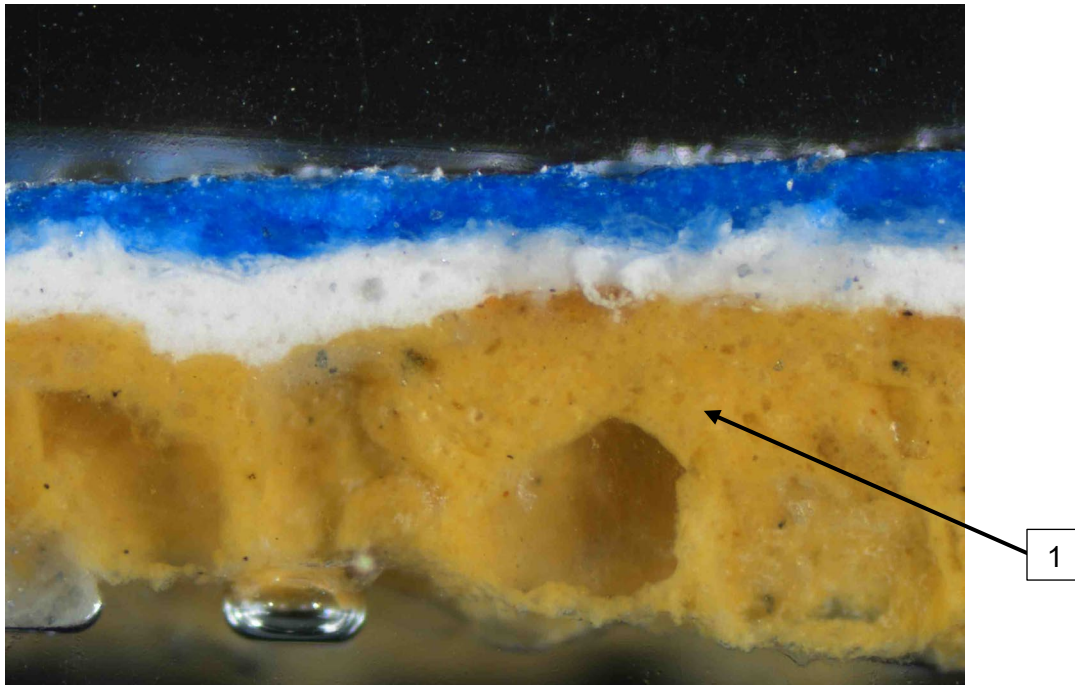
On top of the original pigmented beige stucco, only the current white layer of paint was found on the upper wall (Figure 6); whereas the belt course has a single layer of dark yellow under the current white (Figure 7).

**Figure 6.** Sample HCS.3 from the exterior upper register. Note pigmented stucco (1). The blue top layer is painter's tape used to stabilize the sample during removal. *Visible light, 40x magnification.*

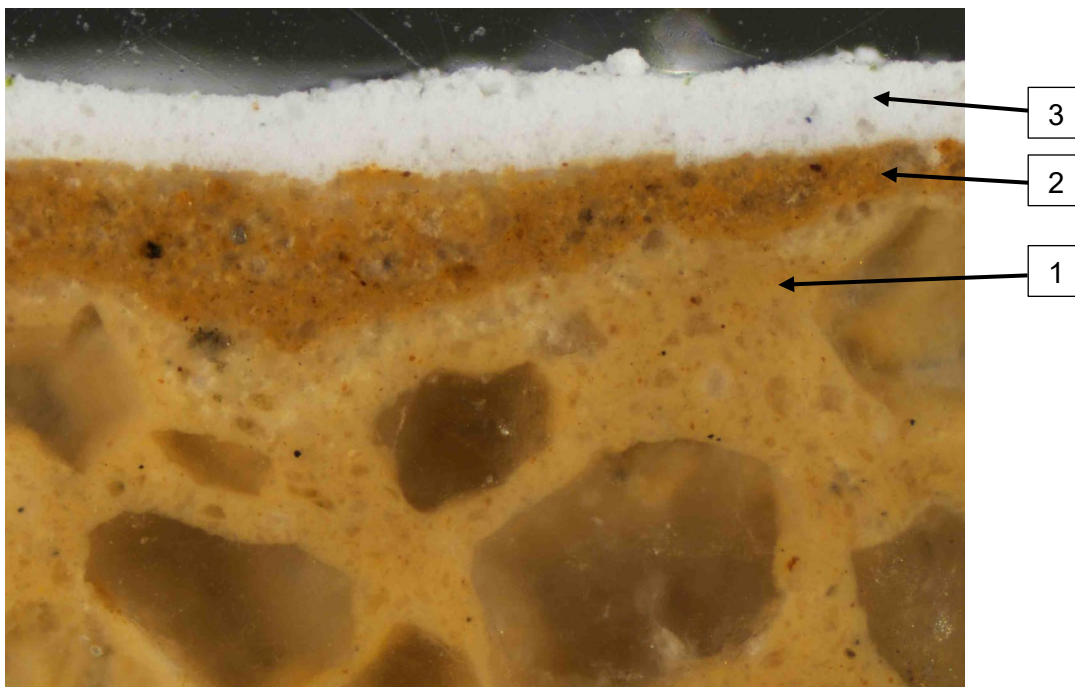
**Figure 7.** Sample HCS.22 from the exterior belt course. Note pigmented stucco (1) and the dark yellow finish layer (2) followed by the present white finish (3). *Visible light, 40x magnification.*

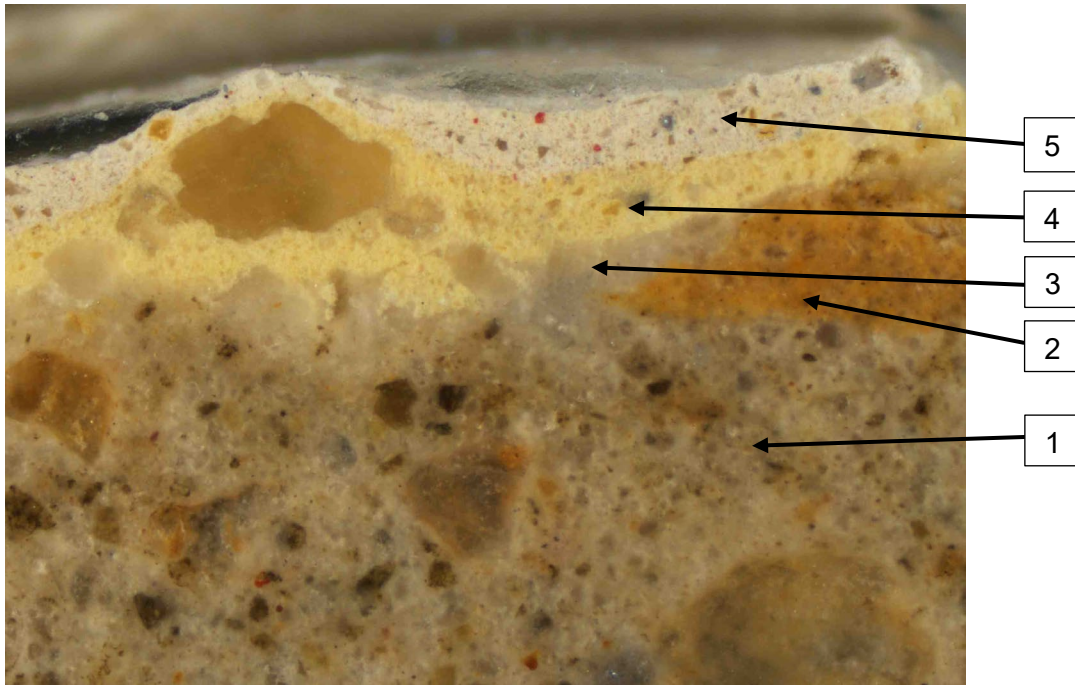
**Figure 8.** Sample HCS.21 from the water table on the north exterior elevation displays the cementitious pebble dash (1), followed by trace remnants of the dark yellow finish (2) and the patching material (3). These are followed by a pale yellow/cream (4) and the present tan finish (5). *Visible light, 40x magnification.*

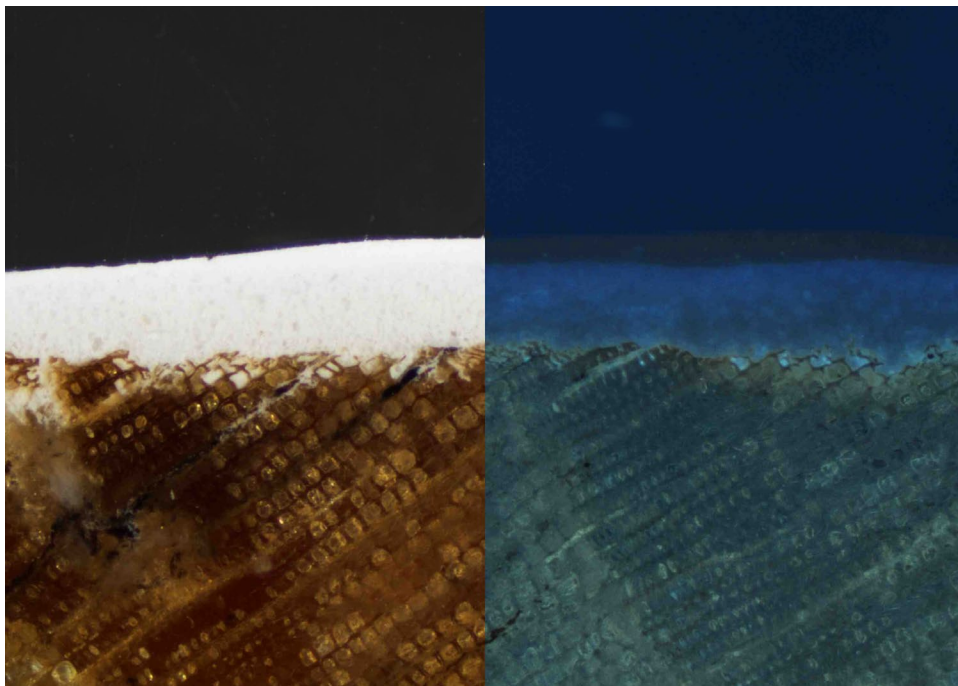
The sample from the exterior window frame on the west elevation exhibits only two layers of a white finish, indicating that the exterior windows have likely been replaced or stripped at some point (Figure 9).

**Figure 9.** Sample HCS.6 from the exterior window case in both visible and UV light, containing only two white paint layers. *Visible light (L), UV Light (R), 40x magnification.*

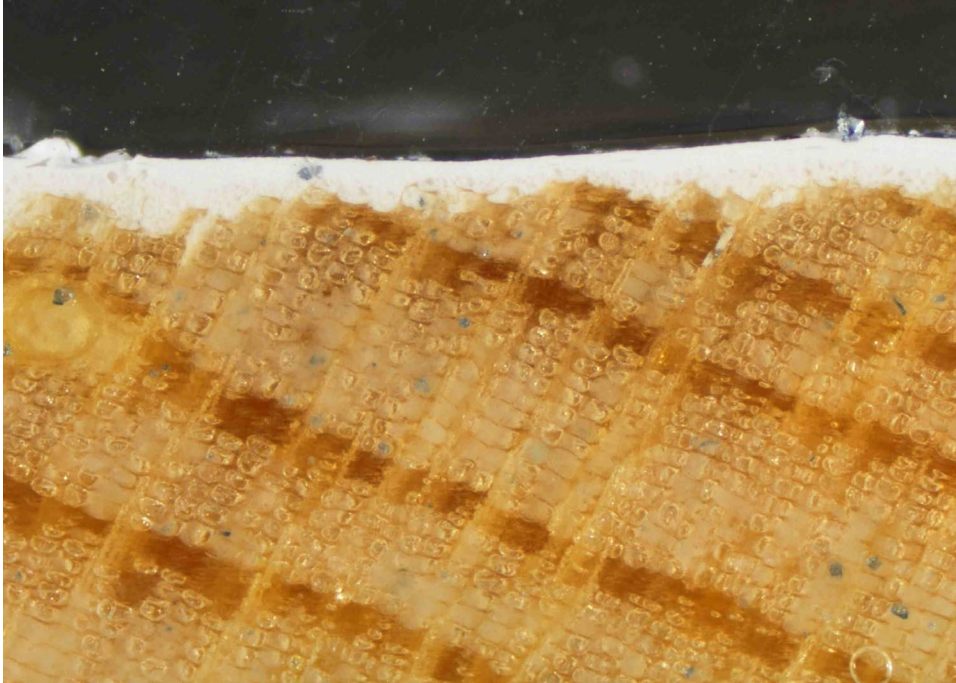
The only samples that differ from this are those removed from three window sash (*HCS.10, 13–14*) (Figure 10). These three samples only contain two finish layers, both of which are white. This evidence suggests that these sash have been replaced, as the window surrounds of these three sash retain the original cream color and subsequent 10–15 layers (*HCS.11–12, 15*) (Figure 11).

**Figure 10.** Sample HCS.10 depicting typical white finish, similar to samples HCS.13 and HCS.14. *Visible light, 40x magnification.*

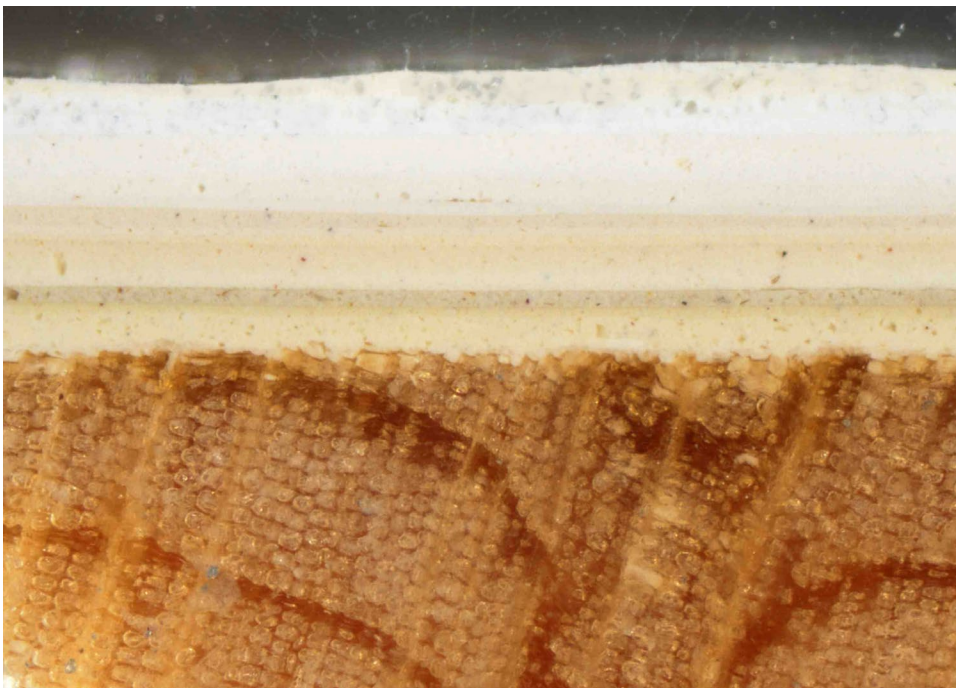
**Figure 11.** Sample HCS.12, representing typical finish layers for interior first floor surrounds, similar to samples HCS.11 and HCS.15. Note early cream and tan colored finishes and subsequent white finishes. *Visible light, 40x magnification.*

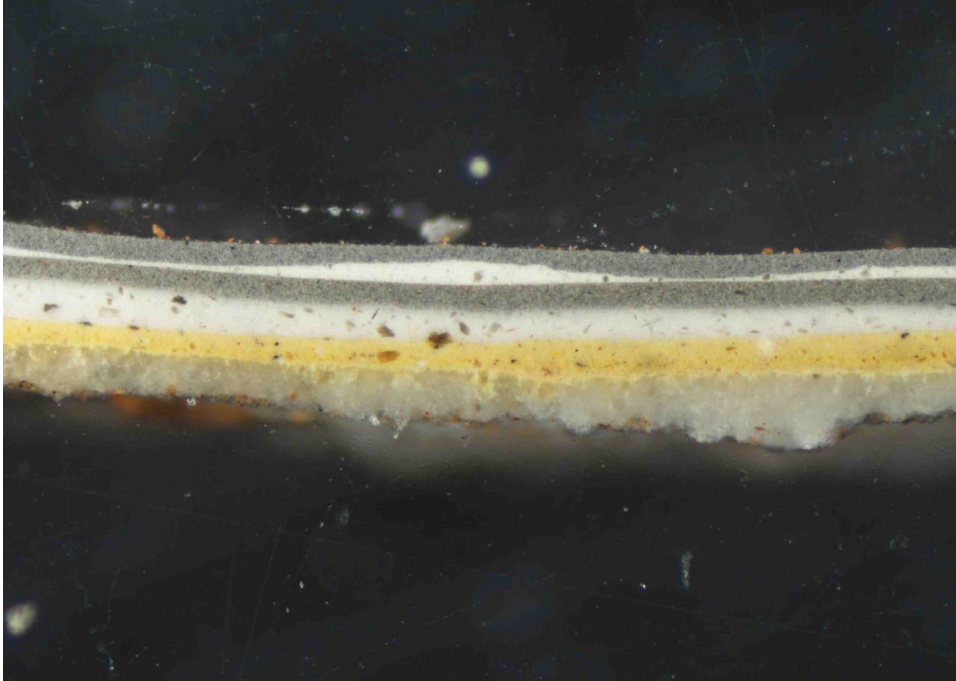
**Figure 12.** *Sample HCS.16*, taken from the lower register of the wall in the segregated women's rest room. Note the limewash first layer followed by a light yellow. *Visible light, 40x magnification.*

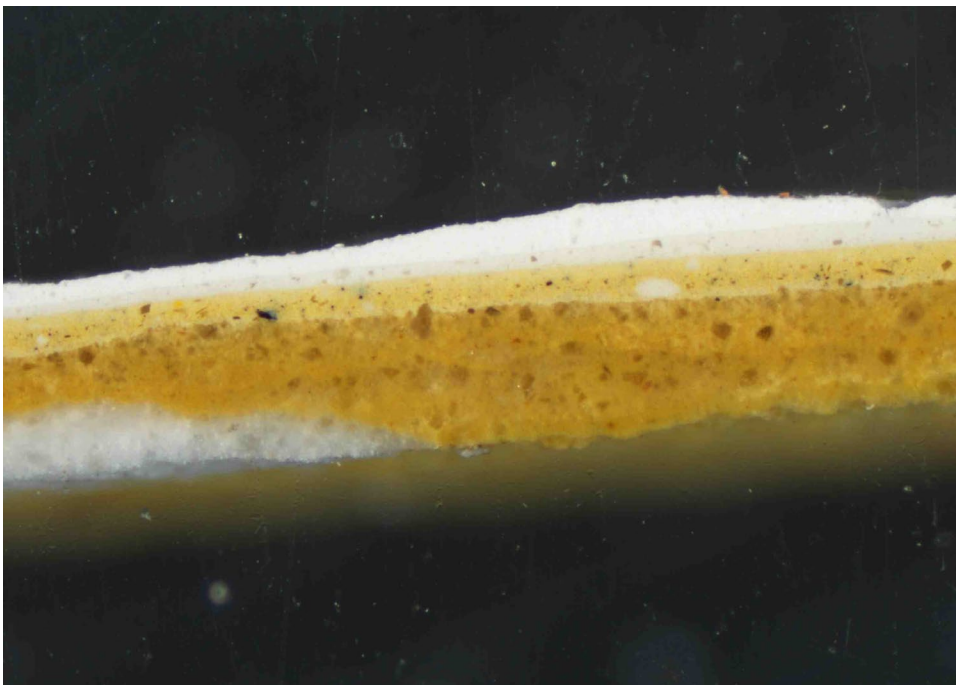
**Figure 13.** *Sample HCS.17*, taken from the upper register of the wall in the segregated women's rest room. Note the lime wash first layer followed by a darker yellow. *Visible light, 40x magnification.*

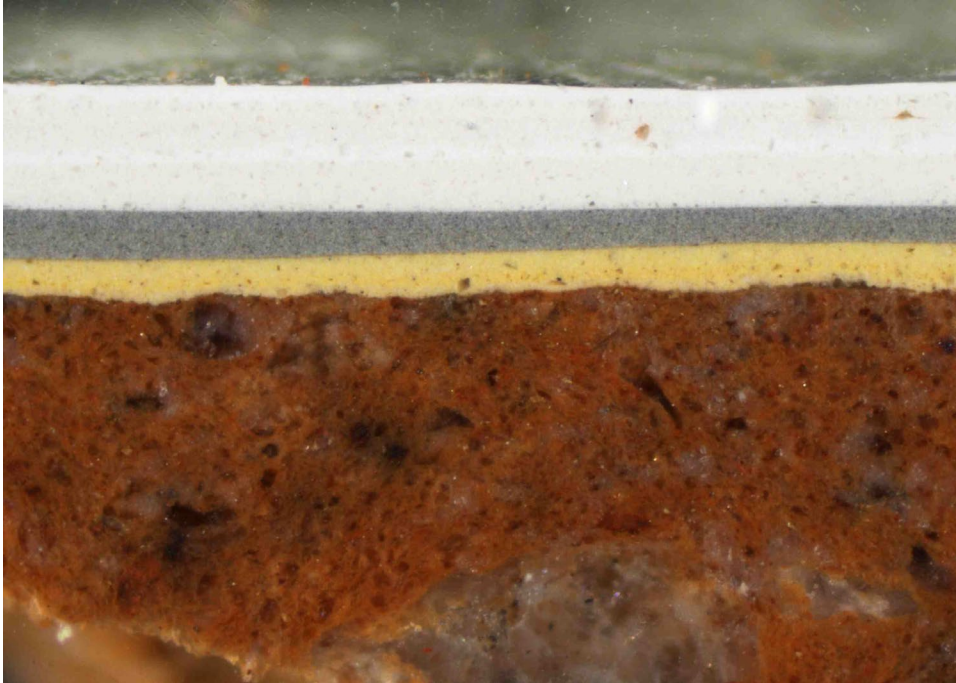
The earliest finish BCA identified in samples removed from the walls of both basement toilet rooms is a pale yellow on the lower register and a dark yellow on the upper register (Figure 14—Figure 15). These colors match the second finish layer of the segregated women's rest room, indicating it is not an original finish. This evidence suggests that these rooms were originally unpainted brick. There is no evidence of limewash in these rooms nor surface disruption, which would have suggested that the earliest observed finishes were altered or missing. Samples from these rooms also do not contain a noticeable layer of dirt between the brick and first yellow finish, which would confirm whether the brick was originally exposed. Due to these variables, however, BCA believes that the walls remained unpainted until the yellow campaign was introduced later to both the segregated women's rest room and the toilet rooms. This finding is a bit surprising, as one would expect a bathroom to be painted for hygienic purposes as well as ease of maintenance.

**Figure 14.** *Sample HCS.27*, taken from the lower register of the wall in the segregated men's toilet room. Note that the first paint layer is a light yellow and there does not appear to be surface disruption or evidence of limewash. This sample is similar to *HCS.24* taken from the lower register of the segregated women's toilet room. *Visible light, 40x magnification.*

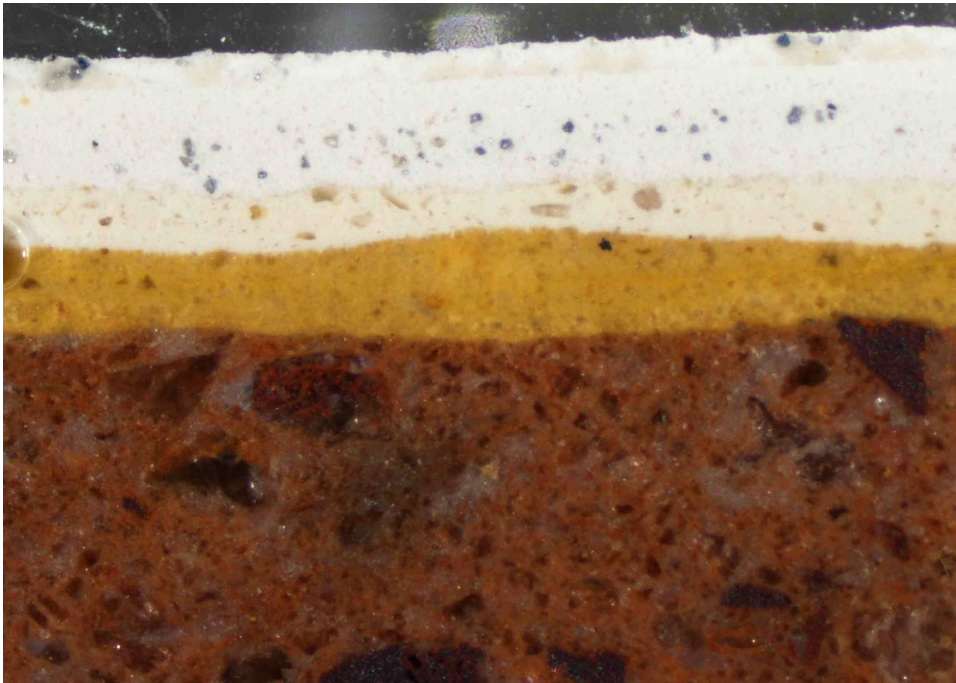
**Figure 15.** *Sample HCS.25*, taken from the upper register of the wall in the segregated women's toilet room. Note that the first paint layer is a darker yellow and there does not appear to be surface disruption or evidence of limewash. This sample is similar to *HCS.28* taken from the upper register of the segregated men's toilet room. *Visible light, 40x magnification.*
