## HISTORIC STRUCTURE REPORT

# Mabry Mill

*This is a report done to examine the historic structure at the complex of Mabry Mill. The structure is located at milepost 176.2, on the Blue Ridge Parkway in Floyd County, Virginia.*

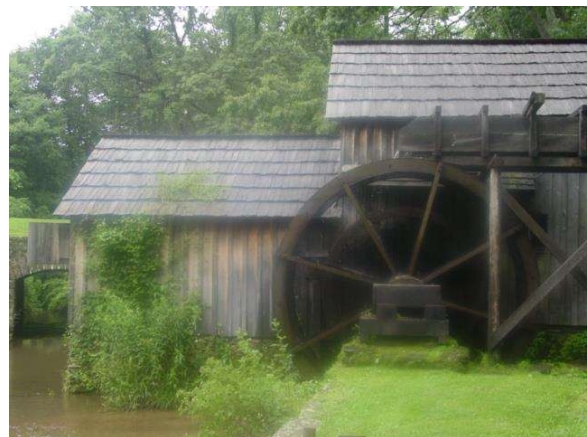
*East Elevation; note the overgrown vegetation on the exterior.*

- There are no gutters on the east elevation of the building.
- There is vegetation on the east elevation that is creating water damage. This vegetation needs to be removed. It is damaging to the structure and takes away from the integrity and character of the structure.

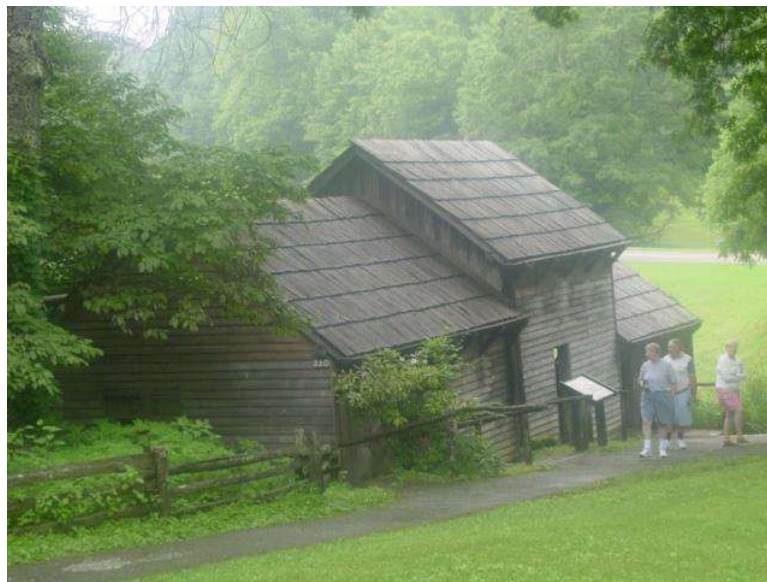
*Viewing the northwest perspective; note the post and railing along the vegetation on the west elevation and the paved walk way that follows the post and railing.*

- There is vegetation touching part of the vertical boards creating moisture damage. Some of this vegetation is poison ivy. Either remove, or move the vegetation so that it is not directly touching the building.
- Gutters need to be cleaned out every 2-3 months to prevent water damage. Check the downspouts regularly for leakage.

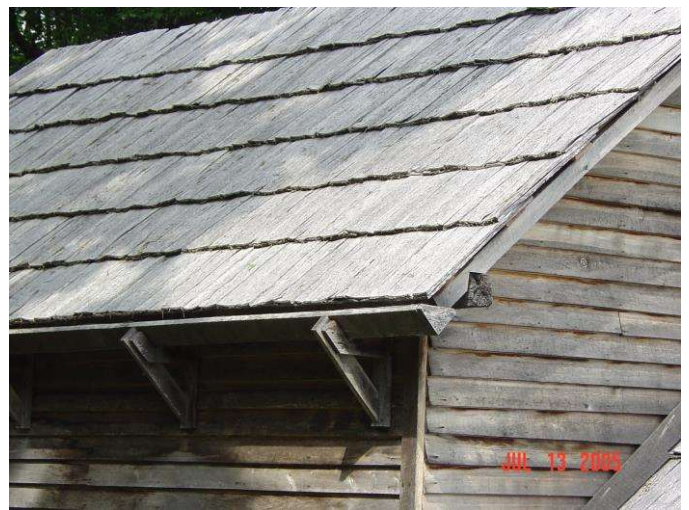
*Viewing the roof shakes on the west elevation of the mill section of Mabry Mill.*

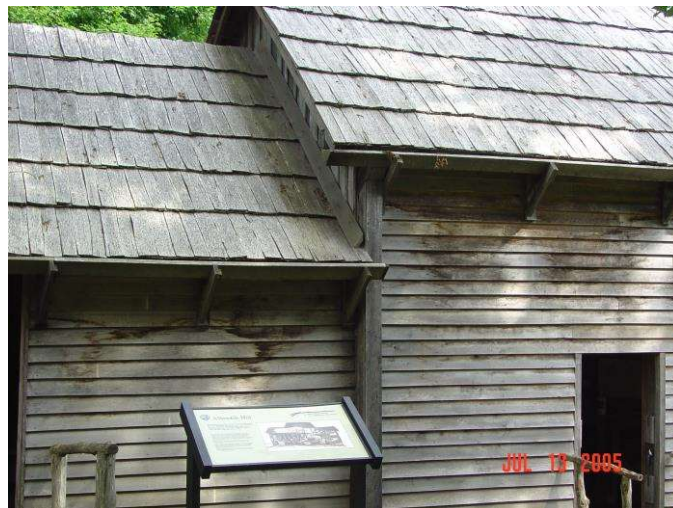
*Viewing the connection on the west elevation of the sawmill shop and the gristmill shop.*

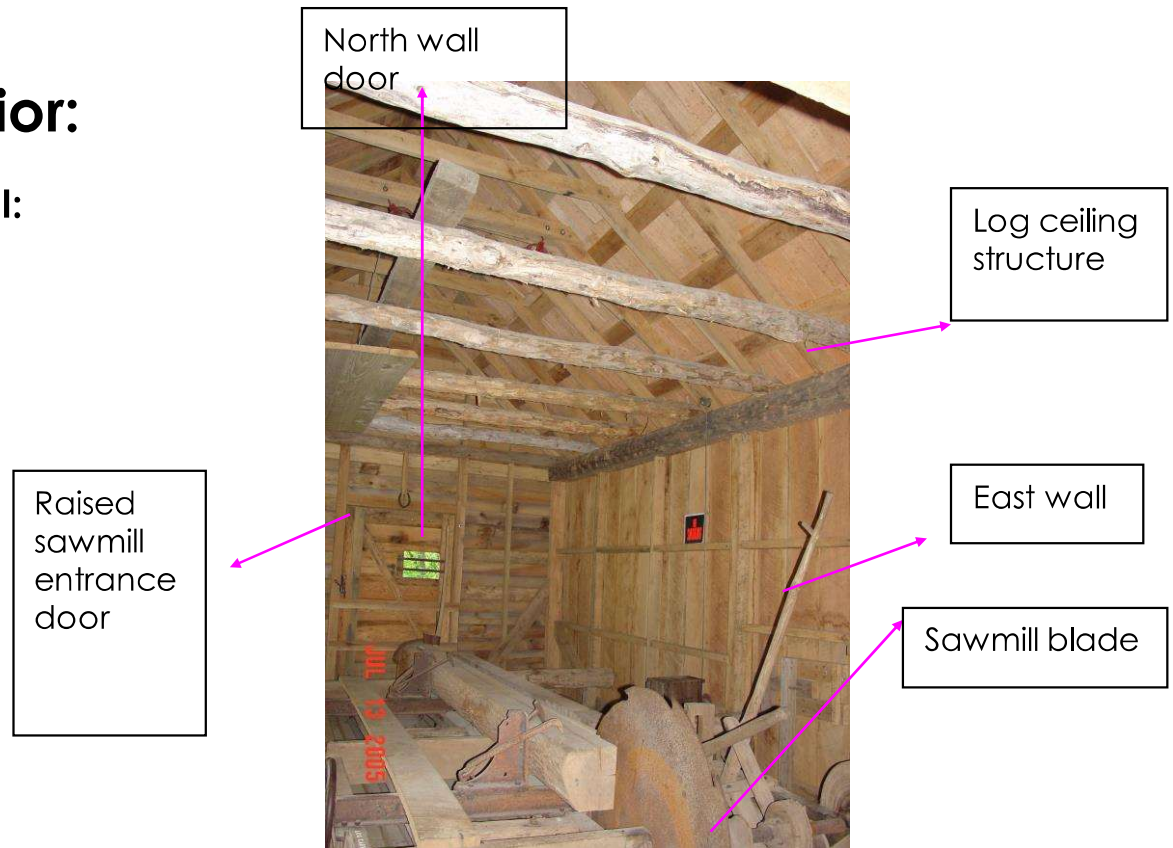
Viewing the sawmill looking towards the north interior wall. Notice the 15" diameter logs used as the ceiling structure [new logs, not original]. Note the door on the north interior wall.

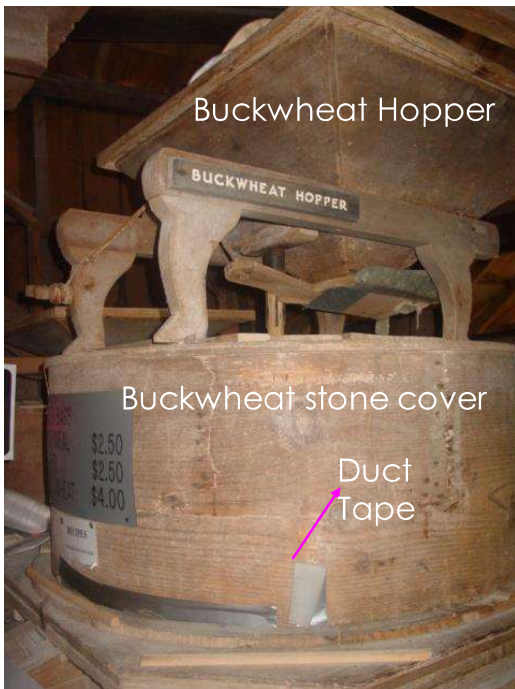
Buckwheat hopper (above)

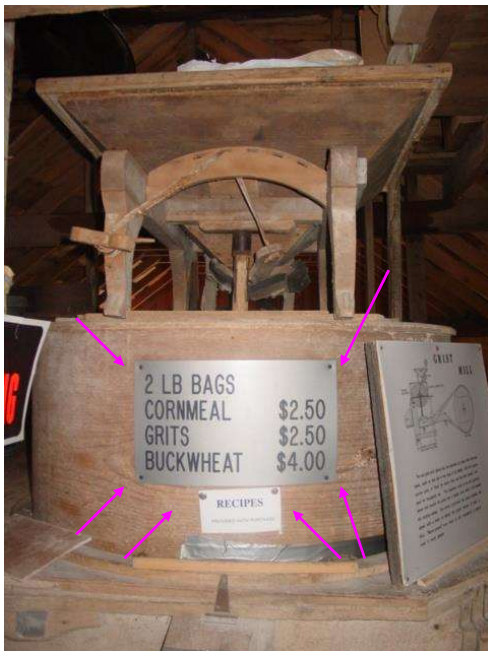
Buckwheat hopper above; note metal screw in buckwheat cover holding the sign.

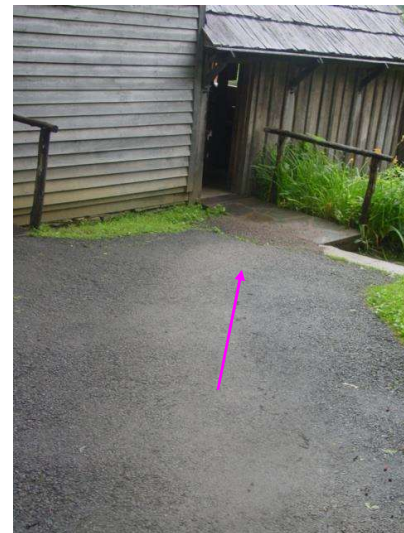
Viewing erosion, photo taken while standing near millstones in from of the west elevation of the mill looking towards the woodworking shop entrance near the north of the mill.

- On the west elevation there is some erosion nearest the furthest northern entrance. The land slopes at a downward angle causing water and erosion to interfere with the handicap accessible walkway. This water goes underneath the building to an open area under the gristmill and causes moisture problems. This problem starts all the way from an opening in a gate on the top of the hill near the road (Blue Ridge Parkway). We suggest that the slope should be regarded and should slope away from the building. Consult with a historical landscape architect regarding the implementation of the idea. No water penetration or erosion should be allowed to continue being a threat to this handicap accessible area.

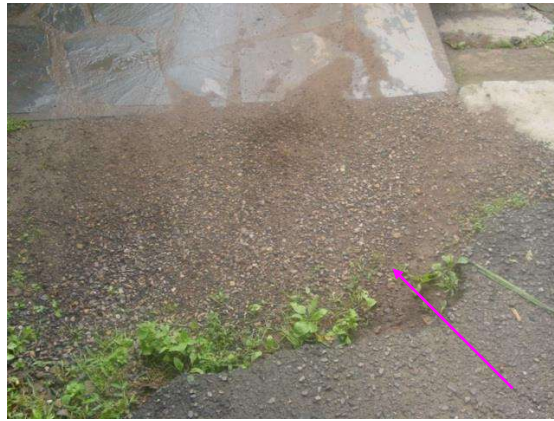
*Erosion on the west elevation side near the carpenter shop entrance*

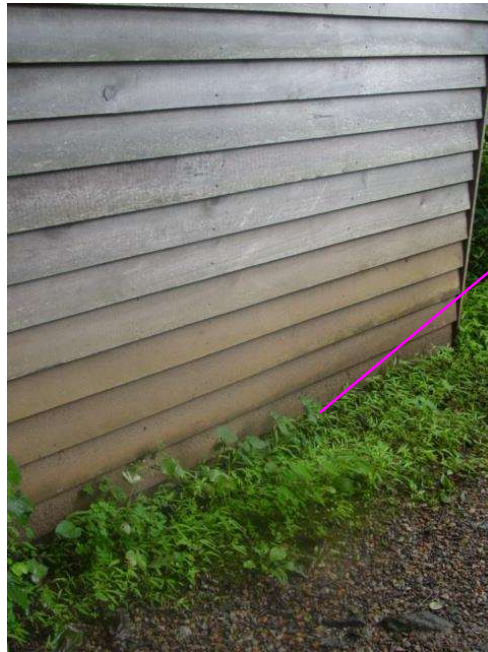
Overgrown vegetation on the north elevation.

*Location to the right of the sawmill door on the north elevation*

- There is overgrown vegetation on the north elevation of the mill near the door creating moisture damage. This vegetation needs to be removed without damaging the original materials of the structure.

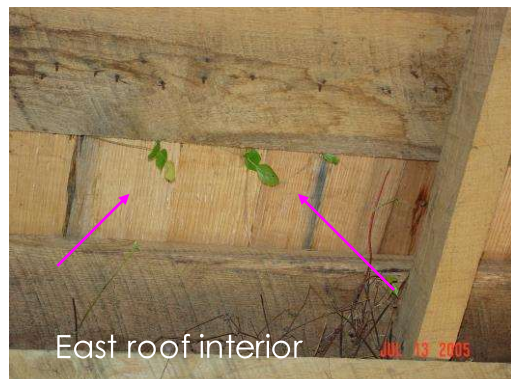
East roof interior

*Overgrown vegetation in the upper corner of the east and south walls in the woodworking shop of the building.*

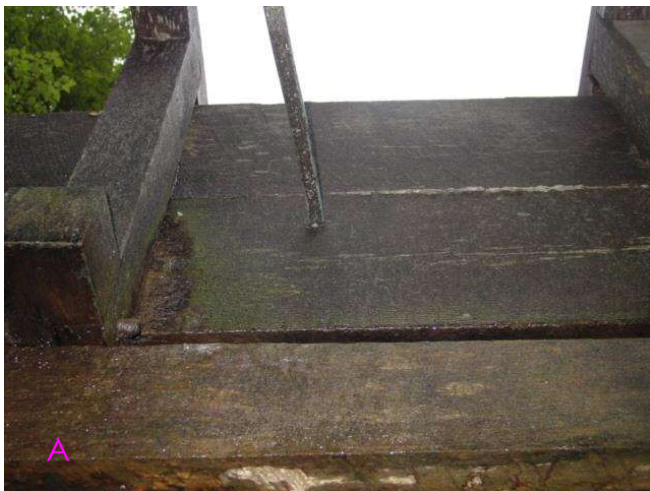
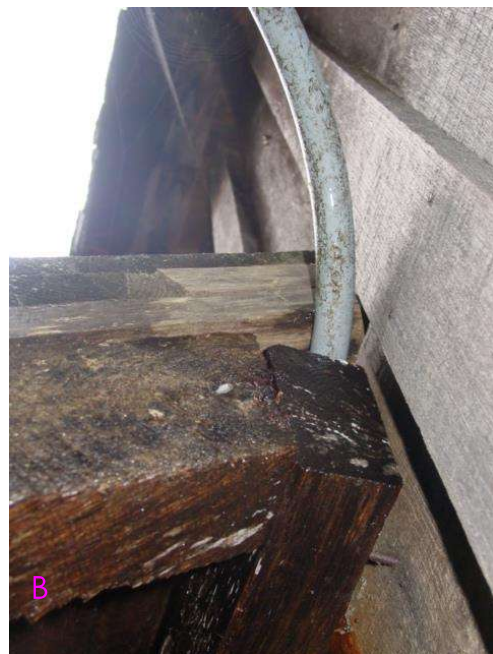
A: Water hose coming from the flume. B: Water hose going to interior of the building; connected from the east elevation.

- There is a hose that leads from the west side of the flume that connects to the east elevation [right above window] in the mill section. This hose has been installed in order to keep the gears wet and lubricated for better performance. However, the hose is not sealed correctly and water flows down the exterior of the hose and wets the east elevation. This hose needs to be sealed/caulked to prevent the water from getting to the exterior and interior of the structure.

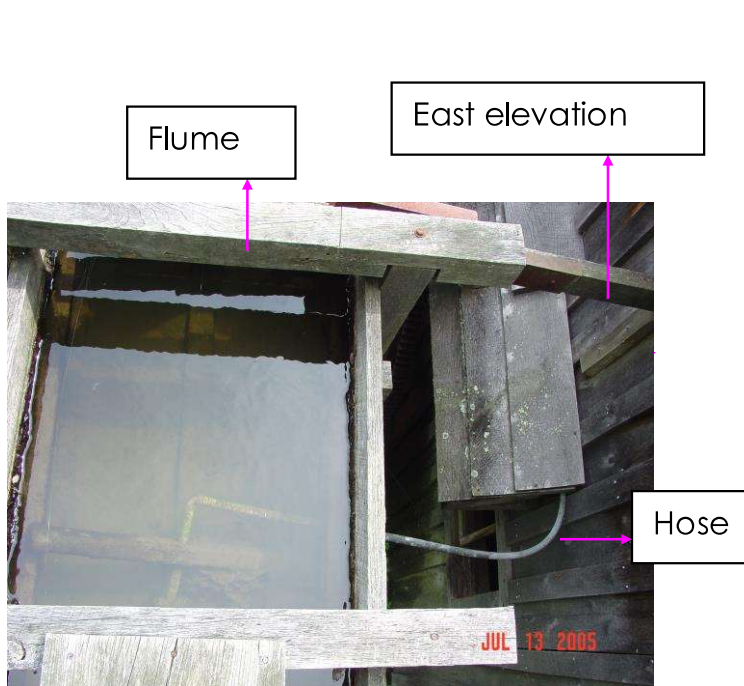
*Viewing close up from the top of the flume looking down to the hose connection going from the flume into the mill on the east elevation.*

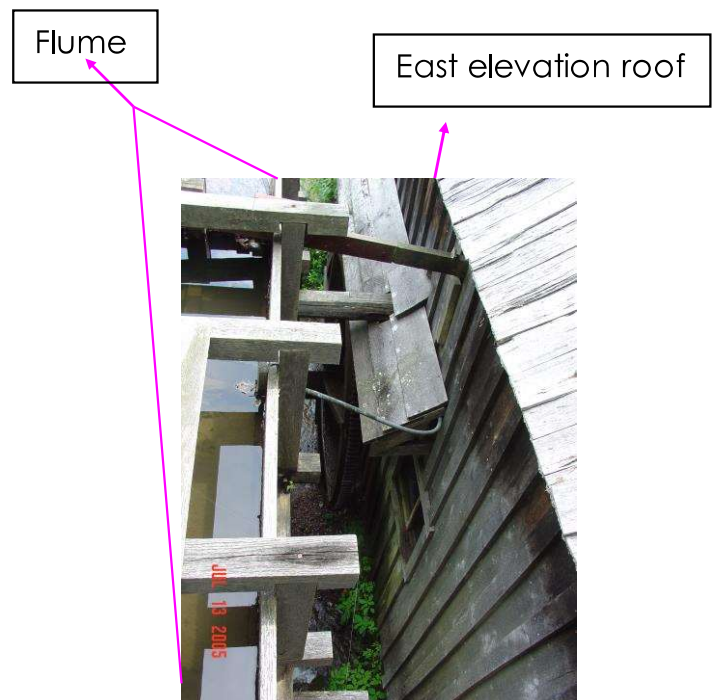
*Viewing close up from the top of the flume looking down to the hose connection going from the flume into the mill on the east elevation.*

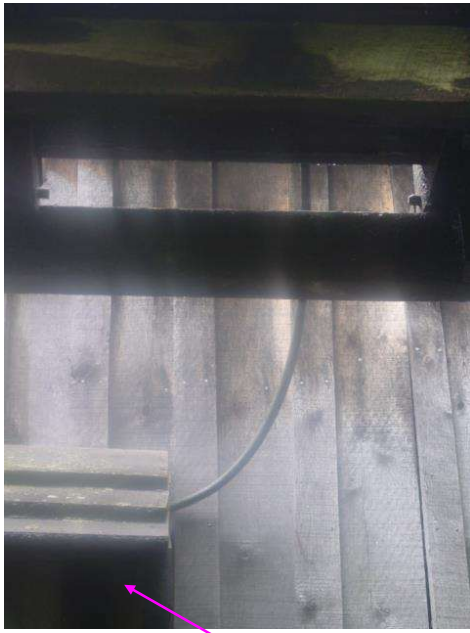
These two pictures show other angles of the connection of the hose to the east elevation; note the Mill section window on the east elevation.

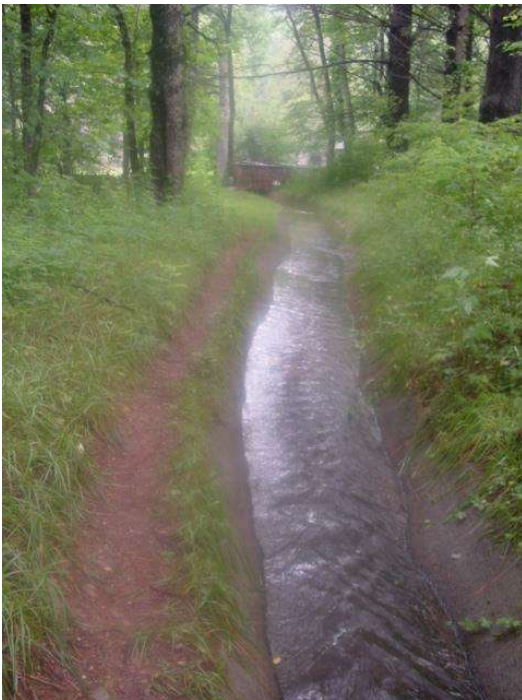
Concrete waterway between areas of the flume. This is another area where siltation from erosion invades the stream.

- There are leaks in the flume due to heavy silt buildup. Cleaning the flume regularly of silt and adding a catch basin would reduce the amount of silt and consequential leaks in the flume. This catch basin should be placed at the beginning of the flume, and again where the flumes start up after the concrete waterway section.

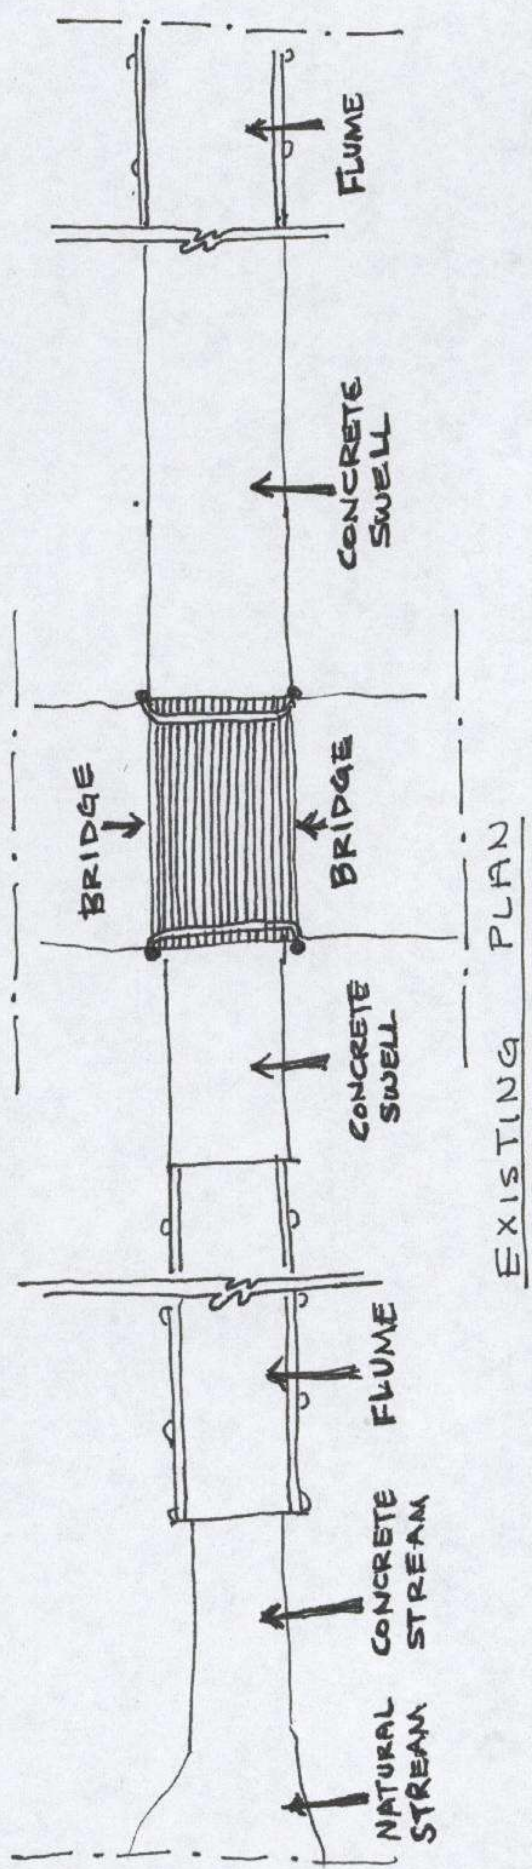
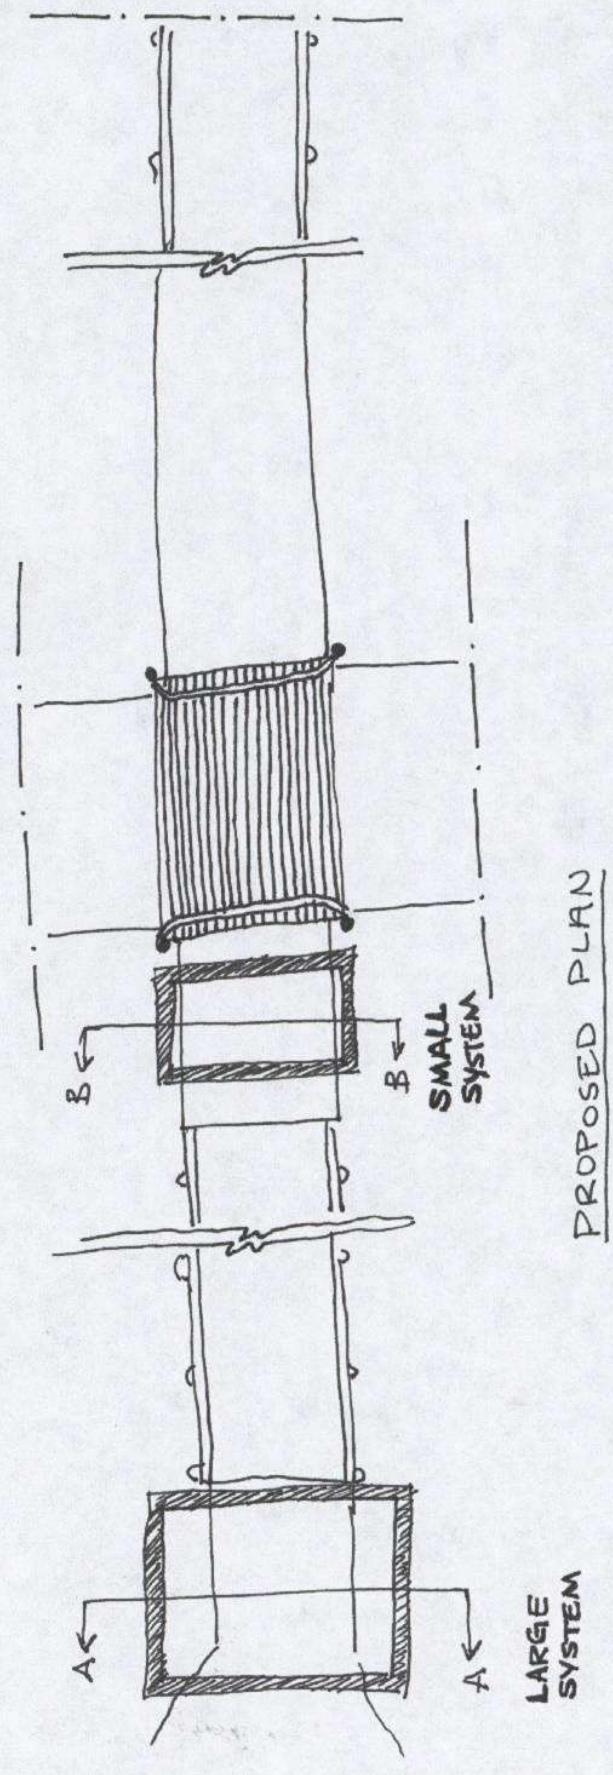
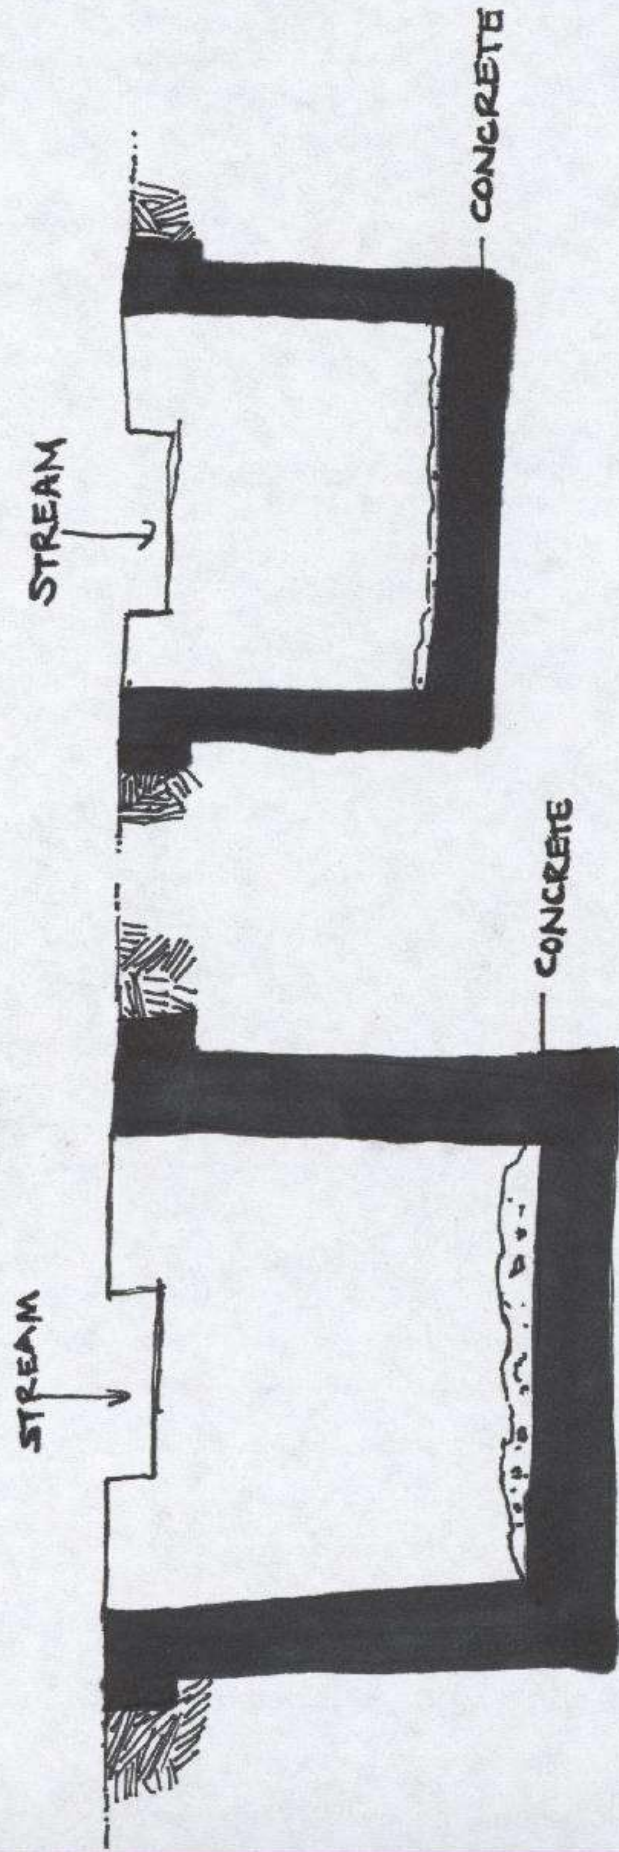
# CATCH BASING SYSTEM: PLAN

LARGE SYSTEM  
PROPOSED SECTION AA

SMALL SYSTEM  
PROPOSED SECTION BB

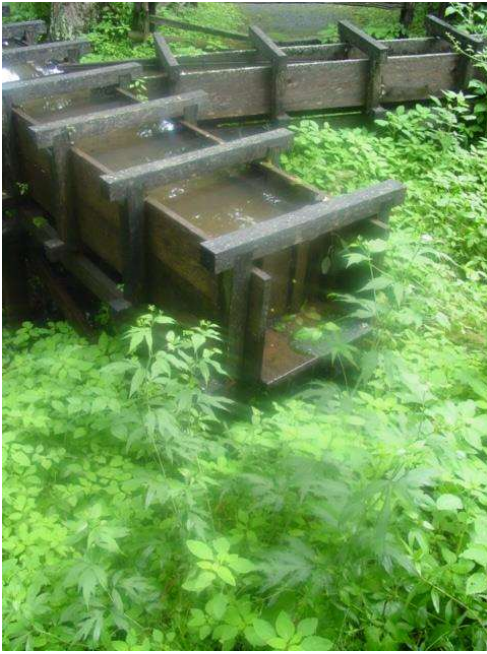
*The end of the race  
attached to the flume.*

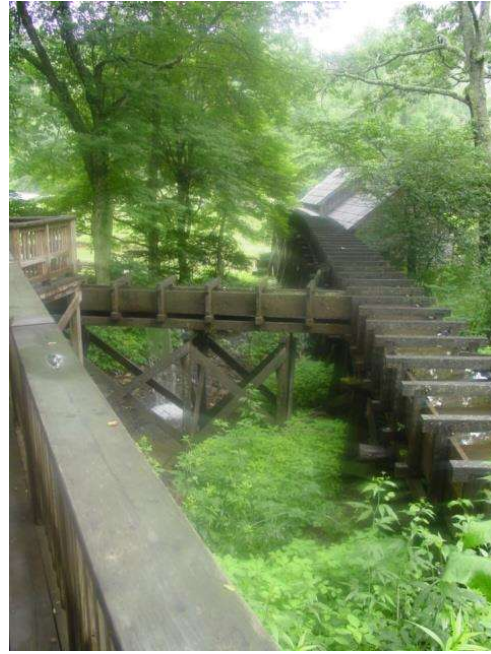
*Connection of the flume  
and race looking south.*

- There are overgrown shrubs and other vegetation on the flumes. The park staff should consult with SERO Historical Landscape Architects and /or with the Parkway Resident Landscape Architect to determine how this harmful vegetation should be removed in order to ensure the good condition and historical character of the flumes

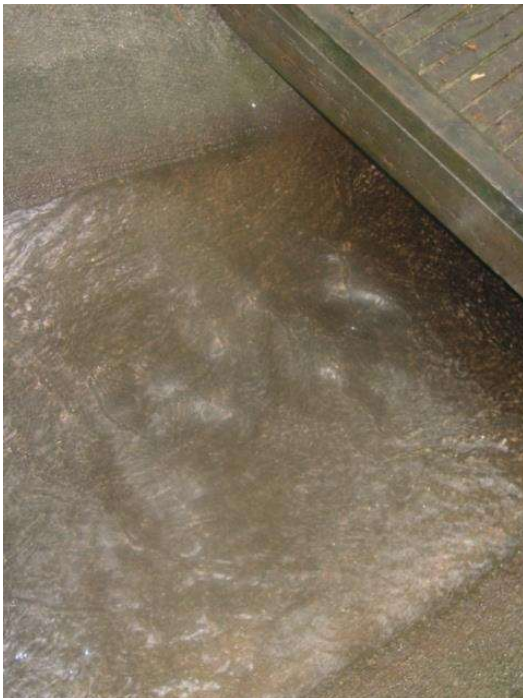
*Clear water in concrete  
waterway as it goes under a  
wooden handicap walkway.*

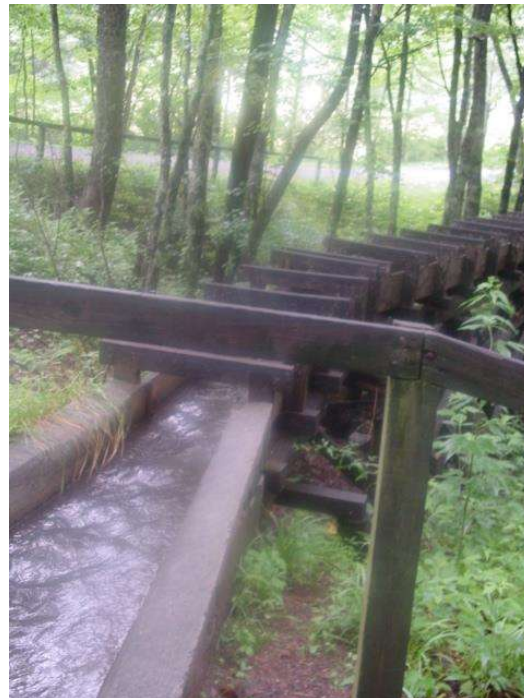
*Concrete swell and flume  
connection; view is from standing  
on the wooden handicap  
walkway, looking east.*

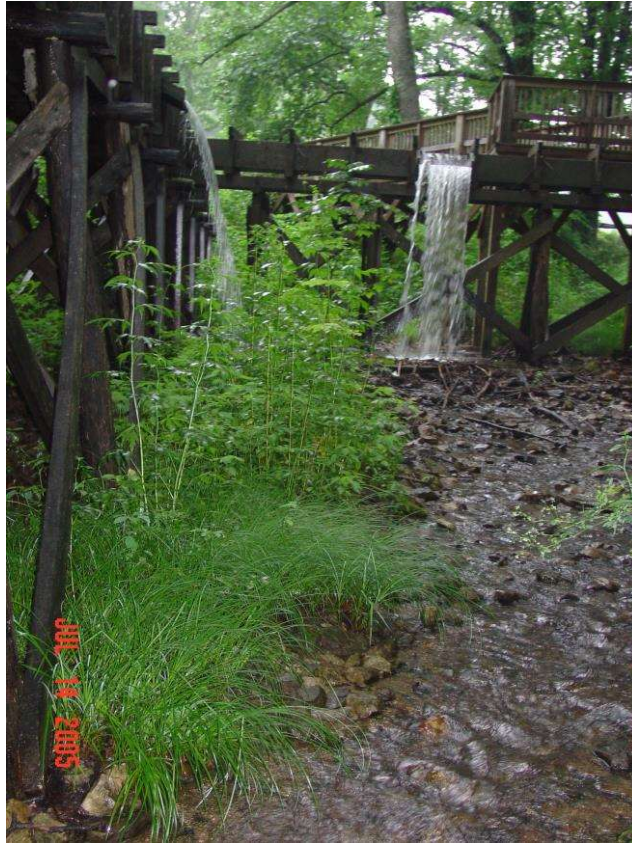
*Water from overflow leaves a stream under flume.*

- The flume overflow stream leading to the pond causes considerable and preventable water damages to the mill's east elevation. The park should periodically monitor this stream-caused damage to the east exterior foundation and exterior walls. Due to the proven damage caused by this stream, the water source should be redirected and angled towards the pond and away from the mill structure and flume piers.

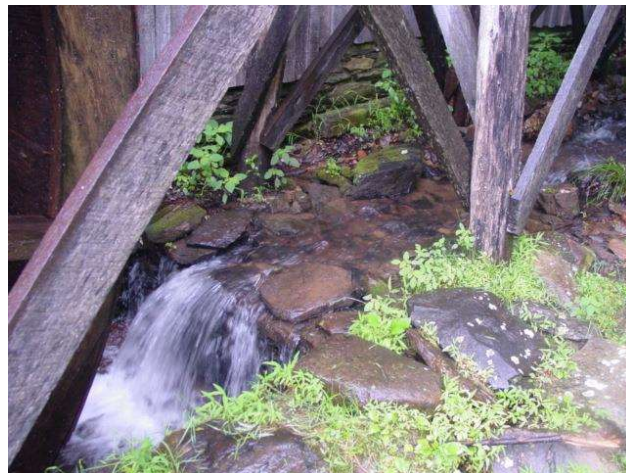
*Siltation-clogged flumes overflow under the flume supports, sending sand/dirt/debris directly into the mill pond.*

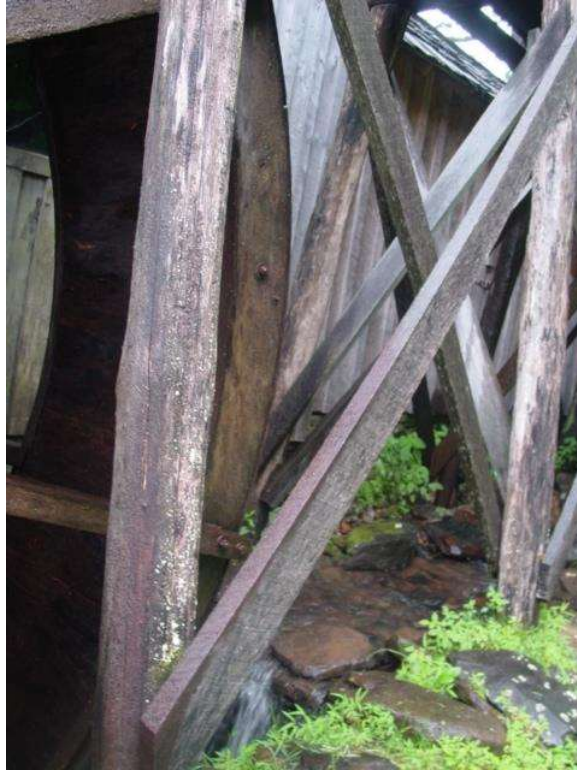
*Flume structure, [which sits on underground concrete piers.*

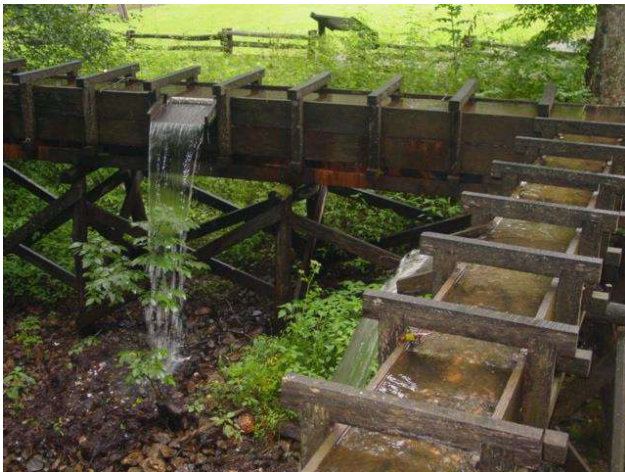
*Viewing from the top of the flume, standing on the wooden handicap bridge/walkway; note that there are 2 overflow sections; mill is off to the left.*

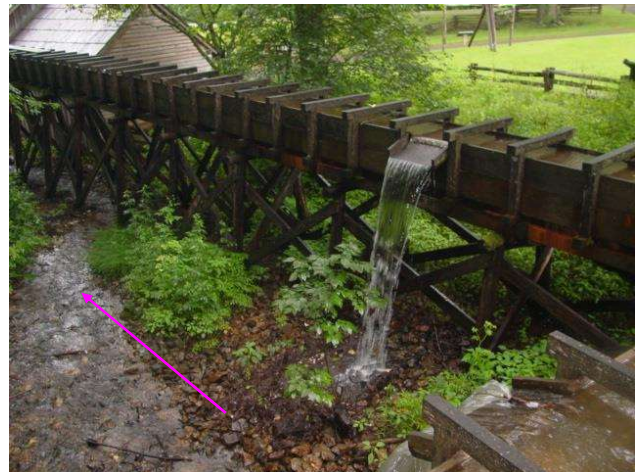
*Water from the overflow goes under the flume and into the pond [near the east elevation].*

- Over flow sections in flumes create moisture that is damaging to the east elevation. It is suggested that the path of water underneath the flumes be redirected away from the structure and angled toward the pond. This action will decrease the likelihood of water damage to the mill's east elevation and create a much less harmful channel of water flowing directly into the mill pond.

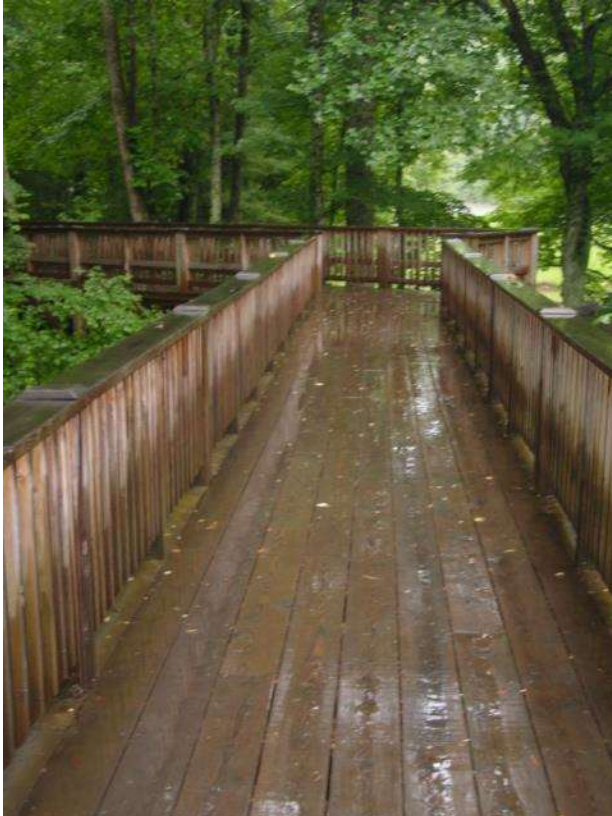
*Slippery walk way/bridge:  
Stays wet during  
rainy/snowy season.*

- The wood that this bridge is made of is very slippery when wet. There needs to be an appropriate floor surface gripping material applied to the walkway structure
- There are other walkways throughout the complex that have fungus and are slippery when wet. After pressure washing, NPS should apply an appropriate floor surface gripping material to ALL of these walkways.

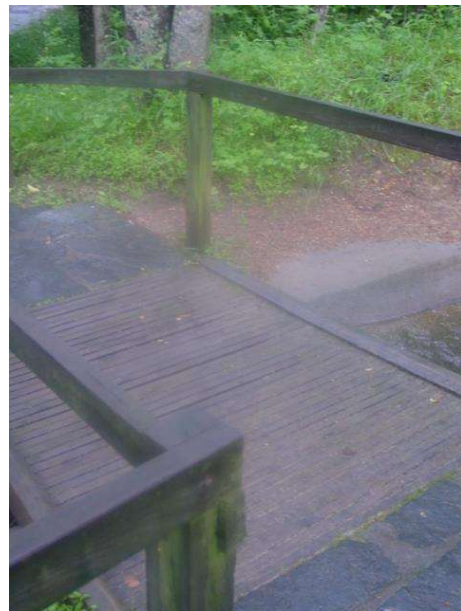
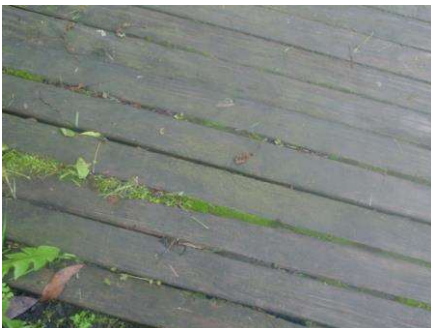
*Algae that form on wet wooden  
walkways near the blacksmith shop.*

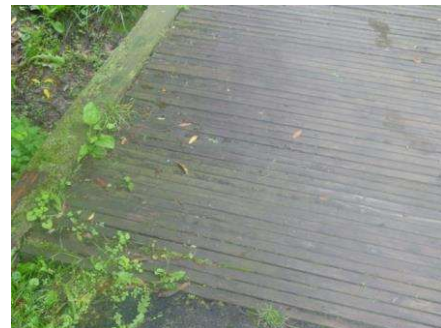
*Slippery walkways are located  
near blacksmith shop and flume.*

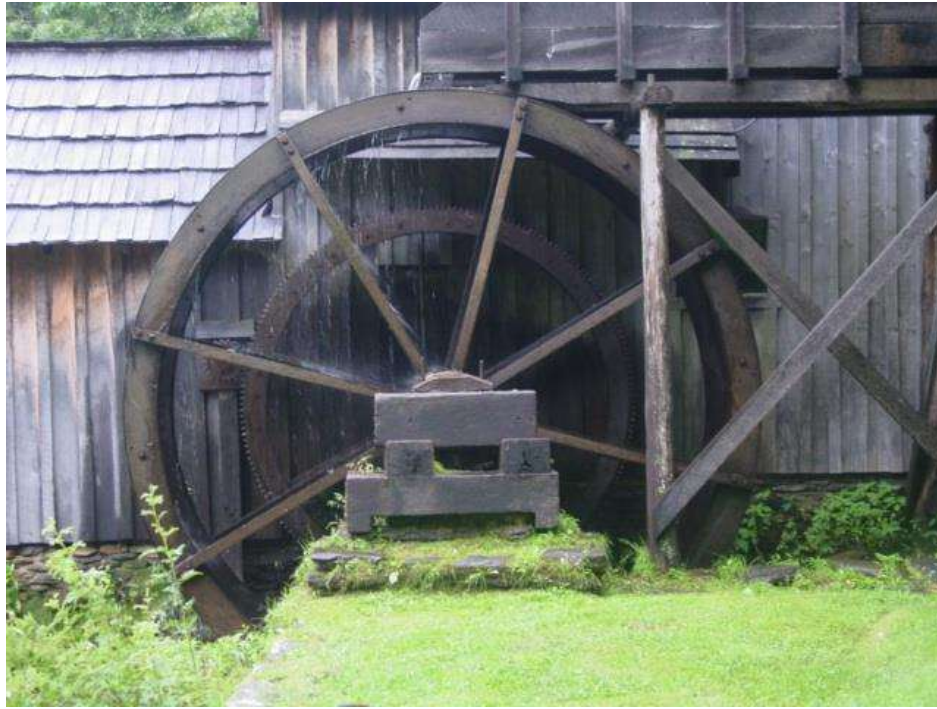
*Note that the east elevation in the background of the wheel is wet.*

*Just as in protection of the water wheel, the East exterior elevation of the building needs to be appropriately protected from possible water splashes; and water should not splash through the axle opening of the mill to the interior.*

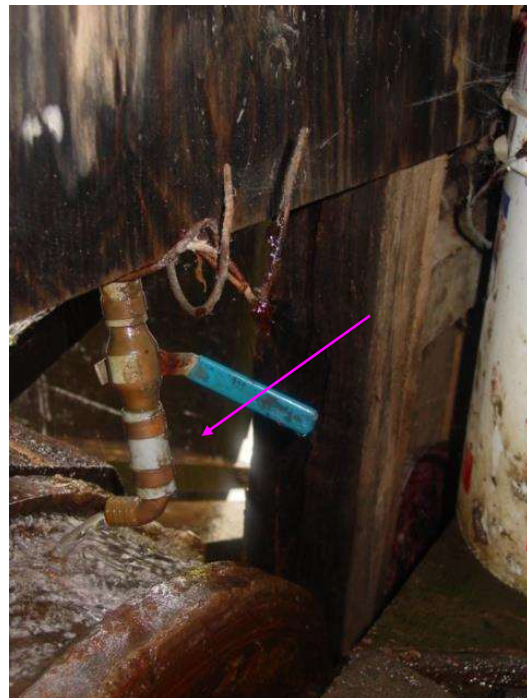
Hose that comes from the flume to the east elevation to the case opening for the wheel axle.

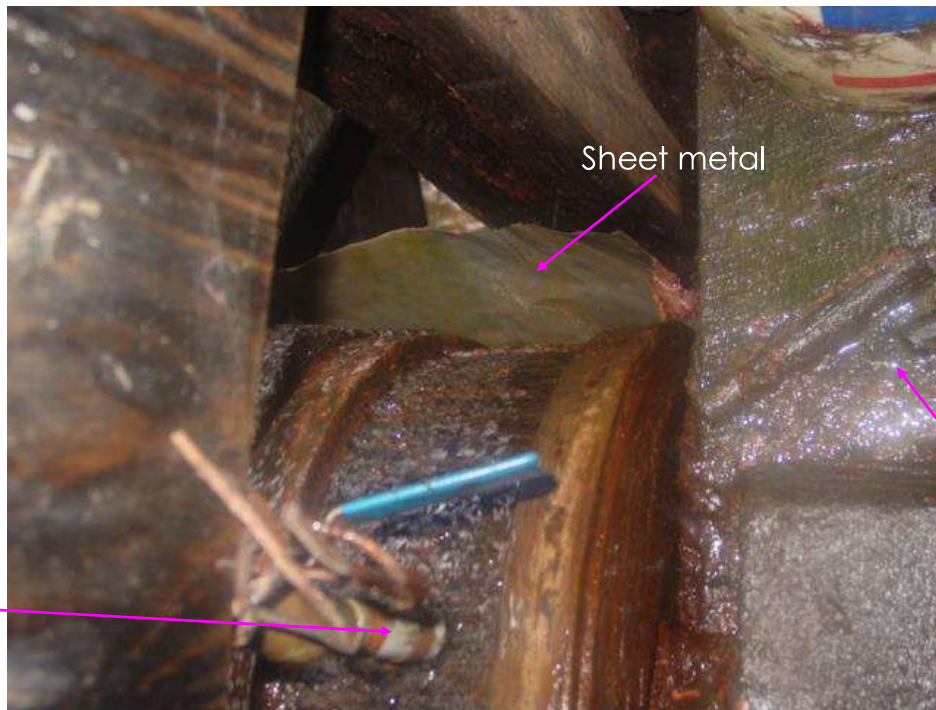
Water hose

Sheet metal

*Sheet metal is placed to keep out moisture. Consider evaluation and recommendations for improvement by a professional; view is from the top of the axle and the case opening.*

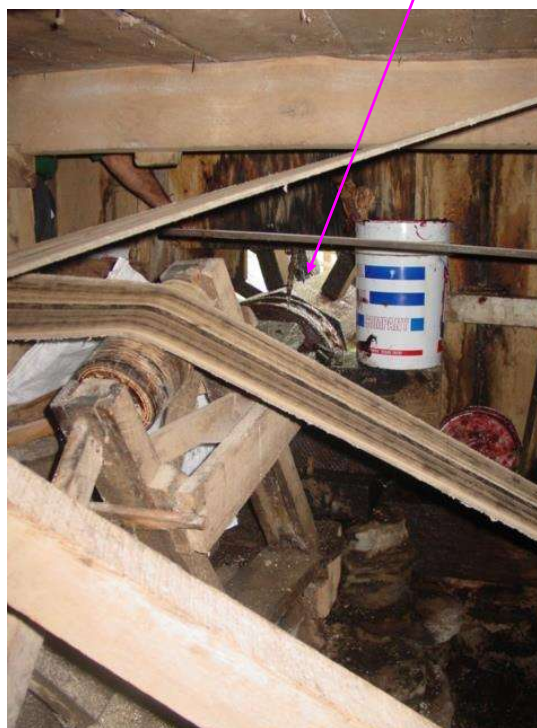
Viewing the interior of the mill, standing underneath the grist mill, looking towards the case opening for the axle of the wheel.

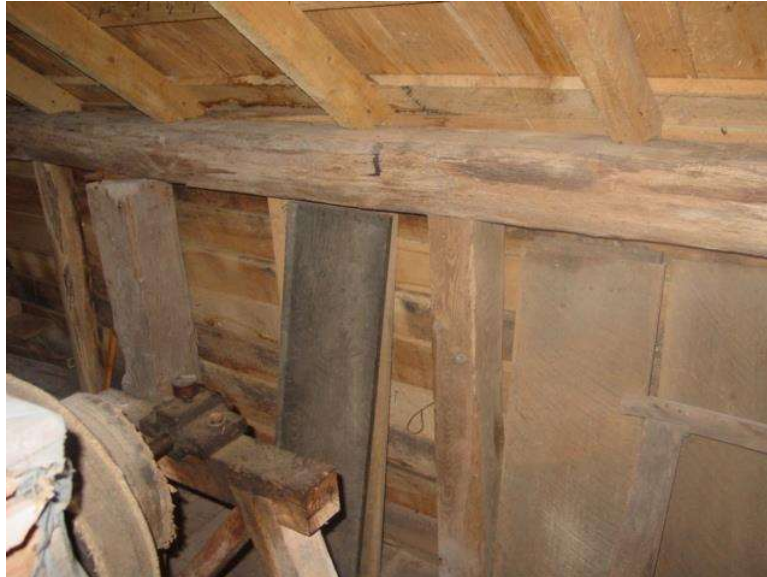
*West wall in the upper loft section of the mill.*

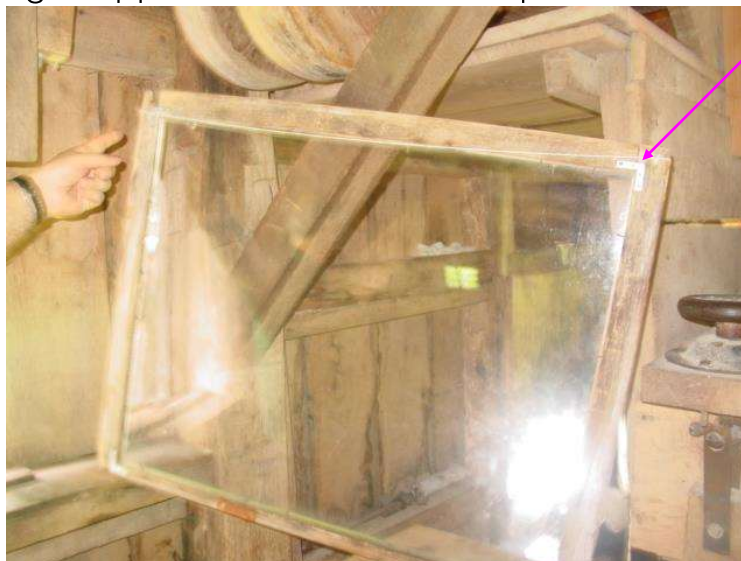
- The east wall is the same through out the whole interior of the mill.
- There is rotting wood on the interior of the opening for the water wheel connection [the axle] due to the water that splashes from the wheel. These pieces of wood should be repaired or replaced if necessary, in kind.
- The window [sash] on the east wall is attached by metal angle supports and needs to be repaired in kind.

*Window [sash] to the mill on the east elevation of the mill section.*

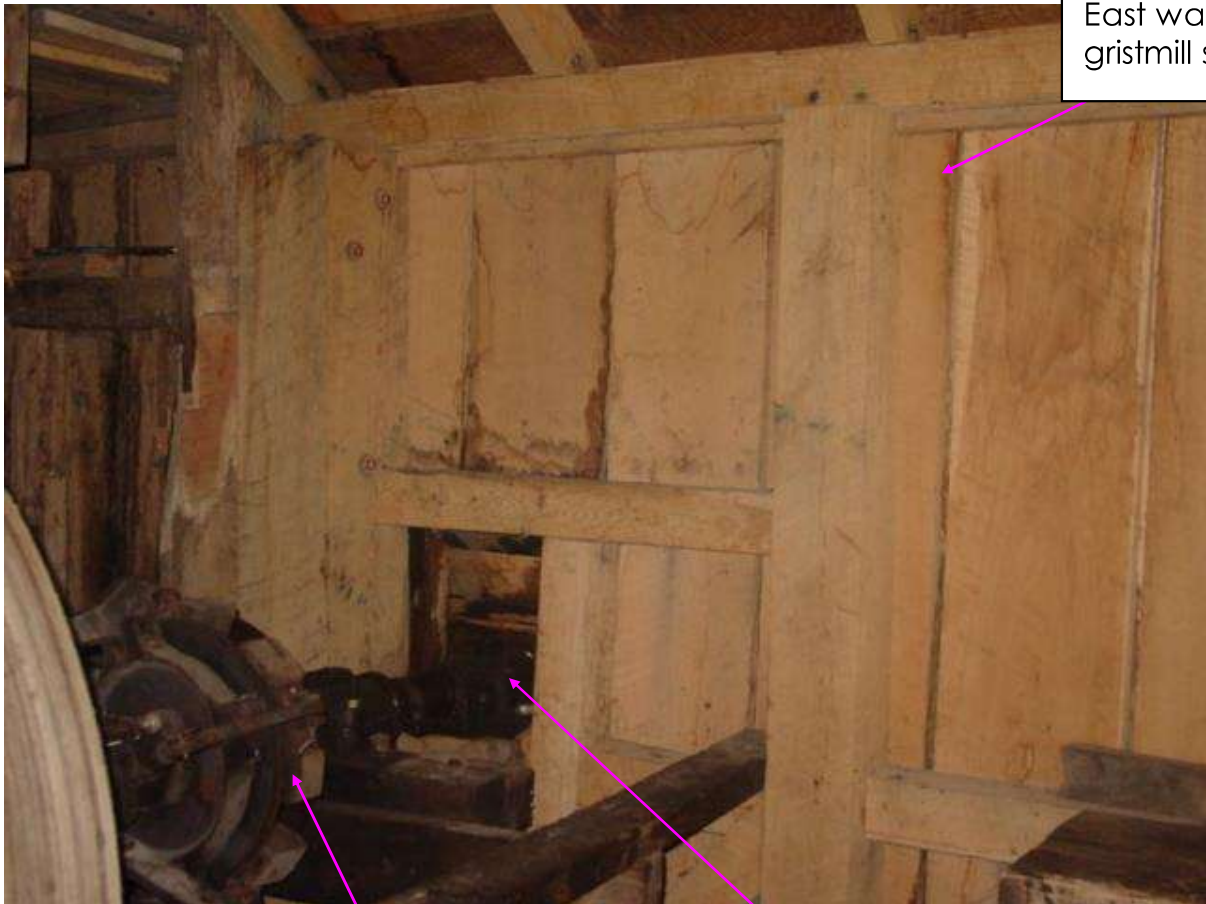
East wall in the  
gristmill section

Gristmill clutch

*This photo of the east wall shows the case opening for the wheel clutch as well as the supporting posts that serve as structure for this wall.*

The opening for the axle connection from the mill to the gears allows water to enter the interior of the structure. This water is damaging to the structure. Consider using an appropriate sealer (in-kind) to protect the east wall.

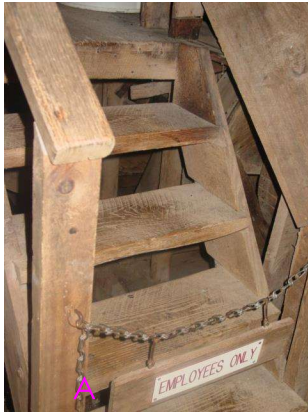
A: Stairs from the ground level to mid level of loft. B: Stairs from the mid level to the upper landing of the loft. C: Stairs from the upper landing to upper level of the loft in the mill section of the structure.

- These stairs are original. The "employee's only" sign should be removed from the original structure.

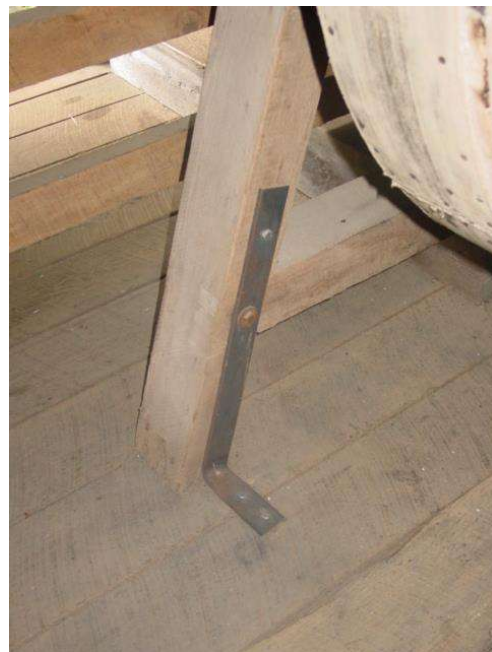
*This is the loft section 1. ground floor 2. Mid loft section 3. Upper loft section.*

*Supports used to stabilize the pulleys in the gristmill section of Mabry Mill.*

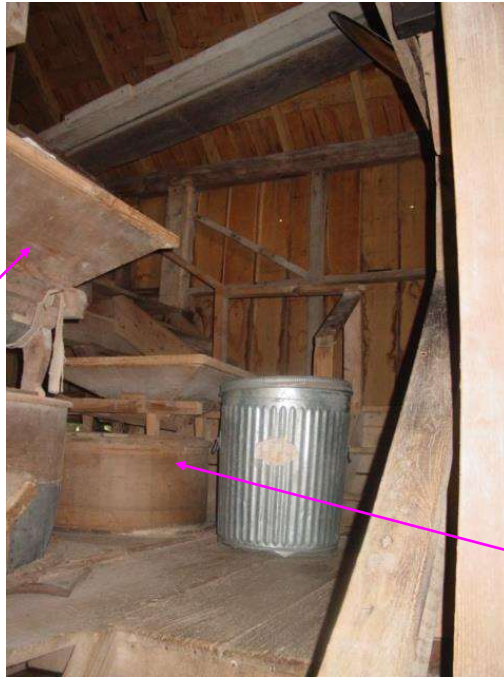
Cornmeal hopper  
(actively used for  
demonstration  
grinds only. No  
products are  
produced here for  
visitor or employee  
consumption

*Mid section of loft used for storage.*

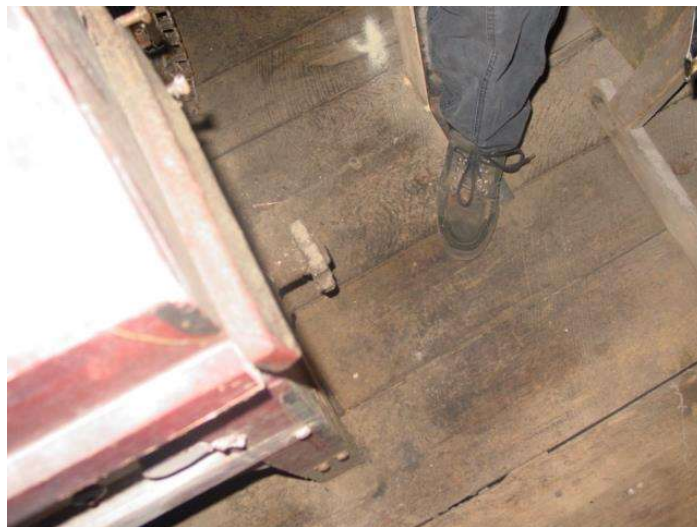
*Floor boards of the stone level [mid loft  
section] of gristmill section of Mabry Mill.*

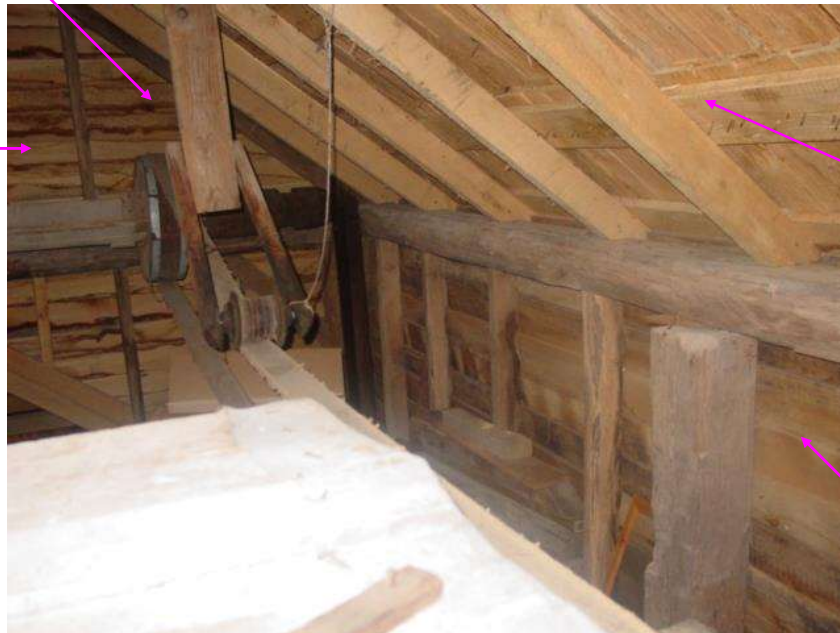
Ceiling and rafters

Upper loft structure

*Upper loft section of the mill section of Mabry Mill. Check for leaks in ceiling.*

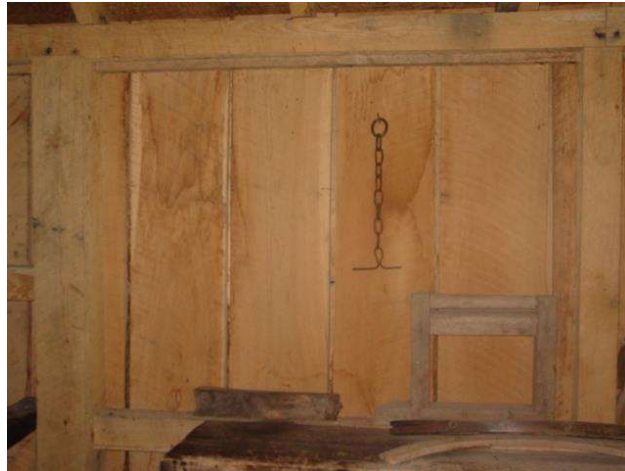
*The east wall in the woodworking shop is shown here with tools similar to those of Mabry's time.*

- There is vegetation intruding from the outside into the east interior wall. This vegetation must be removed in order to protect the wood from moisture damage.
