# Historic Structure Report

**The Blackwell School Alliance Board**

**UTSA** College of Architecture,  
Construction and Planning

Date : 04.24.19

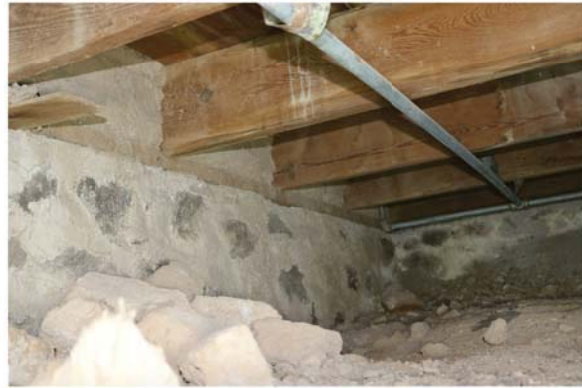
**1** Rubble foundation wall with adobe blocking in-between support joists.

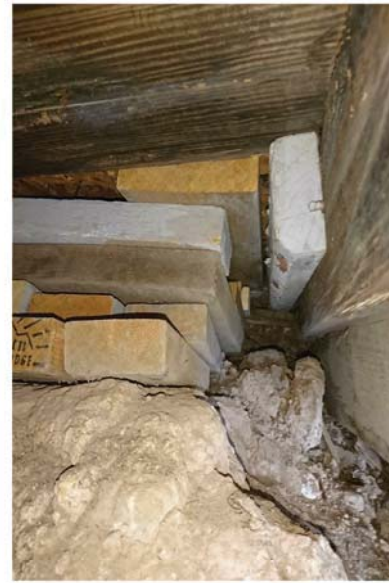
**3** Random assortment of wood blocks support rotten floor above, floor joists in this area also deteriorated.

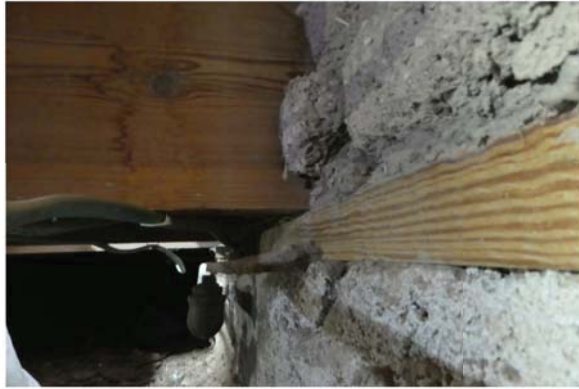
**1** Rubble fondation wall with a wooden ledger embeded below the floor joists.

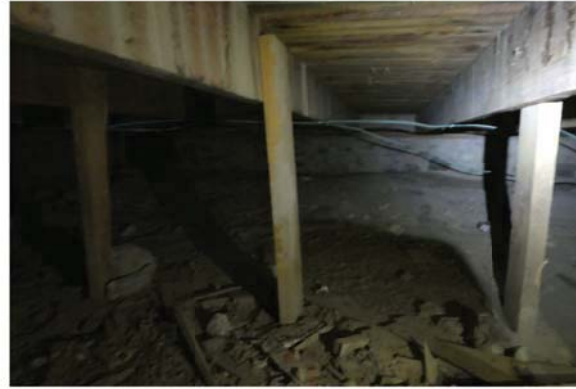
**2** Secondary supports placed randomly under the floor joists.

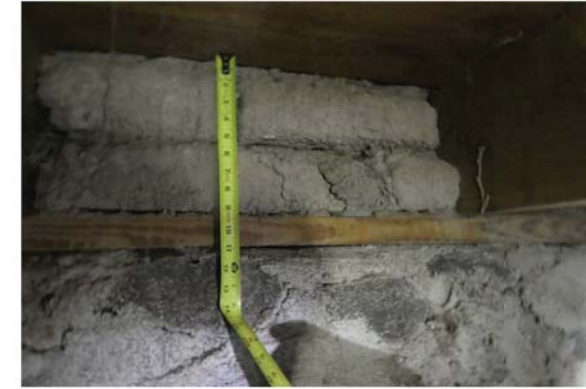
**3** Adobe wall, wood ledger, and adobe brick units.

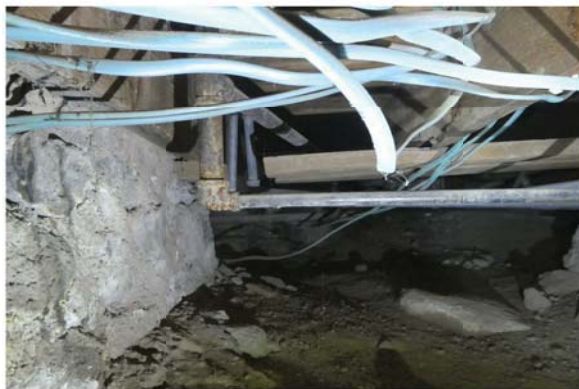
**4** The rubble foundation has been knocked out to provide access , plumbing and electrical lines. The wood ledger supporting the floor joist has been modified and is in a cantilever position which has caused some damage to the floor joist.

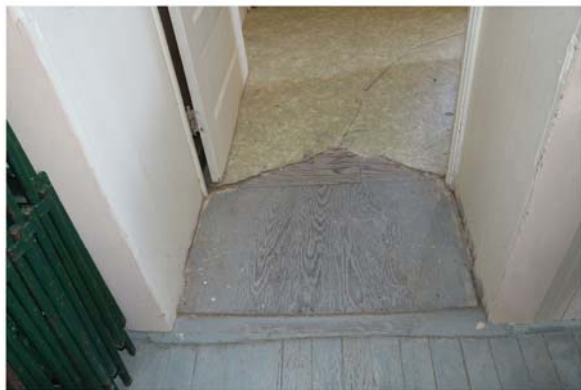
**1** Plywood transition at threshold between blue room and office.

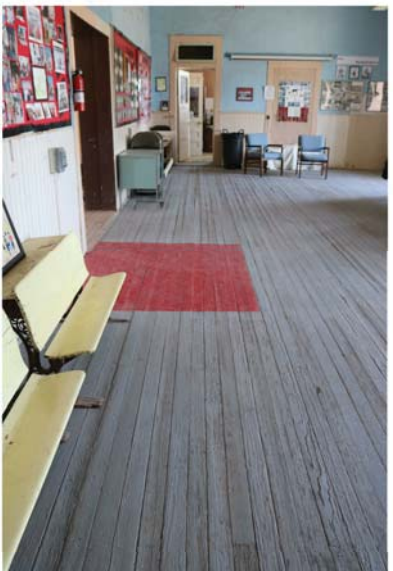
**6** Areas painted red on the floor appear to have indicated equipment locations when the building was used for trades training.

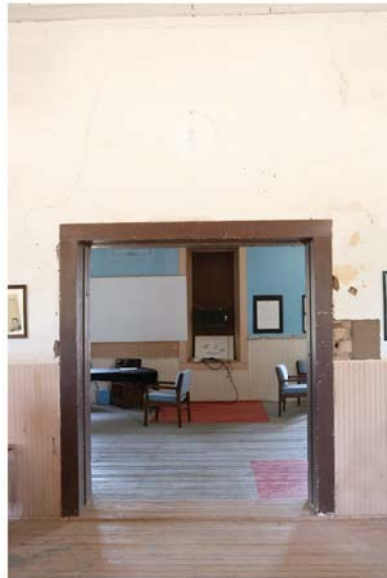
**1** There is a raised wood threshold at the opening between rooms.

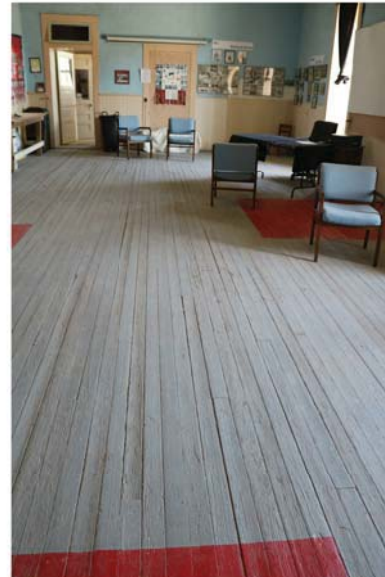
**2** Floor planks show signs of wear and some cupping but are in useable condition.

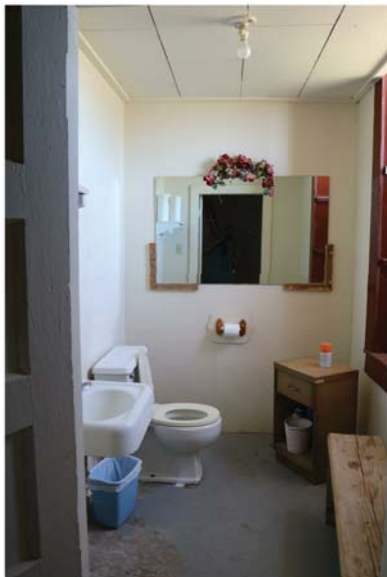
**4** The toilet room floors are concrete.

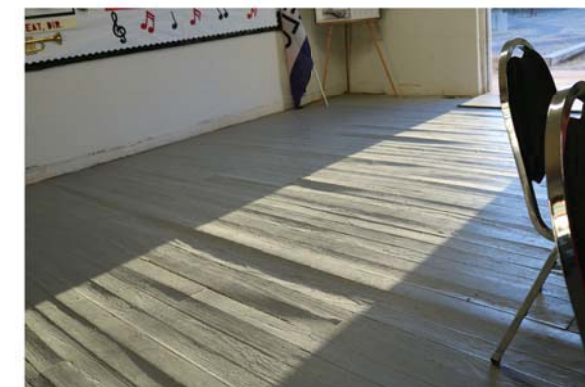
**6** Floor planks in the band hall show some signs of wear and some cupping but are still in useable condition.

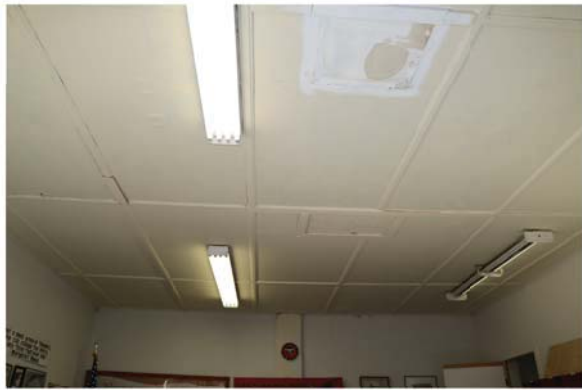
**1** Attic of the band hall is accessible through hatch. Ceiling is patched under abandoned swamp cooler.

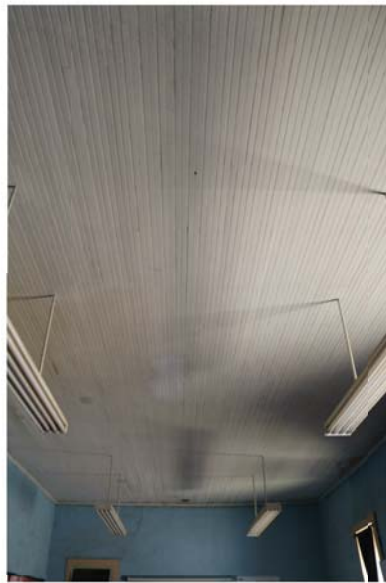
**2** The beaded board tongue-and-groove ceiling boards are in relatively good condition in this area.

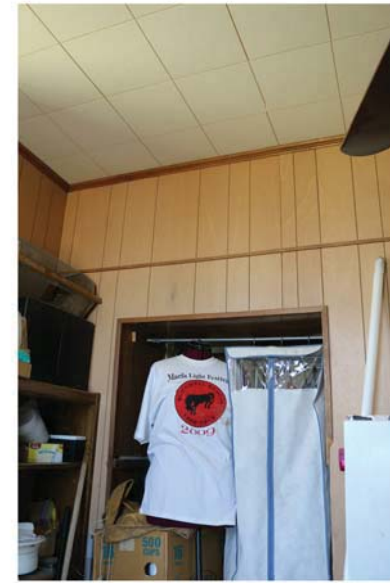
**4** Ceiling in office is non-original acoustical ceiling tiles.

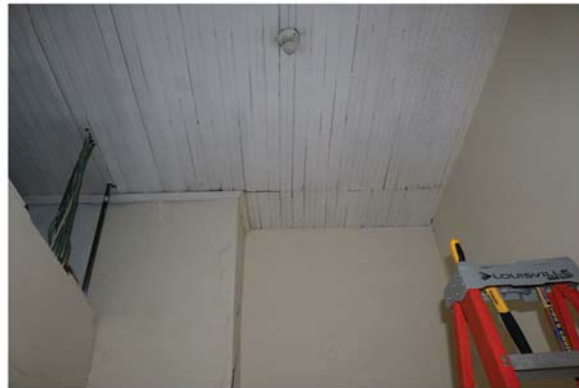
**1** The beaded board tongue-and-groove ceiling boards in the vestibule are patched in where abobe wall was removed.

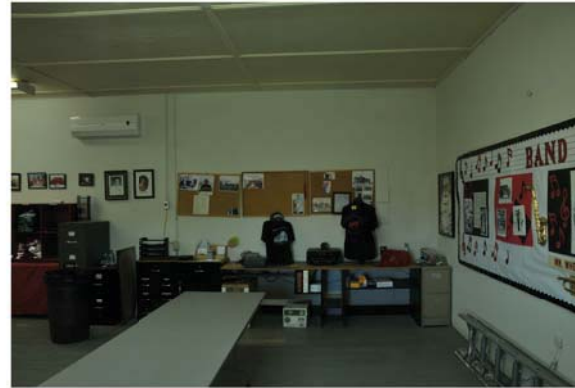
**2** Ceiling In the band hall area has a series of 4' X 8' wood sheets with battens.

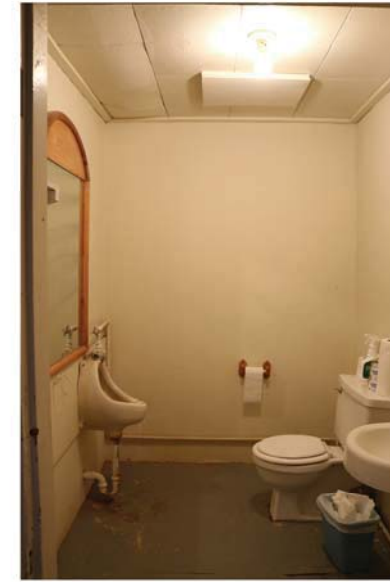
**3** Ceiling in the boys and girls restroom is non-original 16" x 32" acoustical tile panels.

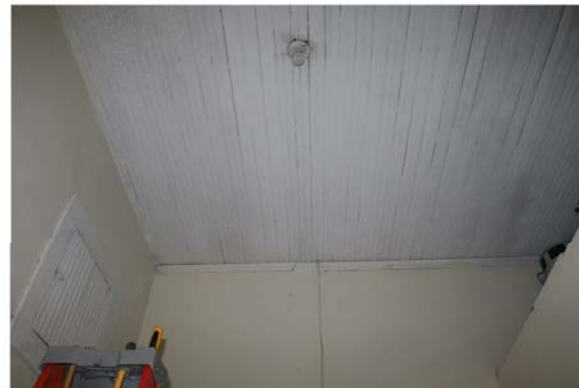
**4** The beaded board tongue-and-groove ceiling boards in the vestibule area run East / West the full width of the interior space.

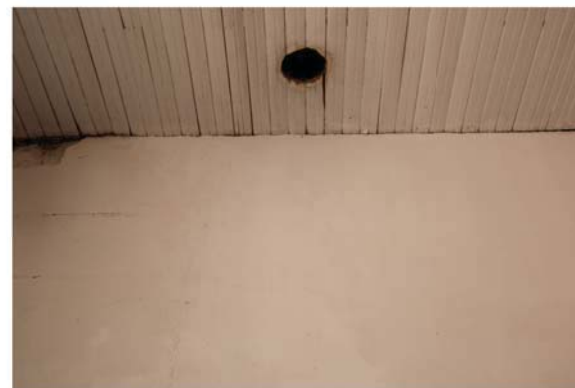
**5** Hole in the beaded board tongue-and-groove ceiling boards from a previously installed chimney flue.

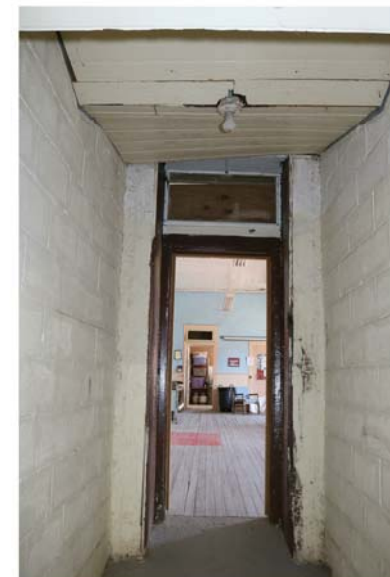
**6** The wood ceiling in the hallway connection is deteriorated, shows signs of previous roof leaks, and appears to be dropping.

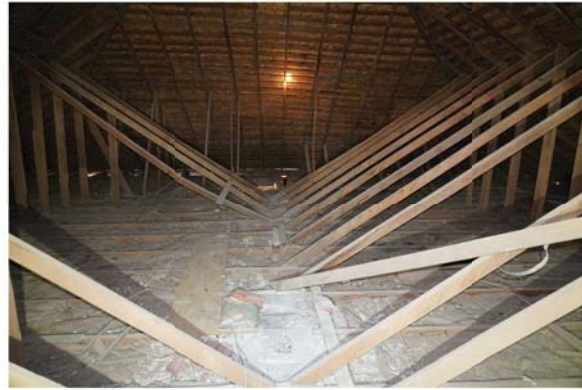
**2** The regular diagonal supports on the south side of the building are missing, lack of support has caused the roof deck to sag on portions of the roof.

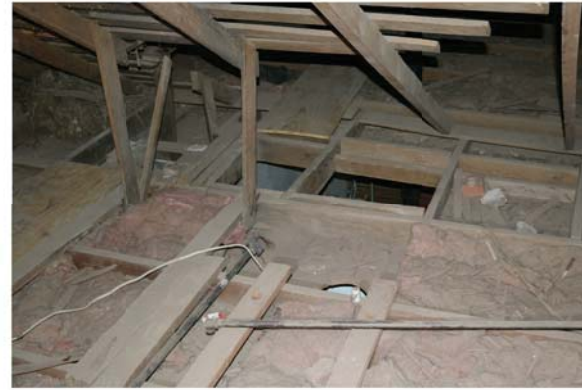
**3** Remains of previously removed brick chimney are visible next to one of the roof attic access points.

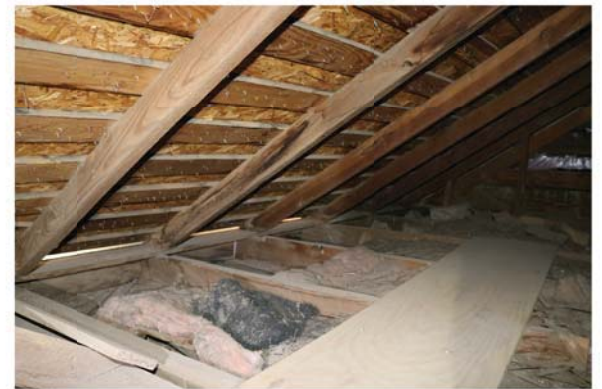
**6** Spaced sheathing used for wood shingles is covered with oriented strand board, presumably installed at time of metal roof.

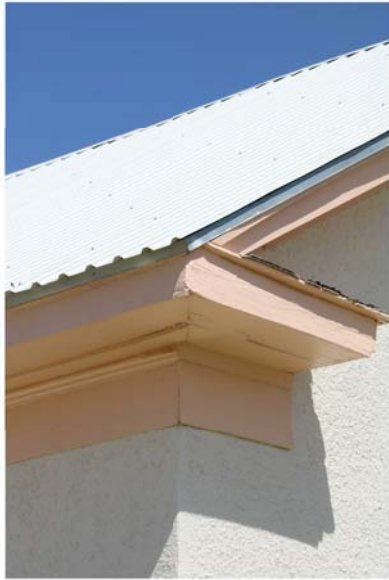
**1** Closed soffit in relatively good condition though some pieces of trim are missing.

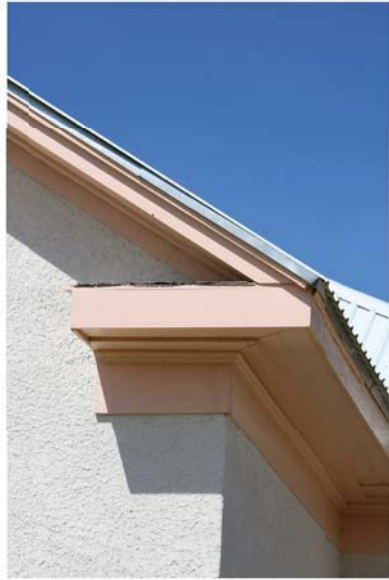
**2** Remnants of original wood shingles still exist at soffit returns

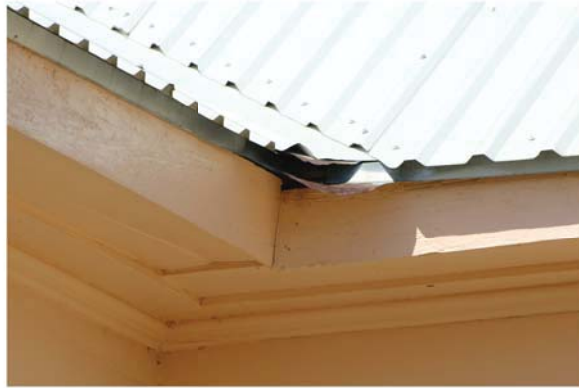
**3** Gap in fascia below valley flashing allows for bird and pest intrusion.

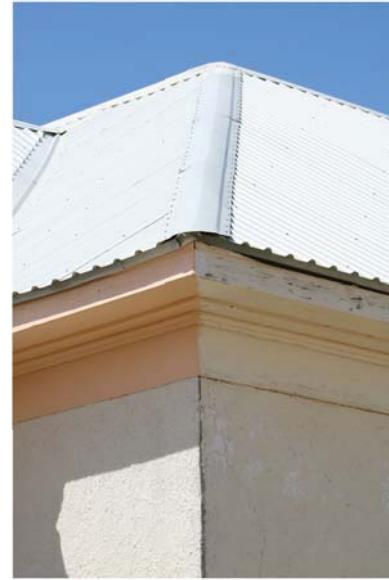
**4** Gap below ridge cap and deteriorated fascia allow for pest intrusion.

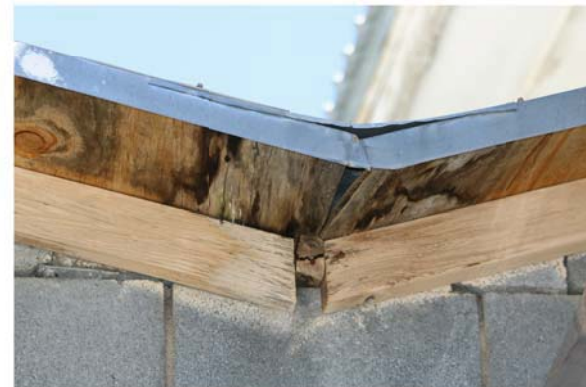
**2** Valley of hallway link is badly deteriorated and poorly constructed.

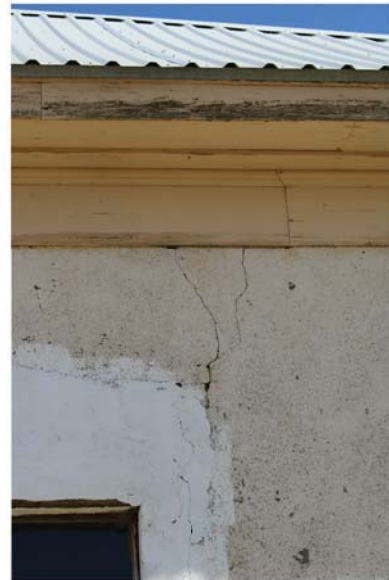
**5** Cracks extending upward from window are not unusual and not of major concern.

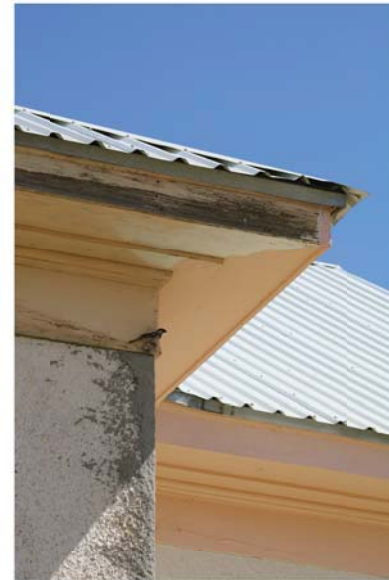
**6** Deteriorated wood fascia and trim.

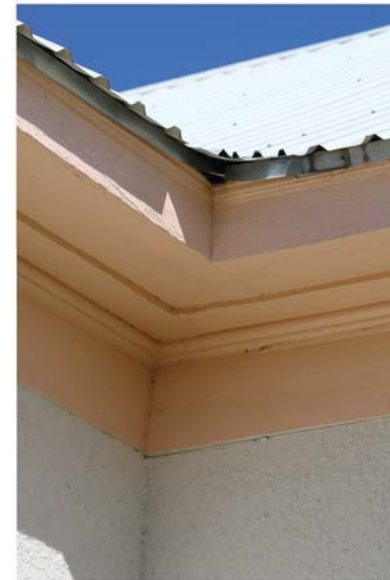
**7** Gap below valley flashing allows for bird and pest intrusion.

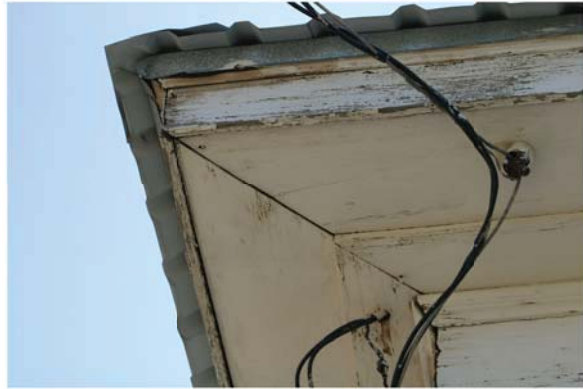
**1** Deteriorated fascia and soffit, gap at drip edge.

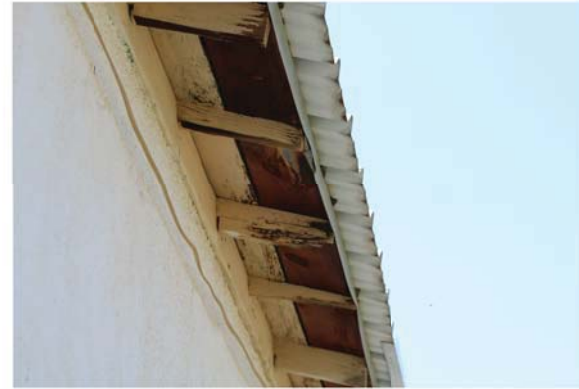
**3** Rafter tails and roof deck are rotted.

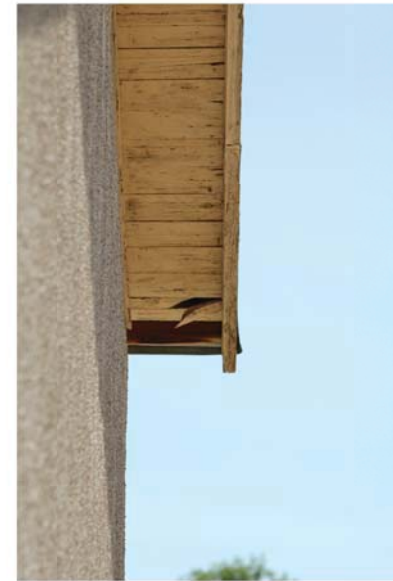
**4** Soffit at rake of band hall is rotted.

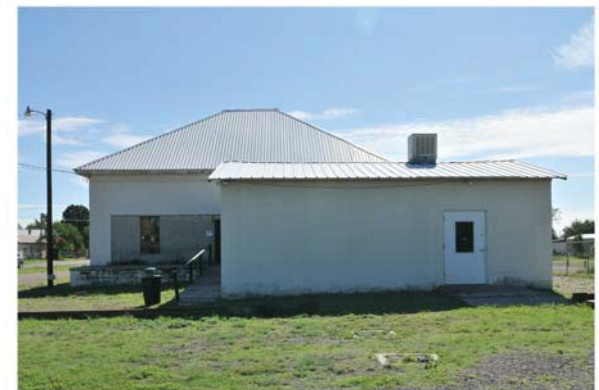
**5** The "ghost" of five previously blocked windows is visible.

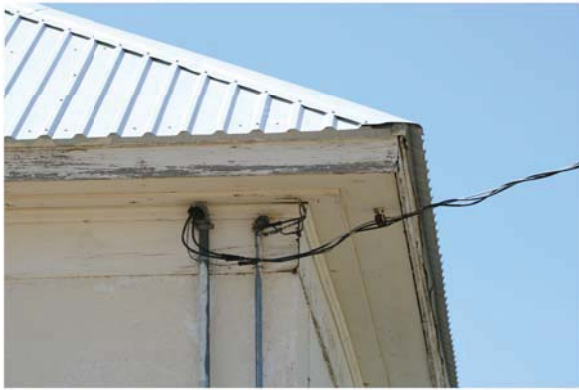
**1** Corner shows hard cement stucco edge and deteriorated fascia and trim.

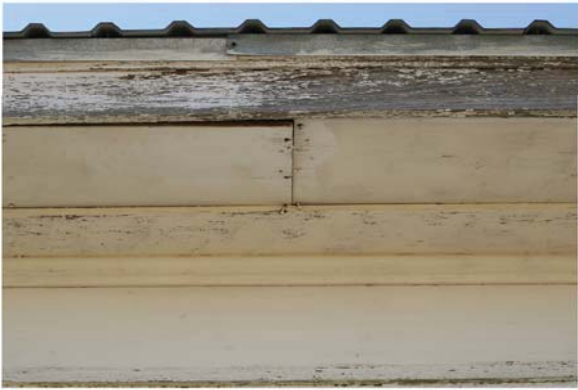
**2** Fascia and soffit are deteriorated and detached from structure

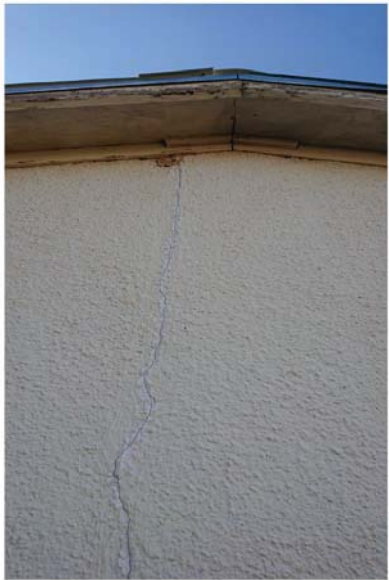
**5** Crack in stucco runs full height of wall at location of abandoned chimney flue.

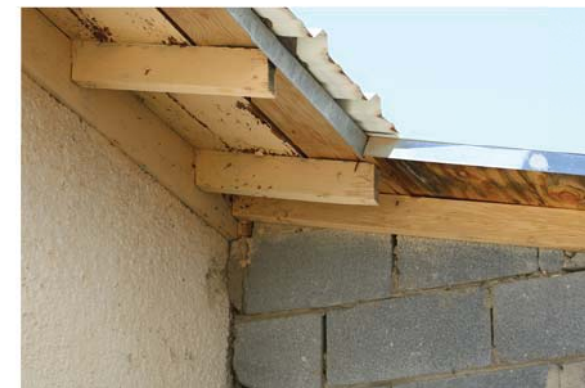
**2** Roof deck board in this area has been replaced.

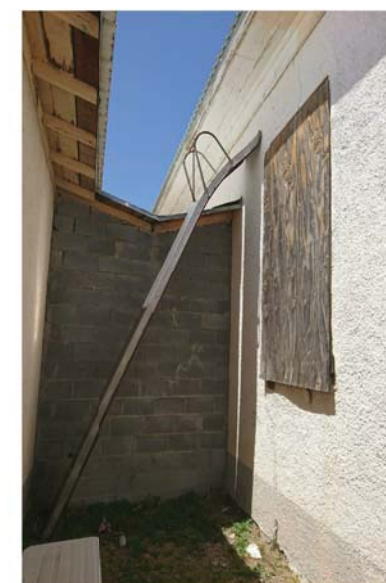
**3** Plywood covers the window opening.

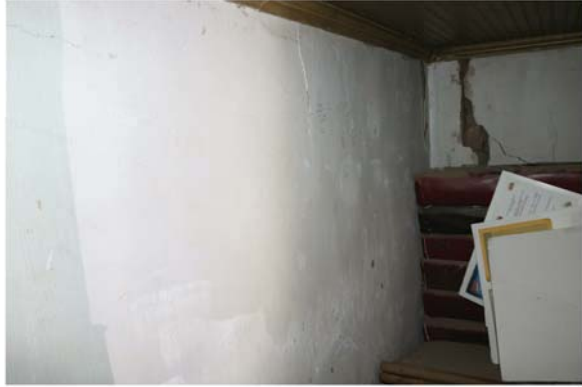
**1** Vertical cracking at inside corner appears in structure along with numerous plaster repairs.

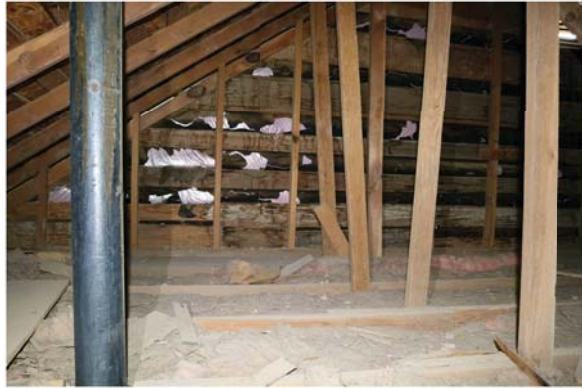
**2** Wood structure at interior face of gable.

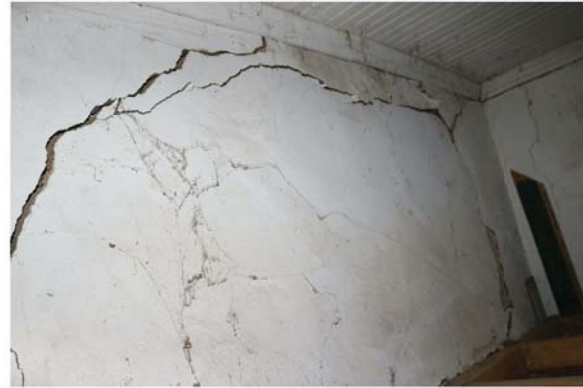
**3** Numerous surface cracks at inside corner reveal delamination from wall and surface plaster is out of plane. Cracks are not visible below office ceiling due to installation of paneling on lower portion of wall.

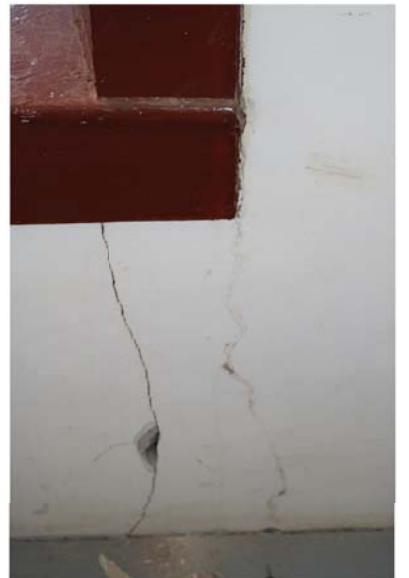
**5** Vertical crack below window shows break in cement plaster which is expected at an opening.

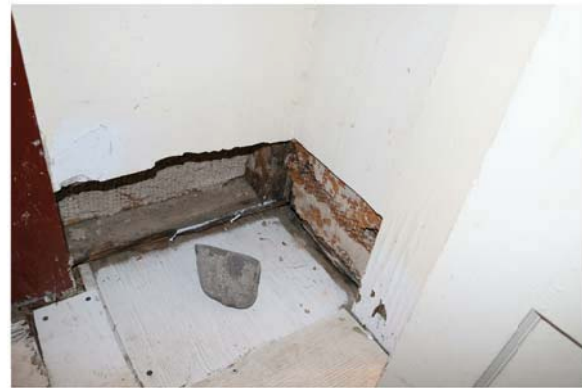
**1** Water leak has caused floor to rot as well as sole plate and studs. Metal lath is rusted.

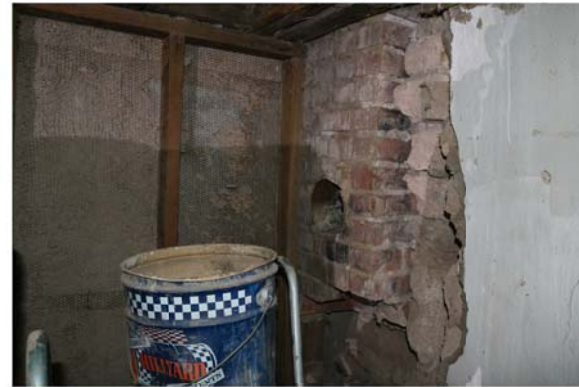
**2** Brick chimney for flu was constructed at top of adobe wall which was dismantled and replaced with stud wall. Chimney no longer penetrates roof.

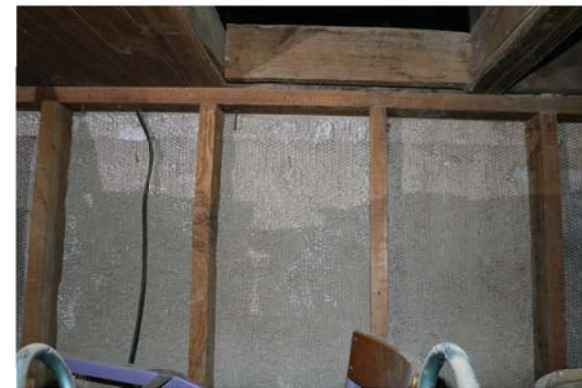
**3** Non-original wood stud wall with expanded metal lath and cement plaster comprises the west wall of the boys restroom.

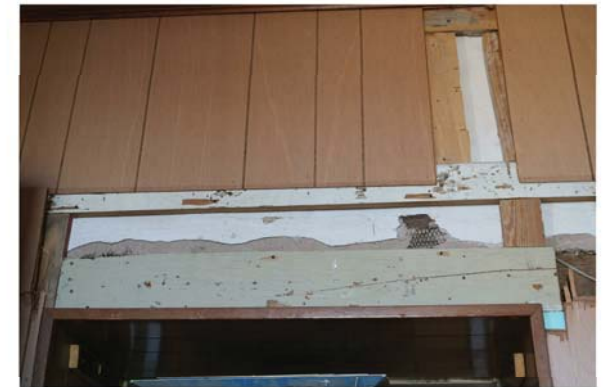
**4** concrete lintel above blocked opening between office / storage area and south classroom.

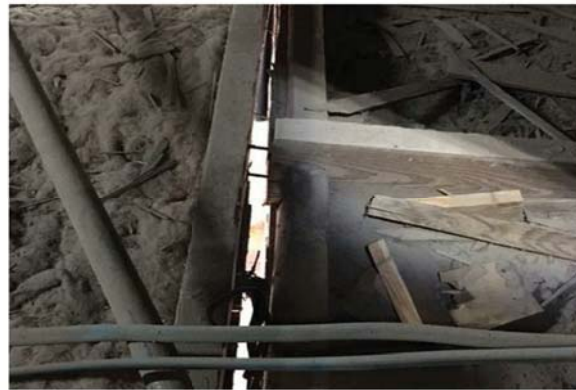
**2** Structural members were pulled apart where structure changes direction.

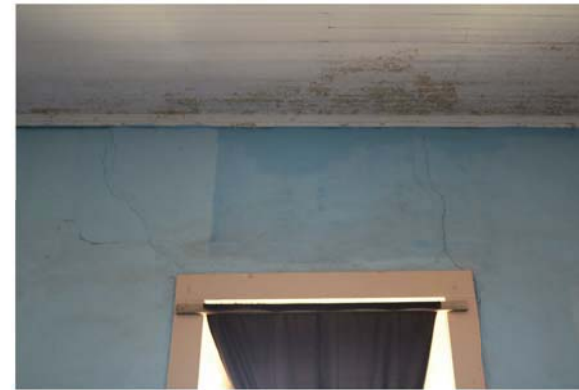
**3** Cracking above window at the corners is common where the window creates a natural weakness in the structure.

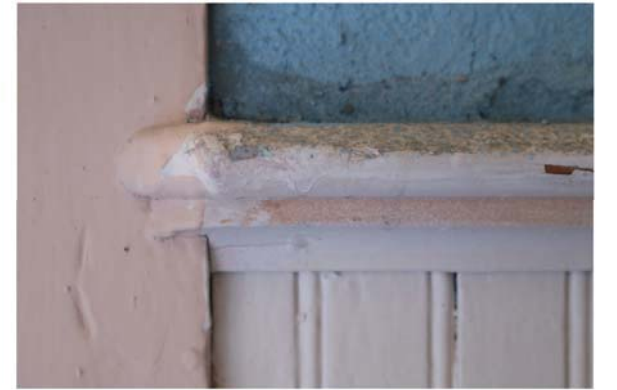
**4** The cap and molding of the beaded board wainscot wraps the casing and is still visible in some areas.

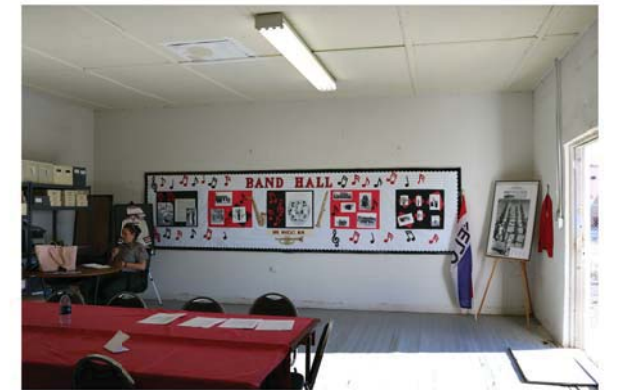
**6** Another line indicated a wood base board was previously installed in the band hall.

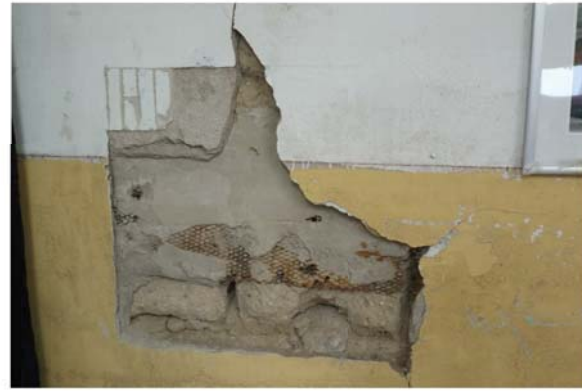
**3** Previous attempt to tie stud wall to adobe wall where original north/south wall was removed. The wainscot along this wall has been removed and is indicated by a difference in paint color.

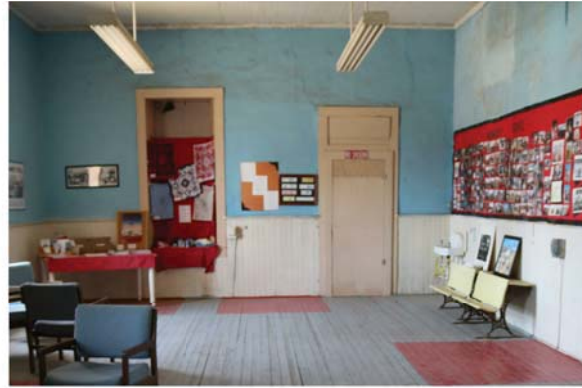
**1** Overall view looking west. window opening is covered by plywood on the exterior and the transom at door is blocked.

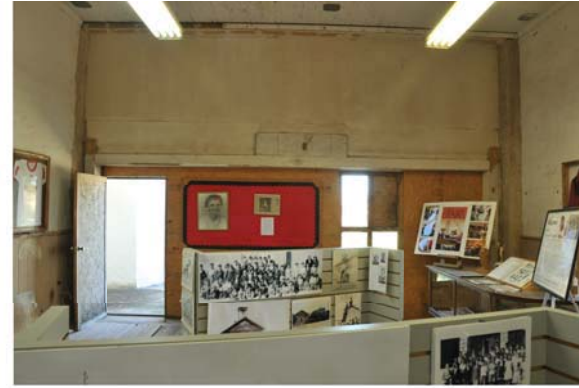
**2** Infill wall at loading dock where original adobe wall was removed and is in poor condition.

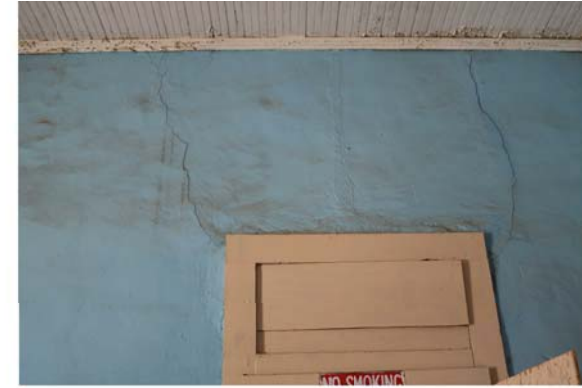
**3** Cracks appear on both sides of door assembly transom is blocked at connection to band hall beyond.

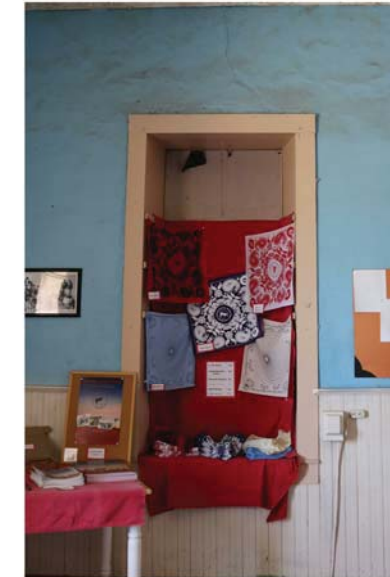
**5** Window looks to band room and is blocked.

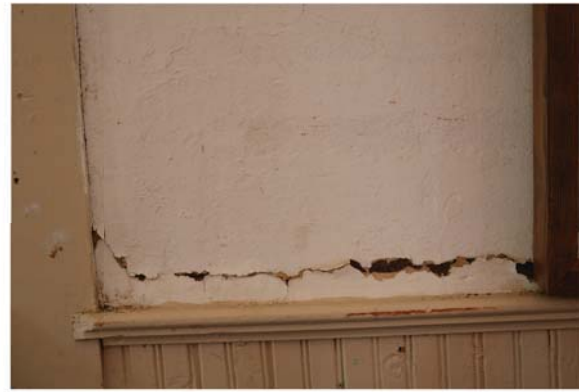
**2** Various layers of plaster have fallen off revealing the adobe beneath.

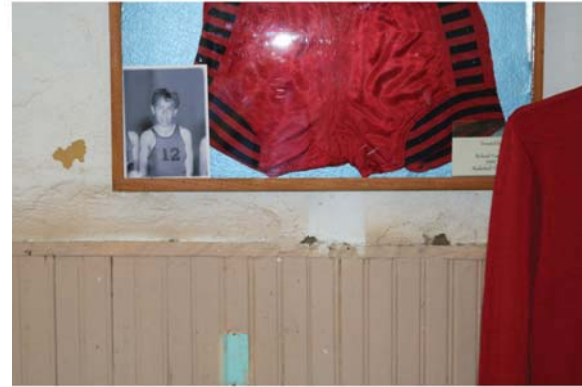
**5** Repairs are evident above the wainscot where the cap has been chiseled off. The missing electrical outlet reveals a previous layer of aqua paint.

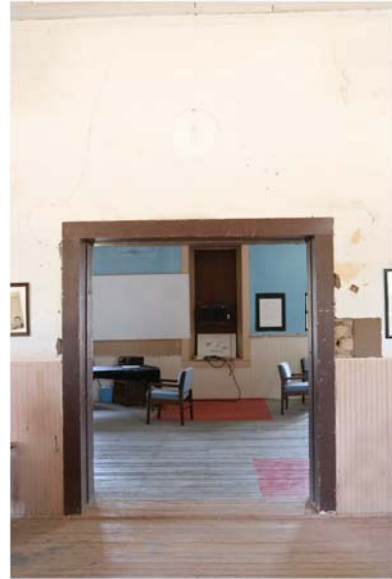
**2** Opening between classrooms shows evidence that hinges and doors were previously installed. Opening may not be original.

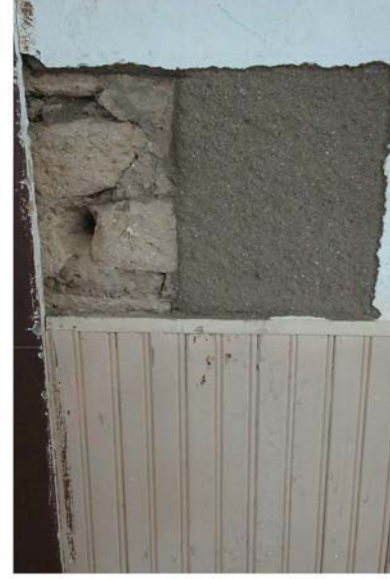
**3** A previous investigation by Cornerstones Community Partnerships, 2008, reveals layers of construction.

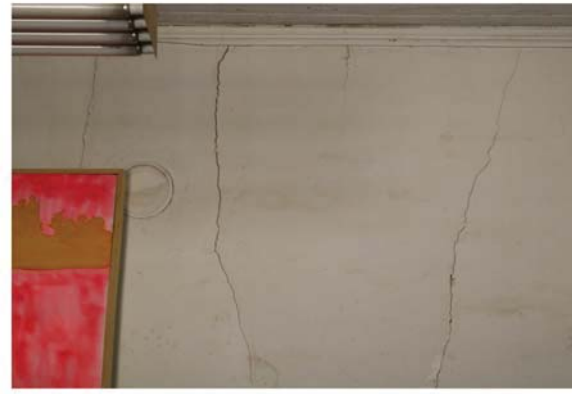
**4** Metal plate covers opening for flue pipe to chimney which has been dismantled.

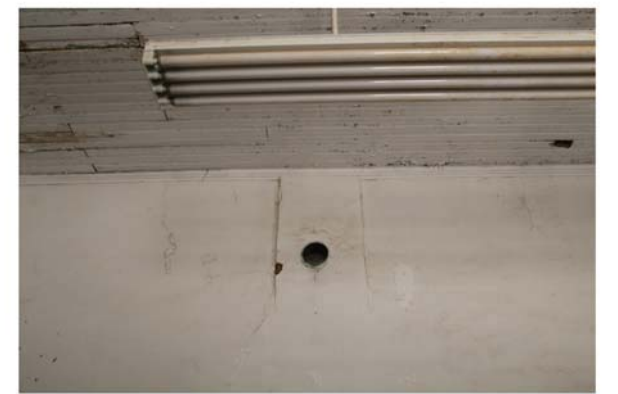
**5** The bulge in the wall defines the location of the brick chimney constructed in the adobe wall and now dismantled at top of wall. Borings were done to verify location of brick to adobe construction.

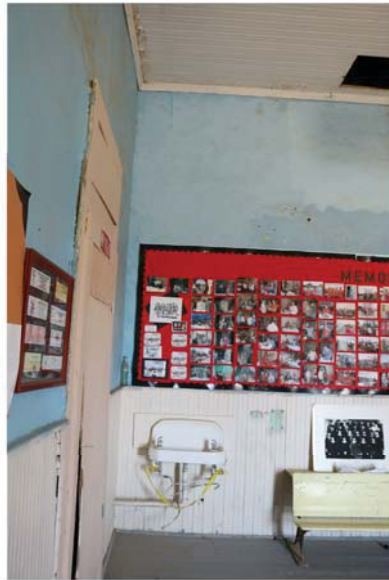
**1** Water fountain appears to have been a source for visible moisture damage. Cap of wainscot has been chiseled off.

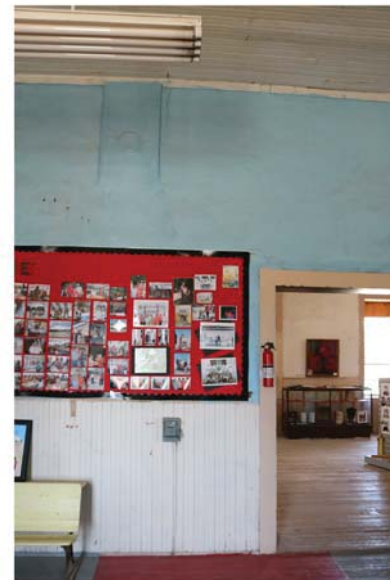
**3** Breaker box may date to period of trade school. Cap of wainscot has been chiseled off. Repair at upper left corner of doorway should be investigated.

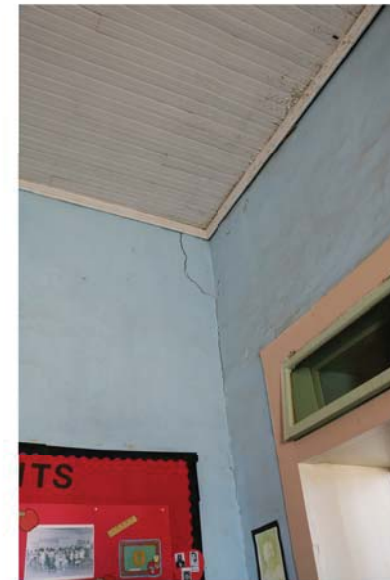
**4** Crack at intersection of walls and plaster which is out of plane indicate movement in the structure.

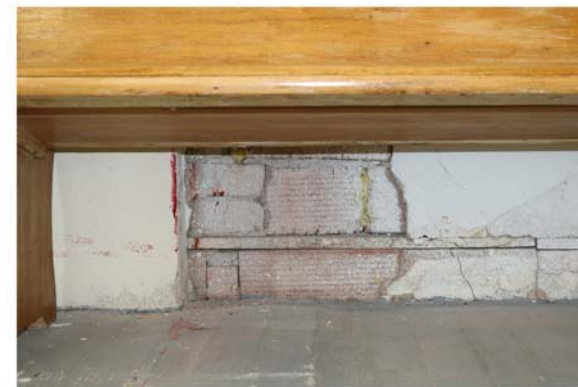
**6** Brick chimney abuts structural clay tile wall. a wood nailer indicated a wood baseboard was previously installed.

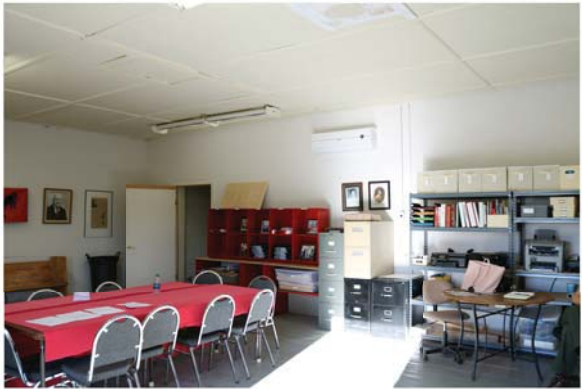
**1** Doorway at ramp to main building. A new mini-split HVAC system has been installed on this wall.

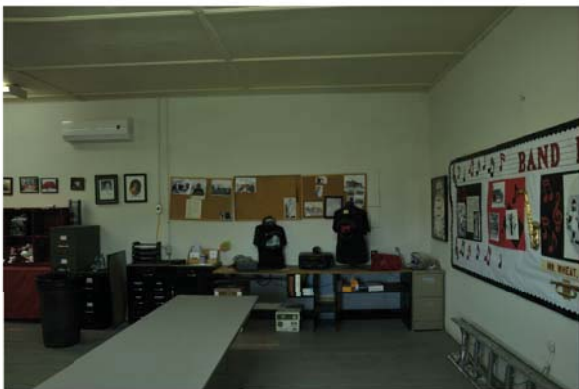
**2** View of the inside of the band hall looking east where there is no evidence of the opening that is visible from the outside.

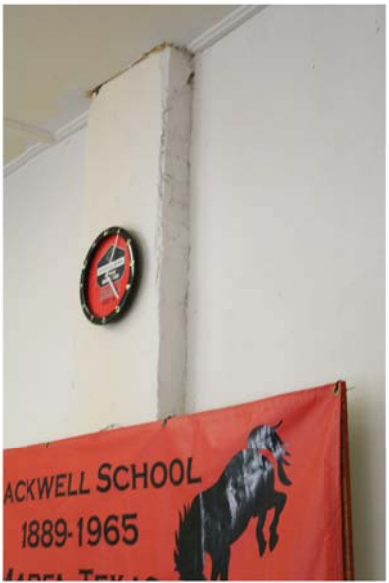
**3** A brick chimney projects from face of clay tile wall.

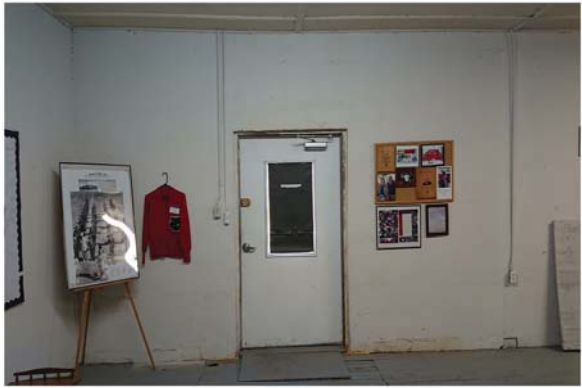
**5** Non-original hollow metal door installed near the location of previous window.
