# Ocracoke Light Station Cultural Landscape Report

# Ocracoke Light Station

## Cultural Landscape Report

January 2016

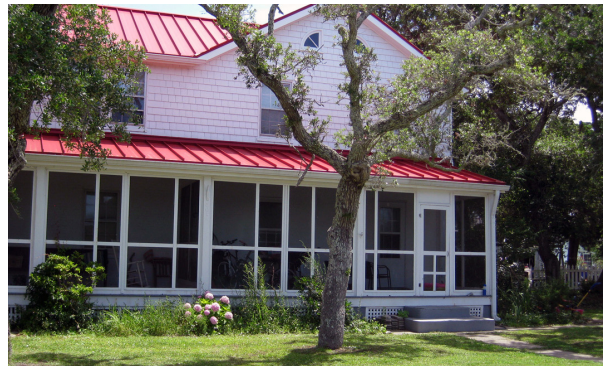
FIGURE 5-3. Perennials beds in need of maintenance, 2013. (NPS/SER-CRPS Collection)

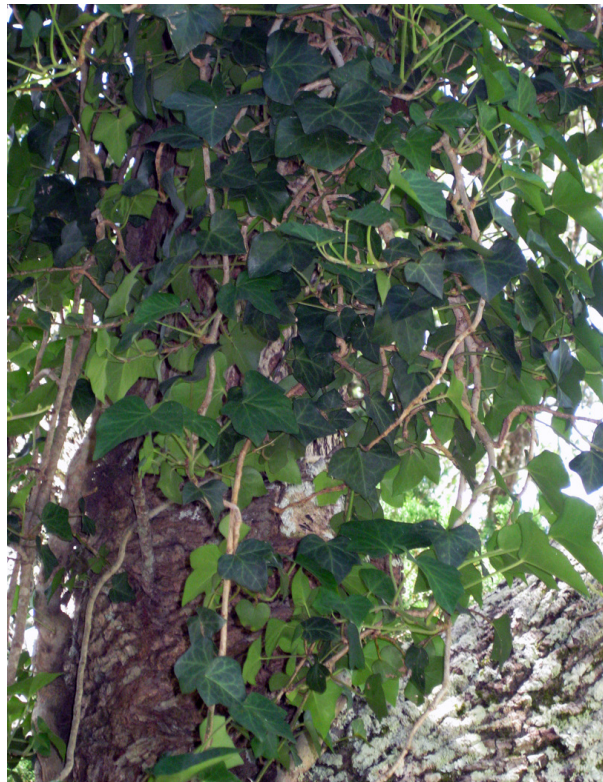
FIGURE 5-4. English ivy growing up a tree, 2013. (NPS/SER-CRPS Collection)

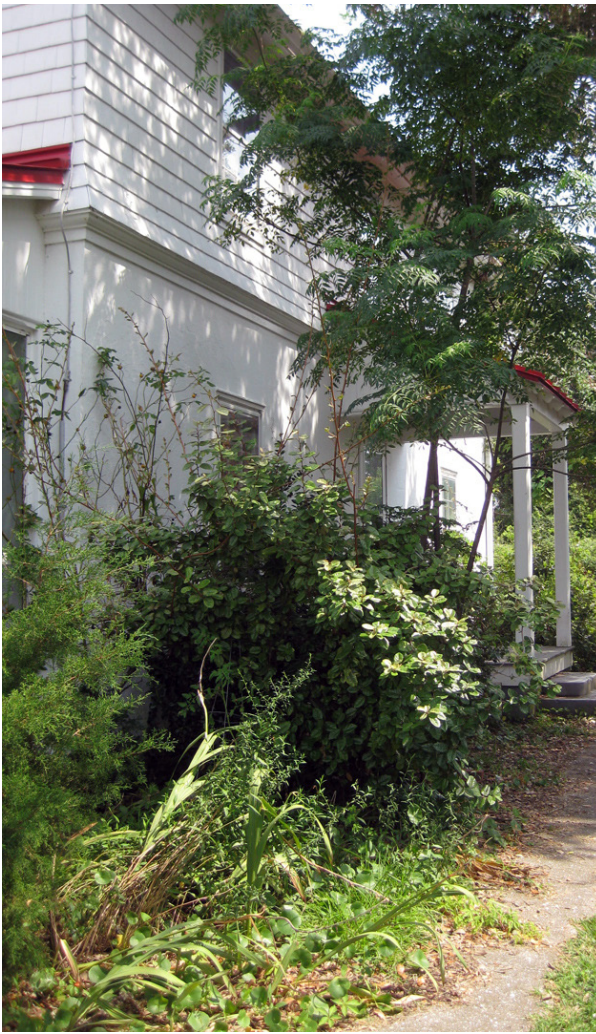
FIGURE 5-5. Chinaberry seedling to be removed, 2014. (NPS/SER-CRPS Collection)

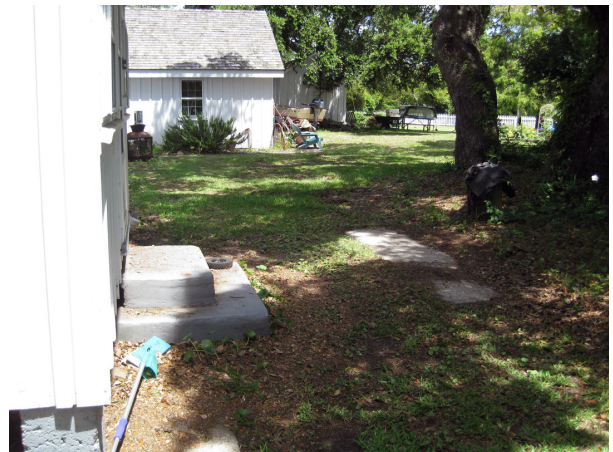
FIGURE 5-9. Section of concrete walkway on the east side of the double keepers' quarters disappearing into the grass, 2013. (NPS/SER-CRPS Collection)

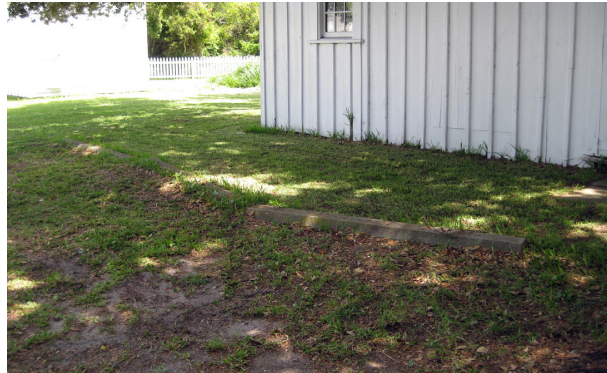
FIGURE 5-14. Concrete parking blocks north of the double keepers' quarters, 2013. (NPS/SER-CRPS Collection)

- Such a change in use would allow the double keepers' quarters to be interpreted without modern vehicles parking inside the station.
- Concrete parking blocks north and south of the double keepers' quarters may remain to accommodate staff vehicles.
- A comprehensive plan that considers cultural and natural resource concerns in conjunction with park management goals in the layout of the parking area is needed before a final design is agreed upon.

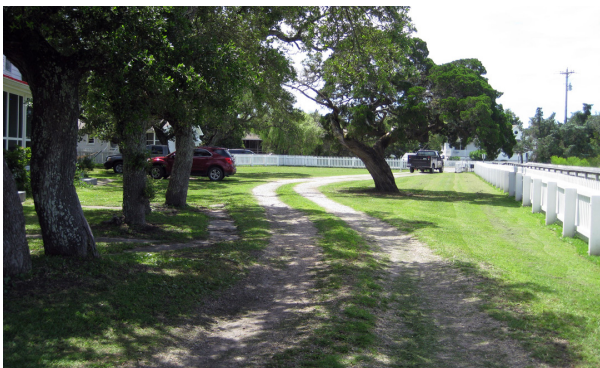
FIGURE 5-12. Alignment of the driveway, 2013. (NPS/SER-CRPS Collection)

- Preserve the alignment of the driveway, which is recorded as early as 1897.
- Restore the original footprint of the boardwalk. Its current configuration with hand rails is an inappropriate design that detracts from the spatial character of the light station and degrades views and vistas.

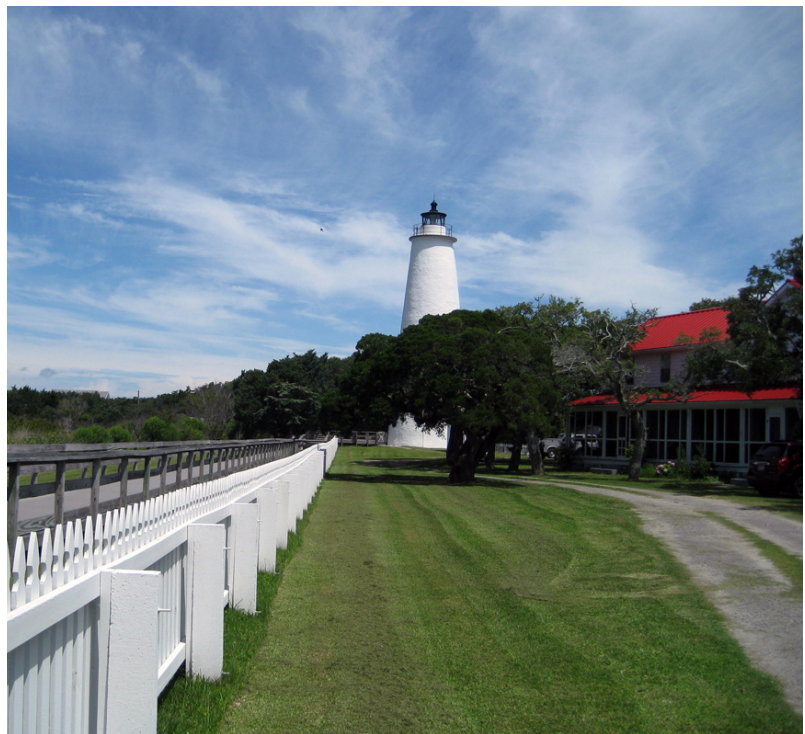
- The viewshed from the bottom of the light tower should also be preserved. A boardwalk that links the parking area and the lighthouse currently degrades the view to the west, but it is the only access for visitors to the lighthouse since the remainder of the light station is not open to the public. If visitor access changes so that visitors enter the station as they did historically through the front gate and driveway, remove the boardwalk to restore the viewshed to the

FIGURE 5-19. View of boardwalk from the entry drive, 2013. (NPS/SER-CRPS Collection)

west or restore to original footprint.

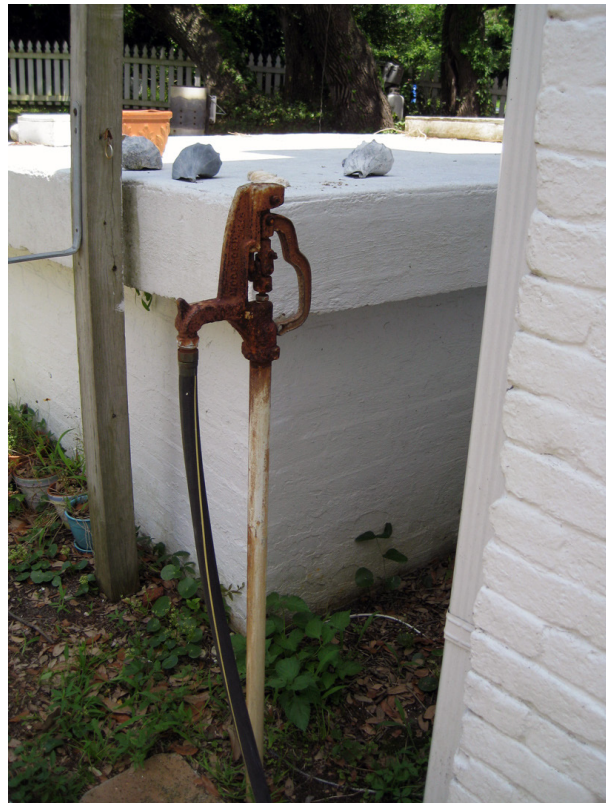
A metal yard hydrant covered with rust is contributing although its age is unknown.

FIGURE 5-21. Metal yard hydrant with hose post in the background. (NPS/SER-CRPS Collection)

- Remove the hose post if staff moves out of double keepers' quarters.
- Picnic tables should be a traditional design of wood, not plastic.
- Bicycle racks may remain as long as their design does not detract from the setting of the site.
