**The Bowman-Hite Property  
Warren County, Virginia**

**Bowman-Hite Farmhouse  
Historic Structures Report**

**Final Submission**

*October 2013*

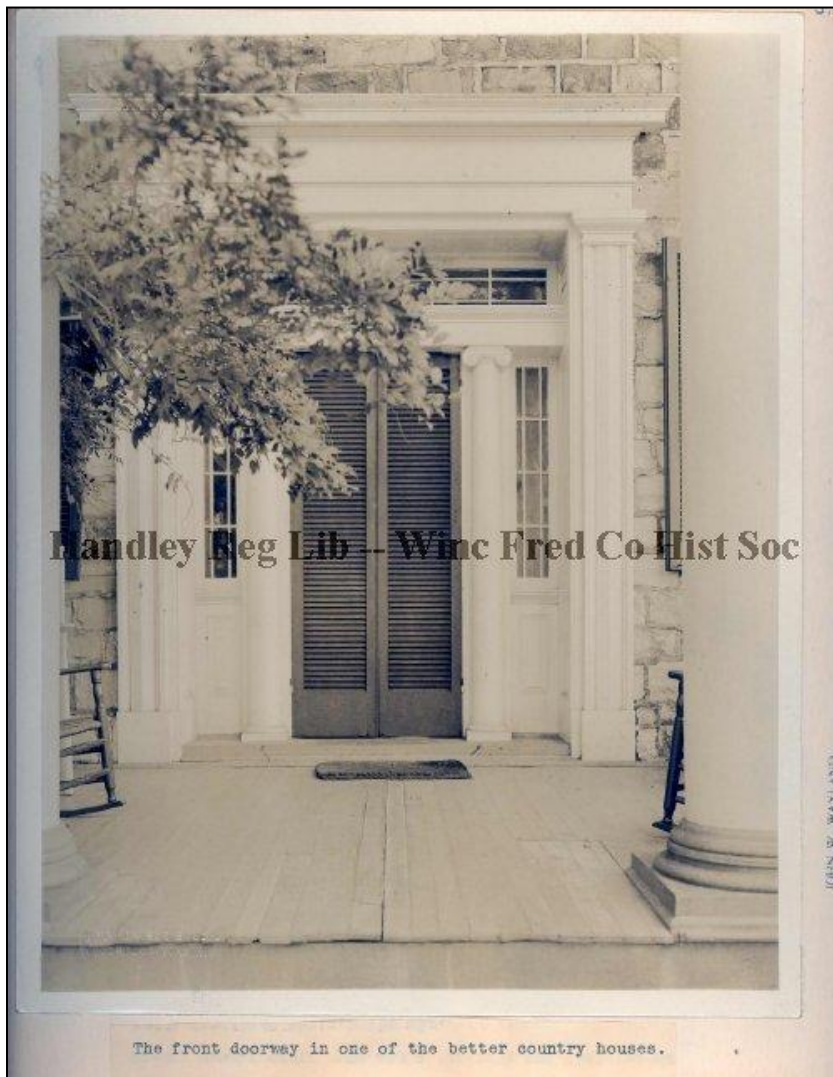
The door surround at the primary, west facing, entryway would have been the most elaborate and illustrates well the structure's Greek Revival influence. Comprised of a transom and two sidelights, the surround resembles Springdale's entryway, another Hite family property in nearby Frederick County (**fig. 33**). Divided by four vertical and three horizontal muntins, the transom spans across the entire entryway. The two sidelights are similar in composition, with three vertical and three horizontal muntins. The two exterior doorways off the rear of the structure were unadorned.

Figure 33: The front door surround to Springdale in Frederick County, Virginia. While added during the mid-19<sup>th</sup> century, this Greek Revival surround is similar in many respects to the less ornate example at the Bowman-Hite house, especially the sidelights and transom. (Photograph from the Handley Regional Library, early 20<sup>th</sup> century)

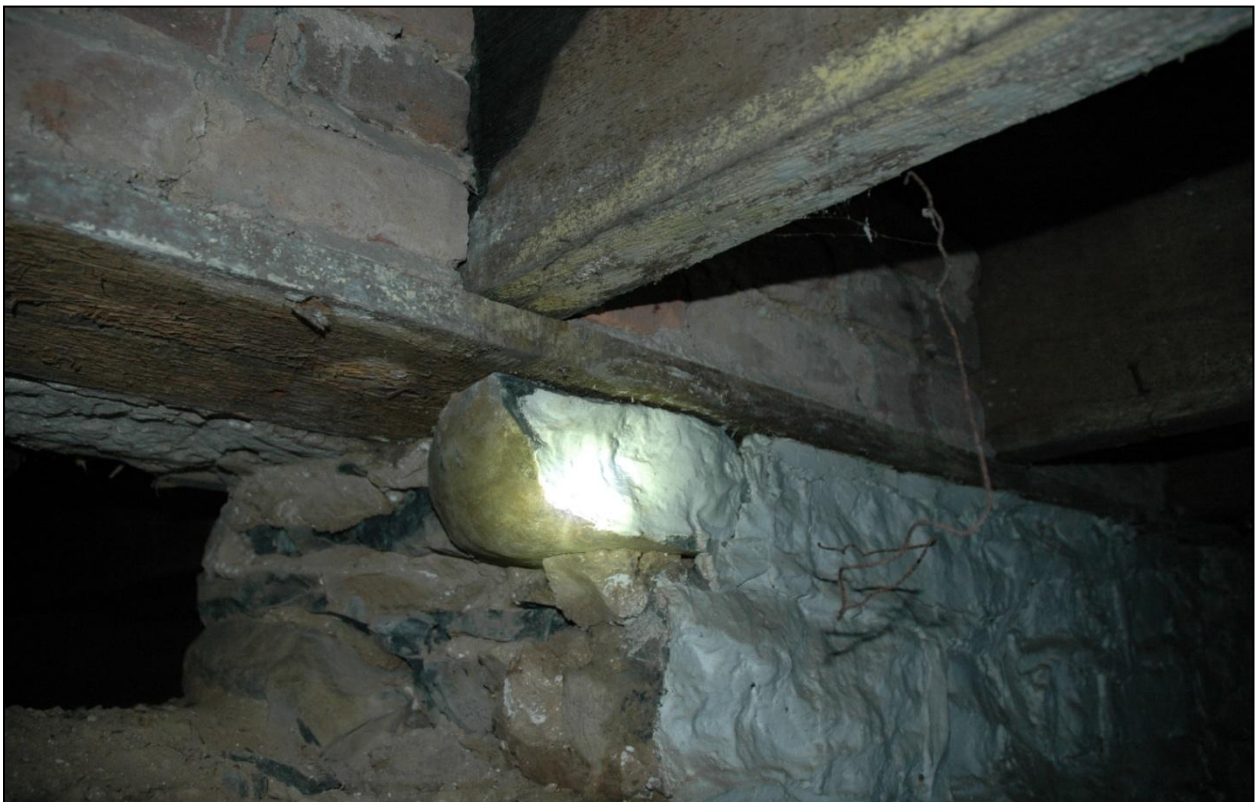
Structurally, the carpenters building the wooden internal support first placed a wooden sill on top of the stone foundation. This wooden sill provided a level surface on which the joists could rest as they were inserted into pockets within the one-and-a-half wythe brick wall (**fig.35**). Floorboards were then laid directly over the joists and fastened using cut nails. Where openings in the floors were required for either stairways or hearths, carpenters utilized trimmers and headers, which were for the most part joined with cut nails. However, the front parlor hearth uses a through tenon rather than cut nails. Joinery was only used elsewhere in the house for finish work, notably the cellar door frame and paneling on the front entryway. The joists of the second floor are set much the same way as the basement, with the brick wall stepping in a half wythe forming another ledge upon which the joists rest.

Figure 35: Basement image at the Bowman-Hite house showing the wood plate resting on the stone foundation. The brick walls are placed on top, with pockets inserted into the walls for the joists to rest. (Photograph by Michael Spencer, 2011)

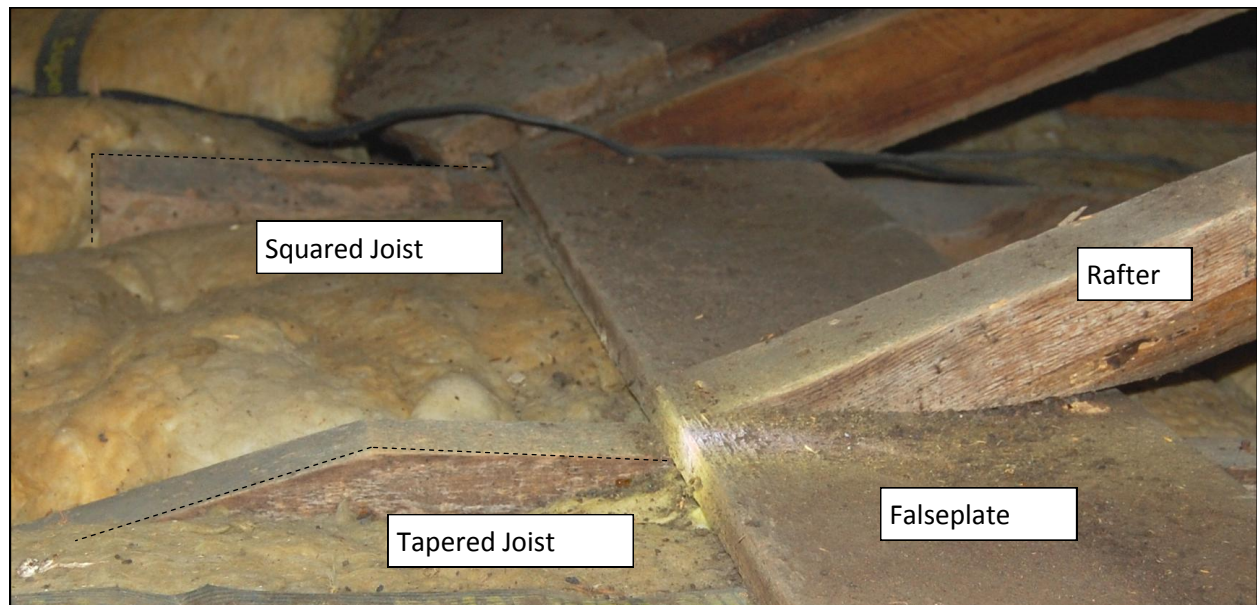
However, the attic joists, rather than resting inside pockets, sit atop the wall. Because of their position, the ends of the joists are tapered to coincide with the pitch of the roof, a typical technique used by carpenters when dealing with brick corbelling at the cornice line. This feature also indicates that the current roof pitch of the structure has been maintained since its original construction date. Furthermore, the presence of un-tapered joists at the intersection with the rear ell confirms it as original (**fig.36**). Resting atop the attic joists are false plates upon which the common rafters are seated and skew nailed (**fig.34**). The use of the lighter, common rafter system indicates that the structure was likely covered with wood shingles rather than a heavy slate, which would require a much more substantial support system. The re-use, reconfiguration, and probable replacement of many of the nailers covering

Figure 36: Bowman-Hite attic image showing the tapered joists typically used on top of corbelling. The taper also indicates original roof slope. The square joist in the background was never tapered due to its concealment under the rear ell. The rafters are seated on the falseplate and are nailed to it with cut nails. (Photograph by Michael Spencer, 2011)

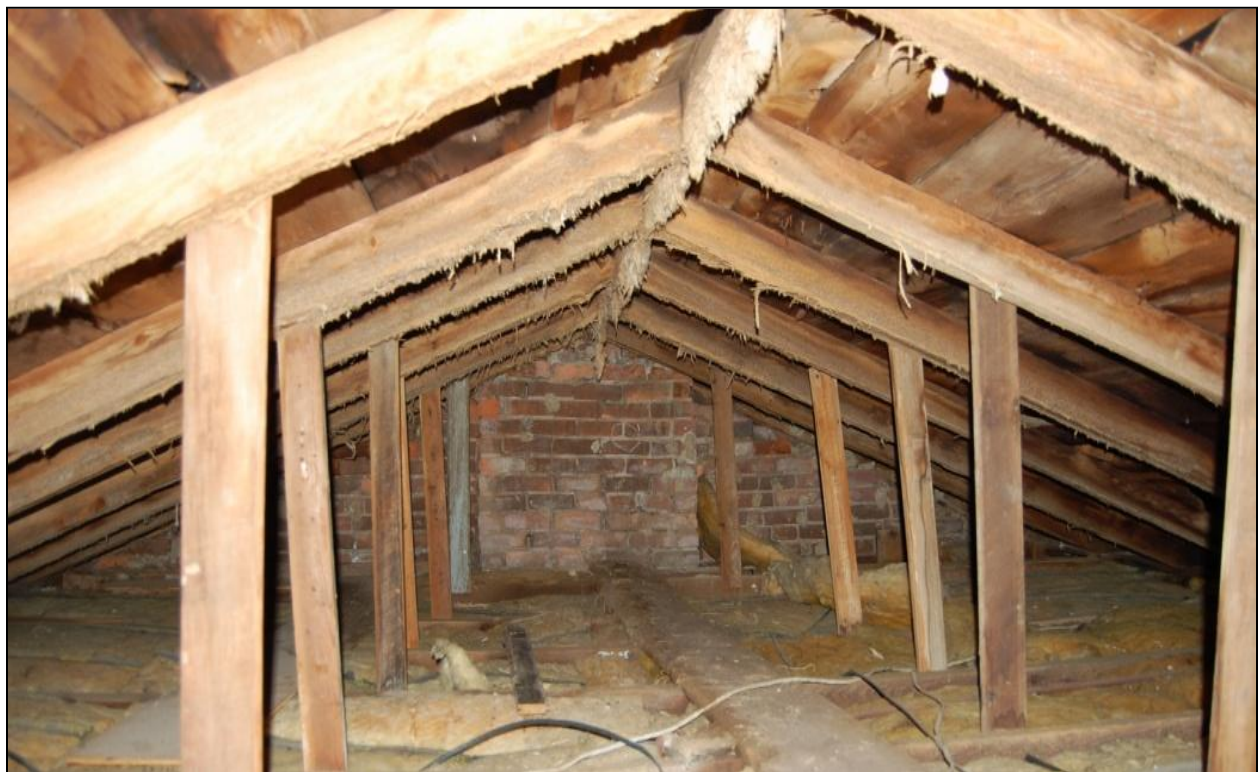
the rafters can also be clearly seen in the attic with both circular and sash saw marks visible. Additionally, the tight spacing of the nailers currently seen in the attic is not typically conducive for wood shingles as it fails to provide adequate ventilation, promoting rot and was likely reconfigured with the installation of a metal roof. Forming the apex of the roof structure is a ridge-board, more typical of an economical balloon frame structure from the later-19<sup>th</sup> century (**fig. 37**).<sup>176</sup> The rafters are all fastened to this board using cut nails.

Figure 37: Bowman-Hite's common rafter system with ridgeboard, something typically found in later-19<sup>th</sup> century balloon frame structures. This system may have replaced the original roof during the ca. 1876-1880s alterations although this cannot be entirely confirmed. (Photograph by Michael Spencer, 2011)

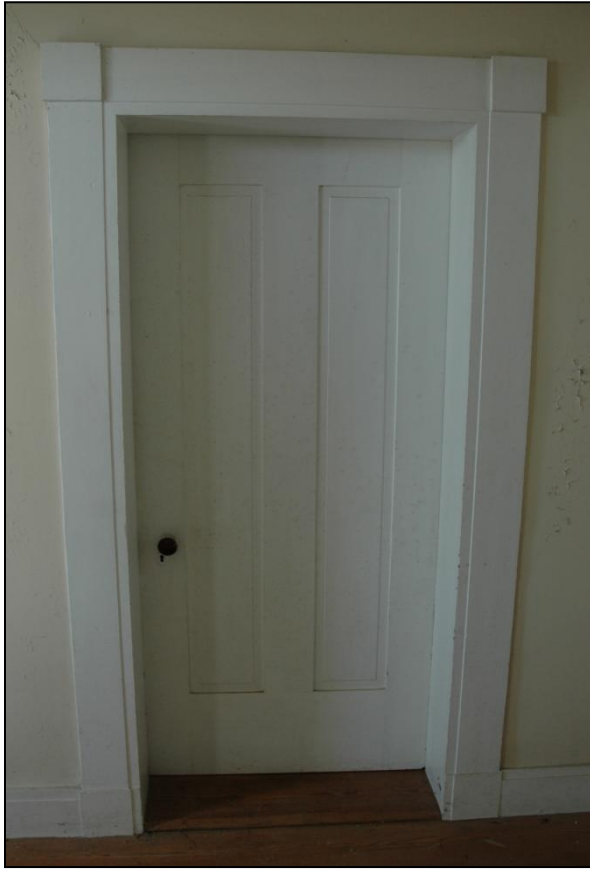
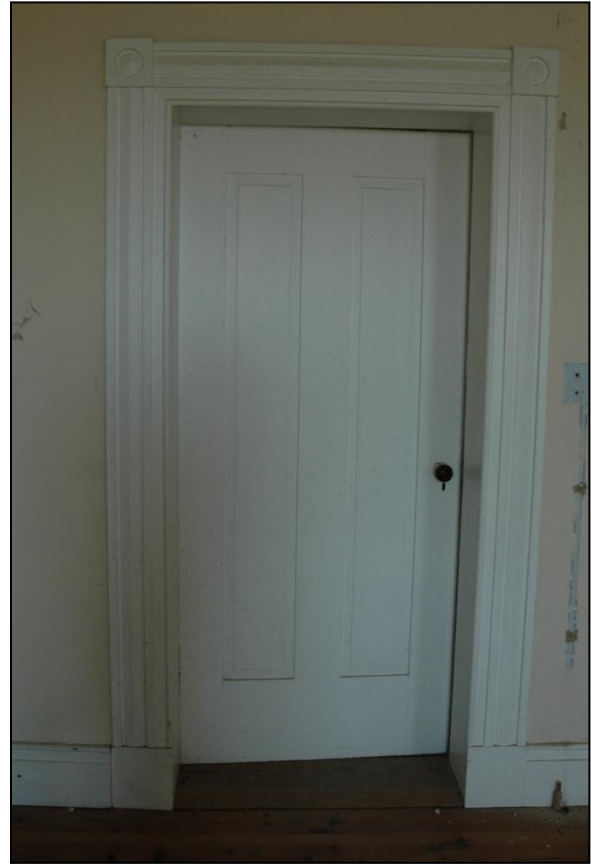
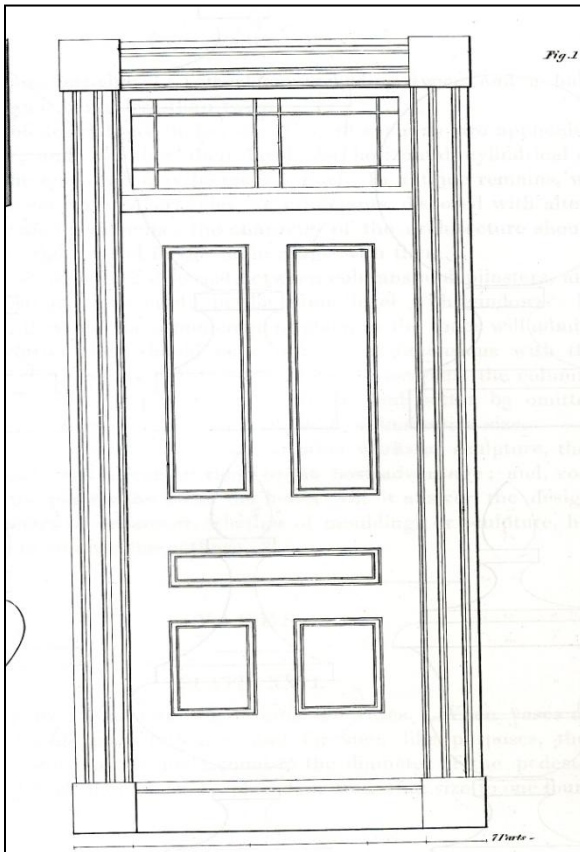
Figure 38: The top left image shows the more vernacular door surround present at the Bowman-Hite house, as well as the Greek Revival two panel doors. The right image is of a front parlor door. Note the elaboration on the door surround as well as the baseboard. The patera are also more intricately detailed. (Photographs by Michael Spencer, 2011)

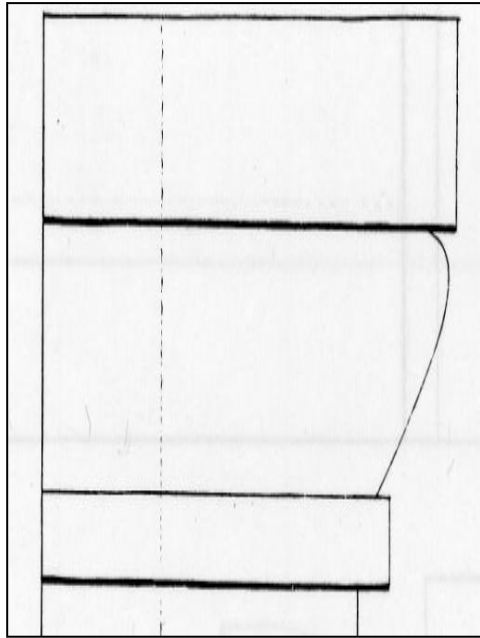
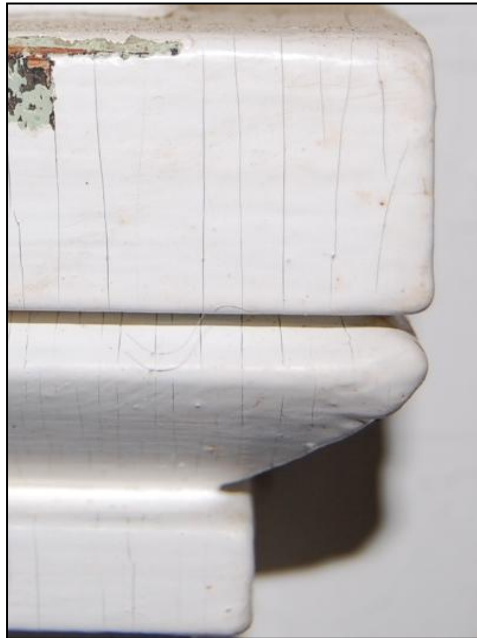
The four mantles located in each room also convey this sense of economical Greek Revival design. Clearly vernacular in nature they only differ slightly from each other, with each bearing similarities to Greek Revival designs illustrated in Asher Benjamin's 1830 publication, *The Architect or Practical House Carpenter*.<sup>177</sup> The relationship to such design patterns is clearly illustrated in the presence of a quirk, or sharp return in the molding, typical of Greek Revival (**fig. 40**). The design of the Bowman-Hite mantles, while simple, was used extensively in Virginia, as an 1854 example from Braehead in Fredericksburg appears very similar. The stark appearance of the mantles is, however, quite different than the elaborate mantles found at nearby Mount Pleasant.

Figure 40: The left image is taken from Asher Benjamin's 1830 *The Architect or Practical House Carpenter* book and is of a mantle molding profile. The right image is a similar molding found at the Bowman-Hite house. (right image by Michael Spencer, 2011)

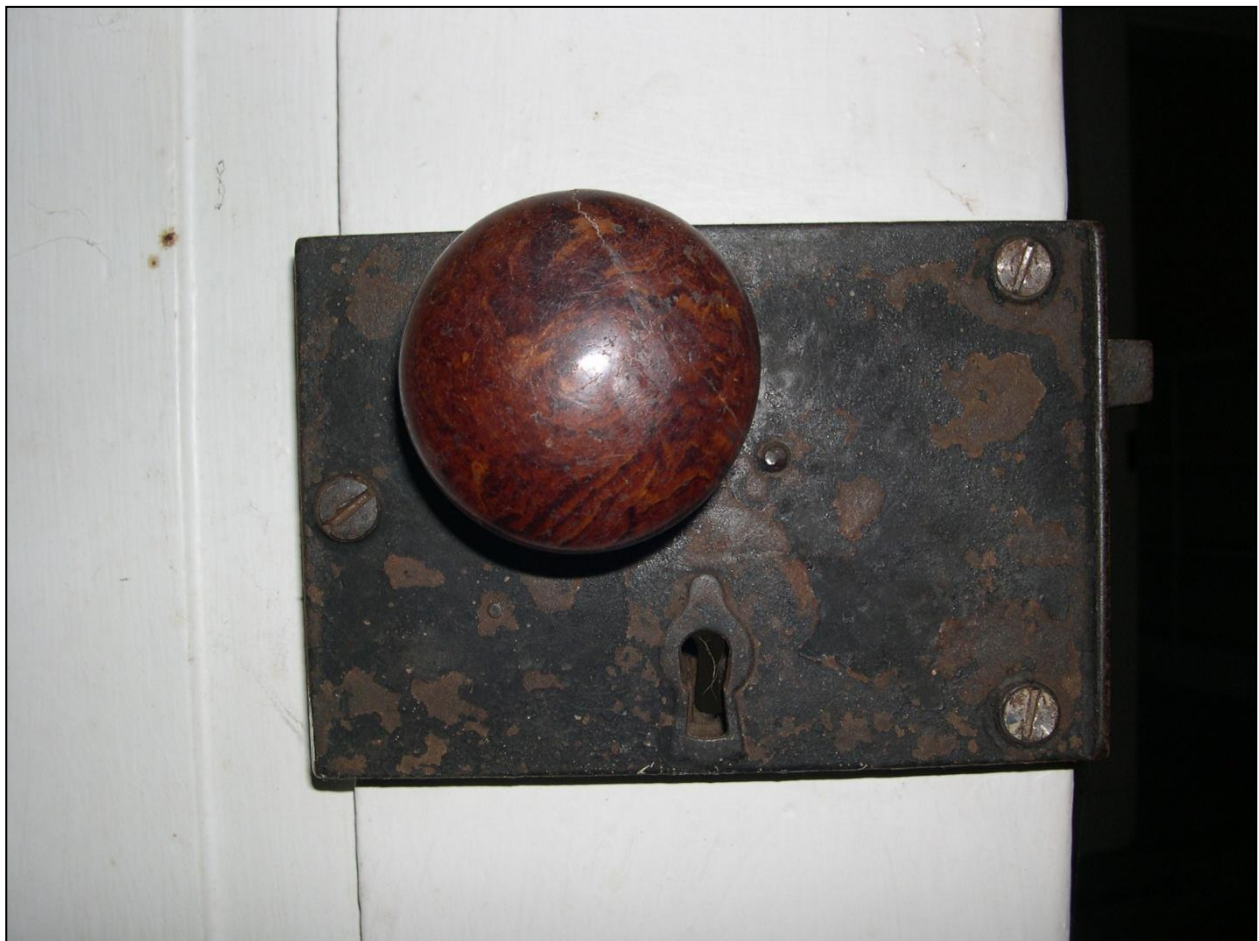
Mount Pleasant where the door panels are raised with “sticking”.<sup>178</sup> Many of the doors at the Bowman-Hite house also retain their original hardware and hinges, as noted by the lack of previous lock mechanisms on the original doors. At the time, the use of butt hinges was becoming increasingly popular, as costs began to fall for iron production. These hinges replaced earlier “H”, “HL” and strap hinges found at places like Fort Bowman. The original 1850s Russell and Erwin Company rim locks with mineral knobs used at the Bowman-Hite house were also different from nearby family structures, having just appeared on the market in the 1850s (**fig. 41**). These knobs and locks found extensive use, both prior to the war, as well as after, as less expensive substitutes for brass.<sup>179</sup>

Figure 41: Original rim lock at the Bowman-Hite house. Developed in the 1850s, these were a popular and cheaper alternative to brass. The mineral knob also dates to the 1850s. (Photograph by Michael Spencer, 2011)

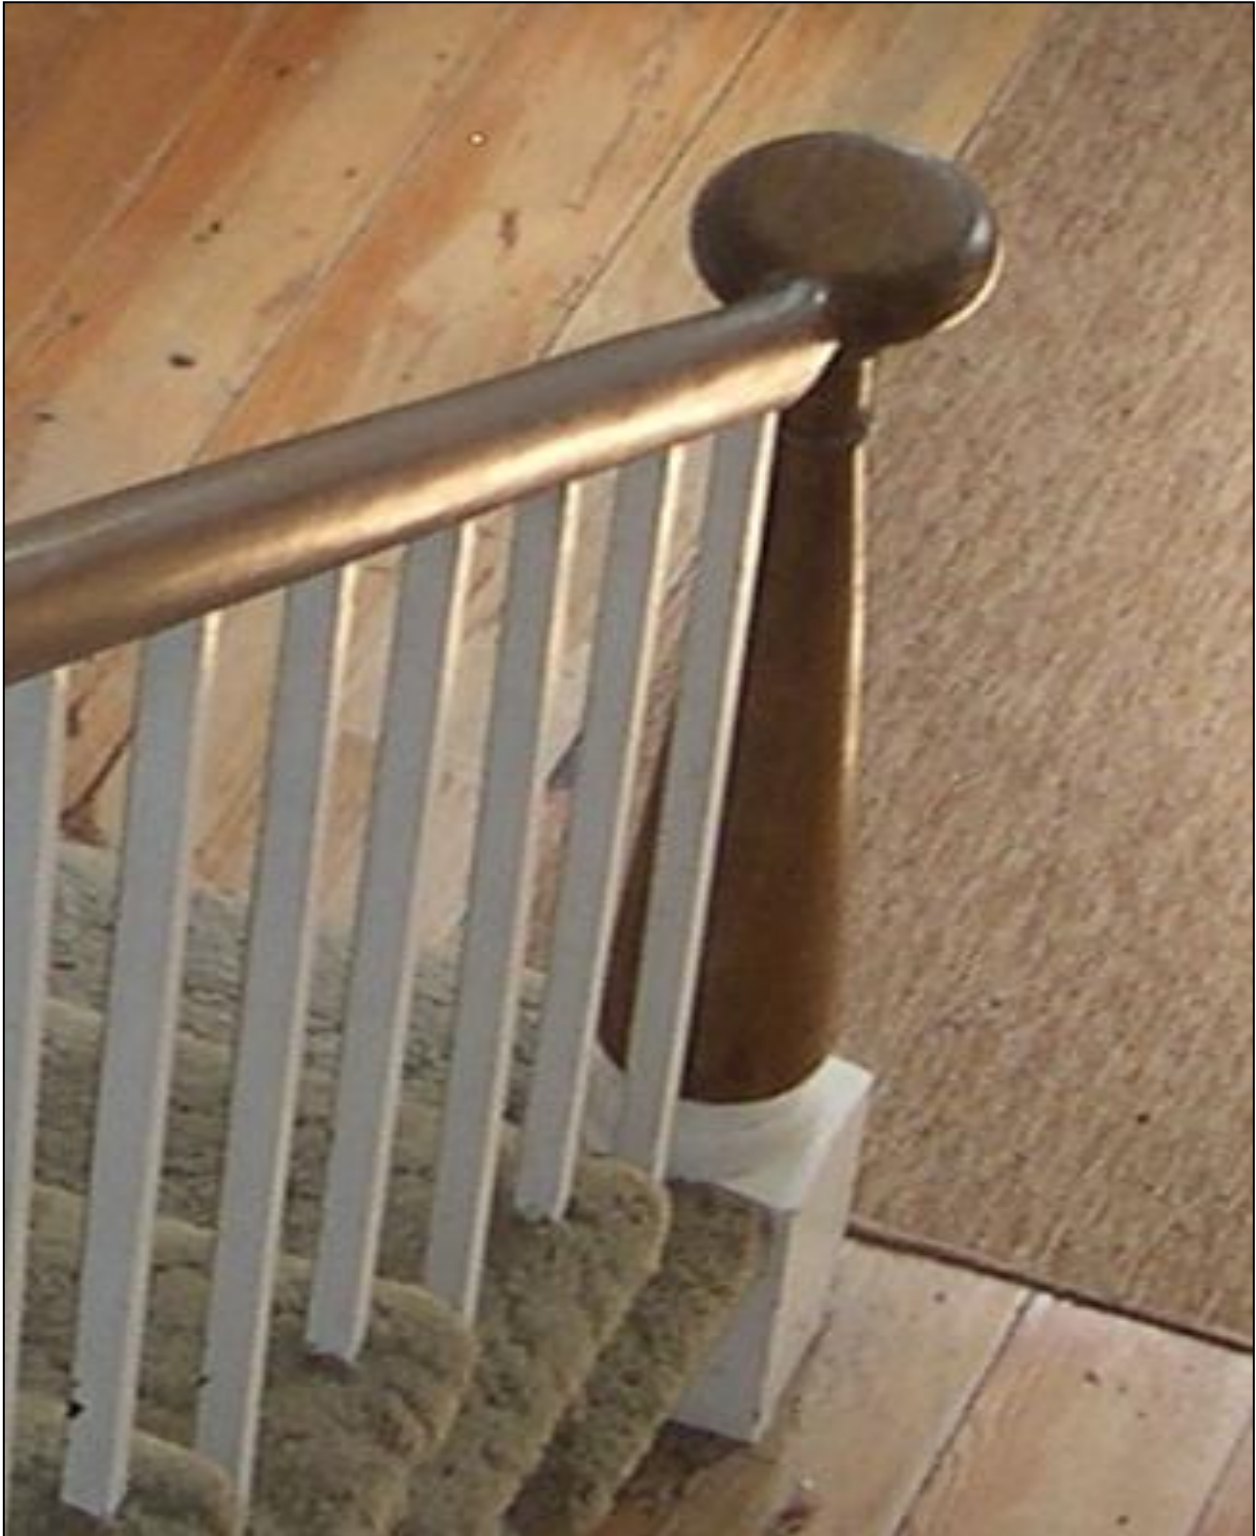
Initial construction of the Bowman-Hite house incorporated two stairways, something not atypical for the period. The primary staircase was designed as an open-well type, with a landing situated along the far wall from the front entryway. From this landing the stair continued, a short flight, from the opposite side of the initial rise along the south wall. Adding light to the stairway was a single window placed on the east elevation just above the stairway landing (**fig. 47**). While decorative elements, such as stair brackets are missing, the square banisters, as well as the overshot, barrel newel post (**fig. 42**), directly reference Greek Revival design and are similar to Jefferson County, West Virginia examples from the 1840s and 1850s.<sup>180</sup> While falling out of fashion during the 1850s, the Bowman-Hite primary stairway also exhibits newel drops or pendants, similar to those found at Mount Pleasant.<sup>181</sup>

Figure 42: The large barrel newel post at the Bowman-Hite house, complete with overshot rail. This design aesthetic was popular during the 1850s. (Photograph by Michael Spencer, 2011)

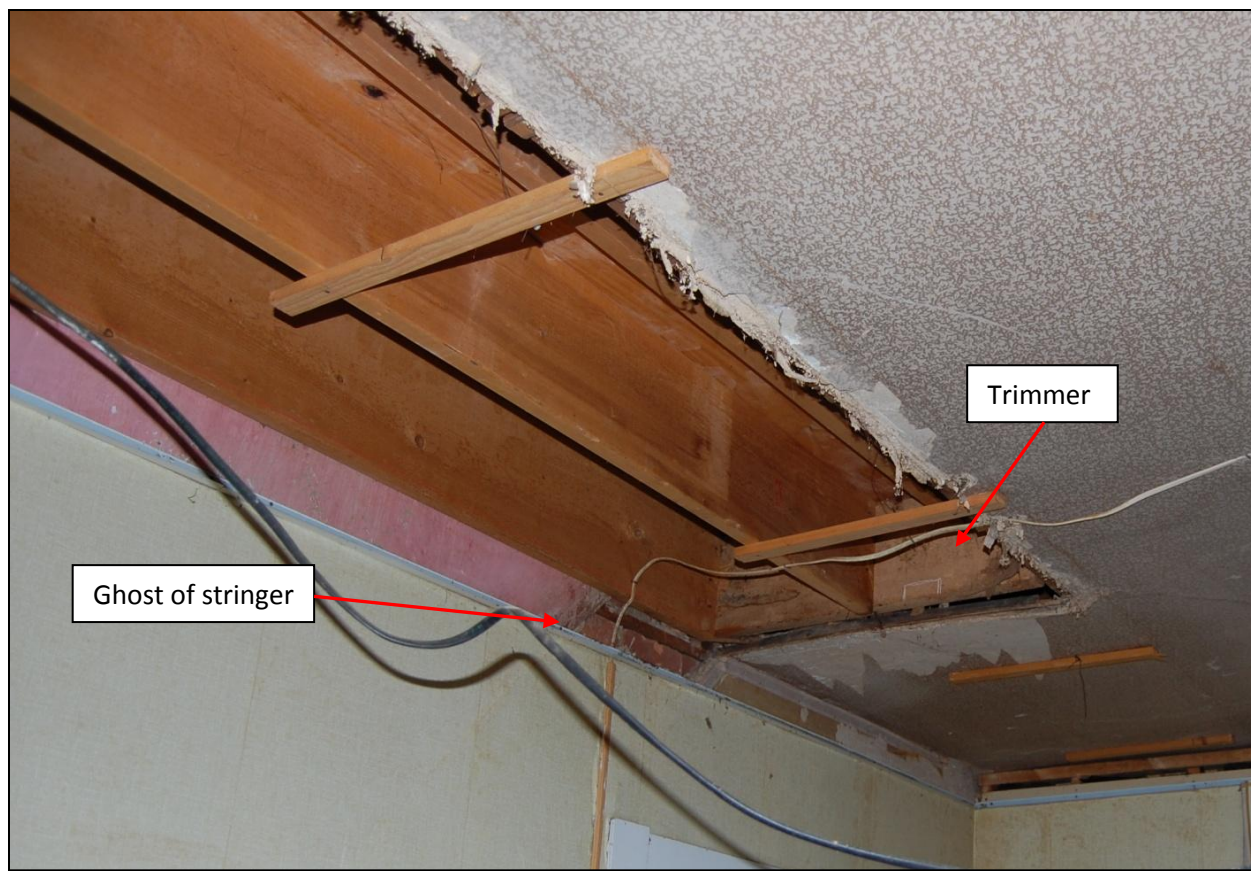
Figure 43: Image showing the “ghost” marks left by the rear stair in the dining room. Note the trimmer with new joists now nailed to it. The plaster also indicates the presence of a previous stringer to support the stairs. (Photograph by Michael Spencer, 2011)

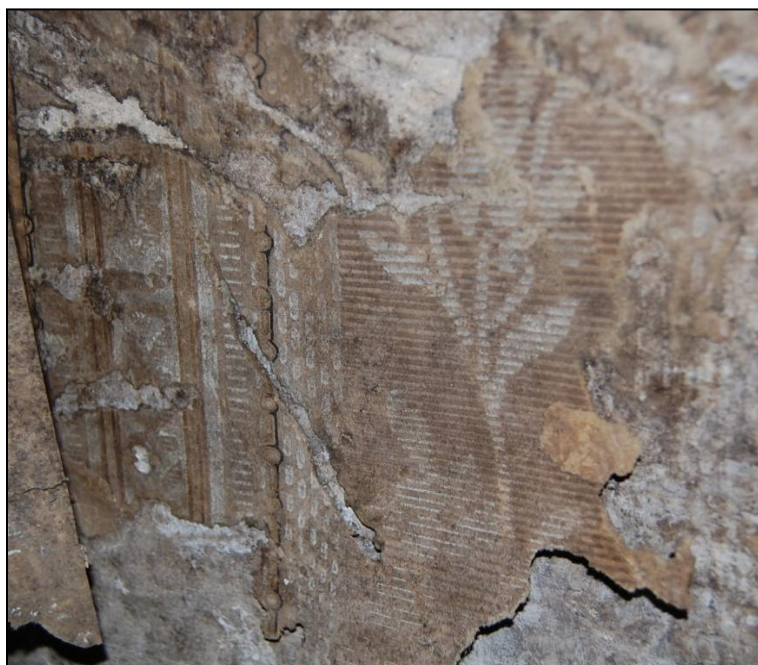
Wall paper was another finish material used in the Bowman-Hite house, with portions still found in the dining room. This original machine printed paper consisted of a shiny floral design popular during the 1850s (**fig. 44**).<sup>183</sup>

Figure 44: Fragment of wallpaper found beneath subsequent layers. Such floral patterns and colorations were popular during the mid-19<sup>th</sup> century. (Photograph by Michael Spencer, 2011)

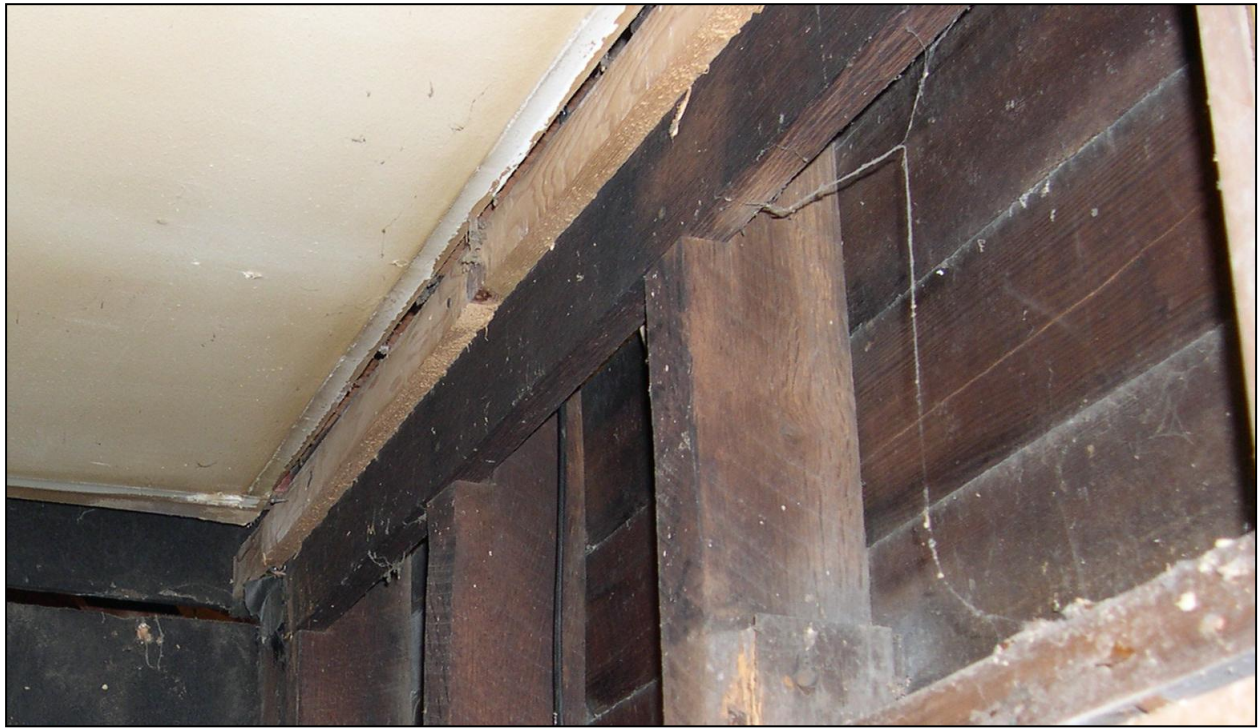
The techniques used for constructing the rear frame addition at the Bowman-Hite farmhouse differed greatly from the early-and-mid-19<sup>th</sup> century methods. Development of new technologies and manufacturing methods after the Civil War led to the proliferation of new construction techniques like balloon frame construction, which used circular-sawn lumber and wire nails. Whereas during the 1850s, circular-sawn lumber was still new, by the 1870s, this method had surpassed sash sawing in the region. The one-and-a-half story frame addition illustrates this well, as it is entirely constructed of circular sawn, dimensional lumber (**fig. 45**). Framing members in the new addition are also held together with wire nails, replacing earlier cut nails found in the original brick portion of the house. Such nails came to prominence in the 1870s and 1880s.<sup>191</sup> Additionally, the presence of a ledger board, notched into the one-and-a-half story studs, is a characteristic of true balloon frame construction, which began to take hold during the 1870s and into the 1880s. The brick used on the chimney also exhibits more modern, late-19<sup>th</sup> century characteristics, such as sharp edges, indicating the use of a machine press, a stark contrast to the hand pressed bricks found in the original portion of the house.

Figure 45: The ledger board, a hallmark of balloon frame construction, as seen on the rear frame addition (ca. 1876-1880s). Note how the ledger board is "let" into the stud rather than simply nailed. Note also the circular saw marks on the studs. (Photograph by Michael Spencer, 2011)

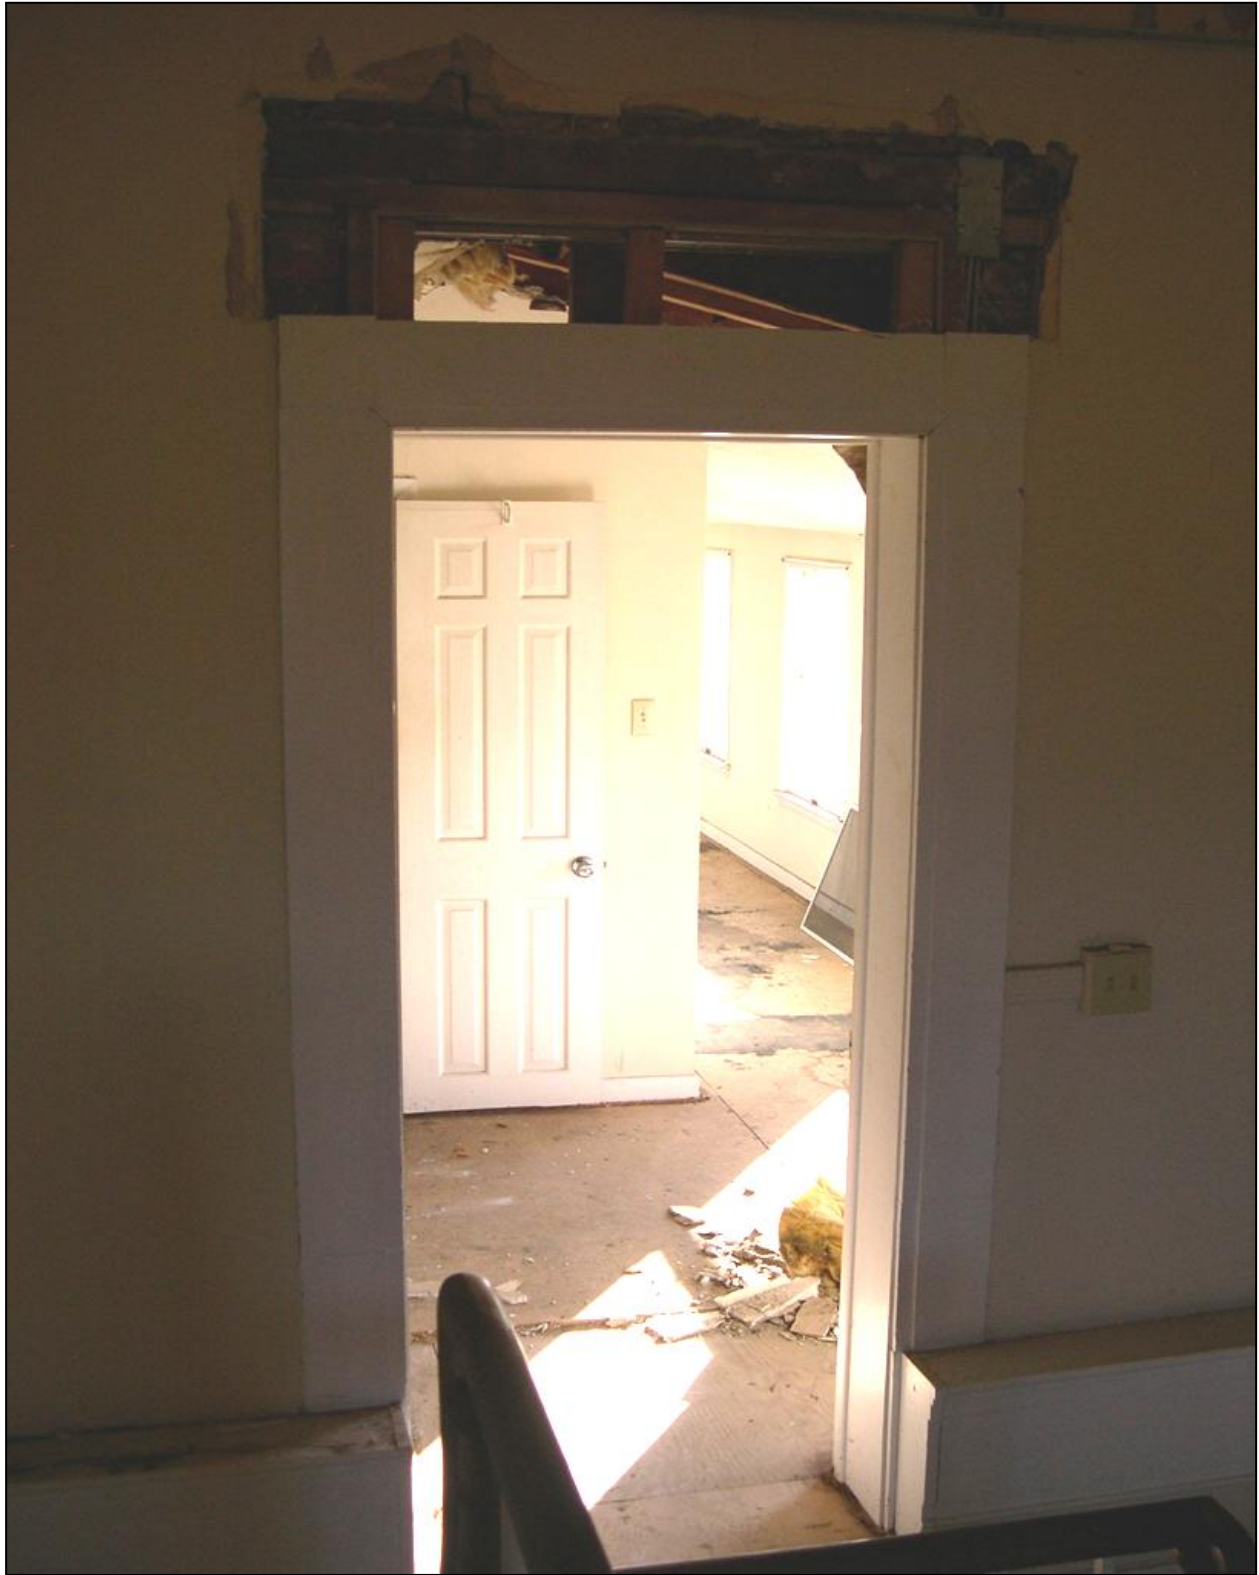
Figure 47: While currently a door, this space used to be a window, which allowed light into the front foyer and primary staircase. The original framing for the window is located above the doorway, as indicated by the header. The casing was adapted to the new use. (Photograph by Michael Spencer, 2011)

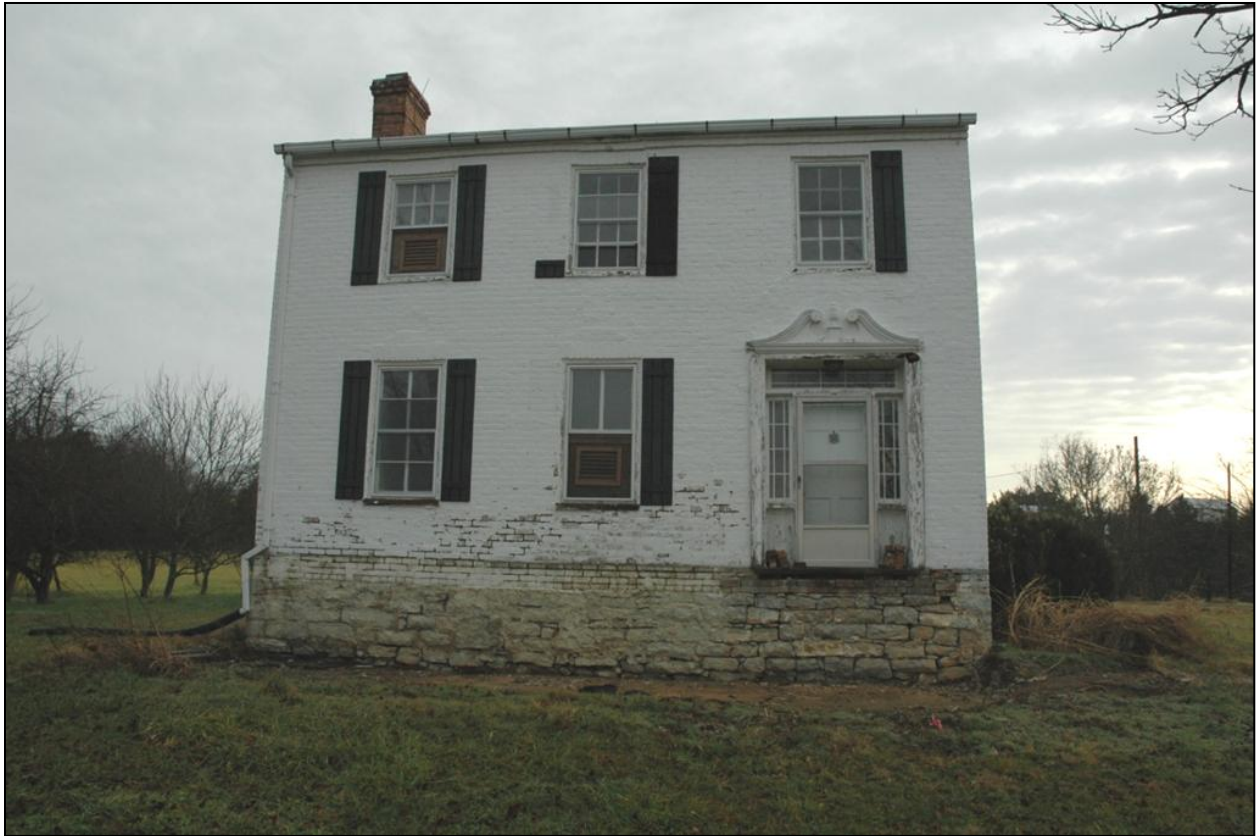
The focal element of the west elevation is the original side passage, front entrance, located on the southern bay. Although the six-paneled door is a modern replacement, portions of the door surround, including the sidelights and transom are original. The rectangular, full transom light is comprised of 3 horizontal muntins and 4 vertical muntins. The center ribbon of glass panes created by this muntin configuration is slight larger than those above and below. The sidelights of the entryway are divided in a similar fashion, with three vertical muntins and three horizontal muntins. Below each sidelight is a raised wood panel. Originally, a small, one-story, one-bay, raised porch would have provided shelter for those entering the house, however in the 1970s, this was removed, and a concrete porch, spanning the entire façade, was installed. As of 2012, this porch had also been removed. The last vestige of the 1970s alteration is the broken ogee pediment with decorative urn. The entire door surround, with the exception of the broken ogee pediment, is similar to that found at nearby Springdale, in Frederick County, Virginia. Located directly above the entryway is an original, six-over-six, single-hung wood window with later, ca. 1970s, fixed, faux wood paneled, black shutters. The wood sill of the window is in poor condition.

The other two bays of the west elevation are comprised of four windows, two on the first floor, and two, directly above, on the second floor. While the wood window casings and trim on the first floor are original, the two-over-two configuration is a later, ca. 1876-1880s alteration. The second floor, single-hung, six-over-six, wood windows, are however, original to the house. Like the window above the entryway, the wood window sills are in poor condition. Splayed brick jack arches are positioned above each window with faux wood, black paneled shutters, on either side.

Figure 49: The west elevation of the Bowman-Hite farmhouse dating from the 1850s. Note the replacement two-over-two windows on the first floor compared with the original six-over-six windows on the second. The broken ogee door surround is a later-20<sup>th</sup> century addition.

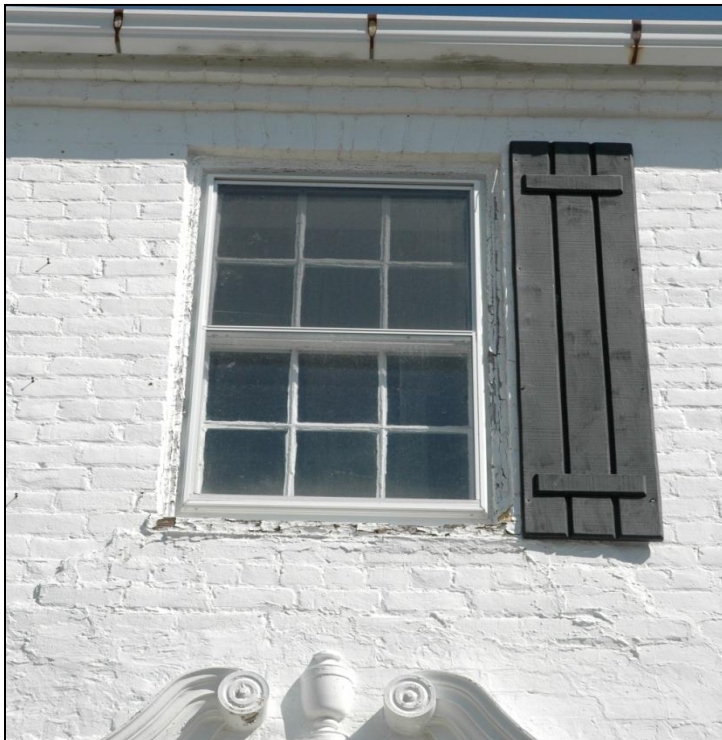
Figure 50: A close-up of an original 1850s six-over-six window. Also seen is the brick corbelling, which, by the 1850s, had begun to wane in popularity. Below the window are ghost marks from the 1850s porch roof.

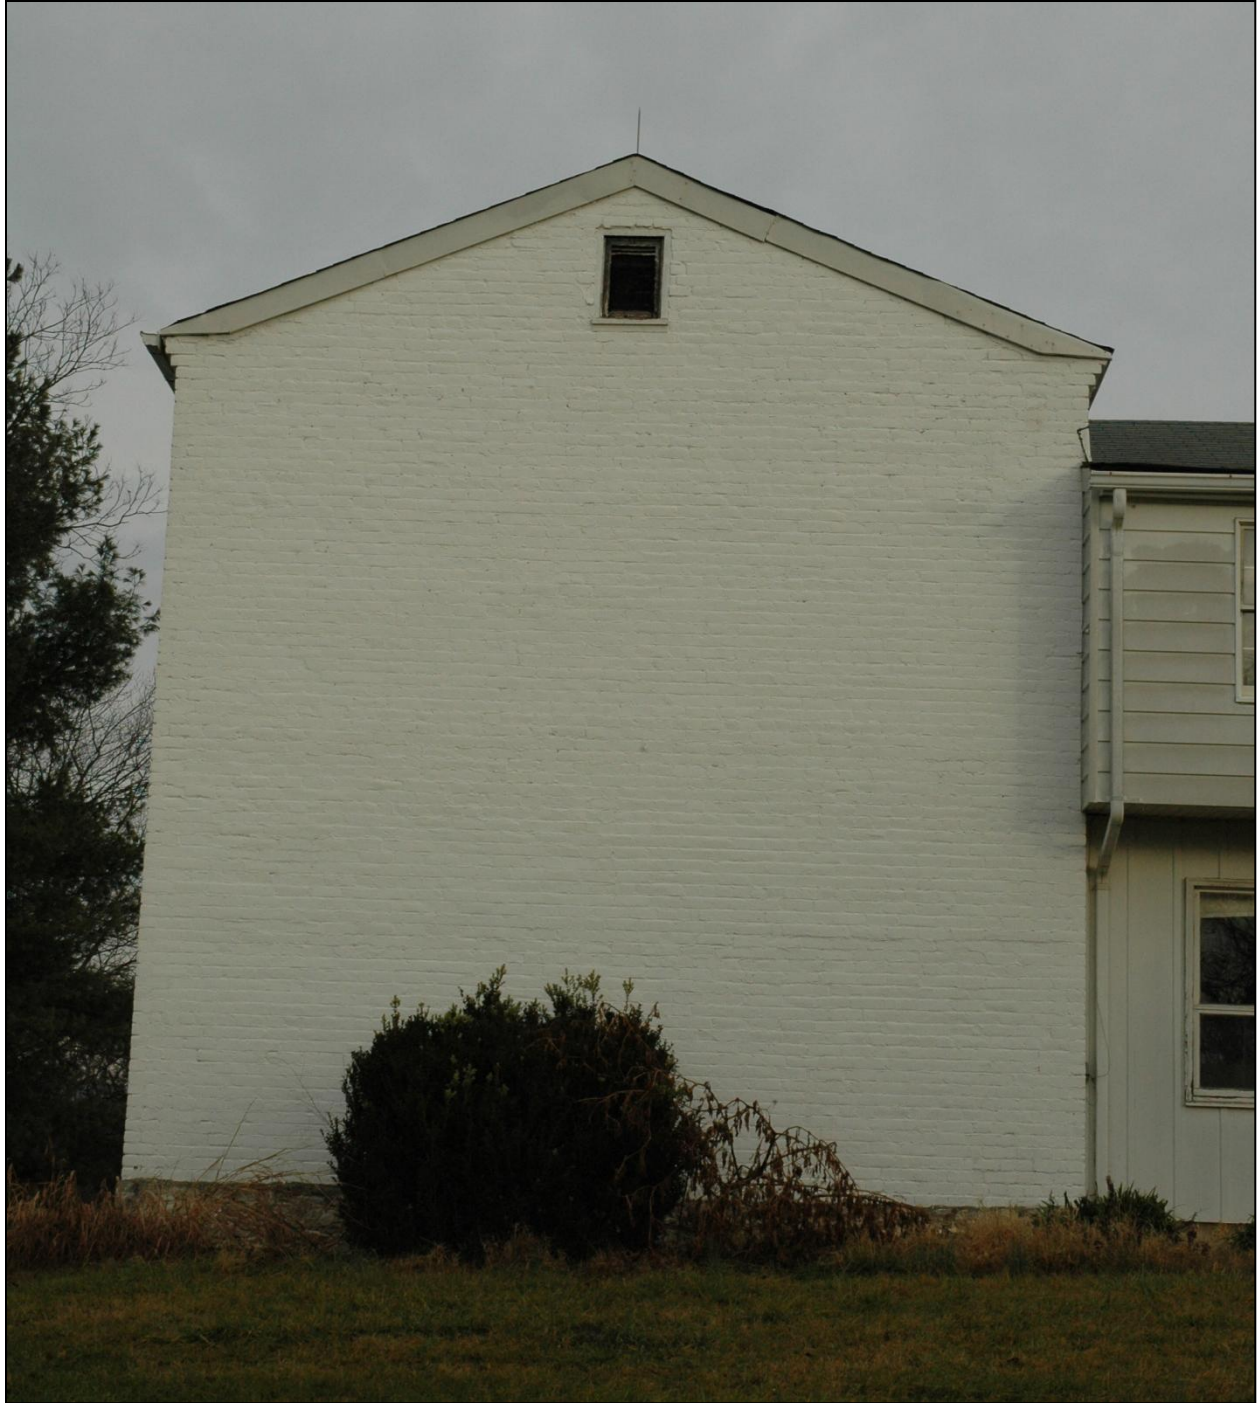
Figure 51: Pictured is the south elevation of the 1850s brick farmhouse. On the right is the later, ca. 1971 Whitham era addition which enclosed the 1876-1880s, John Pirkey frame addition.

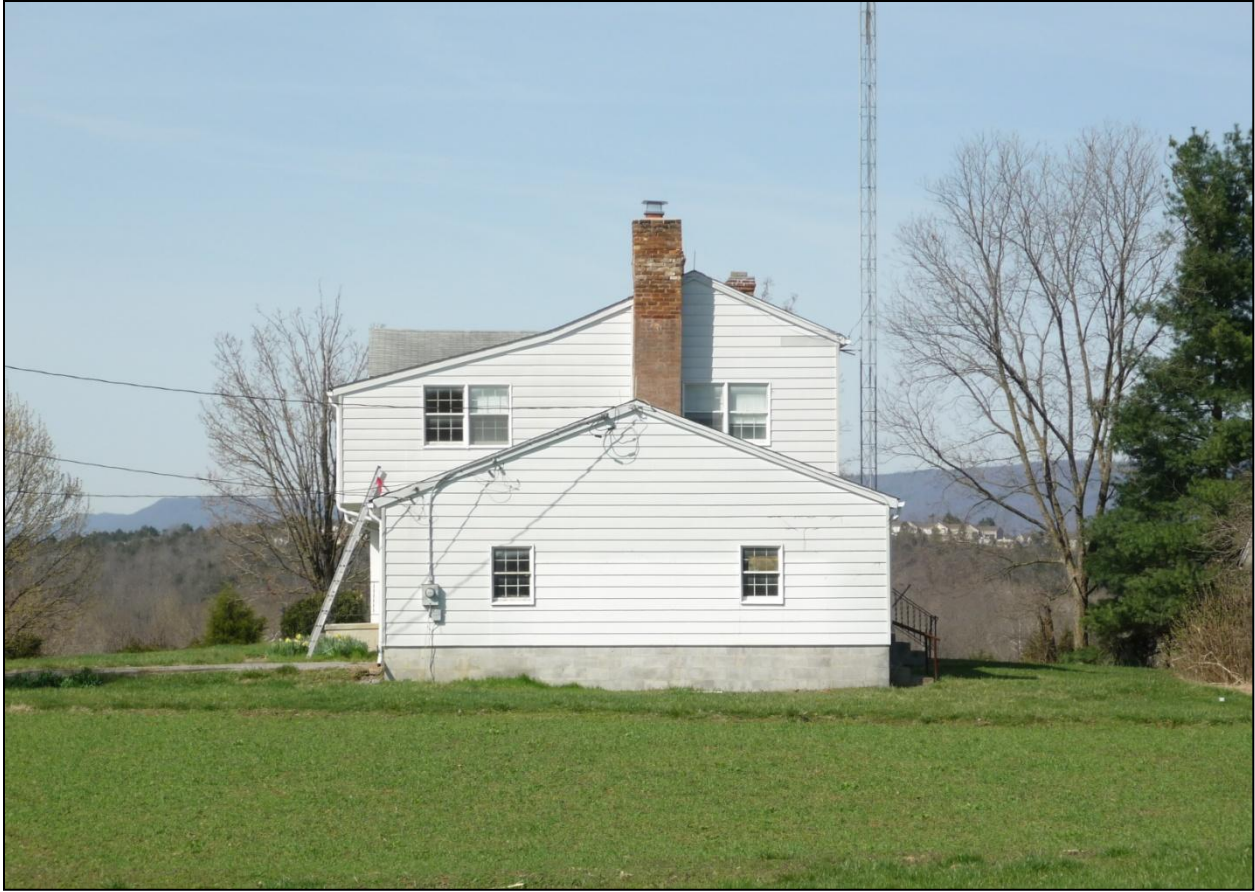
Figure 52: The east elevation as it appeared in 2010. Note the metal tower, now removed.

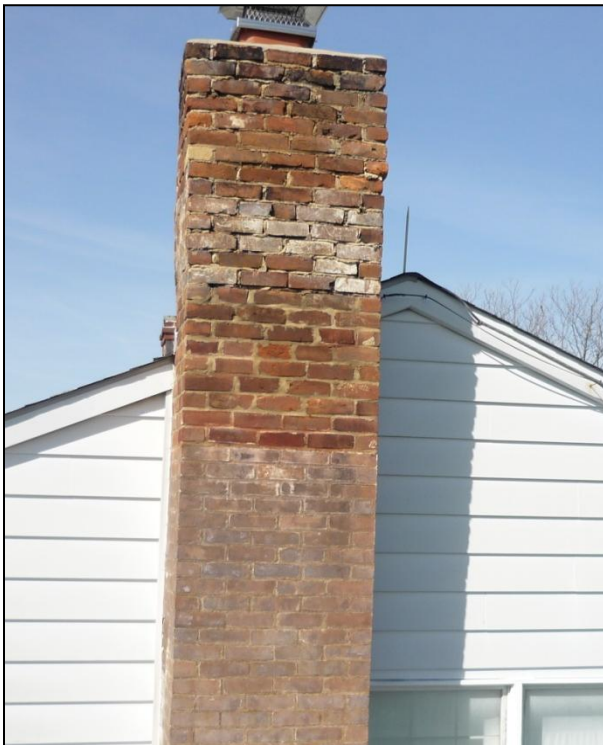
Figure 53: This close-up of the east elevation chimney shows the two construction phases. The first was during the construction of the 1876-1880s rear frame addition. However, during the Whitham era, when a full second story was added (ca. 1971), the chimney was raised.
