**The Bowman-Hite Property  
Warren County, Virginia**

**Bowman-Hite Farmhouse  
Historic Structures Report**

**Final Submission**

*October 2013*

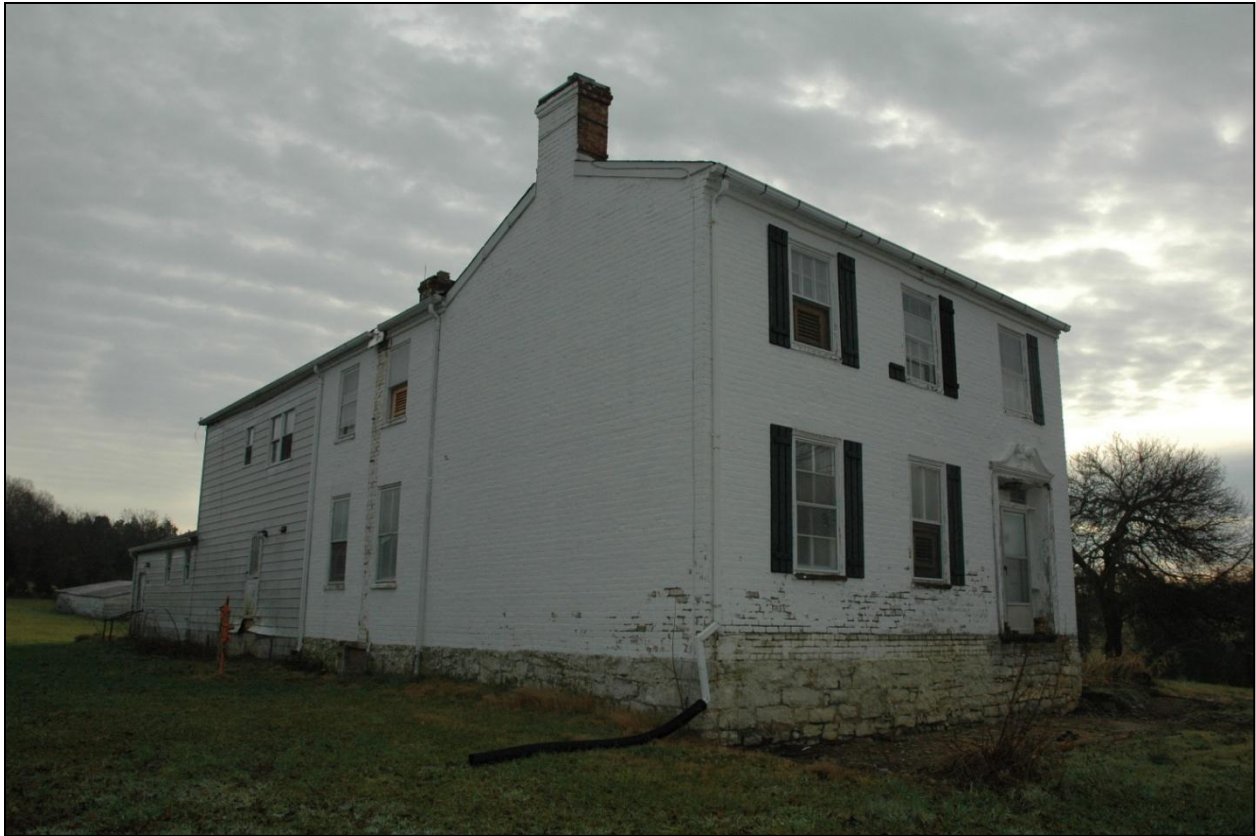
Figure 54: The northwest perspective of the Bowman-Hite farmhouse after the removal of the cinder block front porch. The rear brick ell, original to the 1850s portion of the structure can be seen, as well as the later Whitham era addition.

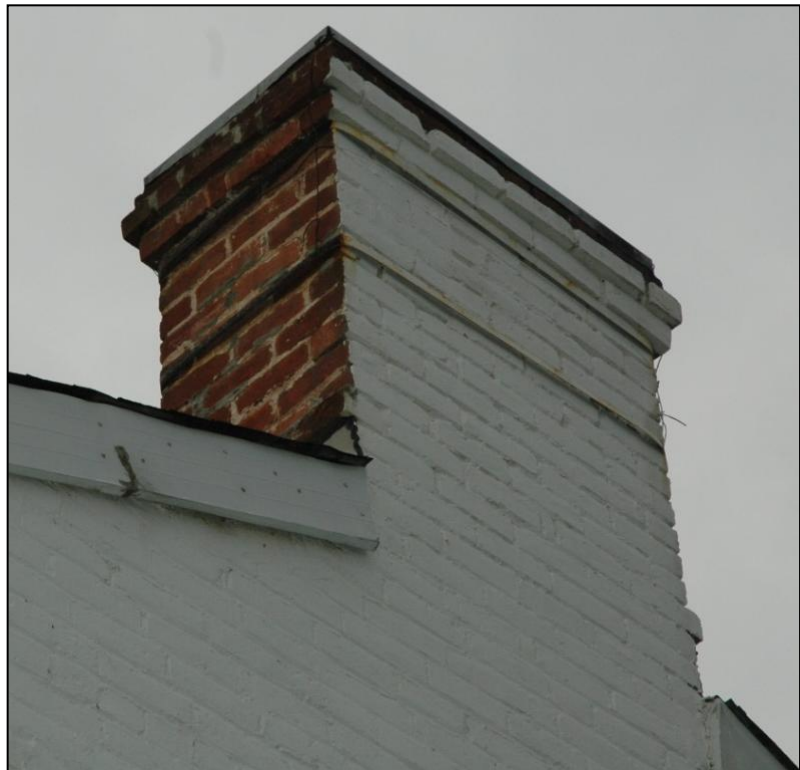
Figure 55: The north chimney stack clearly shows a lack of white paint. However, an early 1863 map indicates a “wh”, possibly alluding to the current white color at the time of the battle. Note the iron banding, as well as the brick corbelling. The broken rake is also apparent and is typical of the region. (Spencer, 2012)

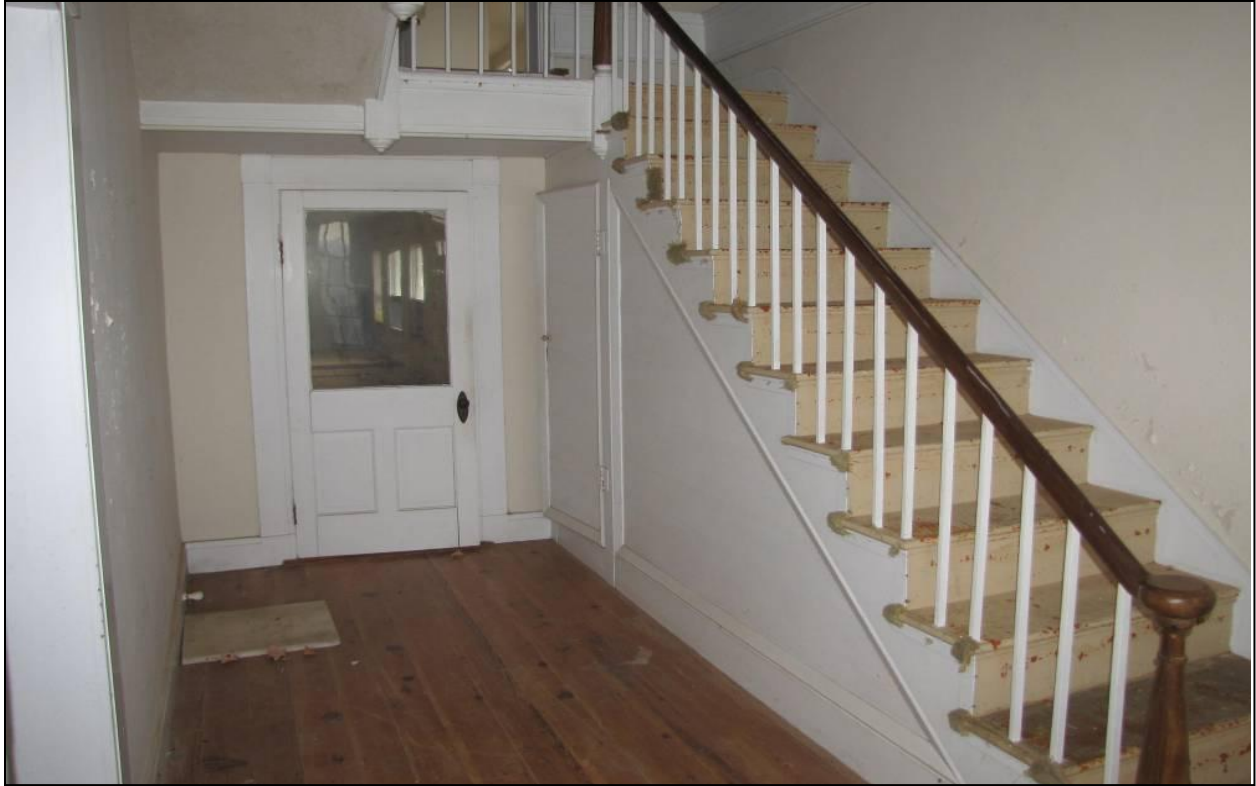
Figure 56: The front entry hall and primary stair with overshot rail and barrel newel post. The door towards the rear is a later 1870s-1880s update, but the opening is original to the 1850s.

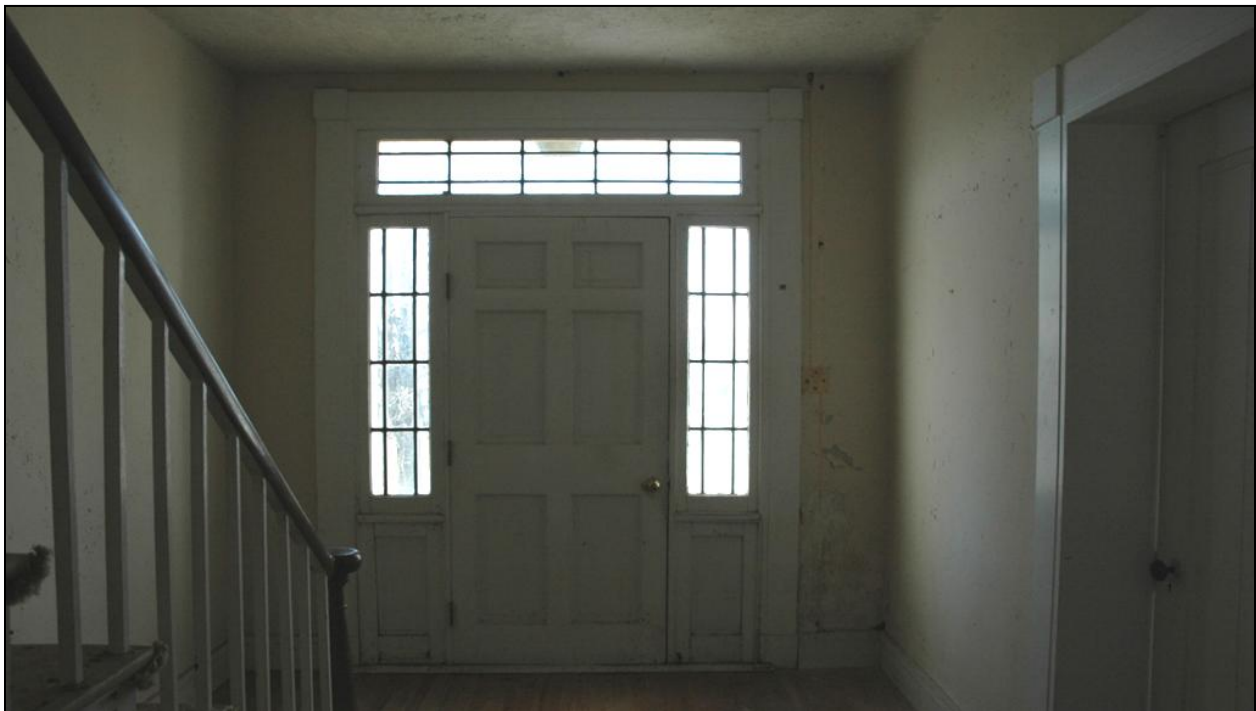
Figure 57: The front entry of the Bowman-Hite farmhouse. The door is a later 20<sup>th</sup> century replacement, but much of the interior surround, including the sidelights and transom, are original.

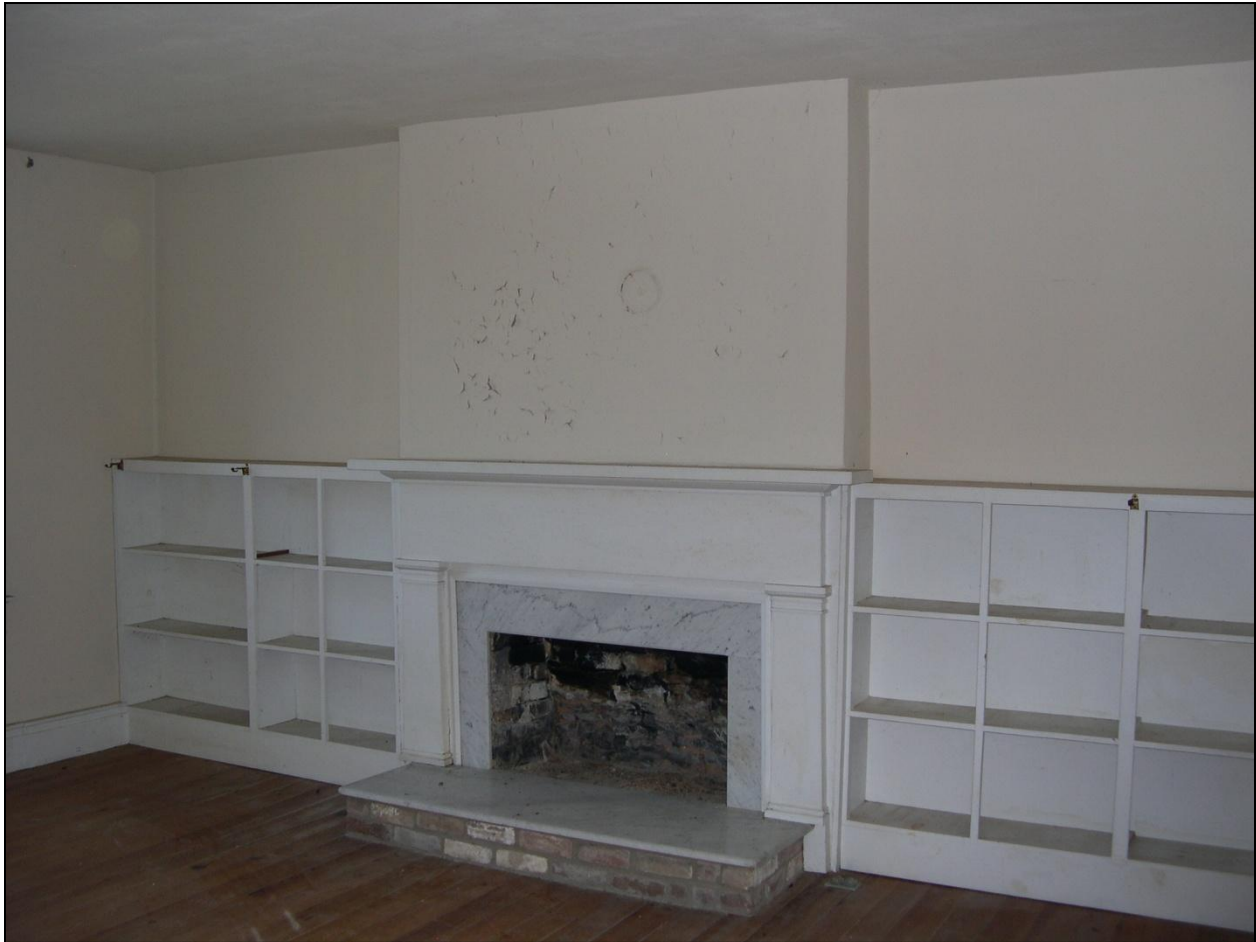
Figure 58: The image above is of the first floor parlor and shows the 1850s mantle. Later, during the Whitham era, the raised hearth was installed and marble veneers applied.

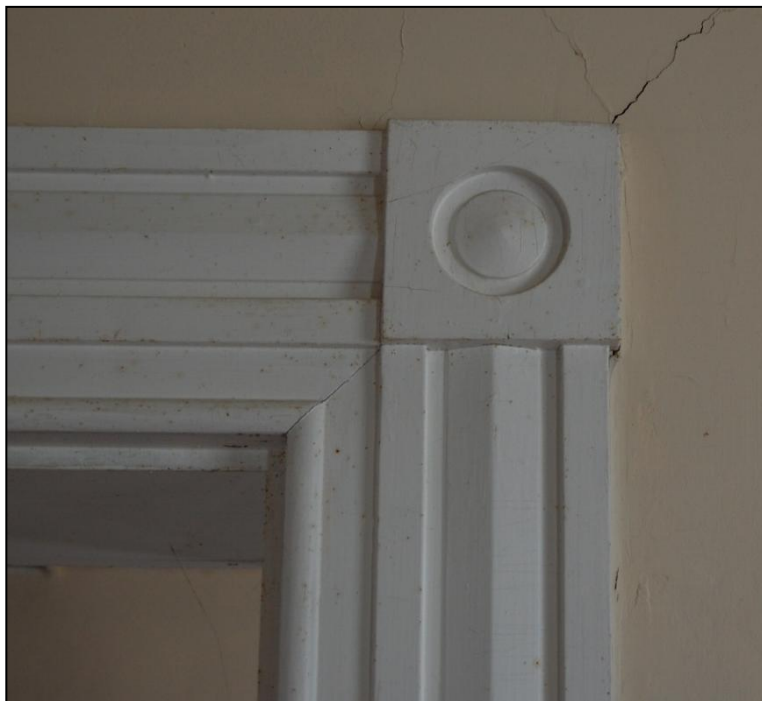
Figure 59: The patera and decorative casings found in the front parlor are found nowhere else in the house.

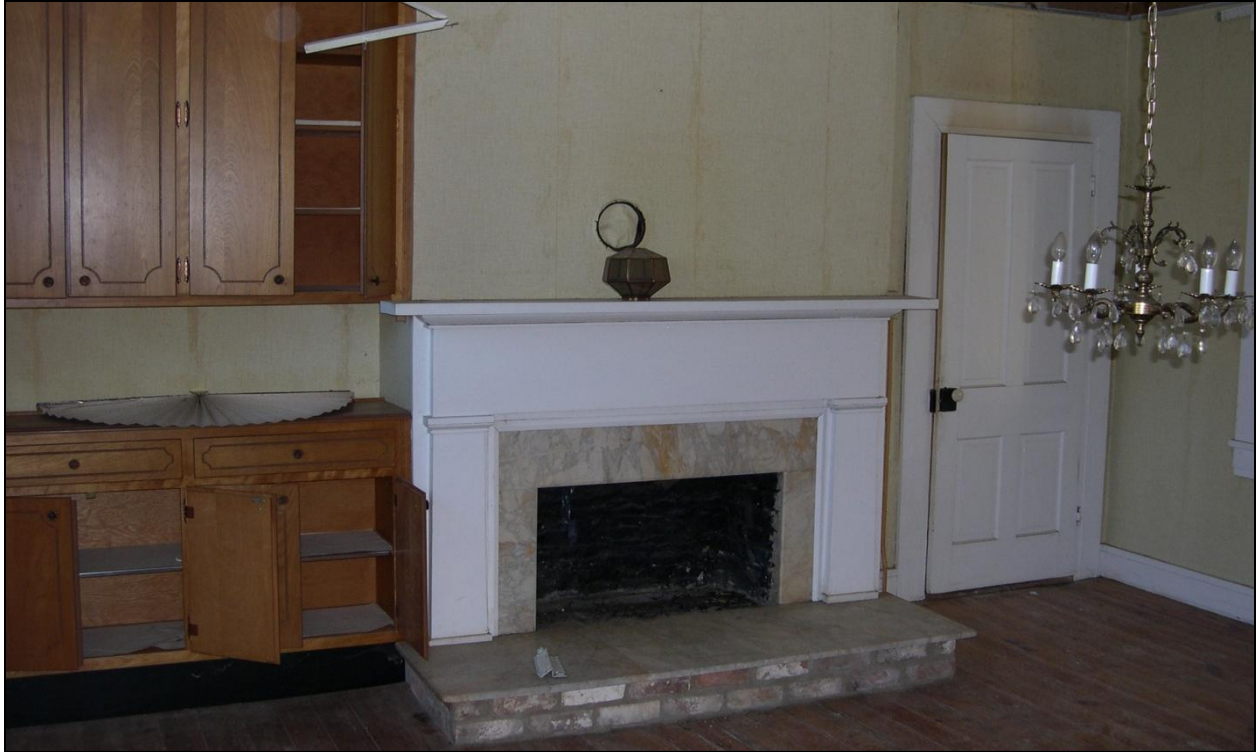
Figure 60: The image above is of the east wall of the first floor dining room. The mantle is original to the 1850s, however the raised hearth and cabinetry are later Whitham era additions.

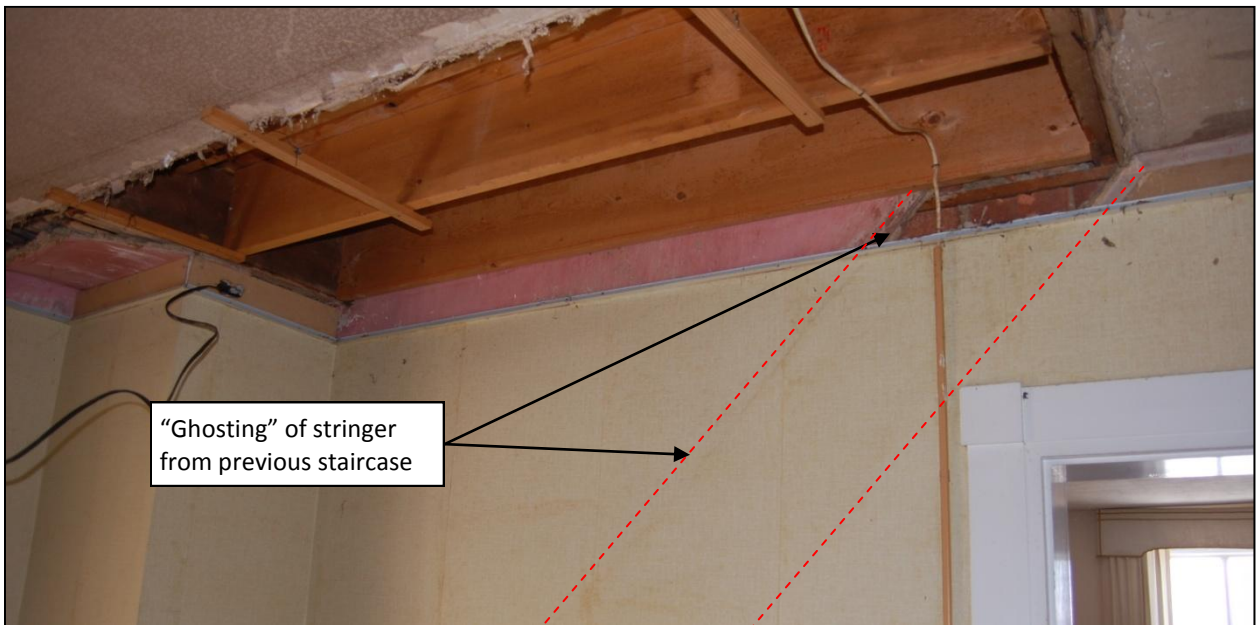
Figure 61: Concealed by a dropped ceiling for years the secondary staircase "ghost", original to the 1850s structure, can be seen in the image. The header as well as ghost marks for the stringer and landing (not shown) still exist providing a good idea of pitch and direction.

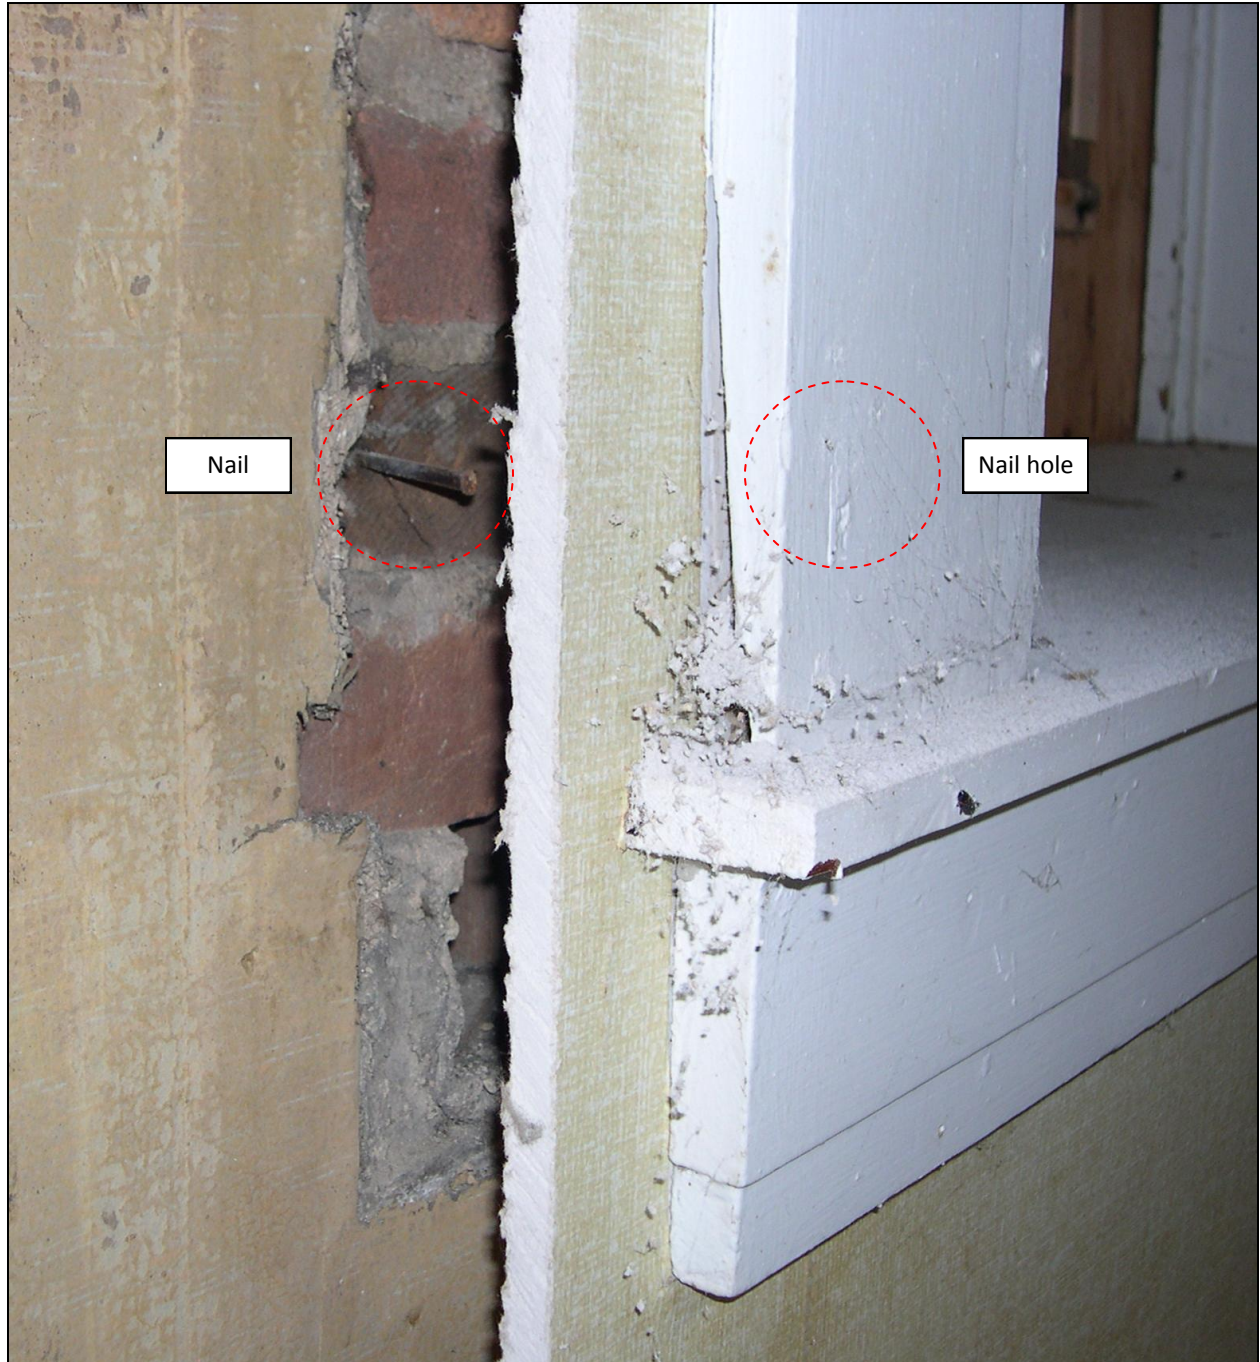
Figure 62: The image above shows markings in the original plaster left behind when the window casings were removed and the wall furred out. Corresponding nail holes, as well as shape and size, confirm the existing window casings as the originals.

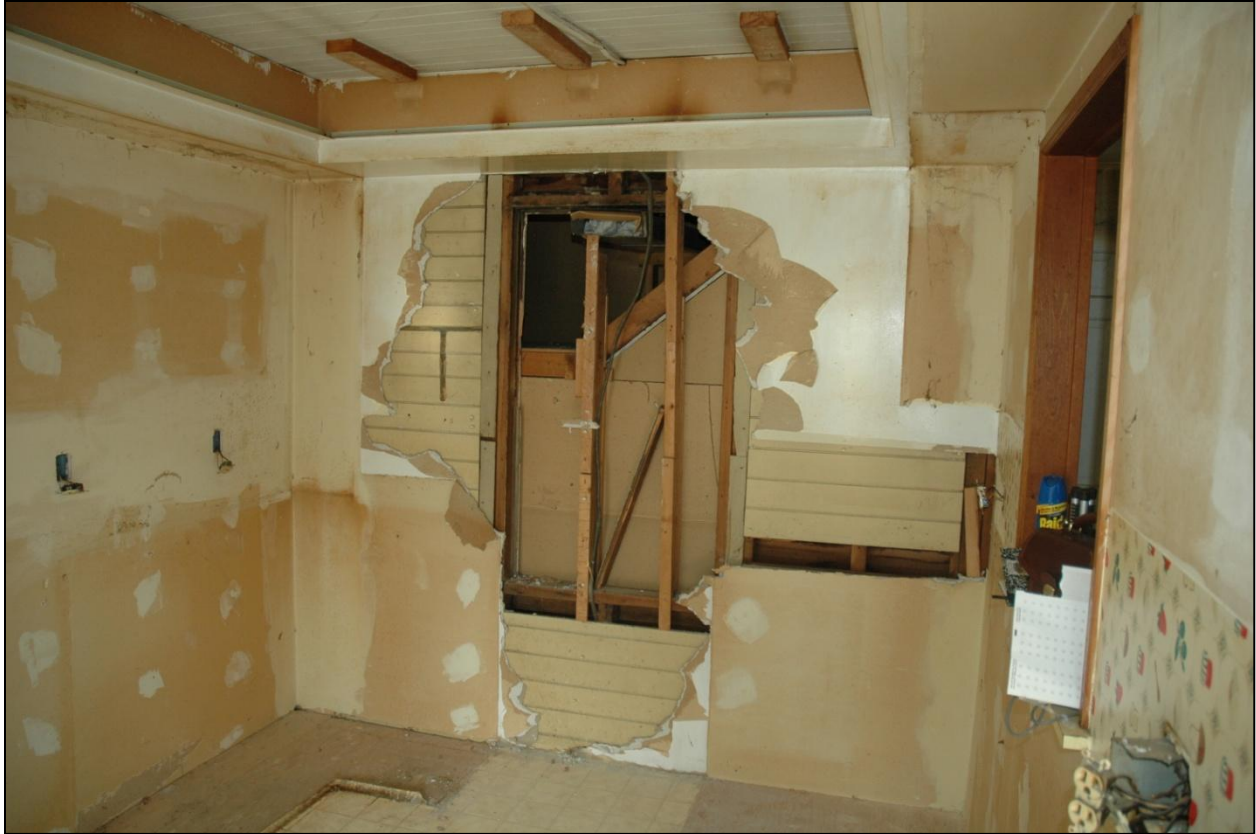
Figure 63: The north wall of the now encapsulated 1876-1880s frame addition. Originally this kitchen window would have looked outside. Note the yellow horizontal boards as well as the boards used to clad the ceiling.

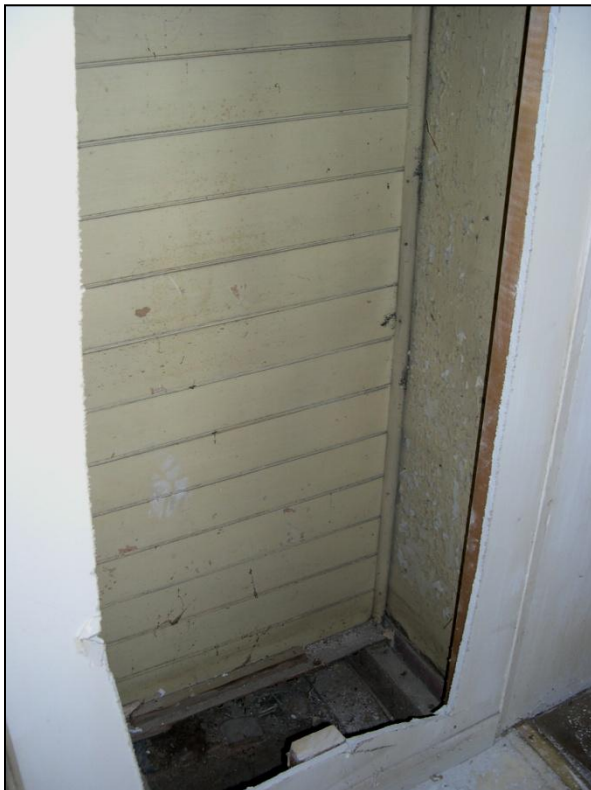
Figure 64: Found beneath removed ductwork, the original horizontal bead board is in good condition and maintains its yellow paint color.

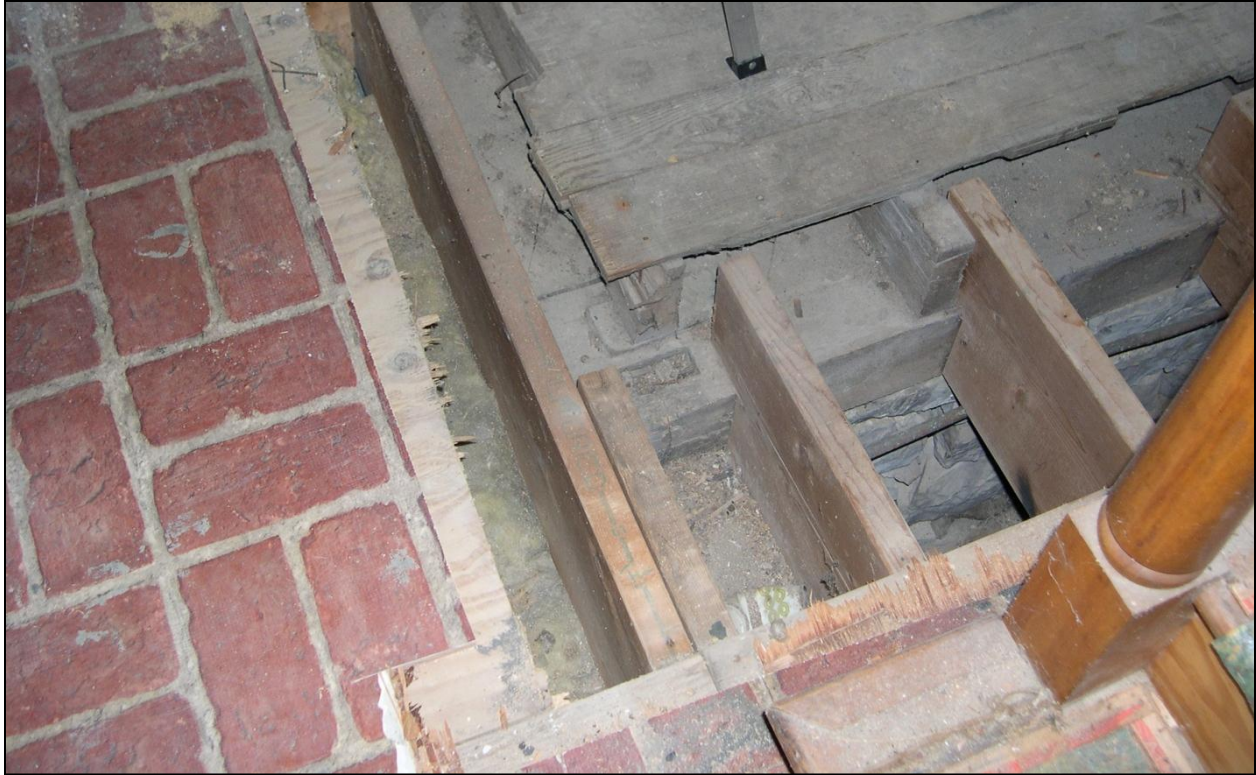
Figure 65: The above image shows the northeast corner of the 1876-1880s frame addition. The foundation and large wood sill can be clearly delineated as can the mortise for the, now missing, corner post.

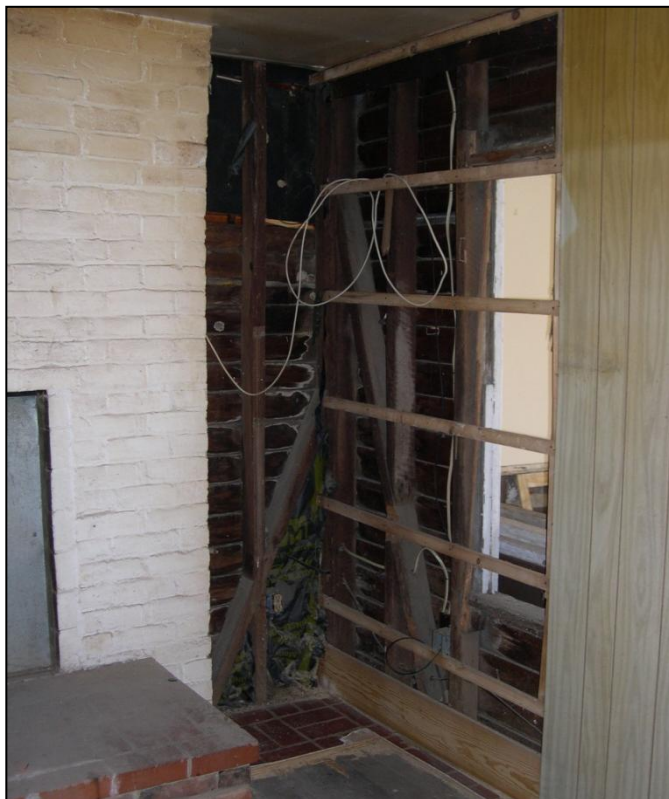
Figure 66: The southeast corner of the rear frame addition, showing components of the balloon frame construction. Despite this new technique, staggered down bracing is still used, as are larger corner posts, rather than “ganged” studs.

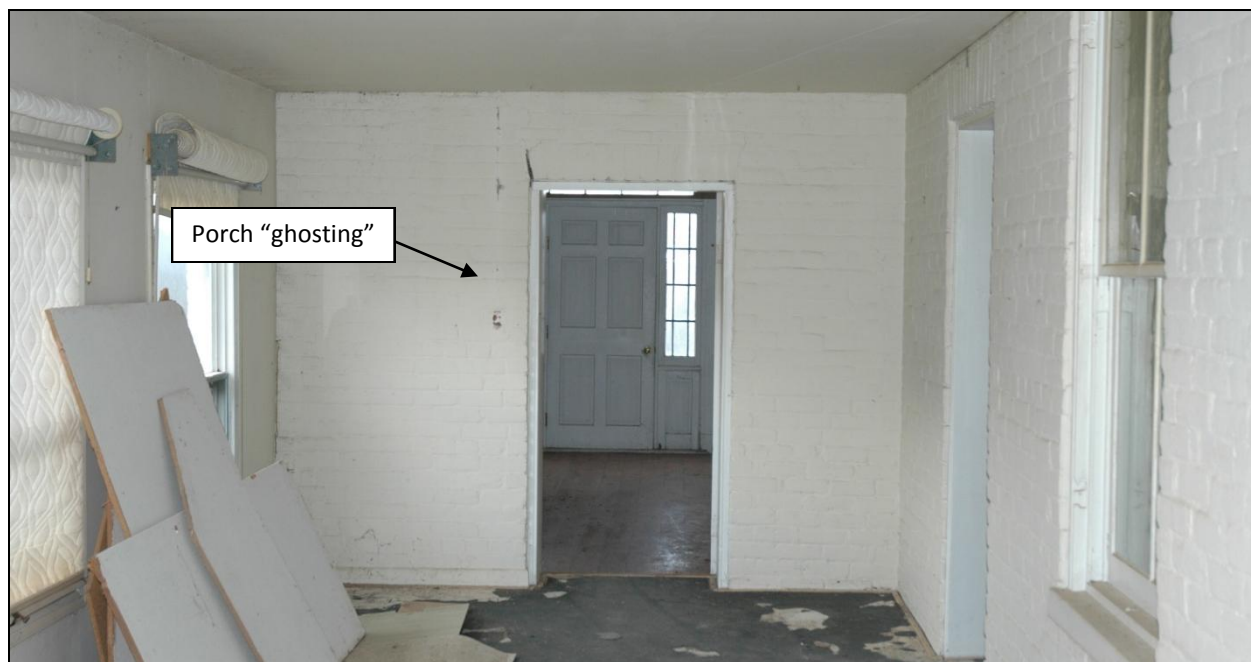
Figure 67: A view of the east brick wall of the original 1850s portion of the farmhouse. The window and door on the right lead to the rear ell dining room. Originally, this area would have been covered by a long porch. Ghosting still remains to the left of the doorway, indicating the location of posts.

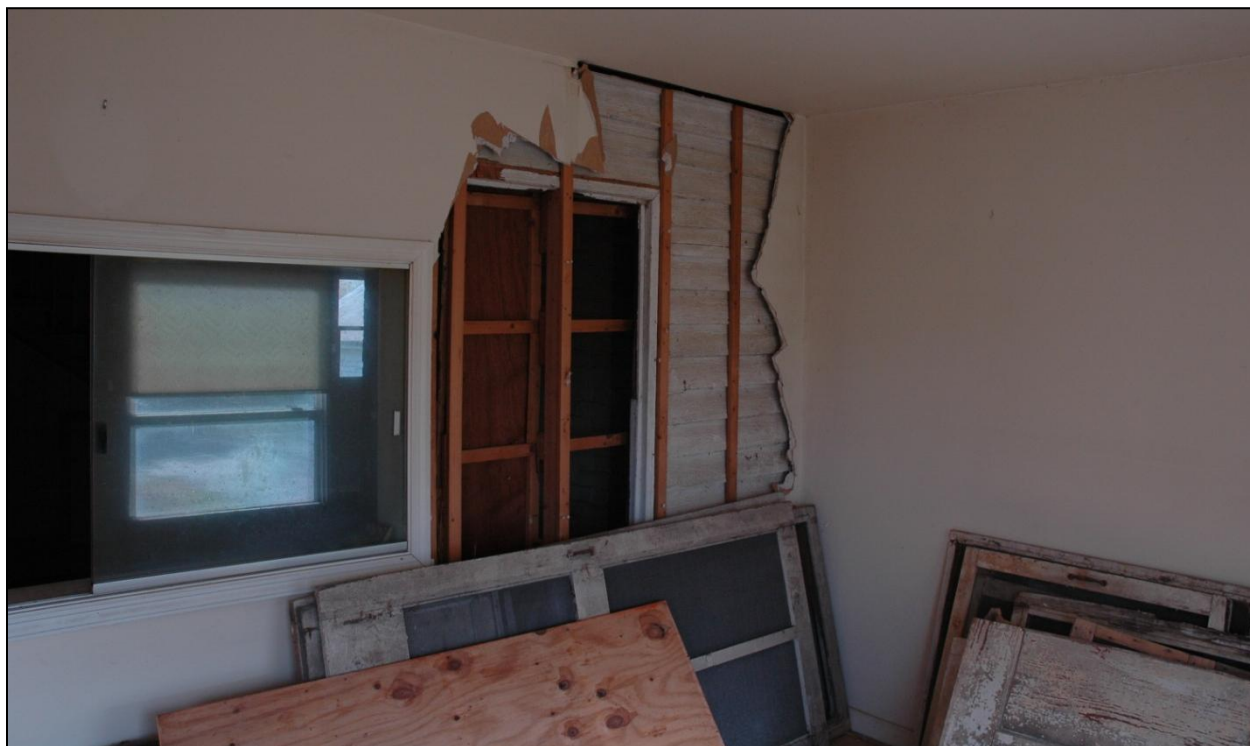
Figure 68: The image shows the southeast corner of the frame addition from what would have been the exterior porch. Note the presence of the window frame. In the foreground is salvage recovered from under the cinder block front porch, now demolished.

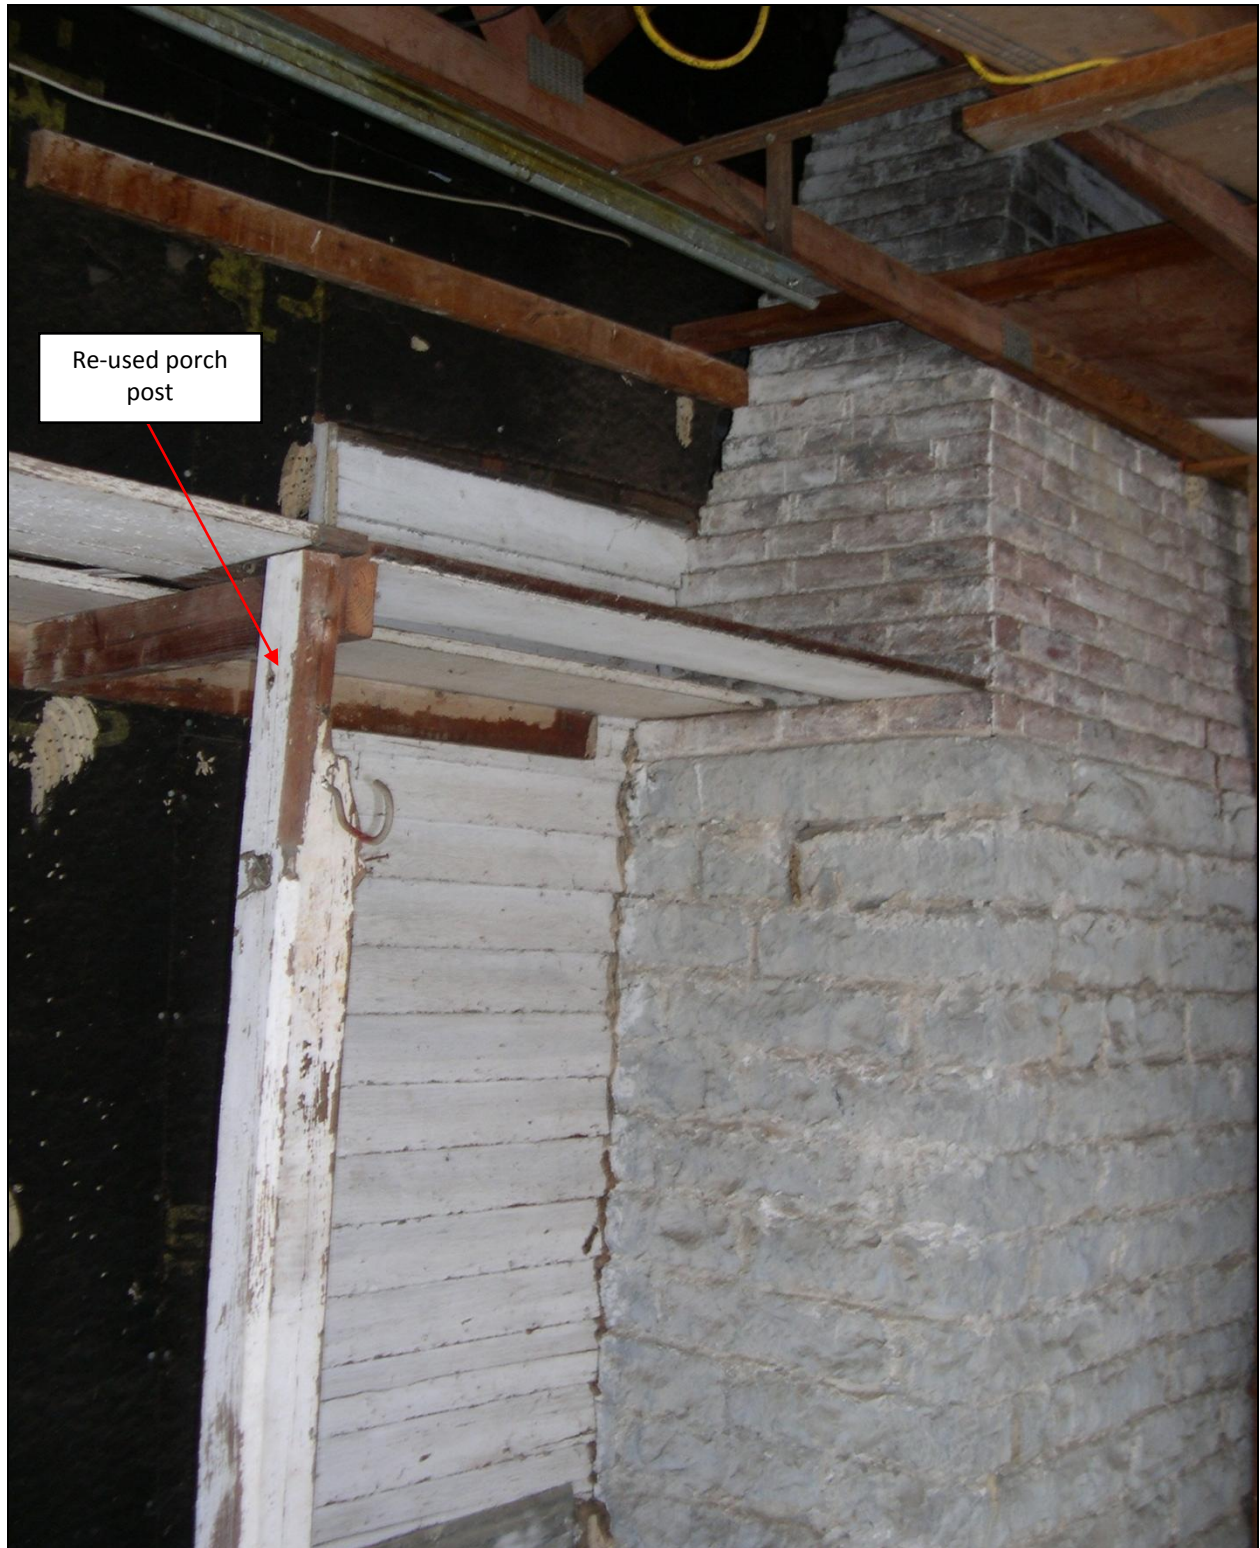
Figure 69: The image above shows the large stone and brick, exterior end chimney, of the 1876-1880s frame addition, now concealed by the ca. 1971 garage.

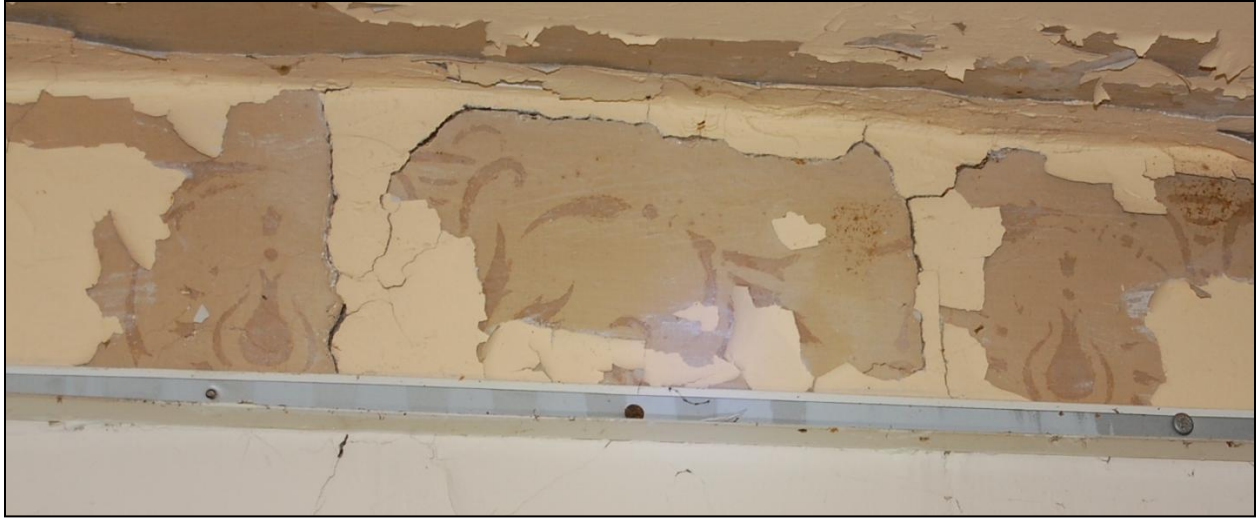
Figure 70: Stenciling was found under the front entry halls dropped ceiling and beneath flaking layers of paint. Further investigation will need to be done to determine whether this is original to the structure.

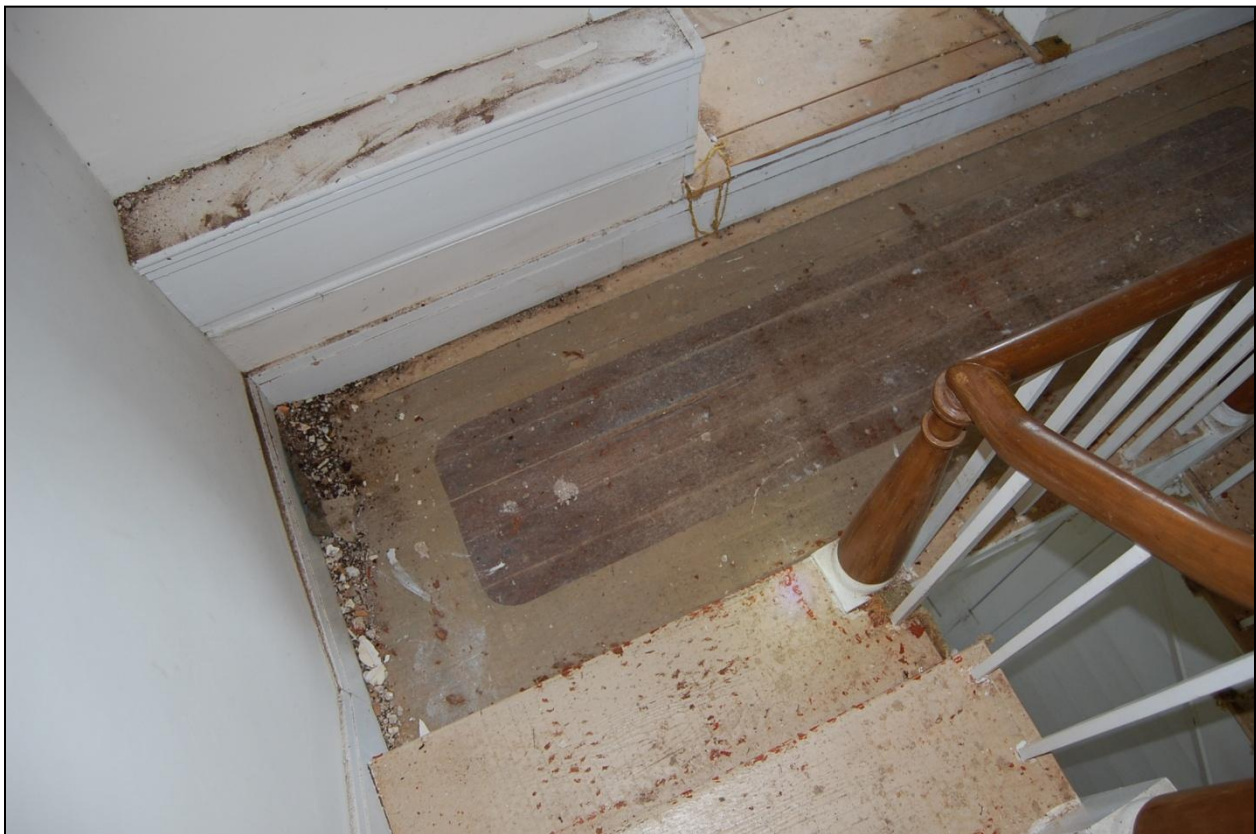
The intermediate stair landing utilizes a floor of tongue and groove boards laid in the north-south direction. A plain painted border with radius corners is present at the landing. The landing's floorboards exhibit some separation in the seams between the boards, and one board is cracked along its length.

Figure 71: Above is an image showing the stairwell landing with the painted floor. When examined closely the painting resembles fibers seen in ingrained carpets of the time. Such a technique was still used during the 1850s. Also of note is the wood trimmed setback of the brick wall as it transitions from five withes to three.

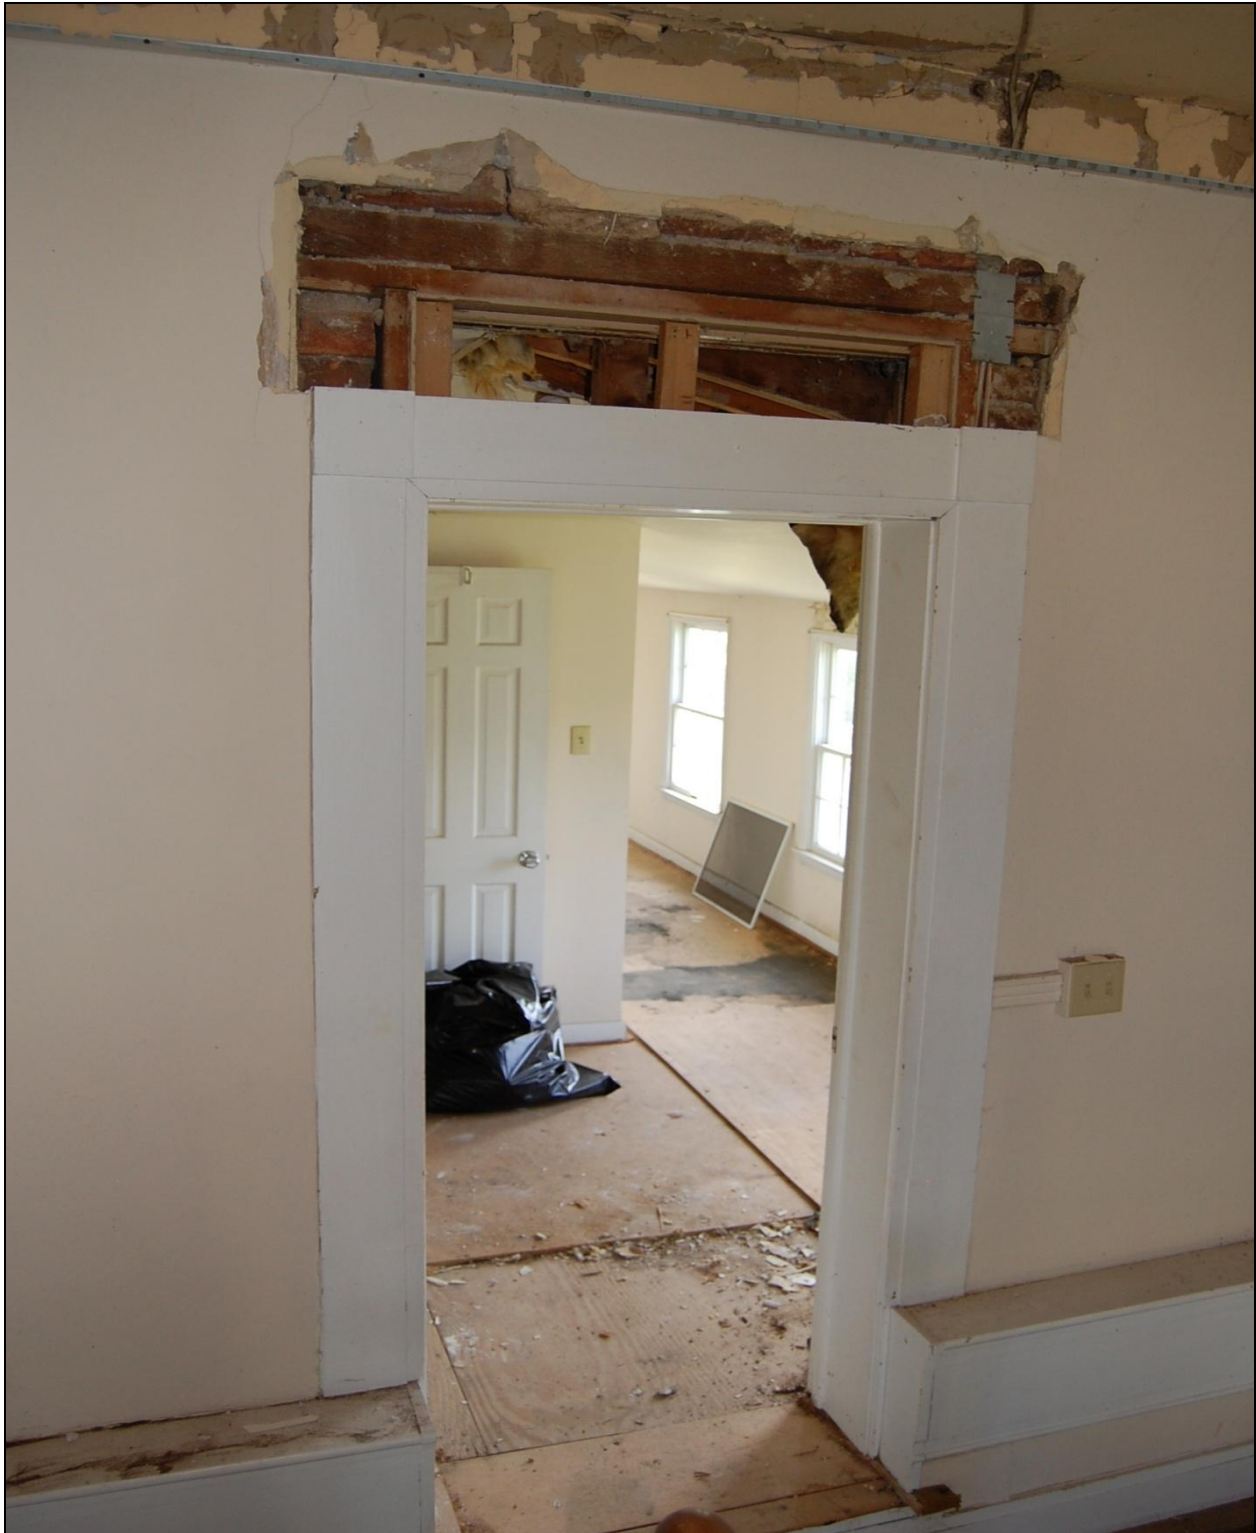
Figure 72: When the Whitham's added the second floor rooms to the south porch they converted the east facing stairwell window into a door. However, the header is still evident and the trim is original, just moved.

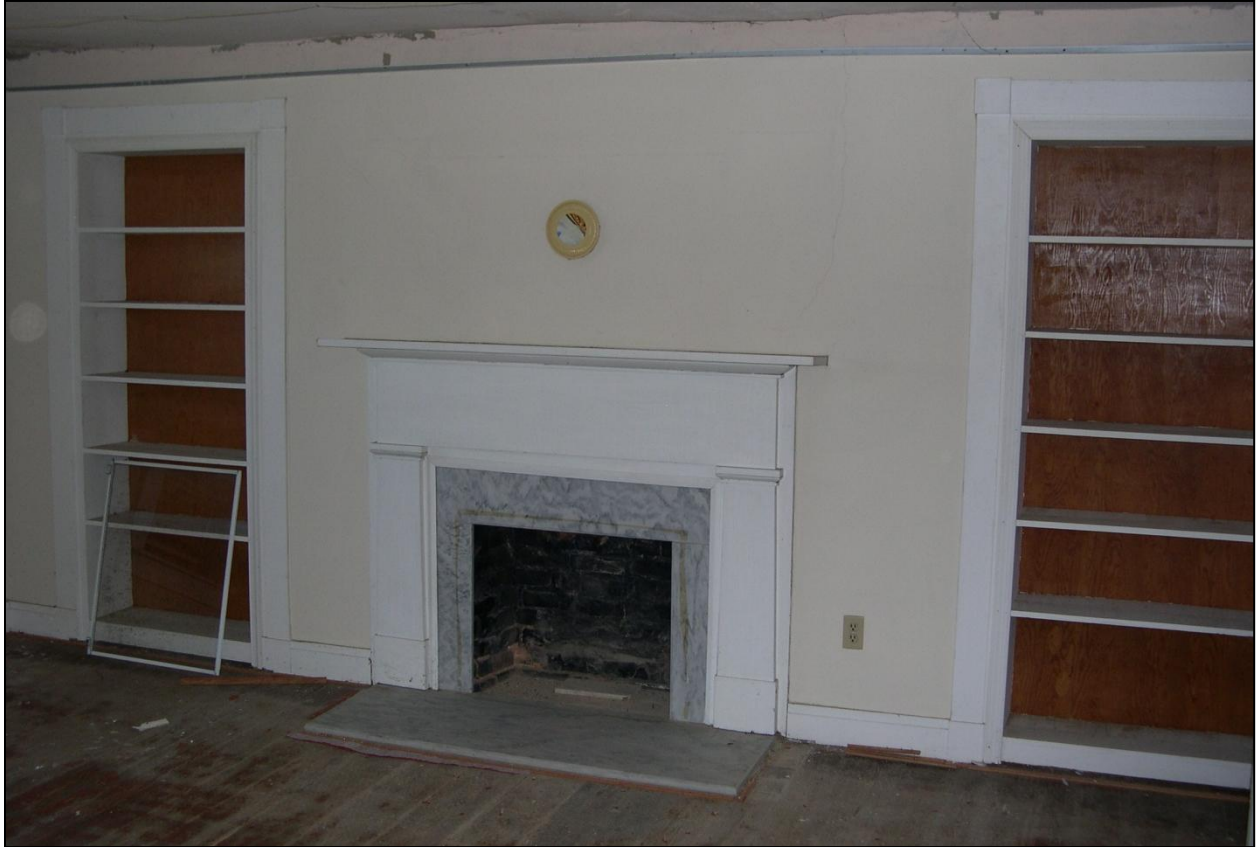
Figure 73: The west, second floor bedroom is shown above with inset bookshelves. While the insets are original, they may have been closets rather than bookshelves. The mantle is original to the 1850s, although the marble veneers were added later and are attached with adhesive.

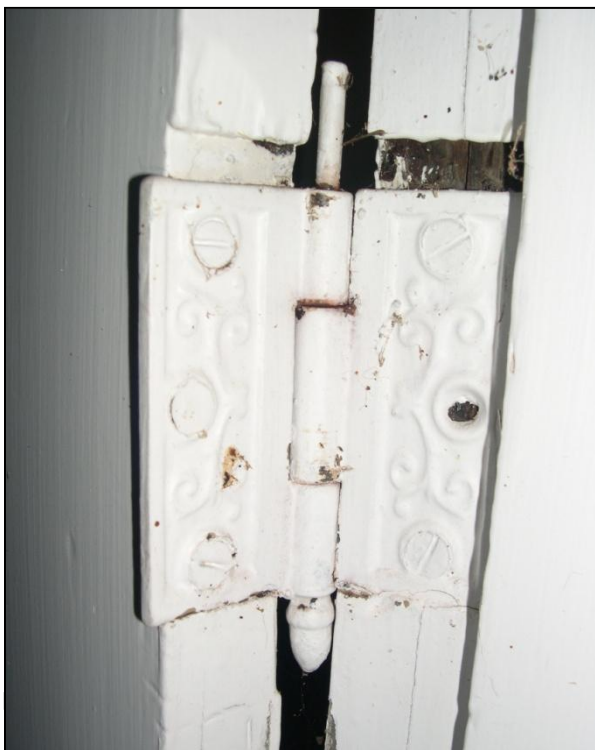
Figure 74: Also found in the west second floor bedroom is this decorative butt hinge. Typical of the 1870s and 80s this hinge was a later replacement, confirmed by the ghost markings above showing a previous hinge.
